TRE'R CEIRI
CONSERVATION PROJECT
1989 - 90
PART 2: PLATES

REPORT ON THE FIRST SEASON OF THE
TRE'R CEIRI CONSERVATION PROJECT
DECEMBER 1989 - MARCH 1990

S.D. BOYLE

PART 2: PLATES

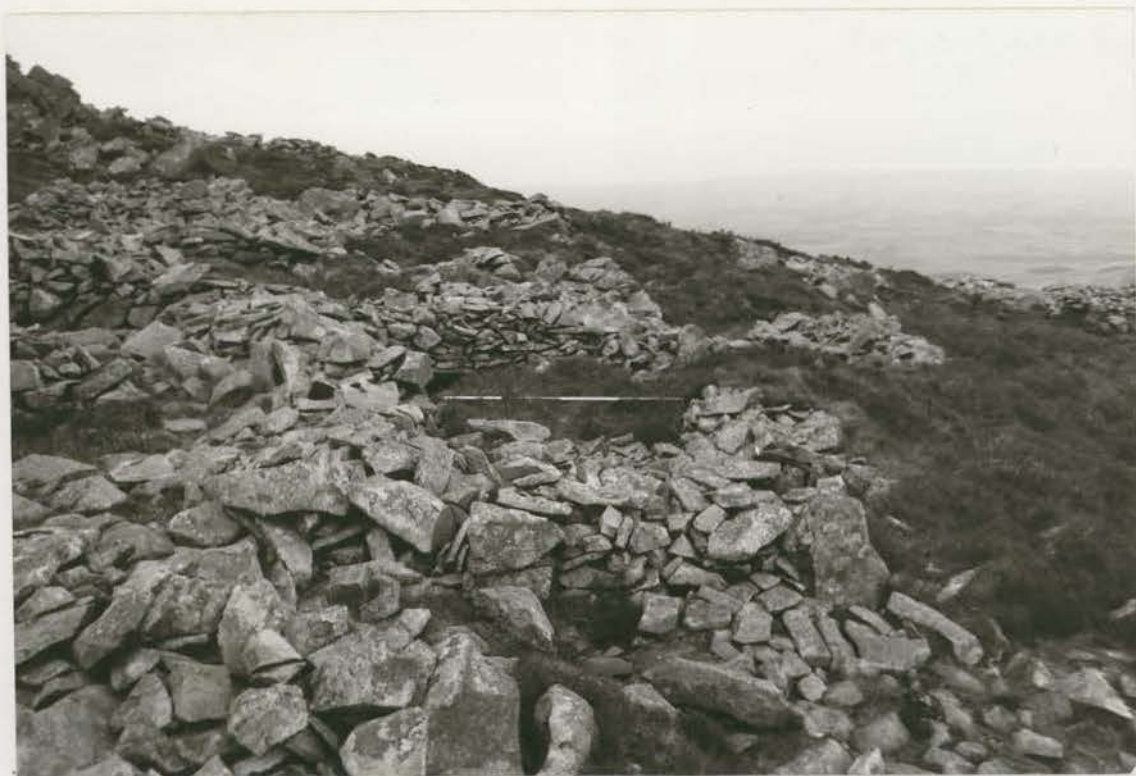
Plate 1. Hut 86 before conservation, looking SE (G1022/001/08).

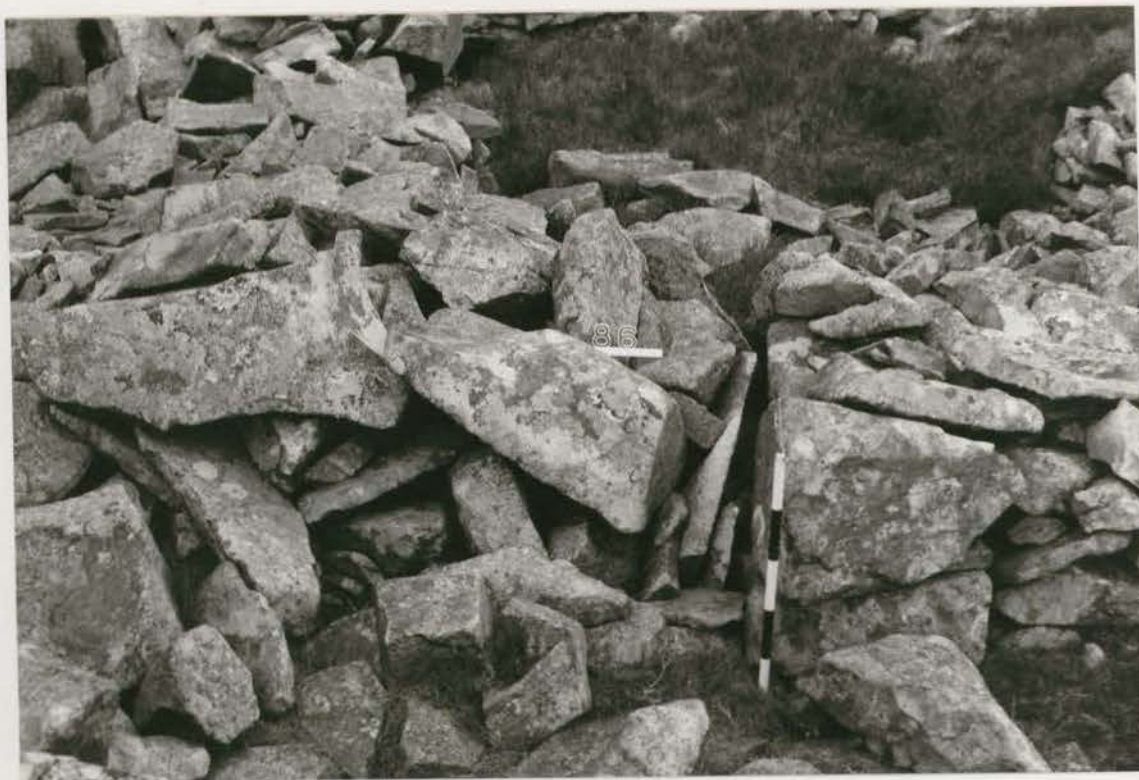
Plate 2. Hut 86: blocked entrance, looking SE (G1022/001/14).

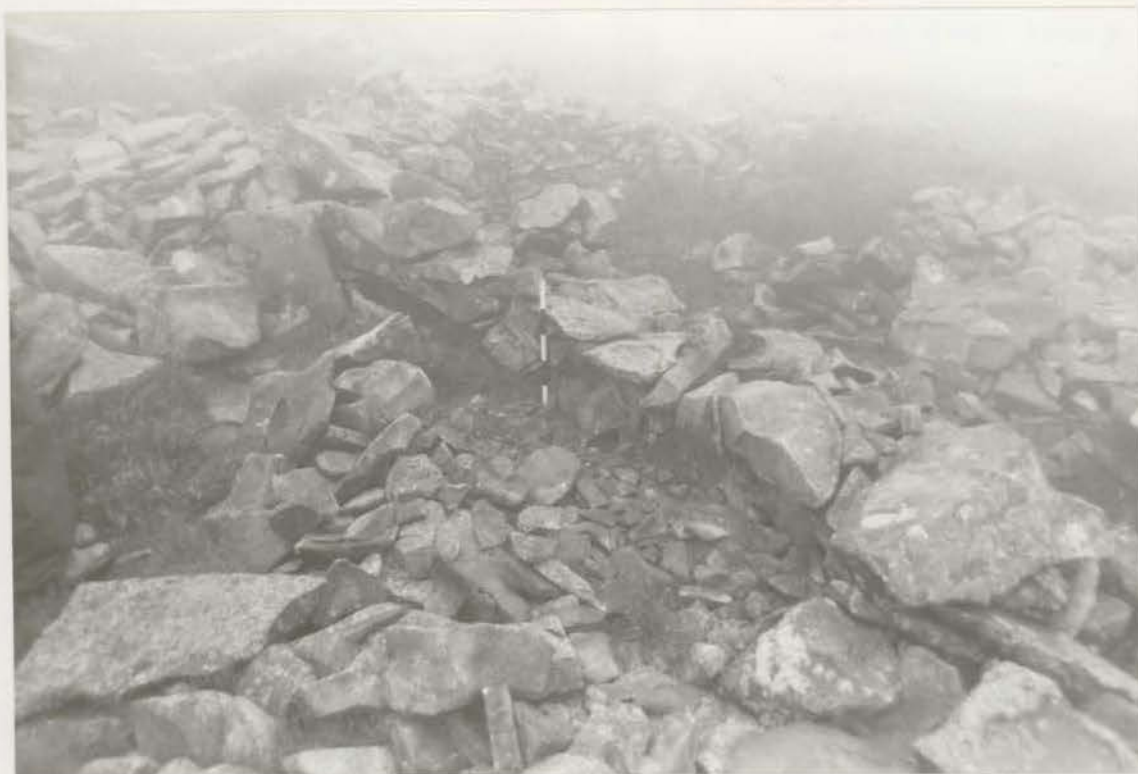
Plate 7. Hut 86: outer face of NE wall after clearance of tumble,
looking S (G1022/005/15A).

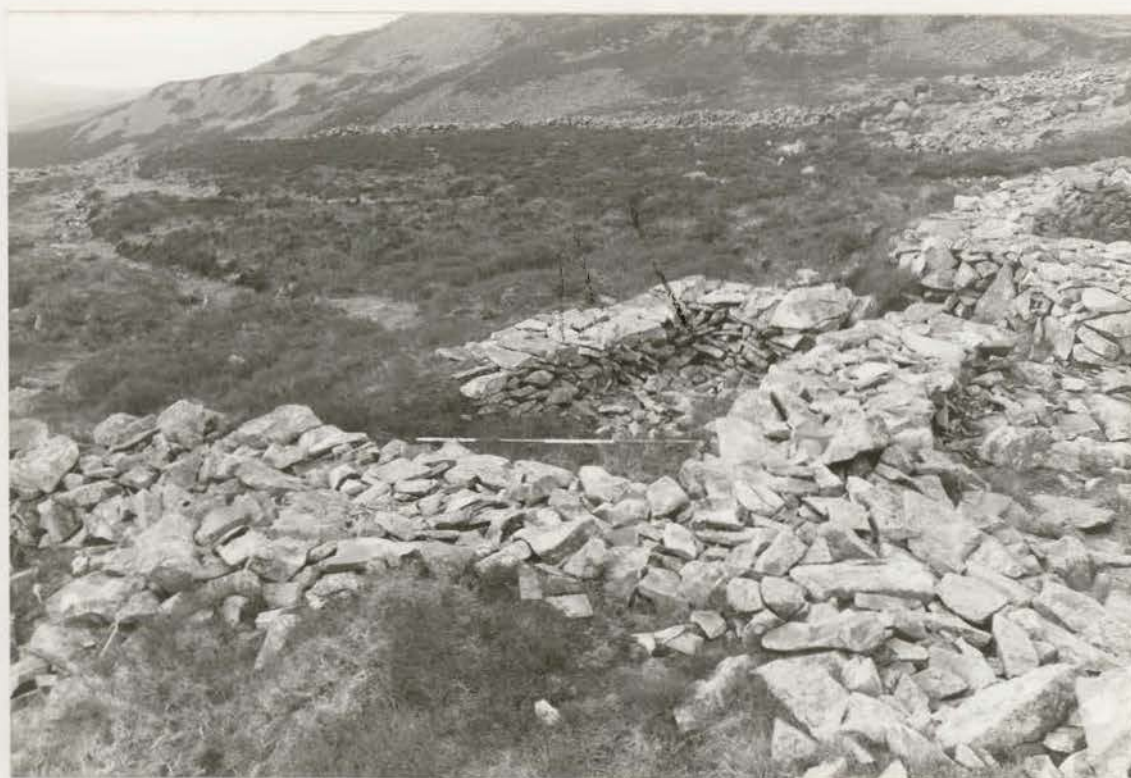
Plate 10. Hut 86 after conservation, looking W (G1022/022/06A).

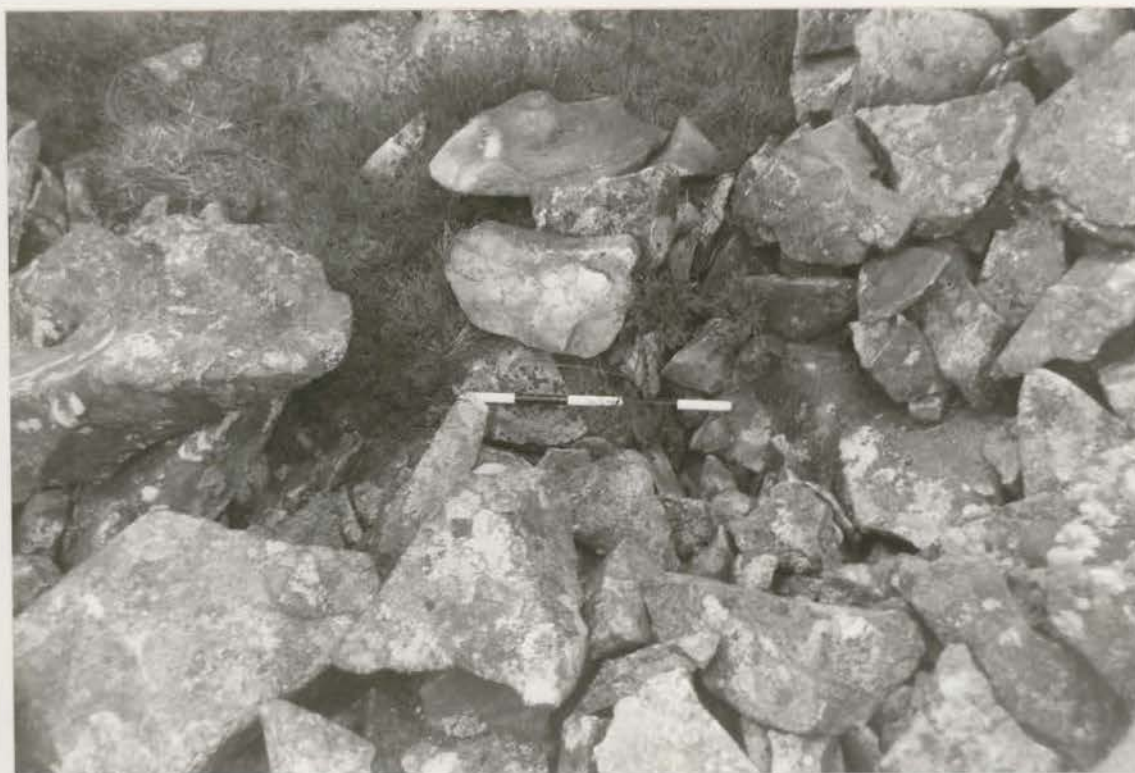
Plate 14. Hut 51, N corner: facing stones revealed (G1022/005/16A).

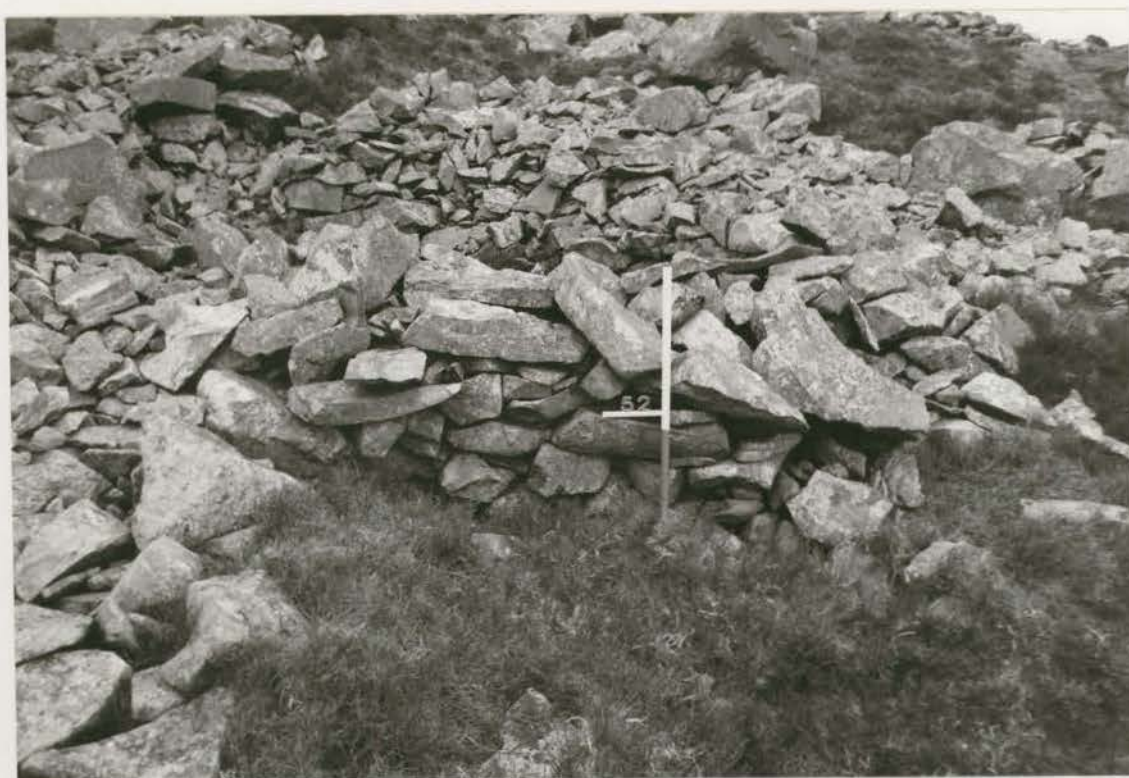
Plate 16. Hut 52: E wall before conservation, looking E (G1022/001/25).

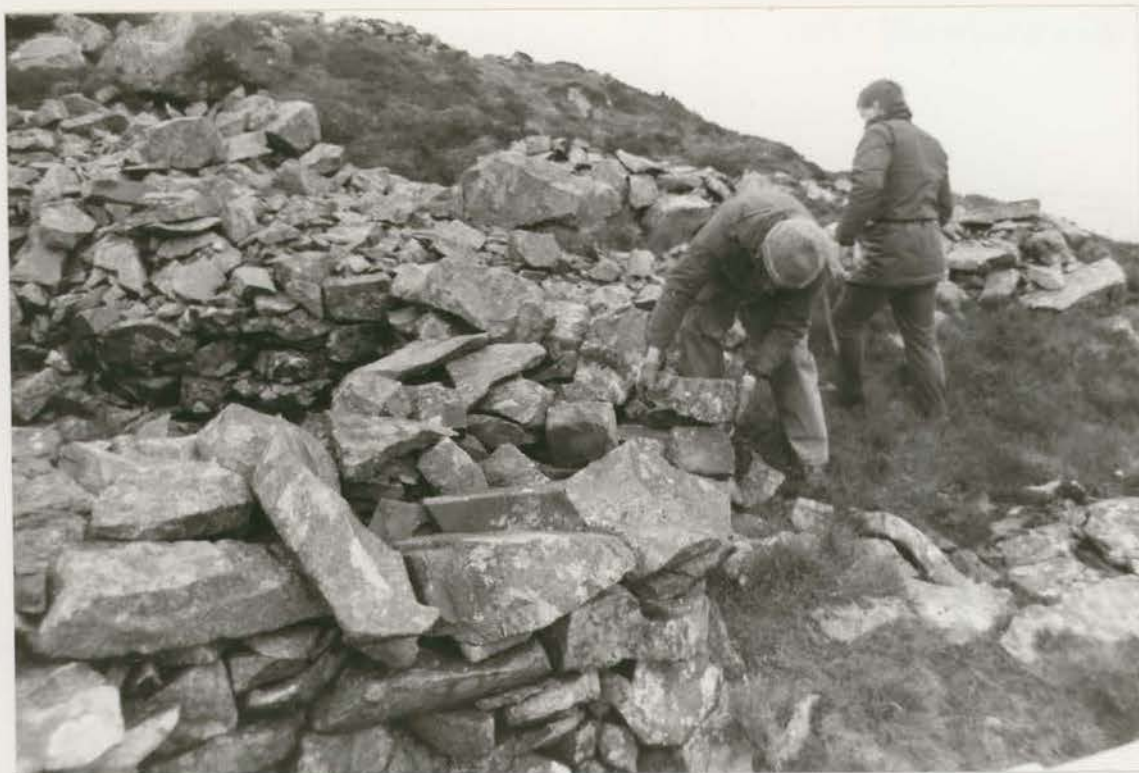
Plate 17. Hut 52: refacing SE corner of hut, looking SE
(G1022/005/17A).

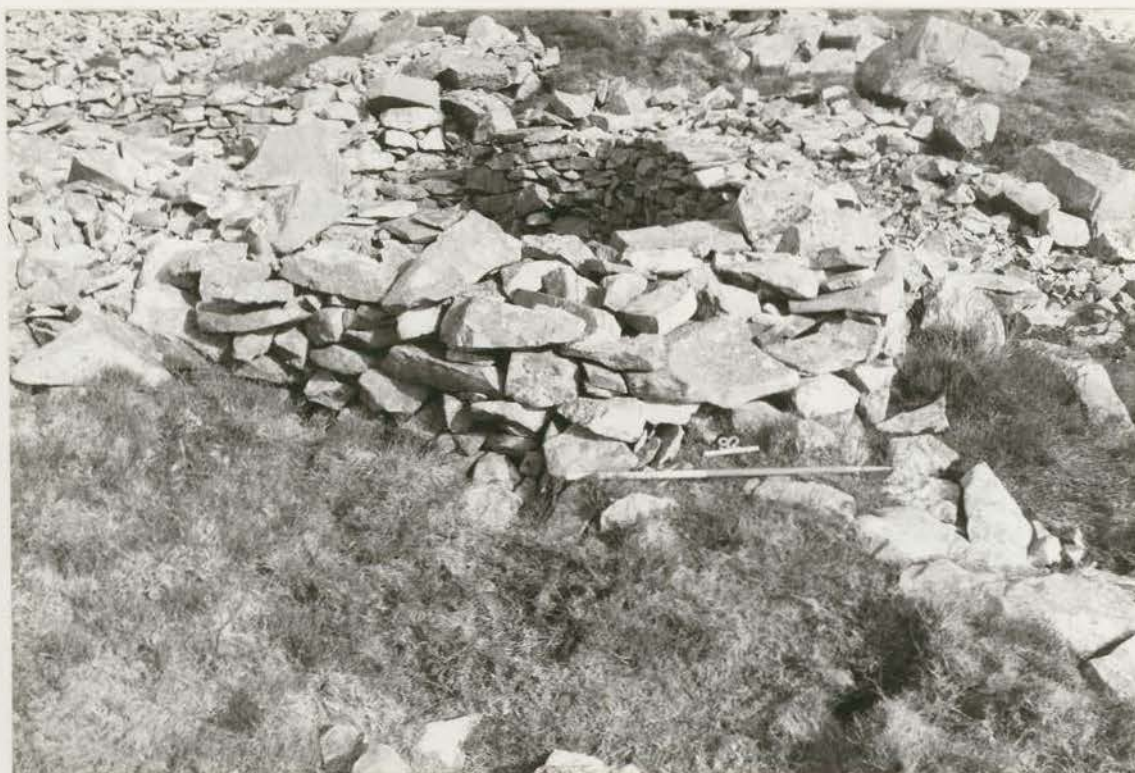
Plate 18. Hut 52: E wall after conservation, looking E (G1022/022/21A)

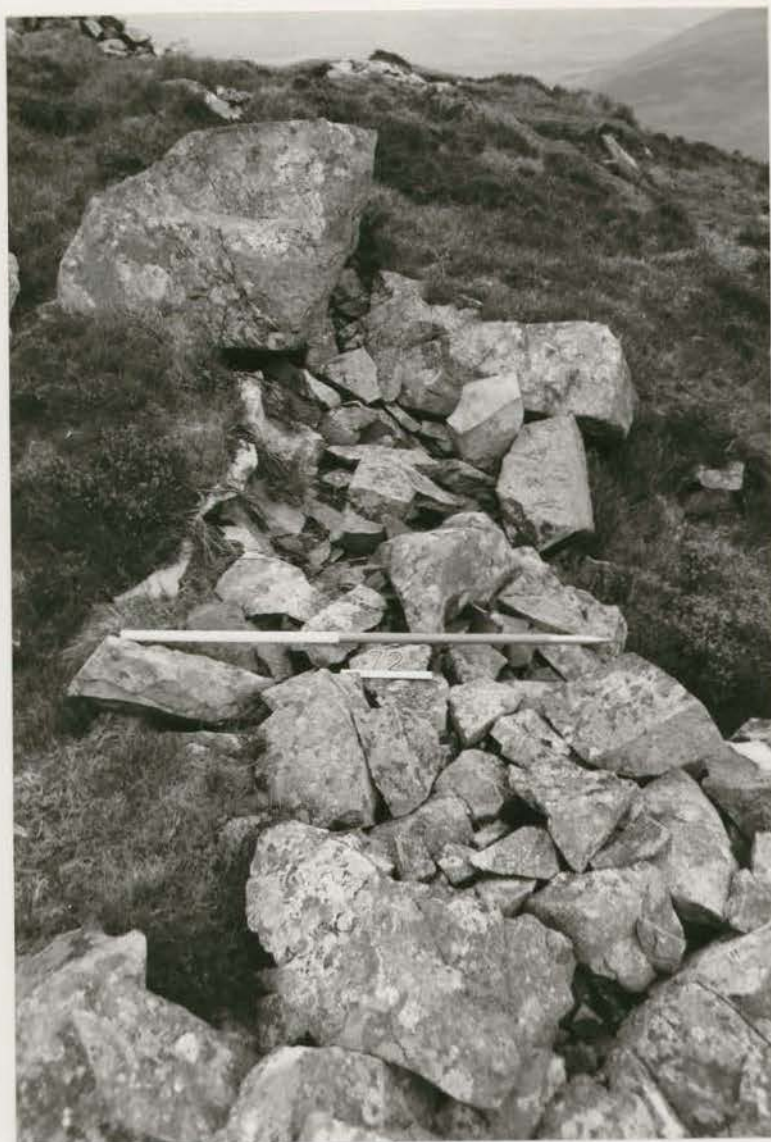
Plate 21. Hut 72: NE wall before conservation,
looking SE (G1022/001/31).

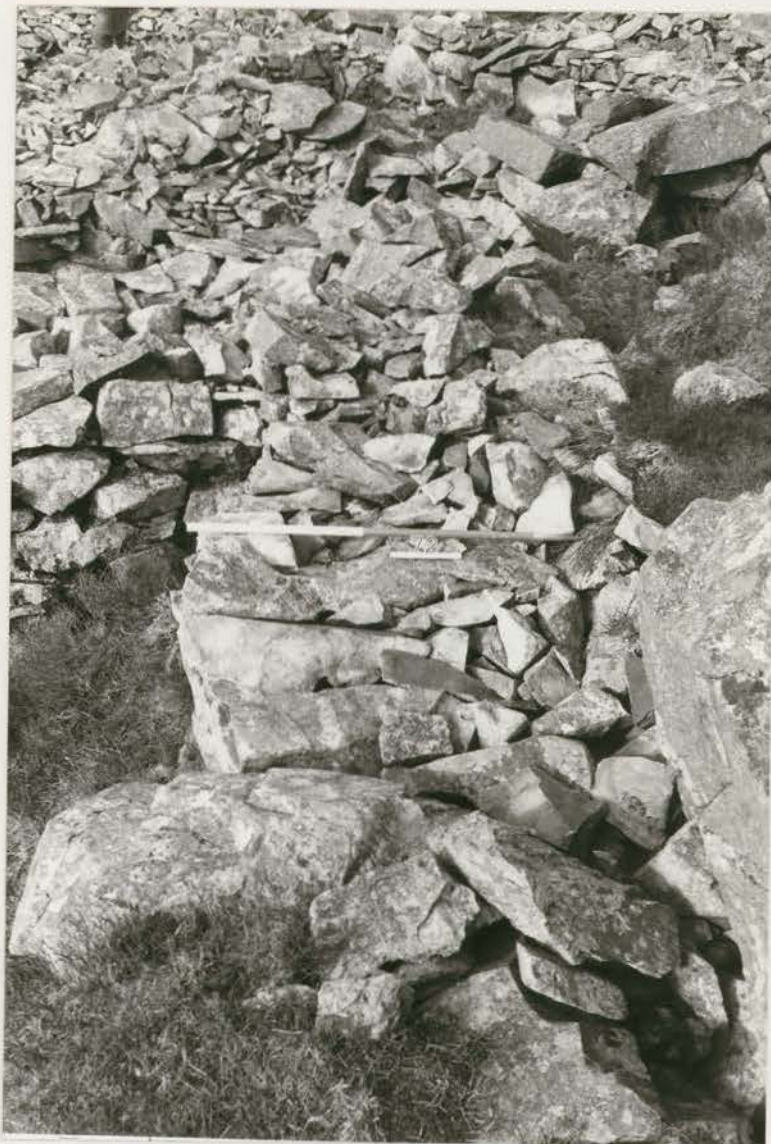
Plate 23. Hut 72: NE wall
after conservation, looking
NE (G1022/022/19A).

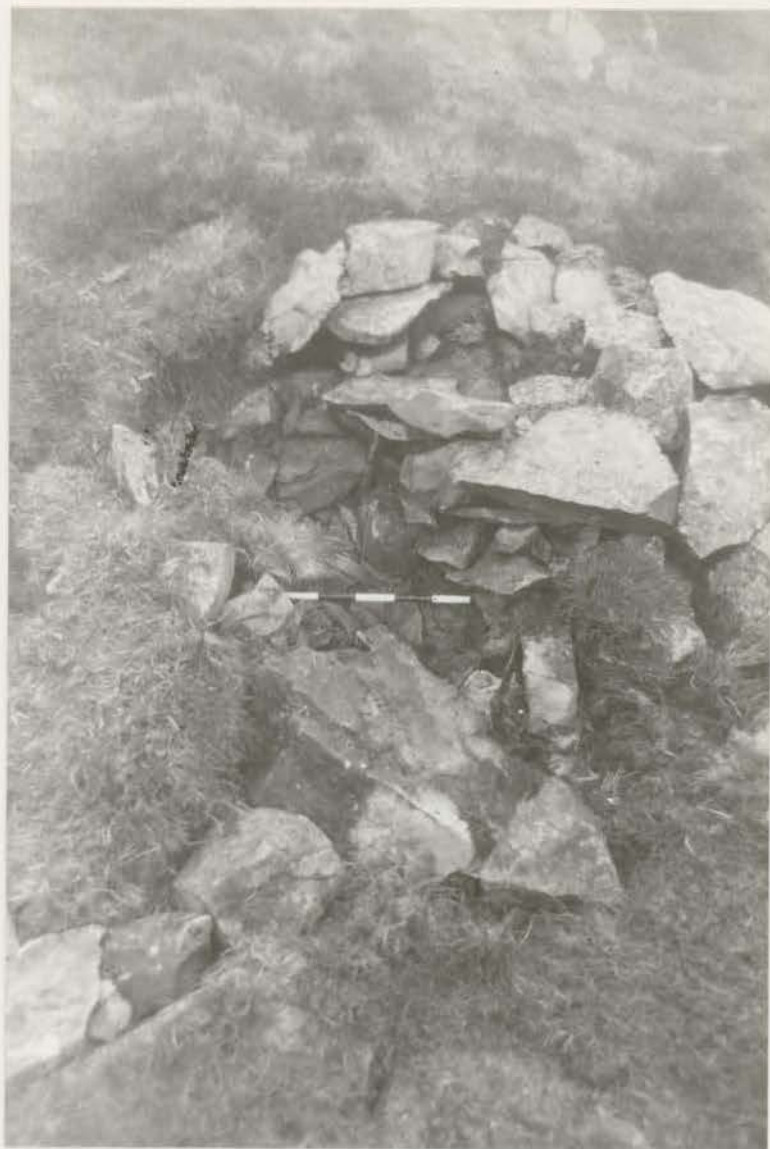
Plate 26. Hut 72: rebuilding
the partition, looking SW
(G1022/005/19A).

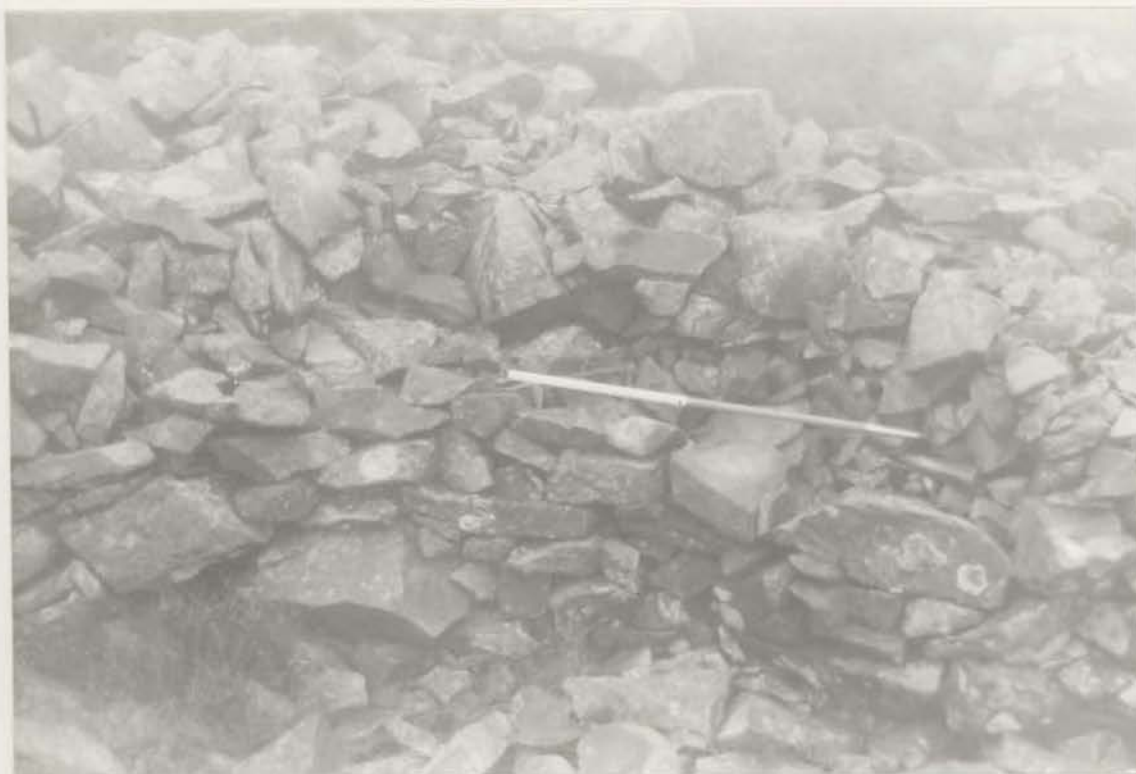
Plate 30. Hut 92: SE wall during conservation, looking SE
(G1022/005/20A).

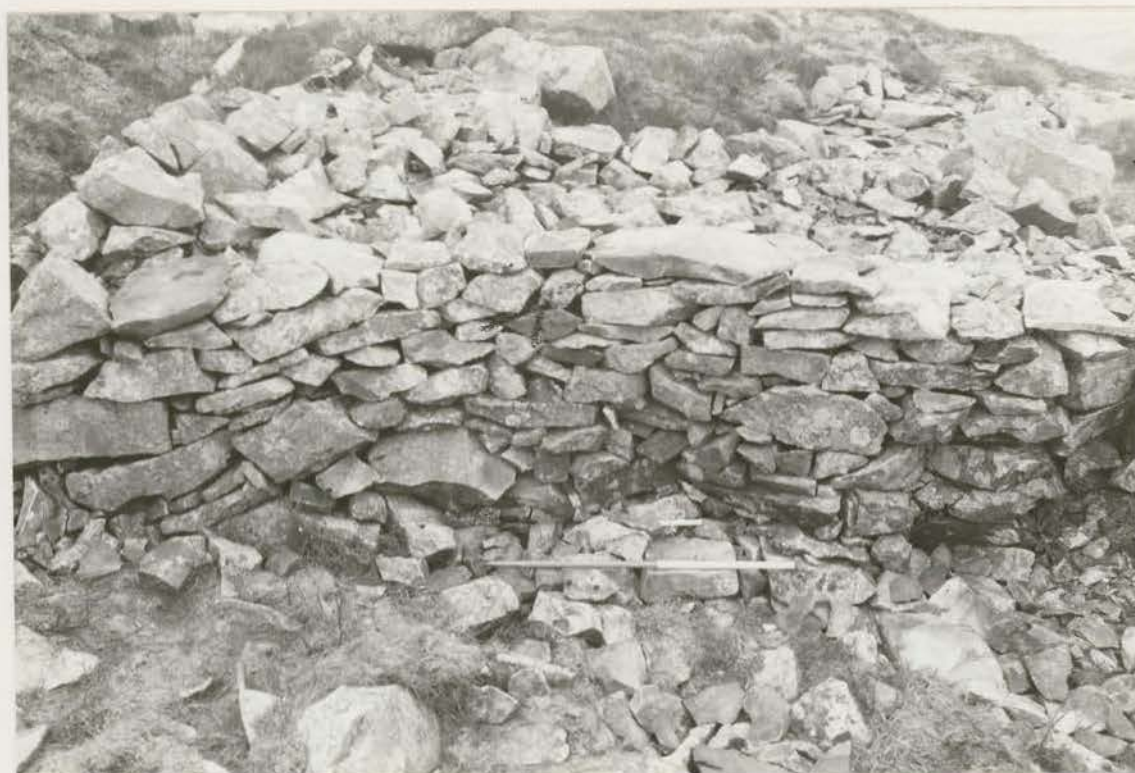
Plate 31. Hut 92: SE wall after conservation, looking SE
(G1022/021/30).

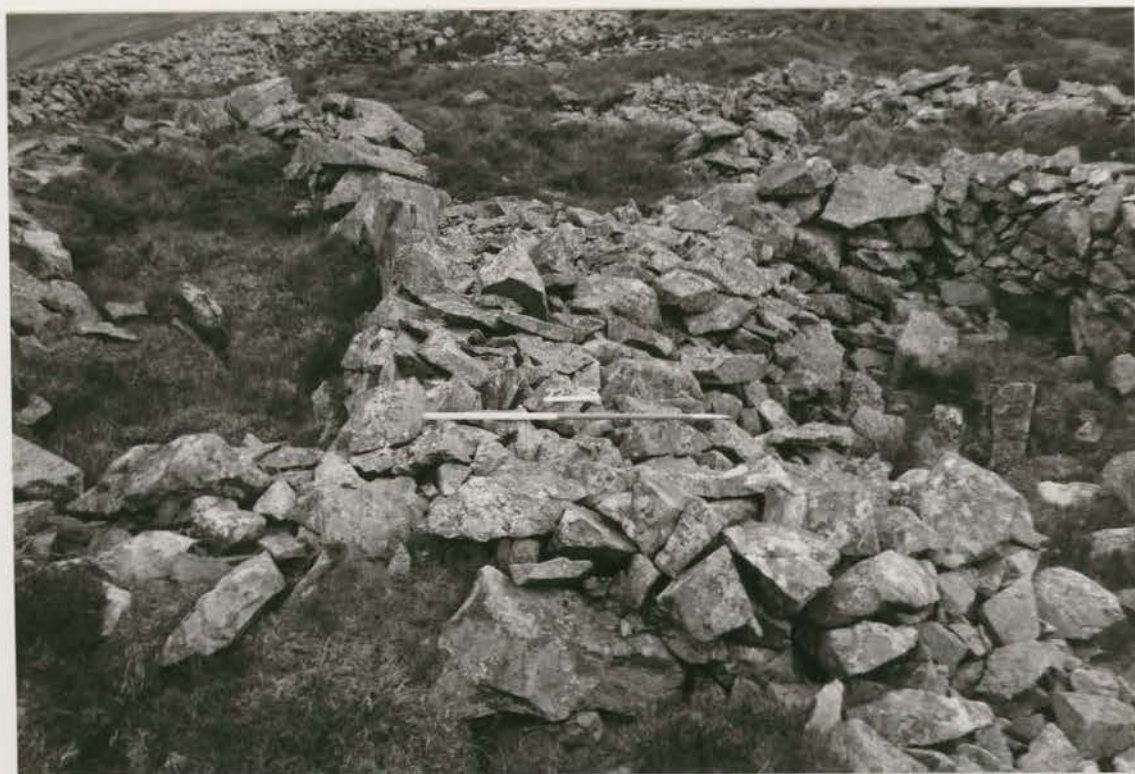
Plate 32. Wall between huts 72 and 92 before conservation
looking SW (G1022/001/32).

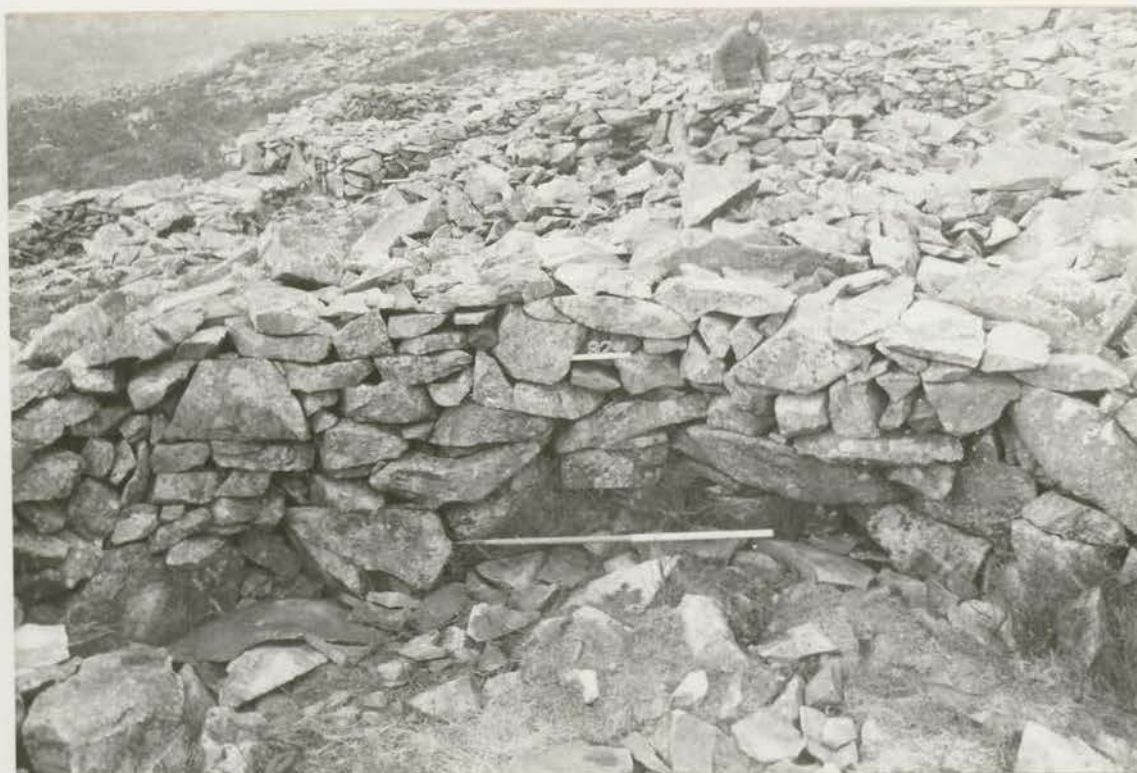
Plate 36. Hut 92: NW wall after conservation, looking NW
(G1022/021/33).

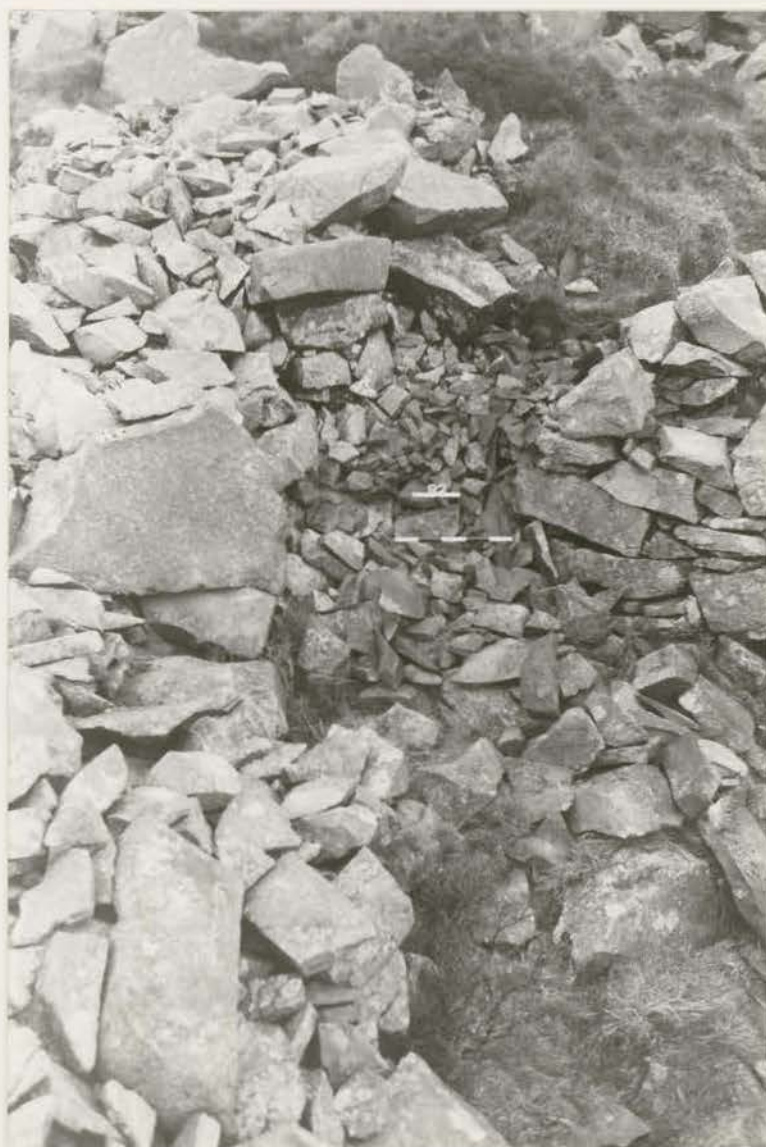
Plate 38. Hut 92: rubble
removed from E entrance,
looking E (G1022/005/24A).

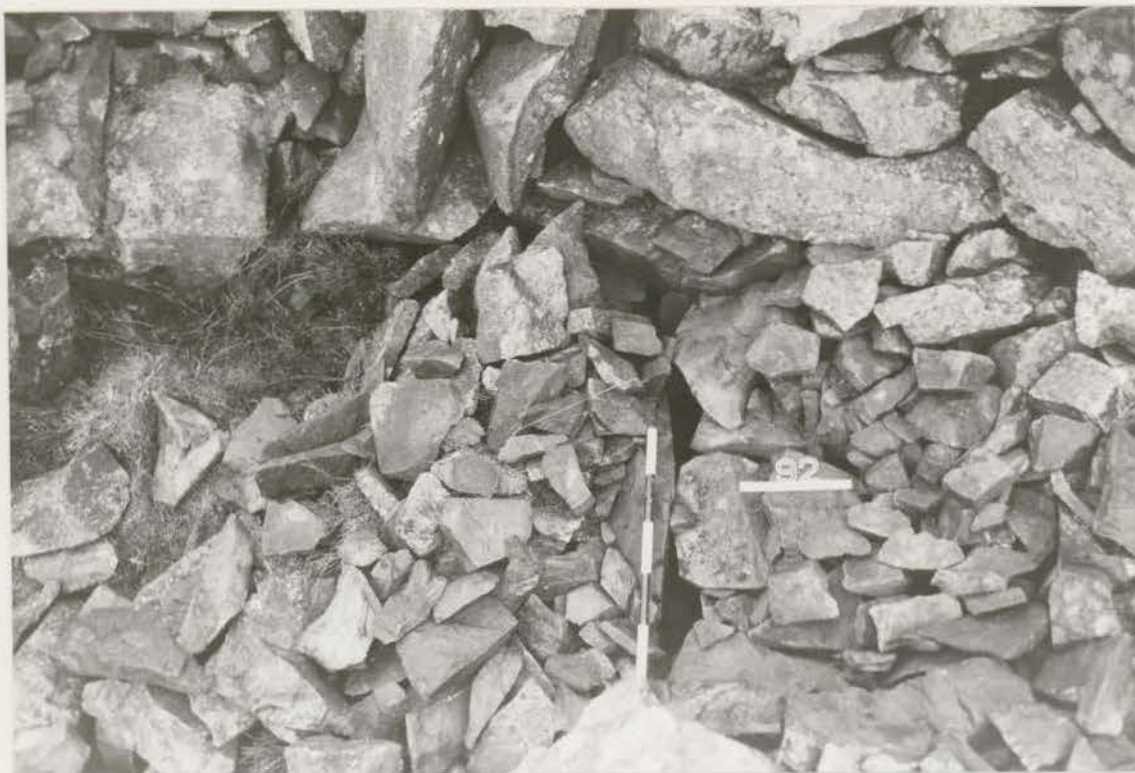
Plate 39. Hut 92: inner end of E entrance, after removal of rubble, looking NE (G1022/005/22A).

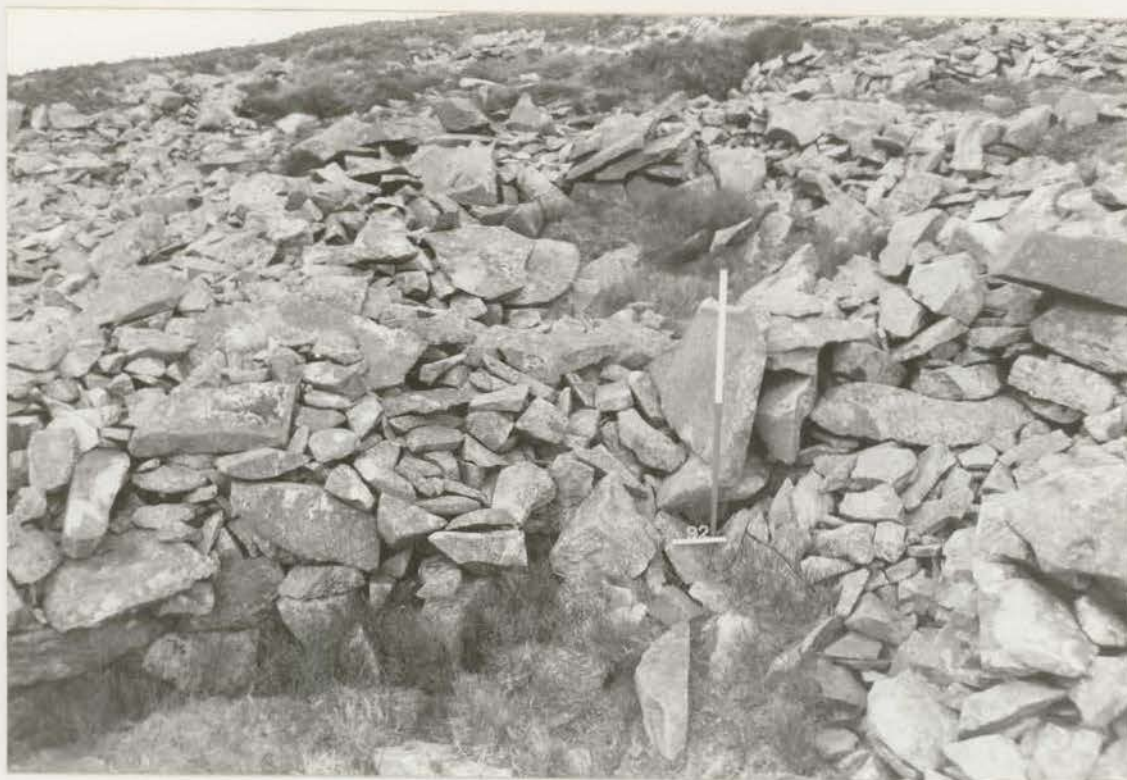
Plate 41. Hut 92: Possible N entrance before conservation, looking N (G1022/002/07A).

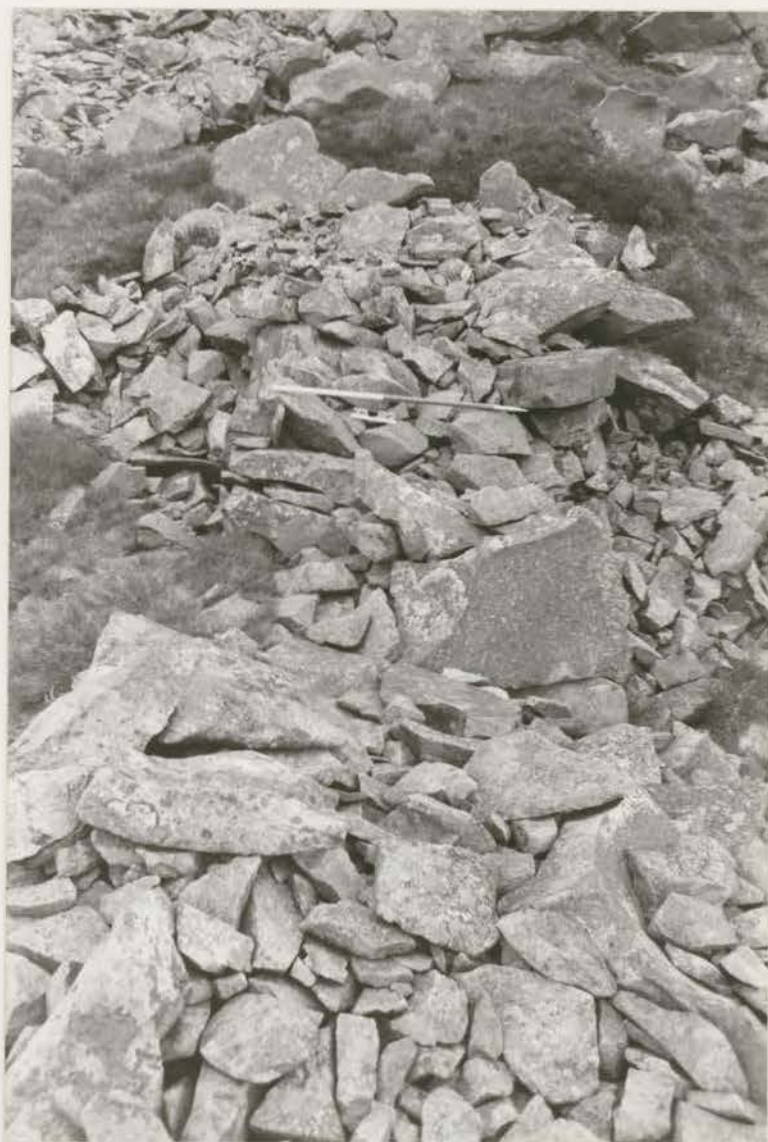
Plate 42. Wall between huts 92 & 73 before conservation, looking E (G1022/002/17A).

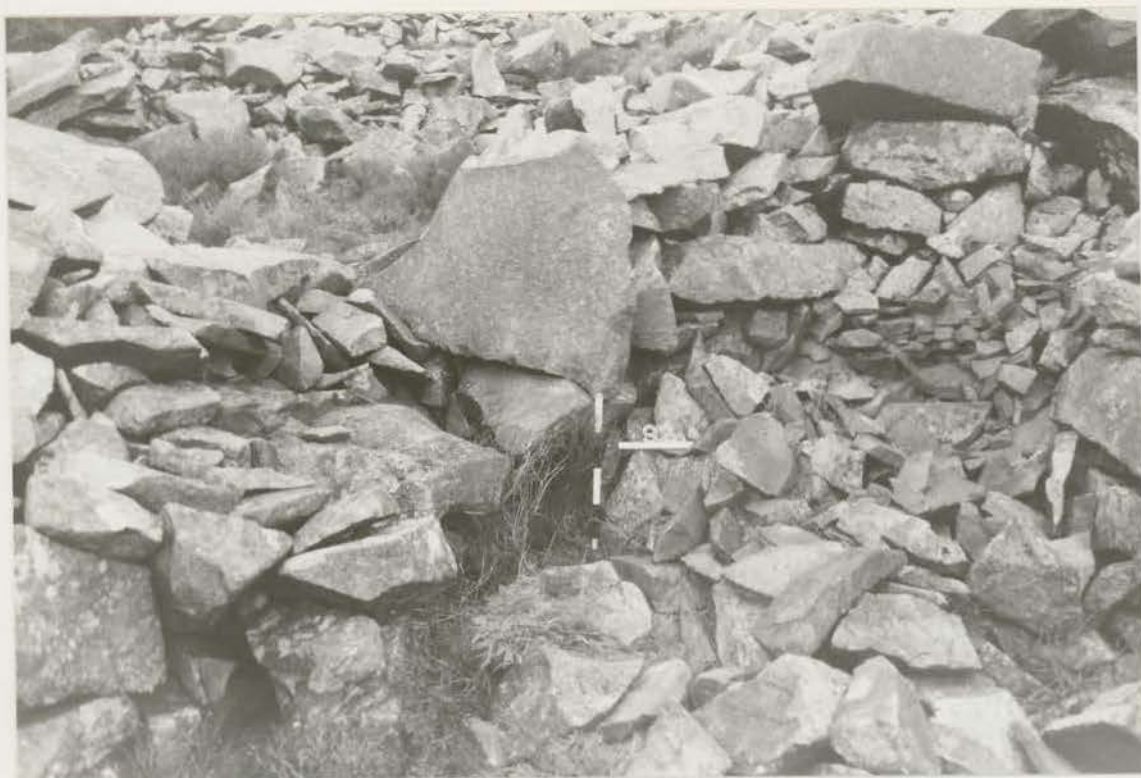
Plate 43. Hut 92: rubble cleared from possible N entrance,
looking NE (G1022/005/23A).

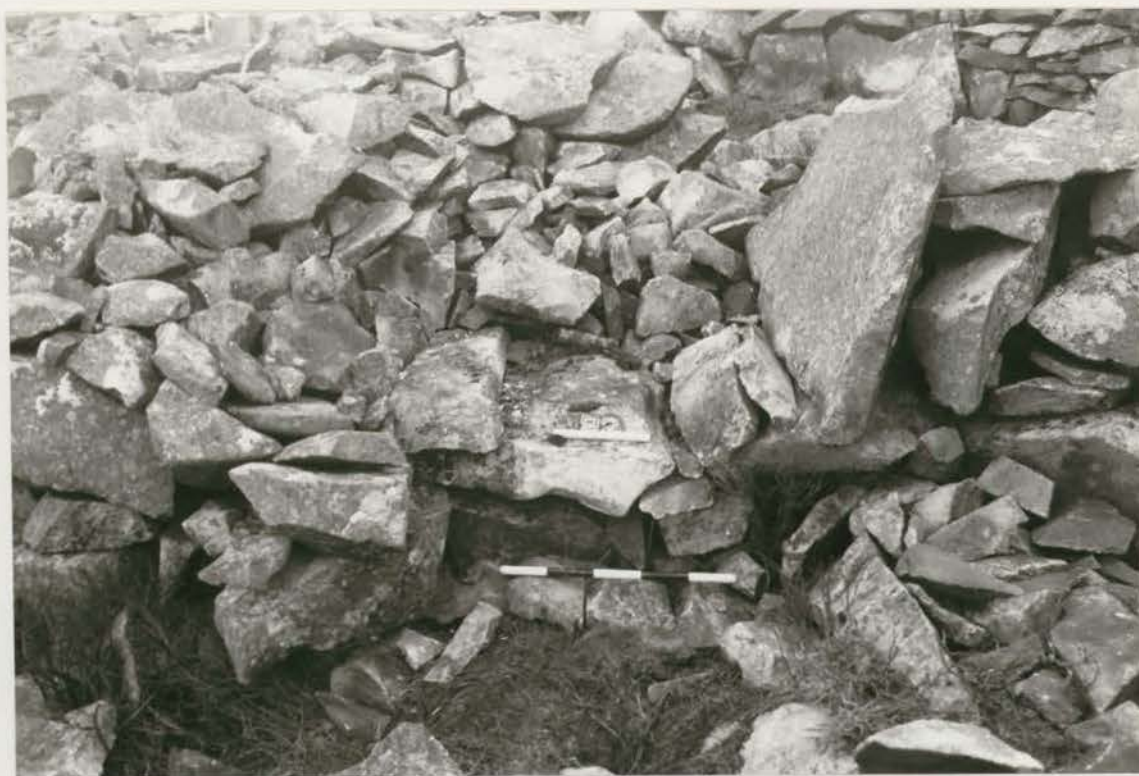
Plate 44. Hut 92: Possible N entrance after conservation,
looking N (G1022/022/35A).

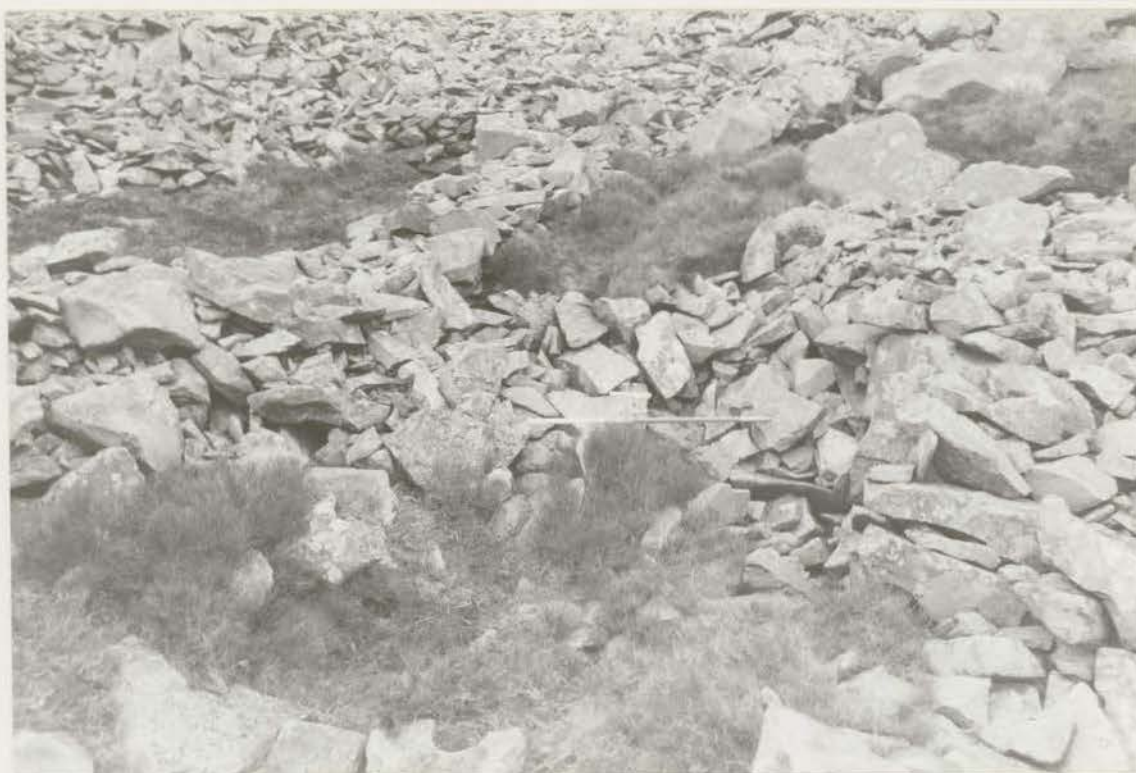
Plate 47. E end of hut 73 before conservation, looking E
(G1022/002/12A).

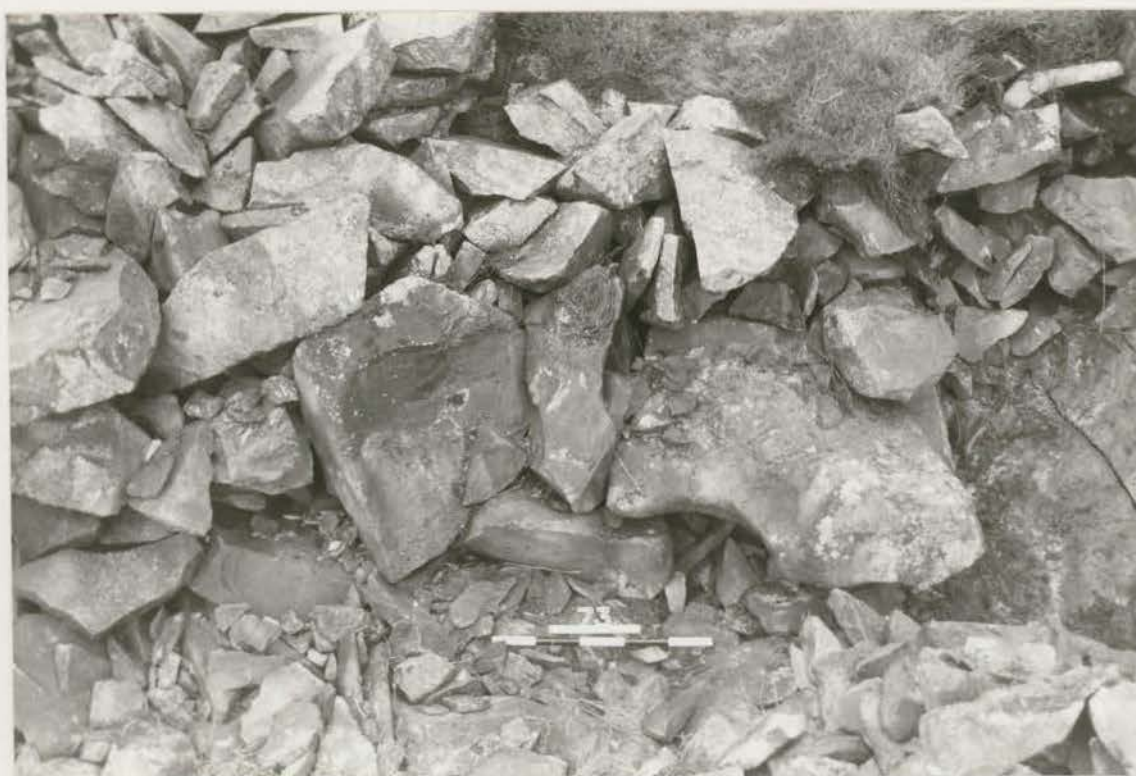
Plate 48. Hut 73: E wall, tumble removed, looking E (G1022/006/02).

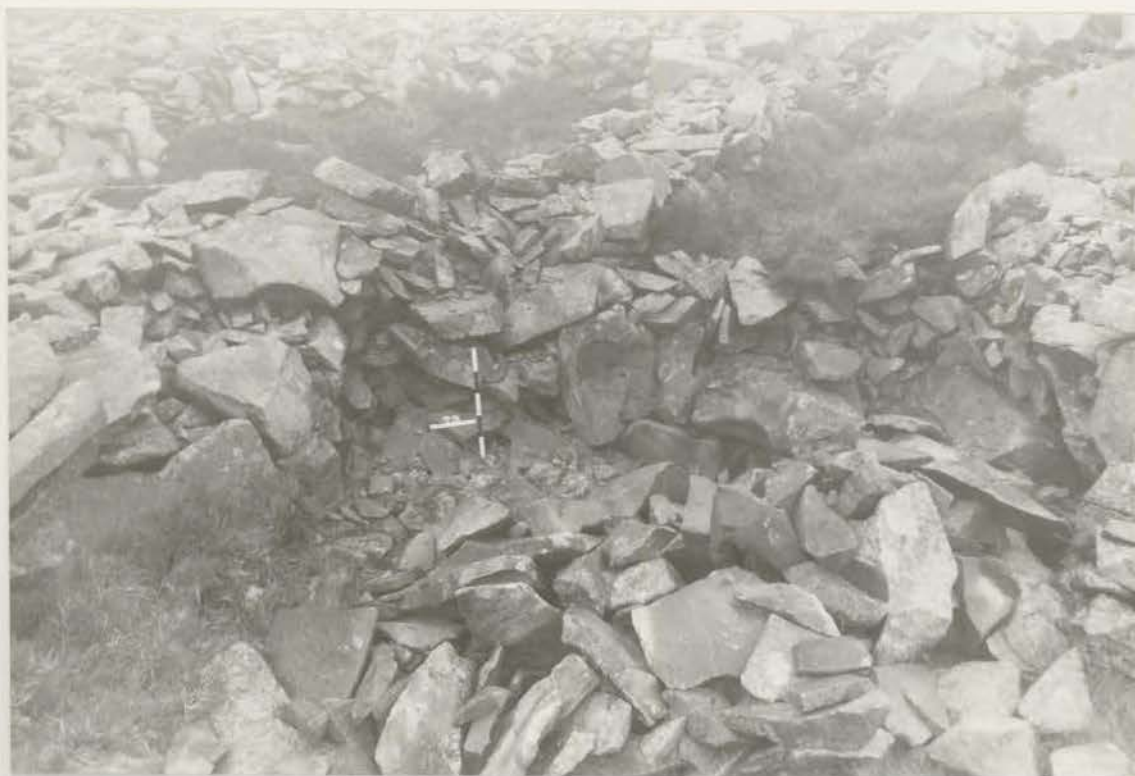
Plate 51. NE corner of hut
73 and W corner of hut 74,
looking NW (G1022/006/06).

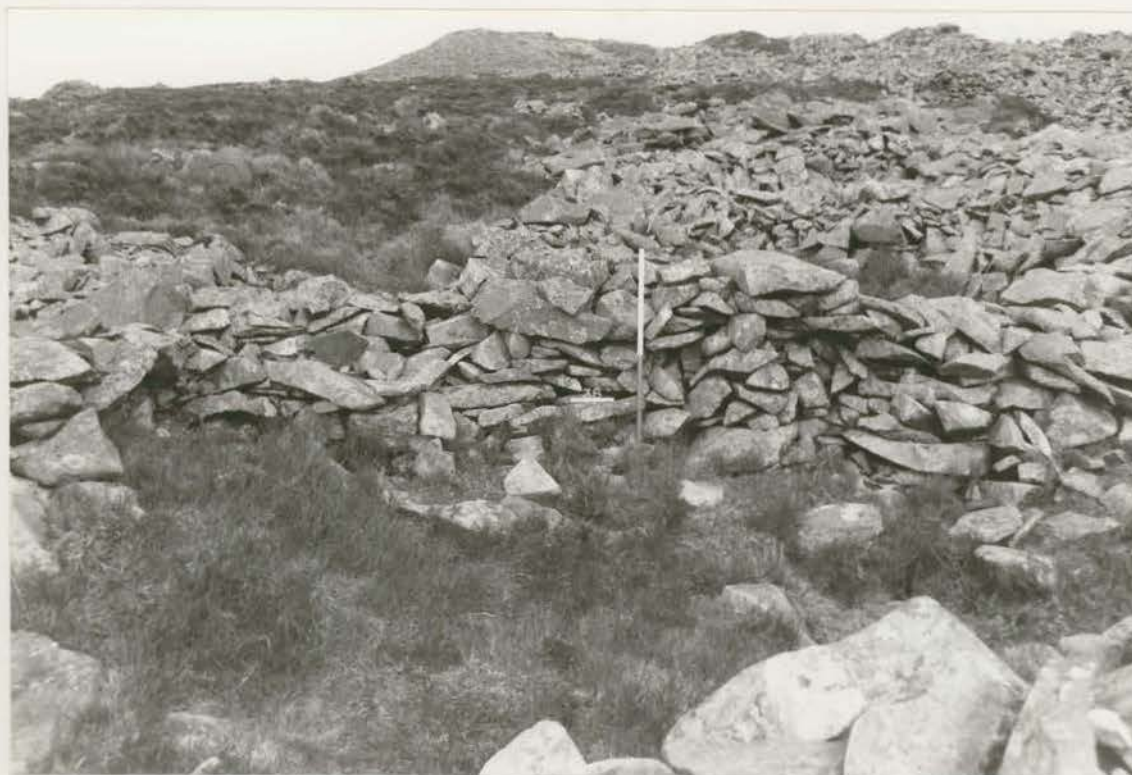
Plate 54. Hut 36: NE wall before conservation, looking NE (G1022/005/08A).
