TRE'R CEIRI
CONSERVATION PROJECT
1989 - 90
PART 2: PLATES

REPORT ON THE FIRST SEASON OF THE
TRE'R CEIRI CONSERVATION PROJECT
DECEMBER 1989 - MARCH 1990

S.D. BOYLE

PART 2: PLATES

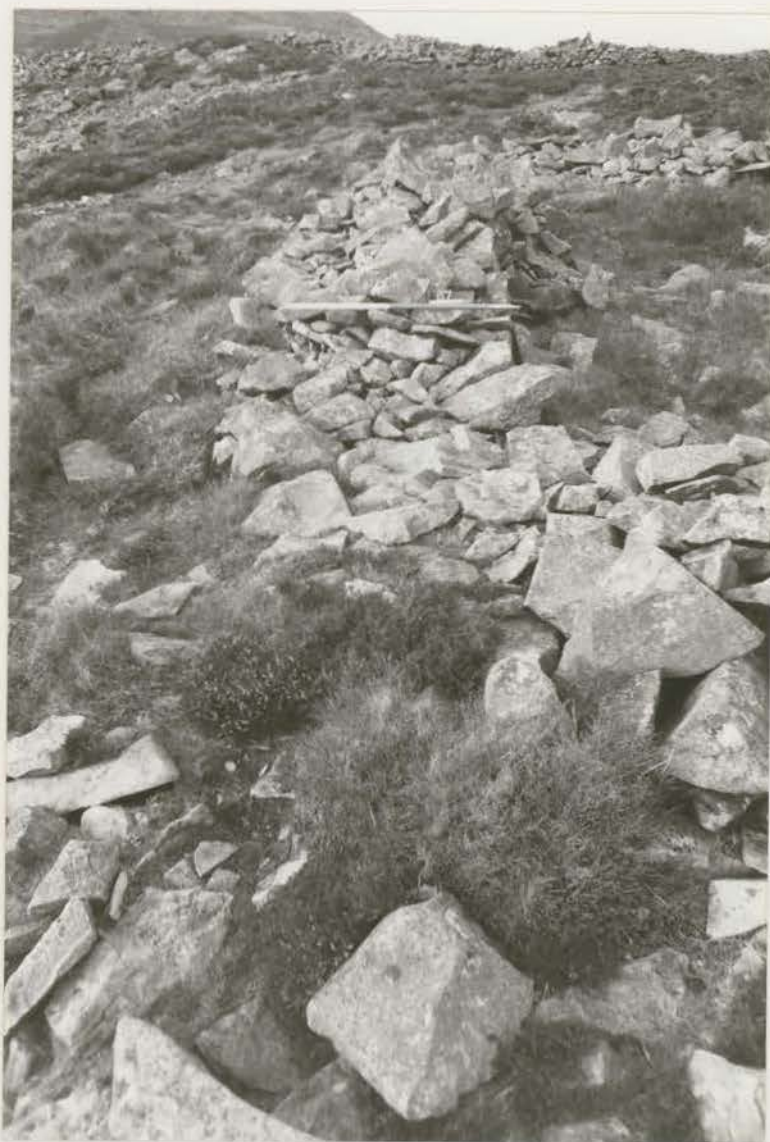
Plate 60. Hut 87: SW wall
before conservation, looking
NW (G1022/004/20).

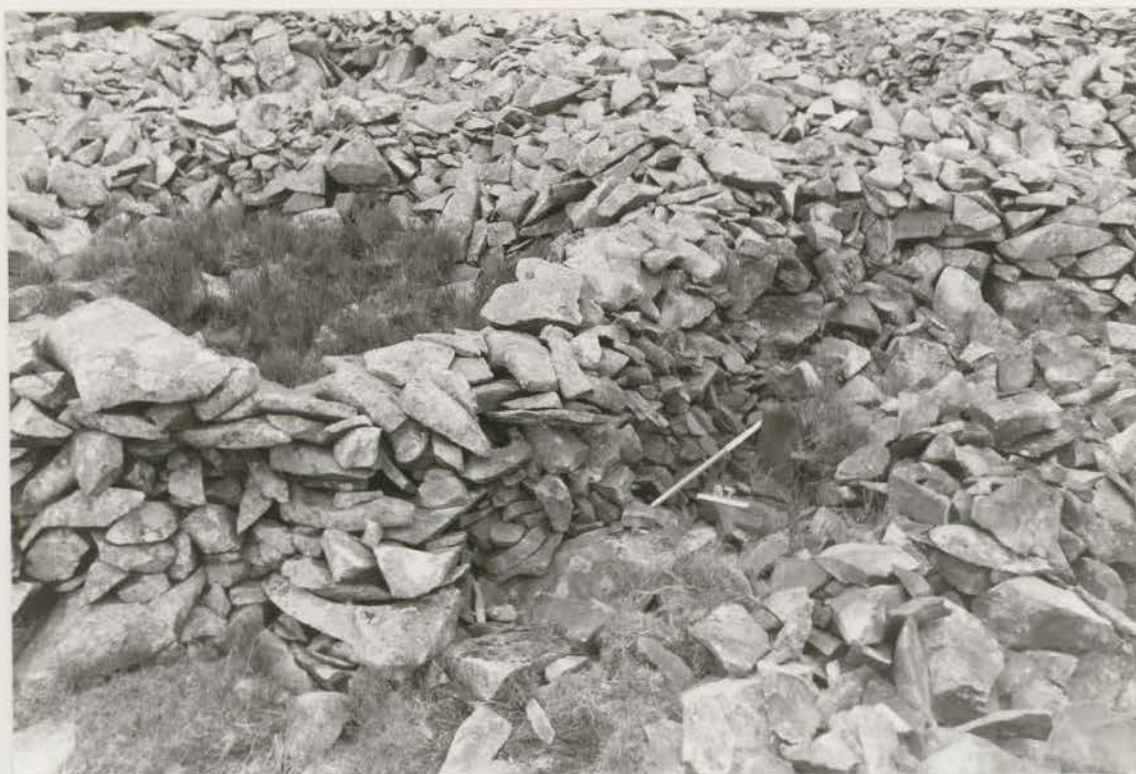
Plate 64. Hut 87: NE wall after removal of tumble,
looking E (G1022/007/04).

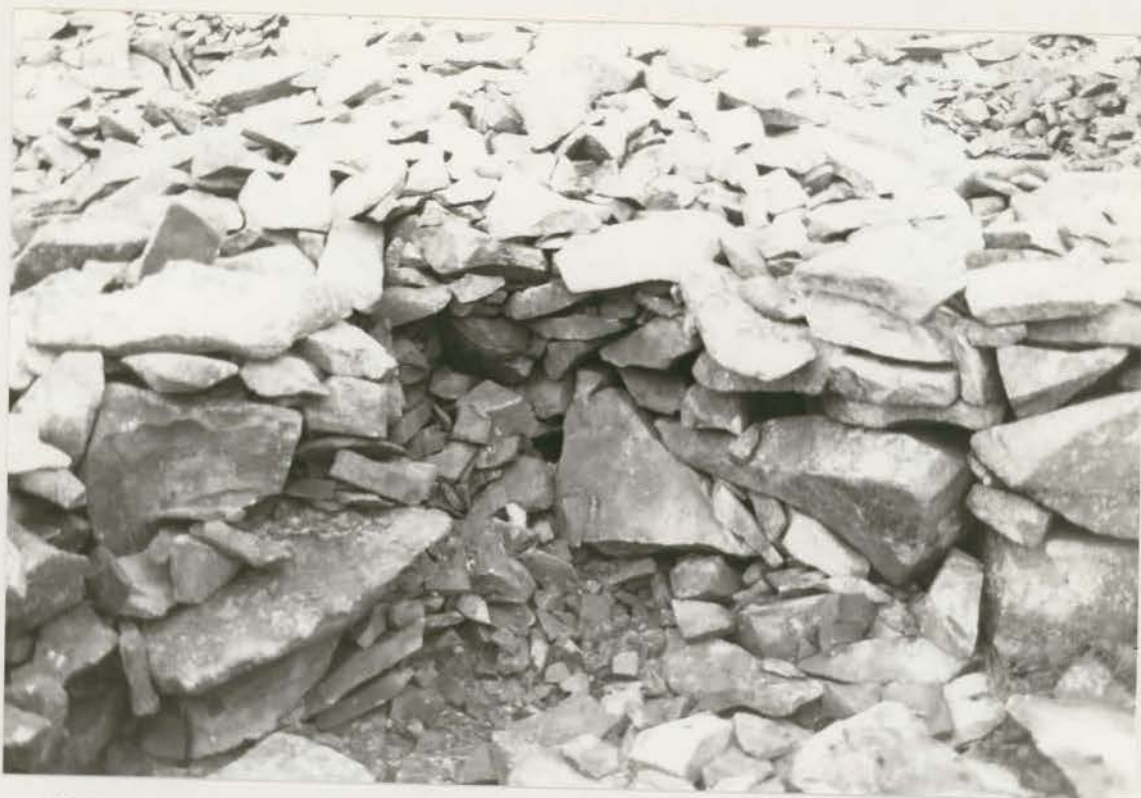
Plate 65. Hut 87: core removed at E corner, exposing outer face of hut 53, looking E (G1022/015/24).

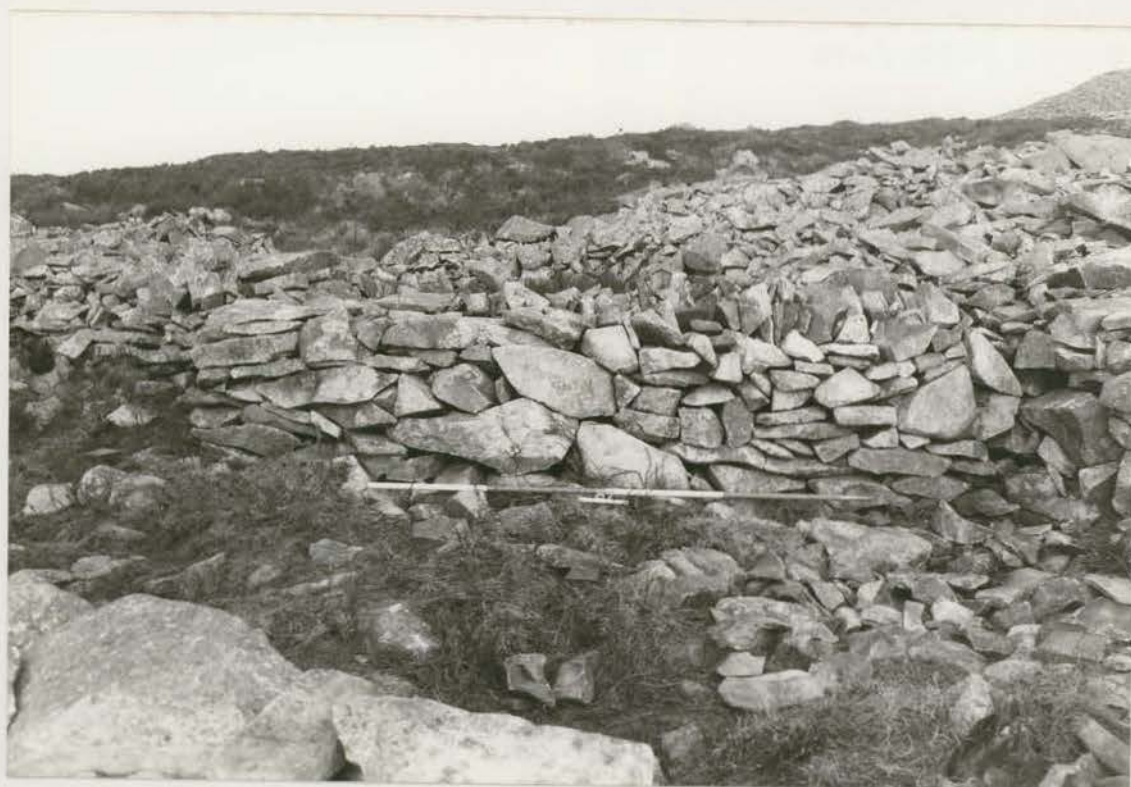
Plate 66. Hut 87: NE wall after conservation, looking NE (G1022/022/09A).

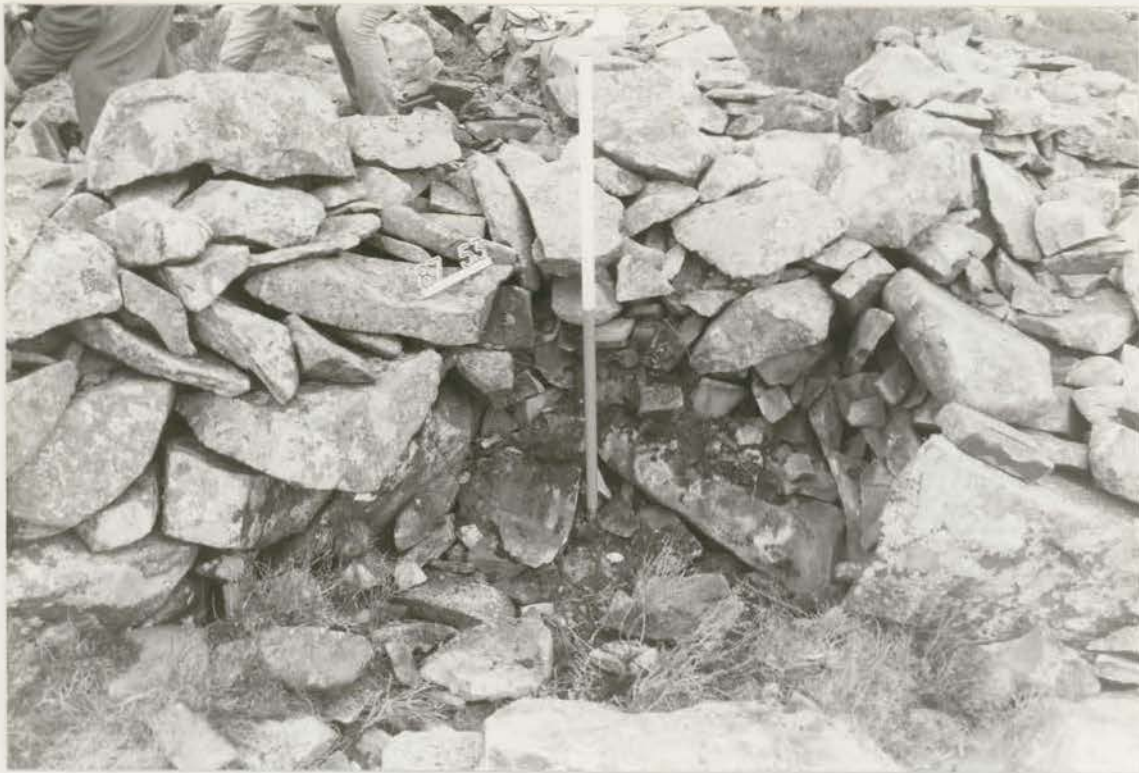
Plate 67. Hut 87: SE corner after removal of collapse, with original outer face of hut 53 exposed, looking SE (G1022/007/13).

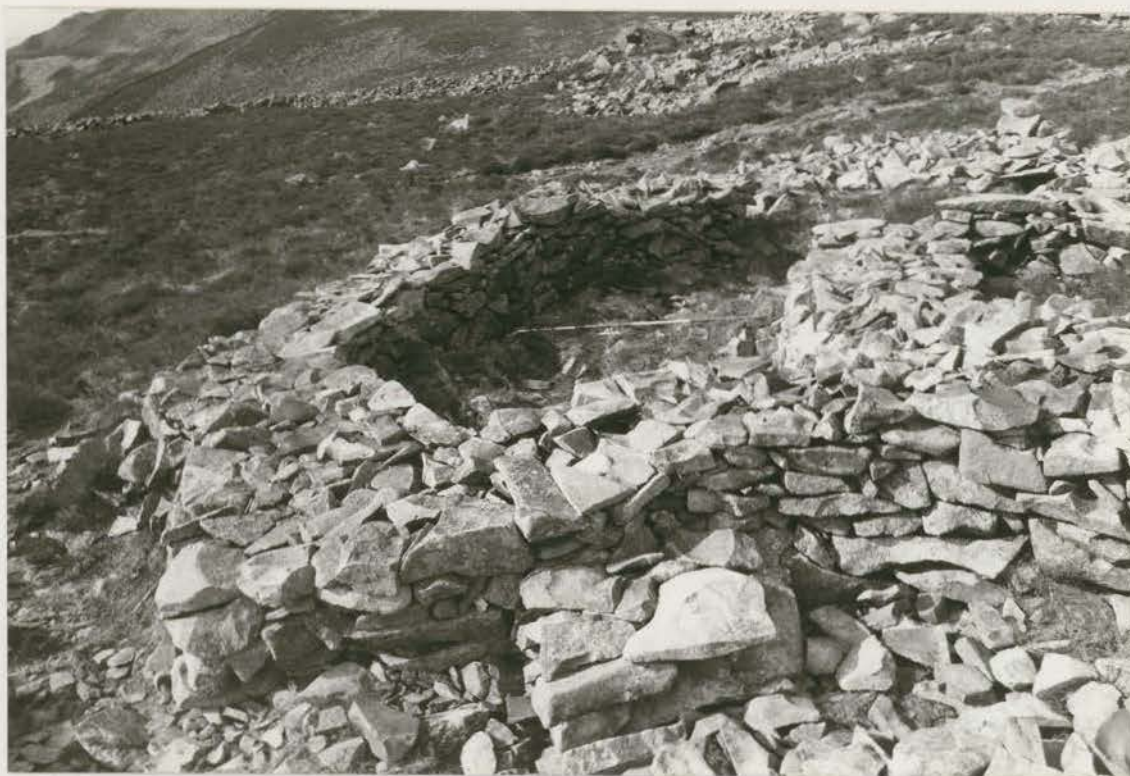
Plate 69. Hut 87 and W wall of hut 53 after conservation,
looking W (G1022/022/11A).

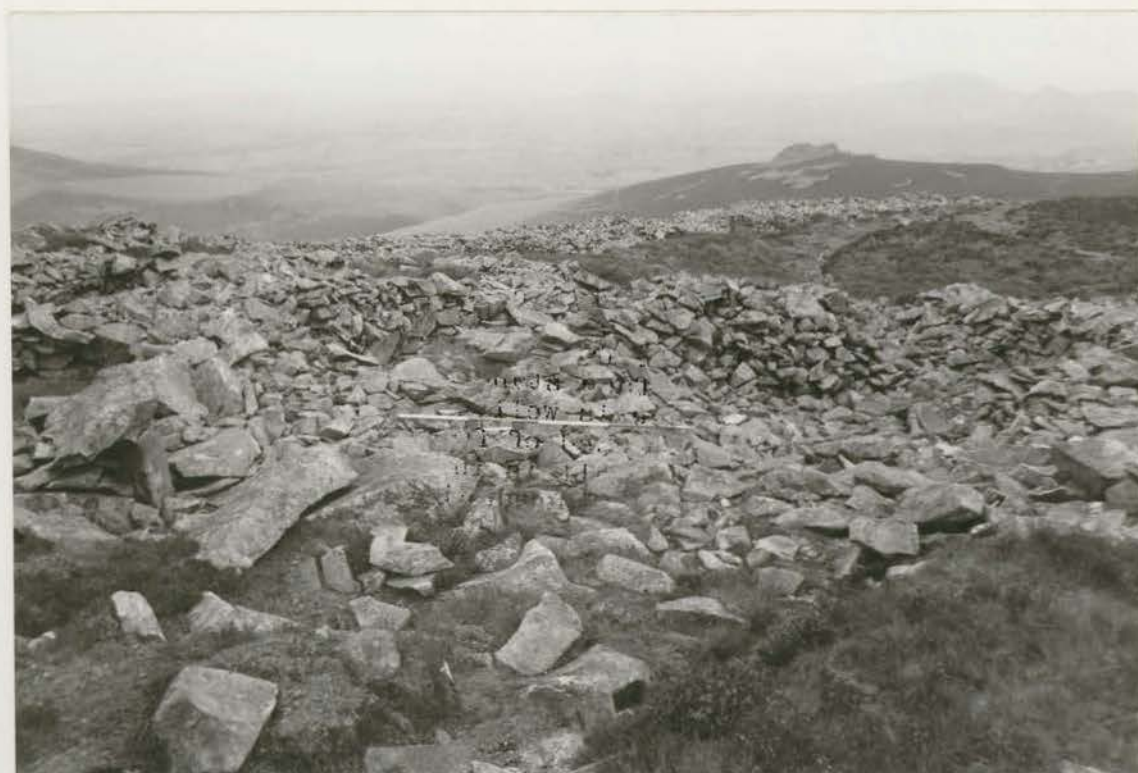
Plate 74. Huts 89 & 90: E and NE walls before conservation,
looking SW (G1022/003/01).

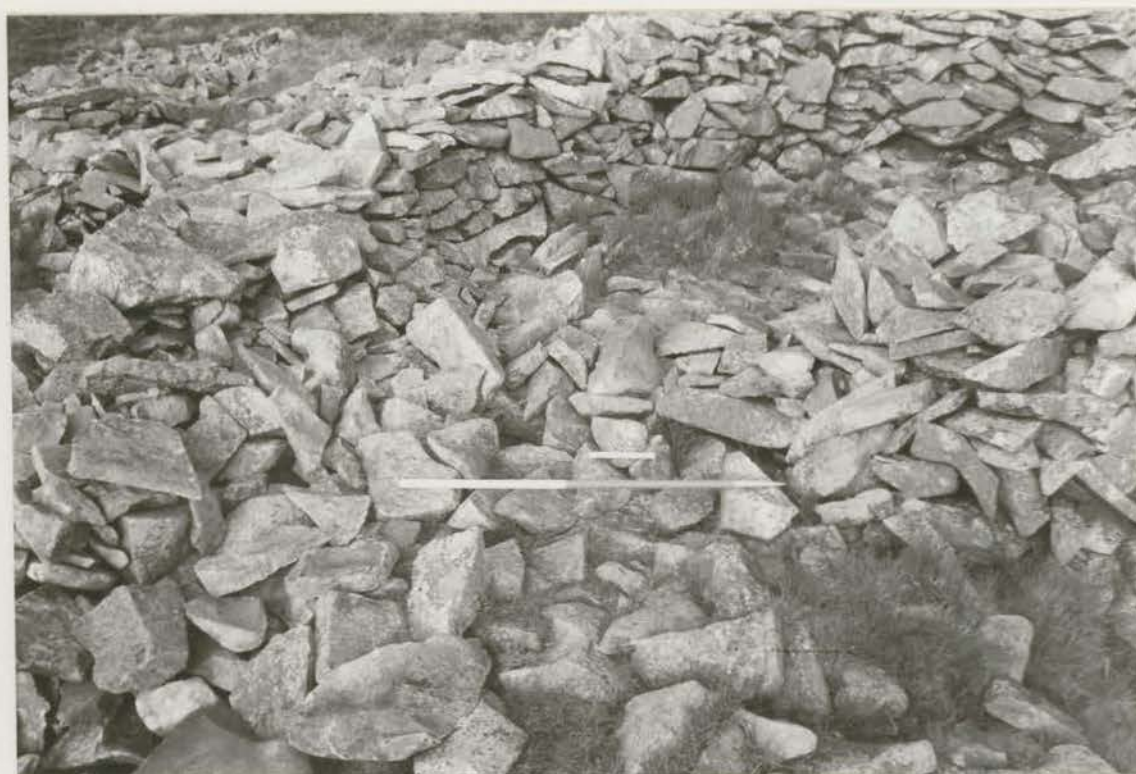
Plate 78. Hut 89: entrance from hut 53 before conservation,
looking N (G1022/004/11).

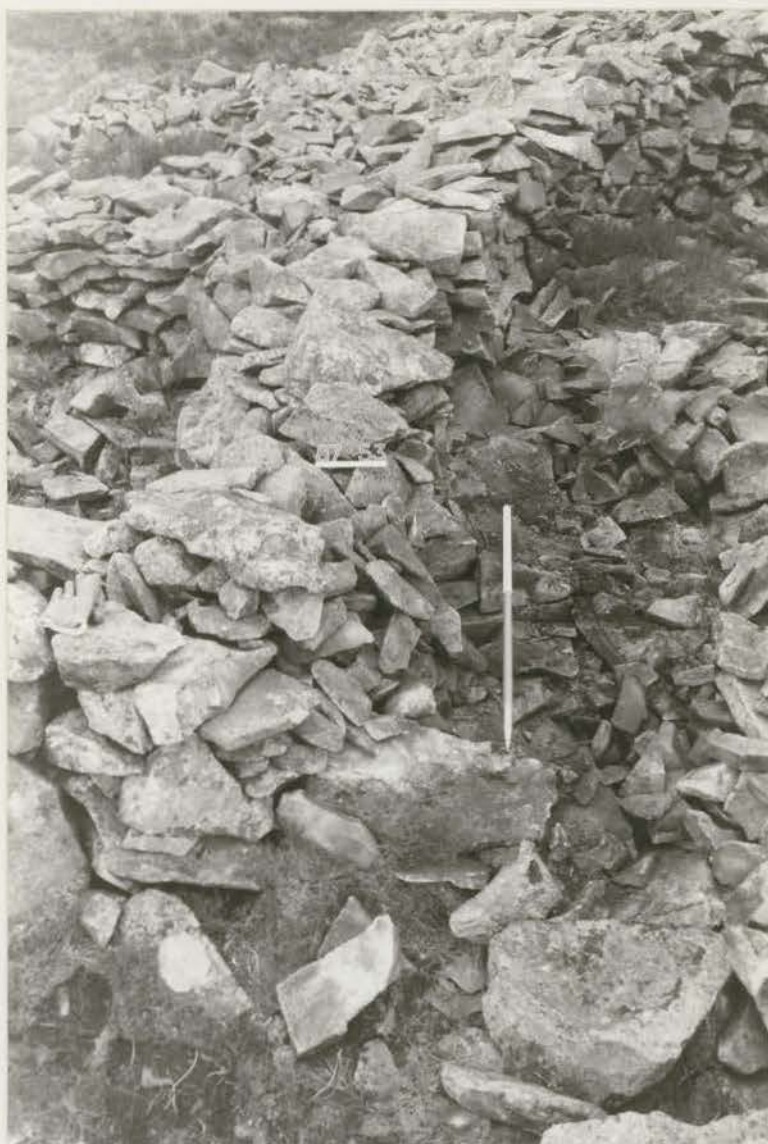
Plate 82. Hut 53: foundations
of W jamb of doorway to hut
89, looking W (G1022/007/15).

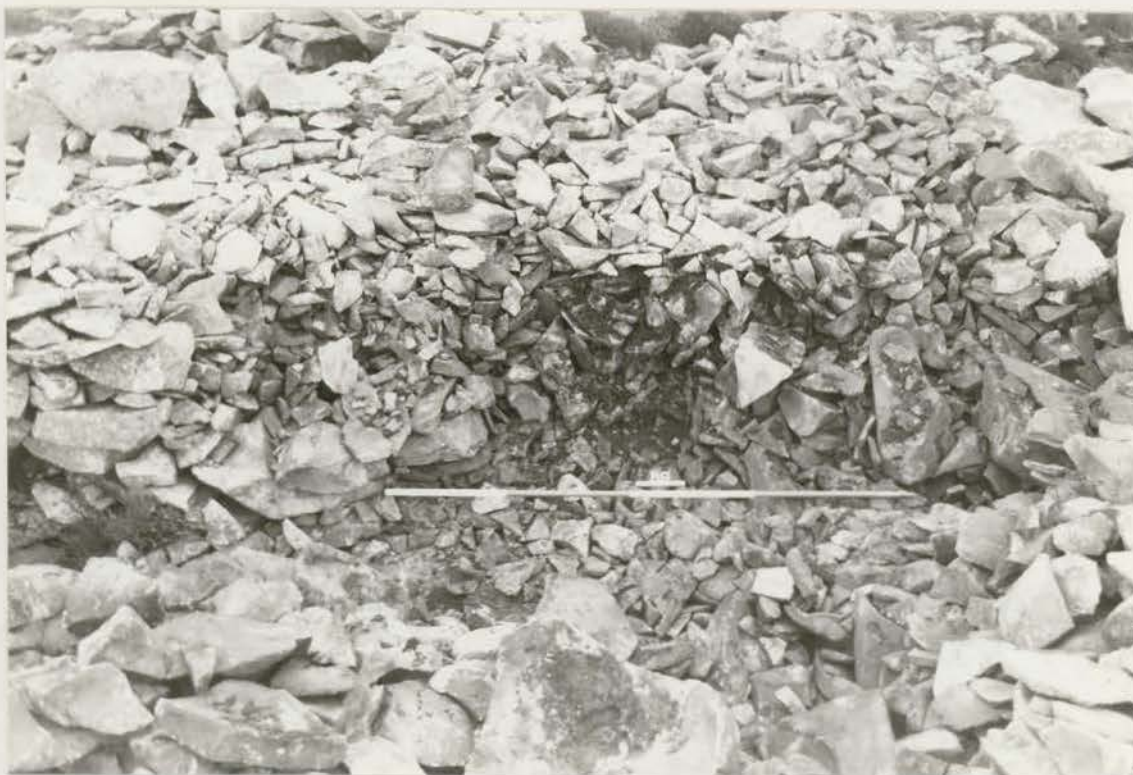
Plate 84. Hut 89: base of NE wall after removal of collapse,
looking NE (G1022/015/36).

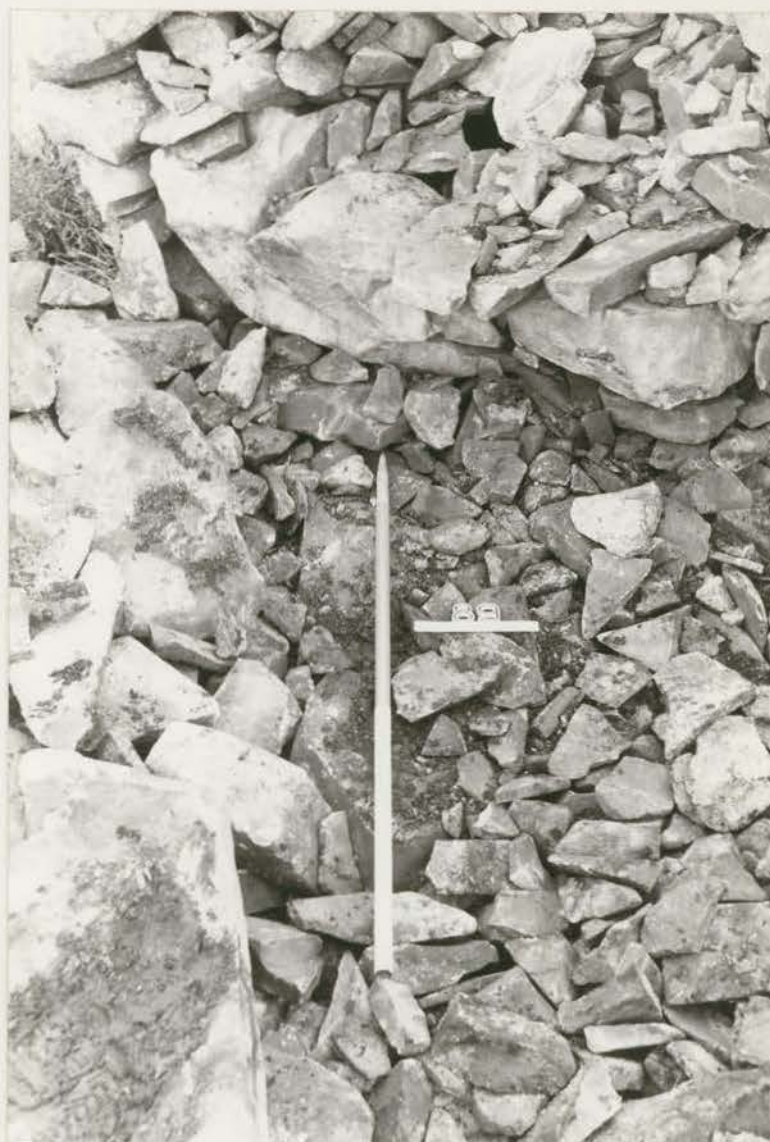
Plate 86. Hut 89: restored N
and NE walls, looking NE
(G1022/022/31A).

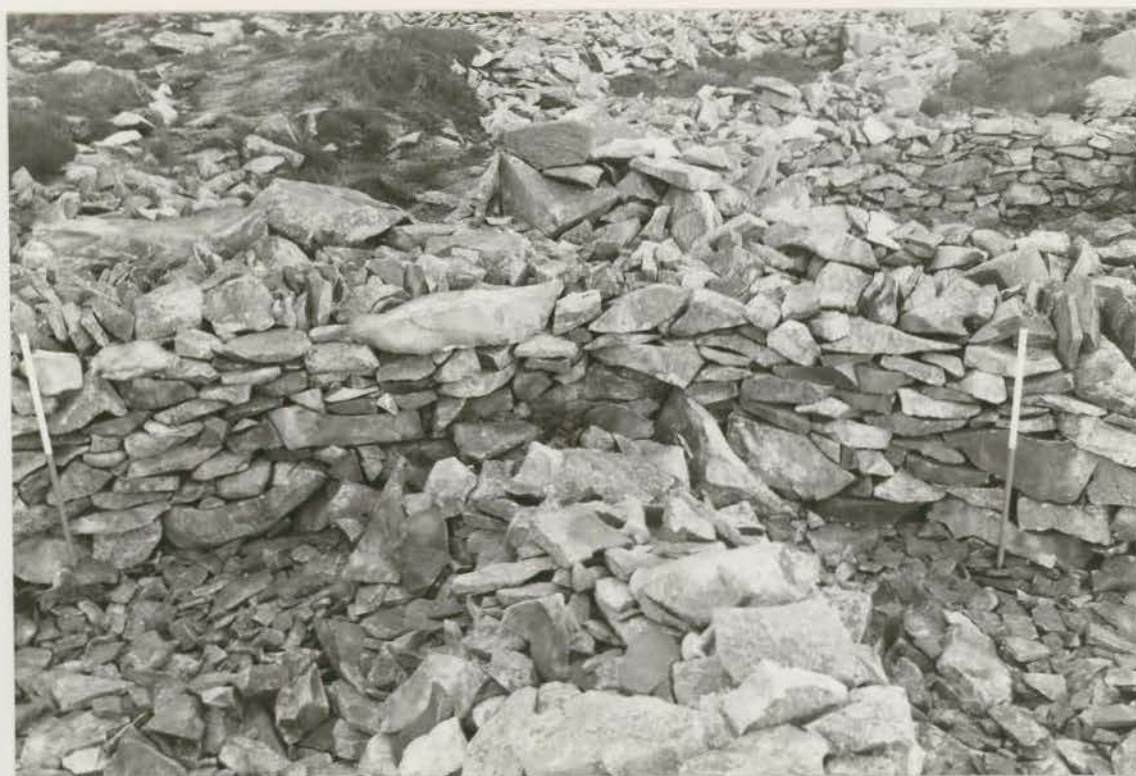
Plate 88. Huts 89 & 90: restored NE wall, looking NE (G1022/022/34A).

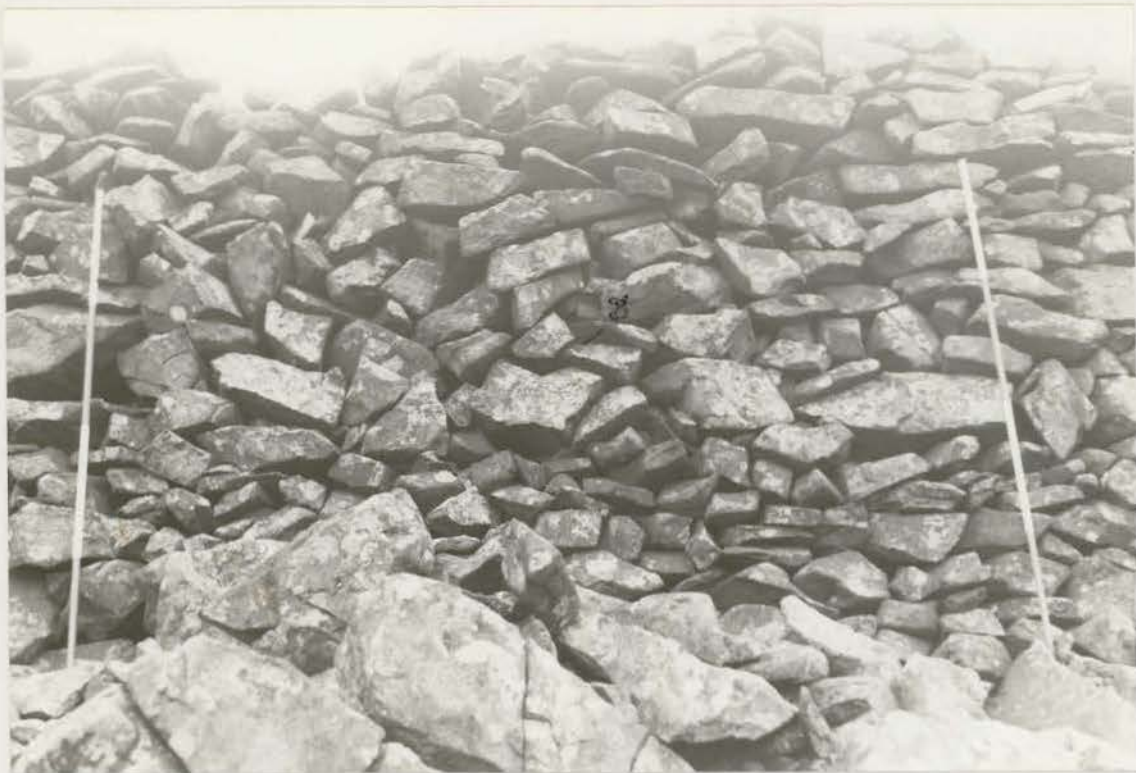
Plate 93. Inner rampart, length D - E, showing changes in construction (G1022/016/23A).

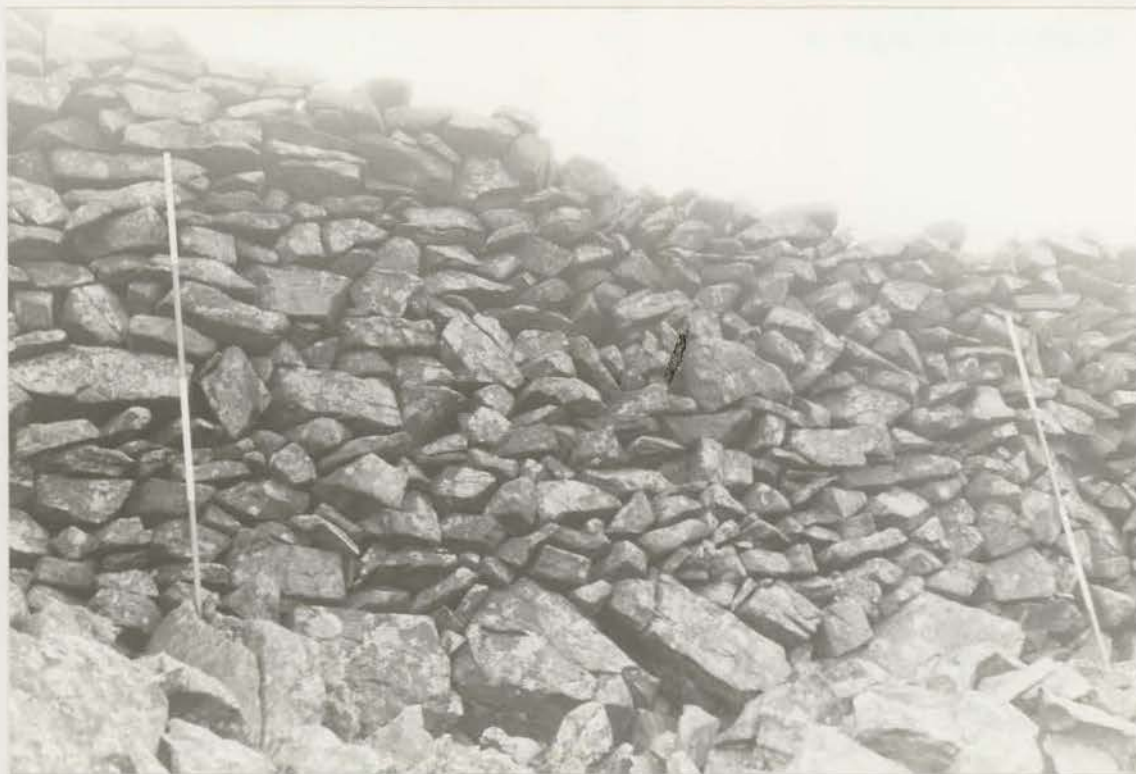
Plate 94. Inner rampart, length D - E, showing changes in construction (G1022/016/31A).

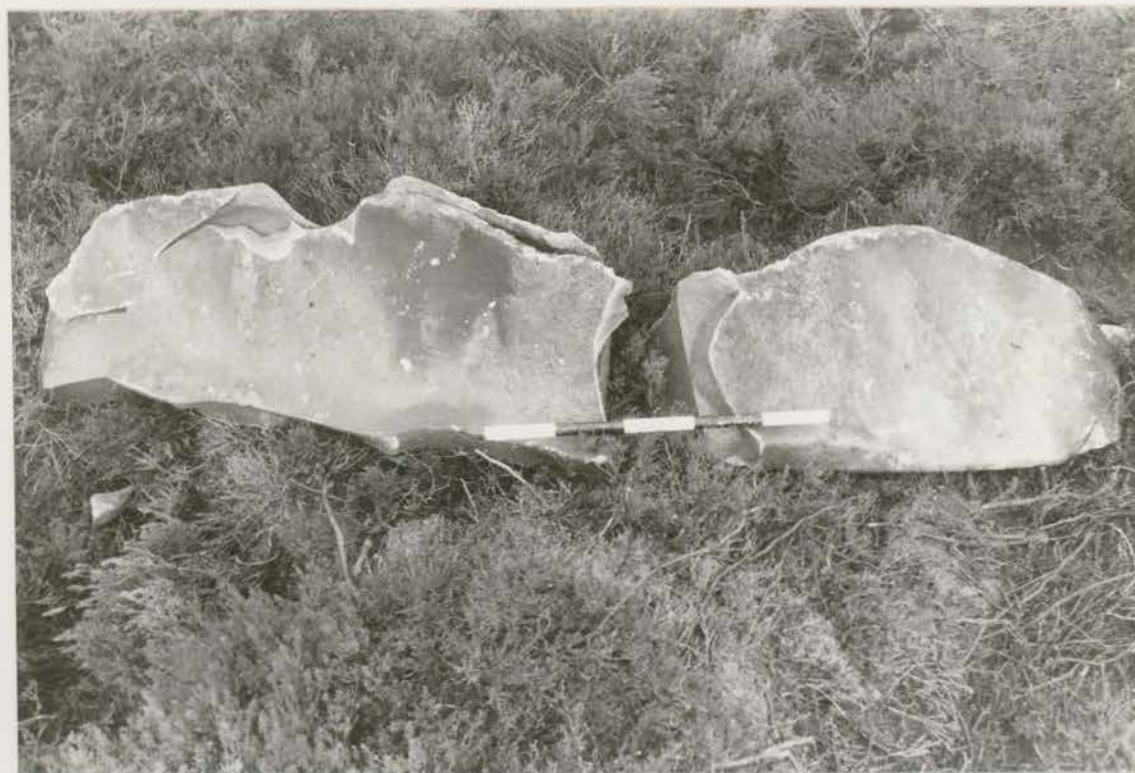
Plate 106. The broken lintel.

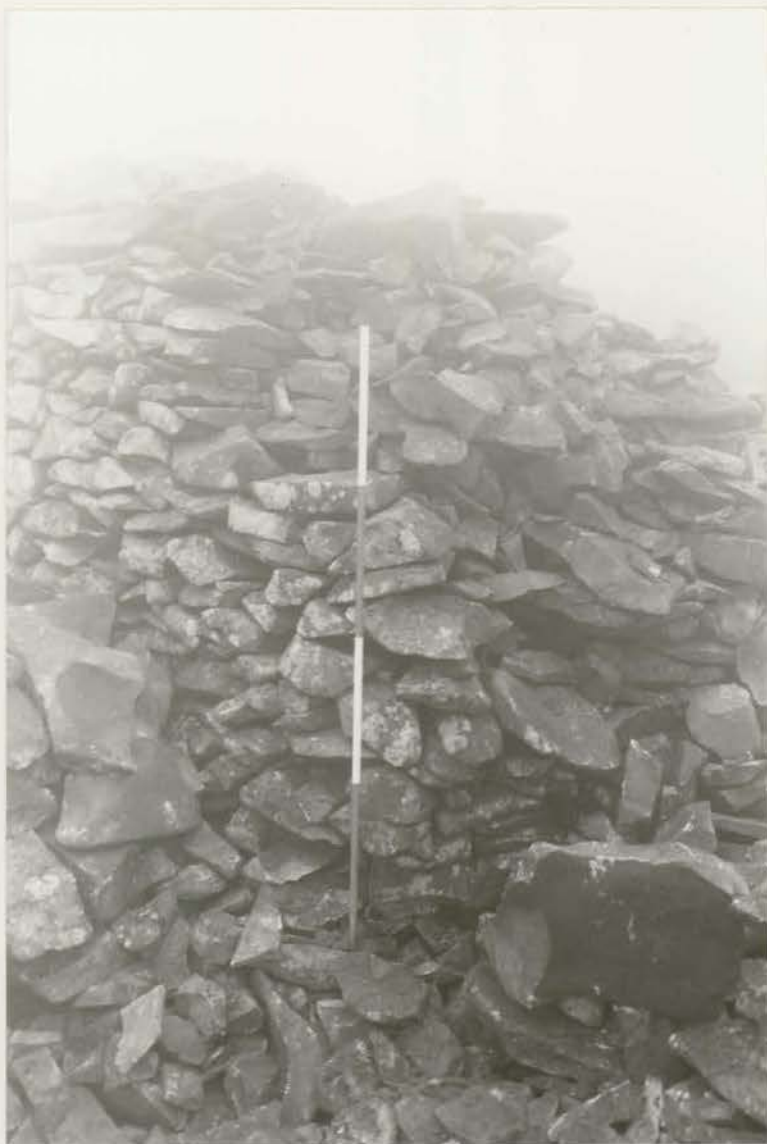
Plate 107. N postern: outer E corner of passage
before dismantling, looking SE (G1022/010/06).

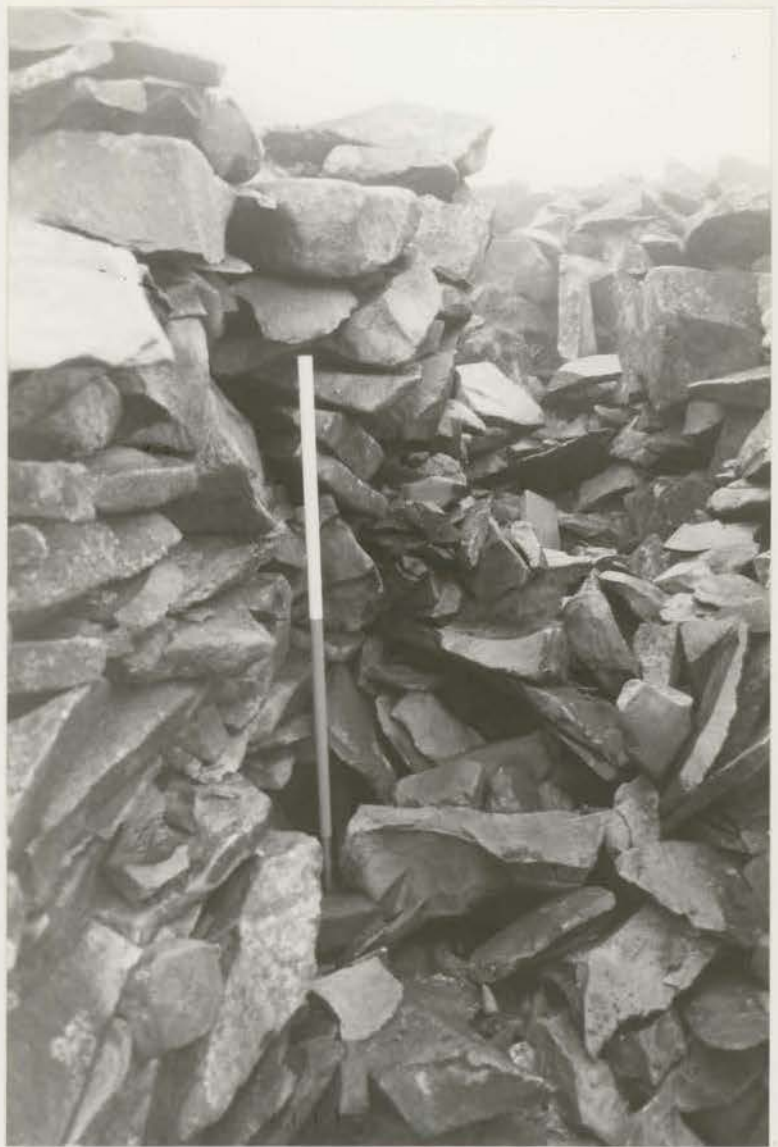
Plate 113. N postern: E side
of passage before dismantling
looking E (G1022/010/11).

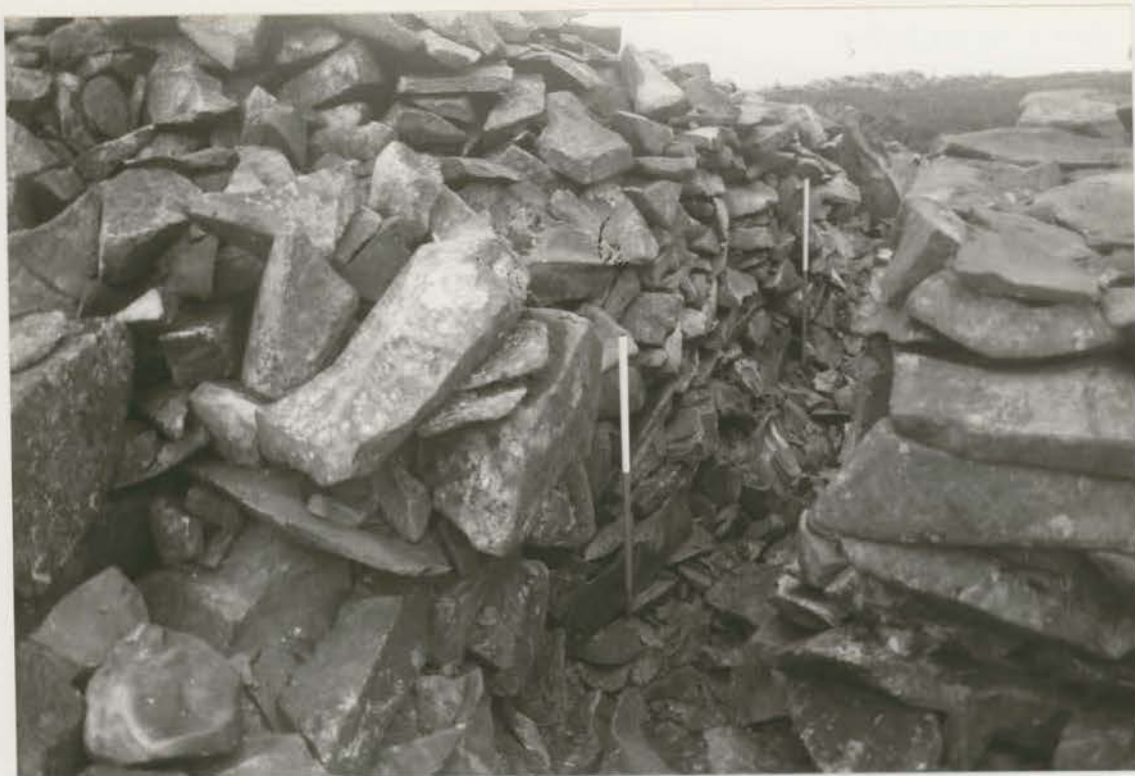
Plate 116. N postern: W side of passage after conservation, looking N (G1022/011/09A).

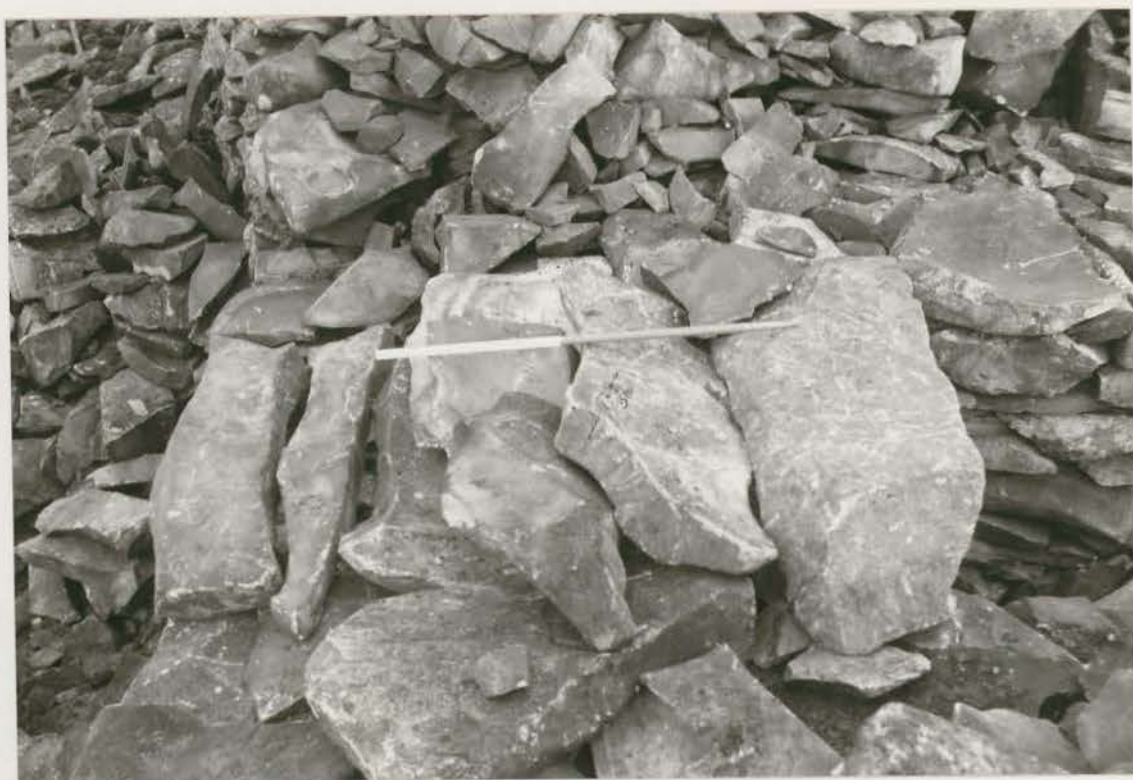
Plate 117. N postern, with replacement lintels, looking E (G1022/011/18A).

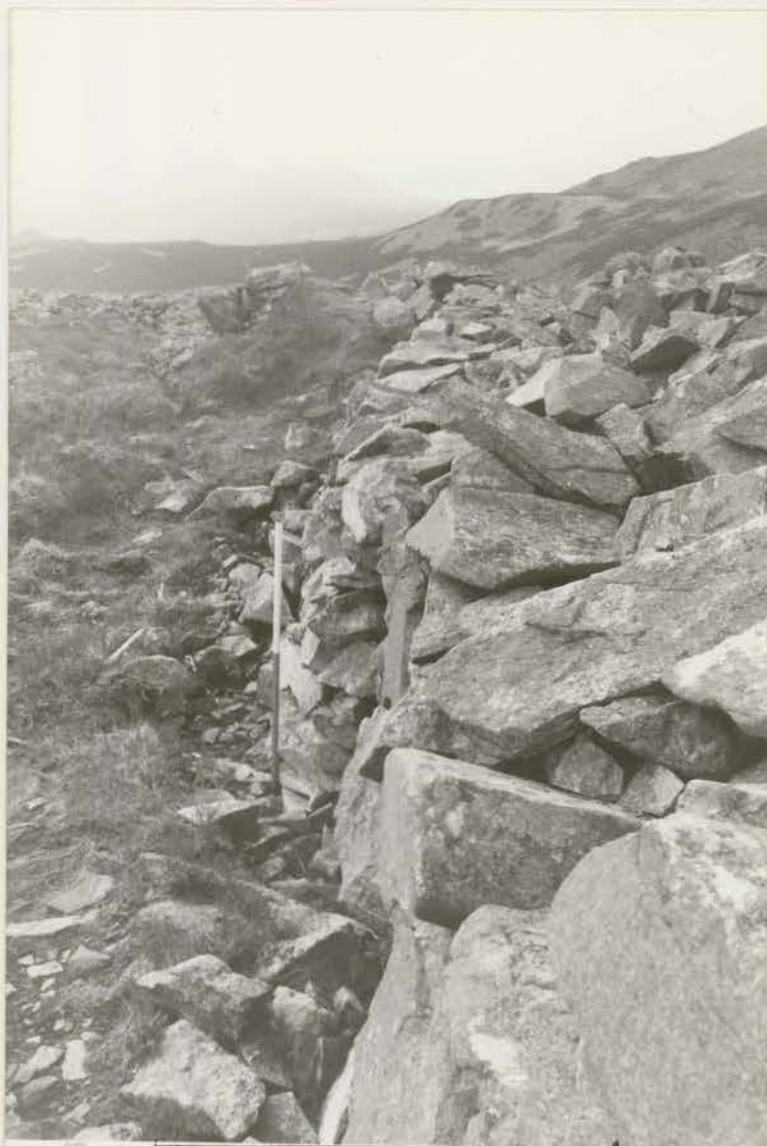
Plate 133. Collapse 'E1'
after conservation, looking
NW (G1022/022/22A).

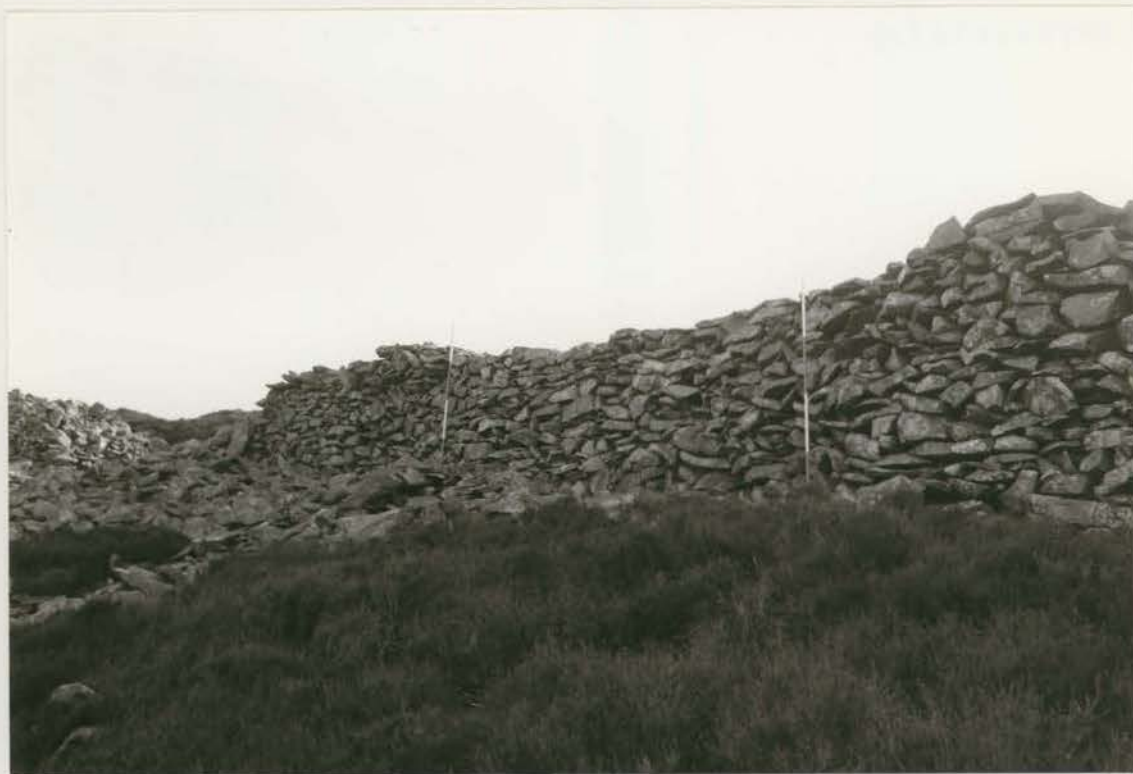
Plate 135. Collapse 'F1' after conservation, looking E (G1022/023/14).
