TRE'R CEIRI
CONSERVATION PROJECT
1990
PART 2: PLATES

REPORT ON THE SECOND SEASON OF THE
TRE'R CEIRI CONSERVATION PROJECT
JUNE - NOVEMBER 1990

S.D. BOYLE

GWYNEDD ARCHAEOLOGICAL TRUST LTD.

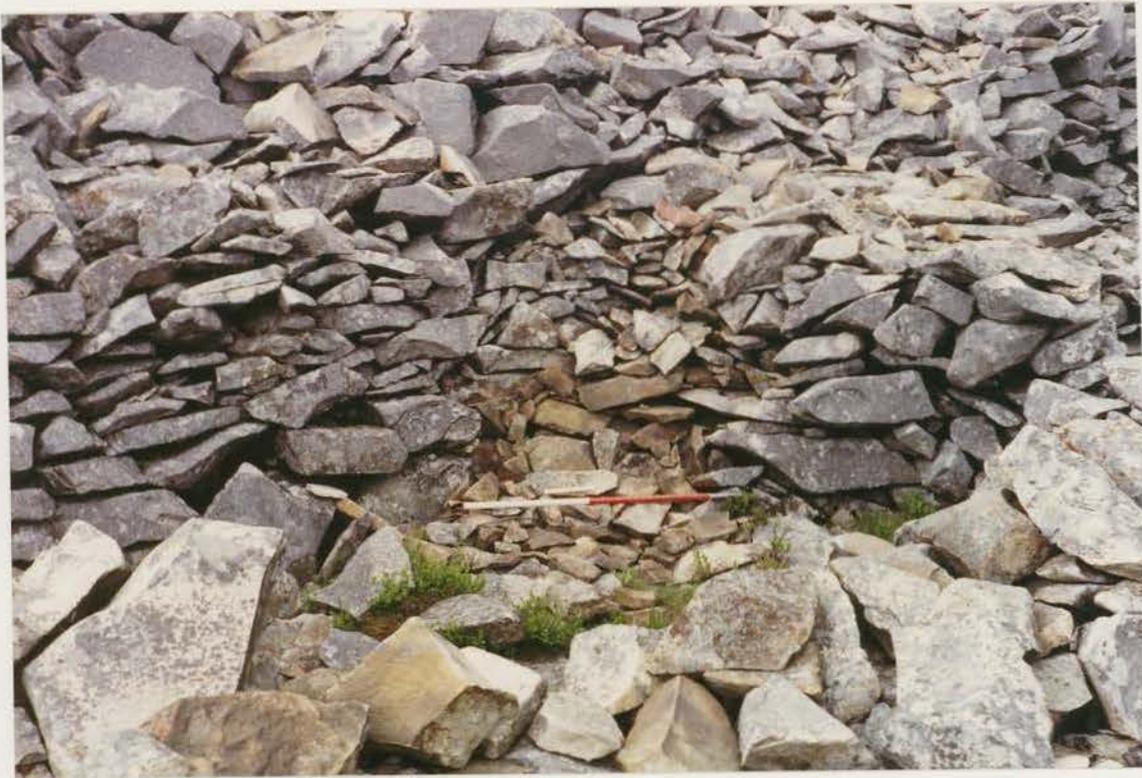
Plate 14. Hut 78: collapsed N corner and hut entrance, looking NE
(G1022/109/11).

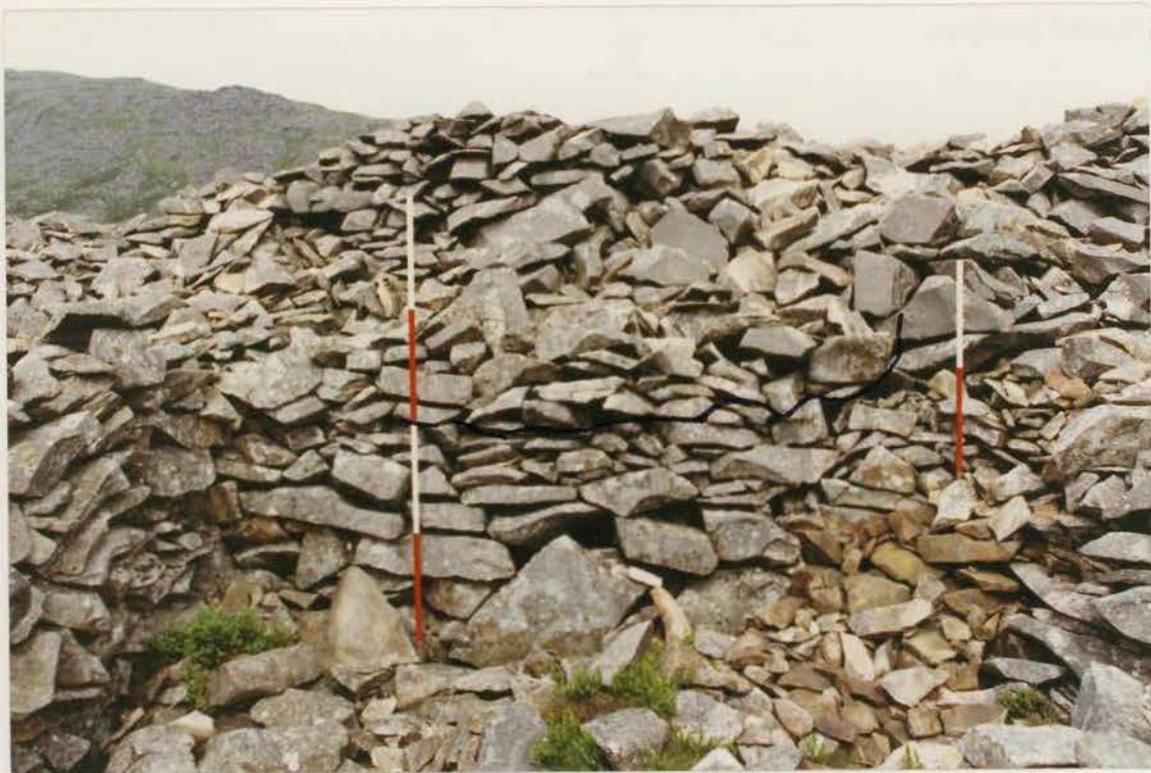
Plate 21. Hut 78: S corner after conservation, looking S
(G1022/119/14).

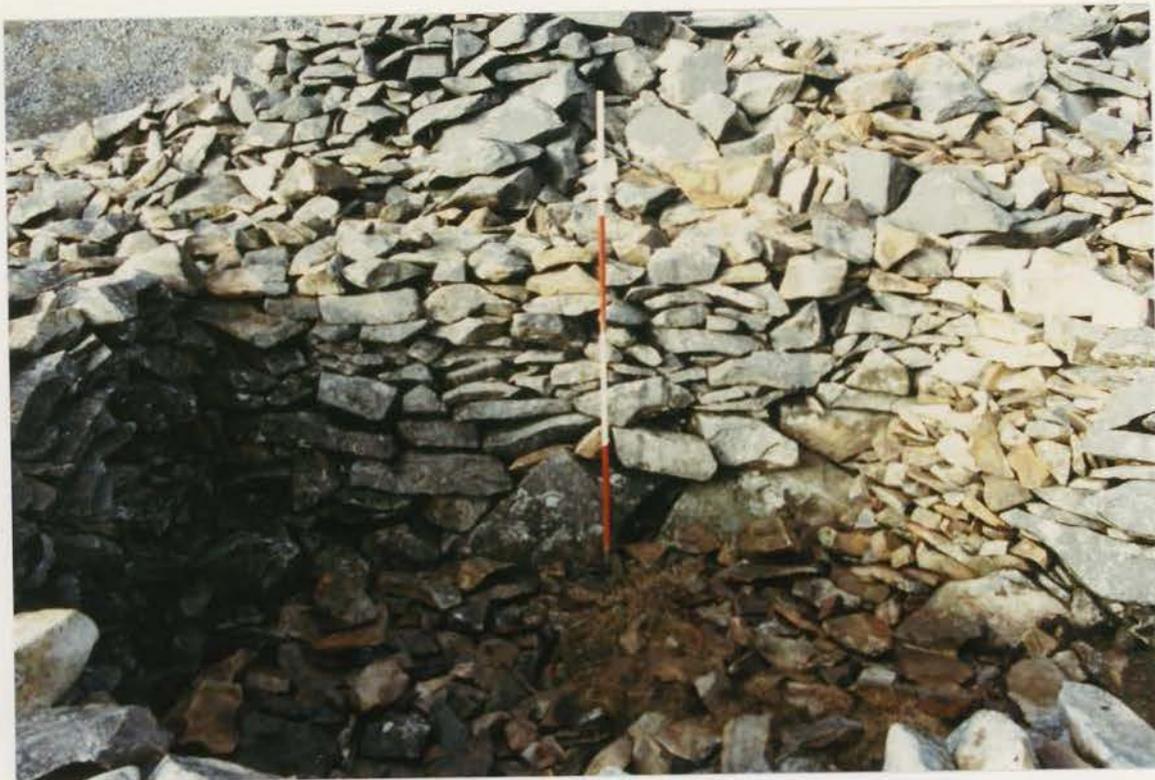
Plate 22. Hut 78: NW wall before conservation, looking NW
(G1022/107/26).

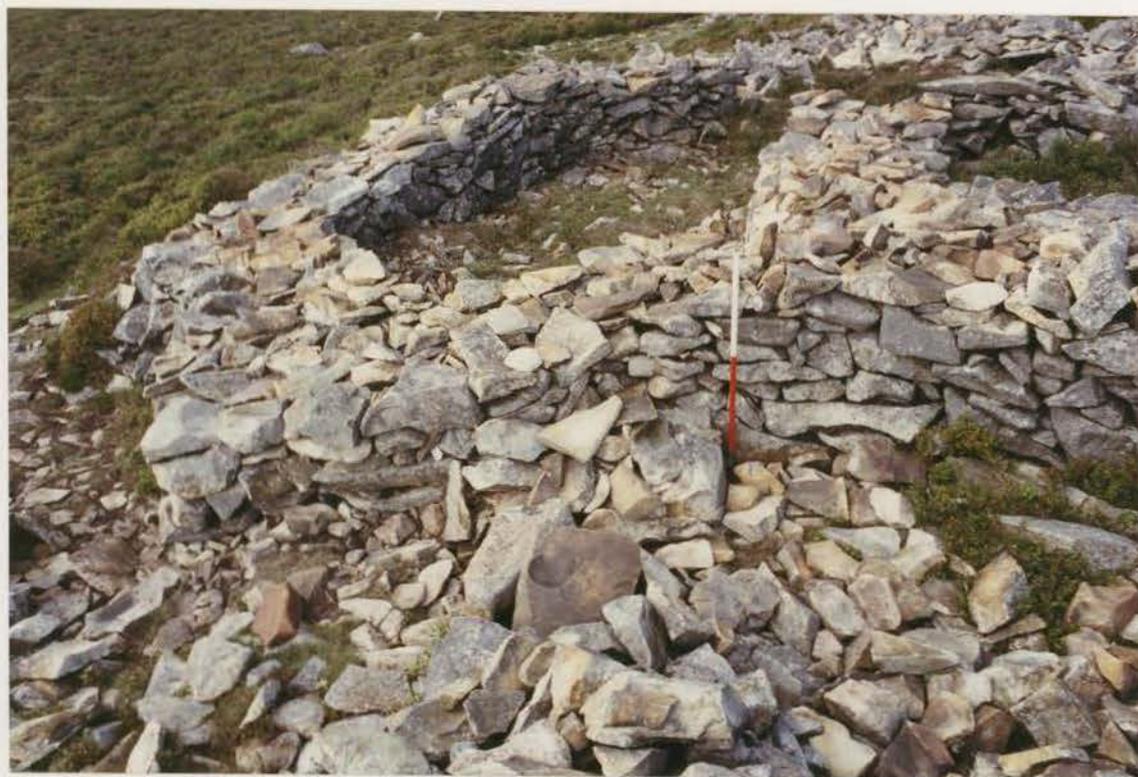
Plate 25. Hut 89: Rebuilt door jamb (bottom centre of frame),
February 1990, looking W (G1022/022/11A).

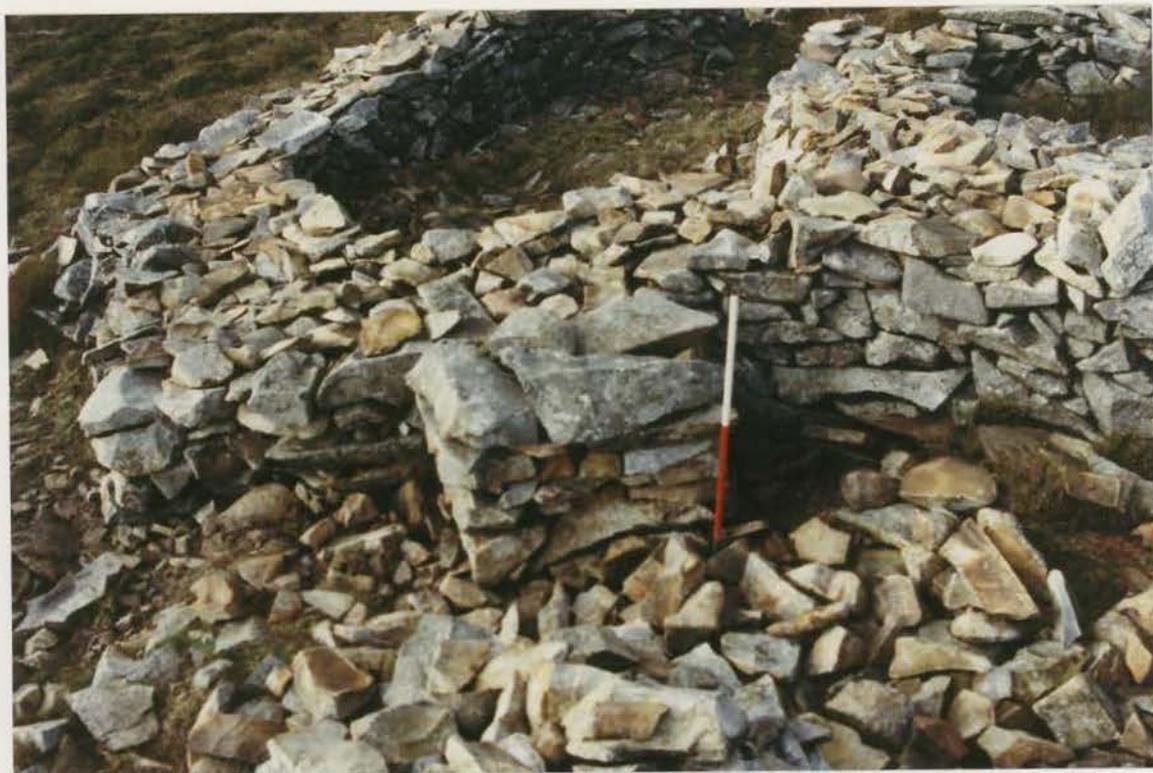
Plate 26. Hut 89: Door jamb collapsed, September 1990
(G1022/115/18).

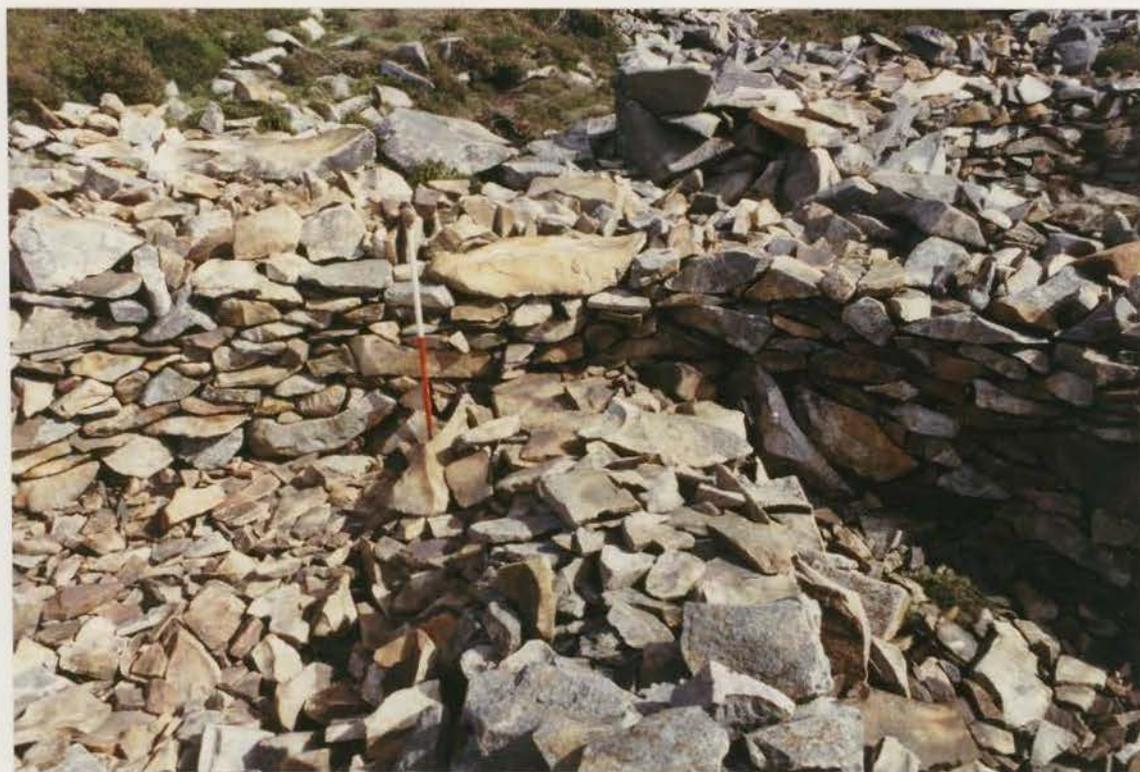
Plate 27. Hut 89: Door jamb replaced, November 1990
(G1022/119/25).

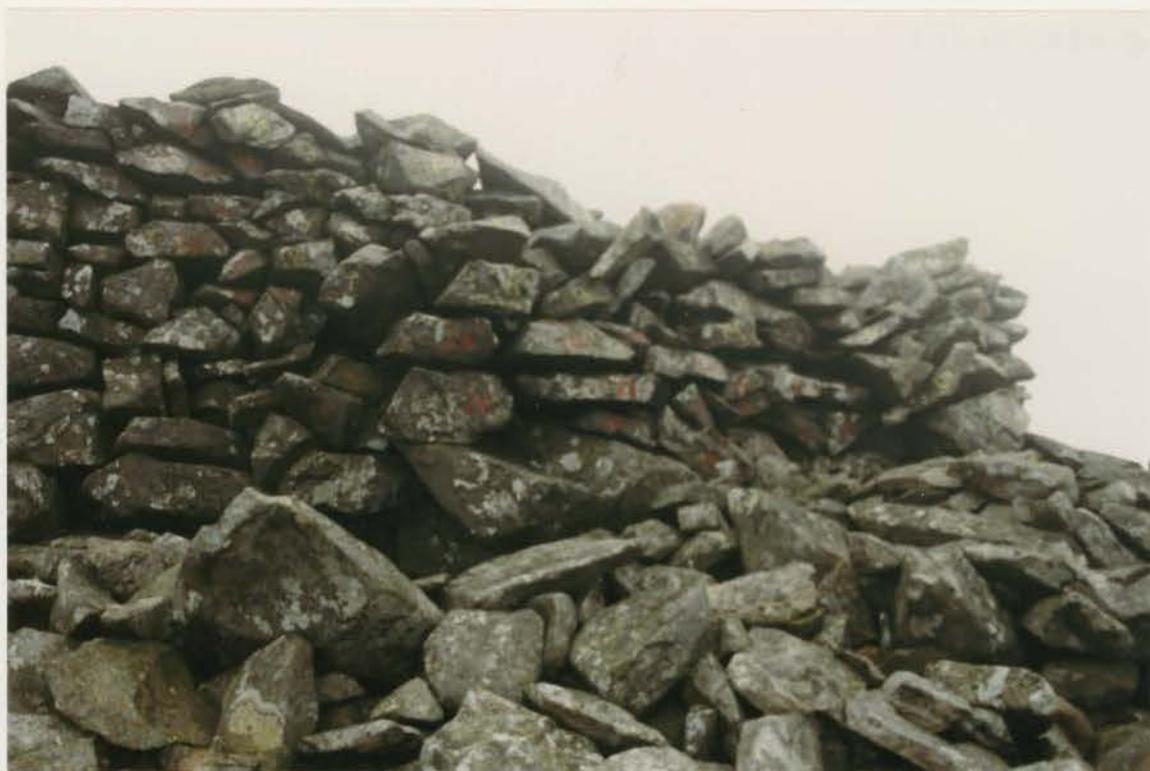
Plate 28. Hut 89: partition at rear of hut, looking E
(G1022/115/19).

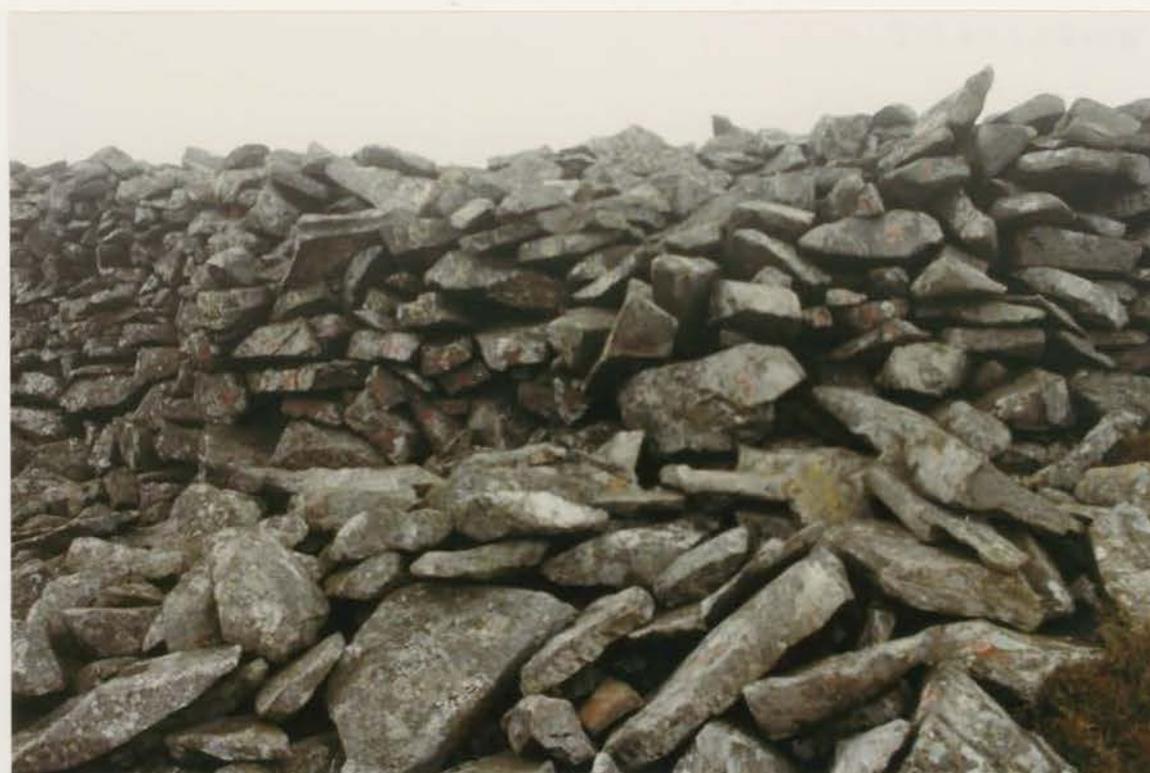
Plate 29. Collapse D before conservation, looking SW (G1022/116/15).

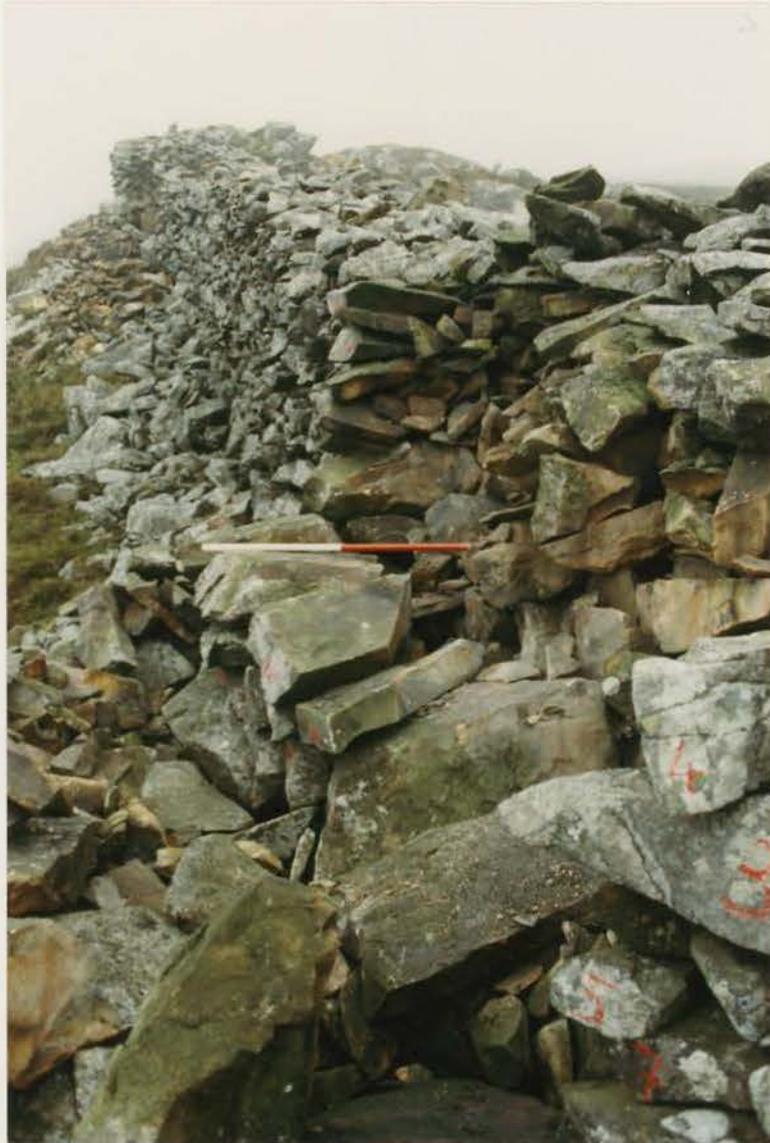
Plate 30. Collapse D before conservation, looking E (G1022/116/13).

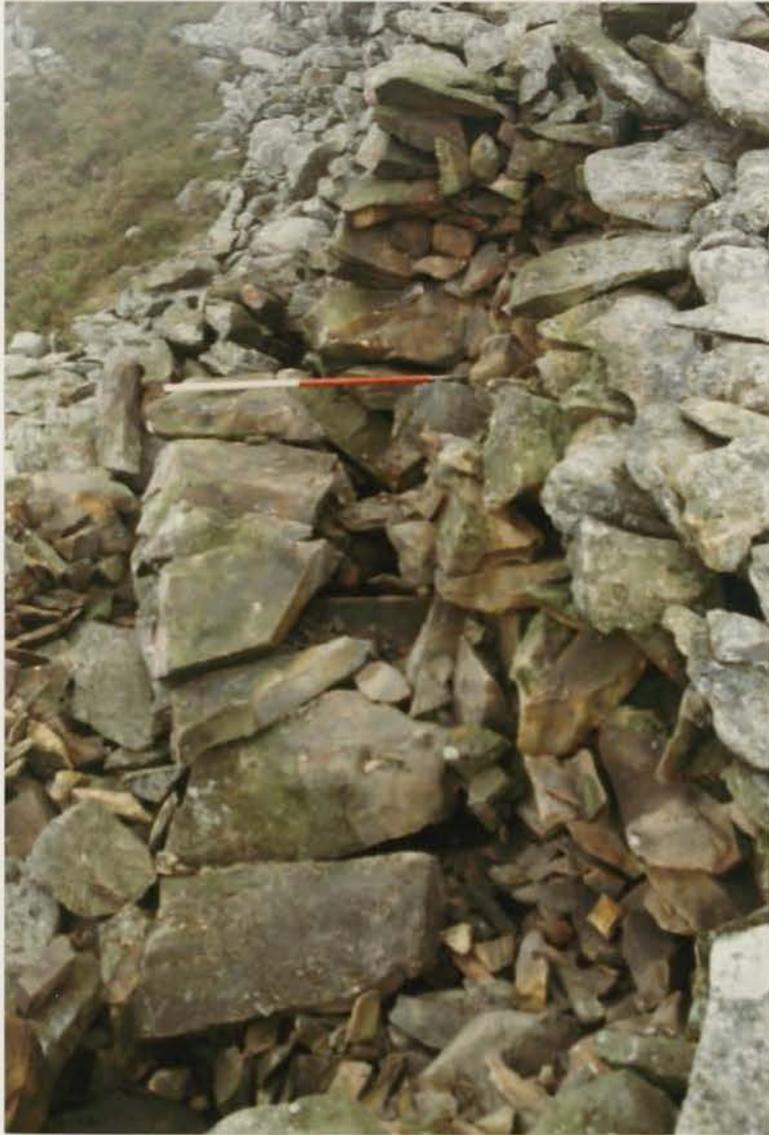
Plate 31. Collapse D after clearance of
tumble/loose masonry, looking NE
(G1022/116/19).

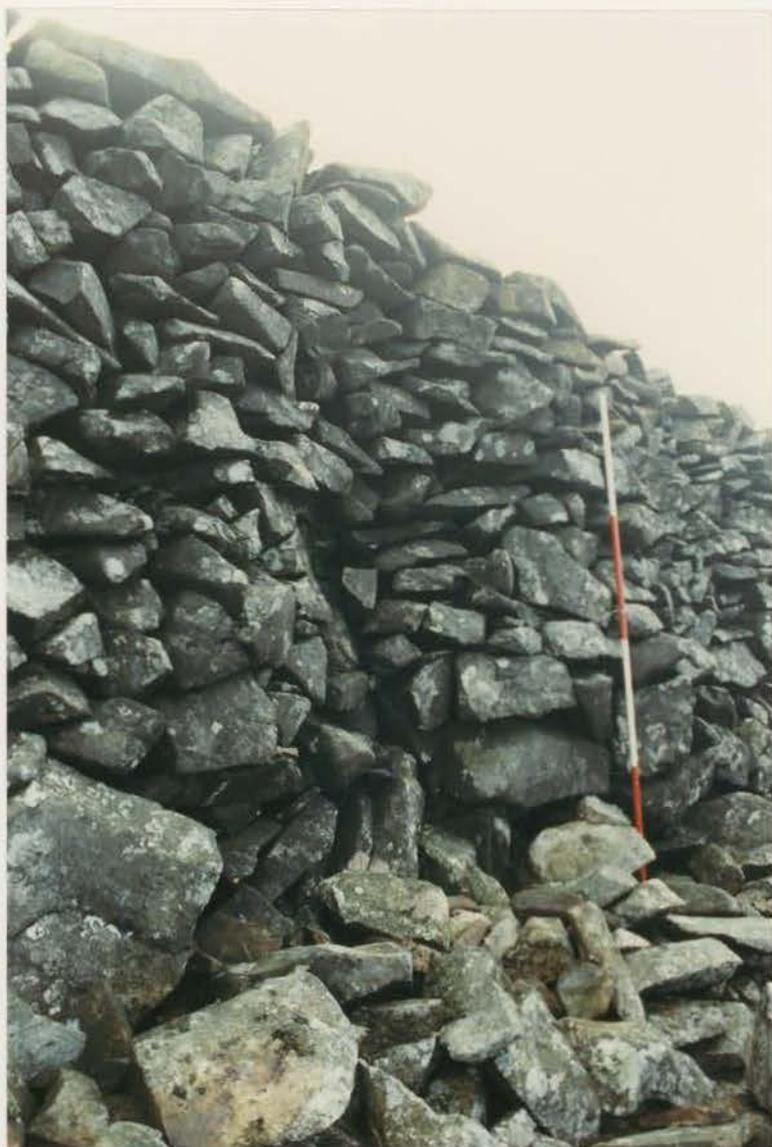
Plate 36. Wall D-E: blocked entrance, looking SE (G1022/15/31).

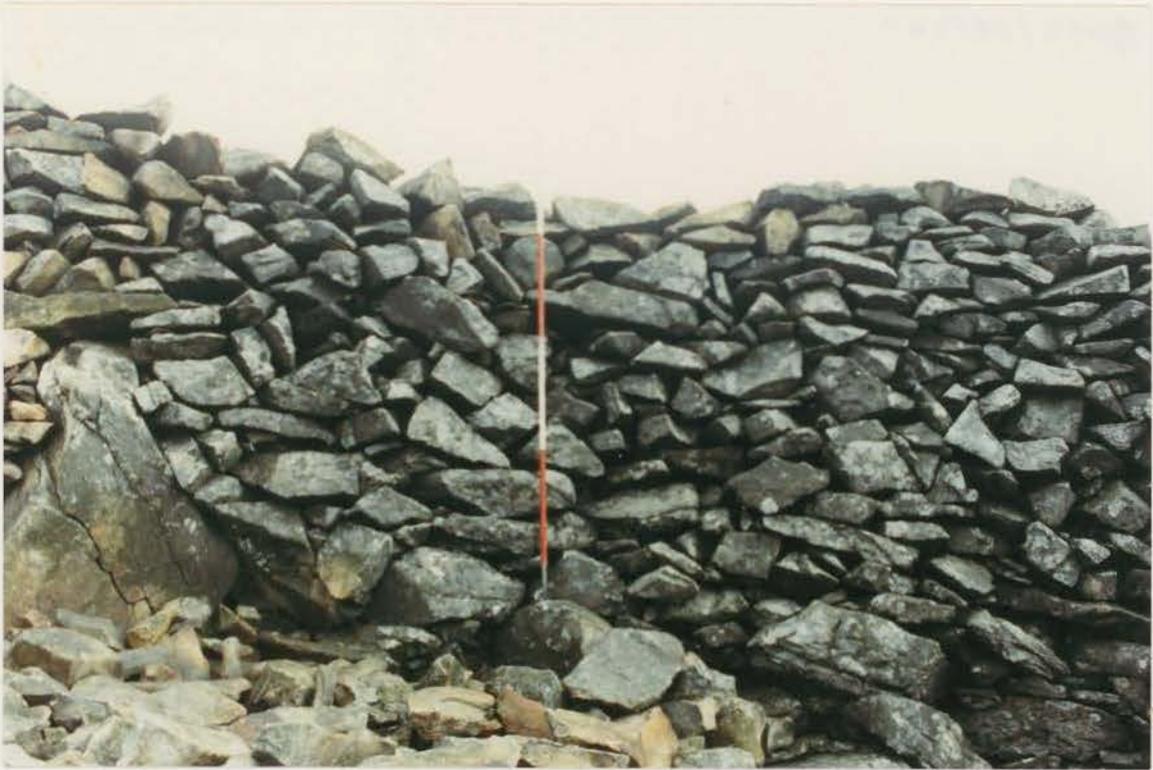
Plate 39. Collapse D2 before
conservation, looking SE
(G1022/115/34).

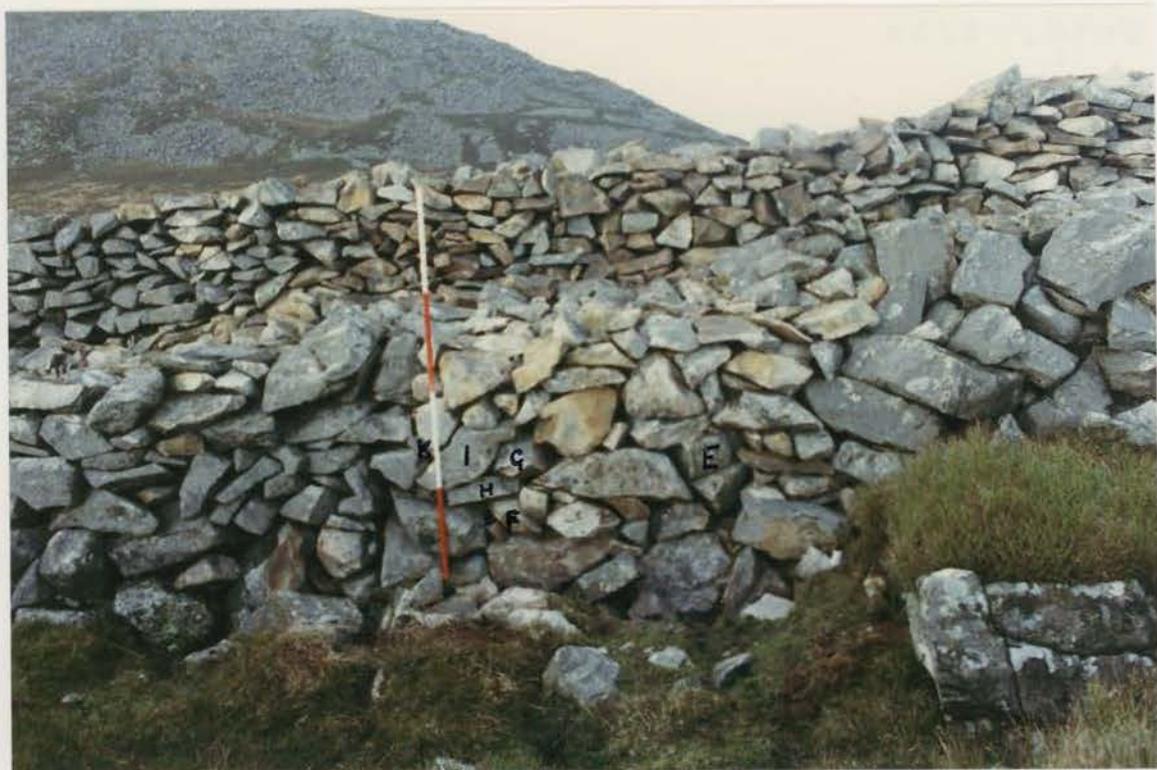
Plate 42. Collapse D3 after clearance of tumble/unstable masonry, looking NW (G1022/115/22).

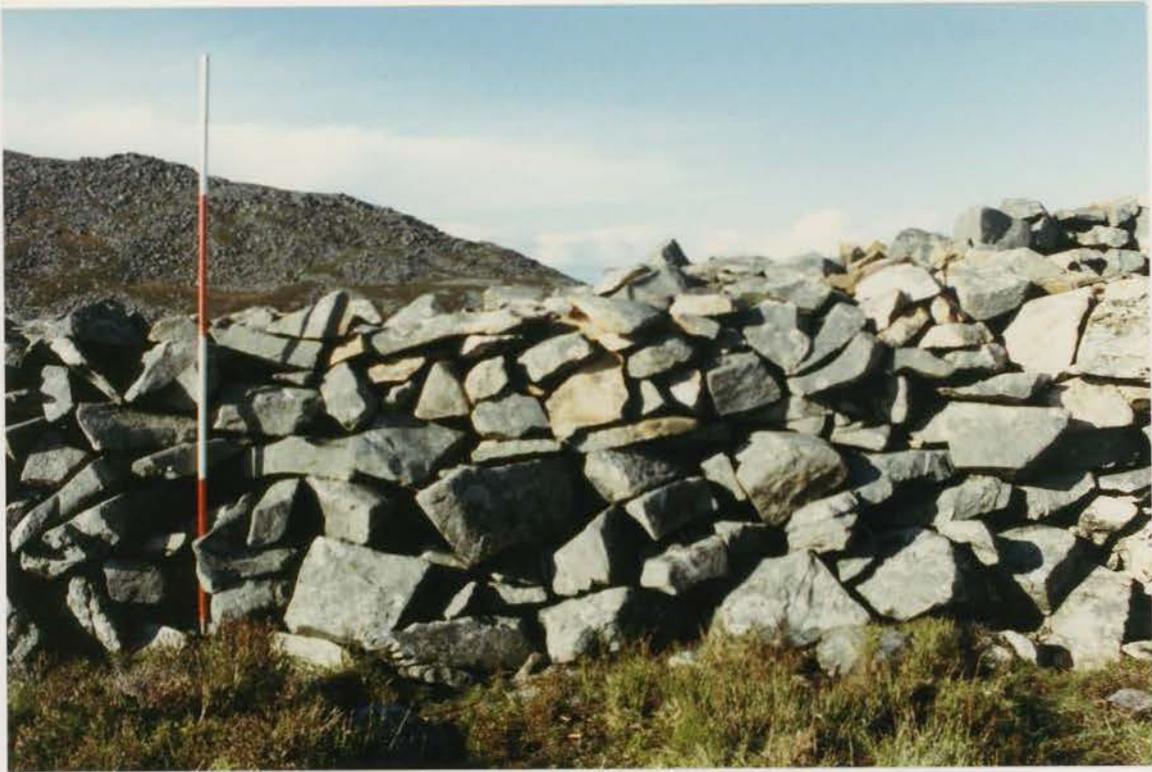
Plate 45. Collapse D4 after conservation, looking NW (G1022/118/35).

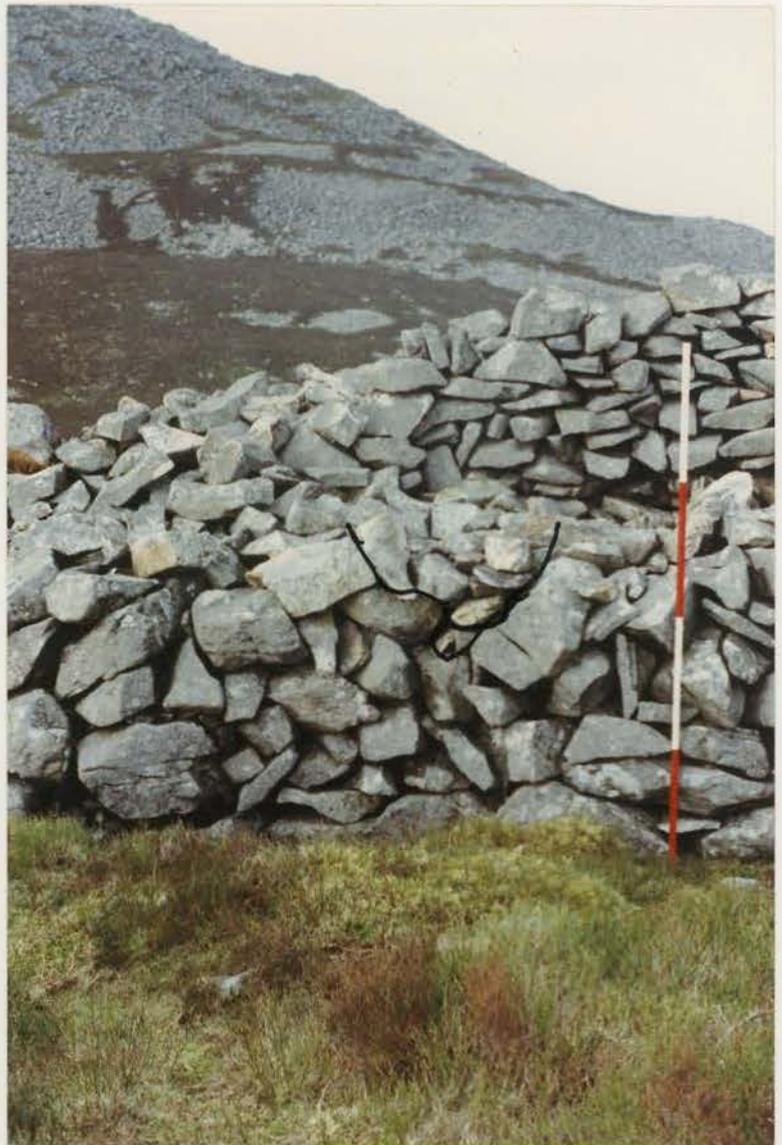
Plate 46. Collapse D5 after
conservation, looking NW
(G1022/118/36).

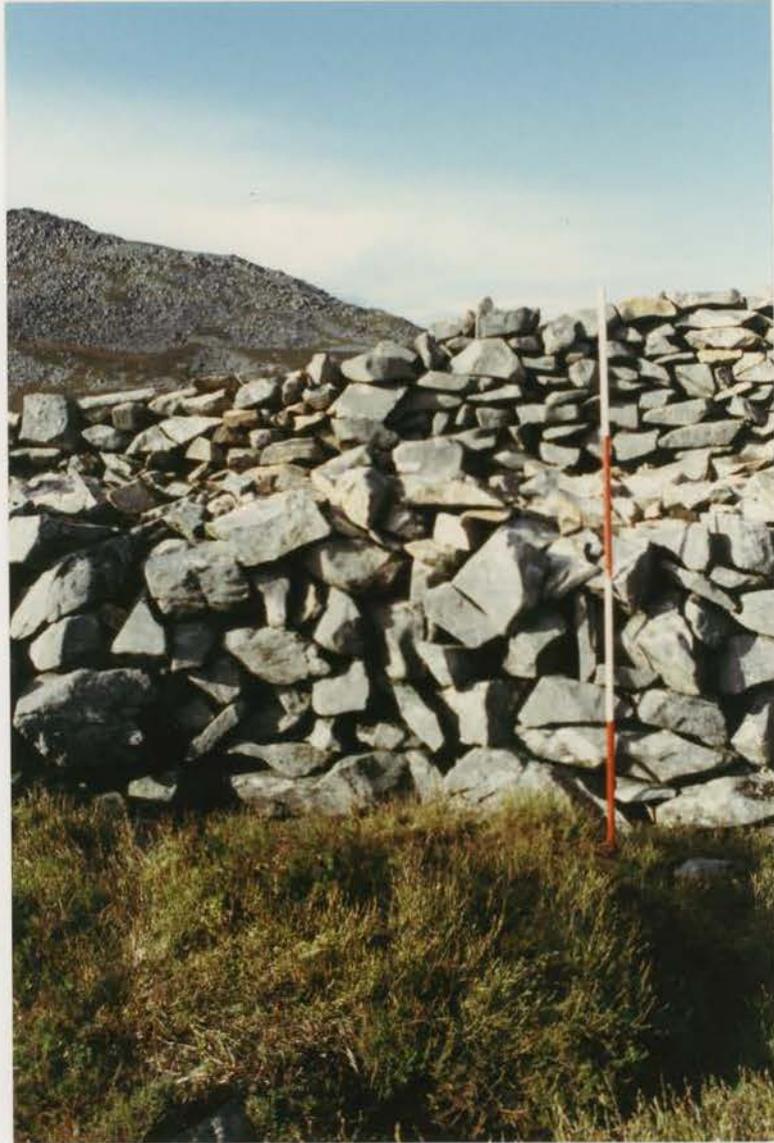
Plate 47. Collapse D6 before
conservation, looking NW
(G1022/104/21).

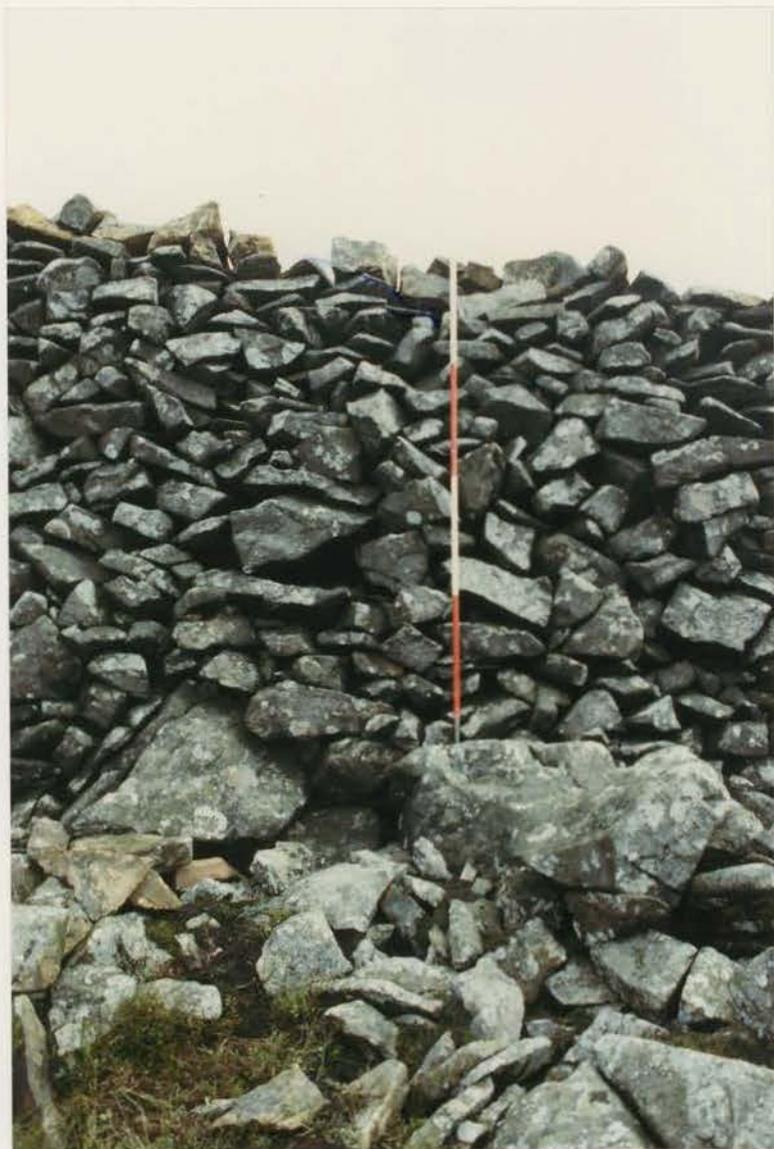
Plate 49. Collapse D7 before conservation,
looking SE (G1022/101/10).

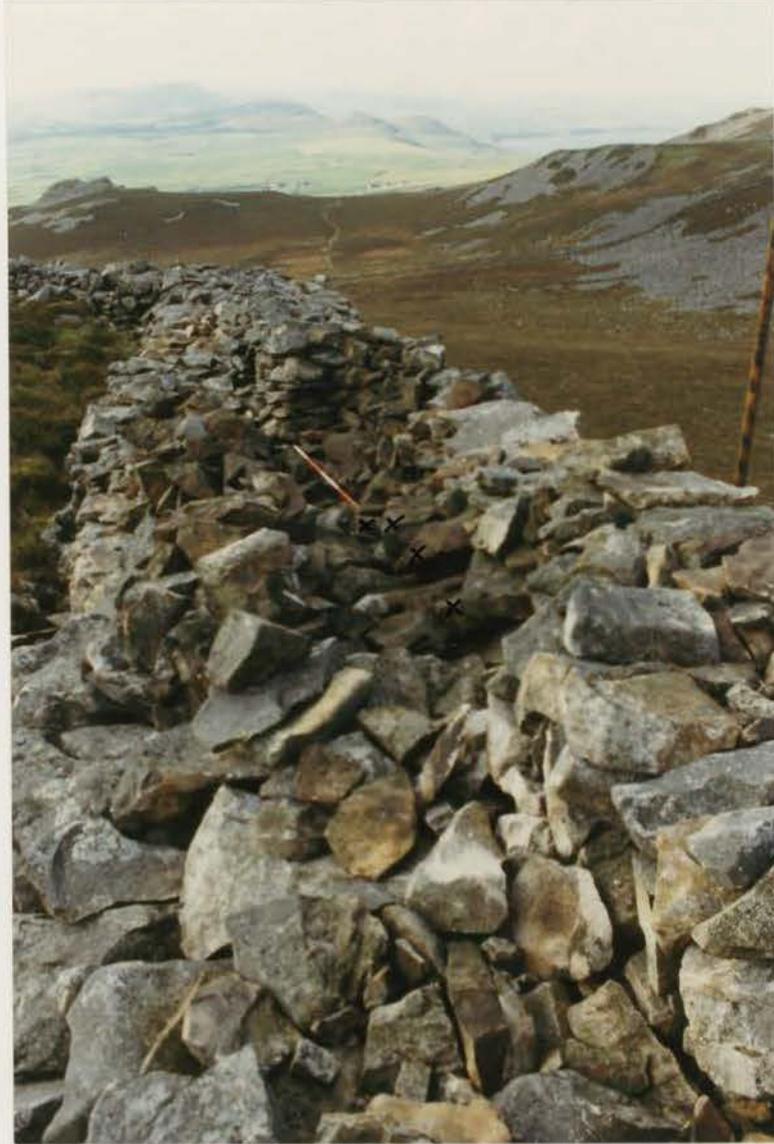
Plate 54. Collapse D10 before conservation, looking NW (G1022/104/11).

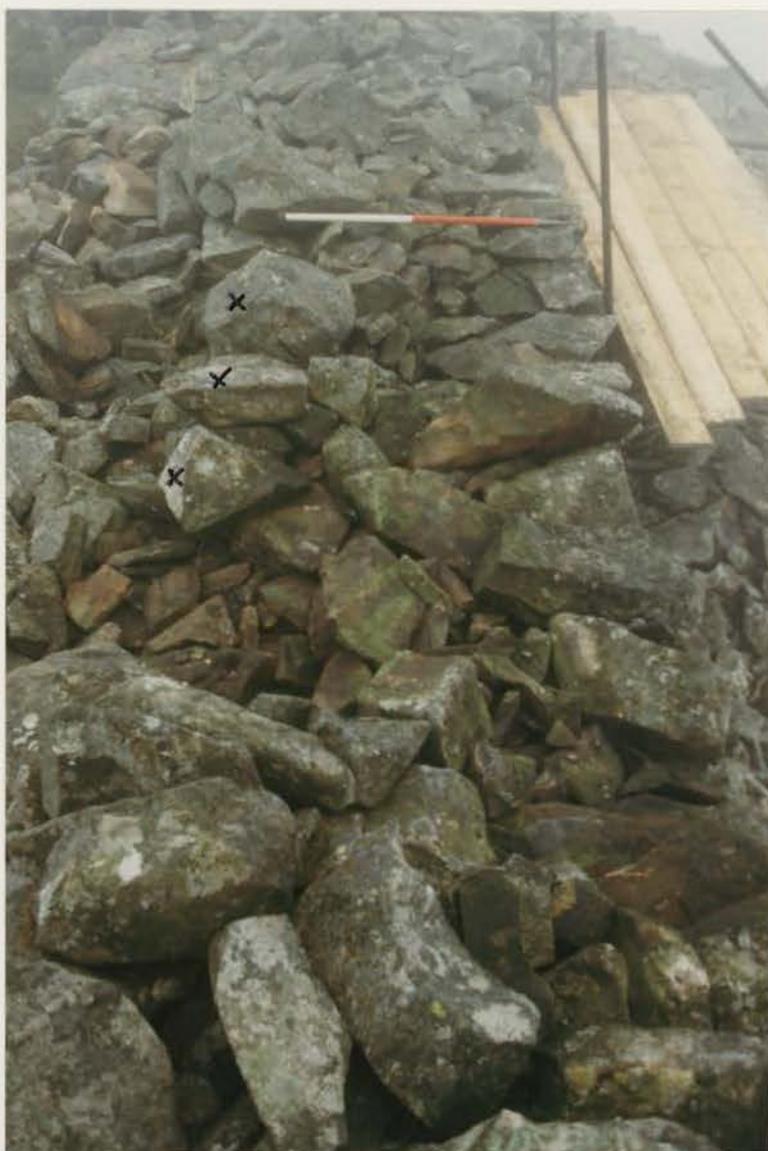
Plate 60. Collapse D11 before conservation, looking NW (G1022/104/19).

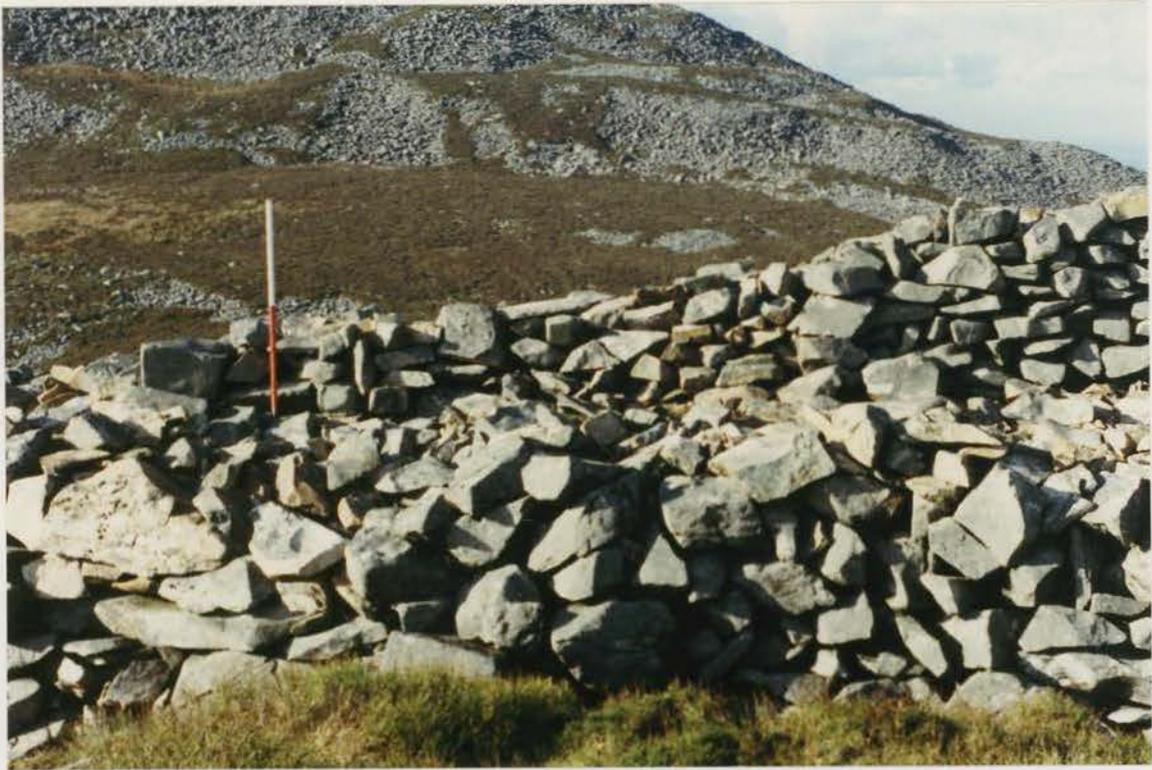
Plate 61. Collapse D11 after clearance of tumble, looking SW (G1022/116/28).

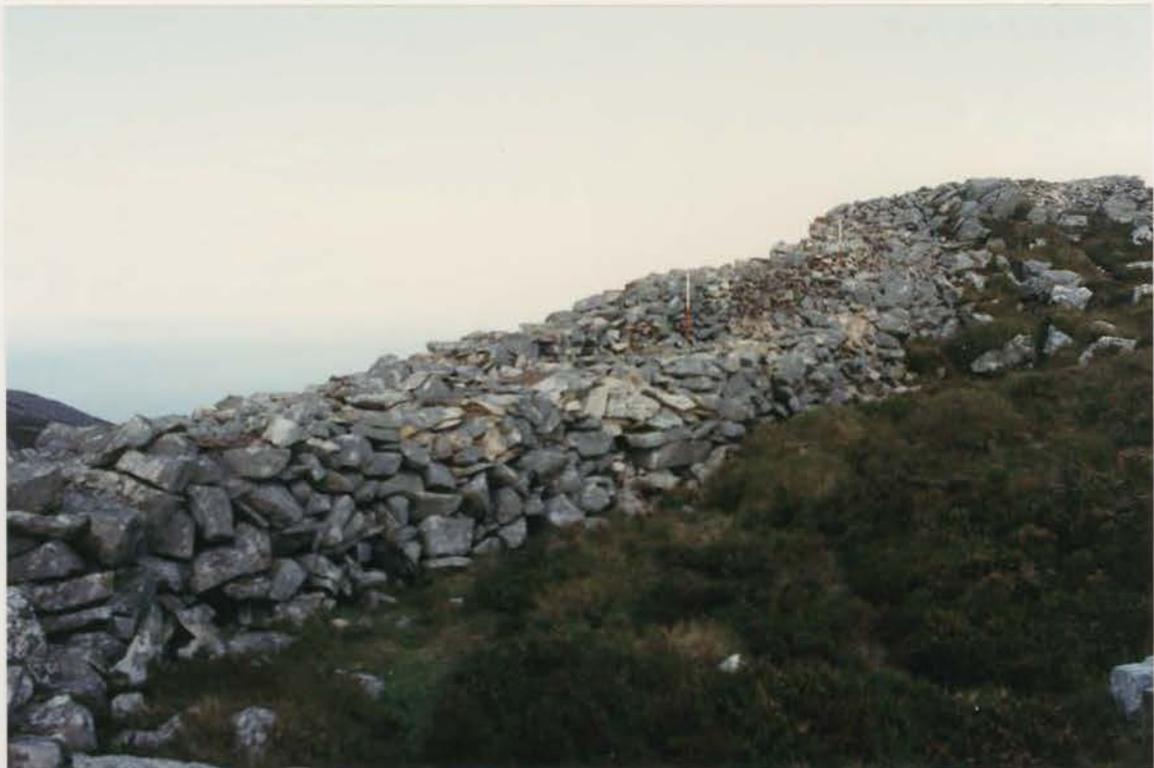
Plate 62. Collapse D11 after conservation, looking NW (G1022/119/04).

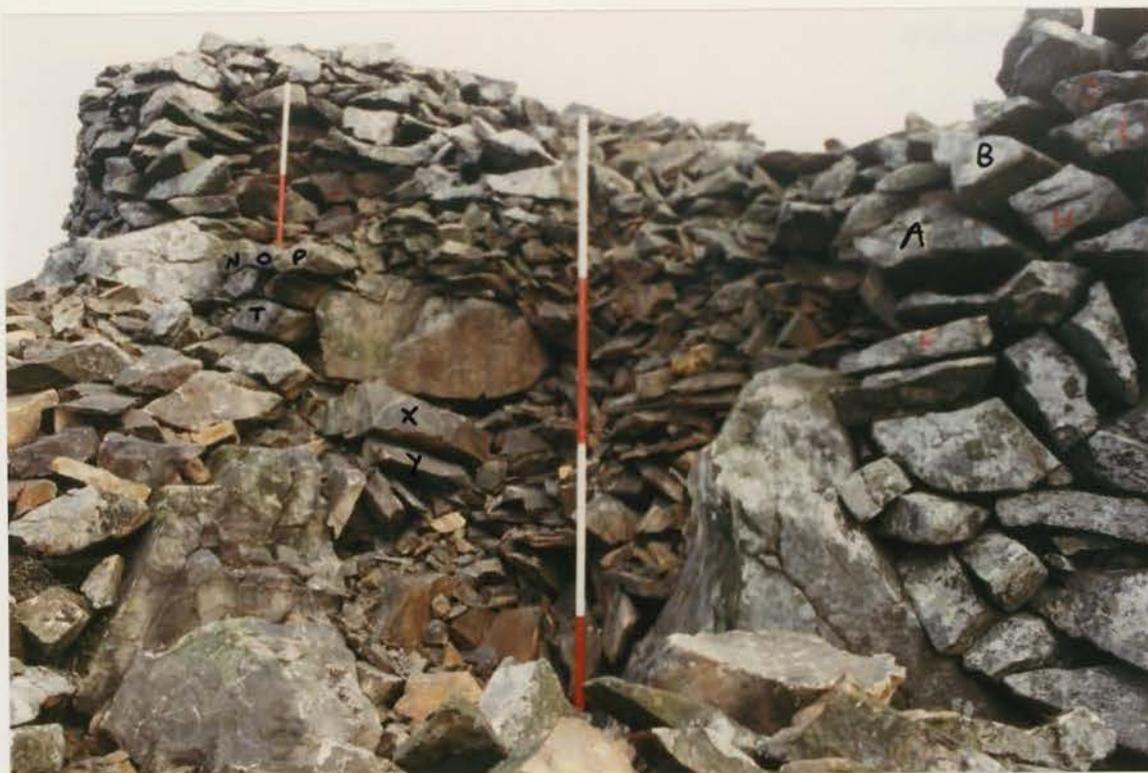
Plate 65. Collapse E before conservation, looking E (G1022/115/21).

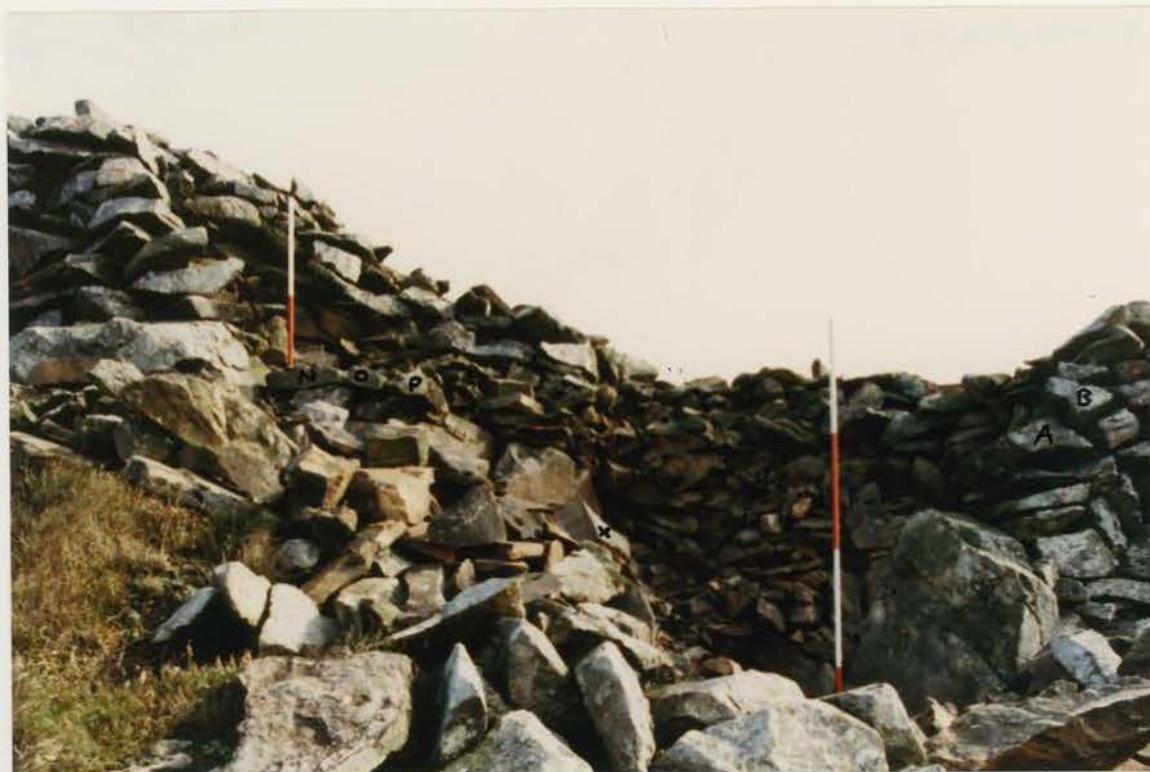
Plate 66. Collapse E after clearance of rubble, looking E
(G1022/116/04).

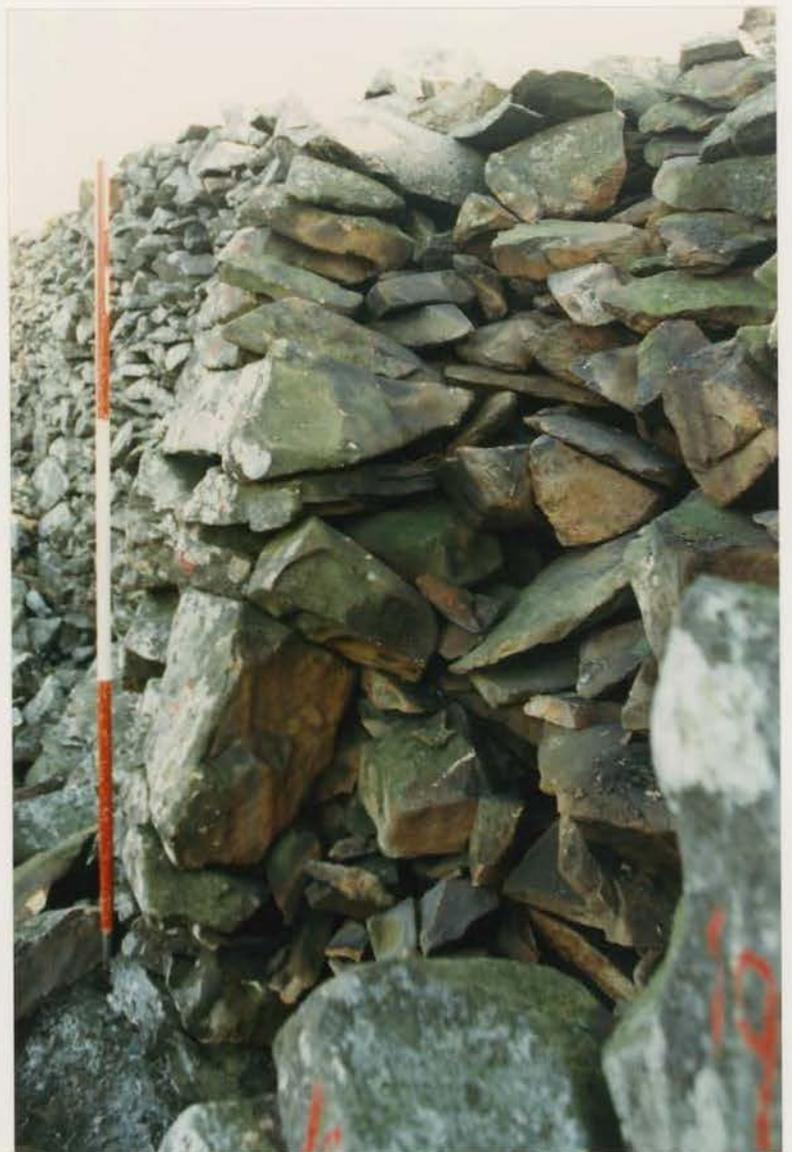
Plate 76. Collapse E3 before conservation, looking S (G1022/116/20).

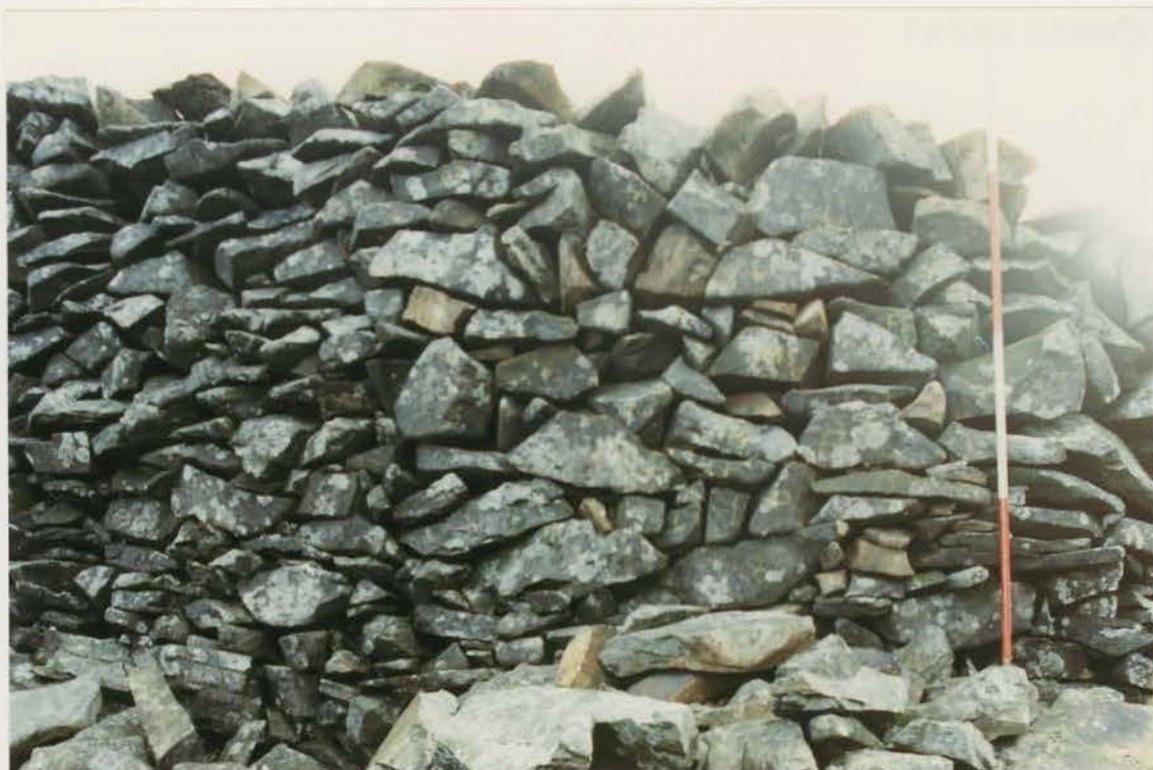
Plate 77. Collapse E3 after dismantling: SW facing section (G1022/116/32).
