TRE'R CEIRI
CONSERVATION PROJECT
1990
PART 2: PLATES

REPORT ON THE SECOND SEASON OF THE
TRE'R CEIRI CONSERVATION PROJECT
JUNE - NOVEMBER 1990

S.D. BOYLE

GWYNEDD ARCHAEOLOGICAL TRUST LTD.

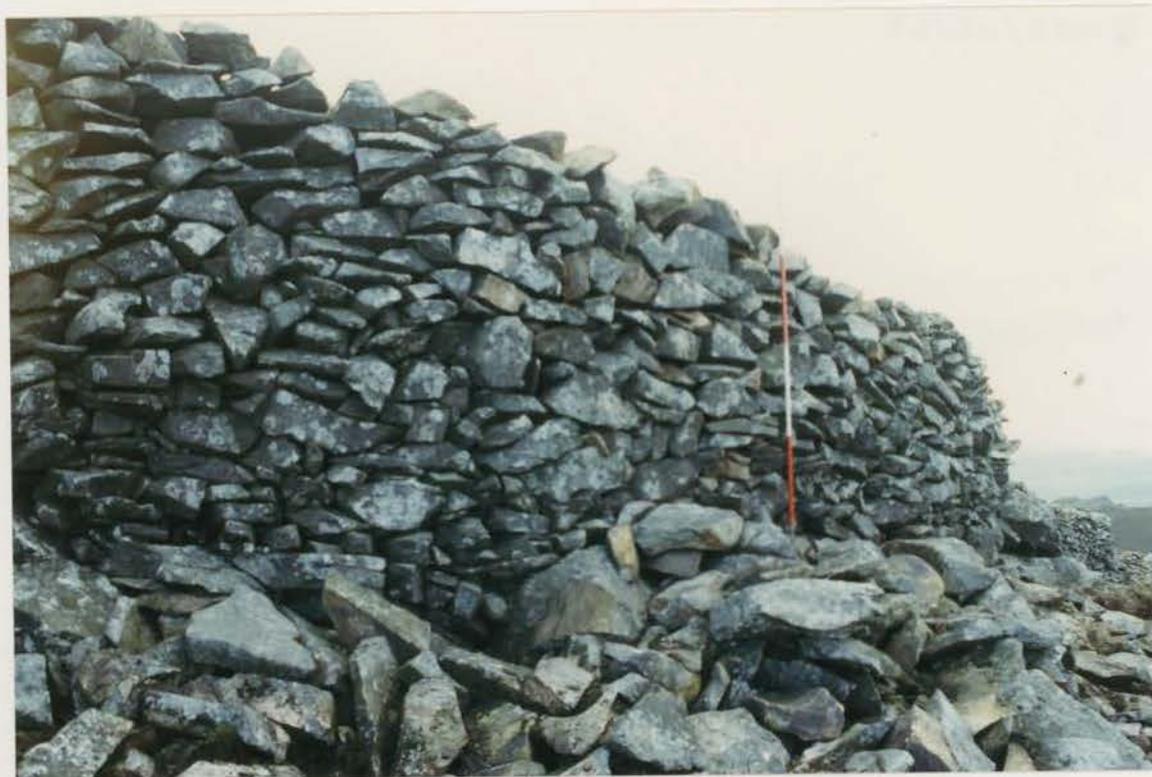
Plate 78. Collapse E3 after conservation, looking SE (G1022/118/27).

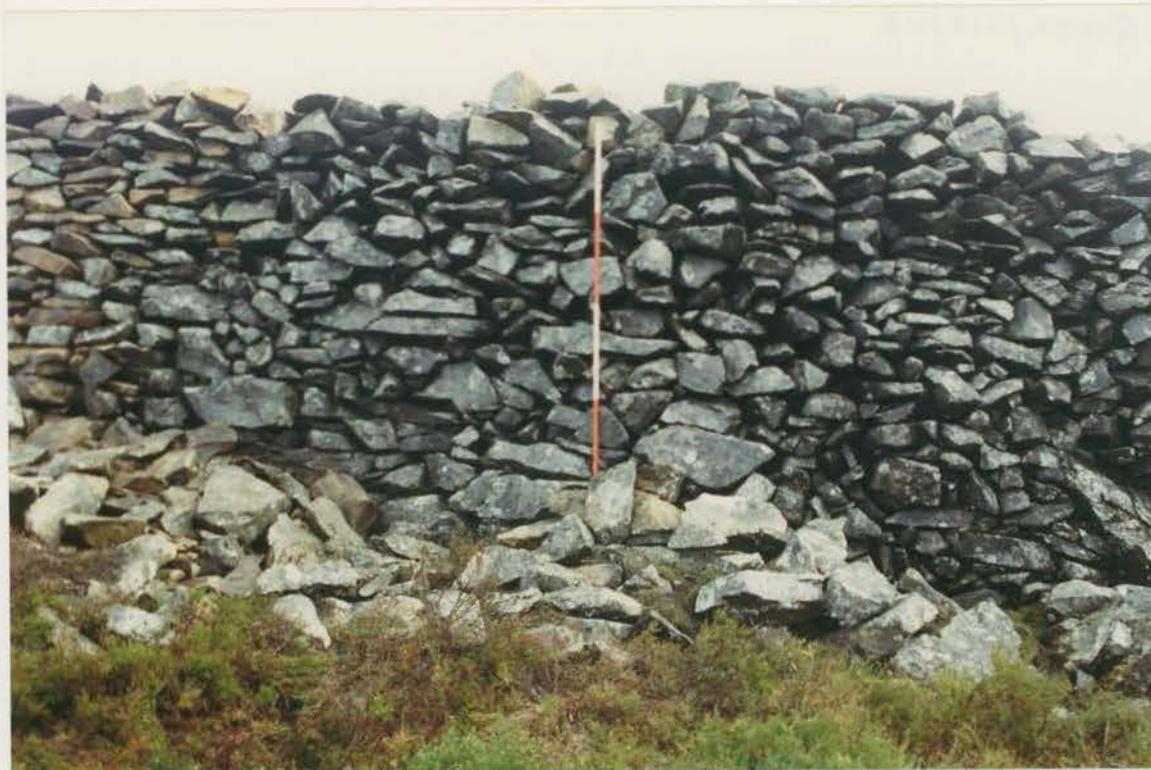
Plate 80. Collapse E4 before conservation, looking SE (G1022/014/12-13).

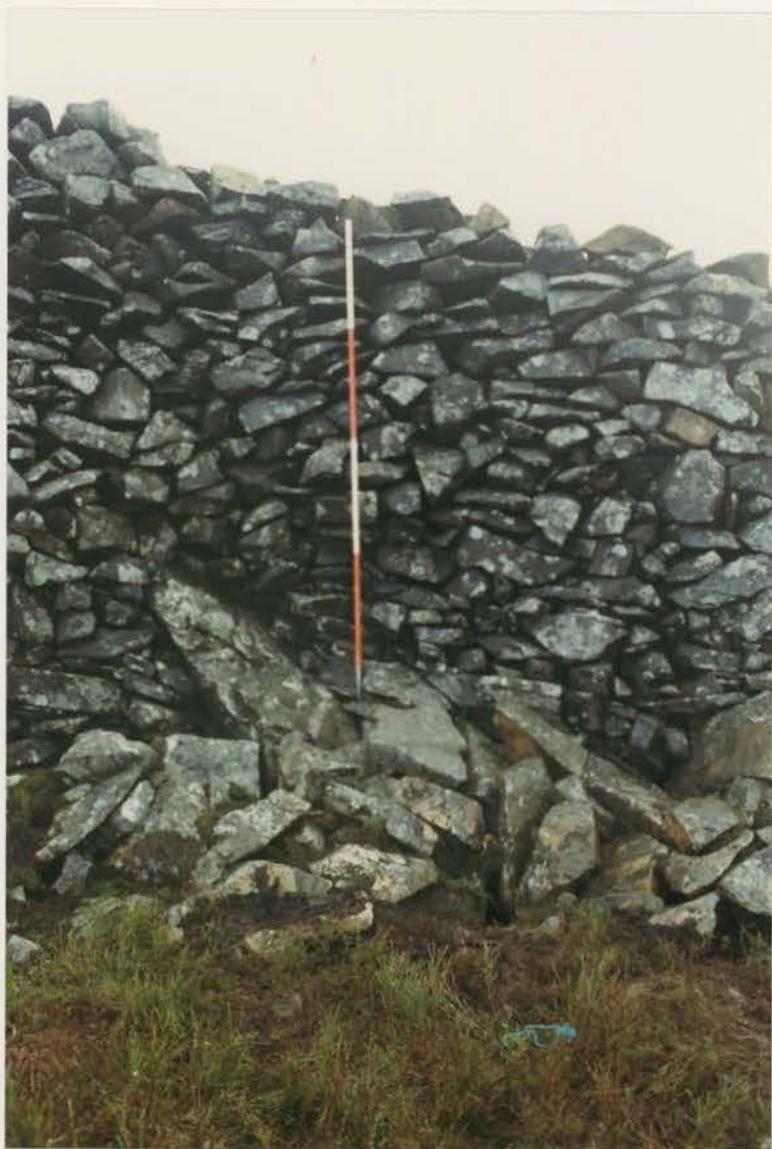
Plate 82. Collapse E5 before conservation, looking SE (G1022/014/09).

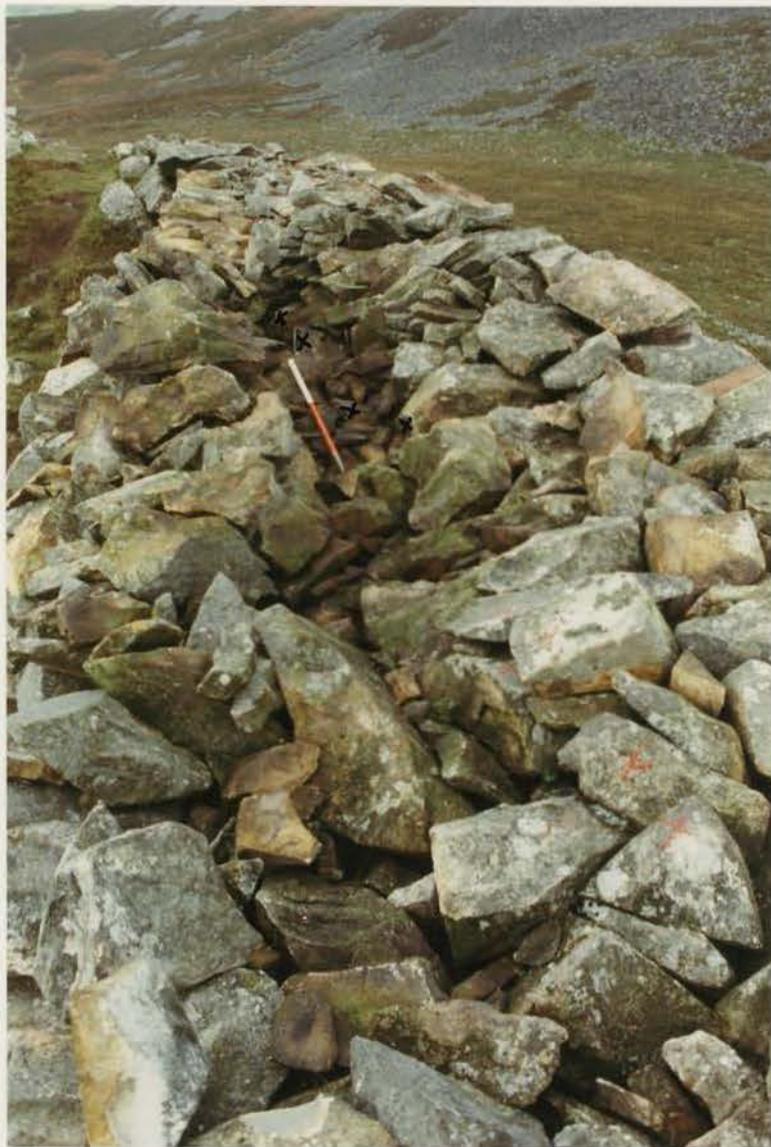
Plate 85. Collapse E6 before conservation, looking NW (G1022/022/22A).

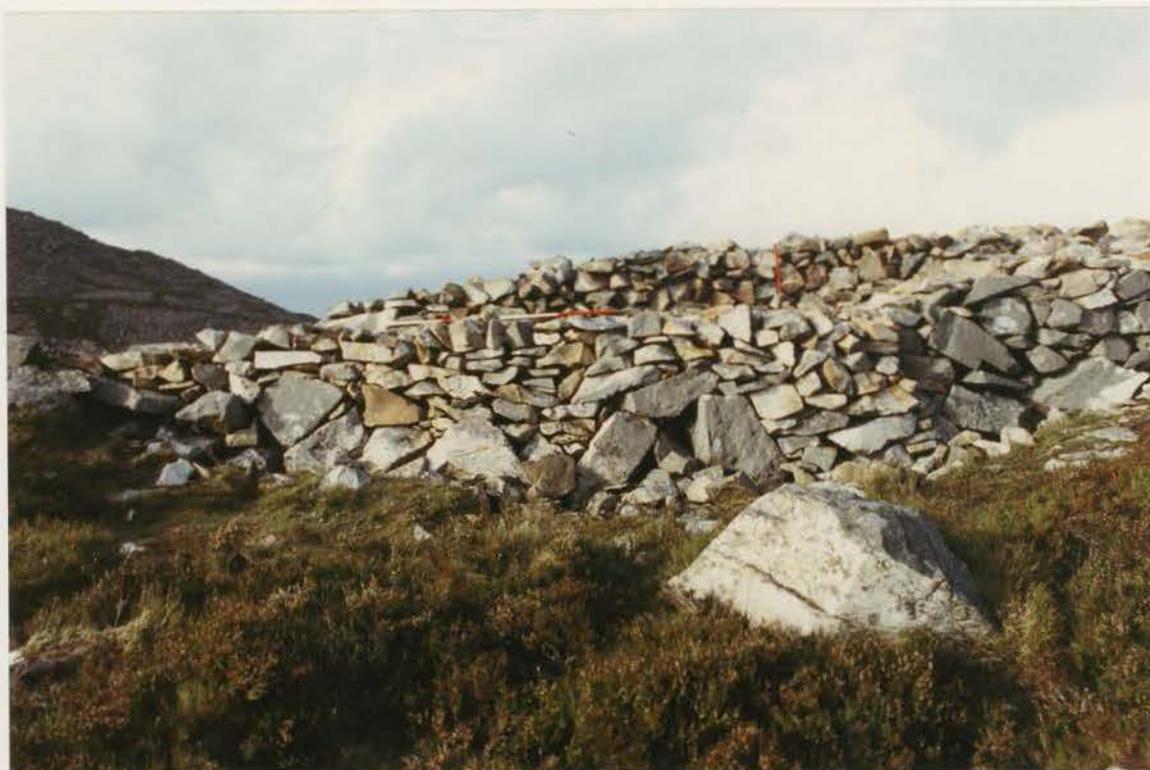
Plate 86. Collapse E6 after clearance of rubble, looking SW (G1022/117/02).

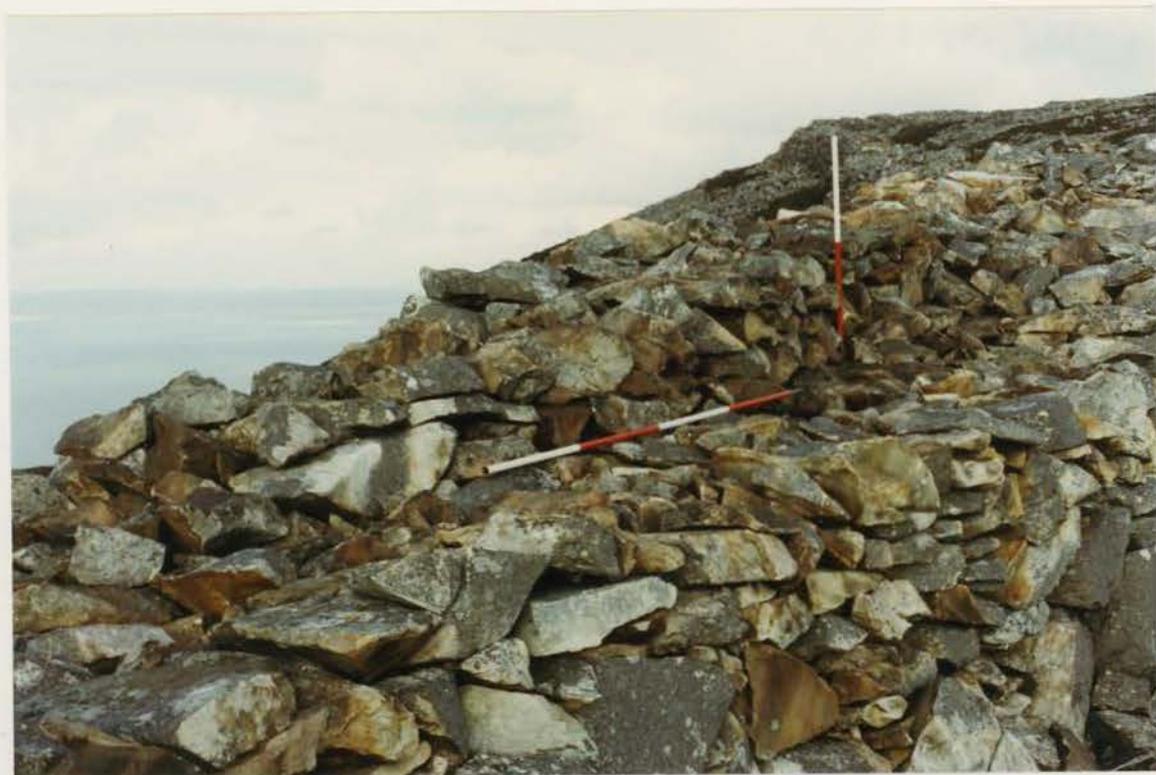
Plate 87. Collapse E6 after conservation, looking NW (G1022/117/15).

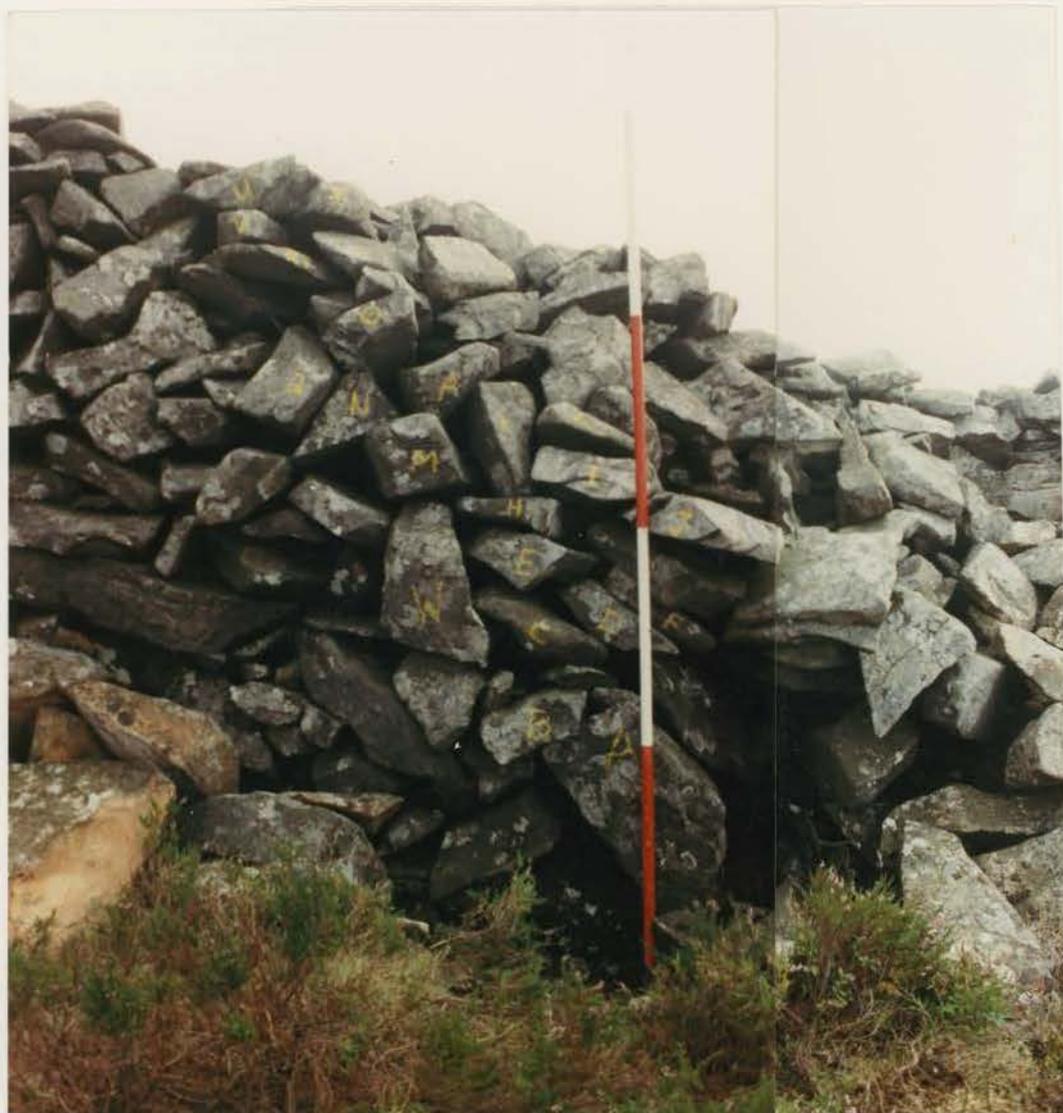
Plate 90. Collapse F before conservation, looking SE (G1022/114/22).

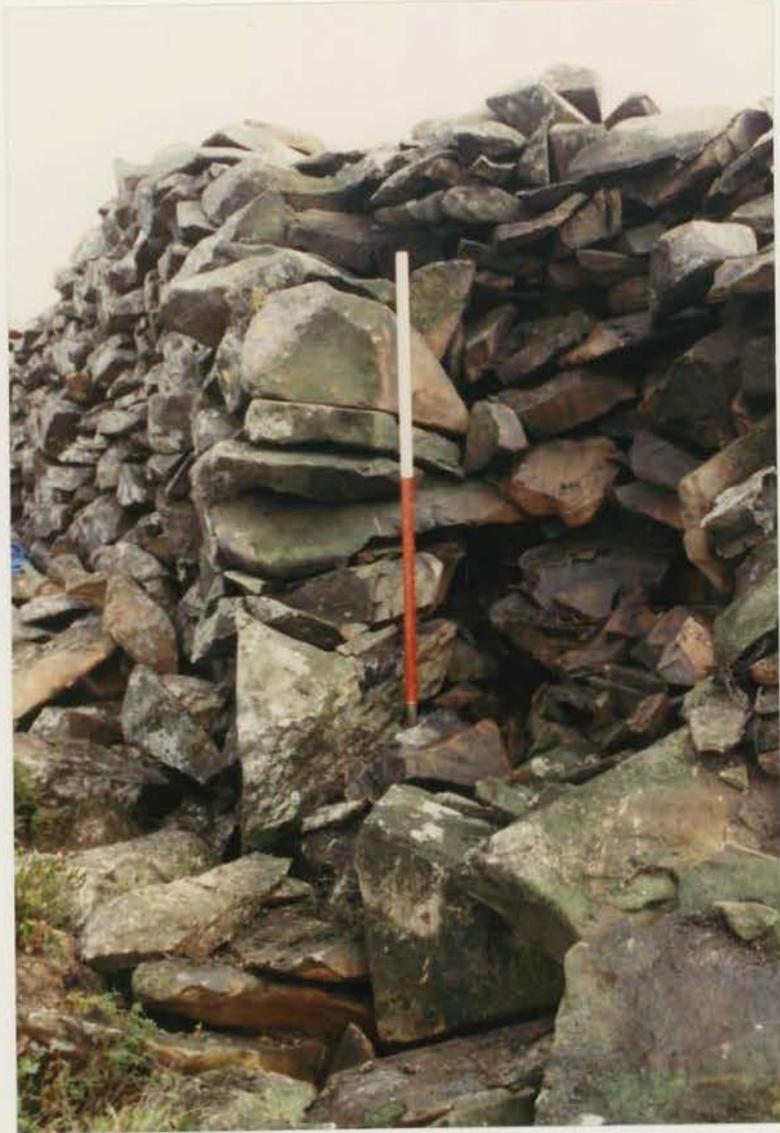
Plate 92. Collapse F: SW edge of collapse,
before dismantling, looking SE
(G1022/114/25).

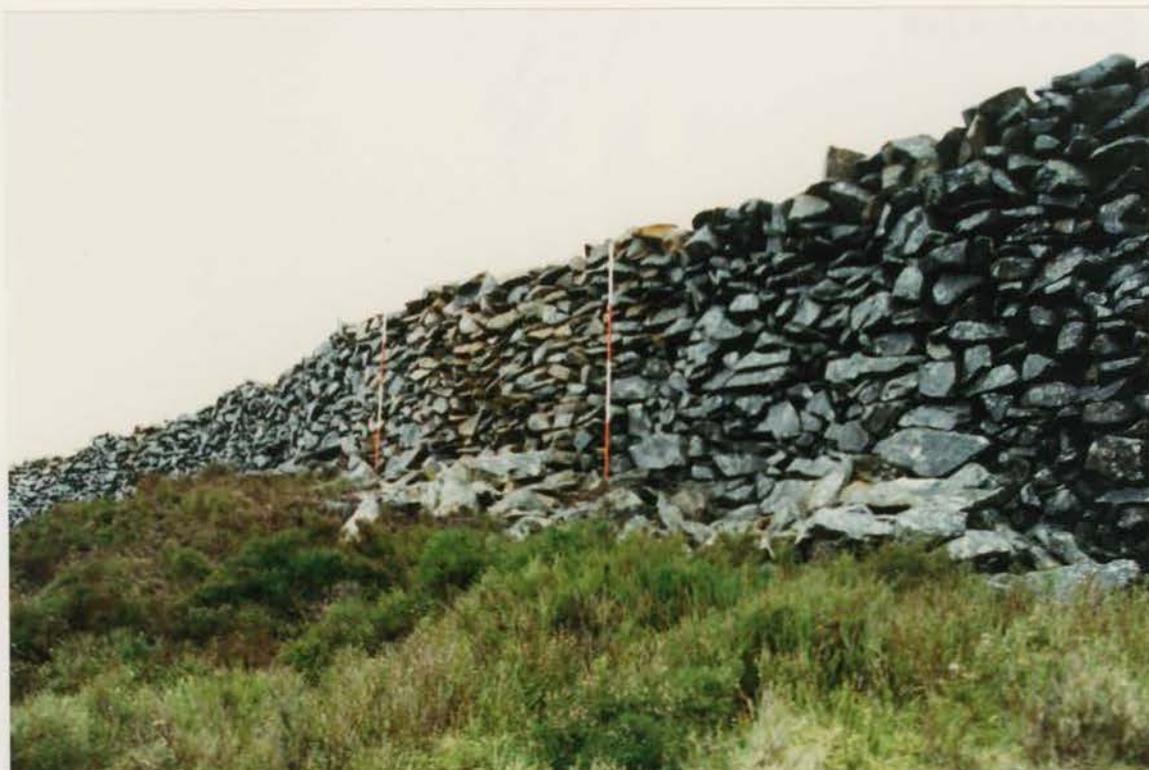
Plate 98. Collapse F after conservation, looking SE (G1022/118/03).

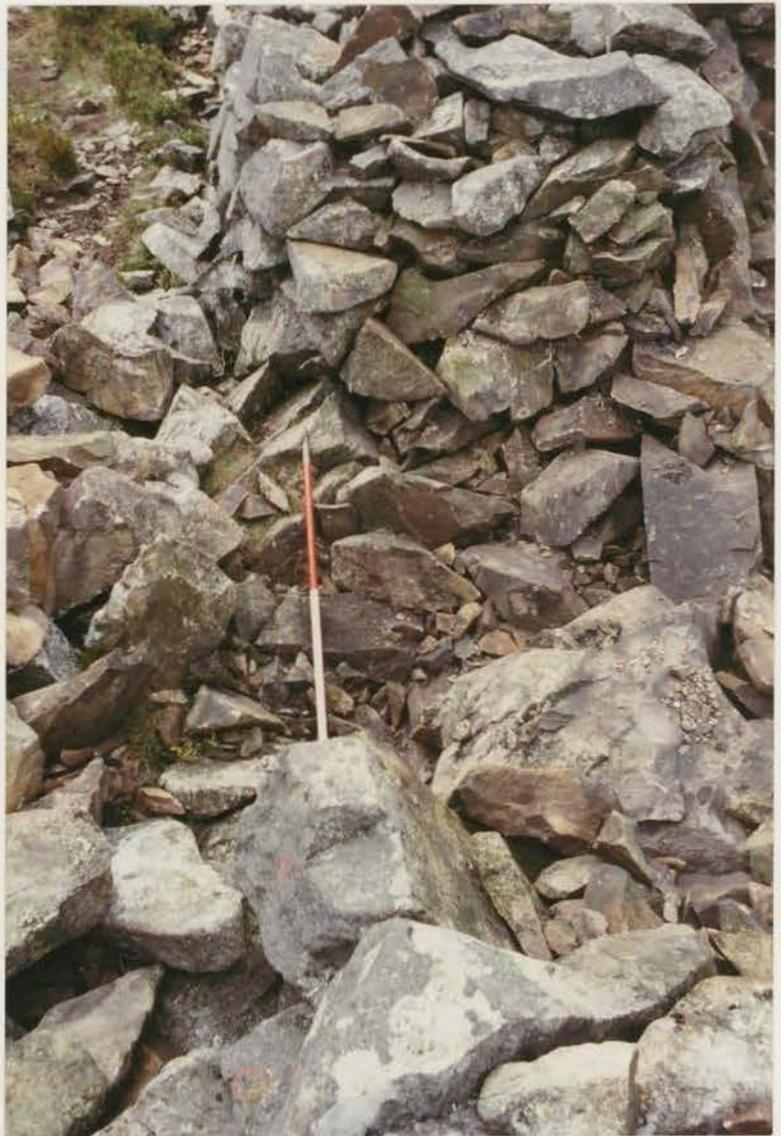
Plate 100. Collapse F (inner face) before conservation, looking NW (G1022/013/09).

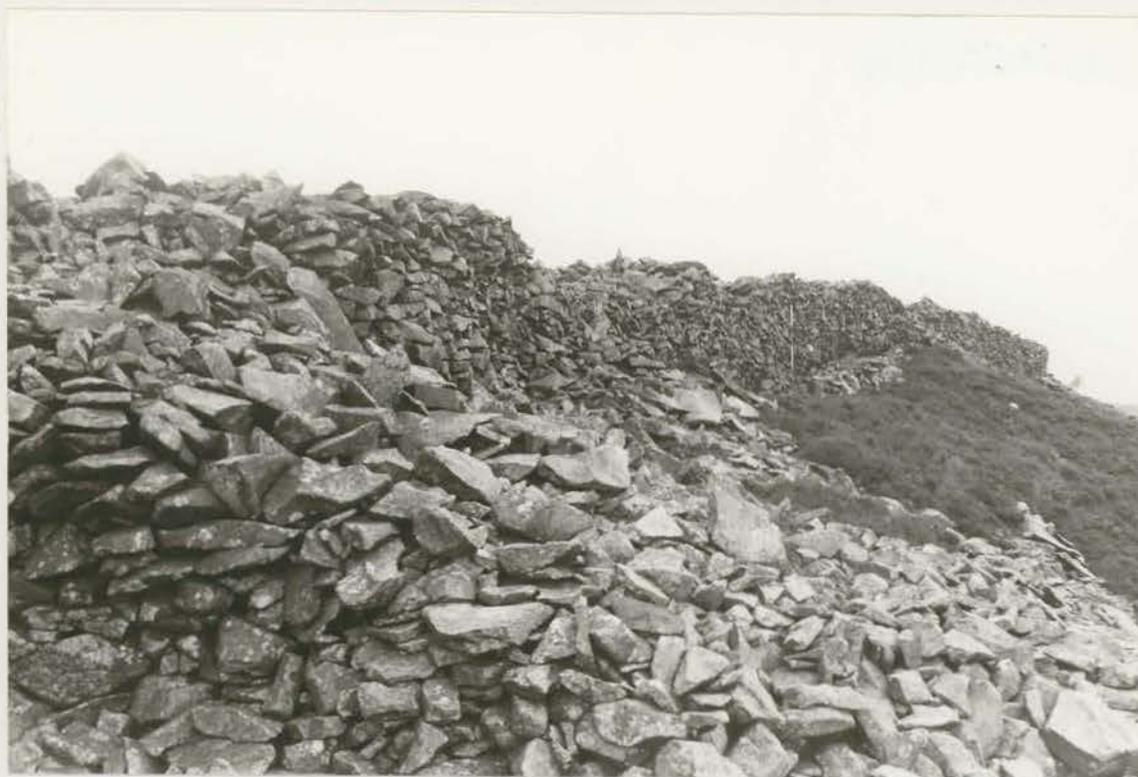
Plate 102. Collapse F (inner face) after conservation, looking NW
(G1022/117/11).

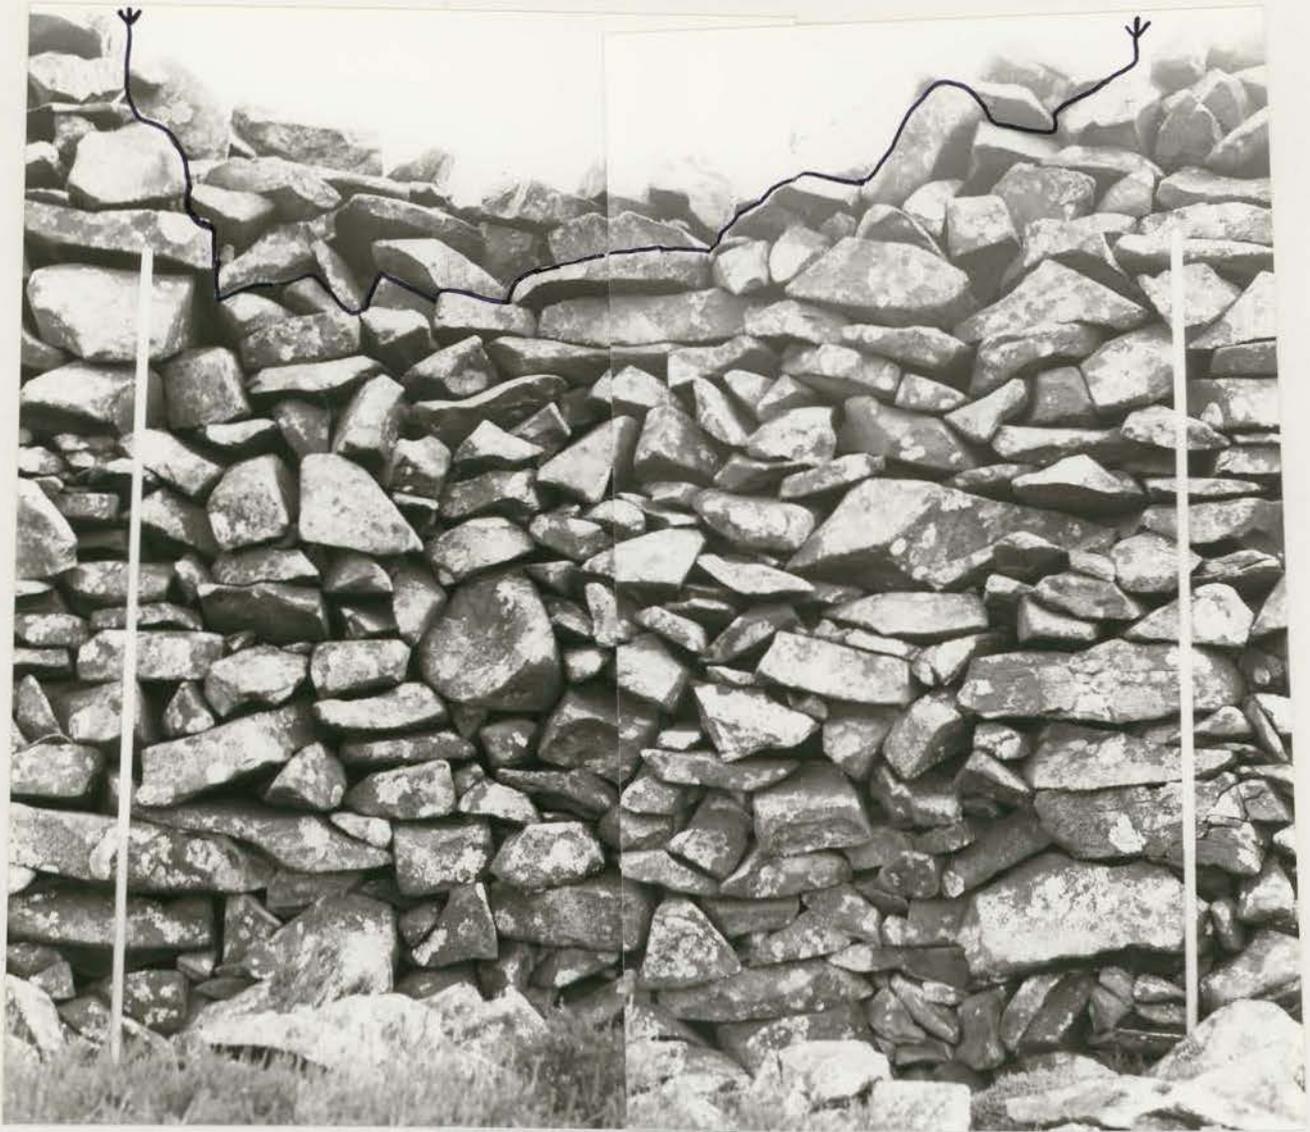
Plate 103. Main Wall F-G: general view before conservation, looking SW
(G1022/015/14).

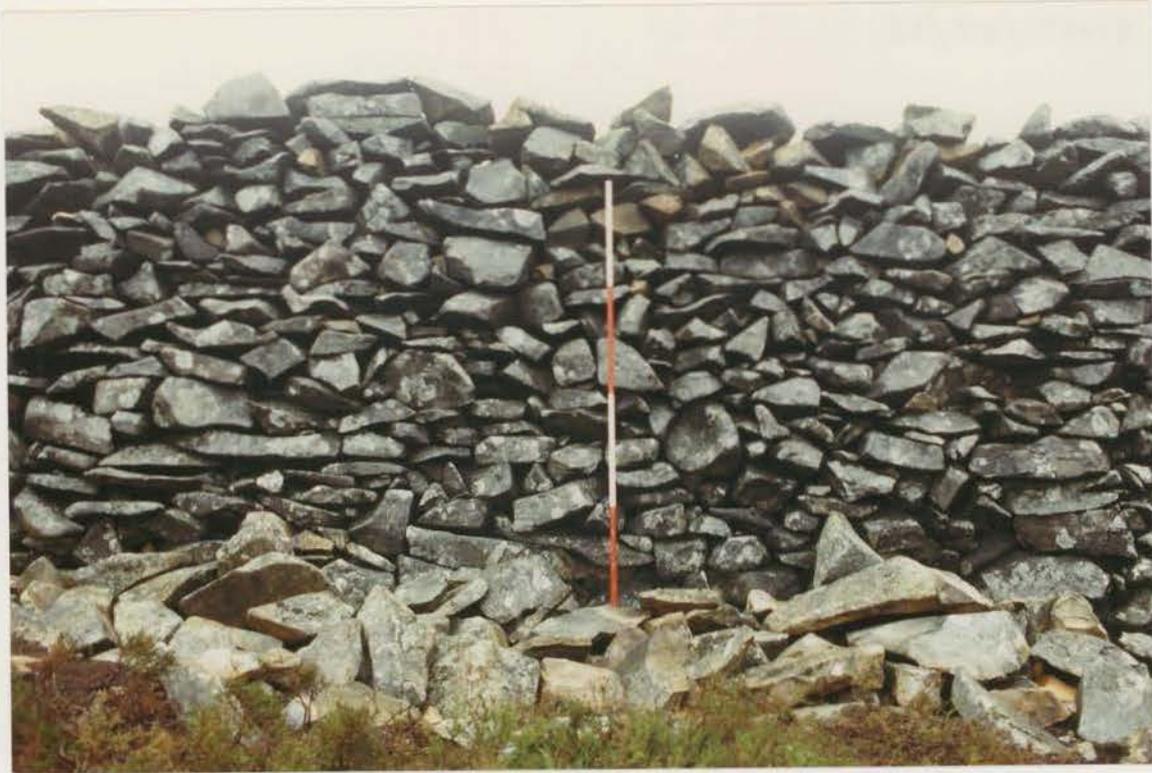
Plate 104. Collapse F2 before conservation,
looking SE (G1022/014/32-33).

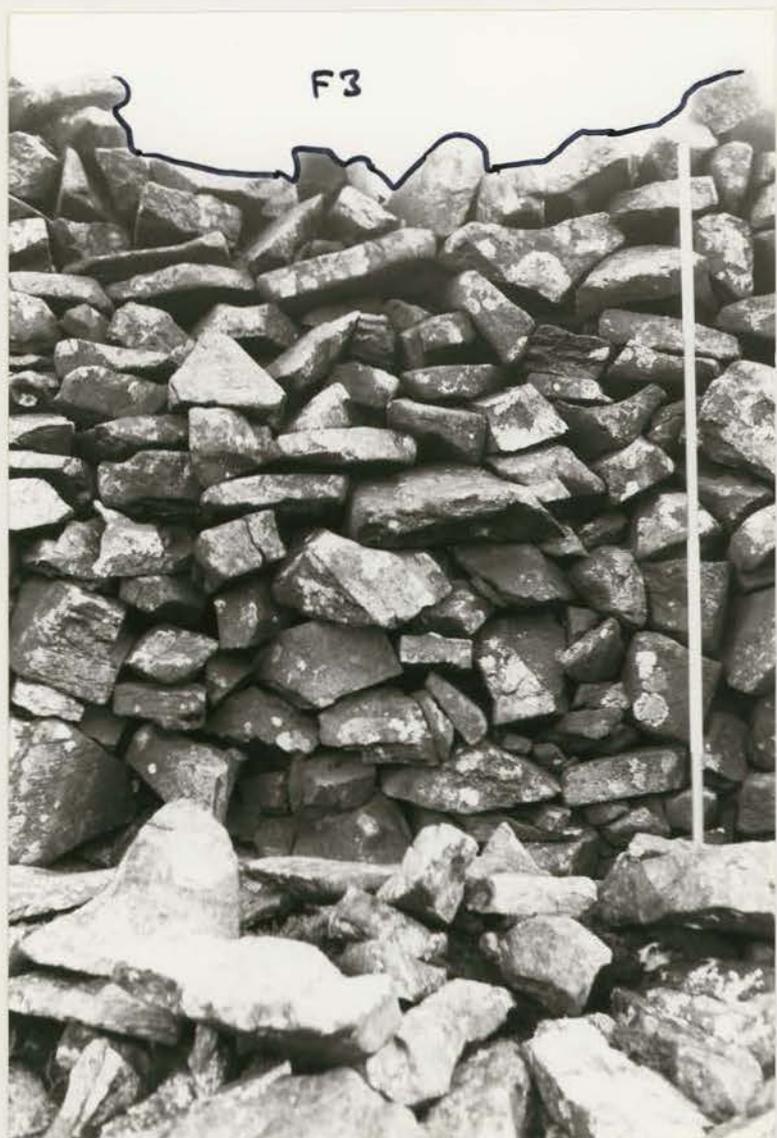
Plate 105. Collapses F2 & F5
after conservation, looking SE
(G1022/117/33).

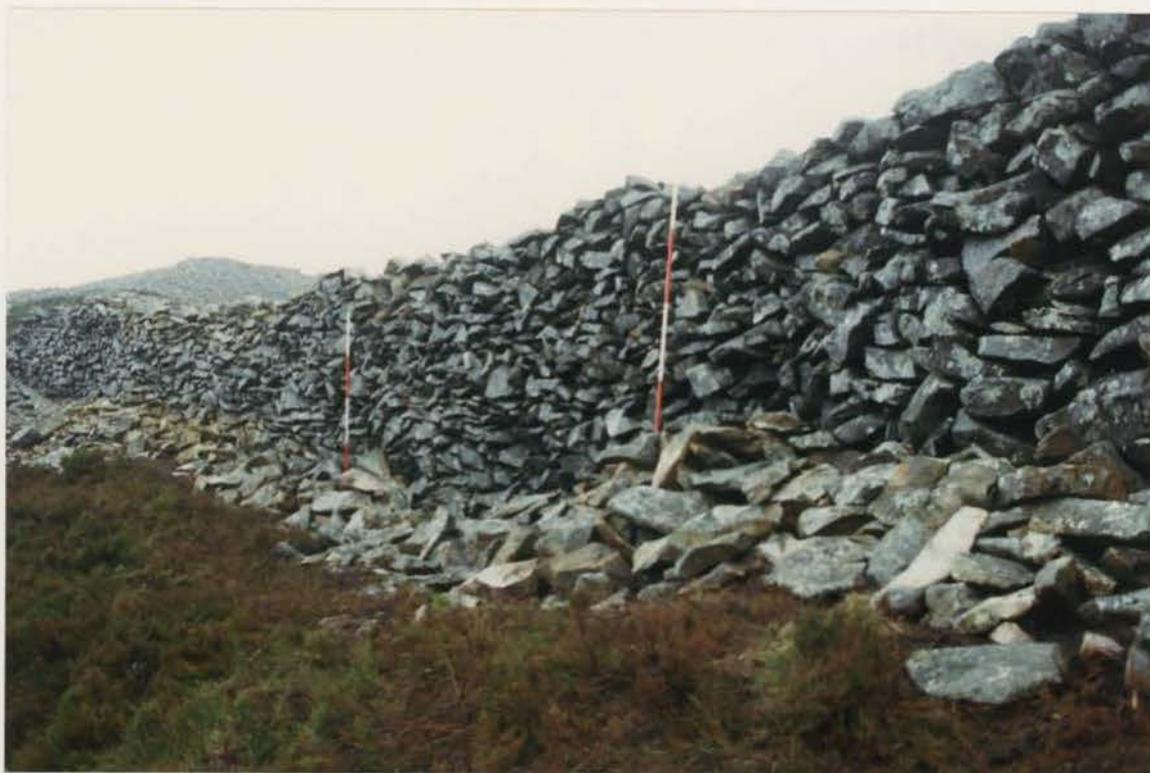
Plate 109. Buttress at Collapse F3, looking S (G1022/118/01).

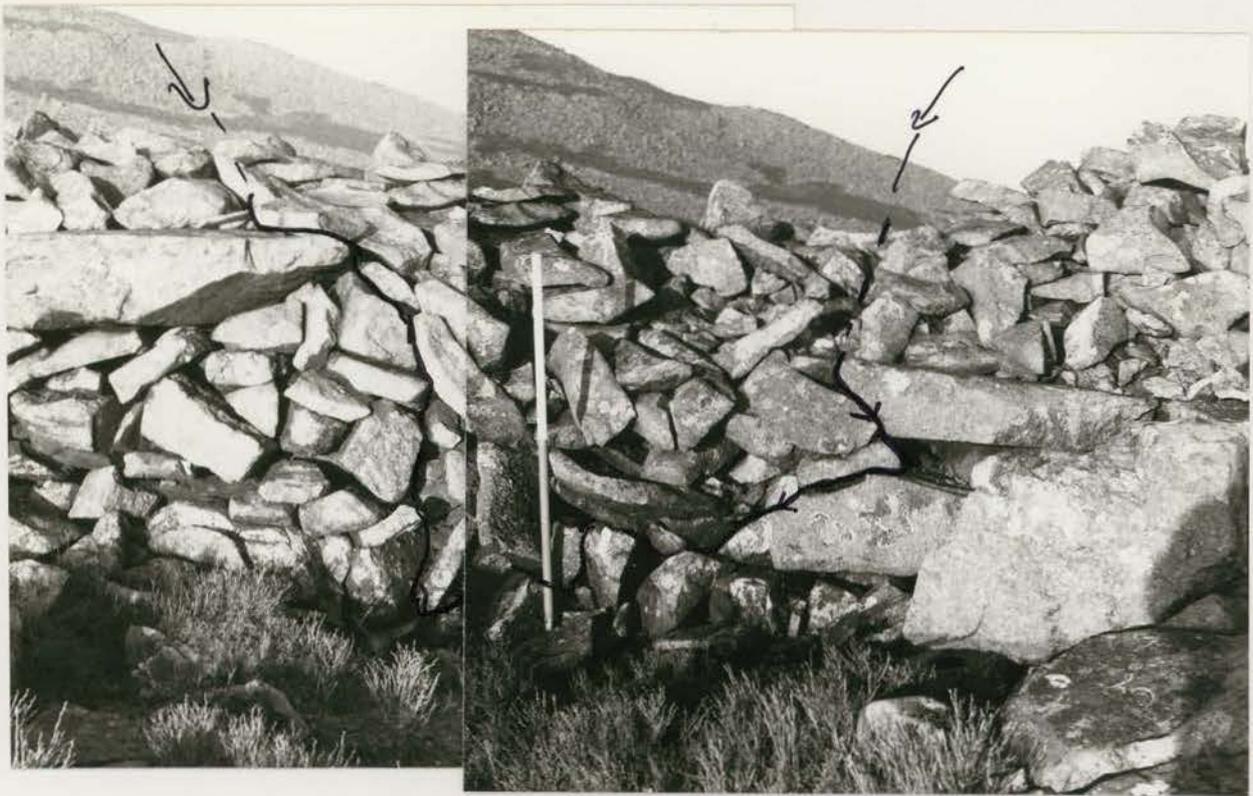
Plate 110. Buttress at Collapse F3, looking NE (G1022/117/36).

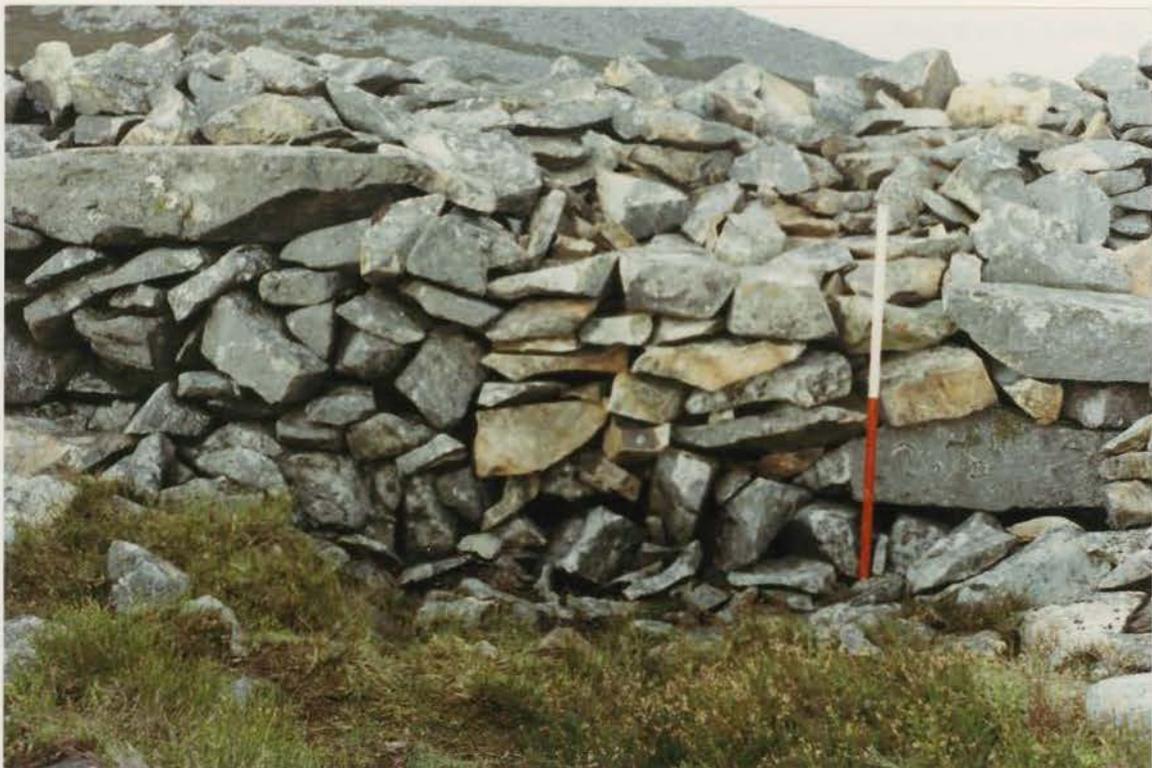
Plate 111. Collapse F4 before conservation, looking NW
(G1022/013/06-07).

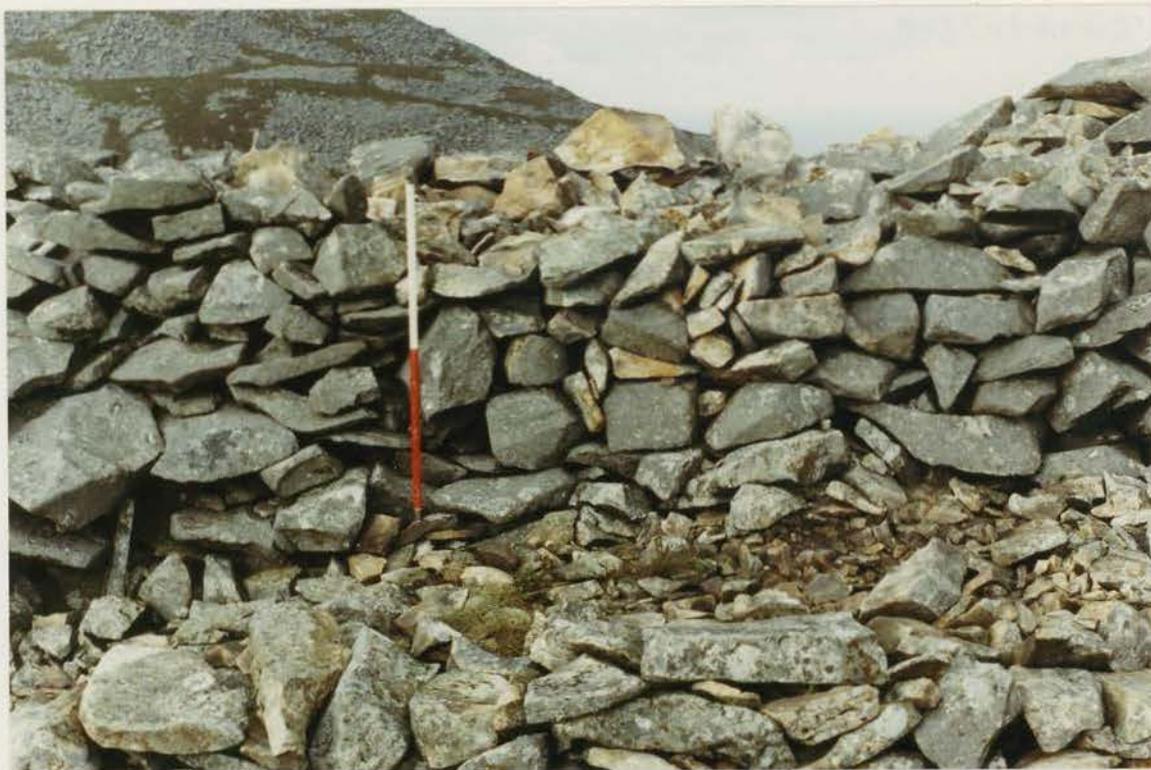
Plate 114. Collapse F6 before conservation, looking NW (G1022/012/31).

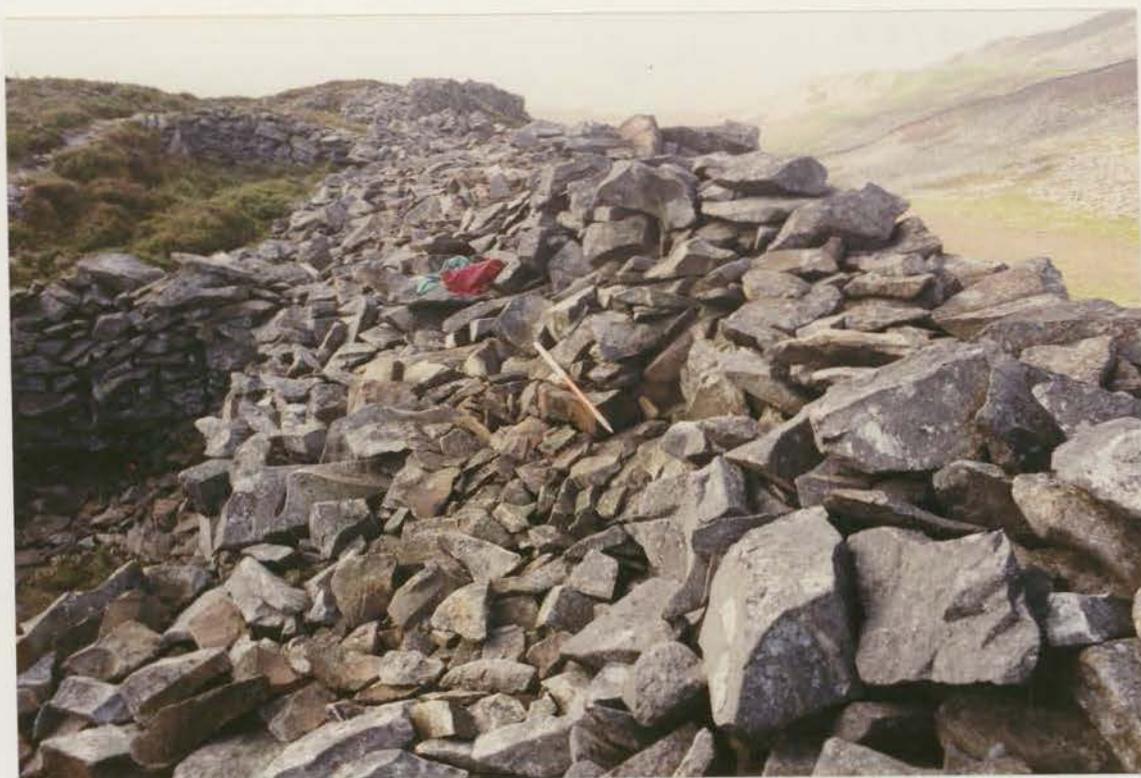
Plate 120. Inner face of main wall at huts 78/78A, before conservation, looking NW (G1022/107/27).

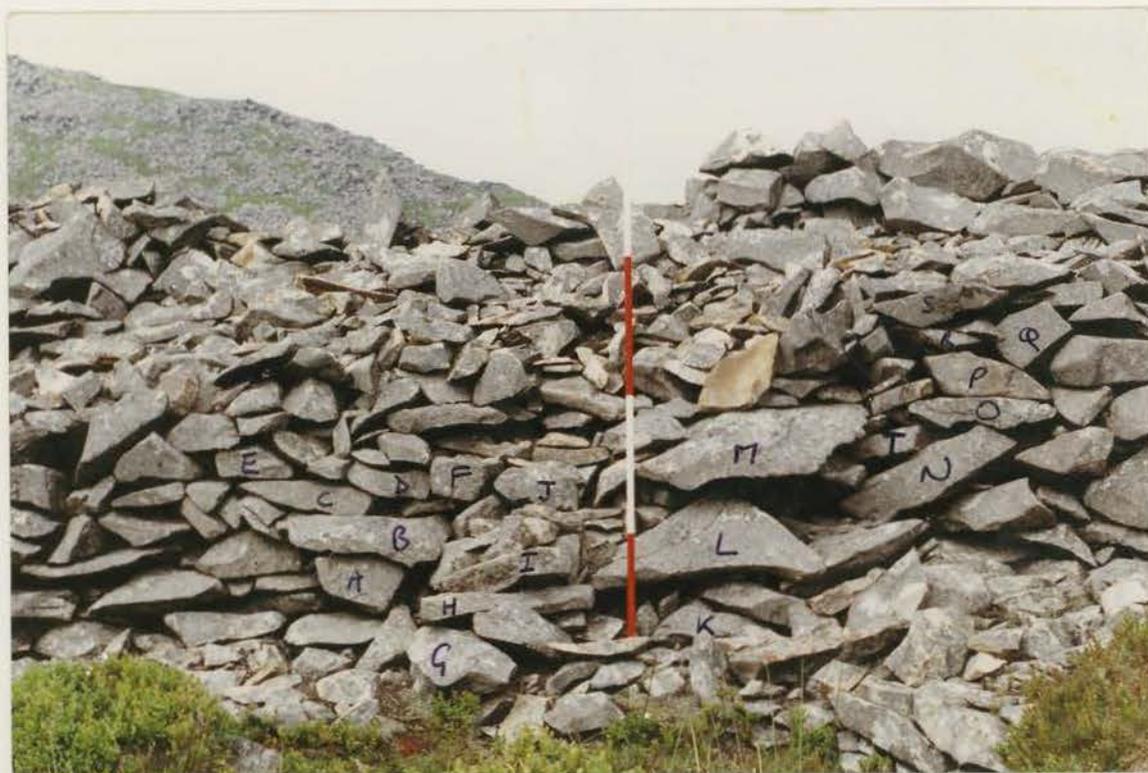
Plate 121. Collapse H2 after clearance of rubble, looking SW
(G1022/113/27).

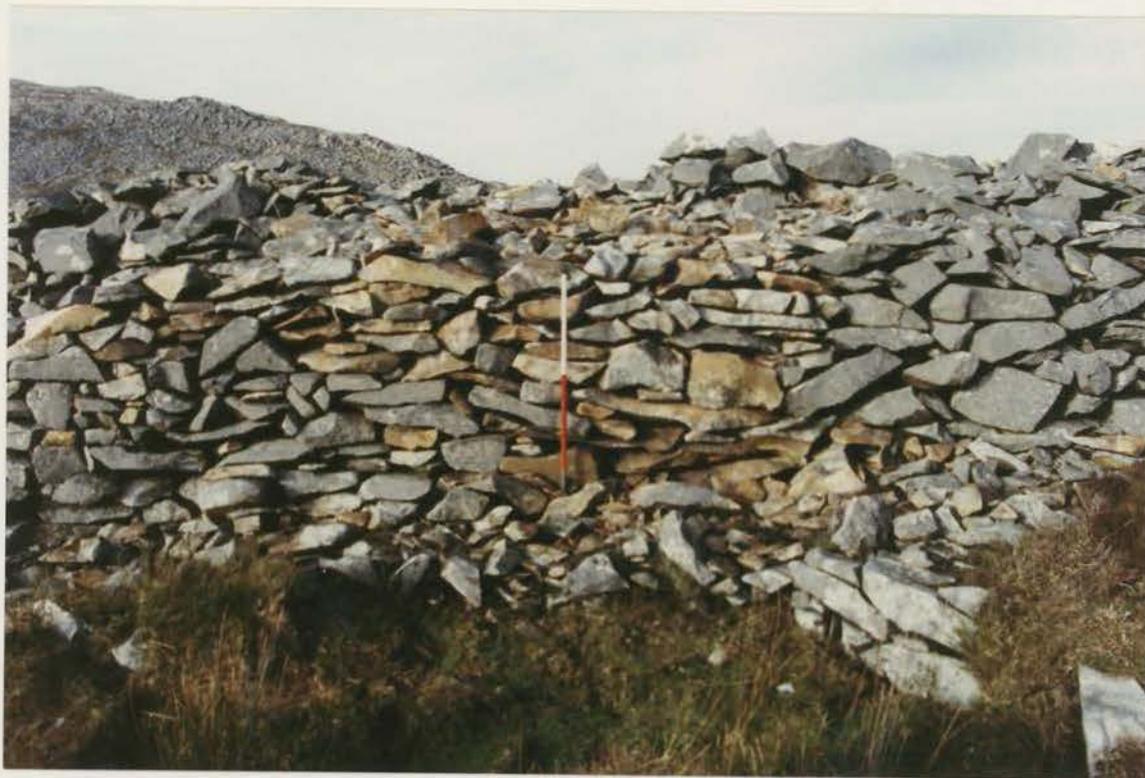
Plate 124. Collapses H2, H3 & H4 after conservation, looking W
(G1022/114/35).

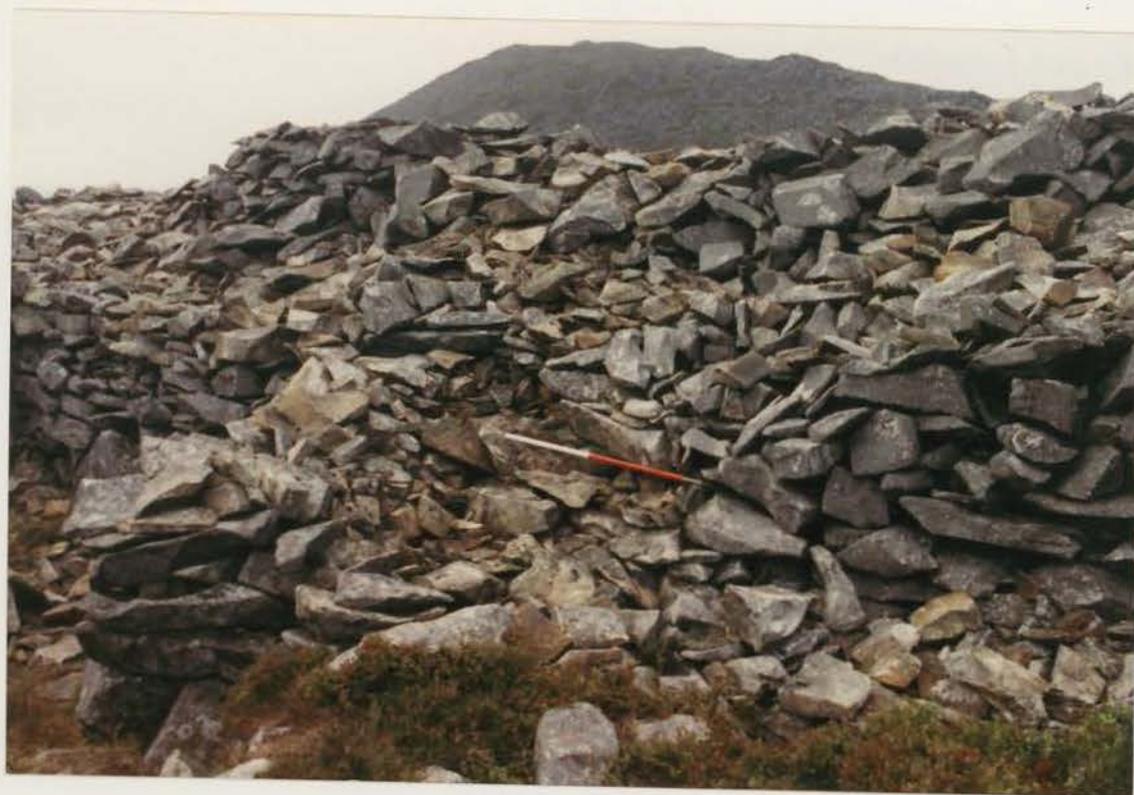
Plate 125. Collapse H3 after conservation, looking NW (G1022/119/06).

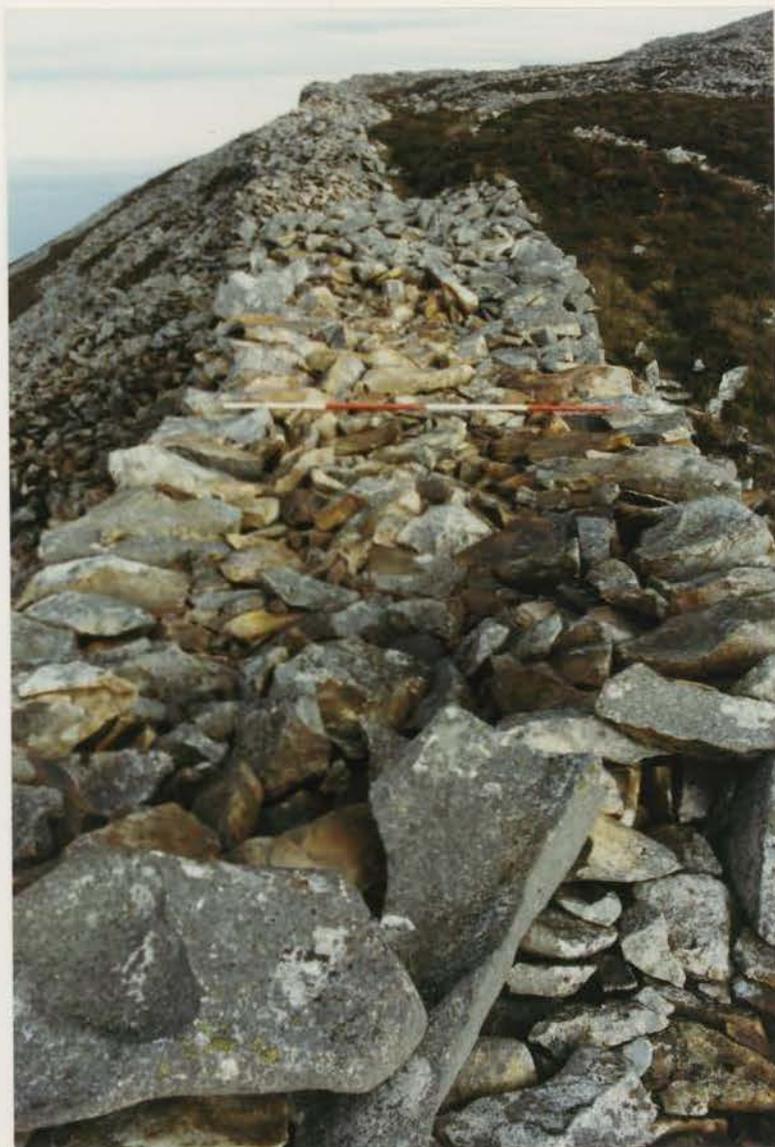
Plate 129. Collapse H4 after conservation, looking NW (G1022/119/05).
