# Assessment and Scheduling Enhancement Maenan Abbey, Llanrwst

Project No. G2213

Report No. 1039

Prepared for : Cadw

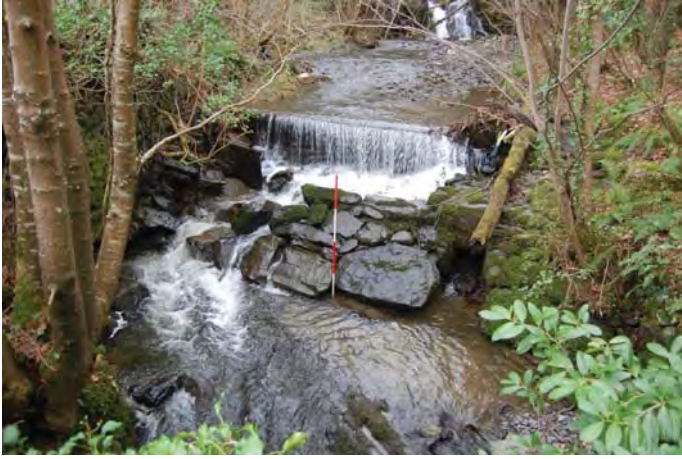
There are no significant threats to the features above the A470, with the exception of the lower weir. This is partly damaged, presumably by water erosion, and some very large stones have already been removed. Further damage seems likely but this is a late, minor feature so remedial work may not be appropriate.

Plate 5: Weir (PRN 34134), from the SW

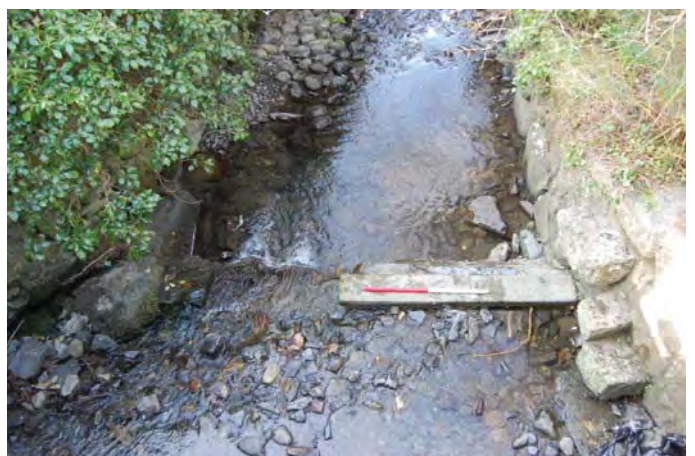
Running across the stream at this eastern end is a small weir or dam (050) (plate 16). This is only 0.4m high and its upper parts are constructed of concrete blocks but these are set on stones and it is possible that the concrete blocks and apron of concrete below the stones are later repairs and that the structure was originally entirely of cut stone blocks. This is likely because stone steps (042) (plate 17) are set in the northern wall of the channel at this point. There are 3 steps and a large flat slab in the base of the stream, giving access to the pool behind the weir to collect water before it was piped from higher up the stream directly to the houses.

Plate 16: Weir, part of PRN 34147, from the NE

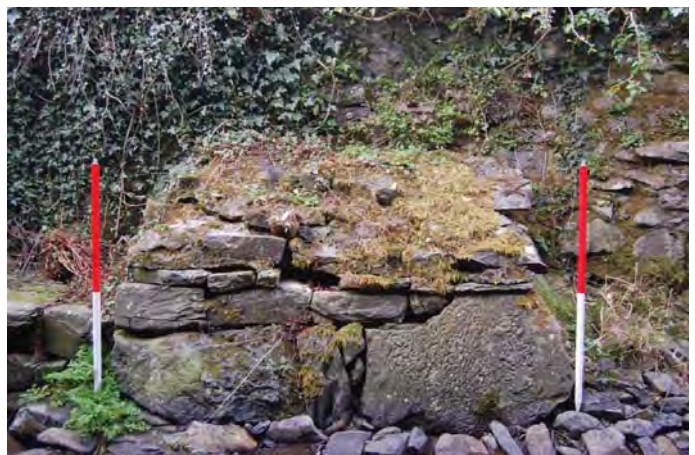
Plate 24: Bridge pier probably dating to about 1801 (PRN 34652), from the SE

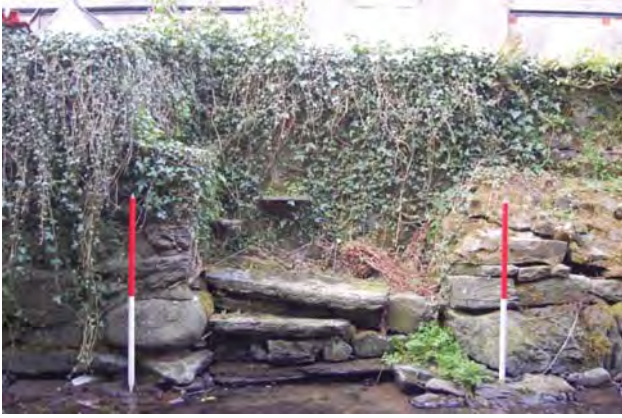
Plate 25: Steps probably dating to about 1801 (PRN 34652), from the SE

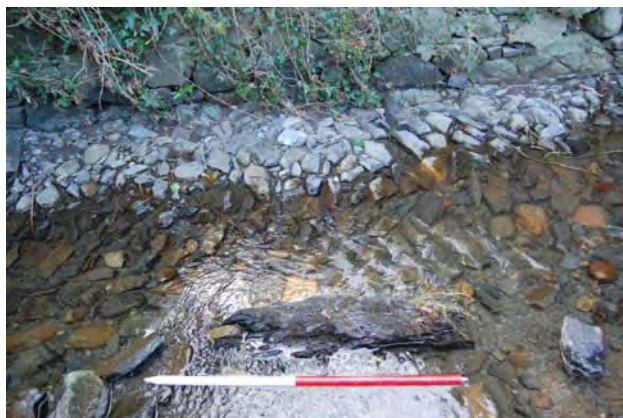
This is deeply embedded on the stream bed, projecting by about 0.1m. It seems likely that this was related to the bridge that ran across to the gateway, although it does not seem to be a foundation for a supporting pier.

Plate 27: Stone in bed of stream (086), part of PRN 34653, from the N

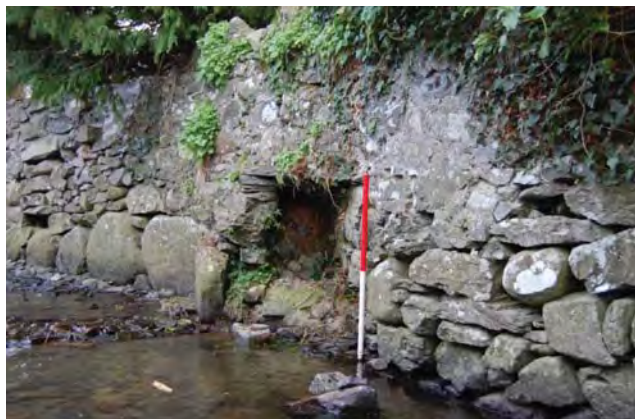
The large drain (023) is certainly of mid 19<sup>th</sup> century date. The foundation plan of the house shows the main drain running from the south of the house directly towards (023) and the plan notes that the drain is running to “the outfall”. The visible angle of the drain suggests that it was deliberately built to take this new main drain and that this was not a reused earlier outfall.

Plate 28: 19th century outfall (023), from the N

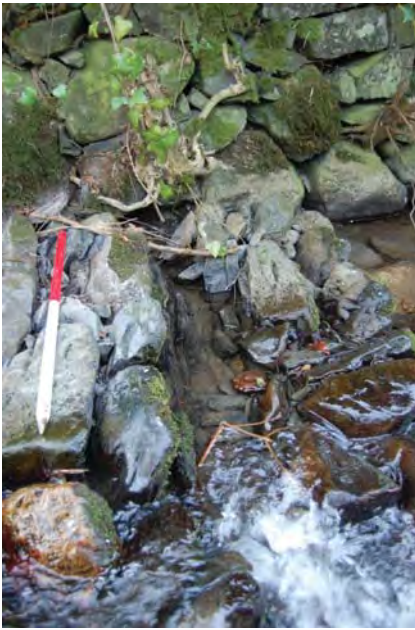
The function of the beams was probably to resist lateral movement of the cobbles, especially when battered by boulders during floods (David Austin pers. com.). The timbers are therefore an integral part of the cobbling. Unfortunately this device intended to strengthen the cobbling over time has created a significant weakness. All the eroded gaps in the cobbles seem to have started from a timber slot. As the timbers rot they present a weakness exploited by the water. Once erosion has started at the beam a small waterfall is created which undermines and dislodges cobbles and works its way gradually downstream. In one erosion hollow a piece of timber was found. This was of exactly the same size and shape as the *in situ* timbers and is almost certainly part of a beam and probably originated from the eroded timber slot adjacent to which it was found.

Plate 31: Timber beam (052) set into wall (002), from the NW

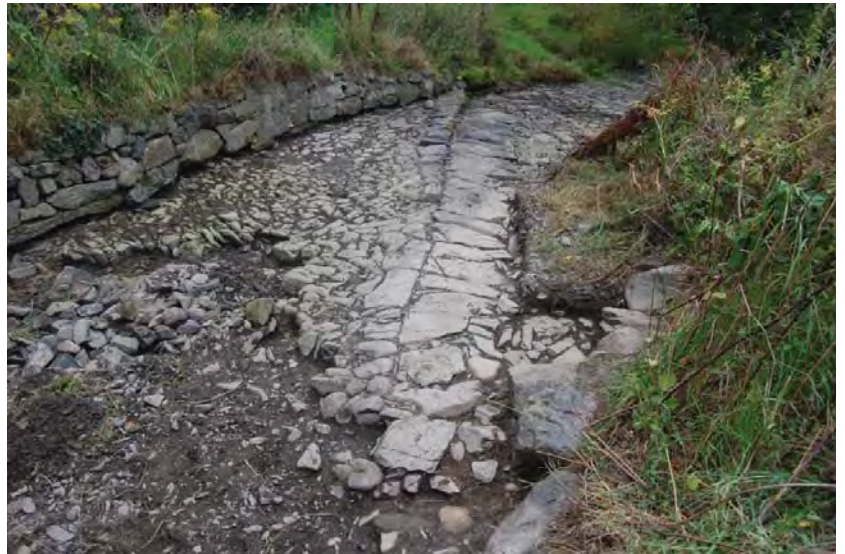
Plate 32: Stone 'weir', PRN 32589, from the E
