**RESTORATION AND INTERPRETATION OF
THE BAKERY AT LLYNON (G1690)**

**REPORT ON PHASE 1 AND
RECOMMENDATIONS FOR PHASE 2**

Client: Oriel Ynys Môn

**GAT Report 1062
(Compiled 18/07/2012)**

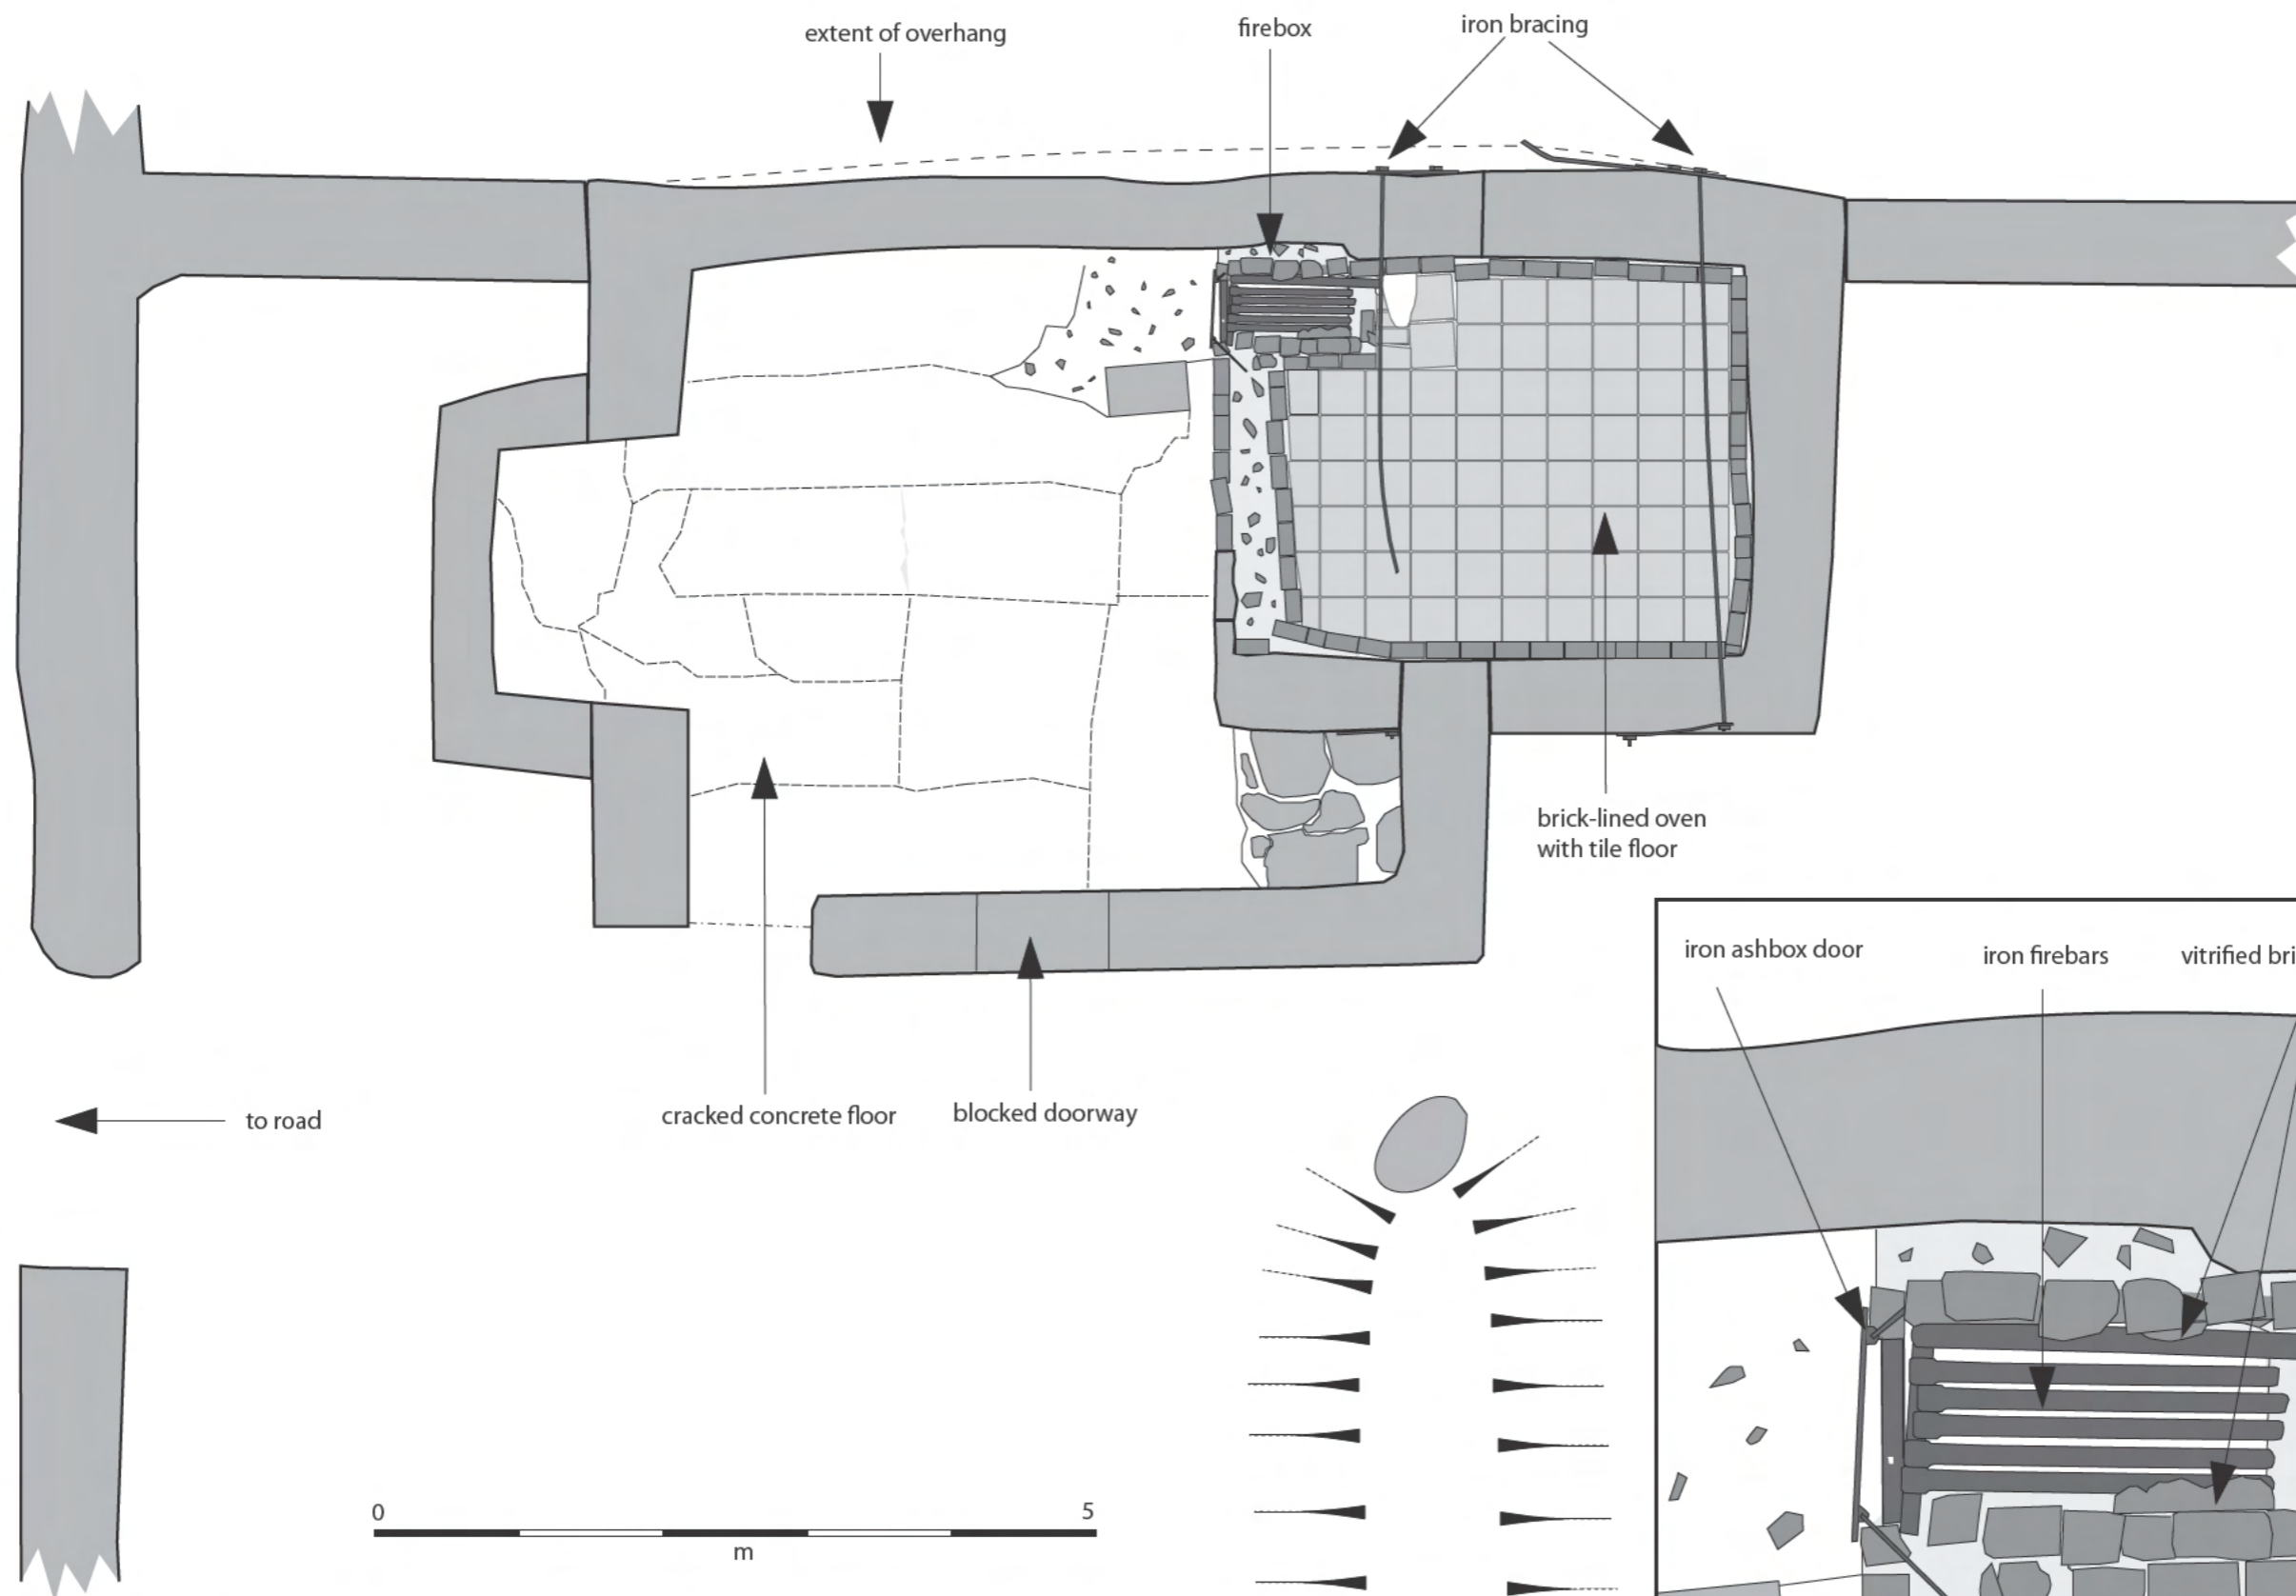
Fig. 2 SURVEY OF STANDING BUILDING WITH DETAIL OF FIREBOX (INSET)

The building could be seen to contain two phases of masonry (see fig. 2). The original cottage appears to have been rectangular with internal dimensions of 9.0m x 10.0m. The walls were constructed from lime mortared, irregular local schistose stones and were typically 0.6m thick. Large stones, some over a metre in length, were used at the corners. The main parts of the walls were, however, constructed from unusually small stones, many less than 10cm in length. Remains of a lime mortar render survive on parts of the interior walls. A blocked doorway, presumably from the first phase of building can be seen in the centre of the southern wall. The southern wall had only survived to a height of 0.4m to 0.6m so there were no surviving windows on this side of the building. A small (2.6m x 3.7m internally) lean-to extension abuts the west wall of the house and appears to be part of the cottage phase as the 1900 ed. 25" OS map shows the lean-to but no oven. The second phase of building is marked by the blocking of the central doorway and the opening of a new doorway at the western end of the southern wall along with the insertion of a stone extension into the eastern wall containing a substantial brick-lined oven (6.5m x 5.0m internally). The bakery floor is of concrete apart from a small area in the south-east corner that is roughly flagged. A regular pattern of cracks in the concrete suggests that it has been laid over stone flags and that stress points have occurred along the flag edges.

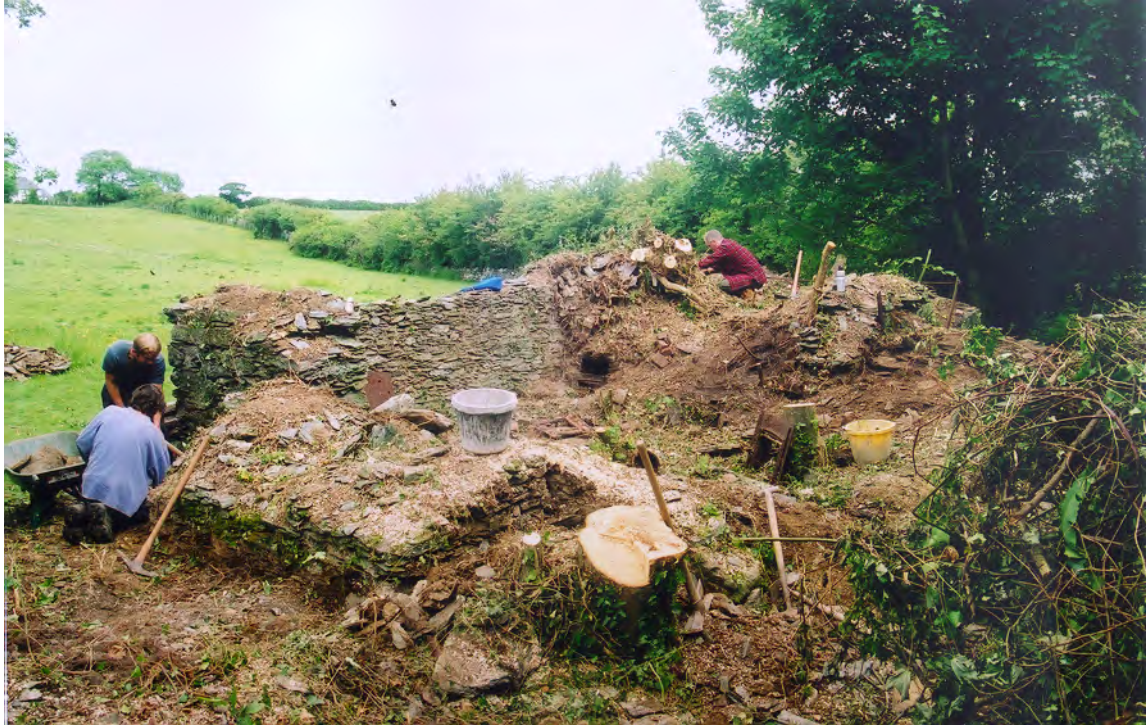
Plate 1 The bakery after tree felling

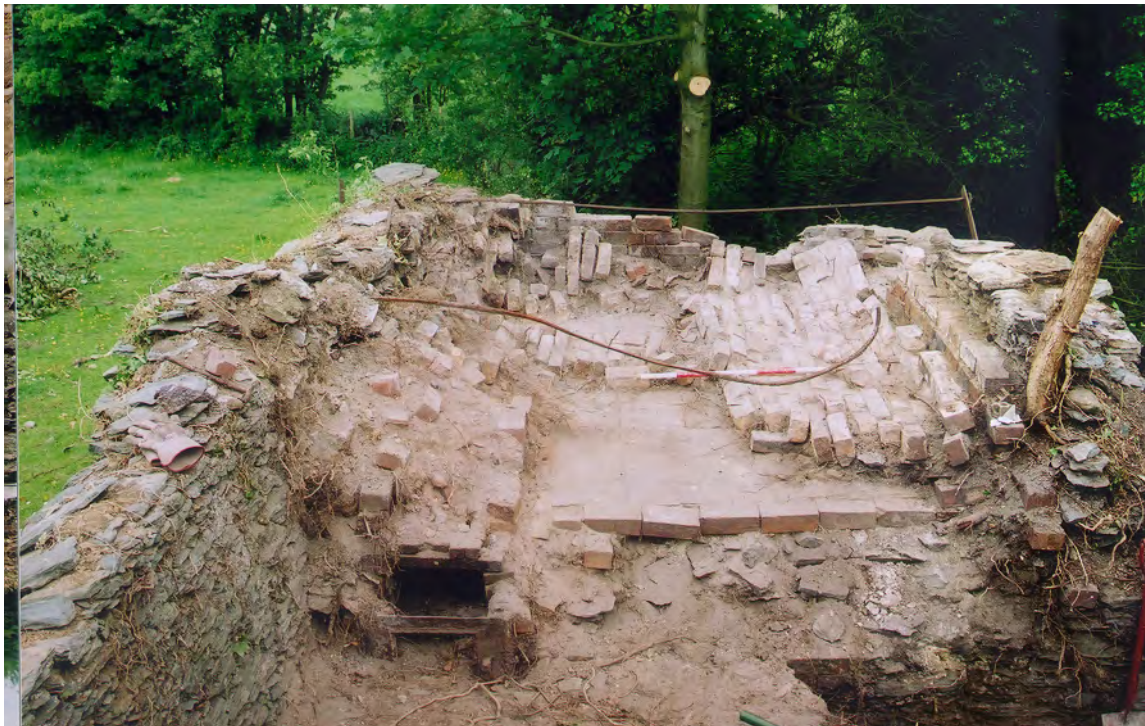
The oven, as noted above, originally had a vaulted brick roof. The remains of iron bracing survives around the outside of the structure. This was presumably installed in order to prevent the walls bowing out from the sideways pressure exerted by the brick vault. One of braces has rusted through and this may have precipitated the final collapse of the roof. The floor of the oven stands 0.9m above the floor of the bakery and is constructed from perforated tiles. The tiles have typical dimensions of 330mm x 330mm and have numerous small round perforations through the upper surface to a smaller number of larger cells on the lower. There were three different patterns of tile randomly distributed across the floor some (not all of the same type) bearing the stamp CATHERAL. There appears to be rubble beneath the oven floor and the tiles therefore seem to have had no function apart from providing a heat

Plate 2 The oven showing collapsed brick vault

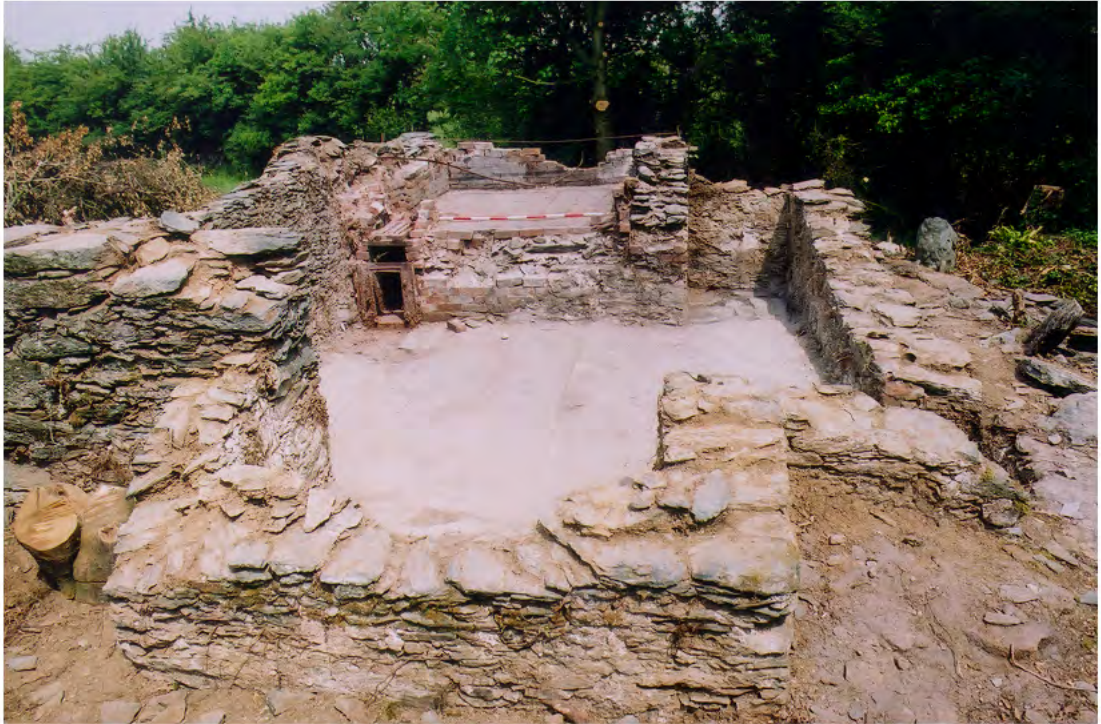
Most of the mortar has eroded from the walls leaving, what is in effect, a dry-stone structure. Root action has further destabilised parts of the masonry. The stone work is generally loose and the wall tops are particularly prone to erosion.

- (i) The north wall. The upper part of this wall has bowed outwards and now overhangs the base by as much as 0.3m and must be close to the point of collapse.
- (ii) The firebox. This has been badly damaged by a combination of root damage and the displacement of the outer wall and the side walls are very fragile. Only a few bricks survive and these are poorly cemented.
- (iii) The front wall of the oven. This is a patched together structure of brick and stone with a rubble infill. The brick edging to the oven is disintegrating and parts of the base wall are also fragile.
- (iv) The brick oven wall. Parts of this, particularly at the front, are beginning to collapse mainly as a result of root action.

Plate 3 The bakery after excavation

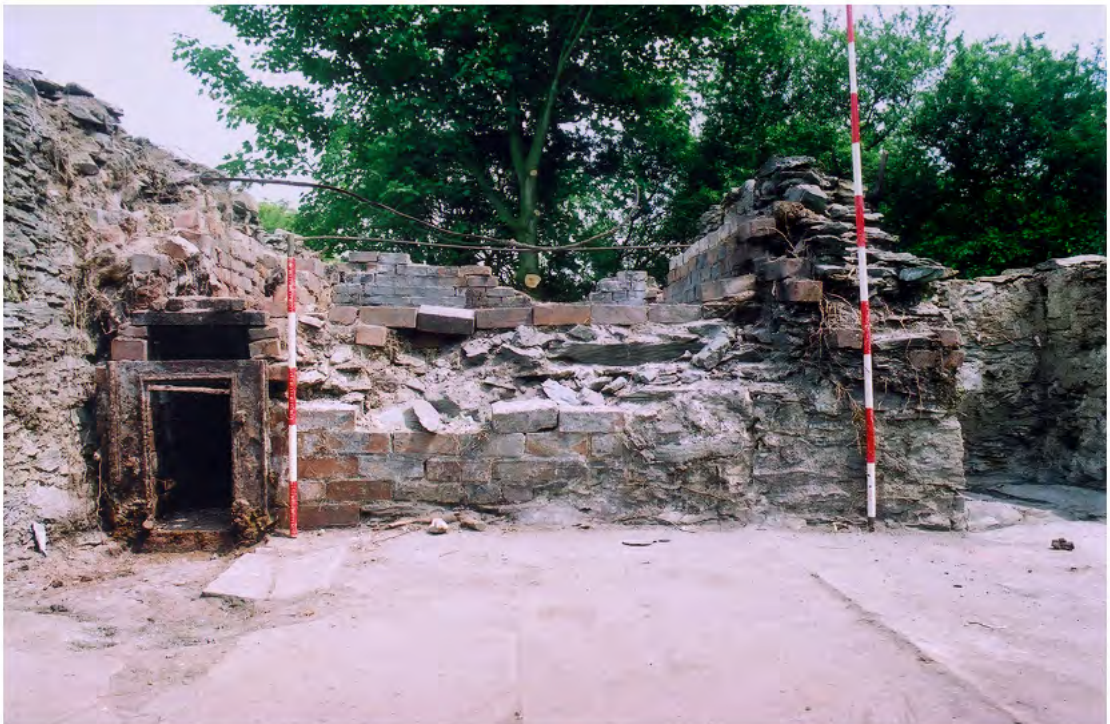
Plate 4 Elevation of the oven base and ash box
