REPORT ON THE SIXTH SEASON OF THE  
TRE'R CEIRI CONSERVATION PROJECT  
JUNE TO OCTOBER 1994

REPORT NO. 143

prepared for Cyngor Dosbarth Dwyfor

by D. Hopewell

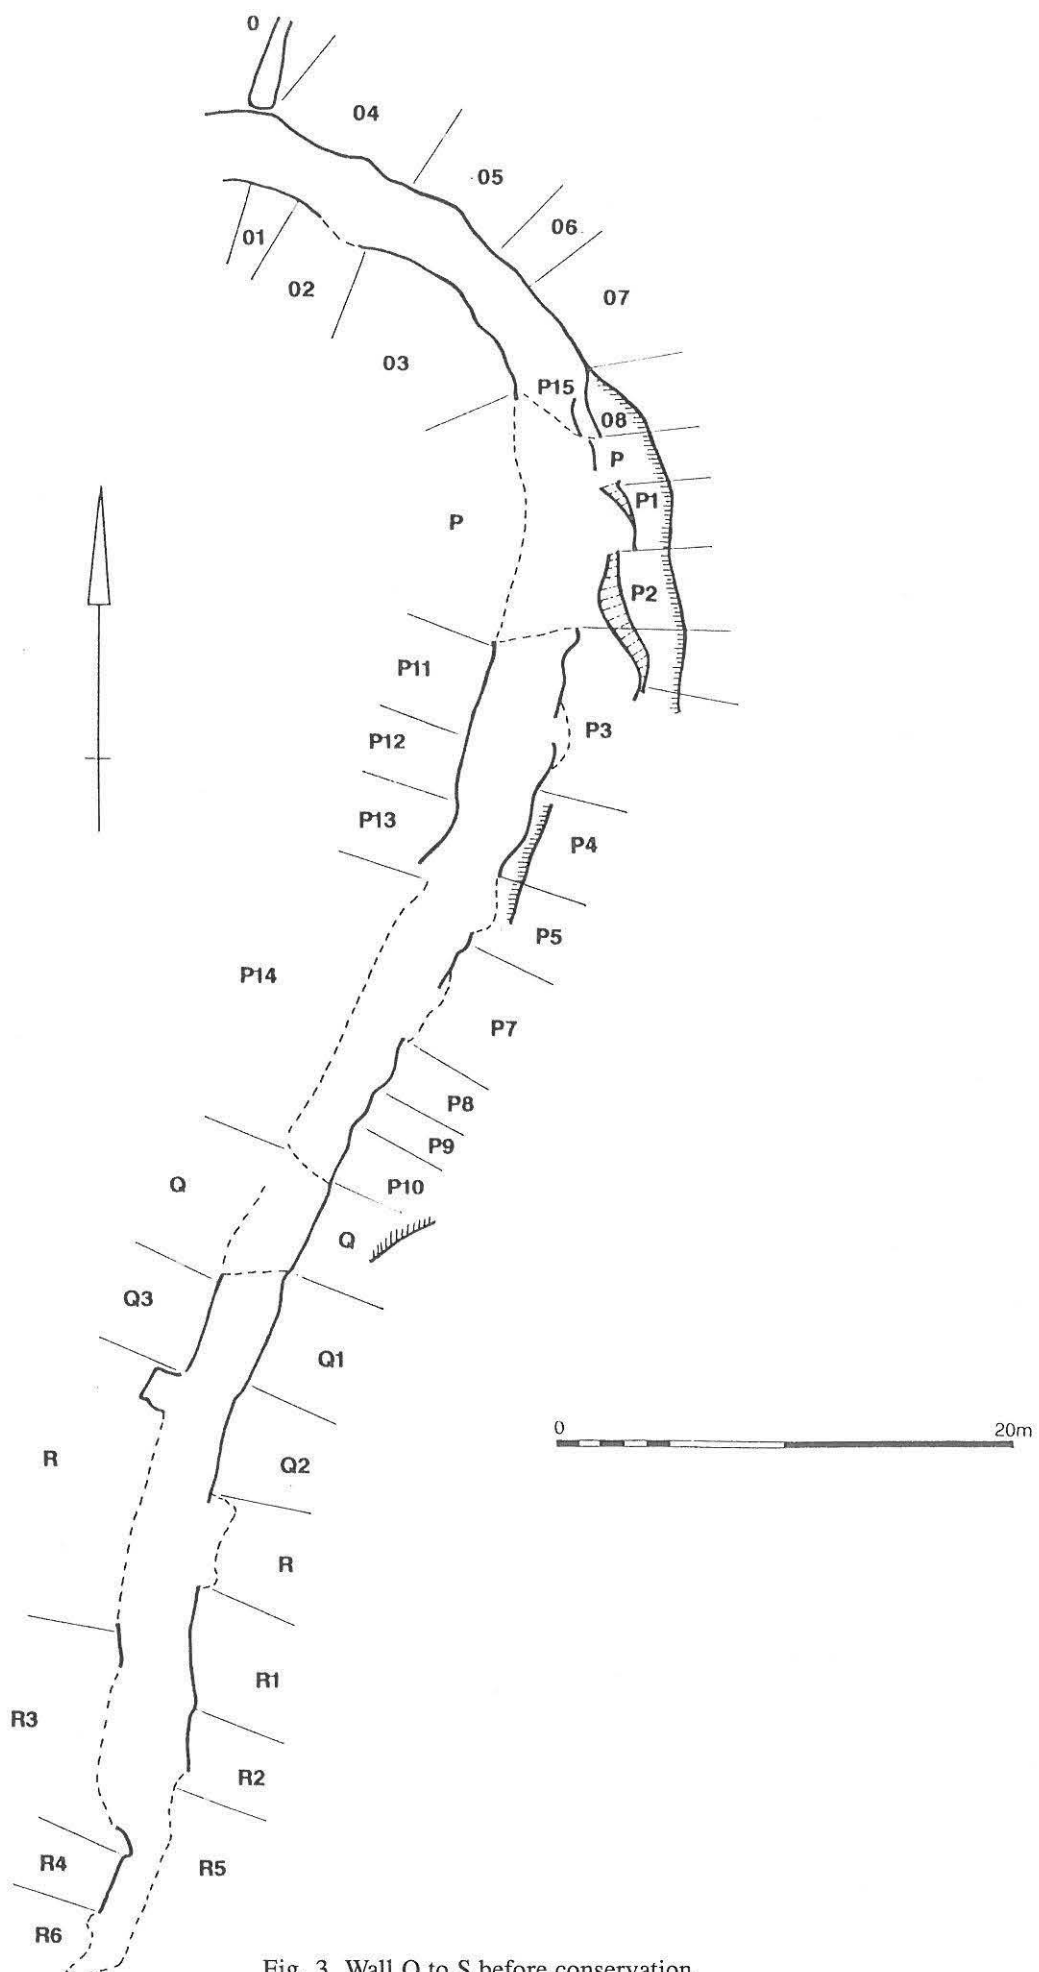
Fig. 3 Wall O to S before conservation.

The 90m stretch of rampart conserved in this season (Fig. 3) was the most severely eroded area of the fort. Visitors have tended to congregate around the cairn, it being the highest point on the site, and walk on the rampart in order to admire the view. This heavy erosion pressure has been compounded by the fact that the rampart stands on very steep scree which is prone to movement and thus does not provide a very firm foundation. The outer face meanders considerably and two lengths of facing (collapses P1 and P2) are up to 3.5m off line. Almost all of the outer face shows signs of recent damage some of which is obviously the result of erosion and unstable masonry. More seriously, several lengths of stable rampart have been deliberately damaged by visitors throwing masonry from the rampart, the scree slopes below these points are littered with broken and unweathered stones. In many cases the outer face was lower than the interior of the fort resulting in a lack of support for and subsequent loss of 41m of the inner face. The majority of the inner face was in a very dilapidated condition with close to 50% of its length only visible as disturbed stones at the edge of the turf line. Thirty seven collapses were identified comprising all but 1.0m of the rampart between field-wall O and outcrop S.

Examination of the scree slope below the rampart revealed several lengths of probable revetting in the scree (see Fig. 3), most notably a 16m long step in the scree exhibiting some untidy c.0.5m high facing below collapses O8 to P3 and a 3.0m sequence of large slabs below collapse Q. A stub of facing built onto the bedrock below collapse R1 was also identified but not as yet located on a plan.

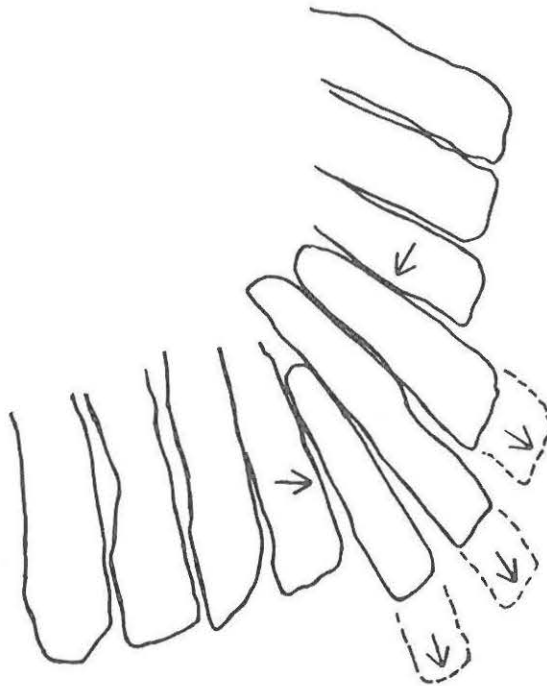
Fig. 4 Sketch plan illustrating the forces acting on stones in convex masonry

This well preserved 4.2m length of rampart, standing between 1.0m and 1.9m above the scree, was stable apart from some disturbance to the upper courses (Plates 15 and 16). The face turned sharply to the south at the south-east of the collapse. At this point the masonry was stable but more irregular. Collapses bulges and instabilities in the facing on the outside of curves and corners are common on Tre'r Ceiri, the wall being most stable when the headers are set at right angles to the line of the wall. The fan shaped arrangement of stones in convex masonry often leads to facing being forced outwards by the weight of the wall to either side (Fig. 4).

Stone A was pushed back and slightly rotated and the collapse was stabilised by the addition of heavy, interlocking slabs to the wall top (Plates 17 and 18).

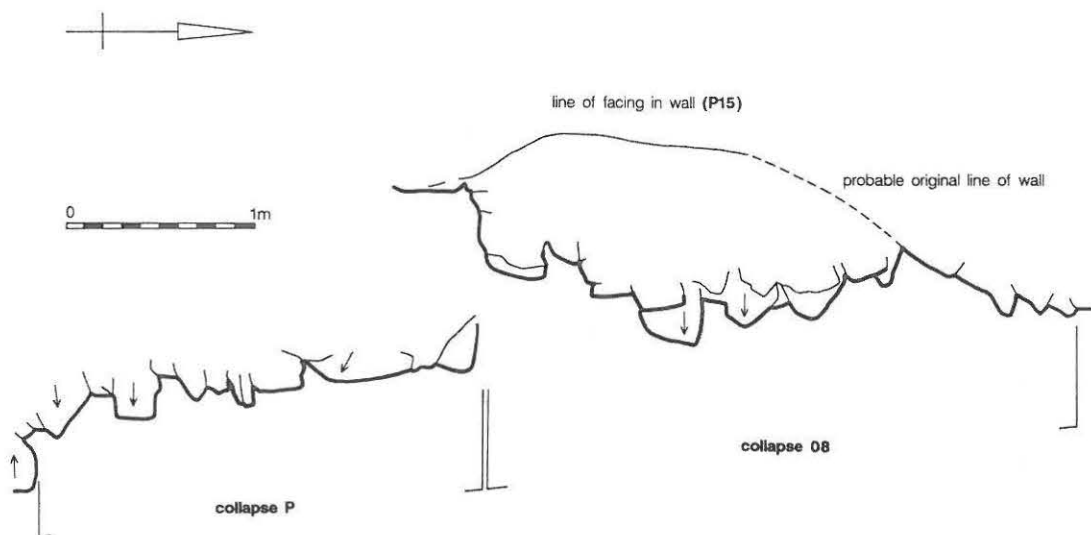
Fig. 5 Plan of collapses O8, P and P15

Collapse O8 was 3.0m long falling from 1.6m at the north to 0.6m at the south where it dropped steeply to ground level and collapse P (Plates 19 and 20). Collapse P was not described in any detail in Dallimore's report but presumably represents the 8.5 m wide seriously eroded area between O8 and P3. A 2.2m length of disturbed headers could be identified in the scree at the north of the collapse (Plate 24) but no facing close to the line of the rampart could be seen beyond this. Two lengths of severely off line facing were identified in the scree below P and reclassified as P1 and P2 (see below).

The north end of collapse O8 was stable but the southernmost metre consisted of almost completely collapsed masonry beneath several courses of unweathered stones, laid as stretchers, suggesting an obvious and rather inept modern rebuild (see Plate 19).

A 1.4m length of facing (P15), set back 0.7m from O8 could be seen standing 0.3m above the wall top (Plate 21). The facing clearly continued down into the rampart for at least 0.6m and its line suggests that it may have been continuous with the south end of O7.

It was decided to initially clear the tumbled stone at the junction between P and O8 as the line of the outer face was not obvious at this point. This revealed four courses of well defined facing at the south of O8 turning sharply towards and abutting P15 1.0m behind the current line of the outer face (Plates 22 and 23). The extant facing at the north end of collapse P followed the modern line of the outer face but was lost 0.9m from the point where O8 deviates from this line. It seems likely that P15 and O7 represent an earlier line of the rampart and that the bulge in O7 was more serious than its current appearance suggests. Collapse O8 appears to have been a later addition designed to minimise the destabilising effects of the bulge and repair any collapsing masonry. The surviving facing in collapse P (Plate 24) was presumably added to this in order to create a more even wall line. Unfortunately the line of the outer face could not be traced beyond this, apart from the somewhat enigmatic structures P1 and P2 discussed below. The area between O7 and P can be compared to collapse D where the corner of the rampart bulged out by 0.75m (Boyle, 1990) giving the appearance of a turret. The outer face to the north-east of this includes two straight joints and facing that turns into the wall core and other evidence of rebuilding. This was interpreted as a two phase entrance in the 1990 Tre'r Ceiri Conservation Project Report. In the light of the evidence for rebuilding around collapse O8 these features could be interpreted as rebuilding after the movement or failure of the sharp turn in the ramparts at this point. This would also explain the lack of evidence for an entrance in the inner face.

Most of the rough basal course surviving at the north end of collapse P (Plate 24) was left *in situ* after clearance of tumbled stone. The modern rebuild in O8 was cleared as it was unstable. The area was planned before consolidation (Fig. 5).

It was decided to consolidate O8, P15 and P by joining the end of P and the point where O8 deviates from the line of the rampart as the *in situ* facing in the inturning end of O8 was weak and there was not much space to add new masonry. A large slab (stone X on Plate 26) was used about half way up the new masonry to tie the facing together. Ideally a straight joint should have been visible in the wall at the junction between O8 and P but as it was felt that the addition of stones to the inturn would have put the original masonry at risk a stronger continuous face was built. It is possible that the original rebuild took this form as we do not know how far the earlier masonry had deteriorated before repairs were made. P15 was stabilised by the addition of a large slab to the top of the facing. A stone was also added to the wall top between O8 and P15 in order to provide additional support. The new stones are shown on Plate 28.

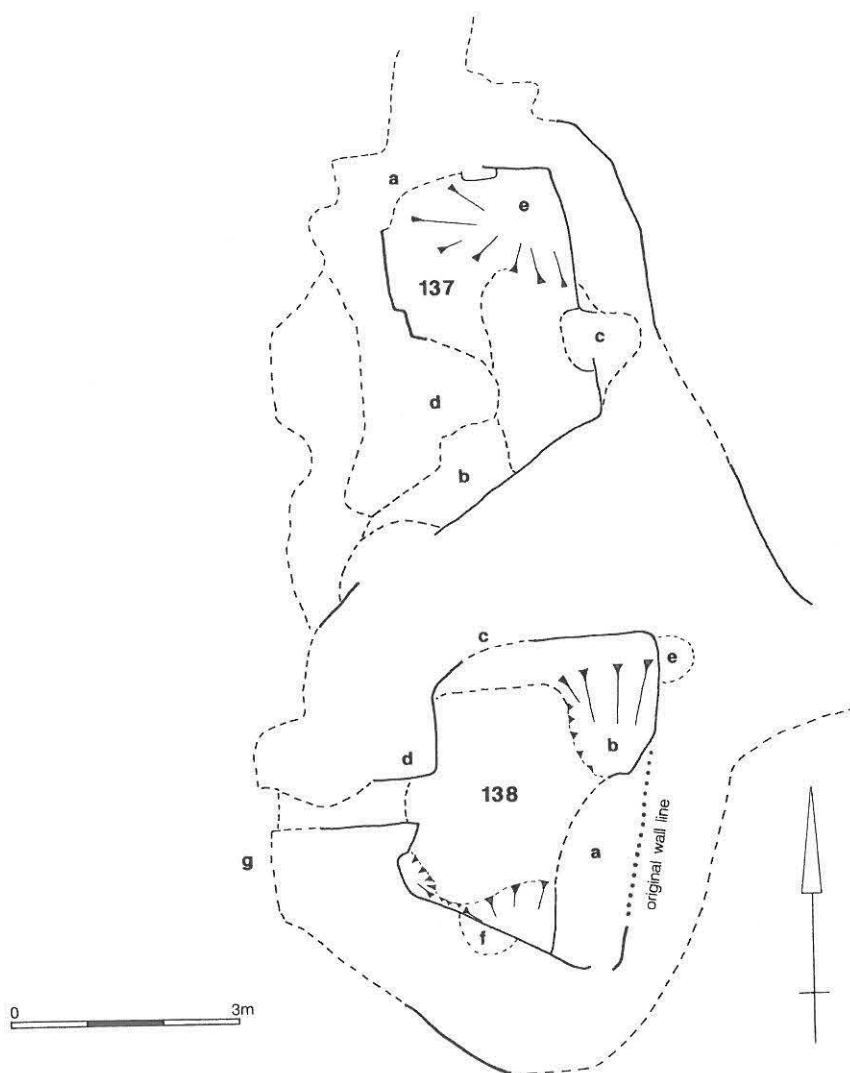
Fig. 6 Plan of huts 137 and 138g

It was anticipated that existing plans, Plowman Craven in particular, could be used to locate the works carried out on the huts but severe inaccuracies in the plans of huts 137 and 138 required that they had to be re-planned by hand. As this was a time-consuming process it is recommended that Total Station plans are made of all huts to be conserved in future seasons.

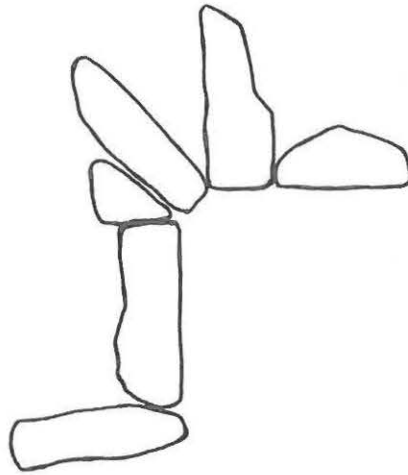
Fig. 10 Sketch plan illustrating the structure of the corners in hut 137

The masonry at the north-east corner of the hut was standing to a height of 1.6m at the beginning of the 1994 season falling almost vertically to the rubble of collapse 137a (Plate 134). The collapsed stone was up to 1.2m deep and was providing some support for the *in situ* wall but as the collapse was still eroding a more stable method of support was required if the unusually well preserved masonry at the north end of the hut was to be retained.

The *in situ* masonry to the east of the collapse was marked (stones A to K, Plate 134) and the fallen stone was cleared (Plate 135). No basal course could be traced between stones K and L (Plate 136) making it impossible to trace the form of the corner of the hut. The other corners of the hut were unusually sharp although still built as acute curves (fig 10). The evidence from Hughes's plan was insufficient to identify the form of the lost corner although if it was partially collapsed when he planned it the original must have been quite acute.

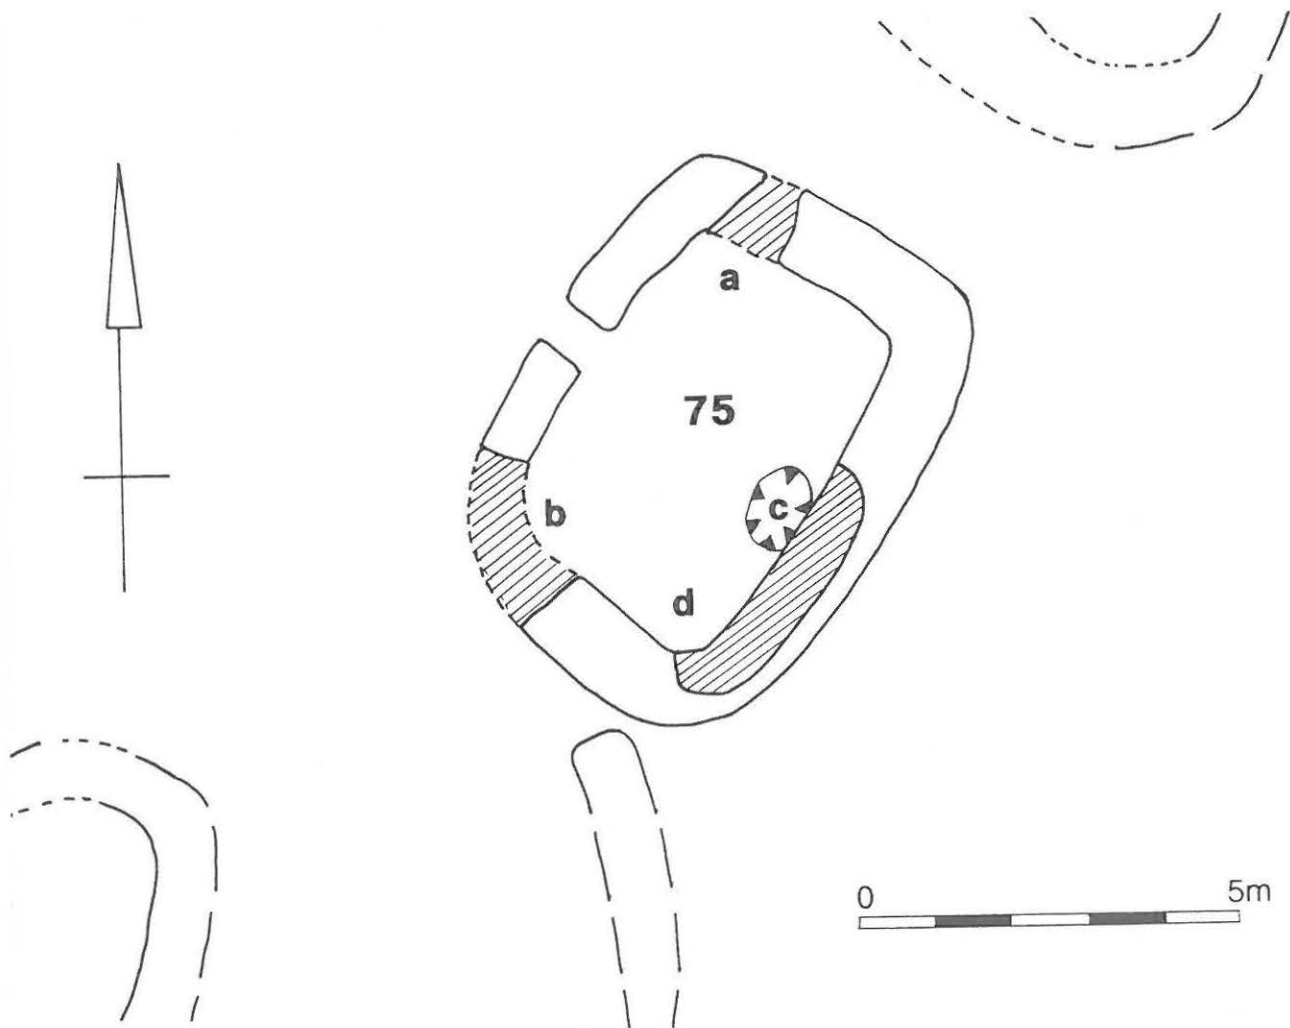
Fig. 11 Hut 75 showing points of collapse (after Plowman Craven and Associates, 1980)

This was a well preserved rectangular hut with a clearly defined entrance half way along the western wall. The Plowman Craven plan was accurate enough to use as a basis for locating the collapses (Fig 11)

Dallimore recorded collapses at the north-west and south-west corners of the hut and noted that the hut floor was much disturbed by treasure hunters.
