# A470 BLAENAU FFESTINIOG TO CANCOED IMPROVEMENT

## ARCHAEOLOGICAL WATCHING BRIEF AND RECORDING

Report number : 717 revision 2

Prepared for  
Richards Moorhead and Laing  
April 2009

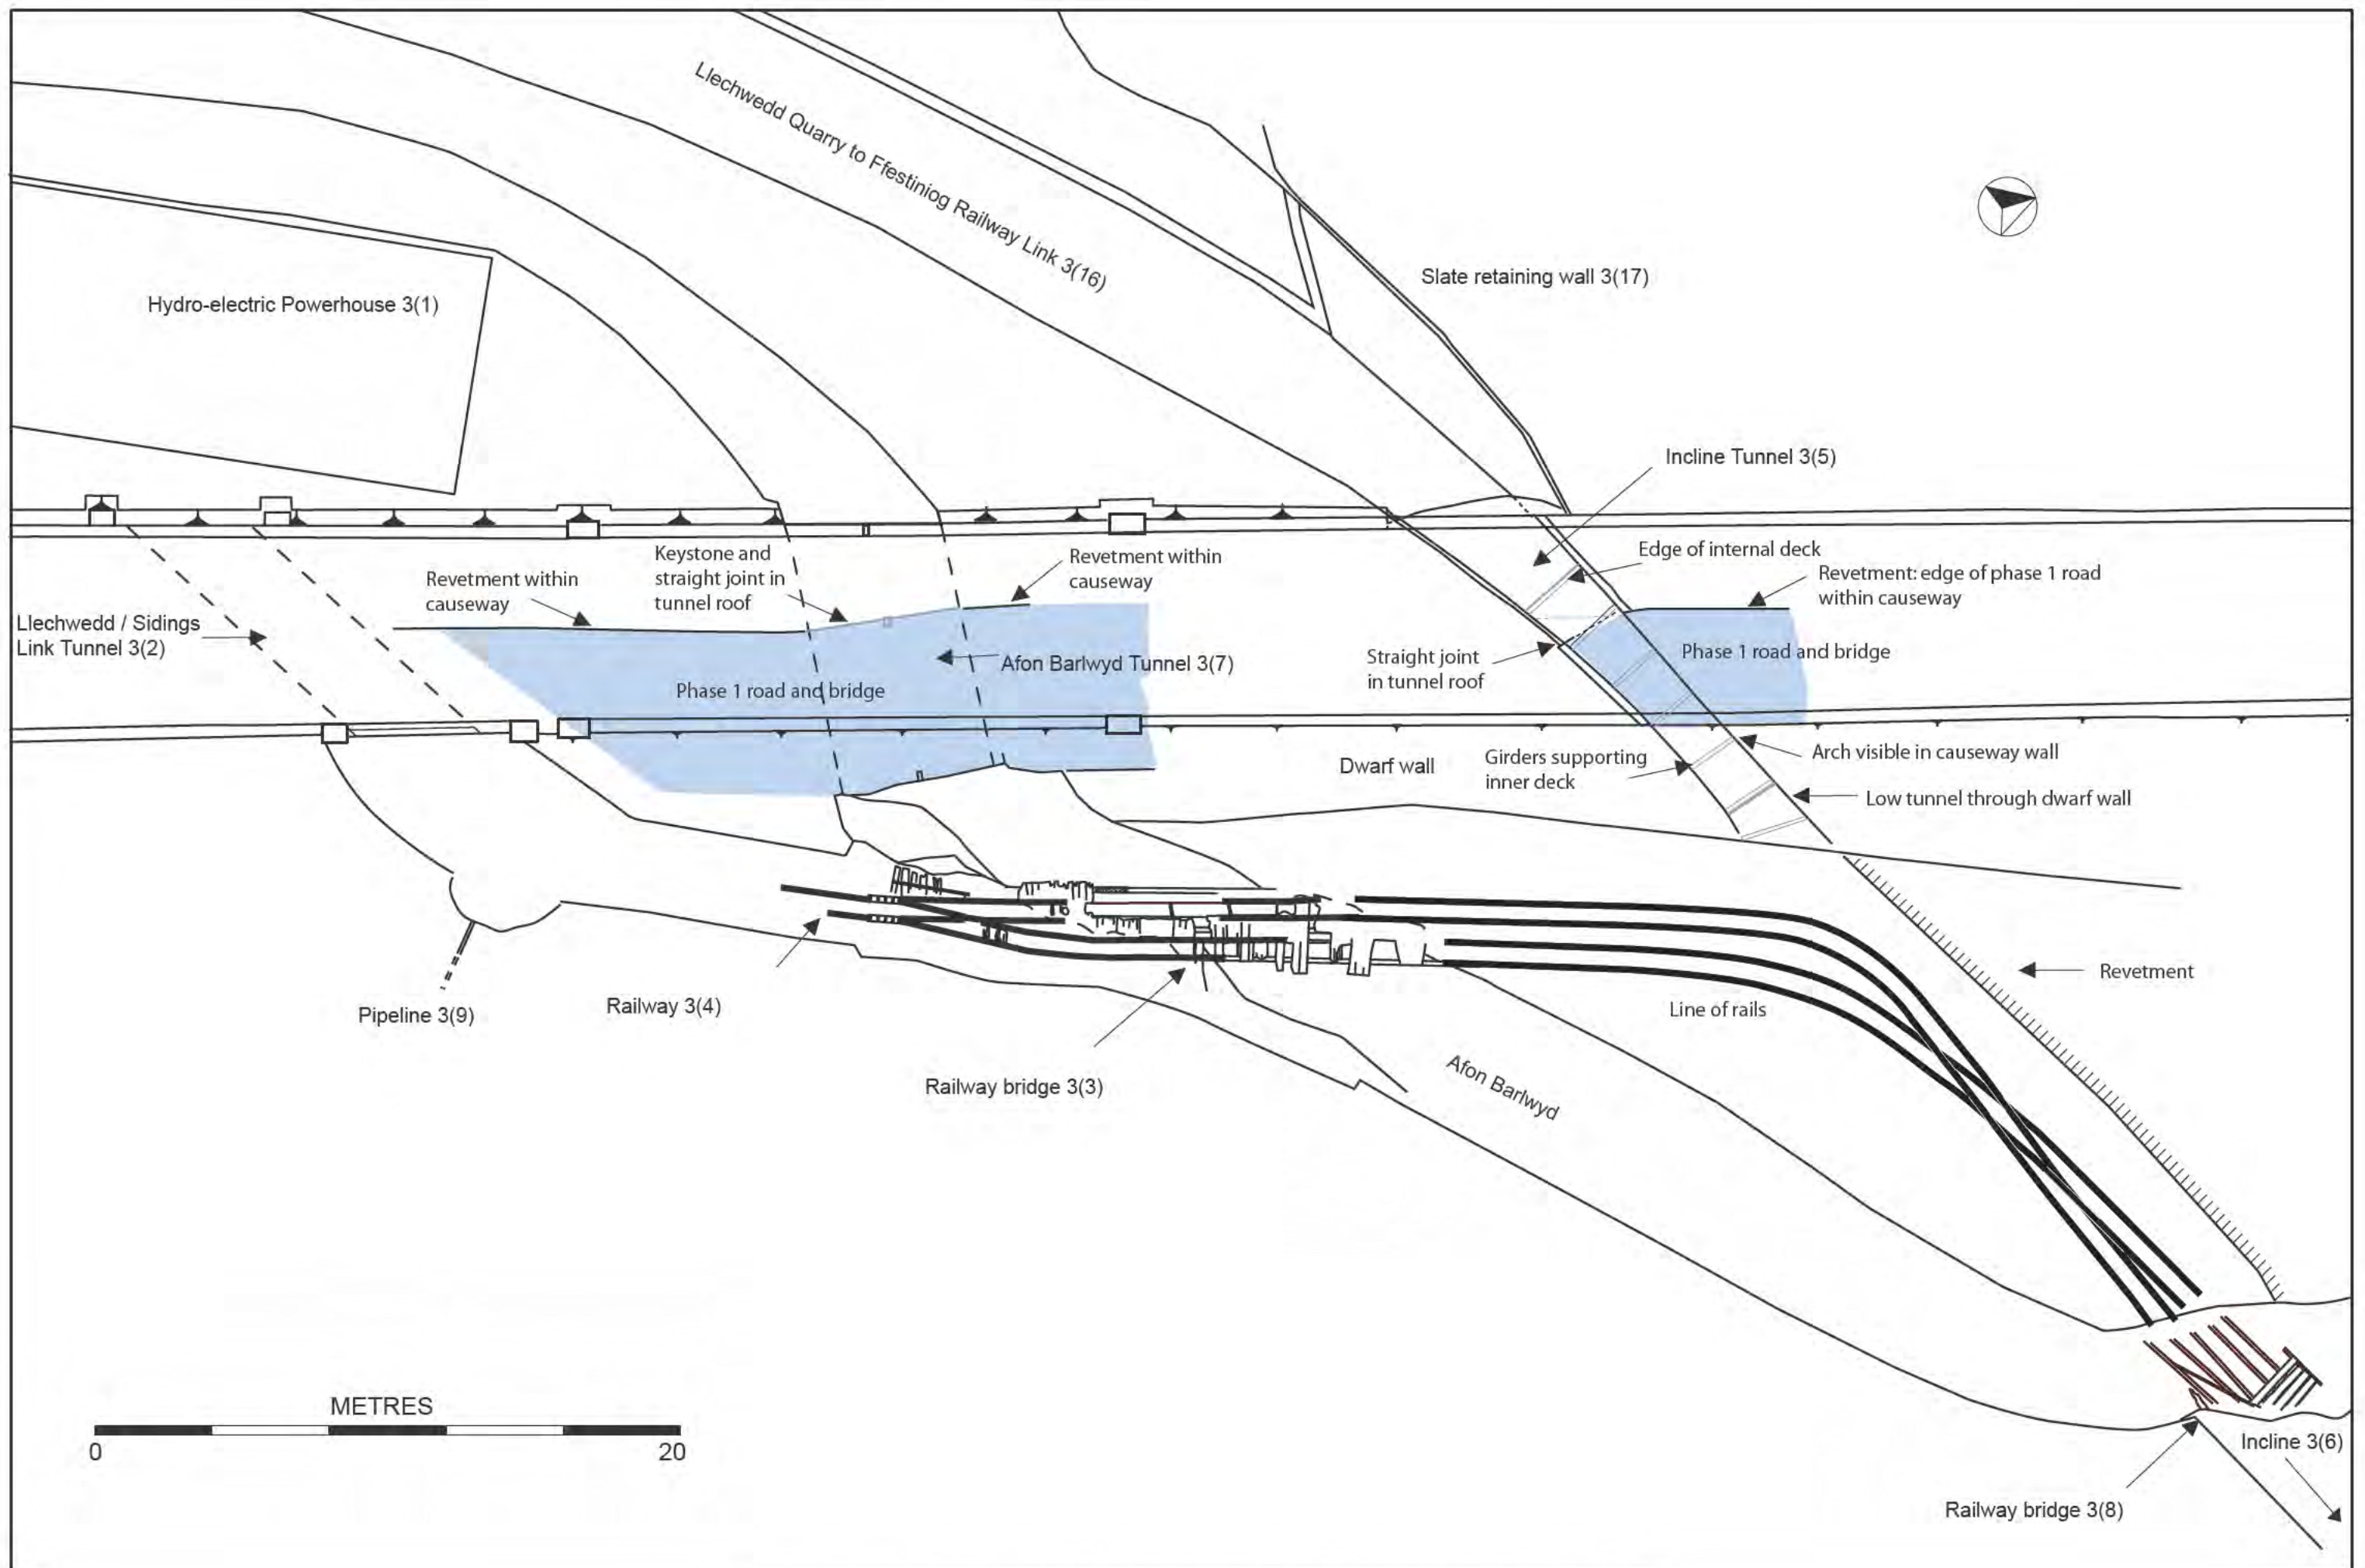
Fig. 10 Llechwedd exchange sidings, north end showing details of the railway 3(4) and road causeway 3(32)

The road causeway and the three tunnels were demolished in advance of the construction of the new causeway. The western side of the causeway was re-photographed after removal of trees as a supplement to the pre-construction phase of detailed recording. A watching brief was kept during most of the demolition. The demolition was carried out in stages using a tracked excavator. The upper part of the causeway was removed in 1.0m to 1.5m deep layers. The lower part including the tunnels was dug out from above starting at the southern end. The demolition method allowed some details of the phasing of the various parts of the causeway to be seen although there was little opportunity for detailed recording. The findings of the watching brief are shown on Fig. 10.

The watching brief successfully recovered a considerable amount of new information particularly in the area of Llechwedd Sidings. The development of the causeway from a low structure bridging the river and tramway, to the final 7.3m raised embankment is of particular interest. Detailed recording in the sidings also identified several phases of development. This has allowed us to produce a fairly detailed account of the development of the site (see Fig. 10):

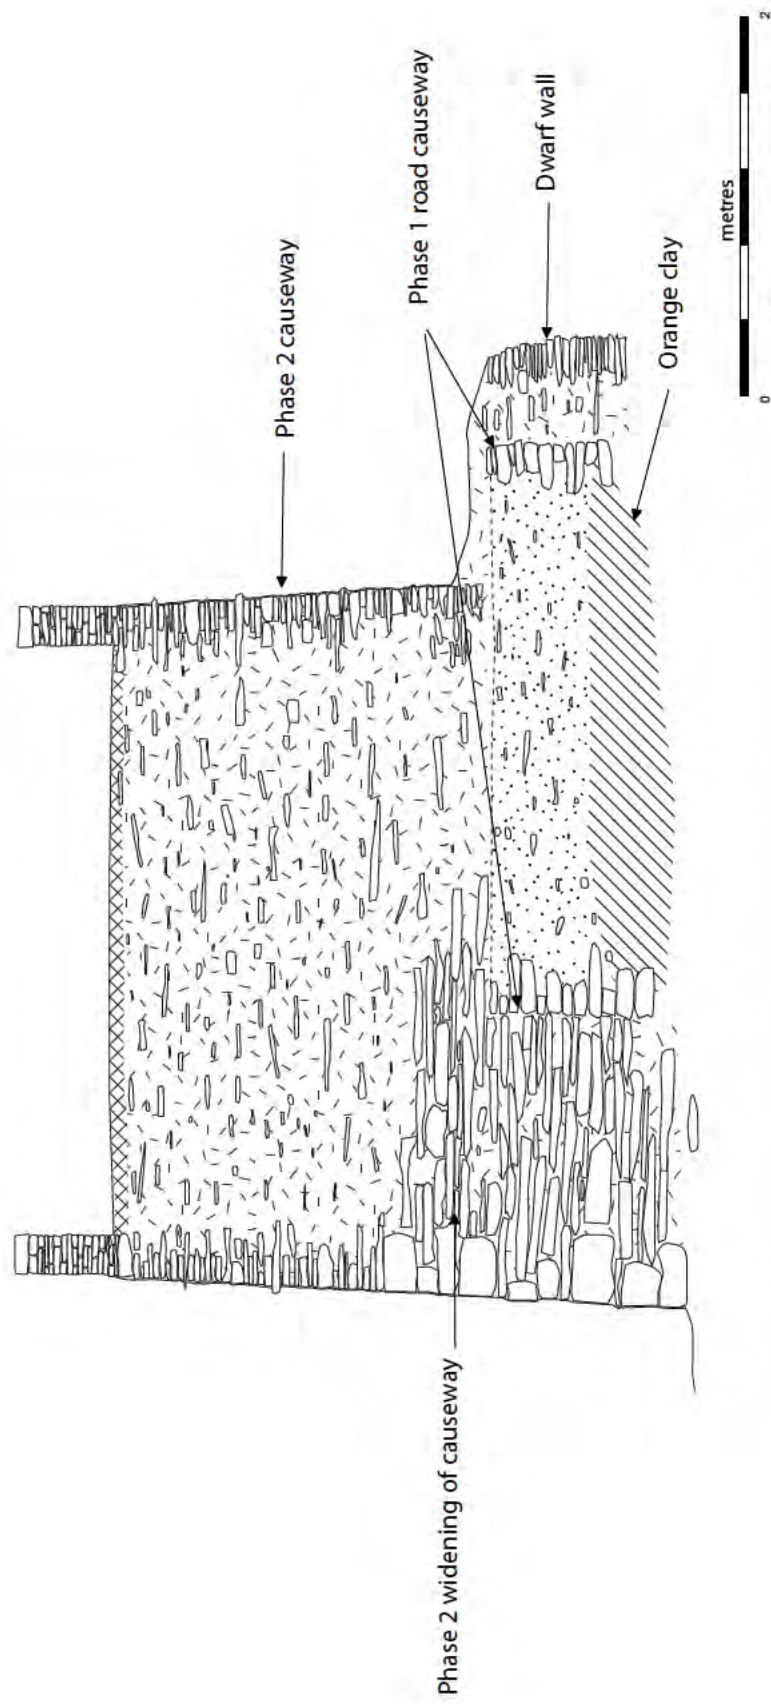
Fig. 15 South facing sketch section through site 3(32) road causeway 5m north of Afon Barlwyd tunnel

The western wall of the phase 2 road causeway was built in front of the phase 1 wall in two stages. The lower 3m was built from large stones the largest of which were 0.7m square blocks. This part of the revetment utilised slate and a variety of other stones. The space between the outer wall of the phase 2 causeway and the phase 1 road revetment was infilled with flat slate slabs, laid horizontally. This construction style extended above the phase 1 road. The slate infill could be seen to overlie the phase 1 road, with the interlocking slabs tying the two phases of masonry together. The rest of the causeway facing was built from small slate blocks and slabs, some laid as headers and some as stretchers, with distinctive protruding long stretchers tying the facing into the core of the structure. The eastern wall of the road causeway was set back from the western edge of the phase 1 revetment, and was built directly on top of the clay infill of the phase 1 road (Plate 13 and Fig. 15).

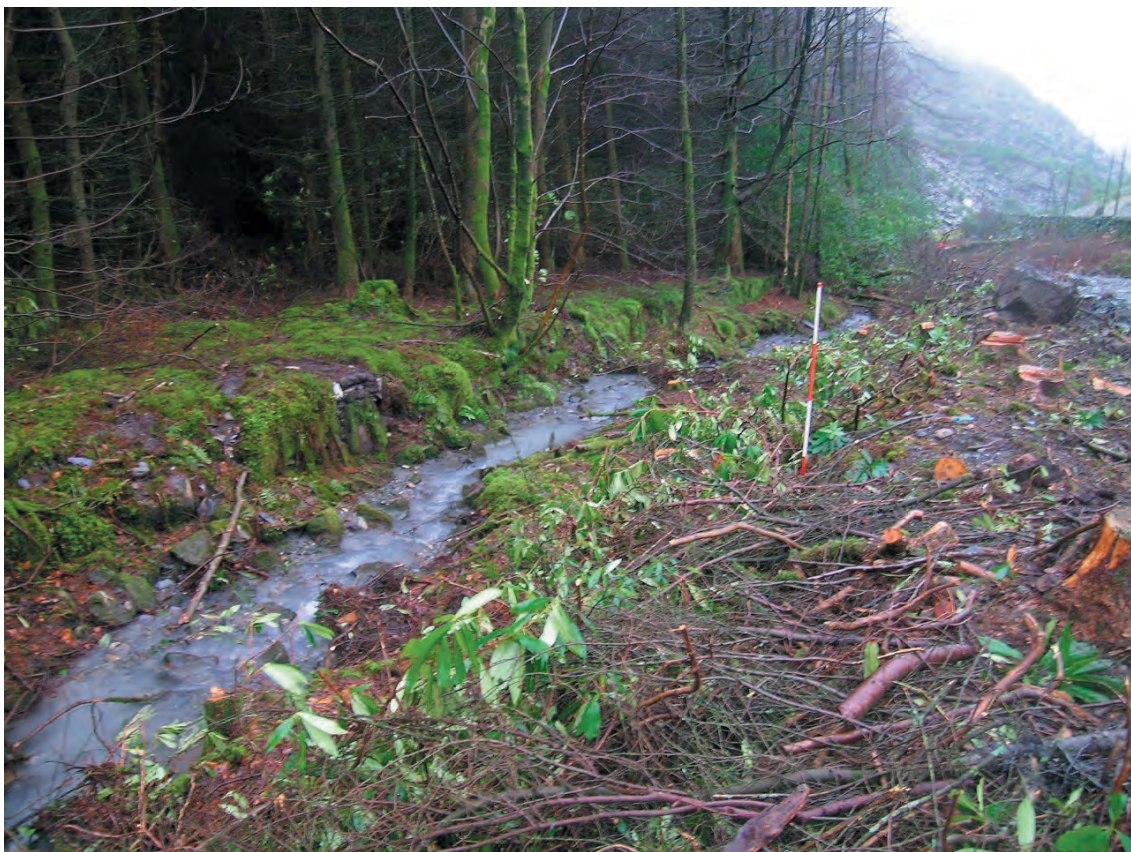
Plate 2 Site 8, Revetting/ walls along stream

The edge of the CPO ran along the line of the stream. The eastern revetment was therefore largely unaffected by the construction works apart from some minor damage caused by wind-blown trees. There has been some remodelling of the western bank but much of the main part of site 8 will be preserved.

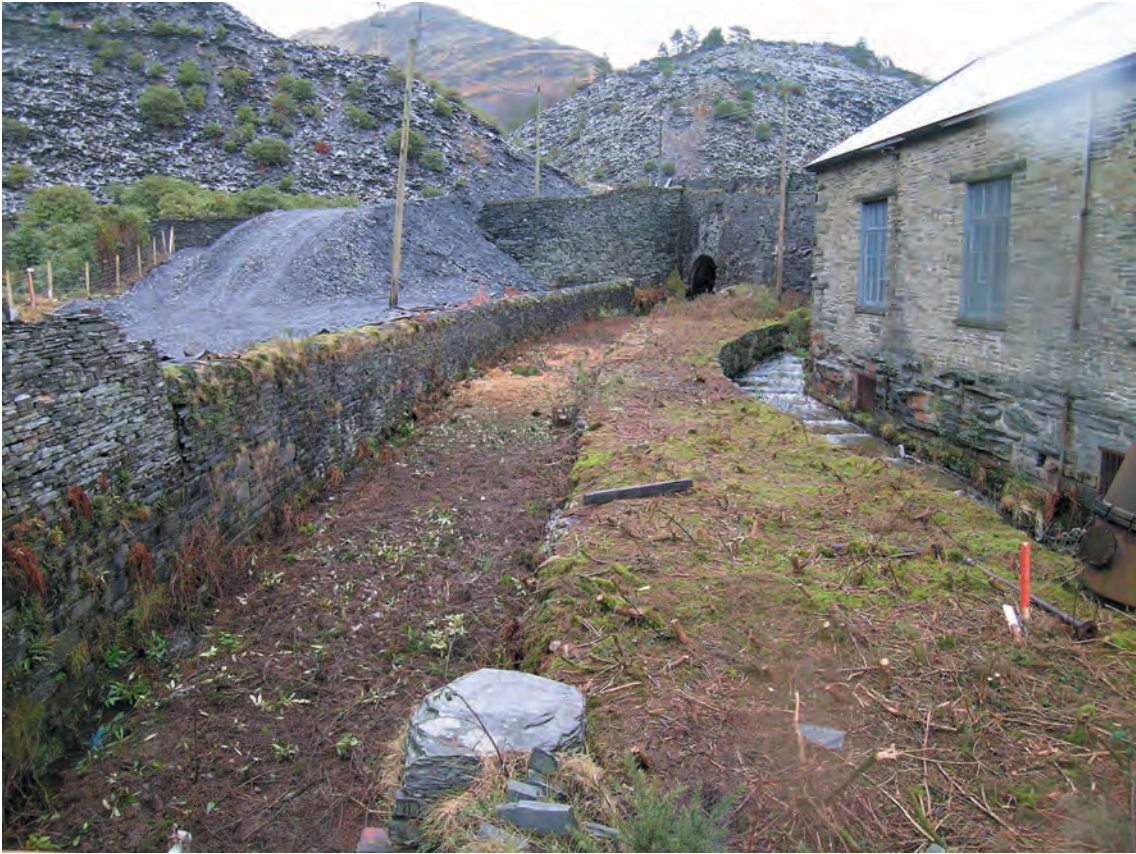
Plate 3 Site 3(16) Llechwedd to Ffestiniog Railway link after clearance

Site 3(16) comprised a 4.0 to 4.8m wide sunken trackbed. The base of the trackbed was of pitched slate. This had been covered by 0.2 to 0.4m of silt that had been washed through the incline tunnel. Some water was found to run through the tunnel and along both sides of the trackbed at all times. This was passing from the Afon Barlwyd channel through the slate and into the tunnel. When the river was in spate it would overflow its banks and a large amount of water would run down the trackbed. The side walls were of stone and slate and contained several phases of masonry probably reflecting the changes in ground level as slate waste was added to the area.

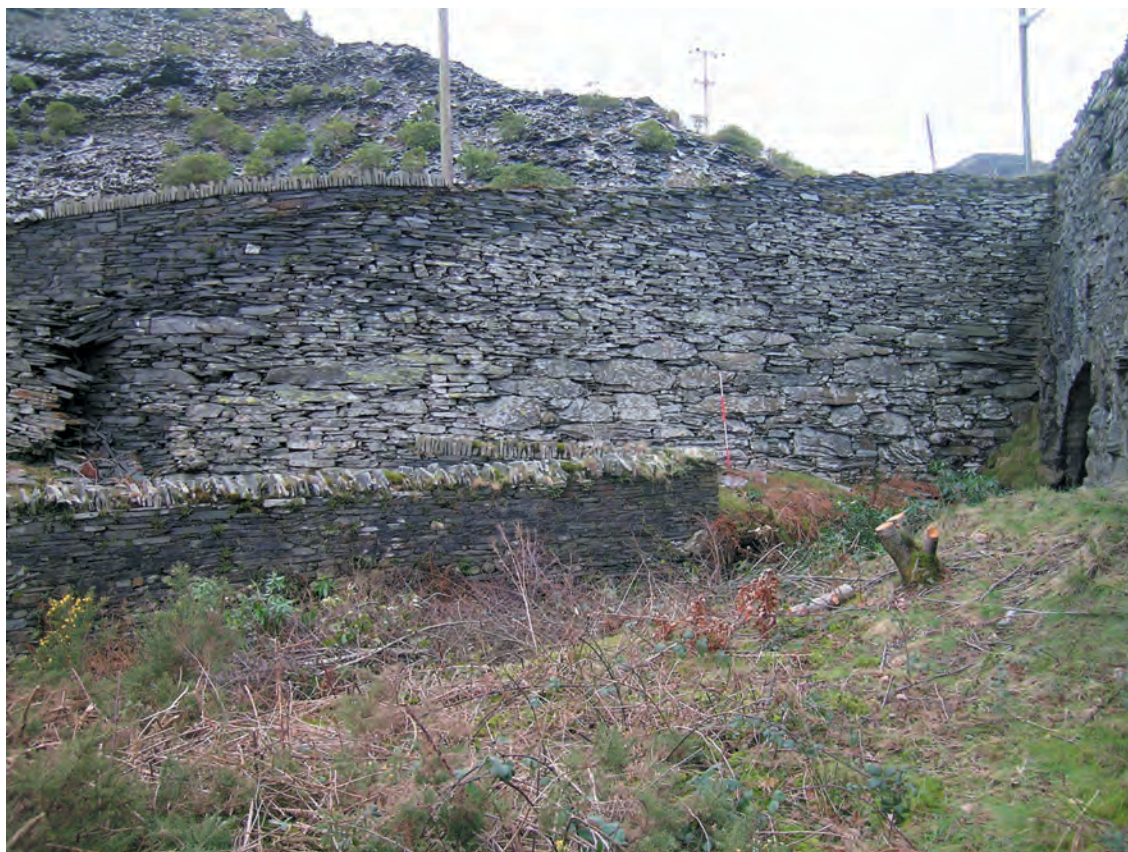
Plate 6 Site 3(17) Slate retaining wall

The eastern part of the slate retaining wall 3(17) was photographed in three sections. The retaining wall marks the end of the sidings area and was presumably built at the same time as the road revetment. It was found to stand to a maximum height of 9.0m and to contain three phases of masonry (Plate 6). The lower 4m adjacent to the road revetment was built from large slate blocks. This extended 12m to the west of the road revetment. A second phase of masonry characterised by smaller flatter stones was standing above this. A third phase of masonry was standing in front of the phase 2 wall further to the west. The upper wall in this area was also of a later phase characterised by upright slate-block coping. Part of the upper wall was demolished to accommodate the temporary diversion. The stone was stored and was reused to reconstruct the masonry. The temporary diversion was built against the remaining wall which was protected by geotextile. The wall immediately adjacent to the A470 was dismantled during the demolition of the causeway.

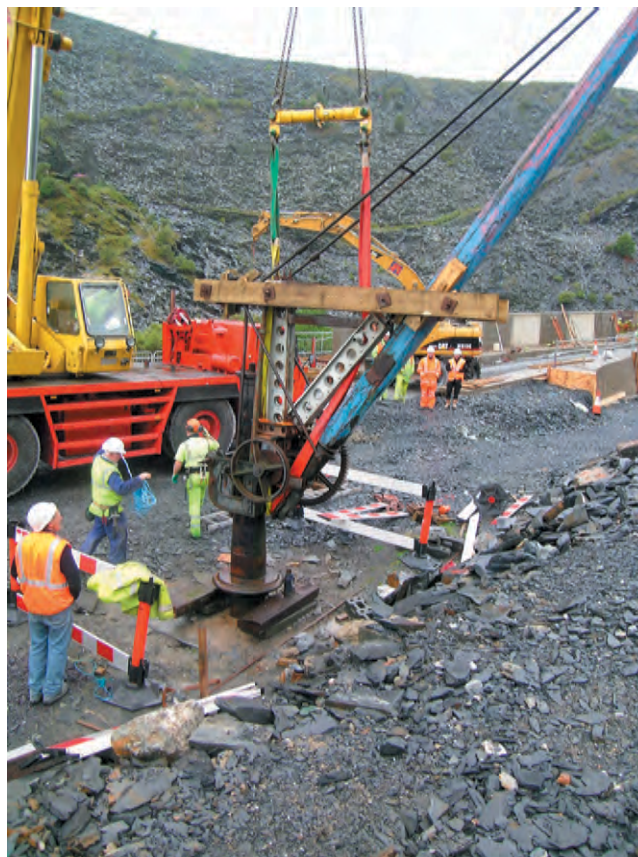
Plate 8 Removal of the upper part of Crane 3(13)

The crane was removed from the site for storage in advance of reinstatement in a different location after the completion of the new road causeway. The removal followed a method statement previously submitted to Cadw. All accessible parts of the crane had been recorded previously (Hopewell 2006). The upper rotatable part of the crane (Figs. 11-13) was supported by a cradle, principally to add stability and prevent sideways loading on the jib. This was then lifted from the base using a crane (Plate 8). This was transported to the works compound and at the time of writing is being stored in the cradle.

The upper part of the crane was generally in good condition although most of the moving parts were rusty and seized. The jib and the head were slightly twisted in relation to the lower parts of the crane. The cast iron section on the end of the jib was also slightly twisted. There was a patch of rot at the bottom of the wooden part of the jib.

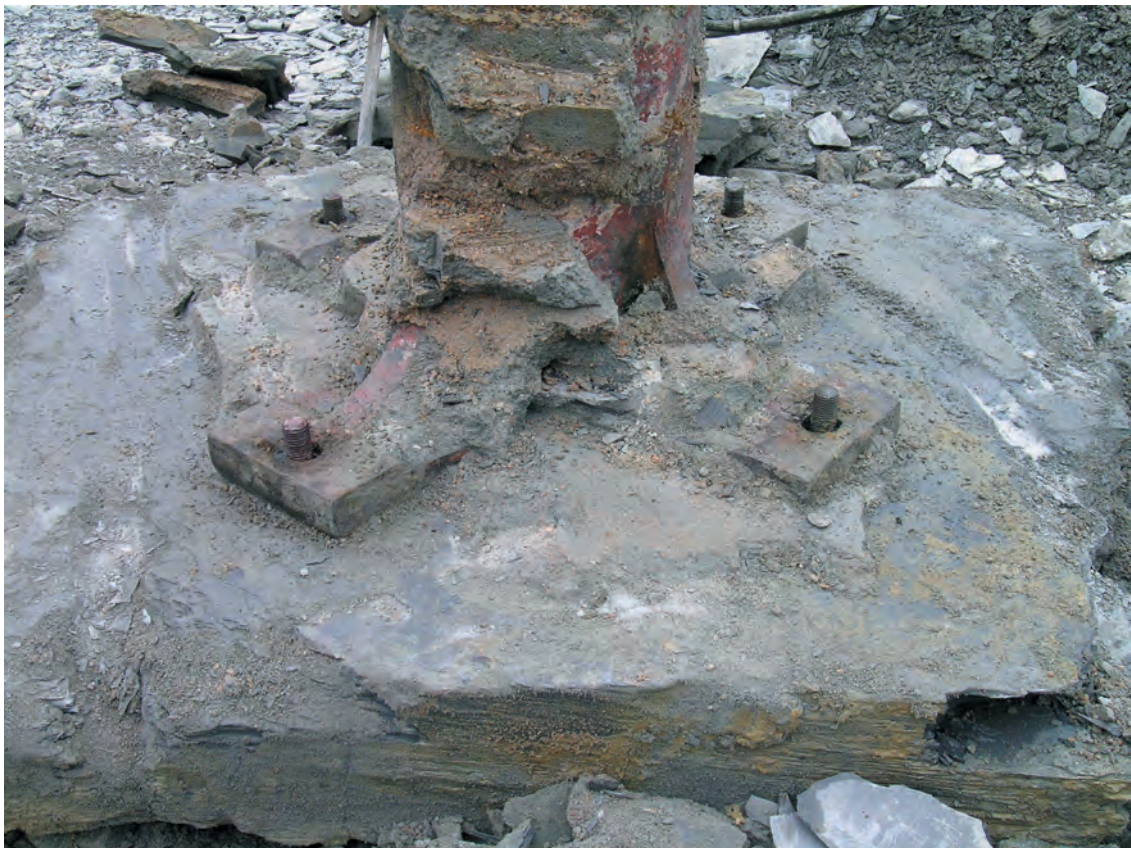
Plate 10 Site 1(13) The crane pillar: flanges and block

The buried portion of the crane was 2.6m high and was a simple tube with flanges at the base. The flanges were used to attach the pillar to a 1.6m square and 0.35m deep slate block using four bolts (Plate 10). The nuts and bolts were uncorroded and were easily undone with a spanner when the two elements were separated. There were steel shims beneath three of the flanges suggesting that the slate base had been placed in the hole first and the pillar added, with shims used to ensure that it was perpendicular. An iron loop was found to run through the centre of the slate block and this had

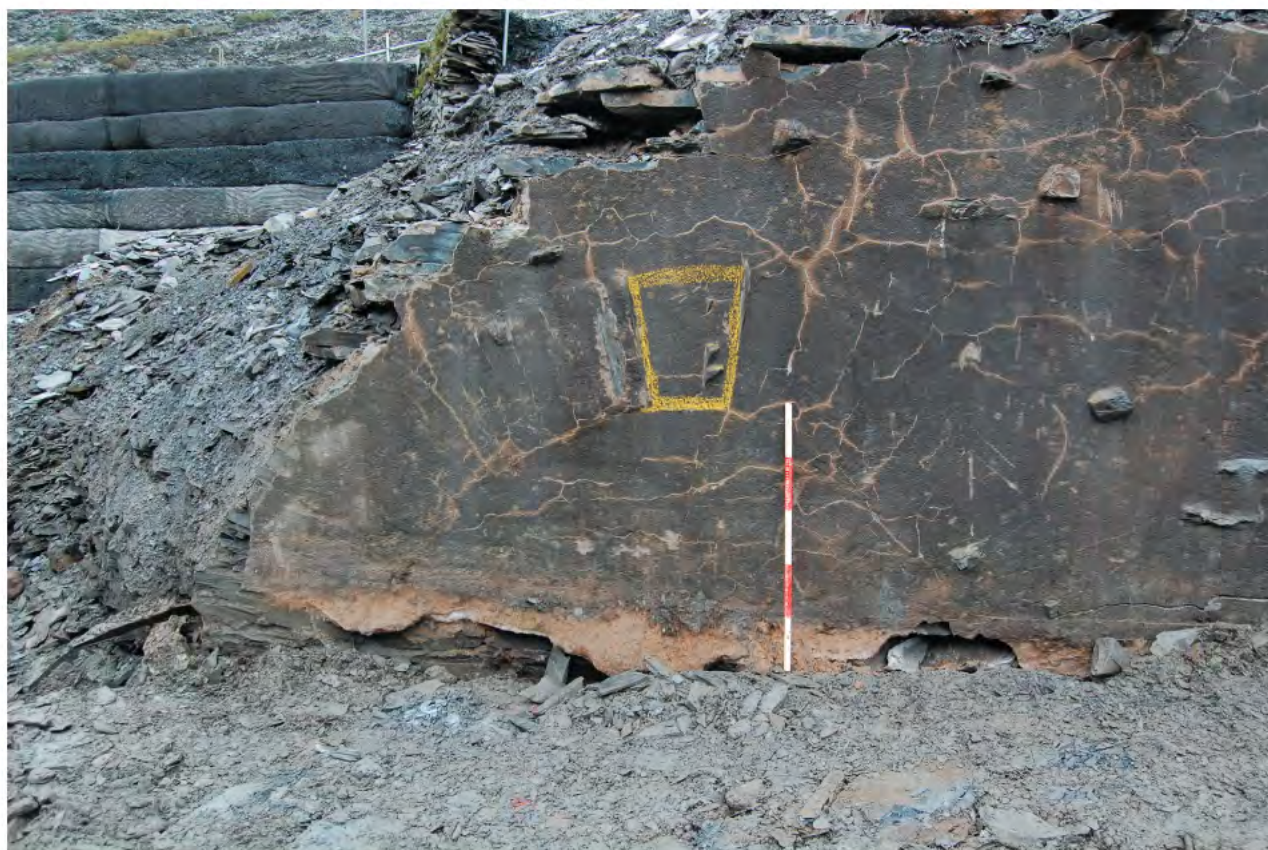
Plate 14 Site 3(32) Road causeway: Blocked incline arch in E side of causeway

The partially blocked end of the original archway was visible in the eastern wall of the road causeway (Plate 14). The reduced height tunnel continued beneath the dwarf wall. This end of the tunnel was 2m wide, mostly below ground level and was almost completely blocked with slate rubble.

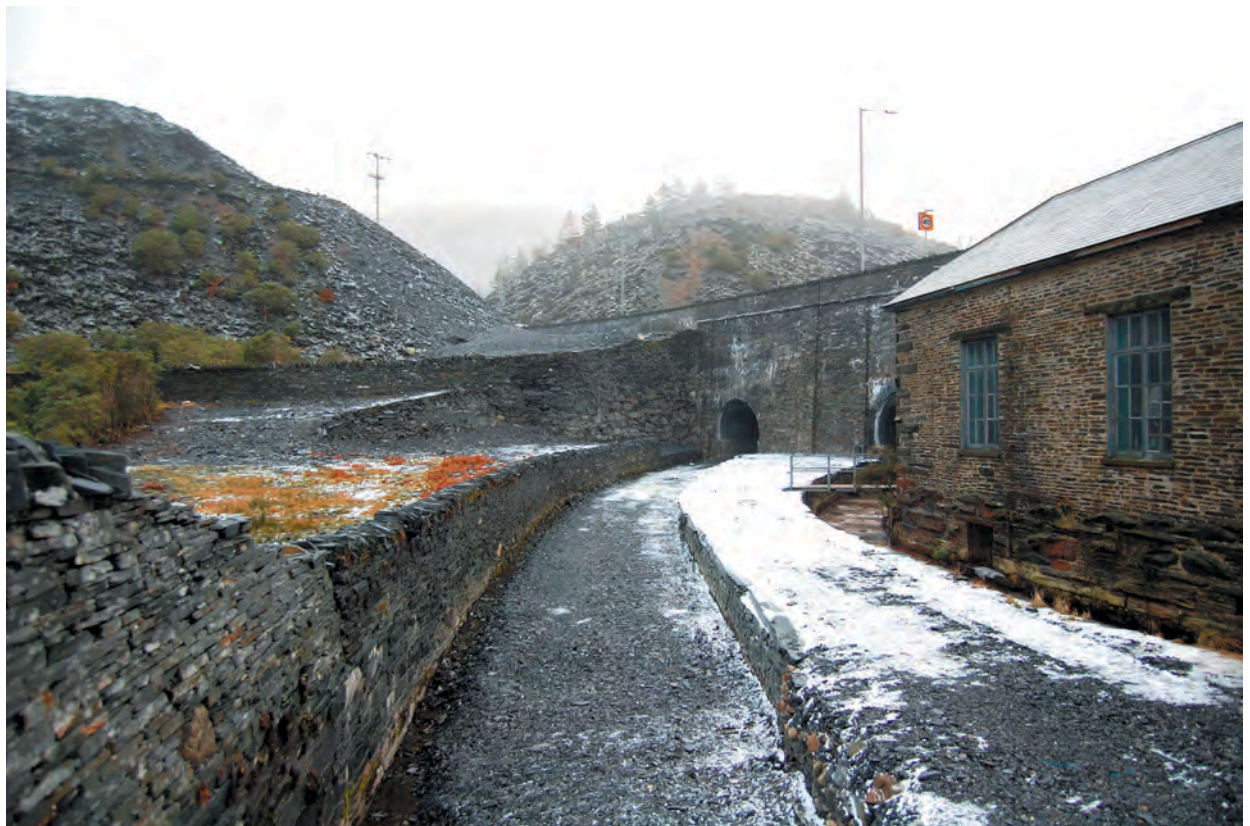
Plate 20 Llechwedd Quarry to Ffestiniog Railway Link 3(16). Trackbed after reinstatement

The temporary diversion was removed without causing any major damage. The eastern end of the phase 3 masonry was however beginning to slump before the project started and was showing further signs of instability after removal of the diversion. A short length of this masonry was rebuilt as part of the reinstatement process. All previously demolished masonry was rebuilt, using the stored stone, in the same style as the original (see Plate 20).

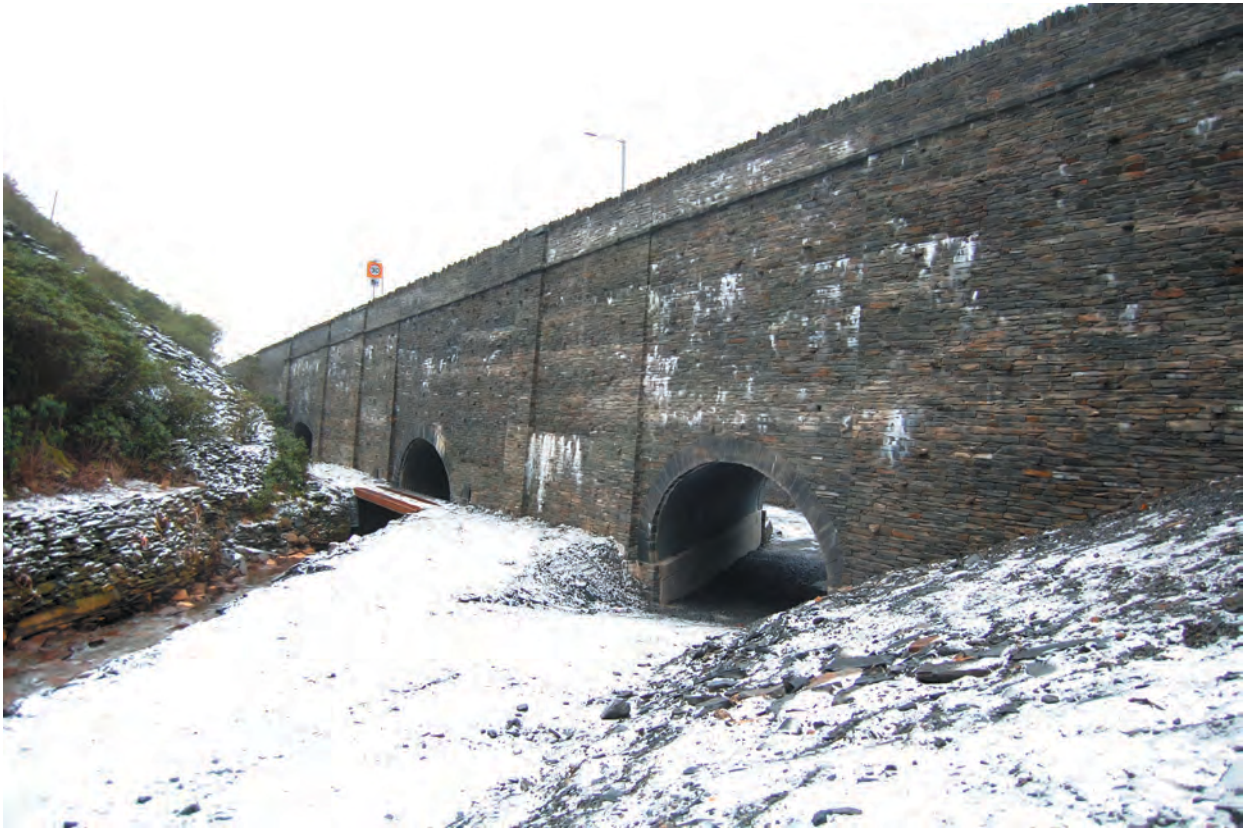
Plate 21 The east side of the exchange sidings after reinstatement

On completion of the project, the area was landscaped using the material from the immediate area. Almost all archaeological features had been removed from the area and the new, wider road causeway had encroached on the area. The reinstated ground level is a little higher than the original to prevent the river from running through the new incline tunnel when in spate. A row of boulders were placed along the side of the Barlwyd channel close to the base of the cascade in order to prevent erosion by the fast-flowing water. Bridge 3(3) was replaced by a new bridge built from large iron girders close to its original position. This abuts the new road causeway. Refer to Plate 21 for a general view of this area after reinstatement.

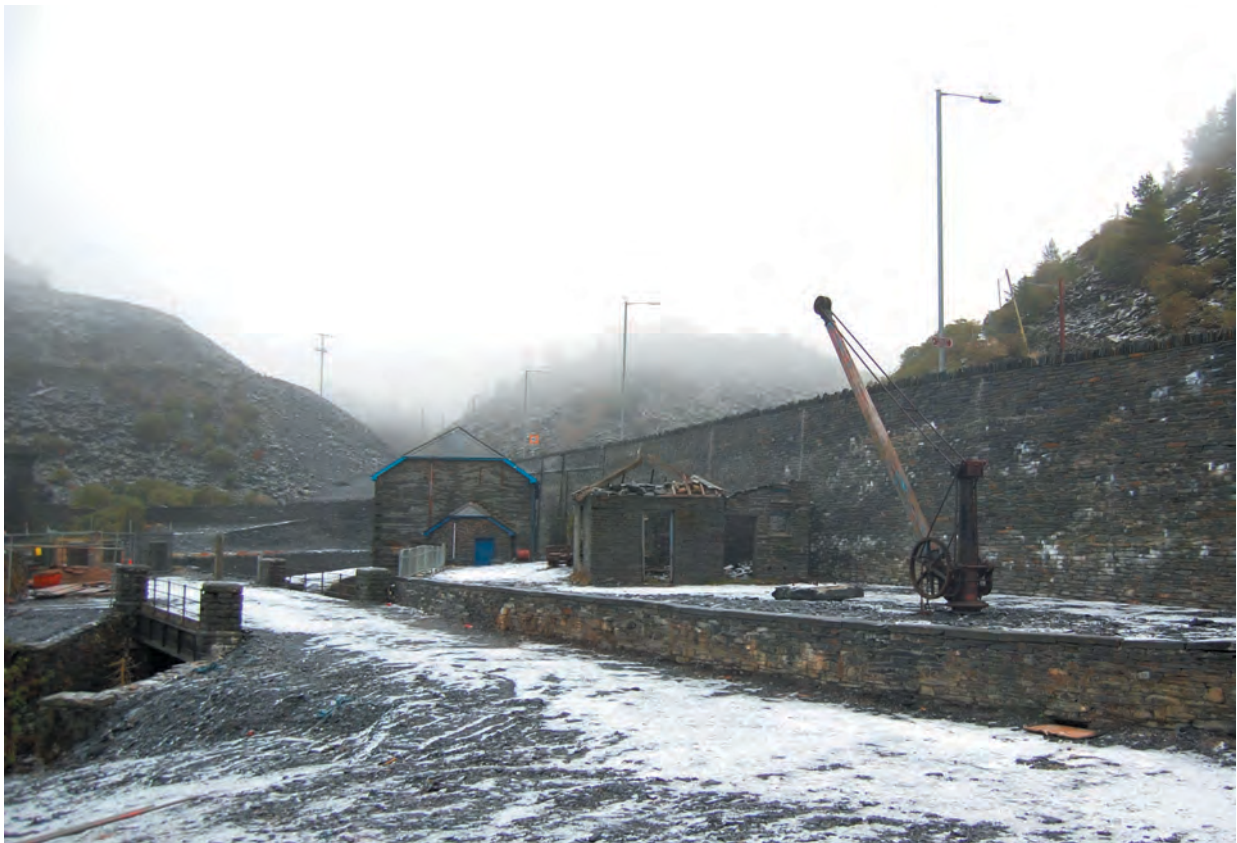
Plate 22 Llechwedd exchange sidings after reinstatement

The crane was reinstated after the construction of the new road causeway. The slate block was not reused due to health and safety considerations. The crane had to be replaced in a different position due to the realignment of the road causeway (as agreed with Cadw). It has been retained in a functionally correct position beside the sidings (See Plate 22 for a general view of this area after reinstatement).

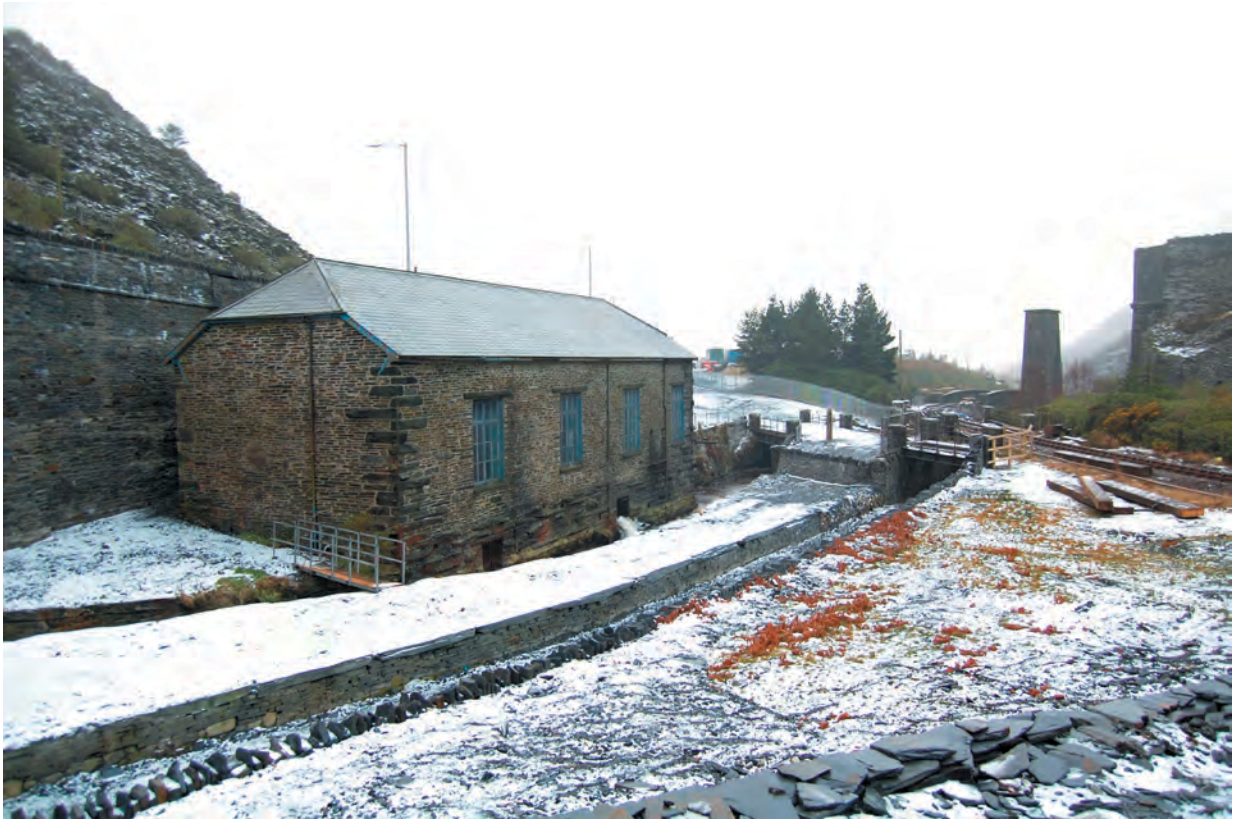
Plate 23 Llechwedd exchange sidings after reinstatement

The old causeway was replaced with a new concrete structure faced with slate. This was constructed in a way that reflected but did not copy in detail the original structure. Three new tunnels were constructed in order to retain the functional understandability of the site using galvanised steel formers. The causeway was faced with slate that included protruding stone piers and the distinctive regularly-spaced protruding stones that characterised the original masonry (see Plates 21 and 23)
