Barmouth Viaduct, Abermaw, Gwynedd

Desk Based Assessment and Site Visit

Report No. 1903

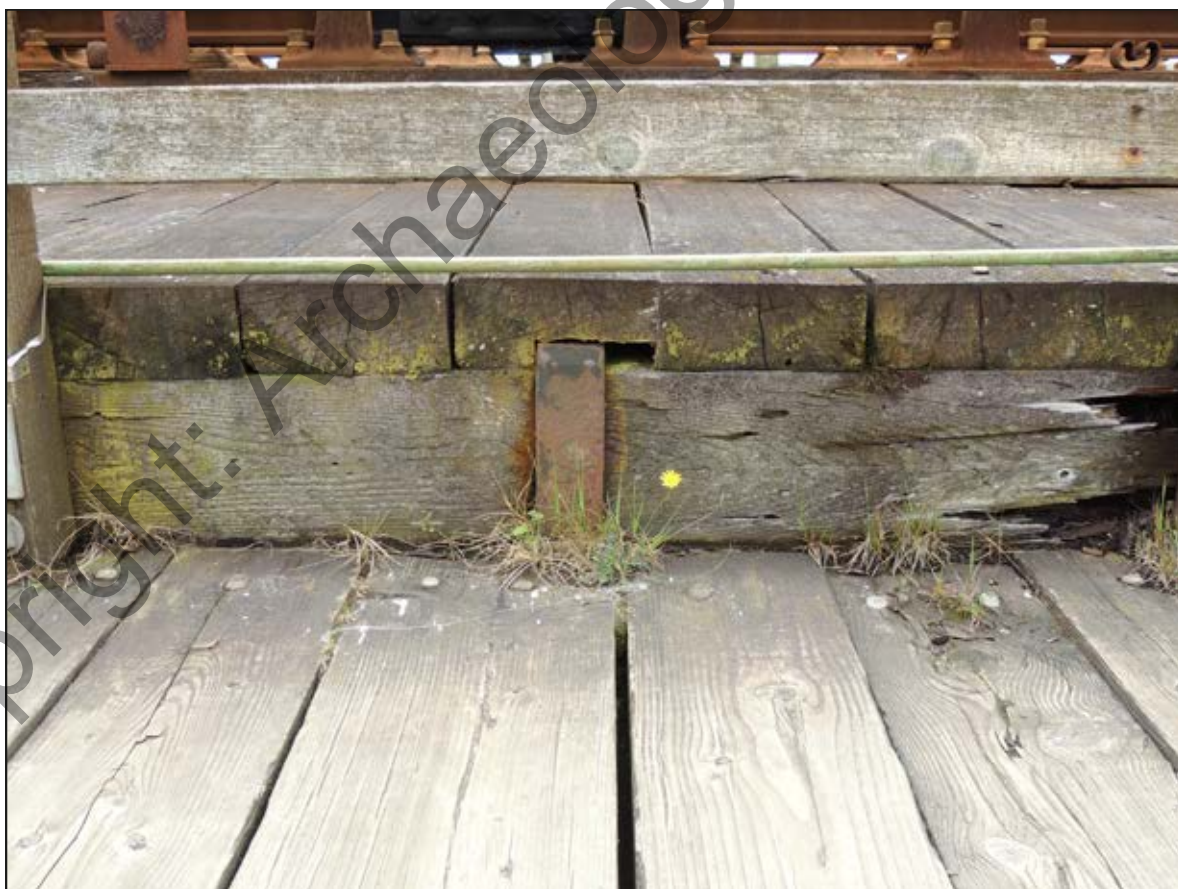
longitudinal outer beams rest on the horizontal support beams of the trestle beneath and fixed together via a metal strap fixing. Some of the longitudinal outer beams, especially those observed between trestles 5 and 6 were in a bad state of disrepair as the wood is rotting away and the metal strap was heavily corroded (See plate 12 and 26). However, refurbishments have been undertaken on other longitudinal outer beams where the wooden beam has been replaced and two metal plates have been bolted to the neighbouring beams either side to offer extra stability (See plate 14). The refurbishments detailed above were carried out within the last five years according to the engineer that was in attendance during the site visit.

Plate 12. SW facing shot of damaged longitudinal outer beam with metal strap between trestle 5 and 6.

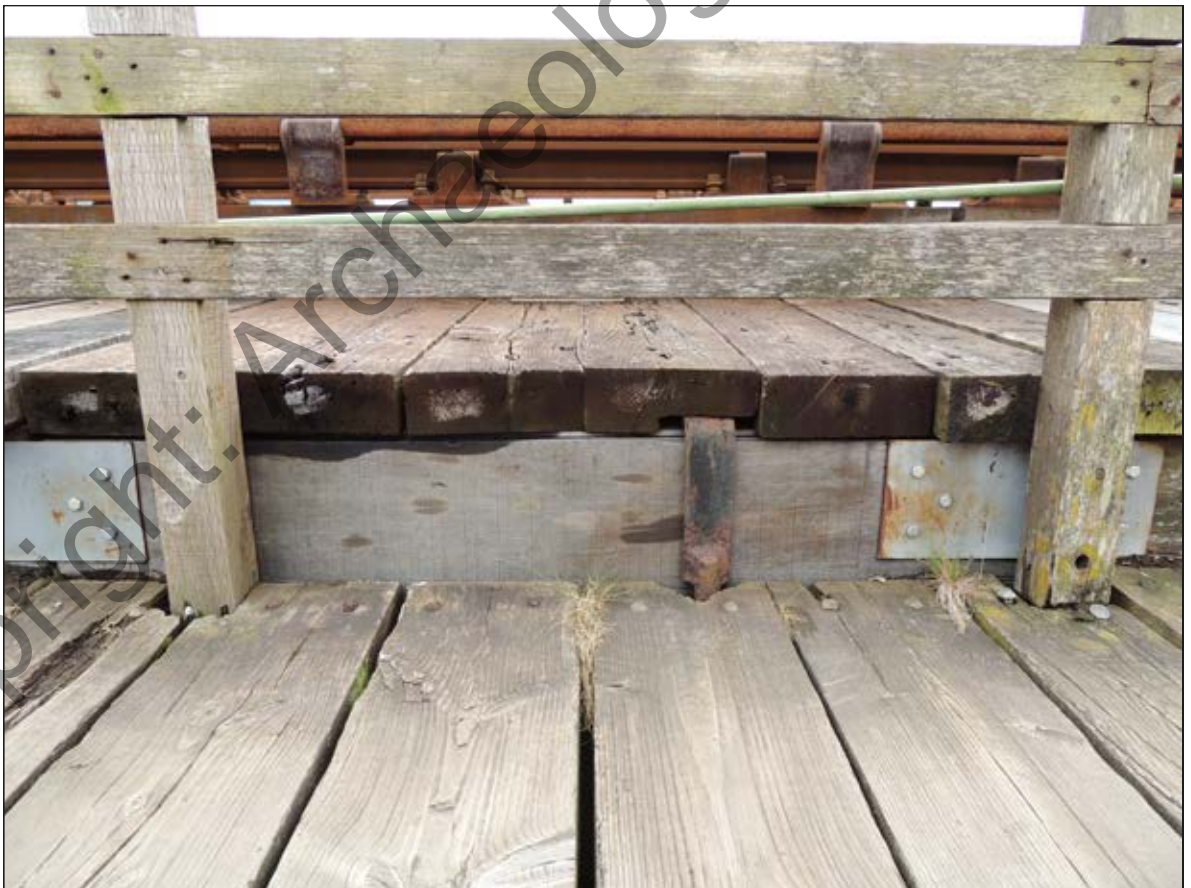
Plate 14. SW facing shot of replacement longitudinal outer beam and metal strap with metal plate reinforcements inbetween trestle 12 and 13.

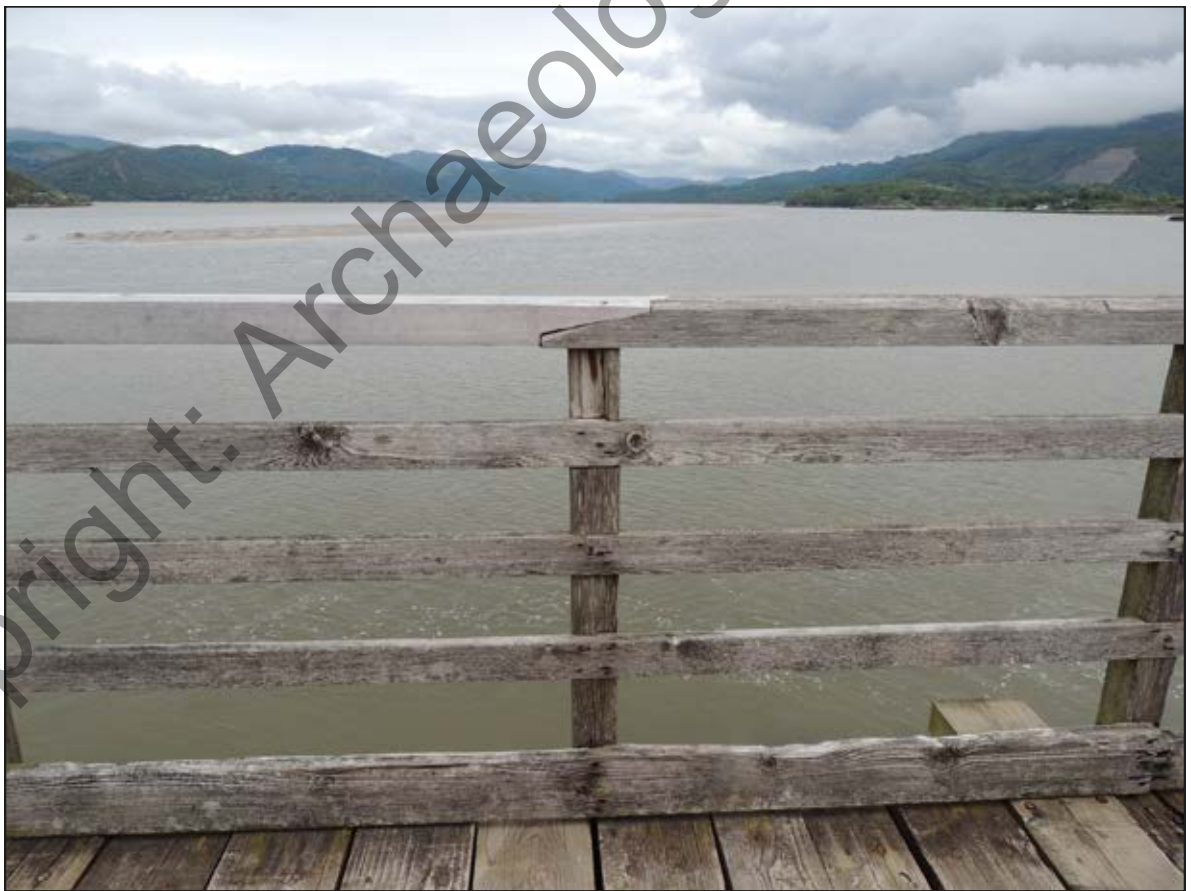
Plate 16. NE facing shot of repaired timber hand rail of walkway at trestle 14.

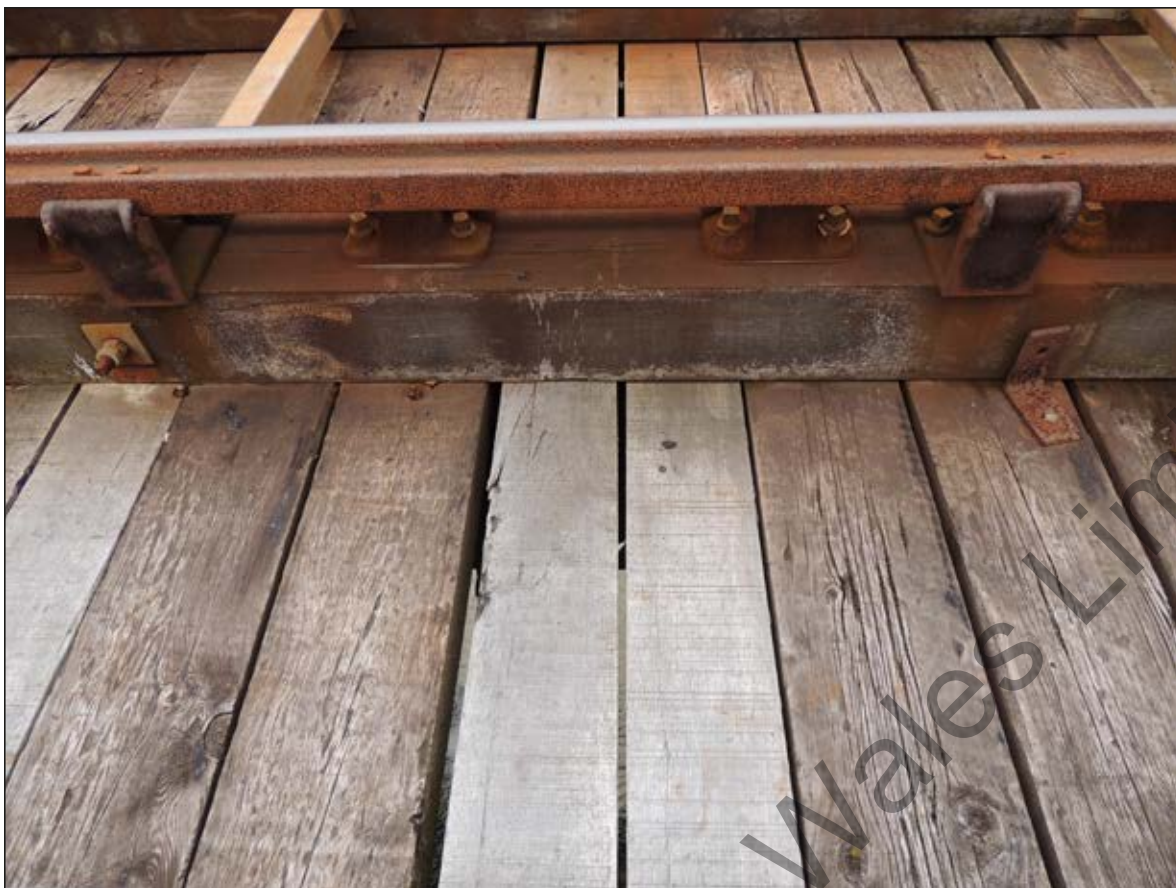
Plate 17. Plan shot of replacement transverse deck planks at trestle 15.

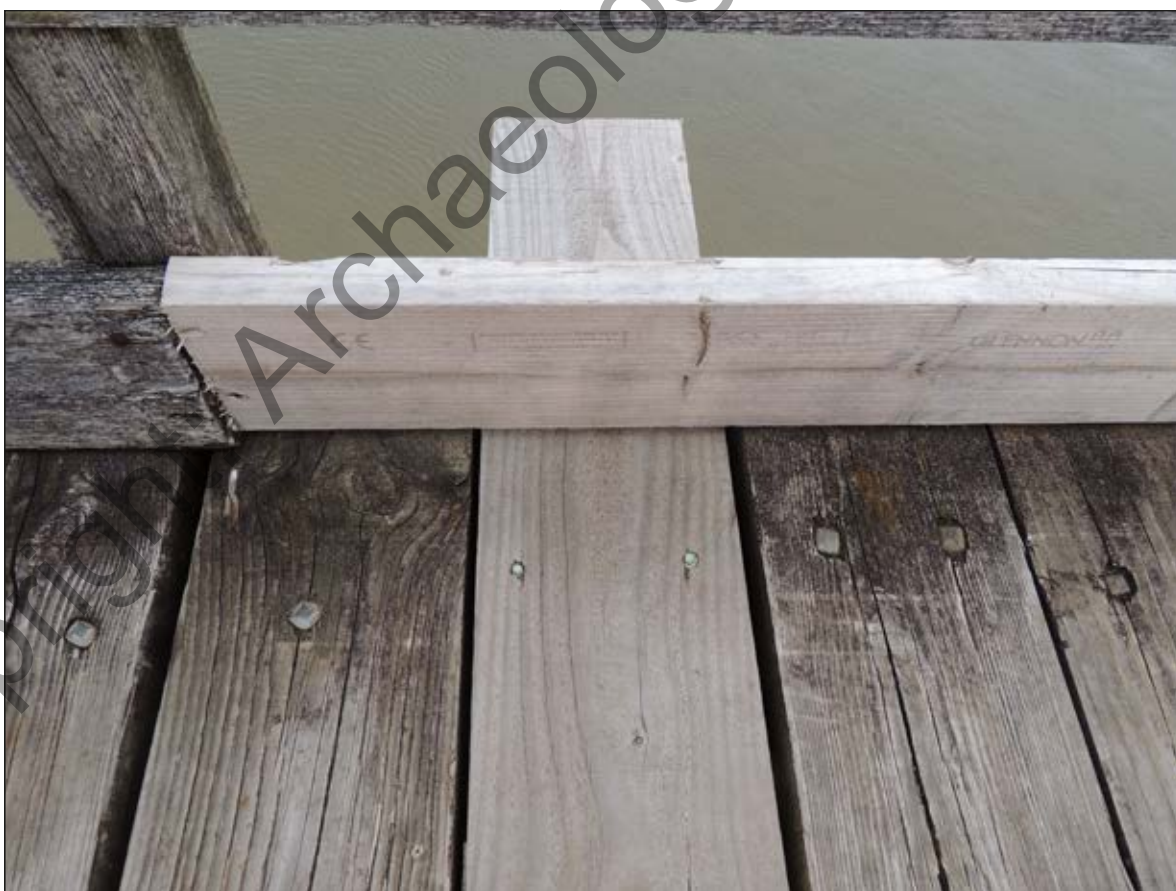
- 7.3.2. The survey commenced from the SE end of the viaduct at trestle one. The transverse deck planks that make up the pedestrian walkway of the viaduct vary in states of preservation, due to them being replaced over time. A large number of the deck planks appeared to have been replaced in recent times due to the colour of the planks being much lighter in appearance, compared to older ones with clear signs of weathering and wear, and a lot of them were clearly bowing towards the centre (See plates 17 and 18). The outer handrail of the pedestrian walkway also contained replacement components exemplified by lighter shaded timbers, again these were clear to see and were most likely replaced at the same time as the transverse deck planks of the walkway (See plates 16 and 18).

Plate 18. Plan shot of replacement transverse deck planks and kick board on handrail on walkway at trestle 20.

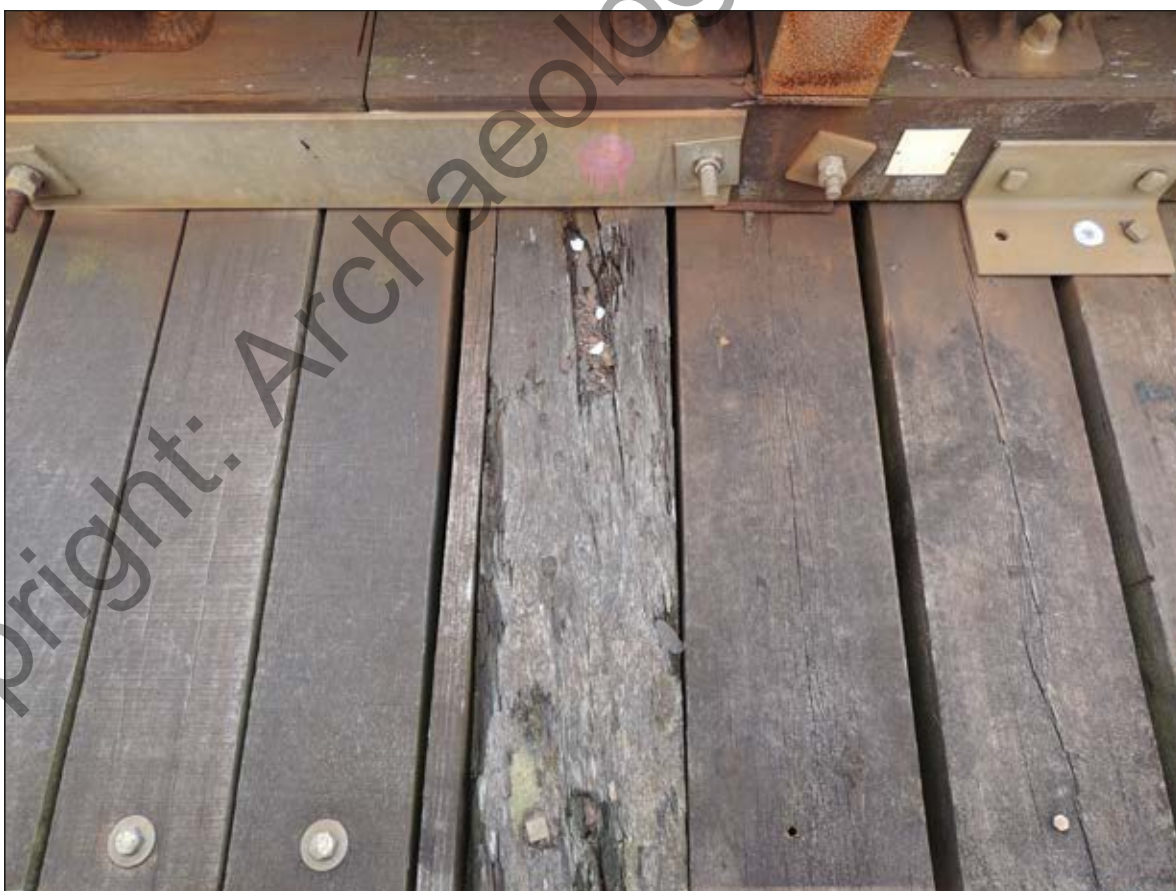
- 7.3.4. There was clear evidence of repairs undertaken on the transverse deck planks on the railway track at various points along the line. These repairs were observed on trestle 50 where there is a group of planks that differed slightly in appearance and fittings used to secure them to the trestle beneath (See plate 20). The planks are all fairly dark in appearance due to weathering and grime, from being in such close proximity to the track as the diesel trains passing over will emit dust and dirt discolouring the timber over time. There is one plank in particular that is heavily decayed and in clear need of replacement, compared to the others either side of it. The metal fittings used on this group of planks to secure them differ in appearance indicating three phases of refurbishment, with the most recent having a much larger bolt with the addition of a washer (See plate 20).

Plate 20. Plan shot of 3 phases of transverse deck plank replacement exemplified by the changing fixtures and preservation of timbers at trestle 50.

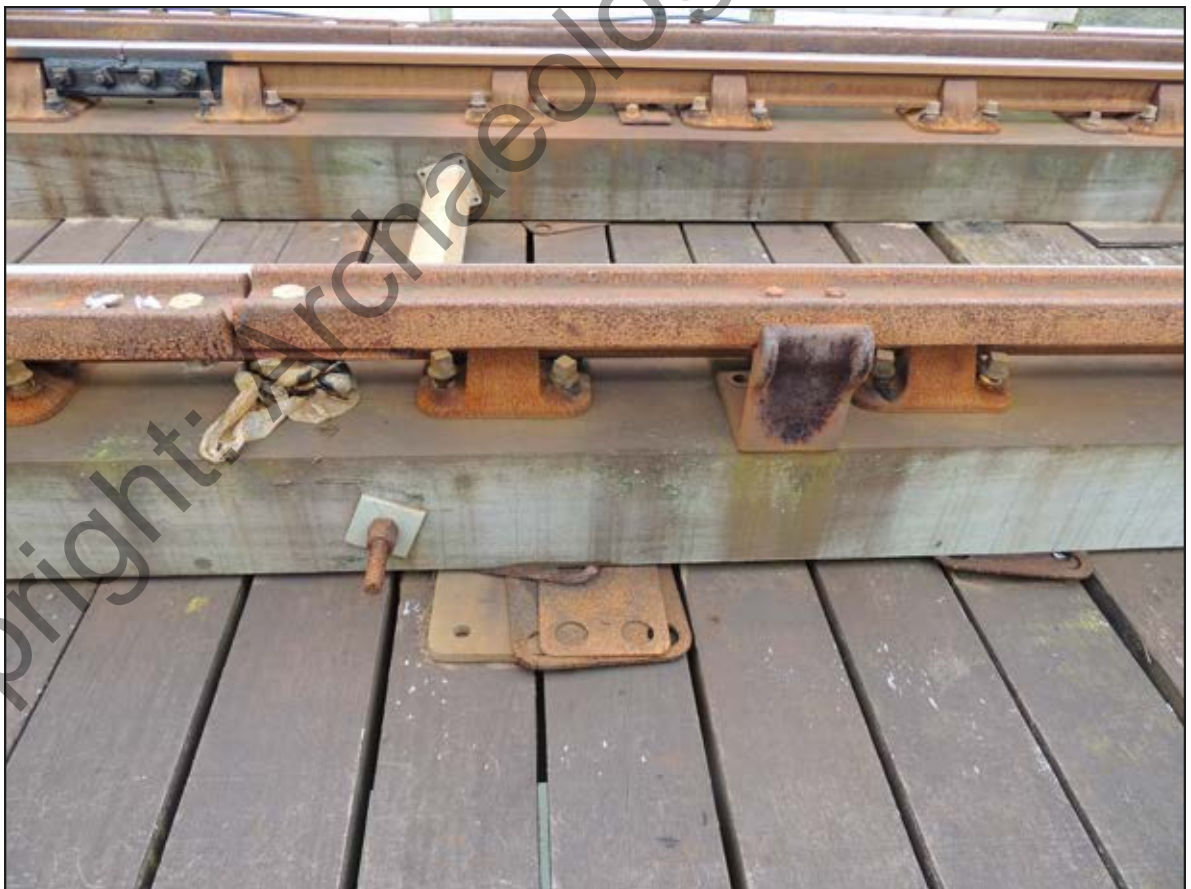
- 7.3.5. Other notable areas that were observed on the railway track were the transverse deck planks at trestle 81 and 82, where a number of planks that the track lies upon are sagging. It appears measures have been taken to prop up the track with metal plates and timber boards to keep the track level. The sagging of these deck planks are most probably due to the horizontal beam atop of the trestle beneath being weakened over time (See plates 24 and 25).

Plate 24. SW facing shot of metal plates supporting the track due to slumping of the transverse deck planks at trestle 81 and 82.

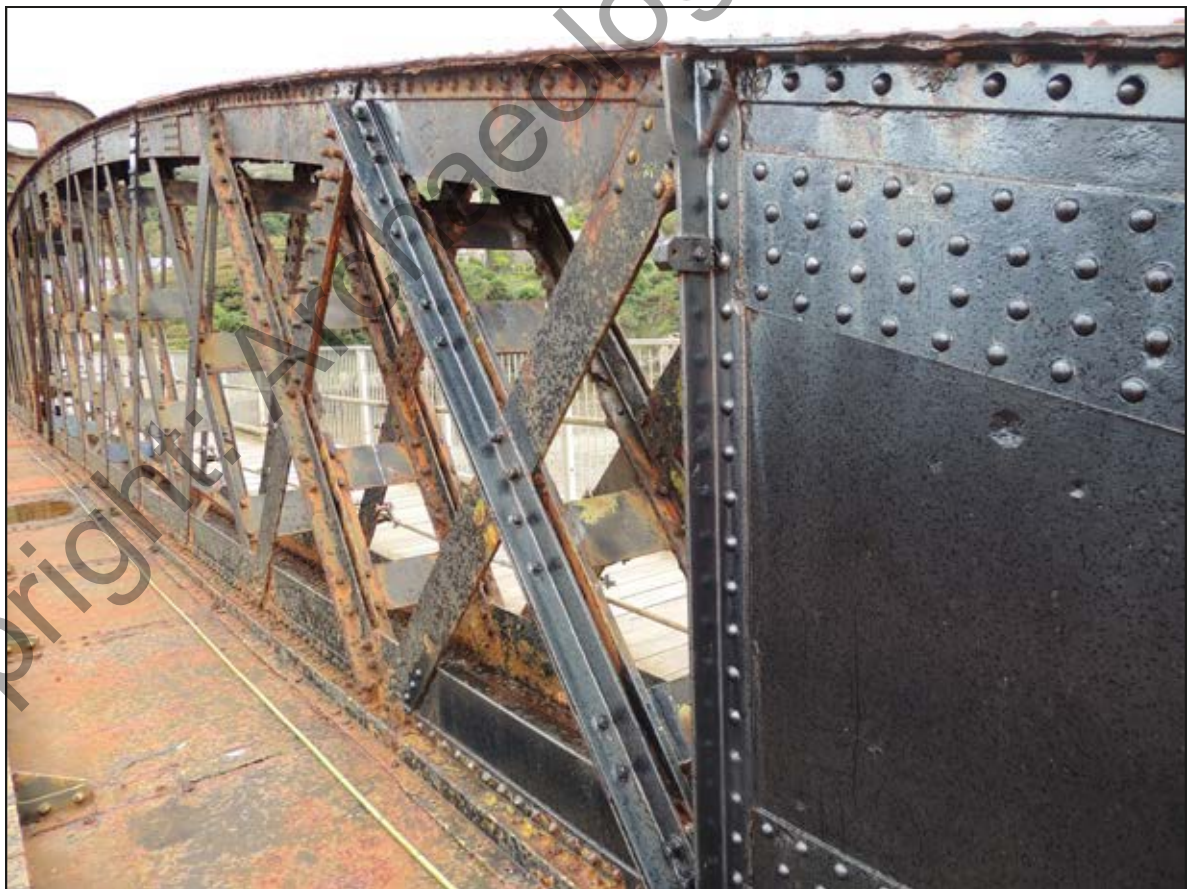
Plate 28. N facing shot of replacement metalwork on the hogback lattice trusses on the span of the viaduct.

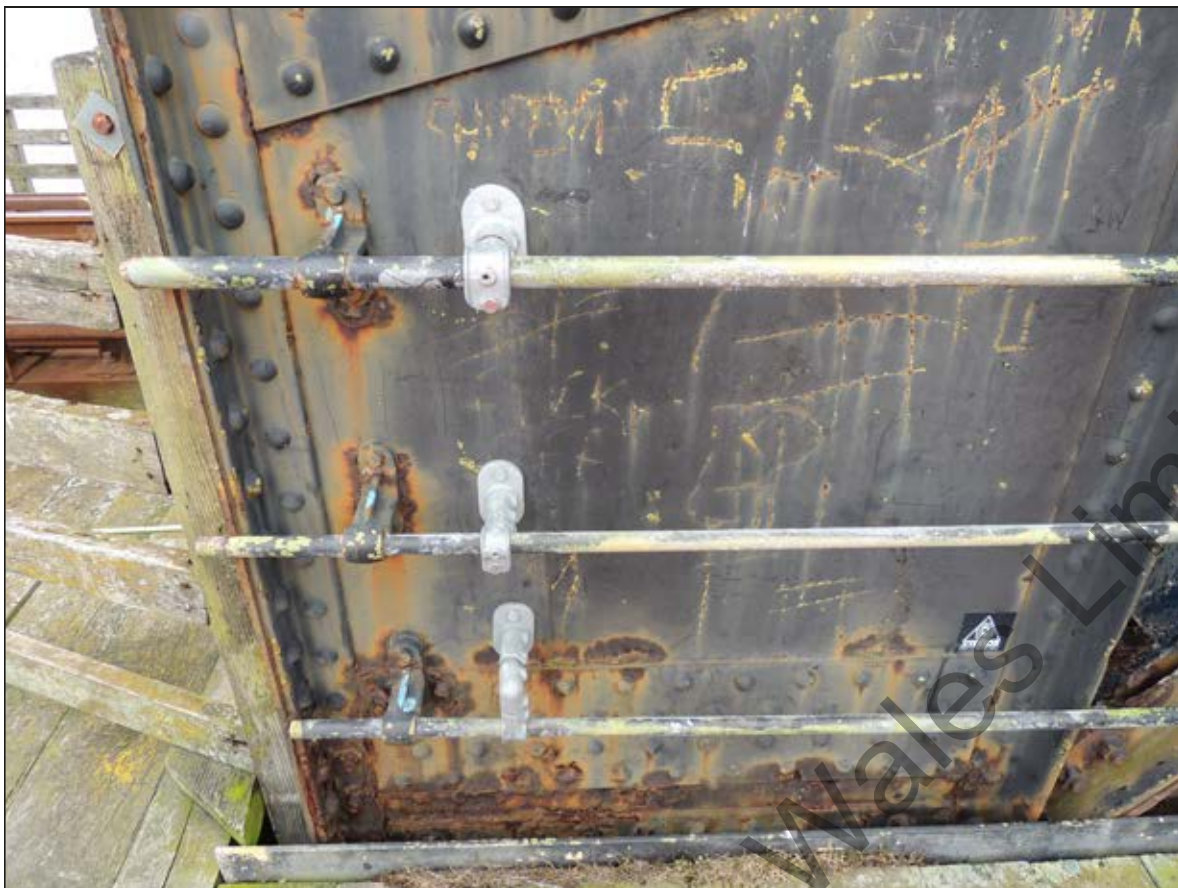
- 7.3.9. A metal handrail with modern stainless-steel clamps was observed on the NE facing elevation of the swing bridge. The handrail runs the entirety of the spans of the swing bridge and is attached to the lattice work on the trusses. Modern stainless-steel clips have been added in recent times as the original fittings have corroded. The stainless-steel clips are clamped to the metal work and do not appear to penetrate it, probably due to the frailty of the metal work they are attached to. Some older fittings were present and functioning and appeared corroded (See plates 31 - 32).

Plate 31. SW facing shot of stainless steel handrail clamps of NE elevation of hogback lattice trusses on the spans of the viaduct.

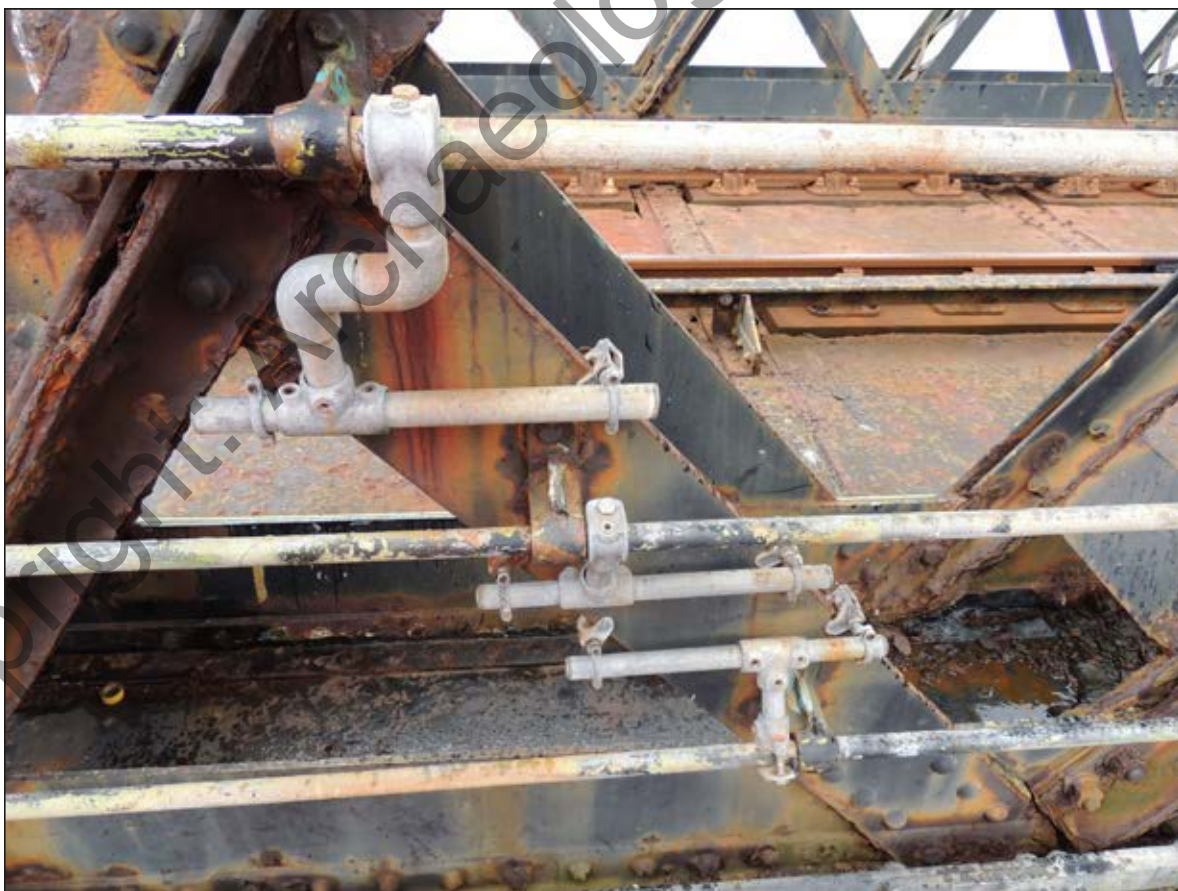
Plate 32. SW facing shot of stainless steel handrail clamps attached to corroded lattice trusses on the spans of the viaduct.

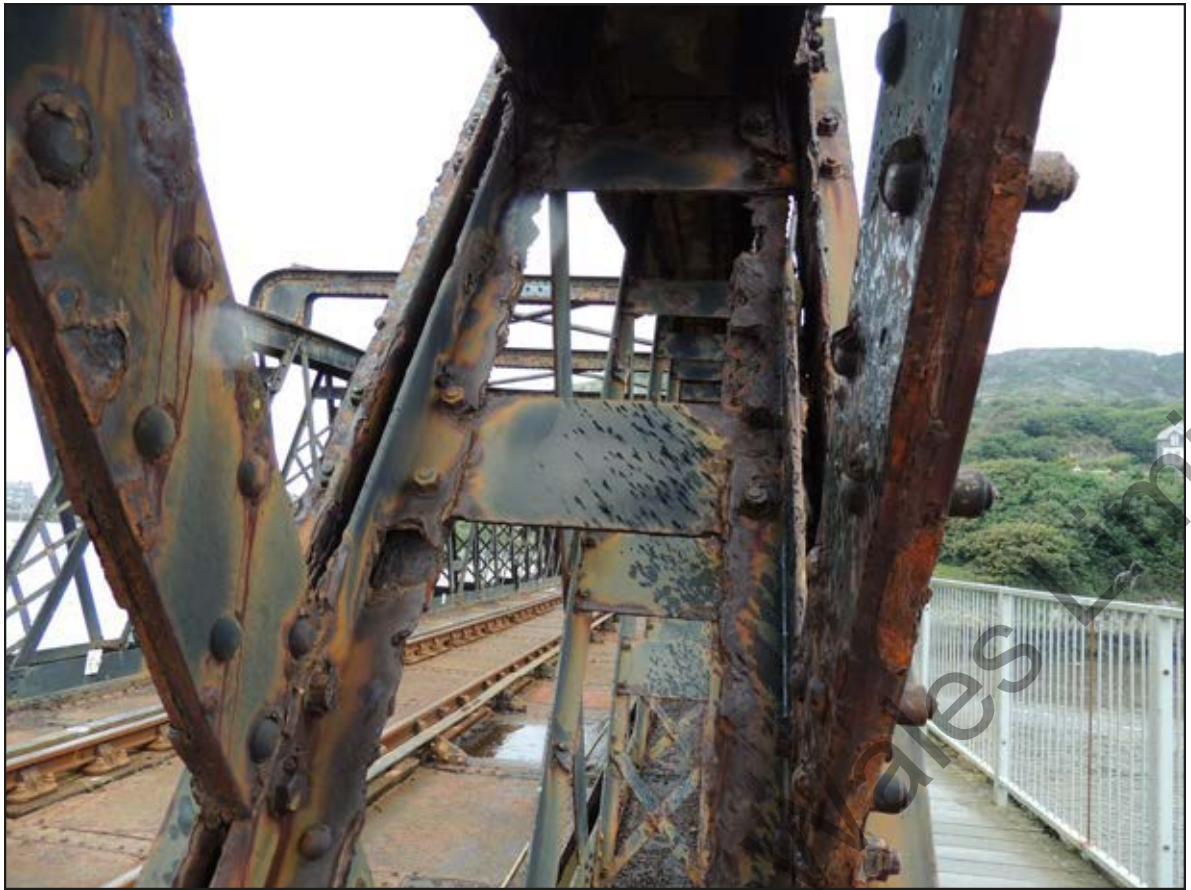
Plate 33. NW facing shot of repairs made to lattice work on the hogback trusses on the span of the viaduct.

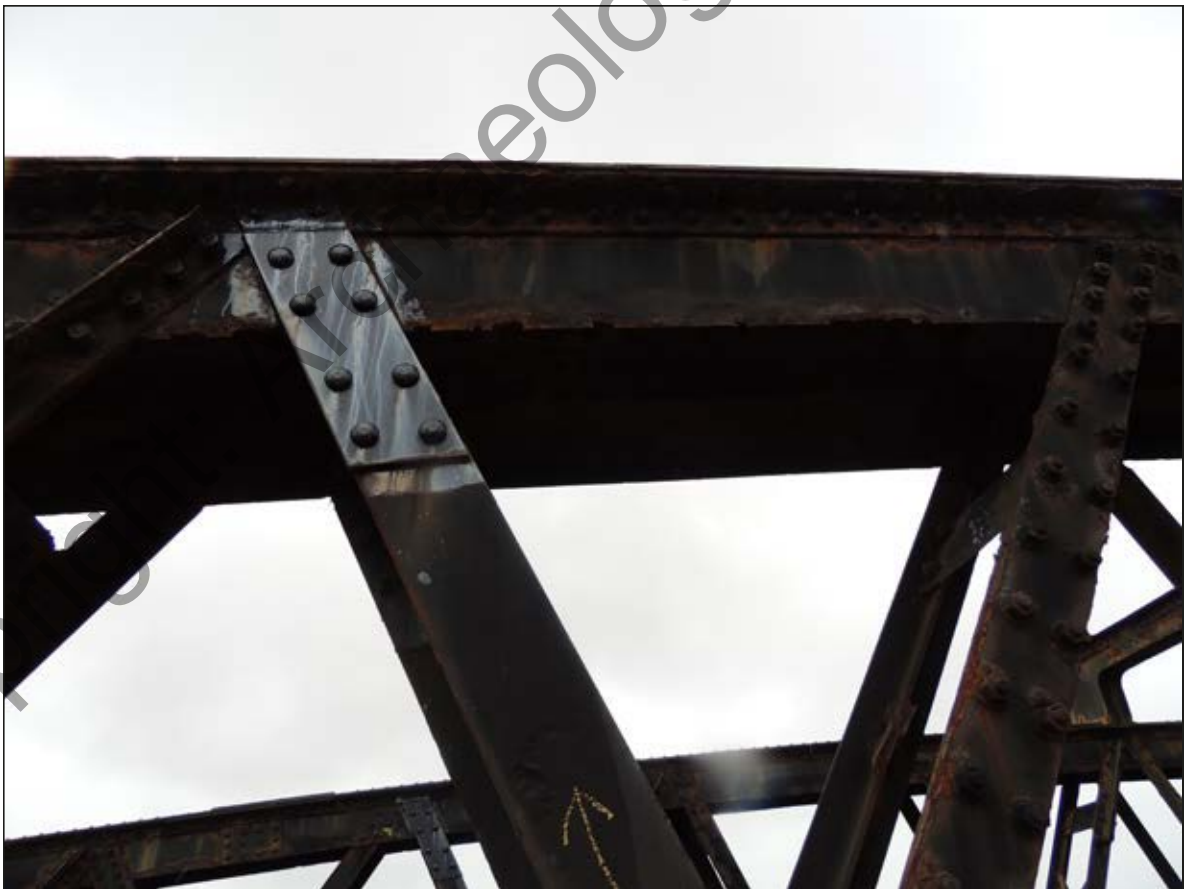
- 7.3.7. In addition to the above, the outer diagonal girders that the rectangular plates are attached have been replaced and fixed to the top of the span via a riveted rectangular plate (See plate 34). The SW facing elevation of the southernmost span retained some of the diagonal lattice work on the trusses, and where there was corroded lattice work, these too have been removed and replaced with riveted rectangular plates. However, on some of the trusses there was an absence of either lattice work or plates and appeared to have no central structure to the truss whatsoever (See plate 36).

Plate 34. SW facing shot of steel riveted plate added to strengthen the lattice trusses on the NE elevation of the span of the viaduct.

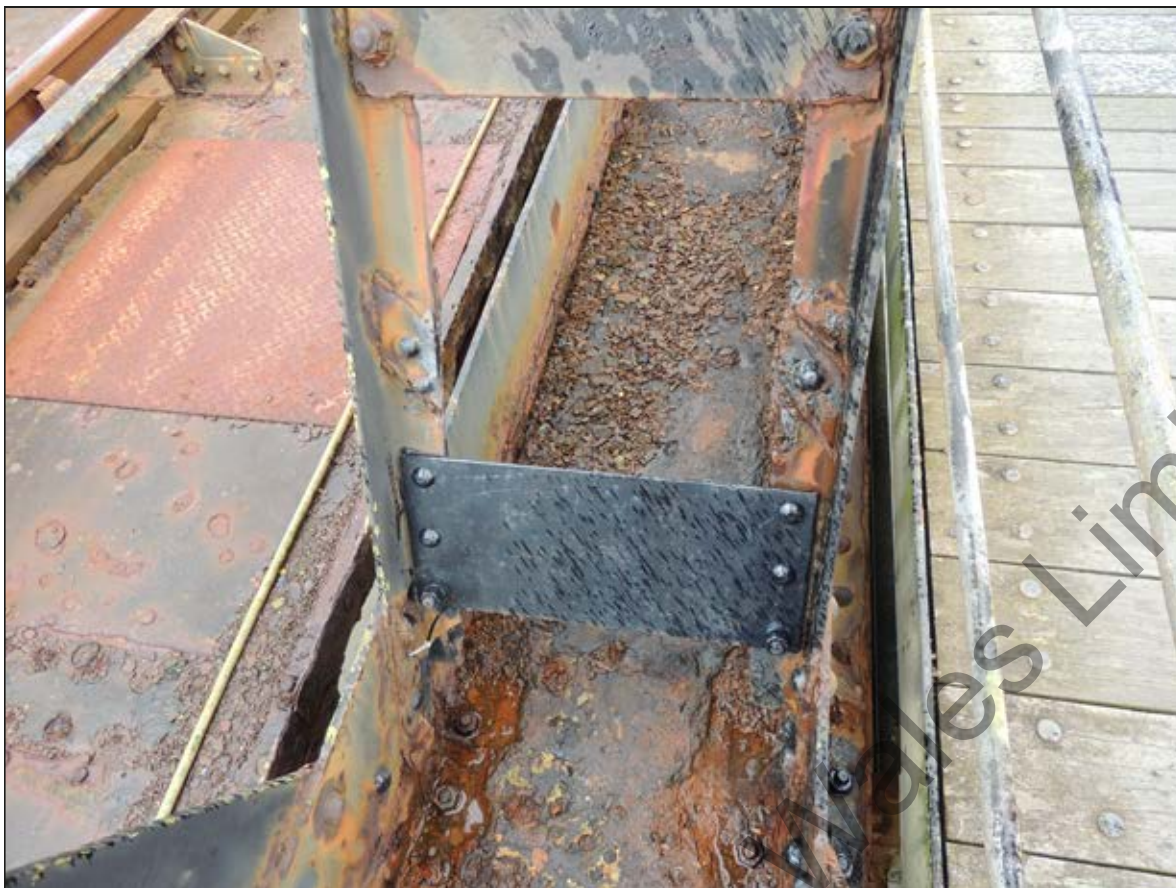
- 7.3.6. The swing bridge located at the northwesternmost end of the viaduct was observed and has had numerous repairs carried out on the structure. The spans of the viaduct are constructed using the hogback lattice truss design, fixed with rivets and bolts. It was evidently clear when surveying the swing bridge that modern repairs to the structure had taken place over time, as the majority of the structure has clear signs of corrosion. This was most evident on the hogback lattice trusses on the spans of the swing bridge, where the lattice supports have been removed due to their state of disrepair (See plates 33 - 36). The lattice work on the on the NE facing elevation of the southernmost span appeared to be the worst affected by corrosion, where the diagonal lattice work has been removed and replaced with horizontal rectangular plates, fixed with a mixture of rivets and bolts (See plate 35).

Plate 35. Plan shot of rectangular metal plate with rivets replacing corroded lattice work on hogback lattice trusses on the spans of the viaduct.

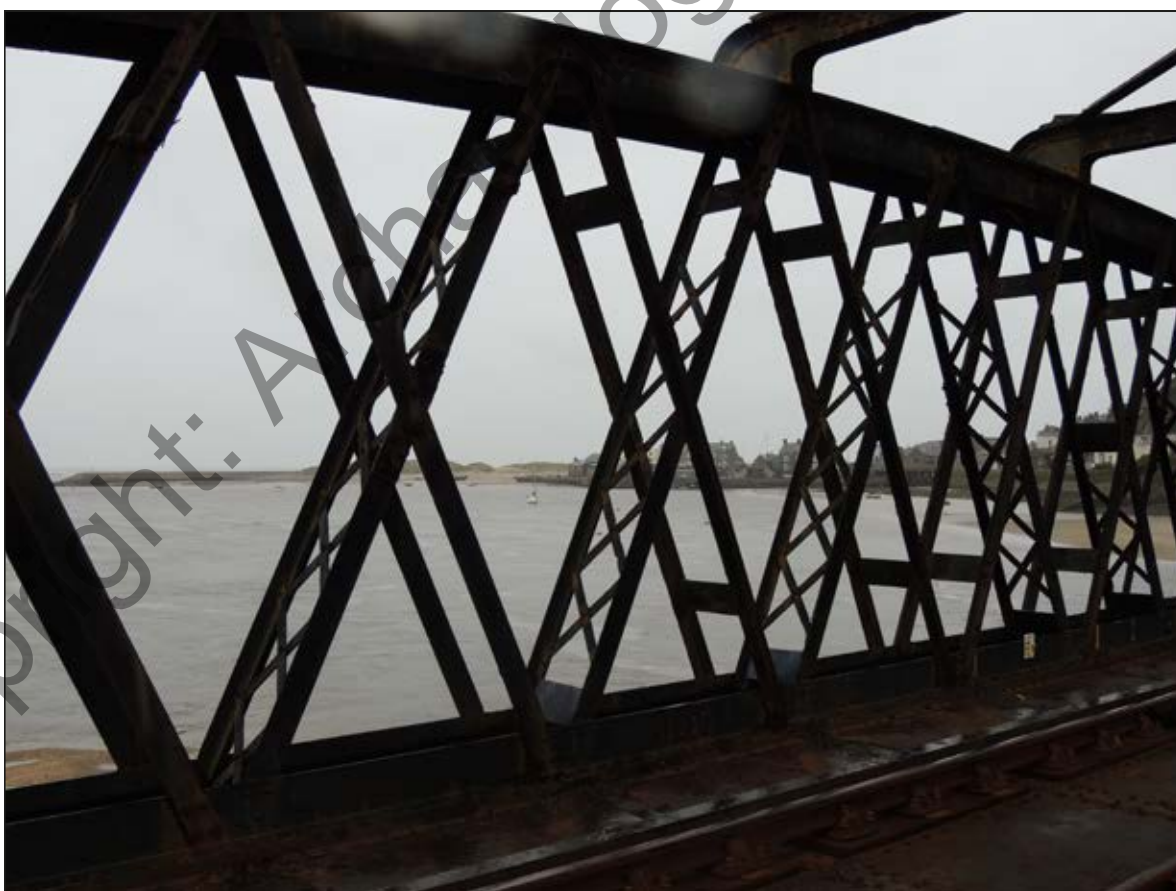
Plate 36. WNW facing shot of intact latticework on the hogback lattice trusses on the SW elevation of the spans of the viaduct.

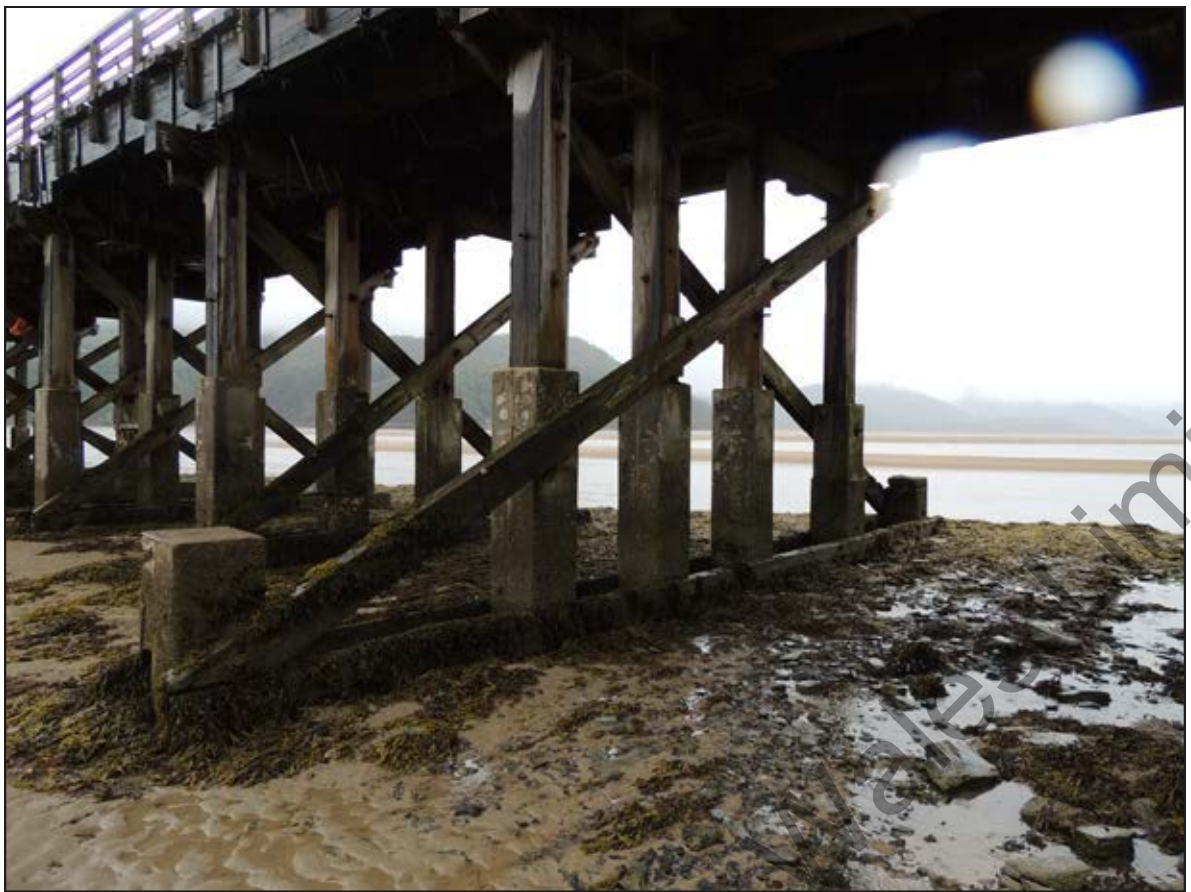
- 7.4.3. The dividing trestle of 2 and 3 has a horizontal waling at its foot, that extends out approximately 2m either side of the 4 piles that make up the trestle. The horizontal waling encloses the bottom of the 4 piles with a diagonal beam attached to the horizontal waling at the bottom, and a reinforced concrete pillar flanking either side of the trestle. The horizontal waling's are only found on every fifth trestle of the viaduct and correspond to the alterations undertaken in the 1980s (See plate 45 and figure 16.1).

Plate 45. N facing shot showing verticle piles with reinforced concrete pile casing and diagonal beam & horizontal waling of trestle 2.

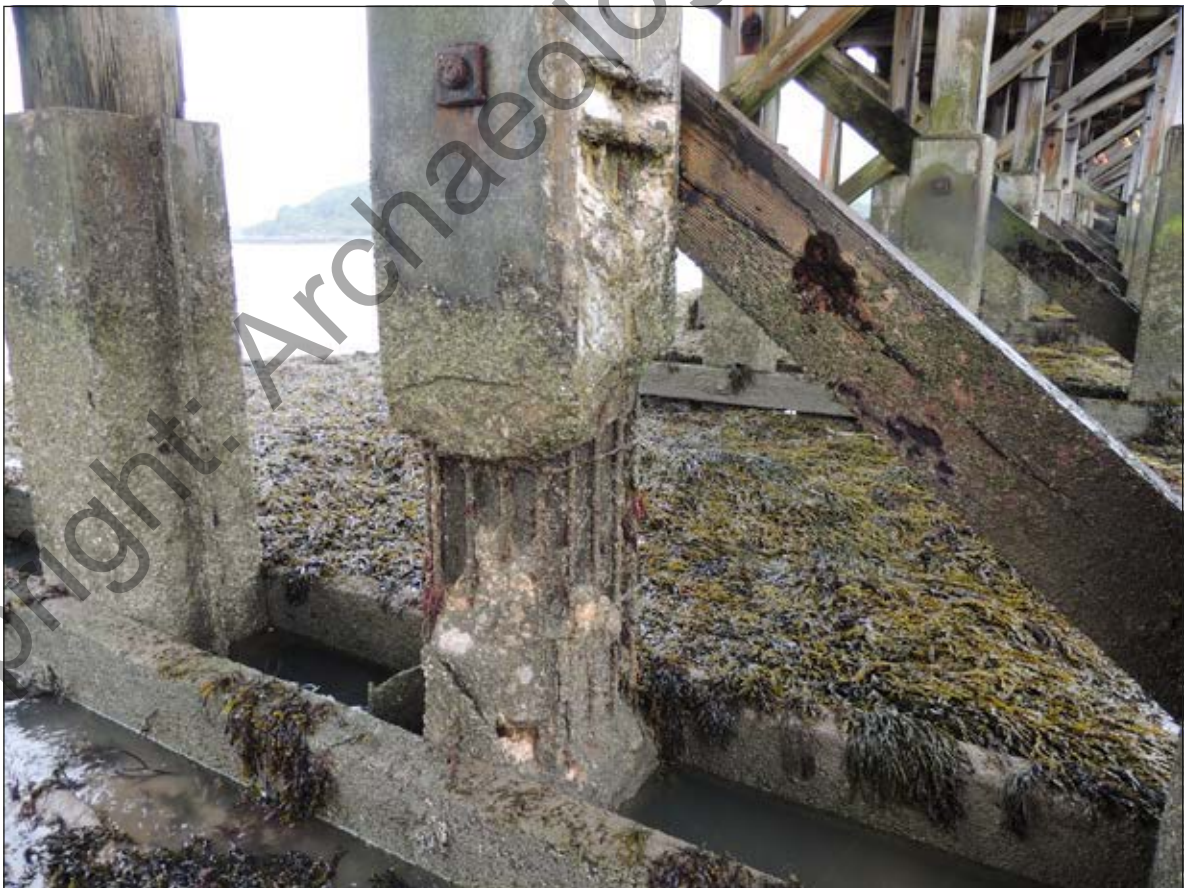
- 7.4.4. Reinforced concrete casings were observed on a majority of piles on the viaduct and were added as part of the alterations of the 1980s. The casings were added to protect the timber piles at the foot of the trestles from *Teredo Navalis*. However, water erosion has caused significant damage to the concrete casings and stripped them down to the rebar beneath (See plate 46). The worst affected by the water erosion are the piles on the seaward side of the viaduct. Observed on trestle 14 and 32 are what appears to be white plastic PVC coverings clipped together on two sides by metal fixings (See plates 47 and 50). Again, engineering plans could not be obtained to determine the date of when these were added, however the engineer who was present noted that they were probably from the 1990s.

Plate 46. ESE facing shot of damaged reinforced concrete pile casing with exposed rebar of trestle 13.

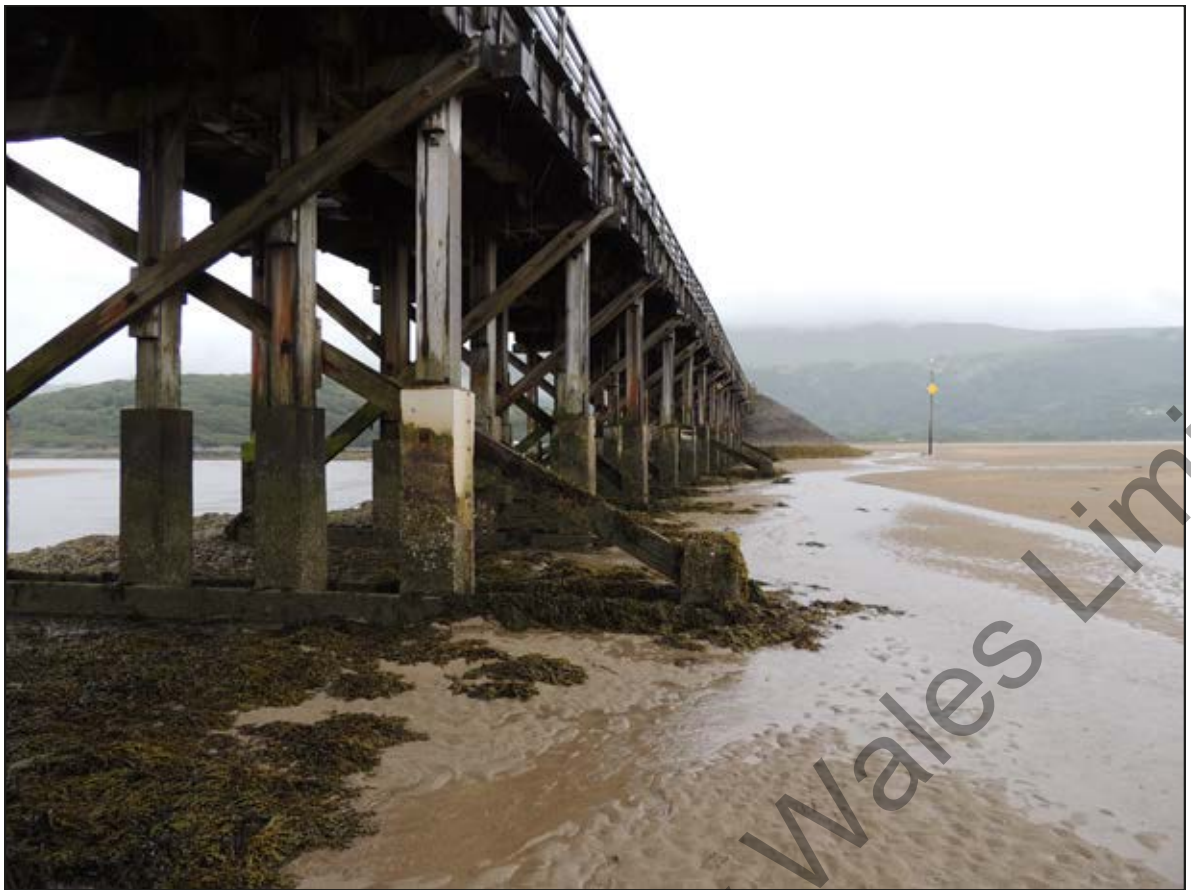
Plate 47. ESE facing shot of trestle 14 showing vertical pile with a protective covering over concrete pile casing.

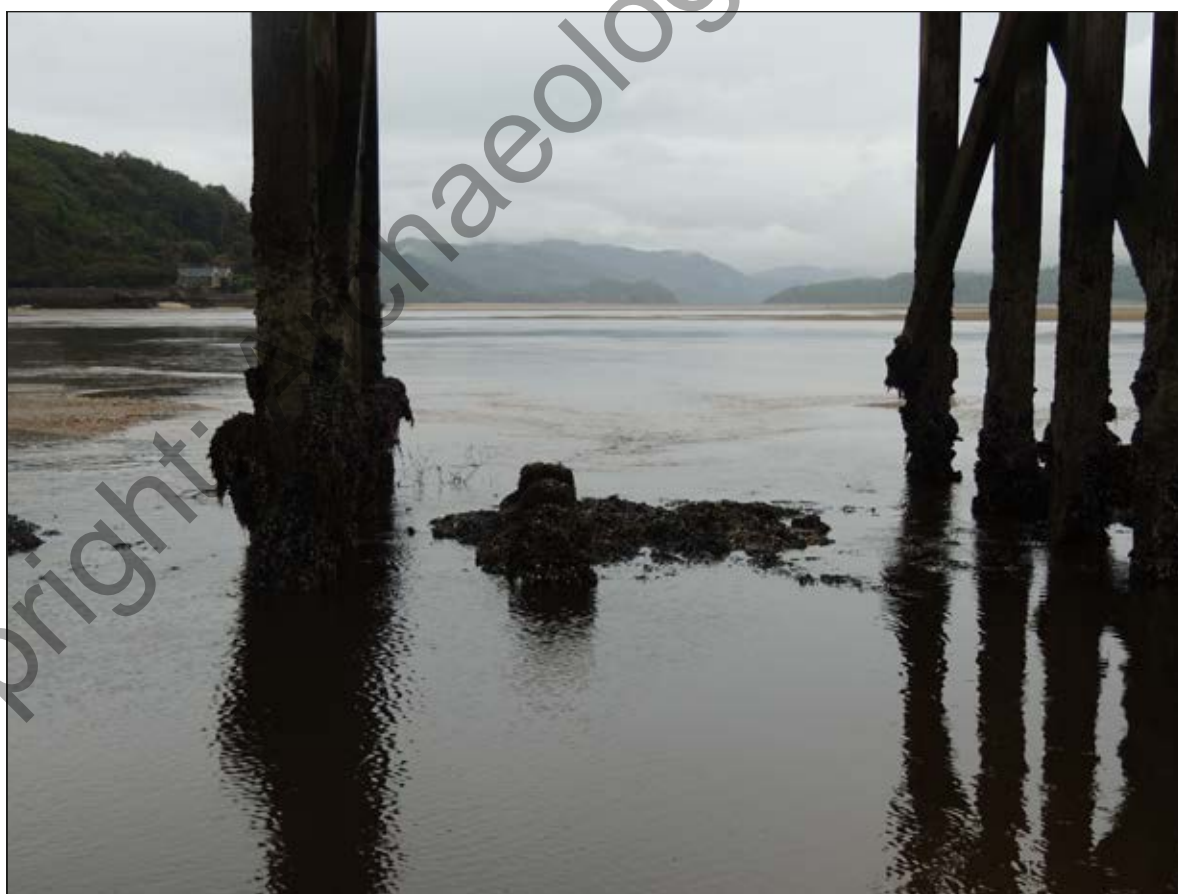
Plate 56. NE facing shot of the remains of old verticle pile stumps under trestle 87.

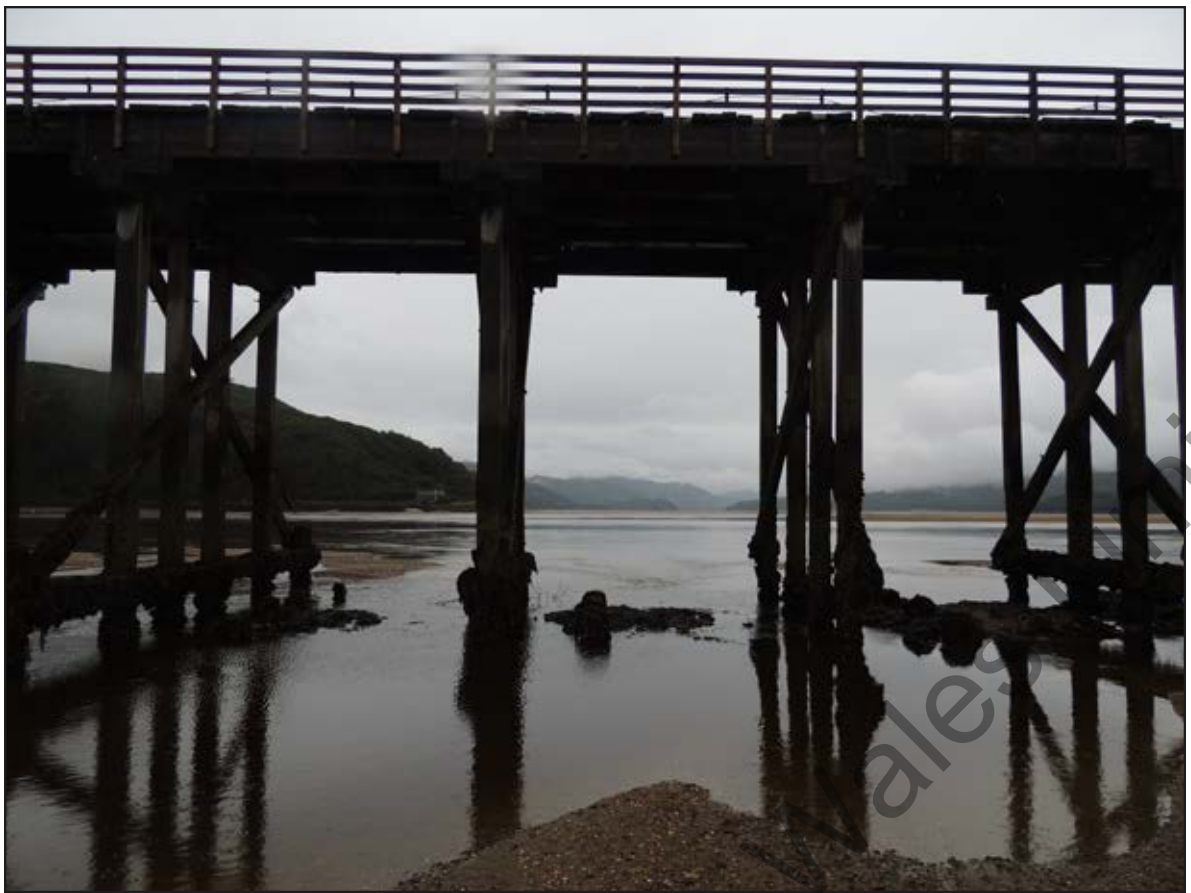
8.7.2. Likewise, during the site visit it was noted that the riverbed contain the remains of possible former piles. The latter must be taken into consideration as they represent the

Plate 57. NE facing shot of the remains of old verticle pile stumps under trestle 86, 87, 88.
