Barmouth Viaduct, Abermaw, Gwynedd

Desk Based Assessment and Site Visit

Report No. 1903

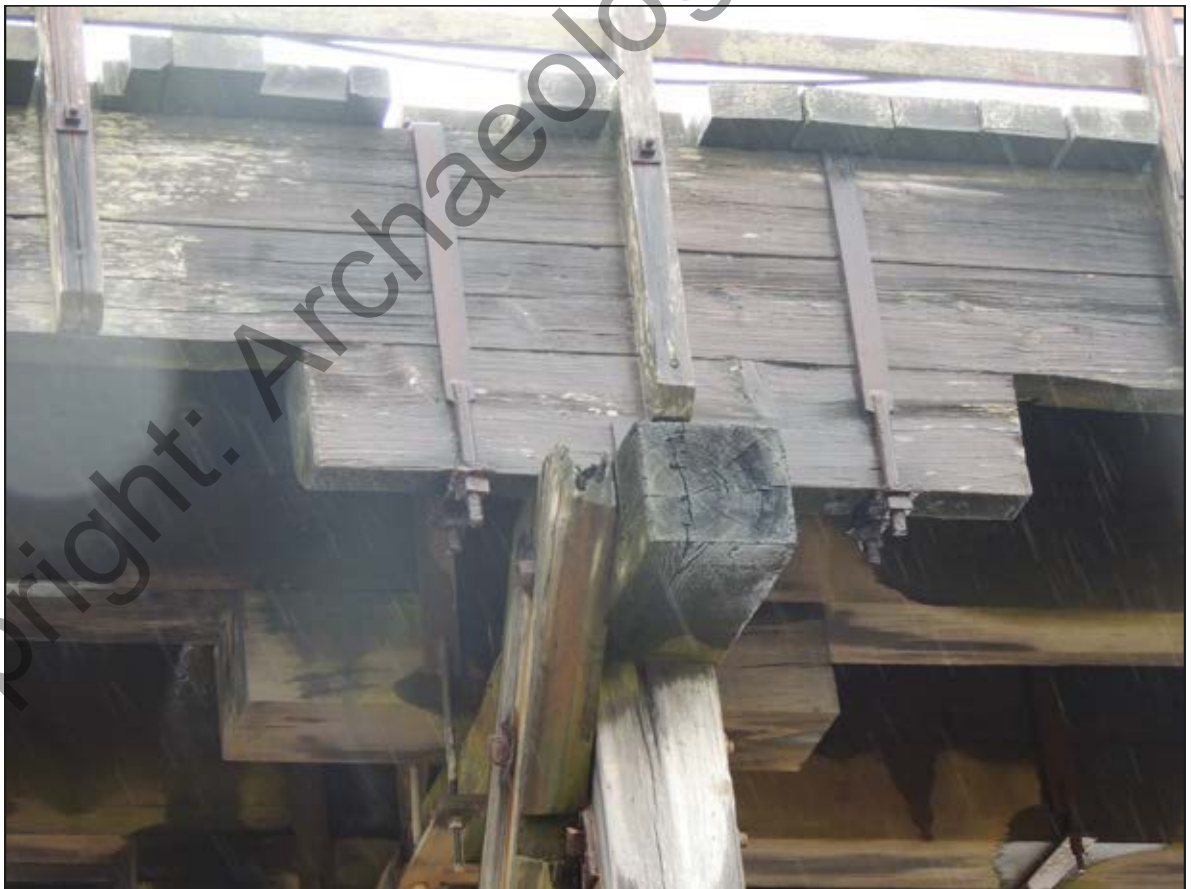
Plate 58. Shot of older steel straps attached to longitudinal outer beam above trestle 86.

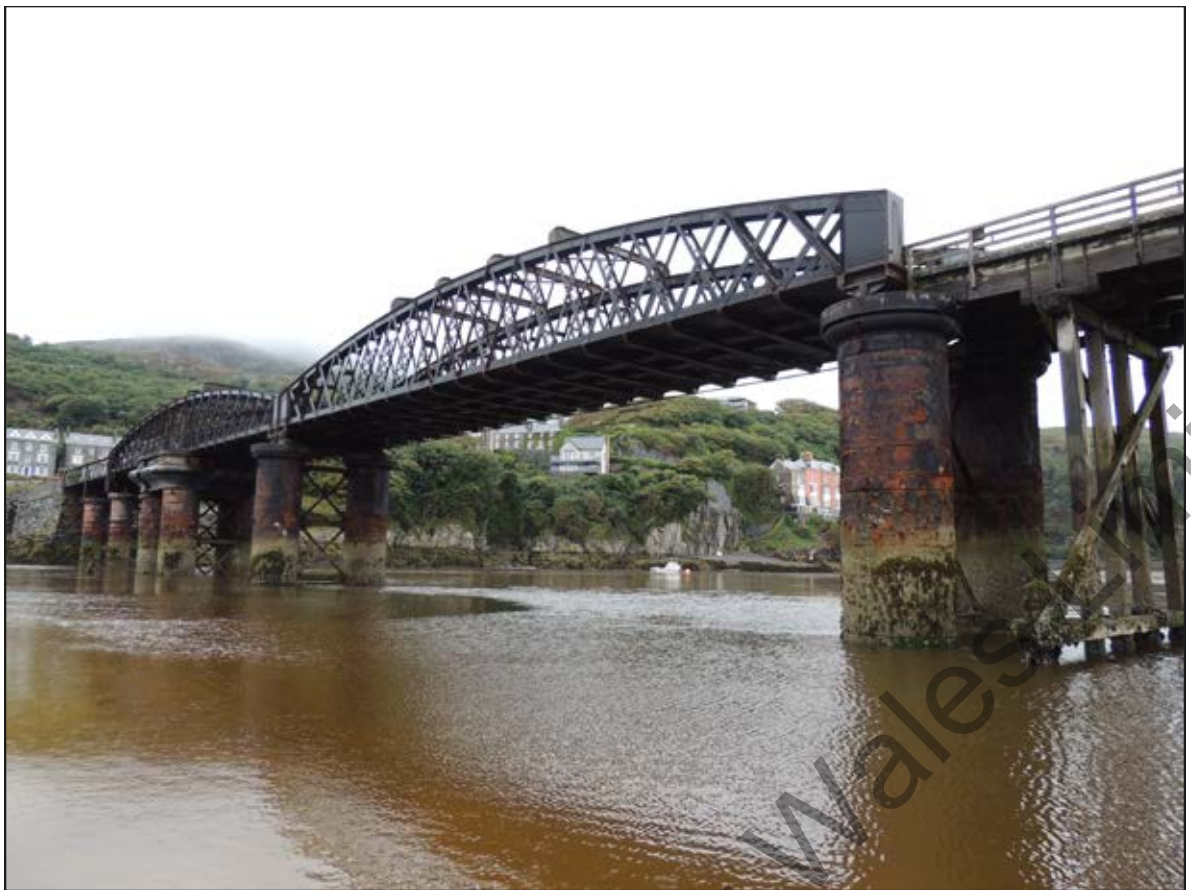
- 7.4.6. The swing bridge section of the underside of the viaduct was inaccessible due to deep waters. The cylindrical cast iron piers of the underside of the swing bridge appeared fairly corroded along with the lattice trusses connecting them. There was no evidence of alterations made to any of the cylindrical piers, however a closer inspection was needed to confirm this (See plates 61 - 64).

Plate 61. N facing shot of swing bridge from Mawddach Estuary.

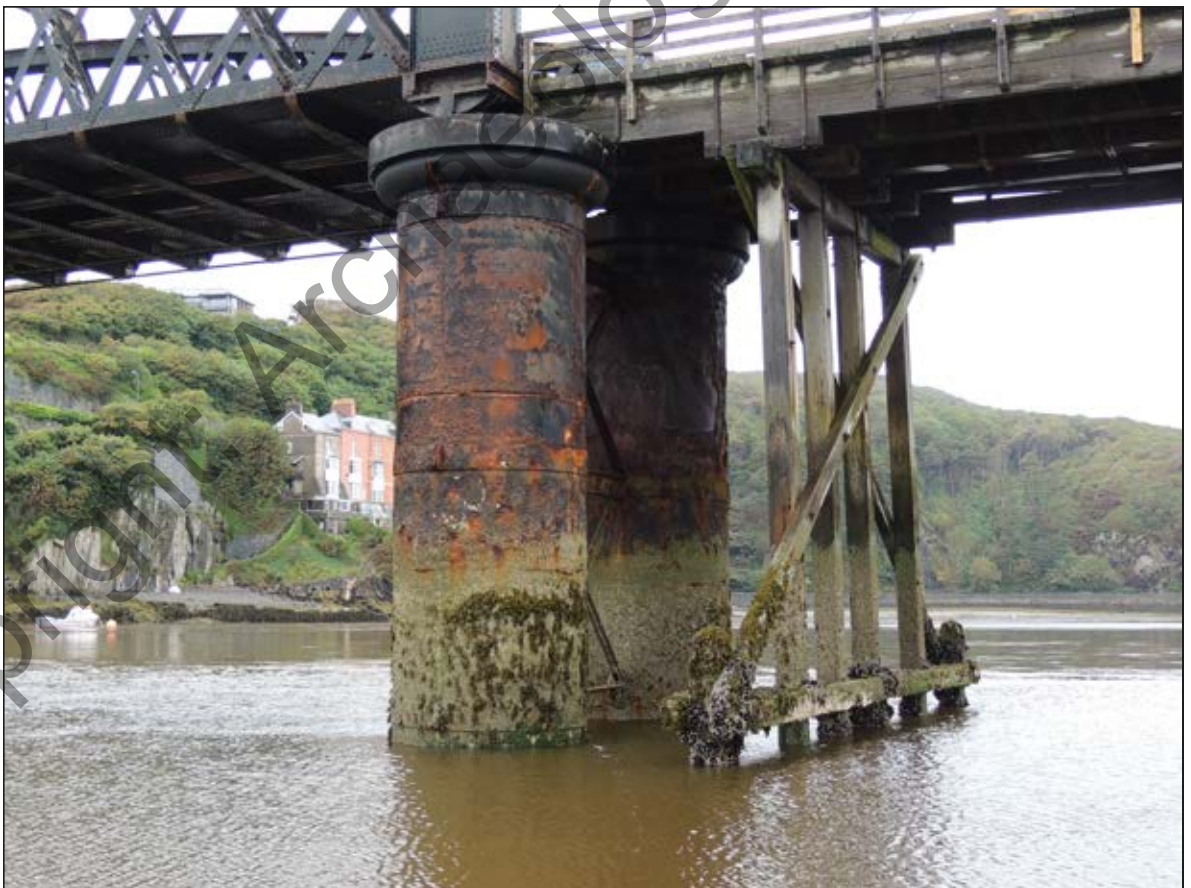
- 7.4.9. The swing bridge and its cylindrical piers beneath are the most intact portion of the structure, though corroded in parts, the alterations appear slight in comparison to the timber sections of the structure. The cylindrical piers and the central pivot have slight signs of erosion and appear relatively sound, though as mentioned previously a closer inspection was needed to clarify this.

Plate 62. N facing close up of cast iron cylindrical piers.
