**Ysgol Bontnewydd**  
**Archaeological Evaluation and Watching Brief on Drainage Works**

***EAS Client Report 2024/18***

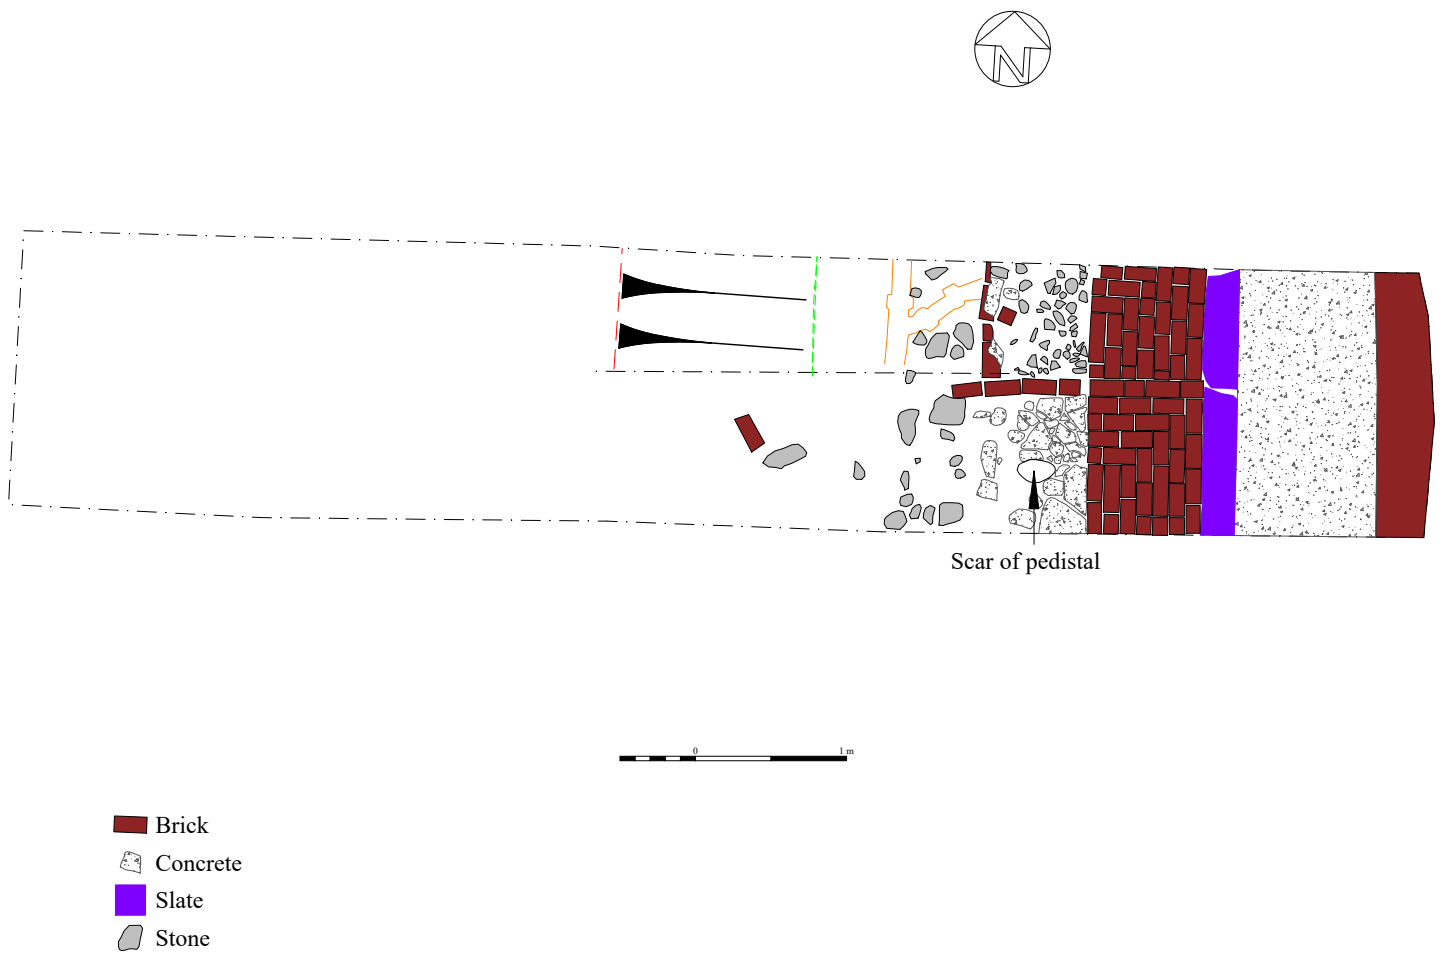
Figure 6: Trench 1 plan  
Scale 1:50

At the eastern end of Trench 1 (Figure 6, Plate 2) is the remains of the girls' toilets which formed the western side of the playground. The eastern, outer wall was constructed of brick and was at least

250 mm thick, extending beyond the extent of the trench. Whilst most of the wall was covered in mortar, the inner surface had brick laid in a header bond. Within the building was a concrete corridor, 940 mm wide which was edged with a band of slate, 240 mm wide along the western side. It is assumed that this band of slate marked the edge of the cubicles.

The cubicles, themselves had a brick pavement which appears to have been divided into individual cubicles by a line of bricks which extended into the area of broken concrete to the rear (western wall of the toilet block). The area of broken concrete was 560 mm wide and on the better preserved, southern side, the curved edge of the pedestal for the toilet itself can be determined. The northern side, however, was more disturbed with brick fragments and cobbles mixed in.

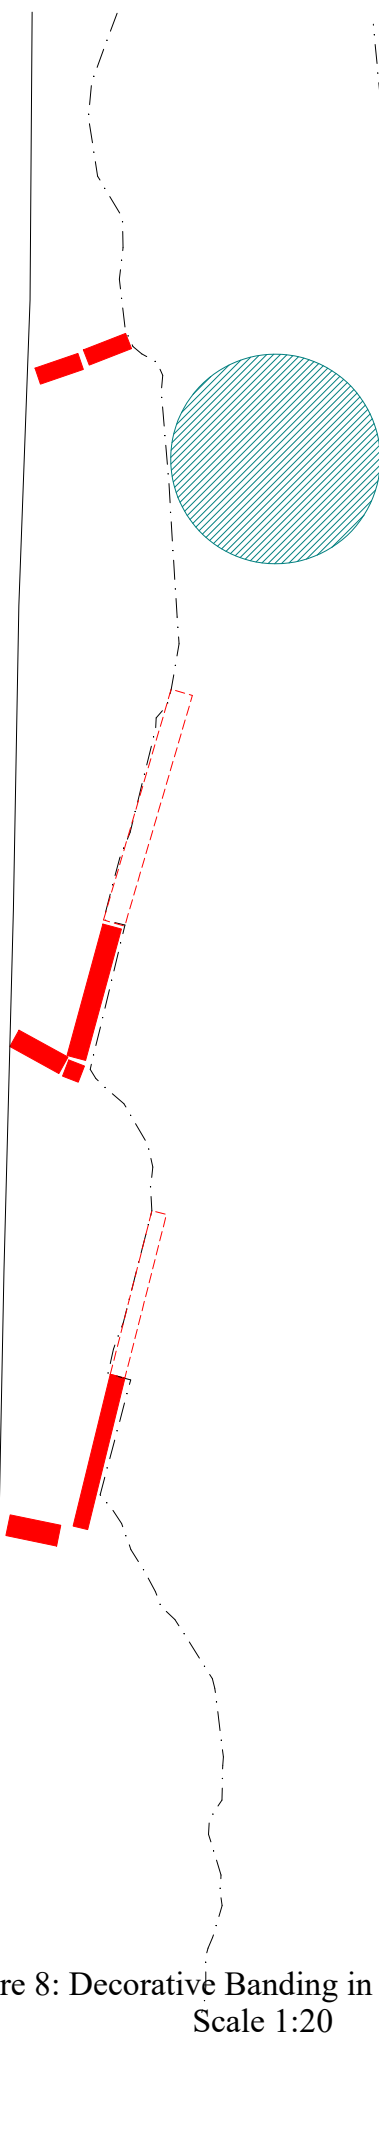
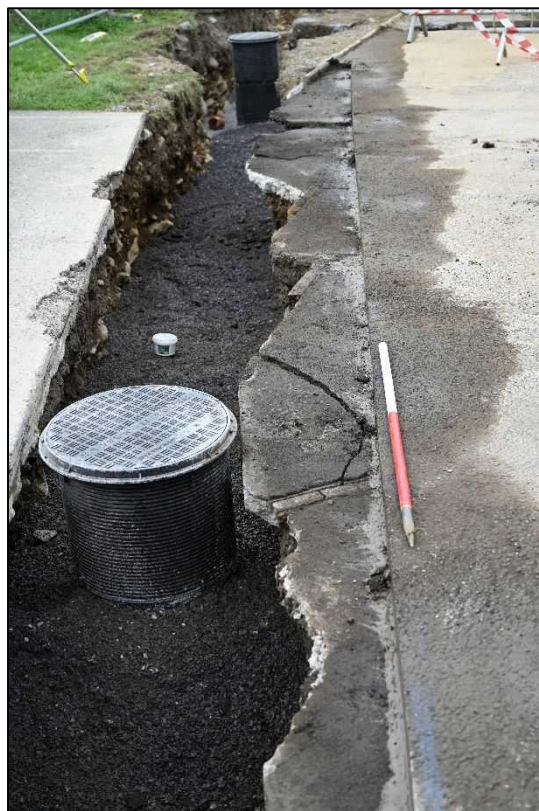
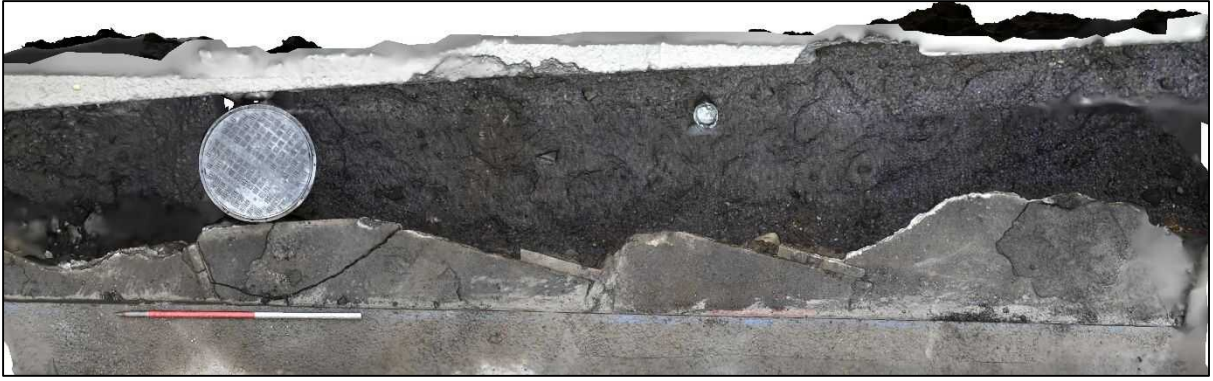
In the southern leg of the new drainage system, the removal of the current tarmac surface of the revealed a series of tile bands set in the underlying concrete surface (Figure 8, Plates 20 and 21). These are probably some sort of decorative element set in the concrete playground laid in 1938 (Brooks 2024, 10). Each of the tiles used for this decoration were up 410 mm long and 50 mm wide, with the hint of a series of right angles within the pattern.

The playground would appear to have been decorated, or at least divided, with red clay tiles forming bands running across and along the playground within the boys' playground to the north. These tiles were only recorded in a limited area and it may be that only the southern end of the boys' playground was decorated in this way.

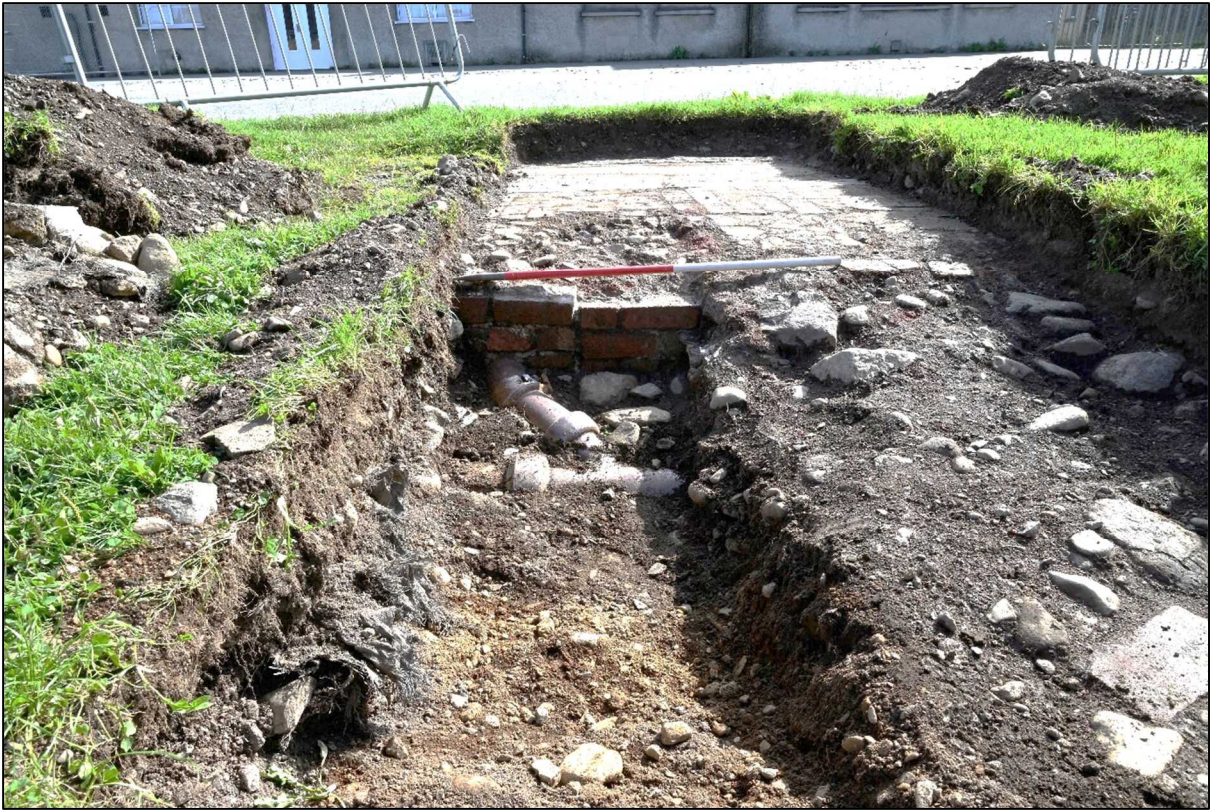
Plate 3: Rear wall of the toilet block

The rear wall of the toilet block was a single skinned, brick wall which survives for at least three courses (Plate 3). Passing through this wall was a sewer pipe 130 mm in diameter which fed into a pipe running parallel with the rear of the block which was 160 mm in diameter. This pipe probably ran along the length of the complete toilet block and is probably the same pipe seen in the watching brief for the drainage works. The outfall is unknown, but it is possible that it simply discharged into the Afon Gwyrfai. The sewage pipes sit within a broad trench 1.05 m wide, running along the rear of the building (Plate 4).

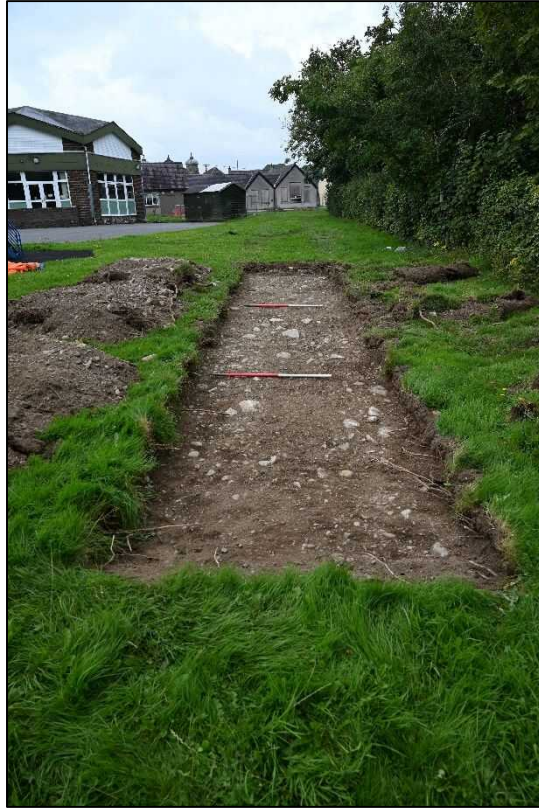
Plate 5: Tr 2, looking east

**Trench 2**, was 9.55 x 1.8 m in size and was designed to sample an area where no archaeological features were known as the area was unsuitable for geophysical survey. 250 mm of topsoil was removed and no archaeological features were recorded (Plate 5). The topsoil was heavily disturbed by roots from the trees growing along the banks of the Afon Gwyrfai. (Plate 5)

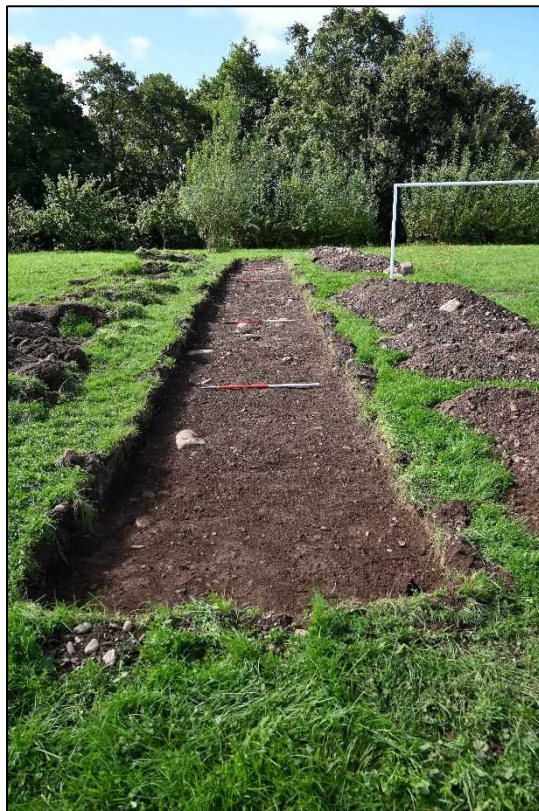
Plate 6: Tr 3, looking SW

**Trench 3**, was 19.57 x 1.8 m in size with 250 mm of topsoil. It was designed to sample a “quiet” area of the geophysical survey. No archaeology was noted from this trench apart from the occasional sherd of post-medieval ceramics. (Plate 6)

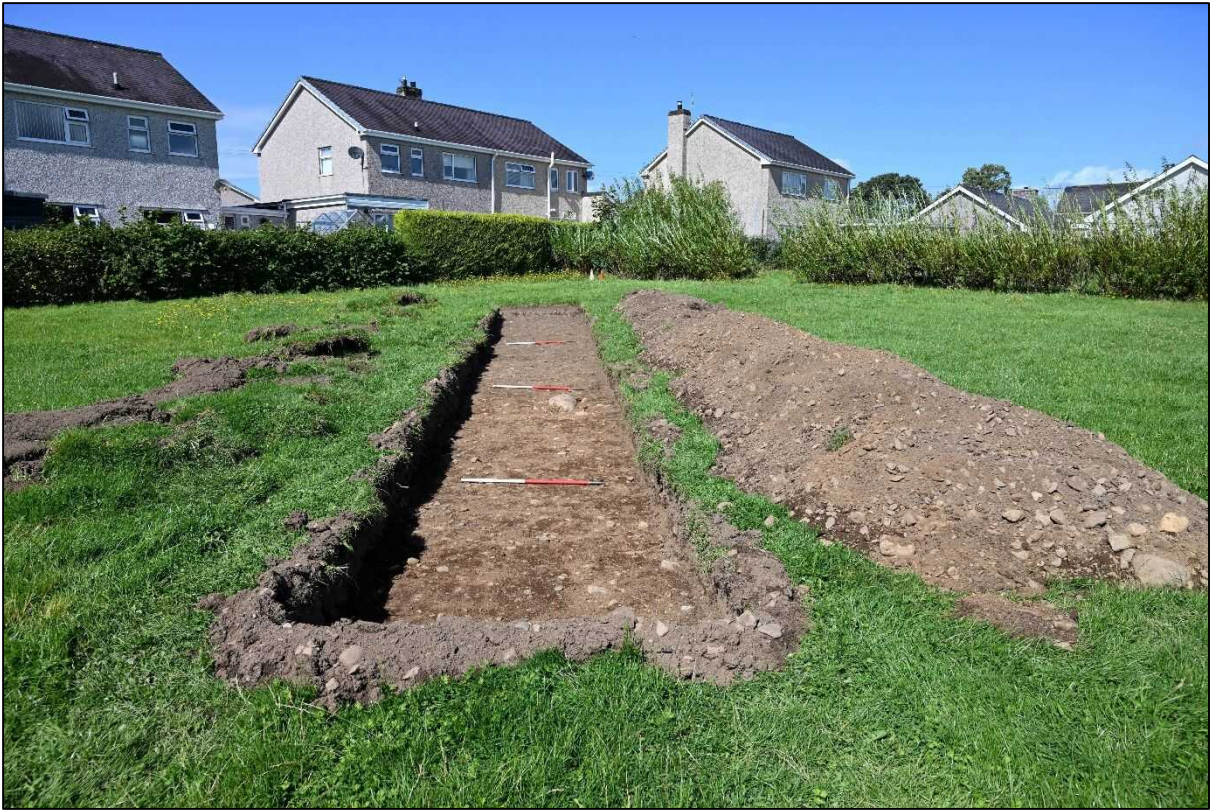
Plate 7: Tr 4, looking north

**Trench 4**, was 14.55 x 1.8 m in size and was designed to sample a potential magnetic anomaly recorded in the fluxgate gradiometer survey (Brooks 2023, PRN 102476). The topsoil was between 250 and 500 mm thick with the deeper areas corresponding to the magnetic anomalies recorded in the Fluxgate Gradiometer survey. No clear edges were defined to the deeper areas of topsoil and it is probable that the magnetic anomalies were the result of paleochannels within the floodplain of the Afon Gwyrfai. (Plate 7)

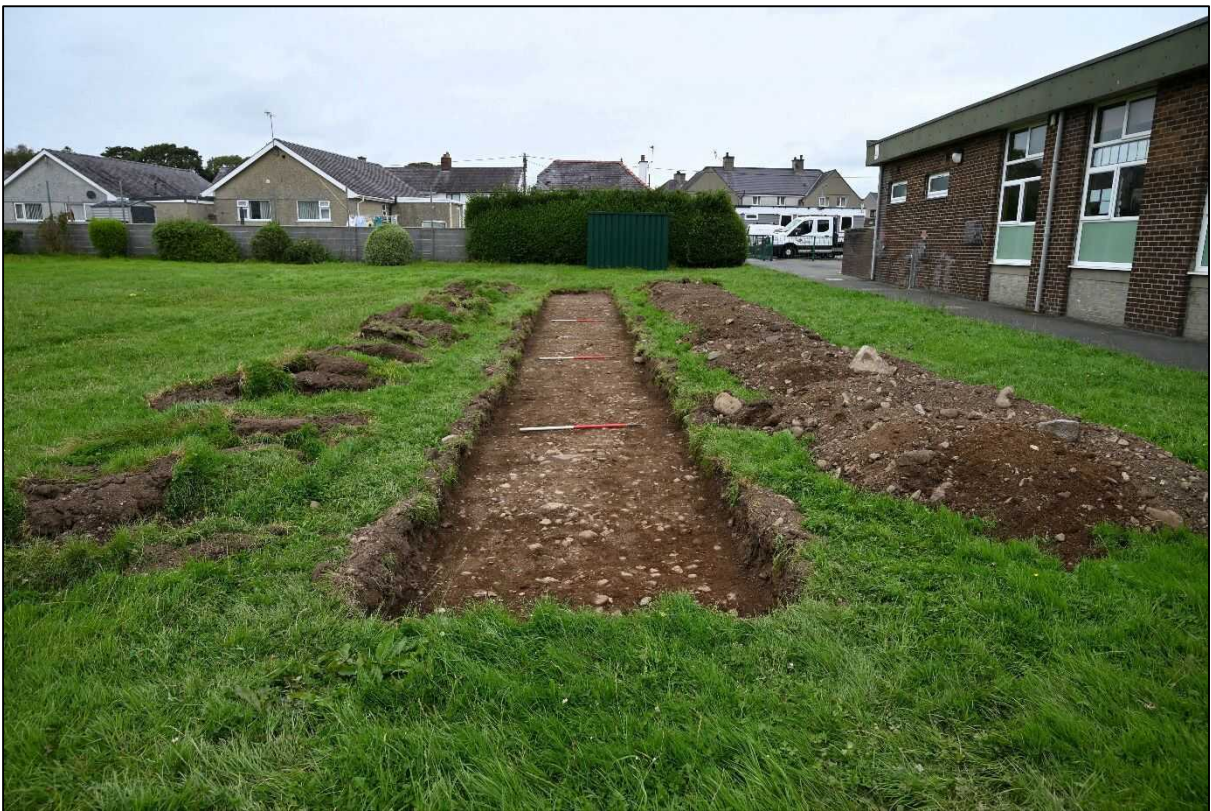
Plate 8: Tr 5, looking NE

**Trench 5**, was 19.62 x 1.8 m in size with 250 mm of topsoil (Plate 8). The trench was positioned to be as close to the footprint of the proposed new school building within the available land. No archaeology was noted, although the quantity of modern building debris within the topsoil was noticeably greater in this trench.

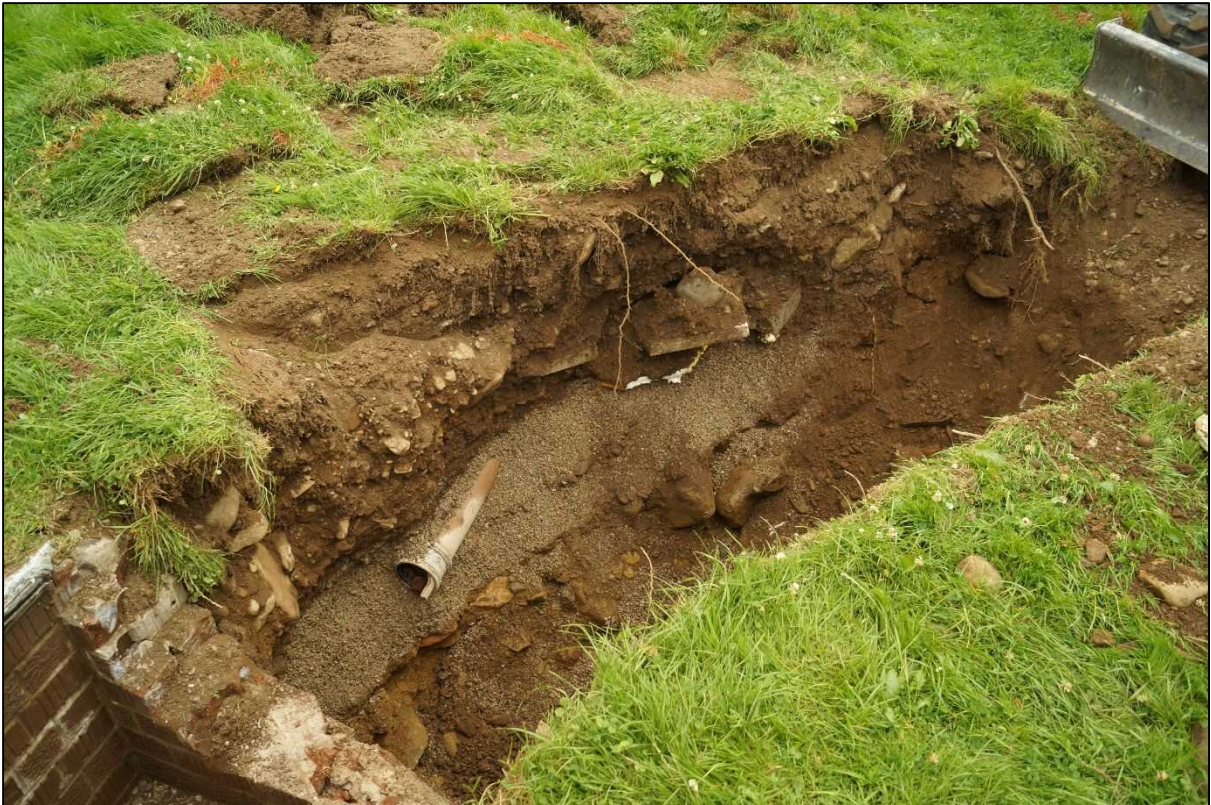
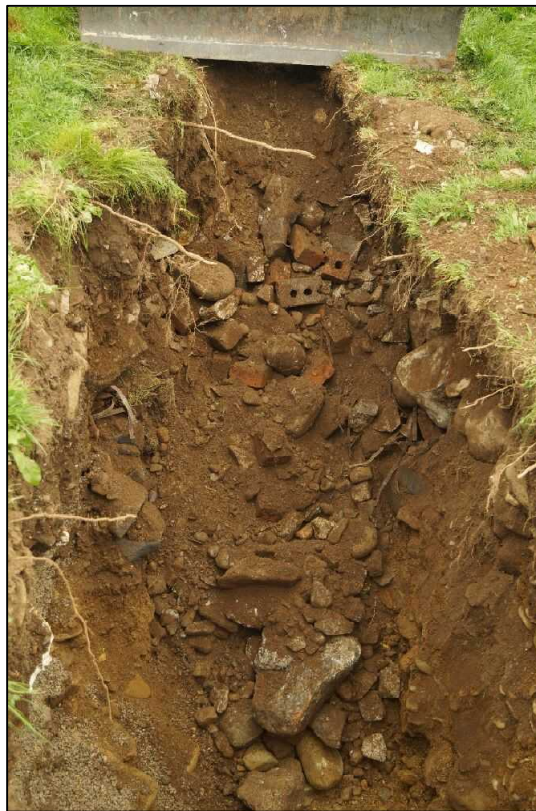
The location of the few features located are shown on Figure 7. At the western extent of the new drain a dump of modern building debris (Plates 9 and 10) was discovered covering an area at least 3.6 m wide. The building debris was of late 20<sup>th</sup> or early 21<sup>st</sup> century date and was probably associated with the construction of the current school buildings. This dump was extremely loosely packed and resulted in a very unstable trench.

Plate 9: Modern disturbance in the new drainage trench

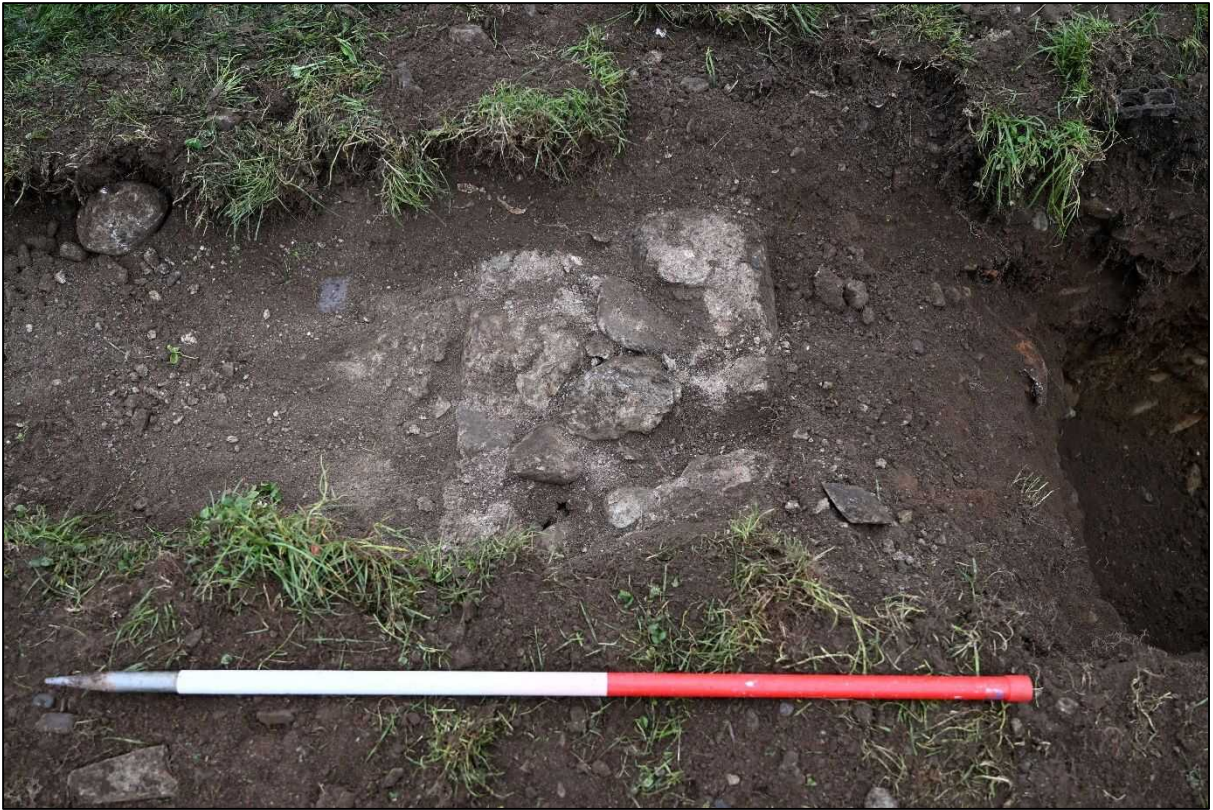
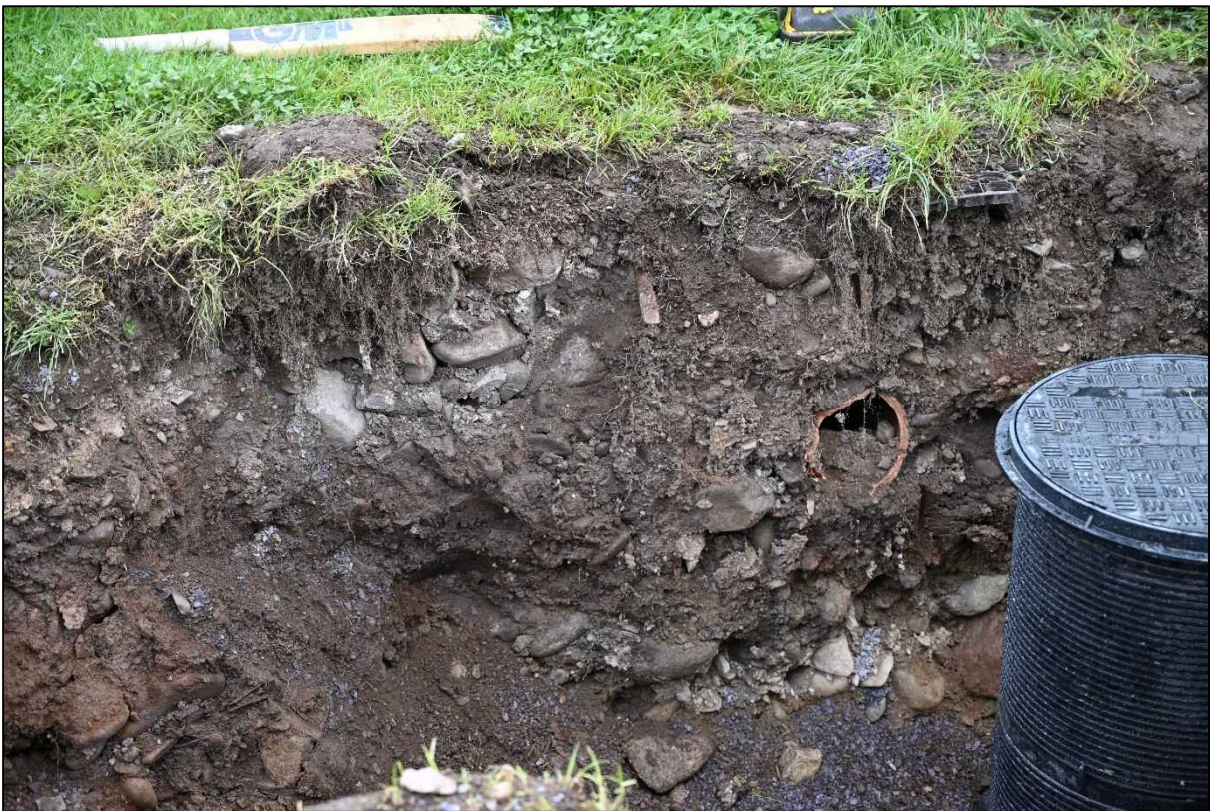
Near to the point where the drain is divided into two, the rear wall of the toilet block was recorded (Plates 11 and 12) together with the sewage pipe which ran along the rear of the toilet block. Midway along the north – south leg of the drainage a stone-built chamber was exposed in the side of the trench at SH 48233 59945 (Plate 14). The chamber was 1230 x 950 mm in size and was at least 950 mm deep. It is built of boulders and has a slate slab roof (Plates 15 – 18). The eastern wall (Plates 15 and 18) has a ceramic drainage pipe set just below the roof which is packed by bricks. It would seem probable that the pipe was inserted at a later period. Whilst the slate slabs are sawn there is no sign of circular saw cuts which may suggest a possible construction date before the first half of the nineteenth century (Gwyn 2015, 115). No sign of the western face of the chamber was observed and it may be that this face was originally open, however, it is equally likely that pressure from the excavation of the trench pushed the face in resulting the boulders scattered within the chamber.

Plate 11: Wall of the toilet block cut by the modern drainage

Plate 12: Section through the wall of the toilet block and associated drain

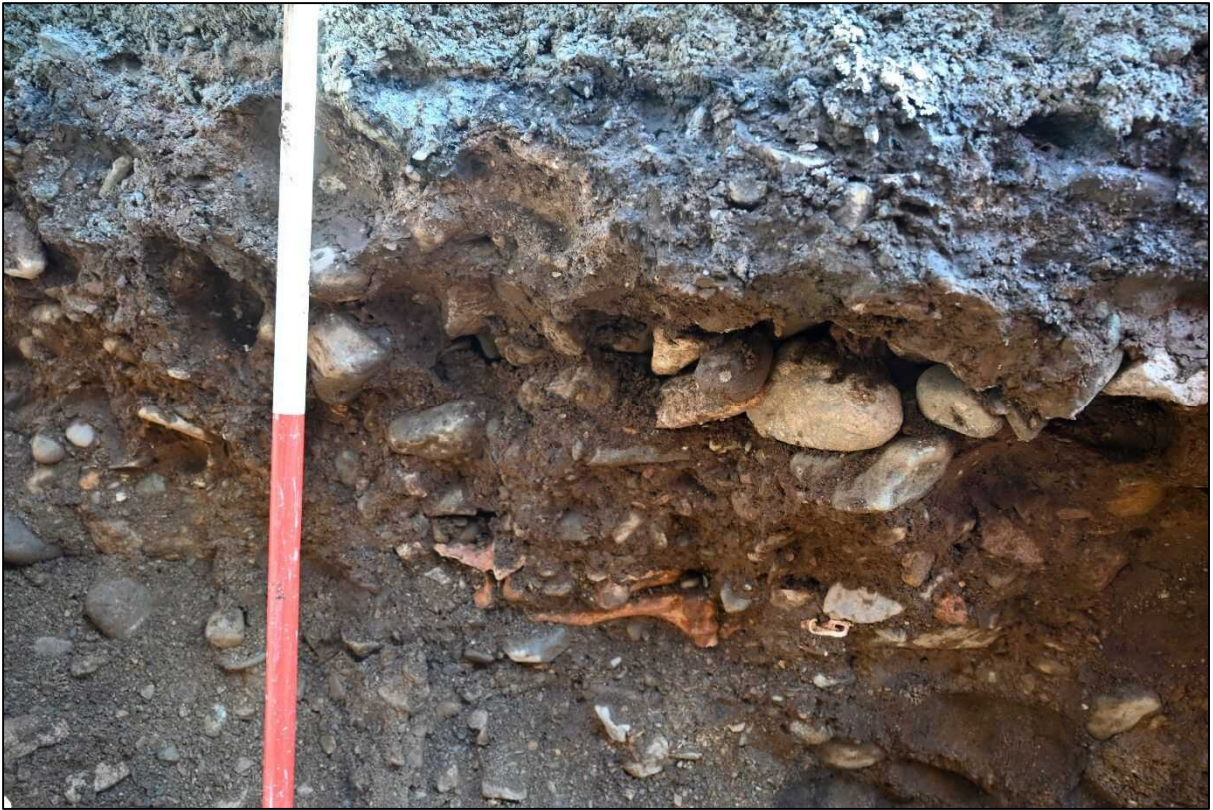
Plate 13: Animal bones

At a depth of approximately 750 mm a series of animal bones were observed in the edge of the trench (Plate 13). These were of cattle and probably represents the burying of dead stock before the school was extended in 1907. No sign of the pit in which these bones were buried could be determined in the side of the trench.

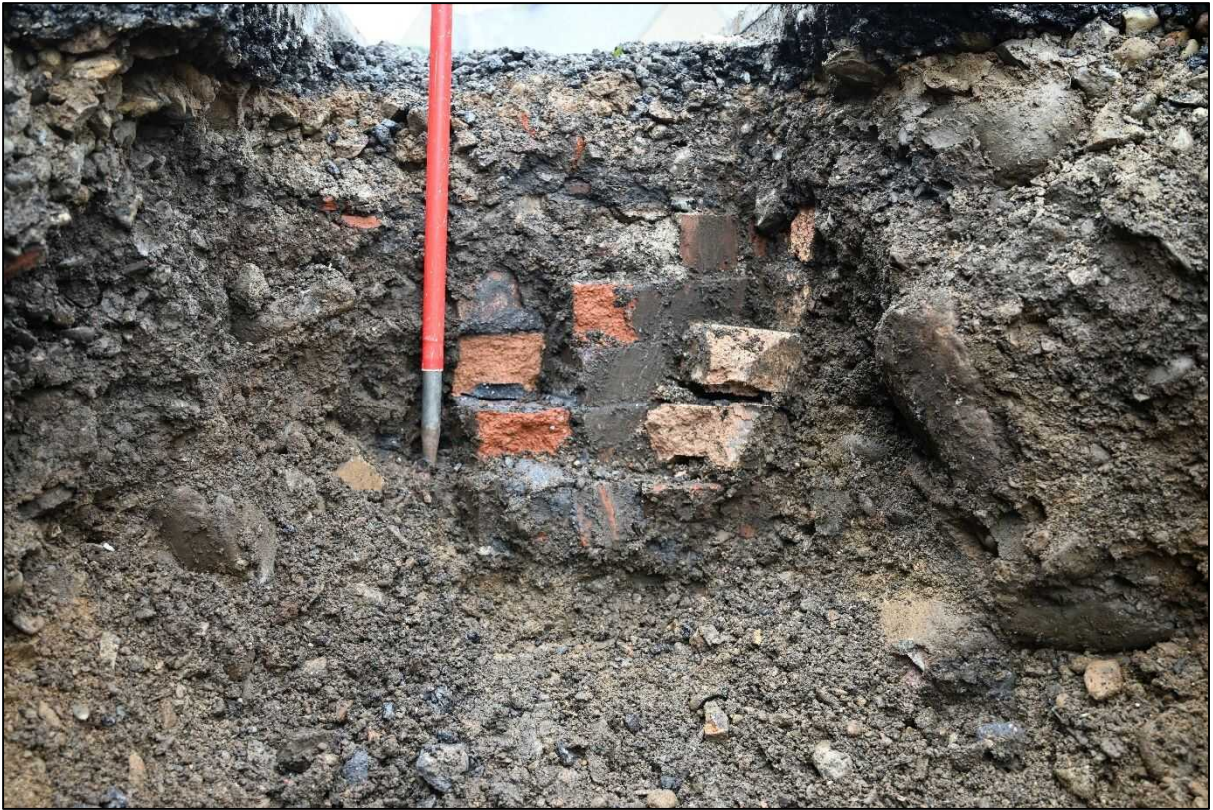
Plate 19: Brick chamber

At the northern end of the drain a brick chamber (Plate 19) was located. This is presumably part of the drainage system for the 1907 school.
