***Land Adjacent to Red Lion Farm,
Llanllechid***

Desk Top Study and Watching Brief

June 2011

EAS Client Report 2011/11

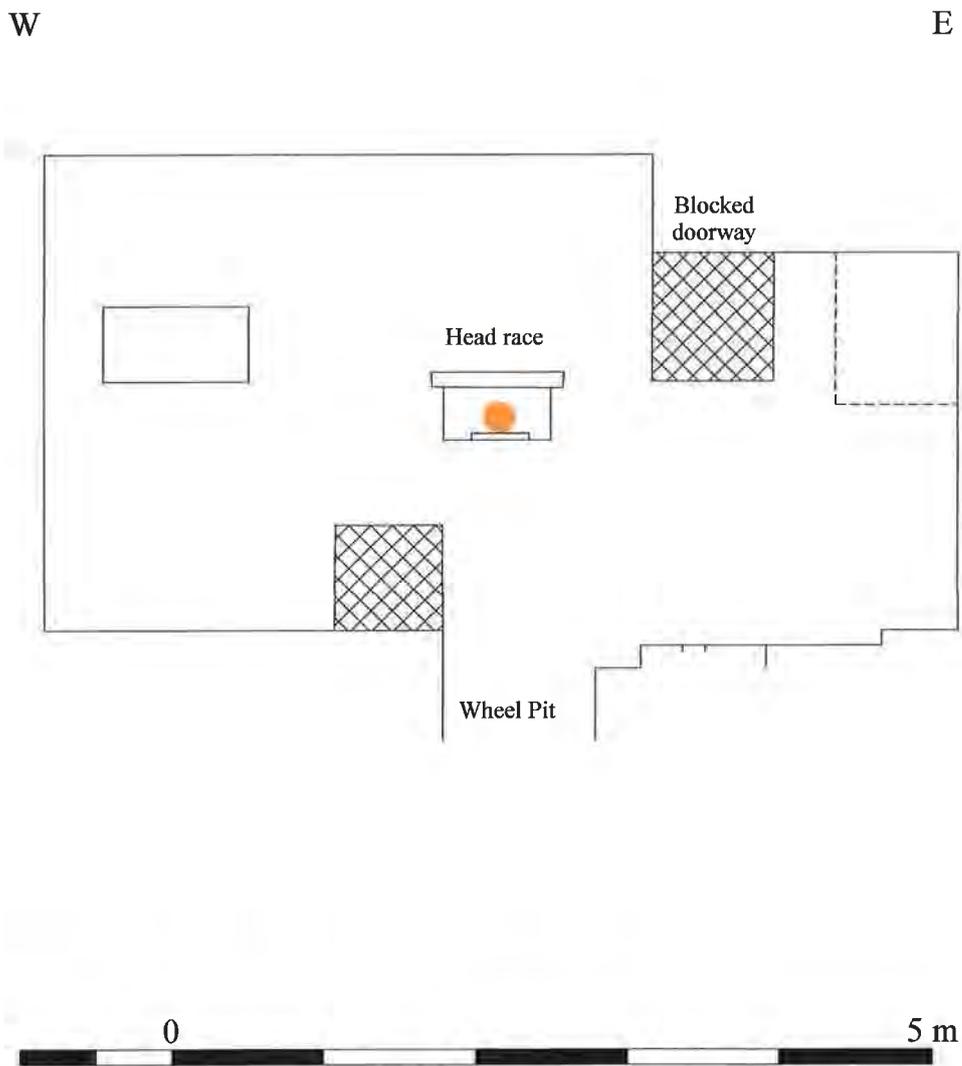
Figure 14: Sketch Elevation of the Rear Wall of the Building
Approximate Scale 1:50

The removal of the fill within the building revealed details of the rear wall of the building (Figure 14, Plate 21). This had a partly blocked doorway towards its eastern end which would have given access to the upper floor of the building (Plate 22). This was 0.8 m wide and probably at least 1.5 m high. The level of the sill to this door was lower than the top of the dam meaning that it was necessary to step down into the building. The leat from the mill pond entered the building through a rectangular opening, 0.7 m wide and 0.35 m high (Plate 23). The position of this opening marks the height at which the head stock was positioned and also suggests that the building contained either an overshot or pitchback wheel. The opening contained the iron pipe which was used to drain the pond after the decommissioning of the water wheel.

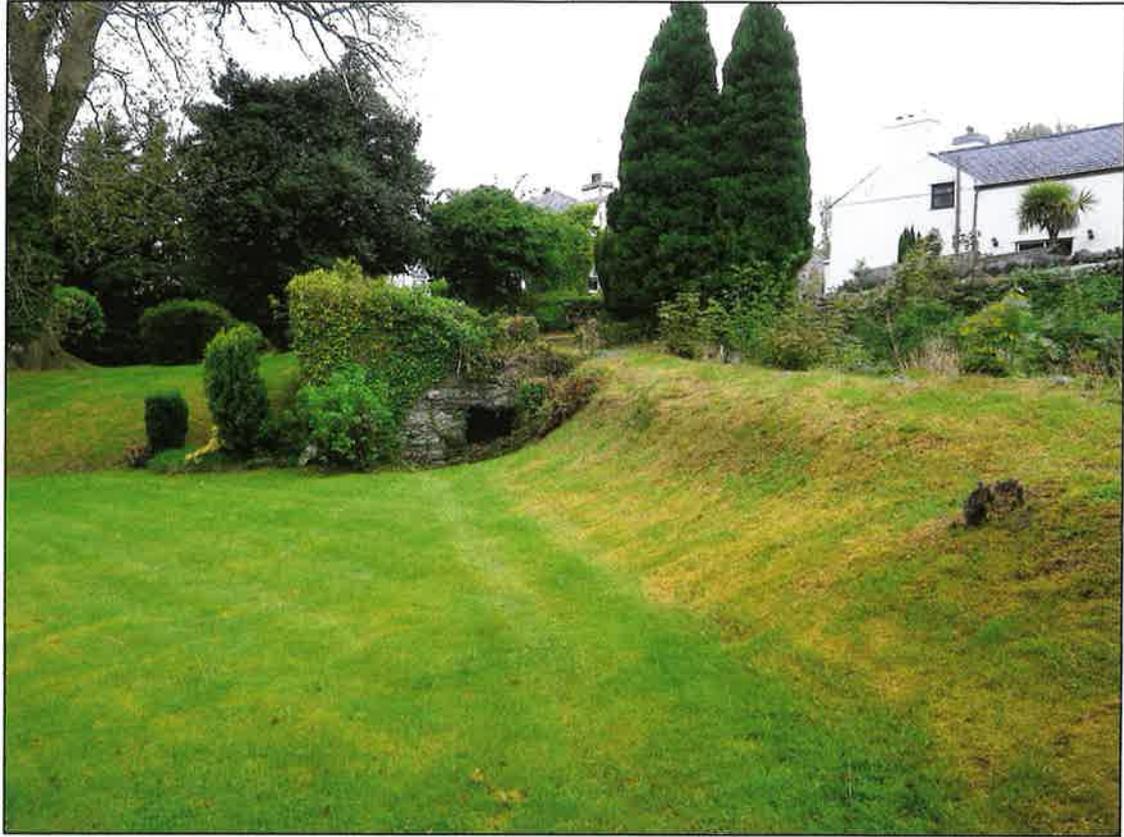
Prior to the construction of the new house the structure was heavily infested with ivy and the interior had been used for dumping garden waste for many years such that the interior details were difficult to determine. It was however, possible to determine the general form and construction of the structure. The building was 6.79 x 4.69 m in size, partly cut into the bank which formed the dam defining the southern edge of the mill pond (Plate 1). It was standing to a height of approximately 3 m on the southern side (Plate 2) which was above the level of the upper floor, but not to the full gable height. To the west the structure was partly buried (Plate 3), however at least part of this was the result of dumping the spoil from a cleaning of the pond in this area (Bevan *pers. comm.*).

Plate 1: General appearance of the structure before construction

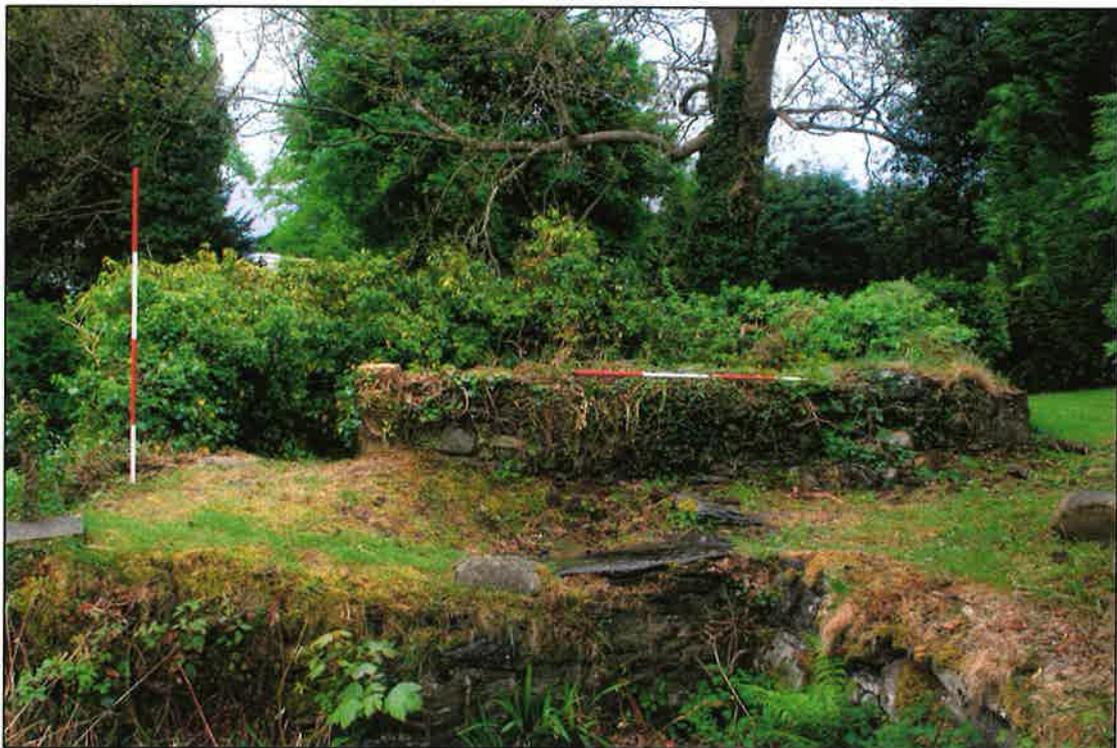
The northern elevation (Plate 4) had one partly blocked doorway in its eastern end, which originally gave access to the upper floor. The eastern elevation (Plate 5) also has a single doorway (Plate 6), however, this gave access to the lower floor. The southern elevation (Plate 2) had a doorway in the western end giving access to the lower floor (Plate 7) and three window opening. One of the window openings was on the lower floor and overlooked the line of the outfall leat (Plate 8) whilst the upper windows were both in the eastern half of the building. They were set at slightly different levels (Plate 9) with the window over the outfall leat being at a slightly lower level.

Plate 4: The northern elevation

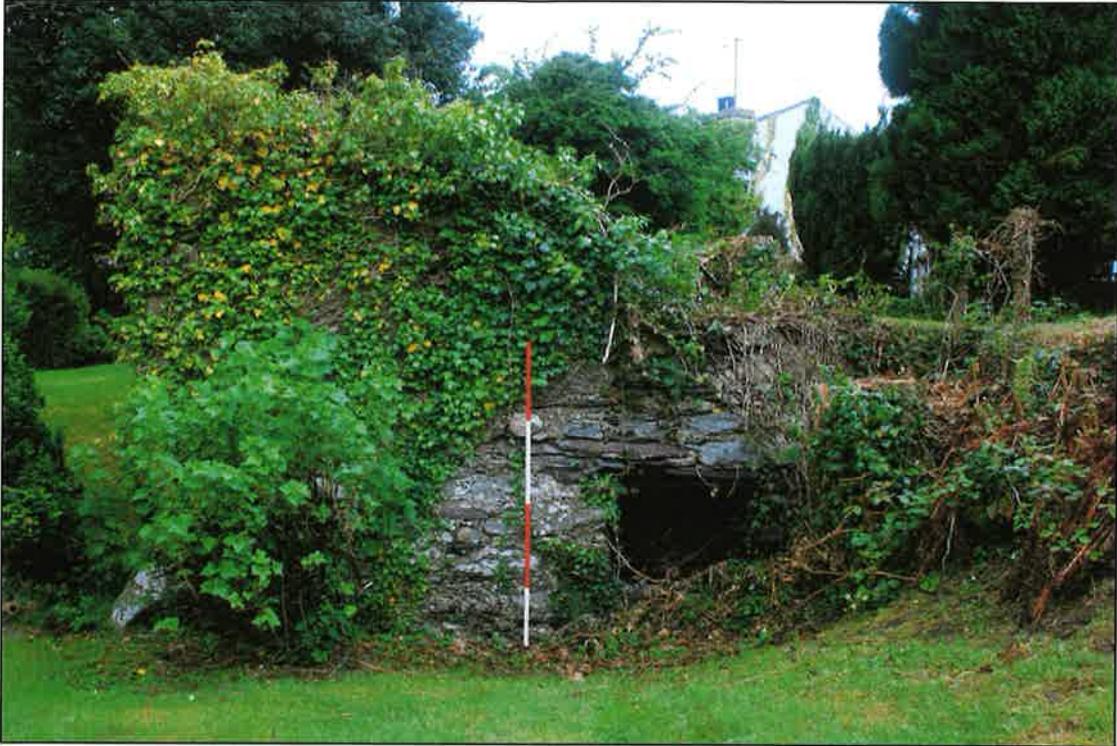
Plate 5: The eastern elevation

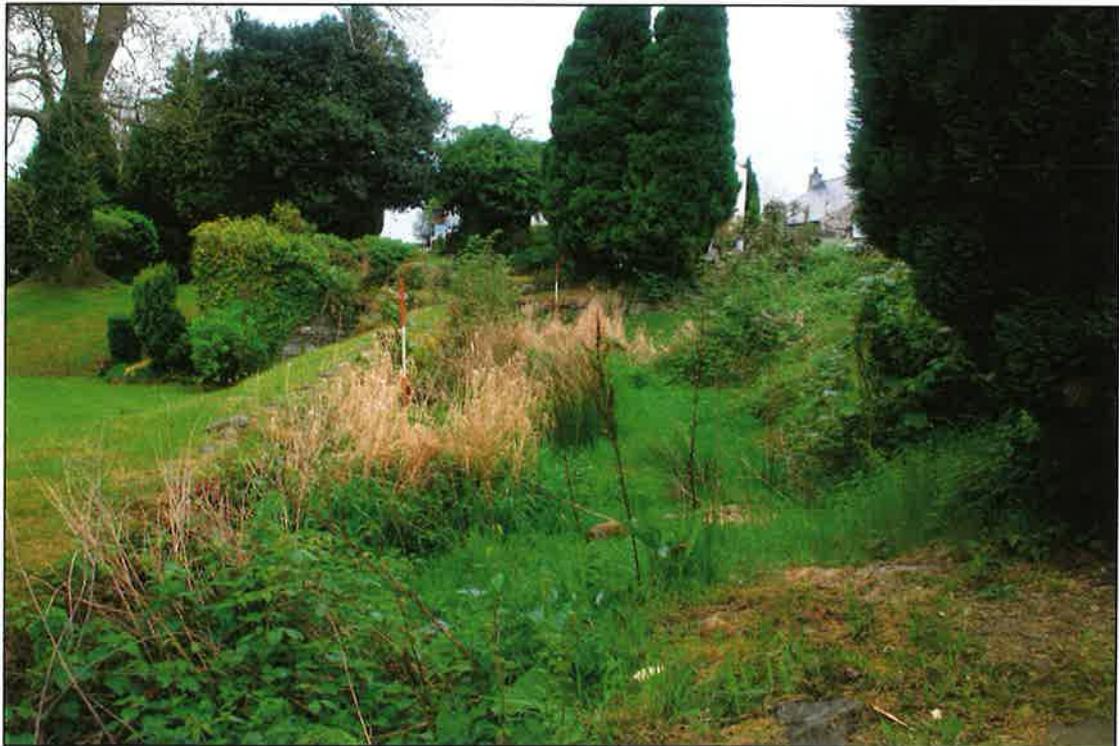
The mill pond was 31.45 m long and up to 5.7 m wide running parallel to the property boundary and roughly at right angles to the line of the Afon y Llan (Plate 10). Although the pond was only damp at the time of the survey it has held water in recent times (Plate 11). At the time of the initial survey the level of the of the pond was above that of the bottom of the mill pond, however the 1914 Ordnance Survey Map (Figure 9) marks a sluice which presumably raised the level of the stream so that it filled the pond. The pond is bounded by the boundary wall to the property on the north and to the south by a bank/dam. This dam had a dry stone wall face to the north (Plate 12) and an earthen bank to the south and was approximately 1.5 m high above the level of the lower ground level. There was a leat opening in the

Plate 10: The mill pond

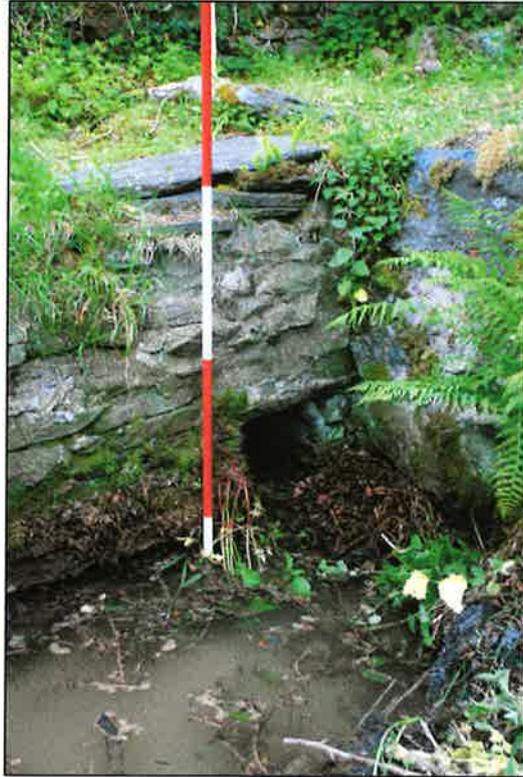
south west corner of the pond which led to the building (Plate 13).

Plate 13: Detail of the leat opening in the south west corner of the mill pond

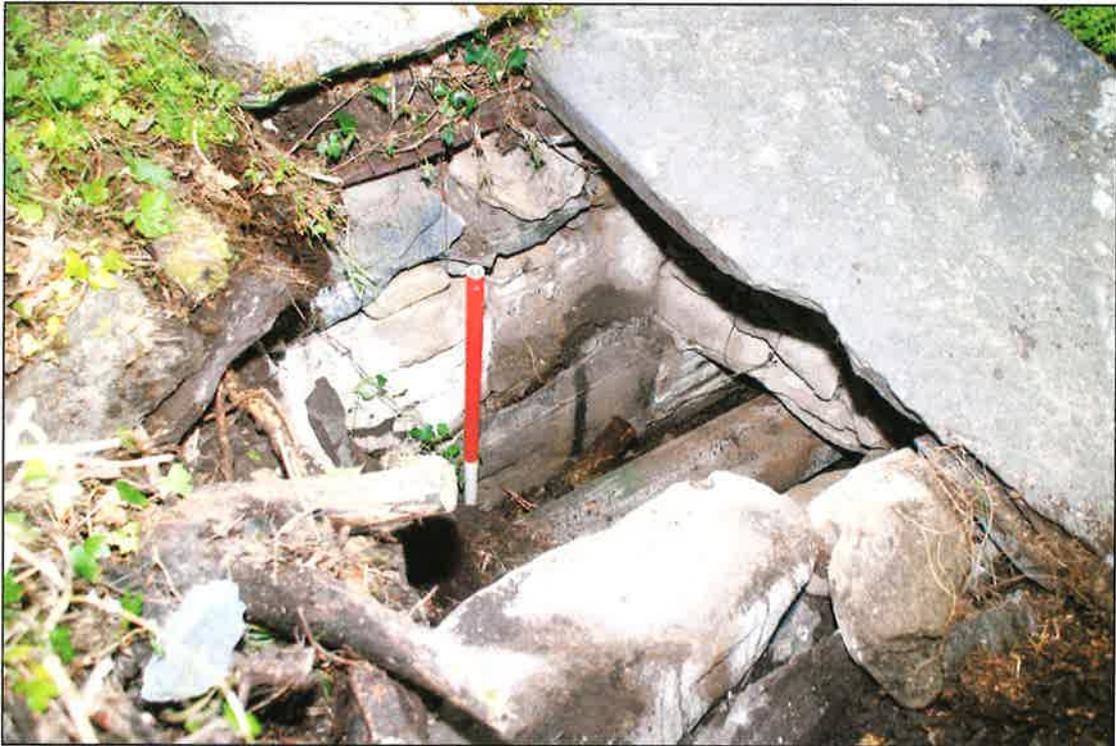
The leat between the pond and the building was slate lined (Plate 18). Once again this had been slightly modified after the mill had been decommissioned to incorporate a cast iron pipe which extended into the main body of the

Plate 18: The joint between the mill pond and the building

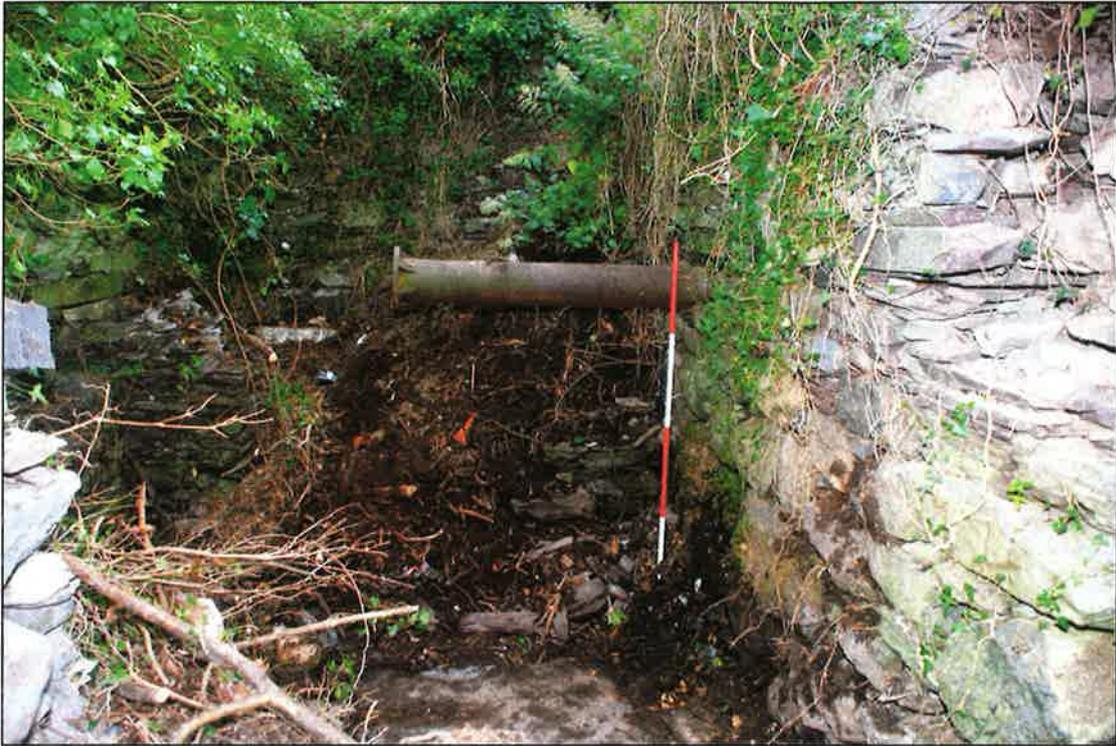
building (Plate 19). This appears to have been inserted into the structure to allow drainage of the pond, once the head stock for the water wheel and the wheel had been removed.

Plate 19: The iron pipe within the building

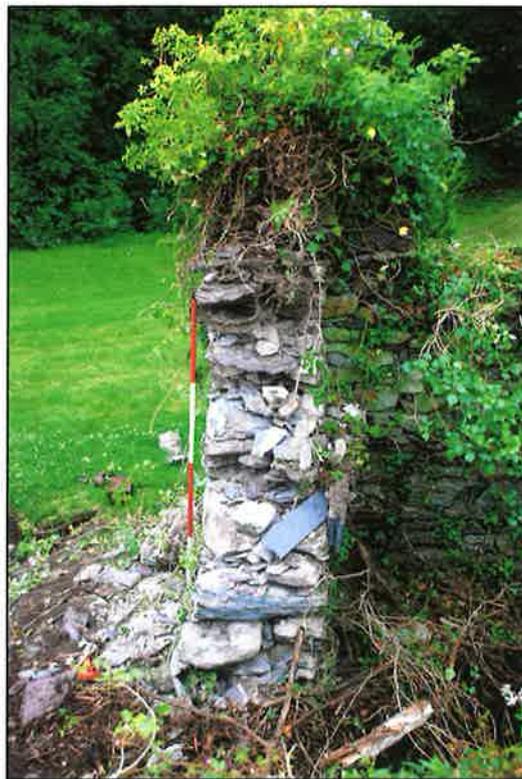
The building is constructed of sub-angular and angular stone blocks which are largely constructed of dry stone walling with some lime mortar pointing (Plate 20). The floor appeared to be of beaten earth with slate slab supports for the water wheel and slate door sills. There is also a wheel pit, 0.97 m wide which crosses the middle of the floor (Figure 13).

Plate 20: Detail of wall construction

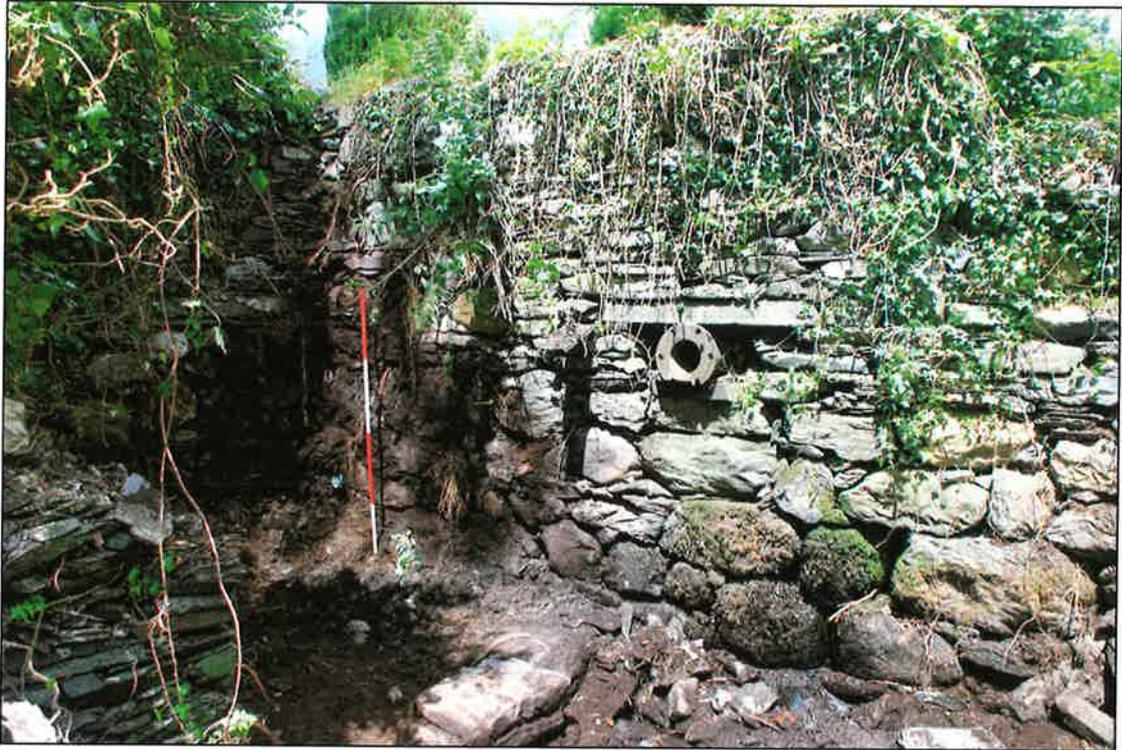
Plate 21: The rear wall of the building

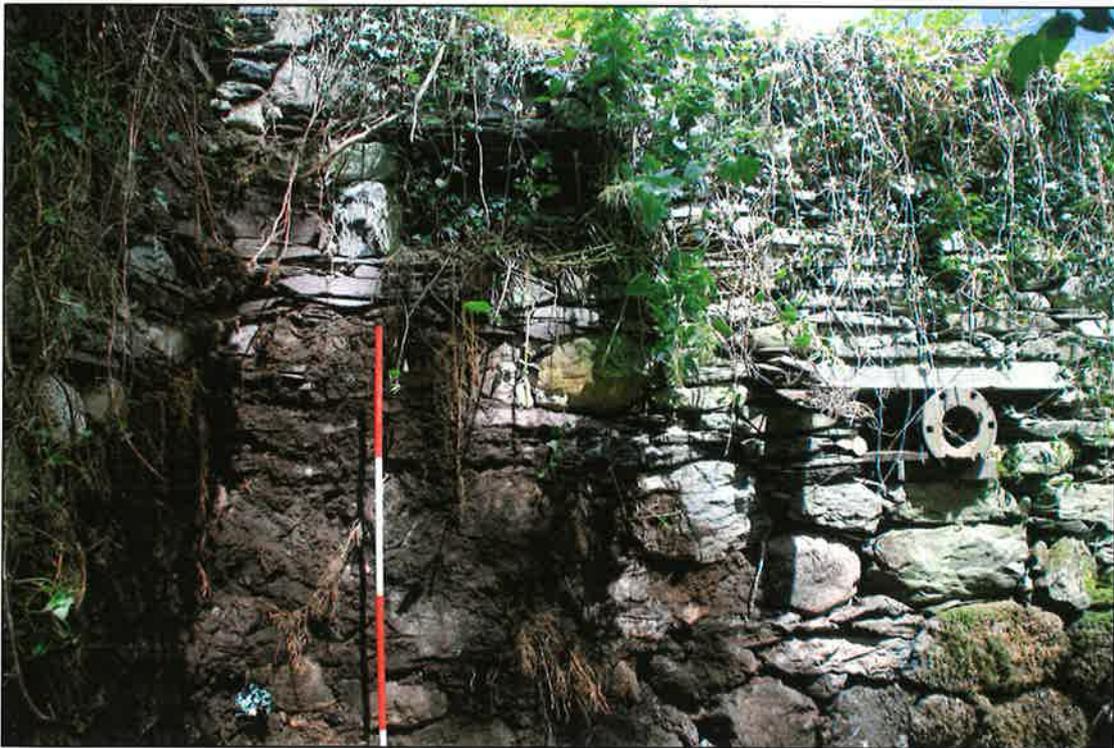
There is a third opening in the western half of the rear wall. This is 0.96 m wide and 0.5 m high and set in the upper part of the building (Plate 24). It is also set

below the level of the top of the dam for the mill pond. Information from Mrs Bevan suggests that this half of the building did not have an upper floor and it is therefore difficult to suggest a function for this opening. Its form is similar to the head stock, however no signs of a wheel was recorded in this half of the building and its position is beyond the extent of the mill pond. It is possible that it was simply a window lighting this part of the building.

Plate 24: The opening in the western half of the rear wall

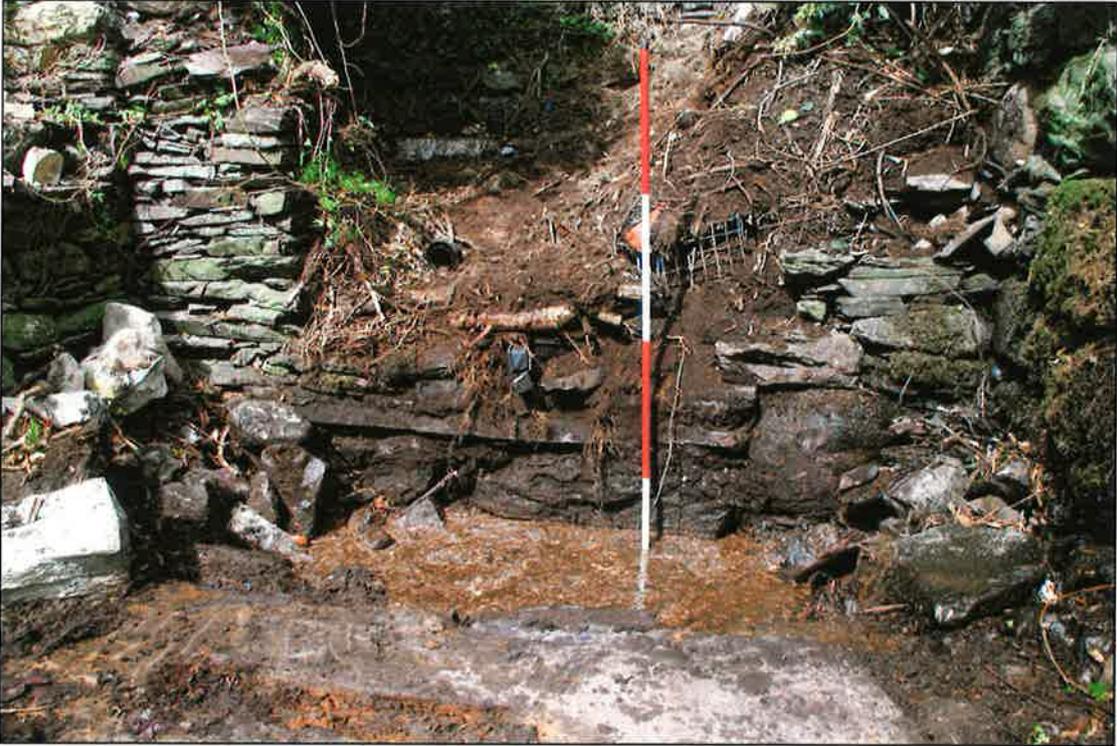
The removal of the gardening debris also revealed two stub walls on the western edge of the wheel pit (Plate 25). These were constructed of dry stone walling and appear to be later than the main structure of the building. It is possible that these were built to support the western end of the upper floor.

Plate 25: Stub walls dividing the building

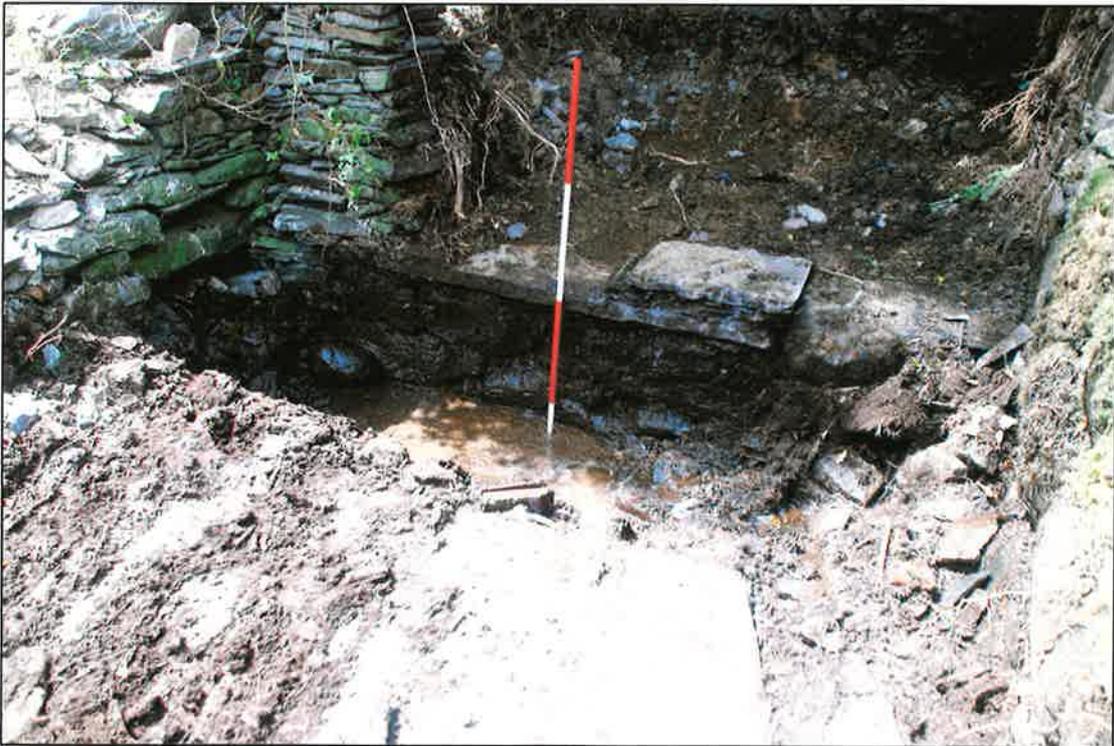
The wheel pit was 0.97 m wide and was lined with stone walls constructed of large stone blocks (Plate 26). It had been deliberately filled with large rounded stones, presumably to make the base of the building safe whilst still giving drainage. It was difficult to assess the depth of the wheel pit because it filled with water on excavation; however, it was at least 1 m deeper than the slate block on which the water wheel was mounted.

Plate 26: The wheel pit

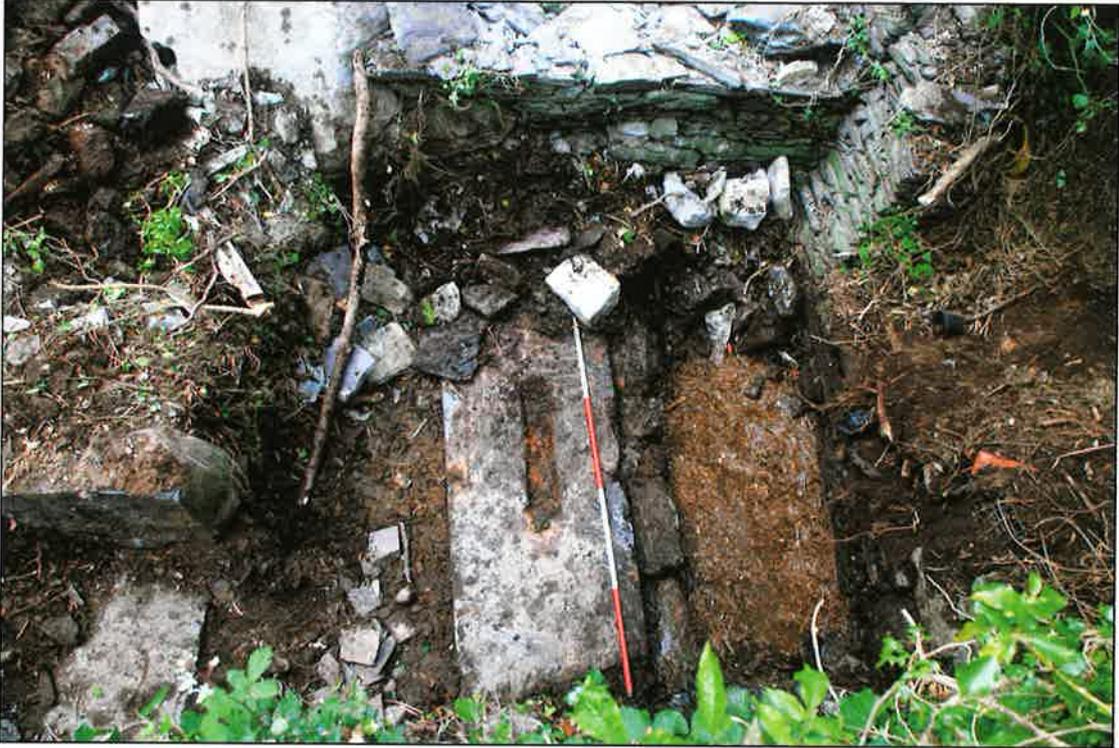
The water wheel was mounted on two slate slabs, either side of the wheel pit. The eastern slab was 1.84 m long and 0.83 m wide with a slot 0.78 m long and 0.14 m wide cut into its surface (Plate 27). There are three iron fittings attached, two studs and an iron plate held by a bolt (Plate 28). The western mounting was broken with the surviving section being a slate slab 0.6 x 0.52 m in size (Plate 29) with an iron stud in its upper surface (Plate 30).

Plate 27: The slate slab for the eastern mounting of the water wheel

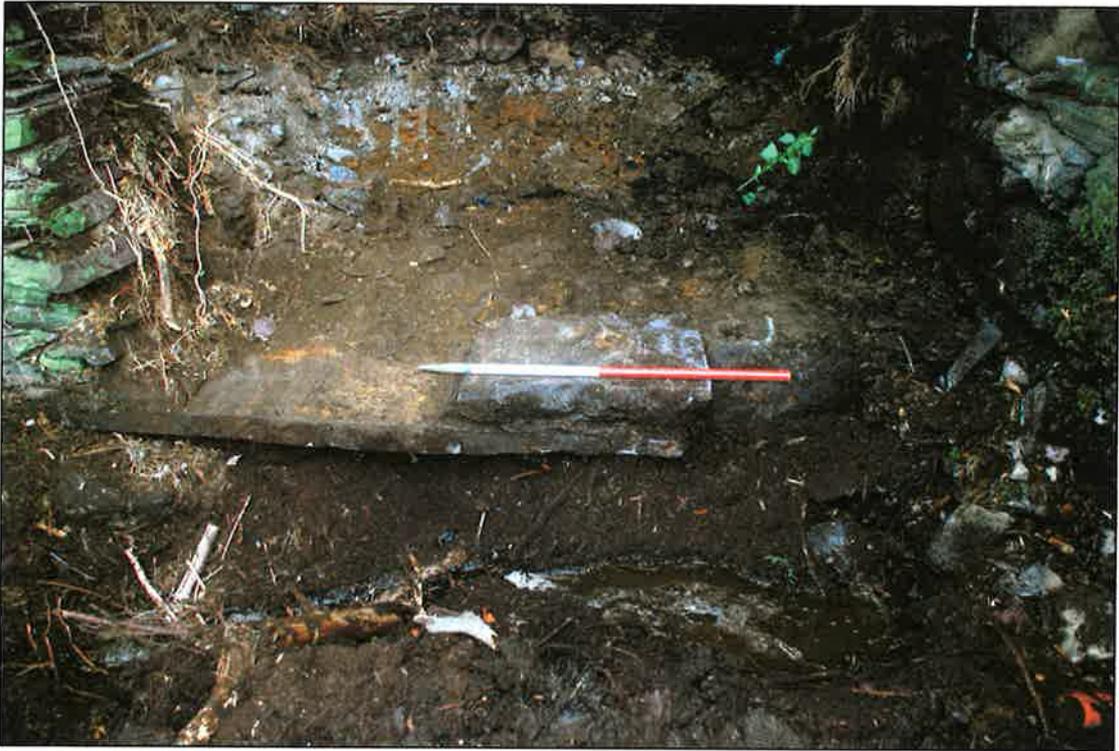
Plate 29: The western mounting block for the water wheel

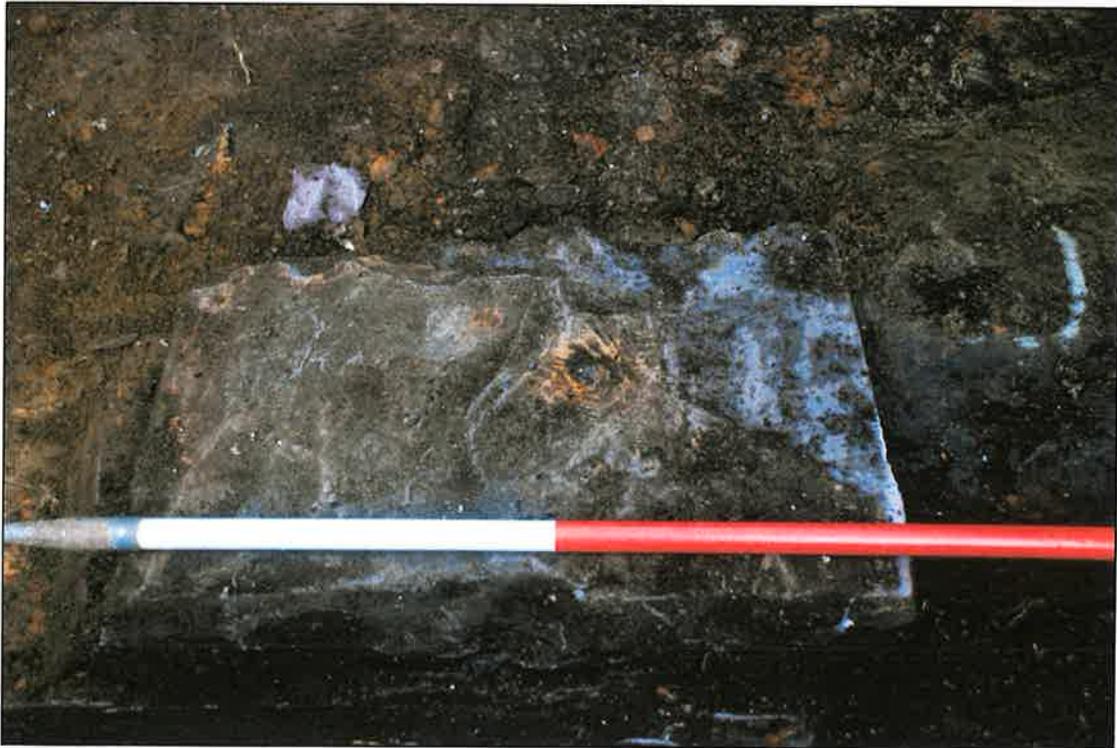
Plate 30: Detail of the iron stud in the top of the western mounting block.

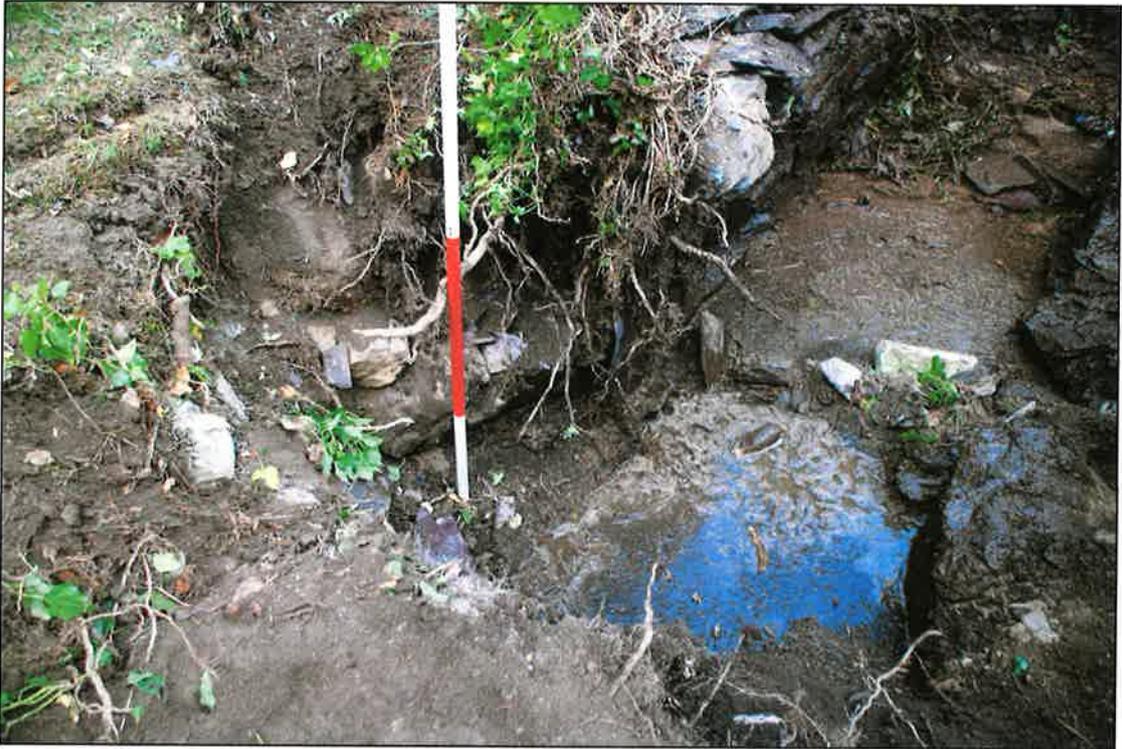
The tail race was through a slate lined leat (Plate 31) that was buried below the

surface of the garden and curved toward the west before issuing back into the Afon y Llan. The route of this leat was partly defined by the need to get a fall on the leat as the levels between the base of the wheel pit and the level of the stream was marginal.

Plate 31: The join between the wheel pit and the tail race.

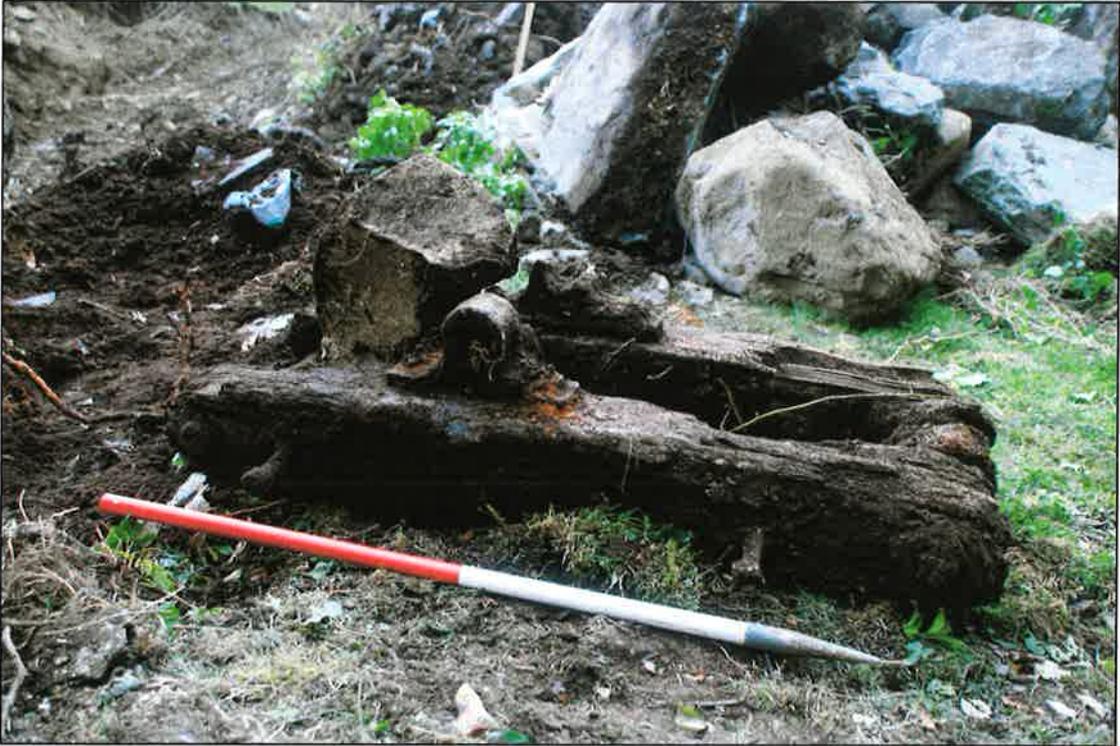
The frame and part of the grind wheel from the upper floor was found. This was a wooden frame (Plates 33 and 34) held together with iron rods and with the bearings for the grind stone in position (Plate 37). The grind stone was approximately 0.52 m in diameter with a hole in the centre approximately 0.07 m square. The likelihood is that this was belt driven as a flywheel with a series of concentric wheels which would have acted as a gear wheel for driving the grindstone was found (Figure 15, Plates 37 and 38)

Plate 33: The grinding frame

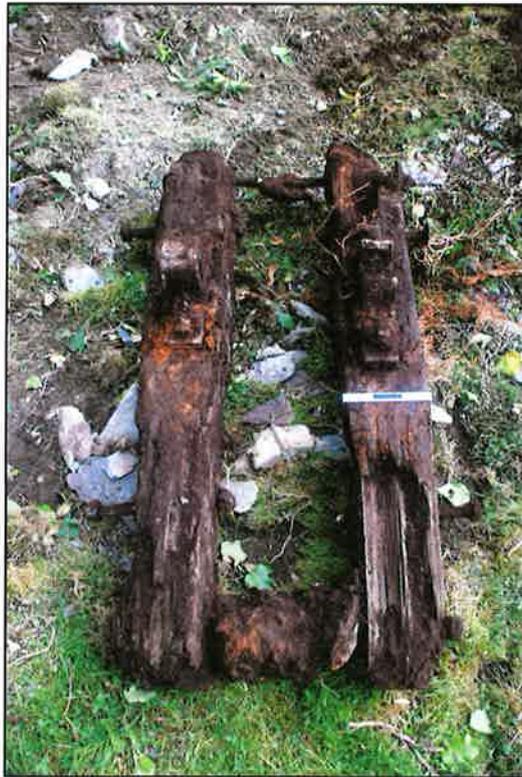
Plate 34: The frame for the grind stone

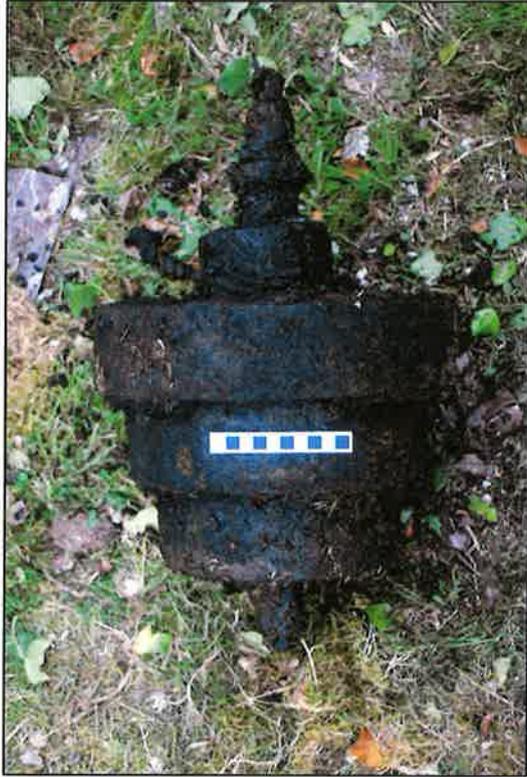
Plate 37: Gear wheel for the drive belt

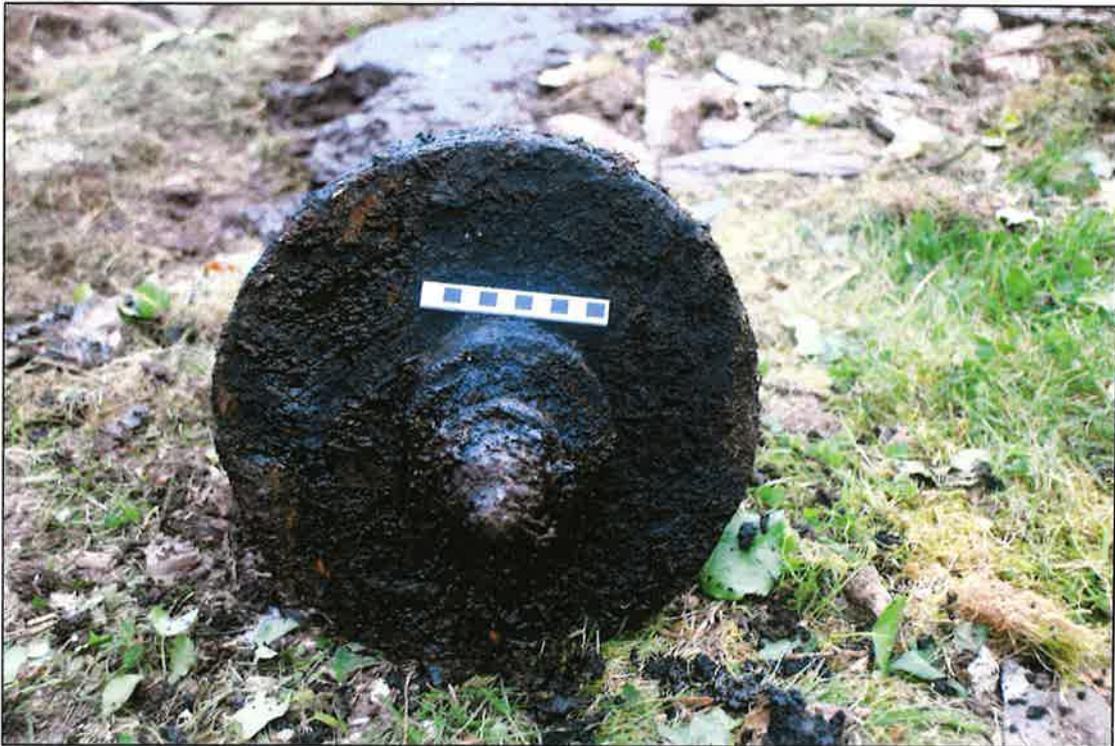
Plate 38: Gear wheel for the drive belt
