**Harlech Castle Gate House Steps
Archaeological Watching Brief**

**Commissioned by
Cadw**

**Fieldwork by
I.P. Brooks
Engineering Archaeological Services Ltd**

EAS Client Report 2023/14

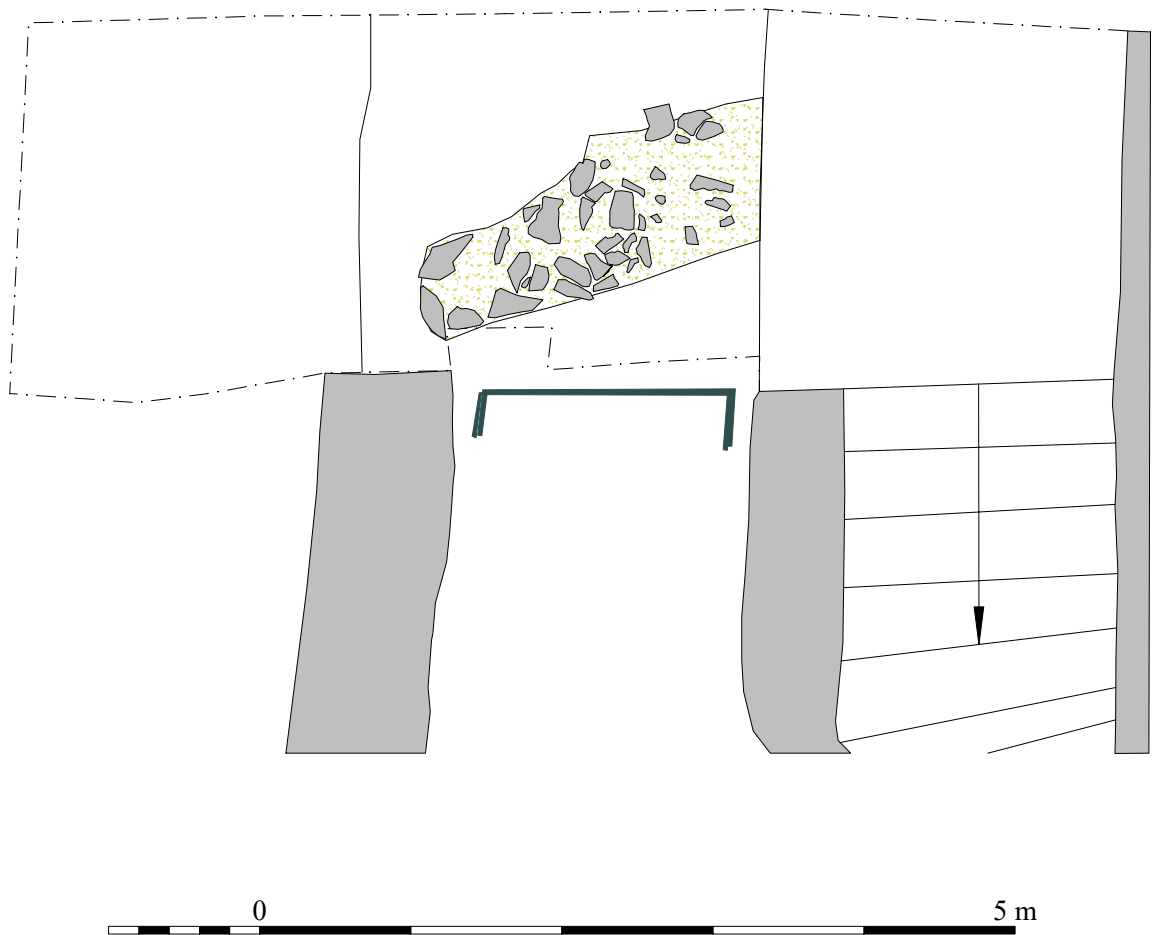
The demolition of the steps in Harlech Castle, surprisingly, revealed the remains of a wall which probably is an extension of the wall which crosses the inner ward from the junction between Ystumgwern Hall and the Granary to a point in front of the gatehouse. These walls are, however, are at an angle of approximately 110 ° to each other. The position of the wall crossing the inner ward and the angle between two wall sections may suggest that neither were structural in nature and may represent an internal division within the inner ward.

Figure 5: Plan of the Possible Medieval Wall
Scale 1:50

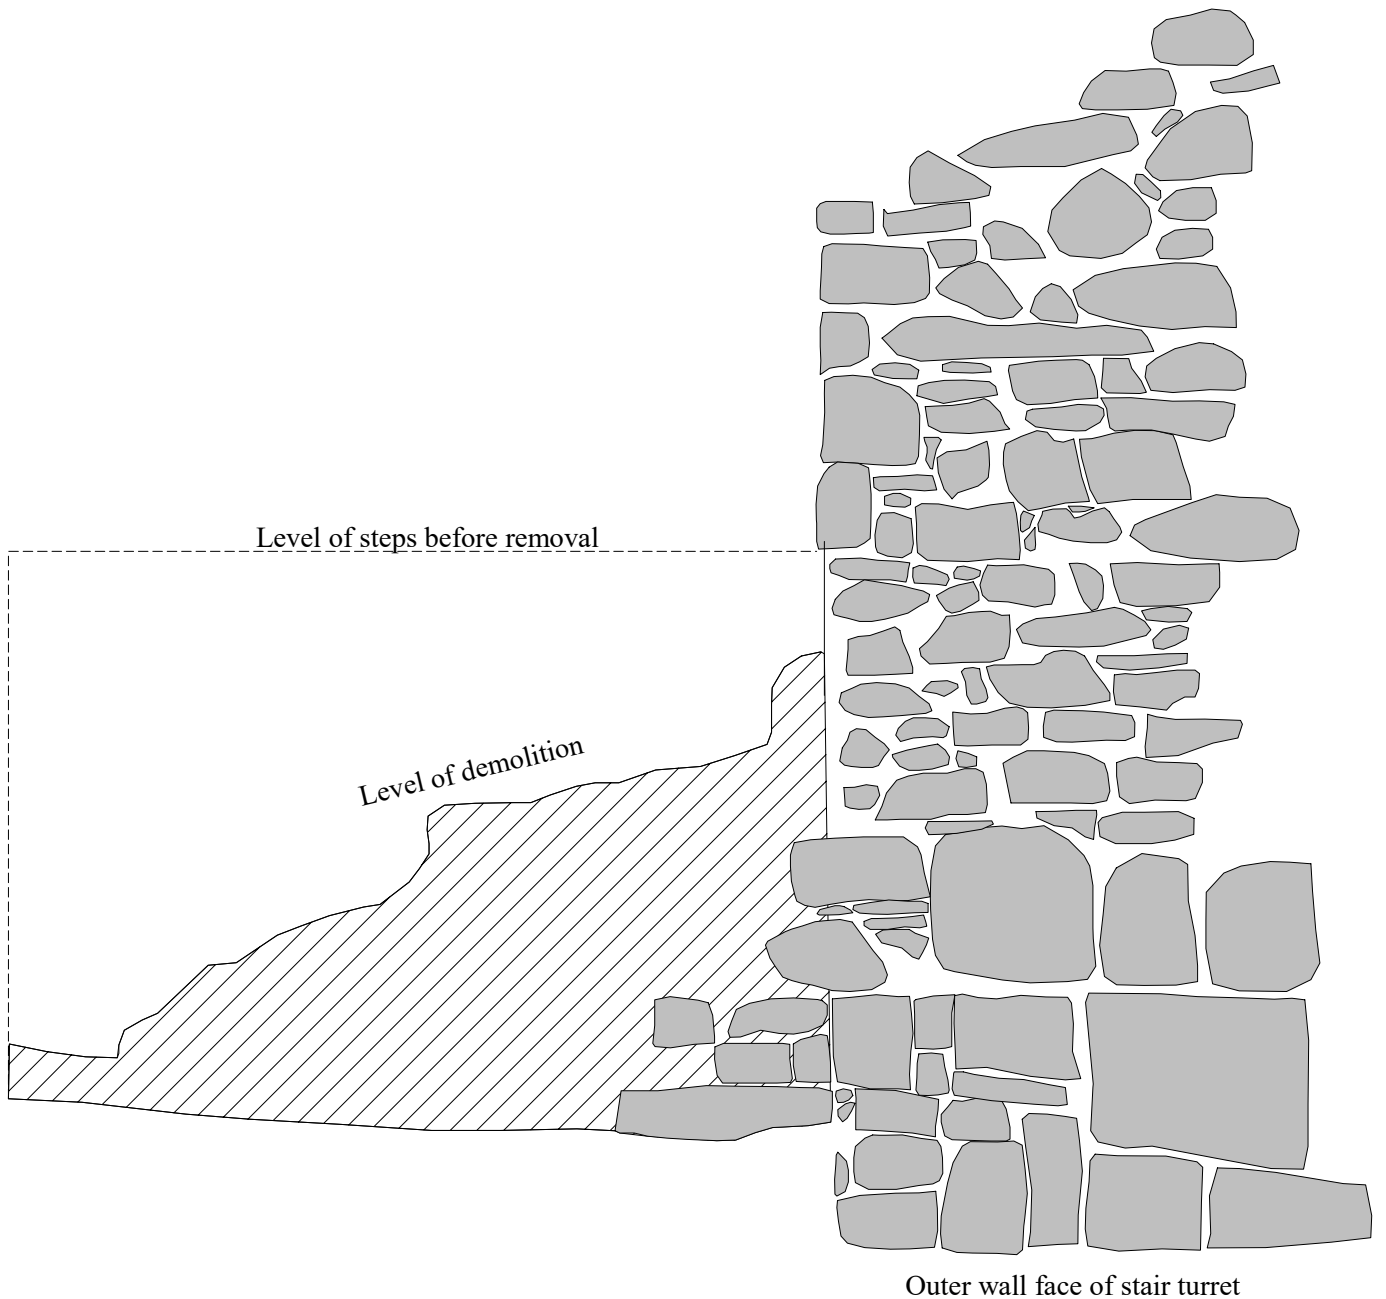
The removal of the steps revealed part of the face of the stair turret (Plate 8, Figure 6) and of the gatehouse (Plate 9, Figure 7). It also showed part of the construction of the stair turret steps (Plate 10). Although the construction of the straight flight of step involved the destruction of the lower portion of the stair turret a few of the facing blocks survived extending the face of the stair turret by approximately 0.5 m (Plate 8, Figure 6). At this lower level it is possible that this facing is part of the “stately stayer” thought to have been constructed before the sixteenth century (Peers, 1923, 74-75).

Figure 6: Extension of the Stair Turret Wall into the Steps
Scale 1:20

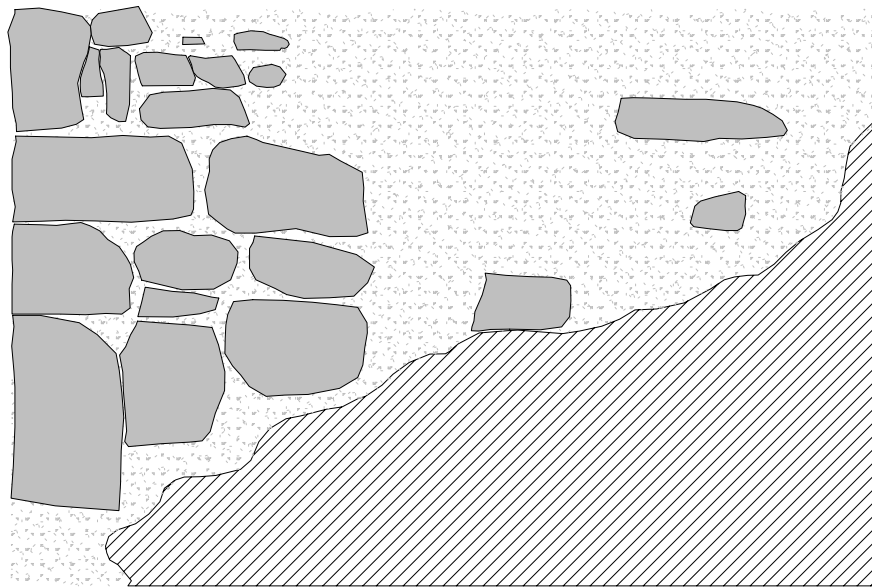
The original face of the gatehouse was also exposed (Plate 9, Figure 7). Although the quoins, to the gate passage, were well defined the remaining area has a skim of lime mortar making the definition of any blocks difficult. It is clear that water had been running down the crack between the stair turret and the gatehouse as the mortar had mobilised in places forming small stalactite like structures.

Figure 7: Face of the Gatehouse behind the Steps
Scale 1:20

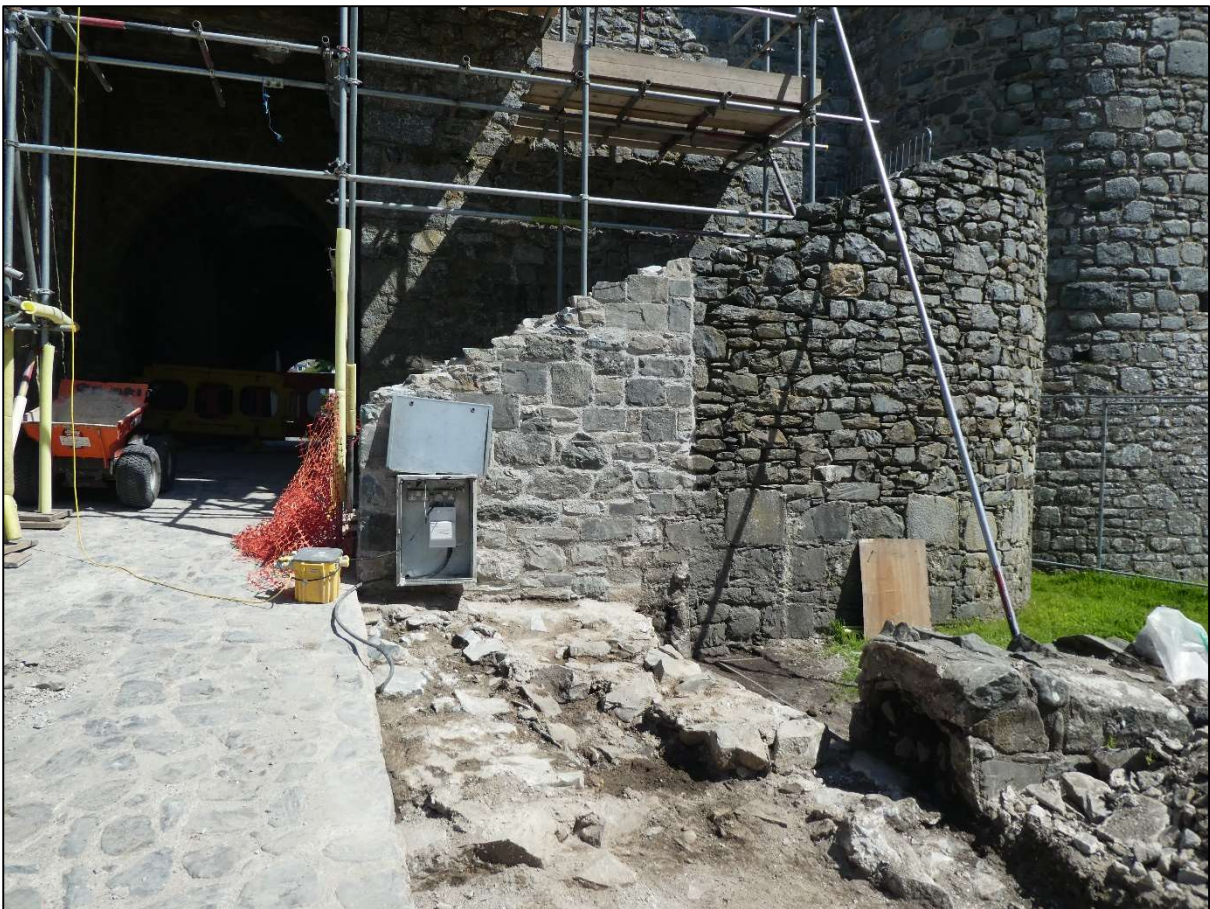
The removal of the bulk of the straight stairs structure was undertaken using a micro-digger with a pneumatic pecker. However, during the course of this work it became apparent that there was a change in the colour and texture of the lime mortar exposed. This was further investigated and proved to be a band of yellowish lime mortar with angular stone blocks, approximately 1.0 m wide (Figure 5, Plates 6 and 7). This runs approximately ENE to WSW at an angle of 111° to the wall that crosses the inner ward from the junction between Ystumgwern Hall and the Granary. Whilst no facing blocks survive the relatively straight southern edge of the feature would suggest that only the facing blocks are missing from this edge. The western end and the relationship to the wall crossing the inner ward has been lost as the construction of the steps has destroyed this end of the feature. It would seem, however, likely that the two possible walls were contemporary.

Plate 6: Possible wall below the stairs

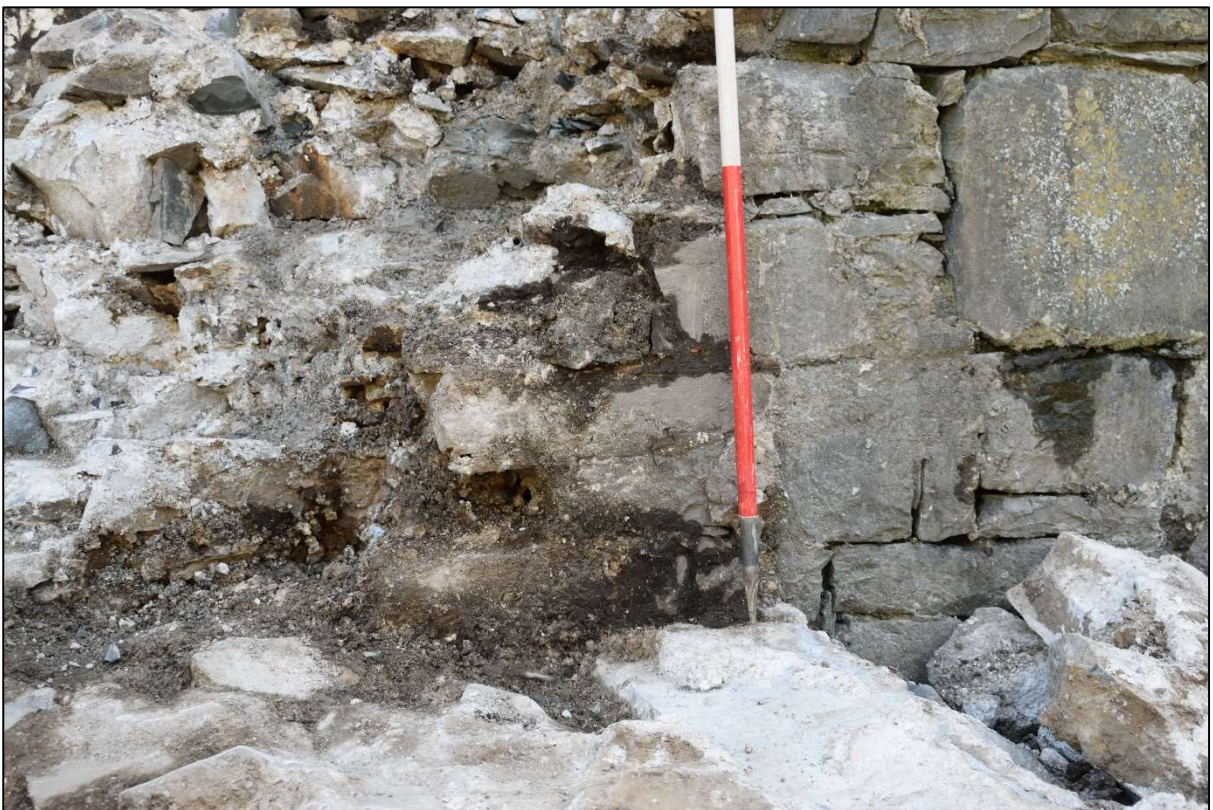
Plate 8: Face of the stair turret wall

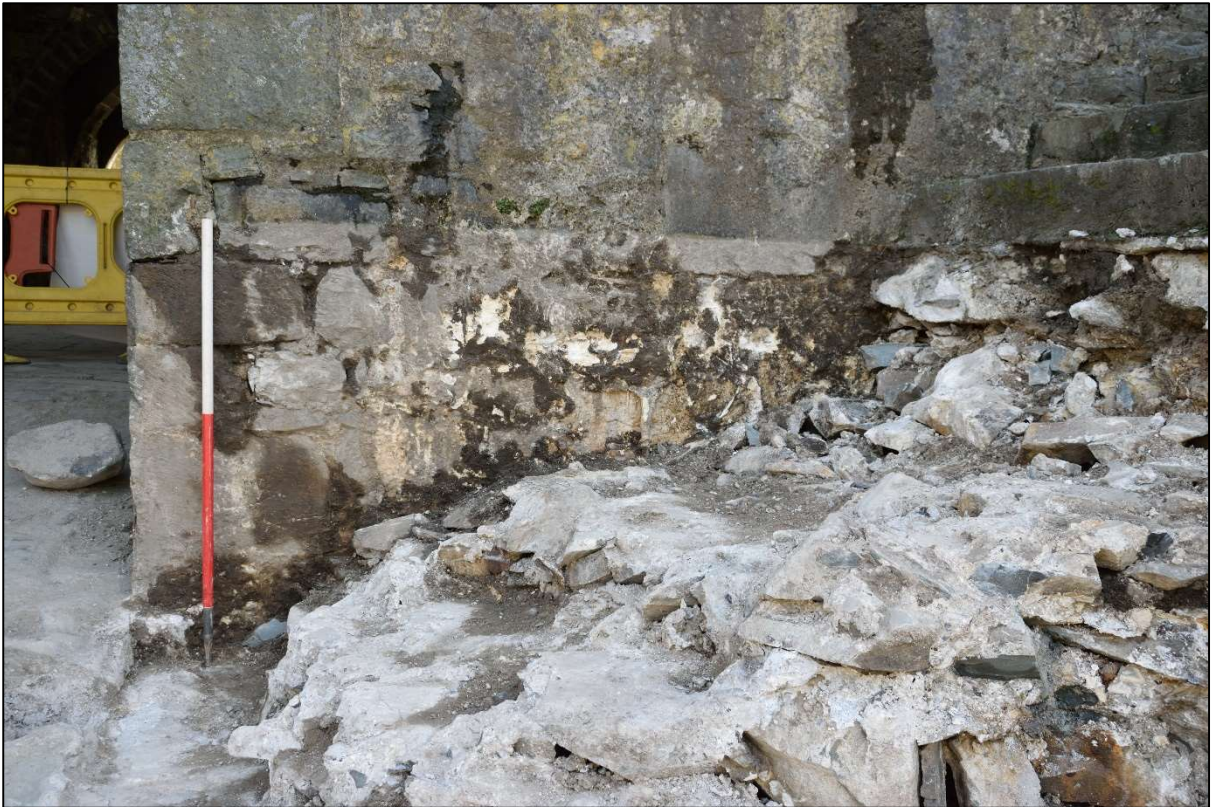
Plate 9: Face of the gatehouse

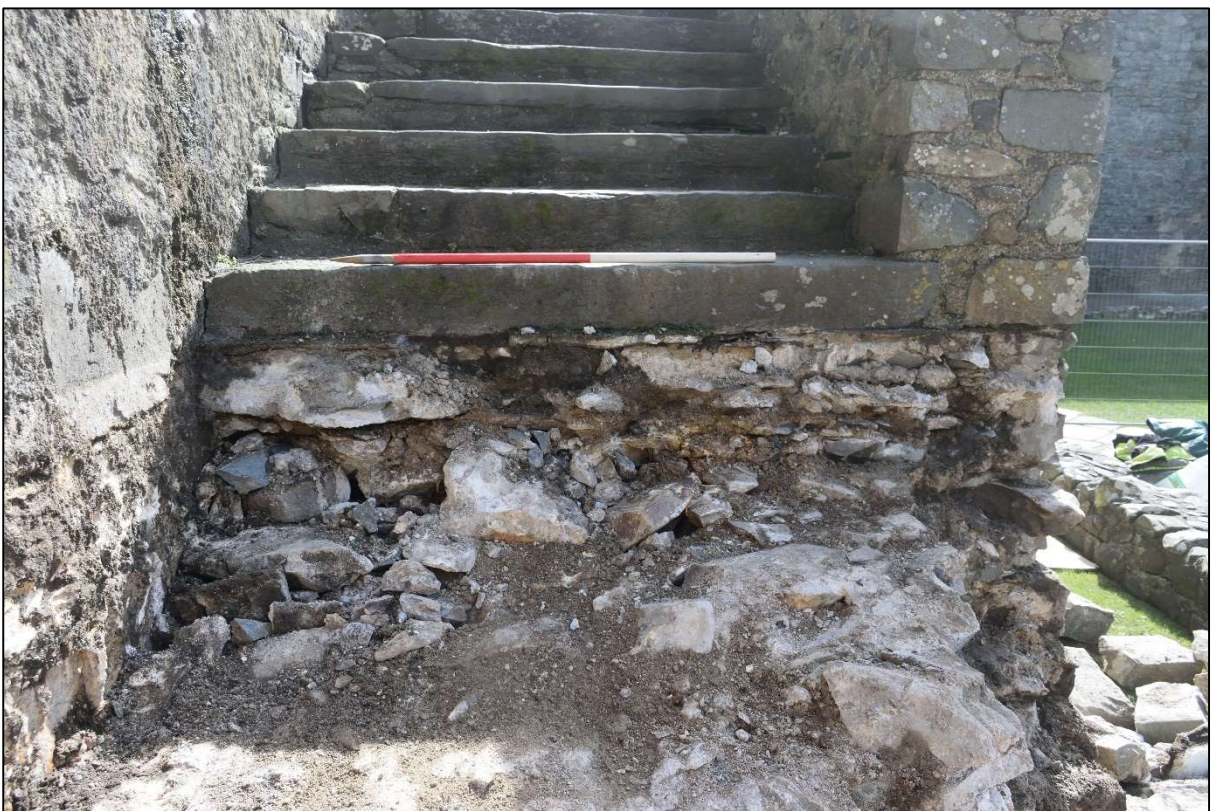
Below the steps of the stair turret its rubble core was exposed by the works (Plate 10).

Plate 10: Rubble fill below the gatehouse steps

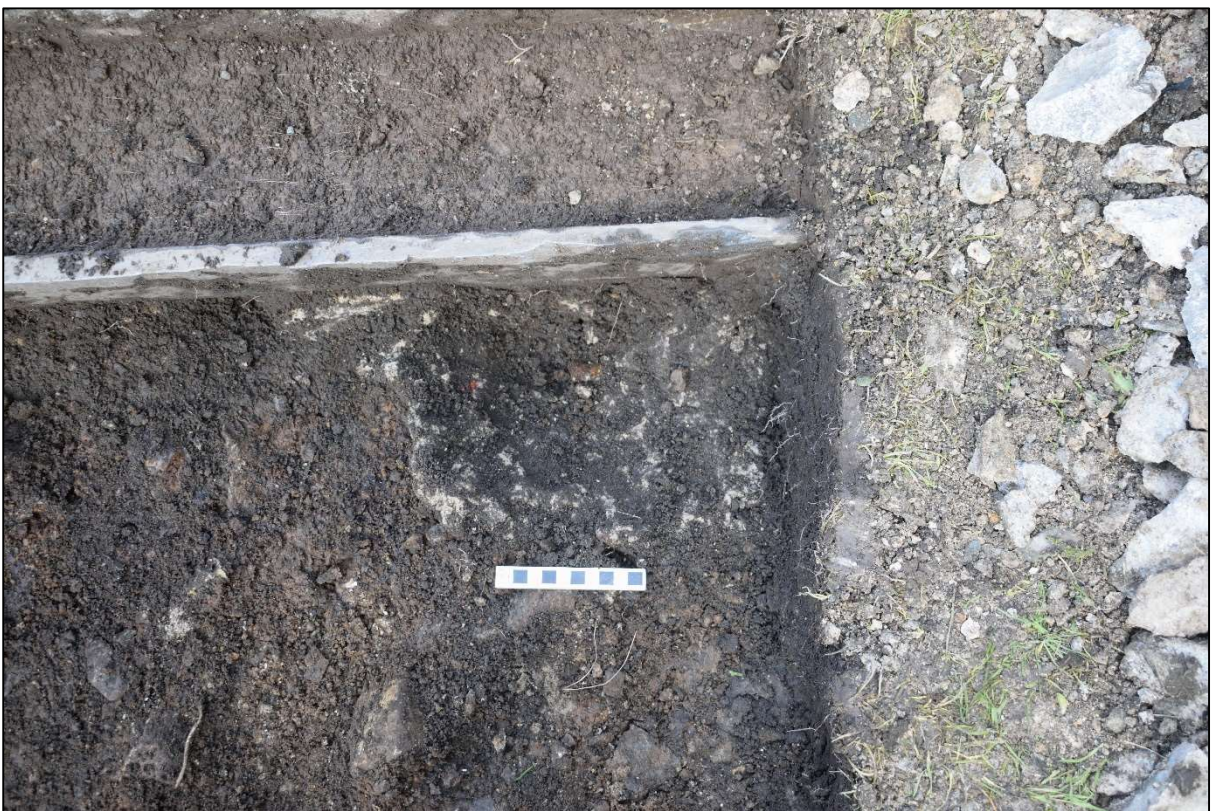
Also within the north eastern corner of the trench was a pad of lime mortar 300 x 200 mm in size (Context 8) with an iron pin at its centre (Plate 12). The pin was 25 mm in diameter and presumably originally supported a notice.

Plate 12: Concrete pad (Context 8) in the north east corner of the trench

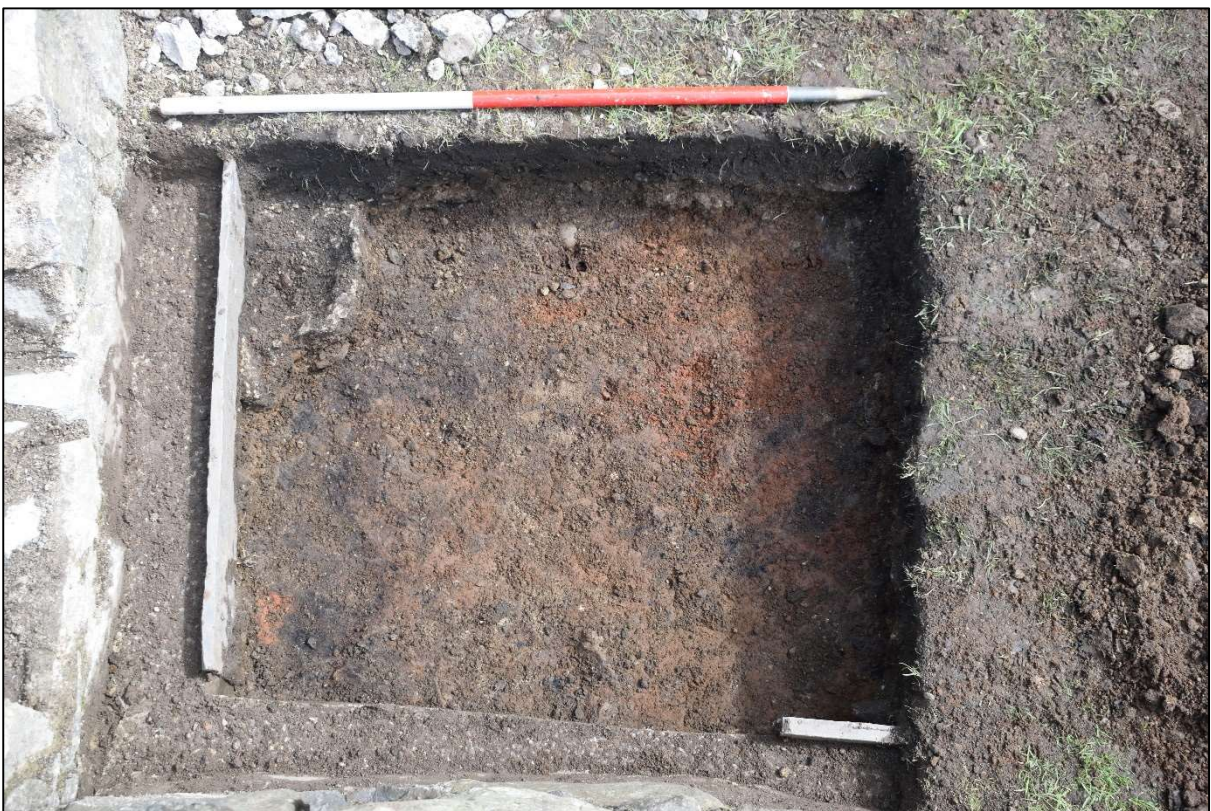
Below Context 5 was a layer of yellow gravelly clay with patches of lime mortar up to 100 mm thick (Context 9). Which, in turn, sealed a patch of clay heated to a bright red colour (Context 10), at least 500 mm wide, in the south east corner of the trench (Figure 10.1 and 11, Plates 14, 16, 19 and 20). This possible hearth had a heat, hardened, top surface and it filled a hollow up to 150 mm deep (Context 17). At the same level as the possible hearth was a burnt surface with a spread of charcoal fragments on a discoloured clayey surface (Context 11). The lower part of this layer contained a series of angular stone chips and fragments up to 150 mm in size. This lower part of the layer was quite loosely packed, whilst the top of the layer was compact and trampled.

Plate 14: Trench after the removal of Context 9, showing the burnt surface and possible hearth (Contexts 10 and 11)

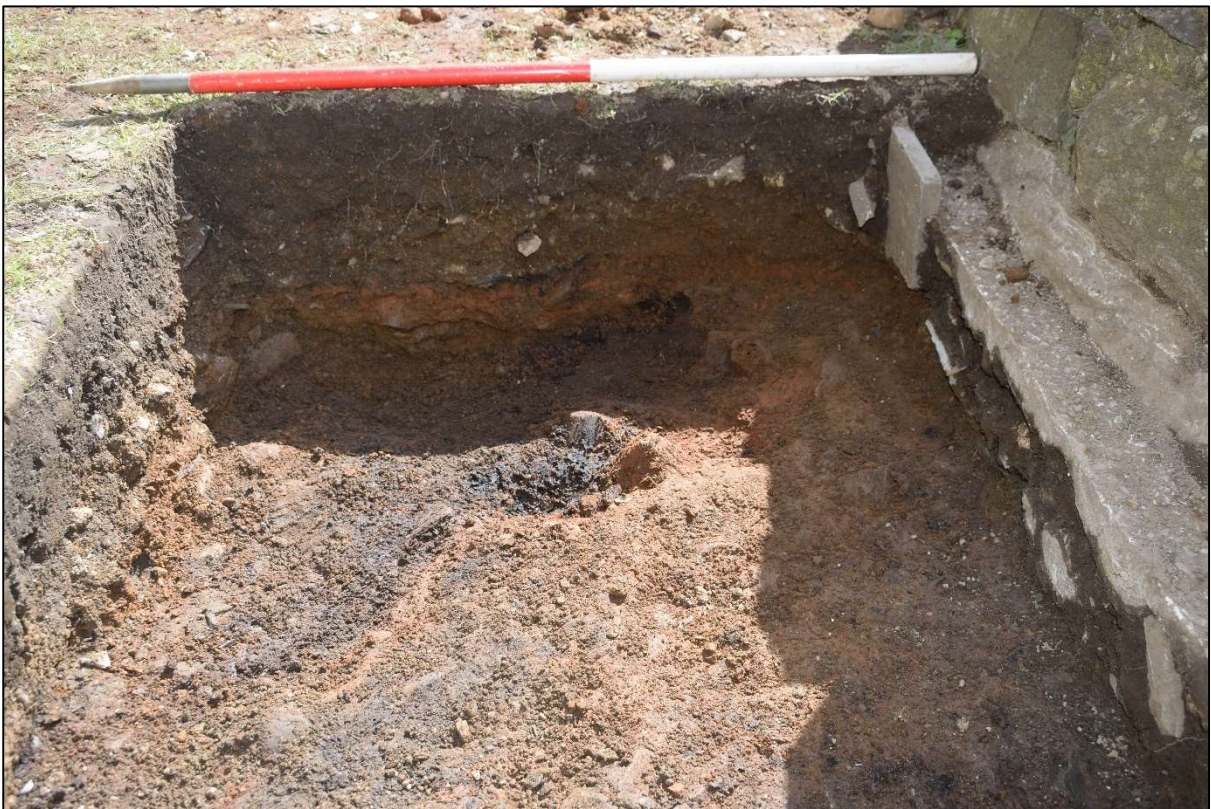
Above this is a possible hearth (Context 10) surrounded by a trampled surface (Context 11) which had also been affected by the heat of the possible hearth (Phase 3). The location of the hearth is curious being so close to the stair turret and the wall crossing the inner ward. It would seem probable that the burning took place before the wall across the inner ward was constructed as it is only 0.5 m away from the edge of the possible hearth.

Plate 16: Section through the possible hearth (Context 10)

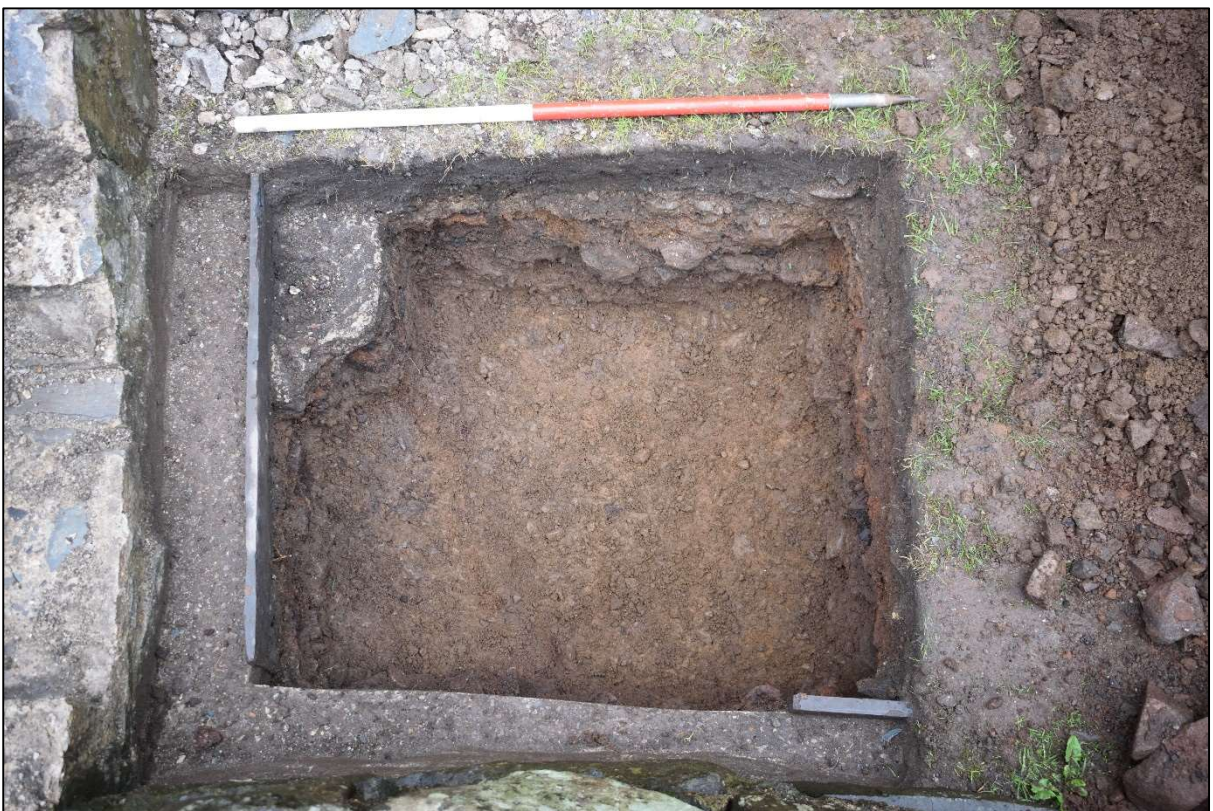
Context 13 sealed a possible, shallow, linear feature 600 mm wide and up to 100 mm deep which was cut into the natural clay (Figures 10.2 and 11, Plates 18, 19 and 20). It was filled with mid yellowish brown sandy gravel with many, small (up to 20 mm) angular stones and rare larger stone fragment up to 100 mm in size.

Plate 18: Possible gully (Context 14)
