**PONTCYSYLLTE AQUEDUCT  
REFURBISHMENT**

**APPLICATION FOR SCHEDULED  
MONUMENT CONSENT:  
SUPPORTING INFORMATION**

Appendix 2  
General items relevant to the  
refurbishment of the Pontcysyllte  
Aqueduct

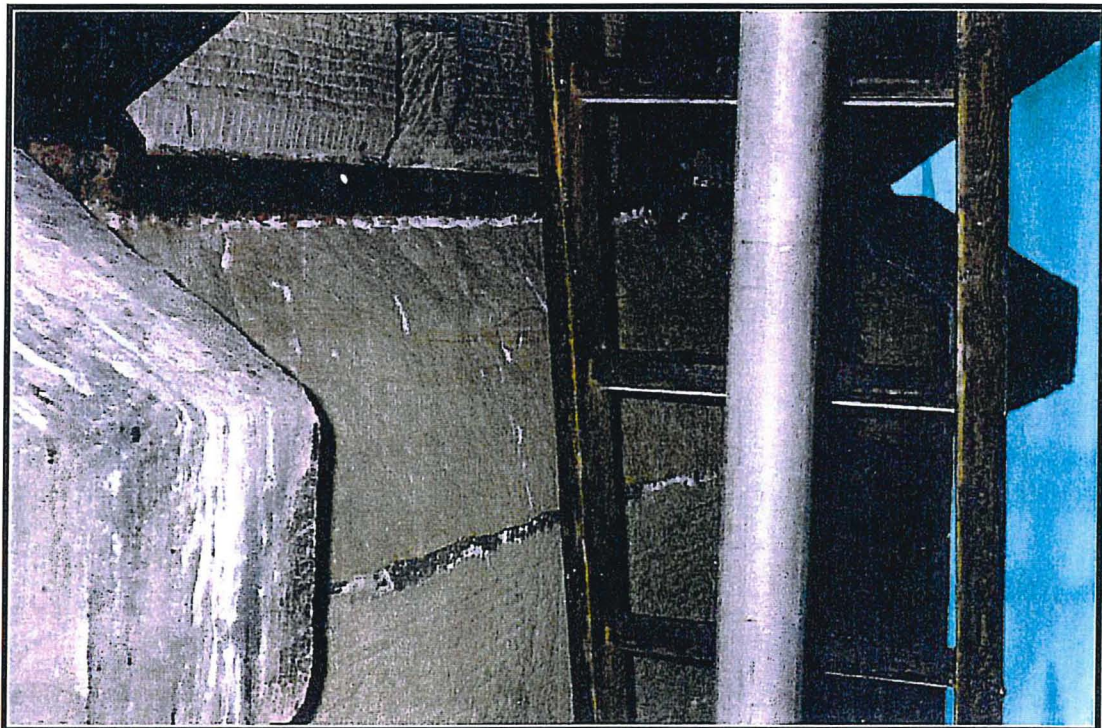
- 1.1 The Trial Refurbishment (February 2000) identified that the masonry corbels are susceptible to cracking and splitting. The deterioration is exacerbated by a water trap formed by poor original detailing of the connection between the corbel and the arch girder bedplate. Photographs from the Trial Refurbishment are shown in Figures 1.1 and 1.2 below.
- 1.2 The masonry corbels will be inspected to assess the extent of the repairs. A photographic survey will be completed to record the current condition of the masonry and to grade the condition of the corbels.
- 1.3 It will be necessary to consult with Cadw's Ancient Monument Inspector at this time to ensure that the most appropriate method of repair/replacement is undertaken. Details of a typical repair as undertaken during the Trial Refurbishment is included in Appendix A.

Figure 1.1 Missing masonry corbel

- 1.4 Every effort will be made to repair the masonry corbels in-situ. If this is not possible the damaged corbel will be removed and replaced with material matching the original masonry blocks. A stone survey has been commissioned to identify a quarry to match the original material. It is understood that the quarry which provided the original material is located in Rhosymedre.

- 1.5 The water trap will be removed by cleaning out and where practical filling with a lime mortar/sandstone mix.

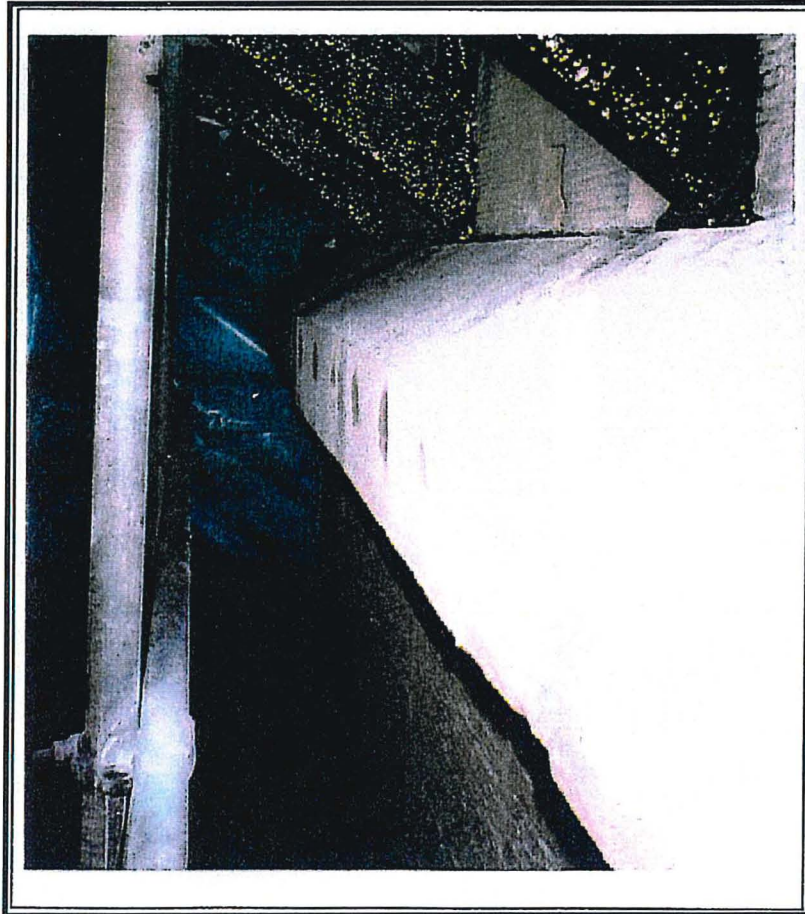
Figure 1.2 Repaired masonry corbel

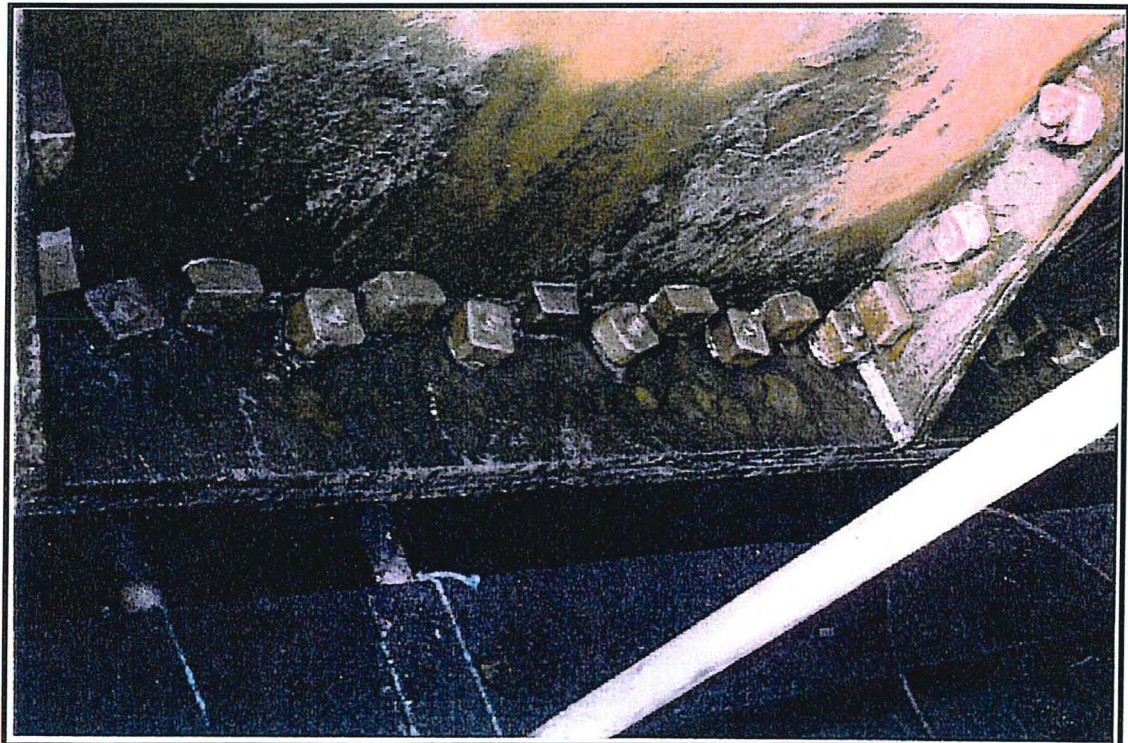
- 2.5 The Trial Refurbishment confirmed that bolts to the external elevations are in very good condition. Photographs of the existing bolts and the removed bolts are shown in figures 2.1 and 2.2 below.

Figure 2.1 External bolts in excellent condition

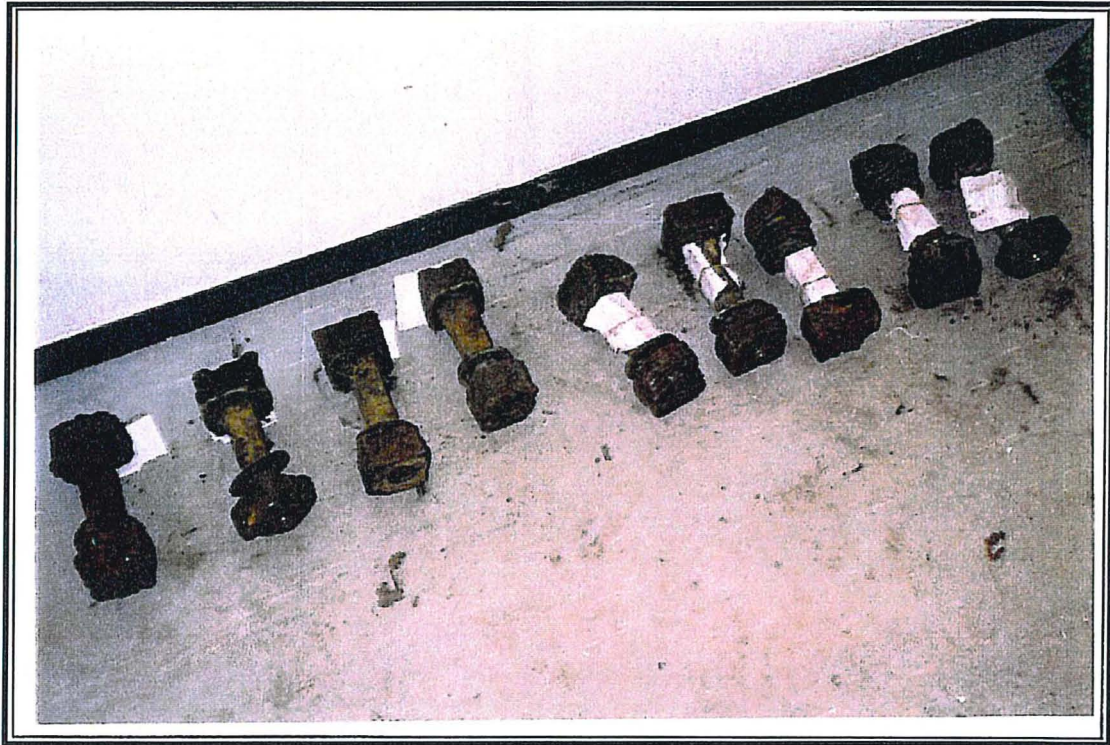
- 2.3 A metallurgical examination of 1 bolt, complete with washers and nut was commissioned. The report on the examination is included as Appendix B.
- 2.4 The bolts on the internal sections of the trough were found to be in a better condition than expected, although the nuts to the bolts have suffered more severe corrosion, especially within the base of the trough.

Figure 2.2 Original bolts

- 2.6 Prior to works commencing on site, replica bolts and nuts will be manufactured in the original material as per the bolt analysis. A date stamp will be applied to the head of the nuts and bolts to enable easy identification in the future.

- 2.13 If the bolted connection is not found to be in a satisfactory condition the bolt/nut will be replaced with the pre-fabricated replica bolts. The recorded information will be updated to reflect the change in bolt.

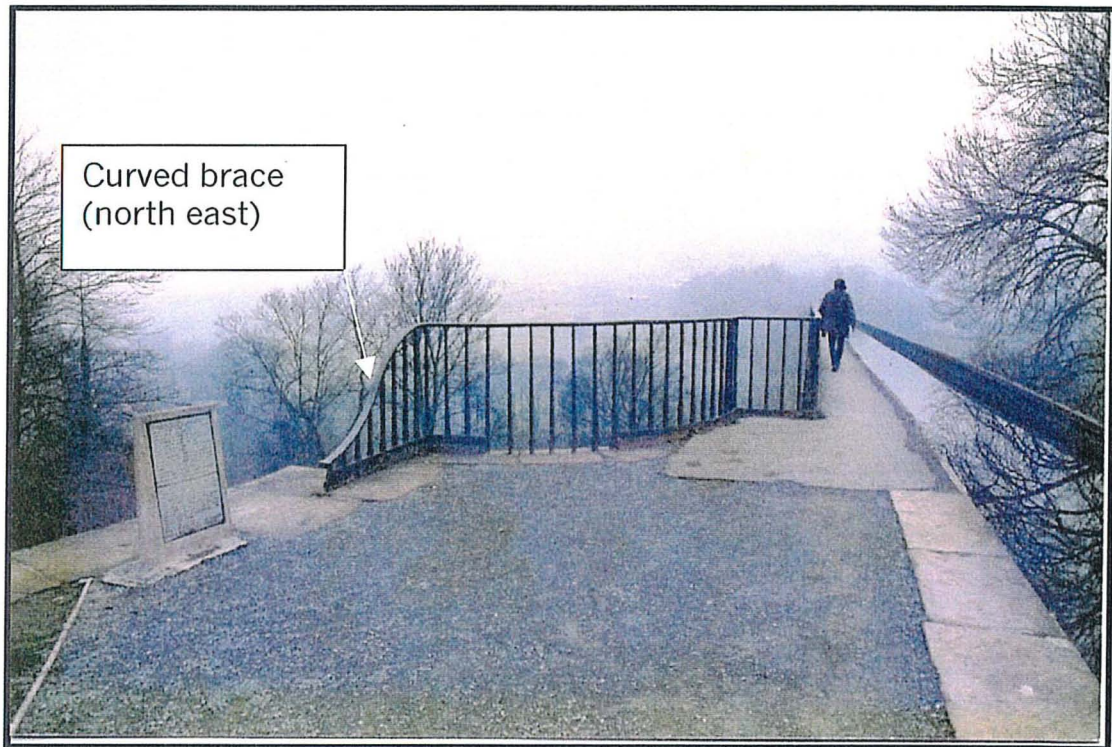
3.2 In 1987, as part of a safety improvement, the curved braces at the northern end of the aqueduct were removed and the existing parapet extended around the approach abutment. The original curved braces are currently stored in the brick building located to the north east of the aqueduct. The original position of the braces is shown in figure 3.1 below, and the modification shown in figure 3.2.

Figure 3.1 – Curved braces – northern end

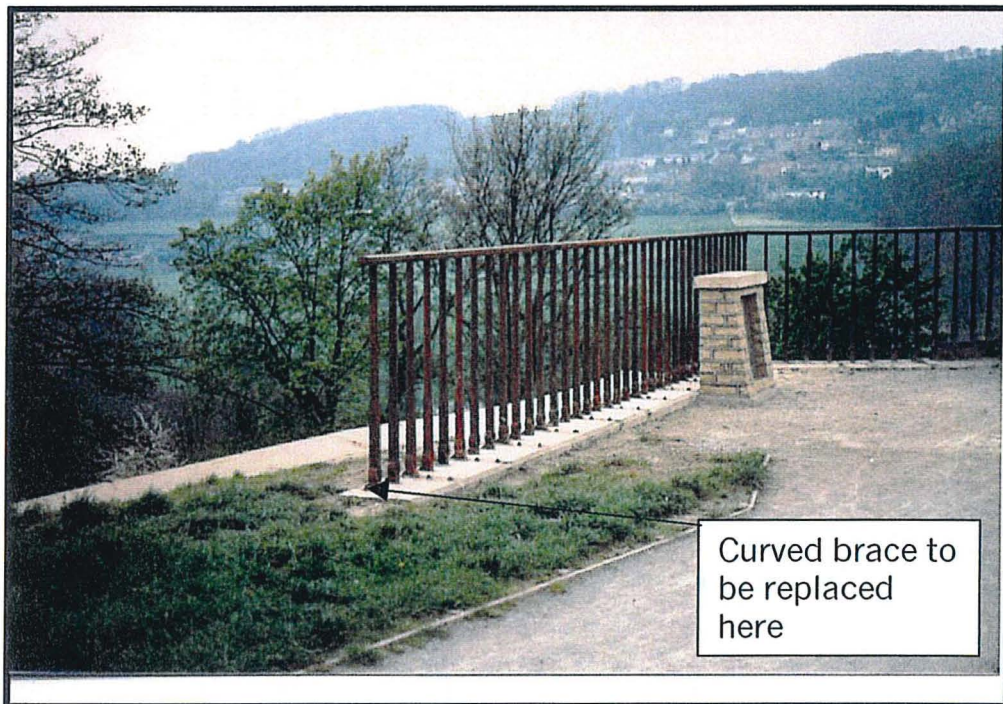
Figure 3.2 – Proposed location of curved braces (north east)

3.3 The refurbishment proposals include restoring the curved braces to the northern end of the aqueduct but in a more northerly position as indicated in figures 3.2 and 3.3. The braces at the southern end remain in place and are original.

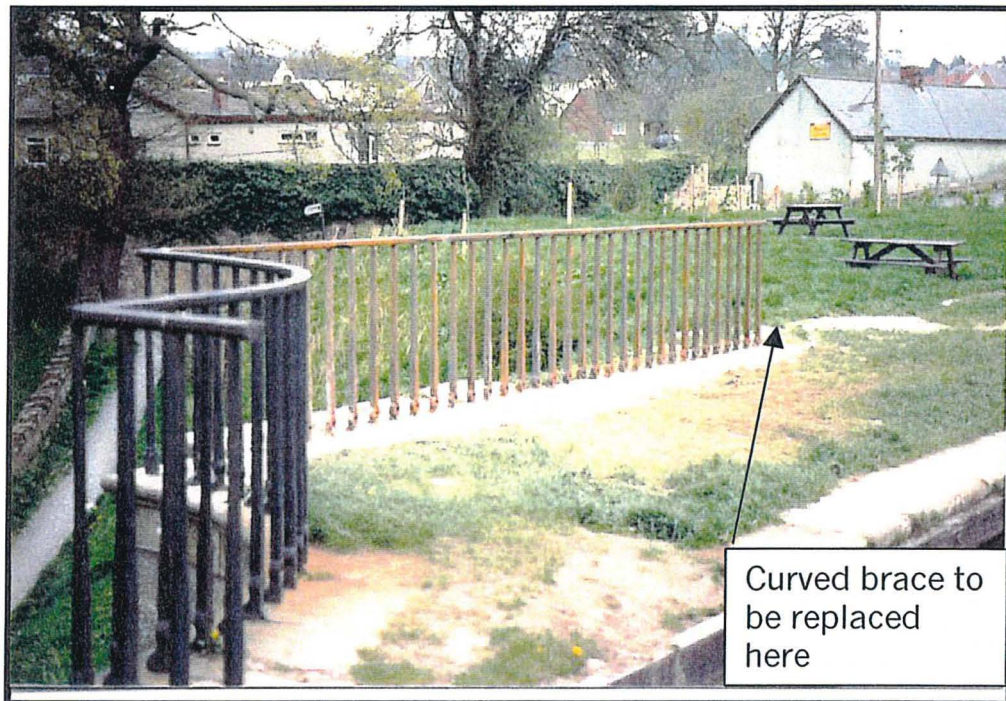
Figure 3.3 – Proposed location of curved braces (north west)

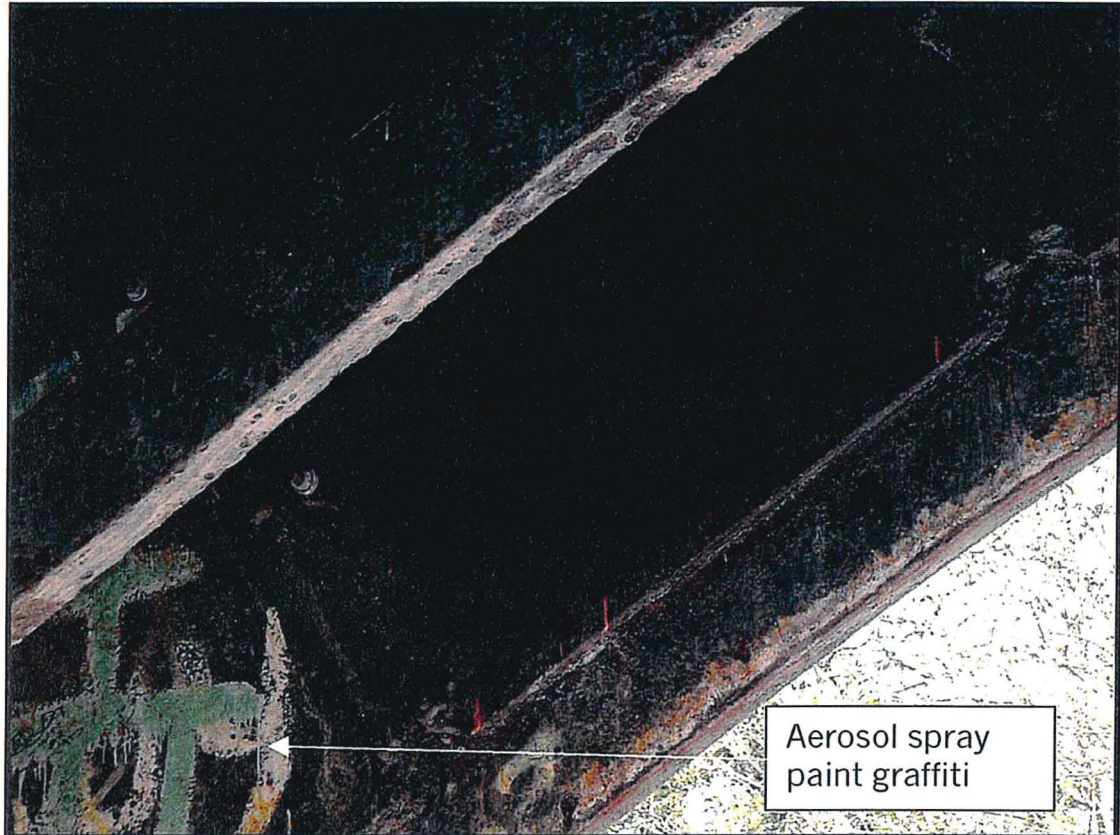
- 5.1 Graffiti damage can be found to the masonry and cast iron sections to the northern and southern ends of the Aqueduct. The graffiti consists of aerosol spray paint, felt tip markers and ballpoint pen markings (see figure 5.1).

Figure 5.1 Graffiti

- 5.2 A site trial to determine the most effective removal system will be undertaken at the start of the main refurbishment works.
- 5.3 The site trial will consist of chemical removal and mechanical removal techniques.
- 5.4 The chemical agents for graffiti removal will include solvent-based paint removers (based on methylene dichloride), other organic solvents, and alkali-based paint removers.
- 5.5 Air abrasive methods will also be trialled to determine their effectiveness and suitability for removing the graffiti without damaging the Aqueduct.
- 5.6 The results of the site trial will be analysed and the most suitable method(s) will then be applied to remove the remaining graffiti.

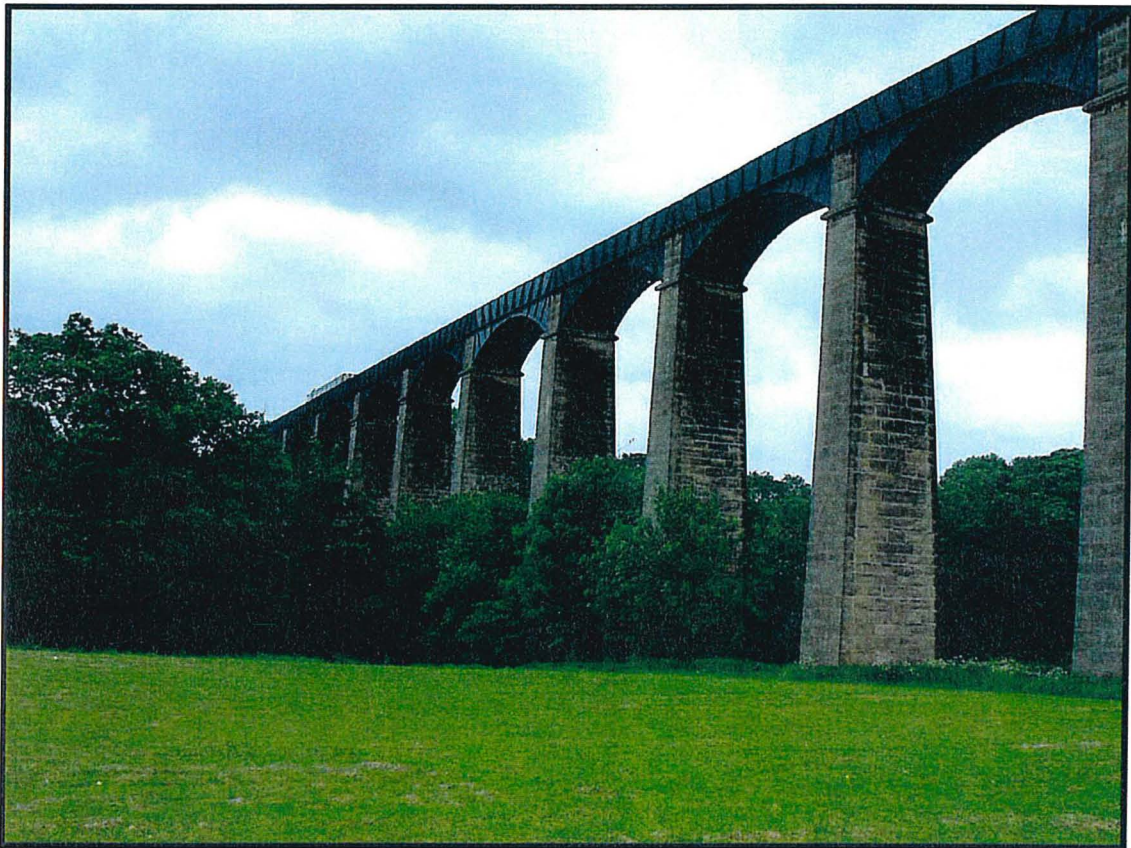
- 6.1 The masonry piers of the Aqueduct are overgrown with vegetation. Creepers and other invasive species are damaging the structure of the masonry and invading the masonry joints.
- 6.2 Deep-rooted trees are a cause for concern to the structural stability of the masonry piers as shown in figure 6.1

Figure 6.1 Vegetation near the Aqueduct

- 6.3 A topographical survey is to be undertaken to record the location of all substantial trees in the vicinity of the Aqueduct. The survey drawing will be used to identify the trees for removal.
- 6.4 The trees are located within a Conservation Area and subject of a Tree Preservation Order. The local Arboricultural Officer will be consulted on their removal and an application will be submitted for approval to remove the trees. Substitute trees will be planted in a more controlled and managed approach.
- 6.5 The trees will be carefully removed by a tree surgeon ensuring that the trees are felled in a manner that does not impinge on the Aqueduct.

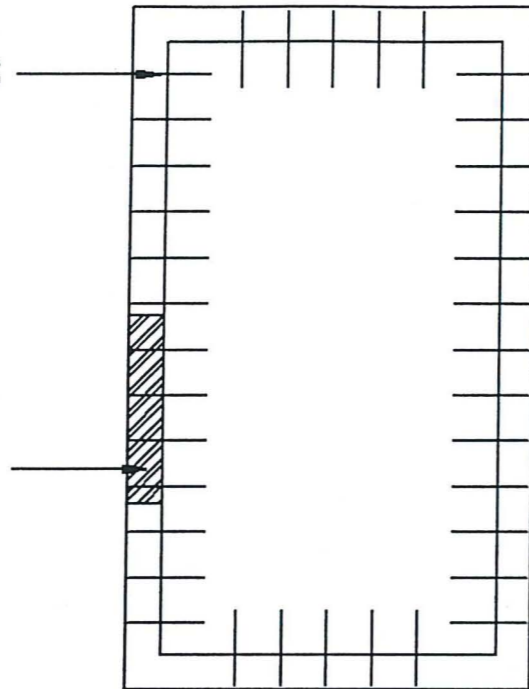
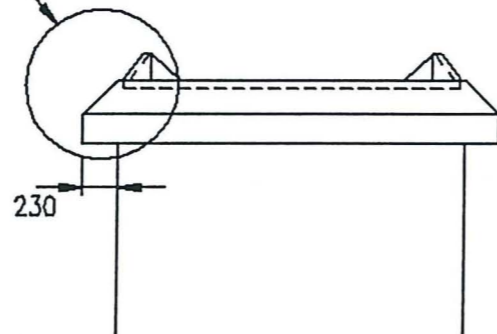
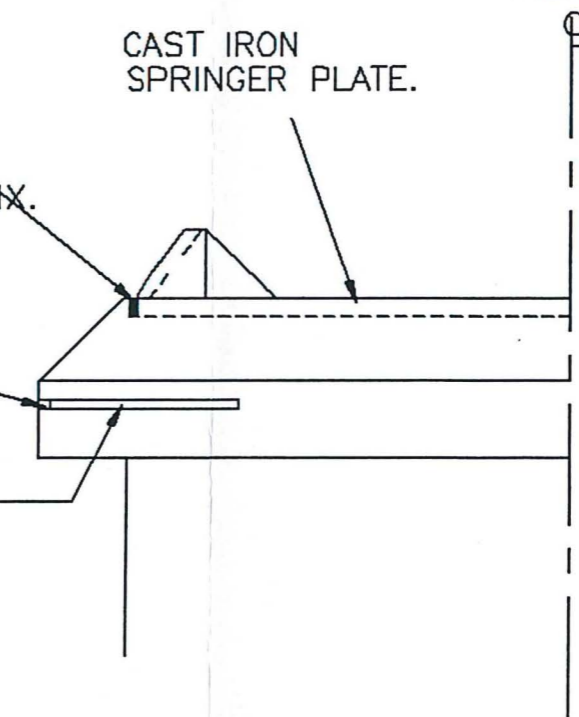
DETAIL H - MASONRY CORBEL

EXISTING DAMAGED / MISSING  
MASONRY TO BE REPLACED WITH  
MATCHING MASONRY.

RAKE OUT JOINT BETWEEN  
C.I. SPRINGER PLATE AND  
MASONRY CORBEL AND SEAL  
WITH SANDSTONE LIME MORTAR MIX.

EXISTING MASONRY CORBELS  
TO BE ARRANGED USING EPOXY  
RESINED STAINLESS STEEL  
DOWELS 500 LONG x 25 $\phi$ .

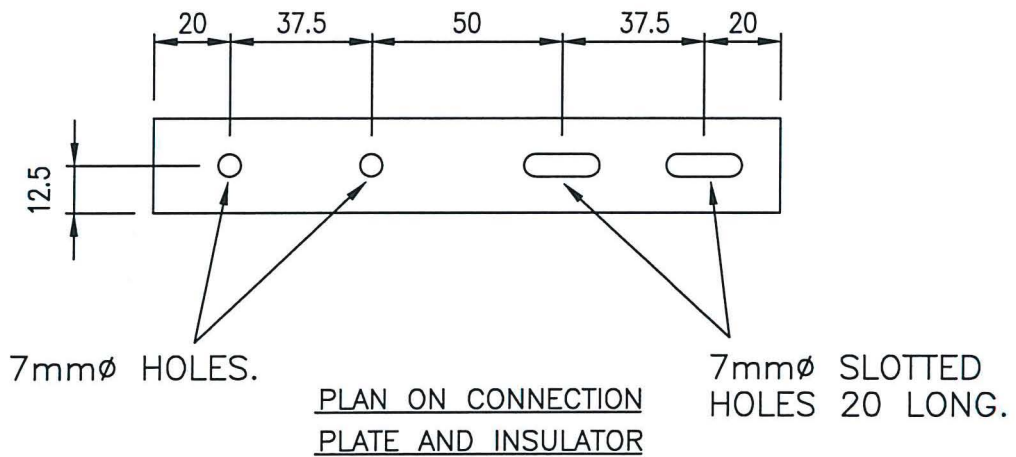
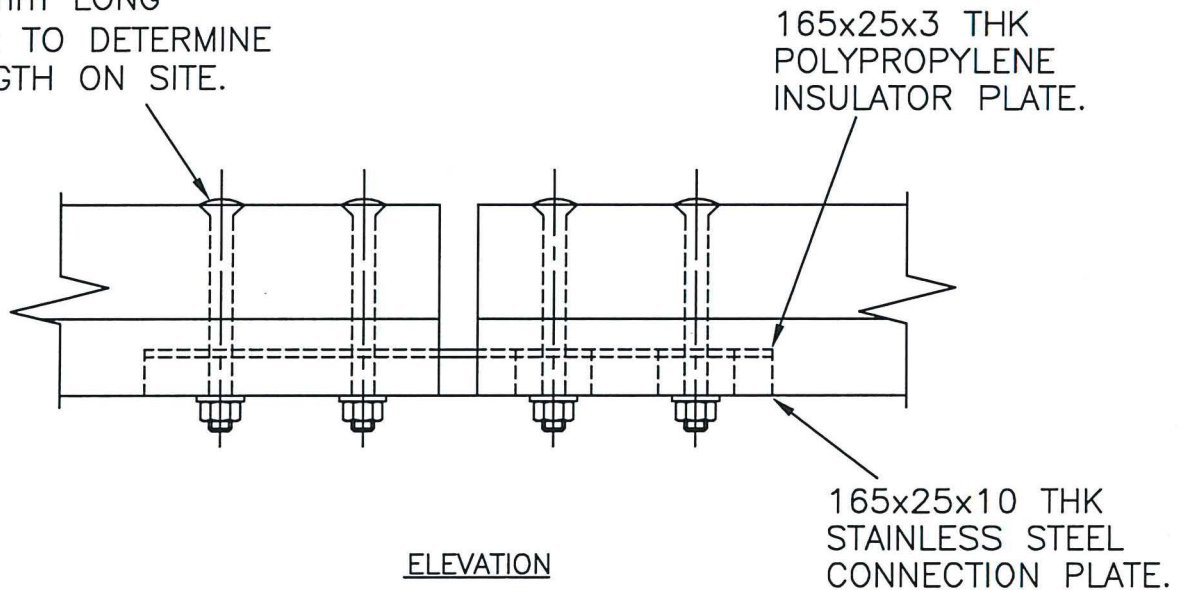
PARAPET HANDRAIL  
EXPANSION JOINT DETAIL

- 3.4 The cast iron top rail is in poor condition, expansion joints have seized causing cracking and displacement. The standard of weld repairs previously undertaken is generally poor.
- 3.5 The parapet posts fit within purpose built openings within the underside of the top rail. The openings have been weathered and elongated.

- 3.7 Repairs to the defective locations will, where appropriate, consist of
- (i) welded repairs to the parapet top rail
  - (ii) reinstating seized expansion/contraction joints. The details of the joints are included in Appendix D.

4No. 6mm $\varnothing$  STAINLESS  
STEEL C/S MACHINE SCREWS  
WITH NUTS AND WASHERS.  
APPROX 60mm LONG  
CONTRACTOR TO DETERMINE  
ACTUAL LENGTH ON SITE.
