**PONTCYSYLLTE AQUEDUCT
REFURBISHMENT**

**APPLICATION FOR SCHEDULED
MONUMENT CONSENT:
SUPPORTING INFORMATION**

**Appendix 4
Towpath restoration**

JULY 2003

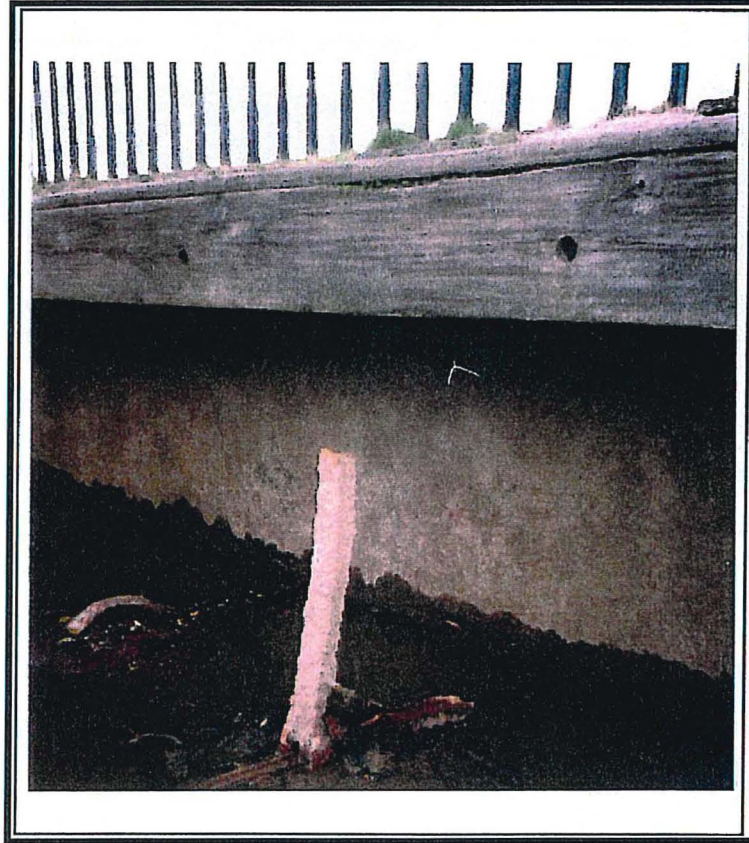
1.7 The underside of the towpath was inspected during the trial refurbishment (February 2000) and in areas, particularly at the ends of the aqueduct, has suffered from the effects of corrosion. The support angles have suffered a significant loss of section, which is a result of poor detailing creating a water trap between the timber fender and the support angle.

Figure 1.1 Damaged cast iron supporting leg

1.8 One towpath support was repaired during the trial refurbishment as shown in figures 1.1 and 1.2 below.

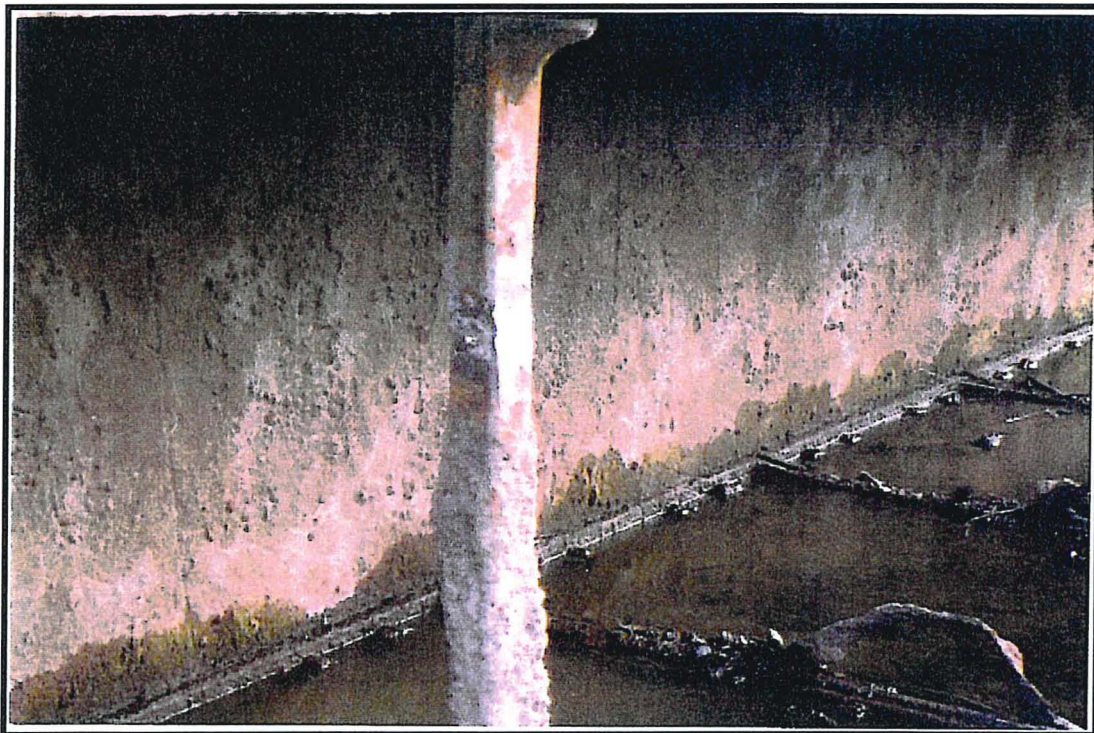
Figure 1.2 Repaired cast iron supporting leg

- 3.4 Where the supports can be repaired a welded repair as undertaken during the trial refurbishment (See figure 1.2) is proposed.
- 3.5 The angle iron, running along the edges of the towpath, is known to be in very poor condition and will be replaced with a modern mild steel angle to the appropriate dimensions for retaining the towpath filling material.

4.4 Where the supports can be repaired a welded repair is proposed as shown in figure 1.2.

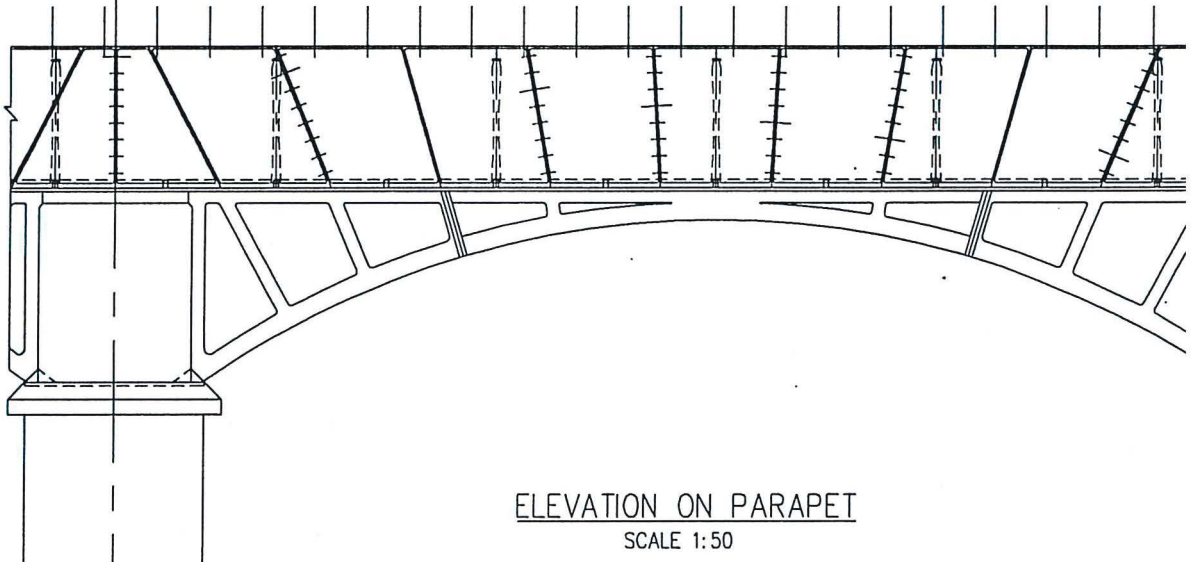
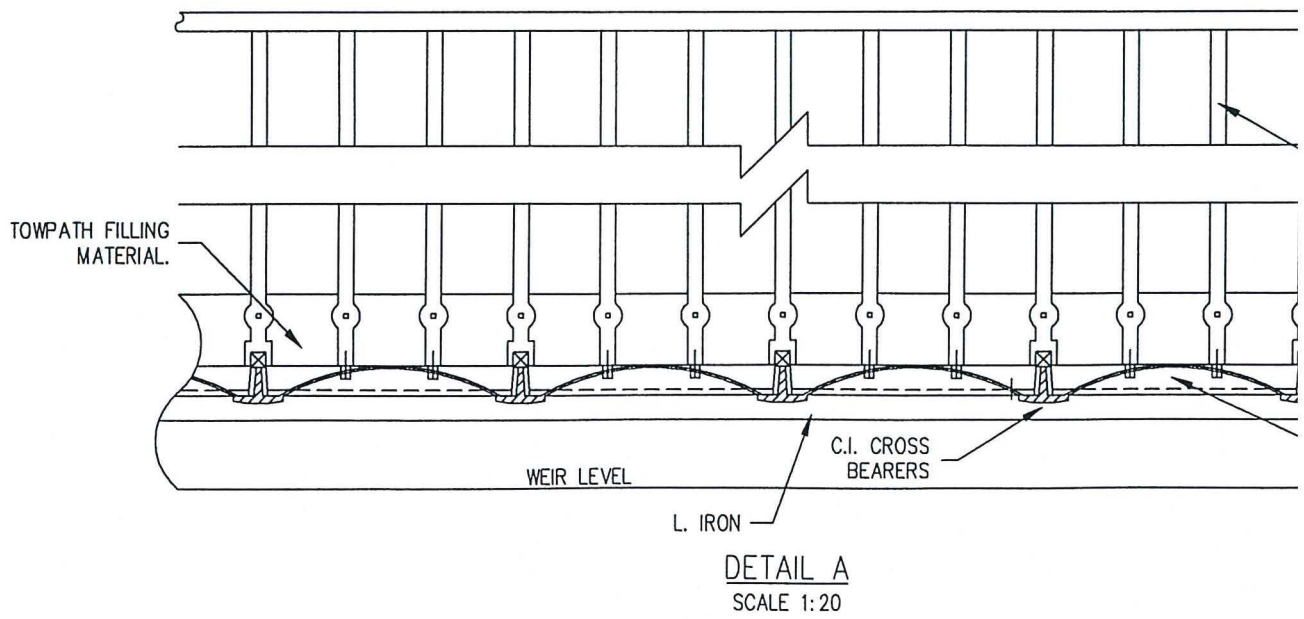
Appendix A – Historical drawing – Dwg No P572/OR/1

1.4 Evidence from the historical research (See Appendix 1) indicates that the towpath was replaced on a number of occasions. The timber construction was replaced in 1879 with a different structure consisting of wrought iron buckle plates (see Appendix A – Dwg No. P572/OR/1)

4.1 This option considers returning the towpath supporting structure to the 1879 wrought iron buckle plate design (See Appendix A – Dwg No. P572/OR/1).

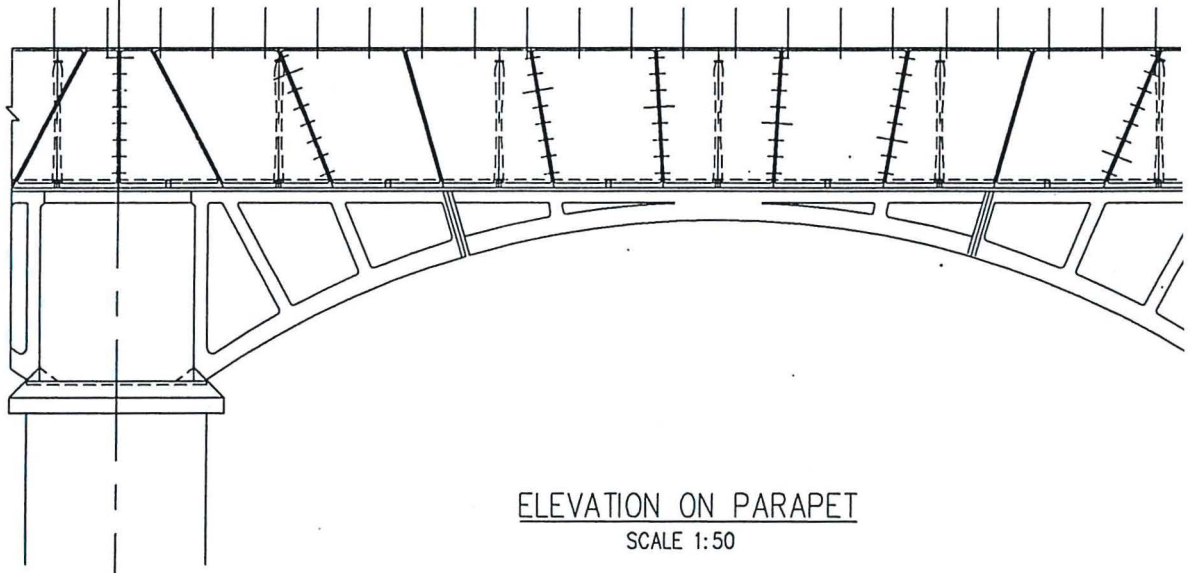
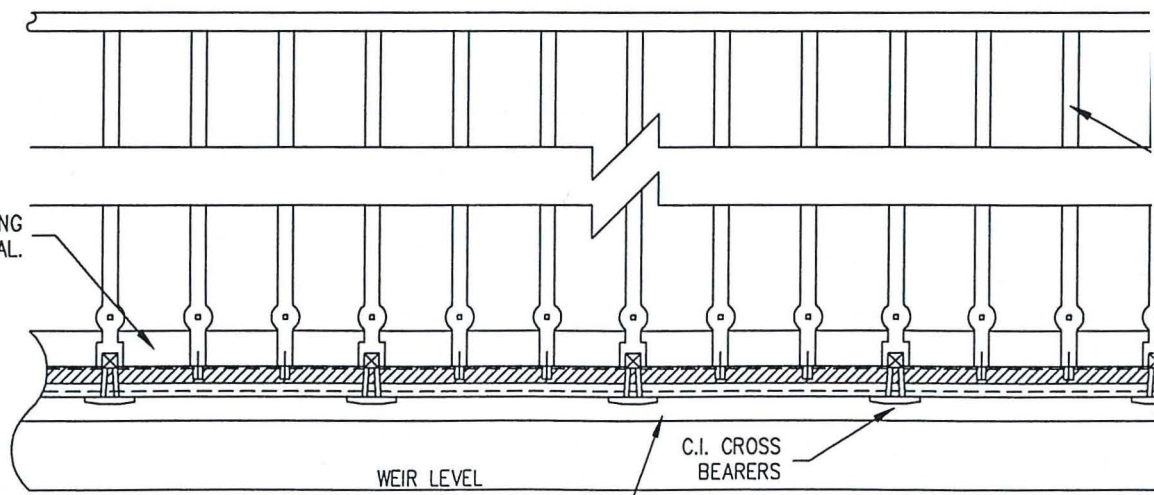
Appendix B – Existing towpath construction – Dwg No. P572/OR/2

1.5 An inspection report from 1965 confirmed that the buckle plates were seriously corroded. The structural configuration was subsequently modified to the galvanised trench sheet arrangement shown on Dwg No. P572/OR/2 in Appendix B.
