# THE YORKSHIRE IMPERIAL METALS SITE, SWANSEA

## A SITE APPRAISAL

## ARCHAEOLOGICAL, CONDITION, AND HEALTH AND SAFETY APPRAISALS BUDGET COSTS

NOVEMBER 2002  
REPORT No. 2002/100

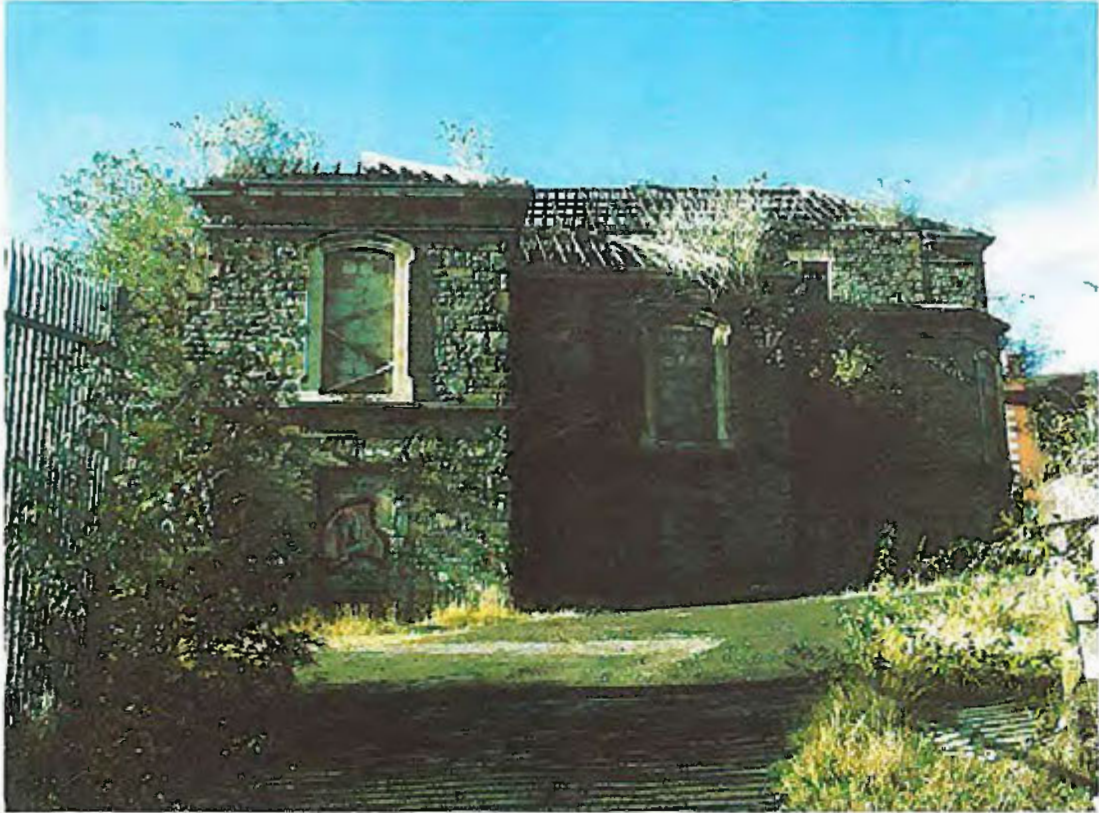
*Photo 3a - Building 2.0 (Laboratory) from the east showing main facade (1880s)*

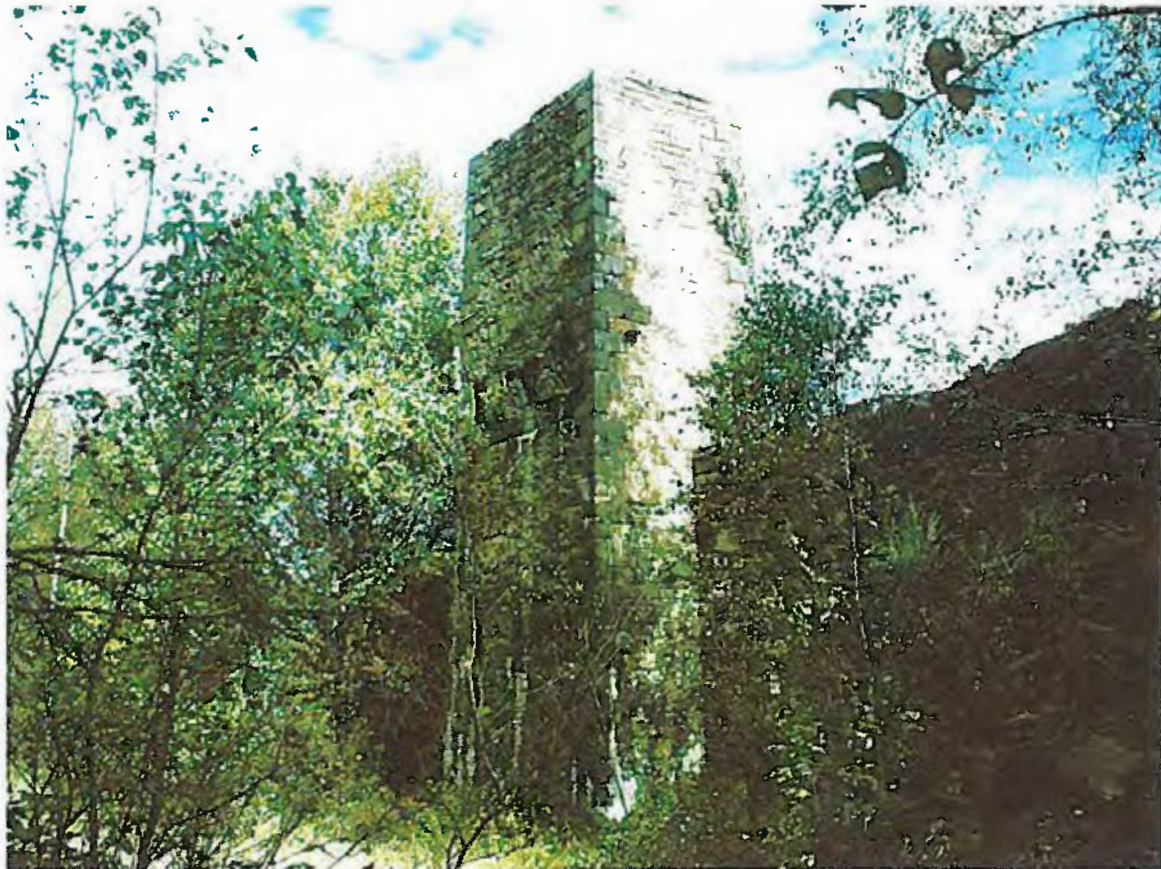
*Photo 4a - Building 3.0 (Pier) from the SW*

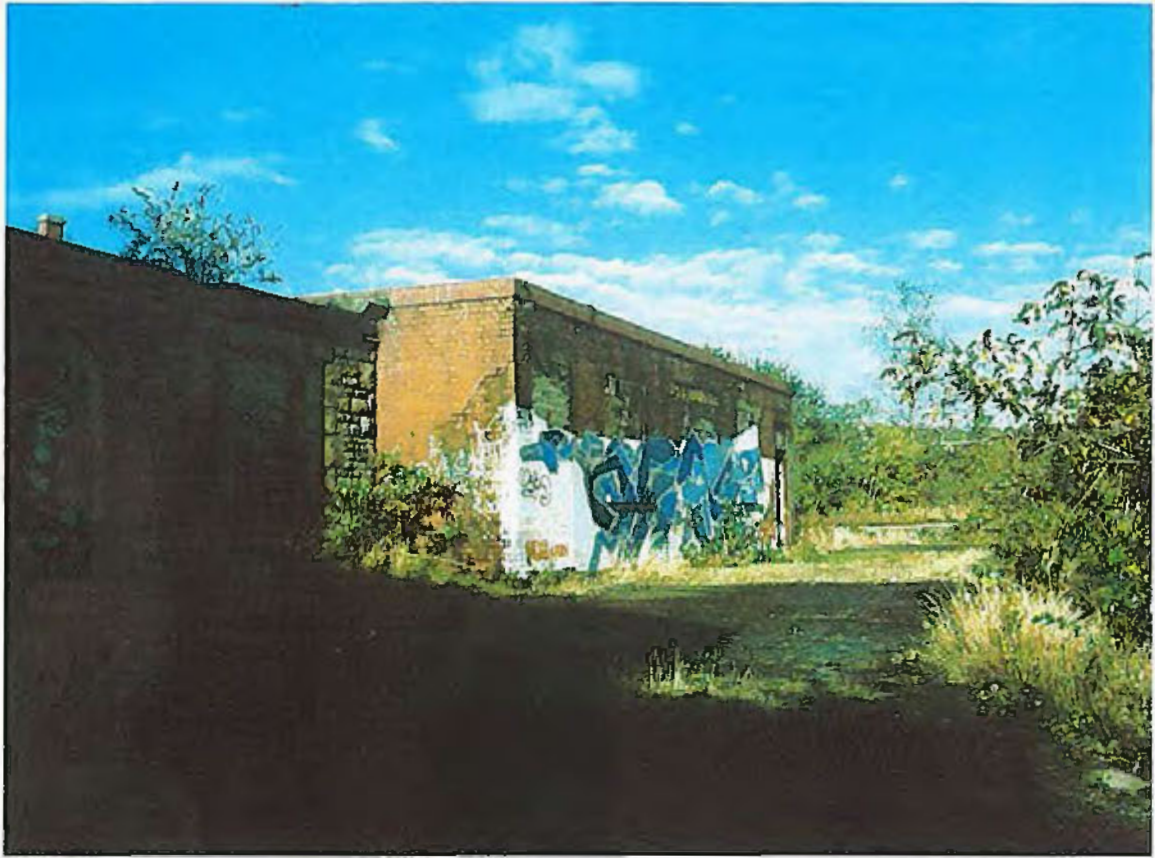
*Photo 11b - Area 1C from the SE showing weighbridge office YIM 30 and stack YIM 7 behind*

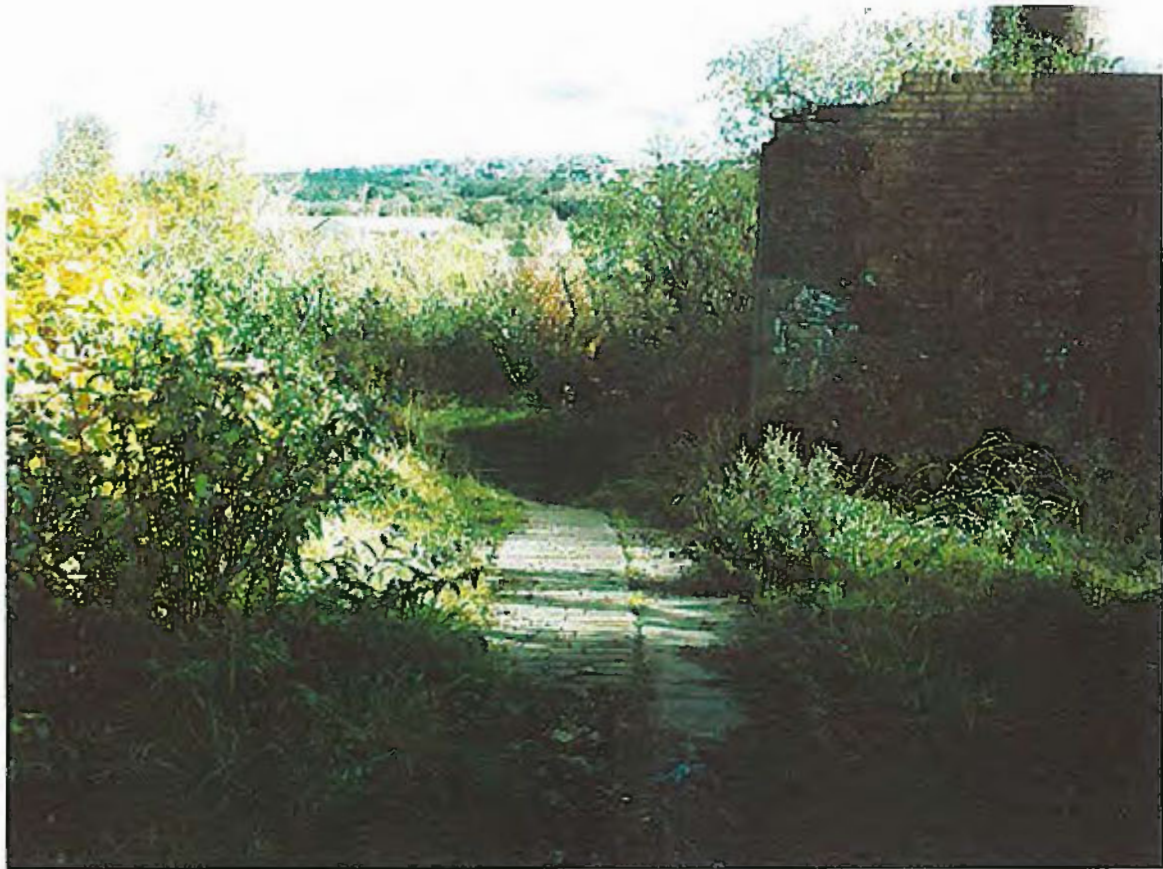
Photo 13 - Area 3A, YIM 38, showing the surviving sett surface from the west

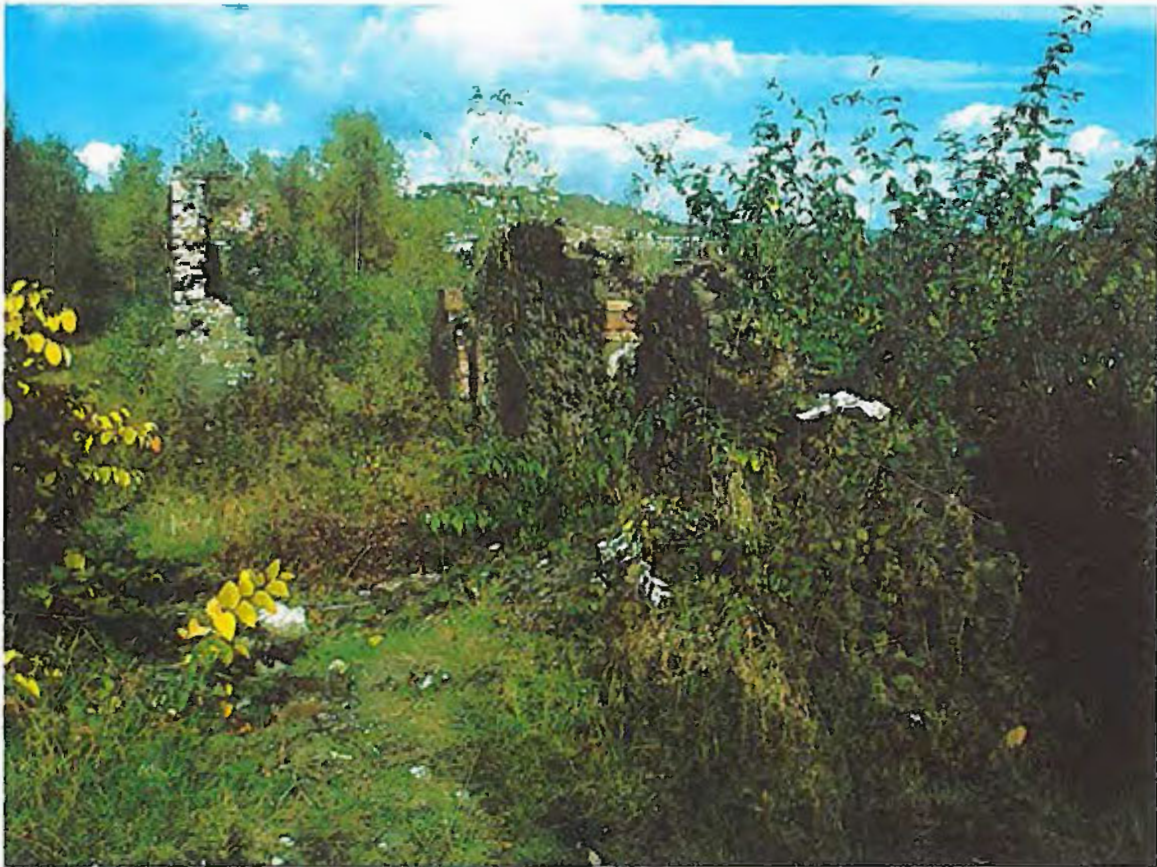
*Photo 14b - Area 4A, part of building YIM 41 from the southwest (exterior)*

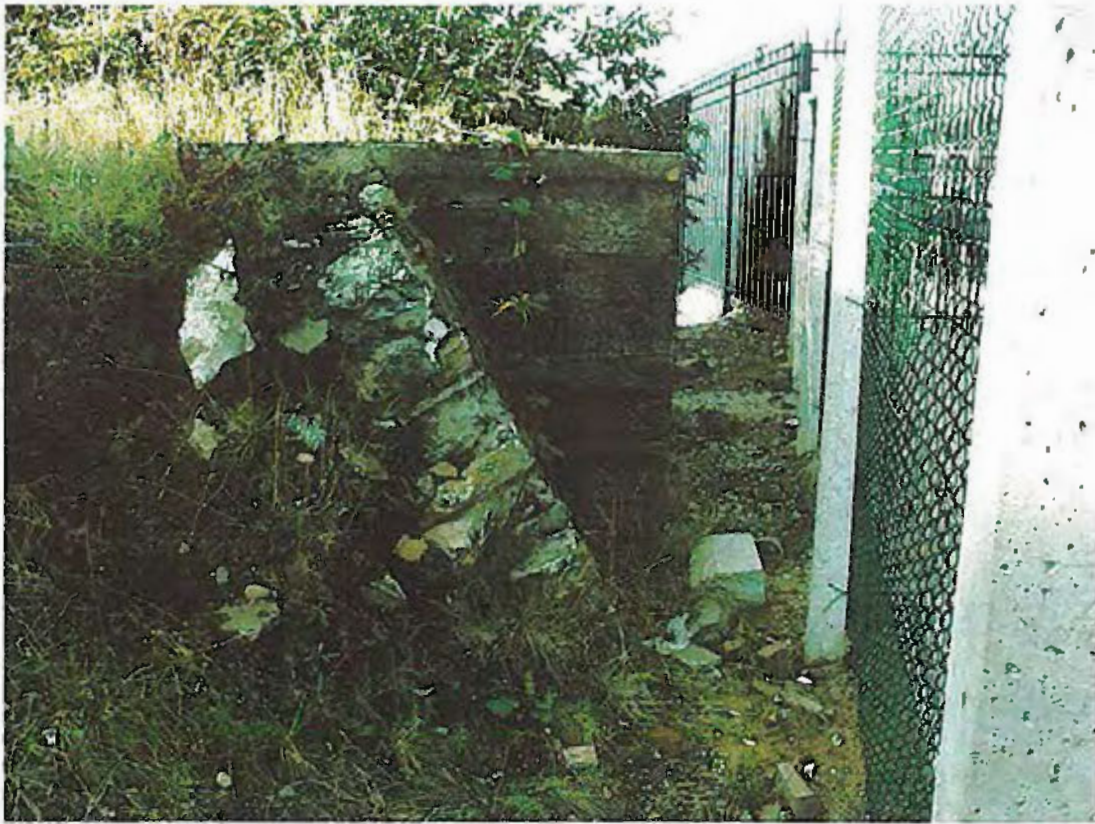
*Photo 14c - Area 4, the remains of revetment wall YIM 42 from the south*

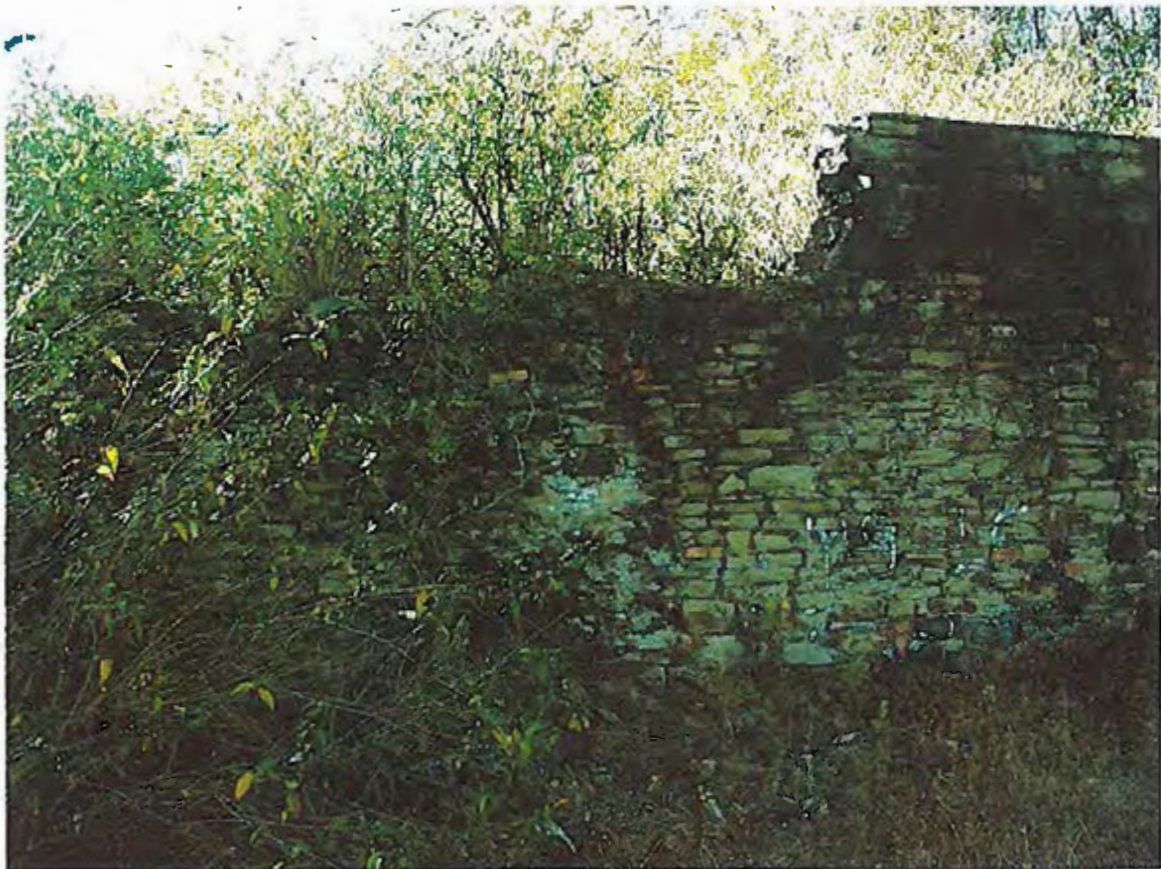
*Photo 14f - Area 4D, exterior of south wall of YIM 5 showing possible weathered flues*

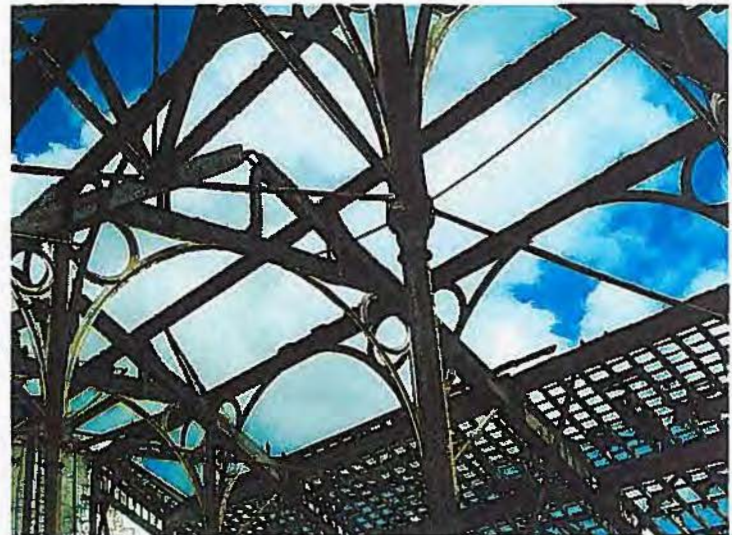
**Below right:** due to the extensive fire damage to the roof timbers over the western portion of the building, temporary ties are required to give restraint to the iron arch braces and supporting columns.

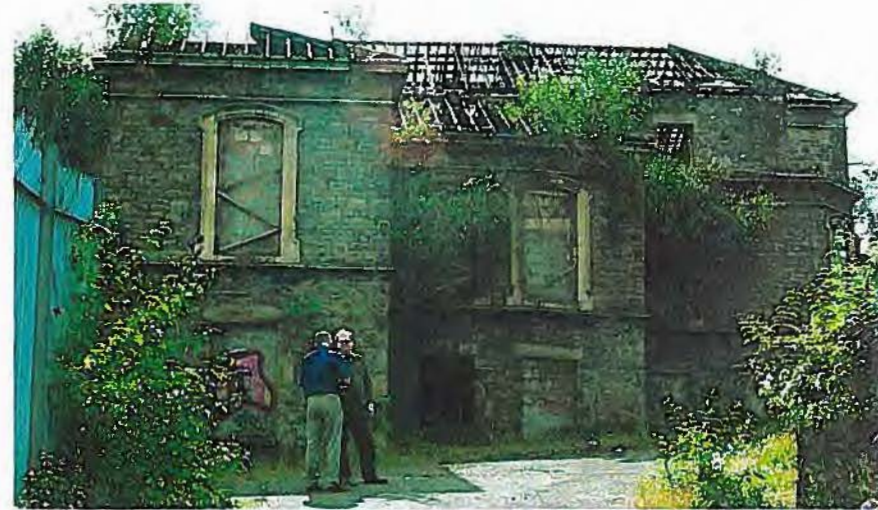
**Right upper:**  
east elevation, the centre portion has subsided towards its north corner causing cracking and distortion of stonework, most pronounced in the sills and lintols of window openings.

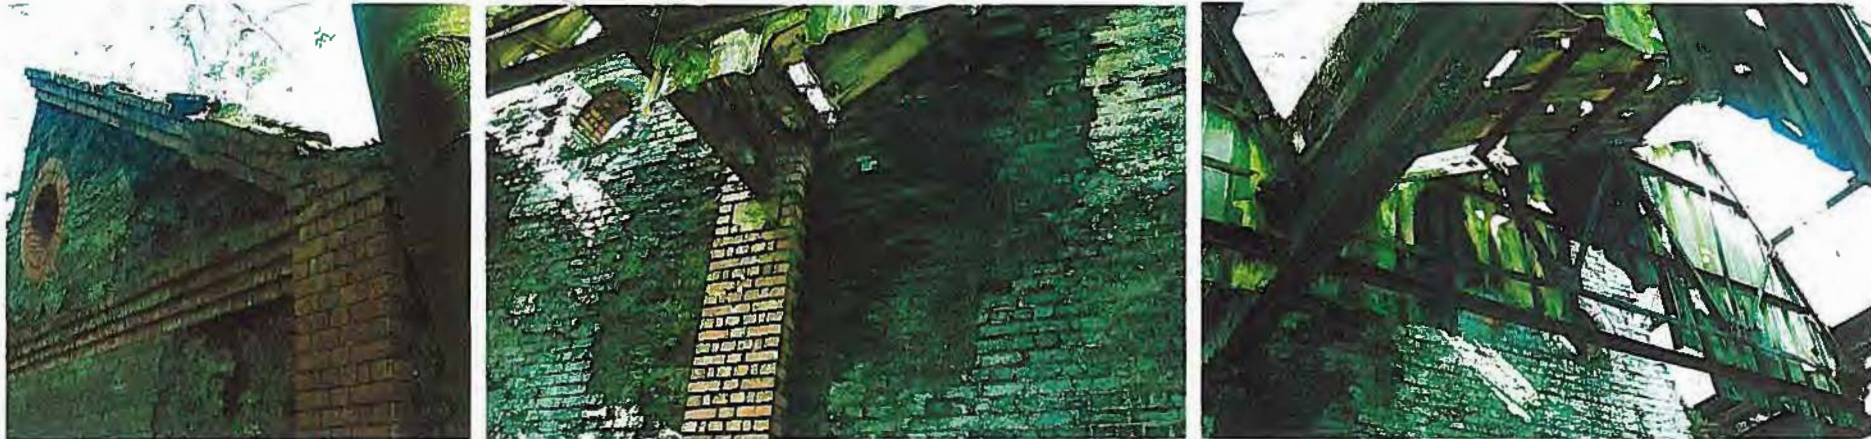
**Above left:** brickwork deterioration and roof structure failure has caused several of the gables to lean outward resulting in the loss of brickwork from the cornices.

**Above centre:** severe deterioration of the grey copper slag brickwork either side of the red clay brick piers probably due to water overflowing from north-light roof gutters.

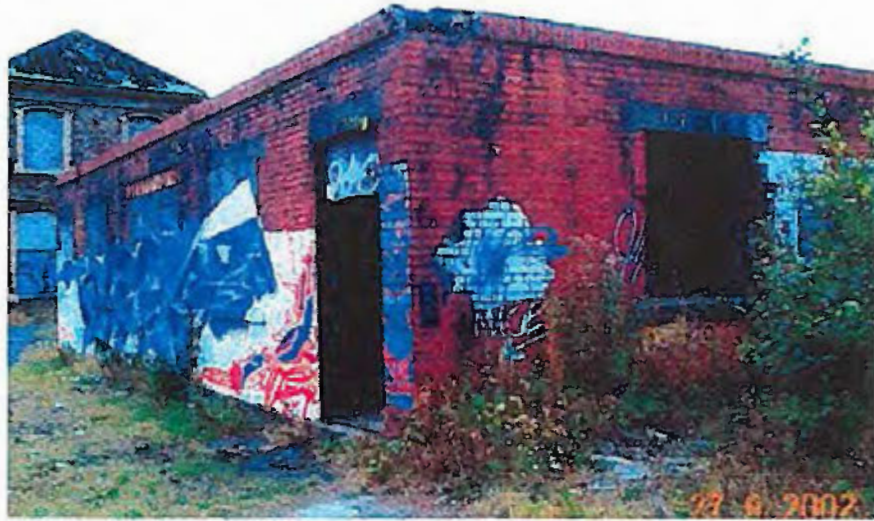
**P22:** Laboratory Building. Risk of falling structure. Risk of dropping through insecure structure.

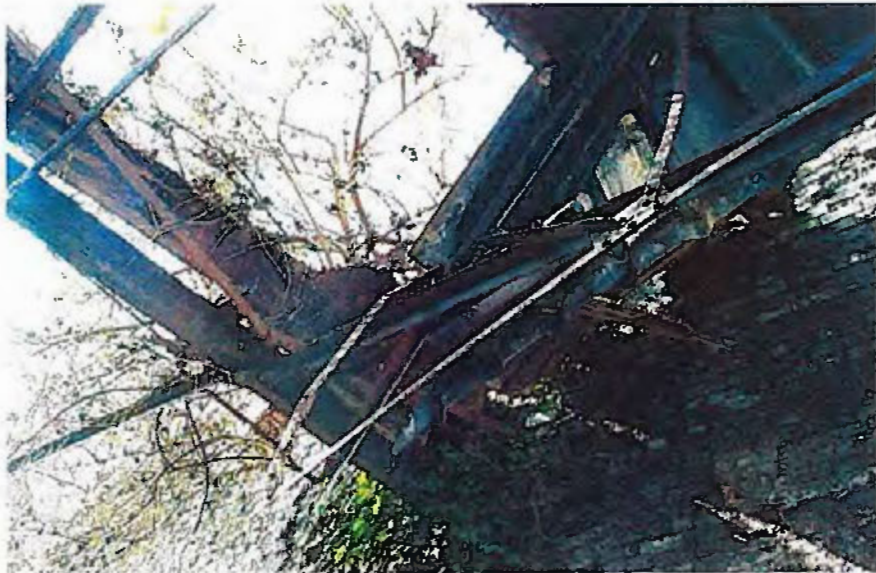
**P33:** Dilapidated condition of roof structure to Locomotive Shed

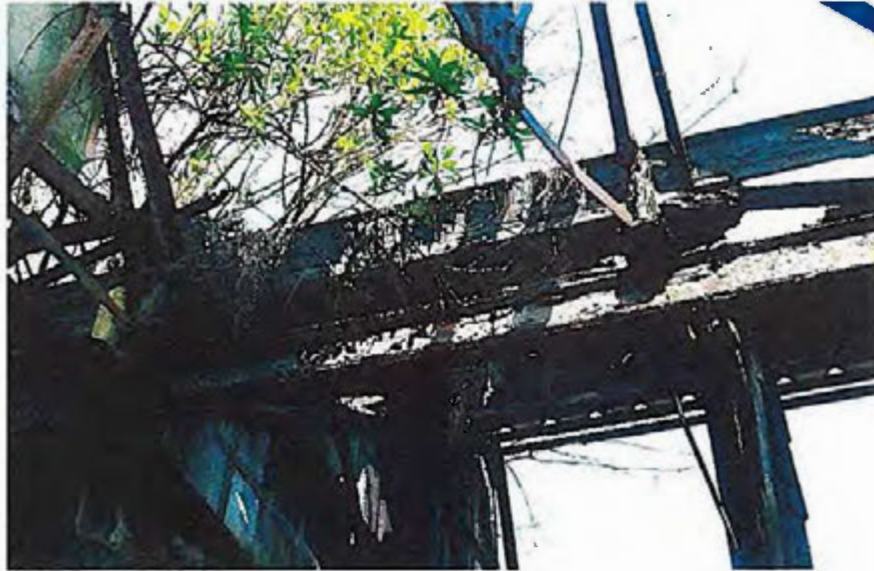
**P34:** Dilapidated condition of roof structure to Locomotive Shed

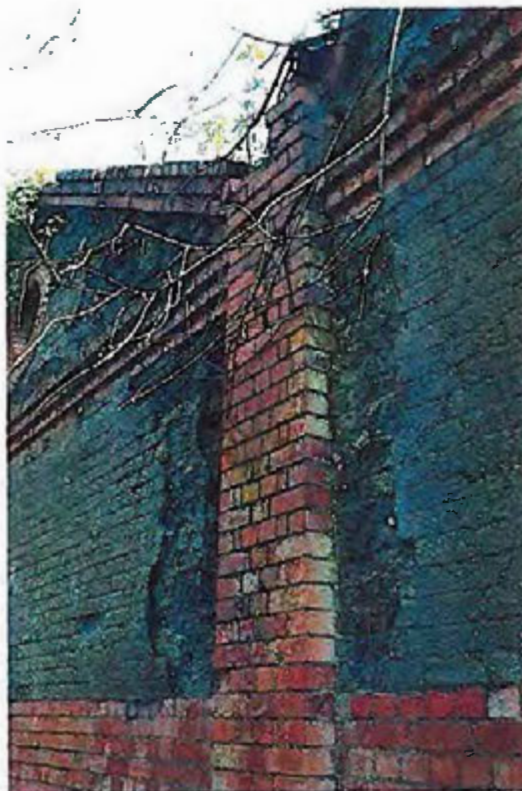
**P35:** Dilapidated condition of roof structure to Locomotive Shed

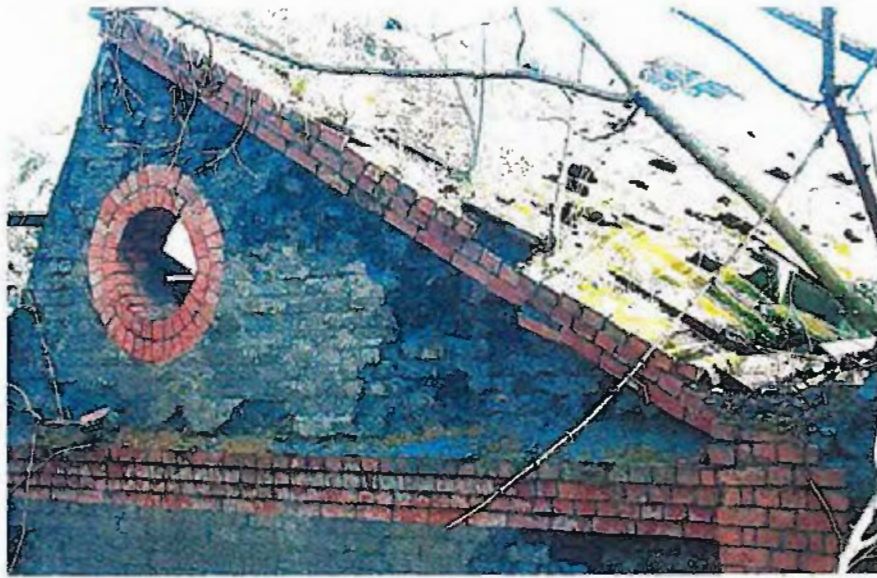
**P36:** Poor condition of brickwork to Locomotive Shed

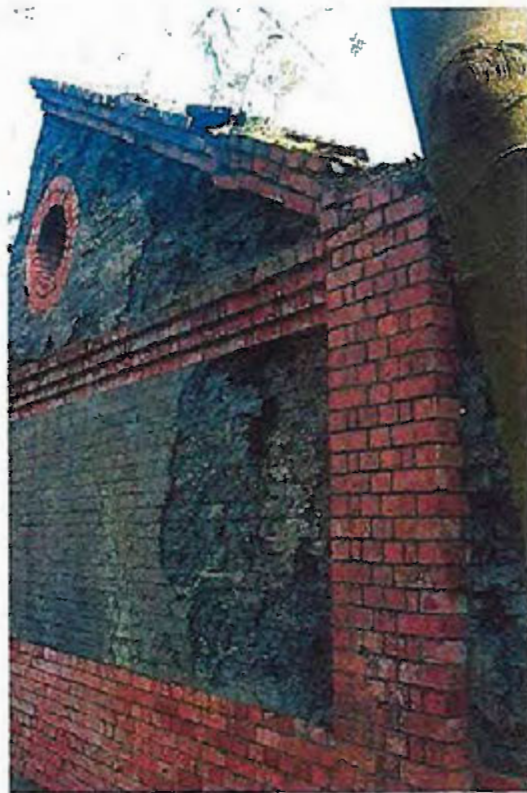
**P37:** Poor condition of brickwork to Locomotive Shed

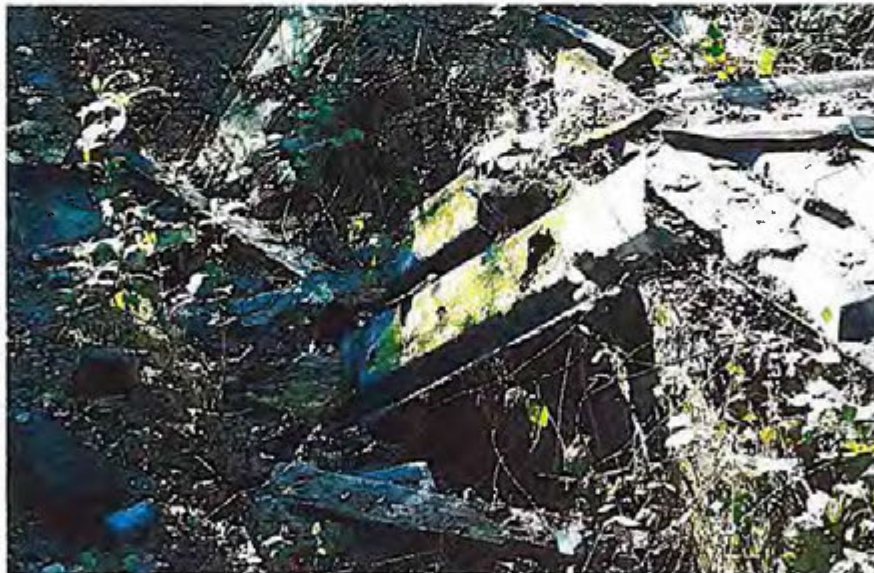
**P39: Broken asbestos sheets lying in Locomotive Shed**
