# YNYSLAS HULKS, YNYSLAS, CEREDIGION: ARCHAEOLOGICAL INVESTIGATIONS 2014 INTERIM REPORT

Prepared by Dyfed Archaeological Trust  
For Cadw

RHIF YR ADRODDIAD / REPORT NO. 2014/39  
RHIF Y DIGWYLLIAD / PROJECT RECORD NO. 107509  
Cadw Project No. DAT 135

Mawrth 2015  
March 2015

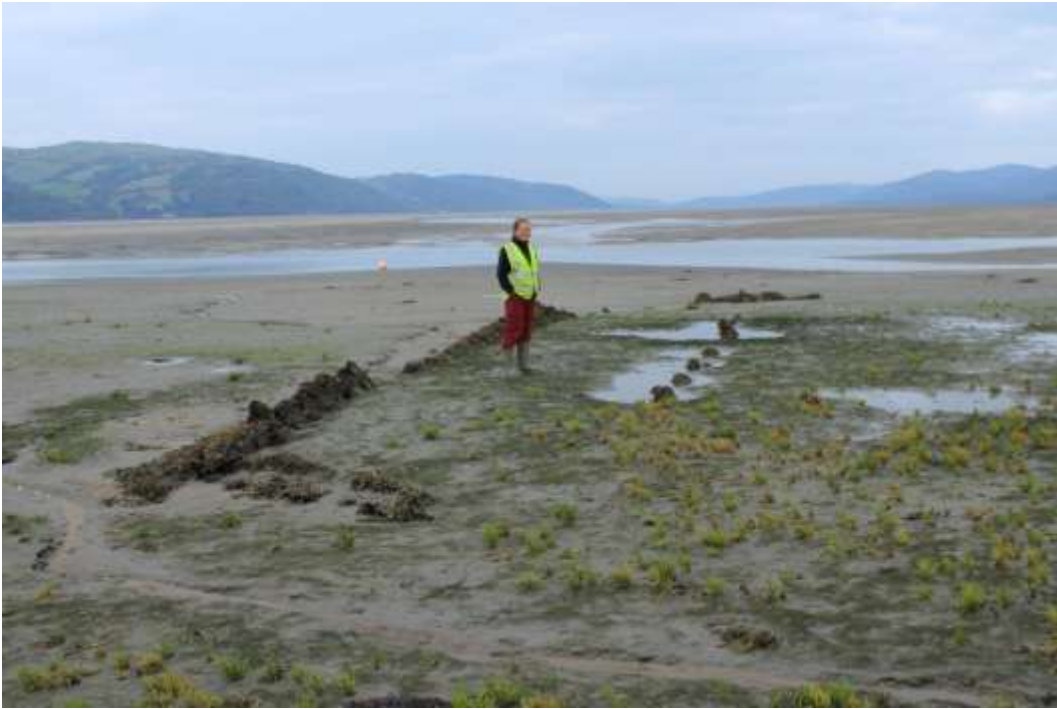
Photo 1: Wreck 1, viewing northwest

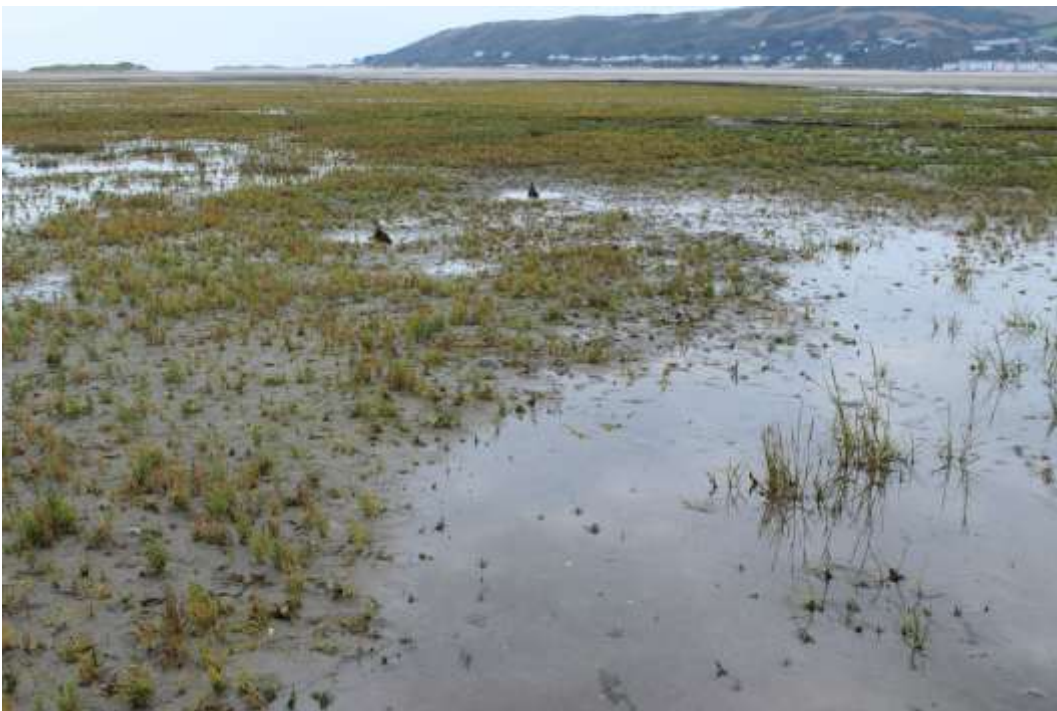
Photo 2: Wreck 2, viewing northwest along centre line of submerged wreck  
(towards upright timber in centre of photo).

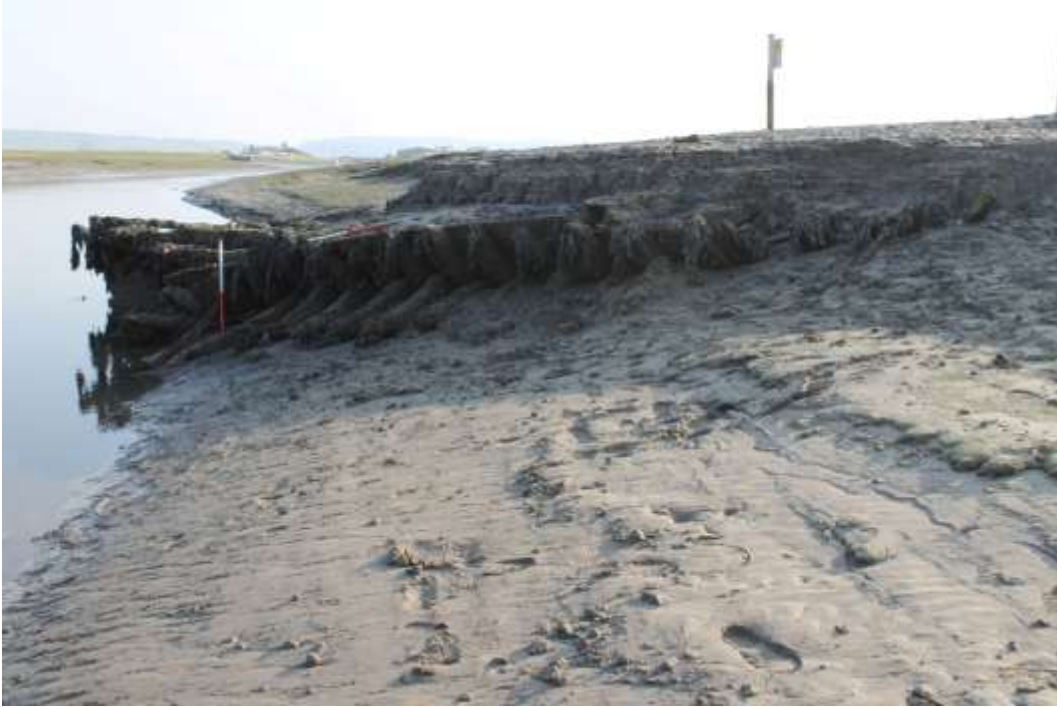
Photo 3: Wreck 3, viewing south on bank of Afon Leri

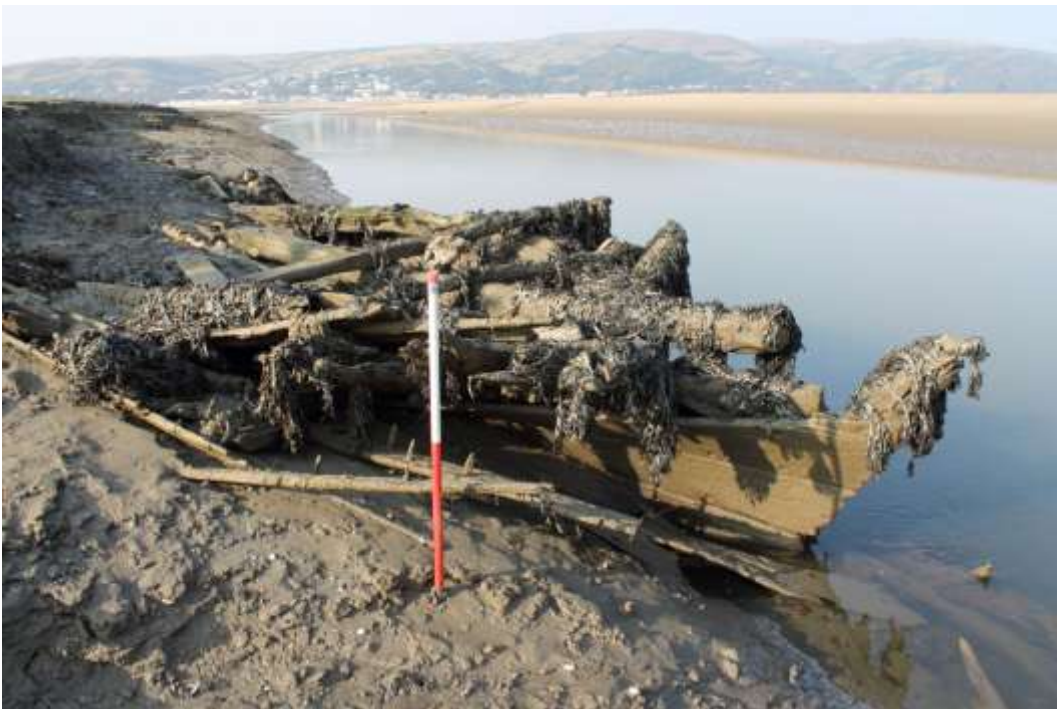
Photo 4: Wreck 3, viewing north on bank of Afon Leri

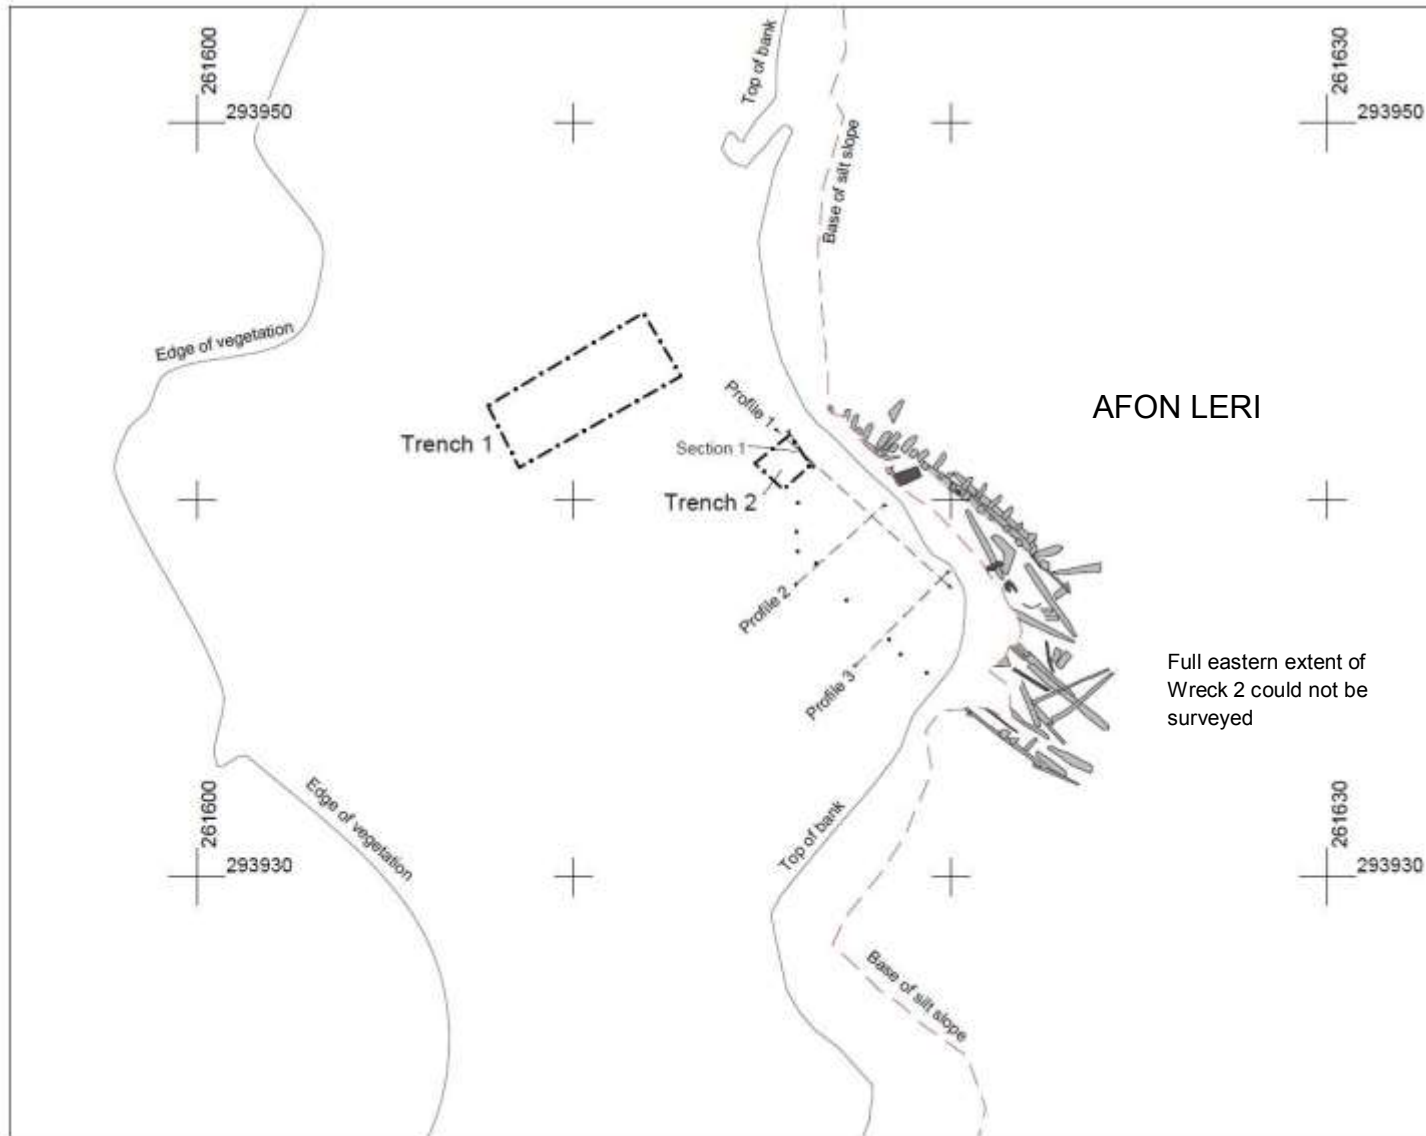
**Figure 4:** Schematic plan of exposed timbers of Wreck 3, with Ordnance Survey grid locations. Black dots represent extents of vessel as determined by DAT / MADU/NAS probing; showing present top of Afon Leri river channel, edge of salt marsh vegetation and upper slope of river channel

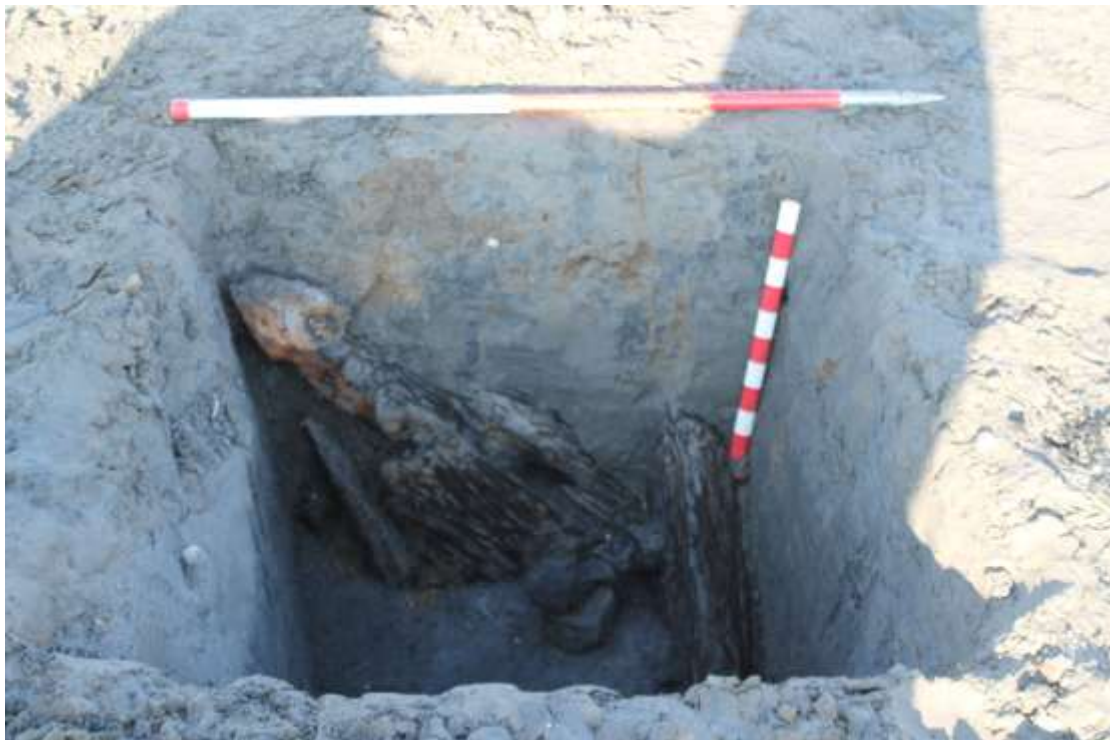
Following the probing exercise the bow of the boat was located and the smaller Trench 2 was excavated on Day 3 down onto the bow revealing the stempost, apron and part of the stemson (Photo 7; Figure 5). The trench was purposefully small to allow excavation, cleaning, recording and subsequent backfilling during a single low tide period.

Photo 7: Trench 2 showing exposed part of the bow of the wreck

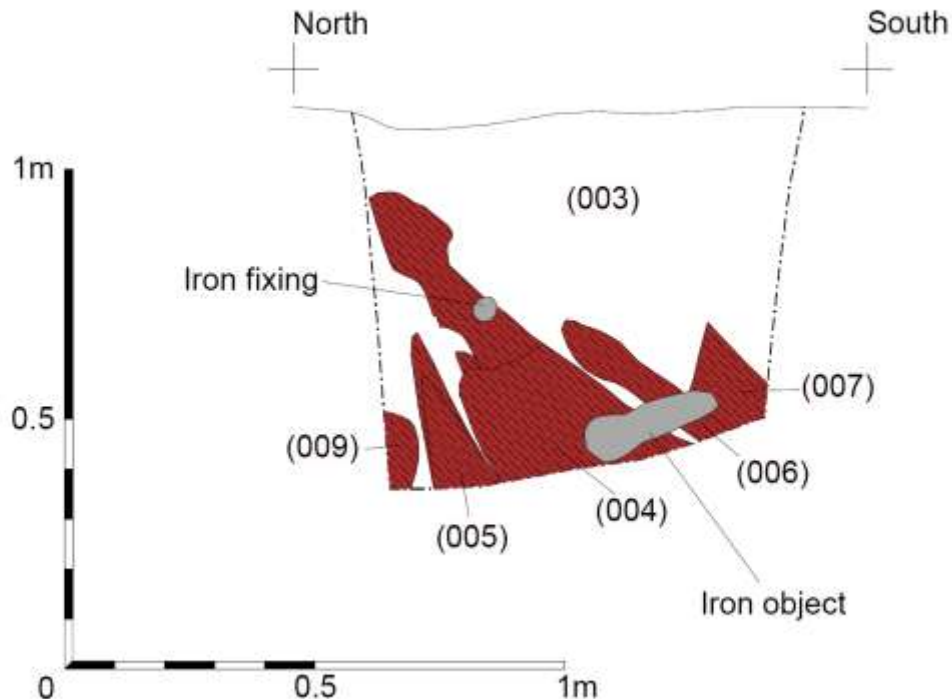
**Figure 5:** Southwest facing section of Trench 2 showing surviving elements of the timbers and possible identification below. (003) – estuarine silts (004) – stempost; (005) – cutwater; (006) – apron; (007) – stemson; (008) not shown and (009) – unknown loose timbers?

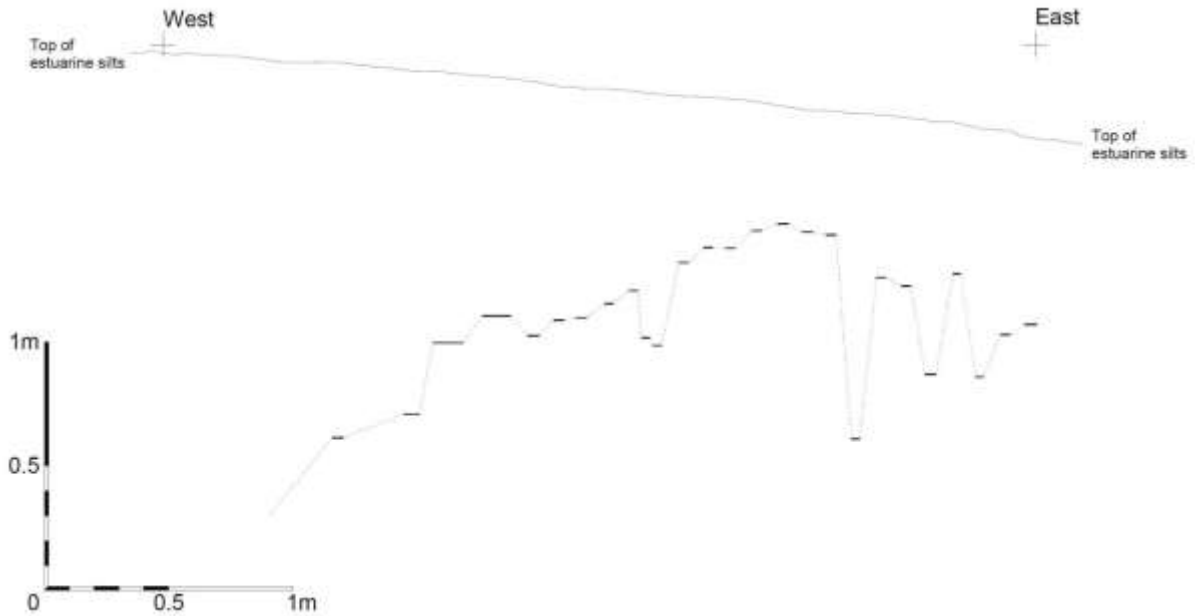
**Figure 7:** Profile 2 along the width of Wreck 2 (northern profile), with readings taken every 10cm. Depths shown are to the top of solid timbers (no timbers recorded to southwest)

The results of Profiles 2 & 3 (Figures 7 & 8) both indicate a similar trend across the width of the vessel. Obviously the silt level drops towards the Afon Dyfi, but it would still appear that the depth of surviving timbers rises towards the southwest. At the northwestern end of Profile 2, no timbers were recorded within the 1.50m depth for which measurement was possible. At the southwestern end of both sections timbers were present at c.0.60m below the top of the silts. This may indicate that the vessel is either tilting towards the southwest, or that the port side of the boat had dropped perhaps as the keel had split.

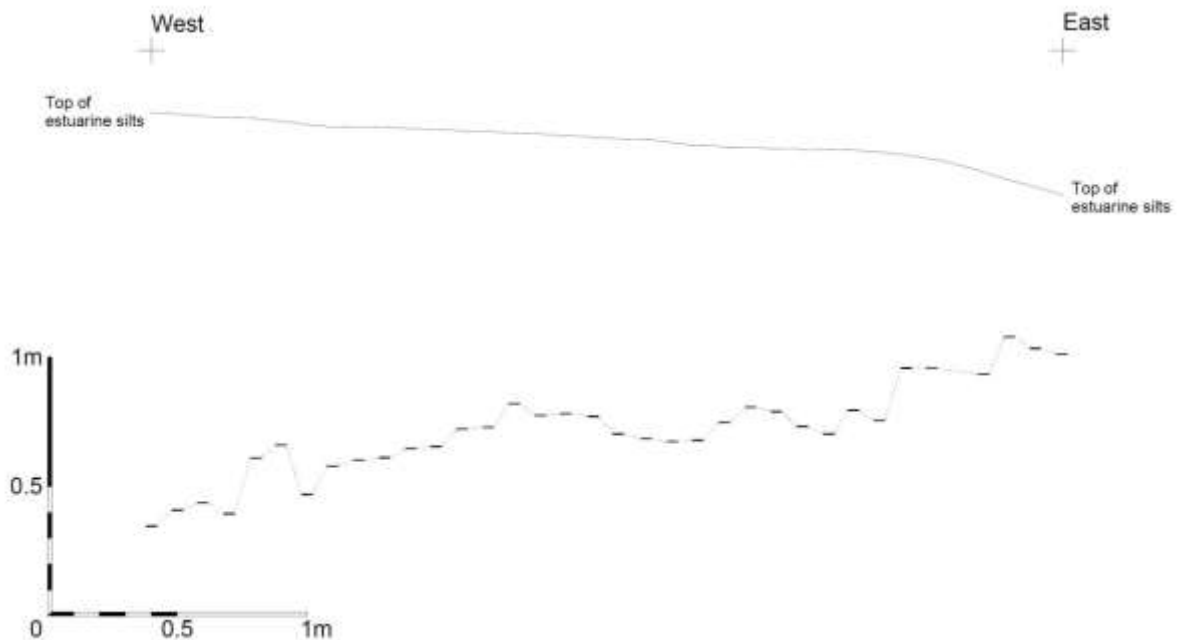
**Figure 8:** Profile 3 along the width of Wreck 2 (southern profile), with readings taken every 10cm. Depths shown are to the top of solid timbers

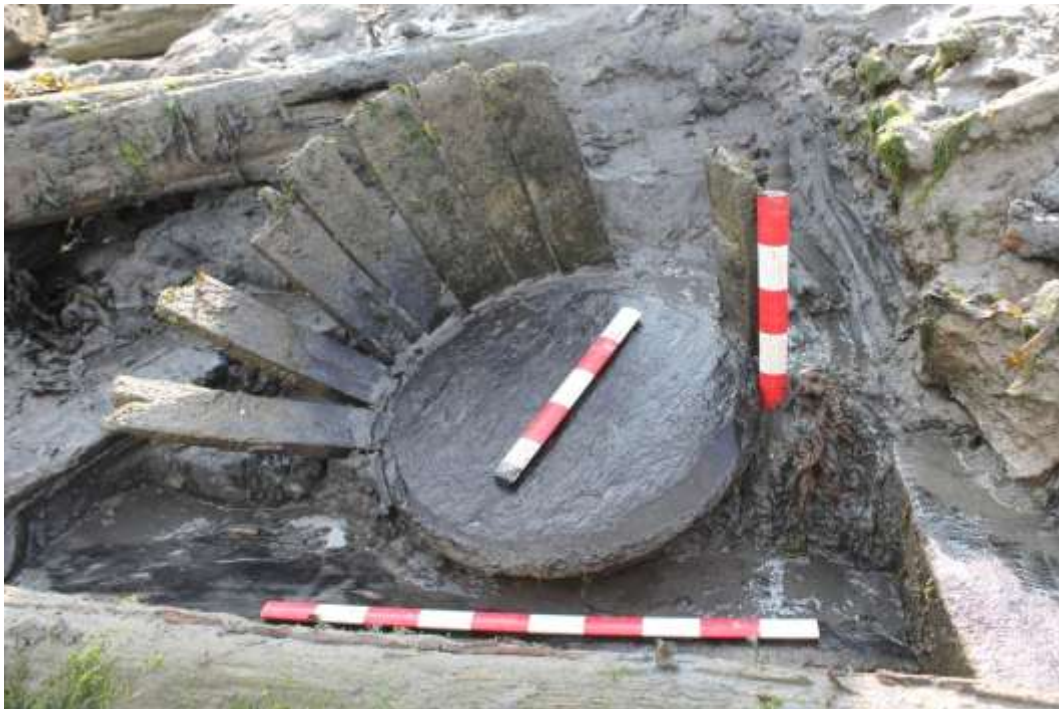
Photo 10: Bucket in the hold of the boat after cleaning and before removal

4.2.3 Evidently a number of artefacts do still survive within the hold (bucket, rope, slate fragments etc), which will be lost overtime. It is proposed that these items are recorded *in-situ* and then removed from the wreck for temporary storage in stable conditions before a detailed programme of conservation can be determined for future years. They will be temporarily stored in lidded plastic

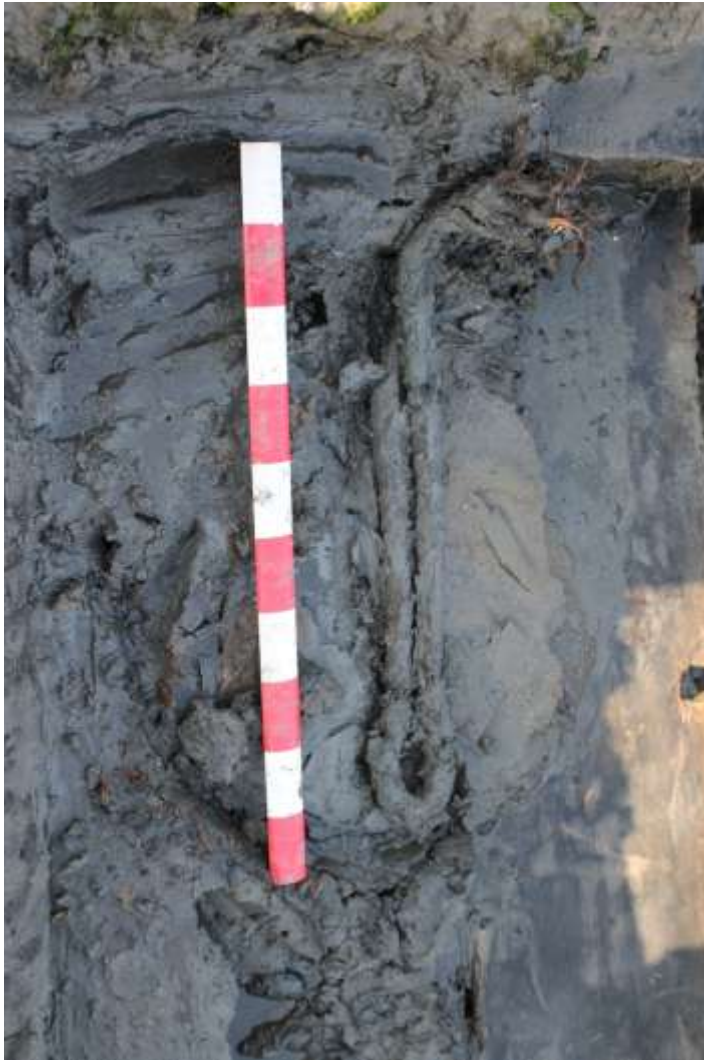
Photo 11: Short length of rope revealed beneath the base of the bucket

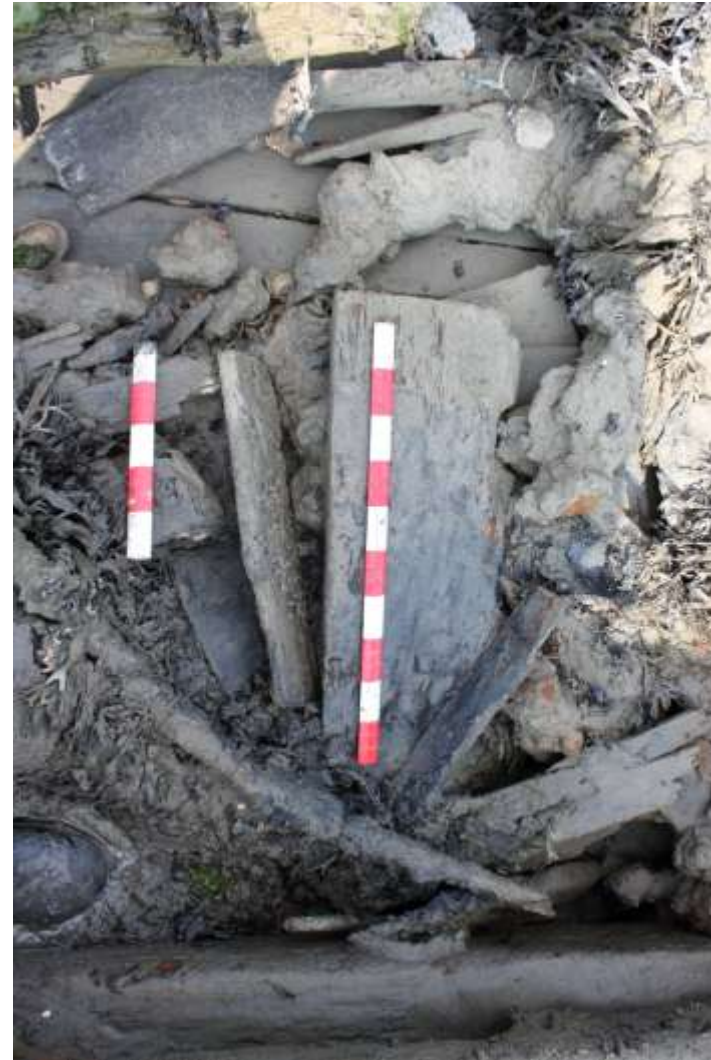
Photo 12: Small wooden boards which may have formed a small box located in the hold, with iron objects (parts of chains) around and beneath it.

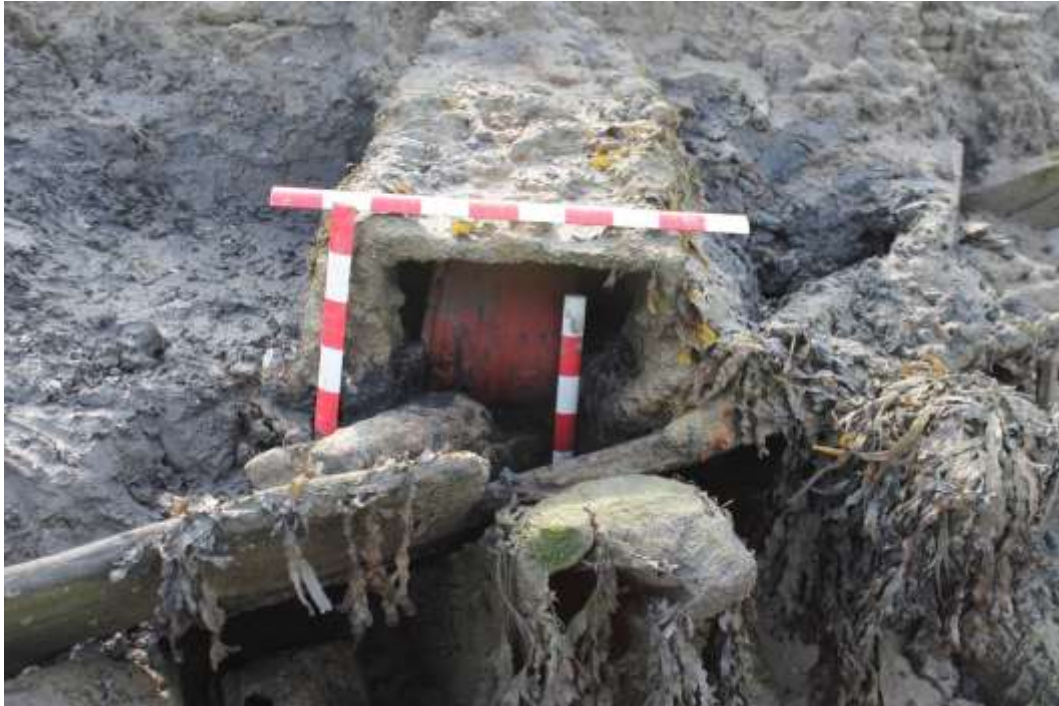
Fragments of slate were also recovered from this area. Larger iron objects were also visible within the exposed part of the hold of the boat, including coils of iron chain (Photo 12), various unidentified fragments and a large rectangular box which could possibly have been the ships stove (Photo 12). An internally glazed mixing bowl or cooking pot was lodged within this box which could not be removed (Photo 13).

Photo 13: Possible ships stove with ceramic mixing bowl wedged within

4.2.2 By excavating only a small stretch of new material any exacerbation of the erosion of the wreck will be minimised. By cleaning up the already exposed surface of the wreck means that works will be carried out in areas already observed by the Royal Navy Bomb Disposal Squad and therefore the risk of further ordnance being present is low. Such works should enable the full size of the possible ships stove being uncovered and recorded.

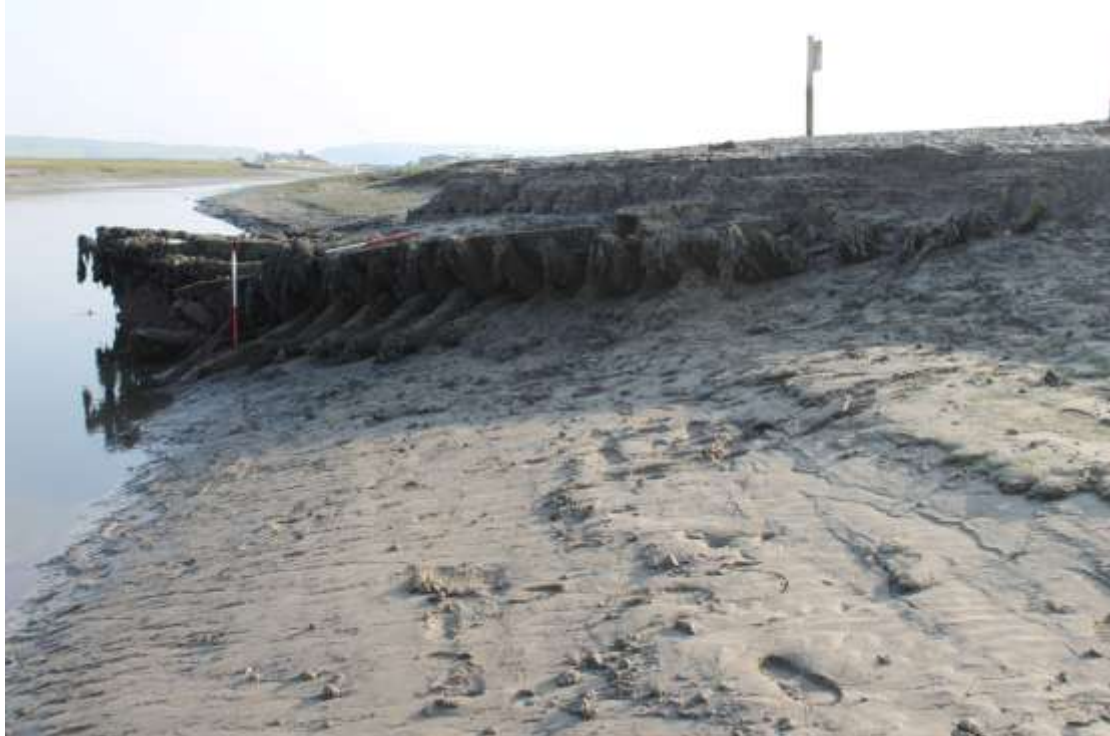
1.1 This written scheme of investigation presents a proposed detailed methodology for further archaeological recording and partial excavation of the eroding hulk on the bank of the Afon Leri, at Ynyslas, Ceredigion (Photo 1). The hulk is one of three located at the junction of the Afon Leri and the Afon Dovey. The hulk to be investigated is eroding from the western bank of the Leri located at NGR SN 61594 93942. The wreck is suffering from significant and constant erosion, exacerbated by the winter storms of 2013-2014.

Photo 1: Showing the hulk eroding into the Afon Leri, viewing south
