YNYSLAS HULKS, YNYSLAS, CEREDIGION: ARCHAEOLOGICAL INVESTIGATIONS 2015 - 2016 INTERIM REPORT

RHIF YR ADRODDIAD / REPORT NO. 2016/15
RHIF Y DIGWYLLIAD / PROJECT RECORD NO. 107509
Cadw Project No. DAT 135

Mawrth 2016
March 2016

James Meek MCIfA

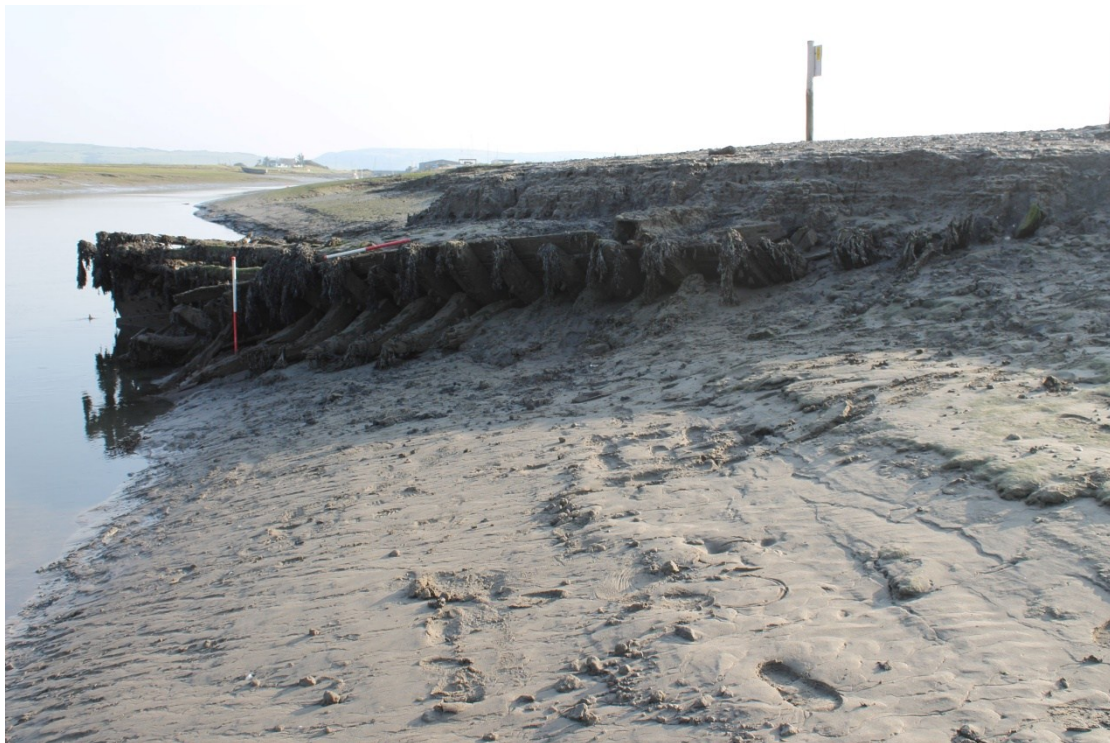
Almost the complete length of the starboard side of the vessel is exposed to some degree (Photo 7). The stern is almost completely exposed, with the wreck becoming more submerged in the silts as you head towards the edge of the river channel. The cant frames towards the bow of the wreck can be seen to curve quite sharply inward in their layout, to produce the blunt nose as the vessel would have originally had (Photo 8).

Photo 7: Full view of the exposed part of the starboard side of the vessel
(September 2014)

It is evident from photographs taken of the wreck since 2010 that the central part of the starboard side had partially collapsed outwards perhaps during its silting up process. Up until 2013 the majority of outer planking survived along this side (except at the stern). In 2013 the outer planking collapsed taking a number of elements of the frames with them. These appear to be the 1st futtocks attached

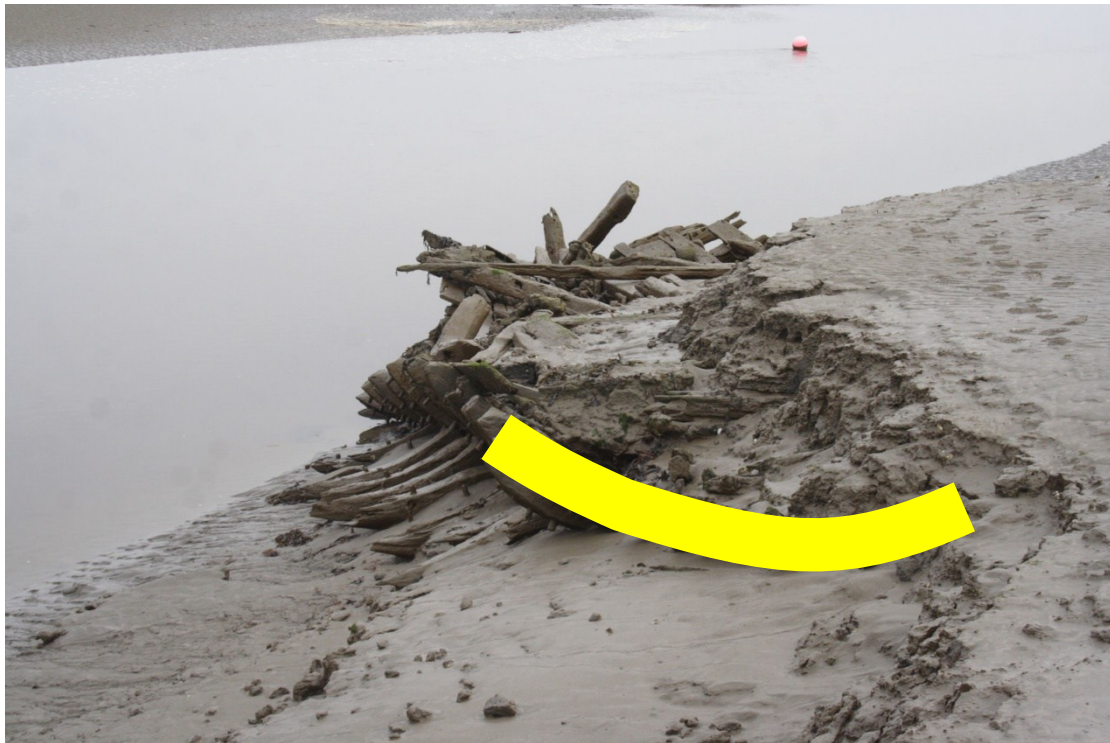
Photo 8: Bow end of the starboard side, with cant frames highlighted curving in towards bow stempost as revealed in 2014 excavation (March 2016)

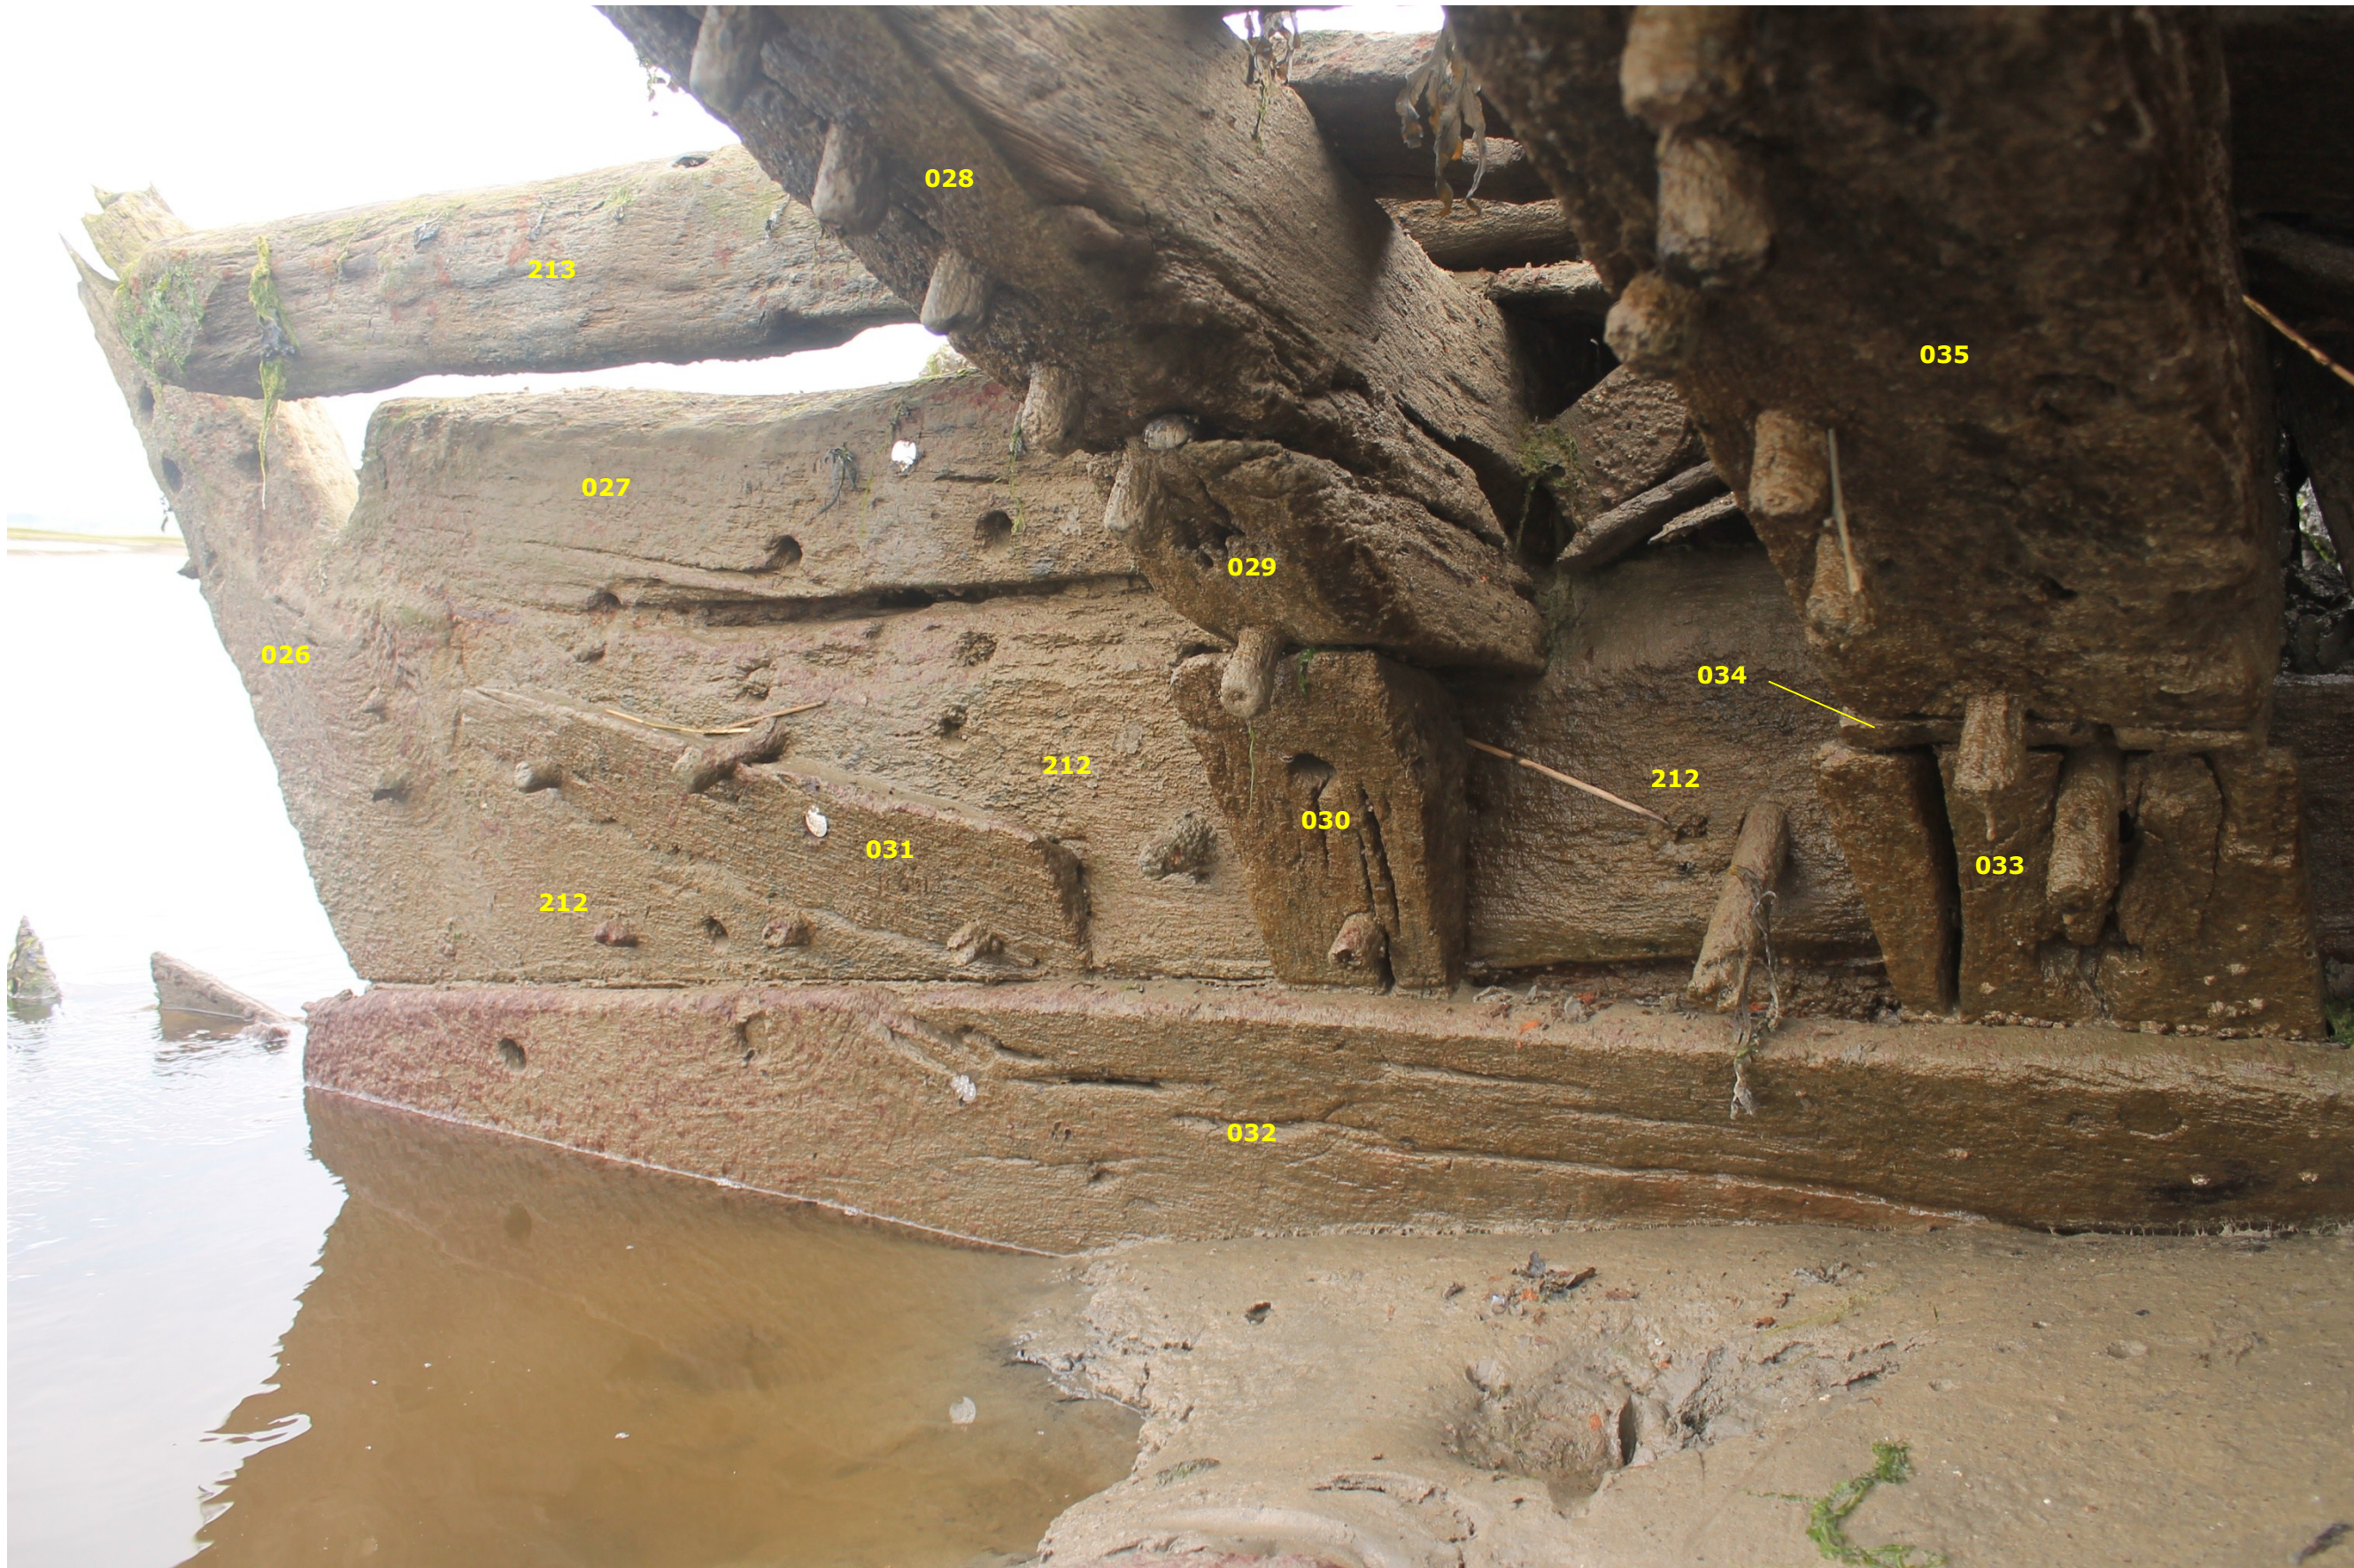
Photo 9 shows the main timber elements of the starboard side of the stern. The stern post, 026 is clearly visible with deadwood fillers between it and the first of the floor frames, 028. The first frame lies on top of a deadwood piece, 212. The next frame, 035, is also located on top of this piece of deadwood, although it has been located into a rebate half way through the timber. The next frames, 066, 065 and 064 would appear to lie directly on the underlying keel which was not visible (other than its upper surface) due to being buried in the silts. The two end floor frames were both attached to two additional filler pieces (029 & 030; 034 & 033) evidently being used to create the shape of the stern of the vessel to which outer planking was formerly attached. Only the lowest outer plank was survived at the stern, 032. This was partially attached to a further shaping filler piece attached to 212, which was an elongated wedge.

Photo 9: Timbers forming the stern on the starboard side (June 2015)

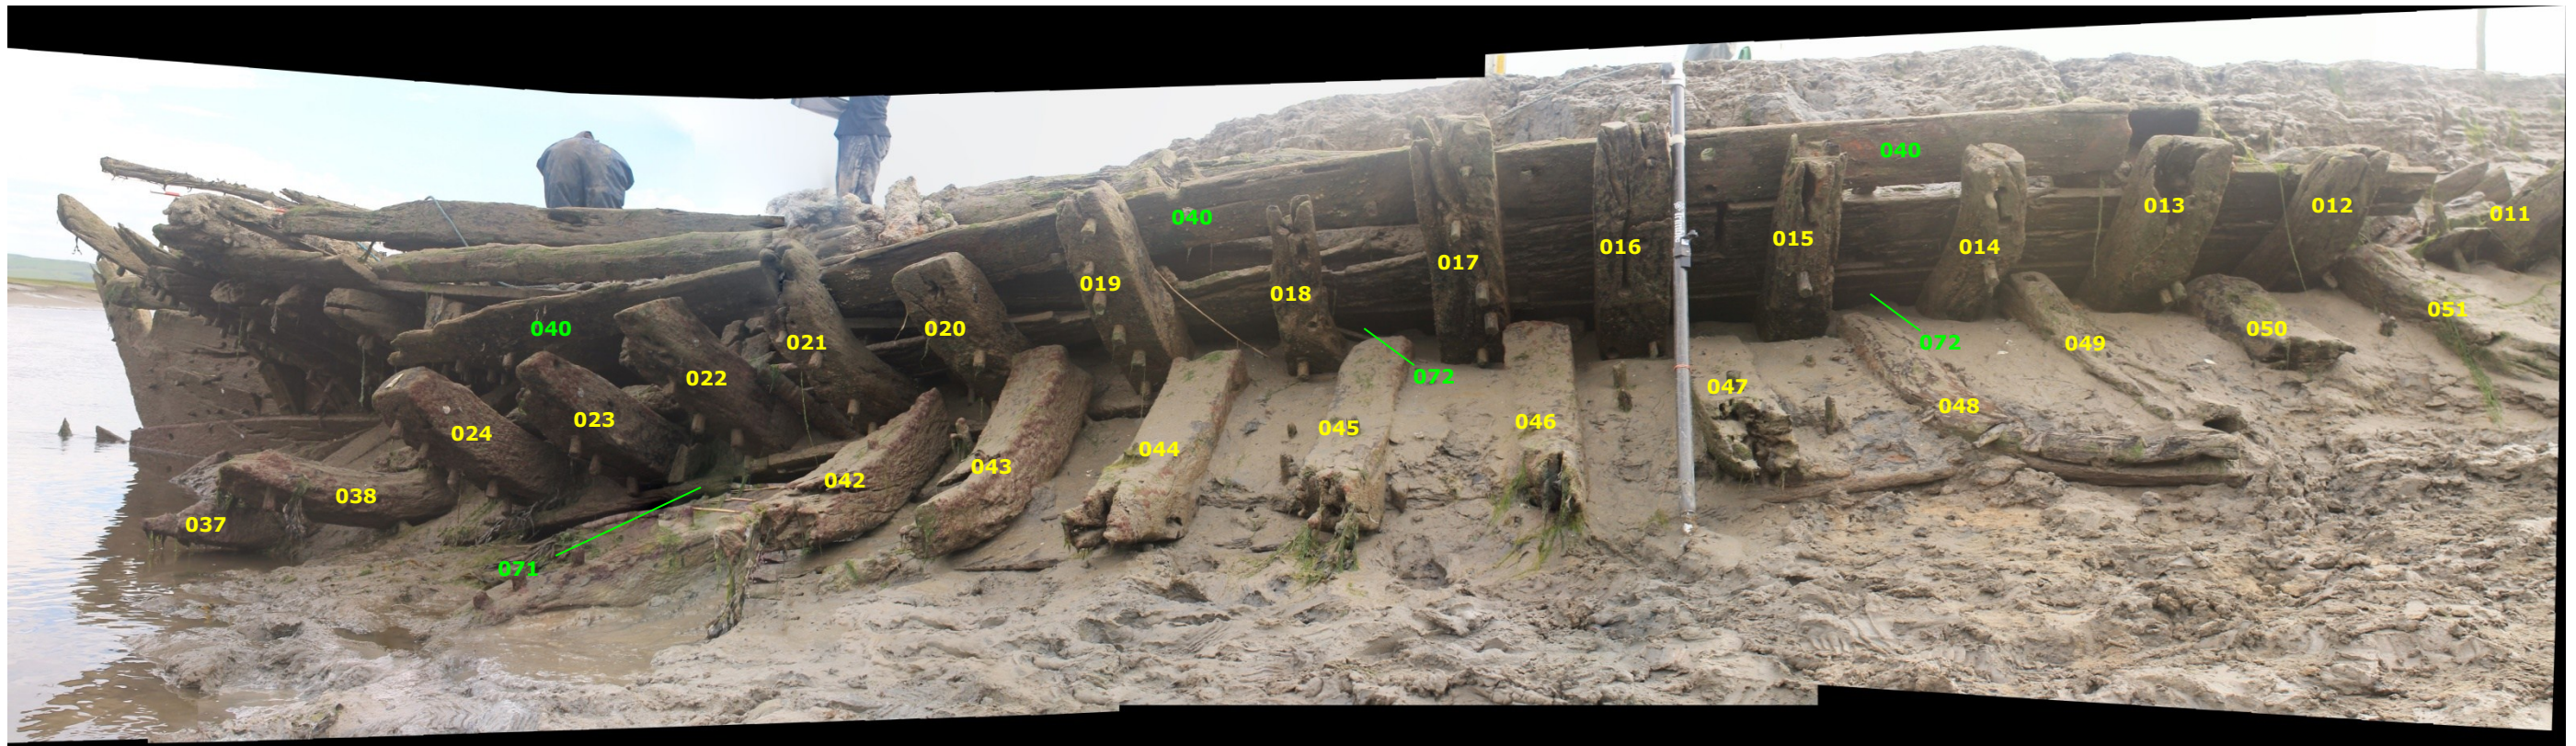
Photos 10 and 11 show the majority of the remainder of the starboard side. Although the ends of floor frames could be identified along the rest of the starboard side, it was not possible to see these attached to the keel which was hidden below silt and other timbers. Collapsed 1st futtocks could be seen, many still attached by treenails to underlying outer planking. Simple scarf joints had been used to join these to the floor frames. Filler frames remained in-situ.

Photo 11: Collapsed frames along the starboard side; Frames (yellow) and inner planking (green)
(merged photographs from June 2015)

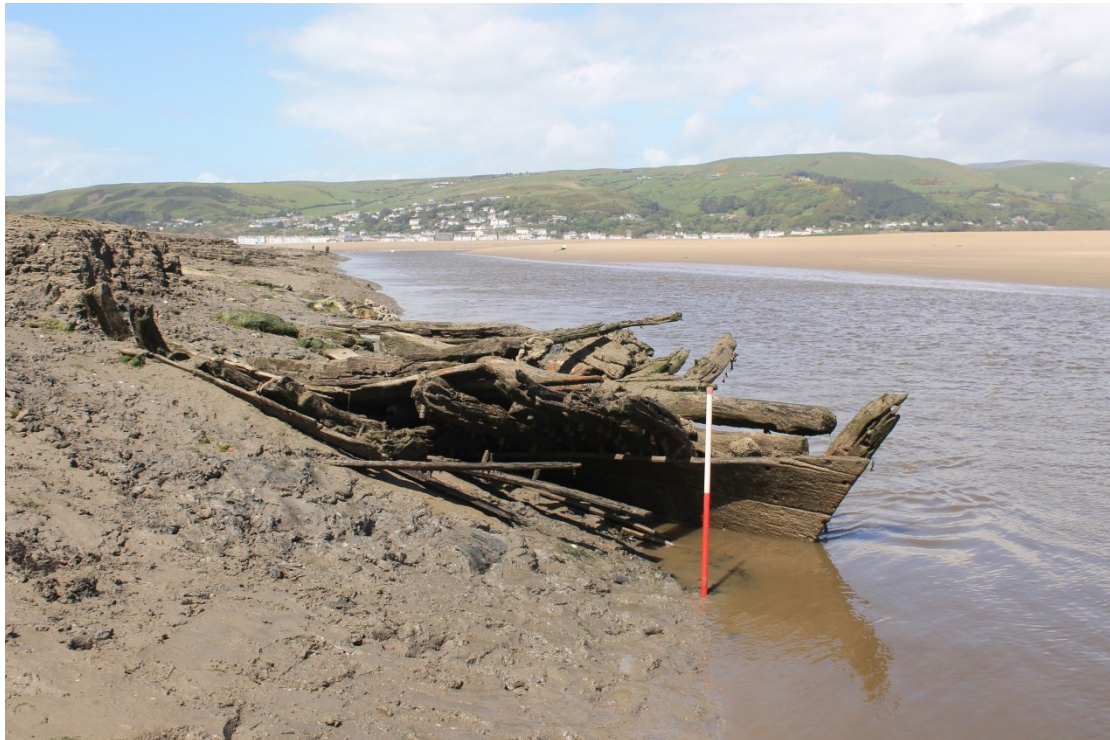
The surviving part of the port side of the wreck still remains mostly buried in the silts of the river edge (Photo 12). It has certainly become more exposed since it was first recorded in 2010, but only the stern of the vessel is exposed to a significant depth. Some outer planking survives in situ, with the uppermost surviving planks towards the stern having collapsed outwards. A number of the frames towards the centre of the vessel project almost vertically out of the silts towards the present river channel edge (Photo 13). The exposed ends of the frames were almost all very badly eroded and decayed.

Photo 12: Full view of the exposed part of the port side of the vessel (June 2015)

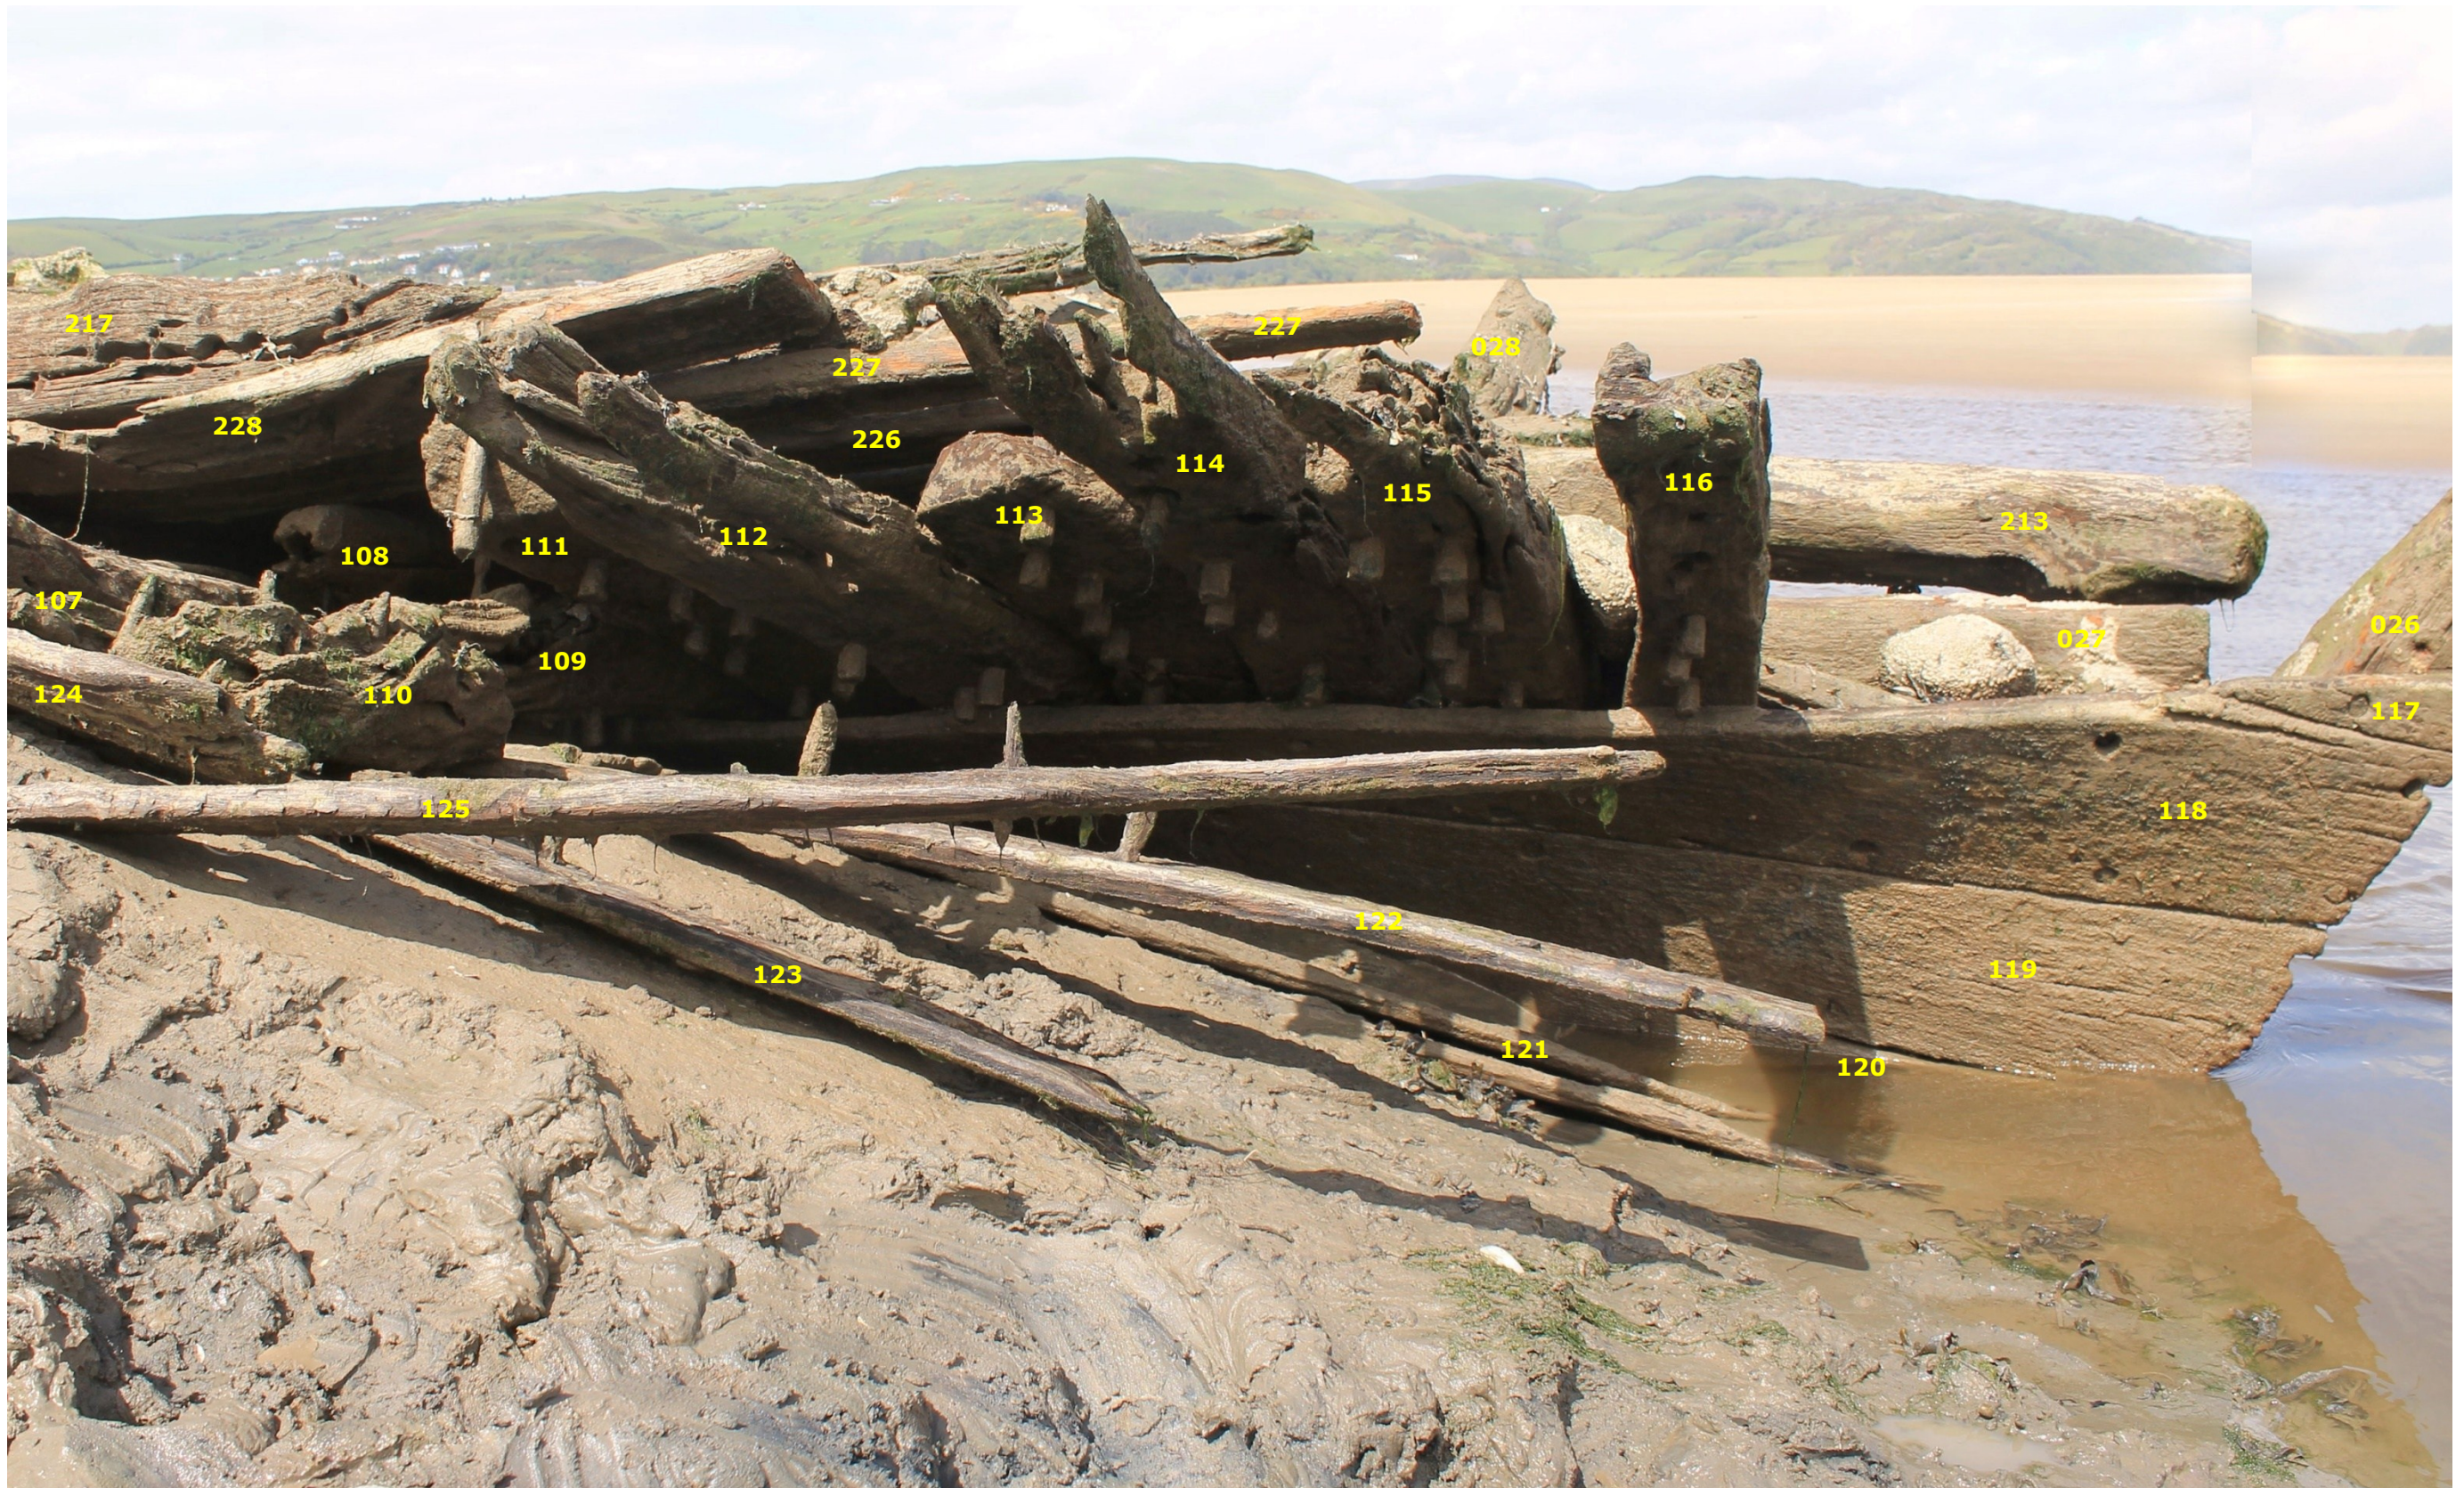
Labelled timbers are shown on photo 15. The end three frames, 116, 115 and 114, are still roughly in-situ, being attached to both the inner planking of the hold and the outer planking, four of which still remain attached to the vessel (217, 218, 219 and 220). These planks have evidently been shaped to fit the vessel to create a streamlined stern as can be seen in Photo 14. Collapsed outer planking is also present, which has become detached from the frames, but is still trapped in the silts to the northwest.

Photo 15: Port side of wreck showing frames and outer planking towards the stern
(merged photographs from June 2015)

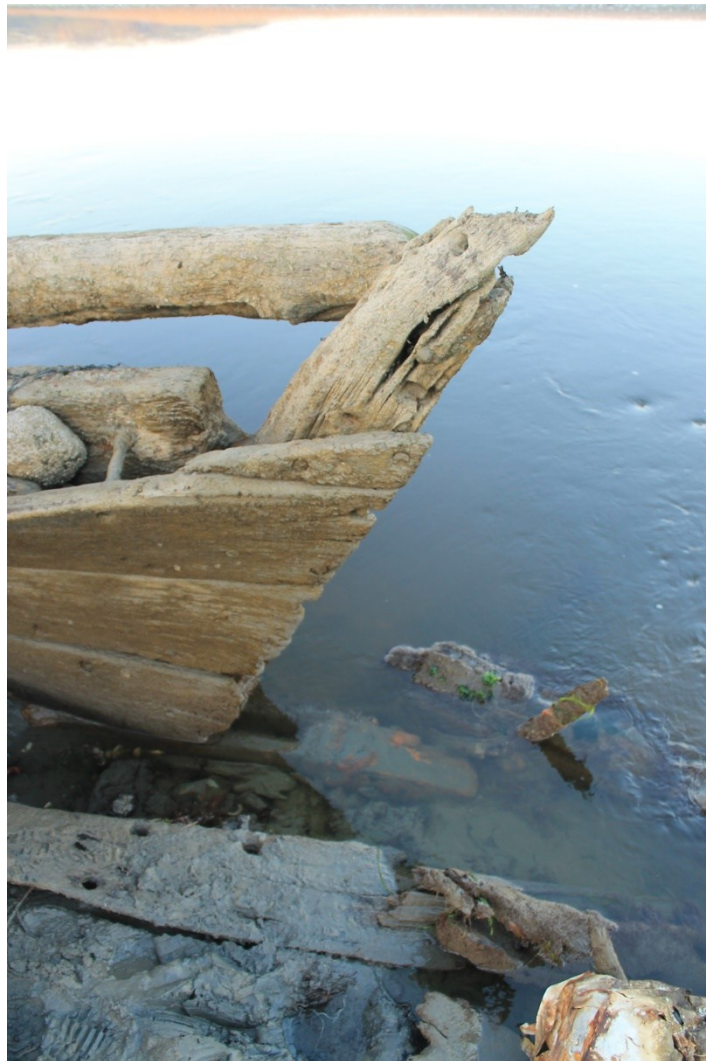
Photo 17: Stern of vessel on port side, showing lower timber projecting below the waterline with hole within it (September 2015)

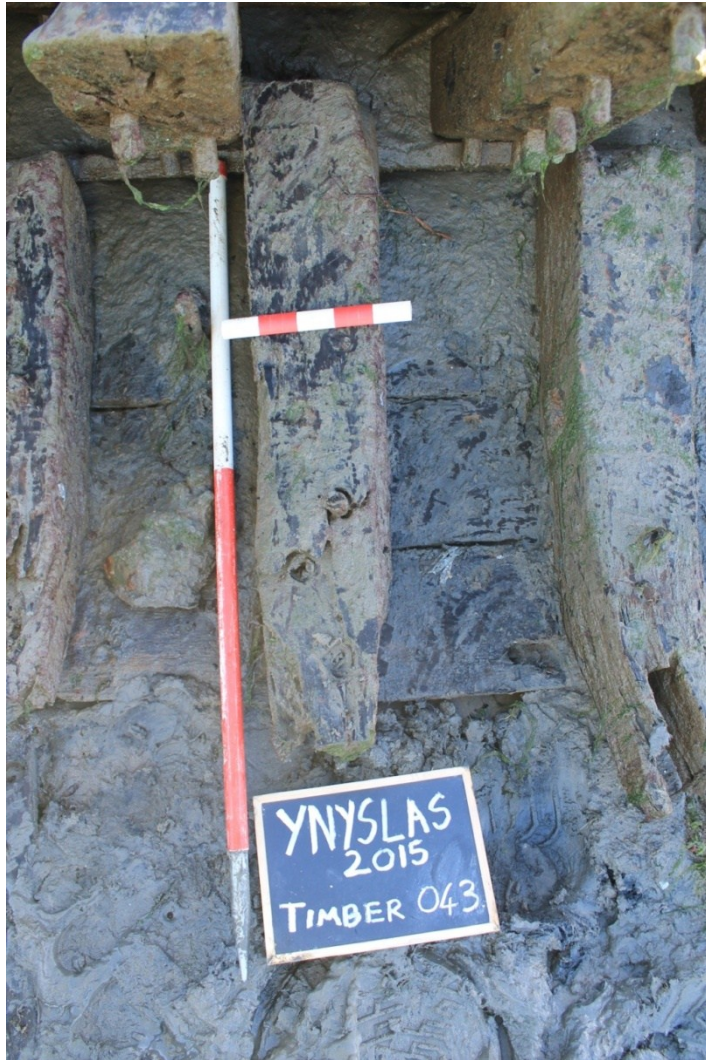
As stated in the 2015 report 'The wreck contains a significant number of timbers, a number of which are loose or collapsing A number of loose pieces are present on the exposed hold. These are under threat of being lost through further erosion and tidal movement.' This still remains true, but in mitigation a record has been made of the timbers to provide a 'present state' record of the vessel (based on the June 2015 survey). Changes were visible by the Phase 2 works undertaken in September, as an example timber 043, a fallen 1st futtock, was attached to the collapsed outer planking (by treenails) in June (Photo 21) but had become detached and moved by September (Photo 22). The timber had not moved much more by March 2016 having been embedded in silts.

Photo 21: Fallen 1st futtock attached to collapsed outer planking in June 2015

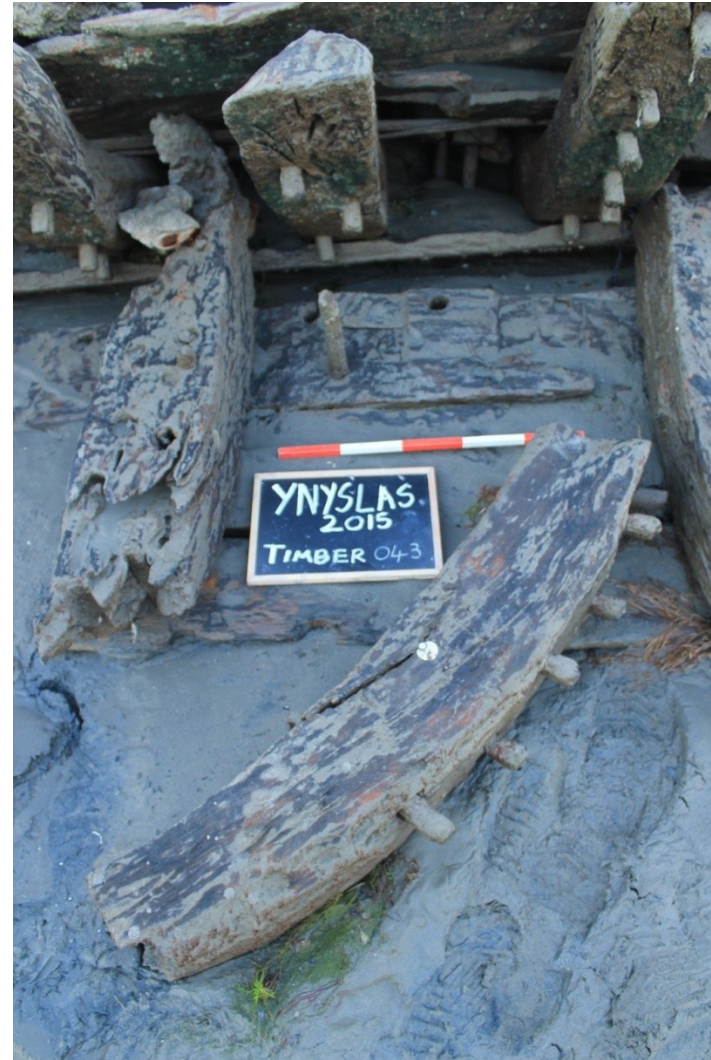
Photo 22: Fallen 1st futtock detached from collapsed outer planking and moved by September 2015

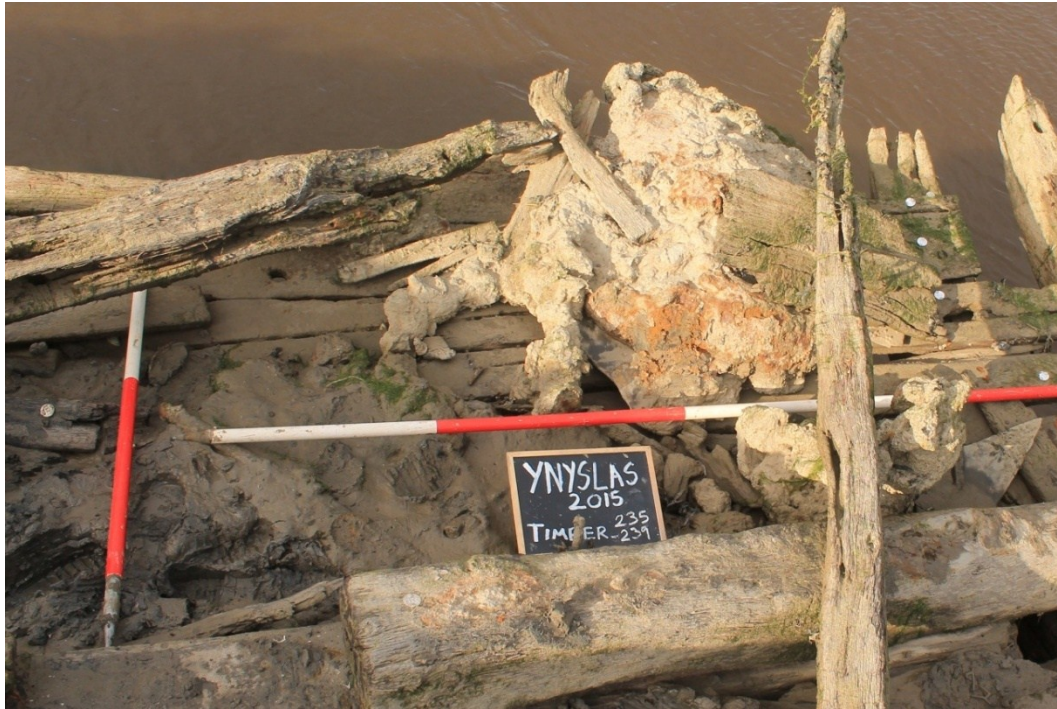
Changes had also occurred to the upper surface of the wreck where objects were quite well embedded in silts during the survey in June 2015 (Photo 23), but by September much of the silt had been washed away and the objects looser and under far greater threat of being lost through tidal movement (Photo 24).

Photo 23: Showing the starboard side of the upper part of the wreck, the hold, showing silts below the photo board (loose timbers 235 and 239 recorded)

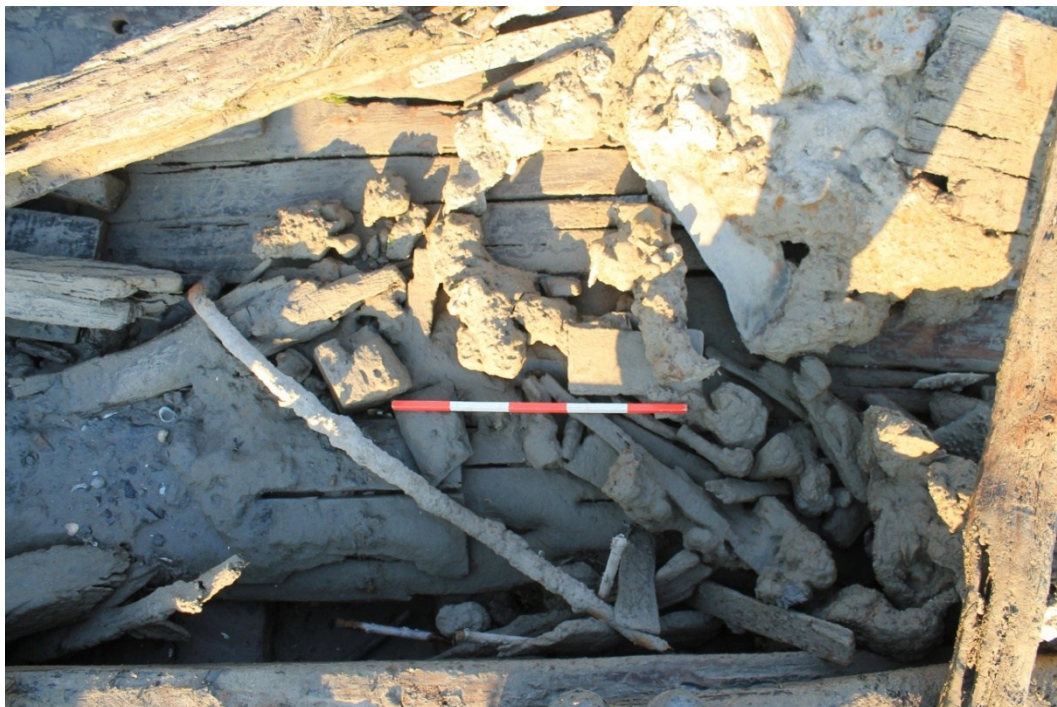
Photo 24: Same part of the surface of the hold of the wreck in September 2015 showing that the silts have been washed away and numerous small objects had become exposed and under threat of being washed away

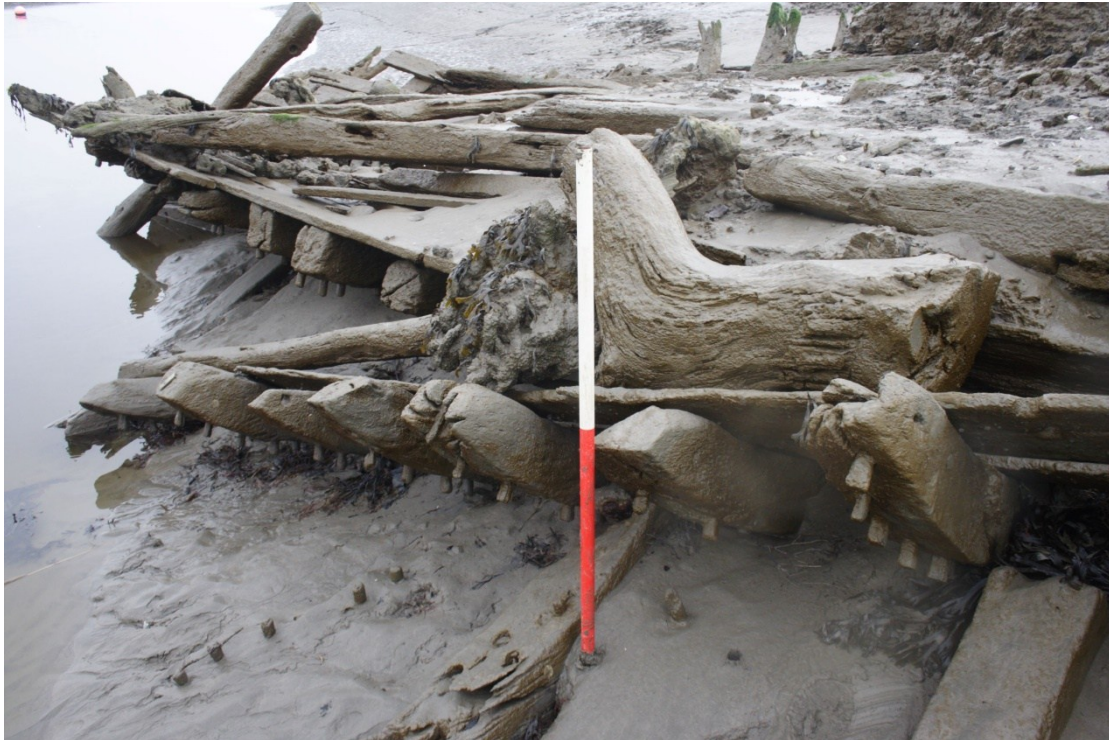
As was noted above, the possible boom 213 that was formerly located on the keelson at the stern of the wreck had moved by March 2016 and also a number of loose timbers and iron on the surface had slipped down the side of the wreck (Photo 25).

Photo 25: Alterations to the wreck by March 2016, showing possible boom 213 over the stern of the wreck in the top left of the photo and loose timber 206 and adjacent lump of corroded iron chain slumped further down on the starboard side

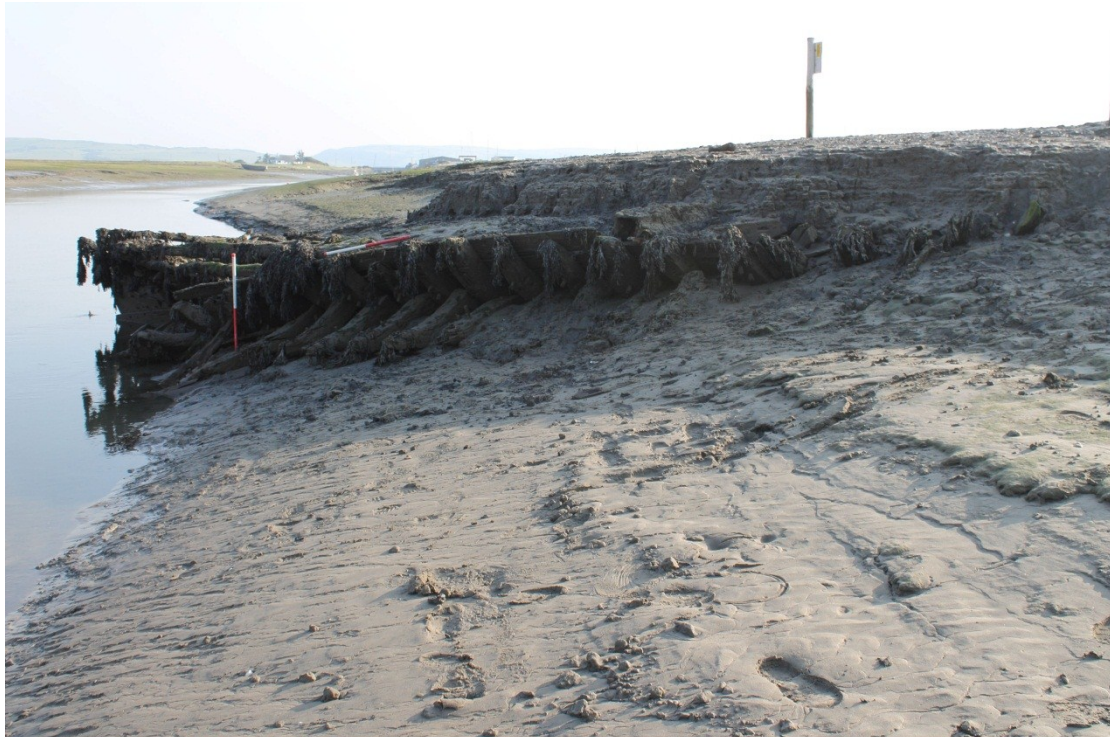
1.1 This written scheme of investigation presents a proposed detailed methodology for further archaeological recording and partial excavation of the eroding hulk on the bank of the Afon Leri, at Ynyslas, Ceredigion (Photo 1). The hulk is one of three located at the junction of the Afon Leri and the Afon Dovey. The hulk to be investigated is eroding from the western bank of the Leri located at NGR SN 61594 93942. The wreck is suffering from significant and constant erosion, exacerbated by the winter storms of 2013-2014.

Photo 1: Showing the hulk eroding into the Afon Leri, viewing south

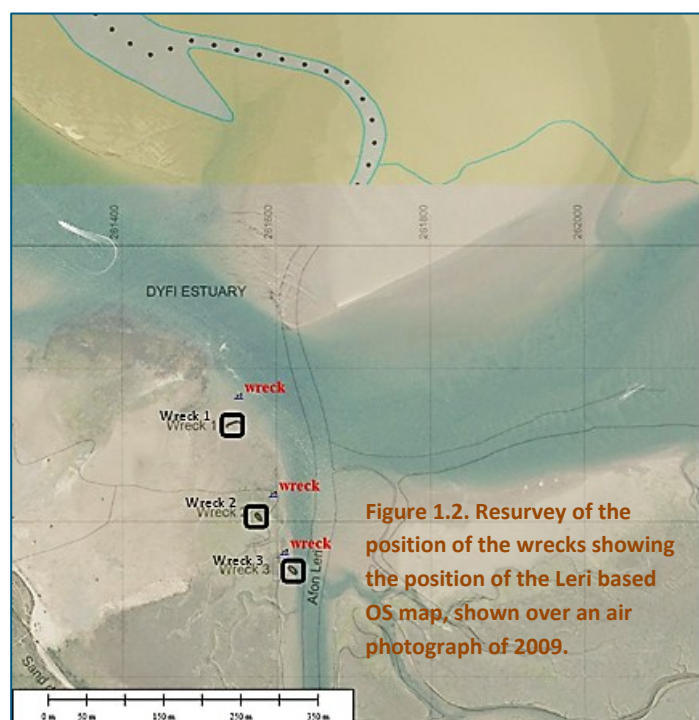
Over the last decade the wrecks have become increasingly exposed. As can be seen in Figure 1.2, as the channel has swung to the west, Wreck 3 is now increasingly at risk from erosion at the edge of the channel. Wrecks 1 and 2 have also become more exposed, although their

Figure 1.2. Resurvey of the position of the wrecks showing the position of the Leri based OS map, shown over an air photograph of 2009.
