CPAT Report No. 1259

Brecon Beacons National Park Scheduled Ancient Monument Condition Survey 2014

Archaeological condition survey

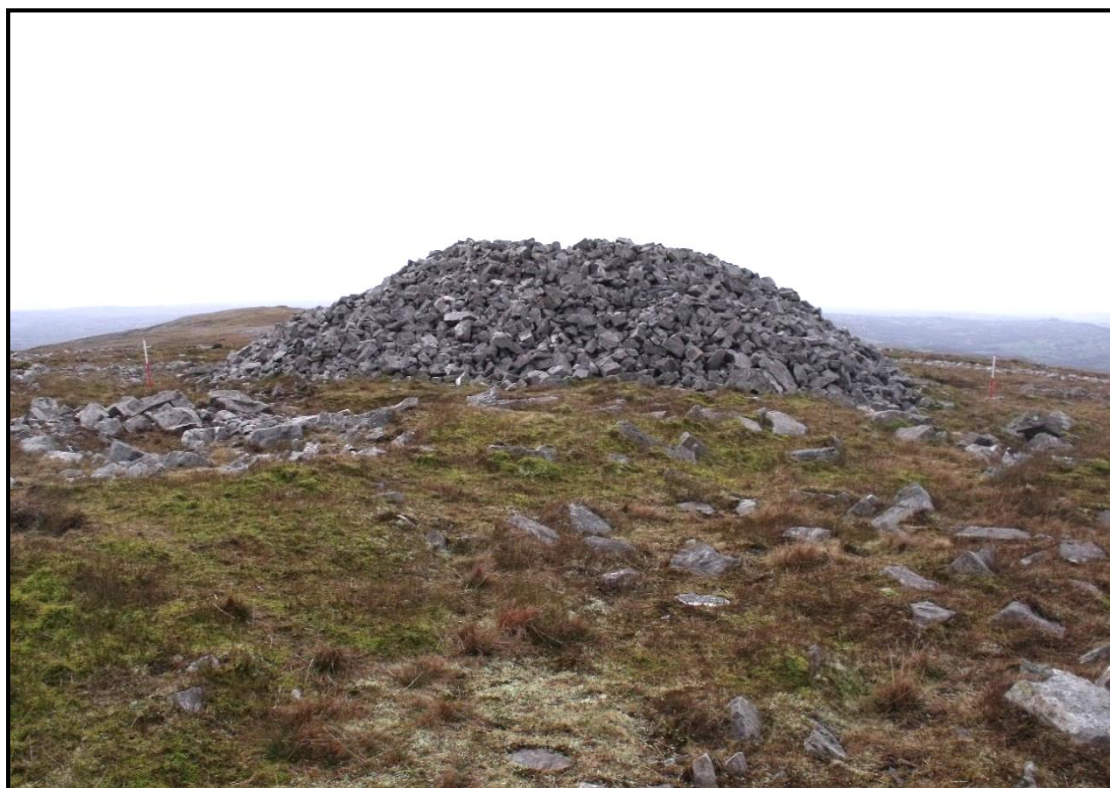
Photo 4. Facing west showing intact SAM CM255 Tair Cairn Uchaf Cairn iii (PRN 4015)

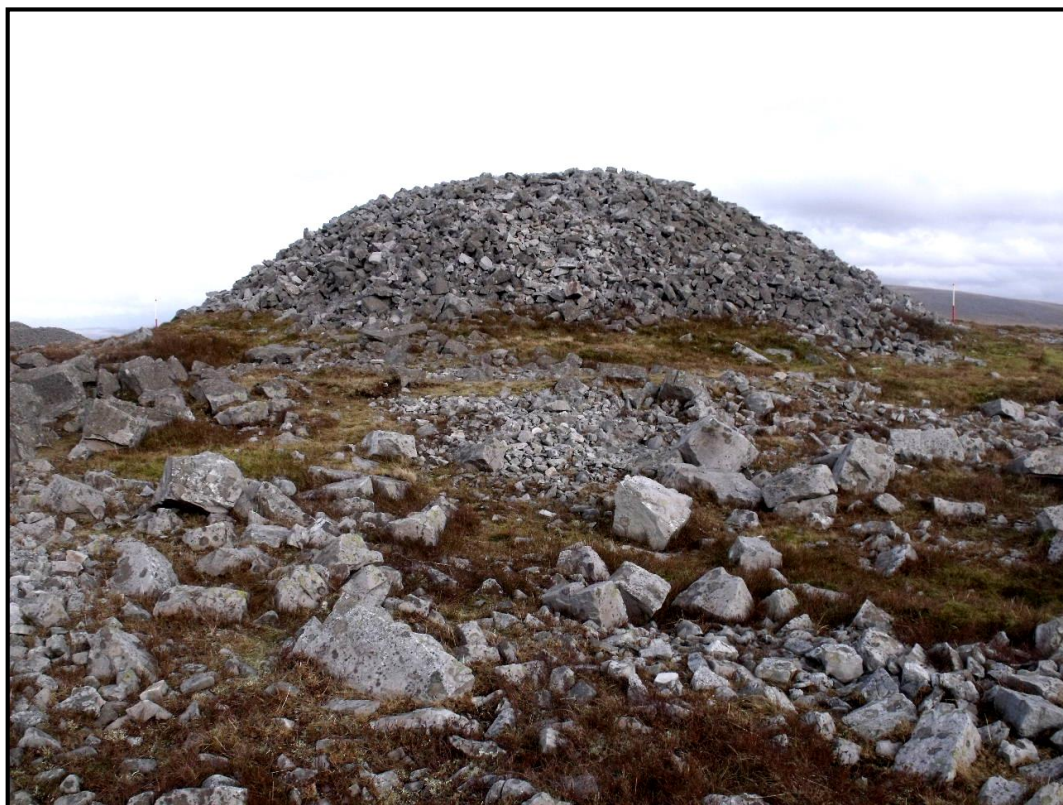
Photo 5. Facing east showing light encroachment of heather around SAM CM255 Tair Cairn Uchaf Cairn ii (PRN 4014) CPAT 3762-0045

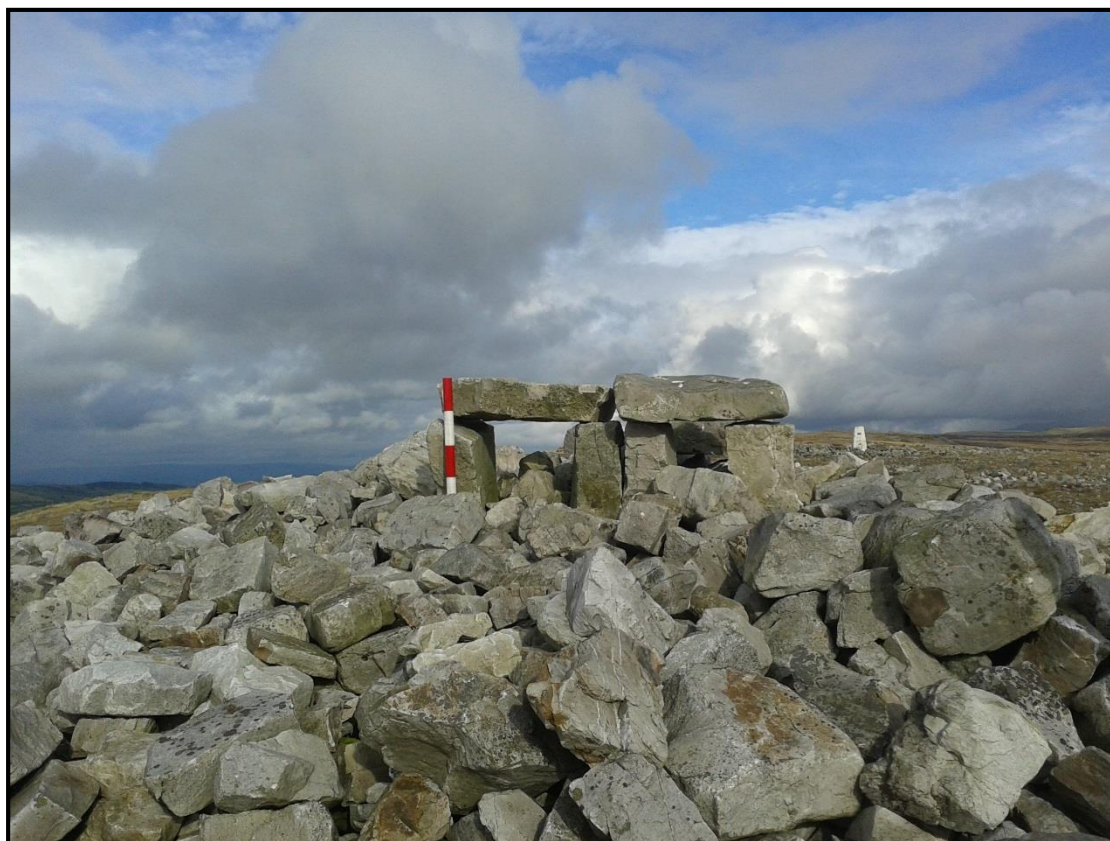
Photo 8. Photo of visitor built structure on top of CM256 Tair Cairn Isaf Carin ii (PRN 5970) as documented by BBNPA Heritage Officer Natalie Ward in October 2012.

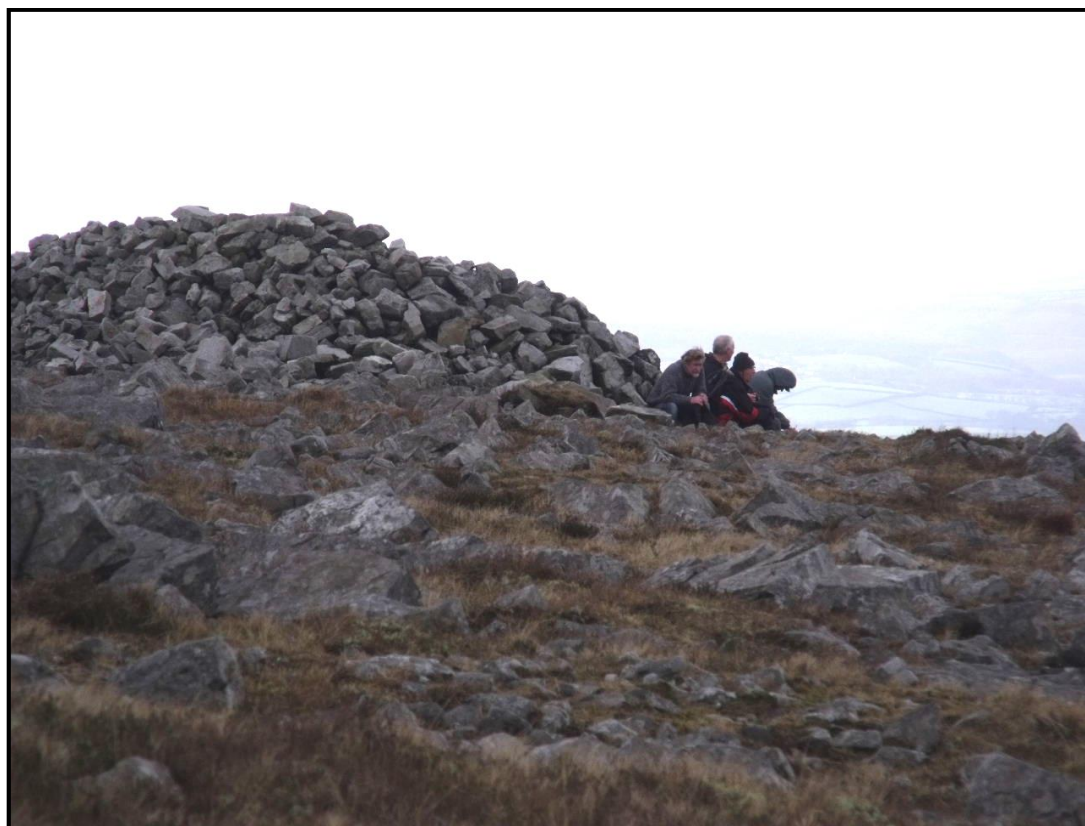
Photo 9. Facing south showing walkers resting at west side of cairn, causing poaching on this side
CPAT 3794-0028

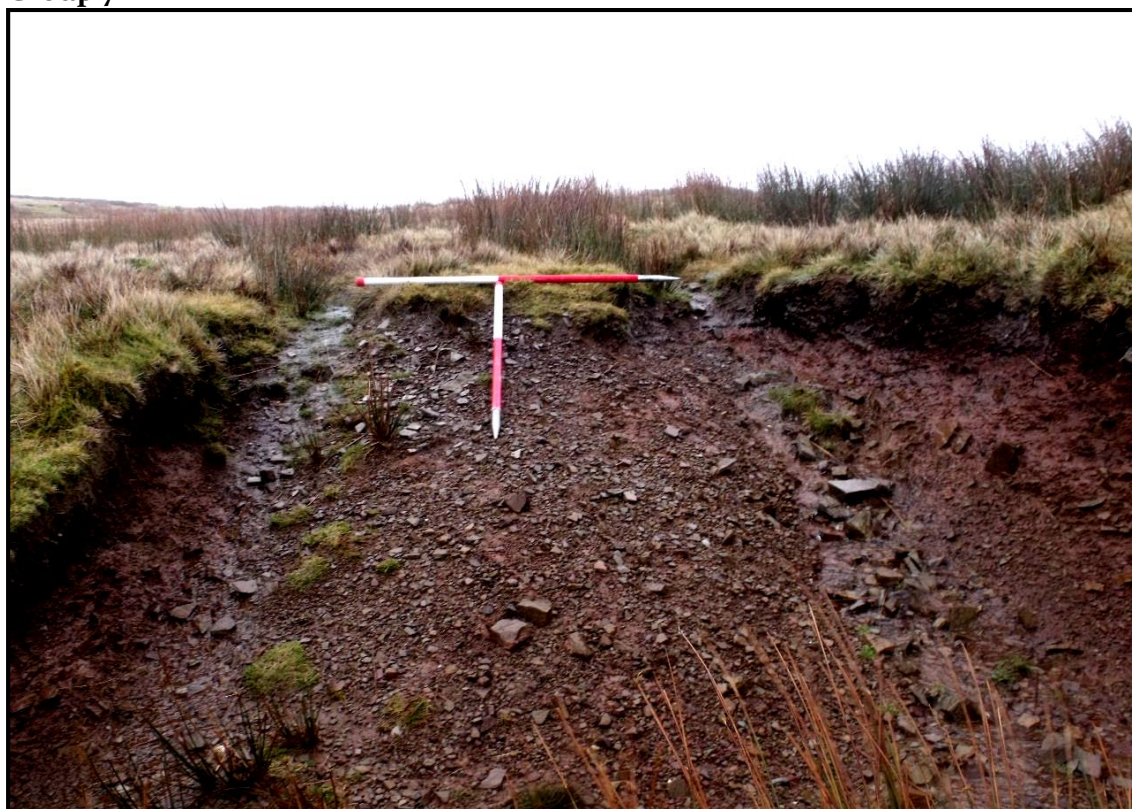
- minor threats and consequently it was considered to be at 'Low' risk. There was evidence of vehicle damage on the site but this was mostly infrequent and at the time of the visit there was no evidence to suggest that this is still an active issue (Photo 16). Following this, the most substantial threat was the presence of gorse across the site (Photo 17). Overall, gorse did not cover a high percentage of the site, but it appears to be a localised threat along the southwest ramparts. The site is being grazed by sheep, which have a low impact (Photo 18).

Photo 16. Photo showing old vehicle damage on BR003 Y Pigwn (PRN 800) CPAT 3792-0008

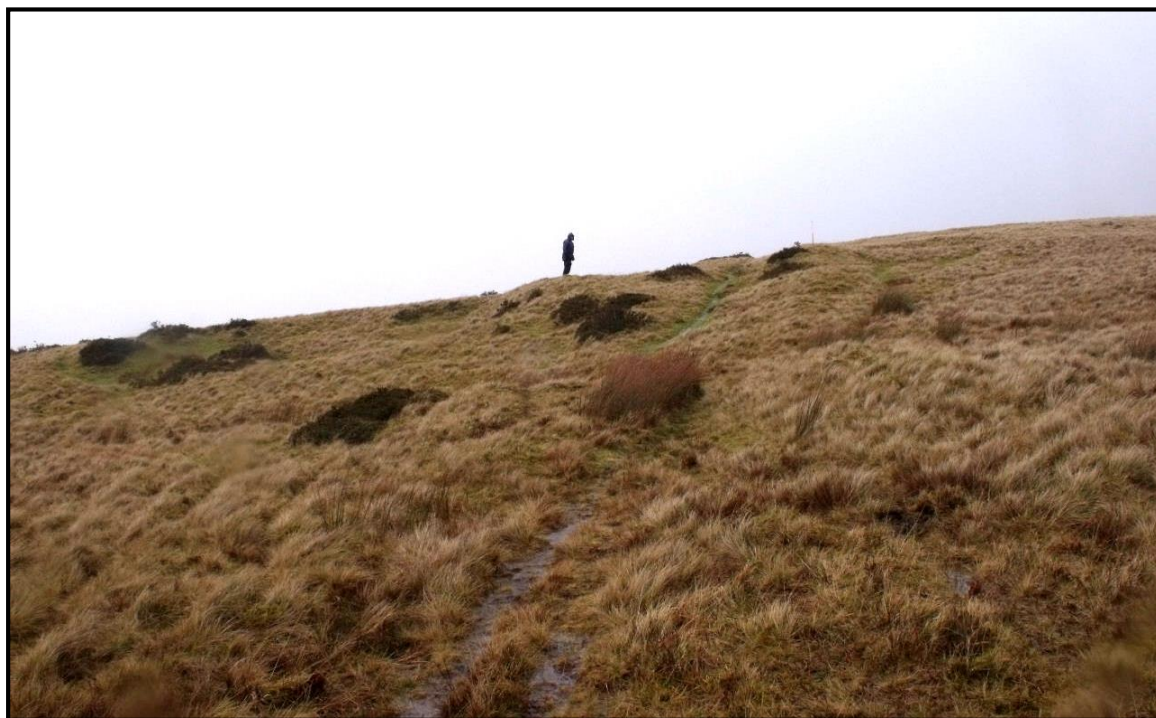
Photo 17. Facing northeast showing young gorse appearing at southern corner of camps of BR003 (PRN 800) CPAT 3792-0010

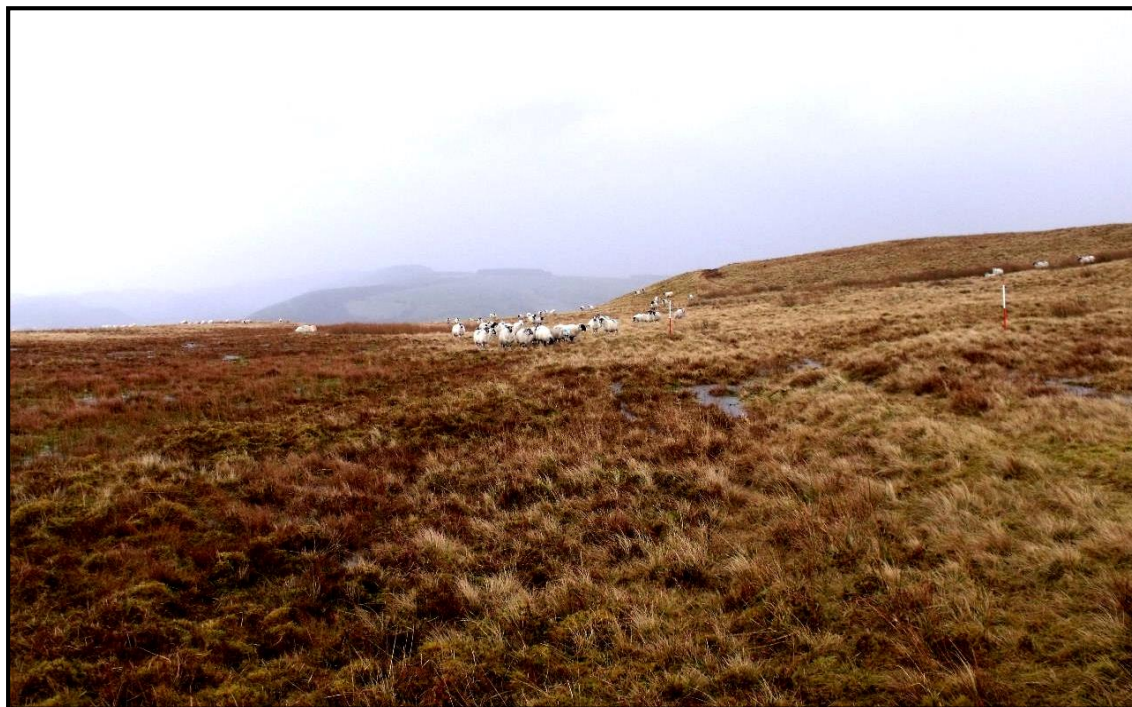
Photo 18. Facing northeast at northern corner of camp, BR003 (PRN 800) showing stock grazing on monument CPAT 3792-0004

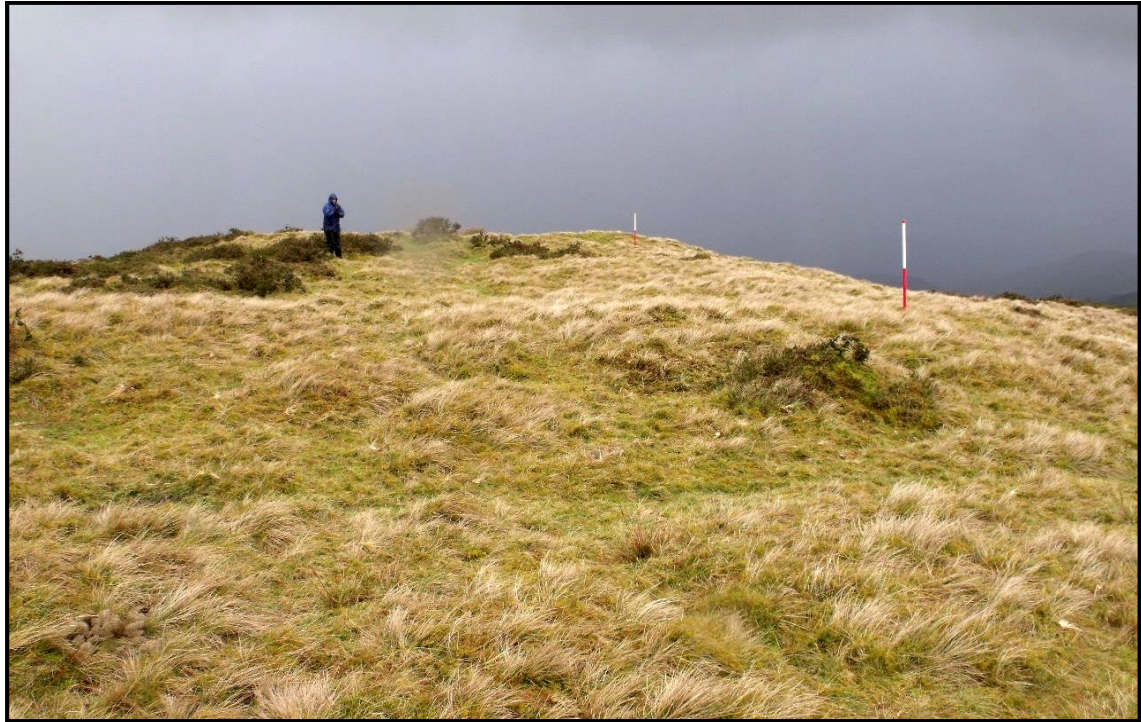
Photo 19. Facing southwest showing gorse within inner camp of CM194 (PRN 4159 & 4160)

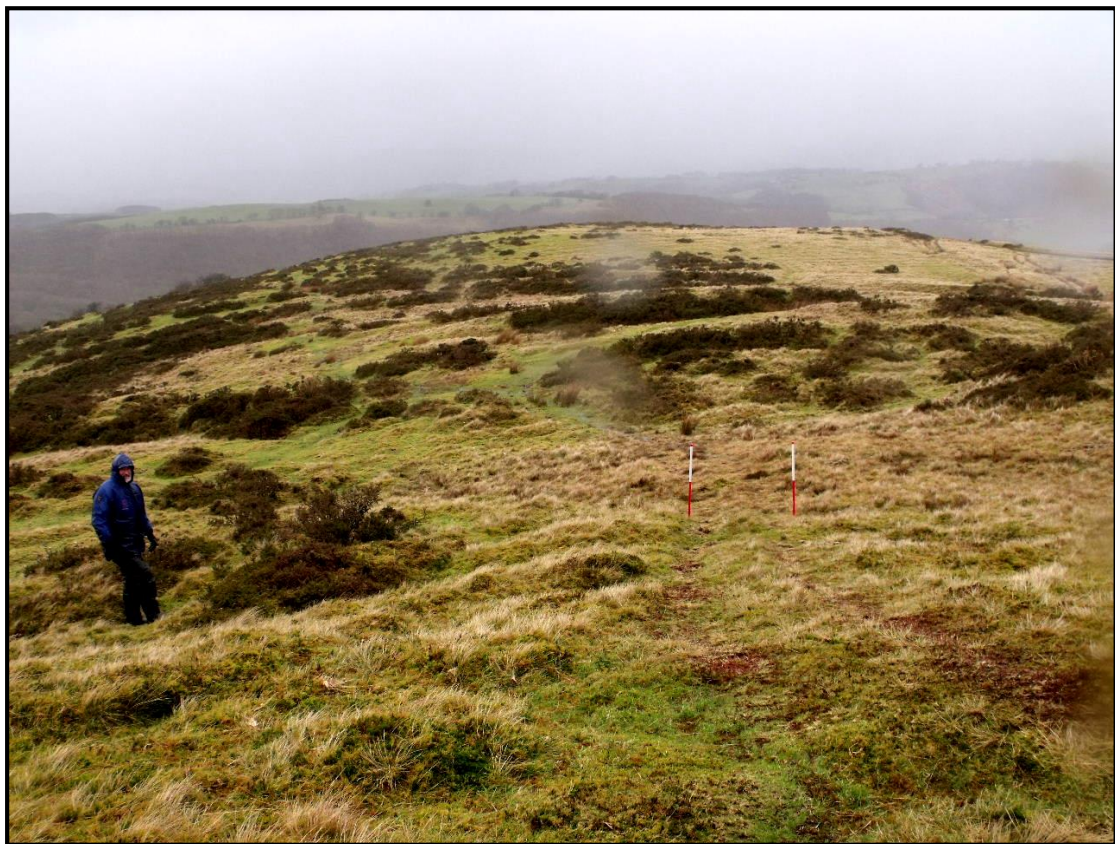
Photo 20. Facing north showing recent quad tracks on CM194 (PRN 4159 & 4160) and gorse encroachment beyond buffer zone

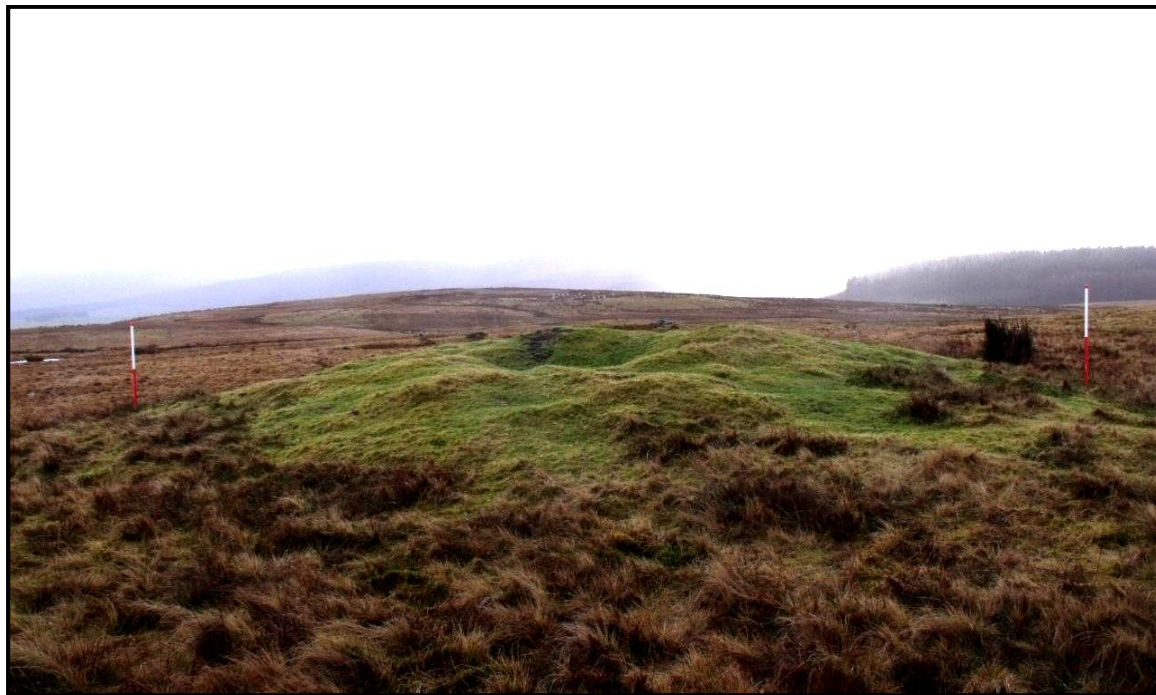
Photo 21. Facing south showing BR142 (PRN 743) and excavation hollow in centre of cairn

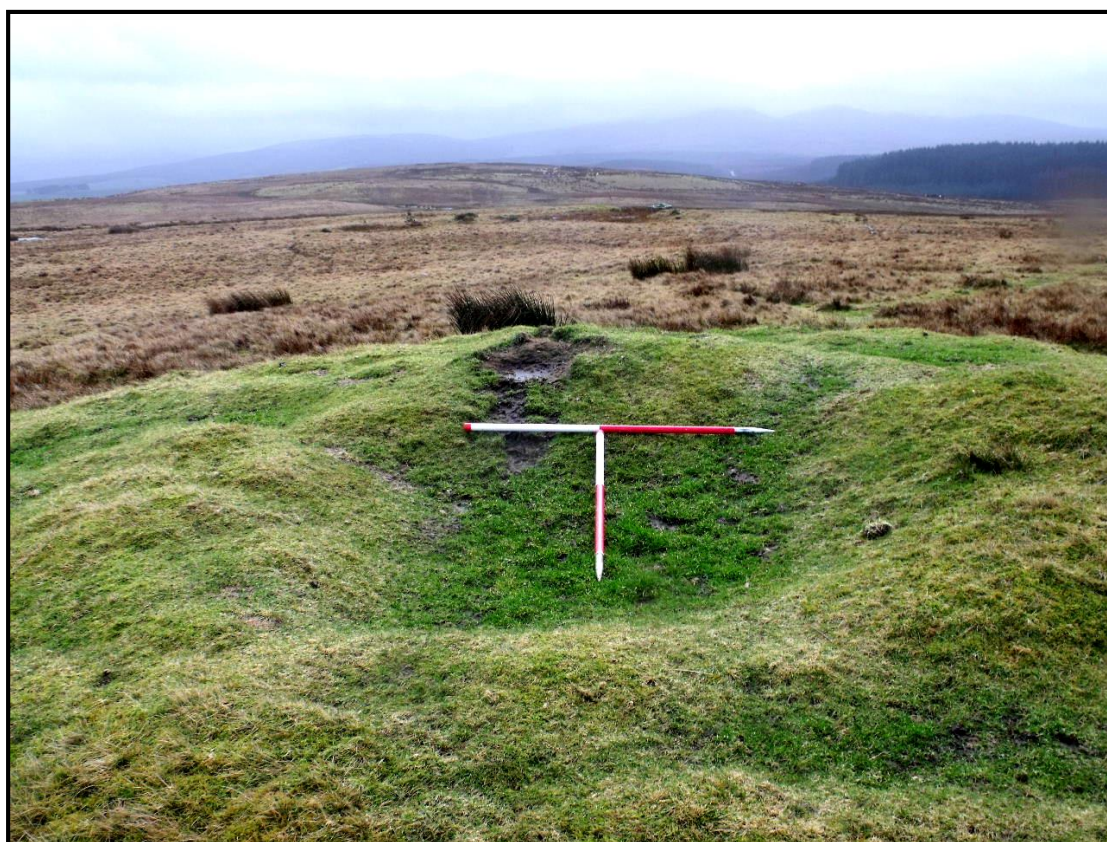
- 4.11 BR141 (PRN 743) is a low turf-covered cairn measuring approximately 10m x 8m in size and 0.8m in height. It was assessed as being at 'Low Risk'. There is a hollow in the centre of the cairn which is believed to be as a result of antiquarian excavations in the 19th century (Photo 21). Aside from this hollow, the cairn is in good condition. The main threat identified here was the low amount of stock erosion on the site that actually manifests itself as a single sheep track that runs along the western edge of the barrow. There was also a small patch of exposed earth near the hollow that is most likely to be caused by animal activity (Photo 22).

Photo 22. Facing south showing area of poaching on BR142 (PRN 0027) *CPAT 3792-0028*

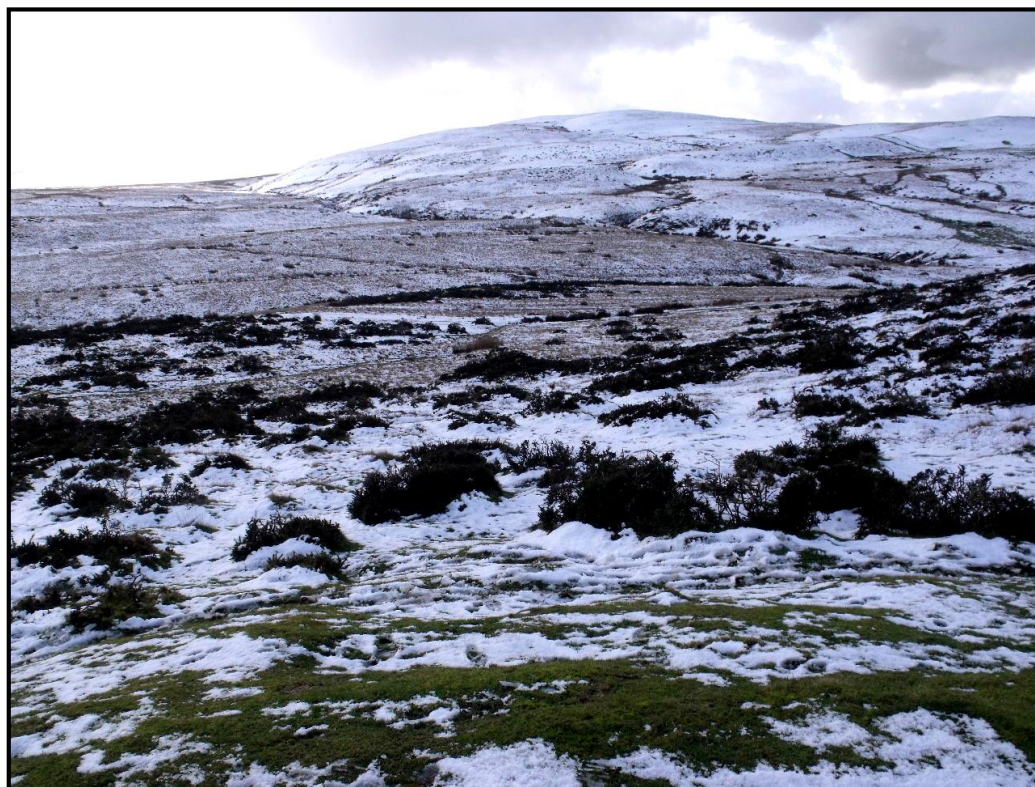
Photo 25. Facing southwest from CM337 (PRN 14418) showing gorse encroaching from within and beyond the 10m buffer zone *CPAT 3793-0009*

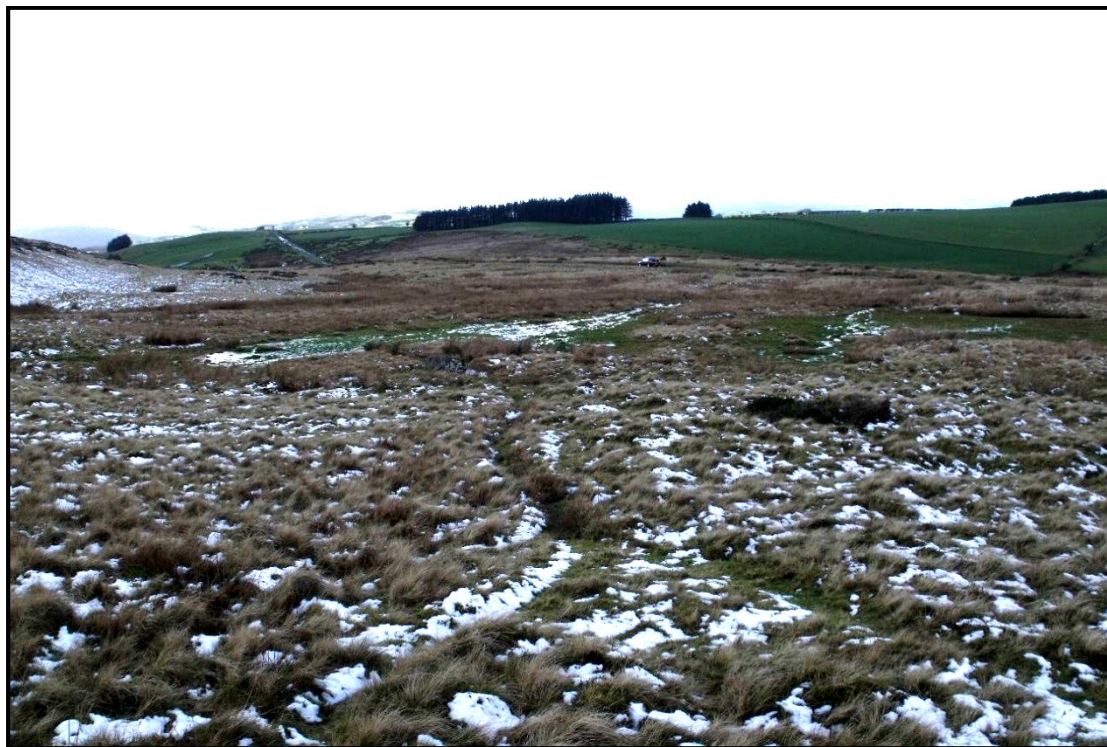
Photo 26. Facing northwest; the northernmost ramparts of (CM174 (PRN 4142) are not visible in this area and are possibly truncated by the road which runs east/west in the background *CPAT 3793-0020*

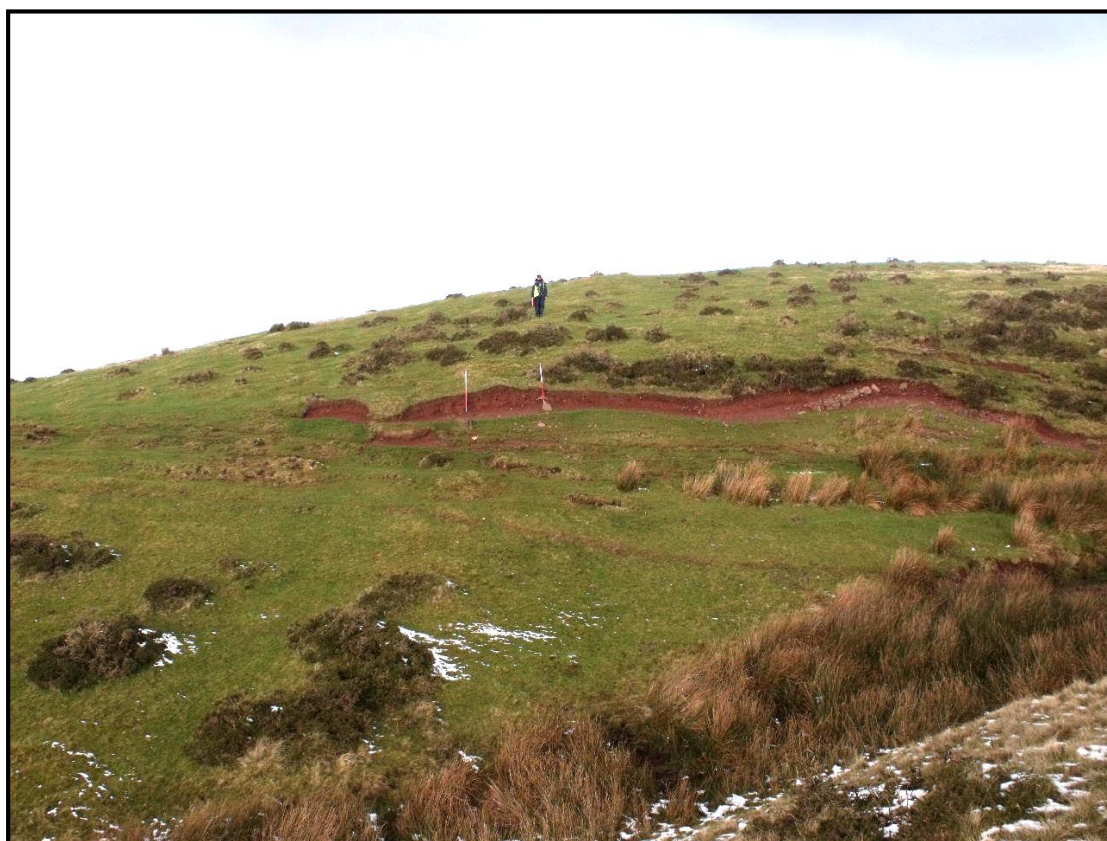
Photo 27. Facing north, looking across to northern bank of a stream which runs northwest/southeast through the southwest corner of CM174 (PRN 4142) causing significant erosion in this area. The author is standing in line with the rampart and the ranging poles mark its location in the section. CPAT 3793-0022

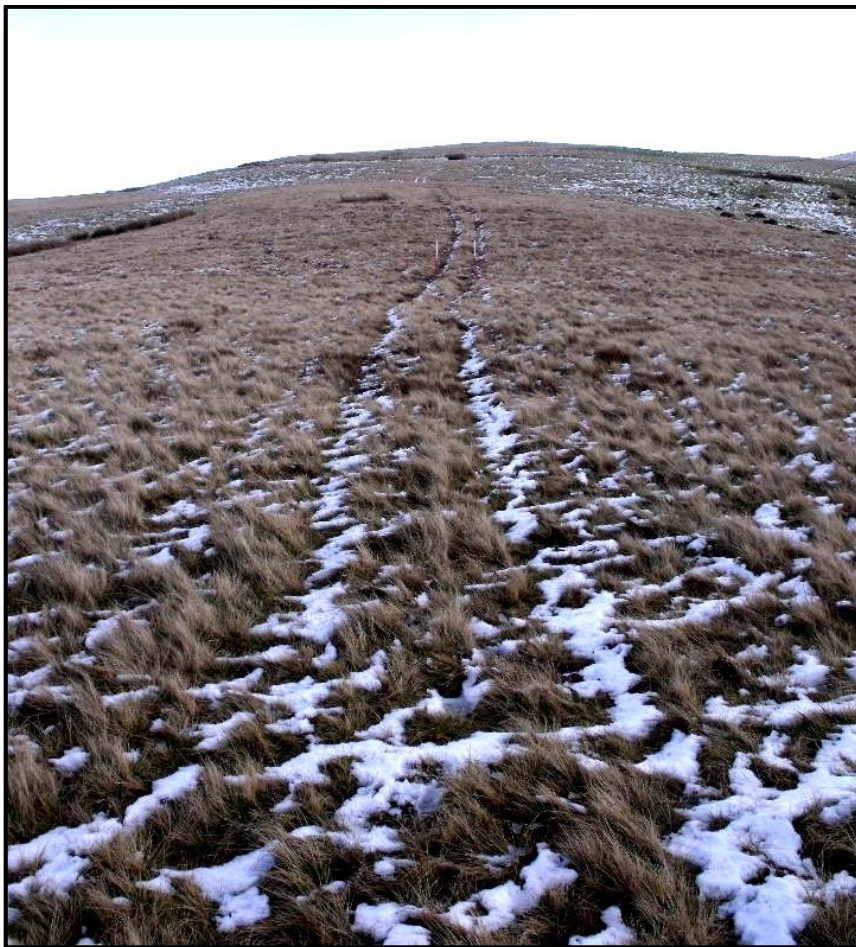
Photo 28. Facing northeast showing recent quad tracks running across CM174 (PRN 4142)
CPAT 3793-0029

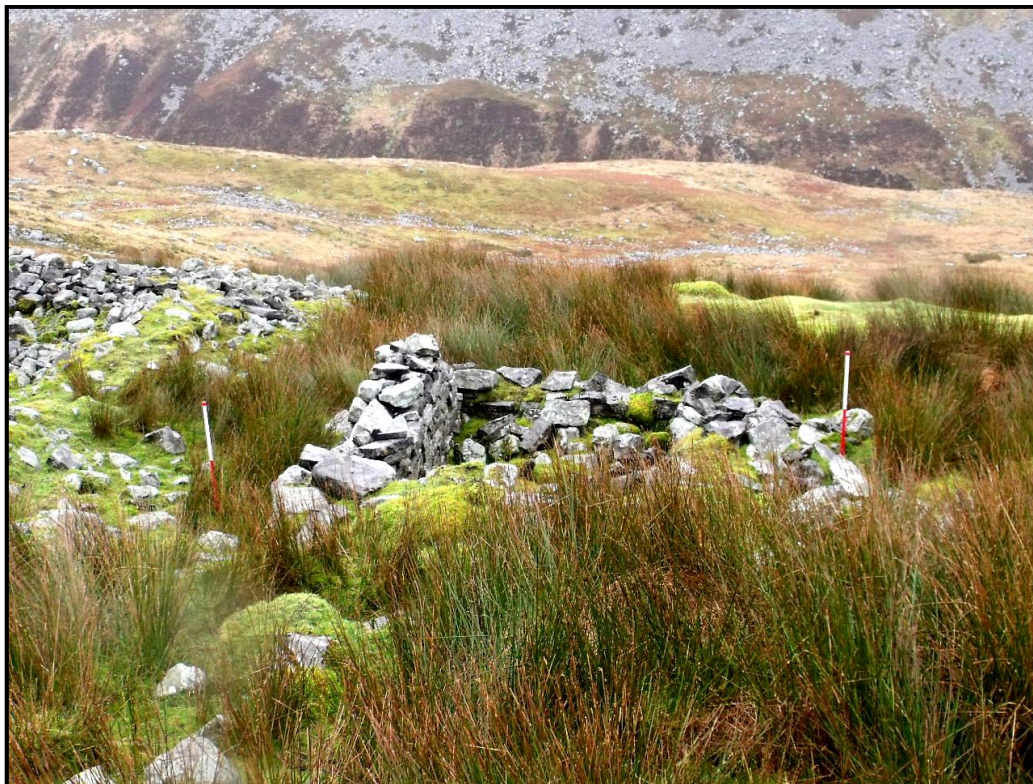
- 4.19 The long hut (PRN 31806) consists of a single-celled building around 3.5m x 2m in plan, with well-constructed walls surviving up to 1m in height on its north side and 0.3m on its south (Photo 33). Aside from collapse, the only active threat identified for this site was the encroachment of lush reeds that almost completely encircle the site (Photo 34). It was considered to be in good condition and at 'Low' risk.

Photo 34. Facing east showing CM355 (PRN 31806) surrounded by reeds CPAT 3794-0002

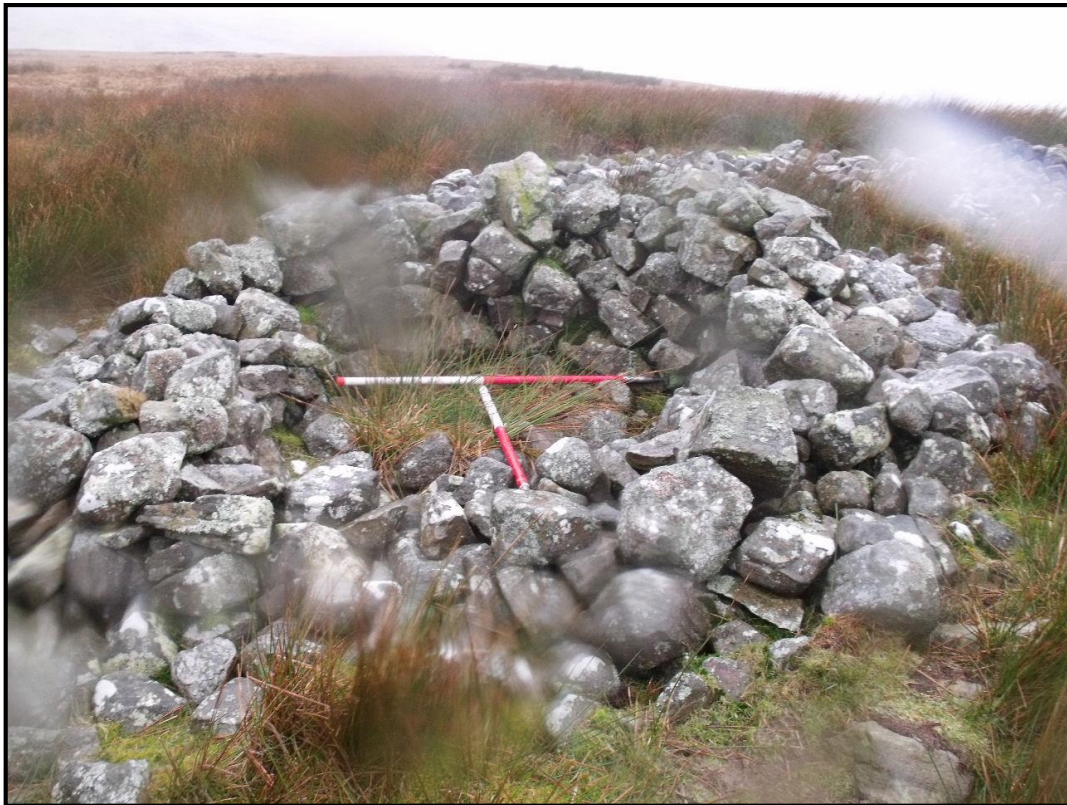
Photo 38. Facing south showing shelter in Cairn I (PRN 00774m) of BR137 CPAT 3795-0005

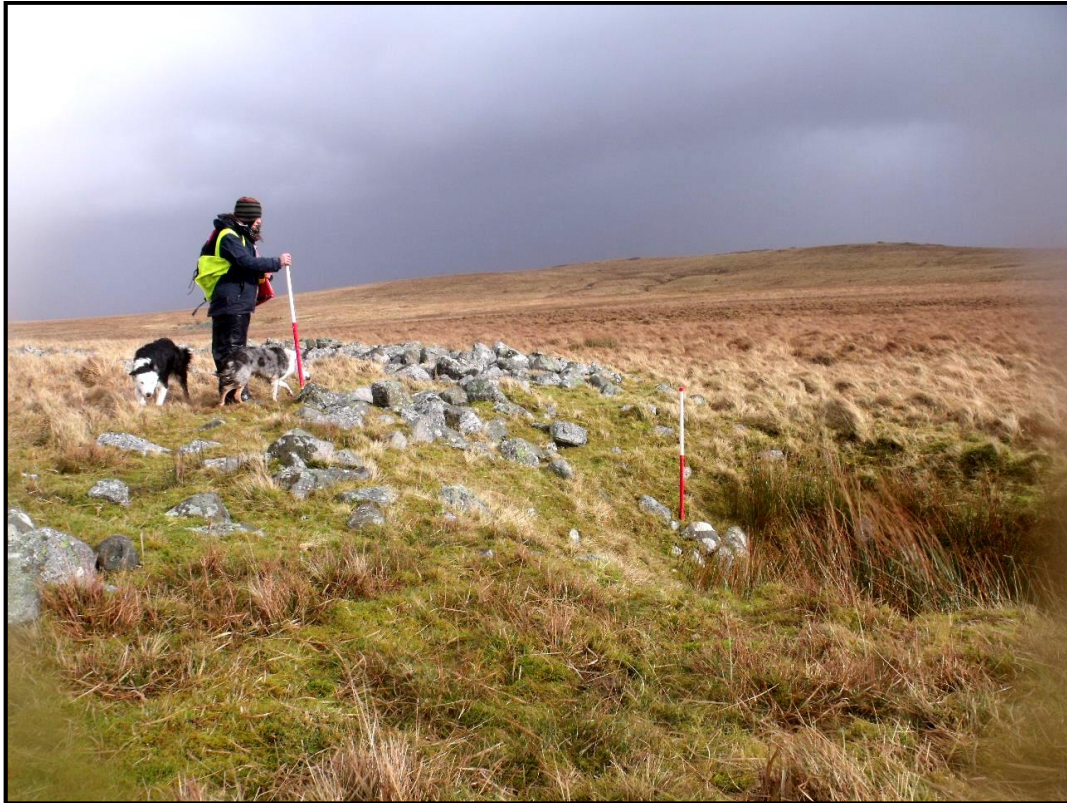
Photo 40. The sinkhole and subsidence at the southwest of Cairn ii (PRN 04491m) of BR137

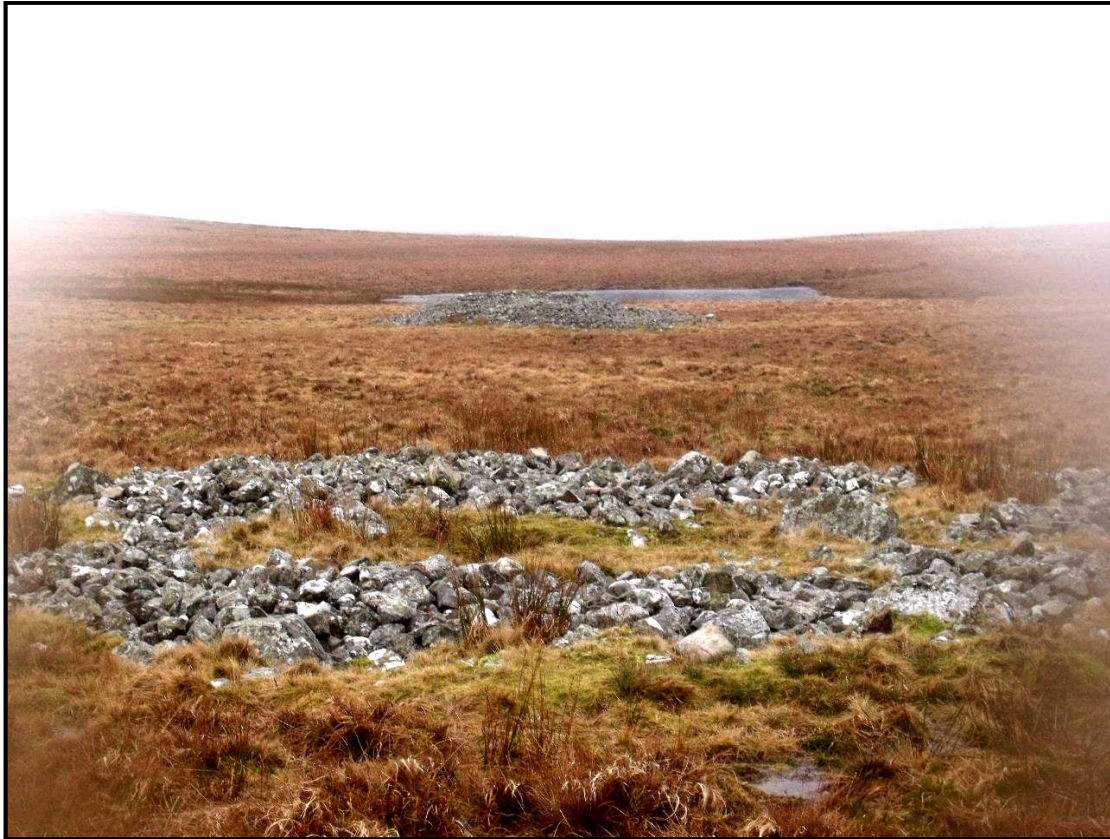
Photo 44. Facing west showing areas of subsidence of Cairn iv of BR137 (no PRN) with Cairn iii (PRN 00768m) in background with large sinkhole (water filled) behind that CPAT 3795-0029

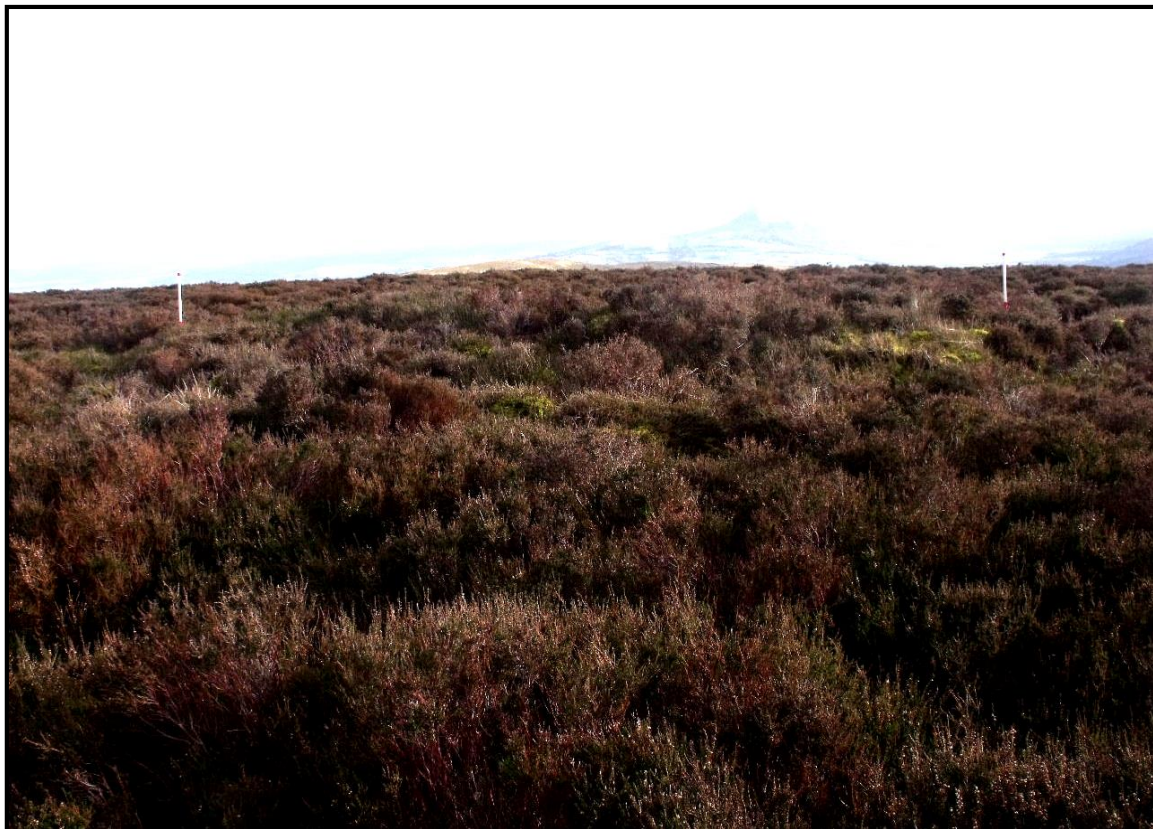
Photo 49. Facing south showing MM302 (PRN 08114g) Cairn ii under thick heather *CPAT 3796-0031*

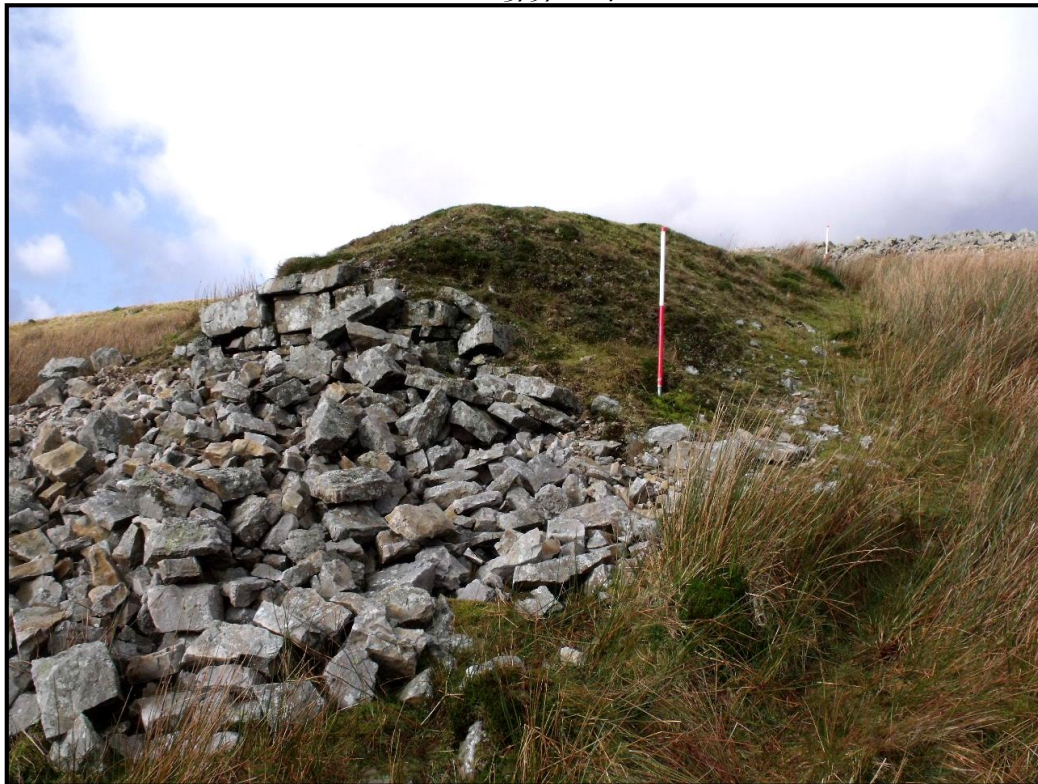
Photo 55. Facing northwest showing collapsed structure at side of tramroad of BR237 (PRN 114089)

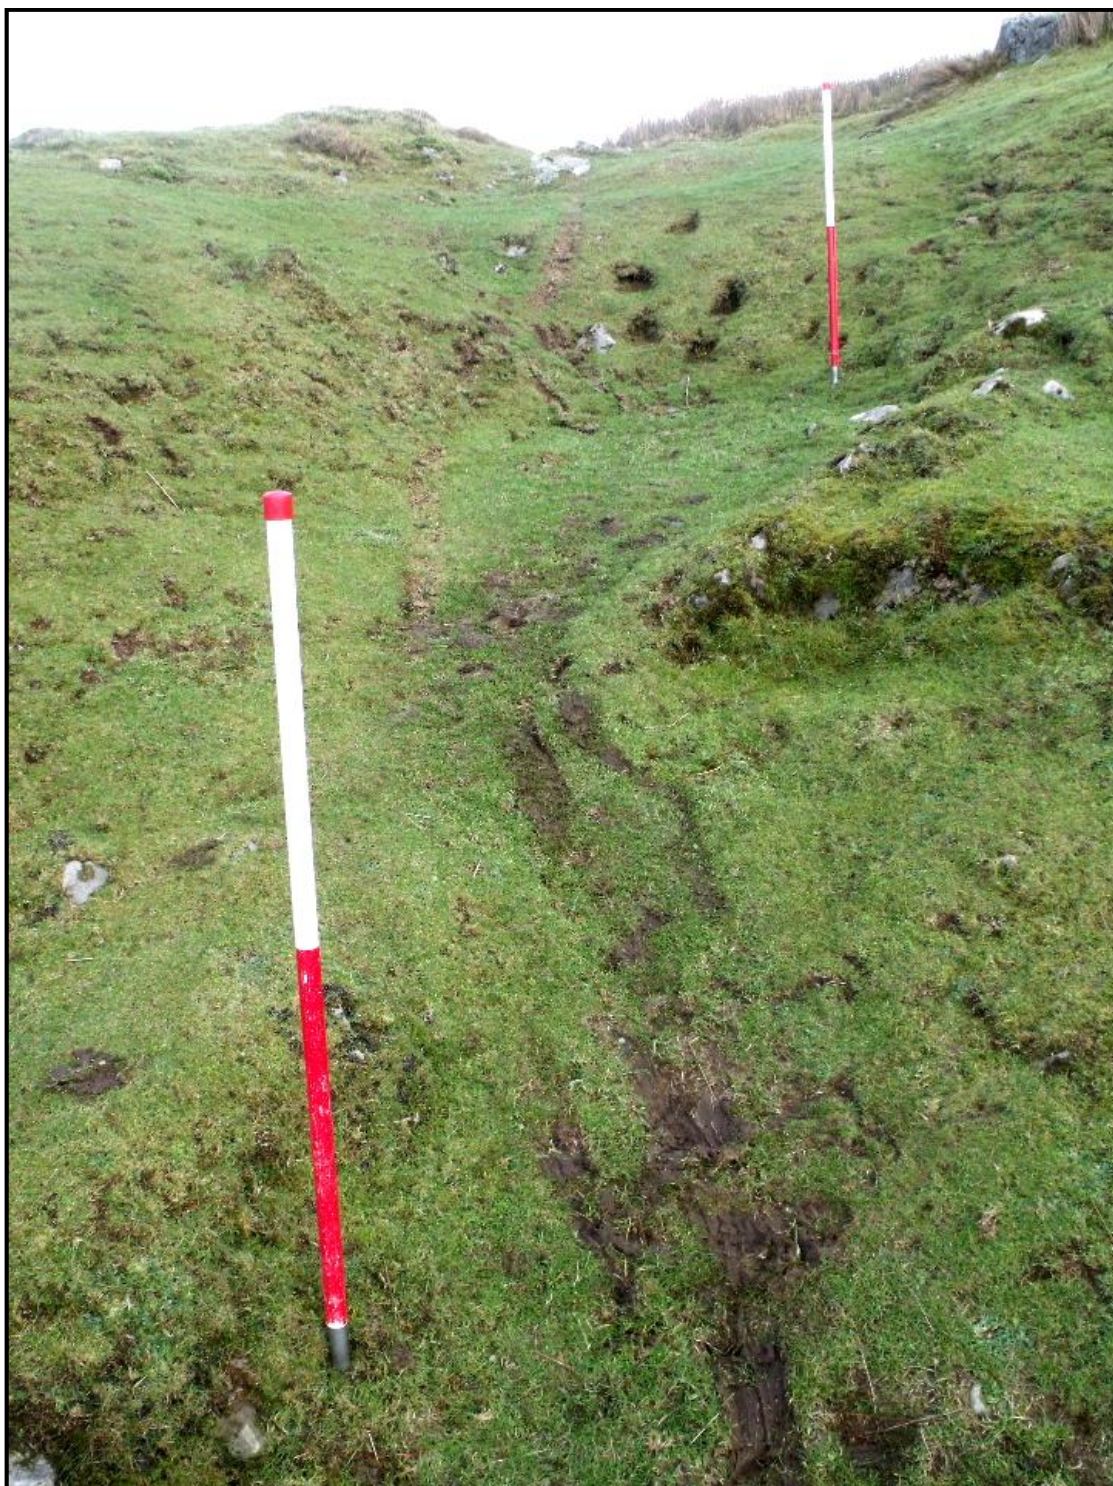
Photo 6o. Facing north showing pony tracks on area of BR137 (PRN 114089) CPAT 3797-0058

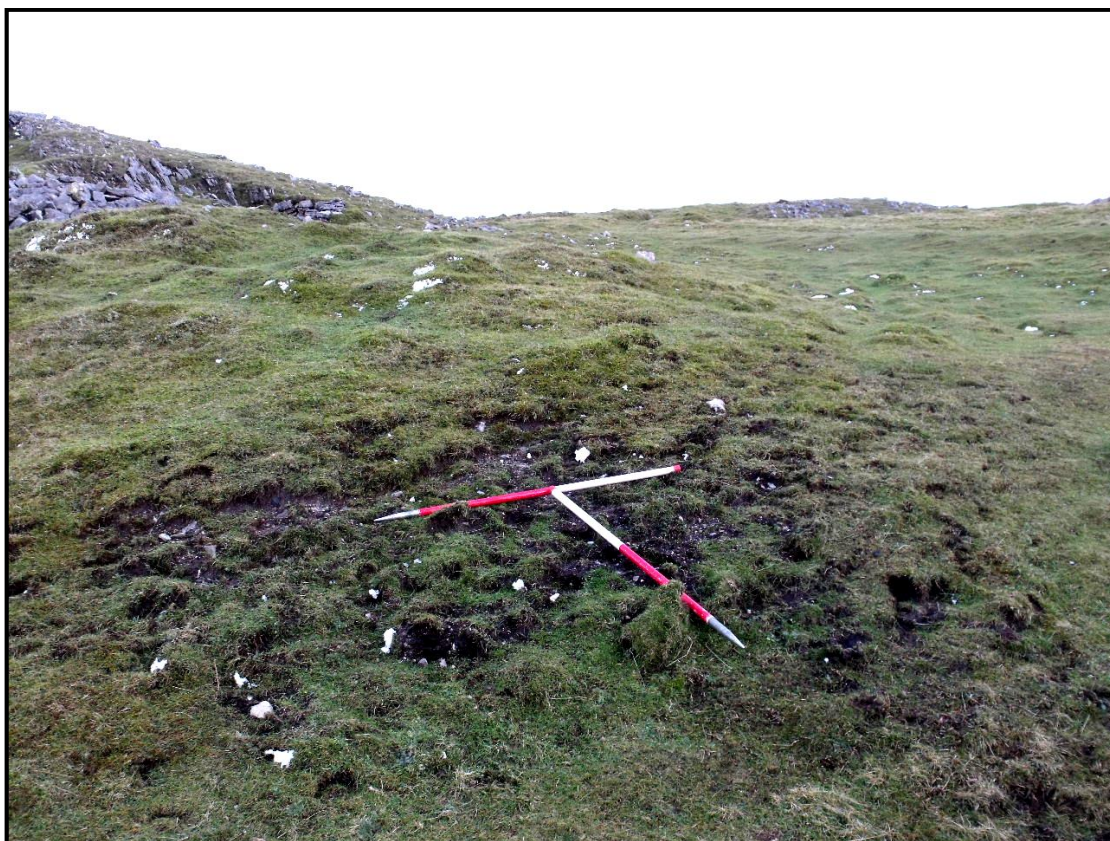
Photo 61. Facing southeast showing area of poaching on spoil tip at BR137 (PRN 114089)
