CPAT Report No. 1259

Brecon Beacons National Park Scheduled Ancient Monument Condition Survey 2014

Archaeological condition survey

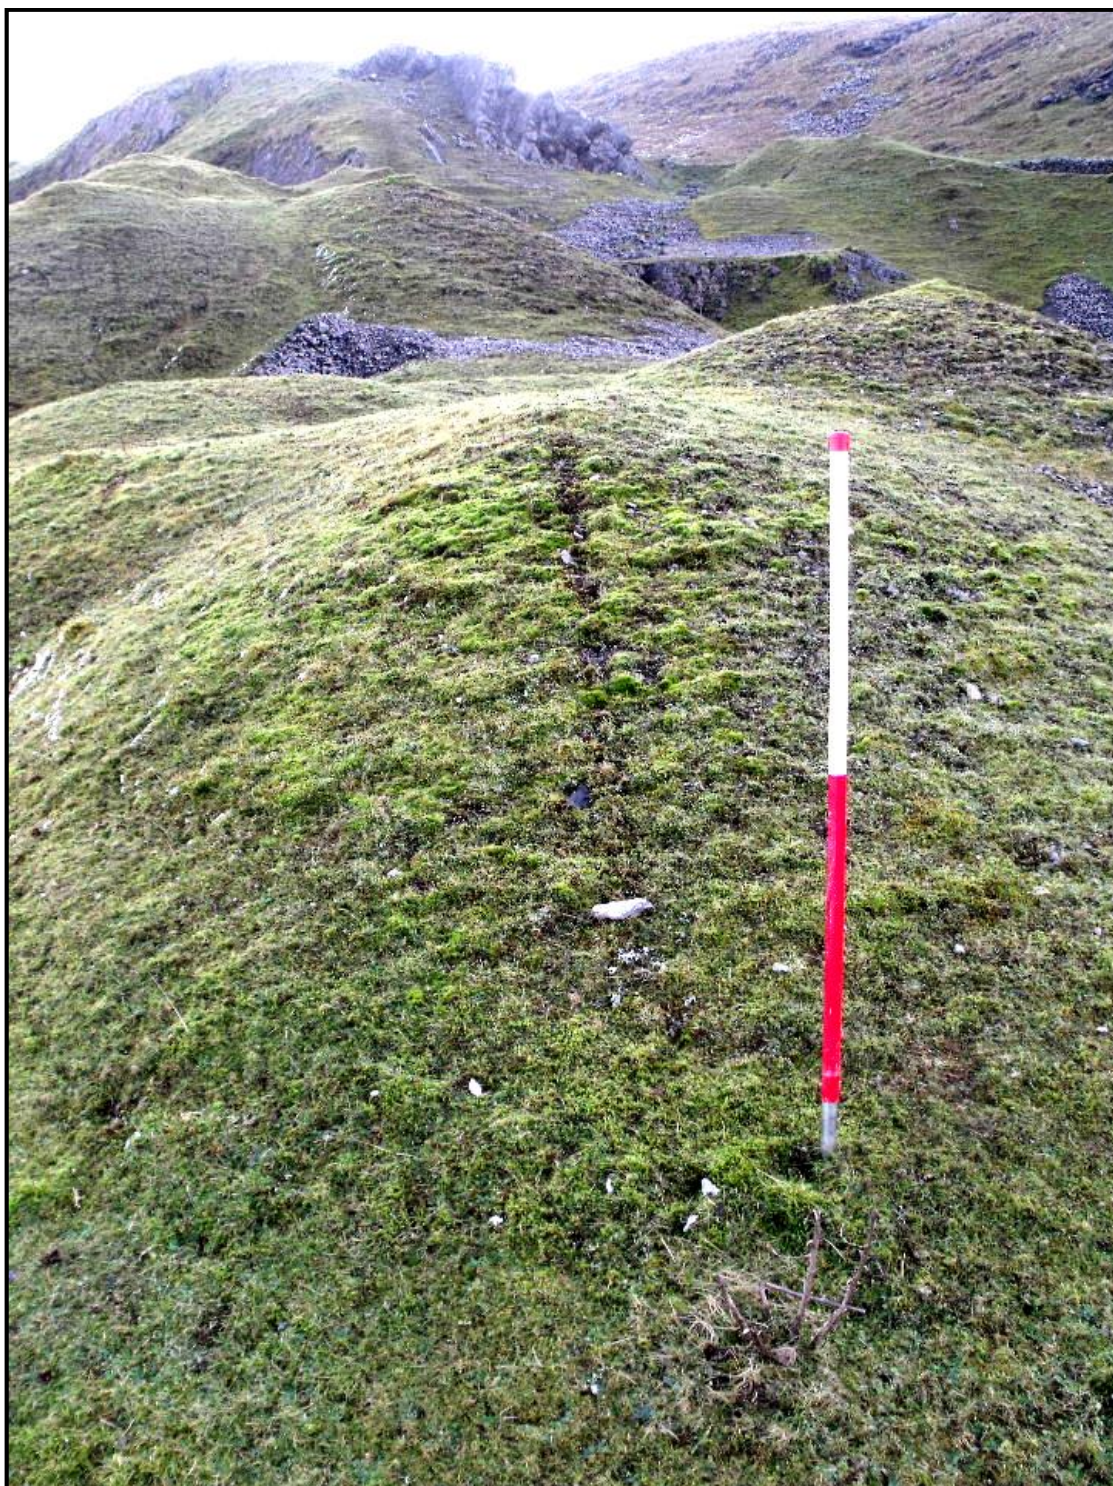
Photo 62. Facing east showing recent mountain bike tracks on spoil tip on BR137 (PRN 114089)

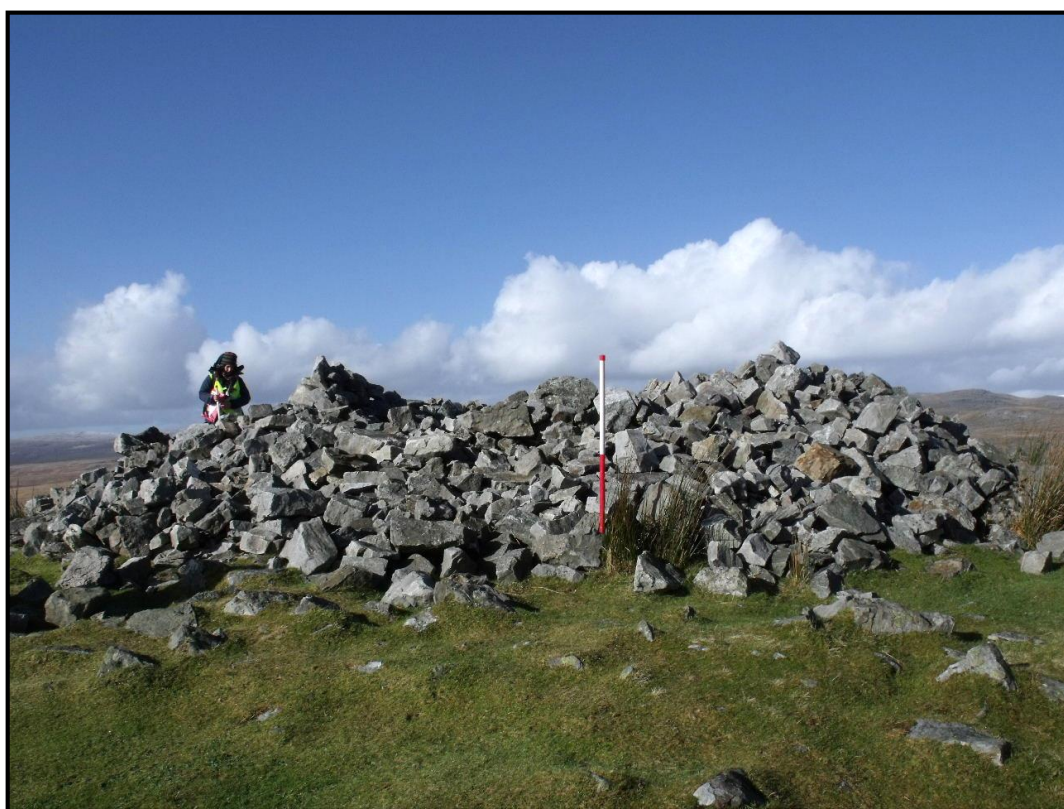
Photo 64. Facing northwest of cairn next to trigpoint on BR137 (PRN 114089) showing shelter in centre of cairn. Note the western edge of the shelter is higher than the eastern edge CPAT 3797-0027

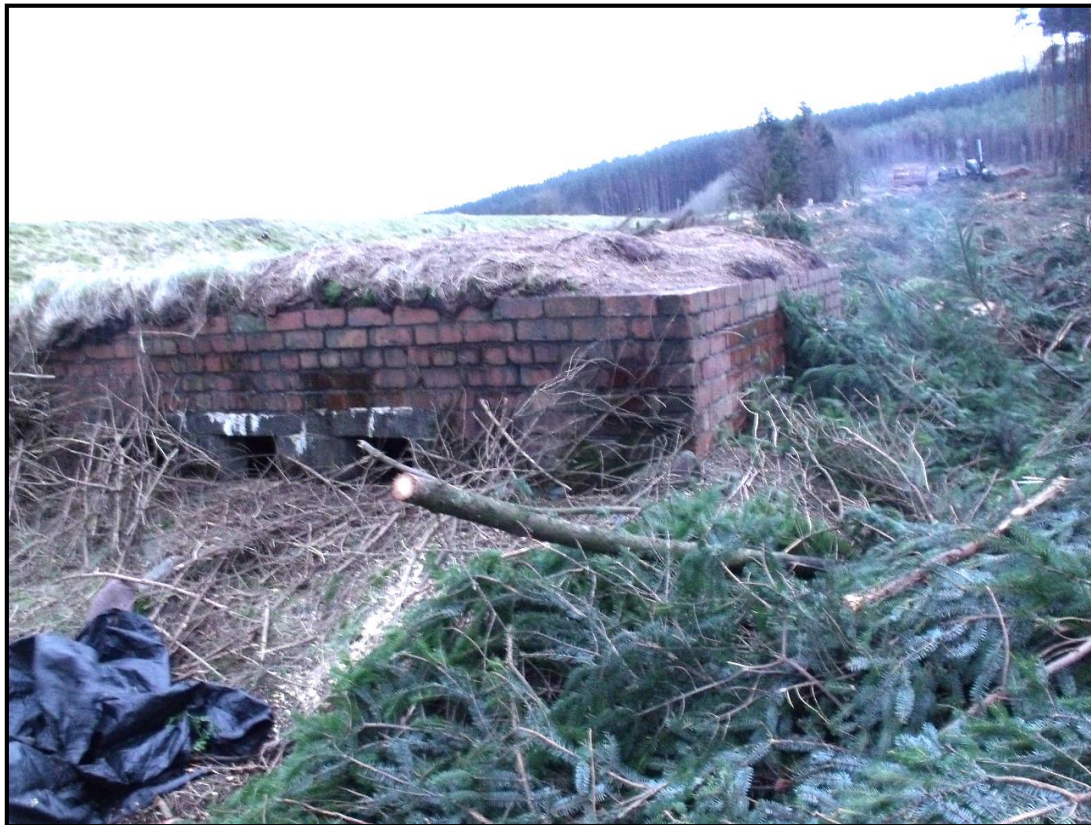
Photo 68. Facing north showing build up of brush against eastern side of Pillbox BR337C

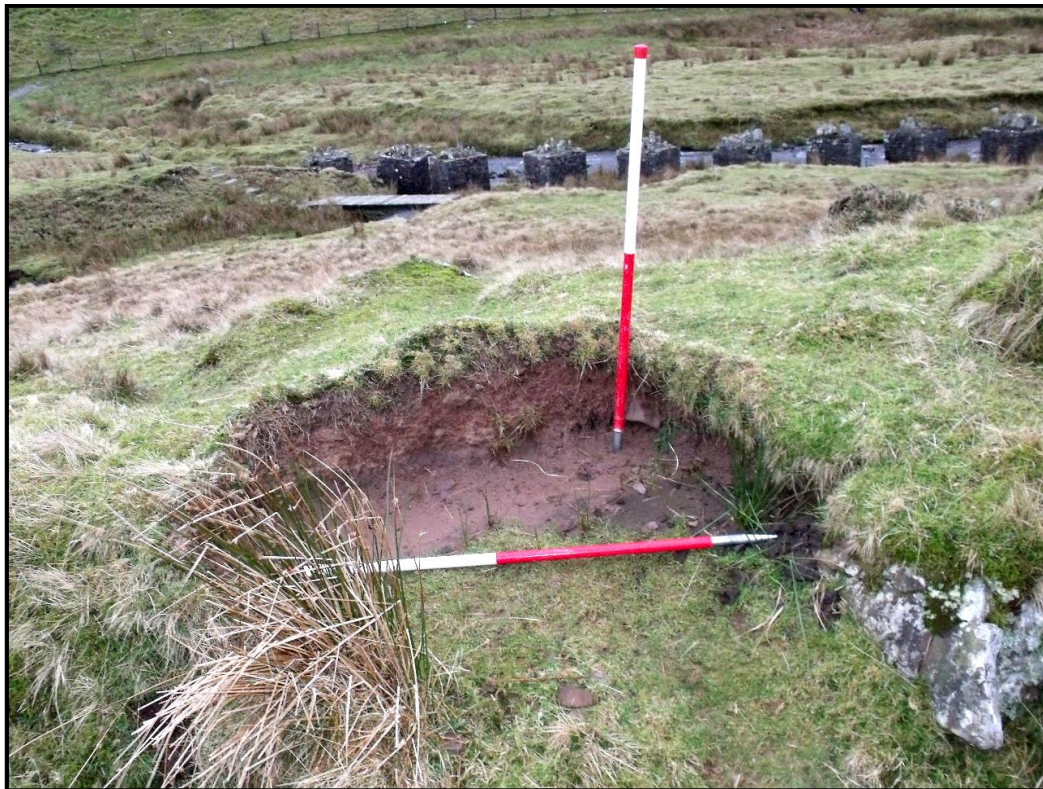
Photo 70. Facing southeast showing sheep scrape on BR337D with western group of anti tank blocks
BR337F in background
CPAT 3798-0016

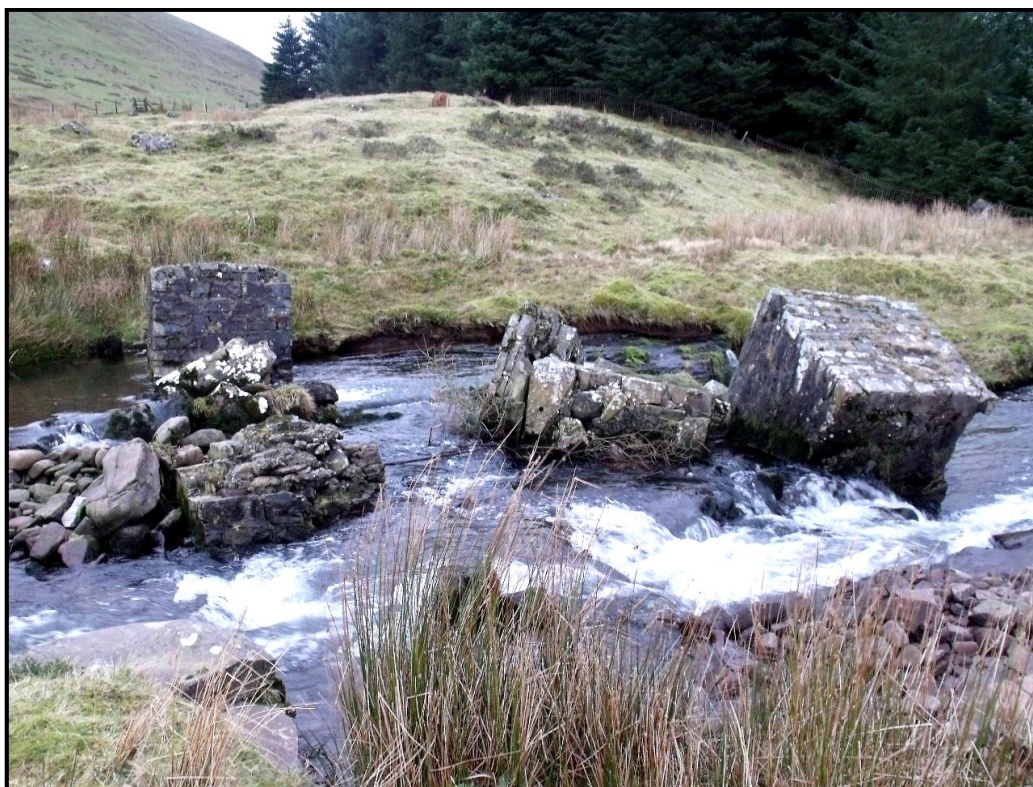
Photo 73. Showing collapse of some of the anti tank blocks of BR337F

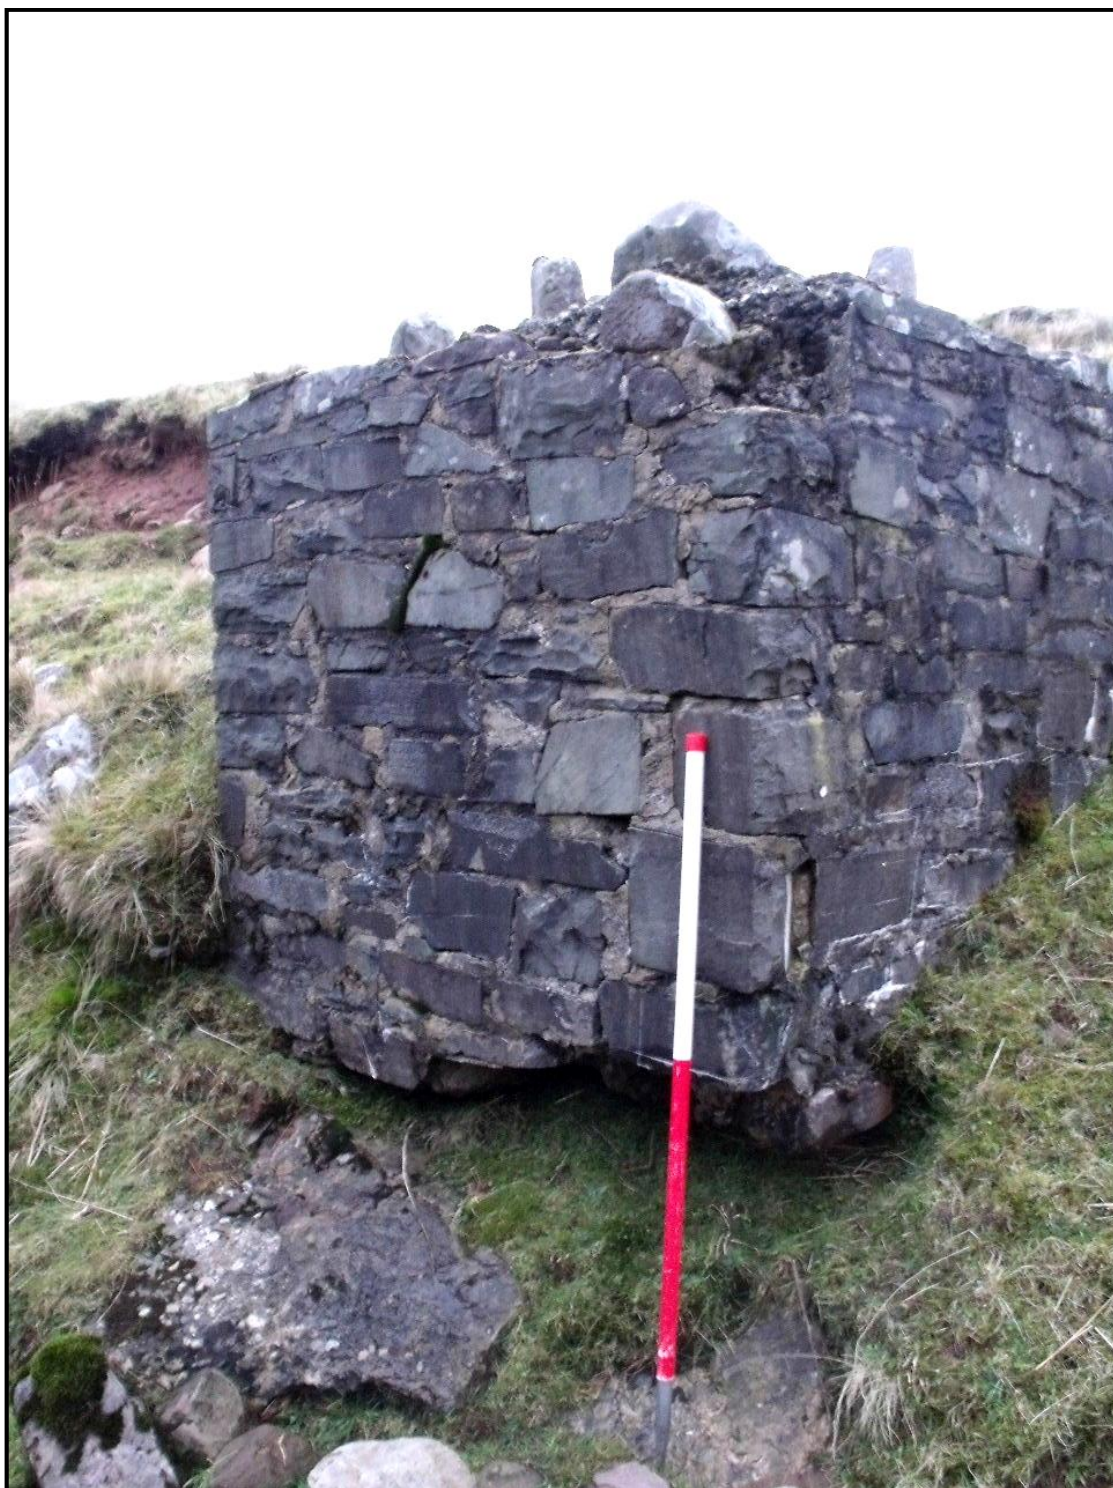
Photo 73. Typical undercutting by water of the anti tank blocks of BR337F CPAT 3798-0041

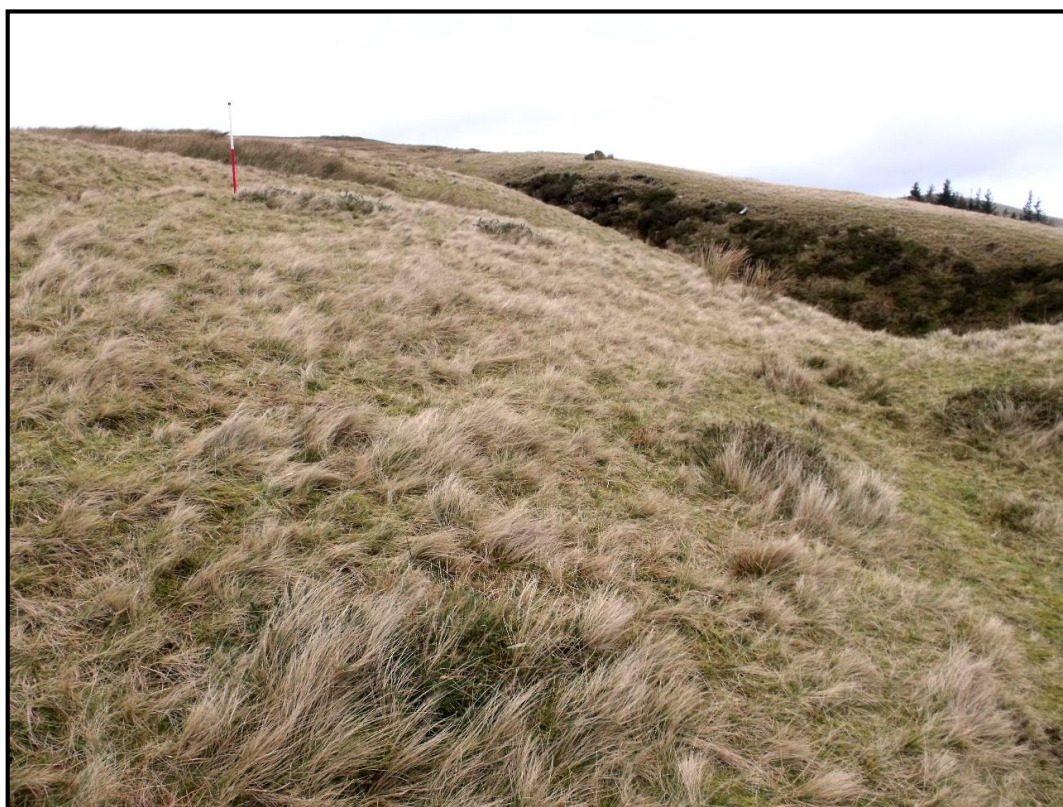
Photo 77. Facing east showing young gorse bushes on BR241 (PRN 3248) CPAT 3798-0011

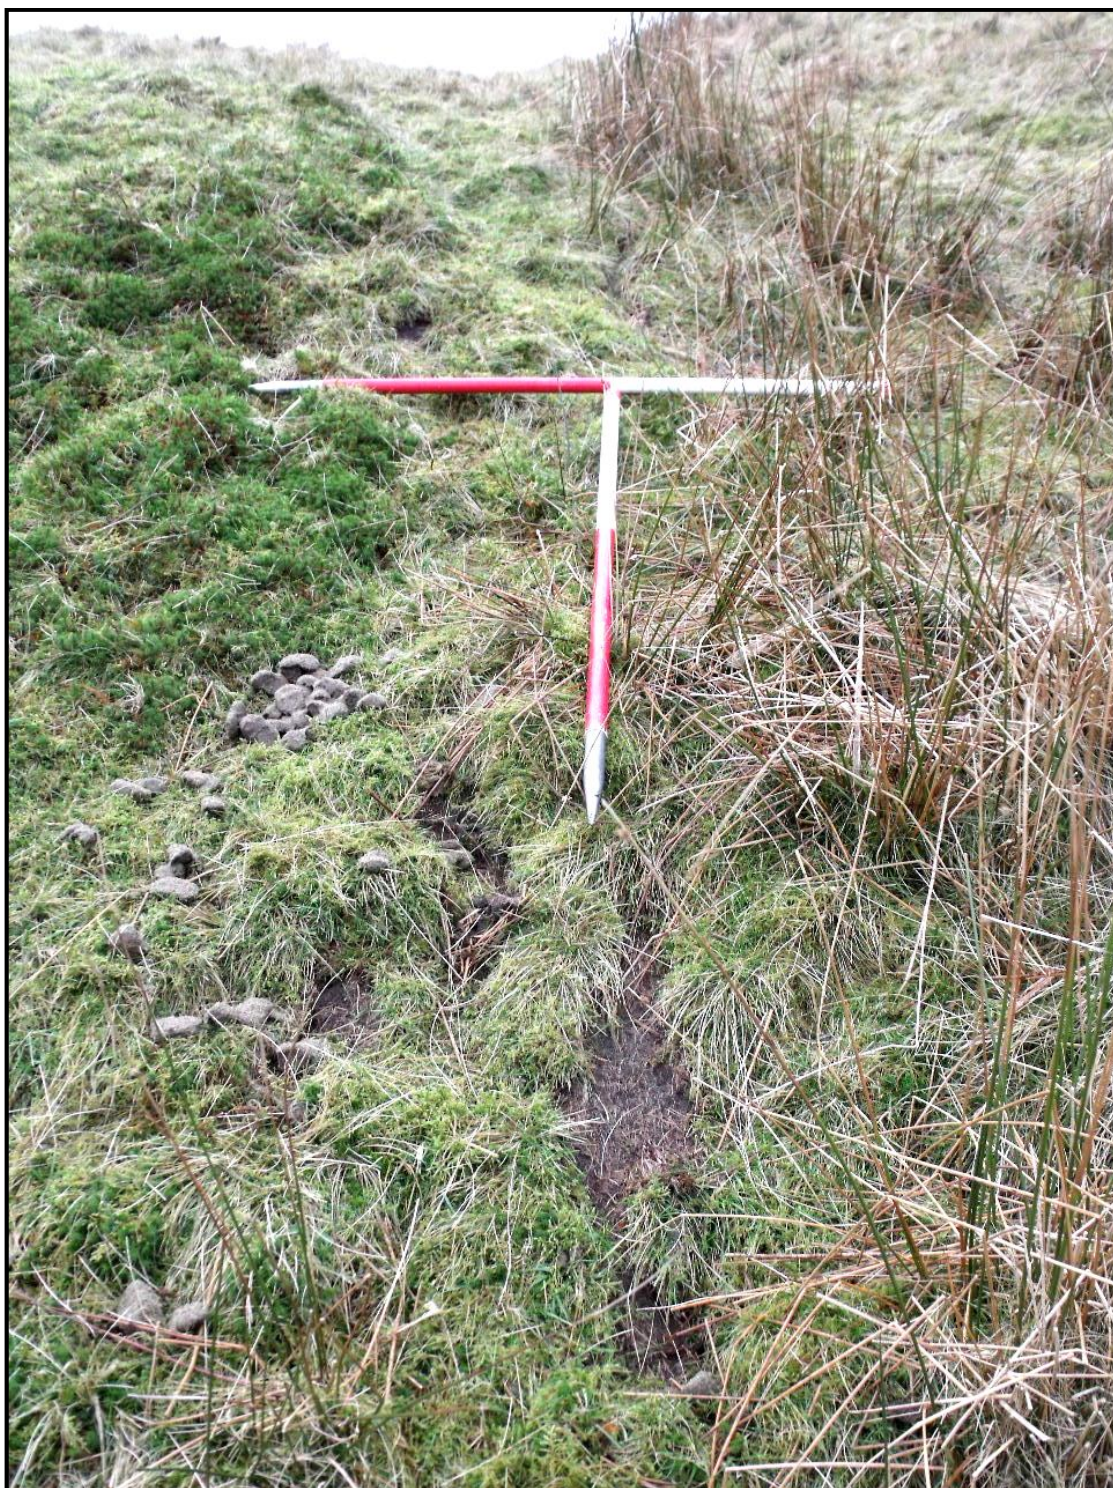
Photo 78. Showing pony track erosion on BR241 (PRN 3248)
