**Moel y Gamelin Round Barrow
S.A.M. De68
&
Moel y Gaer Hillfort
S.A.M. De126
Proposals for Management**

PROPOSALS FOR THE MANAGEMENT OF

MOEL Y GAMELIN ROUND BARROW S.A.M.De68

MOEL Y GAER HILLFORT S.A.M.De126

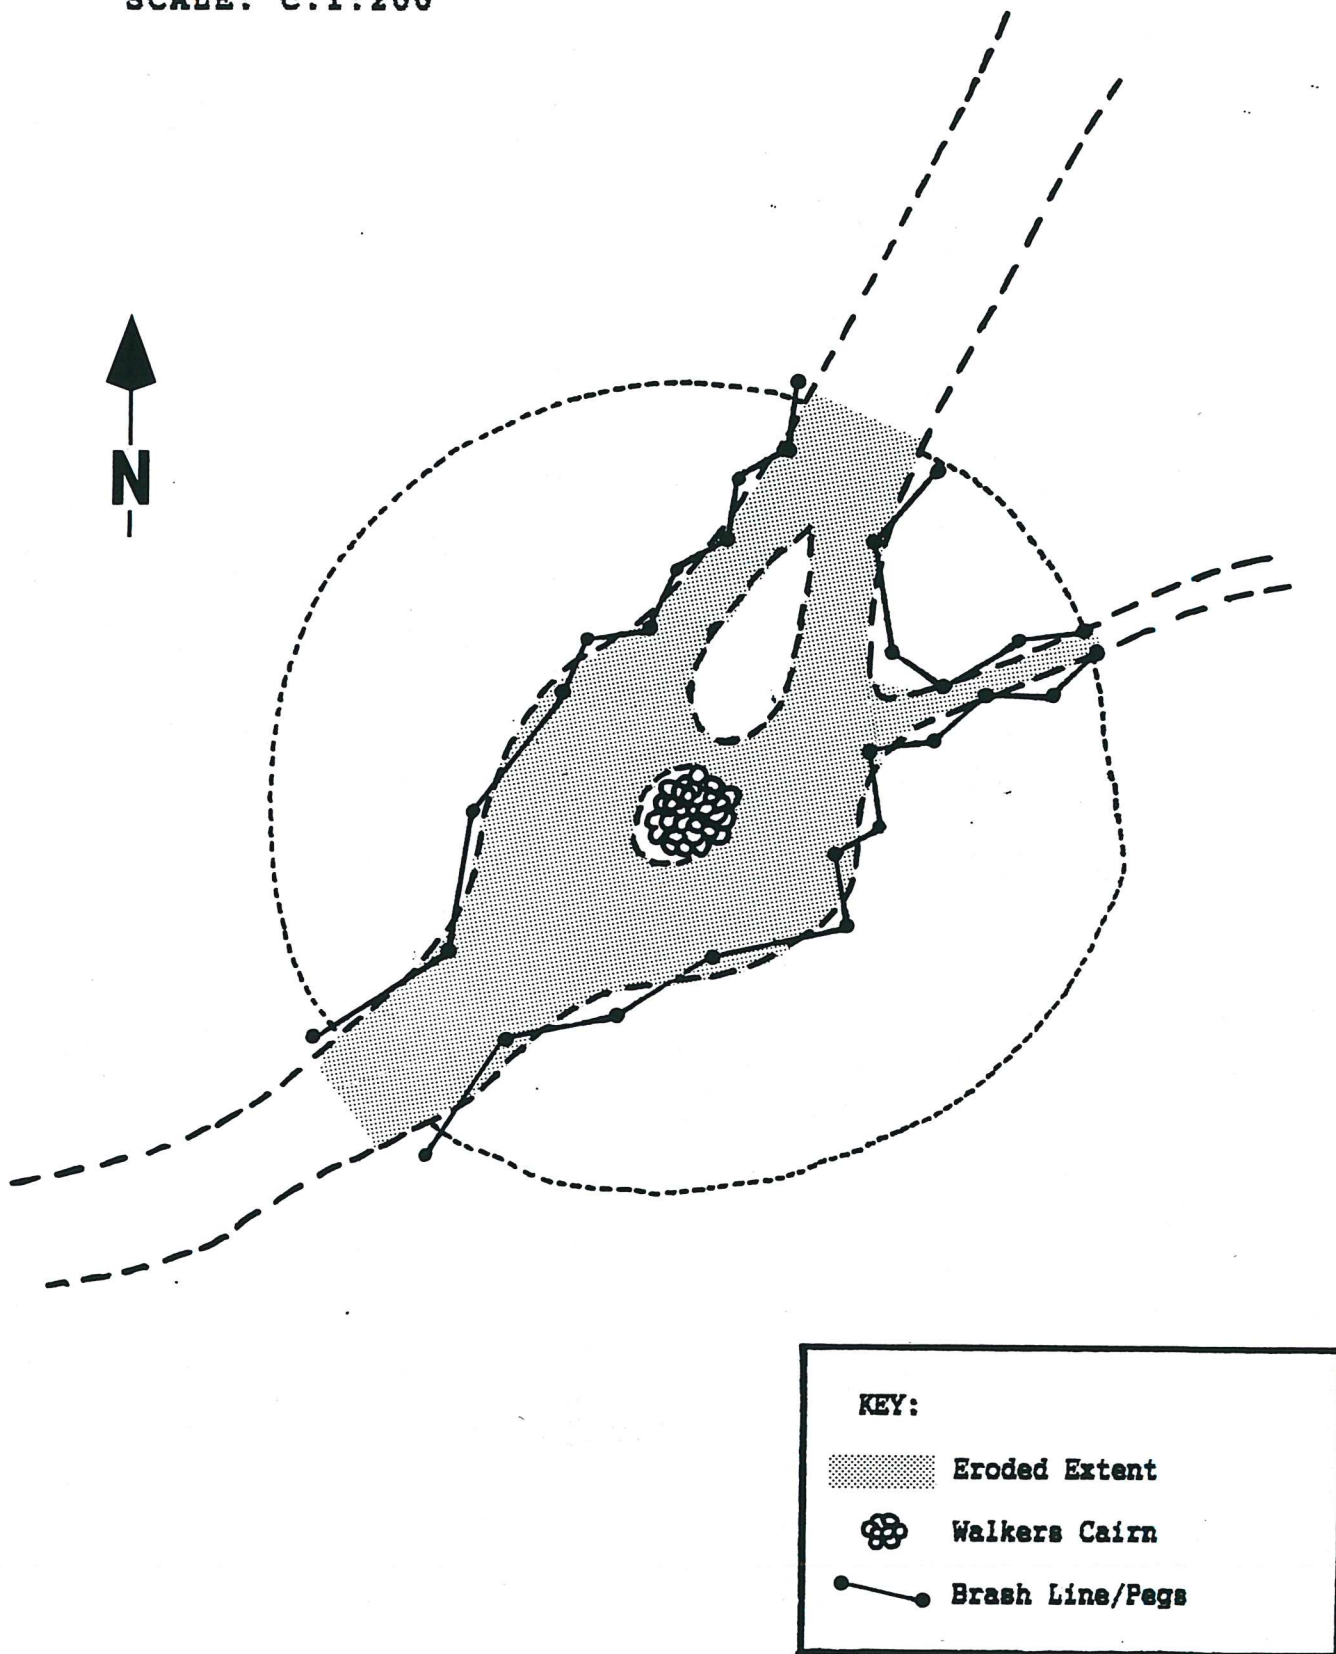
FIGURE ONE a:

Access across the summit of Moel y Gamelin Round Barrow has resulted in the exposure of the shaley substrate through the loss of some 100mm (4in.) of the surface peat. On the north-eastern flank of the monument, where shear action is enhanced by the gradient of the slope, erosion occurs to a depth of circa 200mm (8in.). The extent of this damage is illustrated diagrammatically in Figure 1a.

It is proposed that the eroded surface be covered with a layer of imported soil of local provenance to provide a medium to enable rapid re-vegetation and to afford protection to the exposed archaeological surface. On the summit and south-western flank this material will not exceed 50mm (2in.) in depth. On the north-eastern flank, however, where scarring is more acute it is proposed that the surface be repaired to its former profile, requiring a maximum infill depth of 200mm (8in.). At this location, because of the depth of infilling, it is proposed that the interface between the eroded archaeological surface and fill material be defined using Greenfix Type 13 polypropylene matting.

The eroded extent of the monument is then to be turfed. Where possible it is proposed that turf be derived as a by-product of posthole boring for the deflective fencing. This is to be augmented, as required, by using unimproved turf derived from farmland adjoining the Range but outwith the S.S.S.I.

To stabilise this turf and overcome the potential problems of root shear during the critical establishment phase it is proposed that the turf be secured with Wyretex Fabric-type 8 steel wire/polypropylene matting. This is to be pinned to and through the turf using 5mm (0.2in.) diameter steel pins not exceeding 190mm (7.5in.) in length, to a maximum density of 6 per square metre.

It is proposed that the interface between the repaired area and adjoining extant semi-natural vegetation be protected by a layer of forestry brushings. This is intended to contain access and enable the exclusion of livestock from the margins to facilitate a gradual colonisation by semi-natural vegetation.

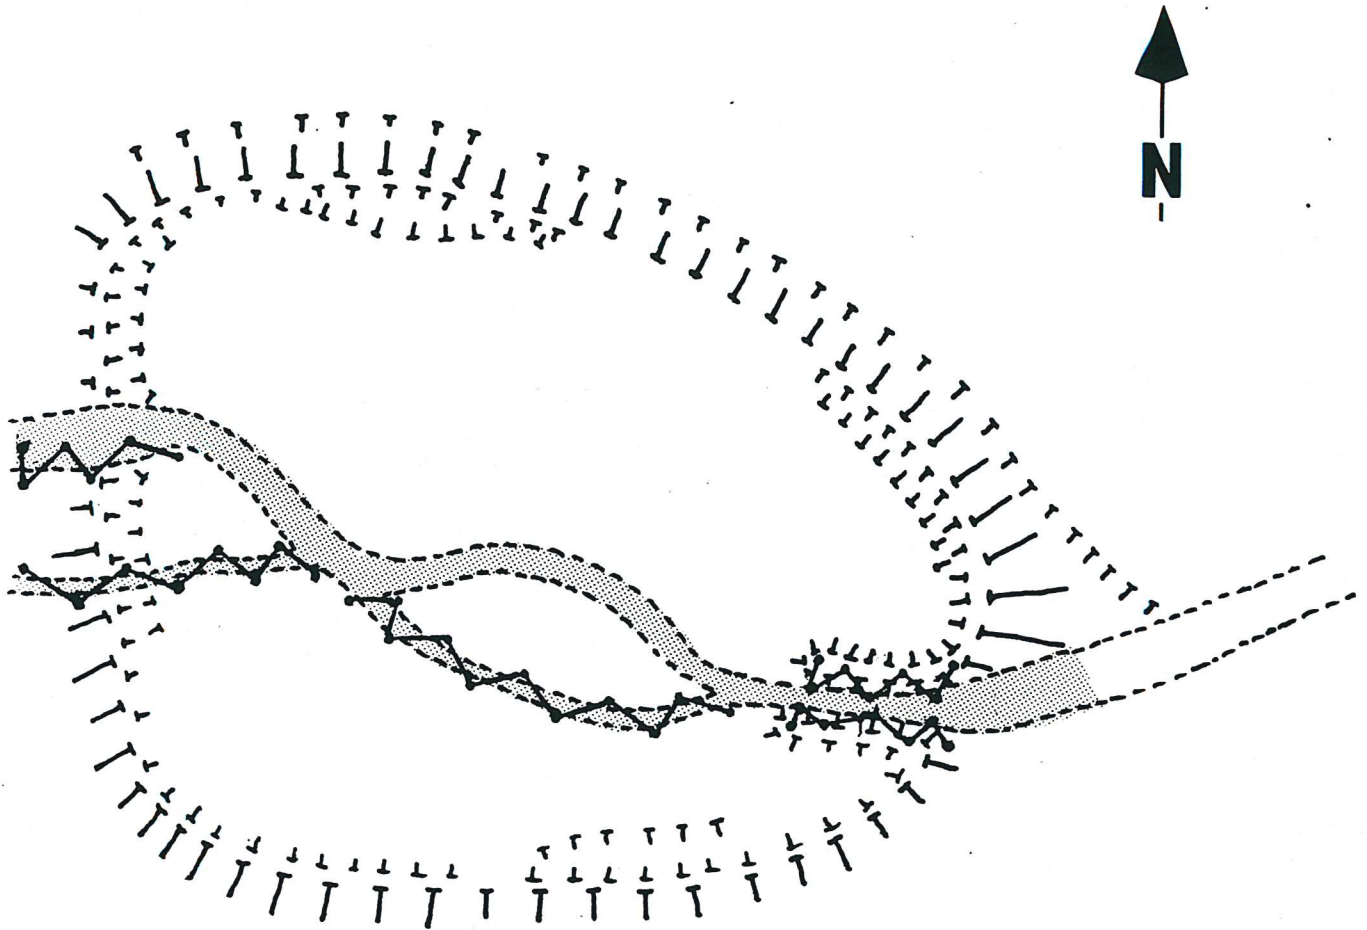
FIGURE ONE b:

Access at Moel y Gaer Hillfort occurs through the eastern inturned gateway. The track traverses the interior of the fort to exit across the western rampart. The track averages 1.5 metres (5 feet) in width extending to approximately 10 metres (33 feet) where it crosses the western rampart. Throughout surface horizons have been lost, with average erosion to a depth of 150mm (6in.) increasing to some 450mm (18in.) across the western rampart. There is evidence of path braiding, as yet embryonic. The extent of this damage is illustrated diagrammatically in Figure 1b.

The nature and depth of erosion damage at Moel y Gaer suggest that the archaeological horizons have been lost along the extent of the track, except in the areas of the western rampart and eastern gateway. It is proposed therefore that works be designed to permit continued access along the existing track, whilst preventing an increase in track width and affording protection to the gateway and rampart areas.

It is proposed that the margins of the track, embryonic path braiding and areas of superficial sheet erosion be brashed as described previously to contain access and exclude livestock. It is intended that brashing will achieve a reduction in boundary layer windspeeds with resultant enhancement of the micro-climate at soil level. It is anticipated that this, coupled with the physical exclusion of livestock, will facilitate recolonisation by semi-natural vegetation. Brashing is intended to reduce overall path width to 1.2m (4 feet).

Where the track passes through the gateway, it is proposed that a 20m (66 feet) length of path be turfed using imported unimproved turf, as described previously. Turf is to be laid onto a 50mm (2in.) layer of imported fill to afford protection to the eroded archaeological surface.

Where the track crosses the western rampart it is proposed that a 1.2m (4 feet) width path be defined at the northern end of the scar where erosion depth is greatest. This is to be turfed as described previously. Elsewhere, it is proposed that path width be reduced to 1.2m (4 feet) using pegged and wired forestry brashings. Given the extensive nature of sheet erosion in this area it is proposed that the subsoil surface first be stabilised and protected against rainwash using Greenfix Type 6 100% coirfibre matting secured using 5mm (0.2in.) diameter 100mm (4in.) pins to a maximum density of 6 pins per square metre. It is proposed that this stabilised surface be allowed to recolonise naturally.
