CPAT Report No. 1739

# Castell Dinas Brân, Llangollen, Denbighshire

Condition Survey

Client name: Denbighshire County Council  
 CPAT Project No: 2457  
 Project Name: Castell Dinas Brân  
 Grid Reference: SJ 2225 4306  
 County/LPA: Denbighshire  
 CPAT Report No: 1739  
 Event PRN: 140340  
 Report status: Final  
 Confidential until: N/A

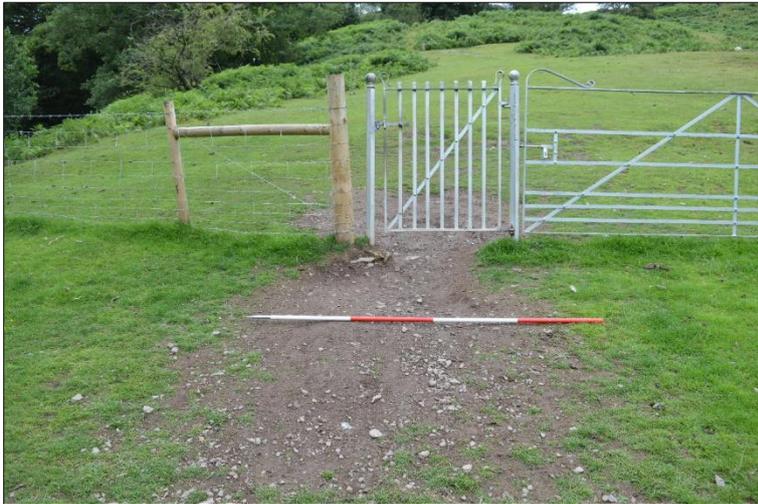
**Description:** Erosion of turf and soil cover around the lower of the two entrance gates, affecting an area of around 2m by 1.5m below the gate and 1.5m by 1.5m above the gate.

**Recommendations:** monitor

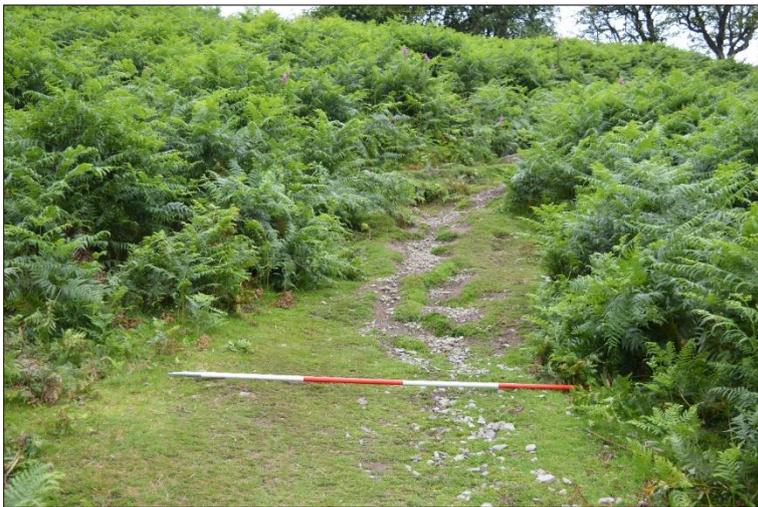
**Issue No: 04**                      **Issue type 1: Visitor****Location:** Eastern access path**Photographic references:** CPAT 4771-0006 to 0007**Stability:** active                      **Impact:** none                      **Priority:** medium**Description:** At the first set of timber and stone steps a new path has developed, cutting the corner and avoiding the steps. Above these steps edge-set slates have been used to form low steps, which are being bypassed by visitors. Potential for future issues with water erosion.**Recommendations:** Monitor. Extend timber and stone steps to replace edge-set slate. Install post and rail fence to prevent shortcut on corner.

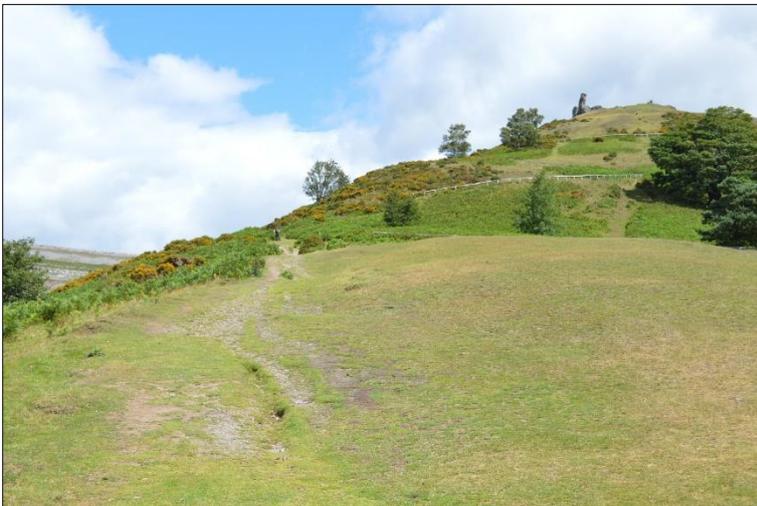
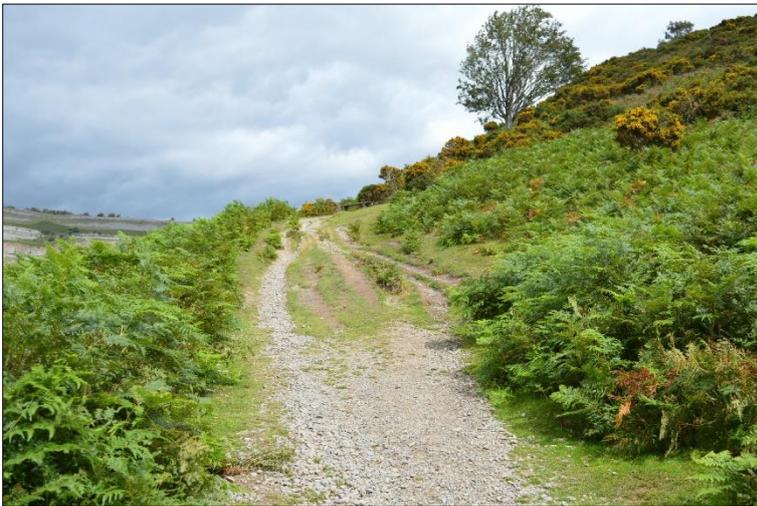
**Description:** The lower section of the western access path is becoming braided, mostly as a result of visitors avoiding the main path, which is often wet and muddy and can be slippery on the decent.

**Recommendations:** Monitor. Install drains to deflect runoff.

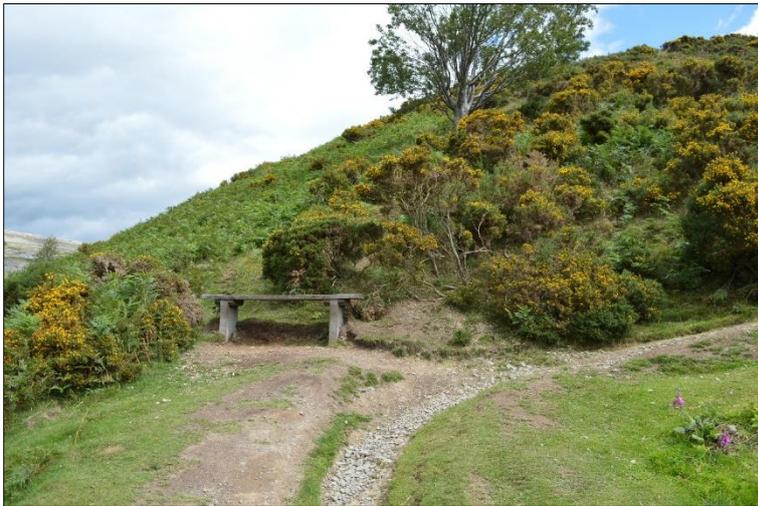
**Description:** On the lower hairpin the path has become a narrow gully eroded further by water, while visitors are cutting the corner, leading to the loss of turf cover.

**Recommendations:** Monitor

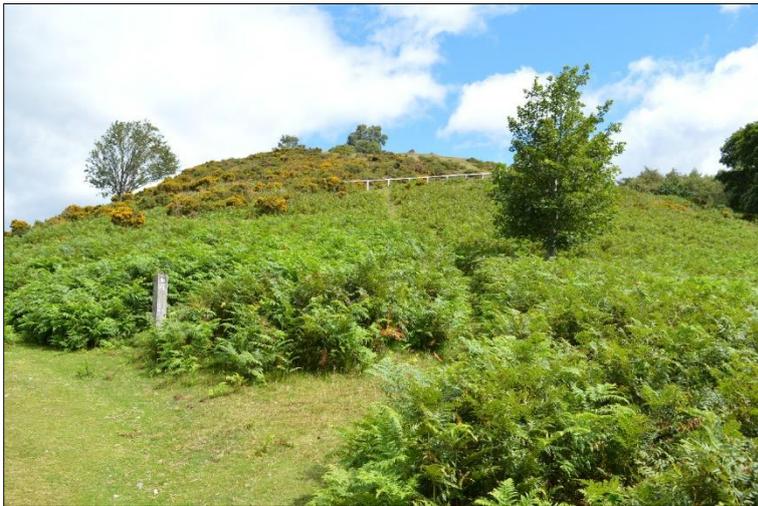
**Description:** A narrow path avoids the lower hairpin, although this was not well used at the time of the survey.

**Recommendations:** Monitor

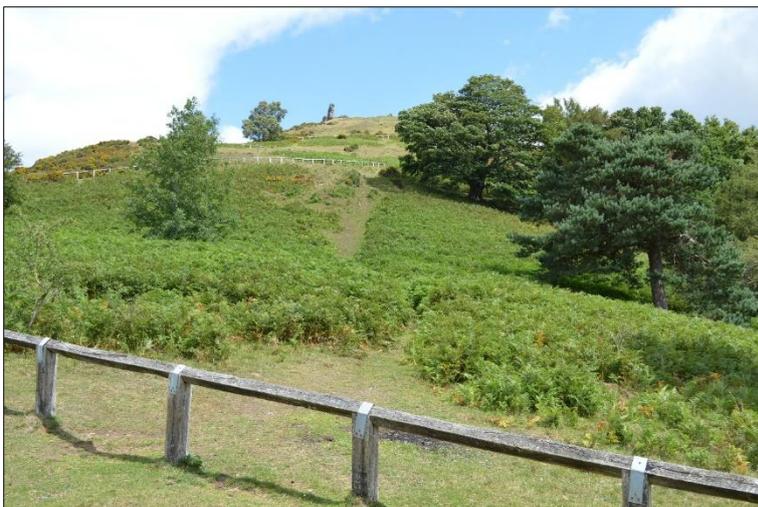
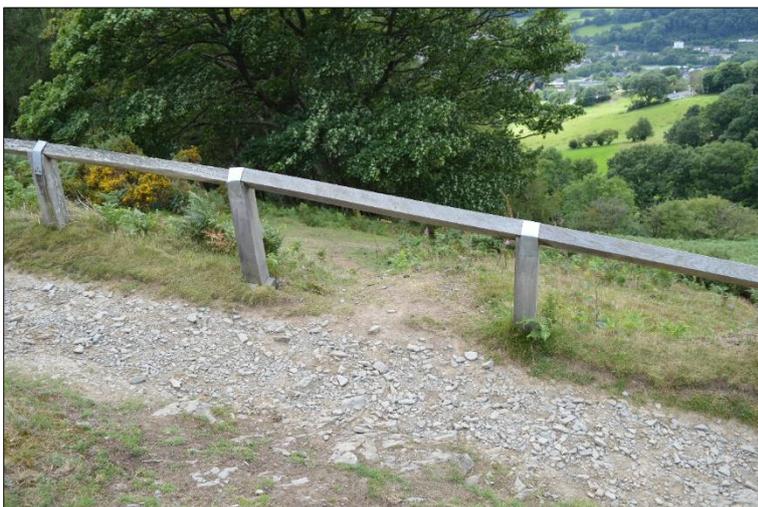
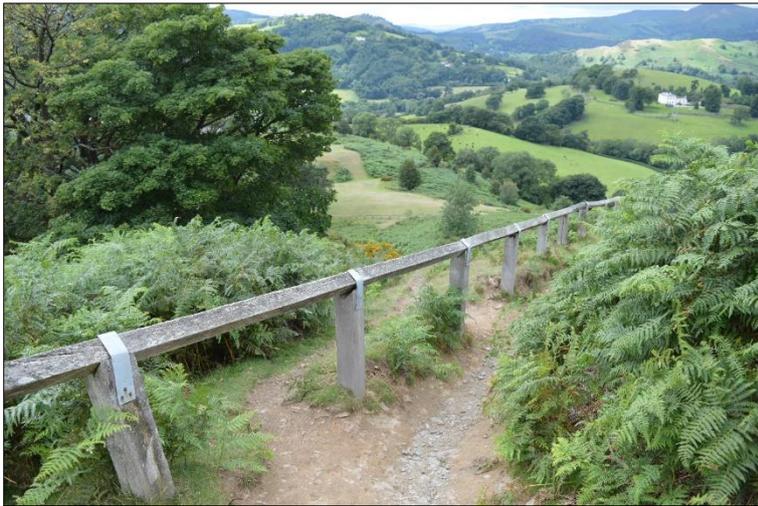
**Issue No: 09****Issue type 1: Visitor****Location:** Western access path**Photographic references:** CPAT 4771-0114 and 0121 to 0122**Stability:** active      **Impact:** none      **Priority:** low

**Description:** Visitors are avoiding the lower section of the path and have created a direct line of ascent/descent to/from the second hairpin. Consideration should be given to introducing a mid-rail in the existing fence.

**Recommendations:** Monitor

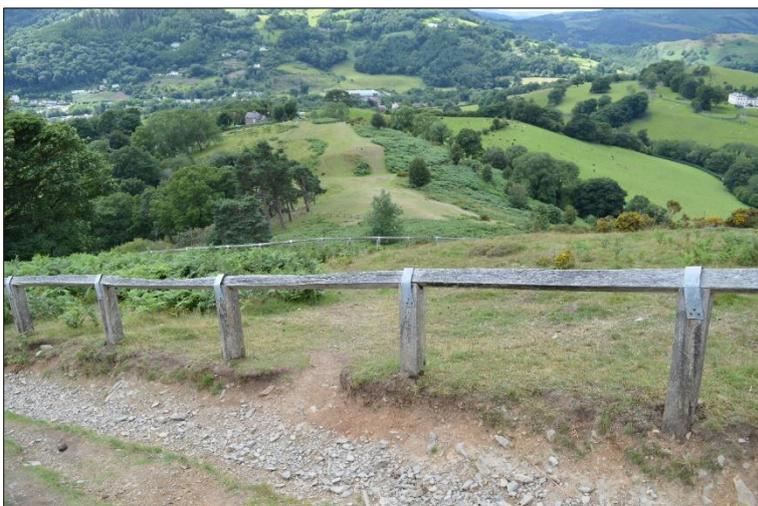
**Description:** Visitors are avoiding the second hairpin and have created a direct line of ascent/descent.

**Recommendations:** Monitor. Consideration should be given to introducing a mid-rail in the existing fence.

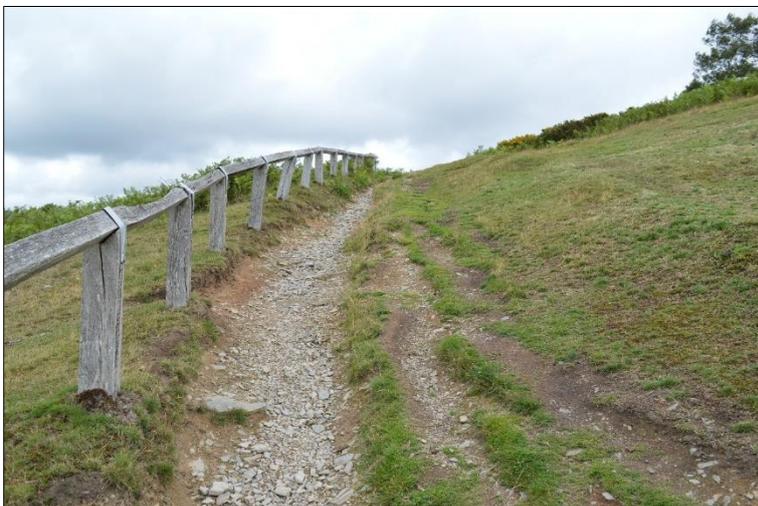
**Description:** Between the second and third hairpins the path is becoming braided.

**Recommendations:** Monitor

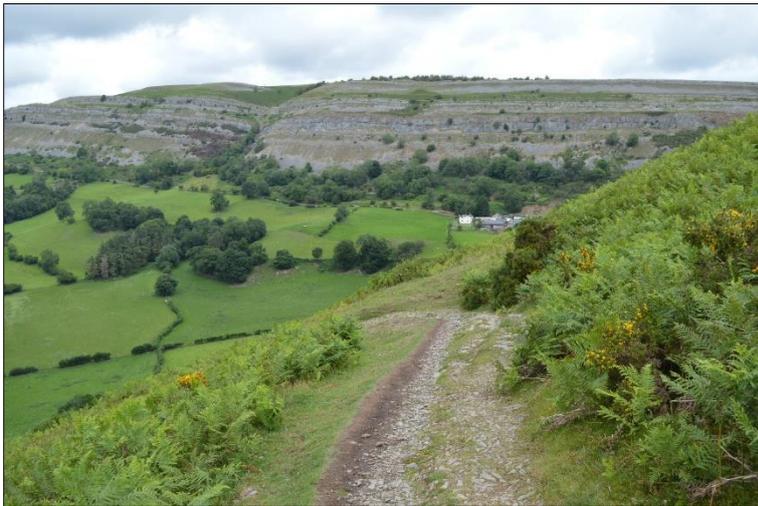
**Description:** The path around the third hairpin has widened, resulting in the loss of turf and potential for water erosion.

**Recommendations:** Monitor

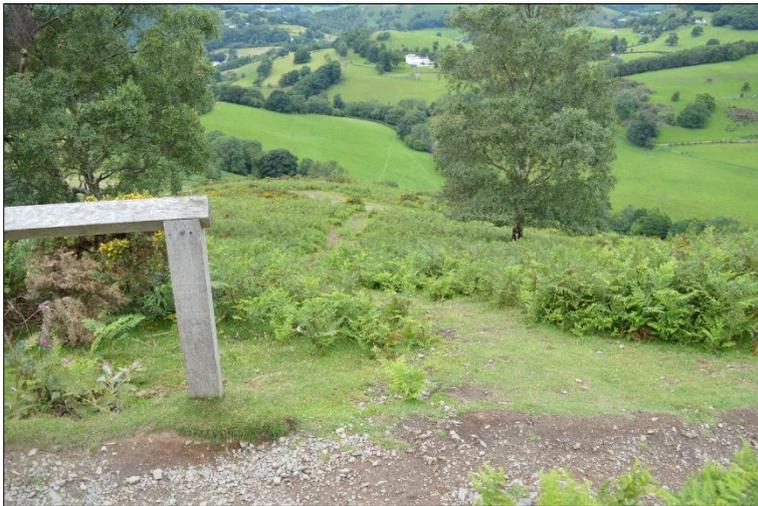
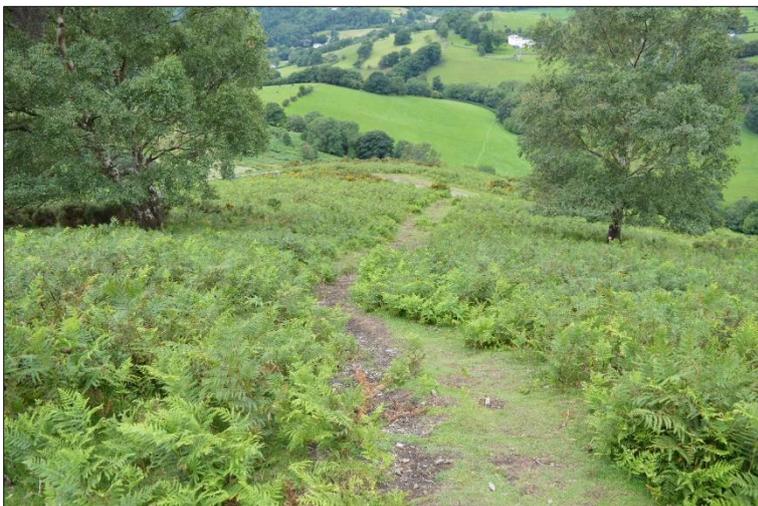
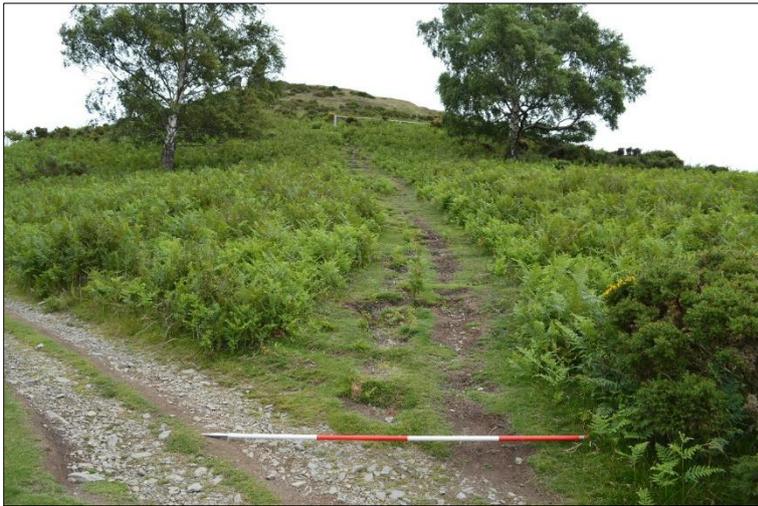
**Issue No: 13****Issue type 1: Visitor****Location:** Western access path**Photographic references:** CPAT 4771-0045 to 0046, 0049 and 0126**Stability:** active      **Impact:** none      **Priority:** low**Description:** Visitors are avoiding the third hairpin and have created a direct line of ascent/descent.**Recommendations:** Monitor. Install fencing across the lower end of the new path and extend fencing at the upper end to deflect visitors.

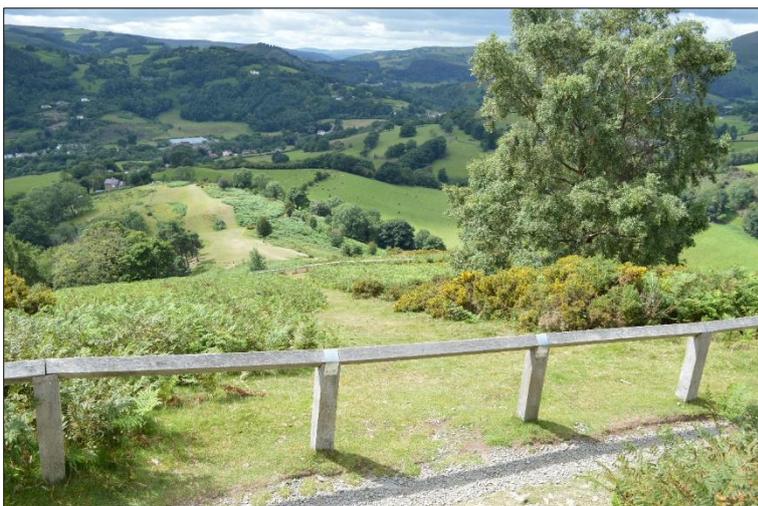
**Description:** Visitors are avoiding the third hairpin and have created a direct line of ascent/descent.

**Recommendations:** Monitor. Consideration should be given to introducing a mid-rail in the existing fence.

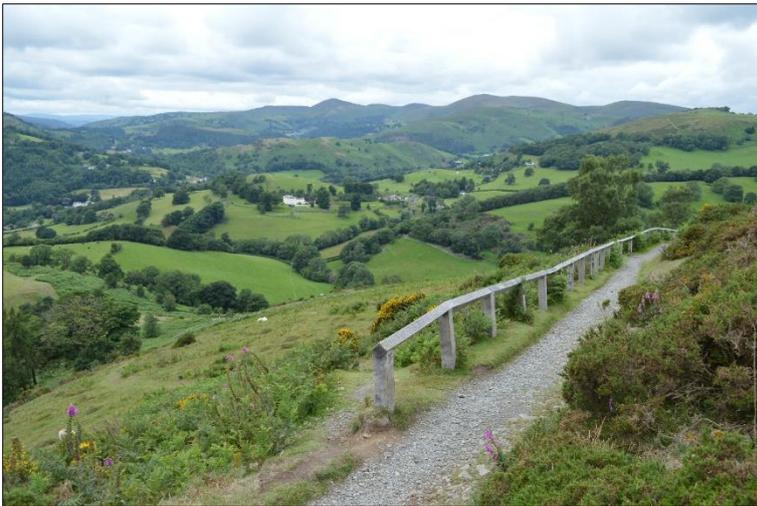
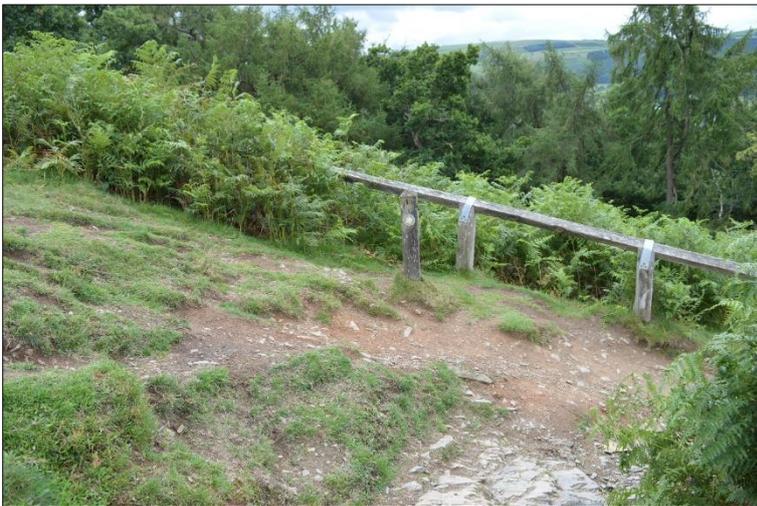
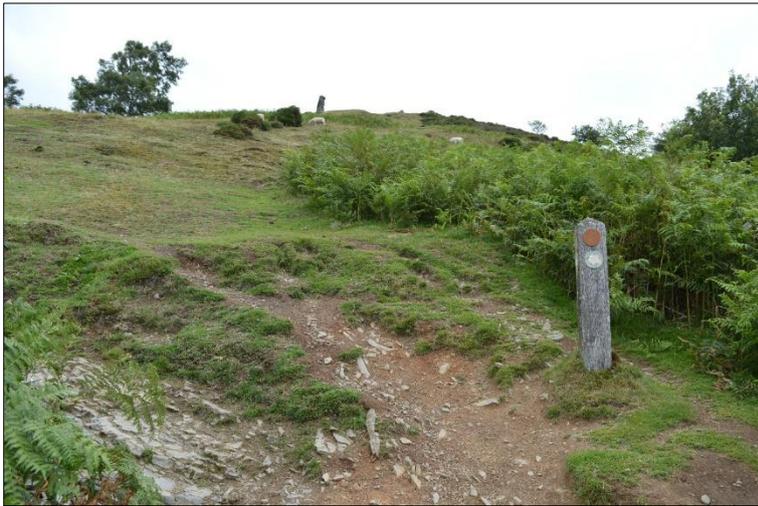
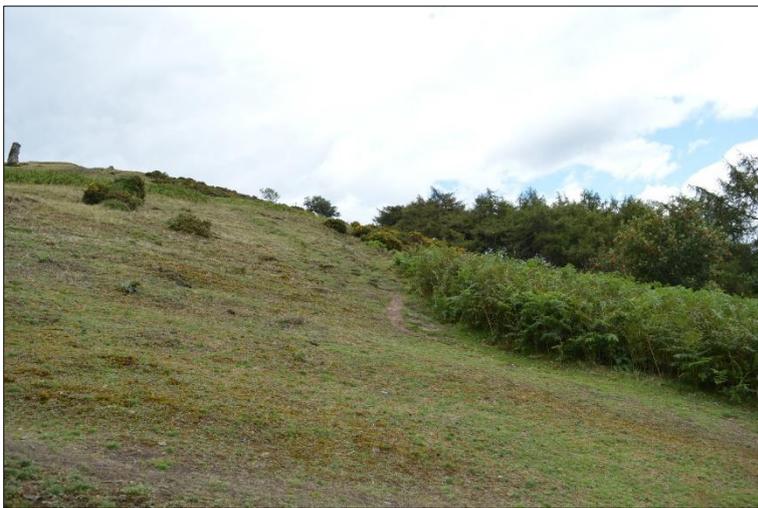
**Description:** A path rising from the second hairpin avoids the third hairpin, creating a direct line of ascent/descent.

**Recommendations:** Monitor. Install fencing across the lower end of the new path, on the second hairpin, and extend fencing at the upper end to deflect visitors.

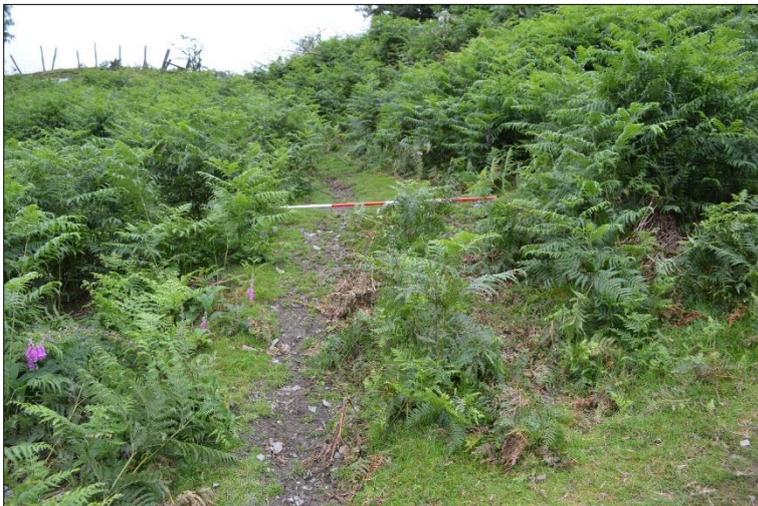
**Description:** An old trackway rises through what appears to be an original entrance to the outer enclosure. The track is used for farm access by vehicles and for driving livestock.

**Recommendations:** Monitor

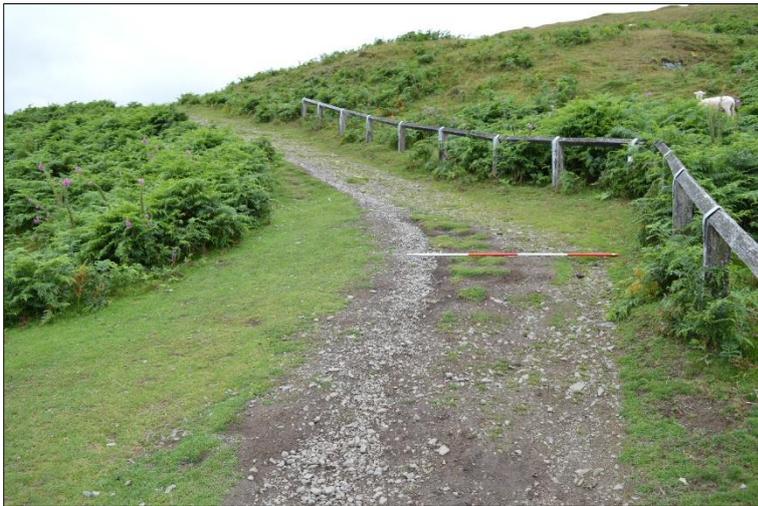
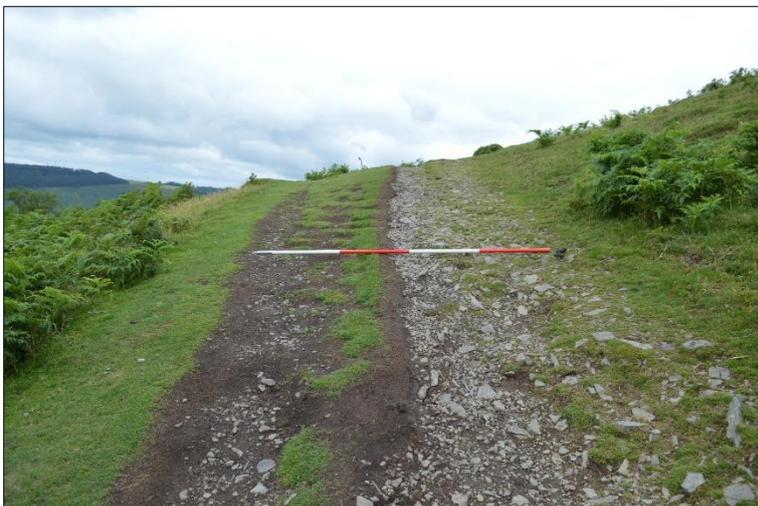
**Description:** Above the second gate and within the area of the outer enclosure the path is gradually widening, eroding the turf cover and leading to the early stages of water erosion and gullying.

**Recommendations:** Monitor. Install drains to deflect water

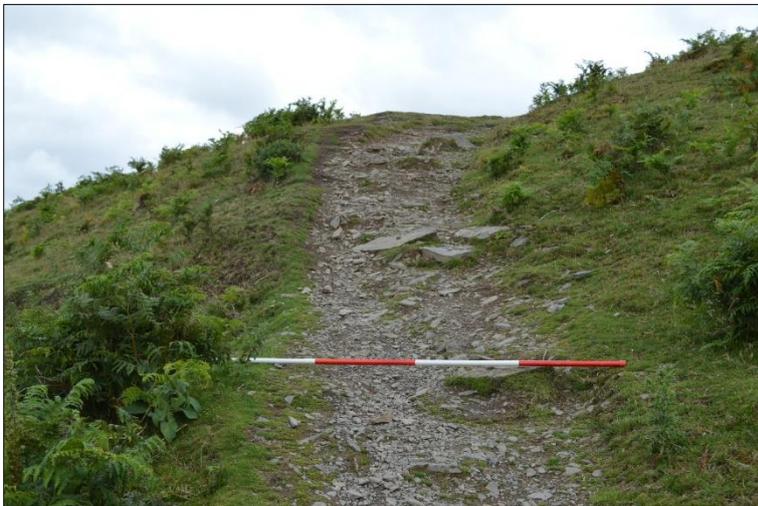
**Description:** The eastern access path crosses the eastern rampart of the hillfort. The stony nature of the rampart has limited the degree of erosion.

**Recommendations:** Monitor

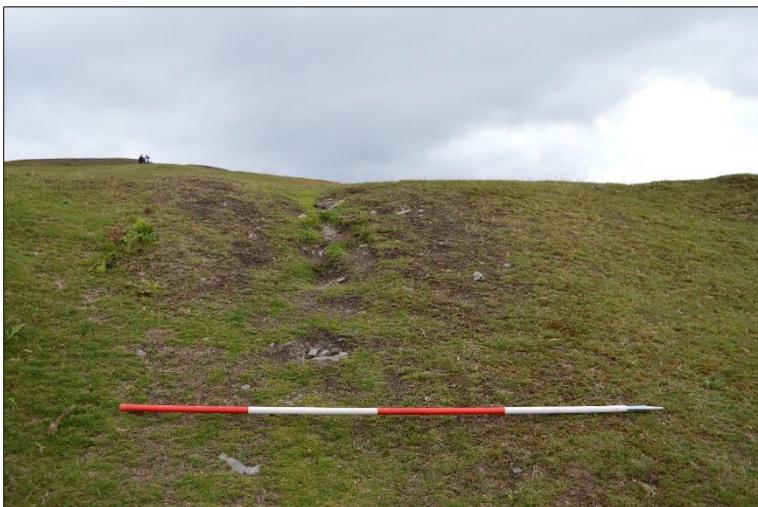
**Description:** A minor path, used mostly by visitors descending the east side of the hillfort, cuts across the rampart north of the main eastern access path. This has led to the loss of some turf cover and the creation of earth steps.

**Recommendations:** Monitor

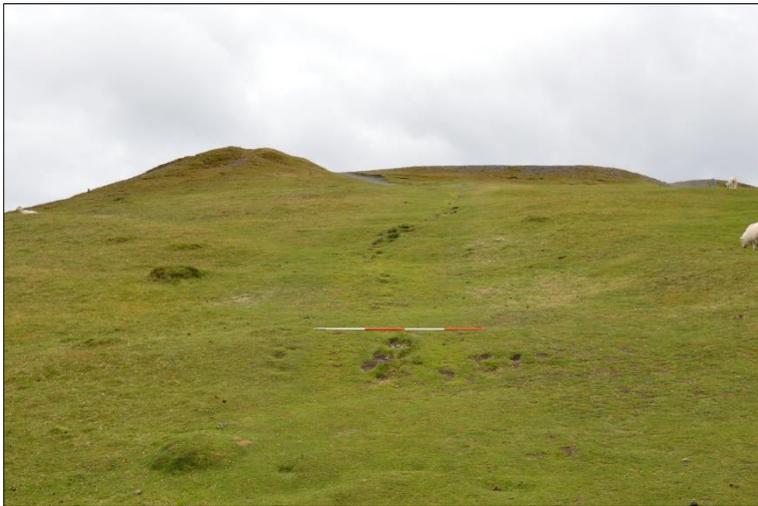
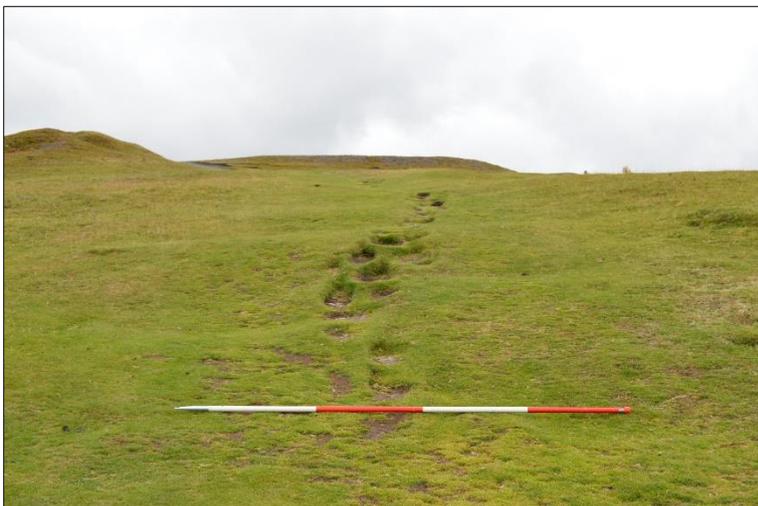
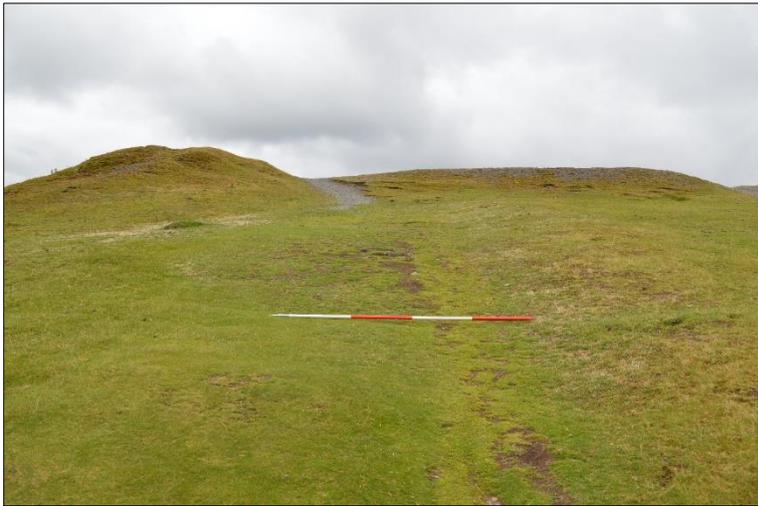
**Description:** The main eastern access path crosses the turf-covered slopes on the eastern side of the hillfort. This has led to the loss of some turf cover and the creation of earth steps.

**Recommendations:** Monitor

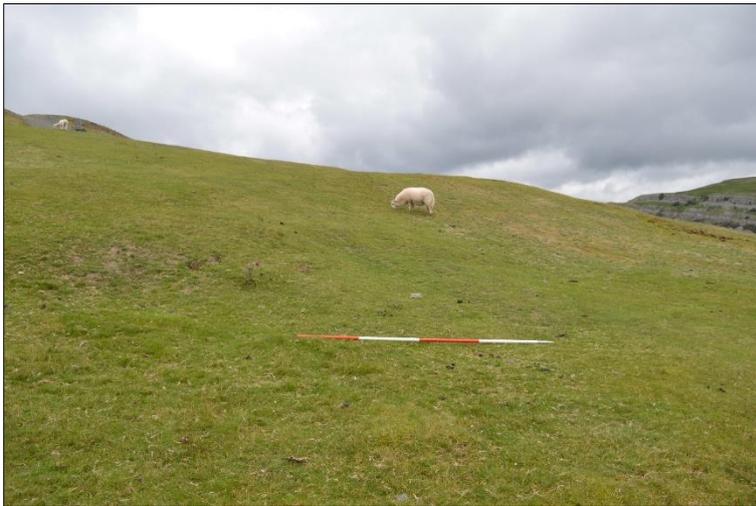
**Description:** A minor path, used mostly by visitors descending the east side of the hillfort, cuts across one of the earthwork platforms on the east side of the hillfort.

**Recommendations:** Monitor

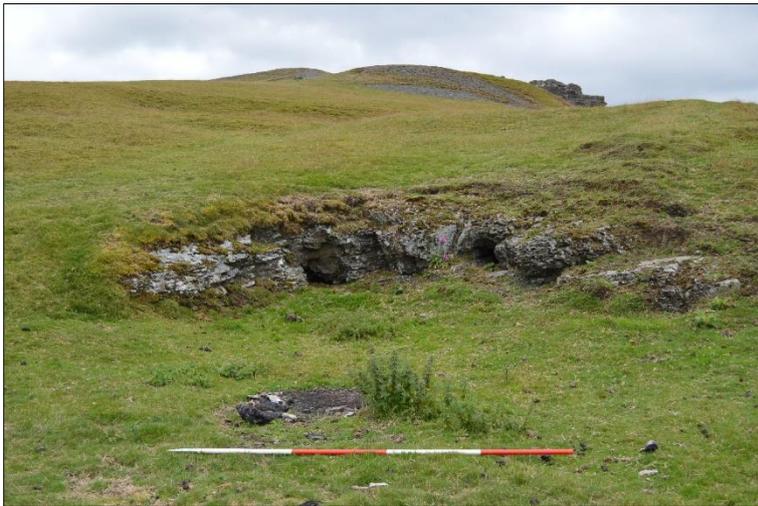
**Description:** A platform, which in part occupies a quarry hollow, has been used by visitors as the site for a camp fire or barbeque.

**Recommendations:** Monitor. Remove evidence of burning.

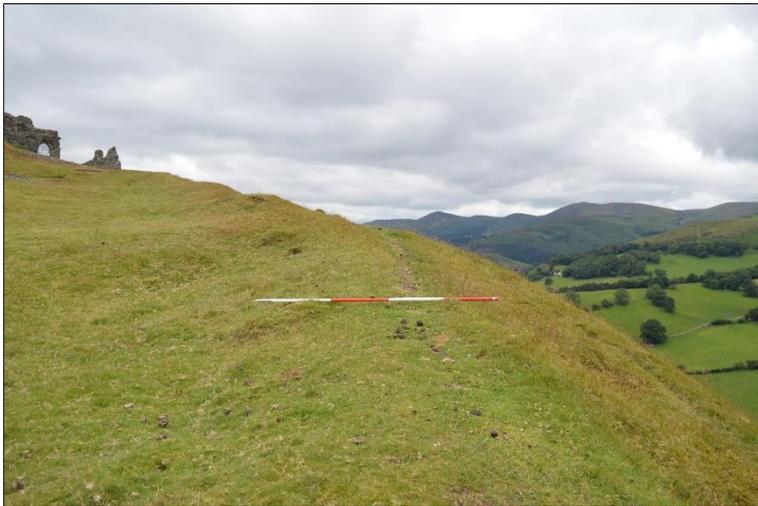
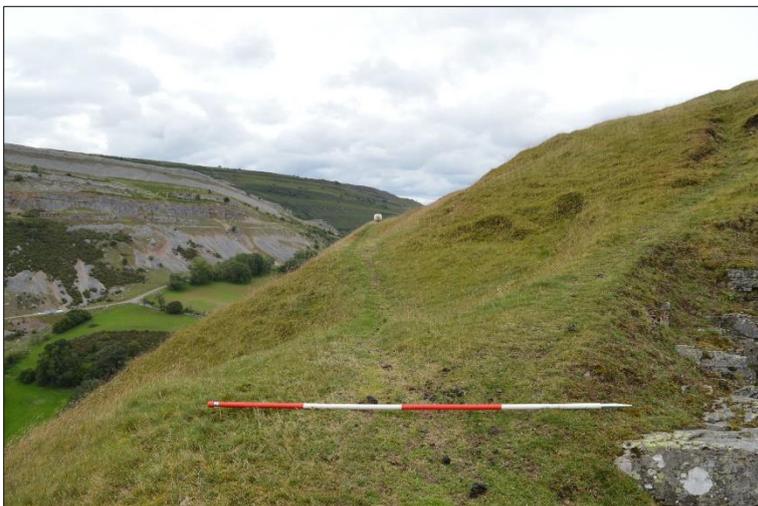
**Description:** A narrow sheep track follows the crest of the rampart before descending the northern side.

**Recommendations:** Monitor

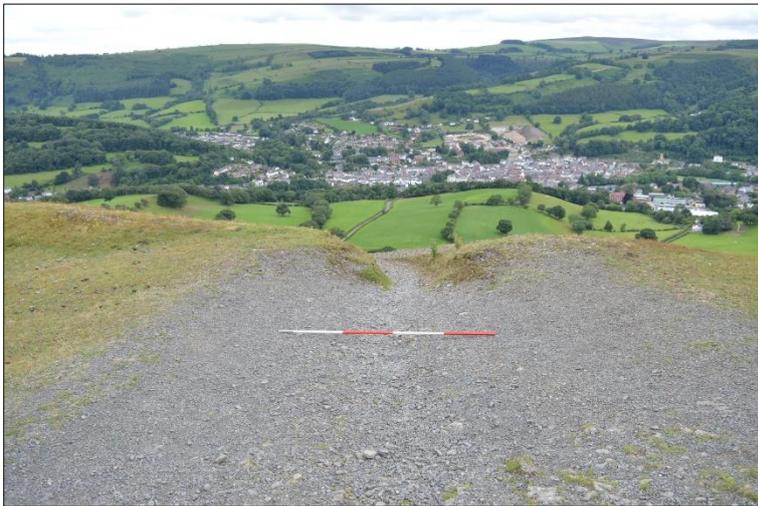
**Issue No: 26****Issue type 1:** Visitor**Issue type 2:** Livestock**Location:** Western access path across hillfort rampart**Photographic references:** CPAT 4771-0057 to 0060**Stability:** active**Impact:** Low**Priority:** medium

**Description:** The western access path cuts through the hillfort rampart above the fourth hairpin. The turf cover has been lost and the path widened by use, although for the most part this has not affected any in situ archaeology. However, where the path cuts through the crest of the rampart there is an active erosion scar on the west side of the path, while on the interior of the rampart the turf has been lost over a wide area, exposing loose scree which is vulnerable to erosion and could expose buried archaeological deposits.

**Recommendations:** Monitor. Consolidate and stabilise erosion scar and rampart interior.

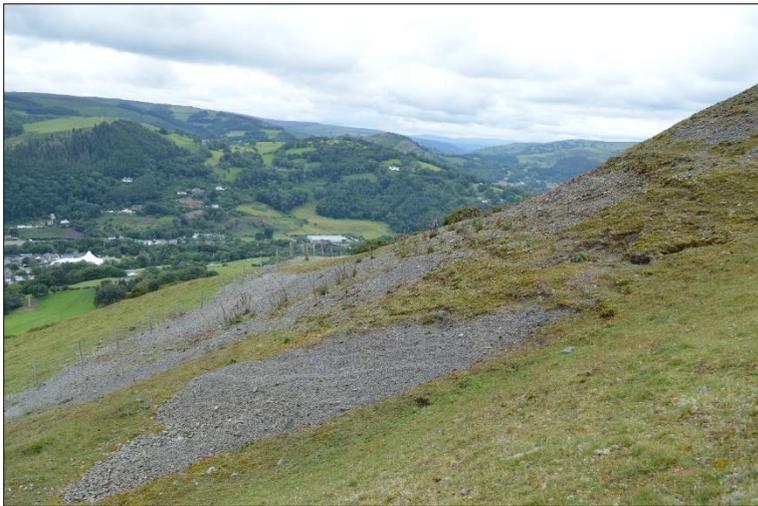
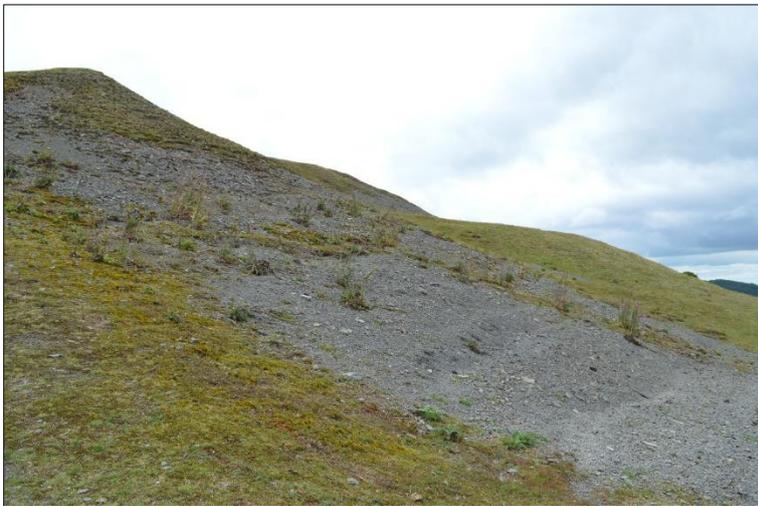
**Description:** The scree slope at the southern end of the large embankment of spoil which occupies the hillfort entrance is affected by active sheep scrapes and tracks, as well as rabbit burrowing, although this does not appear to affect any archaeological deposits.

**Recommendations:** Monitor

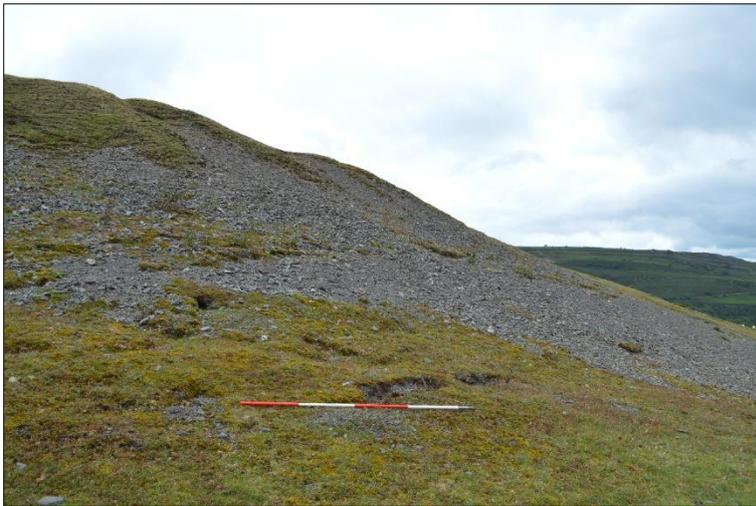
**Issue No: 29****Issue type 1:** Livestock **Issue type 2:** Burrowing animals**Location:** Hillfort interior**Photographic references:** CPAT 4771-0040**Stability:** active**Impact:** negligible**Priority:** low

**Description:** The interior of the hillfort to the east of the entrance is affected by active sheep scrapes and tracks, as well as rabbit burrowing, although this does not appear to affect any archaeological deposits.

**Recommendations:** Monitor

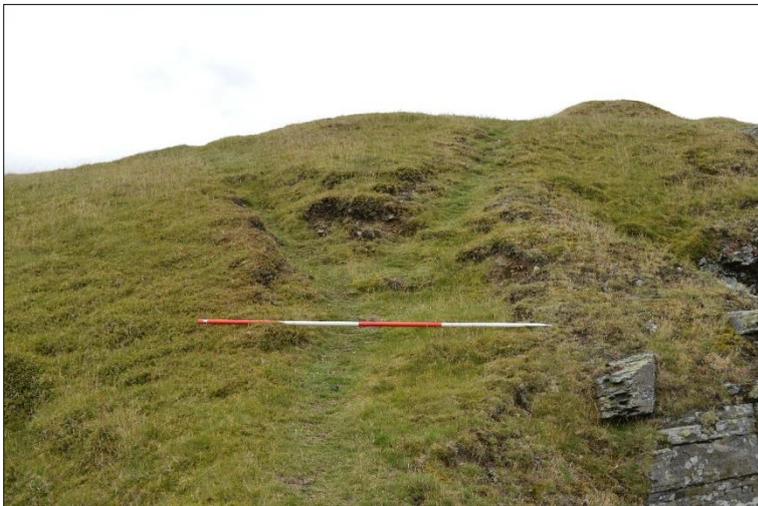
**Description:** Two gullies/paths descend from the northern end of the bank/counterscarp at the north-eastern corner of the quarry ditch.

**Recommendations:** Monitor

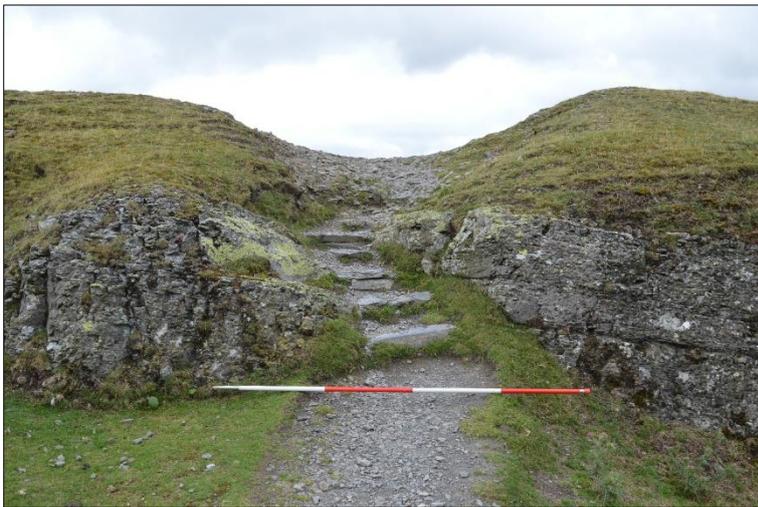
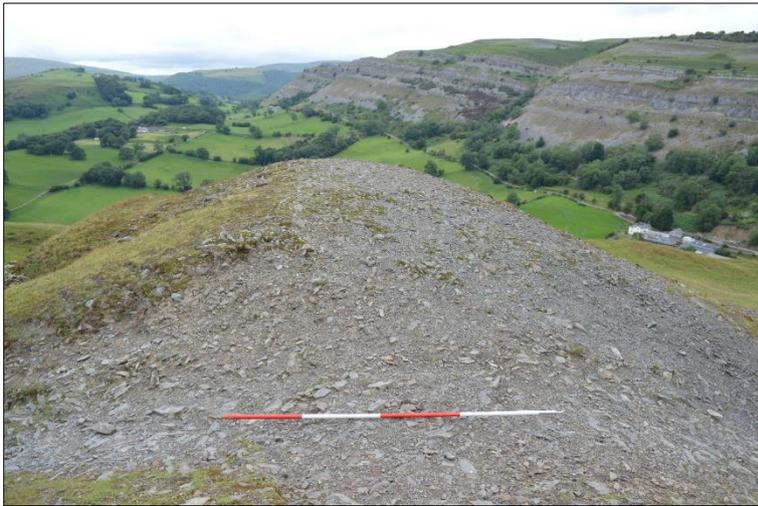
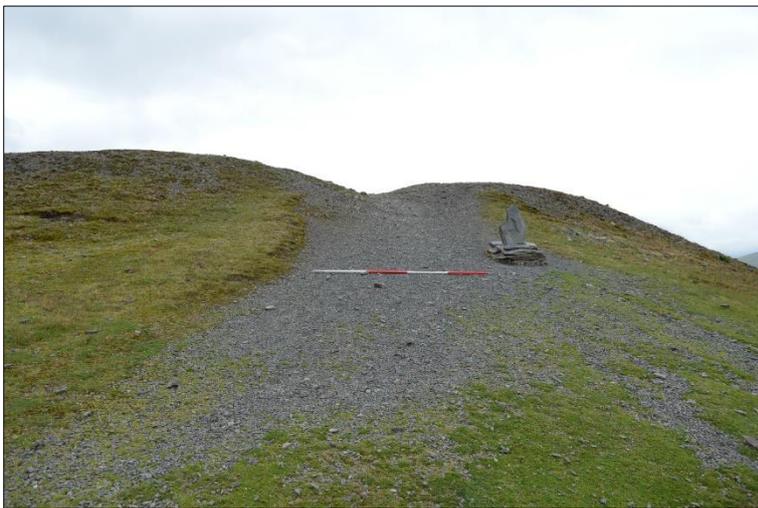
**Issue No: 34****Issue type 1:** Visitor**Location:** Eastern visitor access to quarry ditch**Photographic references:** CPAT 4771-0026 to 0029**Stability:** stable**Impact:** negligible**Priority:** low

**Description:** The eastern visitor access cuts through the bank/counterscarp on the east side of the quarry ditch. Stone steps descend into the ditch and here the path is stable. Where the path cuts through the bank, the stone makeup is exposed, but stable, while on the outer side of the bank there is a broad area of stone where the turf has been removed, although this also appears stable.

**Recommendations:** Monitor

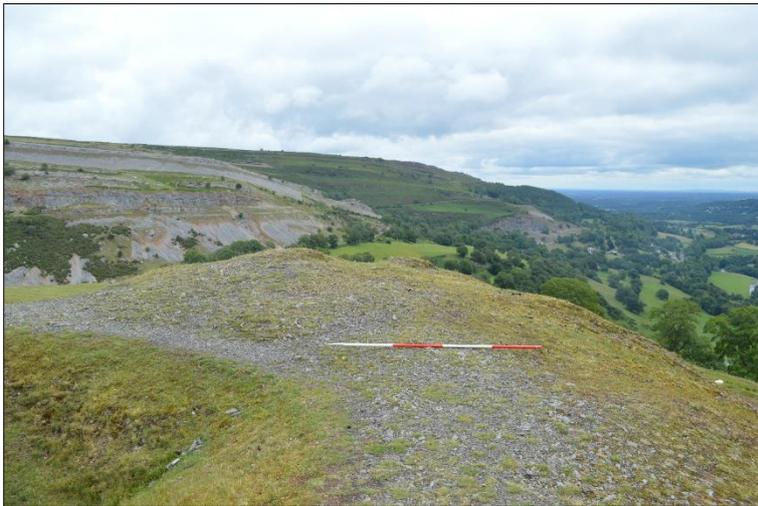
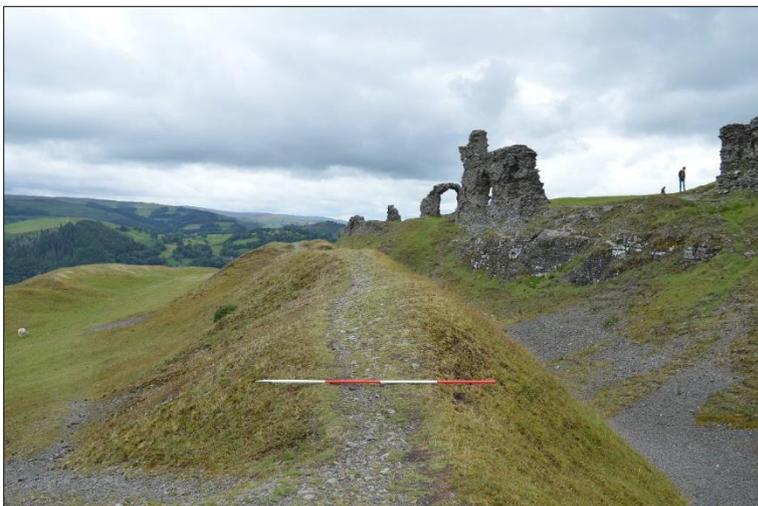
**Issue No: 37****Issue type 1:** Visitor**Location:** Bank/counterscarp south of quarry ditch**Photographic references:** CPAT 4771-0035 to 0036**Stability:** stable**Impact:** negligible**Priority:** low**Description:** A worn path leads from the eastern access path to the corner of the bank outside the quarry ditch, and then westwards along the crest of bank/counterscarp along the south side of the ditch.**Recommendations:** Monitor

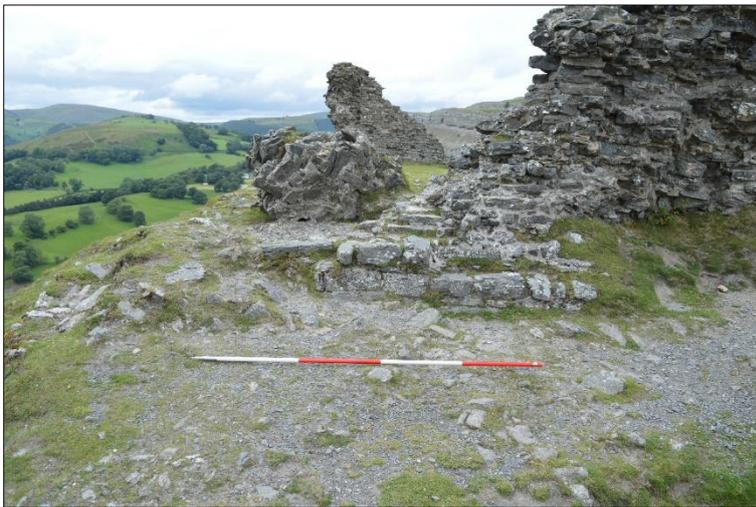
**Issue No: 45****Issue type 1:** Visitor**Location:** south-west corner of castle**Photographic references:** CPAT 4771-0076 to 0077 and 0079**Stability:** stable**Impact:** negligible**Priority:** low

**Description:** The south-west corner of the castle is a popular viewpoint and the turf has been eroded over much of the area between the postern gate and upstanding walling to the north, as well as the area formerly occupied by a camera obscura. However, despite the lack of turf the area appears to be relatively stable.

**Recommendations:** Monitor

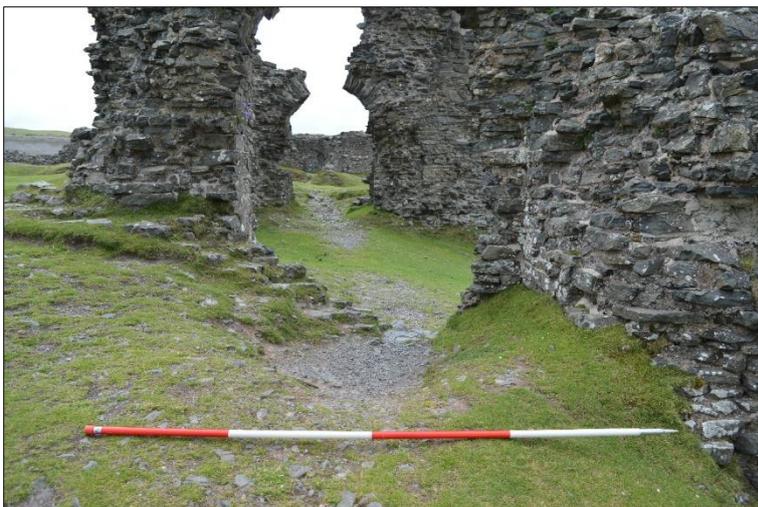
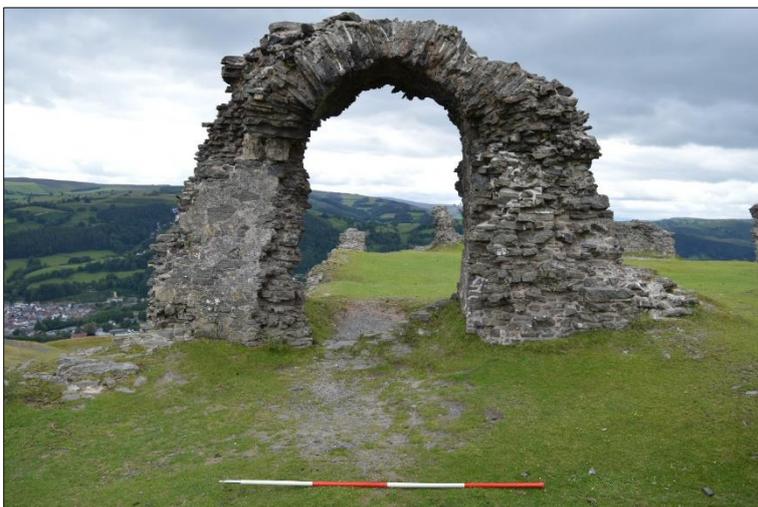
**Issue No: 51**                      **Issue type 1: Visitor****Location:** D-shaped tower**Photographic references:** CPAT 4771-0089 to 0090**Stability:** active                      **Impact:** negligible                      **Priority:** low**Description:** Passage through the eastern arch of the tower has eroded the turf cover internally and externally, although the underlying rubble is stable.**Recommendations:** Monitor.

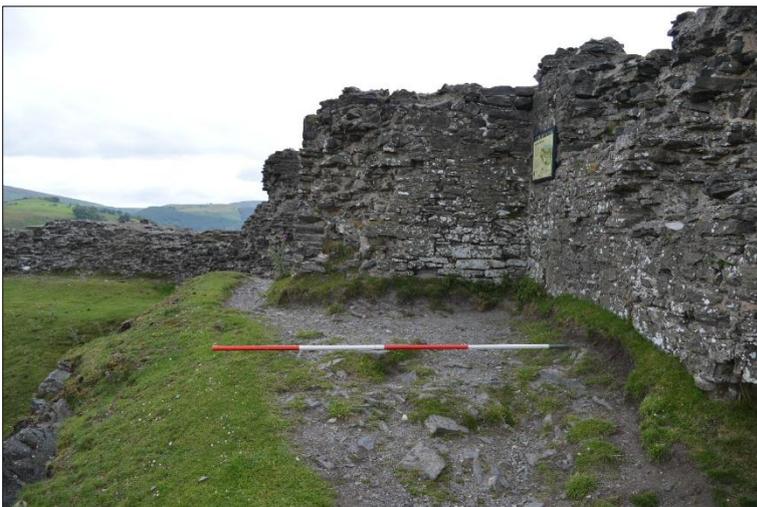
**Issue No: 54****Issue type 1:** Visitor**Location:** west side of keep**Photographic references:** CPAT 4771-0094 to 0095**Stability:** stable      **Impact:** none      **Priority:** low

**Description:** A path runs along the western side of the keep, crossing a short length of exposed masonry, leading to the site of the interpretation panel, where the loss of turf cover is more extensive. The area is, however, fairly stable.

**Recommendations:** Monitor
