*St Cwyfan's Church, Llangwyfan, Denbighshire*

EXCAVATION AND RECORDING 1997

**CPAT Report No 270**

**by W J Britnell**

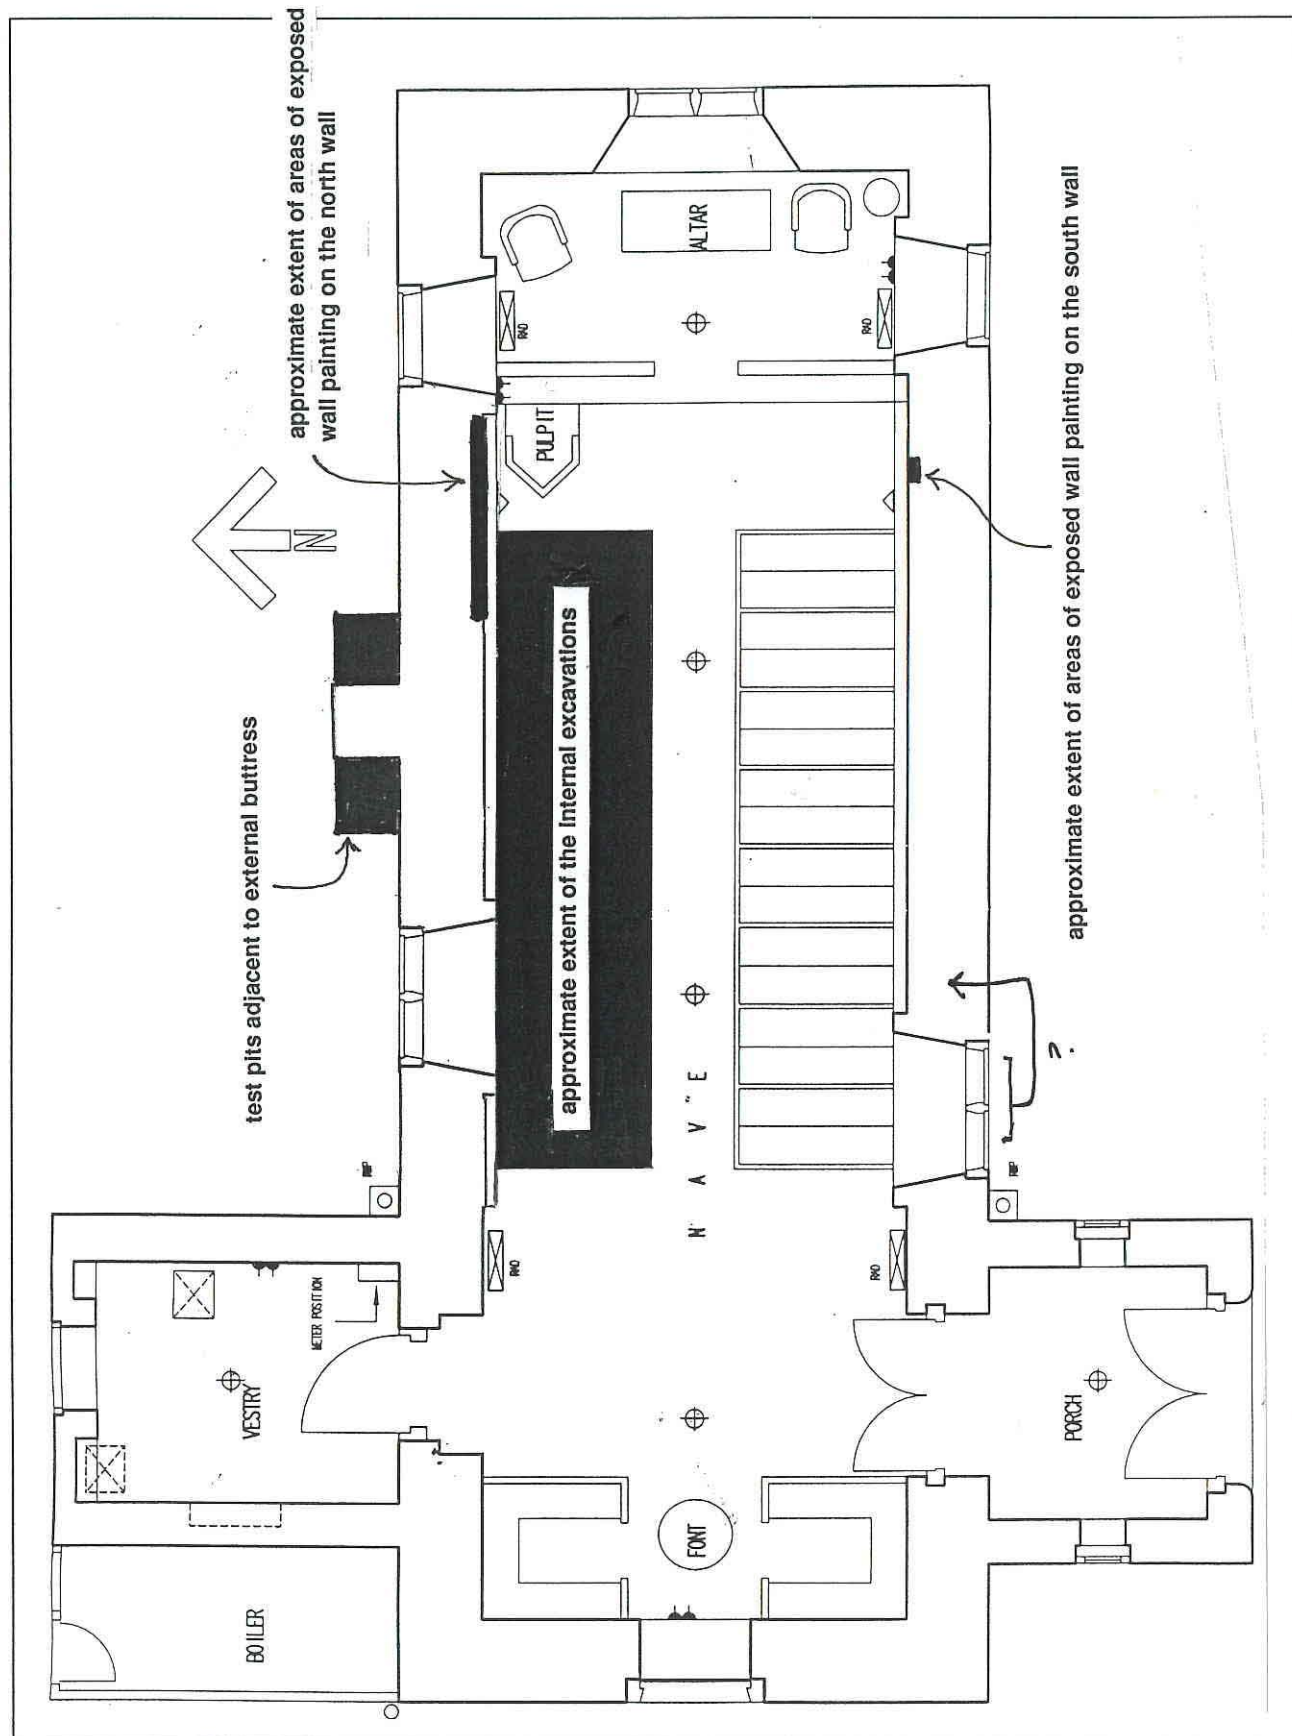
Fig. 1. After architect's plan of church (© Edmund Kirby, Architects, India Buildings Liverpool), not to scale, overlain by details showing test pits adjacent to external buttress, the approximate extent of the internal excavations, and the approximate extent of areas of exposed wall painting on the north and south walls. (Note amendment to position of window in north wall of nave; the window in the south wall of nave should probably also be further to the east.)

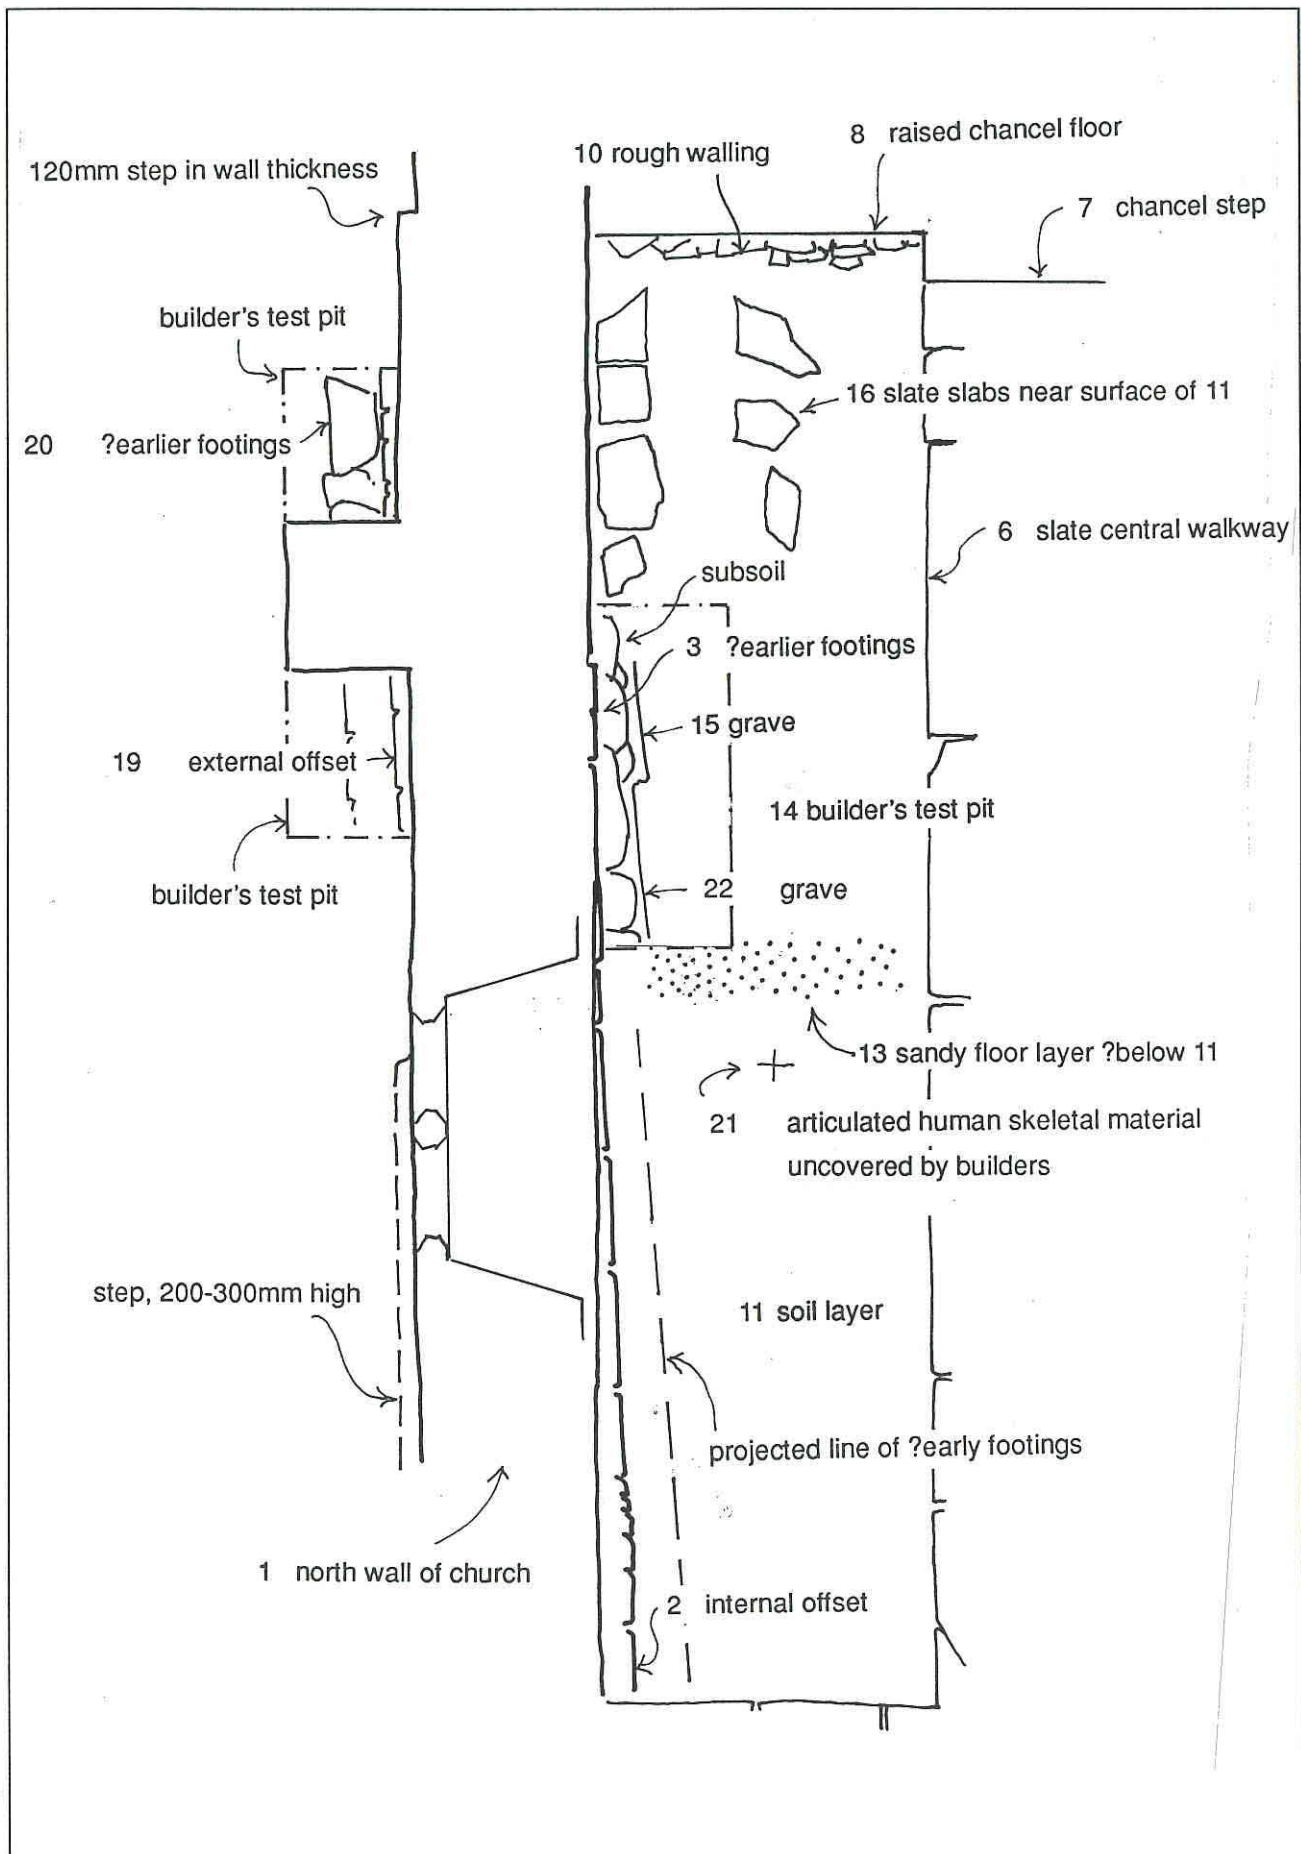
Fig. 2. Plan of excavations on north side of nave. Scale 1:40. Ecclesiastical north to left.

When the site was visited on the 19 September 1997 pits had been already been excavated to either side of the buttress against the outer face of the north wall, concrete having been laid against and below the footings in the pit to the west of the buttress. These revealed that the north wall of the nave is set on slightly offset footings (19) projecting about 0.1m from the wall face from about ground level but that at a depth of about 0.3m below ground level was a further line of boulders (20) which extended about a further 0.3m from the external wall-face (figs 1–2). It appears that these, like the similar boulders recorded beneath the internal face of the wall (3) might represent the footings of an earlier wall. There was only an opportunity to make a photographic record of these pits, which were refilled by the time that a return was made to the site on 22 September 1997, the position of the trenches and broader footings being sketched on the accompanying plan (fig. 2).

and dado had been removed by the builder and a test pit (figs 2–3, context 14), about 0.8m across by 1.7m and 0.9m deep had been dug up against the wall footings on the inner face of the wall to test the nature of the wall footings. Articulated human remains, probably belonging to a number of burials had been found during the excavation of the test pit, none of which remained in situ. Articulated human remains (21) had also been identified by the builder just to the west of the pit (approximate location shown on fig. 2) which were said to run in a north-south direction. These had been recovered prior to archaeological excavation and recording and no attempt was made to re-expose the remains, which were retained in situ.

The builder's test pit (14) provided no evidence that the cracking of the plaster on the north wall of the nave was due to the failure of the wall footings. The proposal to underpin the north wall of the nave was consequently not followed through. The flooring below the pews on the north side of the nave was, however, beginning to fail due to the decay of the joists supporting it. It was therefore proposed to lower the soil level below the flooring and to lay new joists set on a thin bed of concrete above a damp proof membrane.

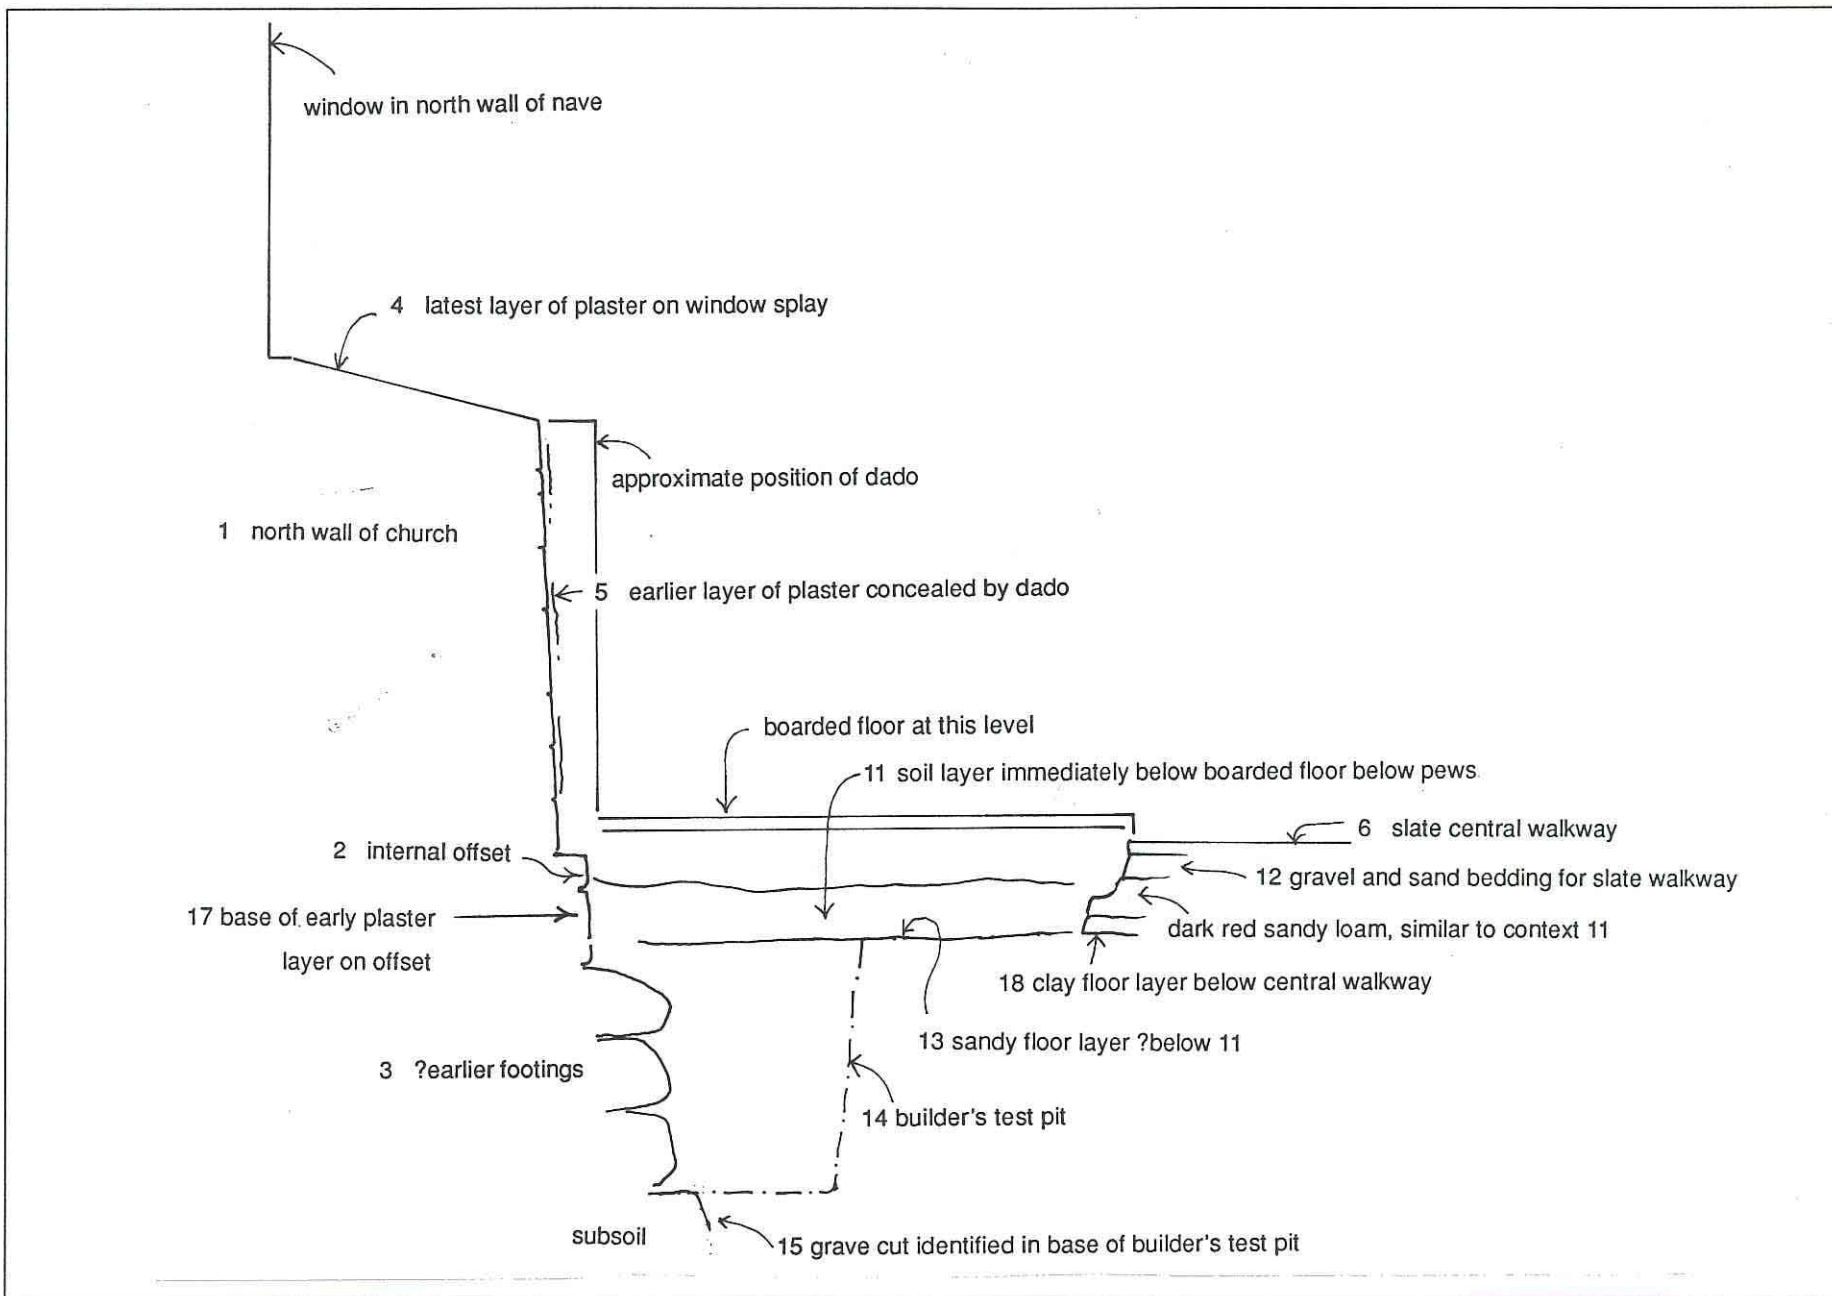
Fig. 3. Partial schematic section through north wall of nave and deposits below pews on north side of nave.

The central slate walkway (figs 2–3, 6) was laid on a levelling layer about 70mm thick of greyish sand and

Details of the footings of the north wall of the nave were revealed along the full length of the area below the pews to a depth of up to about 0.2m and to a depth of up to about 0.9m in the test pit against the north wall. The present north wall (1) is between about 0.95m thick at about ground level. At the west end of the excavated area the north wall overlay a layer of 'footings' (2) about three stones or 0.35m high which jutted out about 0.2m from the inner face of the wall. Towards the east this gradually merged with the face of the wall, disappearing at a point just to the east of the window in the north wall of the nave. The 'footings' in turn overlay three courses of large boulders (3) about 0.65m thick. The boulders lay below the general level of excavation and were consequently only revealed for a length of about 1.7m in the test pit dug by the builder against the north wall of the nave. It appeared, however, that like the 'footings' further to the west the boulder footings were also at a slightly different angle to the present north wall of the church. There was therefore a strong suggestion that the boulders (3) were the footings of an earlier nave wall, partly surviving as the offset 'footings' (2), set out at a slightly different angle to the present north wall of the nave.

This earlier wall would pre-date the window in the north wall of the nave, which is dated to 1684, and is consequently probably of medieval or late medieval date. The outer face of this earlier wall is possibly represented by the offset (19, noted above) below the external face of the north wall, identified in the test pits to either side of the buttress, and by the low step at the base of the wall from below the window in the north wall of the nave to the east wall of the vestry. The large boulders (20) revealed in these test pits are in turn likely to be the same as the earlier footings (3) revealed in the test pit dug against the inner face of the north wall. The apparent merging of surviving lower courses of the earlier wall with the present wall, at a point just to the east of the window in the north wall of the nave, may therefore provide an explanation of the step in the line of the wall at a point about 1.6m to the east of the buttress. This may represent the reuse of the earlier build of the wall at this point, the narrower wall further to the east having been entirely rebuilt. The rendering on the external face of the wall and plastering on the internal face prevents a more thorough testing of this hypothesis.

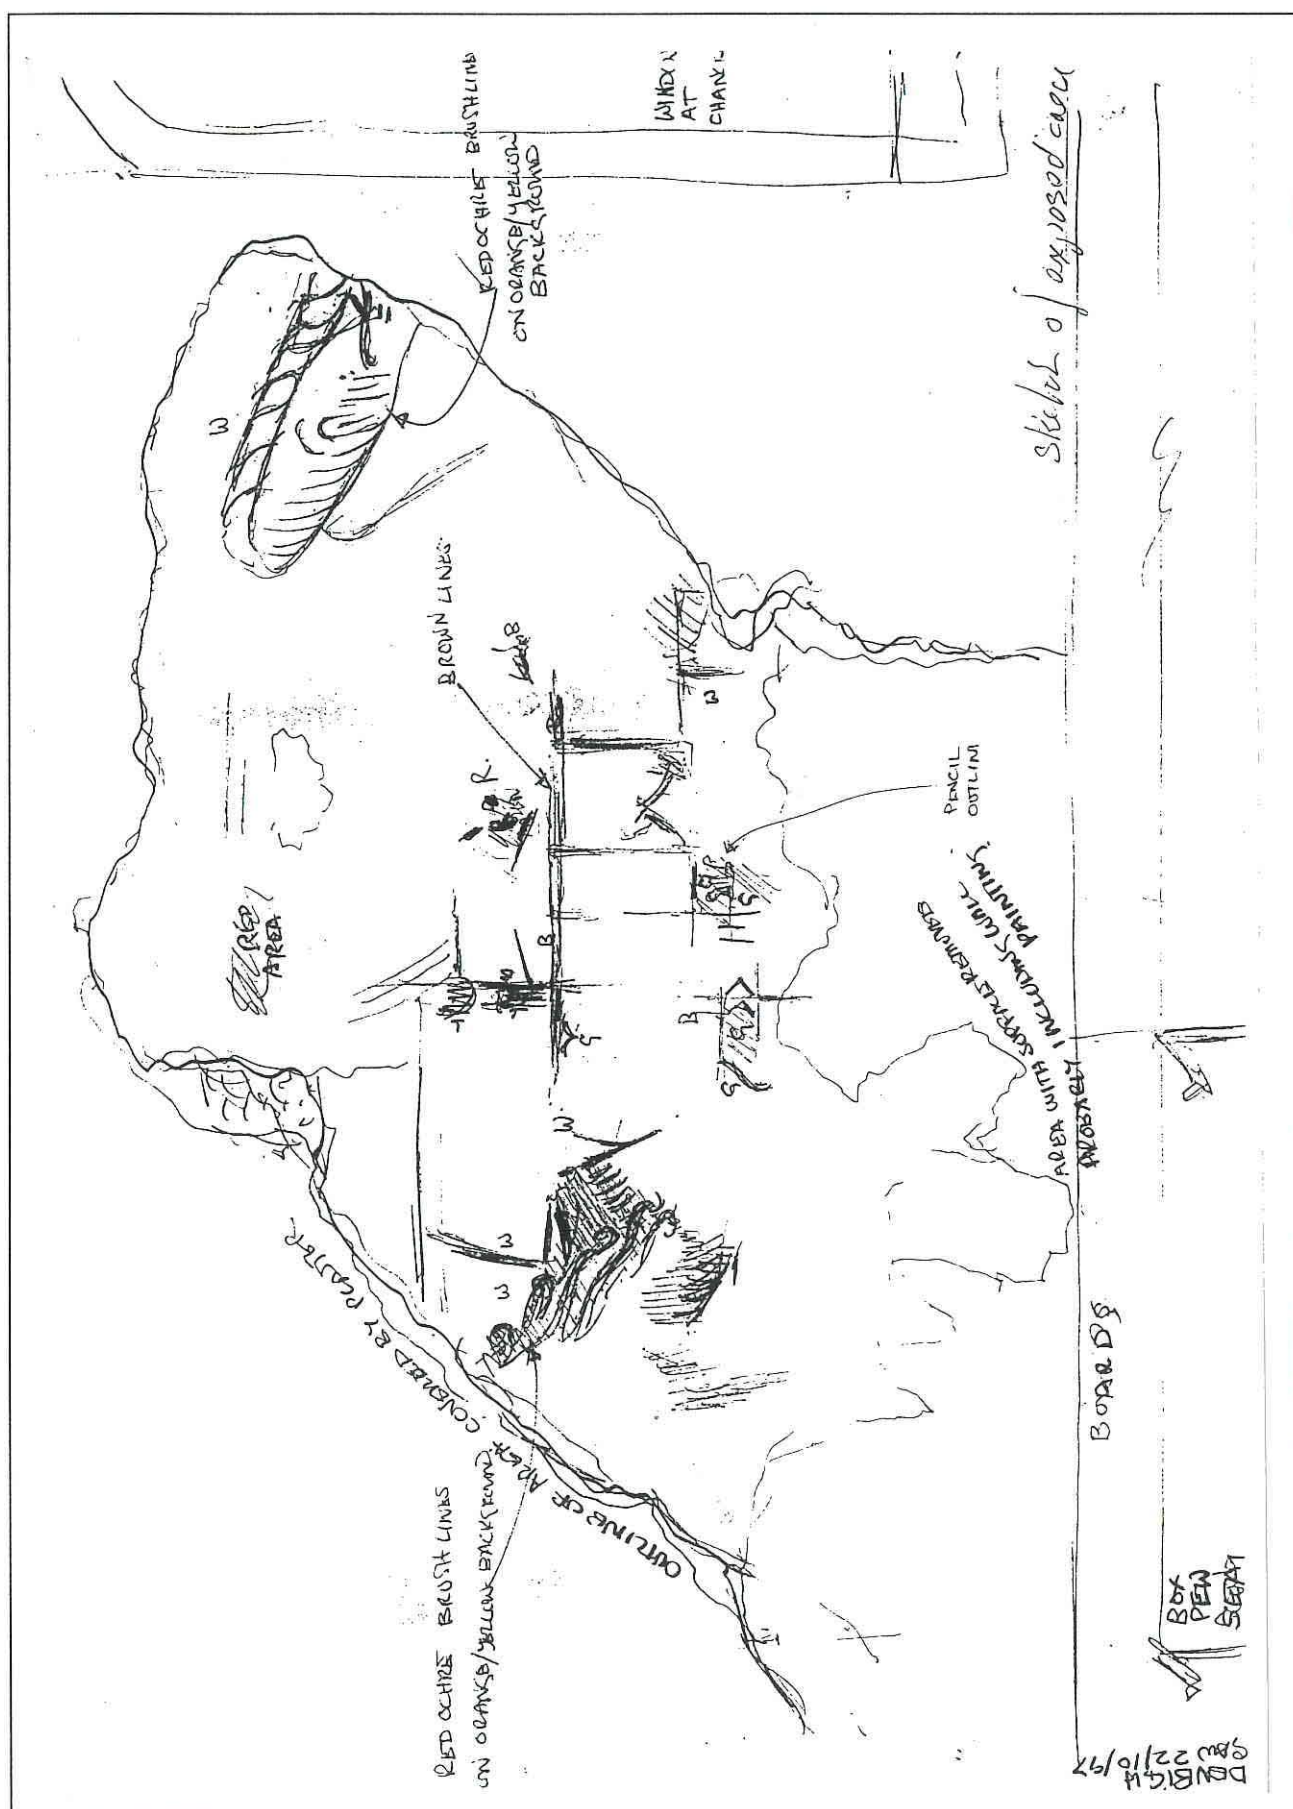
Fig. 4. Copy of sketch by Geoff Ward of RCAHMW (© Crown Copyright) recording fragments of wall paintings revealed on thin layer of lime plaster beneath upper layer of plaster between the window in the nave and the chancel. Not to scale, the exposed area is approximately 1.1m high and 2.18m across.

the removal of 'a small section of addled plaster on the north wall'. Visits made on 9 and 11 October revealed that a defective area of the uppermost layer of wall plaster (4) about 1.1m high and 2.18m long from north to south was removed in an area between the two windows in the north wall of the nave and chancel in the area above the dado (see approximate location on the accompanying plan, fig. 1). This had revealed patches of pigment on an earlier layer of plaster (5), which appeared in places to be sealed below one or more layers of limewash. A sketch and photographic record was made and arrangements made for a visit by staff of the Royal Commission on the Ancient and Historical Monuments in Wales (RCAHMW), who carried out sketch recording on 22 October 1997.

The paintings are shown in the sketch drawing by Geoff Ward of RCAHMW given in fig. 4. The surface of the fragmentary paintings had been pecked in order to key in the upper layer of plaster. Towards the centre of the exposed area was an area with a rectangular grid of brown or black lines with some small patches of green/turquoise pigment and fleur-de-lis apparently drawn in pencil. Above this were areas of red pigment and to either side are patches of linear decoration of red ochre brush lines on an orange/yellow background. It has been suggested by Geoff Ward and Dylan Roberts that the painting is possibly a late Stuart to early Georgian Royal Arms, of late seventeenth to early eighteenth-century date — the linear brush strokes to the left-hand side suggesting a lion's mane, the vertical and horizontal lines towards the centre possibly representing the chequerboard divisions of a coat of arms, and the linear brush strokes on the right-hand side possibly representing a unicorn.

It appears that only parts of the painting have survived, parts of the surface of the surface of the underlying wall having been exposed in places, although more of the design probably survives below coats of limewash. What survived was protected with limewash and recovered in plaster.
