# *Darren-Cilau Tramroad, Llangattock, Powys*

## ARCHAEOLOGICAL FIELD SURVEY

Report prepared for Dŵr Cymru Welsh Water

# **The Darren Cilau Tramroad: A Watching Brief**

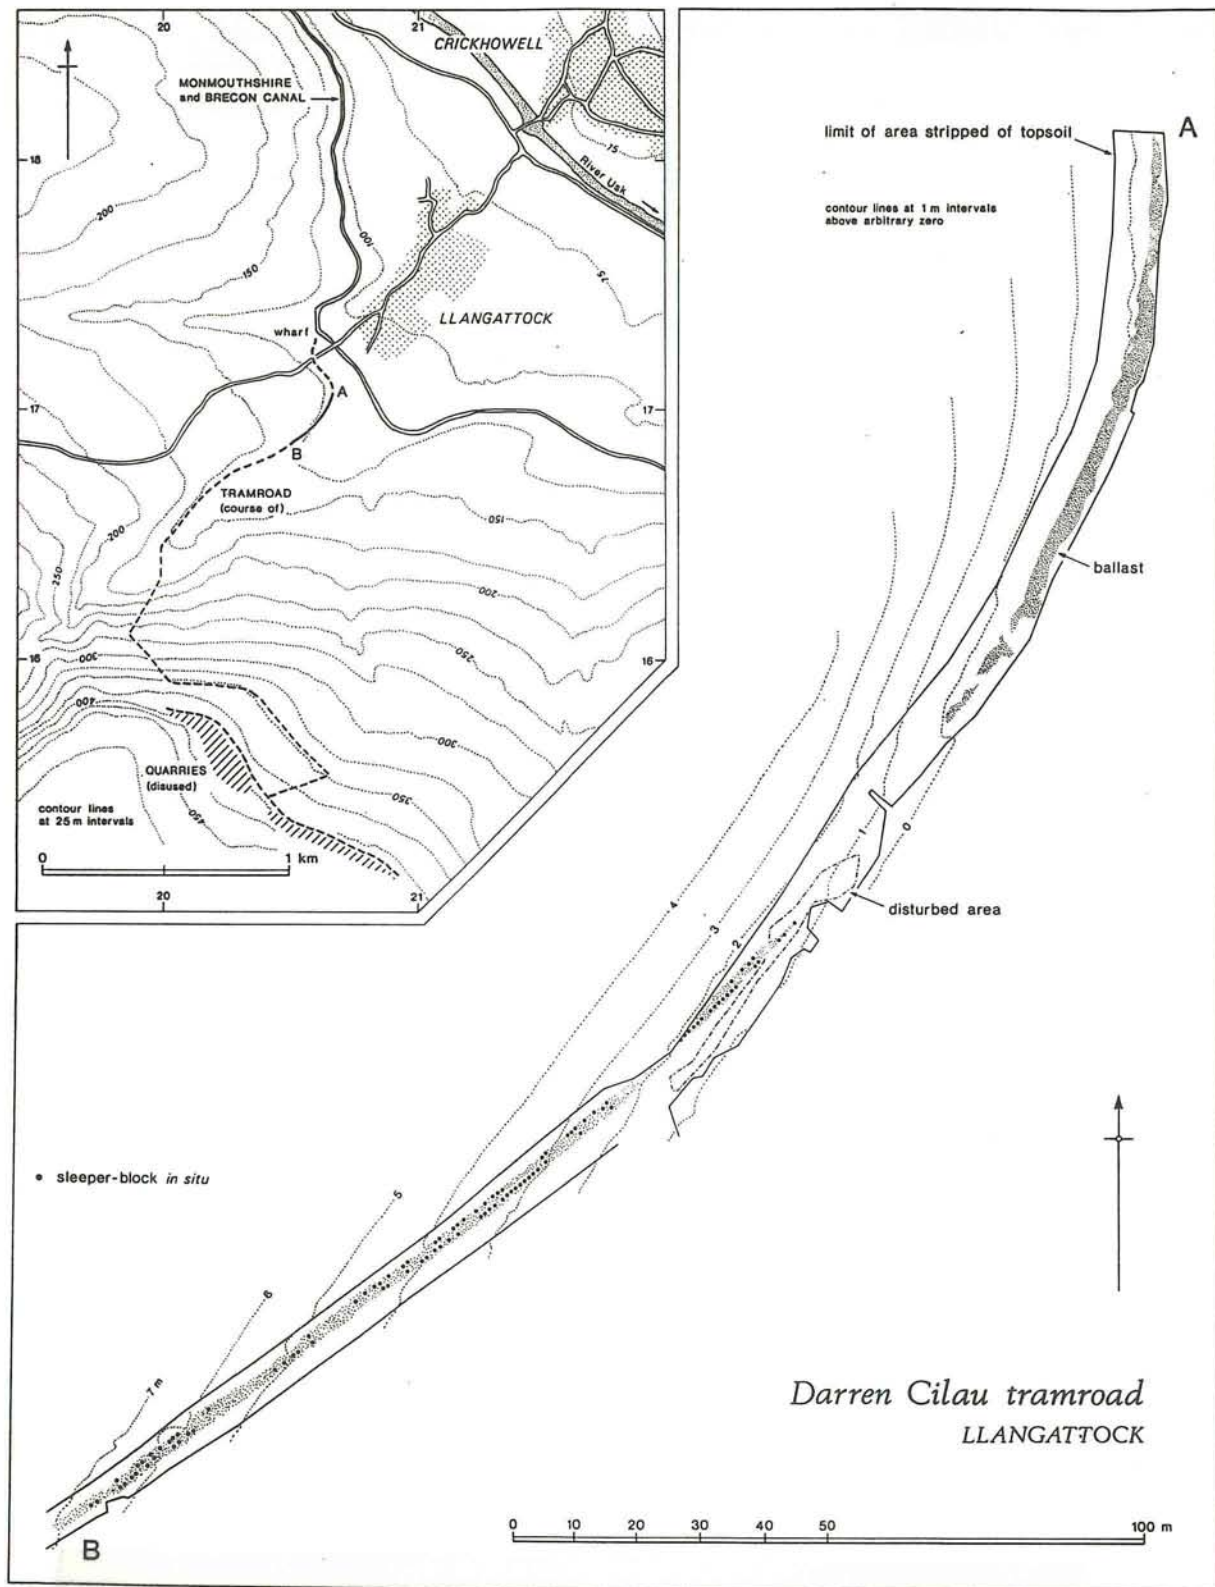
4.1 Topsoiling of the wayleave at the north of the affected area had seriously damaged the surviving remains. Displaced sleeper stones were noted in the spoilheaps and towards the edges of the trench. All that remained of the tramroad itself in this area was an irregular linear patch of limestone ballast.

4.2 The passing loop was originally noted by Mr M Walters (CPAT Curatorial section) at an on-site meeting on commencement of the topsoil stripping. This loop was located near the centre of the survey area but was obscured during the survey by a considerable area of vehicle damage such as ground churning and deep wheel ruts.

4.3 *In situ* sleeper blocks were visible in the southern section of the survey and running into the severely damaged area described above. These dressed sandstone blocks, each with a central hole, originally carried the rails of the tramroad. These rails were fixed to the sleeper stones by means of an iron peg driven into an oak dowel fitted into the perforation in the stone. Some iron pegs were noted *in situ*.

4.4 The tramroad had been much less damaged in this southern section. The distances between the *in situ* stones indicate a gauge of 1.2m (4ft).

Fig 1: Location of the Darren-Cilau Tramroad and survey of the affected areas. Drawing by Brian Williams
