Llandrinio Church, Powys

ARCHAEOLOGICAL WATCHING BRIEF

CPAT Report No 513

R Hankinson
February 2003

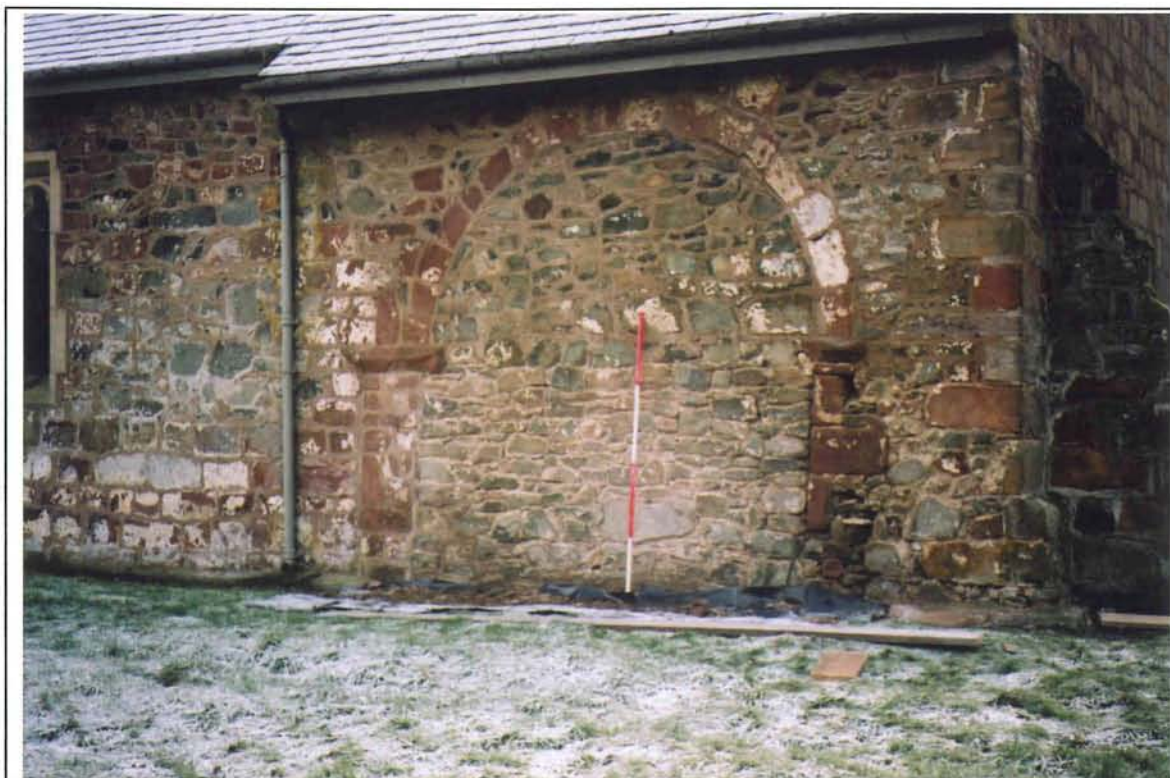
ii) Later in the Norman period the old nave was converted into a chancel and a new nave added to the west. Features which belong to this phase of alteration include the priest's door, the south entrance door, and the font. An aisle was erected on the north side and part of its arcade (Plate 1) is immured in the present north wall.

4.3 The most readily apparent surviving feature of the Norman architecture of the church is the arch at the west end of the north wall (Plate 1). The west part of the internal face of this wall (Plate 2) was also exposed by the removal of some of its facing plaster, which provided an opportunity to examine the relationship between the arch and the west wall of the church. There was no visible joint or difference between the stonework which formed the internal face of the west wall and that which formed the respond (west side of the archway) of the arch, the implication of this being that the west wall and the jamb appear to be contemporary. This does not however mean that the west wall of the church is of Norman date.

Plate 1 External view of the arch in the north wall of the church, from NW. Photo CPAT 1285.01.

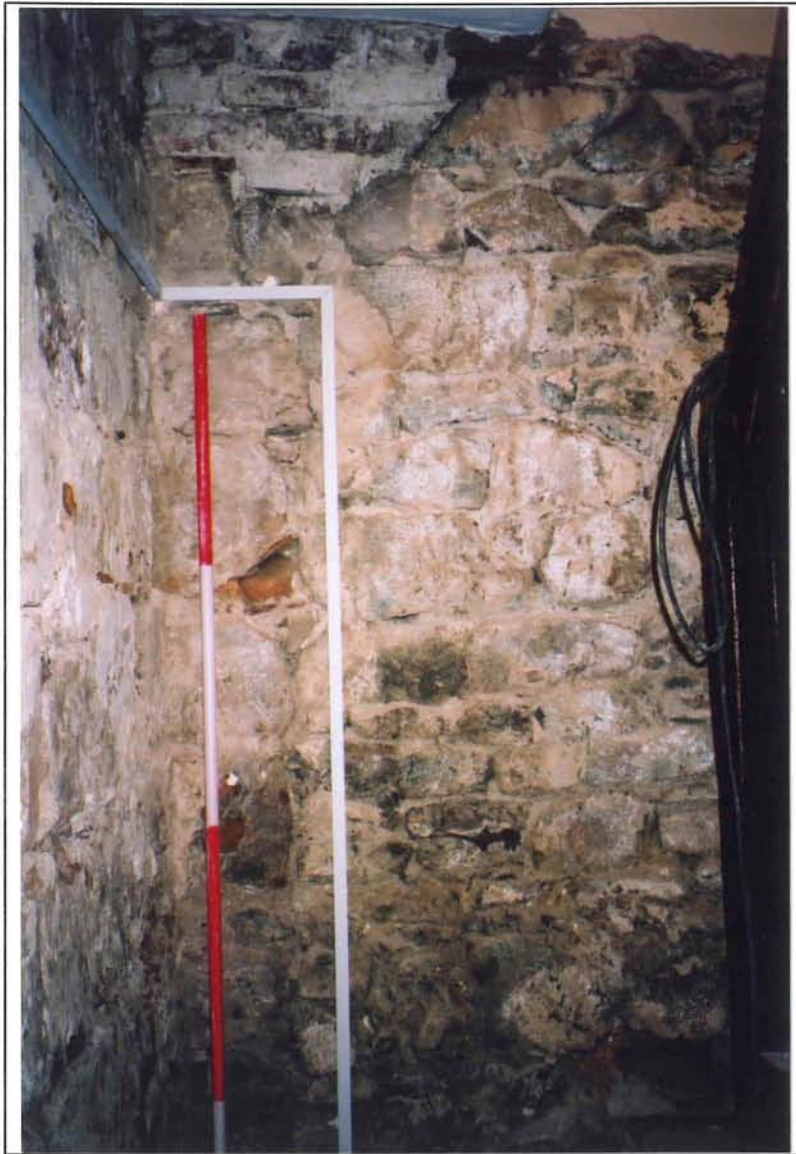
- 4.4 The removal of plaster on internal face of the north wall should have revealed the dressed stones of the arch itself, but these had been removed. The line of the arch can now only be determined from the curved upper edge of the blocking material. The small section of visible wall above the jamb and over the arch blocking material was largely composed of brickwork, though this does appear to be of a relatively early, probably 18th-century, date.

- 5.3 The arch at the west end of the north wall is the most obvious surviving feature of the Norman architecture of the church. Following the removal of the internal facing plaster, the structural appearance of the junction between the west wall and the west respond of the arch suggests that these two features were contemporary. This could imply a Norman date for the west wall of the church, which has already been proved to predate the 18th century (see above). But it is much more likely that the whole west wall was rebuilt in the medieval period (if not later) and that this reconstruction was carried around into the north wall. The internal face of the arch itself has been partially lost and replaced by bricks of probably 18th-century date - this might be a result of structural work related to the construction of the gallery.

Plate 2 Internal view of the west side of the arch, from S. Photo CPAT 1285.10

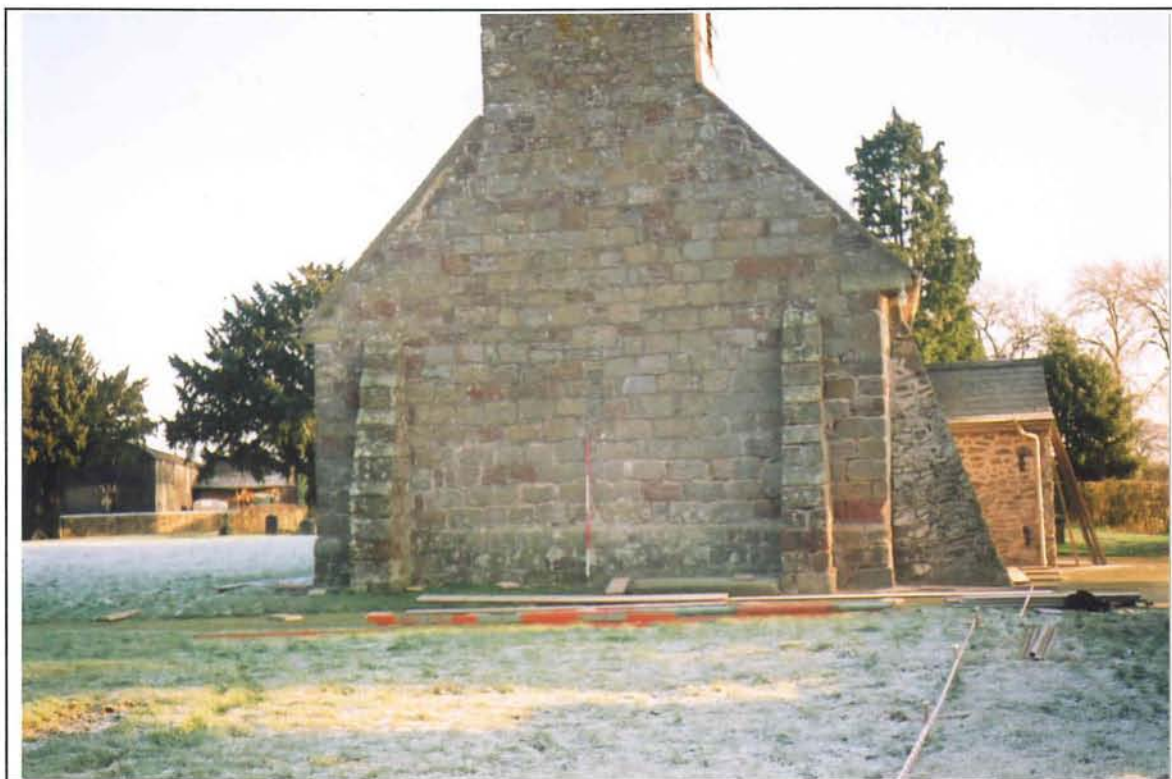
4.2 Examination of the external face of the west wall of the church (Plate 3) revealed a narrow, centrally-placed, blocked window which had not previously been recognised. Examination of the interior face of this wall (Plate 4) during the second site visit, when the covering plaster had been removed, demonstrated that the window was splayed to over 0.6m in width in the interior of the church, though its internal dimensions could not be determined precisely as only its base and north side were exposed. The stones used to block the window had been bonded with lime mortar, laid on top of a plastered surface which survived on the base and the north jamb of the window. In addition, a large timber beam, which forms an integral part of the supporting structure for the gallery, was found to be inserted in the blocking of the window, approximately 0.2m above the window base.

Plate 3 External view of the west wall, from W. Photo CPAT 1285.06.

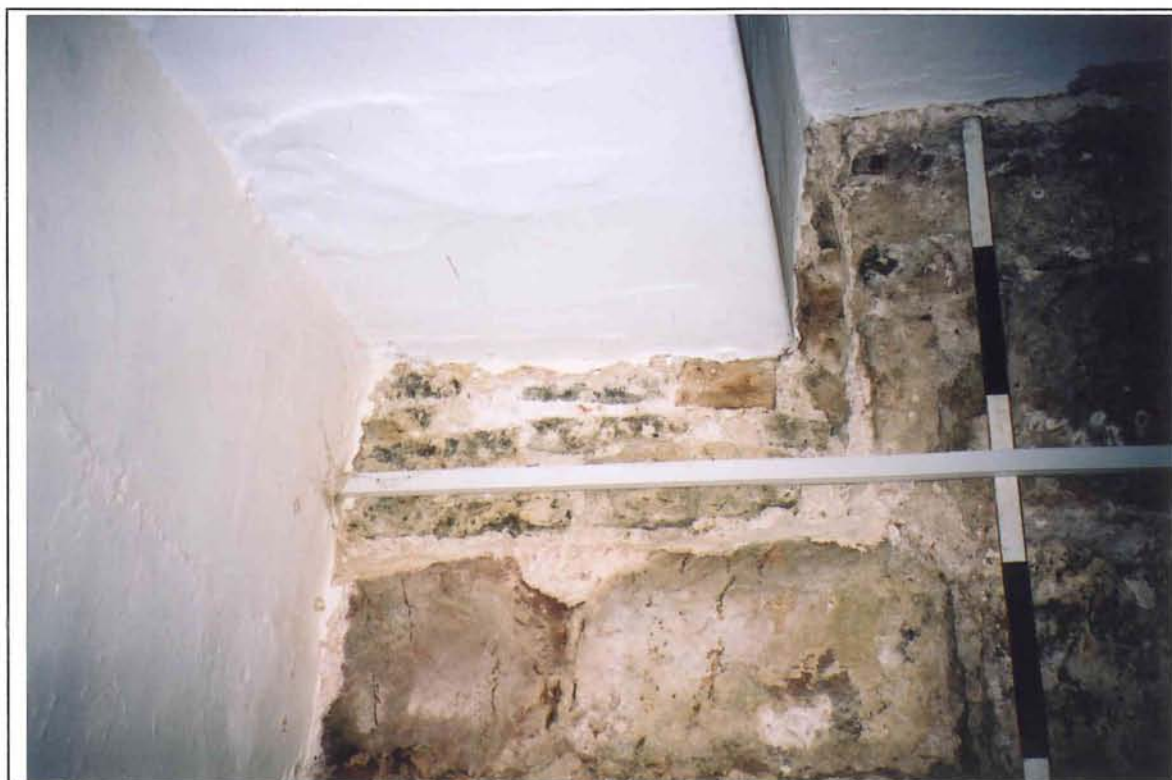
- 5.2 The narrow, splayed window in the west wall of the church appears to be contemporary with the construction of this wall. The fact that one of the major supporting beams of the gallery is inserted in the blocking material of the window demonstrates that the wall predates the 18th century, as the gallery is known to have been built in 1729 (see Frost and Silvester). It could not have functioned as a window with the gallery in place.

Plate 4 Internal view of the west wall, showing the blocked window and the inserted support beam of the gallery, from E. Photo CPAT 1285.13

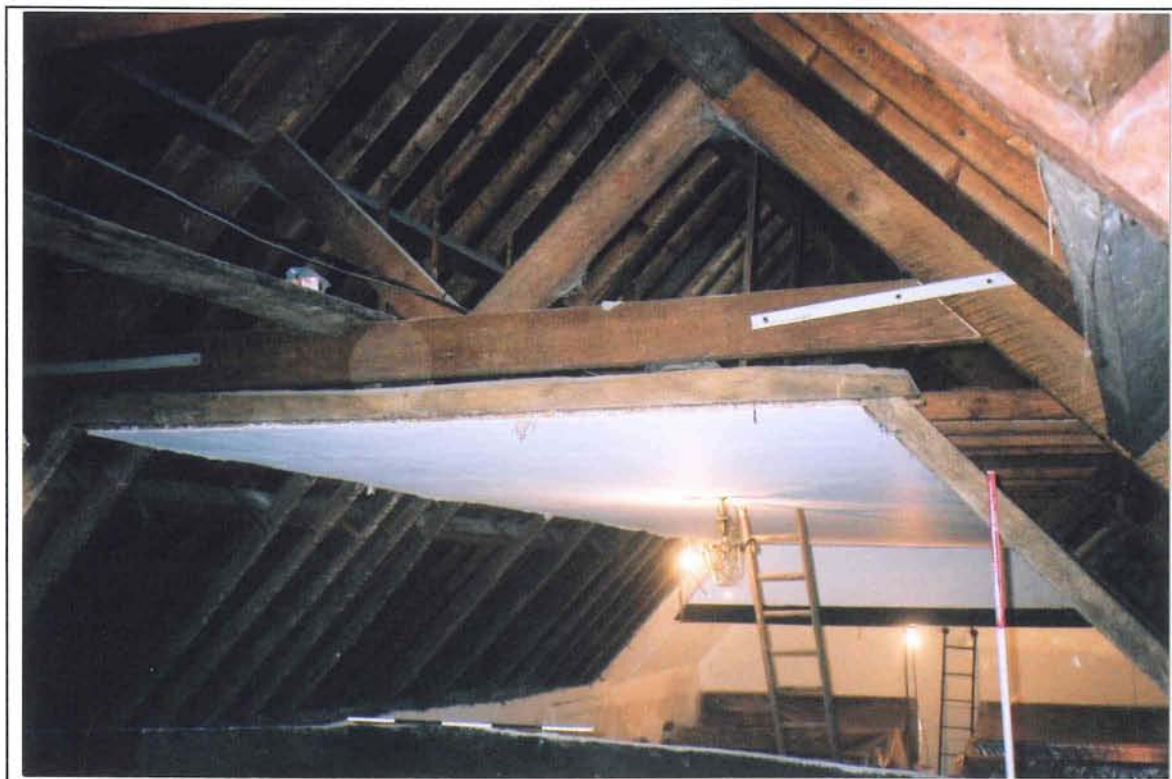
- 4.5 The major remaining element of the repairs to the church consisted of the replacement of the ceiling over the nave and some of the chancel, which had become unsound. Examination of the roof structure demonstrated that all of the main structural roof timbers were of modern softwood; the ceiling seems to have been constructed at the same time using cut down rafters from the previous roof, resting on the inner edge of the wall-plates. The re-used timbers had carpenters' assembly marks on them which seemed to have been made with a cold chisel. None of this timber appeared to be of significance in determining the nature of the former roof; more relevant in that regard is the large beam, 7.45m long and in cross-section, 0.17m wide by 0.33m thick, which was noted by Frost and Silvester as 'a single tie-beam, visible midway along the nave'. Examination of the upper surface of this beam revealed a group of slots which confirm that it supported a roof truss. The arrangement of three slots towards the centre might suggest that the old roof could have been of 'Queen-post' type with a central strut. Although a 'Crown-post' arrangement with supporting timbers going down to the tie-beam cannot be ruled out, this is less likely as the type is restricted to a very small number of examples in north-east Wales. The tie-beam rested on the surviving timber wall-plates of the north and south walls, but did not reach the existing roof-line at its north end, suggesting that this wall may originally have been narrower than it is at present. Some damage was evident at the south end of the beam where wood had broken off on the east side of the attachment slot for a principal rafter.

Plate 5 Internal view of modern roof timbers and the ceiling during its removal, from E.
Photo CPAT 1285.08.

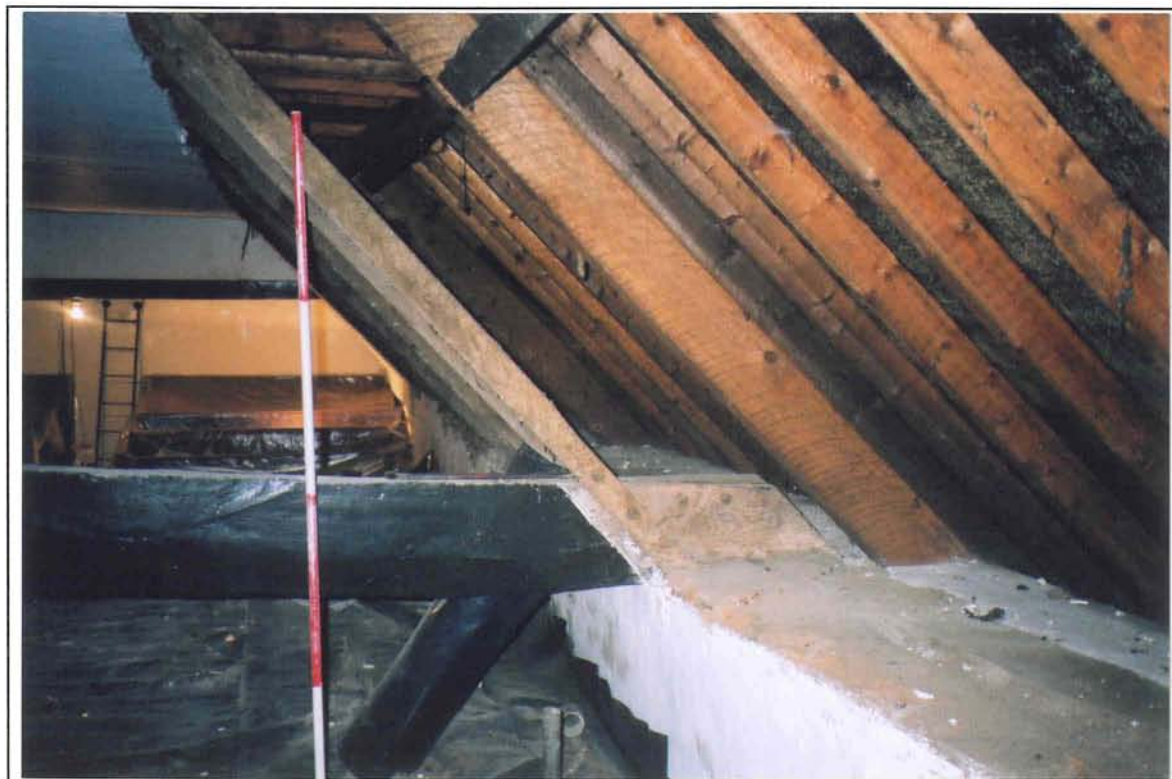
- 5.4 The ceiling of the church, which was removed, appears to have been a relatively recent construction, using material from an older roof. The only in-situ element of this earlier roof that was recognised was the large tie-beam, which crosses the church mid-way along the nave. It seems most likely that the tie-beam formed part of a 'Queen-post' roof, with a vertical central strut. The length of the tie-beam may indicate that the earlier roof was slightly narrower than it is at present.

Plate 6 North end of the timber tie-beam which was formerly part of a roof truss, from E. Photo CPAT 1285.09

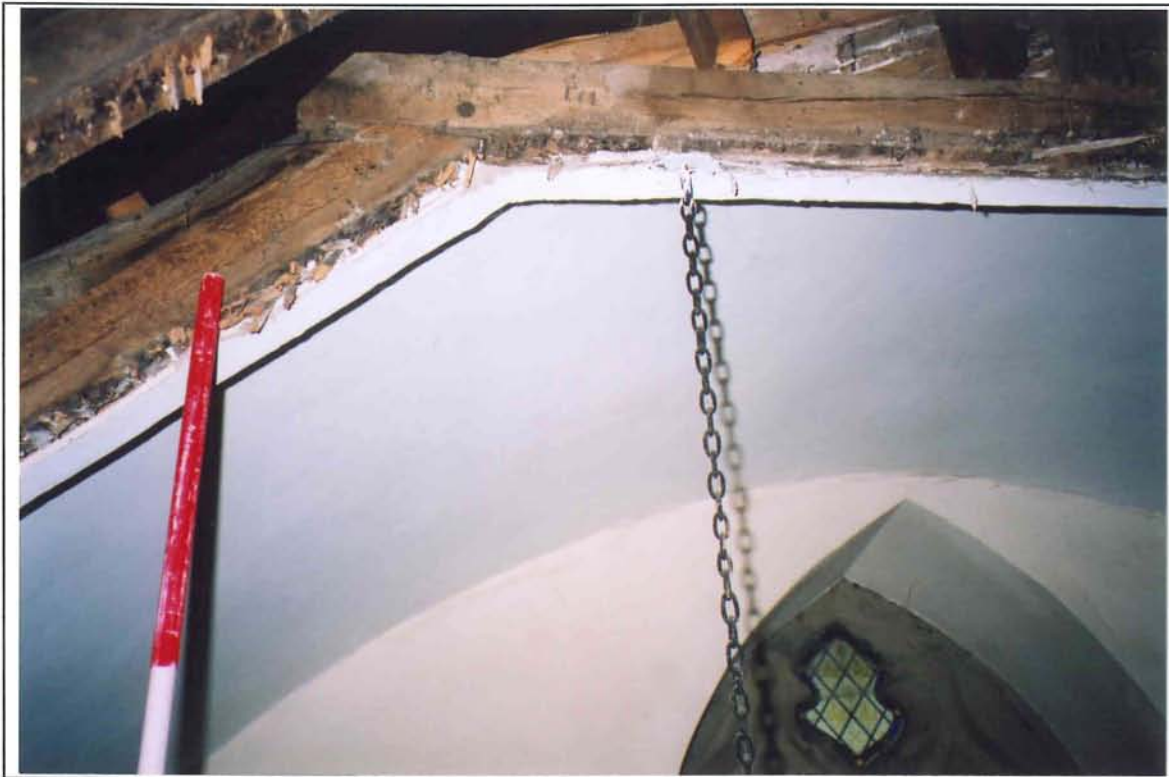
Plate 7 Close-up view of the ceiling at the east end of the church, showing carpenter's marks, from W.
Photo CPAT 1285.07.

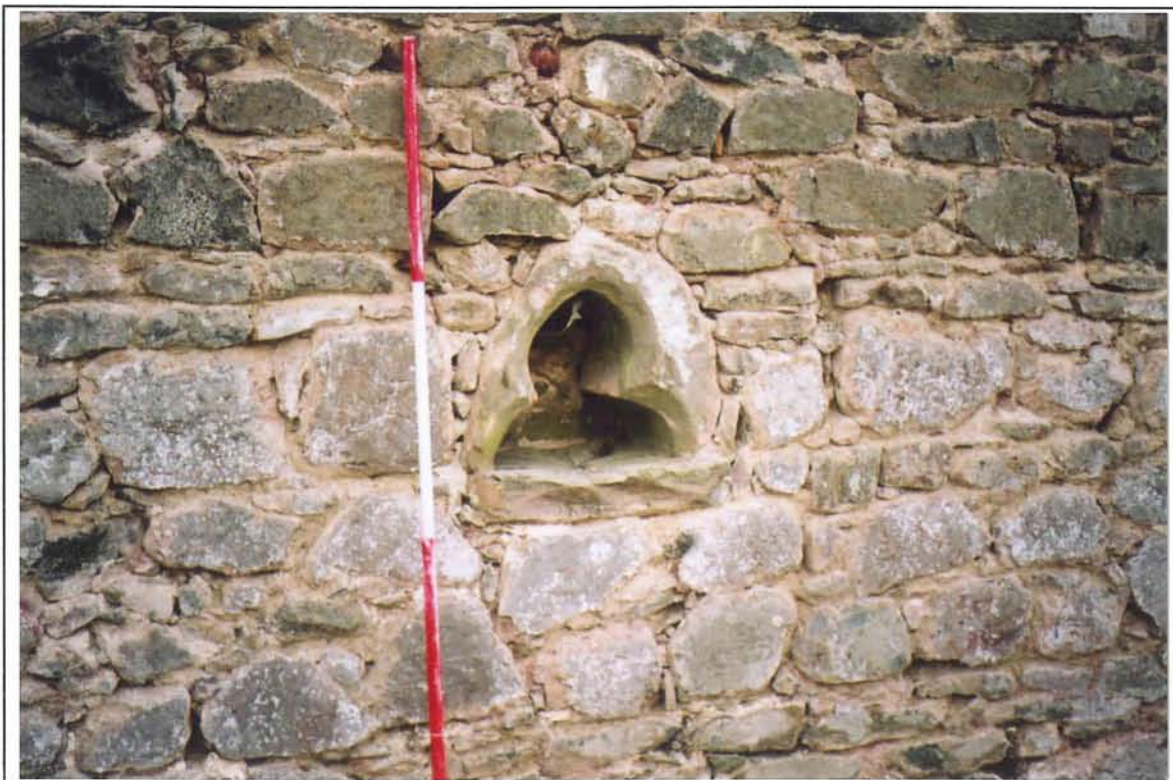
iii) Part of the Norman north aisle is thought to have been converted into a Chantry Chapel at a later date on the evidence of the piscina (Plate 8) sited in the external face of the north wall at the chancel end.

Plate 8 External view of the piscina in the north wall of the church, from N. Photo CPAT 1285.02
