Aberedw Castle, Powys

EARTHWORK SURVEY DEC 1994

CPAT Report No 119

Report prepared for Cadw: Welsh Historic Monuments

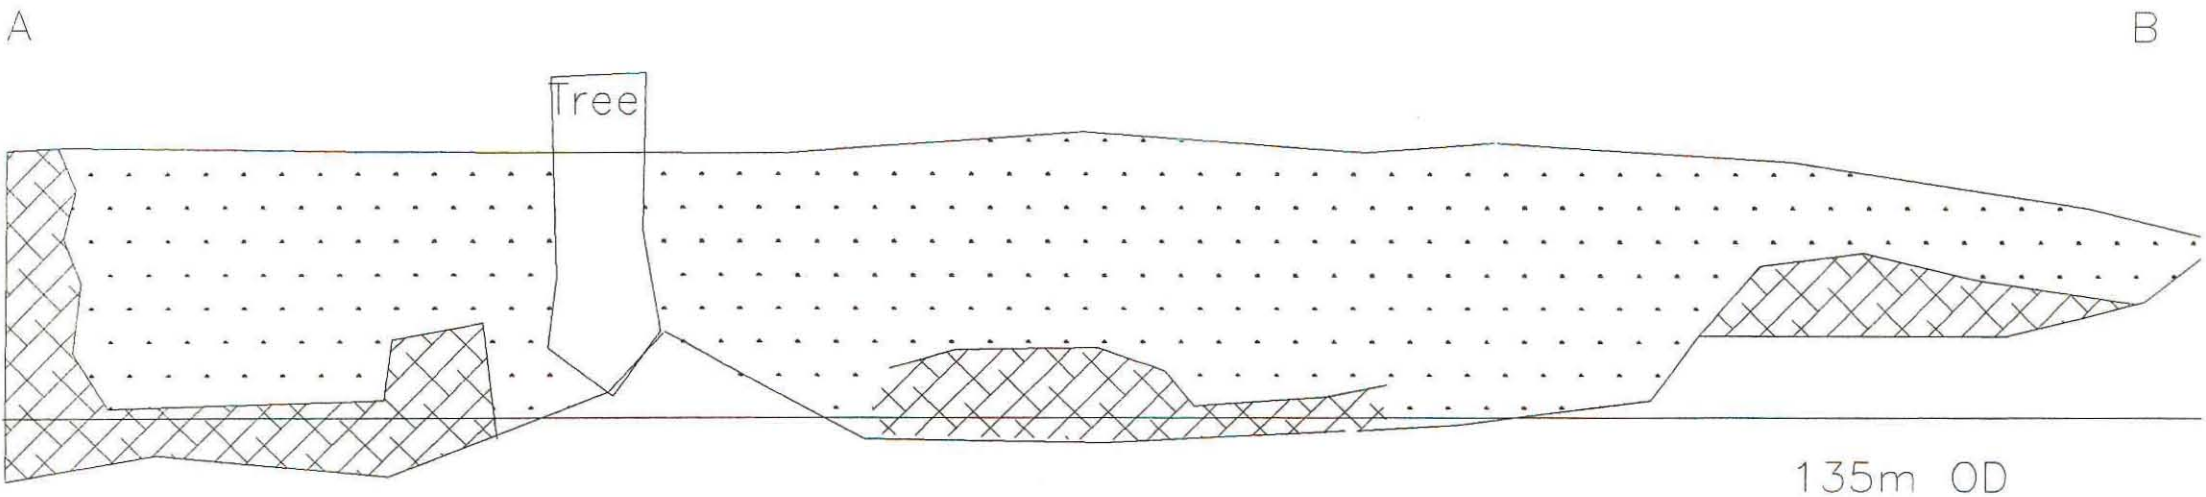
CLWYD-POWYS ARCHAEOLOGICAL TRUST		
Site	ABEREDW CASTLE	
File	ABCEAST	
Description	EAST EXTERIOR ELEVATION	
	SECTION A-B	
Date 16/12/94	Name NWJ	Scale 1:50

- 3.4.1 Although the main entrance is located along this side, there is no surviving external structural evidence which may be associated with it, save for the aforementioned bank across the moat and a corresponding gap in the curtain wall. Internally, the remains of the gate towers survive as low mounds either side of the entrance, with very limited exposed masonry.

- 3.4.2 The wall itself survives to only c.1.3m north of the entrance, with little visible surviving facing. A large tree stump protrudes from the upper part of the wall, with the roots firmly embedded into the corework. The southern section is slightly better preserved, surviving to c.2.1m. Little facing stone survives and the corework is exposed along most of its length. At the southern end a short stub-wall belonging to the southeast tower remains in situ with facing still preserved.

- 3.4.3 There is no visible sign of the wall's interior face, although a bank of grassy rubble lies along the length of the wall.

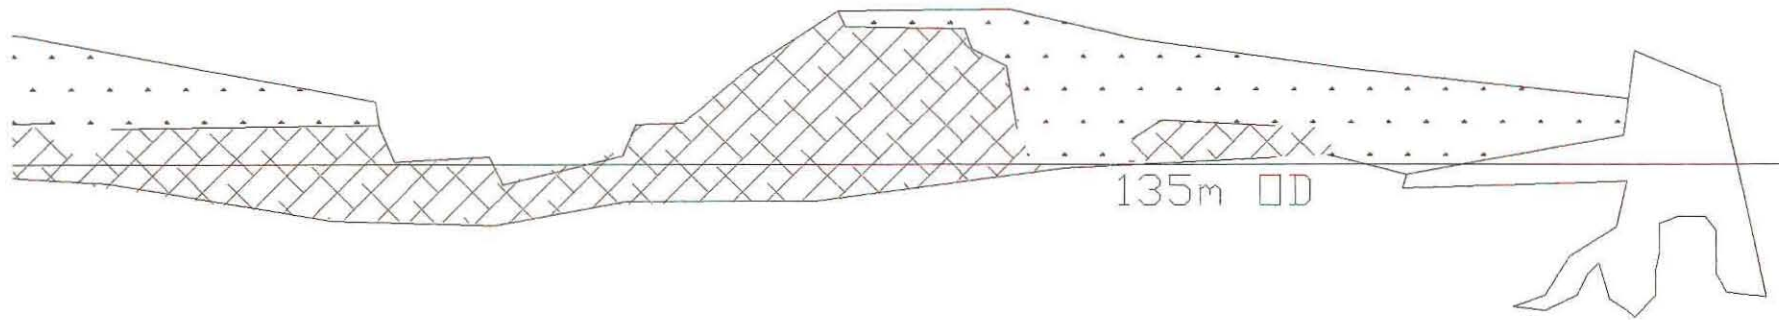
SECTION H-I

- 3.6.1 The masonry remains are now poorly preserved, consisting of a length of wall atop the inner edge of the moat. Both faces of the wall are visible for most of the surviving lengths, indicating a thickness of c.1.8m. Adjacent to the northwest tower, the wall is breached by a modern track, with a further

breach associated with the boundary fence. Externally, visible sections of the wall survive to a maximum height of c.1.6m, with much of the facing stone now missing. Such facing as still survives is in a fairly poor state, and the majority of the elevation consists of exposed corework. Internally, the wall is only visible to a maximum height of c.0.6m, with little facing surviving above ground. The lower courses of both sides are obscured by fallen rubble, behind which it is likely that the facing still survives.

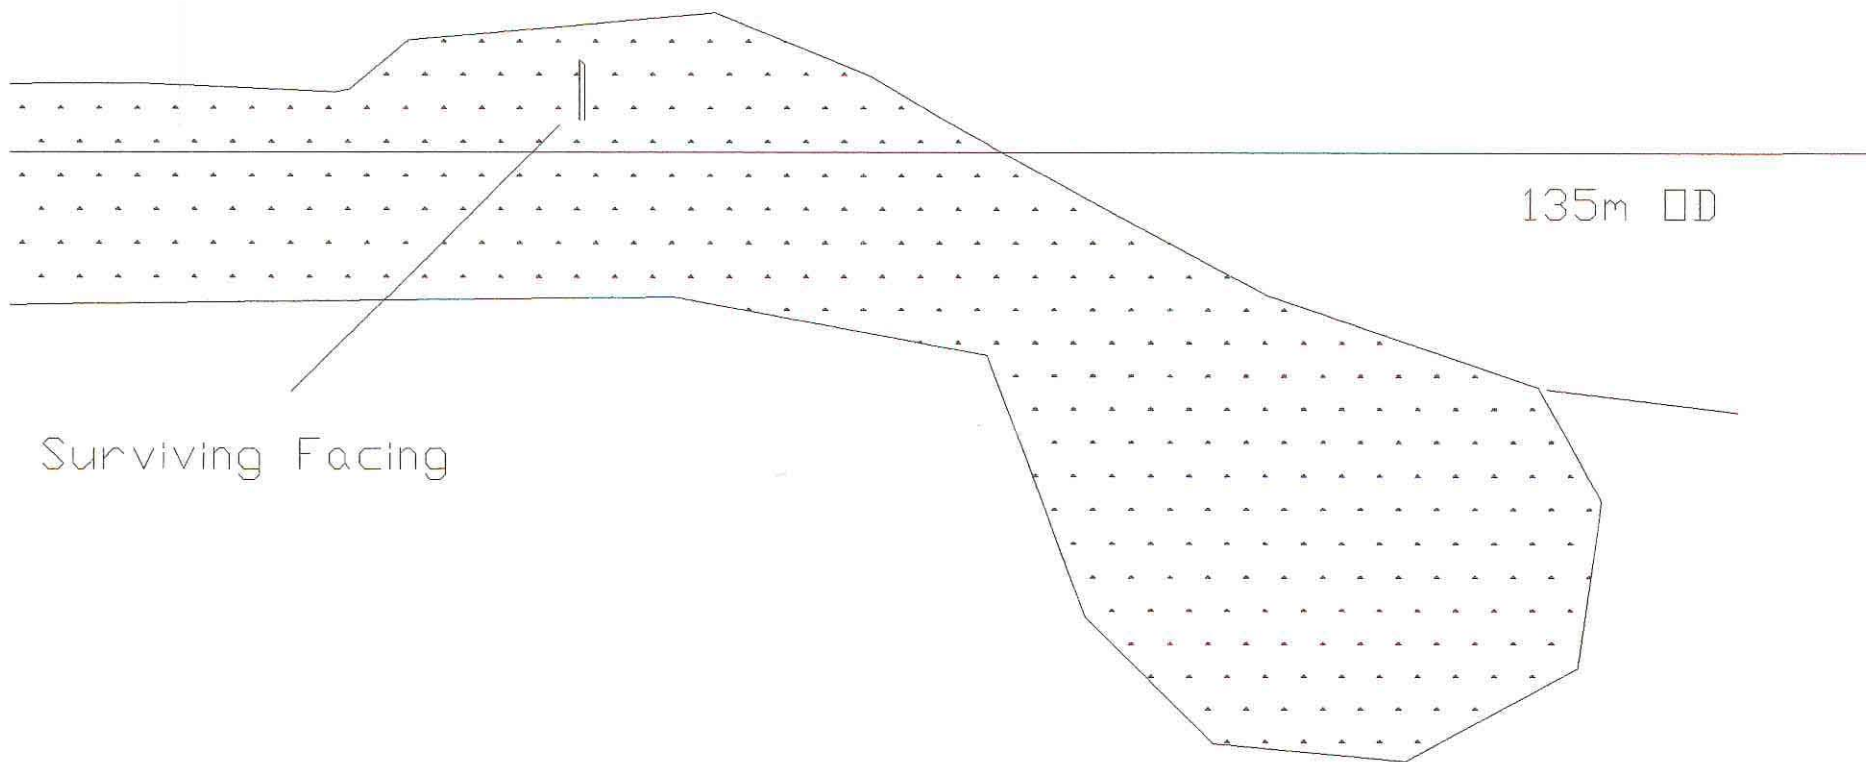
Site ABEREDW CASTLE
 File ABCWEST
 Description SOUTH-WEST TOWER EXTERIOR
 SECTION D-P

- 3.9.1 Very little survives of the tower which has been largely destroyed by the construction of the railway and subsequent erosion. The remains of two wall stubs are still visible where the tower adjoined the south and west curtain walls. Some facing stone survives, particularly relating to the northern wall stub, but the majority of visible masonry consists of exposed corework.

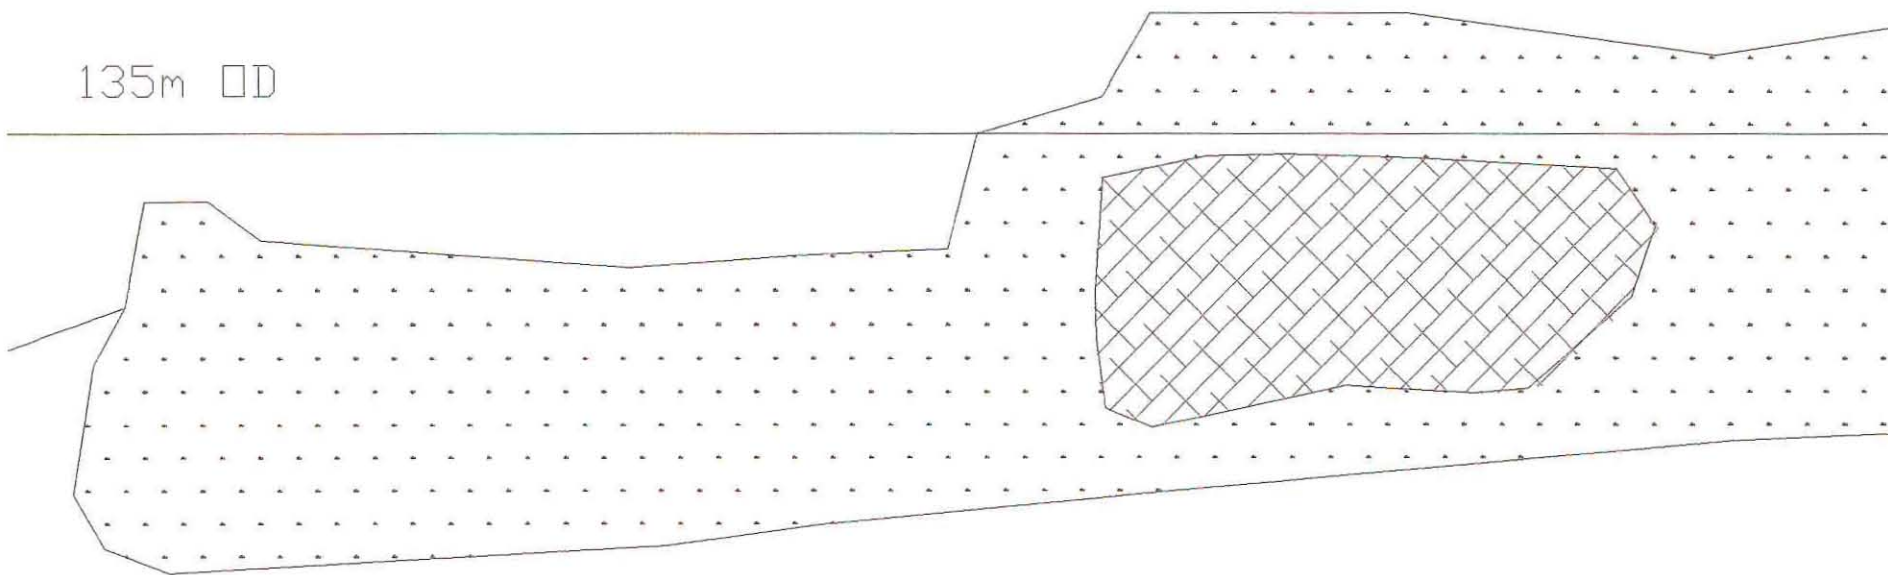
SECTION M-N

- 3.8.1 The steep wooded scarp of the railway cutting on the exterior of the wall made a detailed examination difficult, especially with respect to the photographic survey.
- 3.8.2 The exterior face of the wall is almost entirely absent, due largely to undercutting and erosion related to the railway cutting. Several large trees are growing on and in the remaining masonry adding to the general deterioration.
- 3.8.3 The only surviving facing exists on a relatively short section of wall adjacent to the northwest tower. At this point the wall is largely covered with ivy making a detailed examination of the fabric impossible.
- 3.8.4 Addition damage to the wall is being caused by the dumping a manure and other rubbish from the interior over the edge of the wall towards the southern end.

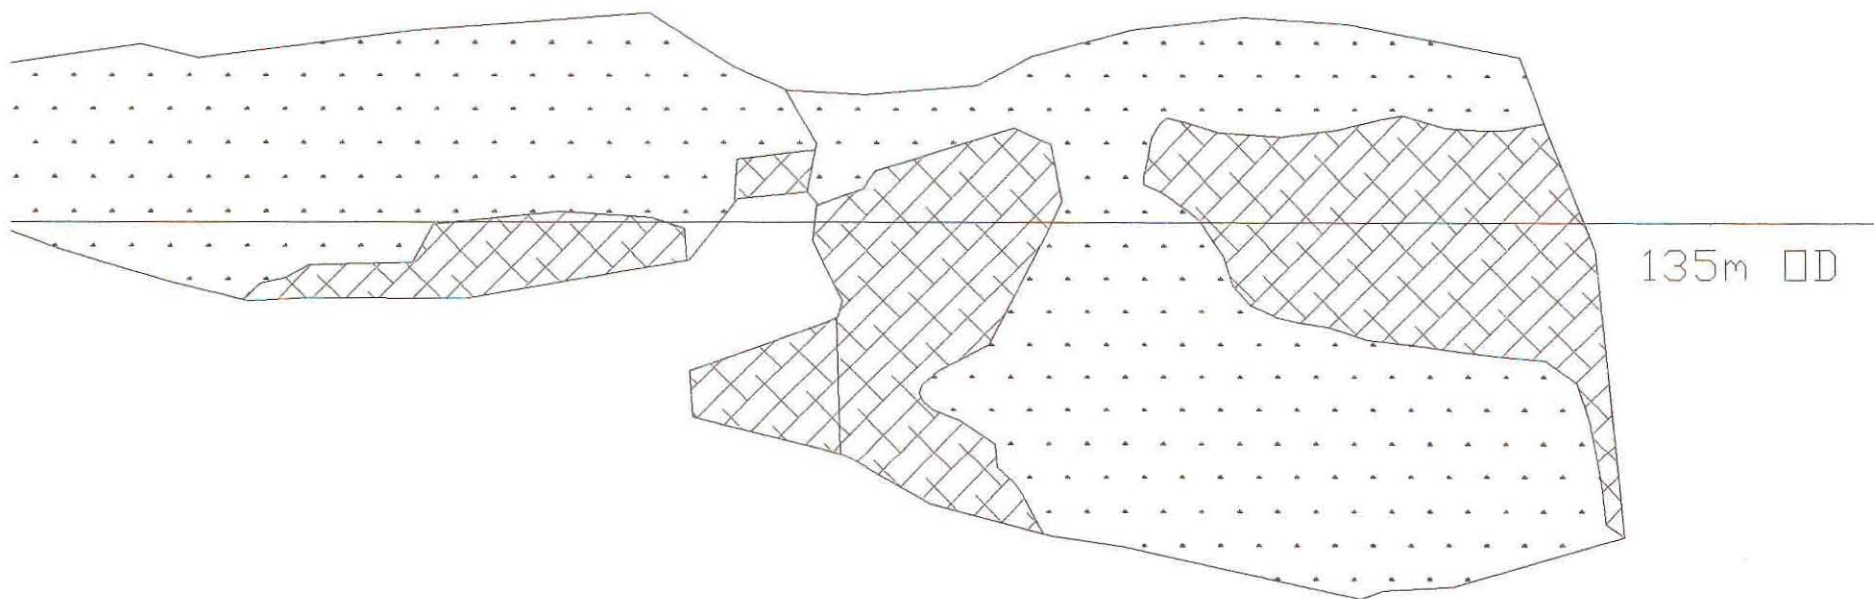
SECTION R-S

- 3.11.1 The Southeast Tower is currently the best preserved, with substantial sections of masonry still standing. However, its condition is such that it is unlikely to survive to any significant extent for more than a few more years.

- 3.11.2 From the surviving remains it is possible to reconstruct the ground plan of the tower, showing that it was originally D-shaped with walls c.1.8m thick. This was presumably true for the other towers also. At present, the walls stand to a maximum height of c.3.7m where the tower protrudes into the moat. A substantial section of wall is now missing along the eastern side, presumably collapsed in antiquity, and the interior is largely filled with rubble. The southern section of the tower is in a fairly precarious state, due largely to the loss of the facing stones at the base having led to serious erosion and undercutting of the wall. The masonry above is actively eroding, with one section showing signs of recent collapse.

- 3.11.3 Along the western side of the tower, at its junction with the south curtain wall, are two sections of faced masonry, the structural significance of which is uncertain.

- 3.11.4 Vegetation growing in the wall, particularly a large briar, are adding to the masonry's deterioration.

- 5.2 The earthworks and standing structures are actively eroding, and their state is such that further significant damage would seem inevitable. The condition of the masonry, and in particular the southeast tower, is now so poor that any remedial work would necessitate considerable rebuilding in order to stabilise the structural remains. It is considered likely that any such rebuilding would involve the dismantling of large sections of masonry in order to consolidate and rebuild the corework as a firm foundation before the facing stones could be replaced.

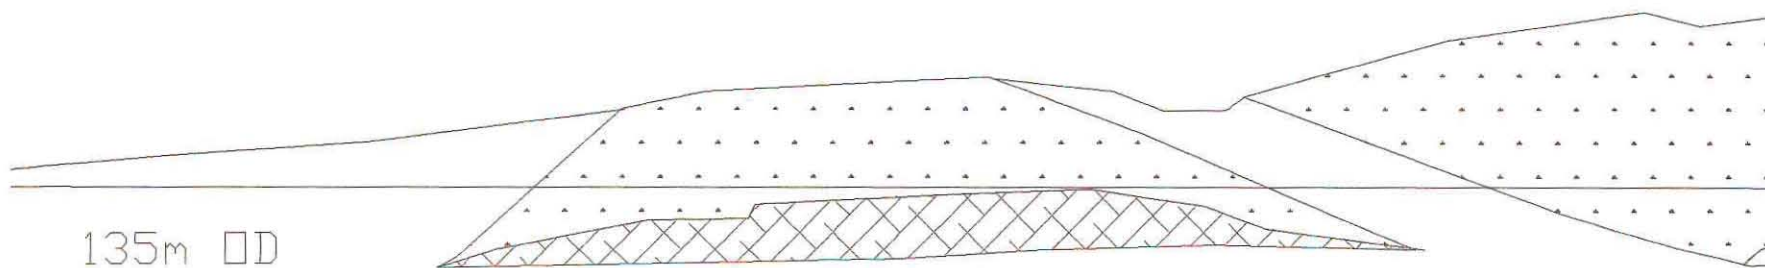
SECTION Q-R

- 3.10.1 The standing remains are considerably less well preserved than those of the north and east curtain walls. Exposed masonry is only evident between the southeast tower and the modern boundary, and there is little facing stone surviving. The lower part of the wall is concealed behind collapsed rubble, while the upper portion consists largely of exposed corework. Mid way along the section, a modern path cuts through the wall from west to east, possibly of animal origin. The interior of the

wall is not visible at any point.

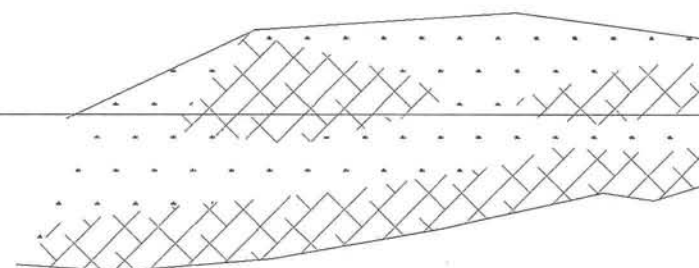
SECTION E-F

- 3.5.1 Little now remains of the tower, which has largely collapsed into the moat. The surviving masonry consists of a short section attached to the end of the northern curtain wall, which stands to a height of c.1.0m, and consists almost entirely of exposed corework.
