St Cyngar's Church, Hope, Wrexham

ARCHAEOLOGICAL RECORDING, EXCAVATION AND WATCHING BRIEF

CPAT Report No 395

NW Jones
October 2000

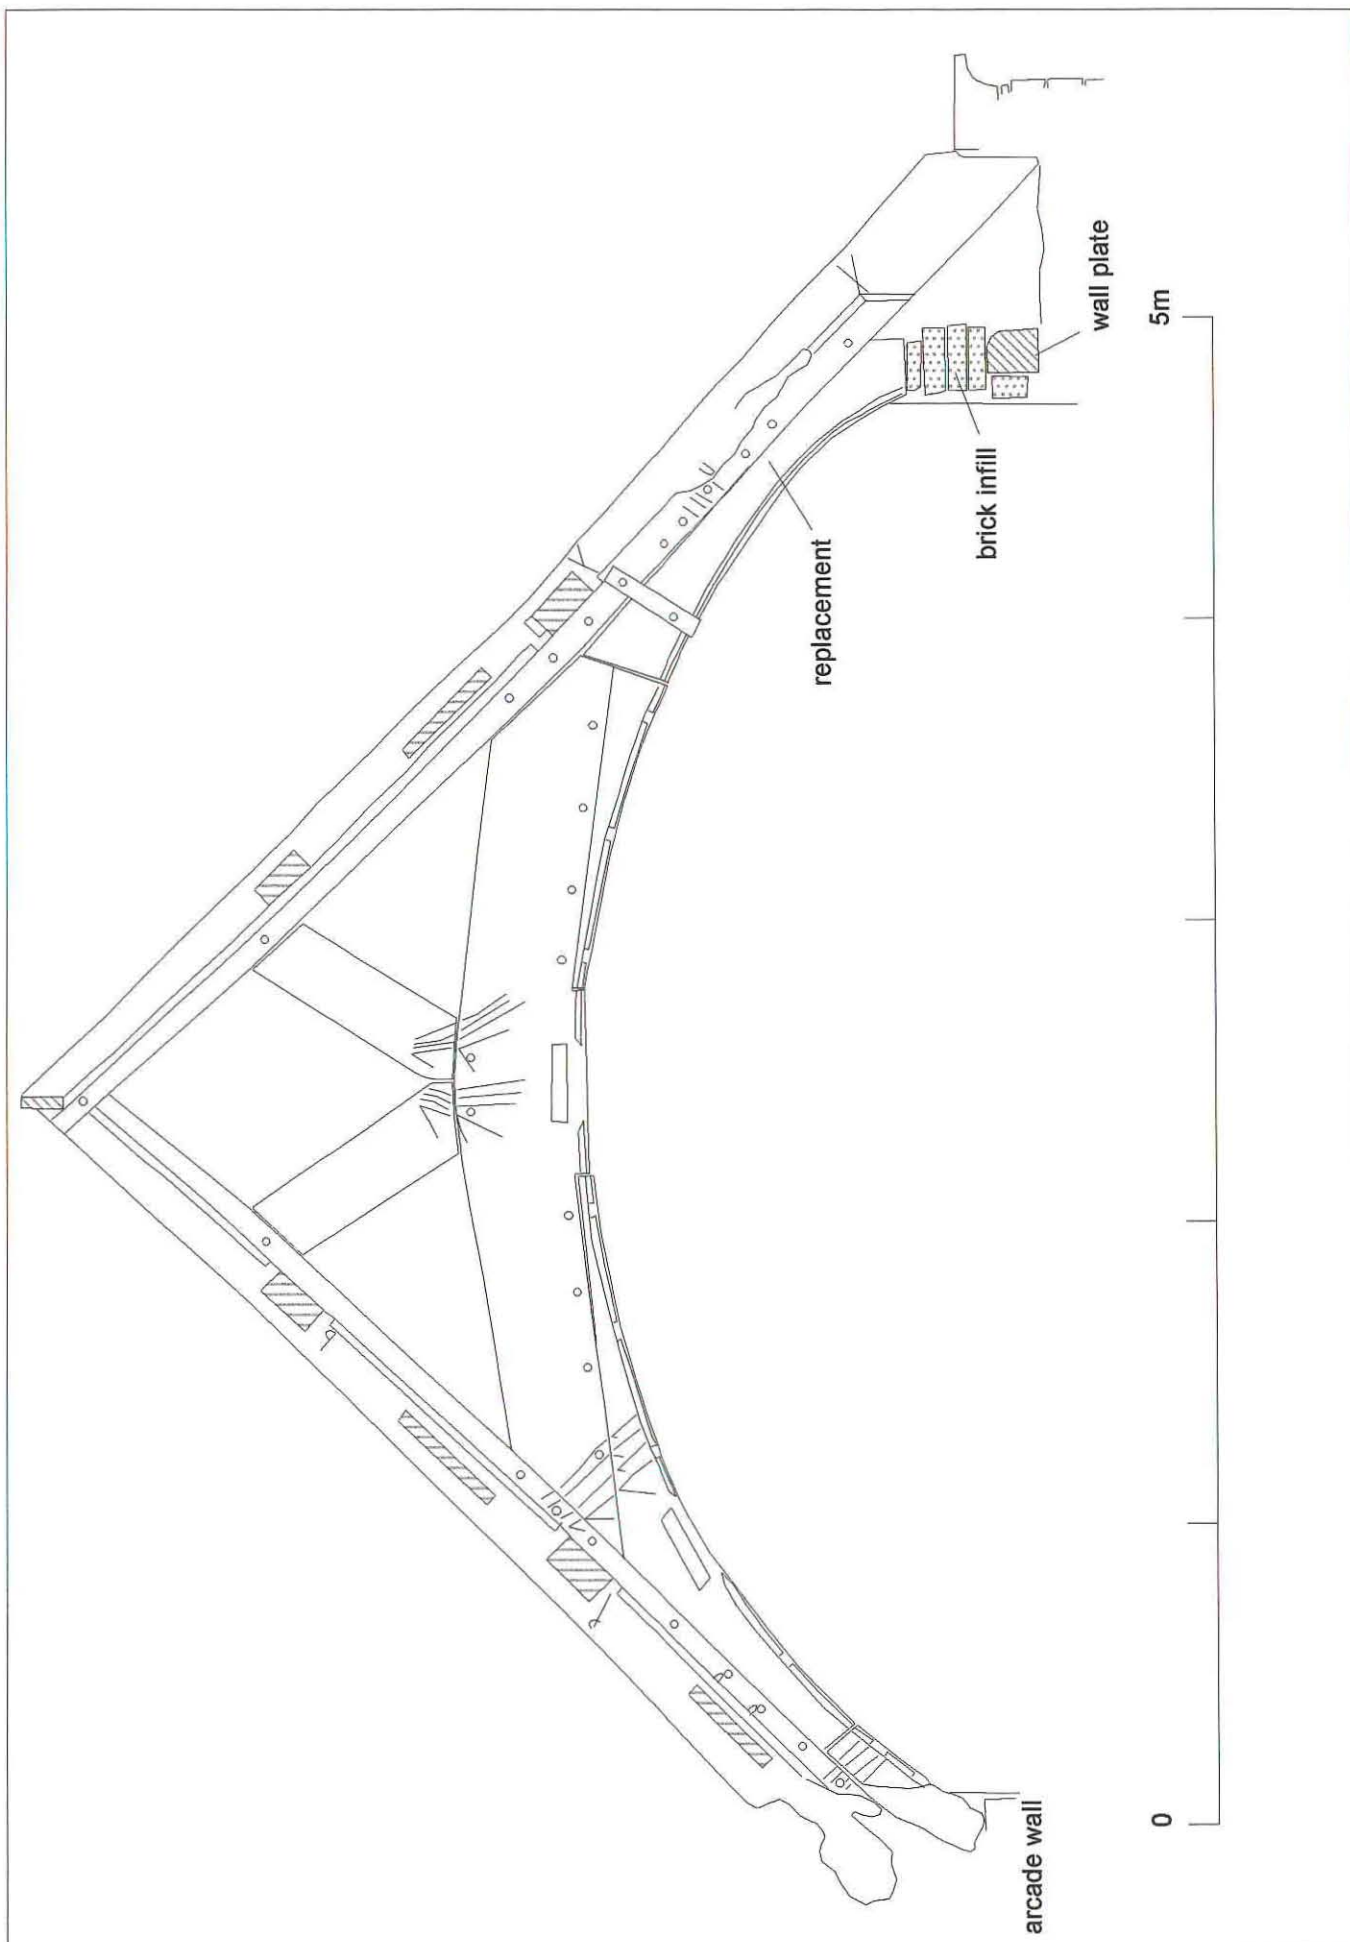
Fig. 4 South aisle Truss 8, west side, 1:25

- 4.6 At the eastern end, trusses 7 and 8 displayed mortises for a former barrel vault (Fig. 4; plate 4). Unlike the other trusses, truss 8 has plain struts, rather than cusped, suggesting that the barrel vault was an original feature with the upper part of the roof not intended to be visible from below.

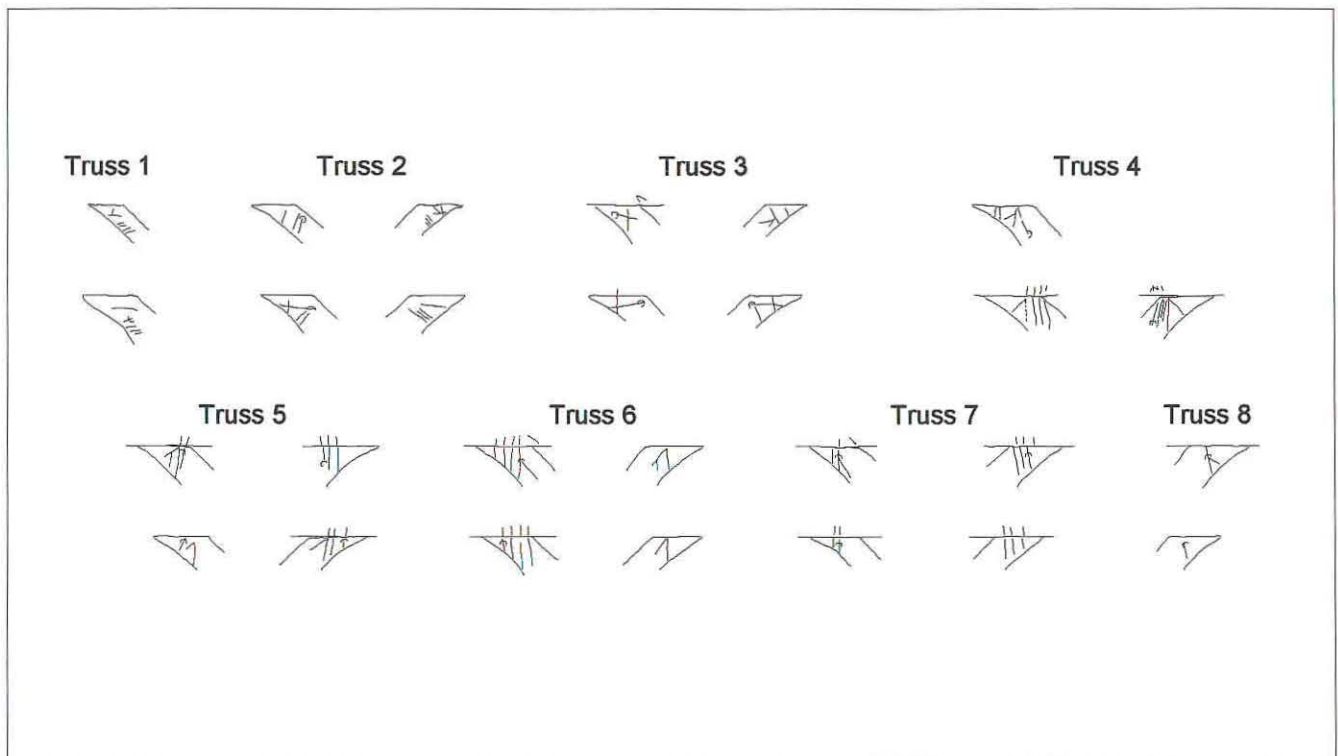
Fig. 5 Assembly marks on South Aisle Roof, northern windbraces and purlins. Scale 1:50

- 4.7 An incomplete set of assembly marks survive on the roof trusses, the northern purlins and associated windbraces, the southern side being generally too badly weathered for any marks to survive (Fig. 5). Only a selection from the windbraces and purlins is illustrated here, although all marks which could be identified were traced onto plastic film or acetate and form part of the site archive.

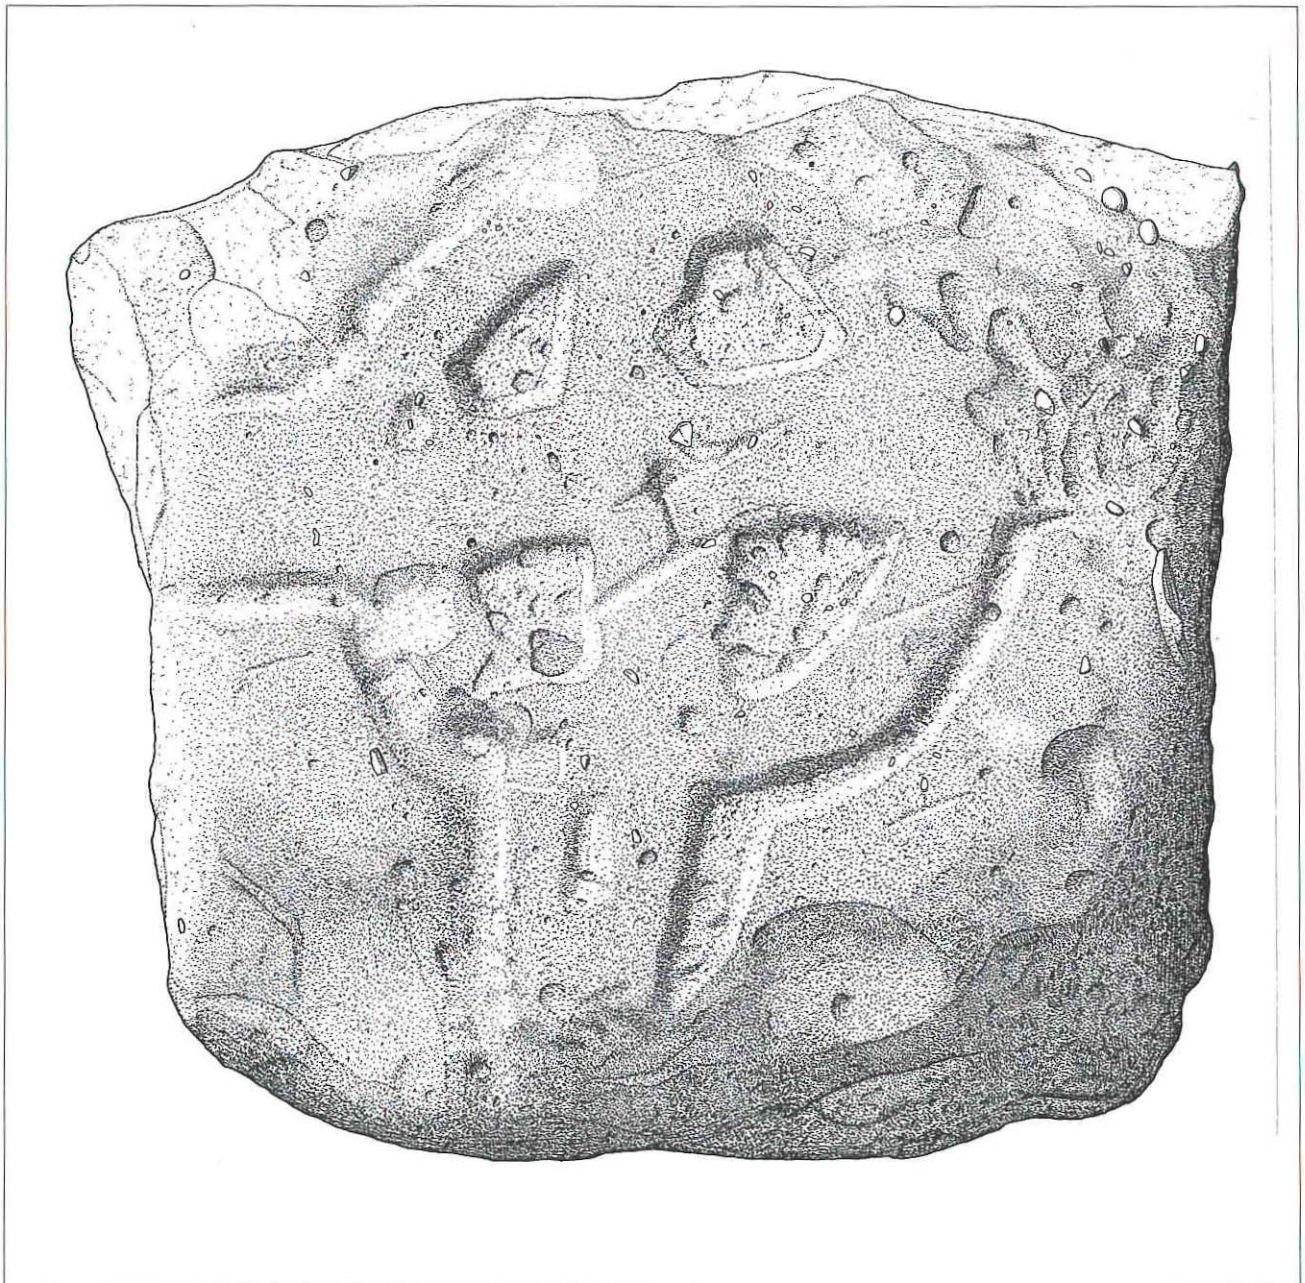
Fig. 6 Celtic cross. Scale 1:2

- 5.7 Inspection of the rubble removed from the core of the wall revealed a block of stone which had been carved with a Celtic cross (Fig. 6). The stone, which measures 30.8 x 28.8cm overall, has been damaged, resulting in the loss of part of the original design. The cross has been identified by Nancy Edwards, University of Wales, Bangor, as being of 9th or 10th-century date. A fragment of carved masonry was also recovered from the rubble infill.

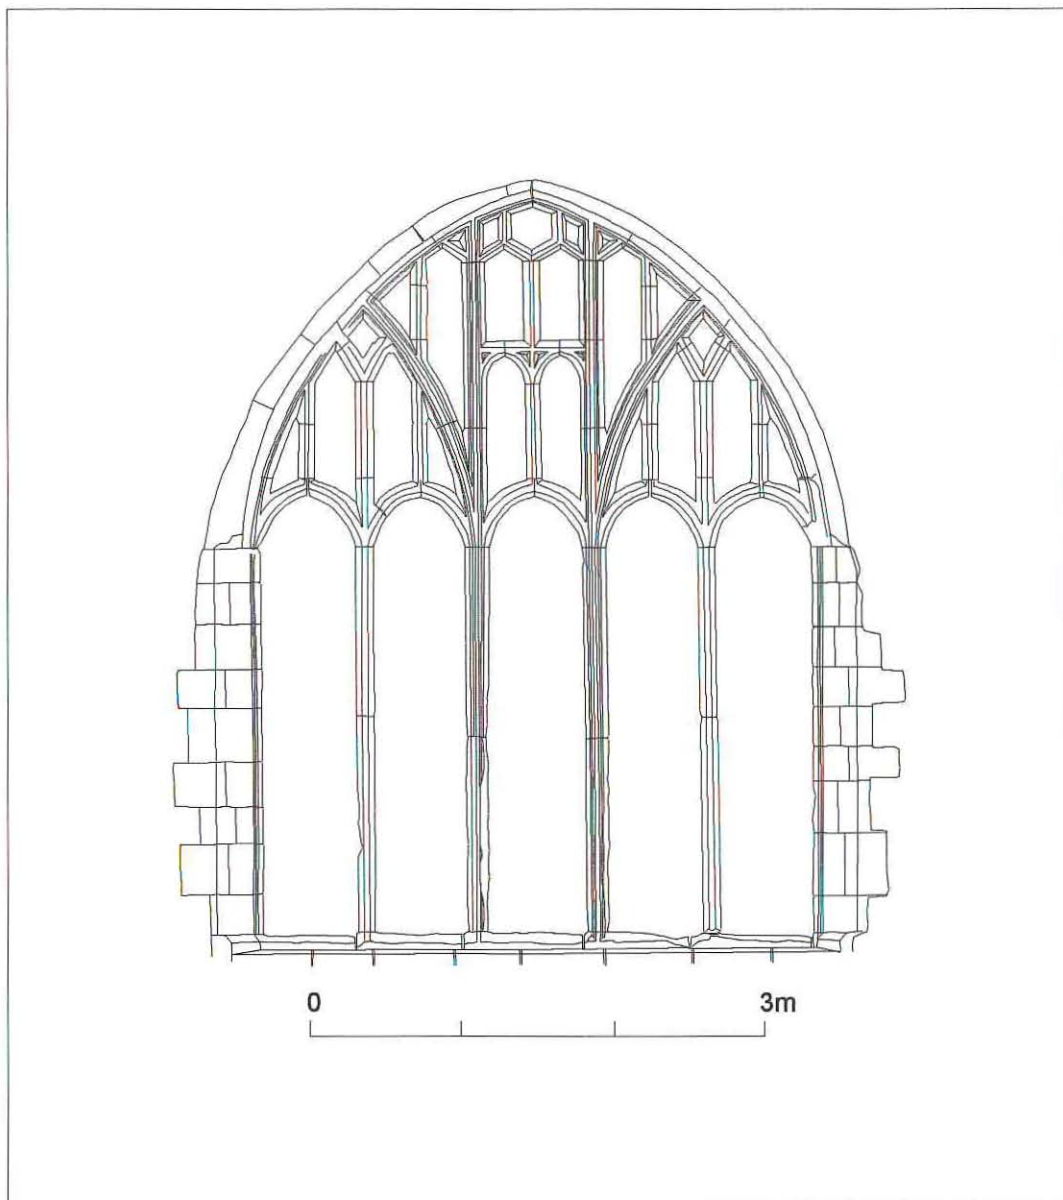
Fig. 7 North aisle east window, interior, scale 1:50

- 6.1 A full photographic survey was undertaken of the internal side of the window prior to the glazing being removed. Rather than record individual stones which were to be replaced, it was decided to record the entire window in detail at a scale of 1:10 on both the interior (Fig. 7, plate 1) and exterior.

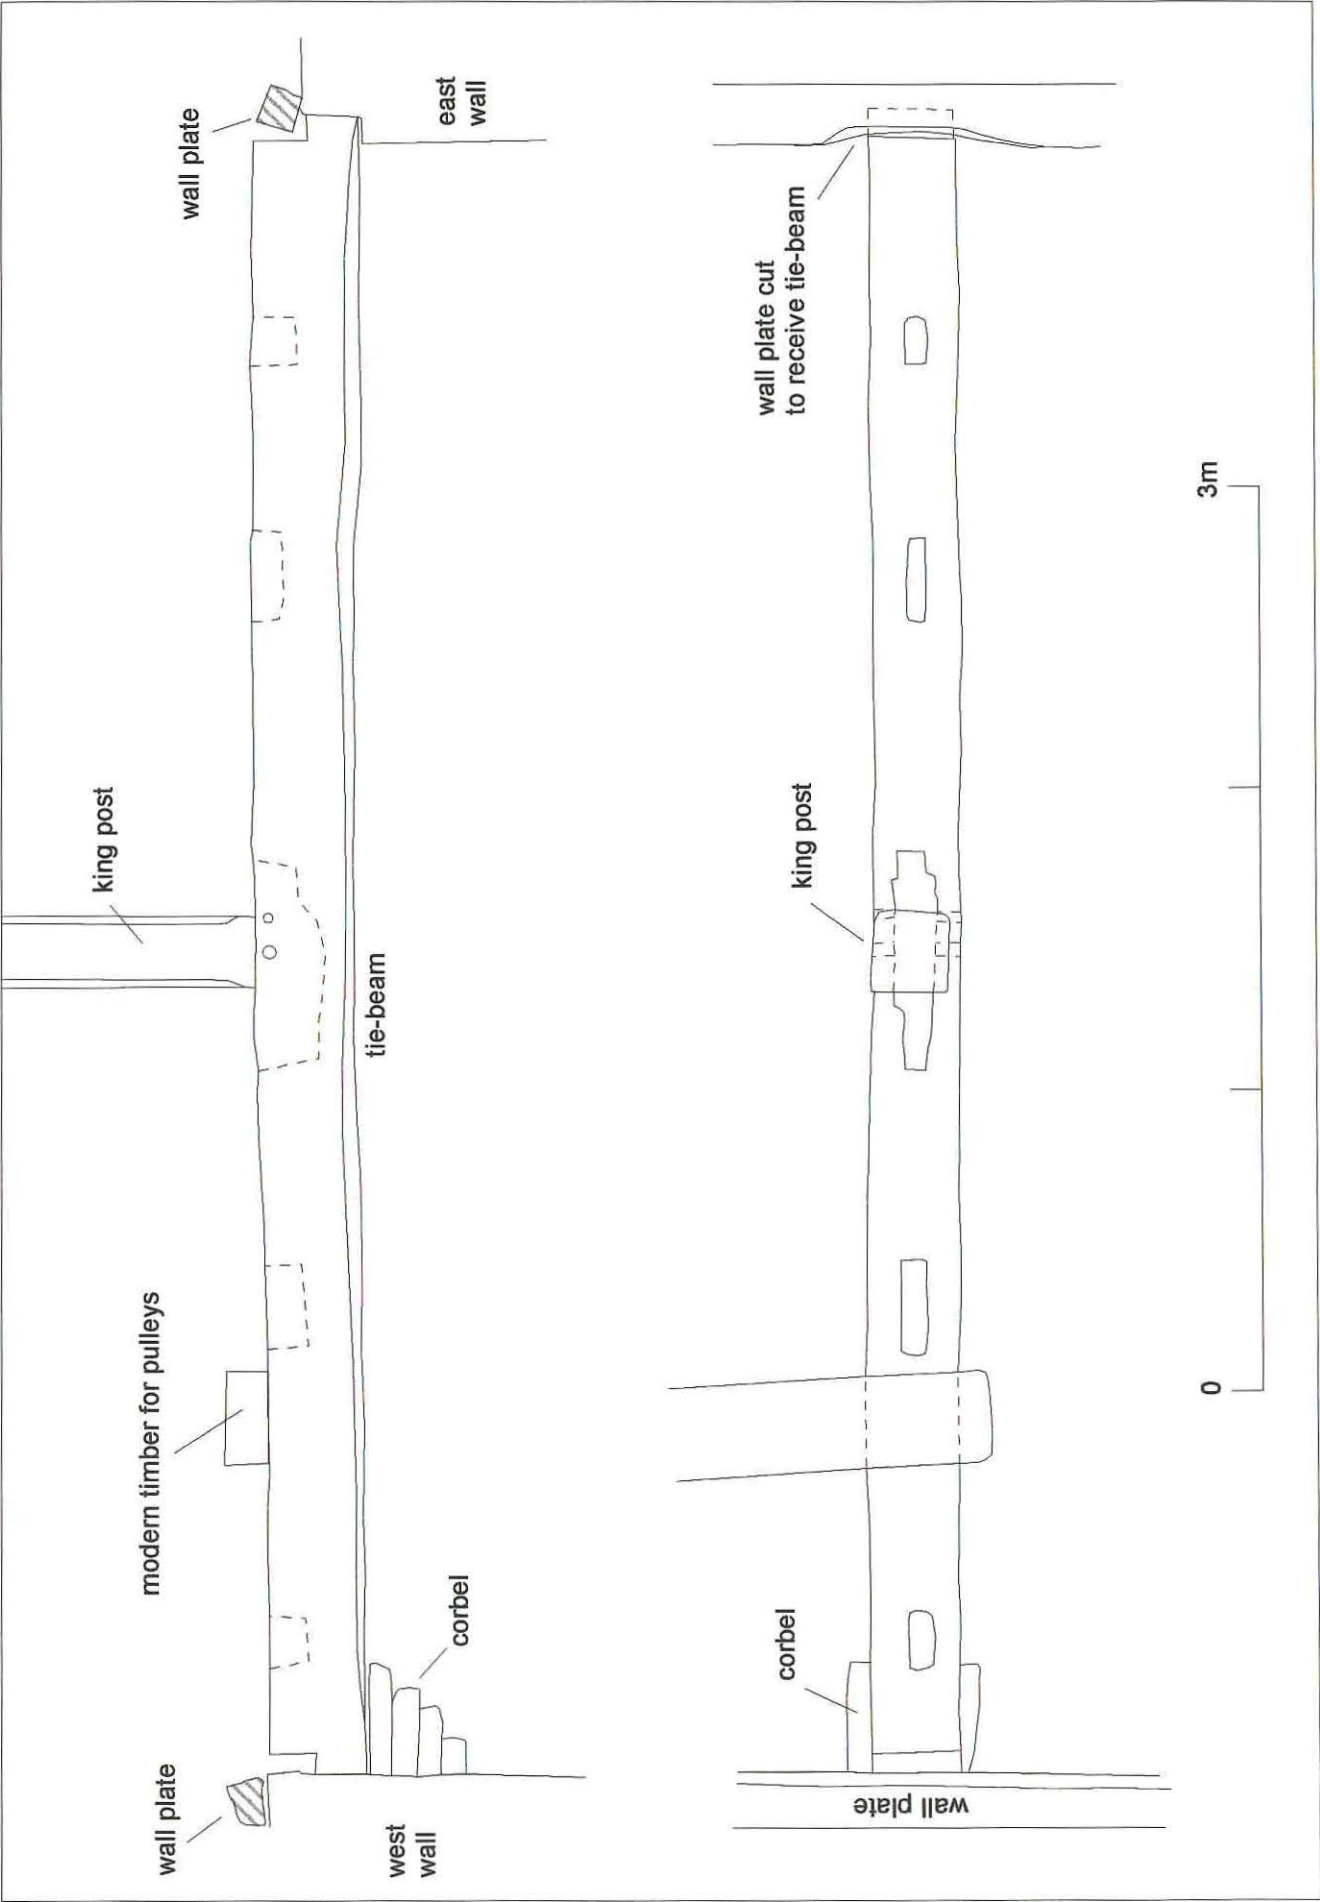
Fig. 8 Bell tower roof, tie-beam and king post, scale 1:25

- 7.1 A full photographic survey was undertaken of the interior of the roof prior to repair works commencing. The main roof structure is contemporary with the construction of the tower in 1568, and consists of a single tie-beam and king post. Both are original, as are the wall plates and dragon-ties, although all of the rafters are later replacements. The tie-beam in particular was in a poor state and was originally intended for replacement although subsequently it was decided to repair and strengthen the post. Following the erection of scaffolding a drawn record was made of the tie-beam and king post (Fig. 8), together with further photographic recording (plate 7).

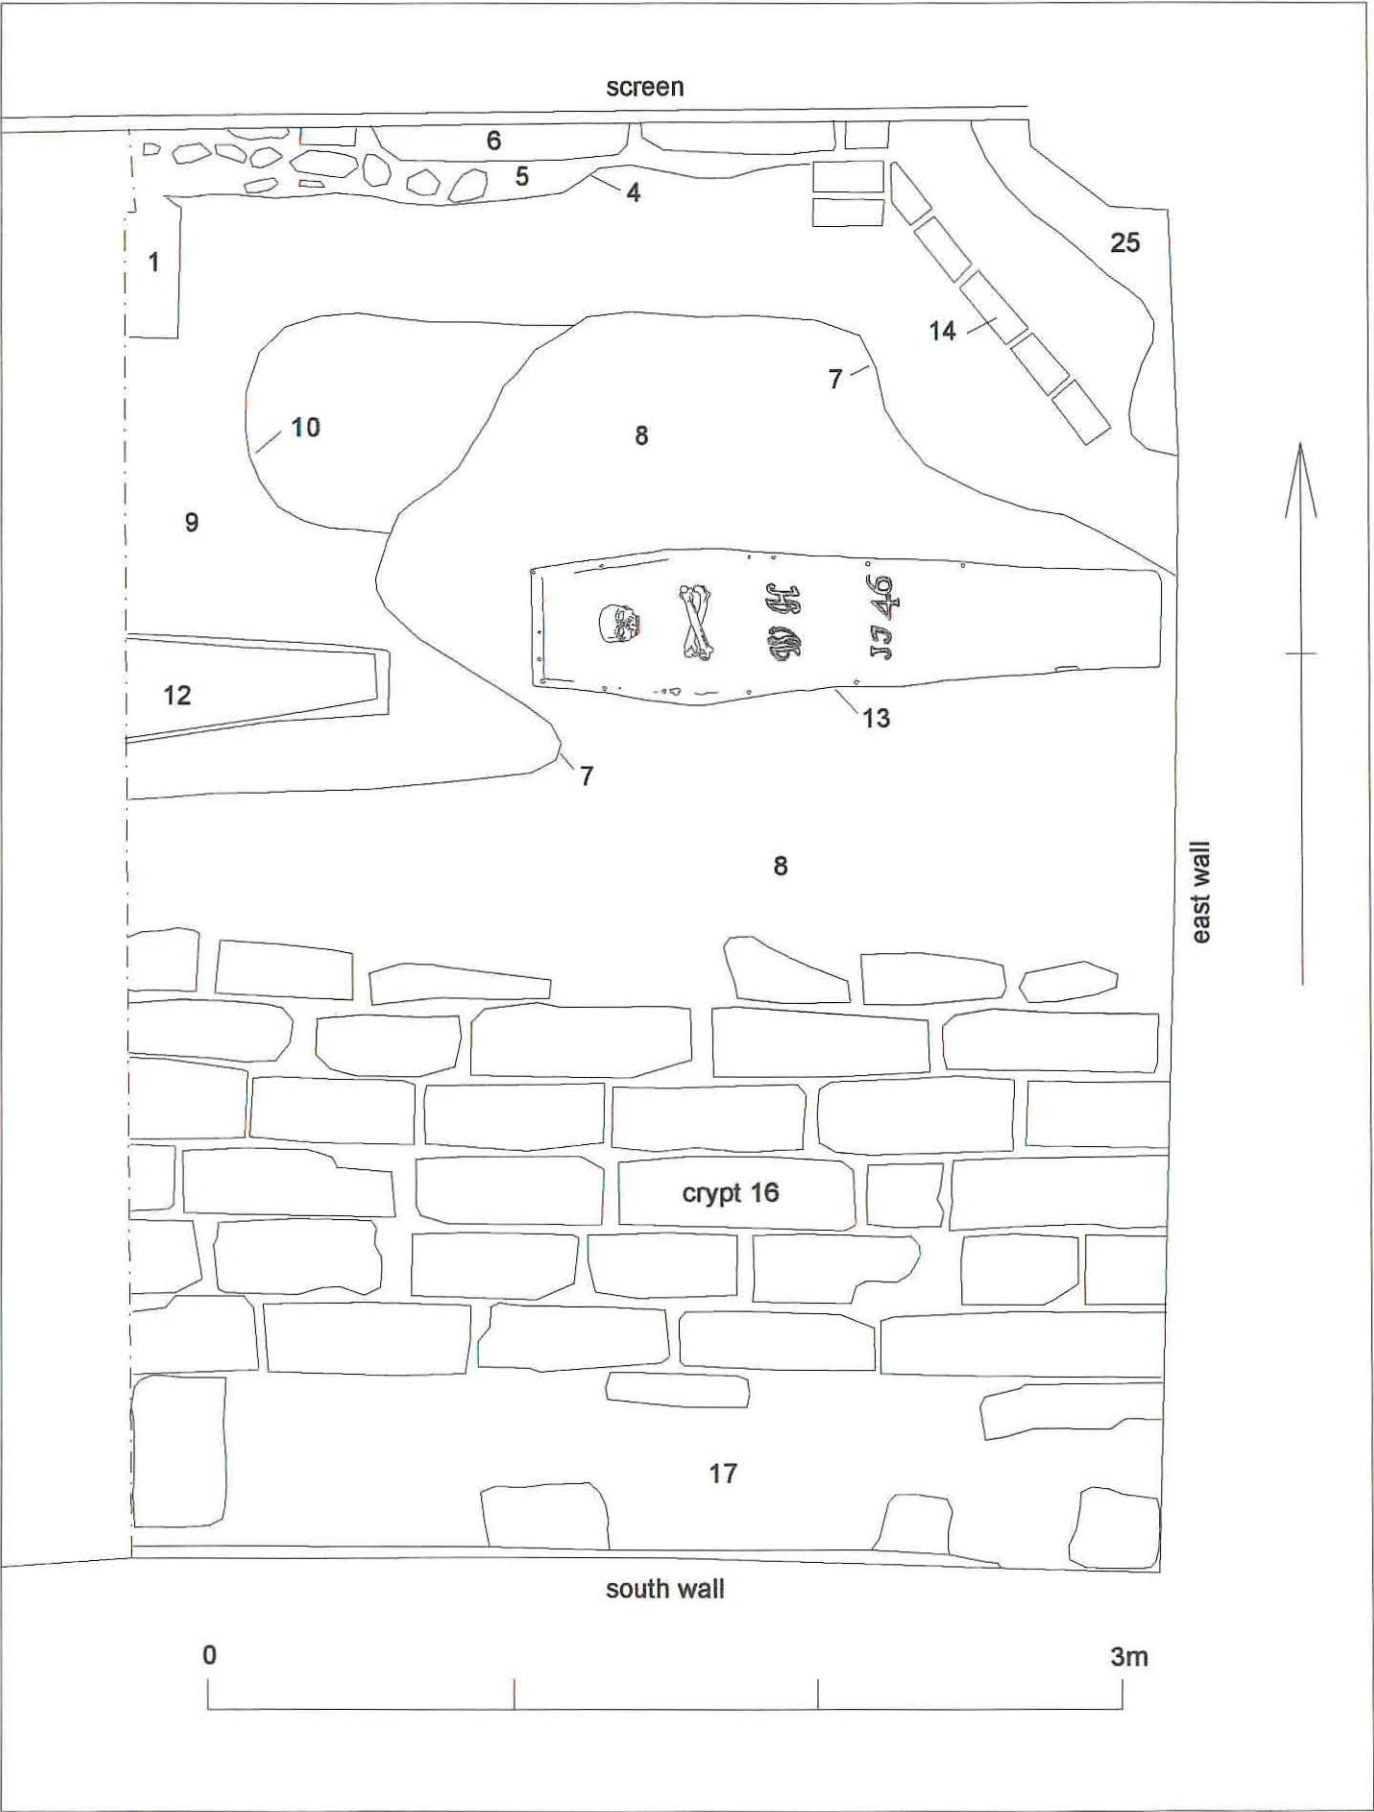
Fig. 9 New Lady Chapel Excavation, scale 1:25

- 8.1 As part of the restoration programme, the east end of the south aisle was to be converted into a new Lady Chapel, prior to which repairs were required to the floor. Subsidence beneath the organ, which was formerly at the east end of the aisle, led to the discovery of a lead coffin (13) beneath the floor in

1997. The coffin lid was embossed with the initials WH and a date of 1746, together with skull and crossed bones. The area for the new floor, measuring 4.8 x 3.4m, was therefore excavated before construction work commenced, a full drawn, written and photographic record being maintained throughout. Numbers in brackets in the following text refer to individual contexts in the site archive. Artefacts recovered during the excavation have been temporarily retained by CPAT until their final deposition has been agreed.

- 8.2 The existing wood block floor (15) and concrete screed (1) were removed by Chester Masonry, after which the area was excavated by hand to a depth level with the top of the lead coffin (13), which lay up to 0.47m below the floor surface. The southern part of the excavated area was occupied by the barrel vaulted crypt (16), which was constructed of mortared, roughly shaped stone blocks up to 0.75 x 0.25m across, the upper surface of which was exposed within the excavation. The date of the crypt is unknown, although it has been suggested that it may be of 13th-century origin (Lloyd 1961). The external entrance to the crypt was beneath the east window, the internal dimensions being 1.85 x 5.5m and 1.9m high. The east end of the crypt was converted into a boiler house in 1884 at which time the rear of the crypt was walled up.

- 8.3 It was evident that a certain amount of disturbance had occurred at the time that the lead coffin was discovered in 1997. The area surrounding the coffin, and extending as far as the crypt, had been excavated (7) and later partly infilled with a loose layer of silty loam (8), within which were a number of disarticulated bones, together with fragments of clay pipe and stained glass. At the west end of the excavation, and extending beyond its limits, an area of at least c. 1.8 x 0.6m remained undisturbed. The concrete screed (1) had been removed to reveal a compact layer of grey-brown loam with a high mortar content (2), up to 7cm thick, which may have been a surviving remnant of an earlier floor surface, or levelling for such. A coin of Charles II of unknown denomination was found within the layer, which was removed to reveal a layer of mid-brown loose loam (3). A second coin was found within this layer: a George III Irish halfpenny dated 1769. Beneath this was a layer of brown sandy soil (9), in the surface of which a wooden coffin (12) was visible extending beyond the excavation to the west. There was no evidence for a grave cut and the coffin appeared to be intact, although the lid had subsided slightly. The top of this wooden coffin was approximately level with that of the lead coffin (13) and was therefore left undisturbed.

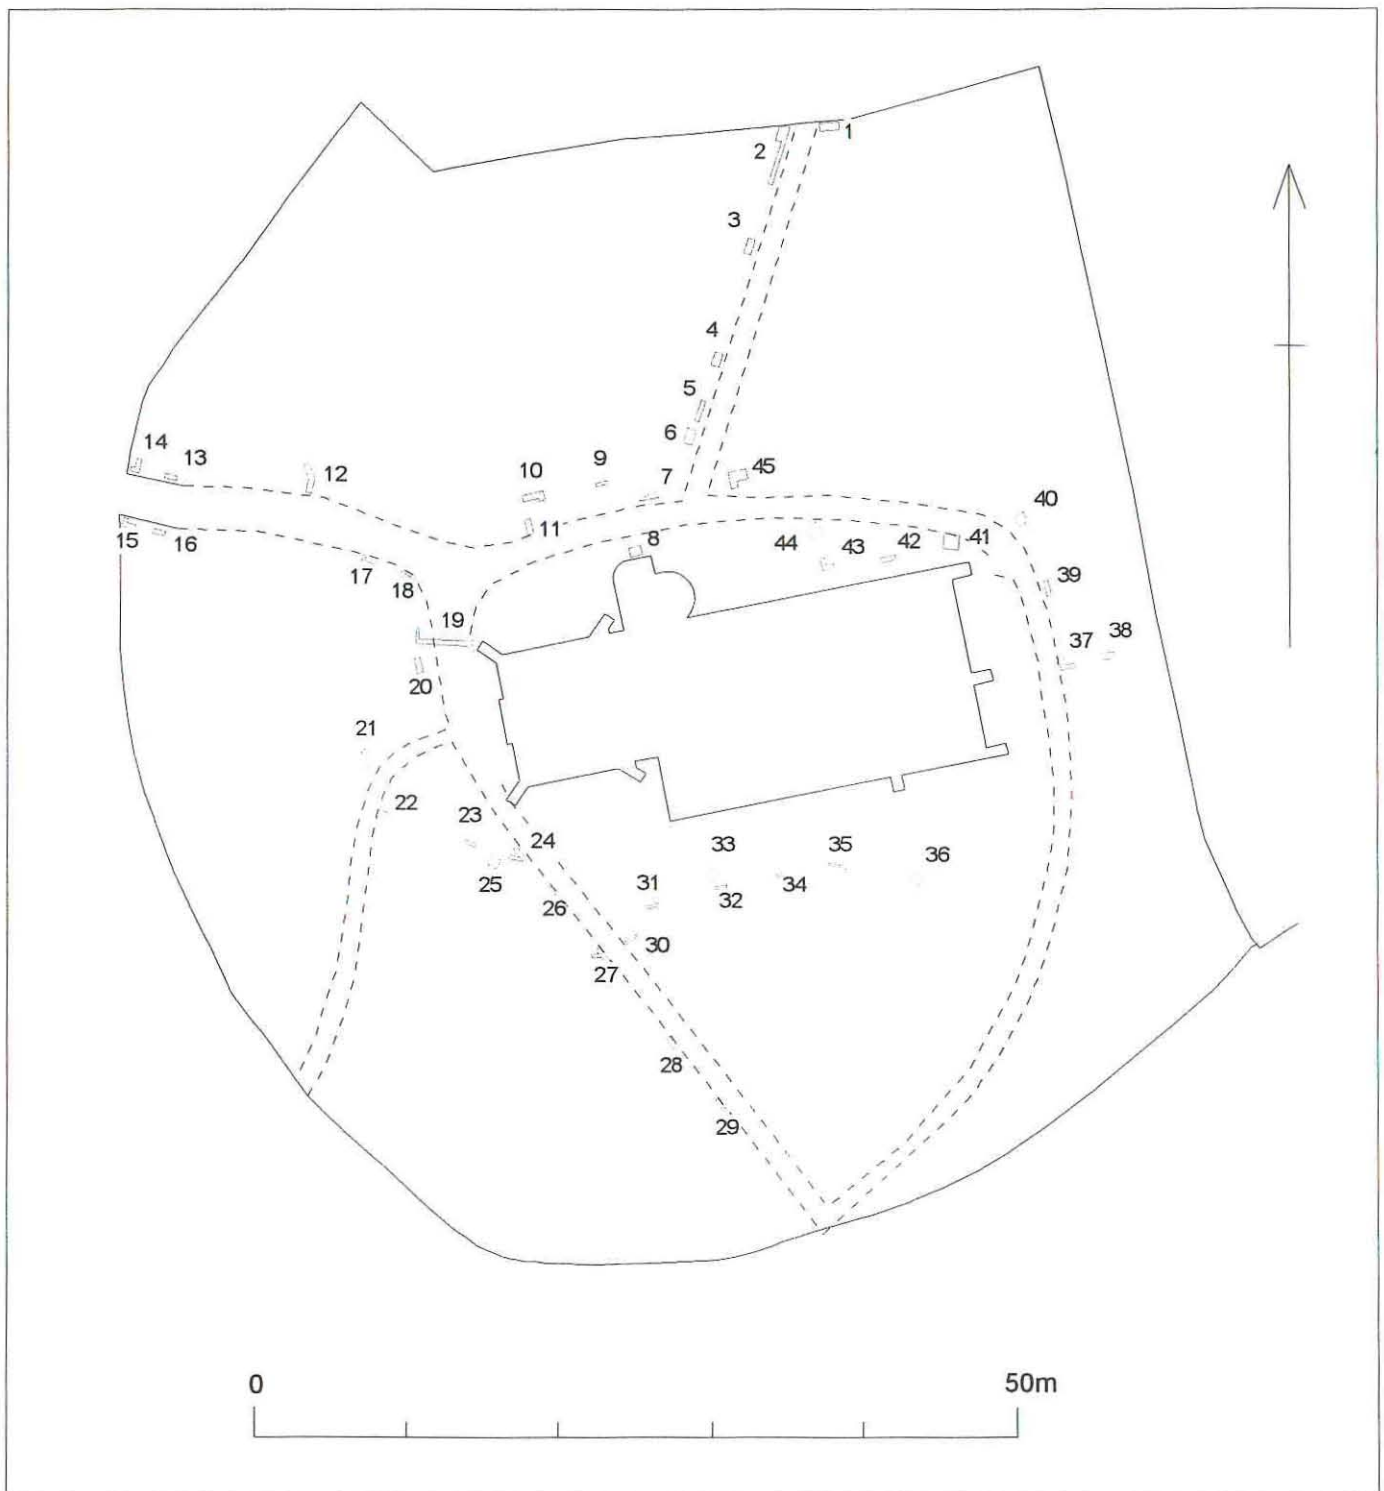
Fig. 10 External lighting trenches, scale 1:500

- 9.2 In all 45 trenches (Fig. 10) were excavated by hand, each of which was subsequently investigated for archaeological deposits. The trenches were of varying size, shape and depth, most being rectangular, although a number had somewhat irregular plans. At the northern edge of the churchyard the electricity supply ran alongside the path towards the church, and then around either end of the building. Several cables ran off the main supply, following the paths to the west and south of the church, to provide power to a number of smaller lights designed to illuminate the paths.

- 9.3 The trenches were inspected by CPAT on 3rd and 5th November 1999. All the trenches were relatively shallow (none being more than 0.8m in depth) and filled with a loose brown stony loam,

except for trench 41 which had recently been dug to take a plastic pipe and was filled with soil and grey gravel. There was little of archaeological interest visible within the trenches, none of which appeared to be deep enough to have disturbed graves. A number of flat stones were visible in trench 18 although at 0.2m wide the hole was far too small to discern their nature. The only other artefact discovered was the rim of a post-medieval pot from trench 23. Although no intact burials were disturbed small fragments of disarticulated bone were found in a number of trenches.

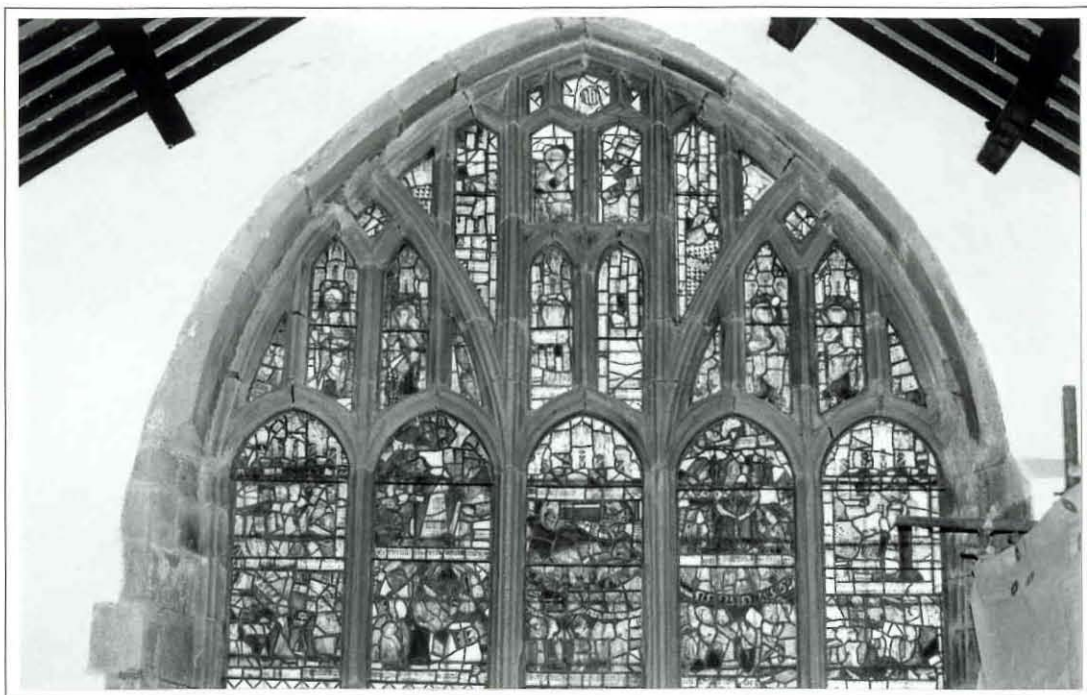
Plate 1 North Aisle east window. Photo CPAT 870.8A

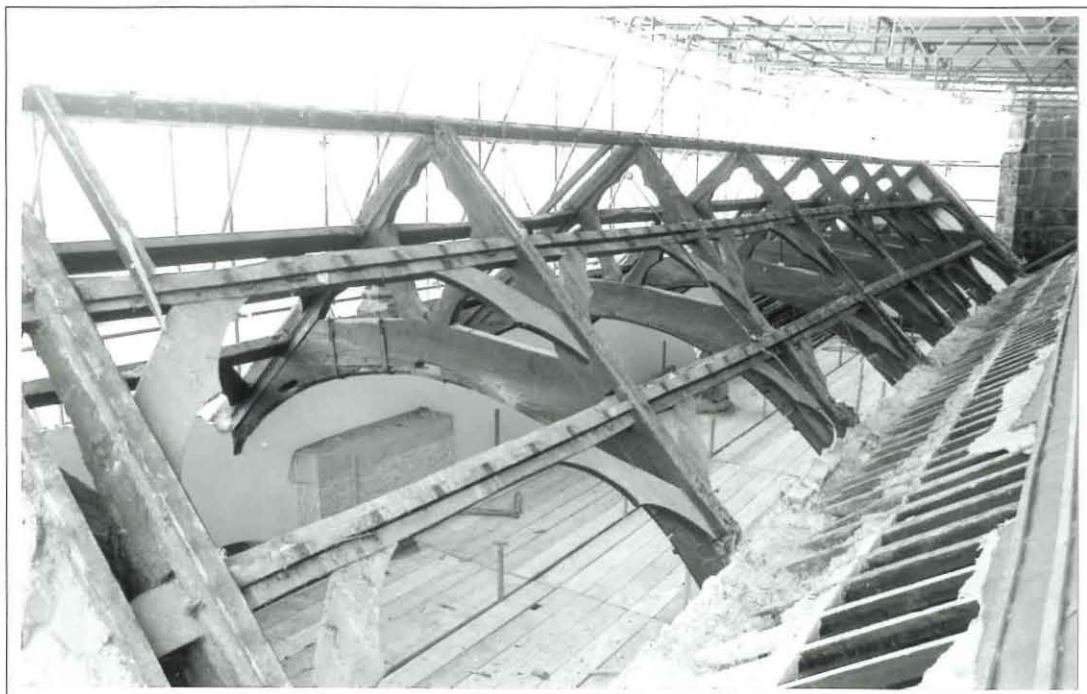
- 4.4 The roof shows extensive signs of repair, particularly at the northern end of each truss, and all the common rafters are modern replacements. The condition of the roof was one of the principal factors which led to the restoration work being undertaken. Many of the timbers showed evidence of decay,

both from rot and wood-boring insect, and the precarious state of the roof led to emergency scaffolding being erected internally to support the roof in 1997. This remained in place until the roof was stripped in March 2000, at which time the scaffolding was re-erected, allowing full access to the roof timbers.

Plate 2 South Aisle roof. Photo CPAT 944.23A

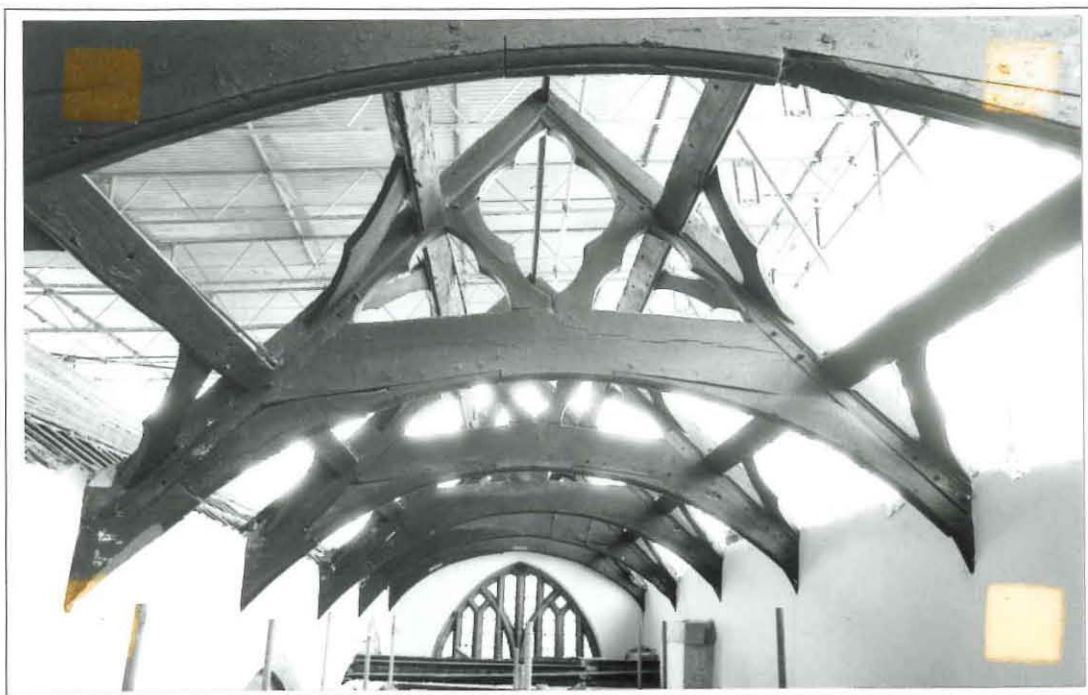
Plate 3 South Aisle roof truss 4. Photo CPAT 940.26

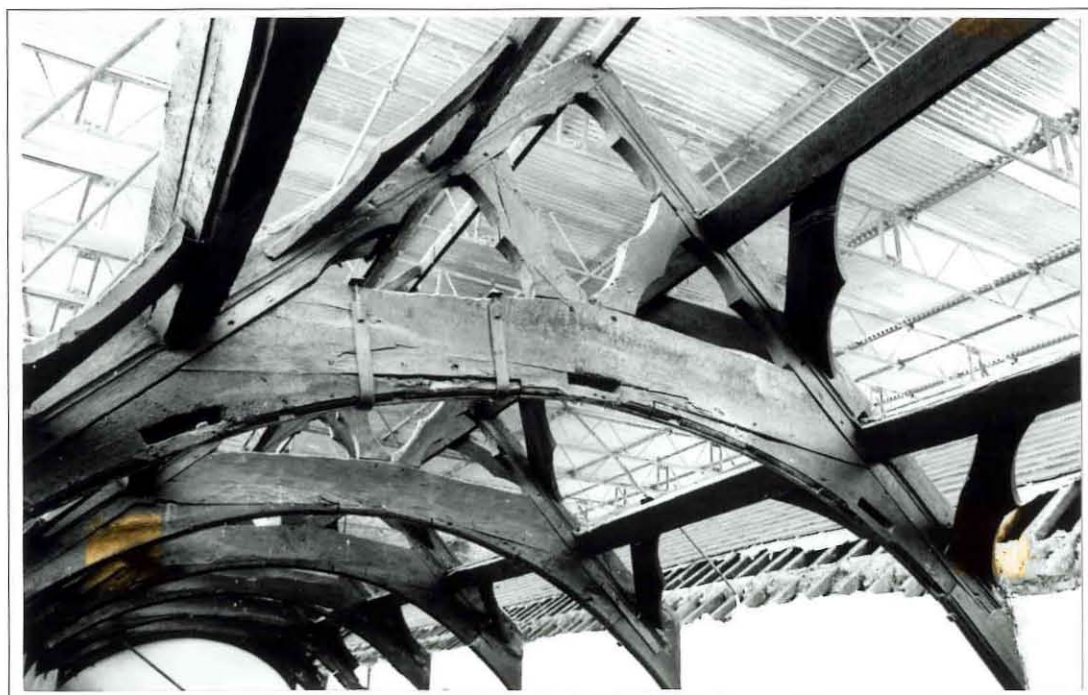
Plate 4 South Aisle roof truss 7. Photo CPAT 940.5

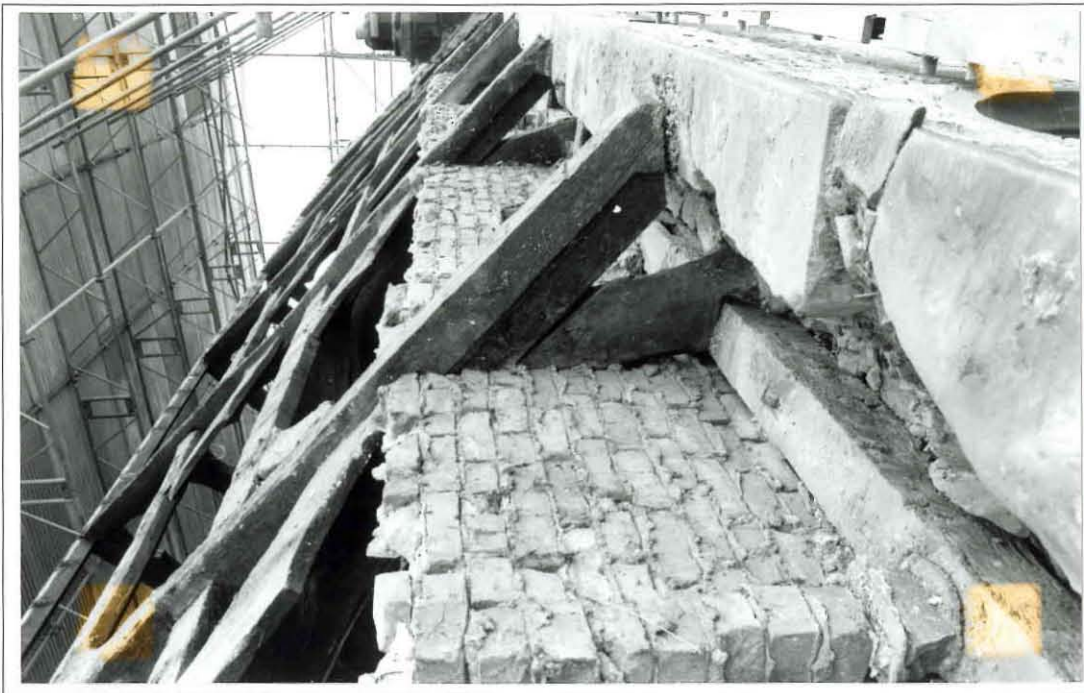
Plate 5 South Aisle roof showing brick infill by truss 3. Photo CPAT 944.12A

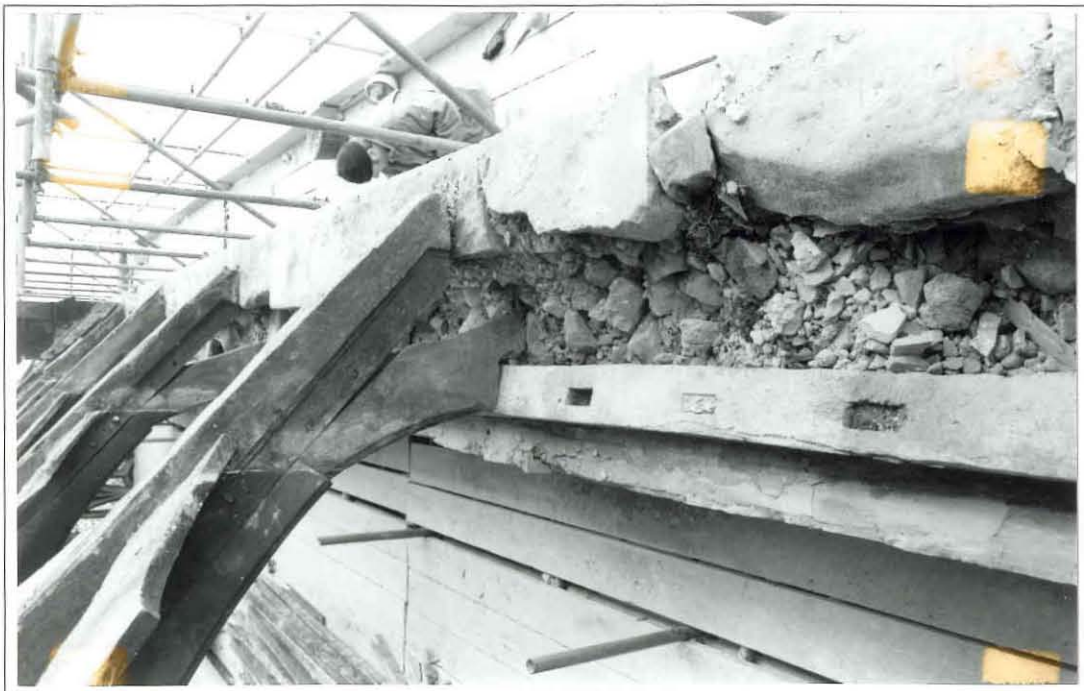
Plate 6 South Aisle roof after removal of brick infill. Photo CPAT 947.25

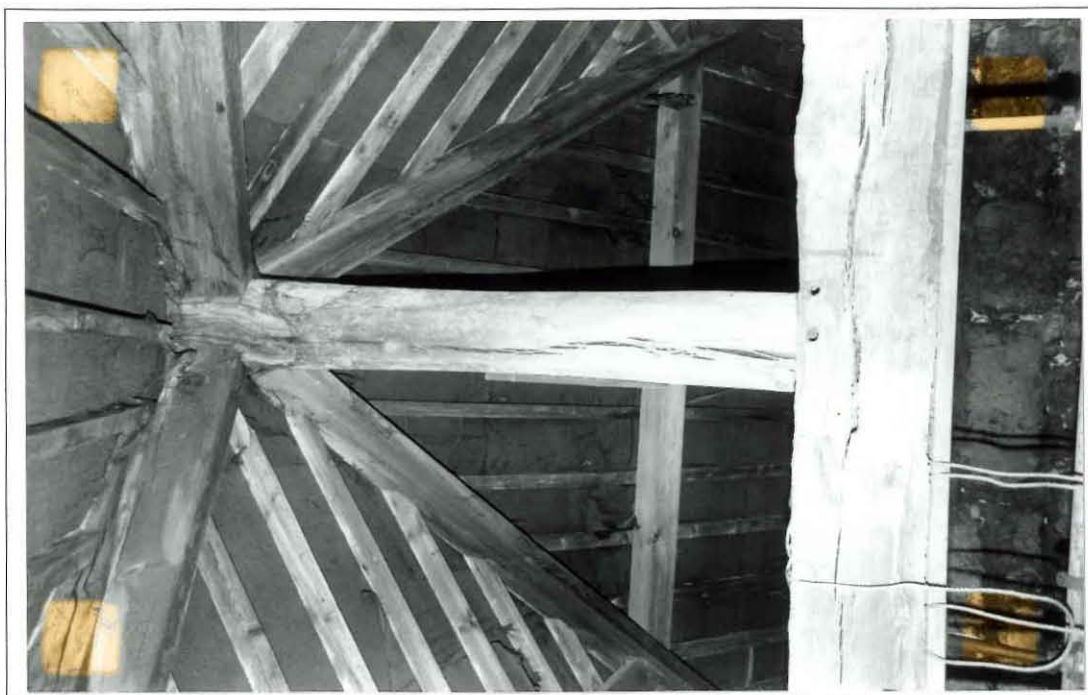
Plate 7 Bell tower roof interior showing king post and tie-beam. Photo CPAT 956.31

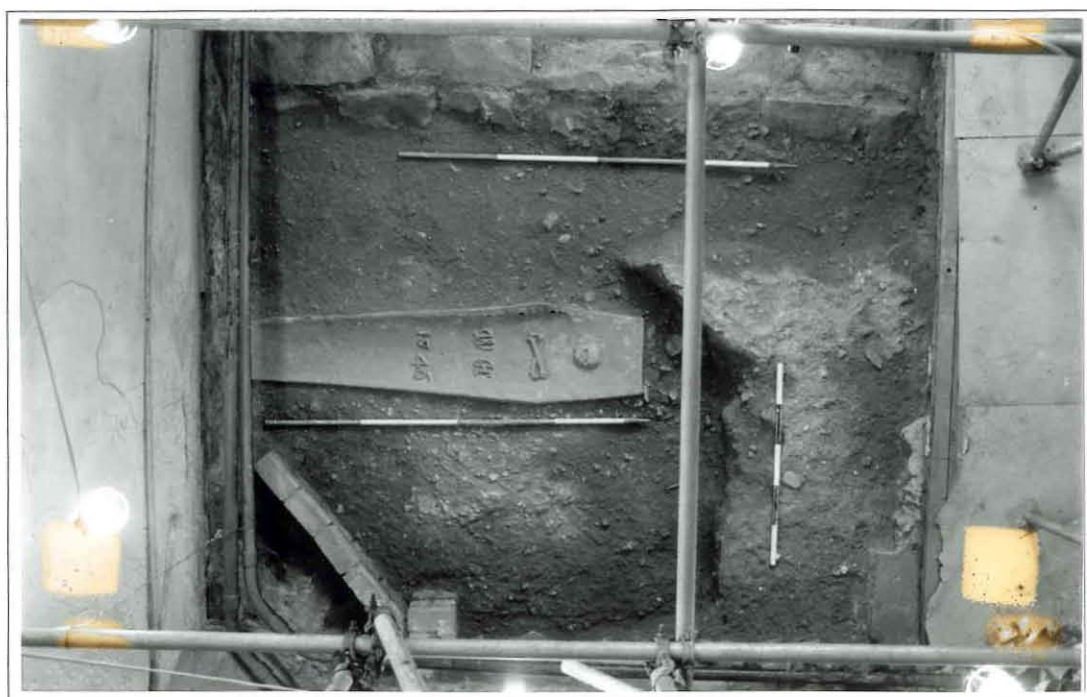
Plate 8 New Lady Chapel excavations showing lead coffin 13. Photo CPAT 945.5
