St Trillo's Church, Llandrillo-yn-Rhos,  
Conwy  
ARCHAEOLOGICAL RECORDING

CPAT Report No 403

**R J Silvester**  
November 2000

Report for Robin Wolley, Esq

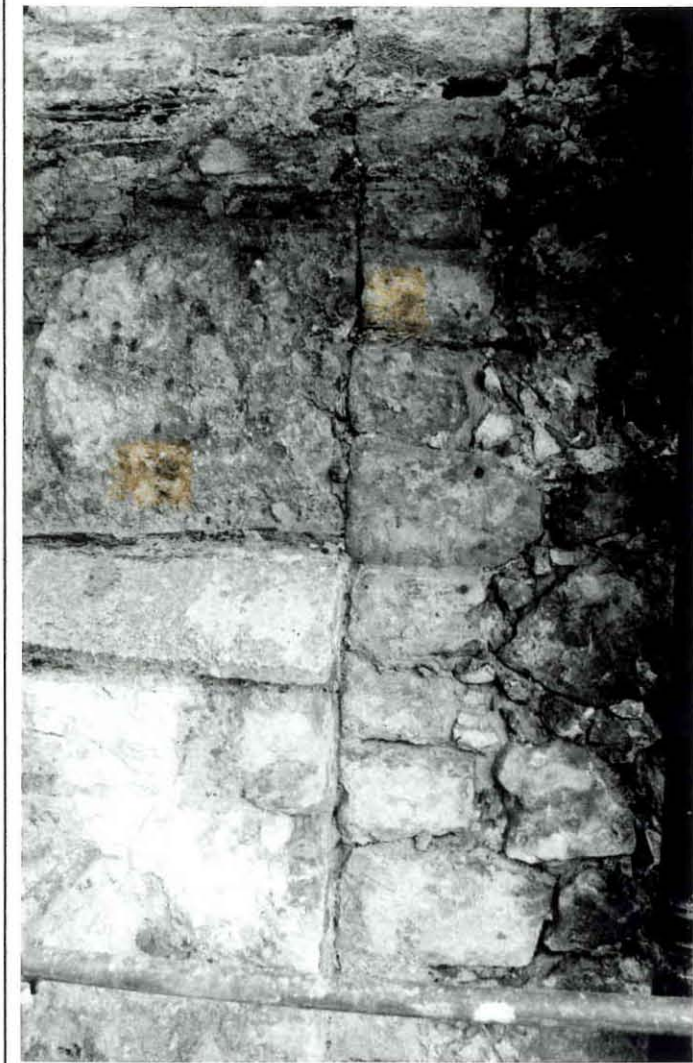
4.1.4 A distinctive butt joint is visible at the juncture of the north and south nave walls (Plate 1). The quoins at the south-east angle of the north nave are predominantly of pink sandstone and though a few have been removed during earlier construction work, most are still in situ. As was only to be expected these are not directly below the valley between the two naves but slightly to the north, confirming beyond any doubt that the north nave is earlier than its southern counterpart. Just below the valley the rotting timberwork of the external truss of the north nave gable is just visible. Likewise at the north-east angle of the north nave the quoins associated with this fabric area are predominately of pink sandstone in contrast to the limestone below.

Plate 1: butt joint between north and south  
naves in east wall

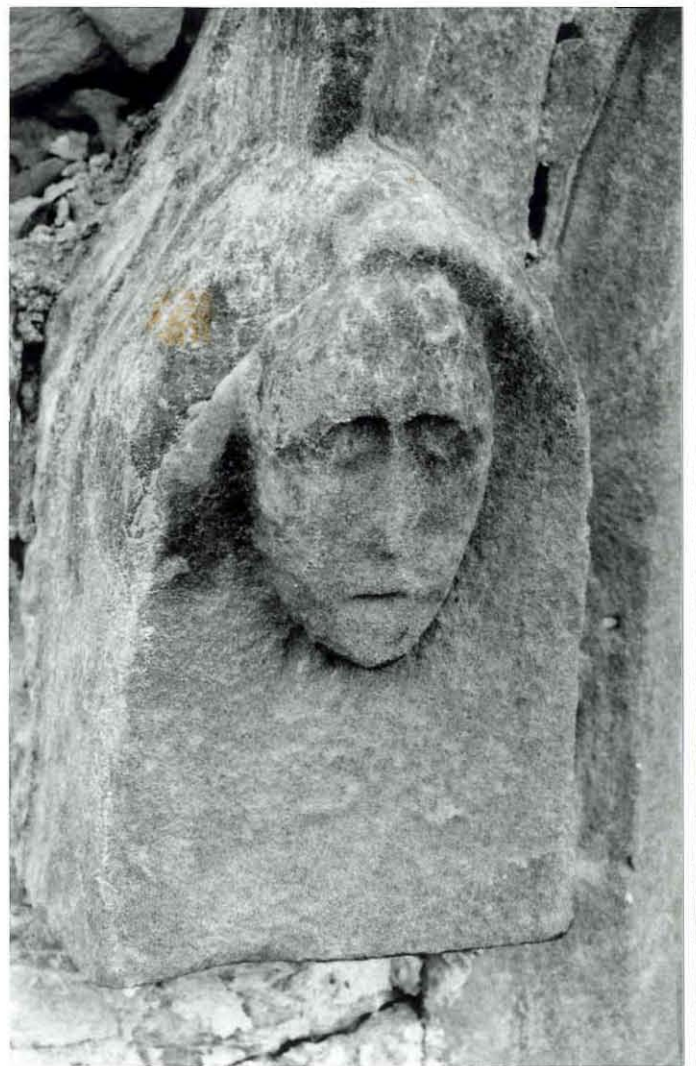
4.2.3 The window is considered to be largely original though the dressings are not much worn. The hoodmould has worn head stops (Plate 2), of slightly different design and size (one 140 x 110mm, the other 135 x 80mm), but the level of wear on the hoodmould stone of which they are an integral part is comparable with that on the other hoodmould stones above the arch.

Plate 2: medieval head stop to east window  
of south nave

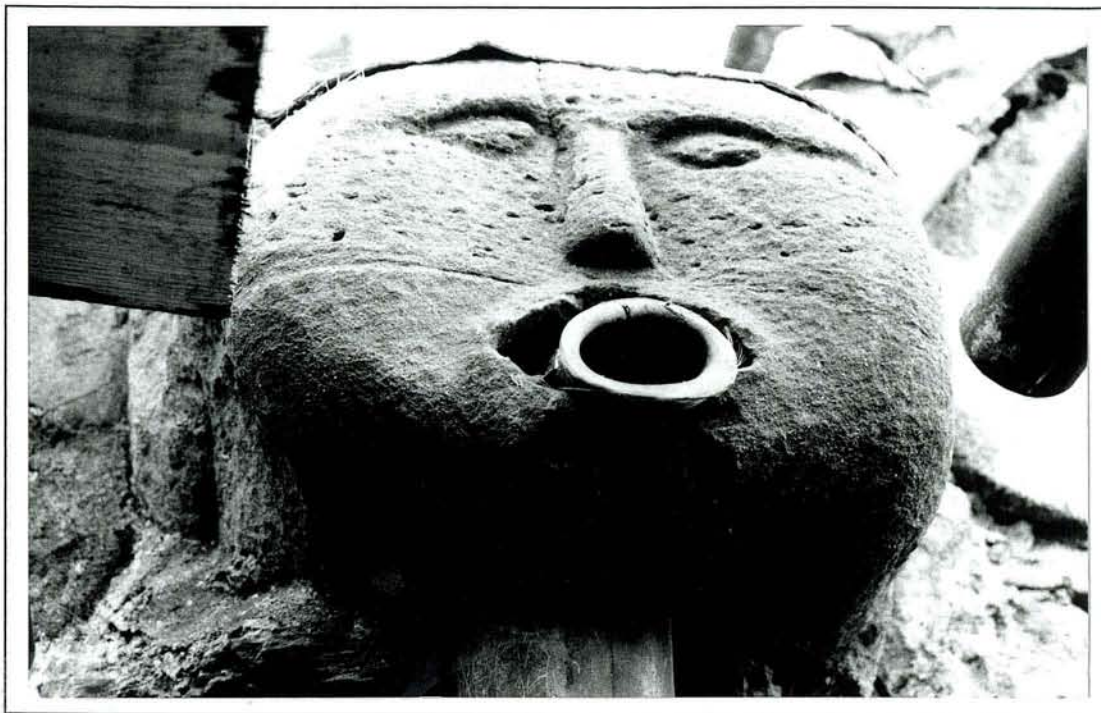
4.1.5 At the valley opening is a 'grotesque' head, worn and pitted, in pink sandstone (Plate 3). The hole in its base to take a downpipe is probably relatively recent and the mouth may have been enlarged to take a lead pipe but the head as a whole appears to be of considerable age. Its dimensions are 0.22m high, 0.33m across and in depth it is greater than 0.32m. Dr N Edwards of the University of Wales, Bangor has suggested to the writer that it is broadly similar to some of (?)13th-century date in Gwynedd, but it remains a puzzle as to why no mention of this head appears in earlier reports on the church.

Plate 3: primitive head functioning as a water spout on east wall

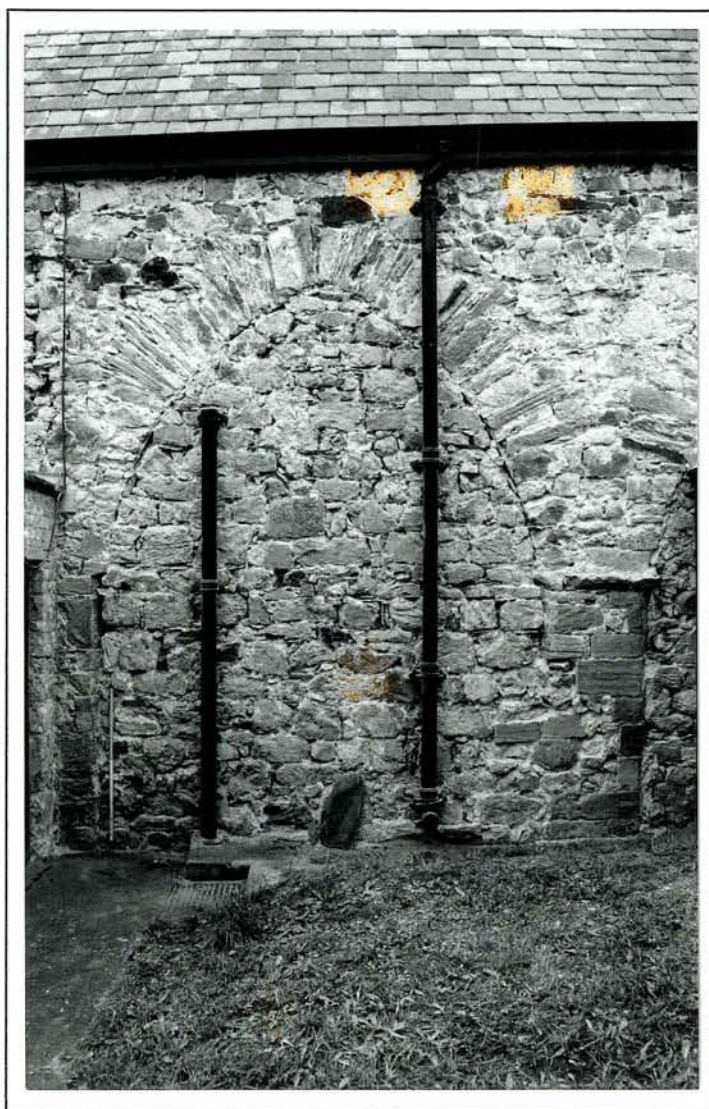
5.3 The central part of the north wall (between the vestry and the organ chamber) has long been a feature of the church because of the blocked arcade immured in the wall. One complete bay of the arcade is visible with part of a second though rather more of it must have been visible (Plate 4) before the choir vestry and its predecessor, the hearse house, was added, and this can be adduced from the interior where two complete arches remain in situ. The complete bay is 3.9m high from ground level to the soffit, and 3.07m wide between the inner faces of the piers. The pier on the east, though partially hidden by the annex to the organ chamber, is almost certainly a respond for there is no evidence of a further arcade arch to the east of it. The chamfered jamb of pink sandstone is complete and there is an indication of an abacus at the top of the pier; between the blocks small plates of shale have been regularly inserted with the mortar. The pier supporting both arches is square or rectangular with chamfered angles, and a complete abacus remains (Plate 6). Parts of the eastern face of the pier have been removed, though the reason for this is unclear. However, this dressed stone may have been re-used in the blocking (see below). The arch consists of voussoirs of both laminated shale (or slate) and pink sandstone, up to 0.6m long; the springers and the arch stones immediately above them are of cruder design than the voussoirs higher up; the original plaster on the soffit of the arch remains (Plate 5). The second (incomplete) arch is of much the same design and appearance as the complete one. The arcade has been blocked up with rubble masonry, well-constructed and intermittently coursed. This is mainly of limestone blocks, occasional blocks of shale with quartz banding, some of which may have been derived from pebbles, and smaller laminating slabs of grey shale used for filling the interstices.

Plate 4: blocked arcade arch in north wall of north nave

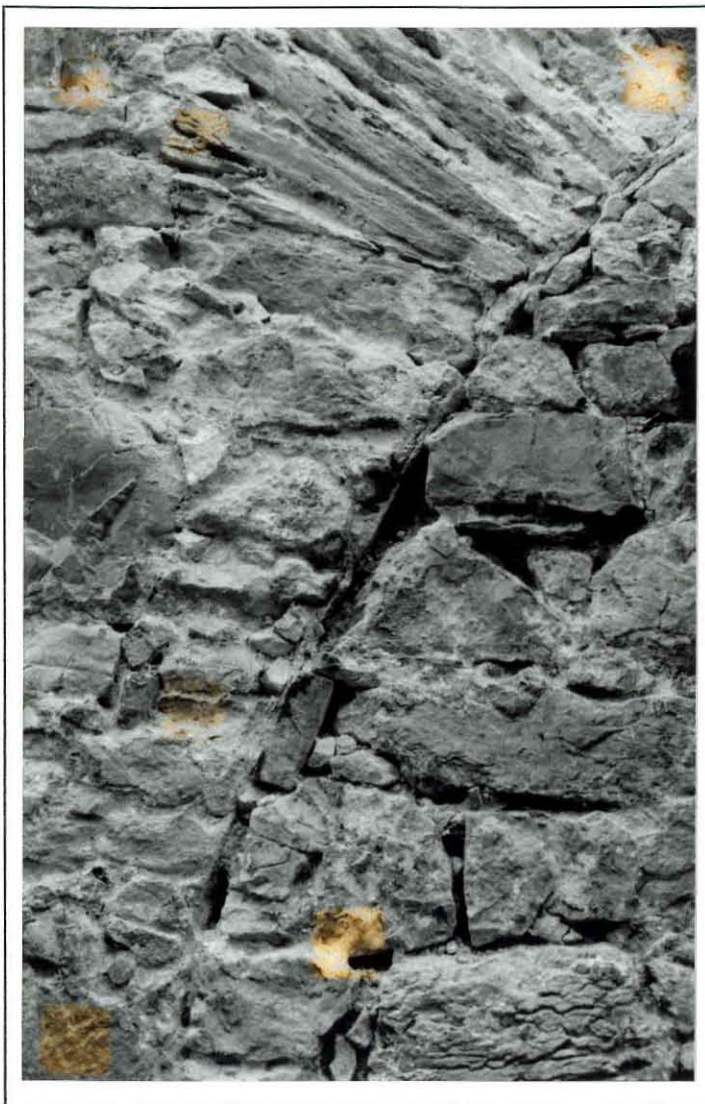
Plate 5: blocked arcade arch in north wall  
- detail of surviving medieval plaster

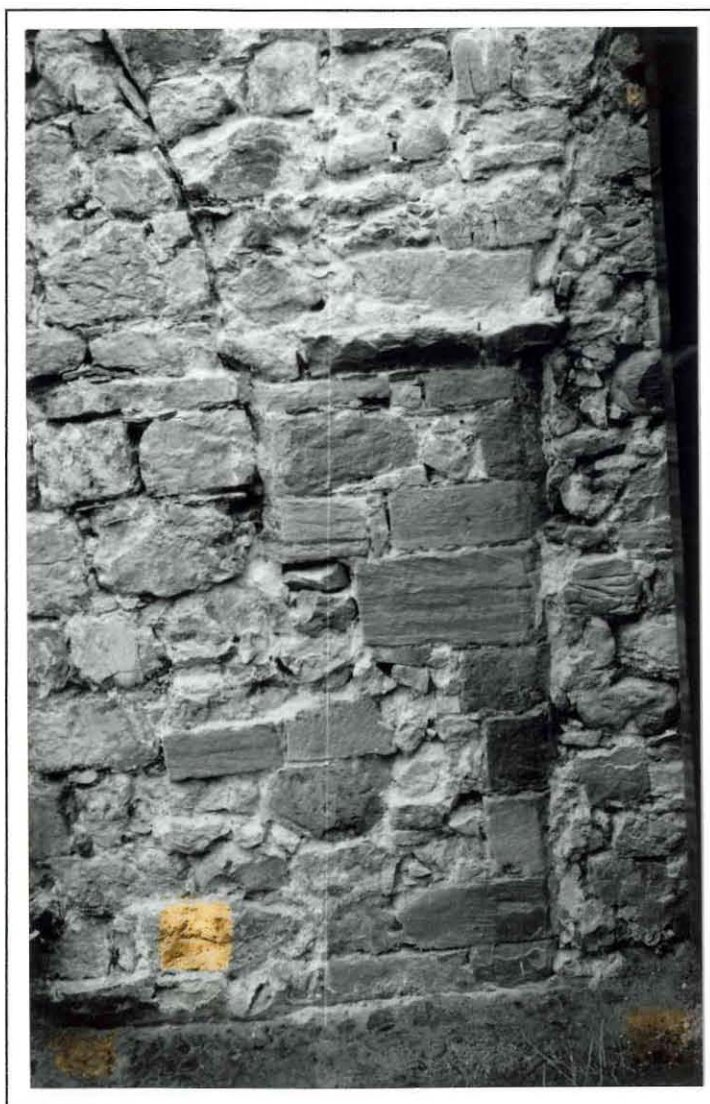
Plate 6: blocked arcade in north wall - details of pier

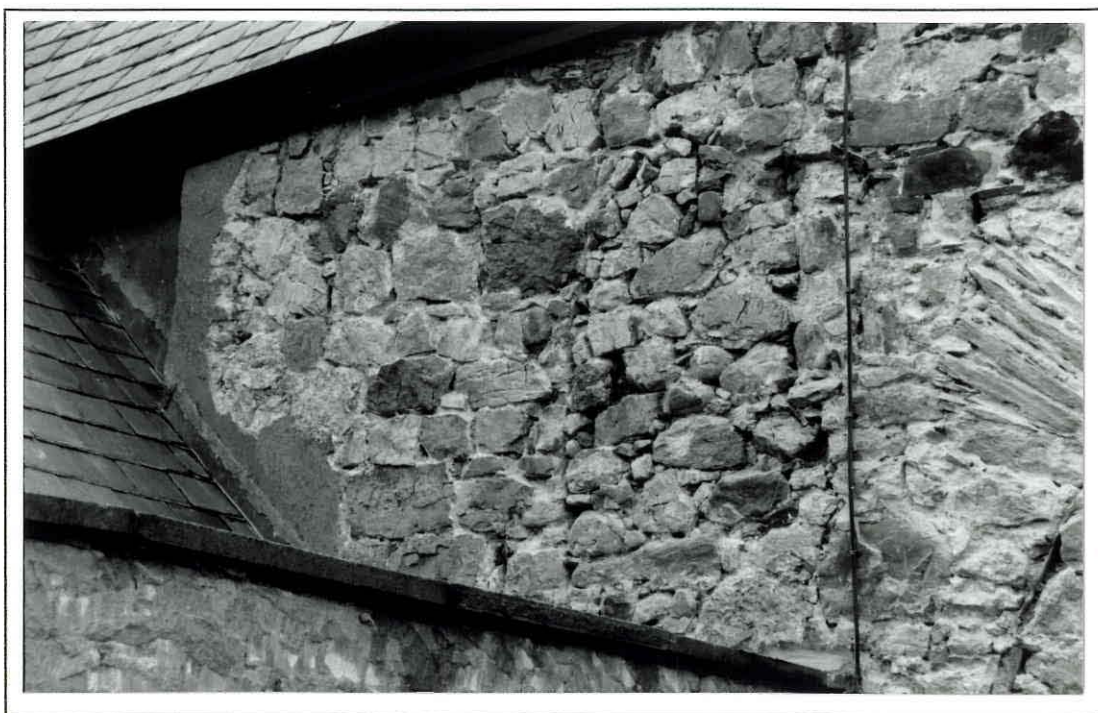
5.4 To the east of the arcade and showing above the annex is a blocked window (Plate 7). Its complete outline is visible, although its base may originally have dropped below the level of the annex roof and thus be disguised. As it now appears, it is 1.75m high and 0.96m wide and its apex is about 0.4m below the roof ledge. Although some of the stones that form the outline of the window are almost good enough to be classed as jamb stones for the frame of the window it is likely that all the window dressings have been removed, not least because of the asymmetrical appearance that the aperture now presents. The blocking of the window is in different masonry (= fabric G) to that of the arcade, being more of a mix of limestone, sandstone and pebbles with small limestone fragments in the interstices. East of the window the masonry is fabric A, but it is impossible to ascertain whether this was an original window or was inserted into a pre-existing wall. Above the window and indeed above and around the arcade arches is a mixed masonry, probably but not certainly B.

Plate 7: blocked window in north wall of north nave

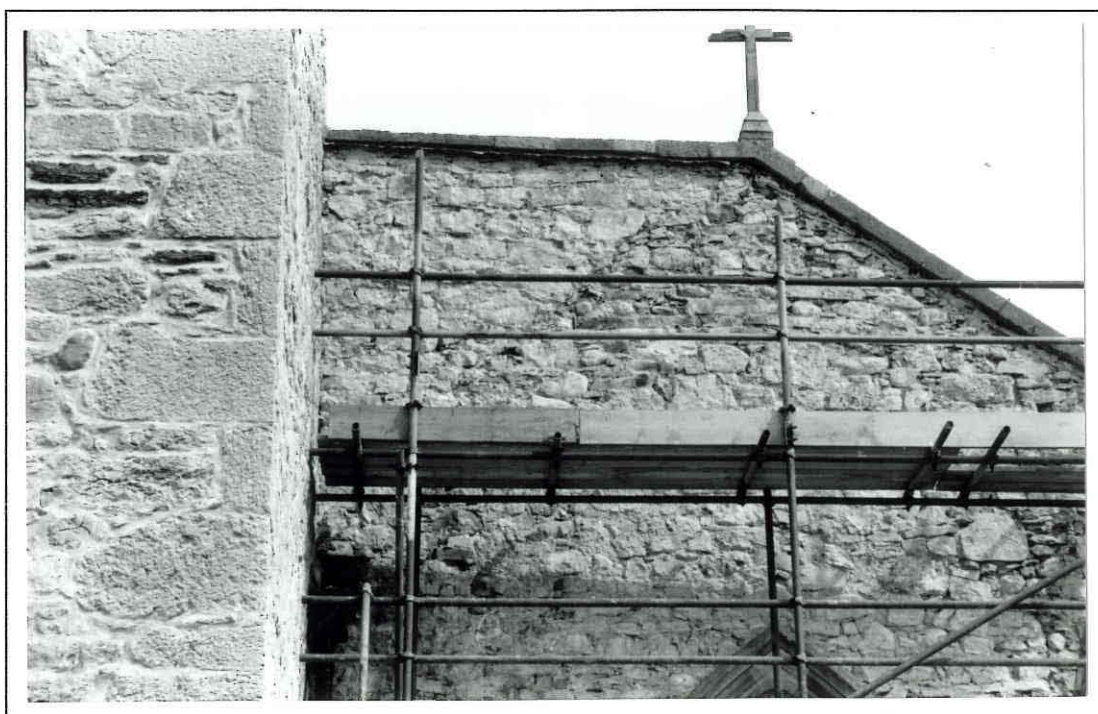
6.7 At the apex, the gable slope has been filled in so that the top edge of the nave runs horizontally to meet the tower wall (Plate 8). This can be clearly seen from the change in masonry to roughly coursed blocks of limestone (fabric F). The original roofline can still be determined though where it meets the tower there may have been some rebuilding. A leaded outlet for the drainage of the valley between the two naves is still in place. No date can be placed on this work but it is likely to be from the last century or so. (Unlike many churches in the diocese, the later 19th-century faculty petitions for Llandrillo church do not appear to have been preserved, so it is not possible to tie any of the structural changes in the building to specified programmes of work in the Victorian era).

Plate 8: masonry infill on top of west wall of south nave

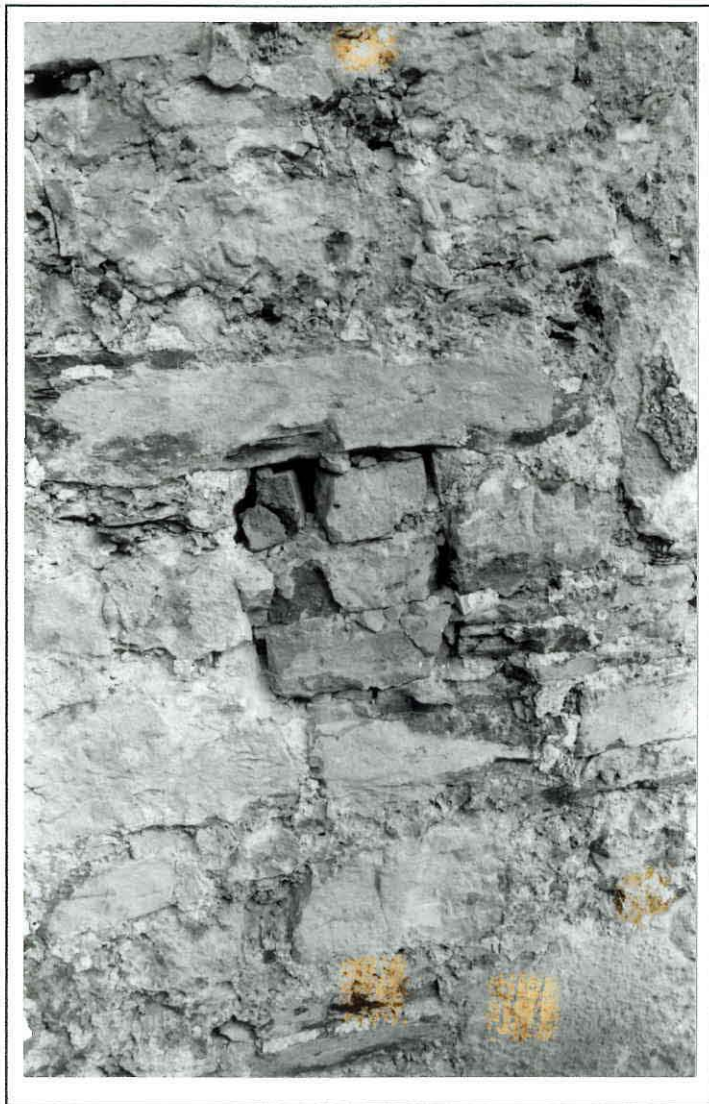
6.6 Putlog holes in this wall face have been filled with brick fragments (Plate 9). A minimum of five can be identified, both to the north and the south of the window, the lowest at 2.44m above ground level. These probably relate to the rebuilding programme.

Plate 9: putlog hole in west wall of south nave

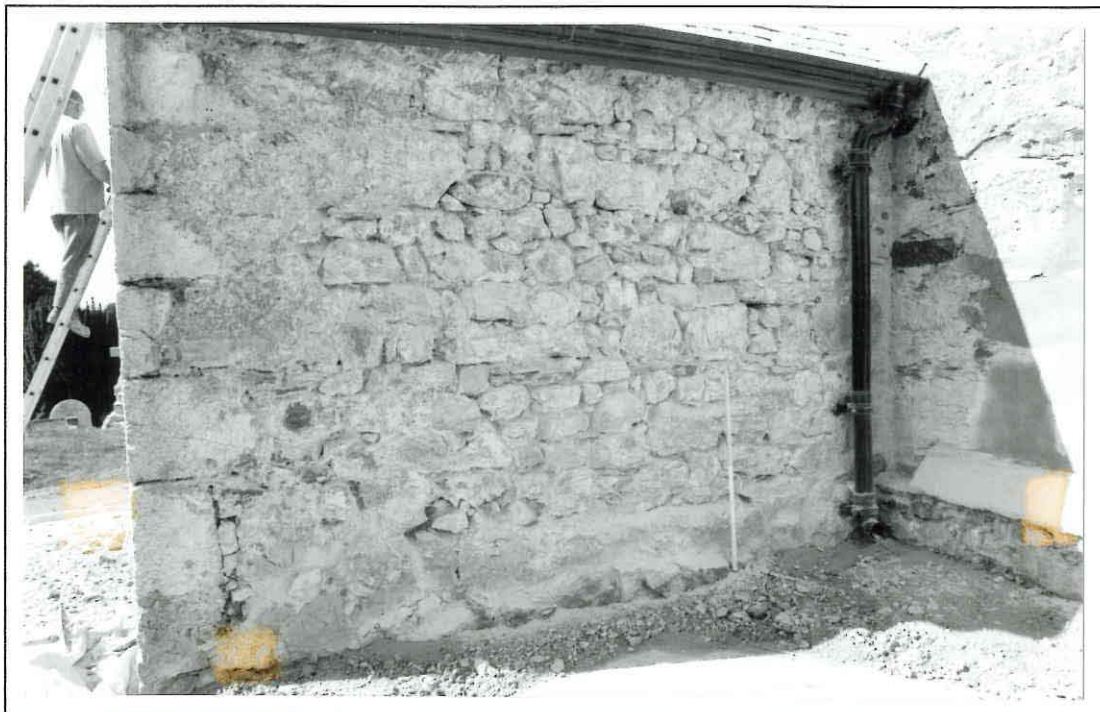
Plate 10: east wall of porch after render removal

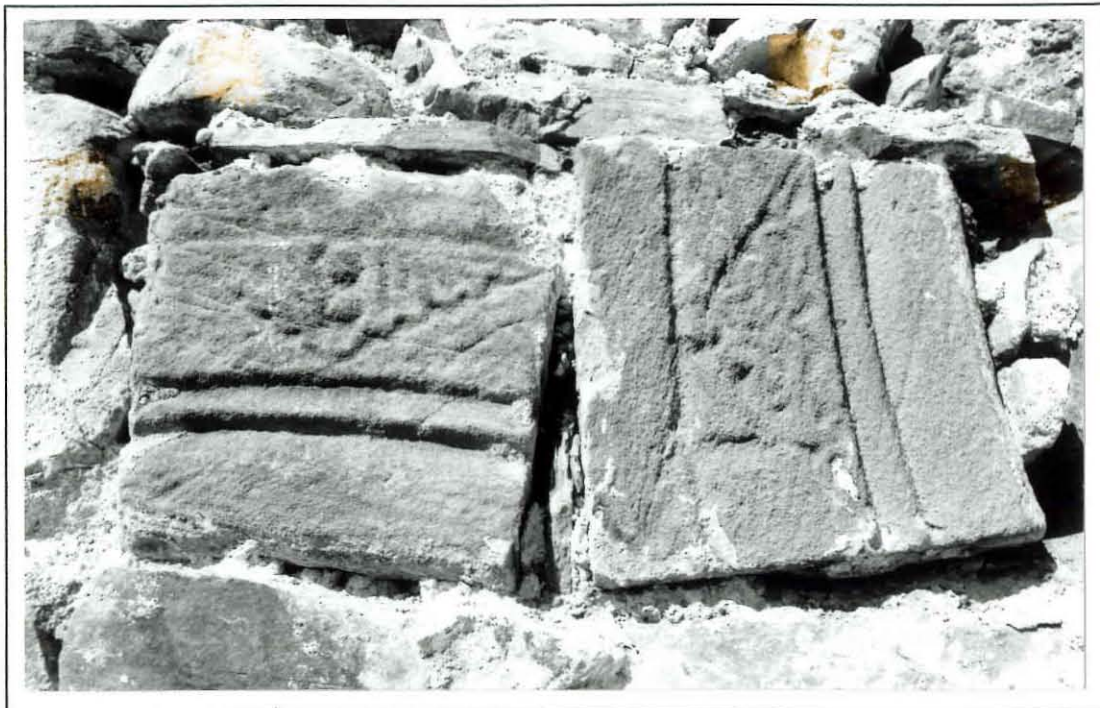
7.6 High up in the wall (about 4.9m above ground level) to the west of the more westerly window are two fragments of decorated stone (Plate 11), in pink sandstone that has weathered to grey. The outer edges have a curve, and assuming that they fit together as seems likely the length of the curve would be approximately 0.45m. Specialist knowledge will be required to determine what sort of church fitting these have been derived from. A little further west and almost directly above the east wall of the porch, but about 1m lower than the previously mentioned fragments are several blocks of pink sandstone, one with a groove across its width (Plate 12). It is not clear whether this is a further architectural fragment. Unlike the two decorated fragments this has not been left exposed but has been plastered over.

Plate 11: reused decorated stonework in south wall of church

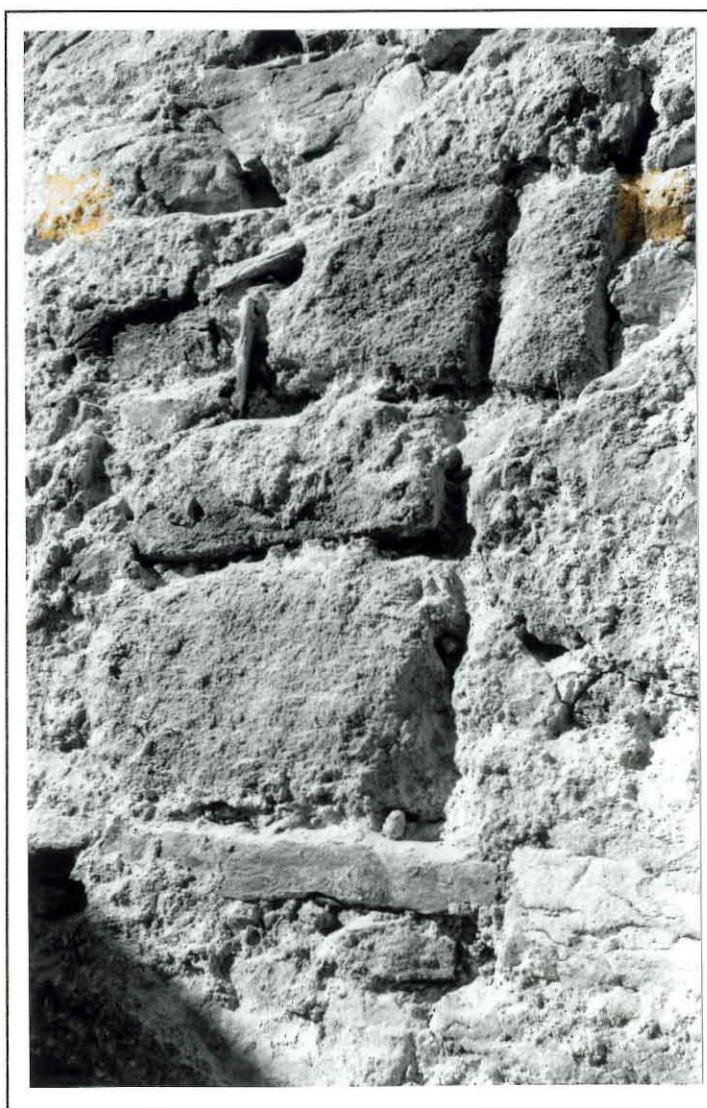
Plate 12: reused sandstone in south wall of church

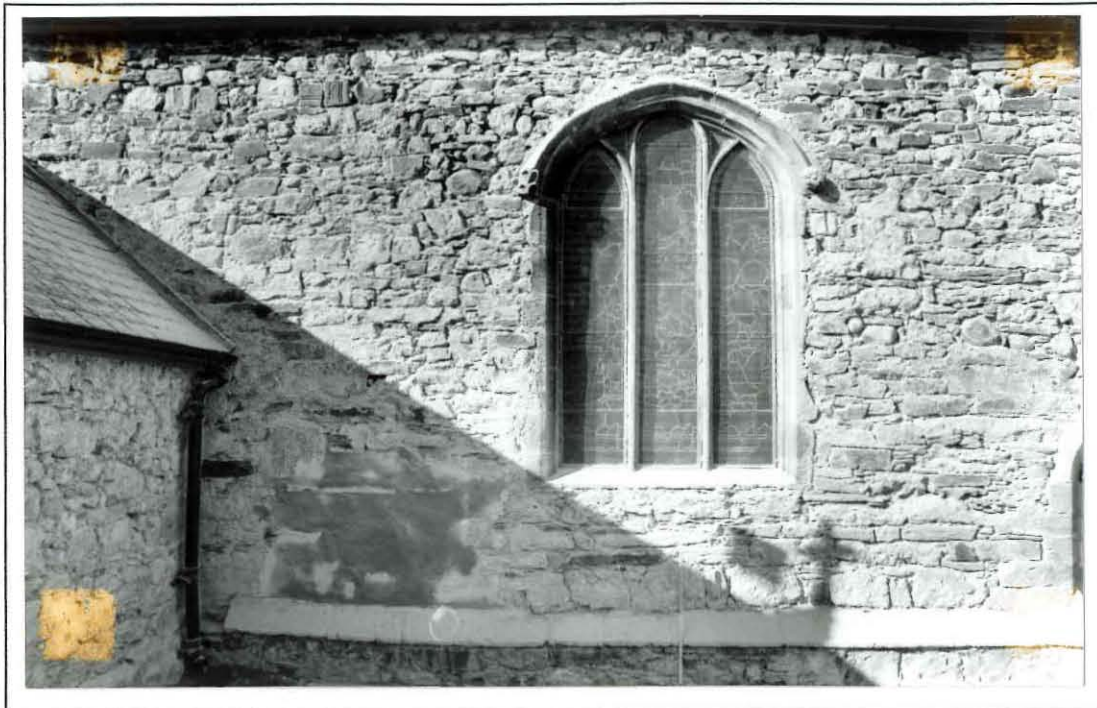
7.4 It is impossible to be absolutely certain how much of the stonework of the two windows have been replaced. In both windows most of the arrises on the dressings are sharp and largely unweathered. The hoodmoulds and their stops are more weathered, and it is thus possible that only the mullions and tracery have been renewed. Possibly relevant here is that the mortar of the stonework above the western side of the more westerly window appears looser and might indicate some rebuilding, in conjunction with the reconstruction of the window (Plate 13); a similar situation occurs close to the easterly window.

Plate 13: west window in south wall with decorated fragments above and to one side

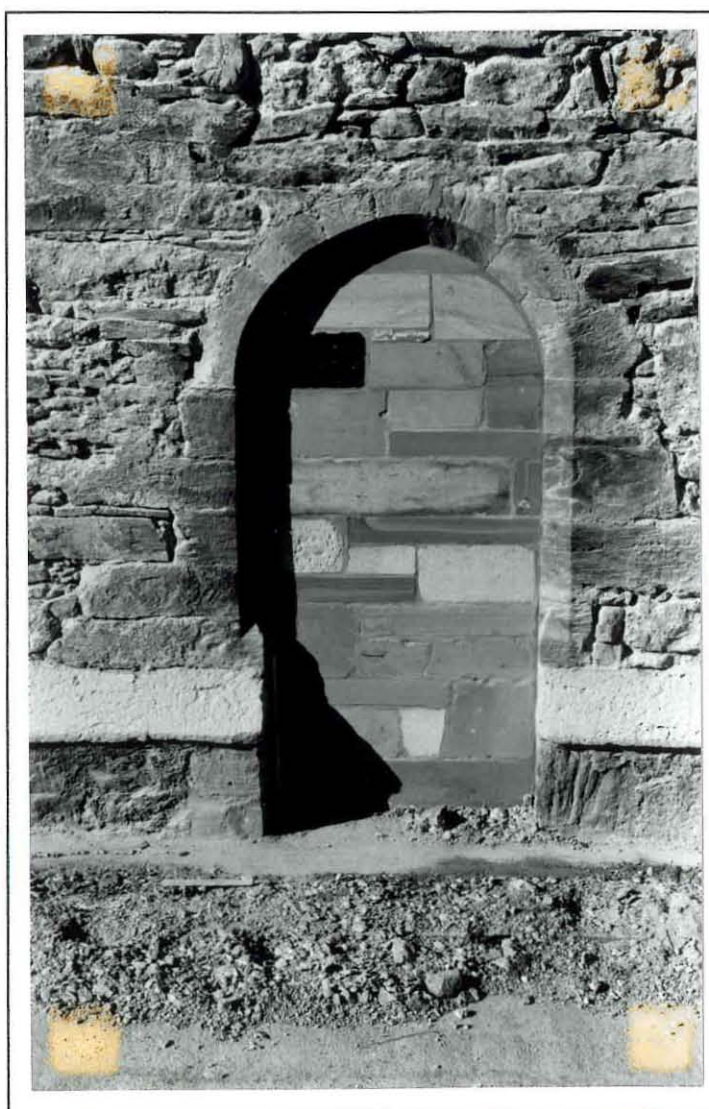
7.5 With the priest's door, the blocking is clearly of recent date (though how recent is uncertain), but again the dressings of the doorway do have sharp arrises and the pyramidal stops to the chamfer are unweathered. Yet while some of the dressed stonework has probably been renewed, the jambstones closer to the base could be original (Plate 14).

Plate 14: blocked priest's doorway in south wall
