**Caerwys Churchyard Wall,  
Flintshire  
WATCHING BRIEF**

**CPAT Report No 589**

**R J Silvester**  
October 2003

Report for Mr R Wolley, B.Arch, RIBA

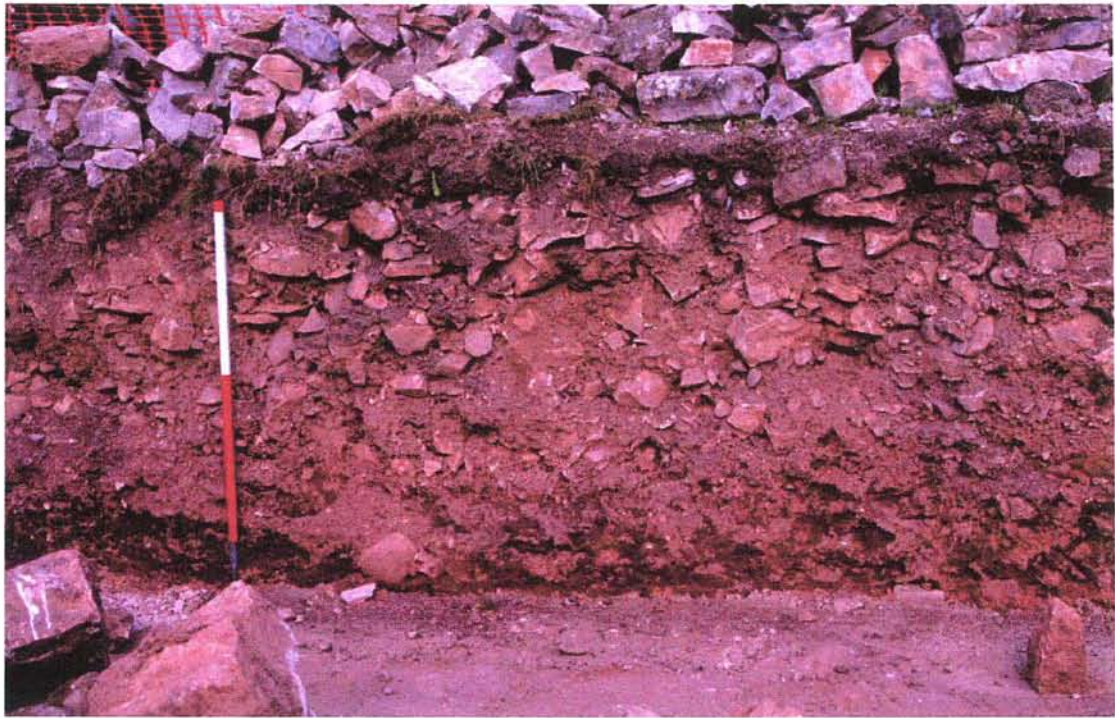
Plate 1 Caerwys churchyard wall, north section (Photo CPAT CS03/51/08)

Removal of the first and more northerly section of walling revealed what might in other circumstances be classed as the backfill of a foundation trench, but here where the wall is effectively a revetment, it is likely that the soil deposits in the churchyard were cut back, the wall built up and then the overcut backfilled. The backfill material comprised rubble in an earthen matrix with occasional mortar flecks to a maximum depth of c.0.95m. One or two artefacts, including a button and a pierced 'pearl' from a necklace, were found by the builders, together with a few fragments of bone but it is not clear whether these were derived from the rubble deposit or from lower levels. Below the rubble was a clean, brown, slightly clayey silt, almost sandy in places which dropped 0.45m to the base of the excavation and may have continued below that level. This contained small lumps and pebbles of limestone up to 0.2m in length. There was no sign of any artefacts or other intrusive material in it (Pl 1).

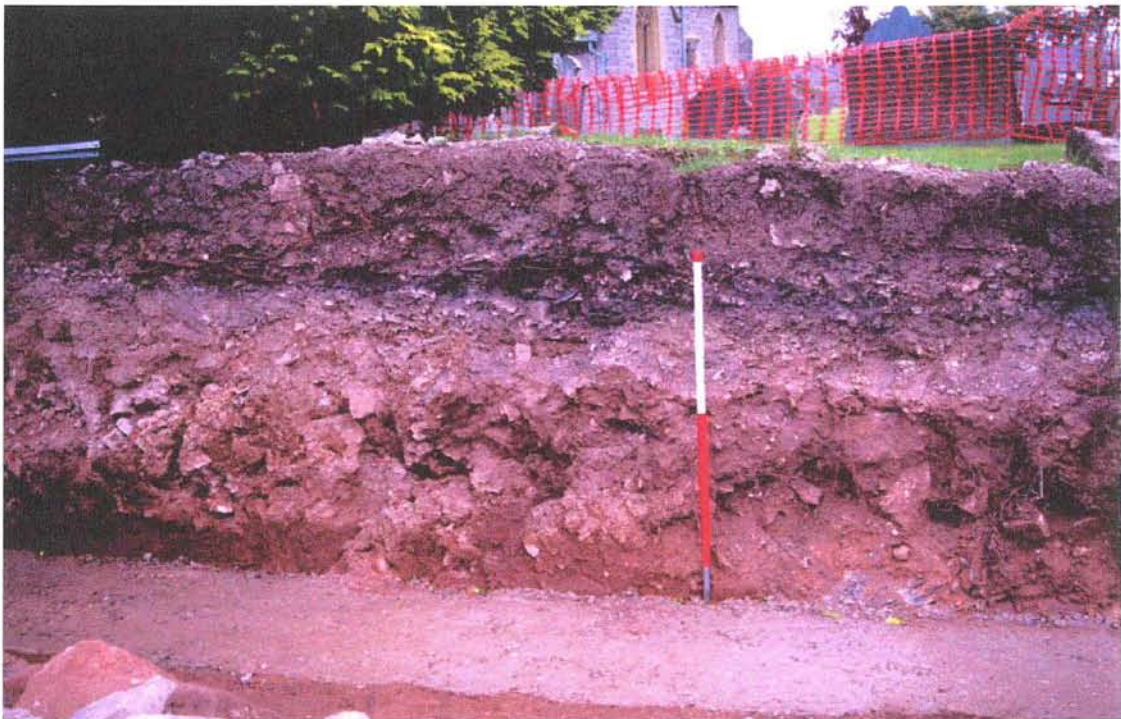
Plate 2 Caerwys churchyard wall, south section (Photo CPAT CS03/51/25)

Removal of the second length of walling, together with the bank on which it sat revealed a slightly different sequence. The internal ground level of the churchyard where it curved to the south was slightly higher than further north and the reason for this became apparent in the exposed section. Beneath a superficial layer of turf and soil was a dump of mixed debris including slate and brick fragments, pieces of clay pipe, mortar lumps and occasional slivers of what may have been window glass. A second layer beneath this was similar but contained ash and/or cinder and the occasional bit of iron. Together these layers reached a maximum thickness of perhaps 0.25m (Pl 2).
