# 1 Mount Street, Welshpool, Powys BUILDING SURVEY

B Williams and N W Jones February 2004

Report for Montgomeryshire District Council

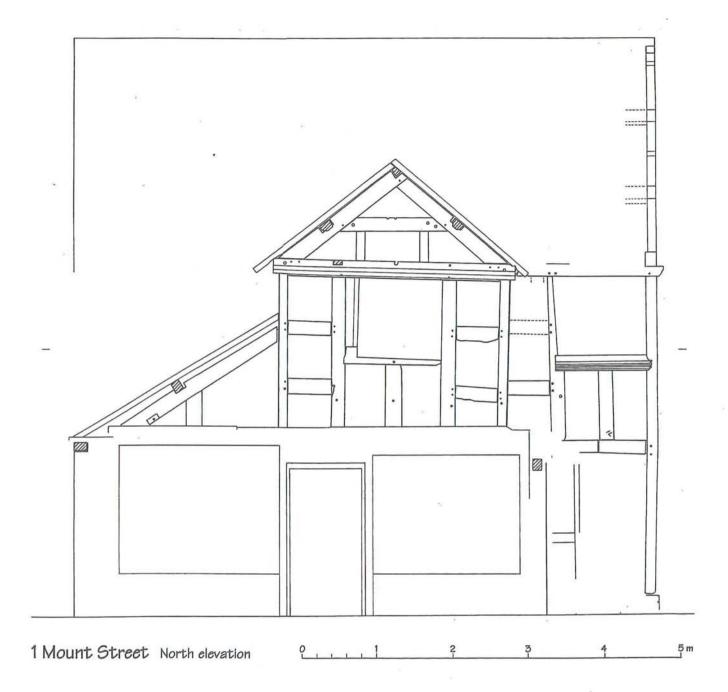
Fig. 2 North elevation

- 2.4 The north elevation is largely occupied by the timber-framed porch and modern ground floor alterations to create the shop front, which incorporates reused timbers. The first floor of the porch has an upper central window which, although not original, would appear to have replaced an earlier fitting. A window on the upper west corner of the main building may also be replacing an original fitting, beneath which an elaborate moulded sill (plate 3) would also appear to be a later insertion.
- 2.5 The roof of the main wing and porch has been much altered, although the purlins survive. These have been cut on the north side to accommodate the porch (plate 1), although not on the south side where the rear wing has been added (plate 2). All of the rafters have been replaced, as has the ridge pole.

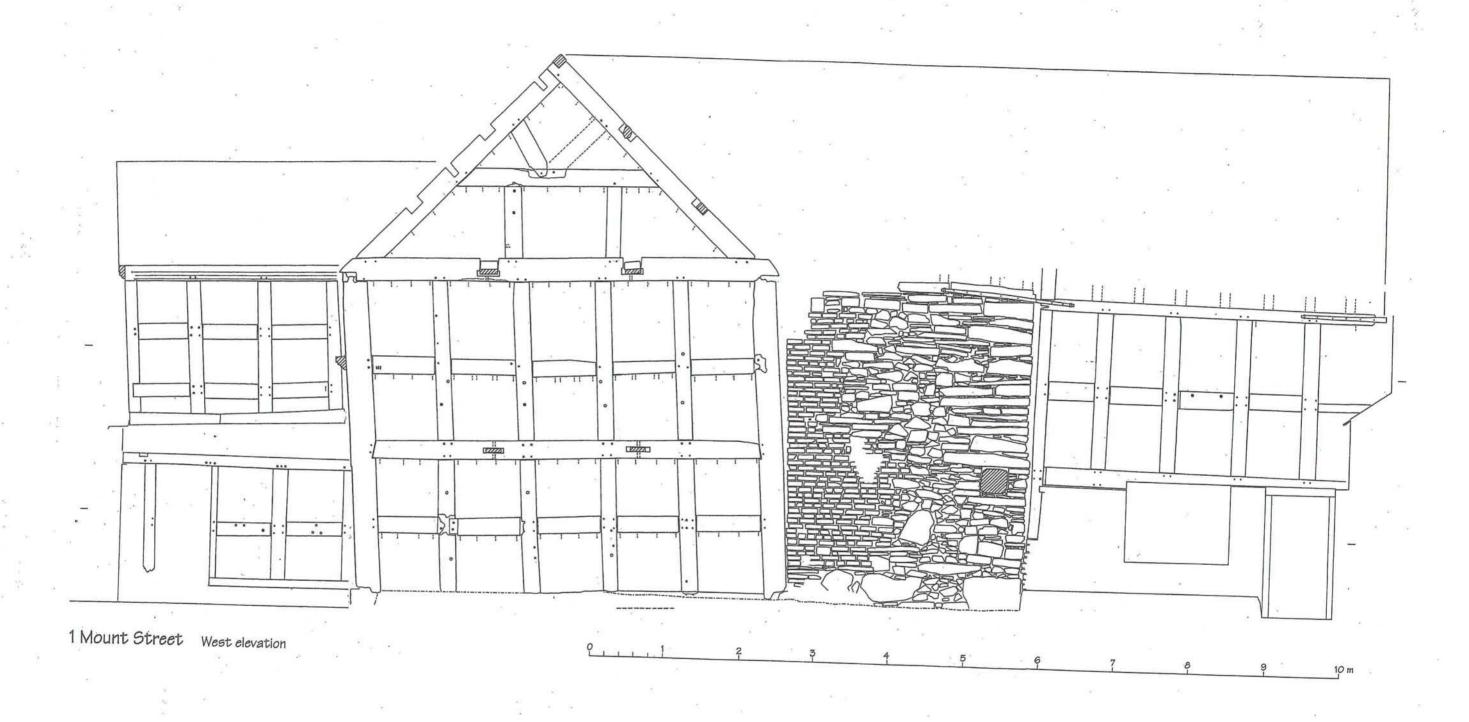
Fig. 3 West elevation

- 2.6 The removal of external render revealed significant survival of the original timber framing. The framing for the porch has been modified on the ground floor, and the brick infill remains, preventing further examination of the structure. The gable end of the main wing now has open timber framing with the breeze-block wall behind (plate 4). The holes for staves to support the wattle and daub panels are apparent throughout and it appears that on the ground floor these were later replaced by brick infill with a plastered interior. On the first floor the wattle and daub was retained with a lathe and plaster covering applied internally.
- 2.7 The lateral chimney in the rear wing is largely of random stone construction, although its northern edge, against the main gable, is of later brick (plate 5). On the ground floor the timber framing of the

rear wing has been replaced in brick with the insertion of a window and door, possibly during the 19th century. The timber framing survives on the first floor with what appears to be an original upper central window opening, indicated by two peg holes in the central timber rail.

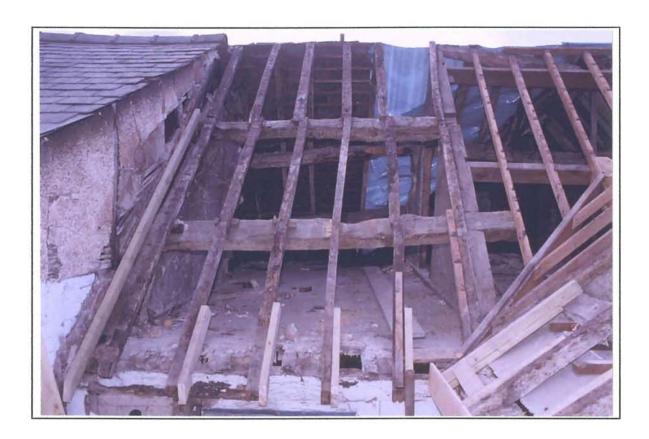
Plate 1 Main roof showing purlins cut for addition of porch. Photo CPAT cs04/06/20

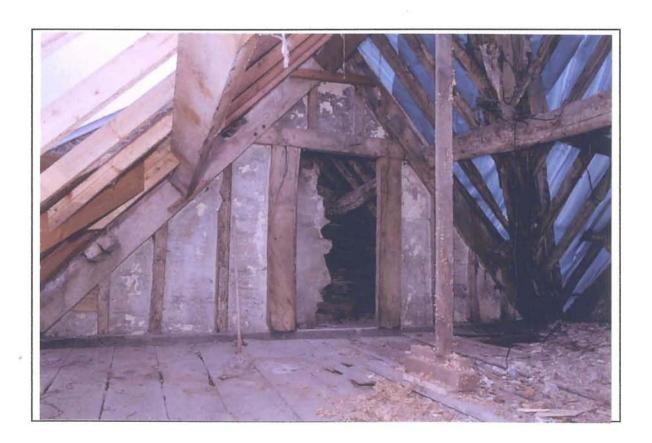
Plate 2 Main roof interior showing partition. Photo CPAT cs04/06/08

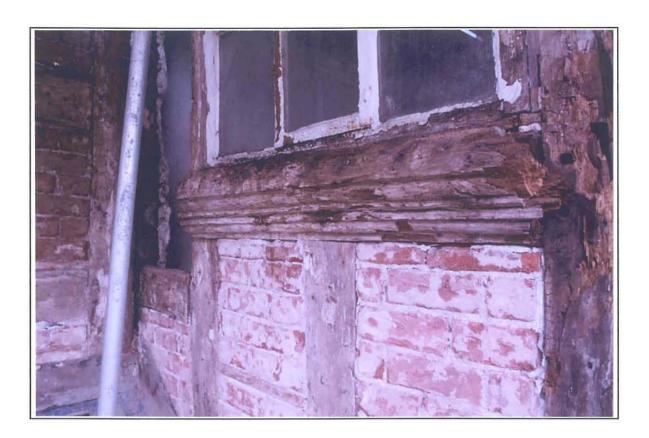
Plate 3 North elevation: inserted moulding beneath first floor window. Photo CPAT cs04/05/33

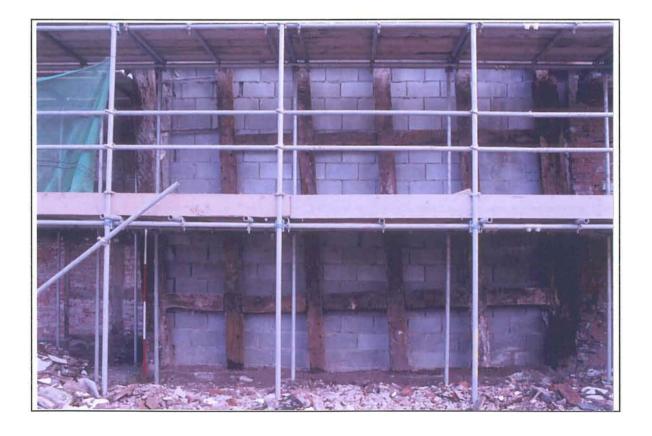
Plate 4 West elevation: open framing for main gable end wall. Photo CPAT cs04/05/04

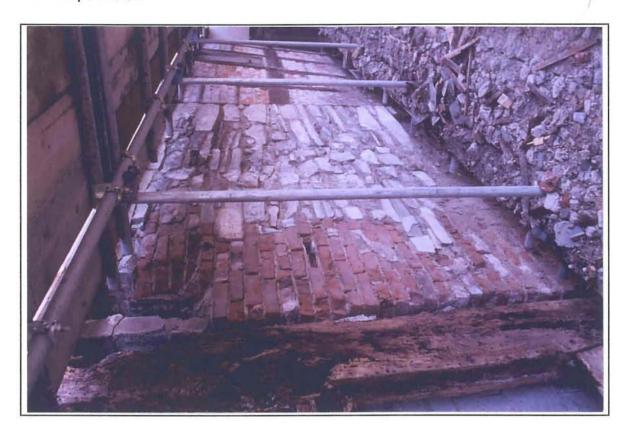
Plate 5 West elevation: rear wing showing stone and brick timber with timber framing beyond. Photo CPAT cs04/05/21

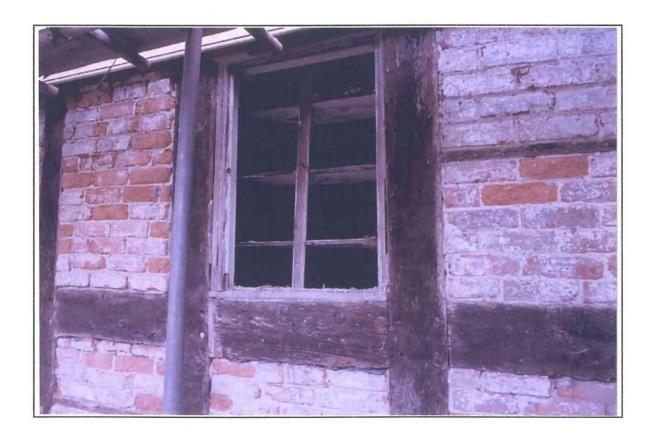
Plate 6 West elevation: rear wing first floor window. Photo CPAT cs04/05/15
