The Old Farmhouse, Waen Farm Denbighshire

ARCHAEOLOGICAL WATCHING BRIEF

CPAT Report No 531

B V Williams
May 2003

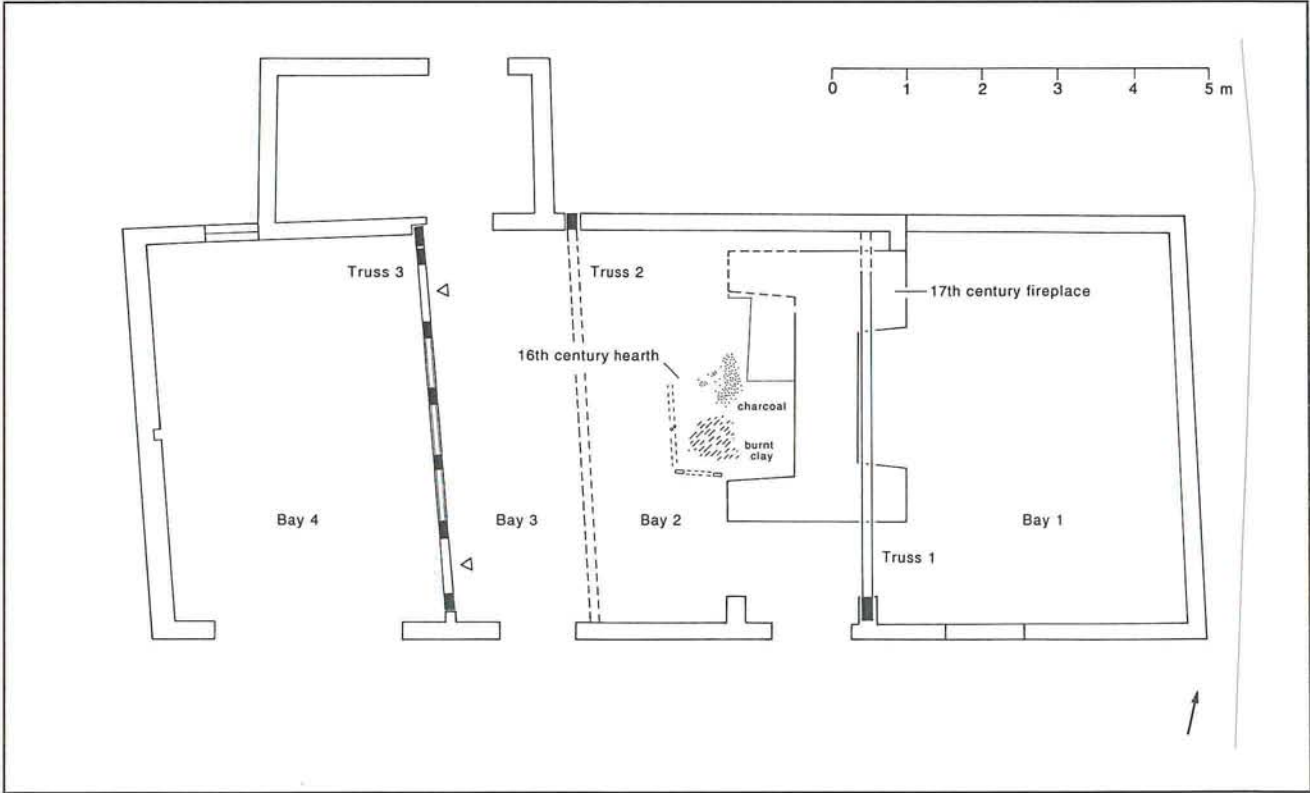
Fig. 5 Plan of the Old Farmhouse showing the main elements of the timber framing and the location of the early hearth. Scale 1:100

- 4.1 The initial visit to the farmhouse followed the clearing out of the building by the contractors, which exposed the surviving floor surfaces.
- 4.2 The remains of three internal trusses of the timber-framed hall-house were noted. Truss 1 had been partially dismantled to allow for the insertion of the 17th-century fireplace. The crucks are truncated on the north and south. Truss 2 is of open raised cruck construction, with an arch-braced collar-beam. The south cruck is truncated. While the north cruck is supported on a modern brick pier, its associated wall post survives within the later brick wall. Truss 3 is of raised cruck construction, with surviving sill-beam, double tie-beam, collar and studding. Wattle and daub infill survives on the upper level. The north wall-post remains intact while to the south the cruck has been truncated.

- 4.8 An area of patchy charcoal and reddened burnt clay some 1.60m N-S by 1.00m E-W, interpreted as the remains of the 16th-century hearth, was exposed just to west of the later fireplace. The hearth was defined on its west and south sides by a shallow gully, some 50mm deep, into which were set small bricks, the remains of two of which survived, approximately 120 x 80 x 50mm in size (Plate 7).

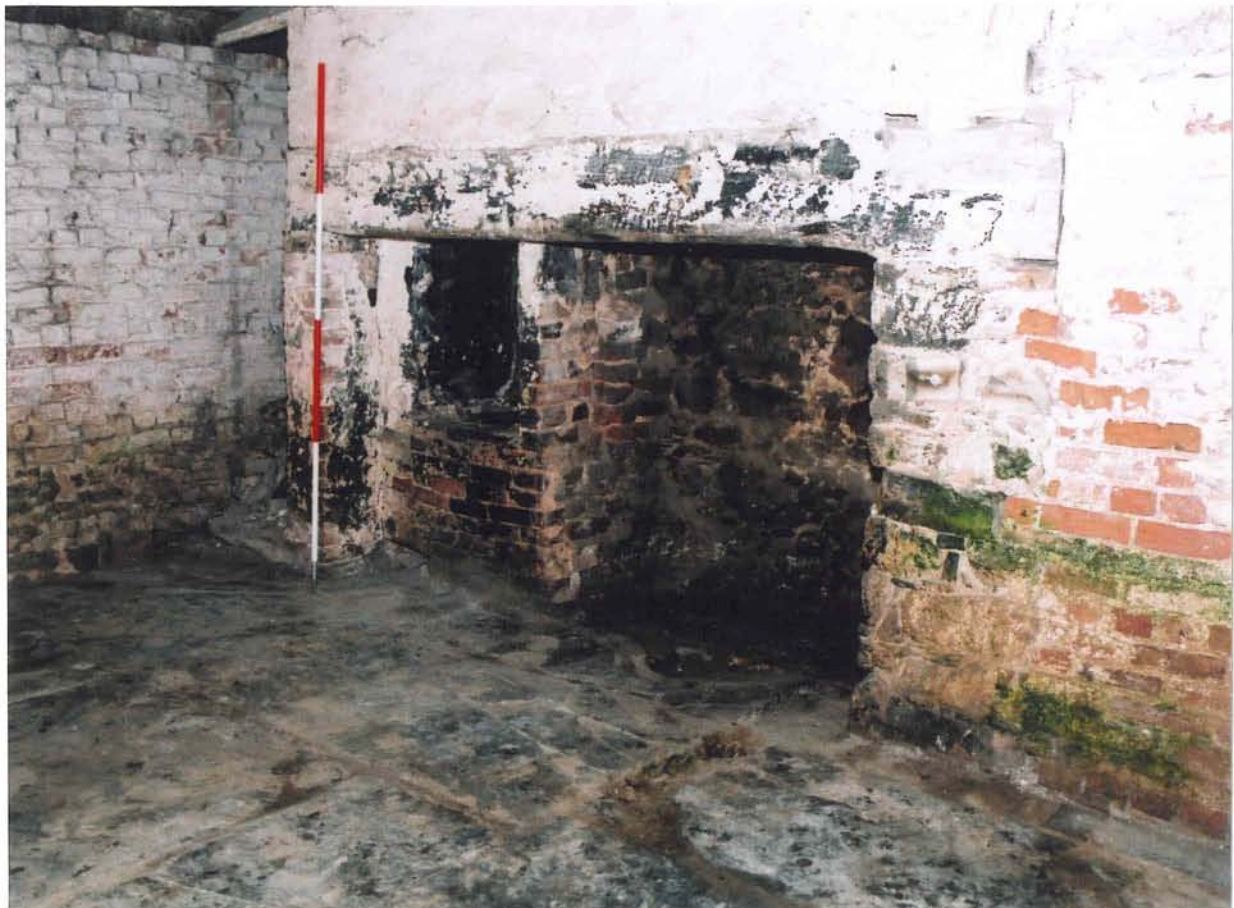
- 4.7 The slate floor occupying Bays 2 and 3, which constituted the hall of the timber-framed building, consisted of cut slabs varying in size to a maximum 1.5m x 1.25m and up to 50mm thick. The removal of the slabs revealed a deposit of clean yellow-brown sand, some 100-120mm in thickness, laid over slightly uneven disturbed red-brown clay. Cleaning of the exposed clay surface revealed the remains of a hearth structure to the west of the 17th-century fireplace (Fig. 5). Also noted was extensive animal disturbance adjacent to the north wall of Bay 2, which encroached towards the hearth remains.

- 5.3 In Bays 2 and 3, the 17th-century slate slab floor had, except for one or two peripheral slabs partially overlain by later brick walling, been relaid on clean sand, probably in the 19th century. The 16th-century floor, formed on the surface of natural clay, and the deposits above it upon which the slate floor was originally laid, were largely removed or disturbed during this operation.

Plate 2 West side of the 17th-century fireplace and the slate slab floor. To the left of the fireplace is access to the later stair, while on the right is the blocked doorway. 2m scale. Photo CPAT 1343.16

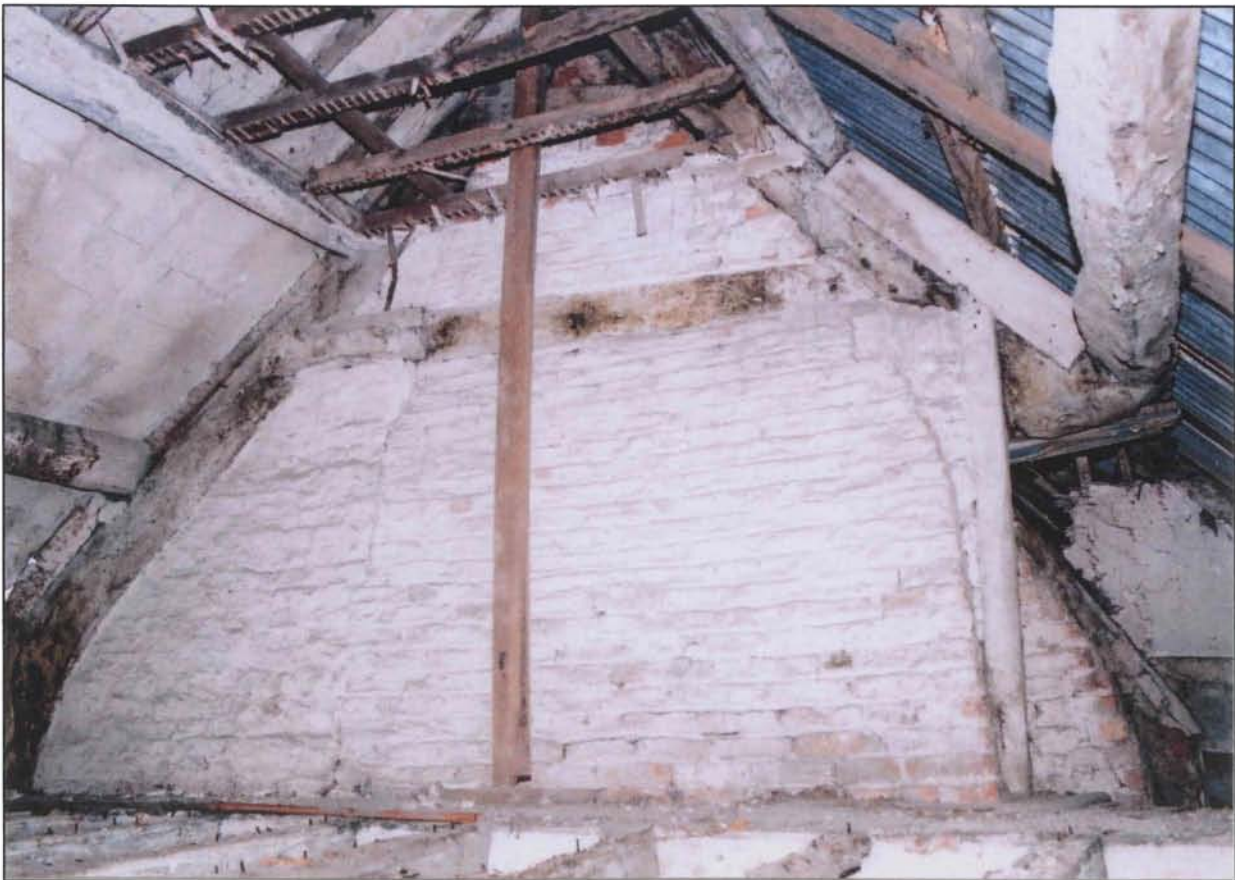
- i) Constructed as a four-bay timber-framed hall house in the early 16th century.
 - ii) In the mid 17th century a stone back-to-back fireplace, with brick chimney structure, was inserted, the positioning of the east side of which required partial dismantlement of a 16th-century truss. (Truss 1; Plate 4). A slate slab floor was laid to the west of the fireplace in Bays 2 and 3, and ceilings were replaced in both end bays.

Plate 4 Truss 1 and the inserted 17th-century chimney structure, from the east. The truss was truncated on the right to allow for the stair. Photo CPAT 1343.22

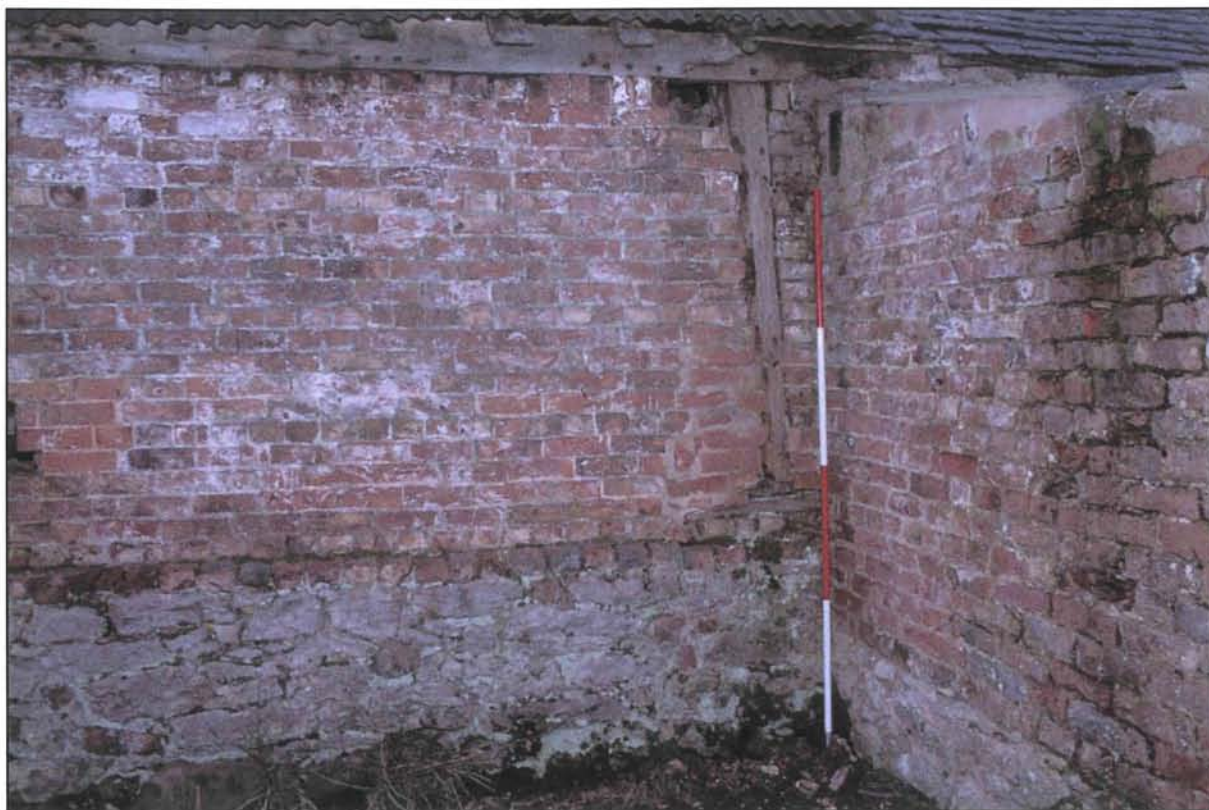
- 4.4 The north wall plate consisted of four scarf-jointed elements 4.70m, 3.60m, 1.90m and 3.80m in length (E-W), some 170mm in height x 110mm wide. Both the Truss 2 and Truss 3 wall-posts survived *in situ*, that of Truss 3 with its braces (Plates 5, 6). Where accessible, the underside of the wall-plate was examined for the presence of stave-holes.

Plate 5 Truss 2 wall-post / wall plate adjacent to the 19th-century outhouse, from the north. 2m scale. Photo CPAT CS03/24.11

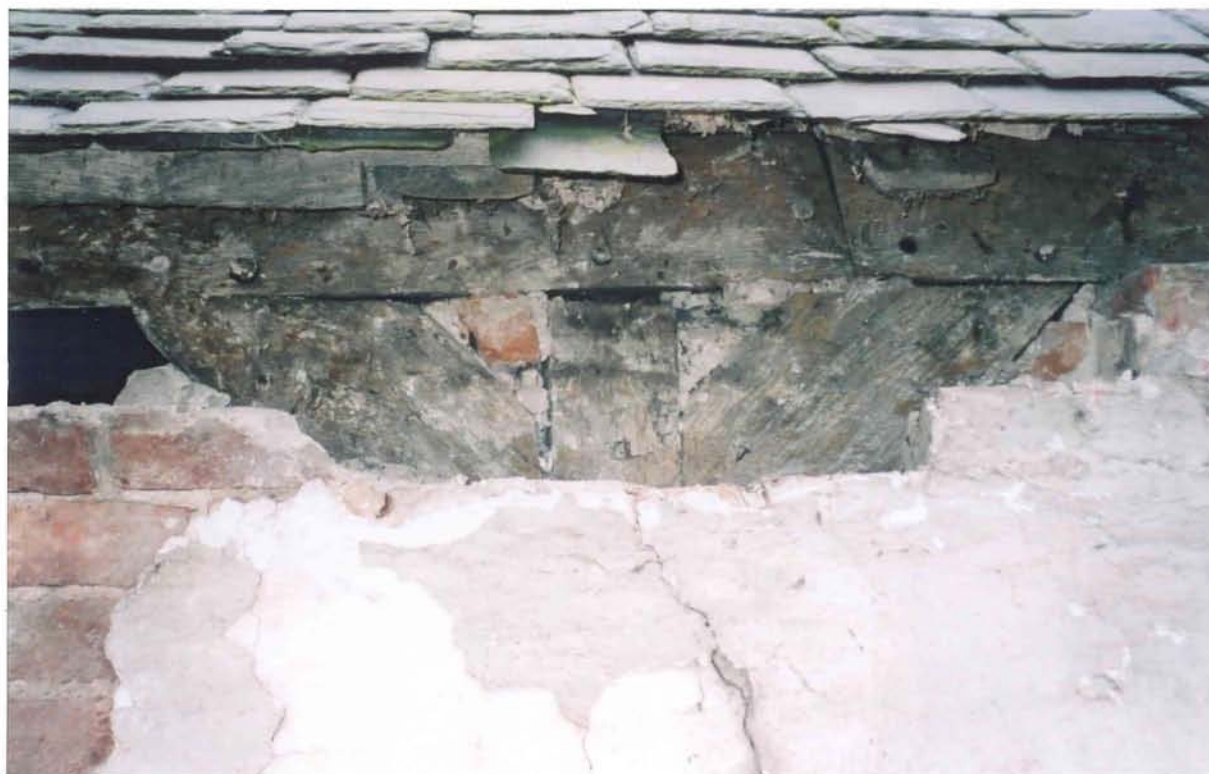
Plate 6 Truss 3 north wall-post / wall plate, from the north. Photo CPAT 1344.27

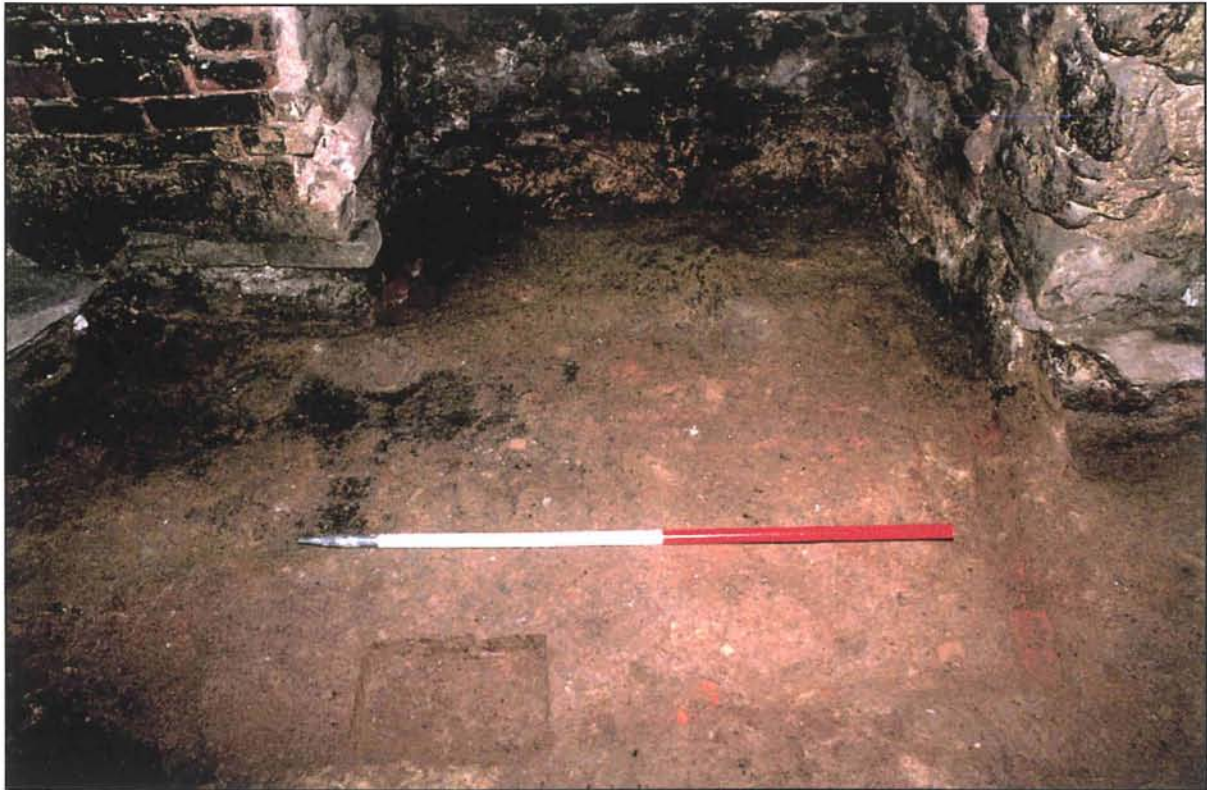
- 5.4 The 16th-century hearth remains were truncated on the east during the construction of the 17th-century fireplace, and suffered further from animal disturbance on the north.

Plate 7 The 16th-century hearth, from the west. 1m scale. Photo CPAT CS03/25.23
