*Nantclwyd House, Ruthin
Denbighshire*

ARCHAEOLOGICAL WATCHING BRIEF

CPAT Report No 766

R J Silvester and I Grant
January 2006

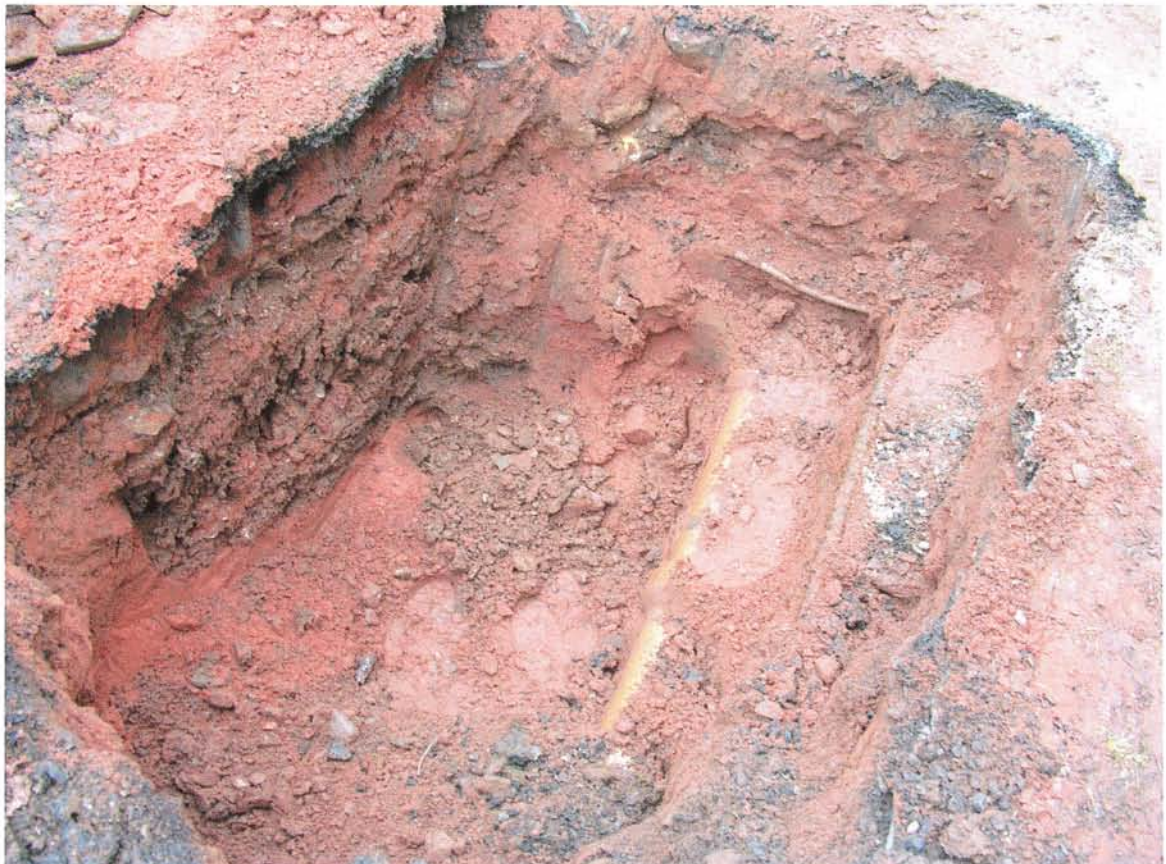
- 2.3 There had been considerable disturbance by services at lower levels (Fig. 3). Where undisturbed the natural subsoil was a brick-red sand, as elsewhere in Ruthin. Occasional 'plates' of red sandstone hinted at the bedrock lower down. In addition to the backfilled service trenches, one or possibly two features were identified.

Fig. 3. Typical levels of disturbance in the alleyway on the north side of Nantclwyd House.

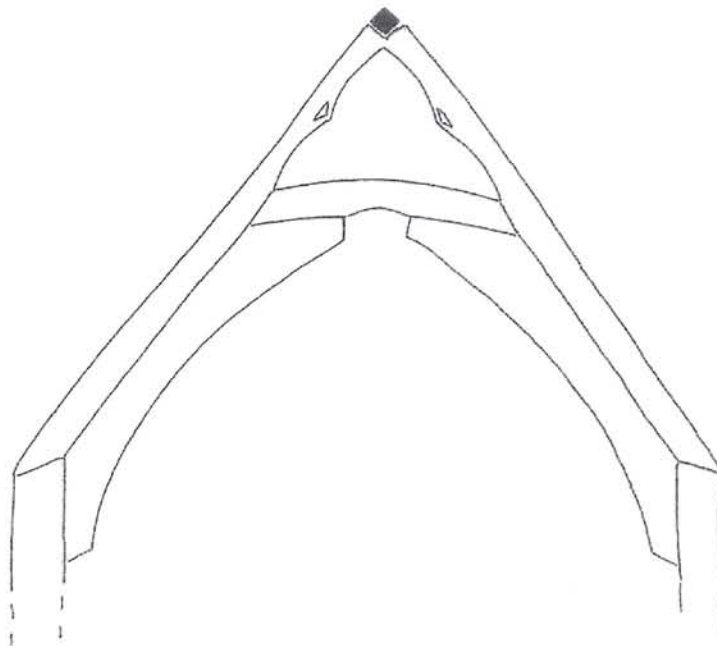
Fig. 5. Truss 1, sketch based on measurements

- 2.16 The *base cruck blades* rise from the floor. Mortice holes in both the blades and the arch braces hold tenons linking them, and peg holes correspond to these. In one case the tenon has gone but pegs are still in place.

- 2.17 The *collar* rests simply on the arch braces. On both sides tenons rising from the arch braces; the mortice holes on the collar, however, are much larger than required, perhaps indicating later modifications. Over time the arch braces have dropped and wooden wedges have been inserted. In addition tenon pieces have been slotted into mortice holes (200mm x 40mm) and kept in place by wooden pegs, nine to each brace.

- 2.18 Both the visible lower part of the collar and the soffits of the arch braces have quarter-round edge mouldings. Stains on the collar indicate where the former coved ceiling abutted it.

- 2.19 The *arch braces* have original moulding and pegs as noted above. Further flat tenons have been slotted through the arch braces into the base cruck blades and then pegged, two or perhaps more on both sides towards springer level. Modern timber wedges have been inserted between the arch braces and the base cruck blades.

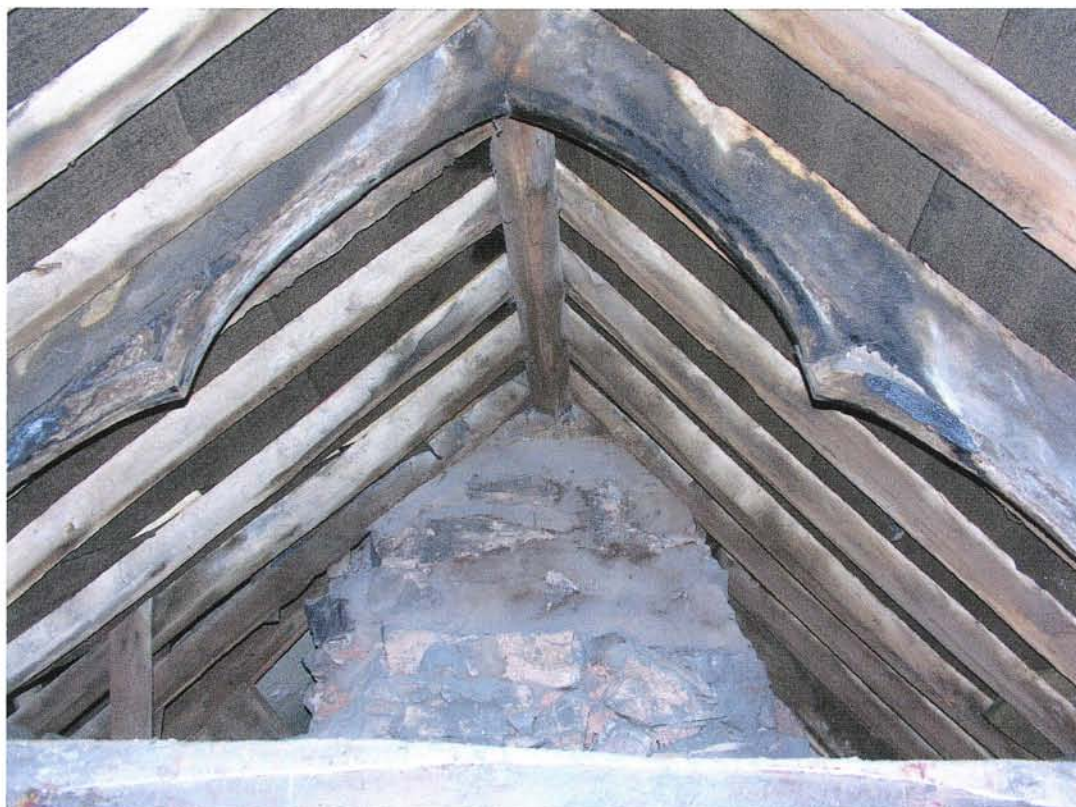
Fig. 6. Truss 1, upper part showing the cusped blades.

- 2.20 The upper *blades* rise to the apex and above the collar both are cusped (Fig. 6). Their edges are chamfered, and the spandrels are hollowed out. There is some indication of burning (or perhaps staining) on the cusped blades. Slots in the blade sides, about 400-500mm long and 40mm deep, originally held windbraces, now gone. (cf existing windbrace mortices in F16, and in Truss 2 in this room where a fragment of the windbrace remains in place).

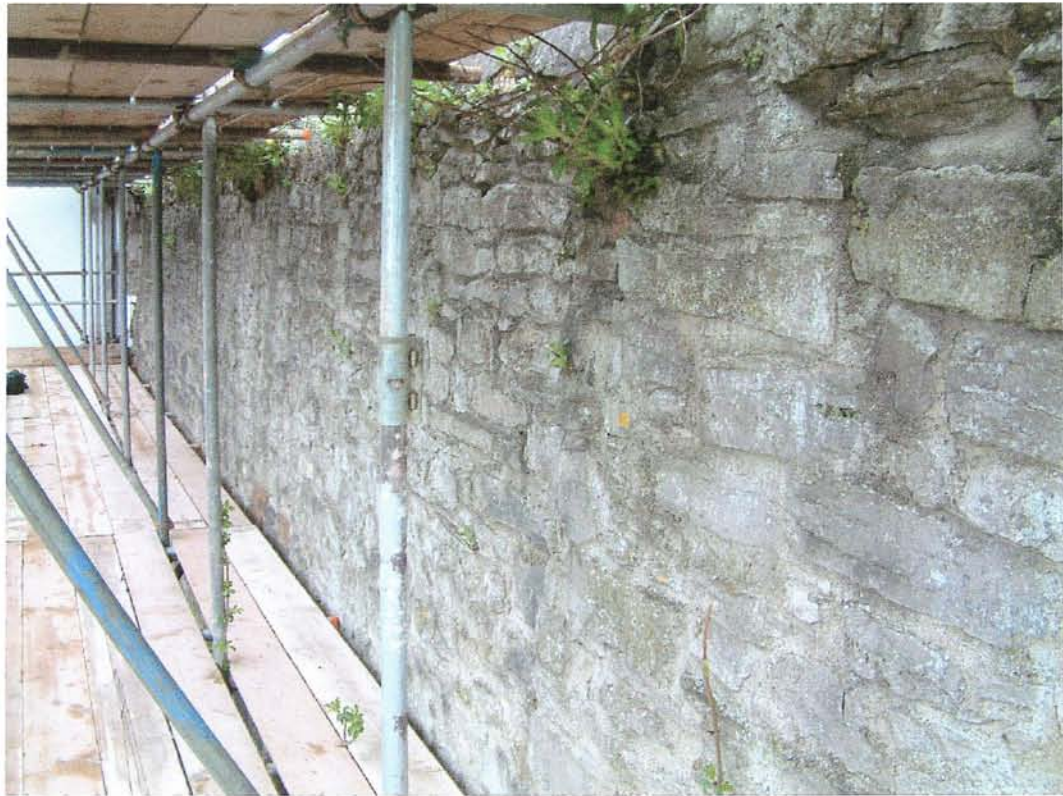
- 2.27 Scaffolding was erected against the southern boundary wall in April 2005 to facilitate reconsolidation work and rectify a slight lean to it. The wall was approximately 5m high and 14.5m long, and built of thin limestone blocks, of a size averaging 0.5m by 0.06m thick, with occasional re-used red sandstone blocks. A lime mortar, with black shale/coal inclusions, had been used to bond the stonework. The mid and upper courses had been repointed, perhaps in the late 18th or 19th century. The upper courses had been re-built incorporating hand-made bricks and finished with cemented (modern cement) coping stones along its entire length. It was these upper courses that were to be removed, lowering the wall's height to approximately 4m, subject to the success of the reconsolidation process.

- 2.28 Features visible in the wall included: a) a bricked-up doorway at the east end; b) a re-used sandstone finial, high up in the coursework and just below the coping; c) a slight buttress on the north-facing side of the wall towards the west end; d) the juncture with the south gable of the house, where it appears that it was once tied in with the house wall at lower levels.

Figure 7. North face of southern boundary wall.
