# **Rhyd-y-Carw Barn Conversion, Trefeglwys, Powys**

**ARCHAEOLOGICAL EVALUATION**

**CPAT Report No 866**

**R. Hankinson**  
May 2007

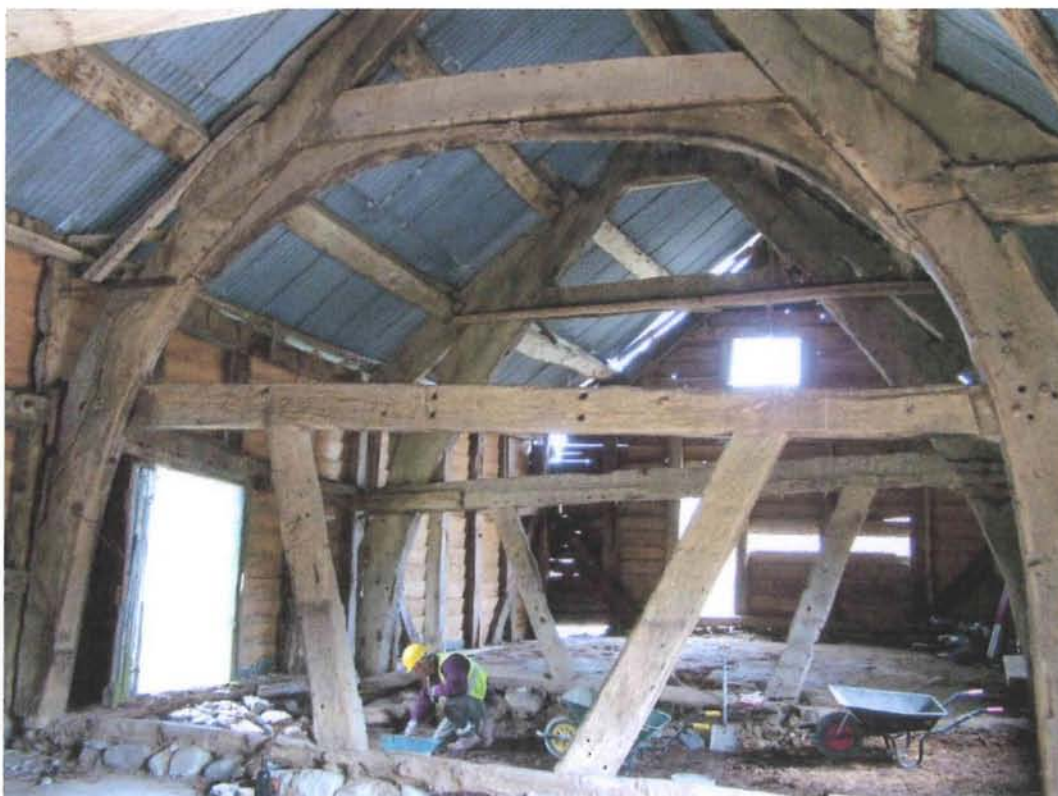
Plate 1 The central cruck of the hall from the west (CPAT Photo 2345-013)

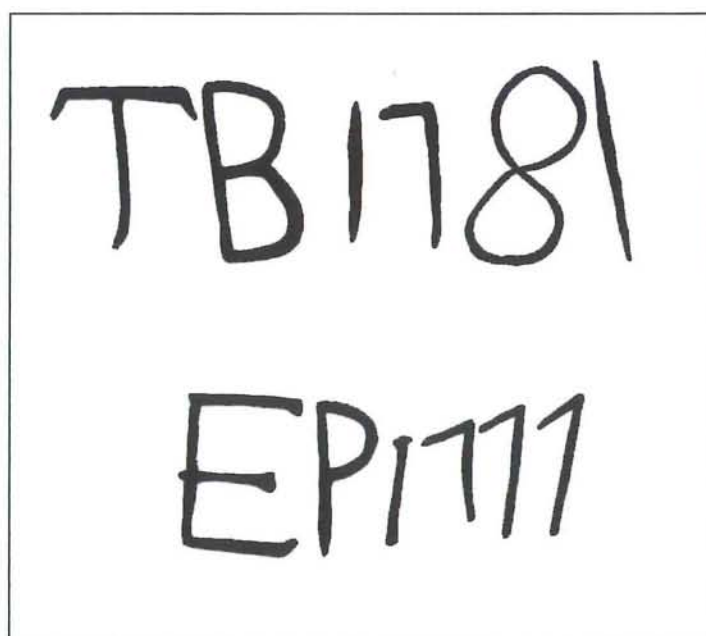
- 2.6 In the course of the evaluation, examination of the cruck frames revealed some 18<sup>th</sup>-century graffiti. Groups of initials were found in various places on the crucks, but of more interest were two dated inscriptions, of 1777 and 1781 (see Fig 1, below), which were found on the northern part of the central cruck. The building was therefore obviously in use in the later part of the 18<sup>th</sup> century. The position of the inscriptions, within easy reach of the ground, does not clarify whether these related to any alterations or modifications to the building, or were just random acts of the individuals concerned.

Fig 1 Dated inscriptions on the northern part of the central cruck (half original size)

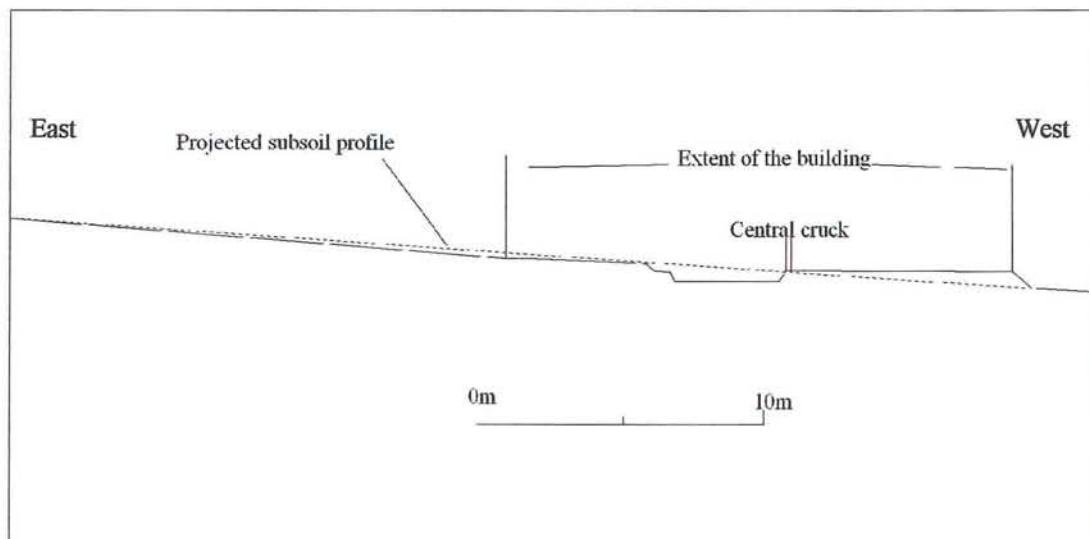
- 3.4 In addition to the excavations, a profile through the interior of the building was recorded. This allowed the level of the various floors in the interior to be compared with the slope of the adjoining ground surface. The results are presented in Fig 2.

Fig 2 Projected subsoil profile in relation to the ground level in the interior of the building

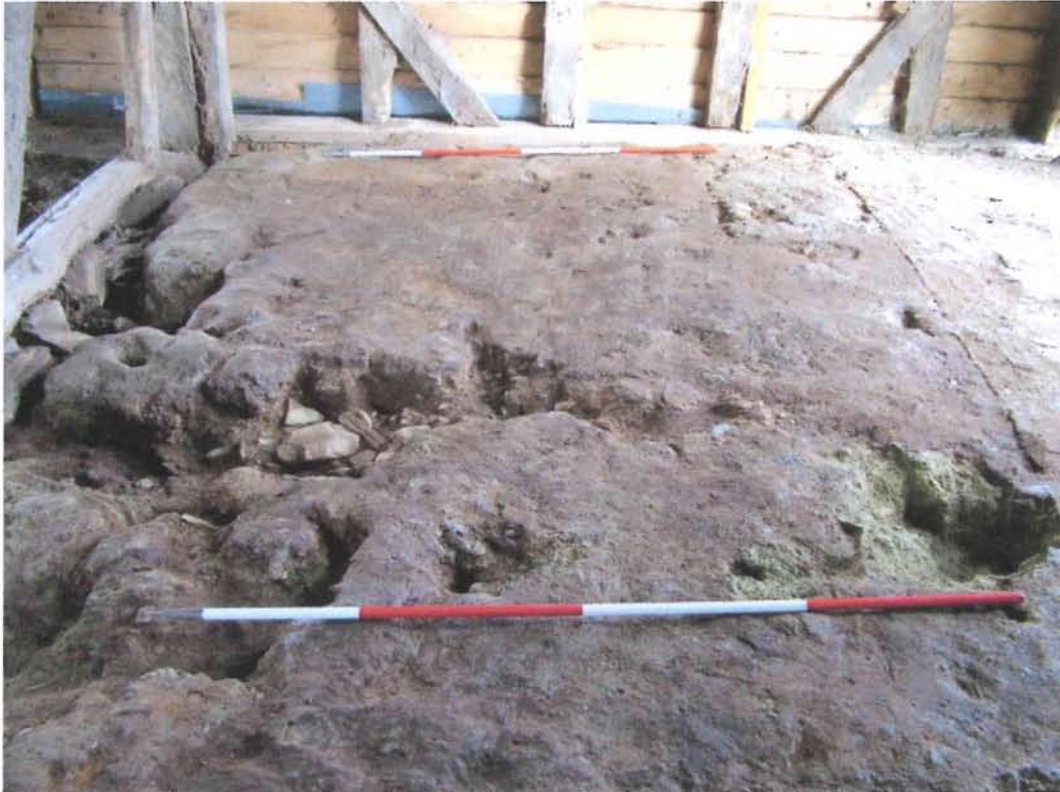
Plate 2 Floor layers and erosion in Trench 1, from south (CPAT Photo 2345-002)

- 3.7 The floor level overlying the natural subsoil (see Plate 2) comprised a layer of dark grey-brown clay silt (2), which was obviously related to the agricultural use of the building. Small areas of a subsequent floor layer (1), composed of orange-brown clayey silt, were found in the northern part of the bay.

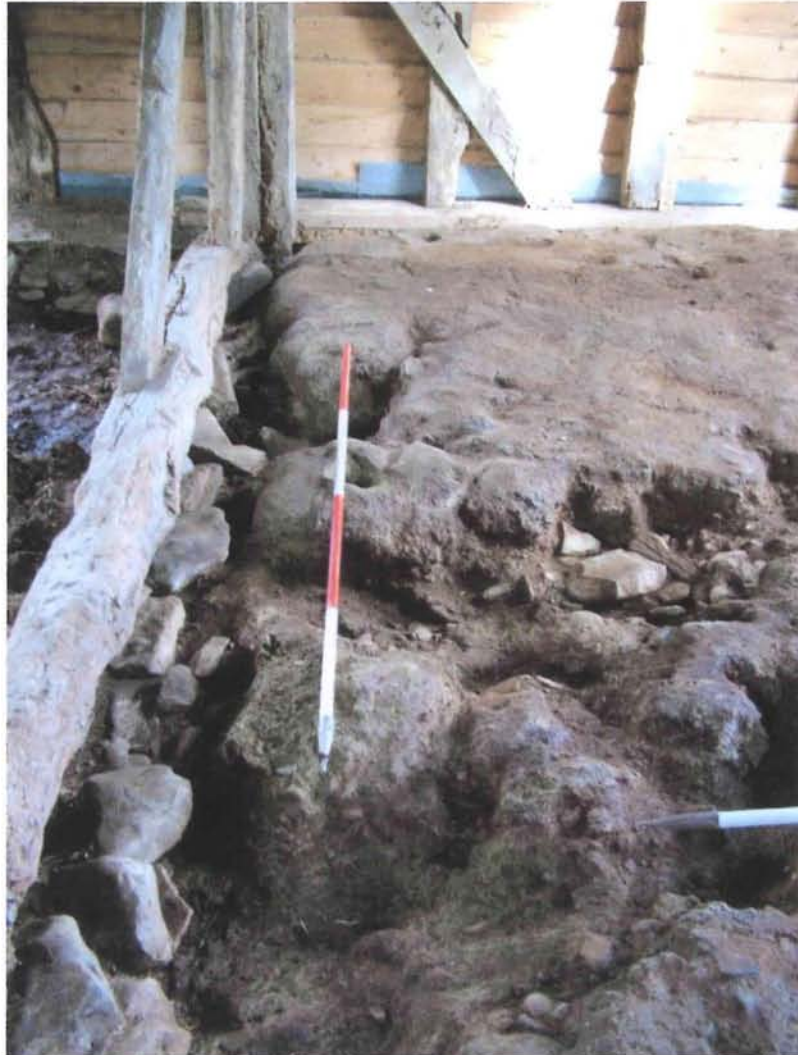
- 3.9 A further cut (17), approximately 0.3m deep, was present on the west side of the trench. This had been cut to provide a level base for the construction of a relatively loosely set, stone, sleeper wall (18), which acted as the base for an oak beam (19), up to 0.28m wide. The beam formerly linked the feet of the cruck that formed the eastern end of the main hall (Plate 3), but is now in poor condition and has become detached from the southern foot of the cruck.

Plate 3 Cut (17) and sleeper wall (18) on the west side of Trench 1  
(CPAT Photo 2345-005)

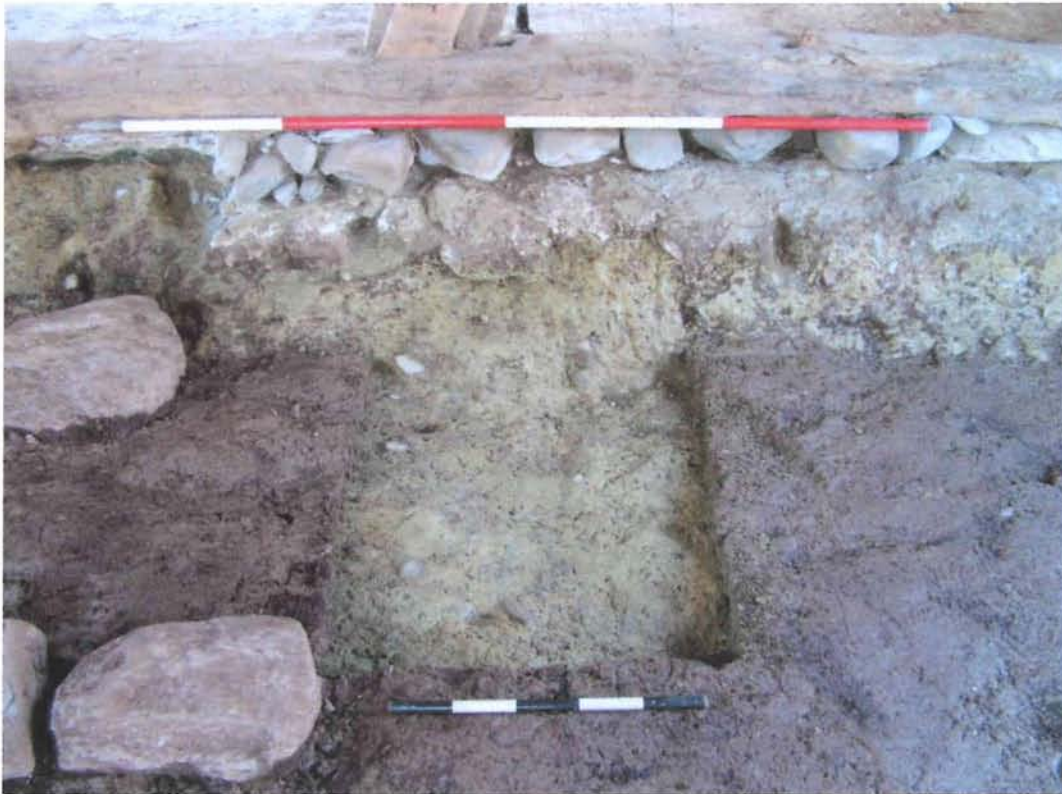
- 3.13 As the excavation progressed it soon became apparent that the level of the subsoil in this bay was markedly lower than that in both adjoining bays. The only conclusion which could be drawn was that the original floor had been dug away and between 0.45m and 0.6m of subsoil had been removed over the entire bay (see Plate 4). Any evidence of the floor layers at the dais end of the hall has been completely removed by this activity.

Plate 4 Sondage through later silt, showing the lowered subsoil level (Photo CPAT 2345-021)

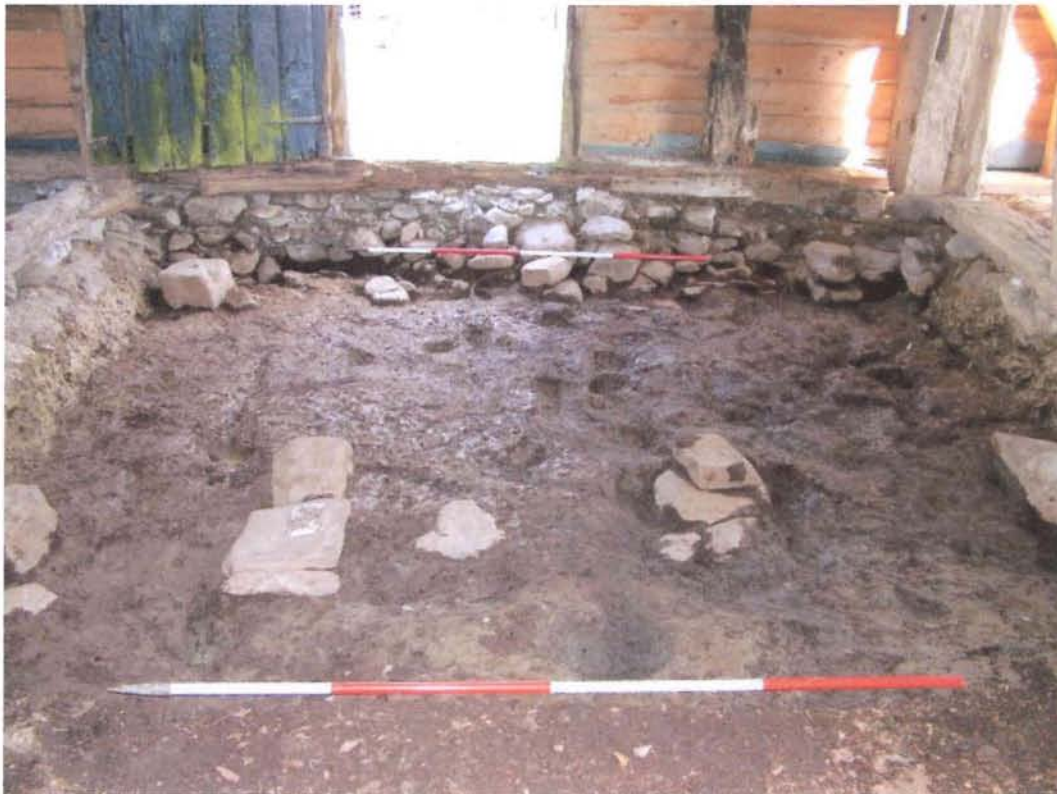
- 3.14 Although none of the timber boarded floor survived at the time of the excavation, it was readily apparent that it had been suspended over the lowered subsoil level, and supported on stone pads (28-35) held together by lime mortar, which can be seen in Plate 5. It seems reasonable to assume that the original floor of the bay was removed immediately prior to the insertion of the wooden floor, as the subsoil was directly overlain by a sticky and slightly greenish-brown clay silt (24), which abutted the stone pads. The silt appeared to have accumulated in a wet environment beneath the wooden floor, probably as a result of erosion in the bay to the east. Some dating evidence was recovered from layer 24, which suggested it was no earlier than 18<sup>th</sup>-century in date.

Plate 5 Soils beneath the wooden floor, and the stone pads which supported it, after the removal of modern waste material (Photo CPAT 2345-016)

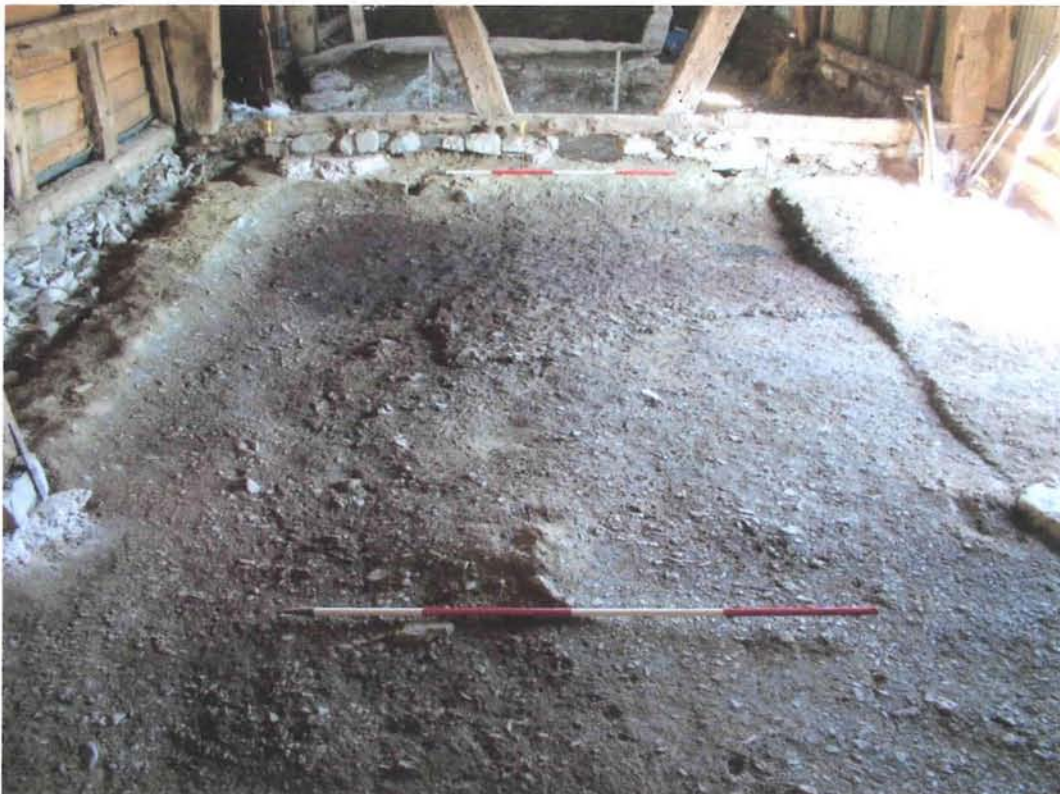
- 3.19 Both the natural subsoil and layer 70 seemed to have been truncated by a cut (68) which probably related to the levelling of the western part of the interior. Up to approximately 0.3m of material had been removed in this process, with the resulting clay surface having a metallated surface (55) of compacted small pebbles created on it, presumably to prevent erosion. A humic deposit of manure and bedding material (58), up to 50mm thick, lay on the surface near the eastern end of the trench, and this demonstrated that the surface had been used for agricultural purposes when the building was in use as a barn/byre. A small sherd of white-glazed pottery was found impressed into surface (55), showing that this was probably in use in the 19<sup>th</sup> century.

Plate 6 Metallated surfaces and associated deposits in Trench 3 (Photo CPAT 2345-038)

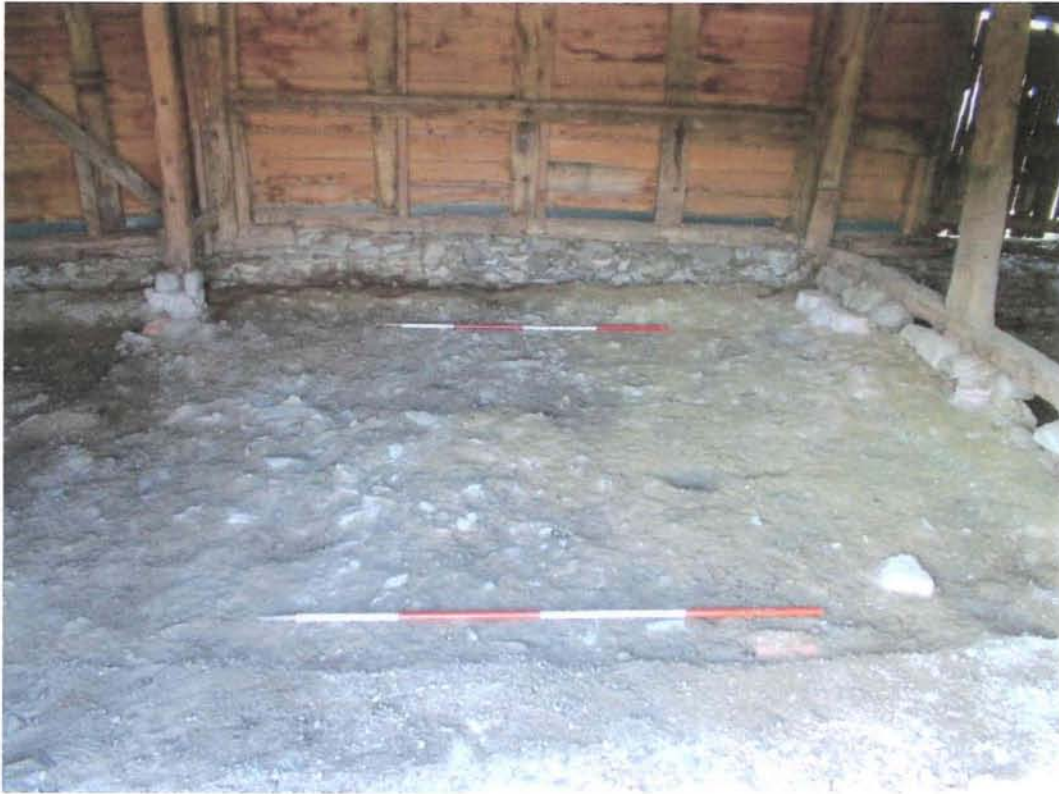
- 3.21 In the period between the abandonment of the metallated flooring and the laying of the concrete floor noted in para 3.17, the ground was raised and levelled by the deposition of up to 0.2m of mid grey-brown gritty silt and local shale (54). A layer of redeposited subsoil (53) was then placed on top of layer 54, but only part of this layer survived, in the eastern part of the excavated area. It is not possible to be certain, but it seems most likely that layers 53 and 54 represent an attempt at re-flooring the western two bays of the building, some of the surface of which was lost in the process of installing the final, concrete, floor in this part of the building.

Plate 7 Layers 53 and 54 in the eastern part of Trench 3 (Photo CPAT 2345-029)

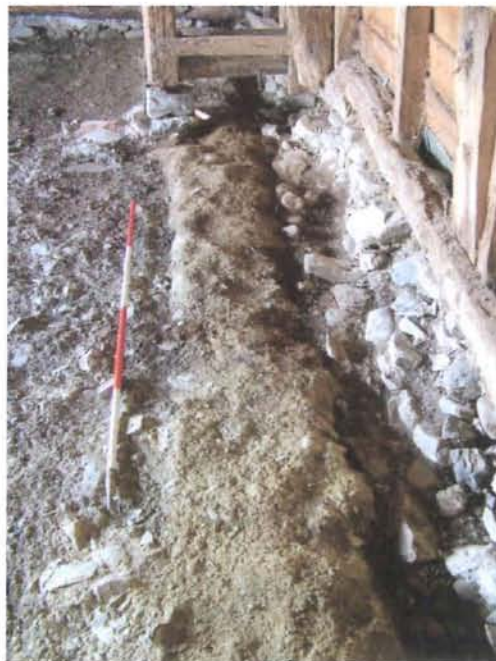
- 3.22 The revetment wall (16) which was recorded in Trenches 1 and 2, and forms the base of the north wall of the building, continued into this trench. Again, there was a gap on its south side, filled by loose rubble and soil (69), but in this case a raised 'bank' (57) of material adjoined it to the south. The bank was composed of natural subsoil in its eastern part and layer 70 in its western part, and had rounded depressions in its upper surface which denote that it once served as the base for a sleeper wall, presumably a predecessor of the current north wall of the building.

Plate 8 The raised 'bank' (57) with hollows in its upper surface (Photo CPAT 2345-030)

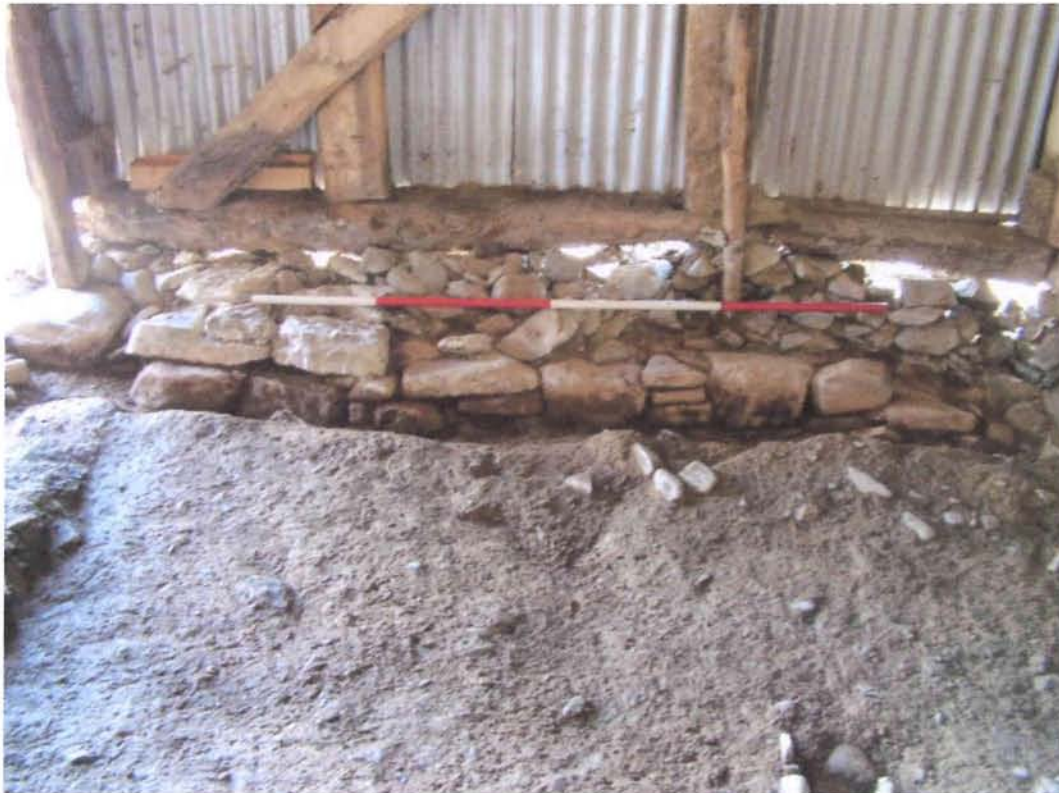
- 3.23 The remains of a low wall (61), which may have defined the south wall of the building, were recorded on the south side of the western bay. This was relatively well-constructed and functioned as a base for the fairly loose upper part (72) of the wall which supports the sill-beam on the south side of the bay.

Plate 9 Low wall on the south side of the western bay (Photo CPAT 2345-034)
