Lower Lea Farm, Lydham, Shropshire

ARCHAEOLOGICAL ASSESSMENT

N W Jones
August 2009

Report for McCartneys, on behalf of Mr R Hughes

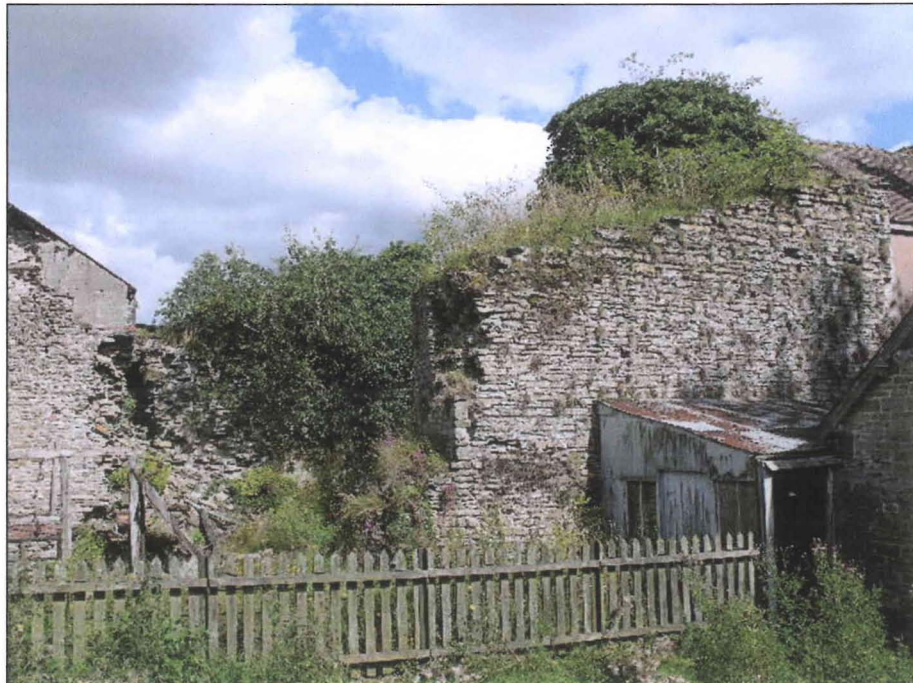
Fig. 5 The remains of the Tower Keep viewed from the west.

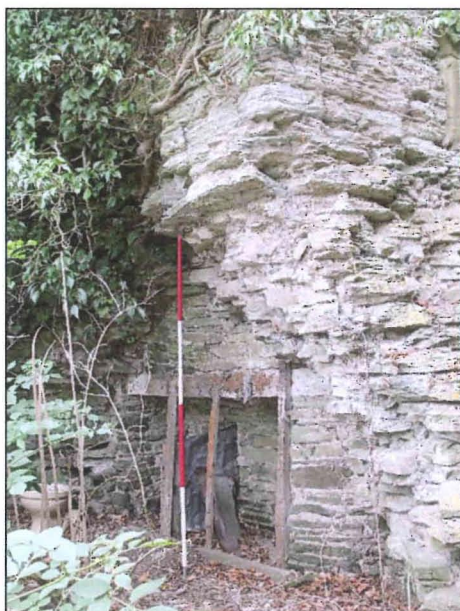
Fig. 6 Probable basement fireplace

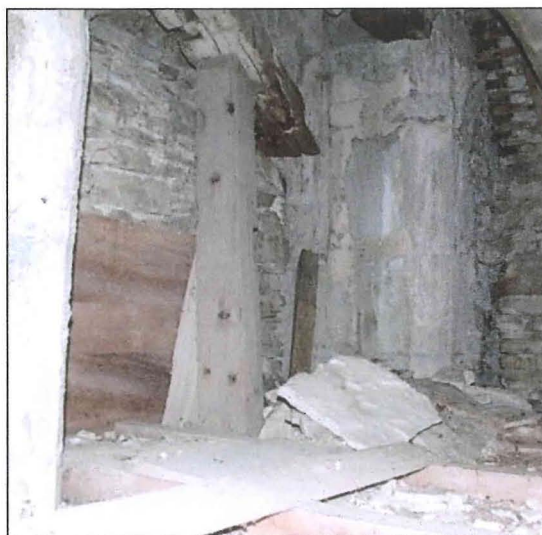
Fig. 7 First-floor doorway viewed from within the attic

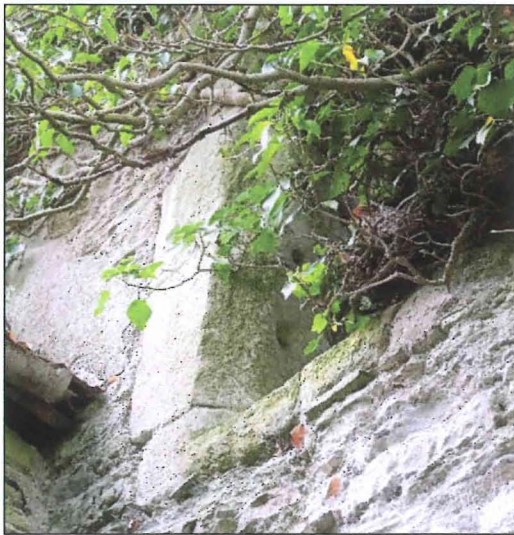
Fig. 8 First-floor window

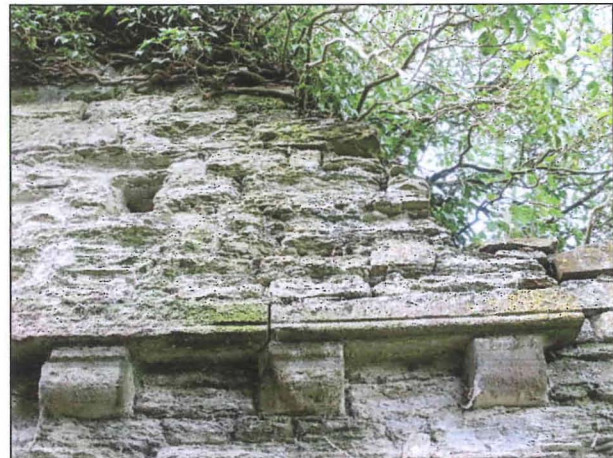
Fig. 9 First-floor corbels and plinth for probable fireplace and chimney

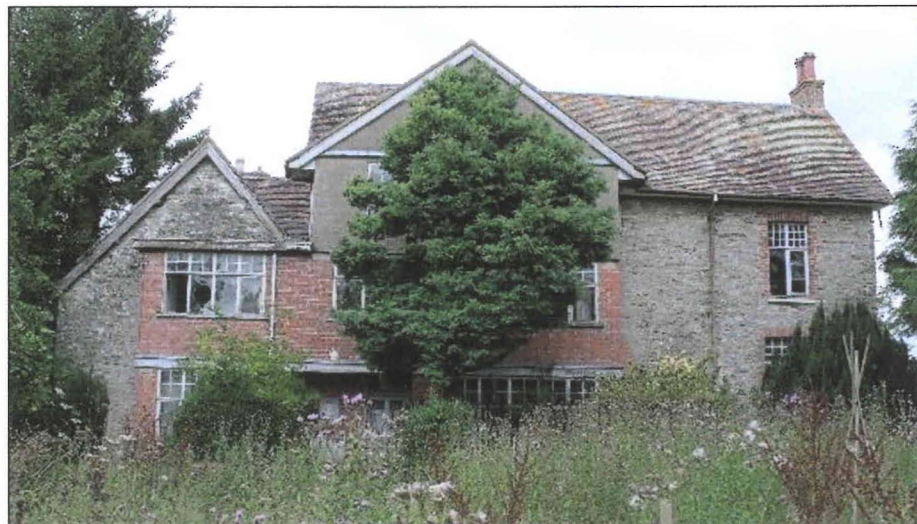
- 4.7 The farmhouse is protected as a grade II listed building (no. 257069) and has remained unoccupied for a number of years, leading to some water ingress where roofing tiles have been lost and windows broken.

Fig. 10 Lower Lea Farmhouse, south elevation

- 6.7 Structurally, the farmhouse appears to be in relatively good condition, with only slight damage from water ingress. However, the house has been unoccupied for a considerable period and would require significant repair to enable reoccupation. The present study has provided a suggested phasing, based on the visible structure. Further details would undoubtedly come to light during repair works and a full building survey should be considered in conjunction with a watching brief while any works are carried out. Consideration should also be given to the preservation of the adjacent goose pens, which are an unusual and relatively rare feature.

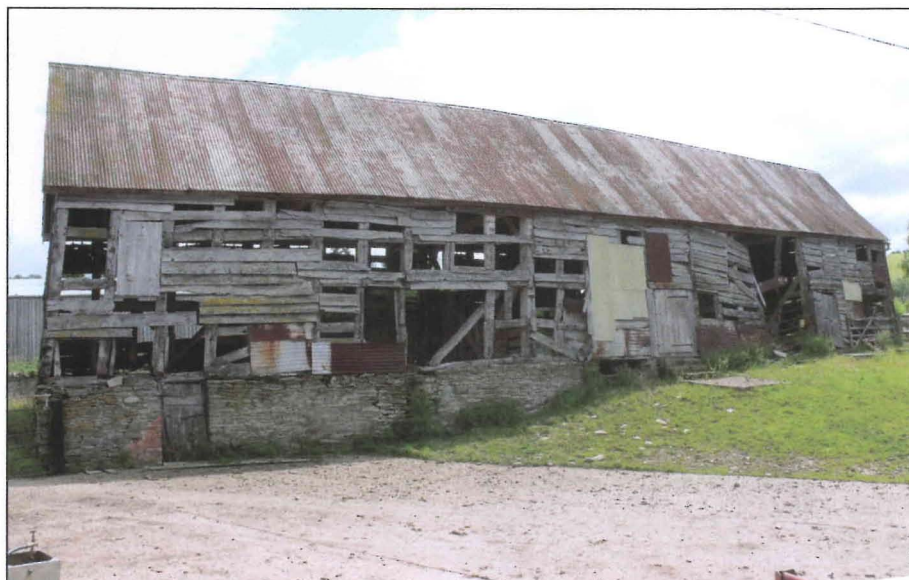
Fig. 14 The barn viewed from the west

- 4.14 The barn rests on a plinth of uncoursed limestone rubble, which stands to a maximum of 1.6m on the north-western corner. The plinth has a curious joint beneath the northern side of the central bay which suggests that its southern part may belong to an earlier structure. The framing is composed of square panels, originally infilled with woven wattles, most of which have been replaced with weatherboarding. The frame includes angle braces and transverse tension braces, despite which significant displacement has occurred, notably at the southern end.

- 6.8 The barn is now redundant and in a poor state of repair, although the main structure itself is in good condition. As noted above, the long term future of the building is dependant on an alternative use being found as the barn does not suit modern agricultural needs. The timber framing is in need of urgent repair and the movement of the frame will need to be corrected. The level of survey undertaken by the present study is considered sufficient unless there are proposals to convert the building to residential use, in which case further recording may be considered appropriate.

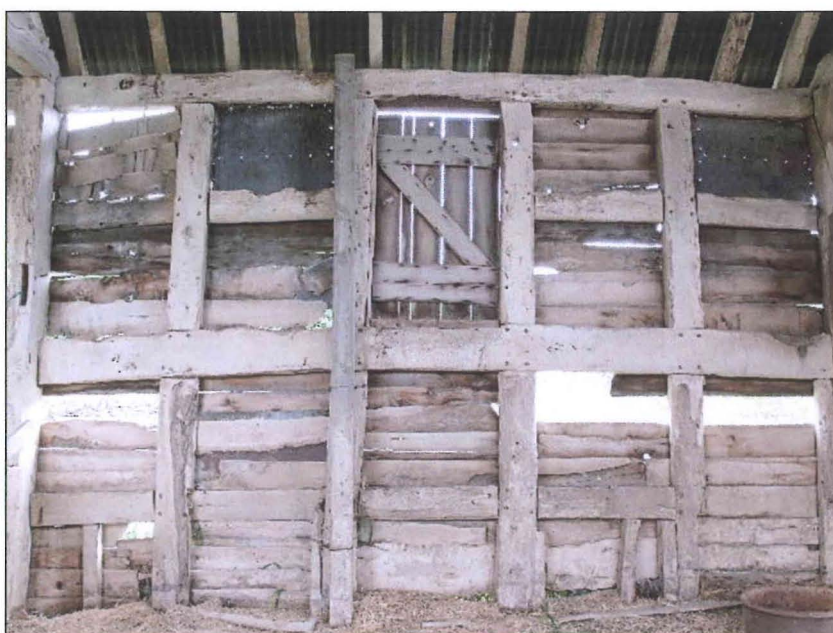
Fig. 15 Eastern interior of Bay 2 showing detail of framing and surviving woven infill

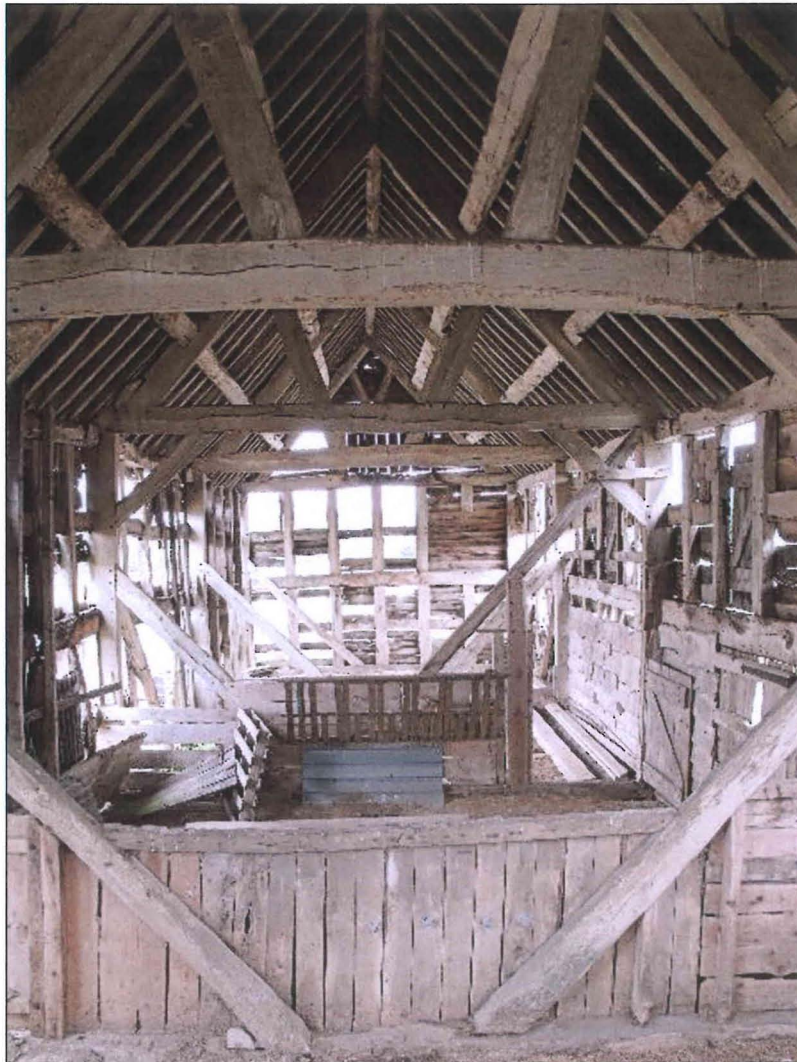
Fig. 16 Interior of the barn showing Bays 3-5

- 4.17 The trusses are in good condition, as is most of the framing, with the exception of the western side where the weatherboard is missing and significant rotting has occurred. The plinth has bowed considerably on the western side, with movement of up to 150mm.

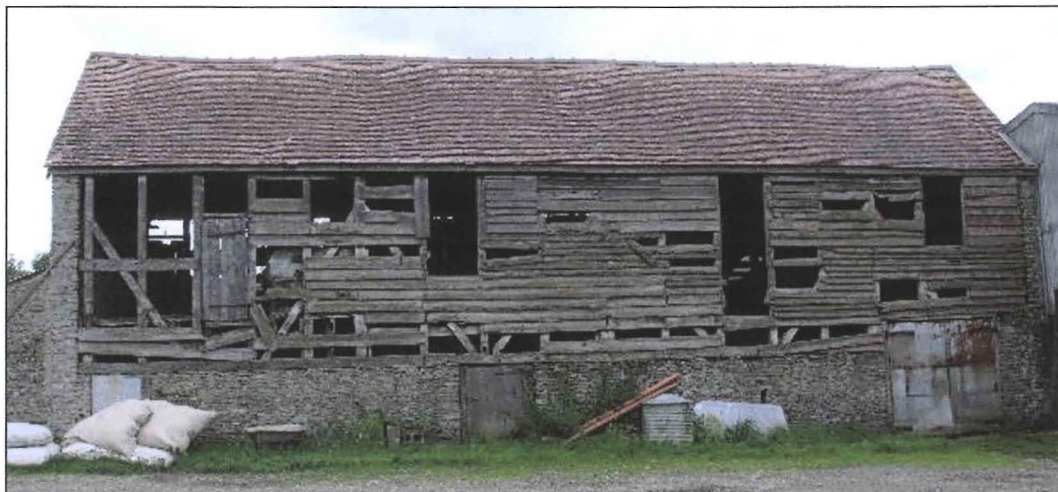
Fig. 18 Cowhouse 1 viewed from the north

- 4.20 The roof has staggered double purlins supported on machine-cut king post trusses with slanted struts and jowled posts, and is clad in plain tiles. The roof is in generally good condition, although there are some missing tiles in the south-western corner. The overall structure appears sound, although there are several visible cracks in the western gable wall.

- 6.9 The 19th-century cowhouse is generally in good condition, with only minor repairs required to the roof. The present form of the building would allow it to continue in use as an agricultural building and this would be the preferred option to ensure its survival.

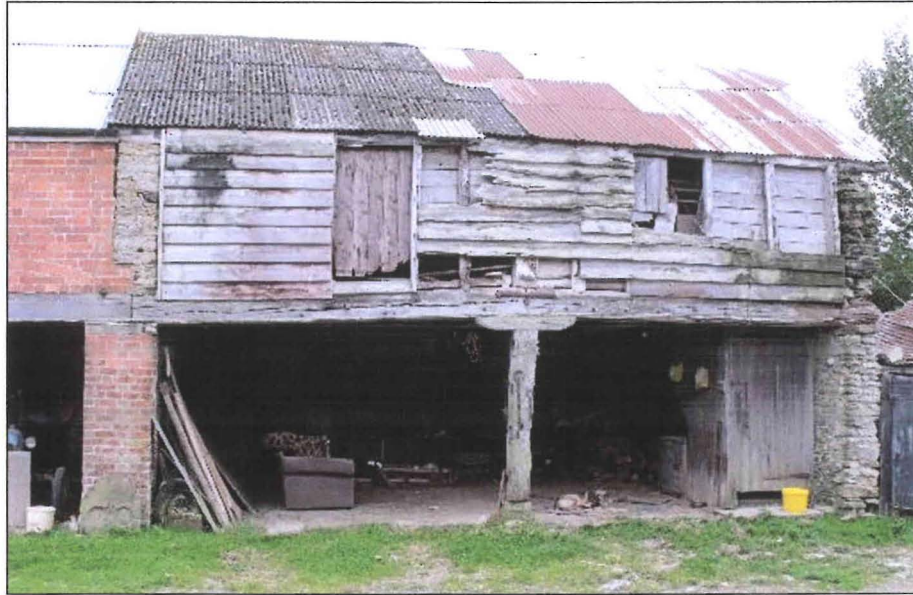
Fig. 20 Mid 19th-century cartshed

- 4.22 The first floor is supported on three large, transverse joists, with a single lintel across the cartshed entrance. This rests on a central post which appears to be a re-used principal floor joist with four joist sockets on either side, a broad chamfer on the inner side and stop chamfers on the outer side. An enclosed internal staircase leads to the first floor, which has loading doors in the north and west walls. There has been some significant recent collapse to the western gable and the whole is now in a precarious state.

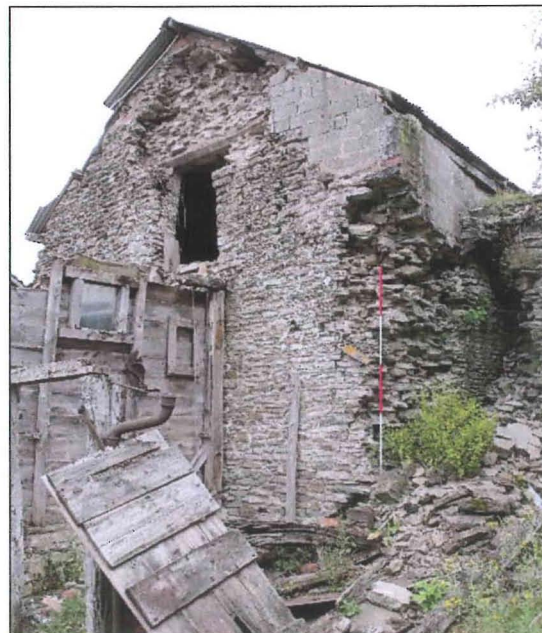
Fig. 21 Recent collapse to the western gable of the cartshed

- 6.10 As has already been mentioned, the condition of the earlier cartshed is a cause for considerable concern. The western gable wall has seen recent collapse and the whole structure is now under threat if remedial works are not undertaken immediately. Stabilisation of the wall is of vital importance to the management not only of the cartshed, but also of the tower keep.
- 6.11 The remainder of the range is in good condition and the first floor is still in use as a grain store. The long-term future, however, may depend on an alternative use being found.
