CPAT Report No 1070.1

Llanymynech Quarry drum house renovation works

ARCHAEOLOGICAL WATCHING BRIEF AND RECORDING

June 2011

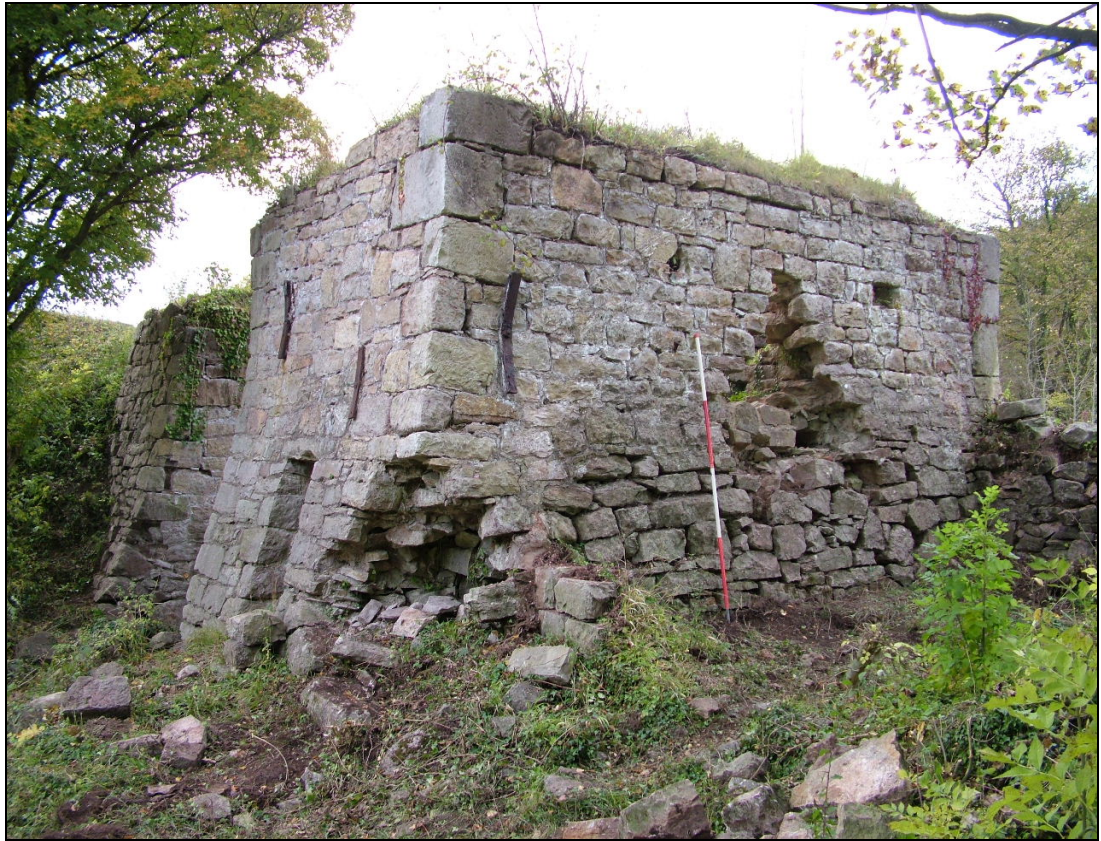
- 3.2.1 The south-west drum house comprises two stone-walled structures with a gap between them in which the drum would have operated on a horizontal axle. A number of areas of damage were noted in the north-east part, as a result of disturbance by intrusive vegetation and erosion by visitors (see Plate 1 on following page). This had led to a number of stones becoming dislodged and it was planned that these areas would be repaired with suitable materials to

prevent further deterioration. The most significant damage was at the east corner of the north-east part, where the basal stones had become detached, leaving a gap in the wall. Some damage had also occurred in the north-east wall of this part, where stones had been displaced. Examination of this area revealed that it had formed the support of the drum axle and had originally contained short timbers placed within the stone structure, perhaps to give it more resilience to shocks transmitted through the axle.

Plate 1 The south-west drum house (PRN 80175) from the east, showing the areas of damage at the east corner and in its north-east wall together with the opening for the brake control rods in its south-east wall (photo CPAT 3186-0014)

- 3.2.4 Some repairs had been carried out to the south-west drum house when the site was revisited on 11 January 2011, particularly the replacement of a number of stones which had fallen out of the east corner of the structure. However, the consolidation work had not been completed at the time of the second visit as the prevailing winter conditions were unsuitable for the use of the lime mortar specified for the consolidation work. The work that had been completed was sympathetic to the original construction methods used. A third visit, in June 2011, revealed a few extra details regarding the rooms appended to its north-east side, mainly evidence that the entrances to these rooms were located in their south-east walls.

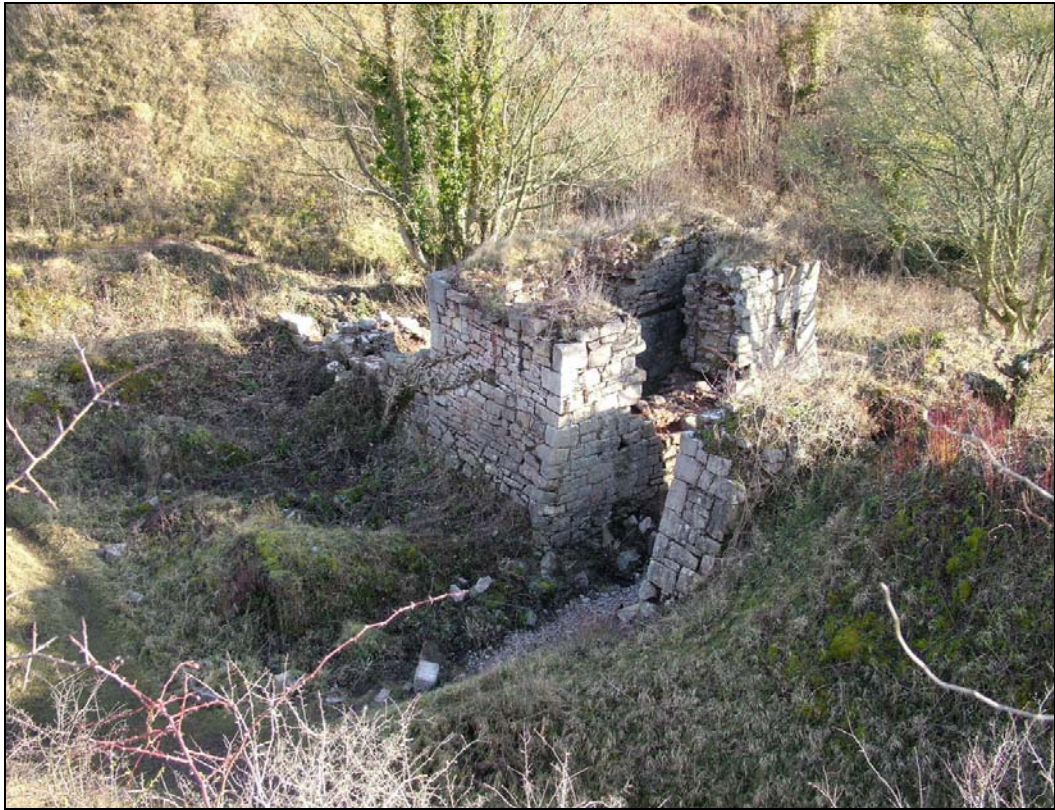
- 3.2.2 The south-west part of the structure is effectively a revetment wall and has little in the way of obvious interest, but the north-east part is rather more unusual, in that its interior is hollow (see Plate 2 on the following page). The hollow section is rectangular and denotes the presence of a braking mechanism that was separate from the main part of the drum, albeit mounted on the same axle. On the front of this part, there is an opening through which the brake control rods passed on their route to the head of the incline, where the operator stood to control the wagons on the incline when it was in use. The photograph above (Plate 1) also shows three tie-rods which were presumably inserted to add strength to the end of the structure owing to stresses from forces acting on the axle. The batter on the south-east side of the walling would have also added strength and stability to the structure in this regard.

- 3.2.3 In addition to the drum house itself, a number of rooms had been appended to the structure, on the north-east and north-west sides of its north-east part. These rooms probably provided shelter for the quarry workers and more specifically for the operator of the incline. It is

Plate 2 The south-west drum house (PRN 80175) from the west, showing the hollow interior of its north-east part, formerly occupied by the braking mechanism, and the overgrown traces of rooms appended to its north-east and north-west sides (photo CPAT 3186-0024)

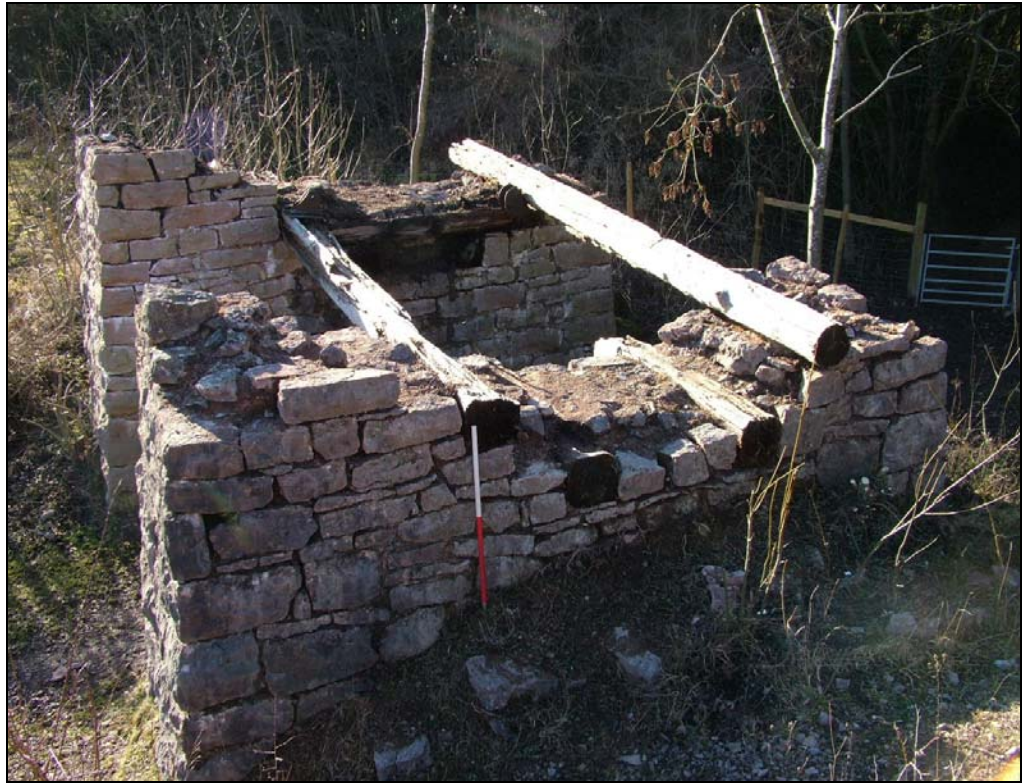
At the time of the second visit to the quarry on 11 January 2011, vegetation had been removed from the second drum house (PRN 80177), enabling it to be examined and recorded. This structure is rather more simple in construction than the first and seems to be significantly later in origin (see para 4.3). It consists of two parallel stone walls with vertical sides and has a room appended to its south-west side, again probably for the use of the incline operator. The remains of a softwood superstructure, which was held in place by the stone walls, survives and provided mountings for both the drum axle and the braking mechanism (see Plate 3, below).

Plate 3 The north-east drum house (PRN 80177) from the east-north-east, showing the timber superstructure with traces of the braking mechanism (photo CPAT 3186-0036)

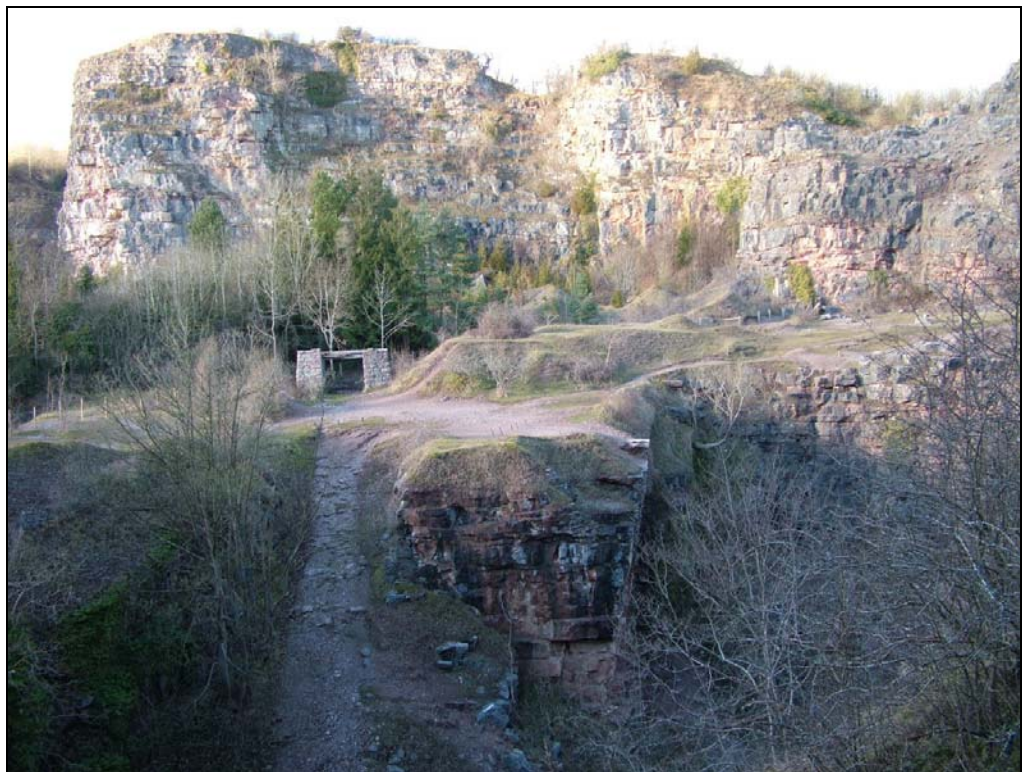
Plate 4 The north-east drum house (PRN 80177) from the south-east, showing the top of the incline and the surrounding quarry workings (photo CPAT 3186-0036)

- 3.3.2 The incline which the north-eastern drum house served was significantly shorter than the one served by the other drum house and this would have greatly reduced the forces to which it was subjected when in operation. At its lower end, the incline (see Plate 4, above) passed through a

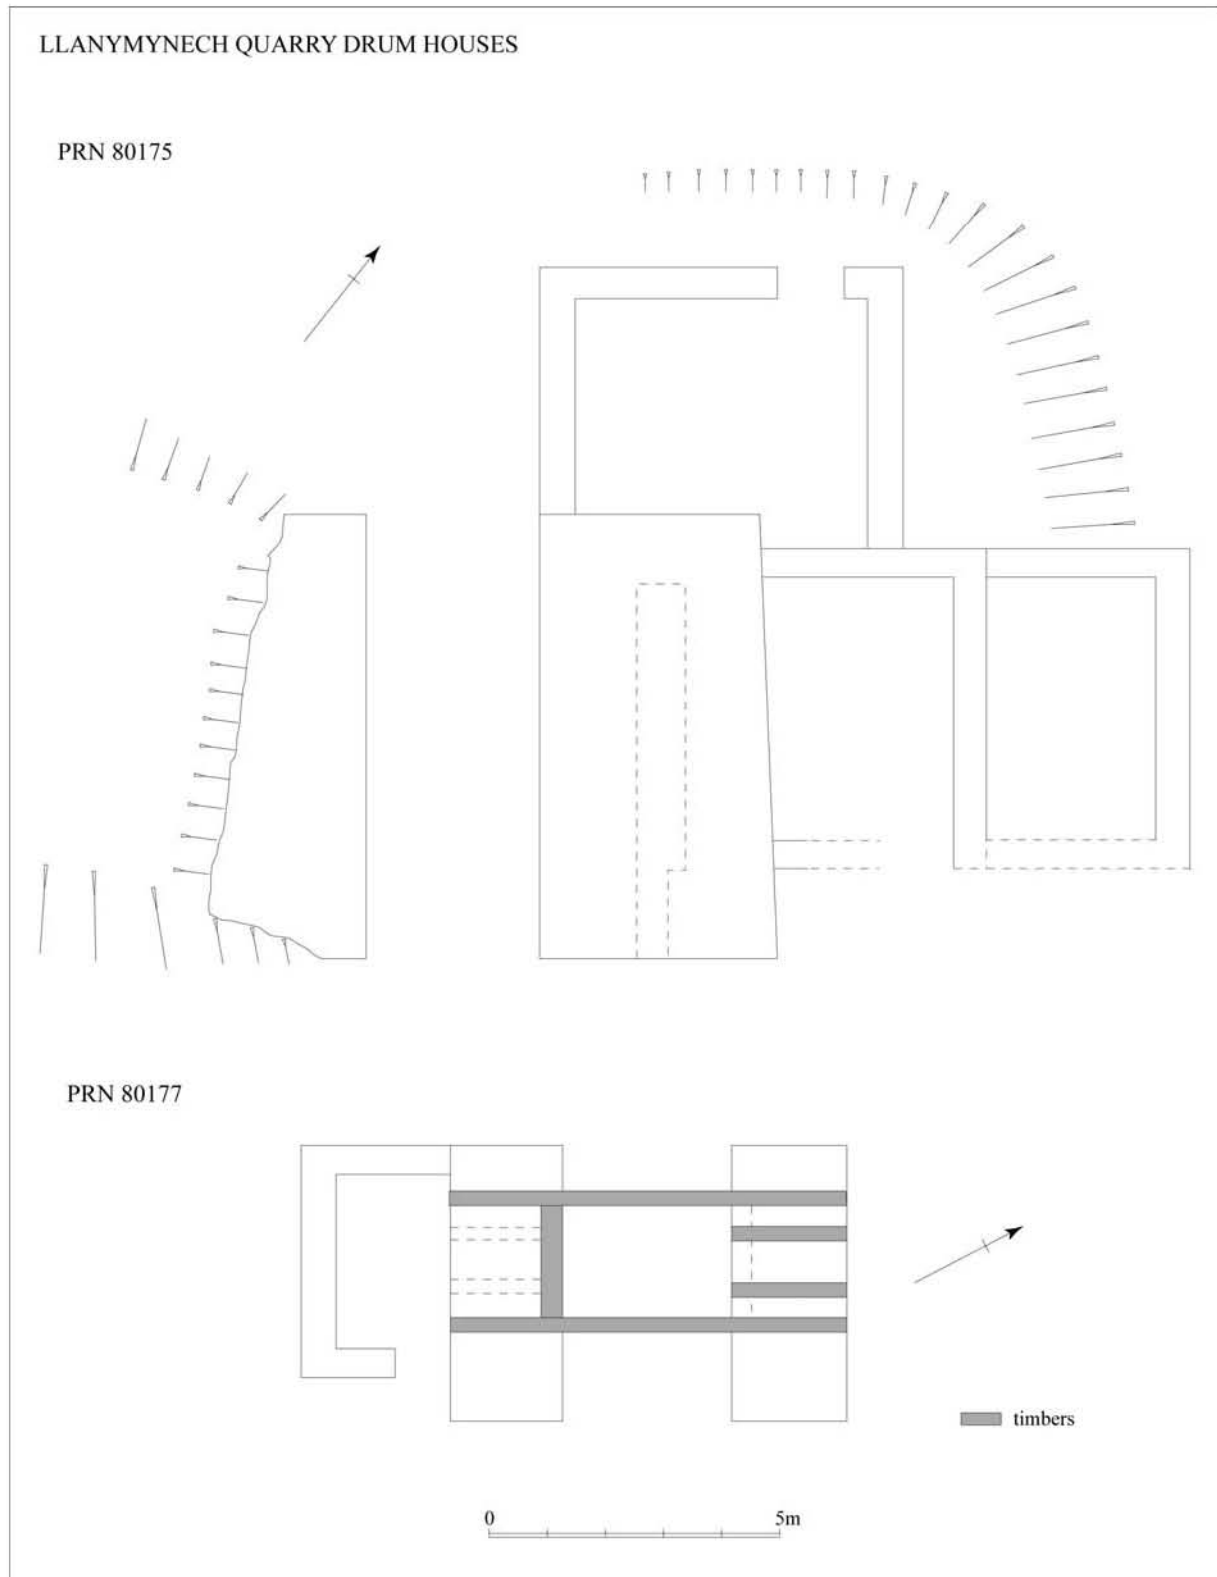
Fig. 2 Plans of the two drum houses utilising the revised measurements

- 3.4 While the watching brief was being carried out, the clearing of vegetation from the drum houses enabled the surviving structures to be more readily interpreted. The opportunity was therefore taken to measure the upstanding masonry, leading to a revision (see below) of the original plans provided at the commencement of the watching brief.

- 4.1 The consolidation works have provided a good opportunity to examine and understand the two drum houses. In particular, the removal of their former cover of vegetation has enabled their structures to be photographed and accurately measured during the watching brief. A revised plan of the drum houses (Fig. 2) has been compiled from the measurements.
