Crychan Forestry, Carmarthenshire

ARCHAEOLOGICAL SURVEY

CPAT Report No 873

Report for Forestry Commission Wales

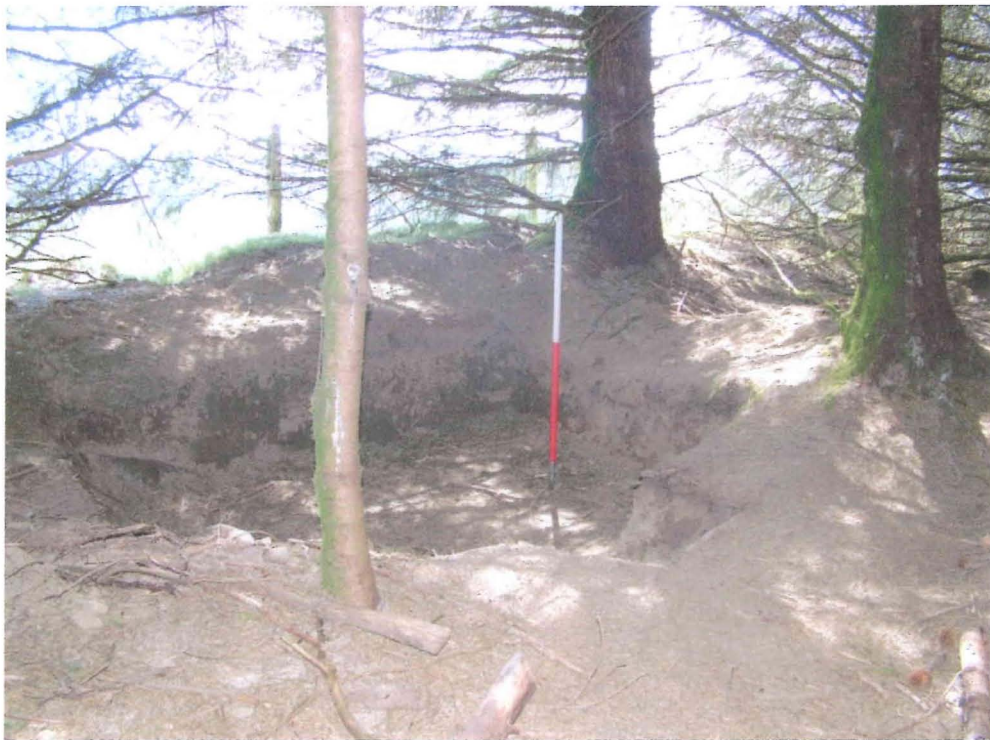
The forested half of the enclosure is covered with mature conifers. In places there is serious damage to the banks and internal ground surface resulting from military activity. Motorbikes have formed eroded tracks across the area and cutting through the banks.

PRN 273 Crychan Forest Fortlet – damage resulting from military dugout. Photo CPAT
2354.004

- 4.2 Perhaps the most significant site within this area of forestry is the putative Roman fortlet (PRN 273), sited in a good defensive position on the crest of a hill. The earthworks are bisected by the forest boundary, with the better preserved north-western half lying within an area of mature conifers, and the south-eastern half in a pasture field. Unfortunately, the earthwork banks within the forestry have been heavily used for military training activities and these, together with much of the interior, are riddled with the large pits of army dug-outs, as well as damage from trail bikes. As such, this site has significant management issues which require urgent attention to prevent further damage and initiate a programme of reconsolidation and repair.

Carefully remove conifers. Monitor and preserve in-situ. Exclude the site and wider area from replanting. Ensure that army activities as well as motor bikes and bike events are excluded from the area. Reinstate the damage caused by military activities.

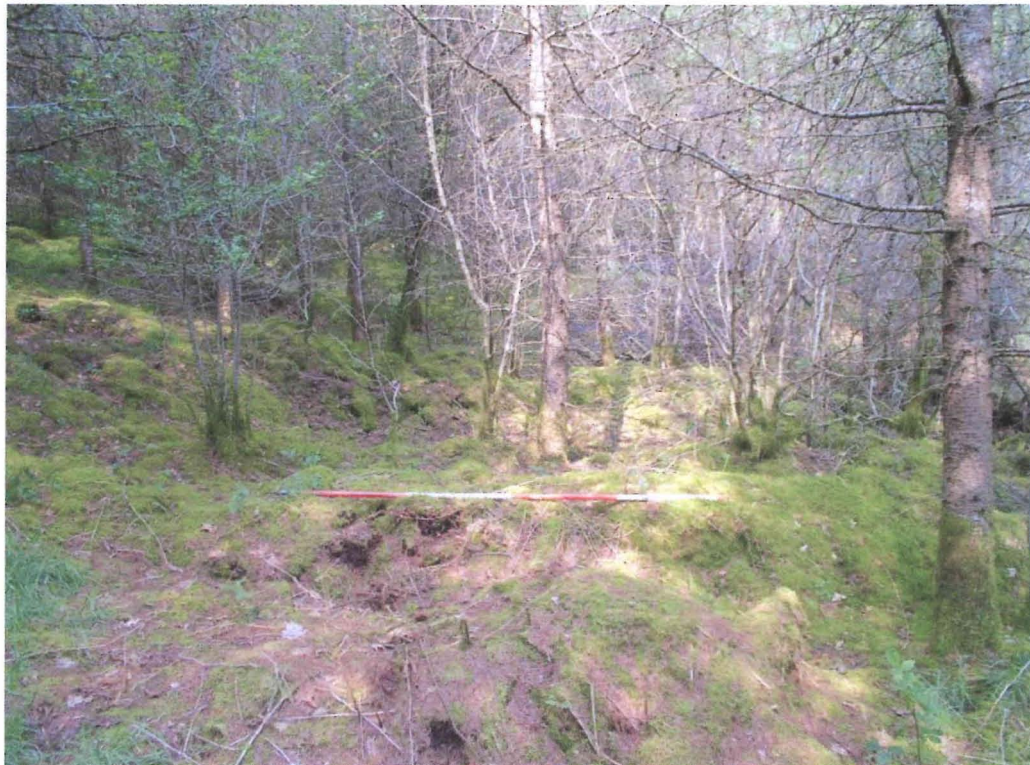
PRN 30214 Noethgrug building from E. Photo CPAT 2354.035

Clear trees and saplings. Monitor and preserve in situ. Fence during felling operations and exclude site and wider area from replanting.

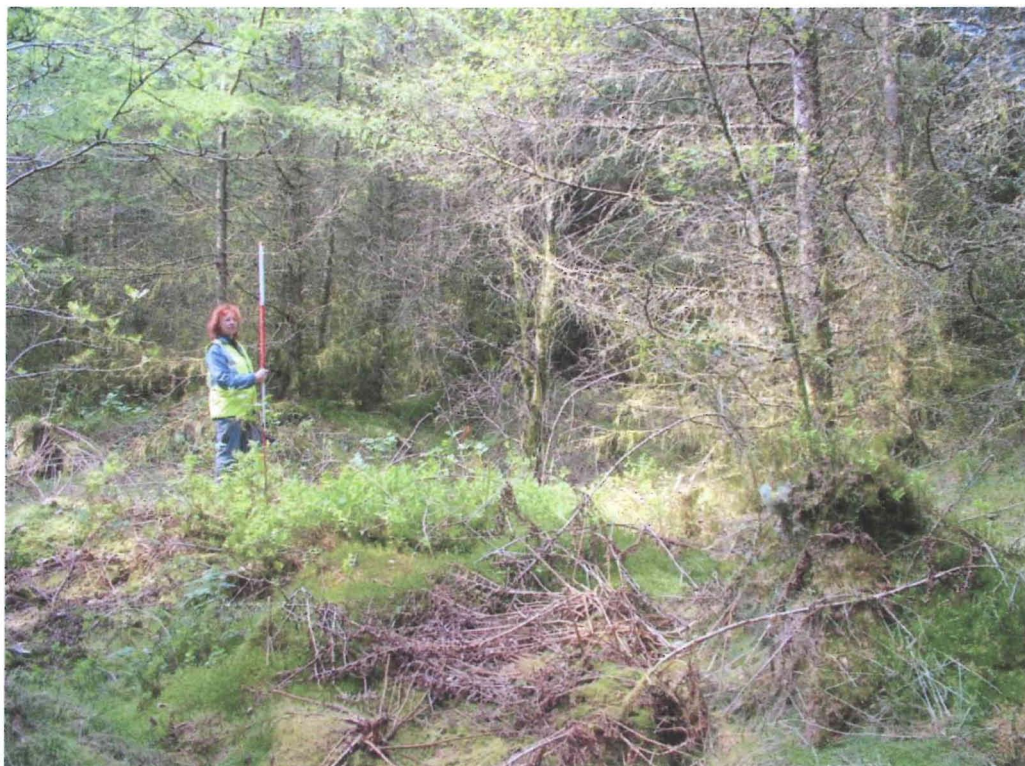
PRN 36095 Crychan Forest Platform from E. Photo CPAT 2354-027

Remove conifers. Monitor and preserve in situ. Fence during felling operations and exclude site and wider area from replanting.

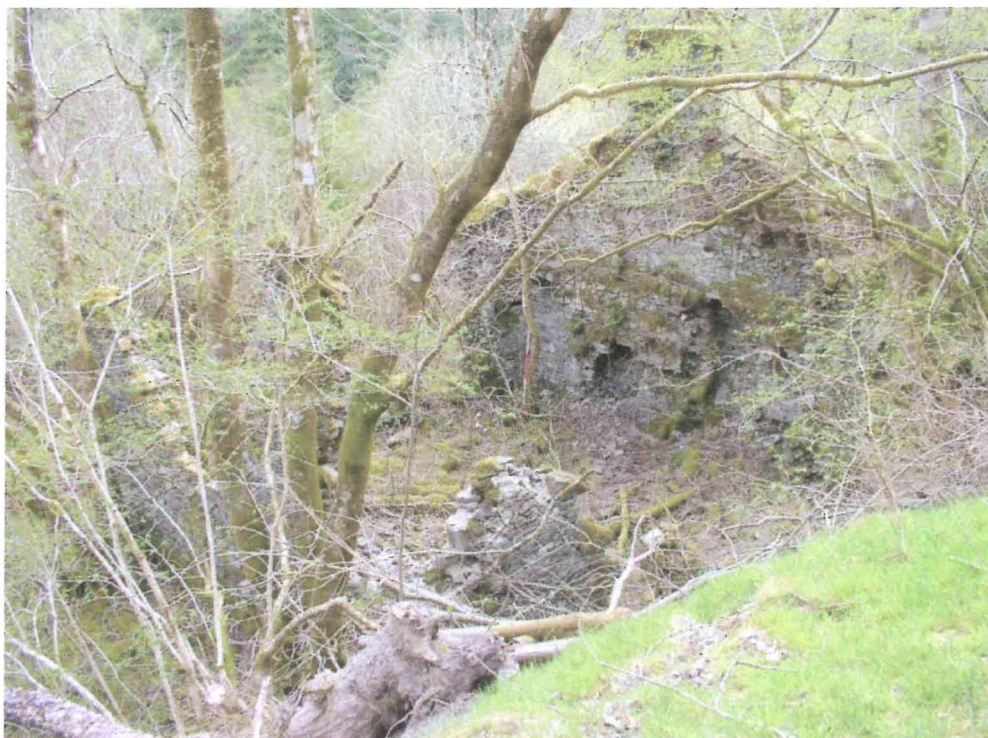
A ruinous stone-built house of two storeys located on a level terrace immediately below the modern forest road. The house is aligned north-east to south-west, and measures *c.* 9m by 7.6m. The south-west gable wall still stands to the full height (*c.* 6m) and contains chimney flues from two ground-floor fireplaces. The upper part of this wall is in a very unstable condition. The entrance is in the centre of the south-east wall, with a window on either side. The house was well-built from random stone rubble, with dressed stone quoins at the corners. Traces of render still adhere to the exterior walls. Internally, there is now no trace of room divisions, but the presence of two fireplaces in the south-west wall implies that the space was divided. In front of the house is a level terraced area 5m wide, possibly a garden. A pigsty (PRN 44670) is located to the south-west, only 2m from the south-west gable of the house. A former road is still evident which links the house with the barn (PRN 44669) to the north.

The whole structure appears fragile, and the gable end walls in particular are in a very unstable and perilous condition. The house is surrounded by the saplings of broadleaf trees, some of which are growing within the structure.

PRN 44668 Scrâch Farmhouse from N. Photo CPAT 2354.022

Clear saplings. Monitor and preserve in situ. Avoid during forestry operations and exclude site and wider area from future planting.

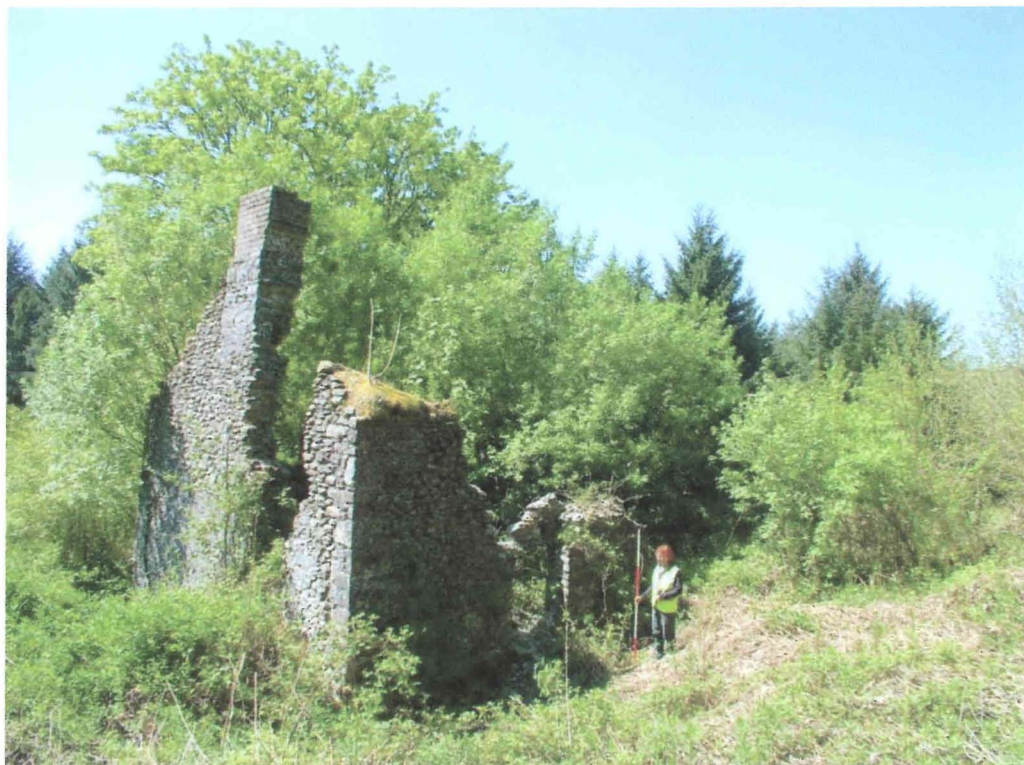
PRN 44673 Glyn-môch Farmhouse from E. Photo CPAT 2354.039

A ruined, two-storeyed, stone-built 19th-century farmhouse, with brick lintels and chimney. The house is aligned north-west to south-east. The house has a central doorway on its south-west side, with a window to either side of it. The windows are slightly splayed, and inside of the building they have timber lintels over them but brick lintels on the exterior. There is a large collapsed fireplace in the north-west gable wall, and a smaller one in the south-east wall. The more collapsed, north-east wall appears to show the remains of two windows. Although the masonry is loose and unstable, most of the gable ends still survive up to their full height, although the north-east wall has largely collapsed. Its dimensions were previously recorded as 12m long and 6.25m wide, with walls 0.75m thick.

Broadleaf saplings within and around the building. The masonry is loose and unstable.

Clear saplings. Monitor and preserve in situ. Avoid during forestry operations and exclude site and wider area from replanting.

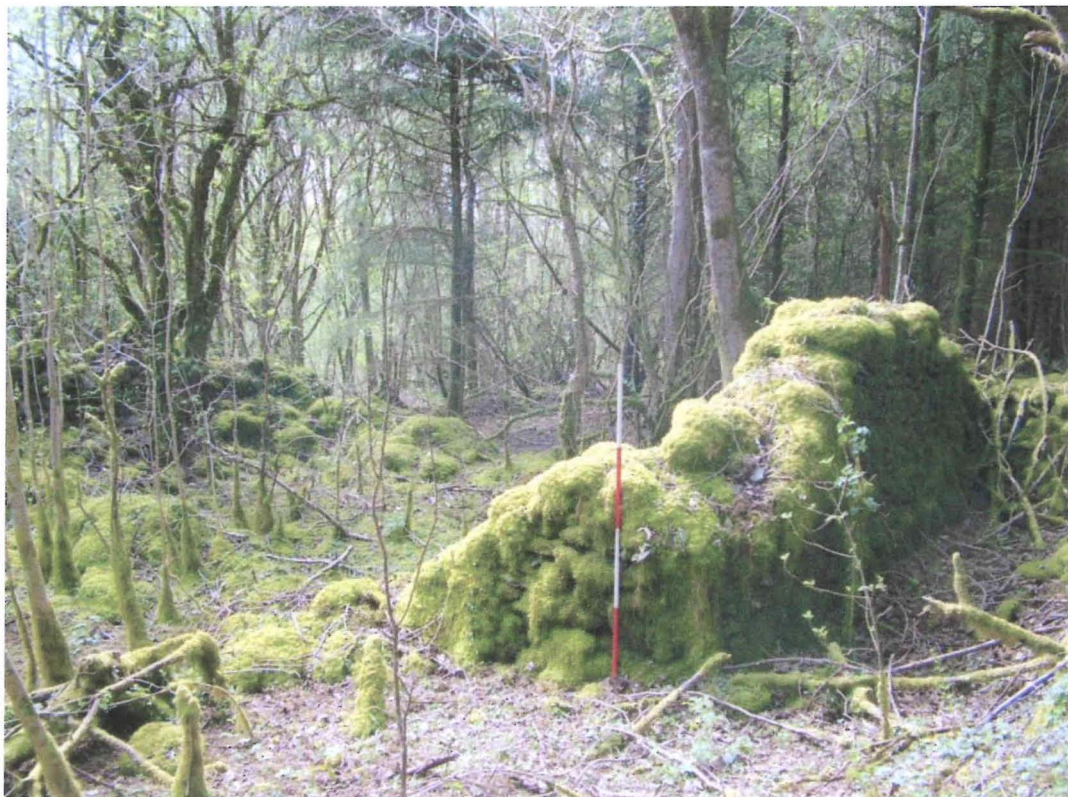
PRN 62776 Cefn-gareg Farmhouse from NW. Photo CPAT 2354.009

The area has been left as a riparian zone between conifers and there has been a natural seeding of broadleaves. The building is in reasonably good condition.

Clear saplings. Monitor and preserve in situ. Fence during felling operations and exclude site and wider area from replanting.

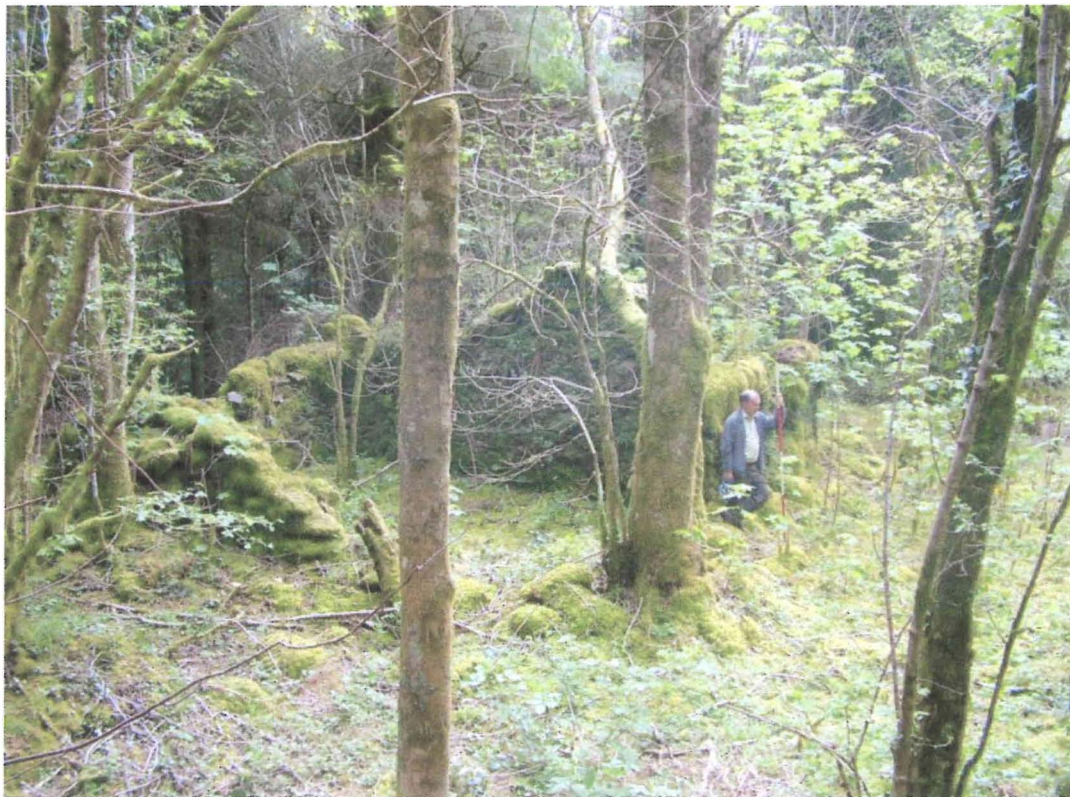
PRN 62777 Cefn-gareg Barn from N. Photo CPAT 2354.009

The area has been left as a riparian zone between conifers and there has been a natural seeding of broadleaves. The building is in reasonably good condition.

Clear saplings. Monitor and preserve in situ. Fence during felling operations and exclude site and wider area from replanting.

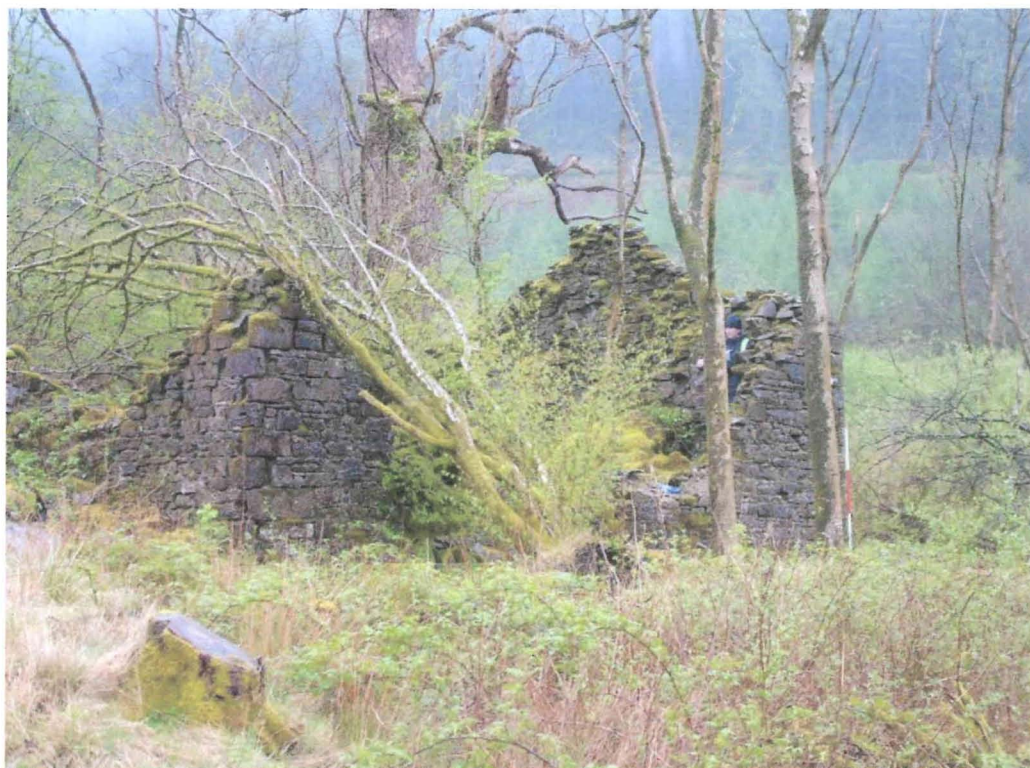
PRN 62778 Cwrte-bach Farmhouse from NW. Photo CPAT 2354.014

The building is in poor condition, and the mortar is now loose. There are small trees and saplings within and around the buildings.

Clear saplings. Monitor and preserve in situ. Fence during felling operations and exclude site and wider area from replanting.

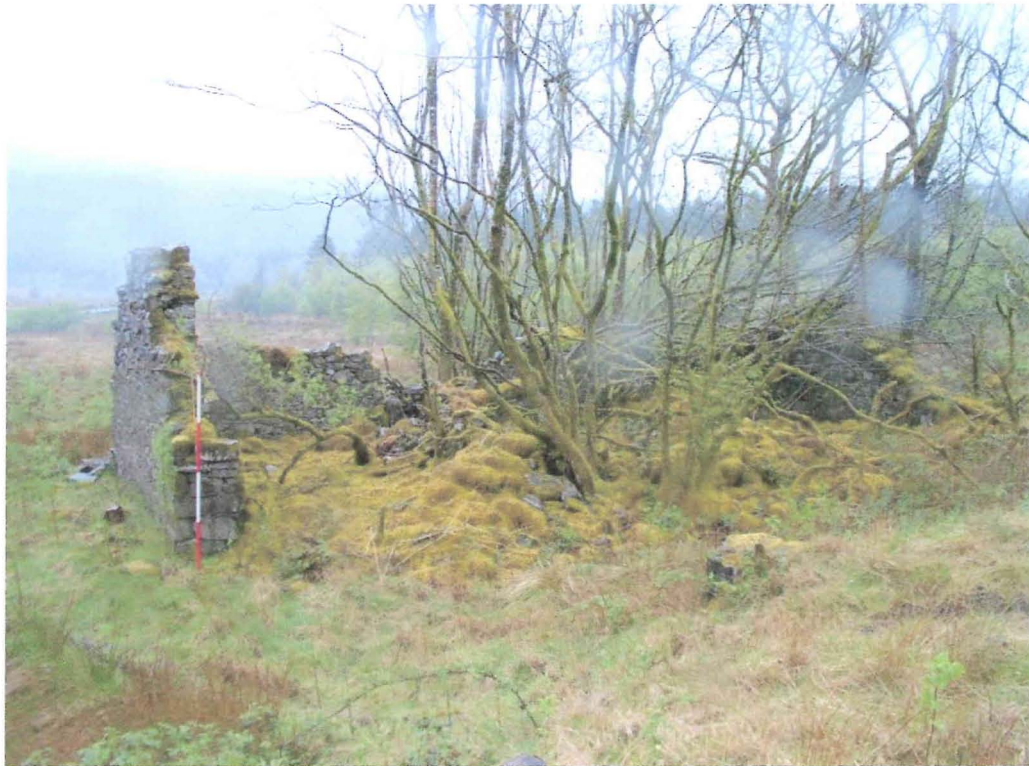
PRN 62779 Cwrte-bach Barn from ESE. Photo CPAT 2354.013

The building is in poor condition, and the mortar is now loose. There are small trees and saplings within and around the buildings.

Clear trees and saplings. Monitor and preserve in situ. Fence during felling operations and exclude site and wider area from replanting.

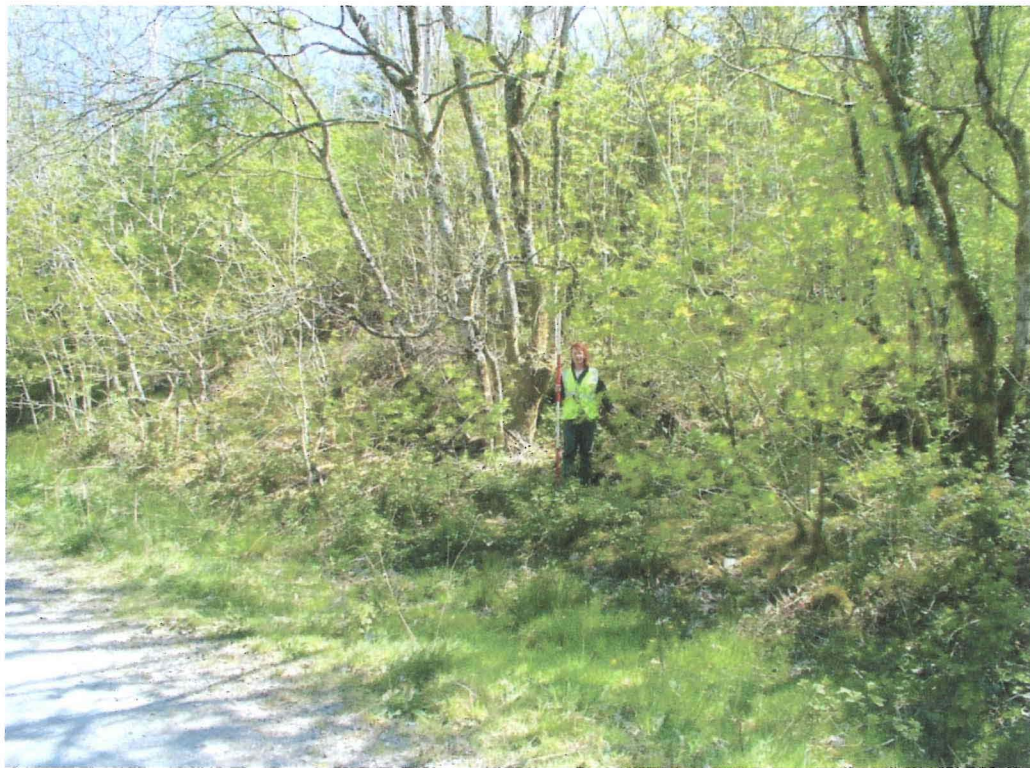
PRN 62786 Pen-lan Farmhouse from WSW. Photo CPAT 2354.037

Part of Pen-lan Farmstead (PRN 30223). There is now no obvious surviving walling of the farmhouse, although there is a large platform terraced into the slope on the eastern edge of the forest road which has a considerable quantity of rubble and possible walling. It is likely that the foundations and floors survive beneath the rubble.

Clear saplings and undergrowth. Monitor and preserve in situ. Fence during felling operations and exclude site and wider area from replanting.

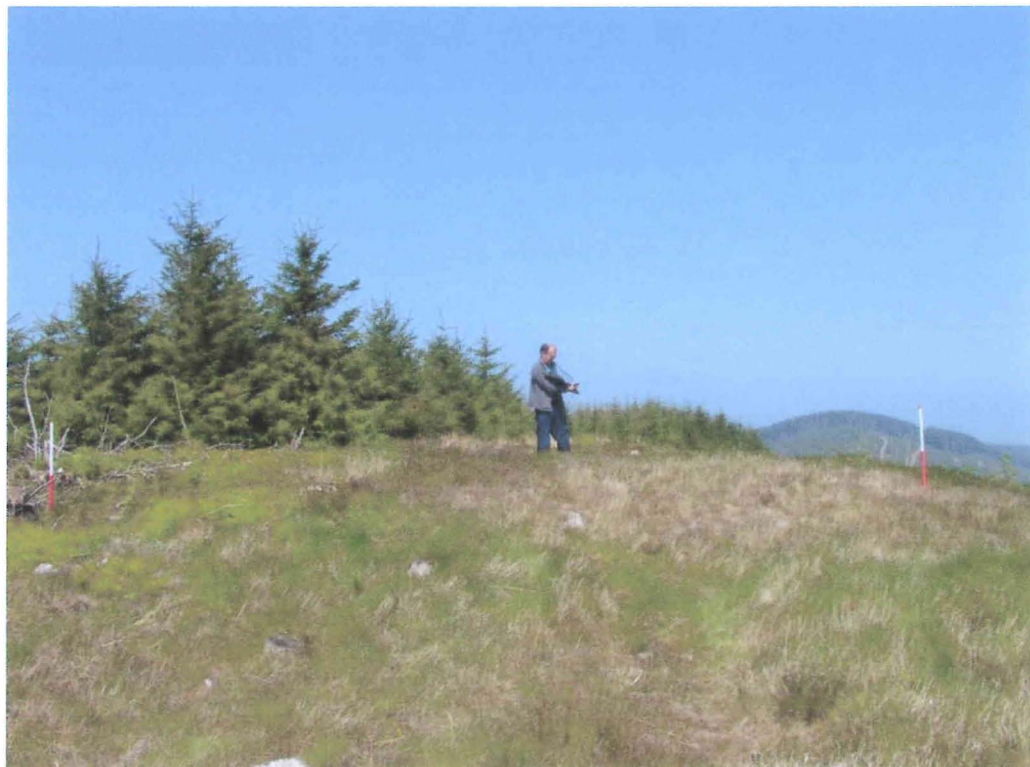
PRN 62788 Castell Craig-y-derwyddon cairn from SW. Photo CPAT 2354.057

The immediate area has been cleared of its conifer crop and left unplanted, though there is some regeneration of deciduous trees. The edge of the nearest planted conifer compartment lies *c.* 10m to the north. Some previous damage to the site has occurred during planting or clearance operations. An access route along the crest of the ridge crosses the site.

- 4.3 One significant new discovery was a probable Bronze Age burial cairn on the ridge of Castell Craig Wyddon (PRN 62788), measuring 9.3m in diameter and up to 0.5m high. Unfortunately, the cairn has been damaged by a forestry access track.

Monitor and preserve in situ. Fence during felling operations and exclude site and wider area from replanting. Exclude the passage of vehicles across the site and divert track

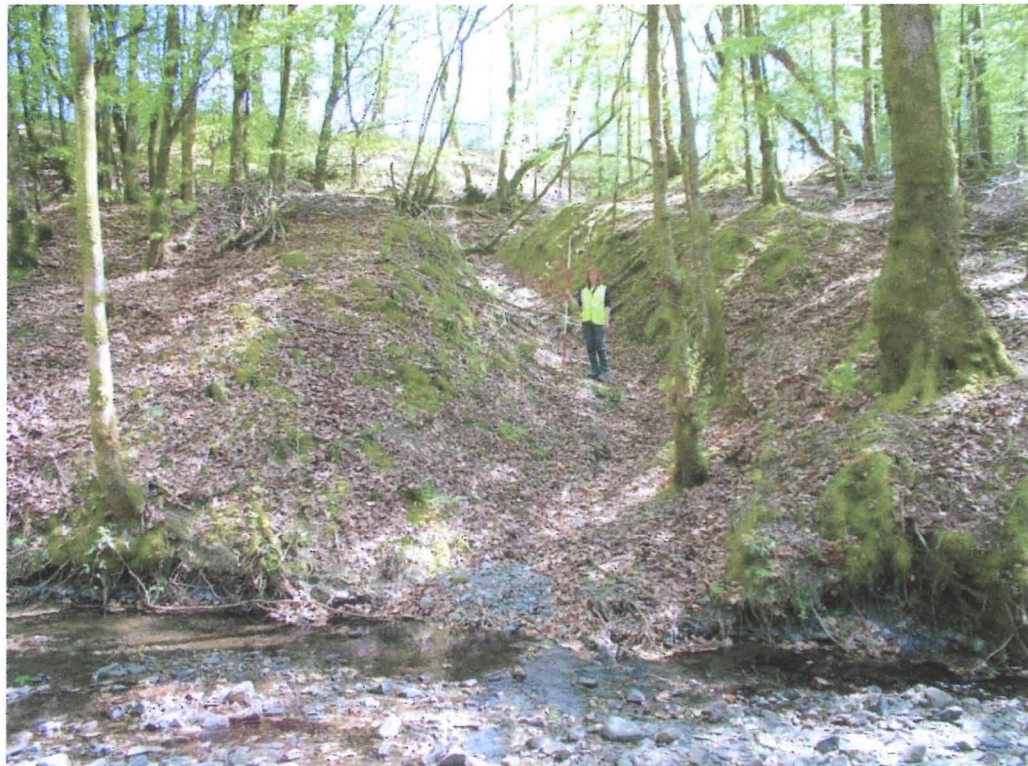
PRN 62793 Ty'n Wern holloway from NW. Photo CPAT 2354.044

A footbridge and ford are depicted on the Ordnance Survey 1st edition map. The field survey found no structural remains of the ford and footbridge, although on the south side of the stream there is a deeply cut holloway ascending the slope.

Monitor and avoid when felling/replanting.

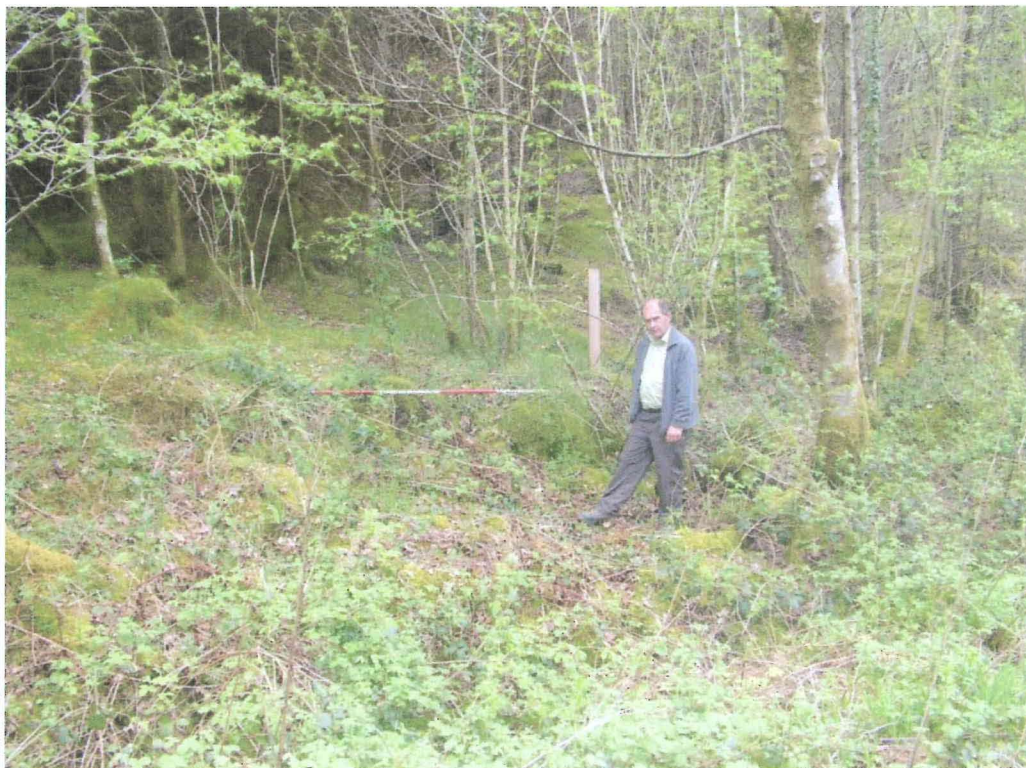
PRN 62804 Cwm Clwydfach Building from NNW. Photo CPAT 2354.012

The site has been heavily damaged by construction of the adjacent forest road. The site lies on the edge of the forest and is not actually forested, although there are saplings.

Clear saplings and undergrowth. Monitor and preserve in situ. Fence during felling operations and exclude site and wider area from replanting.

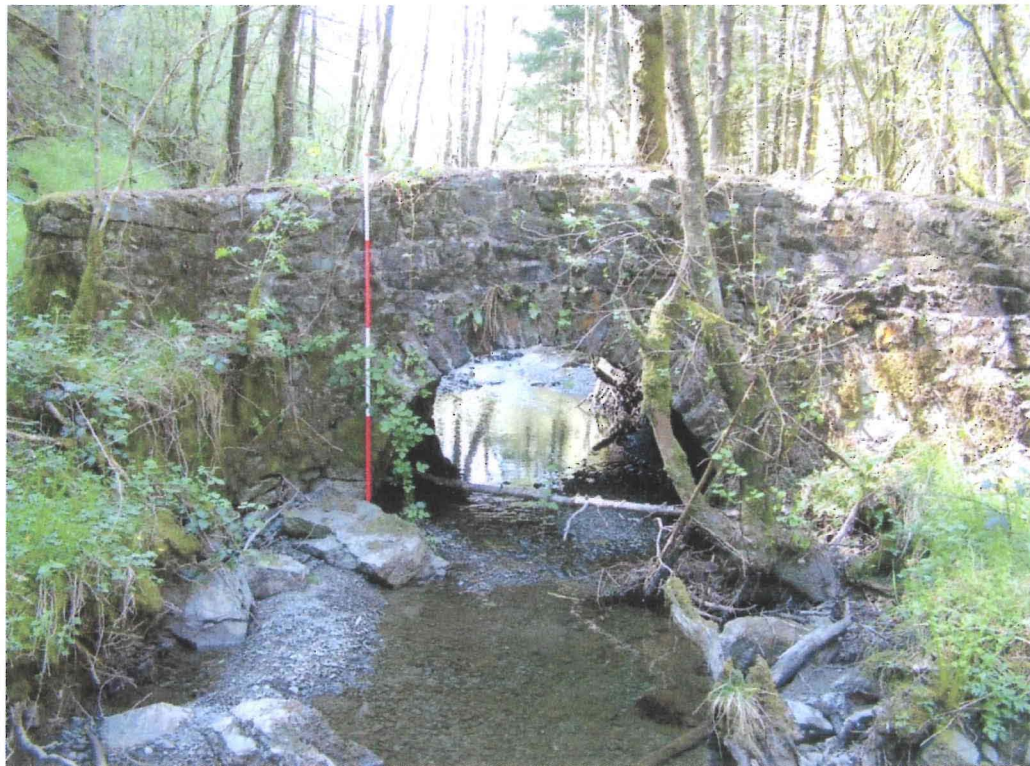
PRN 62807 Crychan stone bridge from ESE. Photo CPAT 2354.046

A single arched stone bridge is sited in a steep-sided valley, crossing a small stream. The bridge measures 6.2m in length and 4.1m wide, and is constructed of random lime-mortared stone and has no coping on the parapets. The bridge is generally in good condition although stones are missing from the underside (at the north-east end) and from the north-west face.

Near intact, although with some missing stones. Saplings and undergrowth are intruding and there are large blocks of stone which have fallen onto the bridge.

Undertake structural survey. Clear saplings, undergrowth and loose stone. Repoint with lime mortar. Monitor and preserve in situ. Fence during felling operations and exclude site and wider area from replanting.
