Fairbourne Flood Defences Renewal, Fairbourne, Gwynedd

Archaeological Building Recording and Watching Brief

Project No. G2315

Report No. 1209

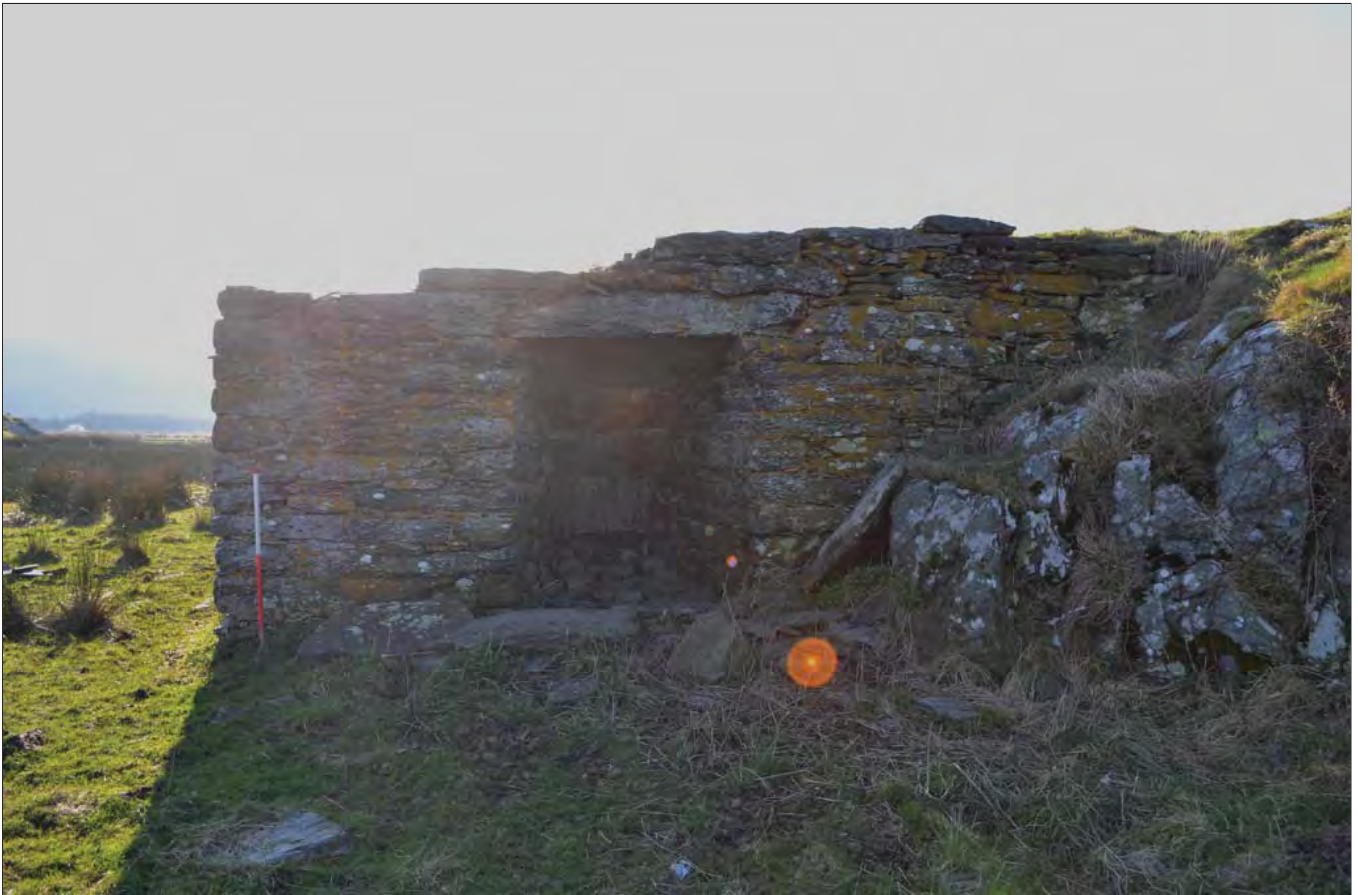
It is built of coursed rough shale fieldstone blocks (up to 1.2m by 0.6m), and is between 1.4m and 2.1m high and approximately 4.5m square (Plates 01-06). At no point does the overall height of the structure rise above the rock outcrop to the west of it (Plate 05). It is built into the east side of a rock outcrop which has in turn been built into the flood defence embankment, and is surrounded to the east by salt marsh. It has stoke holes to the north and south (Plates 02 and 04), and a circular entrance hole for the limestone above.

Plate 01: The Lime Kiln on the Fairbourne Embankment, viewed from the east. Scale 1m

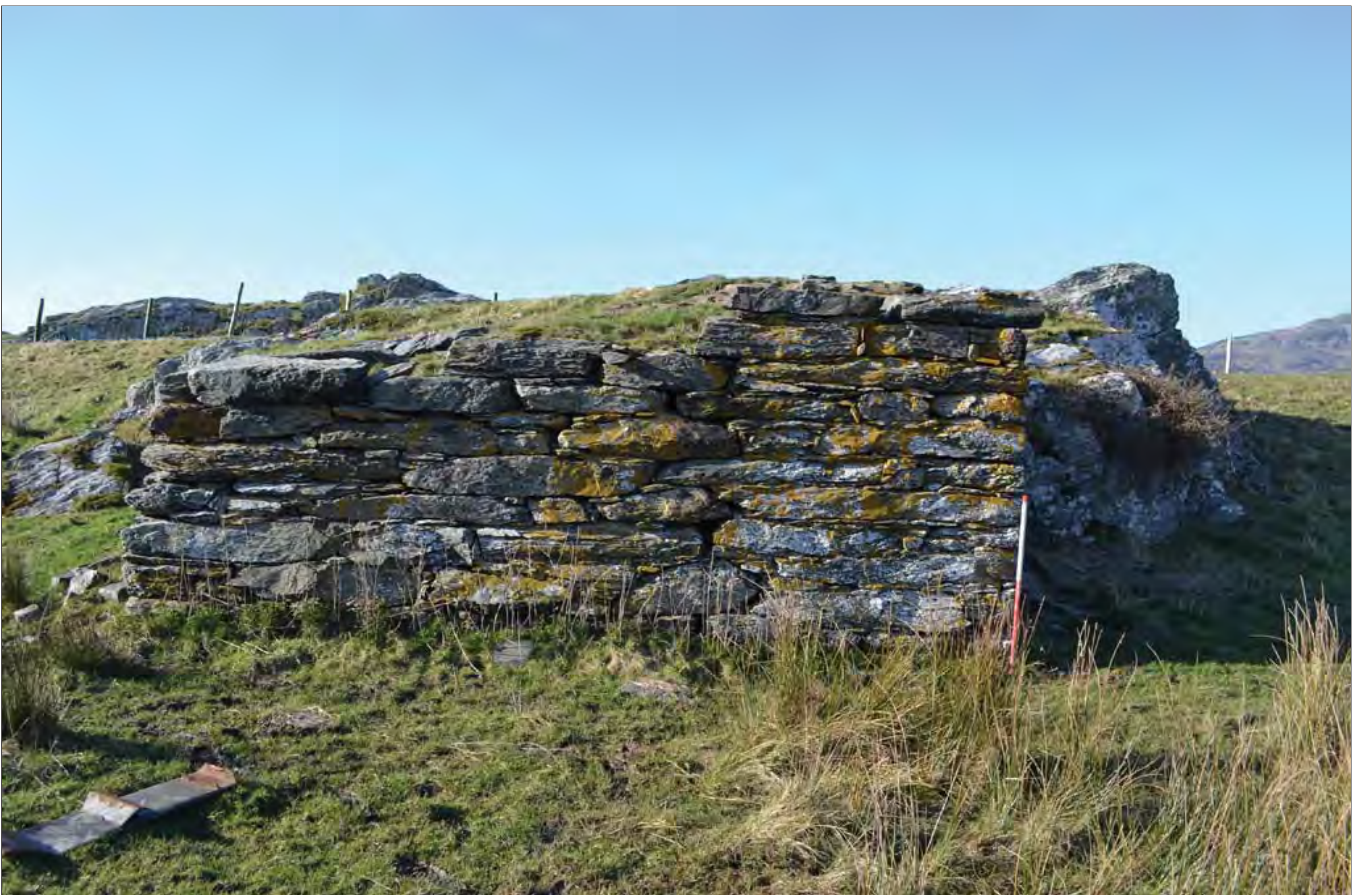
Plate 02: The Lime Kiln viewed from the south. Scale 1m

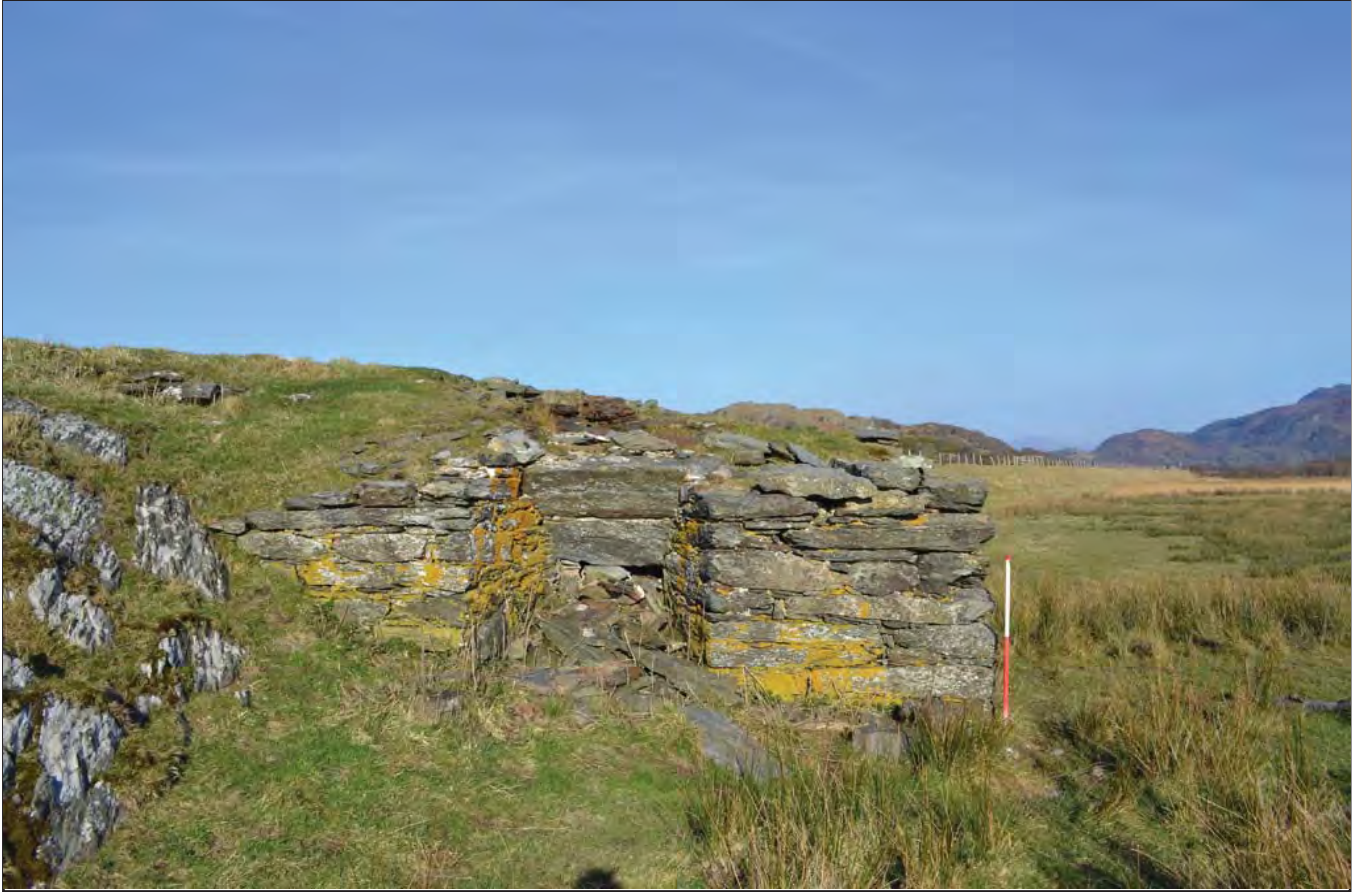
Plate 03: The Lime Kiln on the Fairbourne Embankment, viewed from the west. Scale 1m

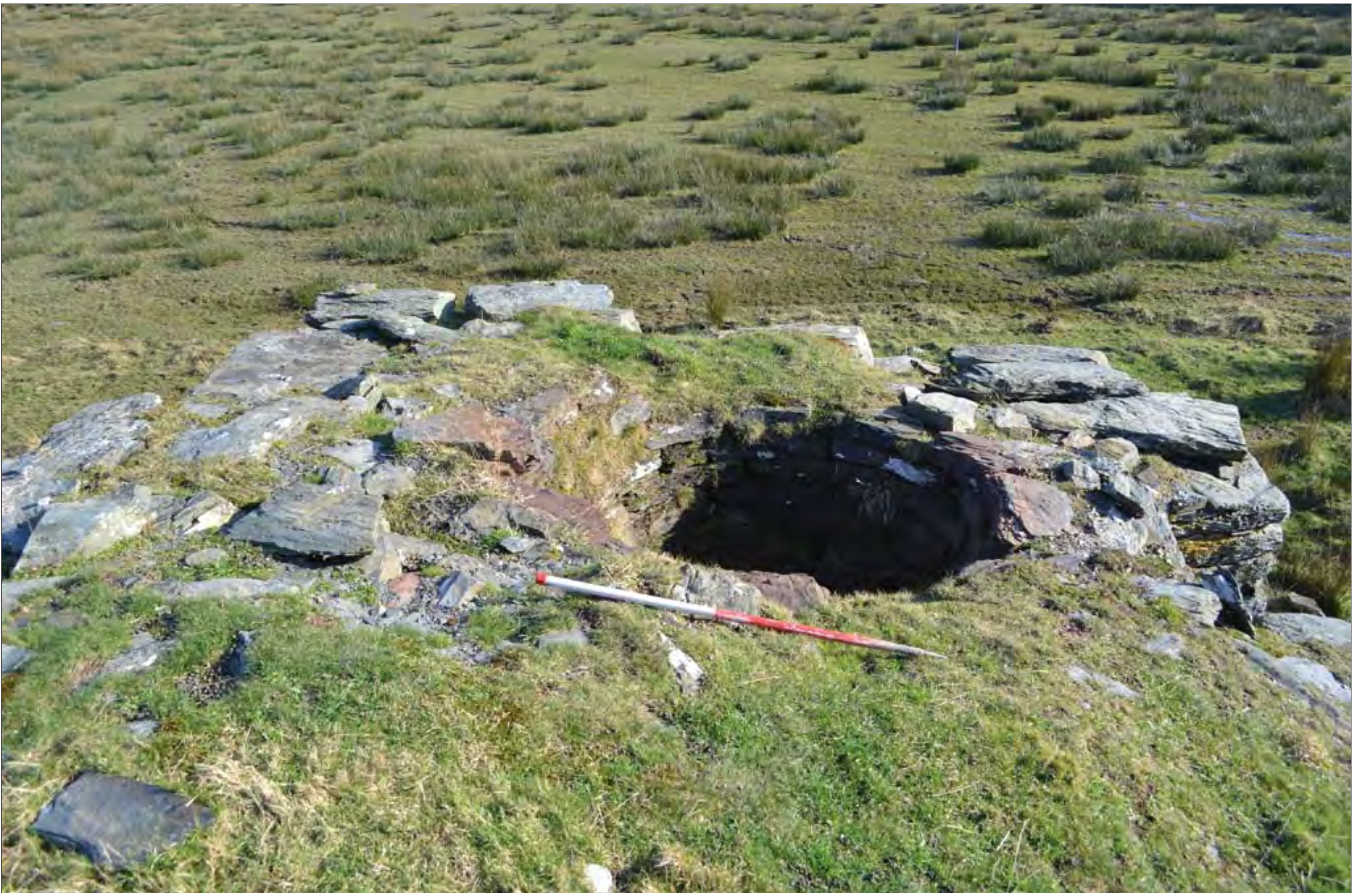
Plate 04: The Lime Kiln viewed from the north, showing hole into which the lime and fuel was shovelled. Scale 1m

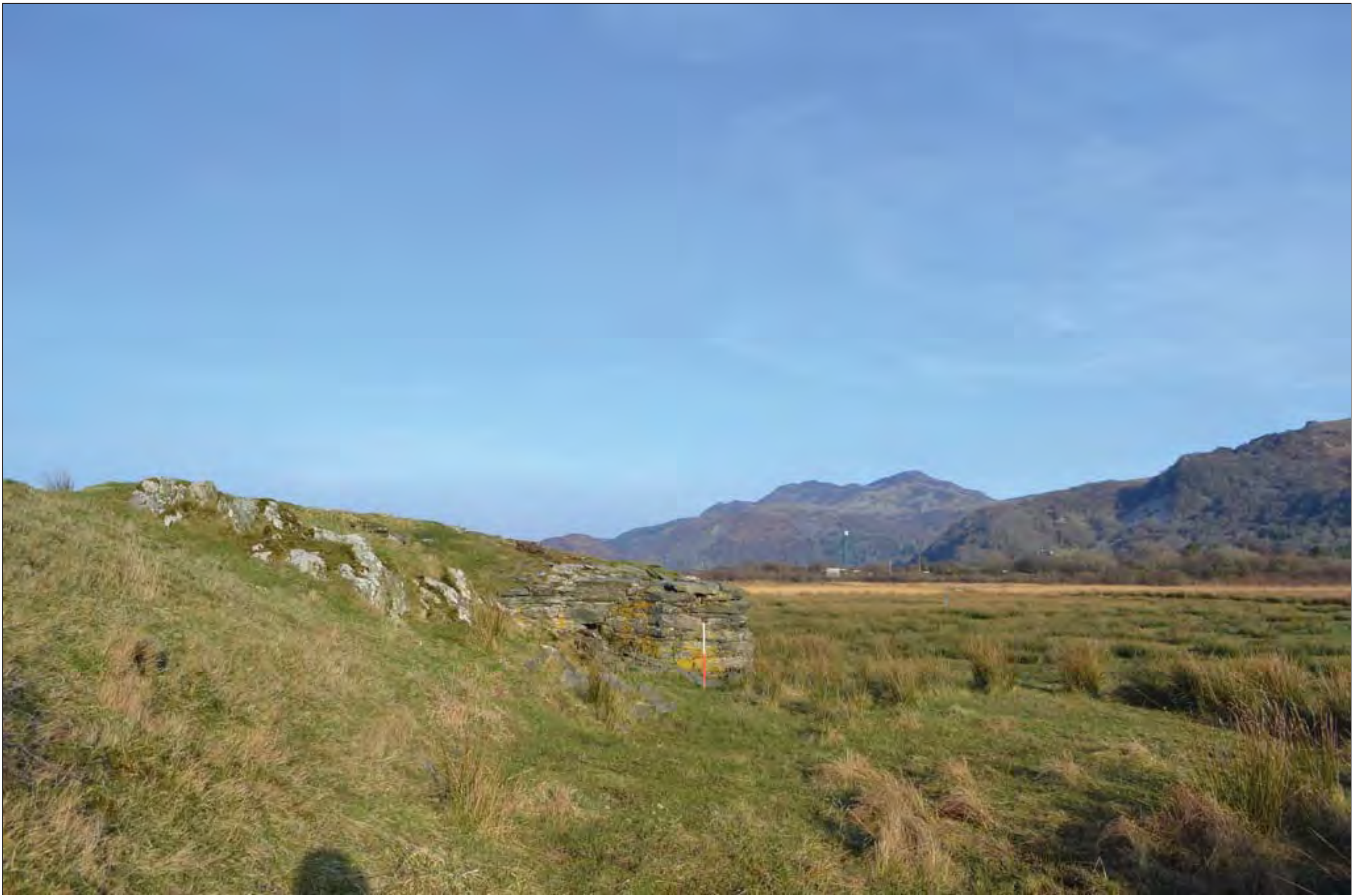
Plate 05: The Lime Kiln on the Fairbourne Embankment, viewed from the west, showing relationship with the rock outcrop built into the Fairbourne embankment. Scale 1m

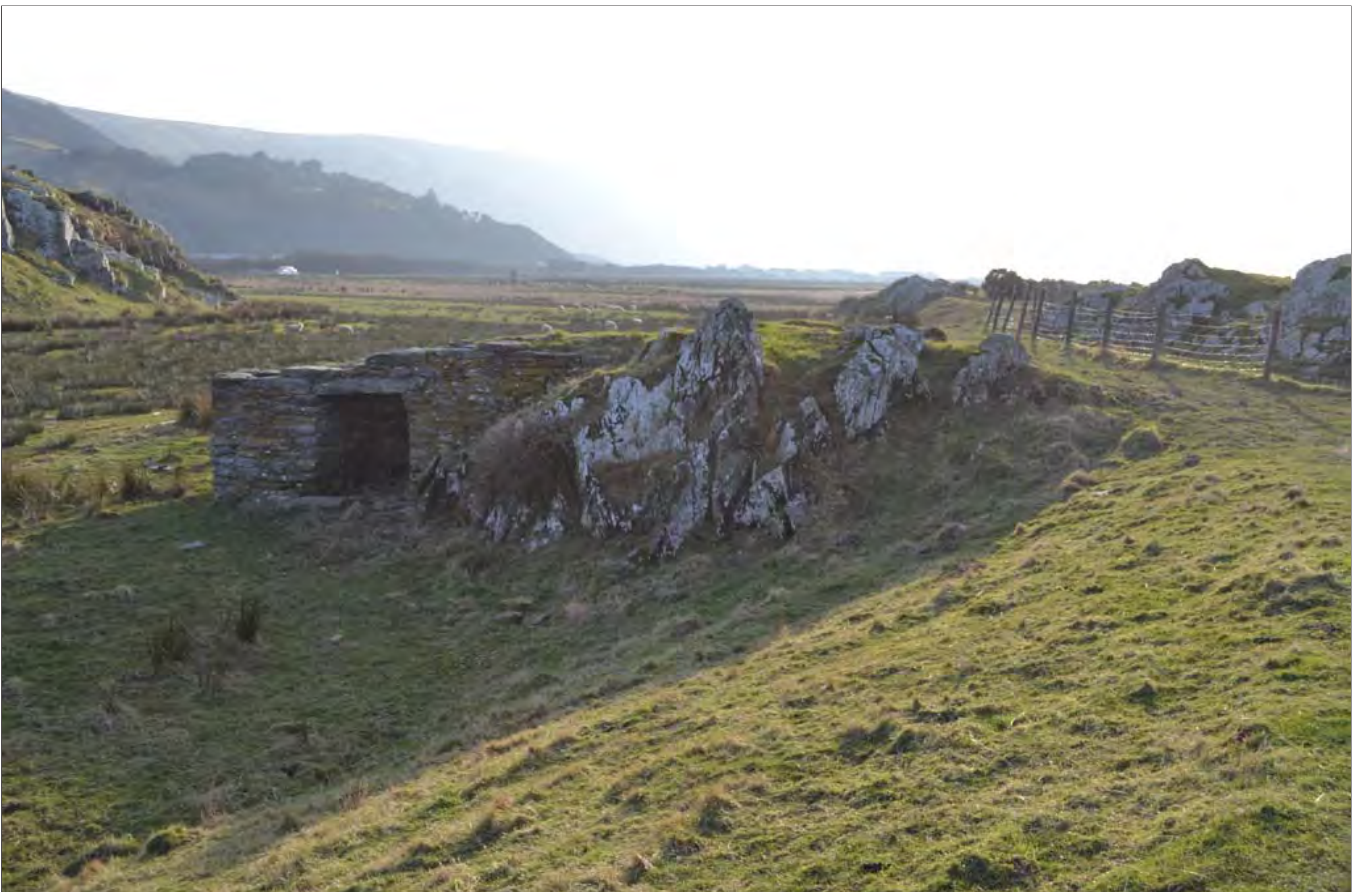
Plate 06: The Lime Kiln viewed from the east south east, showing hole into which the lime and fuel was shovelled. Scale 1m

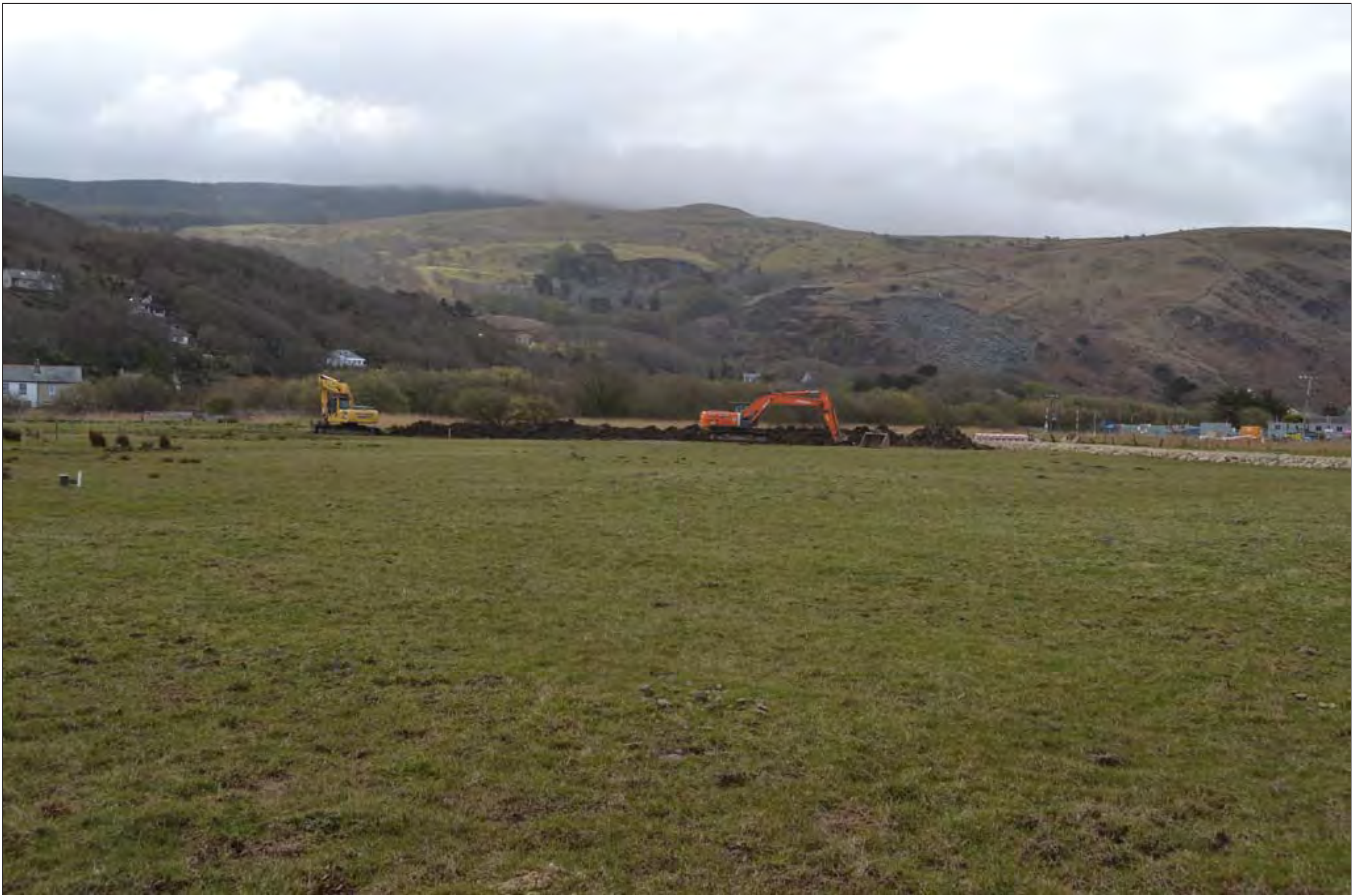
The remains of a former brickworks is noted on the 2nd edition 25 inch Ordnance Survey map of 1901 at NGR SH61781320, close to the areas of late 19th and early 20th century development in Fairbourne (Plates 7-10). Close to this area, but to the west of it, a borrow pit was excavated, covering an area of 8,000m². The main site of the brickworks, where the wooden and corrugated iron buildings were formerly located, and as shown on the 25 inch Ordnance Survey Maps, was avoided. During the stripping of this adjacent area a topsoil depth of up to 0.4m was noted, overlying rubble and brick at the east end, covering an area of about 24m by 40m, which was close to the location of the brickworks. This deposit was quite shallow (about 0.3m), and overlay a light yellowish brown clay about 0.25m thick which in turn overlay a blue grey waterlogged clay. Earlier geotechnical testing had indicated that at a depth of 0.6m a peat deposit would be encountered. These were not reached during the borrow pit excavation, which was restricted to the clay deposits above. These clay deposits overlying peat are consistent with natural estuarine deposits overlying earlier peat formation. The excavation work generally avoided the brickworks area, with clay excavated to the west of it (Plate 09). However a single course of brickwork, two bricks wide, running WNW-ESE was noted at SH61741315. The purpose of this is unclear, and it does not appear to have any foundations.

Plate 07: Excavation work on the borrow pit adjacent to the former brickworks site

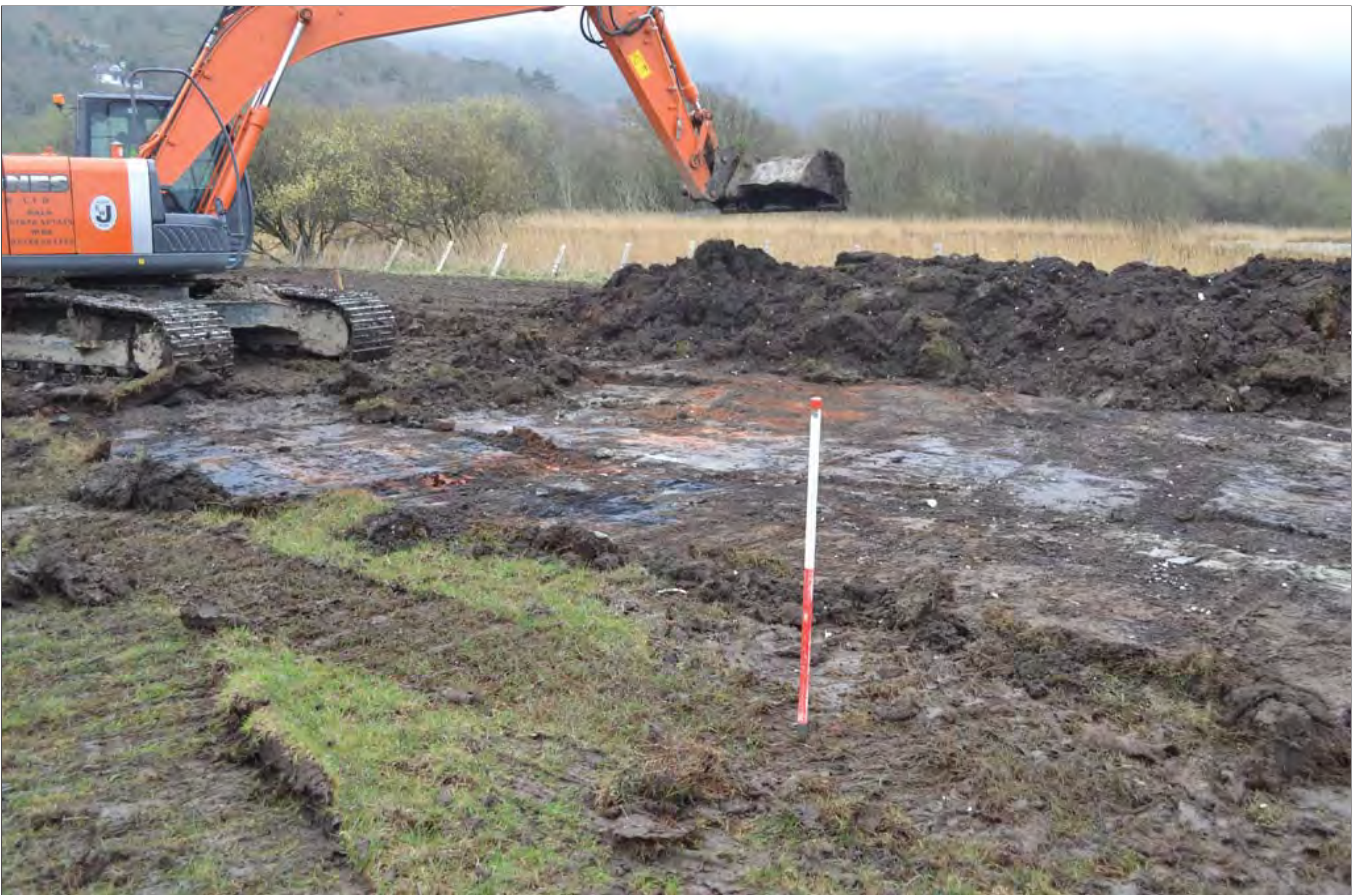
Plate 08: Evidence of brick rubble within the topsoil, presumably related to the works at the Fairbourne Brickworks. Scale 1m

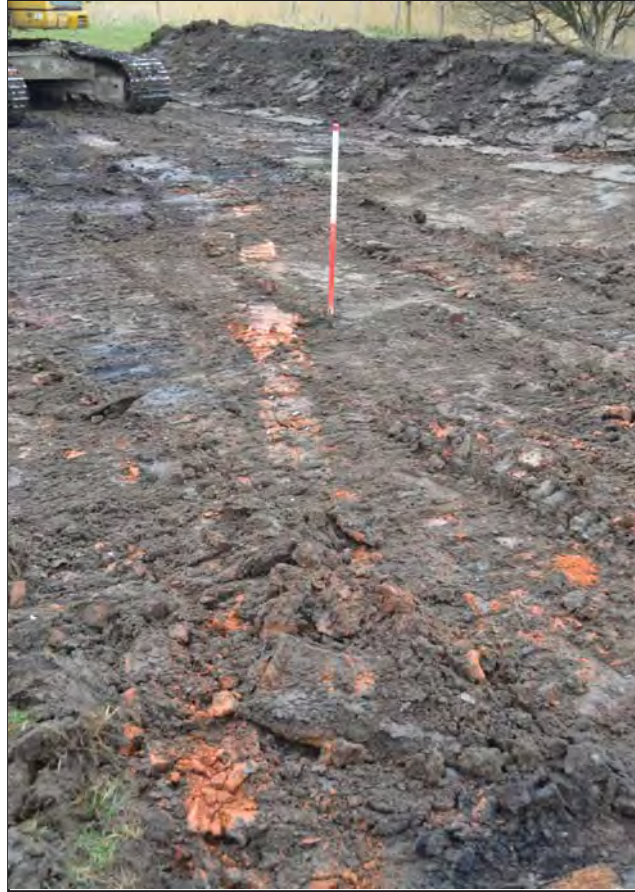
Plate 09: Excavation work on the borrow pit adjacent to the former brickworks site, showing double thickness of brickwork, which does not appear to be structural

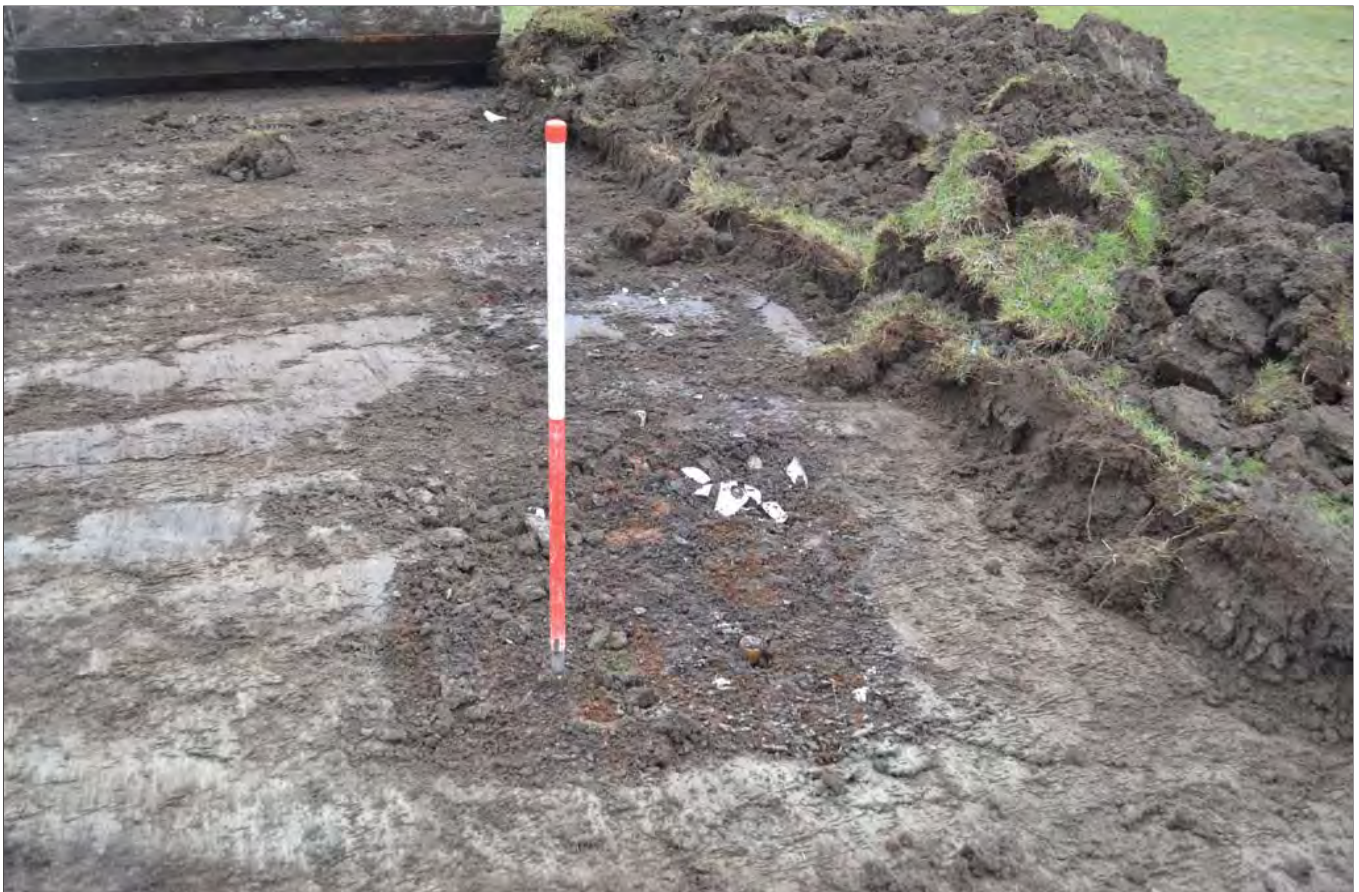
At the eastern end of the borrow pit excavation there was much late 19th century to early 20th century waste, consisting of glass, pottery and stoneware jars noted within the topsoil. This material although unstratified, is probably waste material from the time that the brickworks was in use (Plate 10).

Plate 10: Evidence of a rubbish pit at the former Fairbourne Brickworks site. Scale 1m

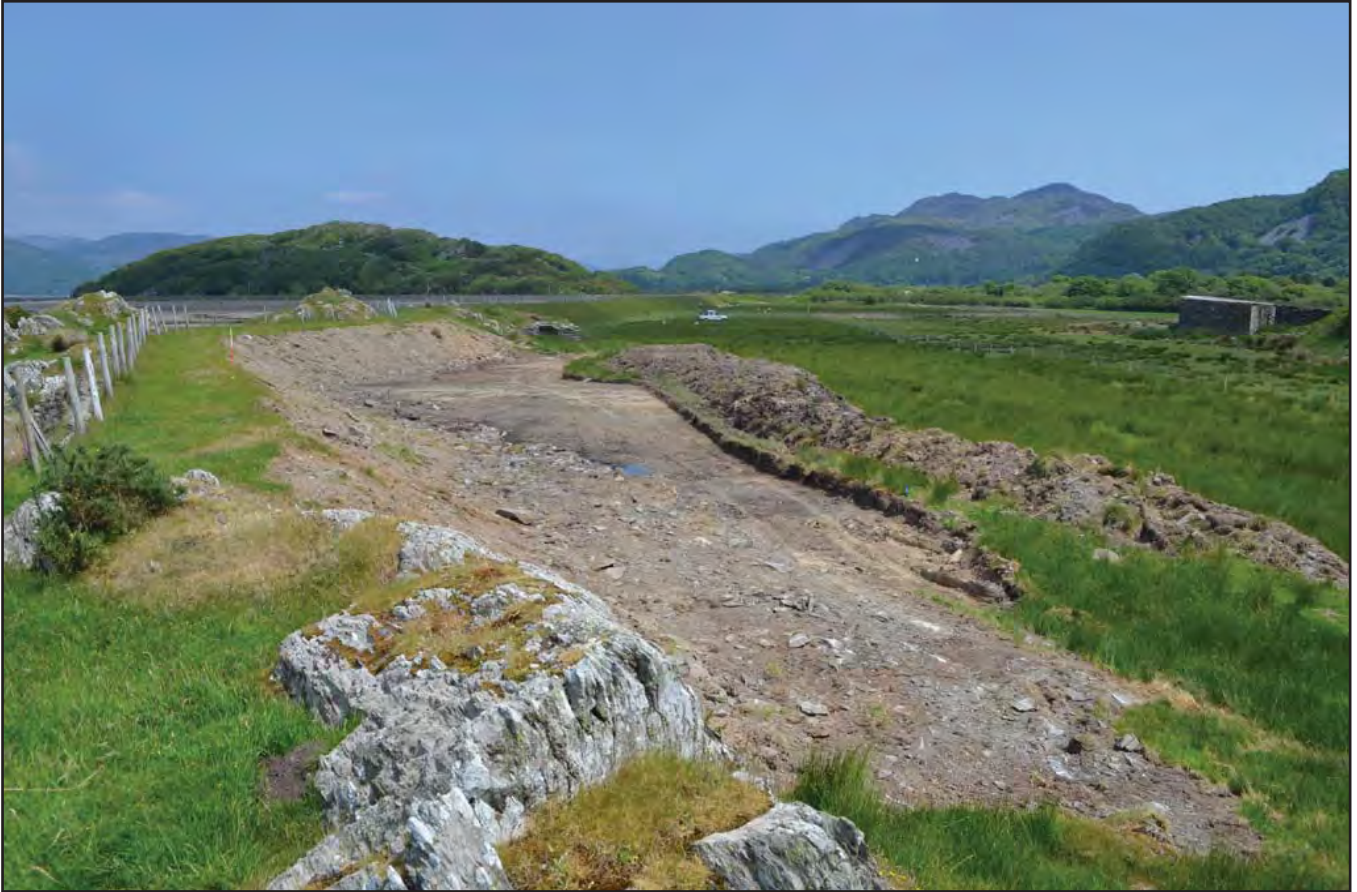
Plate 11: Topsoil strip adjacent to the embankment. View looking east

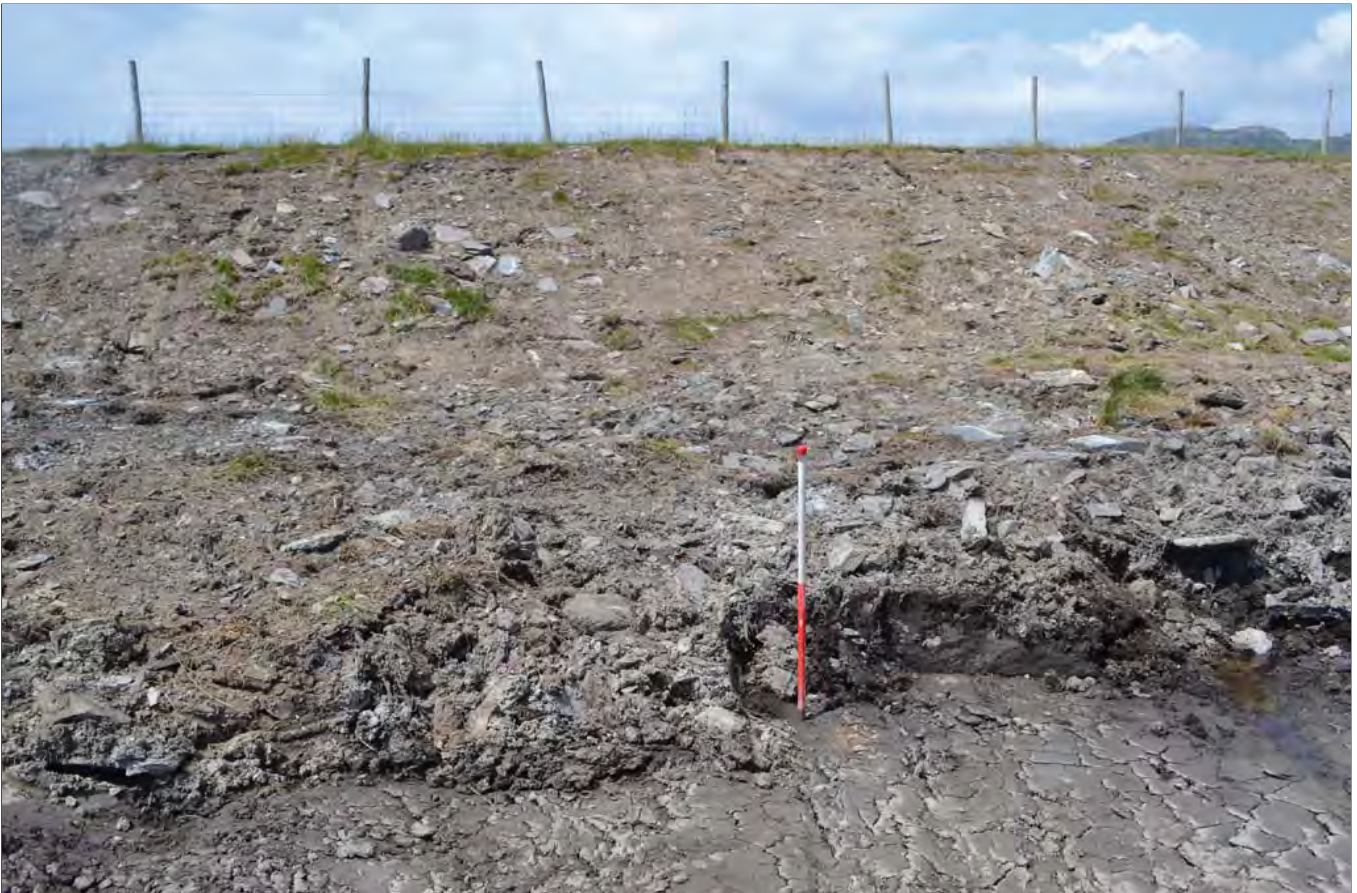
Plate 12: Fairbourne embankment, showing shale and clay make-up. View from the north. Scale 1m

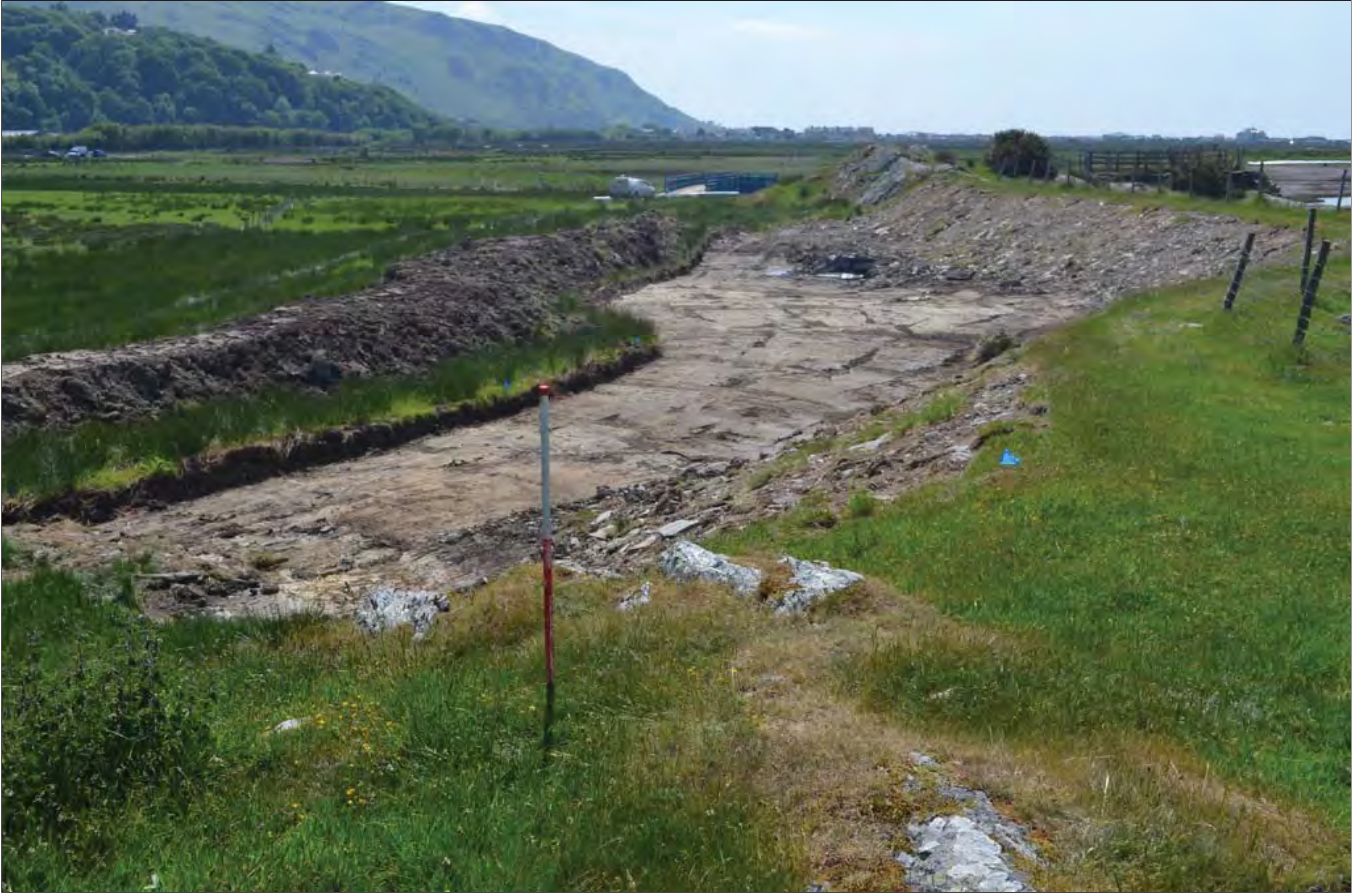
Plate 13: Topsoil strip of haul road east of the lime kiln. View looking west. Scale 1m

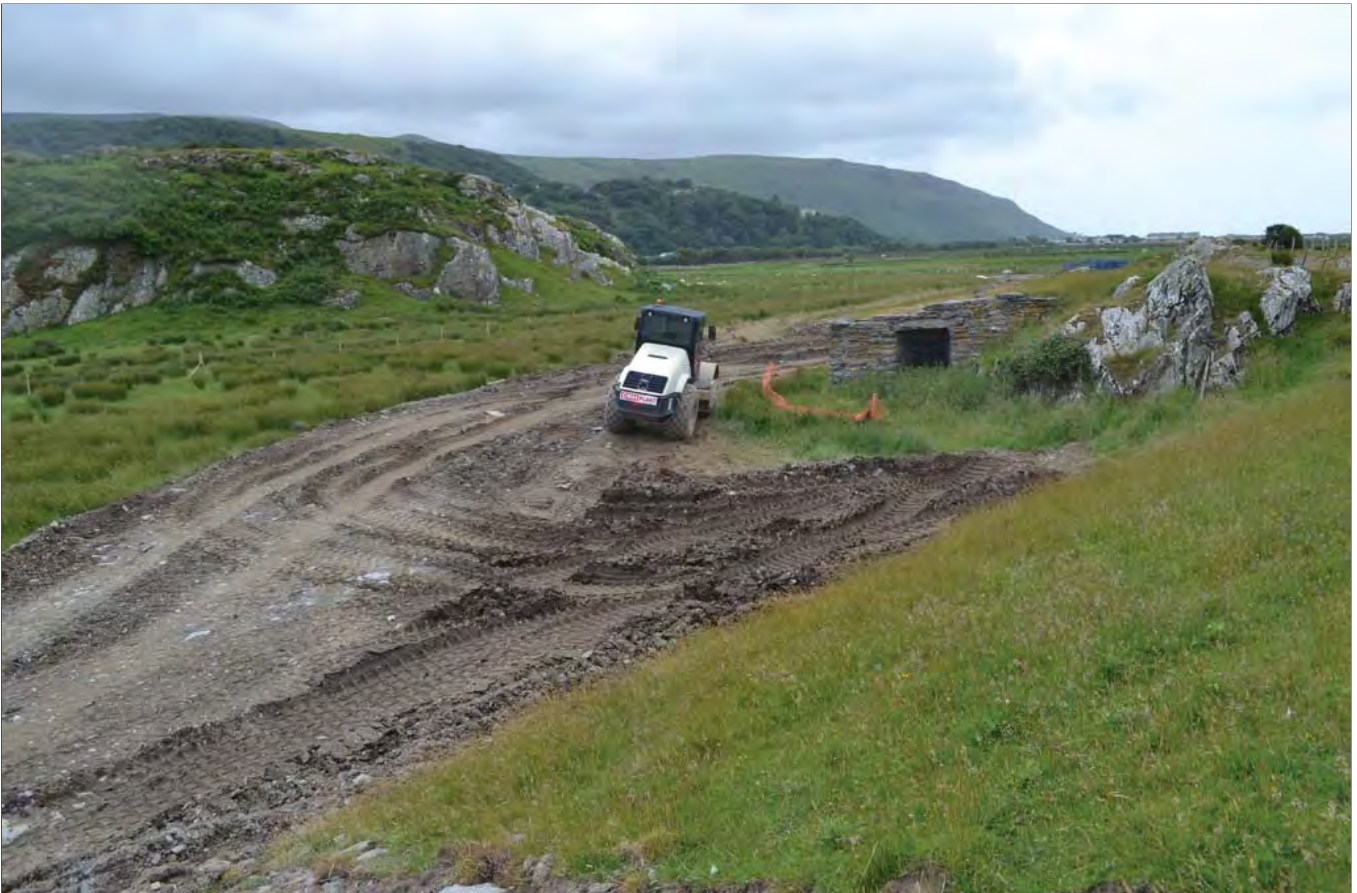
Plate 14: Use of the haul road adjacent to the lime kiln and Fairbourne Embankment. Scale 1m

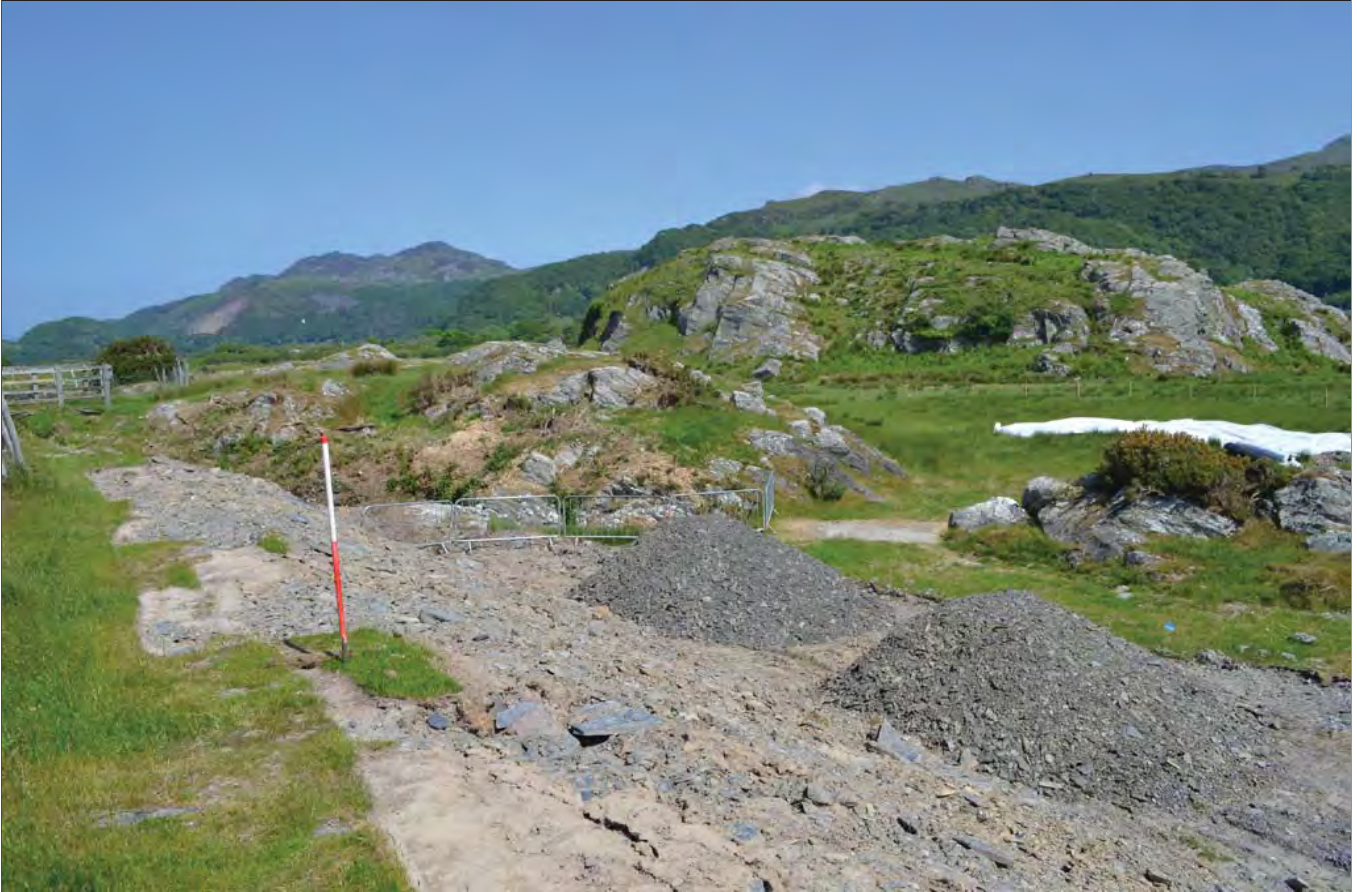
Plate 15: Stripped Topsoil showing clay and shale make-up of the embankment. View looking west. Scale 1m

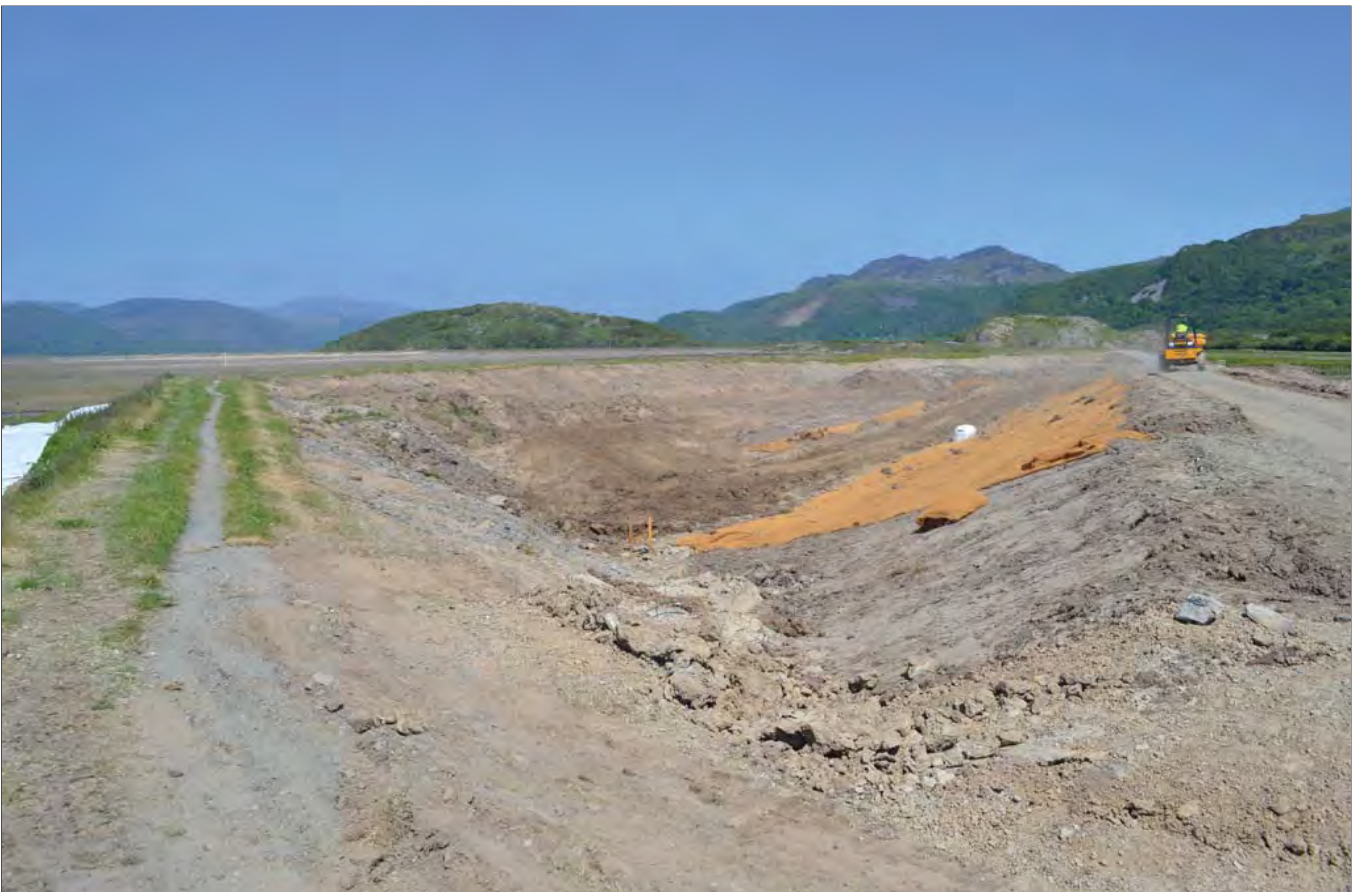
Plate 16: New section of Fairbourne Embankment removing the right-angled junction at the west end of the scheme.
