# Aber Castle Mound, Ty'n y Mwd: **Aber**

## Scoping Report

GAT Project No. 1814

Report No. 566

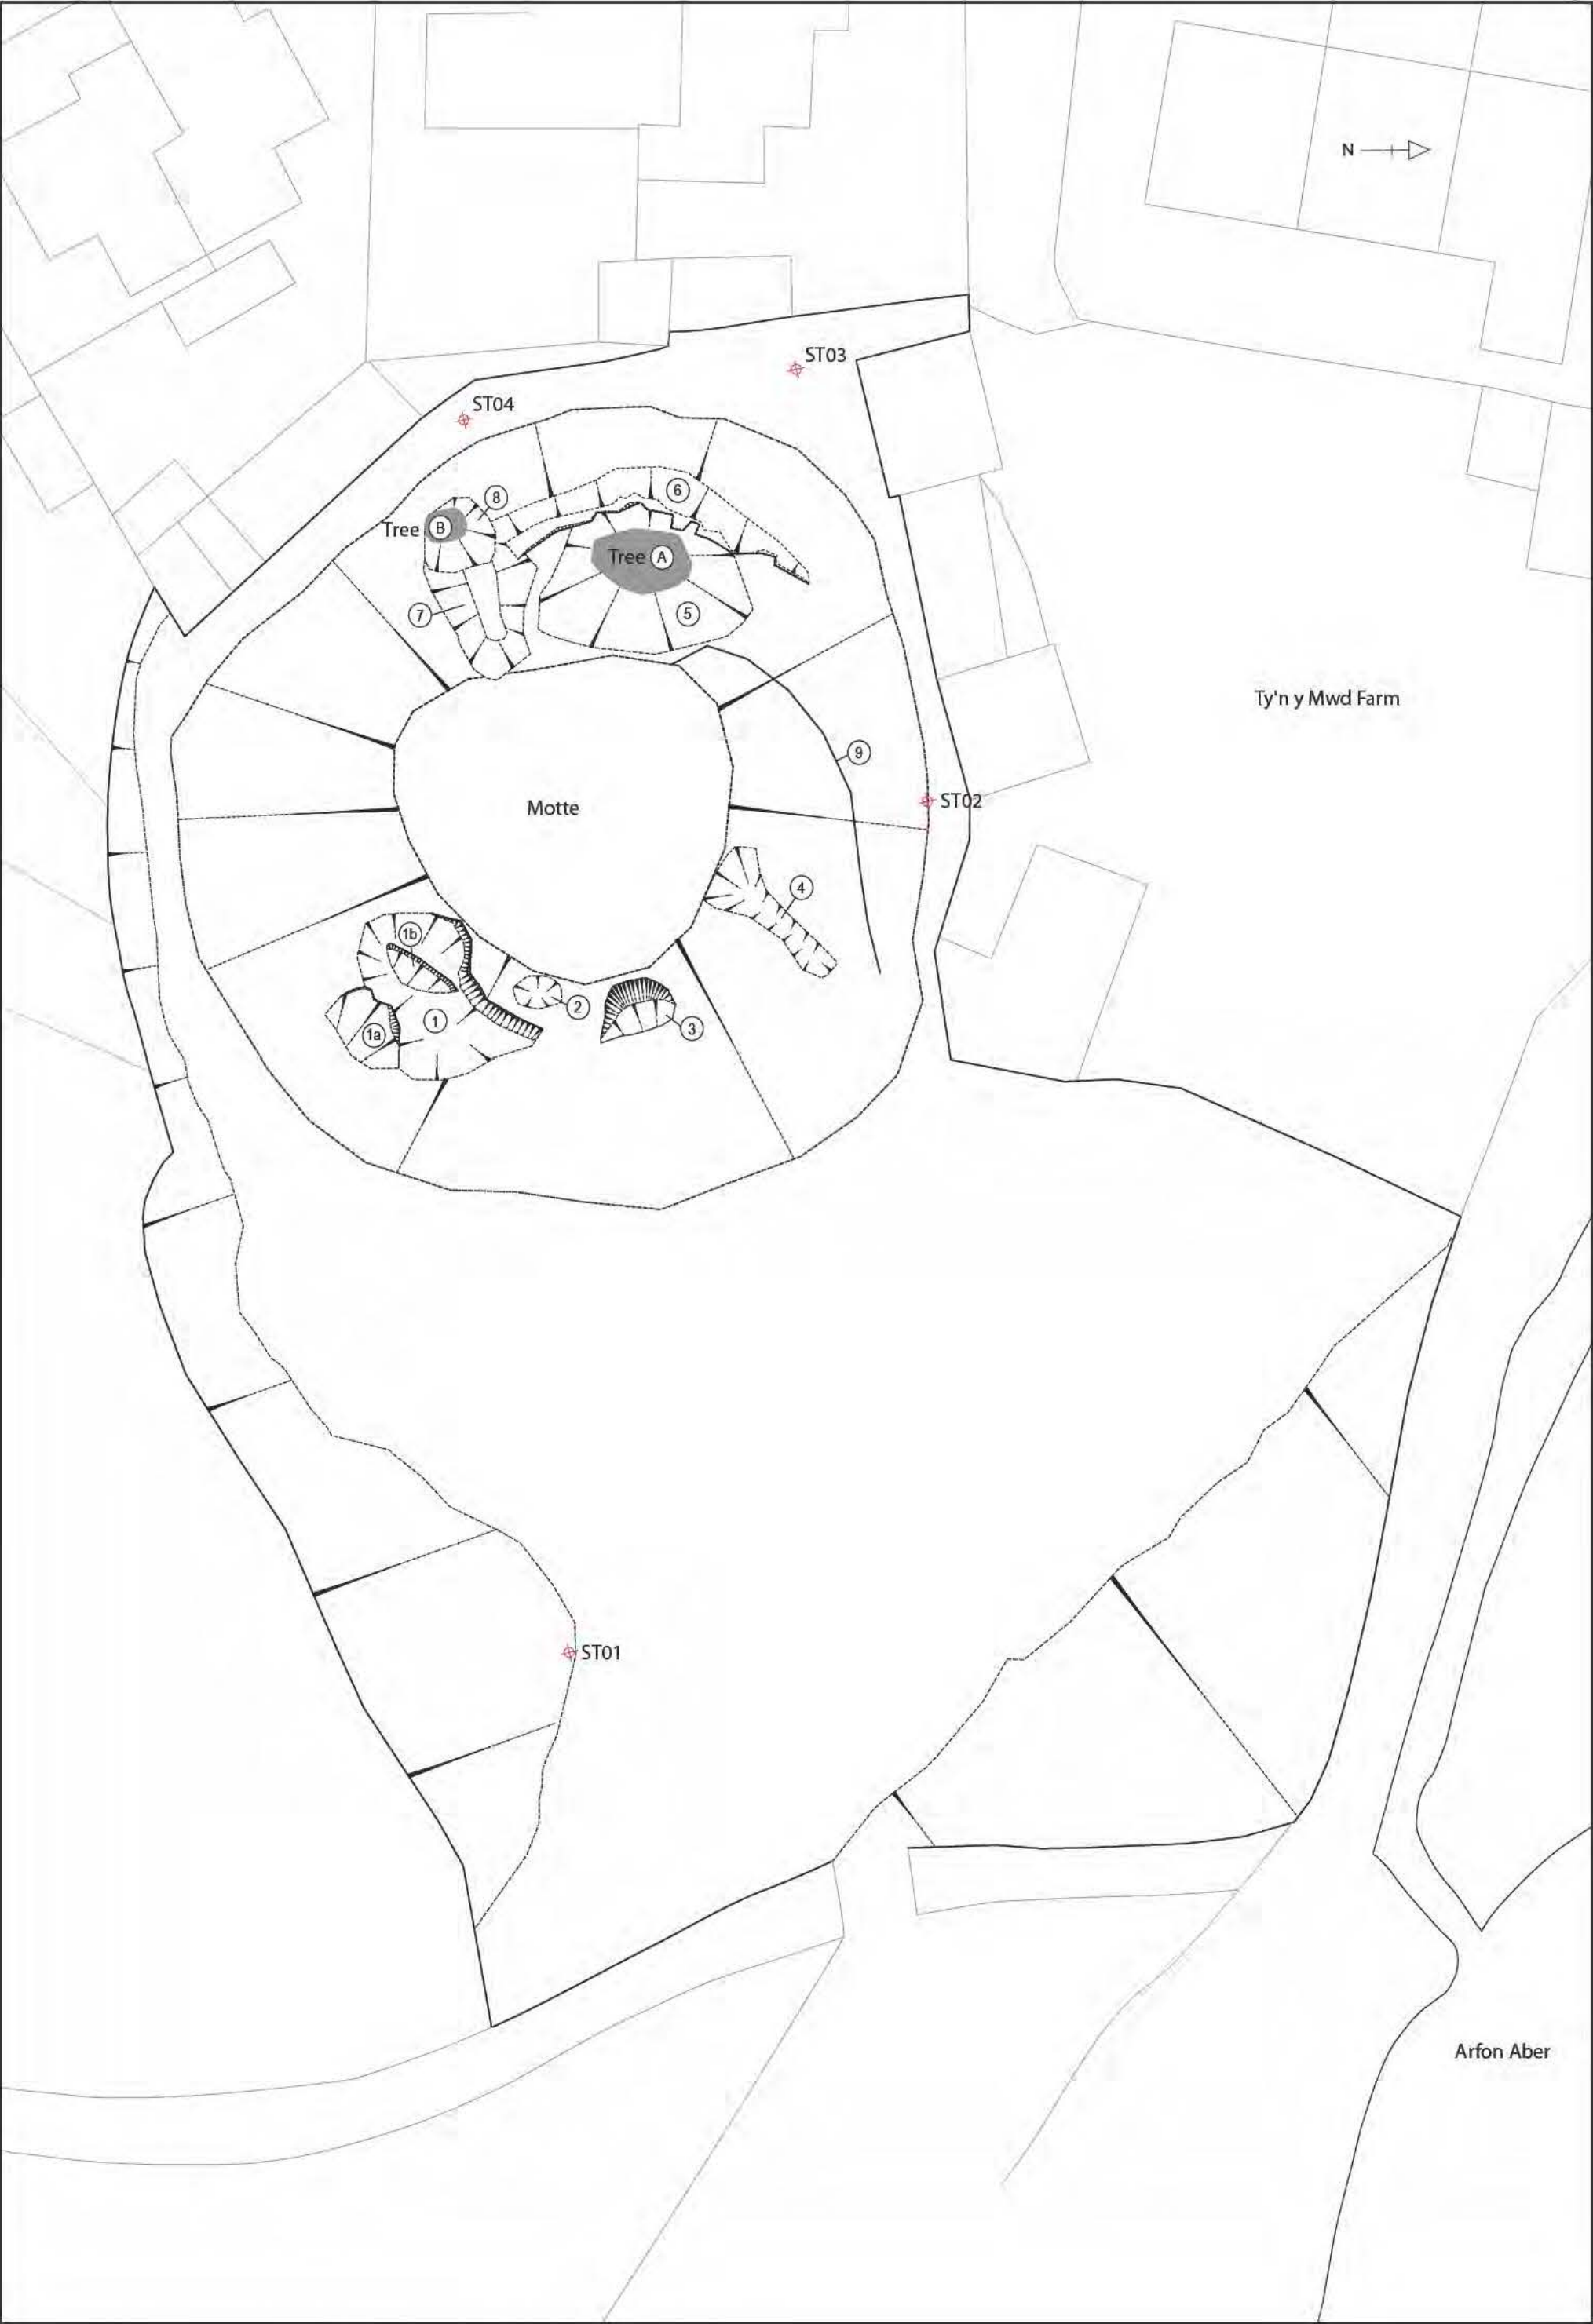
Figure 2. Survey of the motte at Ty'n y Mwd, Aber, including erosion scars. (Scale 1,300)

The scars occur in two specific locations, on the west side focussed around two oak trees (marked A and B on the plan), and on the south-east where a tree had formerly existed, but has been removed within recent years. Each of the scars is shown in figure 2, and dimensions given in the tables below. The area occupied by the trees has been calculated, so that should they need to be removed sufficient material can be brought in to compensate for the removal of the roots. A figure is calculated in table 3 for the amount of materials required.

**Table 1: Erosion scars**

| Scar number | Maximum width | Maximum length | Maximum depth | Area | Approximate volume |
| 1 | 8.22 m | 7.99 m | 0.17 m | 43.78 m <sup>2</sup> | 4.96 m <sup>3</sup><br>(5.89 m <sup>3</sup> with 1a and 1b) |
| 1a | 3.38 m | 2.34 m | 0.13 m | 8.04 m <sup>2</sup> | 0.69 m <sup>3</sup> |
| 1b | 3.68 m | 1.10 m | 0.12 m | 3.00 m <sup>2</sup> | 0.24 m <sup>3</sup> |
| 2 | 2.24 m | 1.47 m | 0.08 m | 2.52 m <sup>2</sup> | 1.68 m <sup>3</sup> |
| 3 | 3.58 m | 2.38 m | 0.22 m | 6.53 m <sup>2</sup> | 0.96 m <sup>3</sup> |
| 4 | 2.86 m | 6.64 m | 0.10 m | 10.78 m <sup>2</sup> | 0.72 m <sup>3</sup> |
| 5 | 9.49 m | 6.70 m | 0.25 m | 47.45 m <sup>2</sup> | 7.91 m <sup>3</sup> |
| 6 | 13.33 m | 1.94 m | 0.34 m | 19.87 m <sup>2</sup> | 4.50 m <sup>3</sup> |
| 7 | 4.16 m | 5.07 m | 0.12 m | 17.98 m <sup>2</sup> | 1.44 m <sup>3</sup> |
| 8 | 3.49 m | 3.24 m | 0.10 m | 8.14 m <sup>2</sup> | 0.54 m <sup>3</sup> |

**Scar 1.** has two further areas of erosion within the scar (**1a and 1b**). The scar is quite wide and deep and will require three lengths of oak boards to support the fill. Greenfix matting and Wreytex mesh should cover the filled scar. One piece of Wreytex mesh should cover scars **1** and **2**, although scar **2**, which is too shallow for oak boards, should have a separate piece of Greenfix matting.

**Scar 3** is quite deep and therefore will require one length of oak board to support the fill.

**Scar 4** is too shallow for oak boards but as it is on a steep slope the Greenfix matting will have to hold it in place.

**Scar 5** is caused by the roots of tree A which will have to be covered up to some extent, but the roots will take the place of oak boards in supporting the fill.

**Scar 6** is so steep that would not be practical.

**Scar 7** will require three lengths of oak board to support the fill as it is both deep and wide.

**Scar 8** will not require boards as it is very shallow and will contain the stump of tree B.

**Scars 5, 6, 7 and 8** should all have individual pieces of Greenfix matting but they could all be covered in a continuous area of Wreytex mesh.

The erosion caused by the trees would be best eliminated by cutting them down close to ground level, and repairing the ground around. It would then be necessary to monitor any re-growth of the tree stumps.

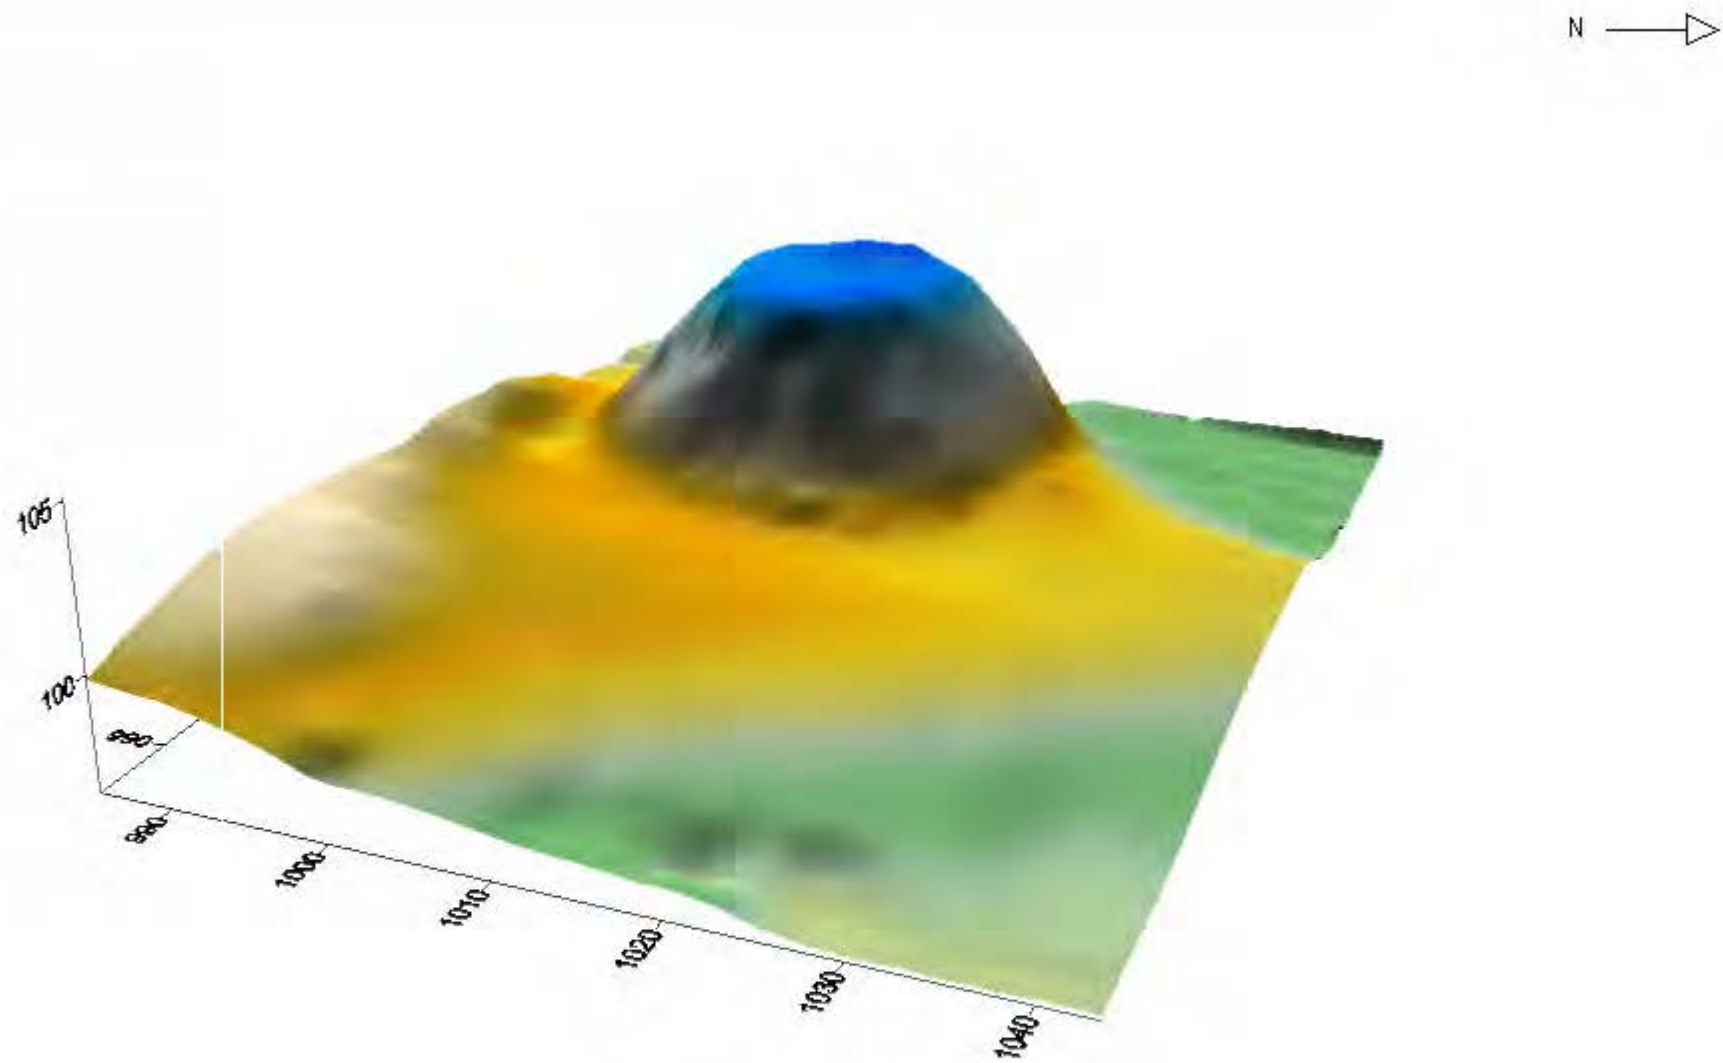
Figure 3. Model of the motte at Ty'n y Mwd, Aber.

The results were subsequently downloaded onto computer, and a combination of CAD and illustrative software used to process the results. Modelling software was used to produce both a contour survey, and a three-dimensional view (figure 3). Calculations were undertaken for each of the scars and the results of these are presented below.
