# GLAMORGAN-GWENT ARCHAEOLOGICAL TRUST CONTRACTS SECTION

ARCHAEOLOGICAL EXCAVATION
FAN LEAD MINES, LLANIDLOES
NOVEMBER 1993

GGAT REPORT NO.93/076

PROJECT NO.A151 EXCAVATION NO.236

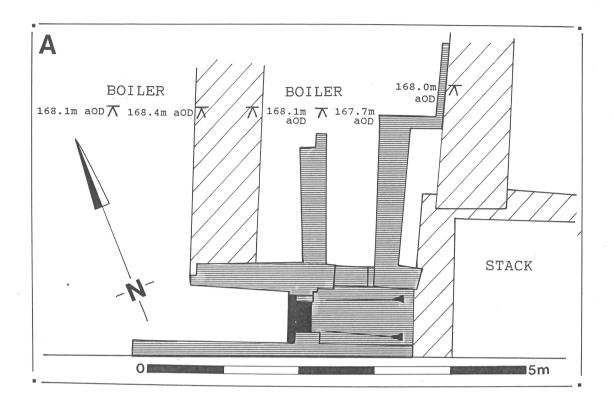
Figure 3: Detail of flue system showing later blocking

The flues and stack were located at the south end of this structure. Both flues (fig. 2,3) were made of yellow brick, and while the northern boiler flue had been infilled by red brick, the other had the remains of an iron flue door. Both these flues opened onto a single, upward-sloping yellow-brick ramp, that measured 1.3m x 0.8m, and that in turn led into the stack. The exterior of the stack itself measured 2.8m x 2.4m and was

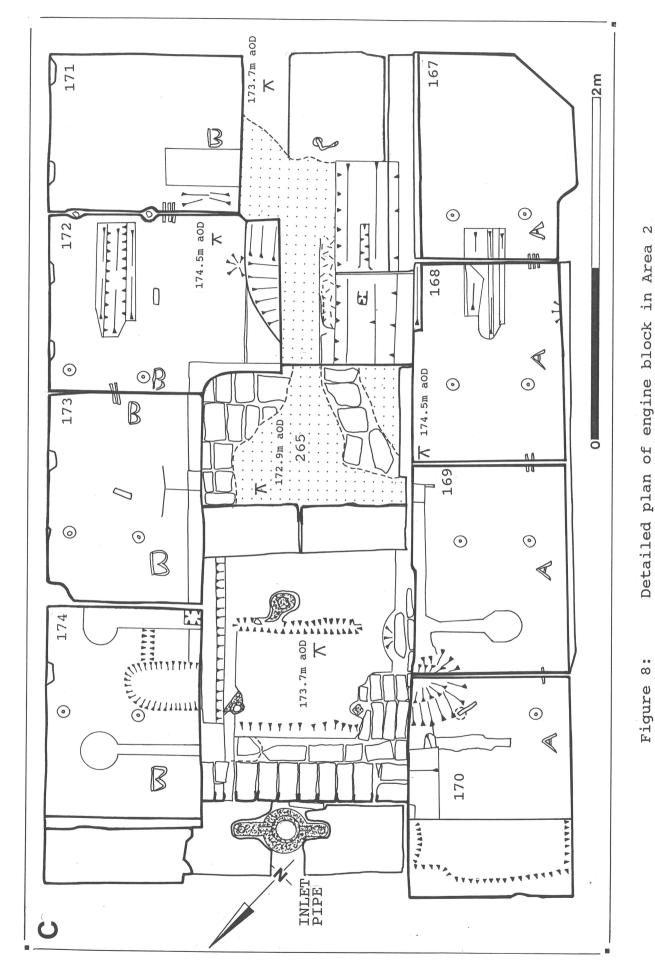
Detailed plan of engine block in Area

The most important feature found in this area was the Engine Block (fig.8, Plate 13), fully described by Bick (1991, 7 and 7a). It consisted of 21 large pieces of Millstone Grit that had been carefully shaped and fitted together. Cut into the blocks were recesses for cranks, holes for tie rods, and joist sockets for the floor; also visible was part of the base flange of the 30" cylinder, tie rods, and the main 6" inlet pipe.

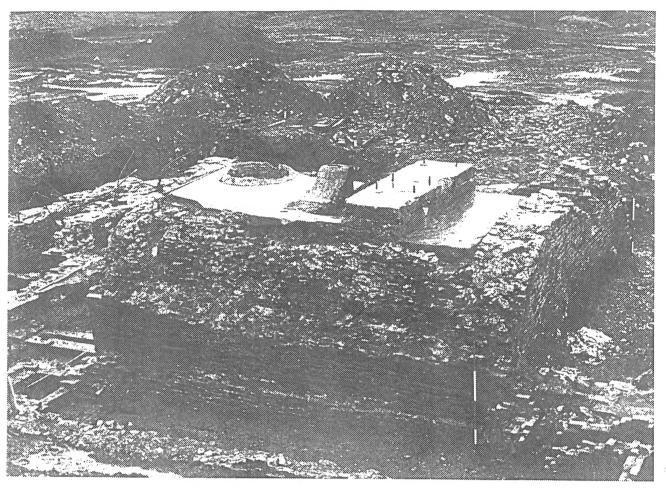
The Phase I construction of the engine house (fig 2, Plates 3 and 4) was a rectangular structure made of shale, bonded with lime mortar, and measured 8.6m x 8.2m. Built into this structure were three wells, 007,008,009 (fig 2,4,6), the central one (008) being the Hot Well. The west well (007) was 2.5m x 0.9m, and was excavated to a depth of 3.6m. The only features uncovered were two voids (013,014) in the east wall (Fig 5), that led into the central well (008); they were both 0.6m x 0.25m, and extended for a distance of 1m. Within each of these openings large wooden beams (045,046) 0.25m square had been inserted in the roof, apparently as a support, but the size of the beams was excessive for this purpose.

The uppermost feature, visible prior to excavation, consisted of a concrete base (Fig 3, Plates 3 and 4)  $6.4m \times 3.35m$  and 0.2m thick. On this platform were several concrete machine bases and tie rods; the use of red brick was noted. A further use of red brick was uncovered in the south wall of the structure, where a cross-shaped mounting  $2.5m \times 2m$  had been built (fig 4).

Plate 3: The number 30 engine house from the northwest. The boiler house is visible in the foreground, and building 29 can be seen to the left. (2m scale)

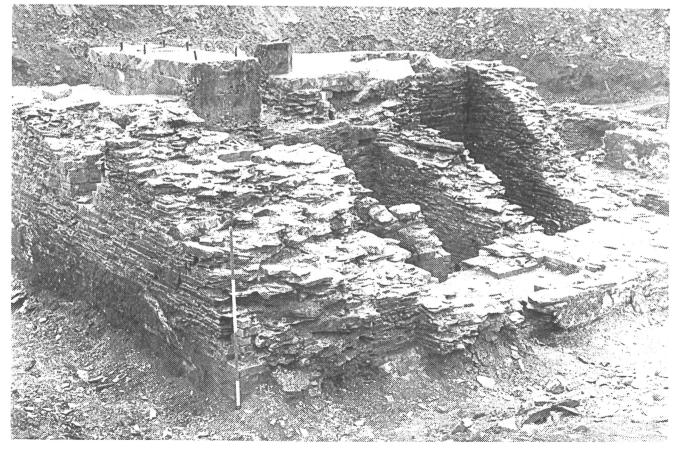
Plate 4: The number 30 engine house from the south (2m scale)

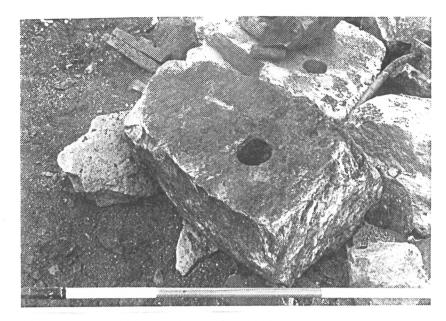
Plate 5:

The three diagnostic finds, both from building 30, included two portions of the broken engine block (Plate 5), and a wooden beam with an iron attachment (Plates 6,7), that was possibly a section of the bob beam.

Remains of the engine block from Area 1 (scale divisions 0.50m)

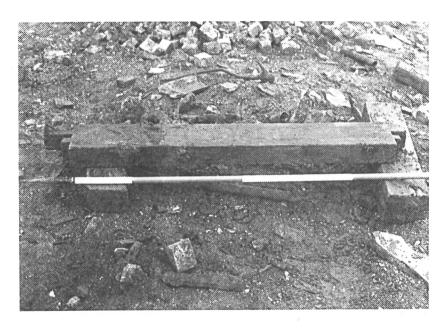
Plate 6:

Remains of the possible Bob beam (scale divisions 0.50m)

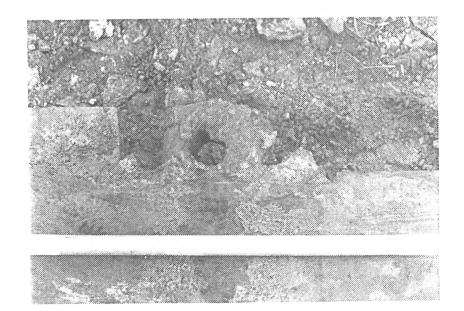
Plate 7:

Detail of iron fitting on Bob beam (scale division 0.50m)

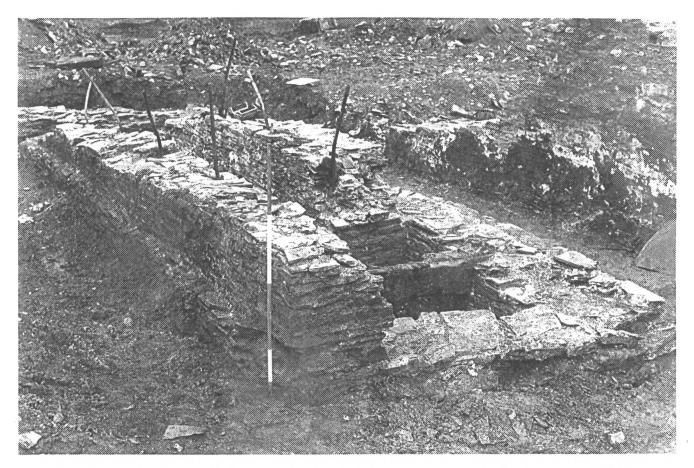
This structure (fig. 2,6, Plates 8 and 9), a possible angle-bob pit, appears to represent a single phase of construction. It was rectangular in shape, measuring 12m x 3.5m, and made predominantly of shale with a lime mortar. Along the top of the east wall (112), were four 0.04m diameter tie rods, 115,119,123, and 127, (Bick mentions five tie rods, 1991, 14). These were 1.20m apart, and were mirrored on the west wall (113) by 131,135,139 and 143. These rods appeared to have been cut off, leaving an average of 1.10m visible above the masonry.

At both ends of the structure, wells (147,154) had been constructed (figs.2,6, Plates 8,9,10 and 11); these were not fully excavated due to the presence of two timber cross-beams (Plates 8 and 10). In the north well (147), the upper beam (148) was aligned east/west, and was located within beam slots found in the east and west walls. The beam was secured at both ends by square iron plates (150), held in place by a nut and bolt (149), the bolt having been built into the walls. This beam was also visible in the exterior walls and was flush with them. The lower beam (151) was of similar dimensions, and on the same alignment, but was built within, and not through, the two side walls. This arrangement of wooden beams was also uncovered in the south well, and although the upper beam was missing, the tie rods 156 and 158 remained in situ.

Plate 8: Building number 29 from the north (2m scale)

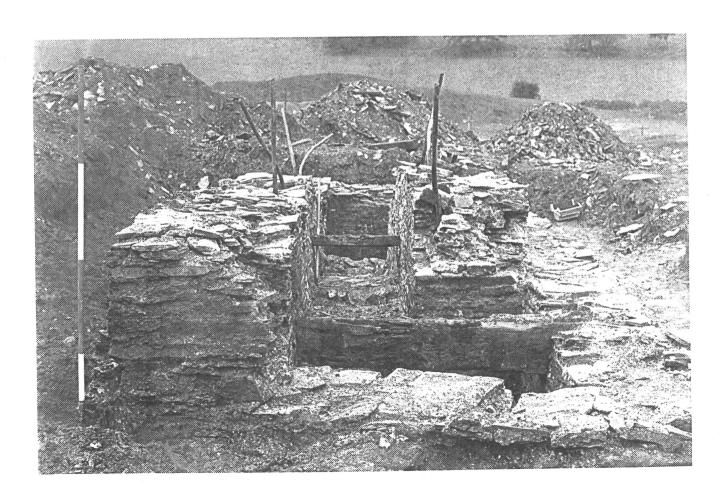
These wells were connected by two channels (fig. 6). The upper channel (Plate 9), 114, was aligned north/south, and was 6.5m in length by 1.9m wide. At the centre of this channel was a wooden beam 0.1m wide, that spanned the trench east/west, 0.35m above the base of he trench. The second channel, 152 (Fig. 6, Plate 11), underlay the first, was brick-lined (Plate 11) and measured 1.9m wide.

Plate 9: Building 29 from the northwest (2m scale)

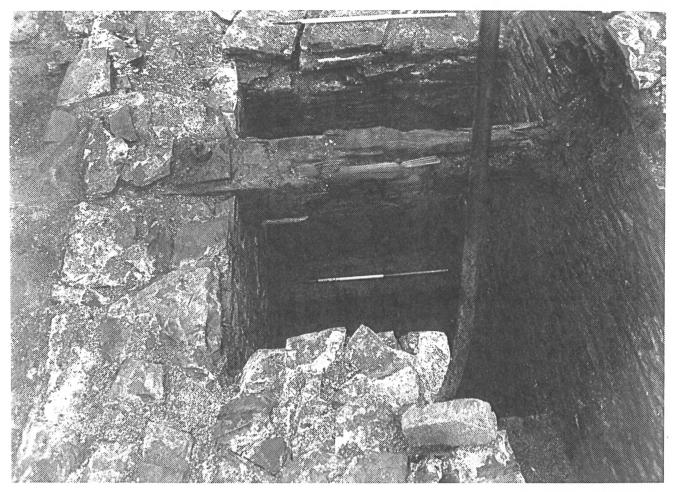
Plate 10: West well of building 29 from the southeast (1m scale)

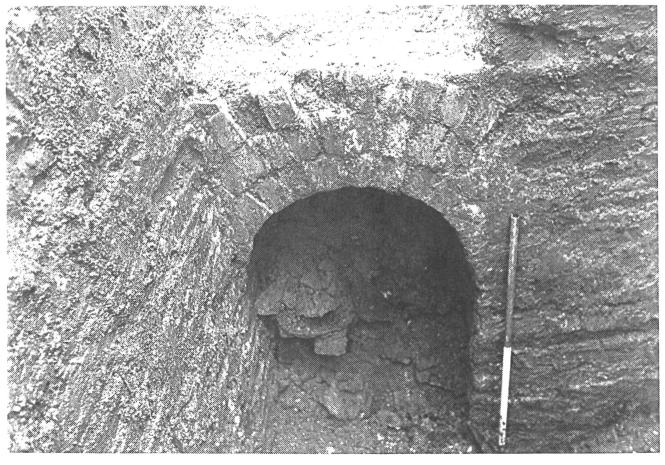
Plate 11: West end of the brick lined lower culvert (1m scale)

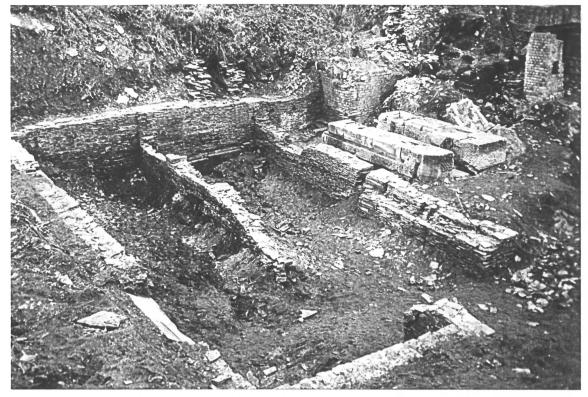
Immediately to the southwest of the engine house was the boiler house (Fig 7, Plate 12). This was a rectangular building 13.8m x 3.8m that was excavated to a depth of 2.3m. It was bonded to the engine house and made of shale with lime mortar. The wall at the southeast end of the building had been demolished and there were two doorways, each 2.5m wide, one leading into the engine house, and the second leading into the coal bunker.

Adjoining the boiler house was the coal bunker (Plate 12). It was the same size as the boiler house, and had a coal chute, made of a single stone slab 1.95m in length, located in the southwest wall. No brick lining was identified in this room, and no flue opening was uncovered, where one might be expected, if this had been used as a boiler house.

Plate 12: General shot of Area 2 from the south, with the engine block to the right

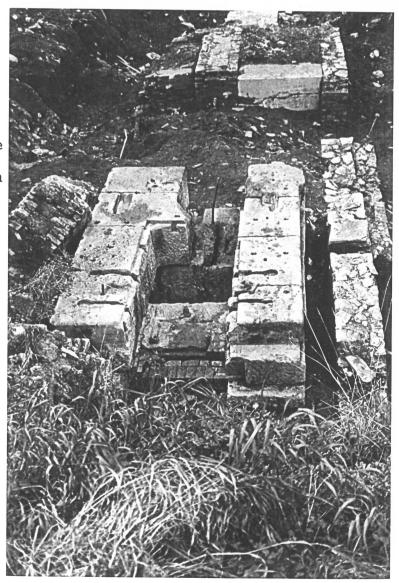
## Plate 13:

General shot of the engine block from the northwest, with the possible clutch base at the rear.

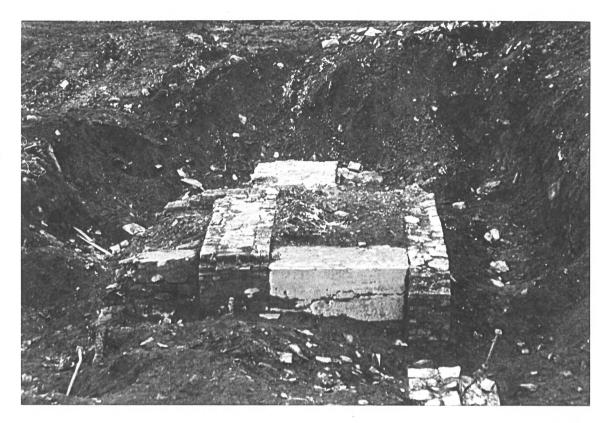
Plate 14: View of the possible clutch base from the northwest

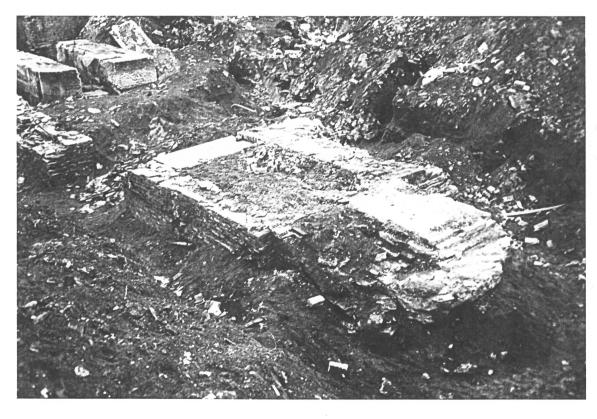
Plate 15: View of the possible clutch base from the south

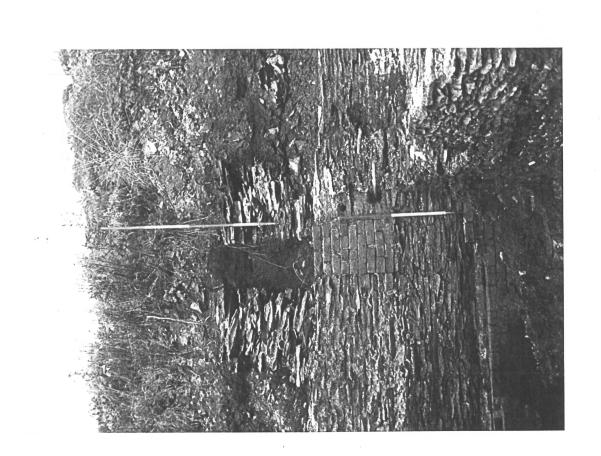
Plate 16:

Engine House number 9 was altered at some stage, either to provide extra drive for the Halvans Mill, or perhaps to replace power lost due to a damaged boiler, as indicated by the bricking up of the second flue of the number 30 boiler house. The power could have been transferred by a second clutch mechanism alongside the first (which would explain the size of the machine base), the power being transferred to the mill through flat rods. Plate 1 shows the position of the Dolly-wheel stands (the flat rods are only just visible), but what is clear is that the flat rods emanated from between the engine house and the boiler house. This suggests a later addition, as it means that the flat rods were squeezed up against the boiler. It also suggests, that the feature to the northwest of the boiler house (Fig. 1,7; Plate 16,17) is a flywheel pit.

View of the flywheel pit located on the northwest wall of the boiler house in Area 2 (1m and 2m scale)

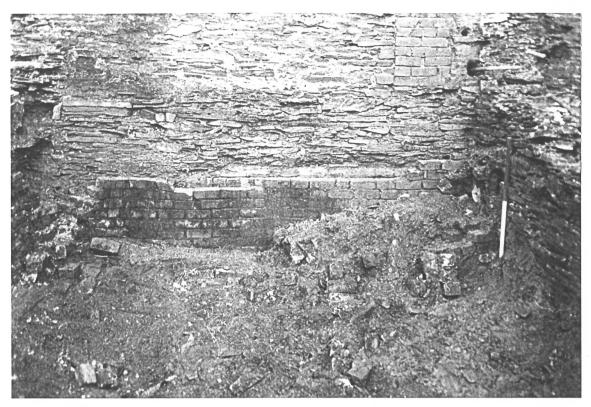
At the northwest end of the boiler house several features were identified. The back wall was brick-lined (Plate 18), and in the southwest corner the brick lining curved rather than following the 90 degree corner of the shale wall. In the opposite corner, a hole pierced the wall between the boiler house and the engine house, and this was lined with a heavily corroded metal door and frame. Its location suggests that this was the southwest end of

Plate 18: View of brick lining on the northwest wall of the boiler house in Area 2 (1m scale)

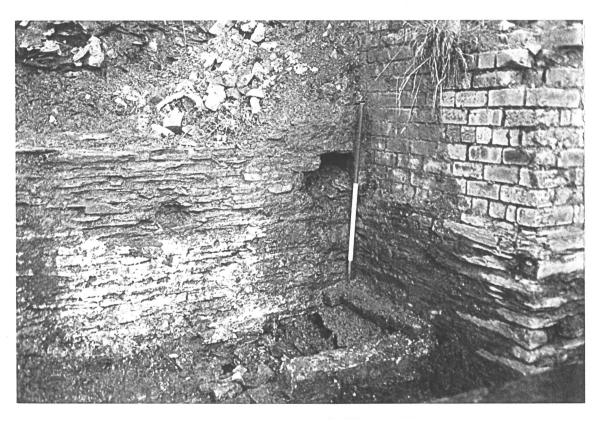
At the northwest end of the boiler house was a stack (fig. 7, Plate 19) that measured 2.3m  $\times$  2.25m, by 2m in elevation. Leading into this was a flue, measuring 2.2m  $\times$  0.55m, made of brick, that abutted and followed the line of the northwest wall of the engine house. The depth of the flue was not obtained as it was not excavated.

Plate 19: View of the stack (to the right) and the flue (lower centre) in Area 2 (1m scale)
