Penywyrlod Long Cairn Talgarth, Powys

SURVEY & RECOMMENDATIONS

W J Britnell January 1992

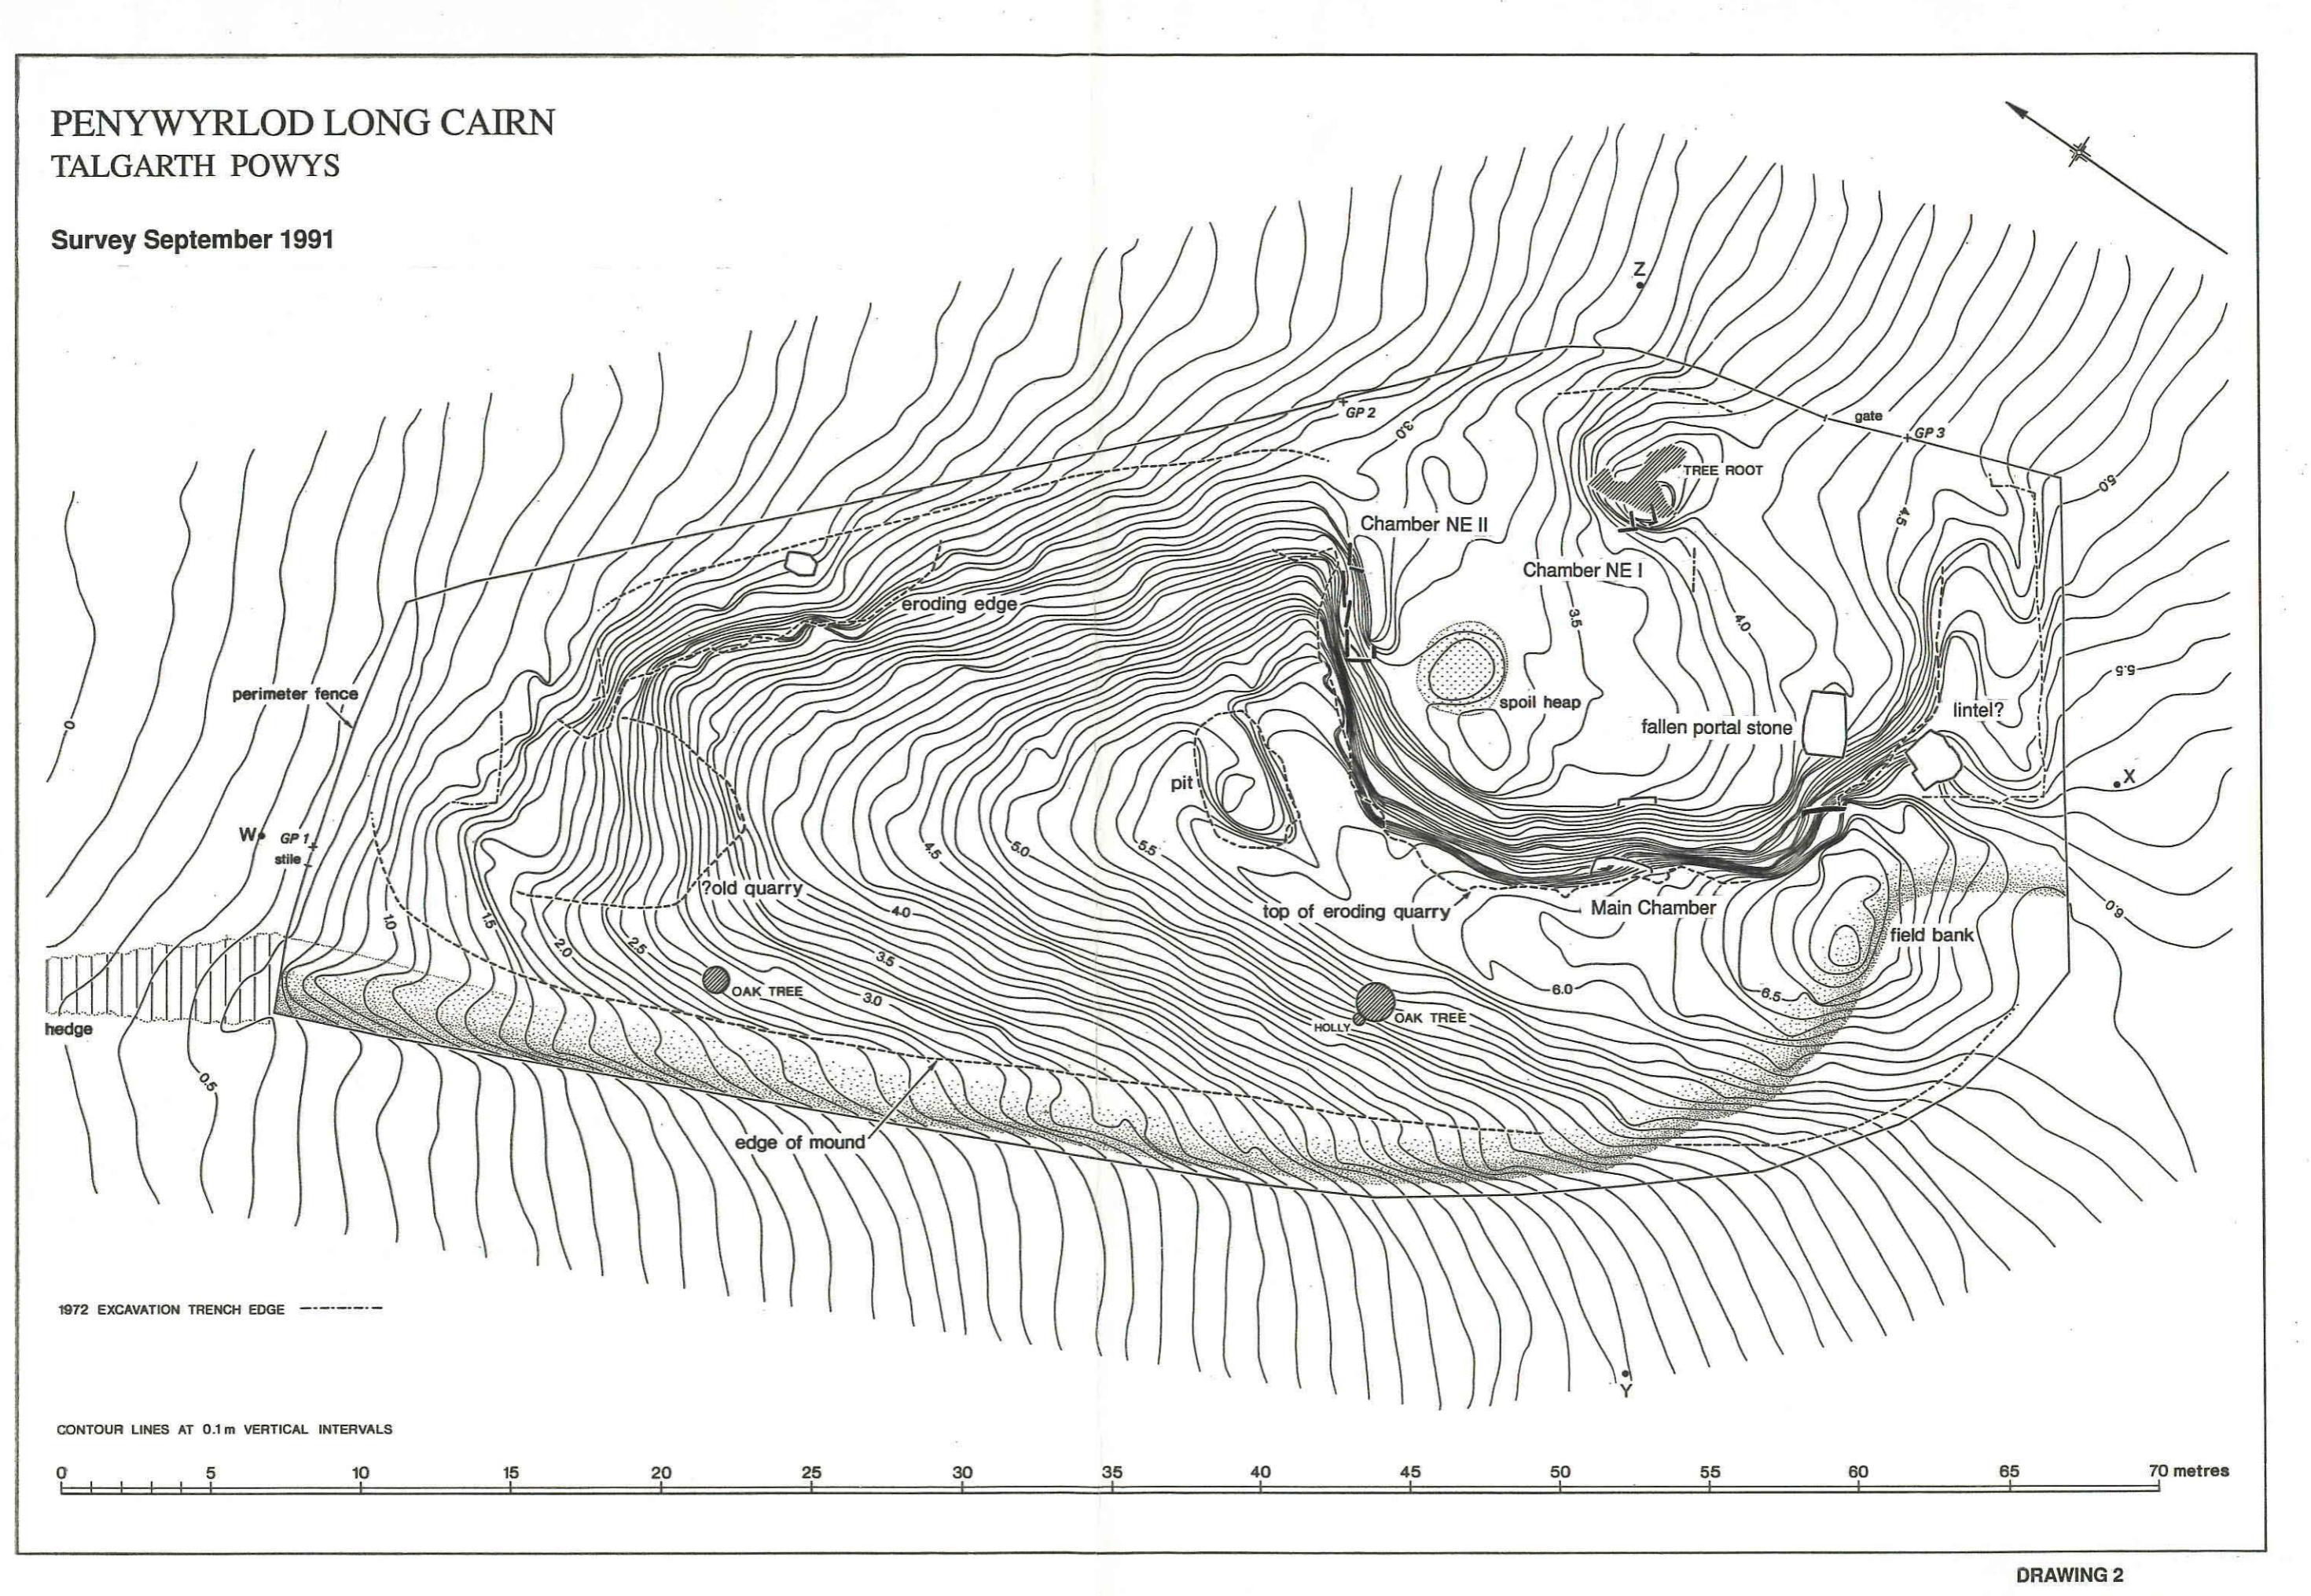
Many of the features noted in Savory's published report remain visible, including the Main Chamber, Chamber NE I, NE II, and the portal. Chamber NE III, and the stretches of the inner and outer revetment walls identified at both the narrow and broader ends of the cairn and along the NE side are, however, no longer visible.

A moderately large stone slab (c 0.7×1.0 m across) is visible on the ground surface in the vicinity of the chamber entrance (see Drawing 2; Slide SL22/Colour Print CF1.22). The slab does not appear to be noted in the excavation report (although it may be the slab visible to the left of the figure in Savory 1984, pl 10a). Its origin is obscure.

The former hedge-line crossing the SW side of the cairn is still visible as a low bank (see Drawing 2). At the NW end of the site the inner and outer edges of the bank up to c 2m wide and 0.2-0.3m high are clearly distinguishable, but further to the SE only the S edge of the bank is visible as an earthwork.

The main areas of recent quarrying and other disturbance to the cairn have been as follows (see also Savory 1984, 15-16): the main quarry c 13 x 15m across towards the SE end; the removal of part of upper part of the tail of the cairn at the NW; slight cutting back of the upper edges of the cairn to either side of the entrance to Chamber NE III; slight scarping to the NW of Chamber NE II (see edges shown on Drawing 2). The NW horn of the cairn has been less severely quarried than the area of the cairn in the main quarry, represented by a step between the floor of the main quarry area and the horn to the NW of the fallen portal stone. As noted by Savory (1984, 16) most of the rest of the cairn appears to have escaped disturbance, apart from a small pit c 3 x 5m across and 0.6m deep on the main axis of the cairn to the W of Chamber NE II, and a possibly less recent quarry near the NW tail of the cairn (see '?old quarry' marked on Drawing 2).

Parts of the edges of some of the trenches excavated in 1972 are still visible, including two corners of the area excavated near the tail of the cairn (in an area obscured by bracken to the NW of Chamber NE III), a short length to the S of Chamber NE I, and more extensive stretches on the NE, SE and SW sides of the area excavated on the northern horn (see Drawing 2). An old spoil heap c 3m across and 0.3m high is still visible on the floor of the main quarry between the Main Chamber and Chamber NE II (see Drawing 2).
