Machynlleth CSO Phase 2 ARCHAEOLOGICAL WATCHING BRIEF

CPAT Report No 744

N W Jones October 2005

Report for GallifordTry Construction Ltd (North)

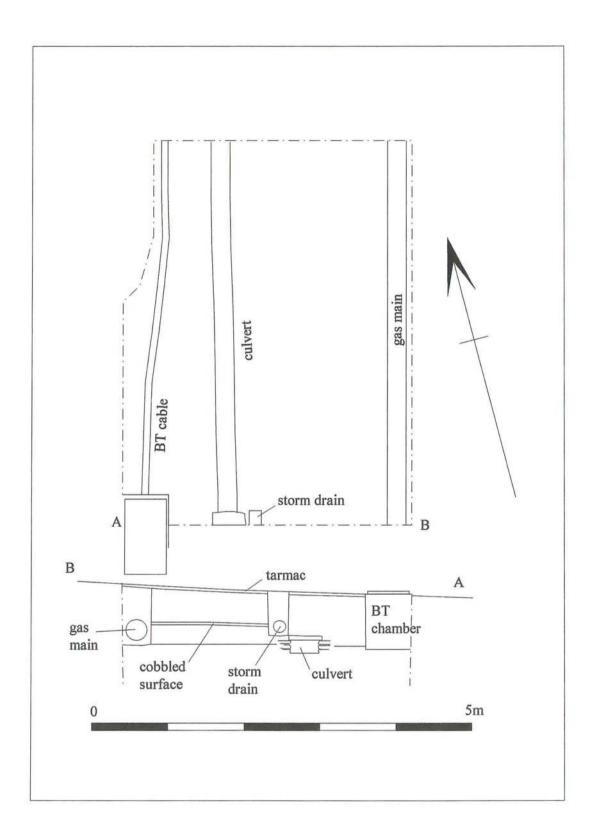
Fig. 2 Trench plan and section

- 2.3 Observation of the southern section (Fig. 2) revealed what appeared to be a fairly homogeneous layer of compacted small stone below the tarmac which sealed a layer of cobbles at a depth of around 0.4m, evidently a former road surface. This suggests that the present road and pavement level had been raised significantly, possibly in a single event. The cobbles lay above one or more layers of small stone, possibly also previous road surfaces, lying on top of the natural river gravel, the surface of which was about 0.65m below the present pavement. At the north-west corner of the trench the surface of the natural gravels was at a depth of 0.95m below the pavement, with the northern section displaying a similar stratigraphic sequence, although with a greater thickness of levelling material beneath the modern road and pavement surfaces.

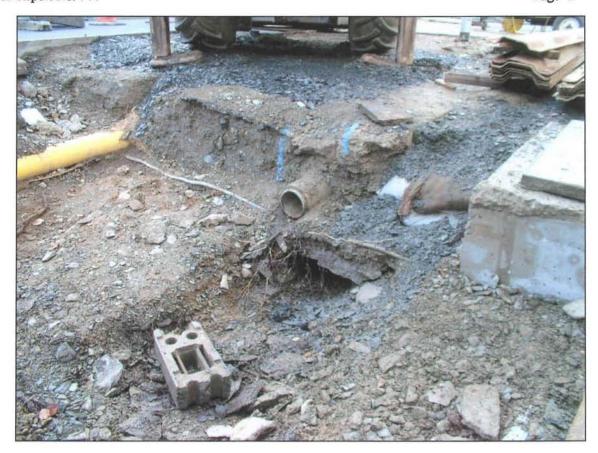
- 2.4 The only feature of archaeological interest was a stone culvert in the western side of the trench, running from south to north, and cut into the natural river gravel. The culvert had flattened river stones in the base with dry-stone walling on either side and was capped by flagstones, forming an enclosed channel 0.3m wide and 0.25m deep. The top of the capstone was 0.55m below the pavement, although it was not possible to determine the level from which the feature had been excavated.

Plate 1 Stone-built culvert visible on the southern section of the trench.

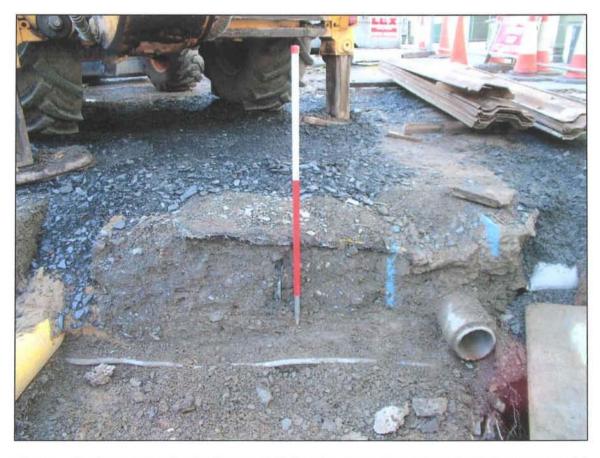
Plate 2 Southern section showing former cobbled road surface (at base of scale) with levelling material above.
