MILITARY AIRCRAFT CRASH SITES IN NORTH-WEST WALES

Volume I - Project Report

Project No. G2180b

Report No. 1038

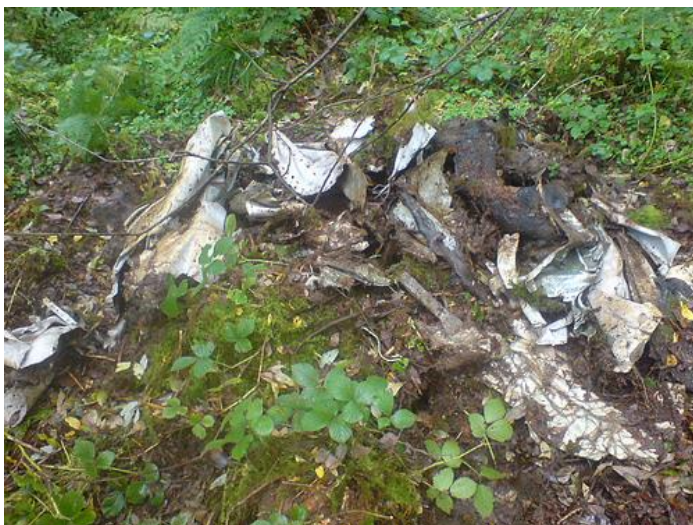
Figure 1 The remains of North American P51D Mustang 44-72340 lie within forestry and require positive management in association with the Forestry Commission Wales. Image copyright Matthew Rowe, source: <http://www.flickr.com/photos/28731066@N03/5059627490/sizes/m/in/photostream/>

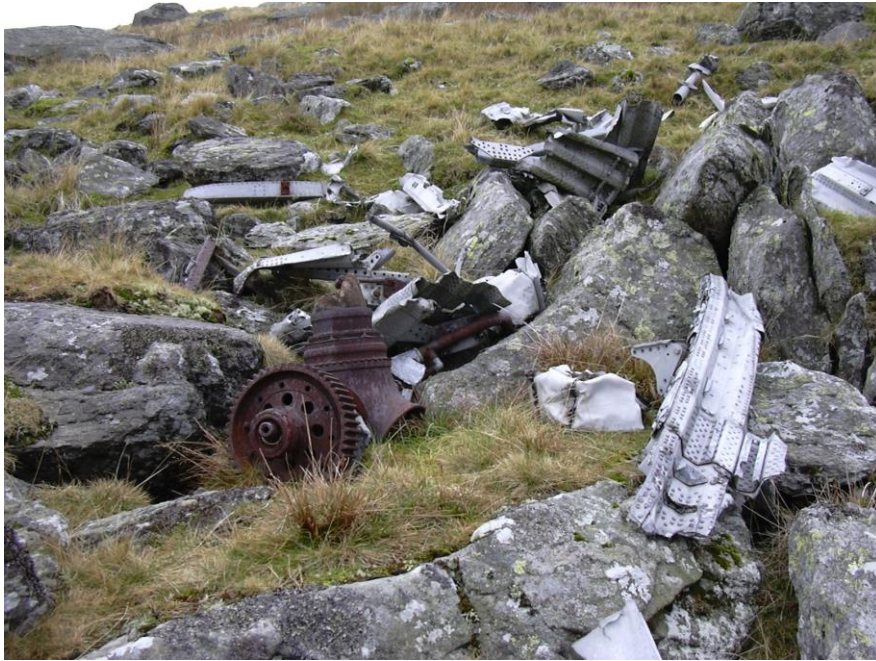
Figure 2 Armstrong Whitworth Whitley BD232, photographed prior to a 2005 licensed recovery. Now only small fragments remain of the aircraft. Image copyright Rob Lockhart

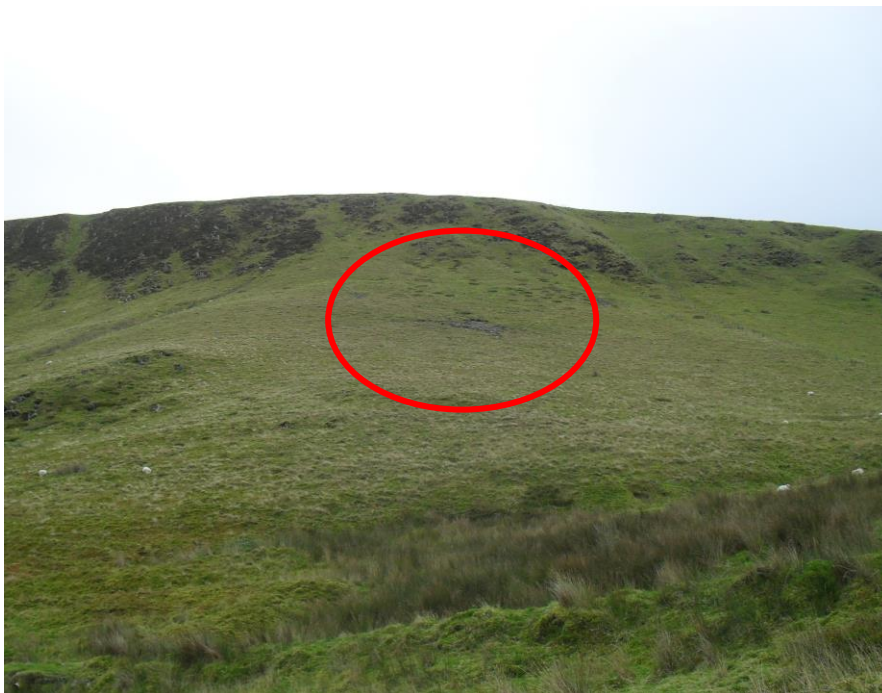
Figure 3 The burn site of Boeing B-17G Flying Fortress 44-8639 is clearly visible from the road below. Image copyright Matthew Rimmer

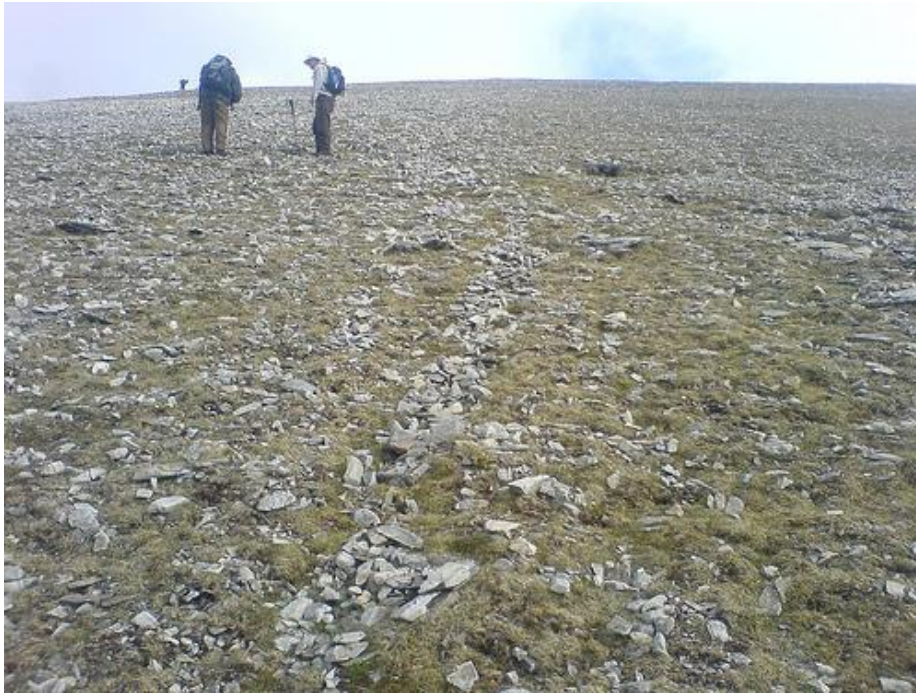
Figure 4 Parallel marks in the scree show how Martin B-26G Marauder 44-68072 slid along the ground on impact. Image copyright Seán Moran, source:

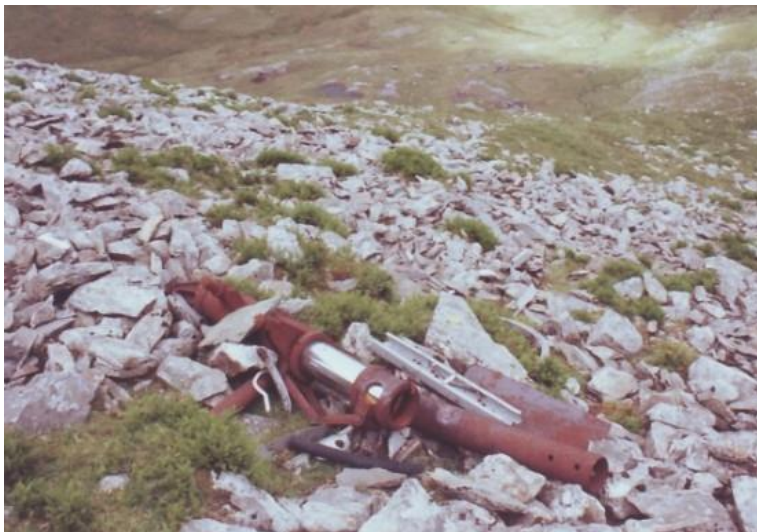
Figure 5 Other components of the Marauder such as undercarriage sections are scattered down the adjacent valley and demonstrate the potential for widely dispersed crash site evidence in upland landscapes. Image copyright Mark Sheldon, source: <http://www.peakdistrictaircrashes.co.uk/pages/wales/wales44-68072.htm>

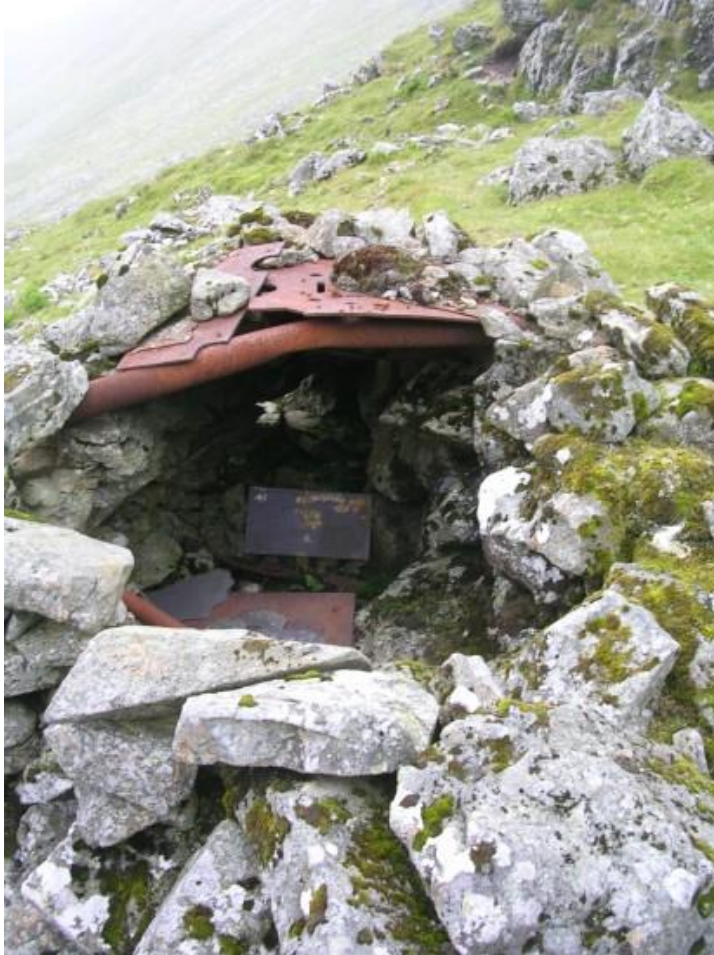
Figure 6 A shelter constructed from components of Avro Lincoln RF511, containing some earlier memorials to the crew. The wreckage should not have been tampered with but it shows that human intervention does render crash sites a victim of their own inherent interest and potentially makes them more complex entities. Image copyright Alan Clark, source: <http://www.peakdistrictaircrashes.co.uk/pages/wales/walesrf511.htm>

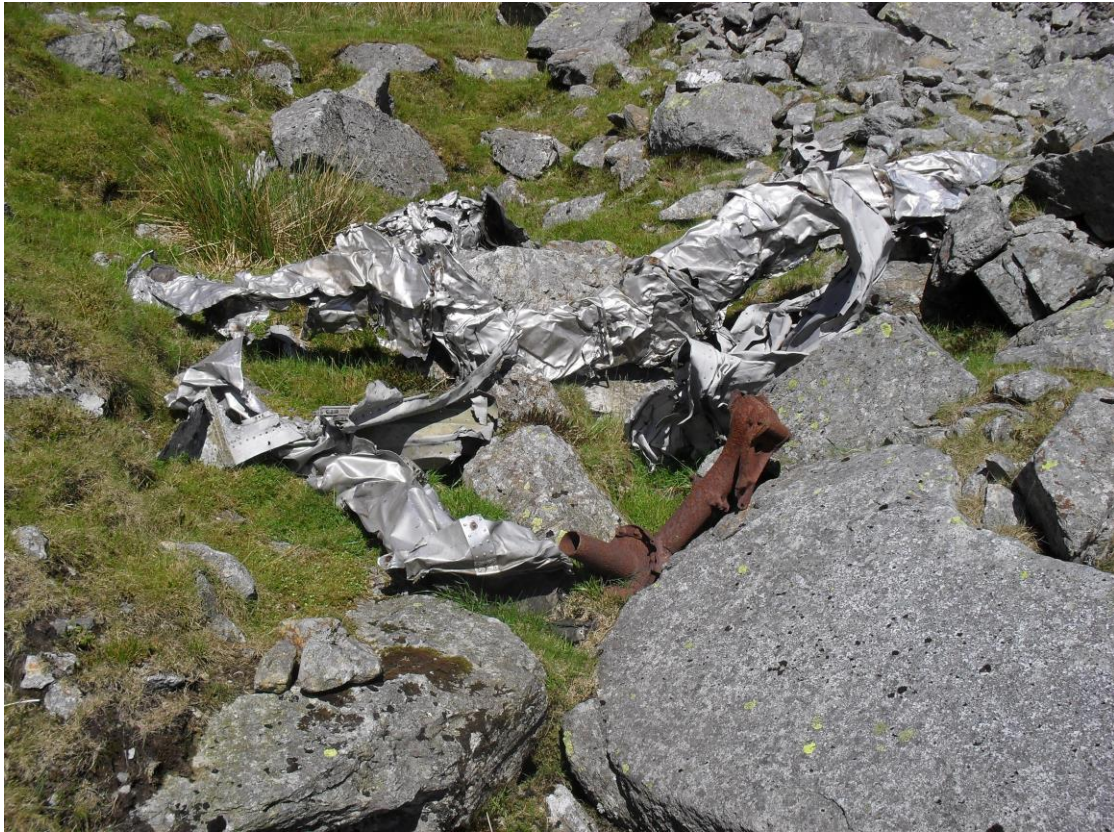
Figure 7 Image taken in May 2010 of the supercharger exhaust and other elements of Republic P-47 Thunderbolt 41-6246 on Aran Fawddwy. Image copyright Matthew Rimmer.

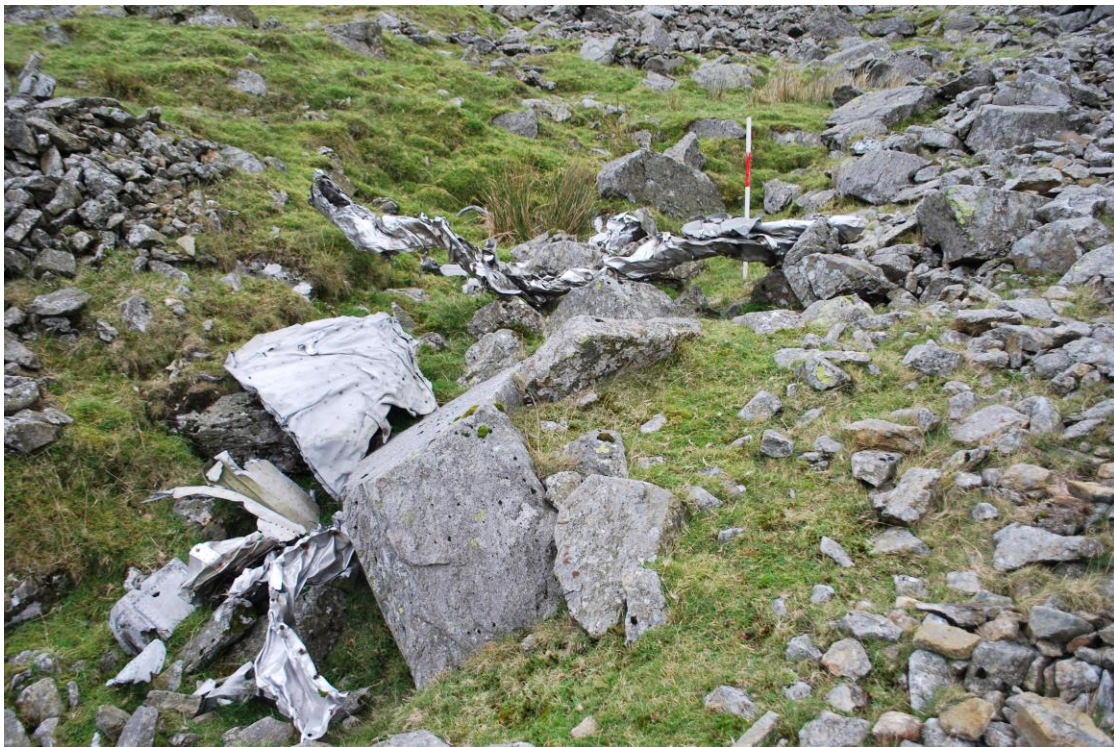
Figure 8 Image taken by Gwynedd Archaeological Trust of the same components in October 2011. The wreckage gives the impression of having been manipulated to make a more evocative photograph.

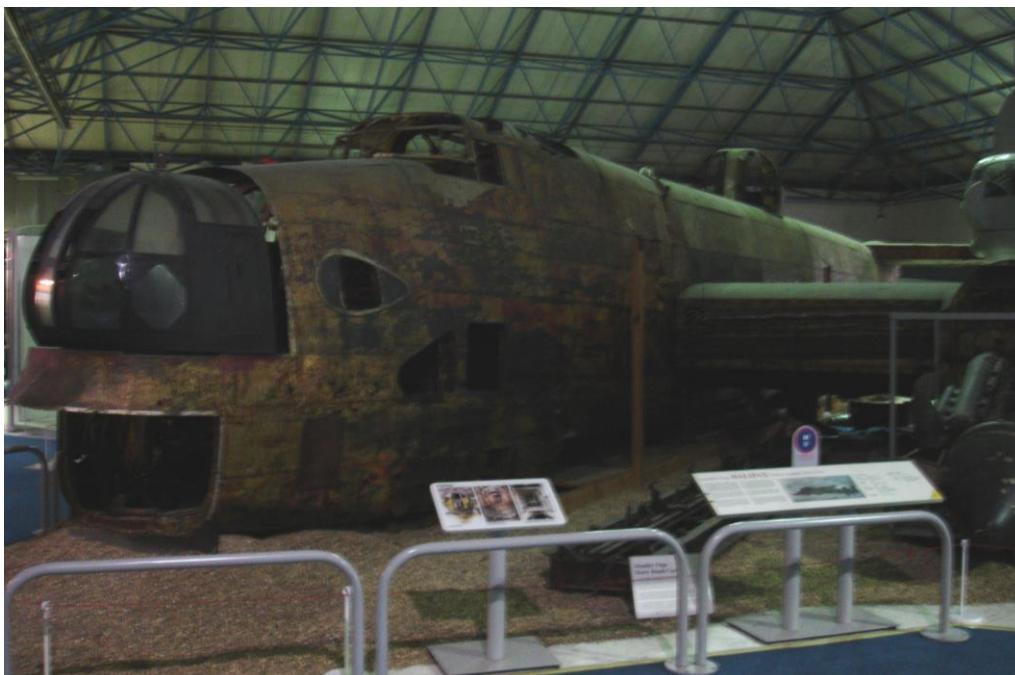
Figure 10 Halifax W1048 on display at RAFM London. Elements of the aircraft have been rebuilt, including the front gun turret. Image taken by the author.

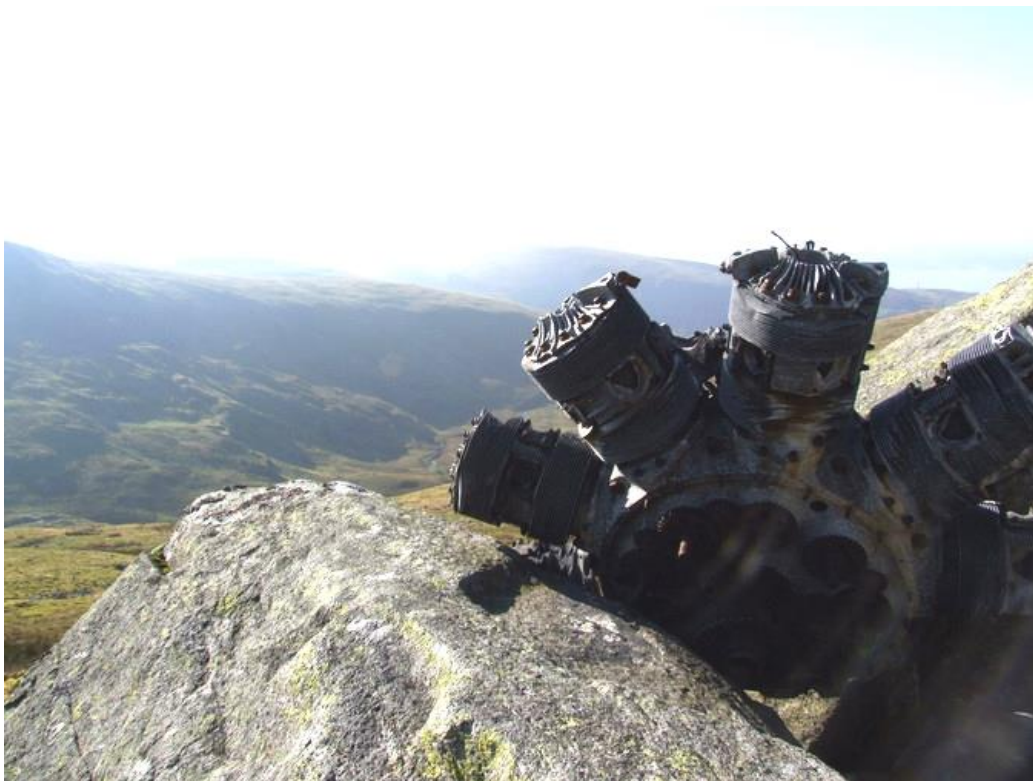
Figure 11 The engine of Blackburn Botha L6202 wedged in the rocks of Llwytmor has become an iconic image for photographers of aircraft crash sites and demonstrates the aesthetic value that can be inherent in military aircraft crash sites. Image copyright Graham A. Stephen, source: <http://geotopoi.wordpress.com/2009/09/26/llwytmor-blackburn-botha-mk-1-l6202-no-11-radio-school-28-aug-1943-1/>

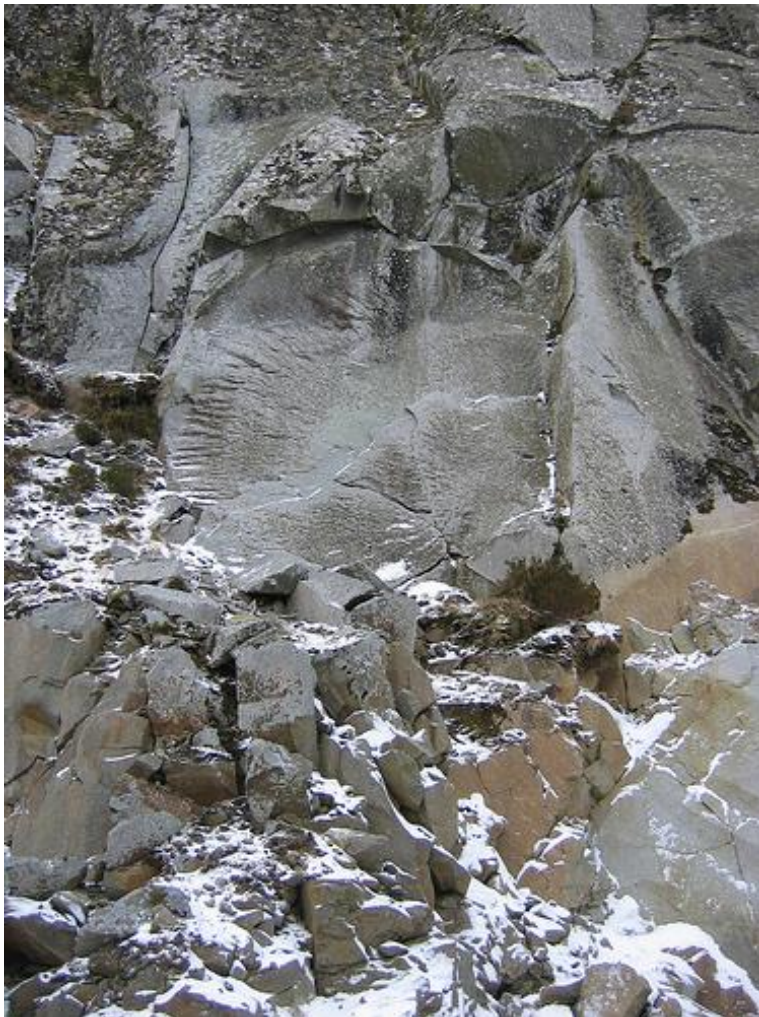
Figure 12 In the case of Gloster Meteor WA794, there no longer appears to be any trace of the aircraft, but a scar is evident on the granite face of the quarry. Image copyright Seán Moran, source: <http://www.flickr.com/photos/8607835@N03/3250442182/sizes/m/in/photostream/>

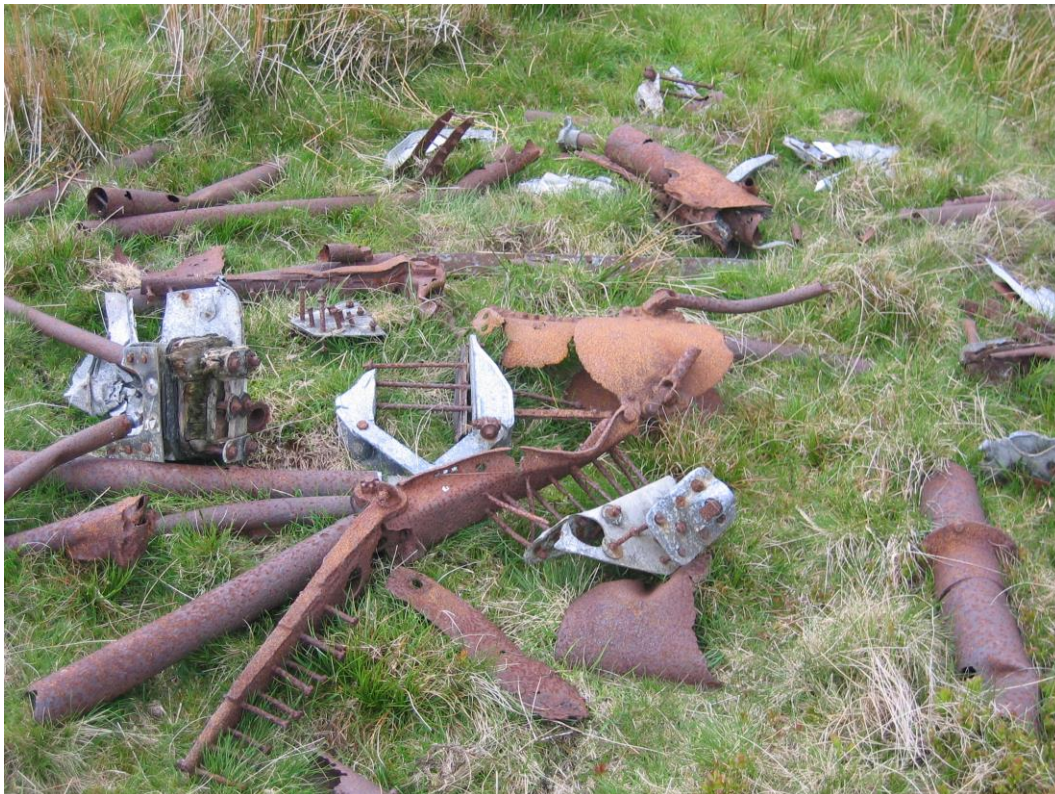
Figure 14 Image taken by an individual keen to document crash sites in a non-intrusive manner. This site, De Havilland Mosquito HX862, was photographed in 2004 and disturbance to the site noted. If it can be successfully harnessed, this approach can allow the MoD and heritage managers to track changes at military aircraft crash sites and provide a form of monitoring, also informing site management processes. Image copyright Rob Lockhart

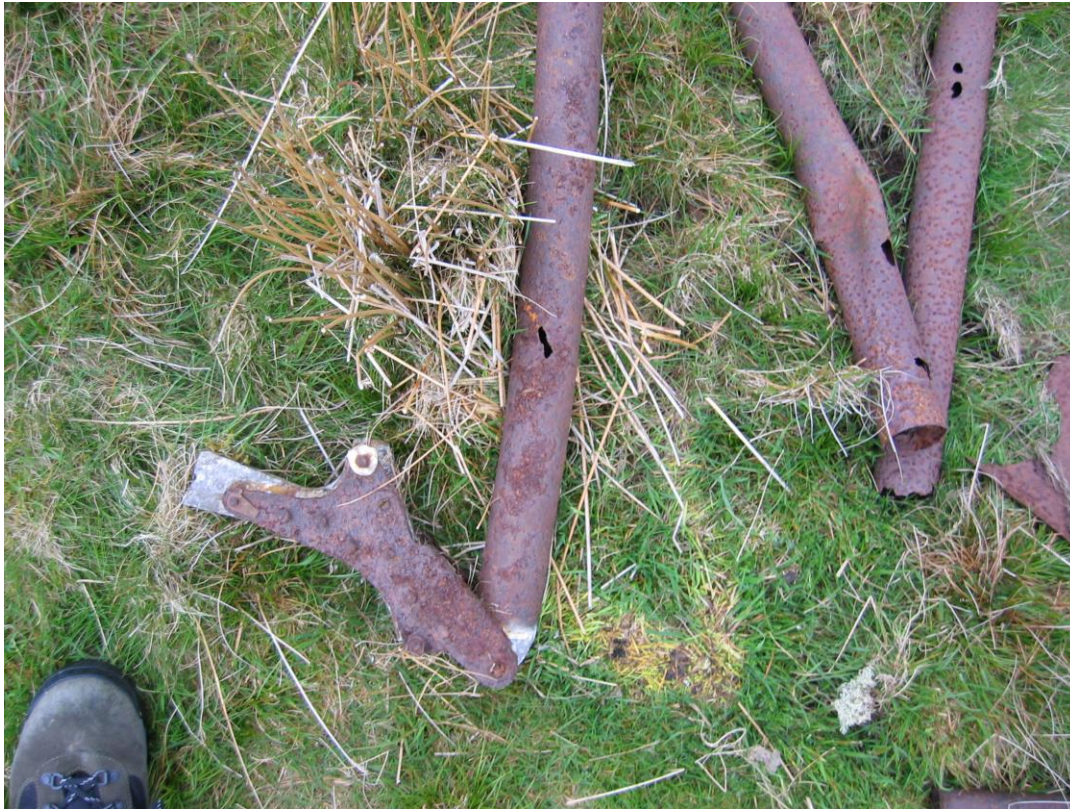
Figure 15 Another view of the wreckage from De Havilland Mosquito HX862 showing recent disturbance of the fragments. Image copyright Rob Lockhart.
