# Second World War Defences, Fairbourne Seafront

## Archaeological Recording and Excavation

Project No. G2400

Report No. 1301

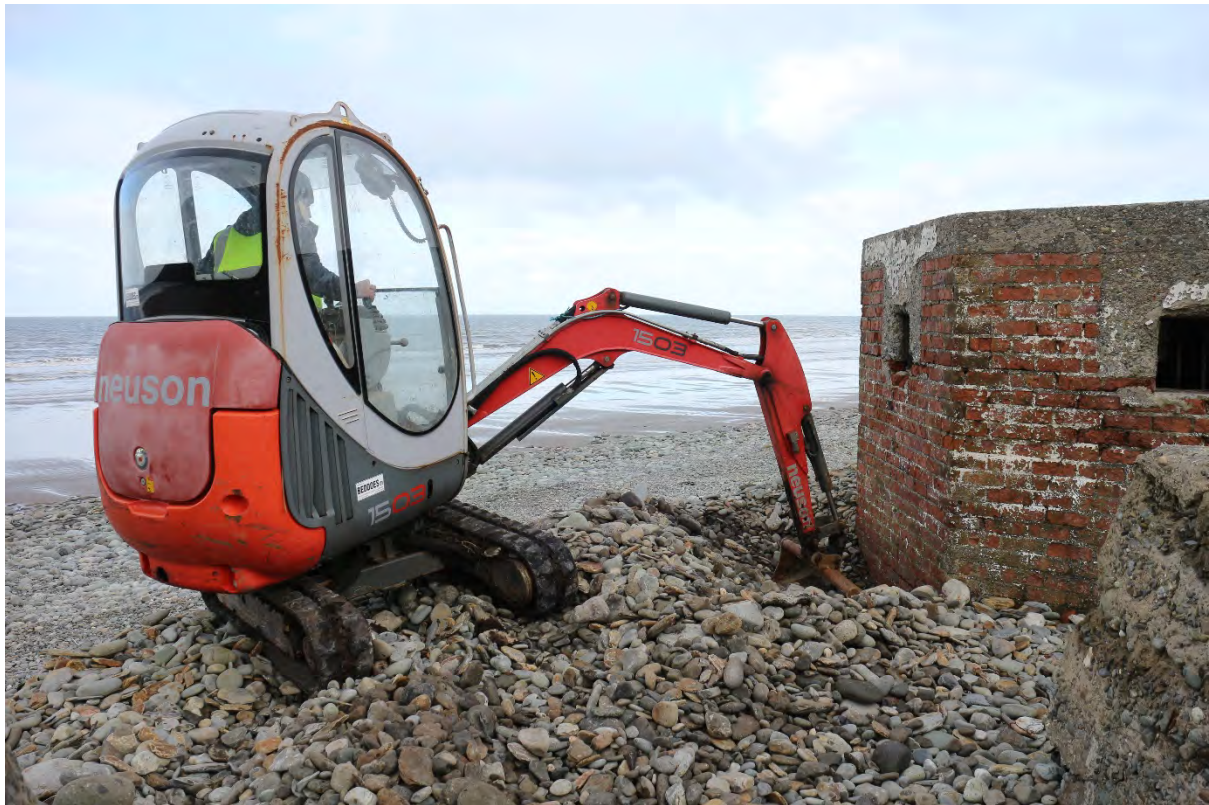
*Neuson 1503 mini-excavator cleaning back beach pebbles to reveal lower brickwork courses, IMG\_9773, 03.03.2016*

Reprofiling was undertaken so as to restore the level of beach pebbles to that existing prior to cleaning back.

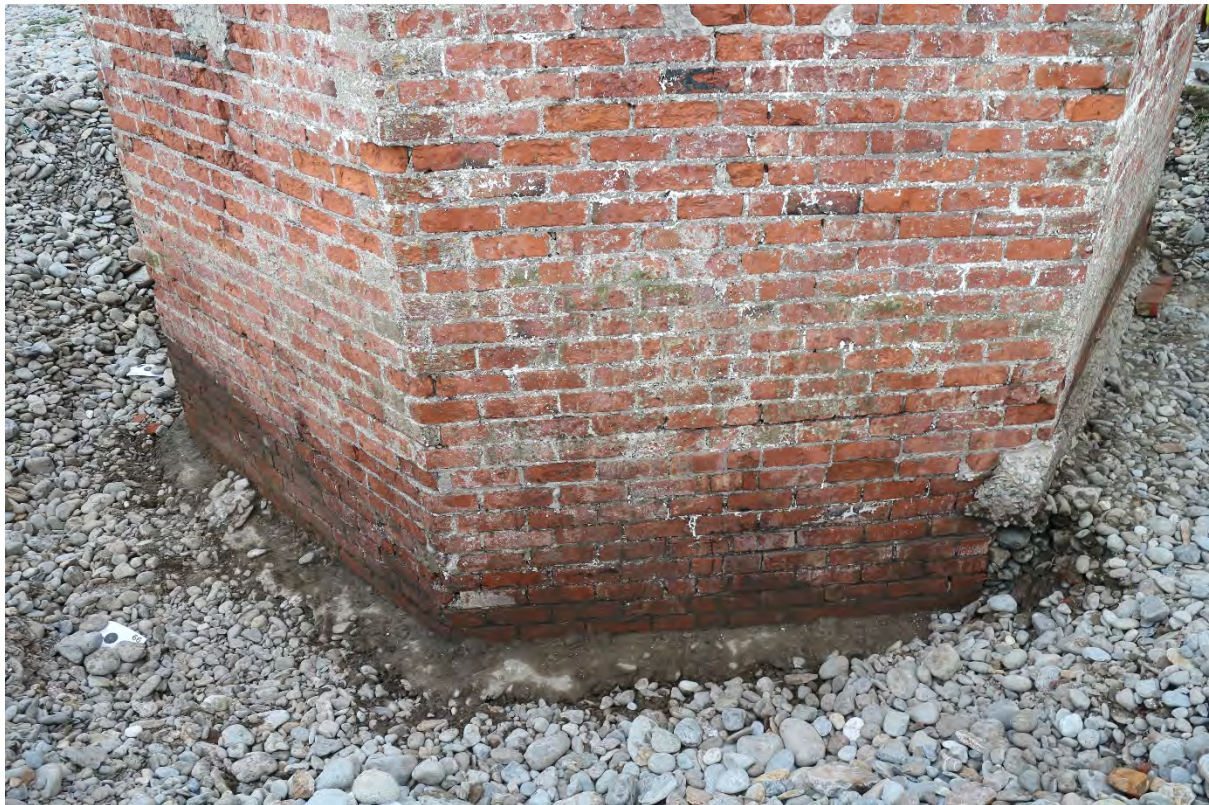
*Fully revealed footings and lower brickwork courses, IMG\_8296, 26.10.2015*

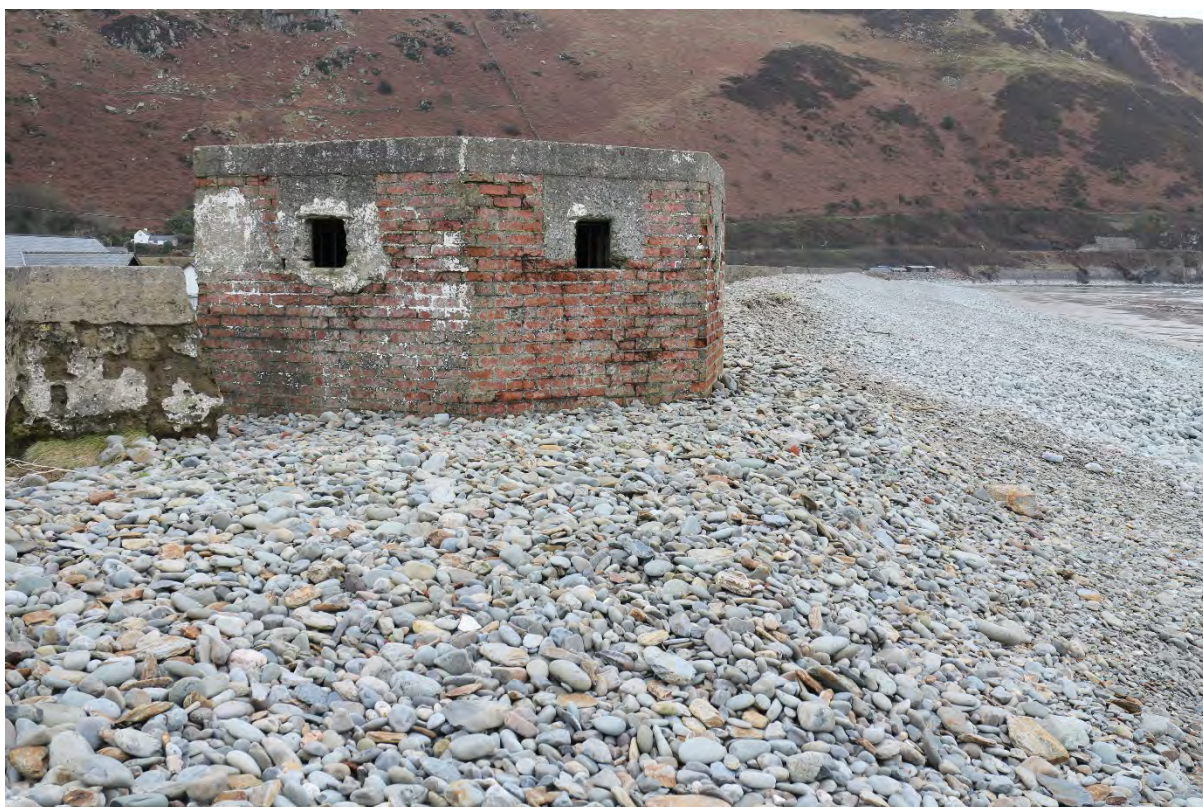
*Shingle beach seaward of pillbox after erosion during Storm Imogen, IMG\_9764, 03.03.2016*

In addition, some work was undertaken to restore beach pebbles to the seaward side of the pillbox, to partially address the significant erosion of the beach during the winter storms.

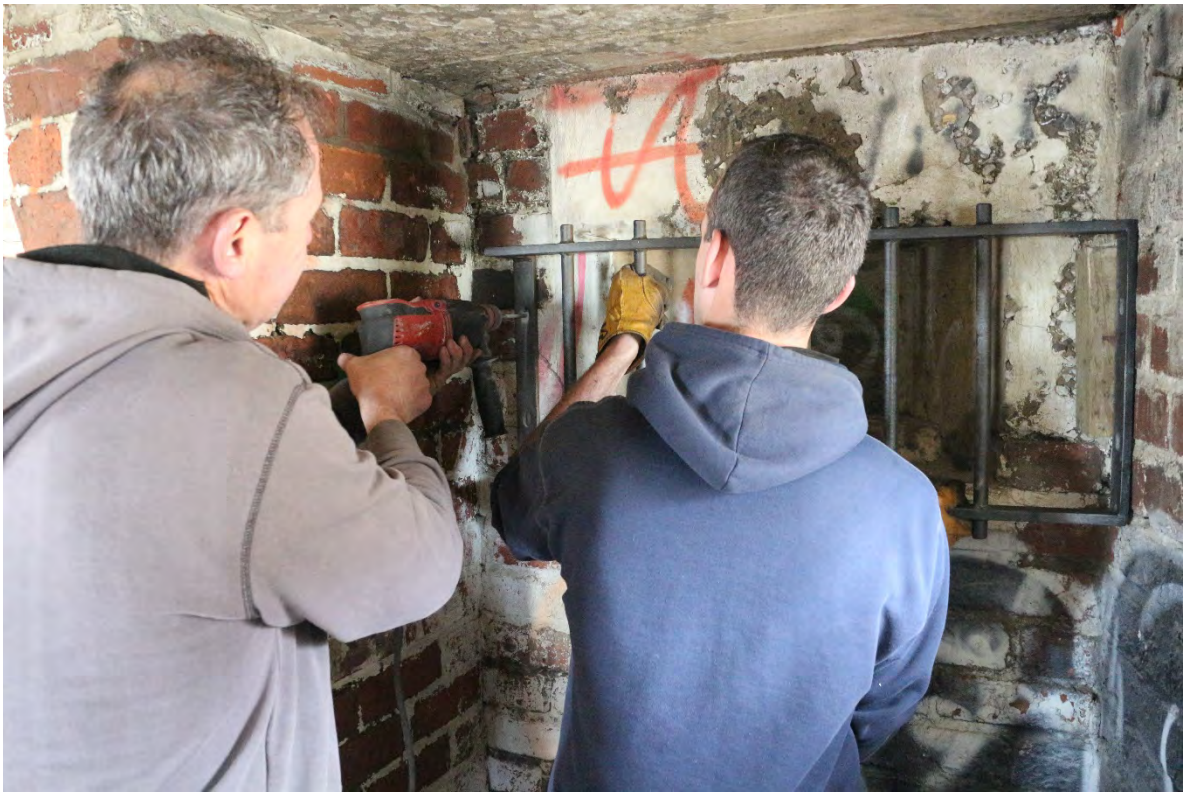
*Drilling mortar joints for fixing points for the embrasure grilles, IMG\_8320, 27.10.2015*

All embrasures were closed with steel grilles, constructed of 40 mm x 12 mm flat bar with 20 mm diameter round bar inserts. Bars are spaced at 120 mm centres to comply with current regulations. The embrasure grilles stand 100 mm off from the face of the interior elevations, with returns on each side to the elevations where fixing points are mounted. Fixing points are positioned top and bottom to align with mortar coursing in the brickwork.

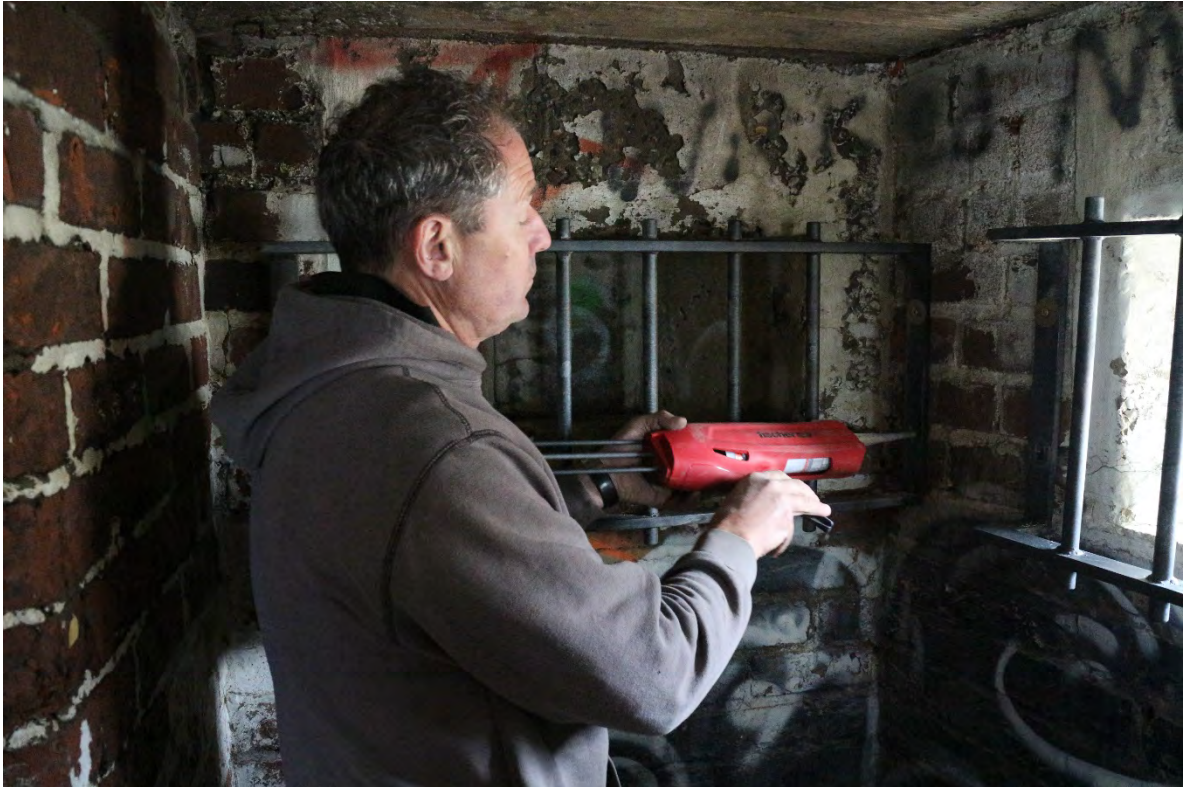
*Securing stainless steel anchor pins using Fischer FIS VT 380 C vinyl ester solid injection mortar, IMG\_8339, 27.10.2015*

All grilles are fixed using stainless steel, threaded anchor pins, set using Fischer FIS VT 380 C vinyl ester solid injection mortar. Standard, stainless steel hexagonal fixing nuts are capped with A2 stainless steel armour rings to obstruct easy removal.

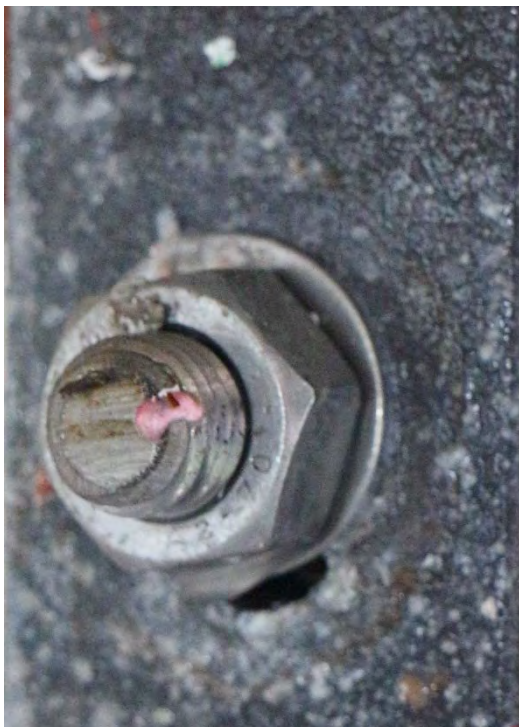
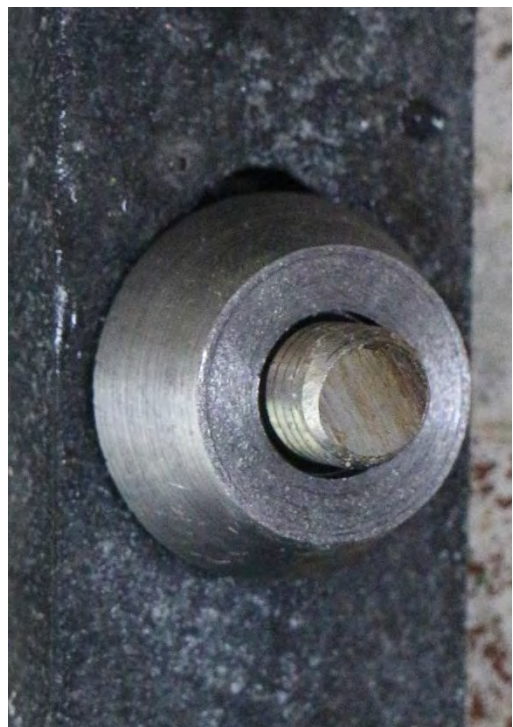
*Steelwork fixings, before (left) and after (right) installation of A2 stainless steel armour rings, IMG\_9805 and IMG\_9806, 03.03.2016*

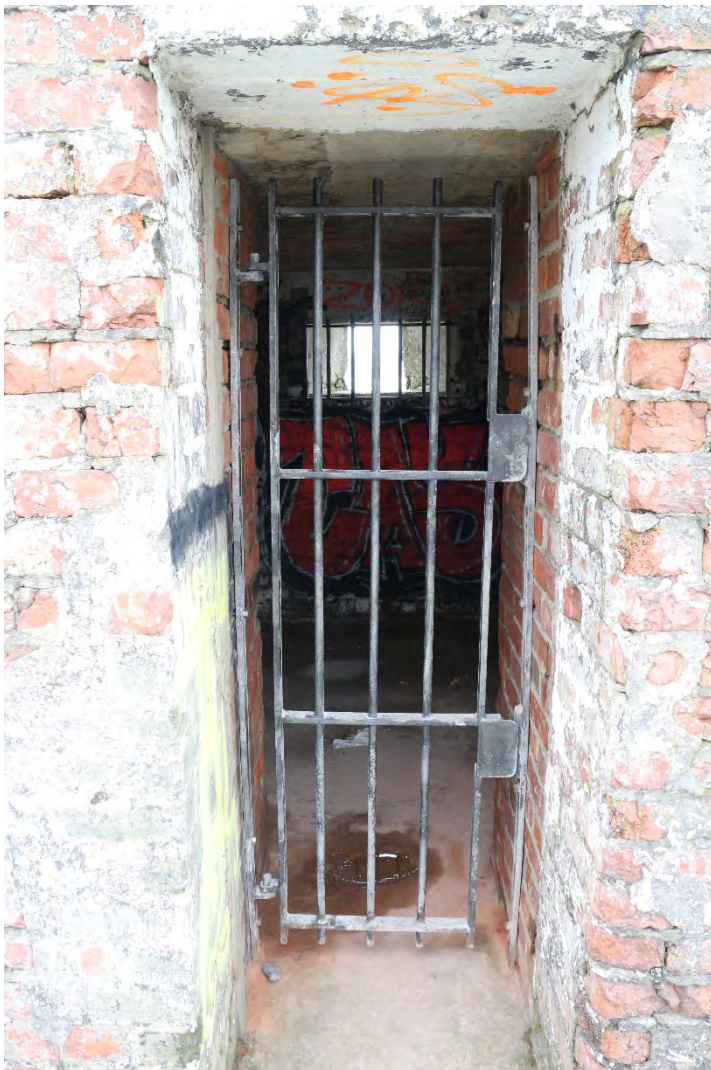
*Entrance way grille, IMG\_9769,  
03.03.2016*

The entrance way is closed with a steel grille door, constructed of 40 mm x 12 mm flat bar with 20 mm diameter round bar inserts. Bars are, again, spaced at 120 mm centres to comply with current regulations.

The door grille is designed to open outwards and lies more-or-less flat with the wall when fully opened. The door grille is positioned at least two brick's width forward of the rear (interior) edge of the side return walls and is hung on two 'pin' hinges. Due to the perceived weakness of the side return walls, hinge and lock fixing points are mounted on 40 mm x 12 mm flat bar, bolted through the thickness of the walls. The door grille is secured using two, keyed-alike bullet locks, top and bottom.

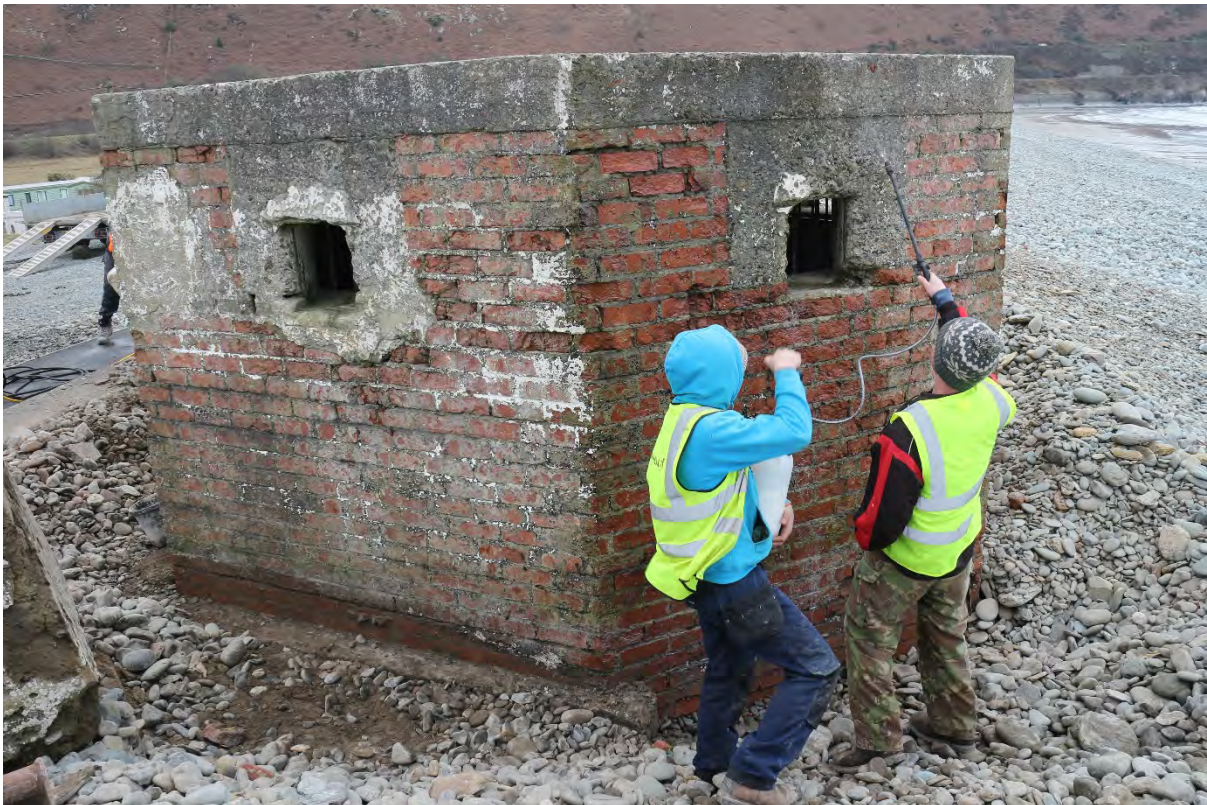
*Applying Kingfisher Storm Seal, IMG\_9800, 03.03.2016*

The intention of the treatment is to inhibit saltwater penetration into the brickwork and mortar joints, thereby slowing the rate of deterioration through spalling.

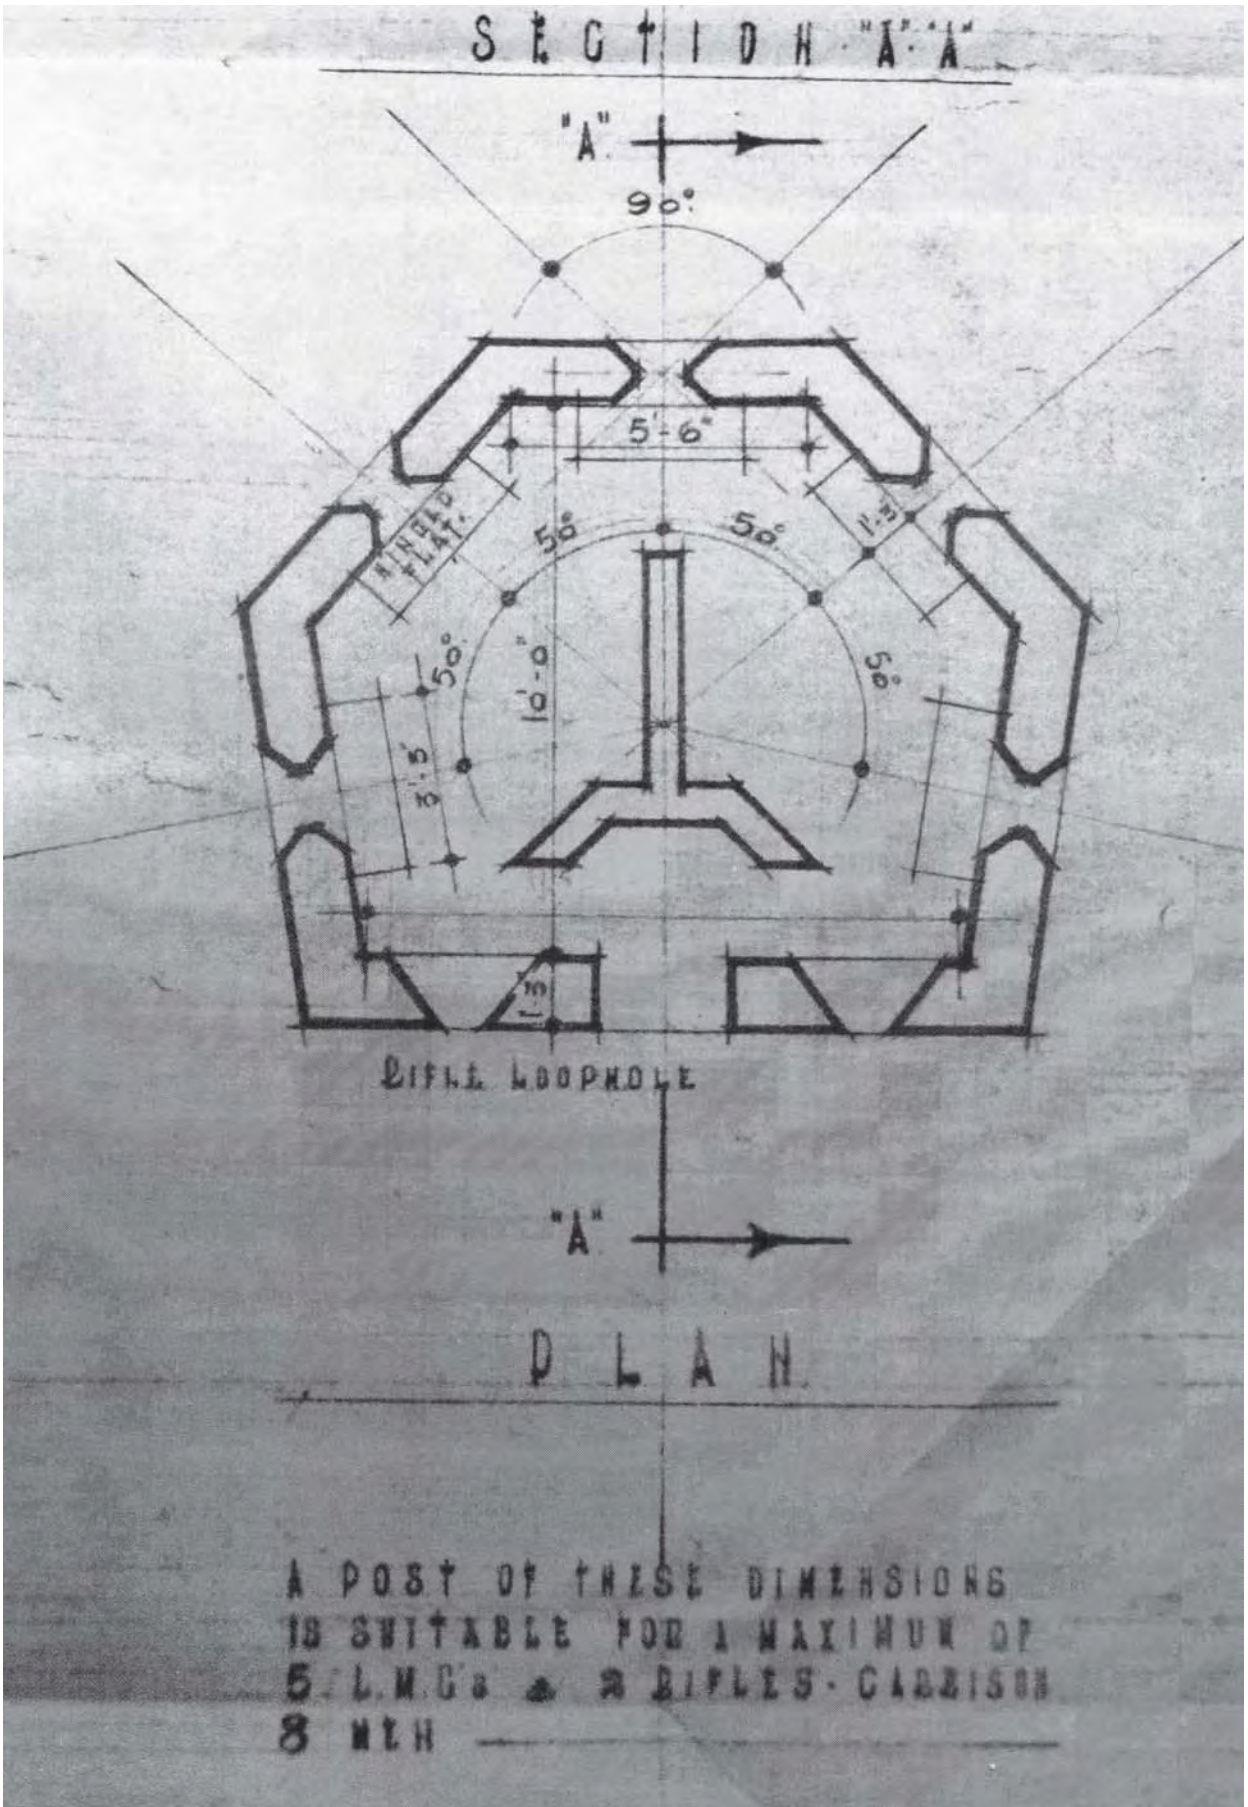
Figure 2. Directorate of Fortifications and Works plan of Type 24 pill box

The Type 24 was one of the most numerous of the standard designs (figure 2) and this is reflected by the comparatively large number which still exist; The Defence of Britain Project (DOBP) noted that more than 1700 Type 24's existed in the UK at the time the DOBP database was compiled.

The War Office design for the Type 24 pillbox called for the construction of an internal anti-ricochet wall. This was to be of a Y-shape, with the top of the Y toward the pillbox entrance (figure 2). The wall was generally constructed from the same materials as the pillbox and usually extended to roof level, though reference has been made to partial height walls, and examples have been noted elsewhere of Type 24's do not appear to have ever had the anti-ricochet wall constructed.

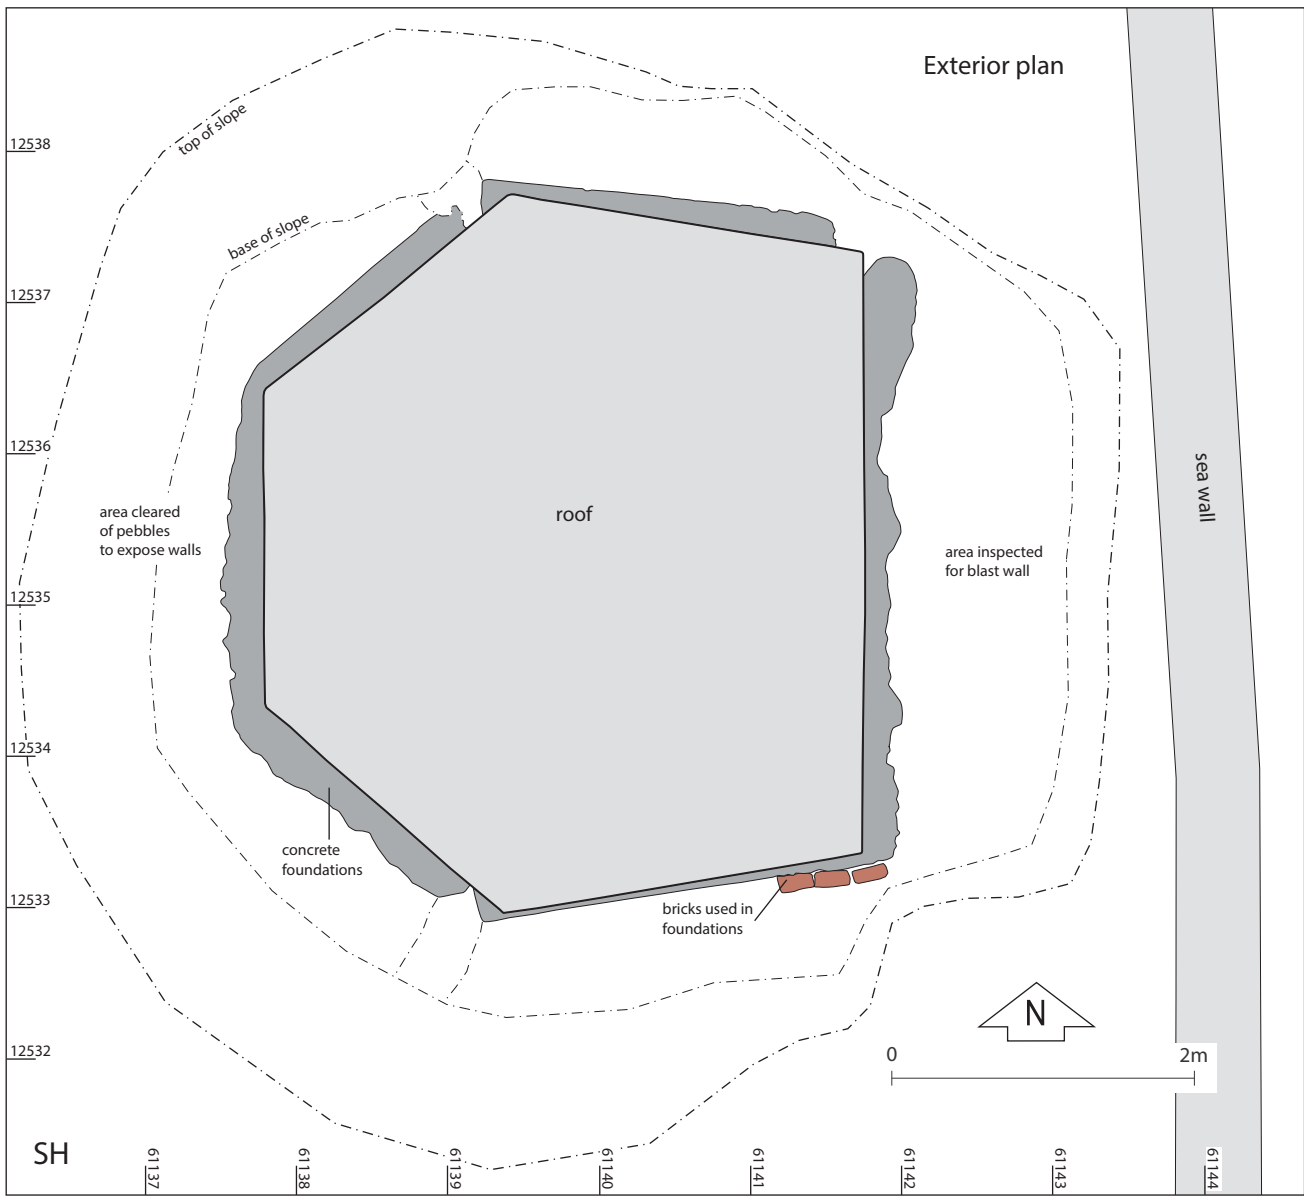
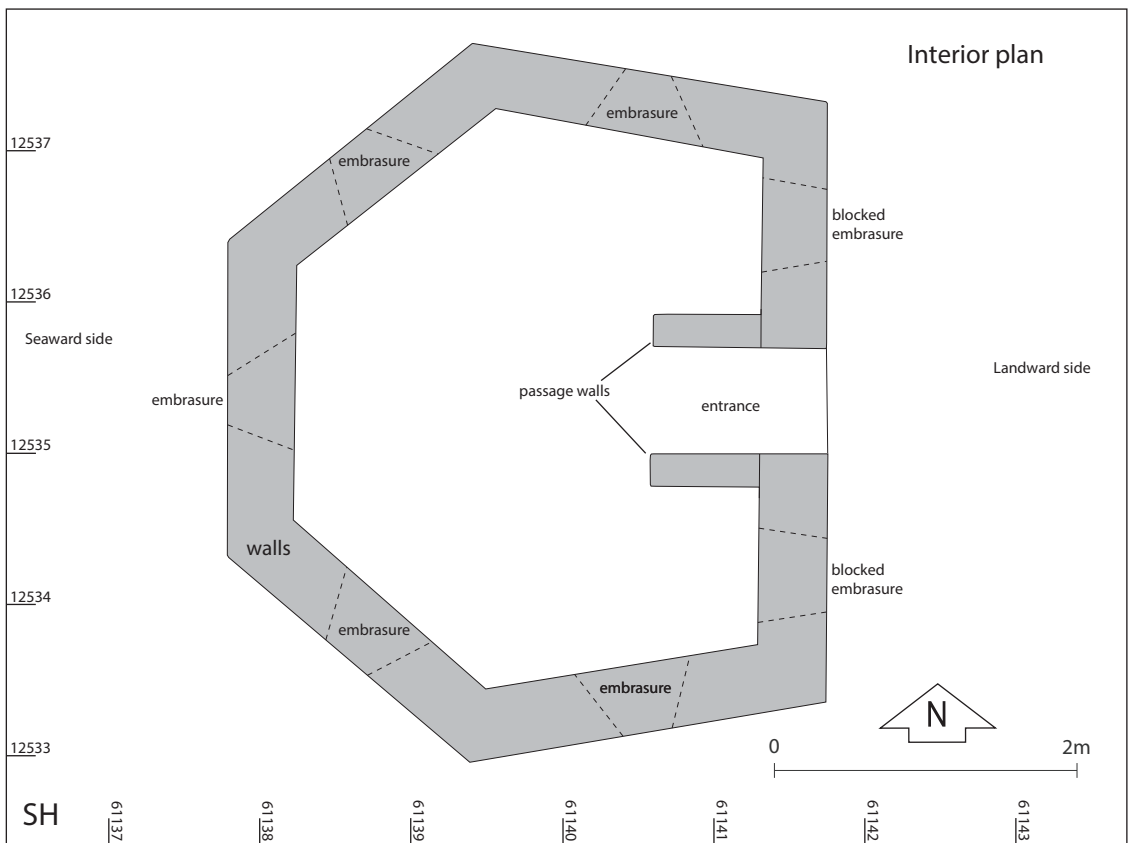
Figure 4. Plans of pillbox PRN 34151 at 1:50

The walls are built from a double skin of brick with a roughly concreted rubble core and are all 440mm thick. The bricks measure 230 by 110 by 80mm and are laid in stretcher bond with occasional headers in the middle of the walls to ensure the correct length of the wall. Externally the bricks are generally quite badly cracked and eroded. The mortar used is hard and grey and made with beach sand. Some concrete bricks have been used in the northern side, but these may have been repairs.

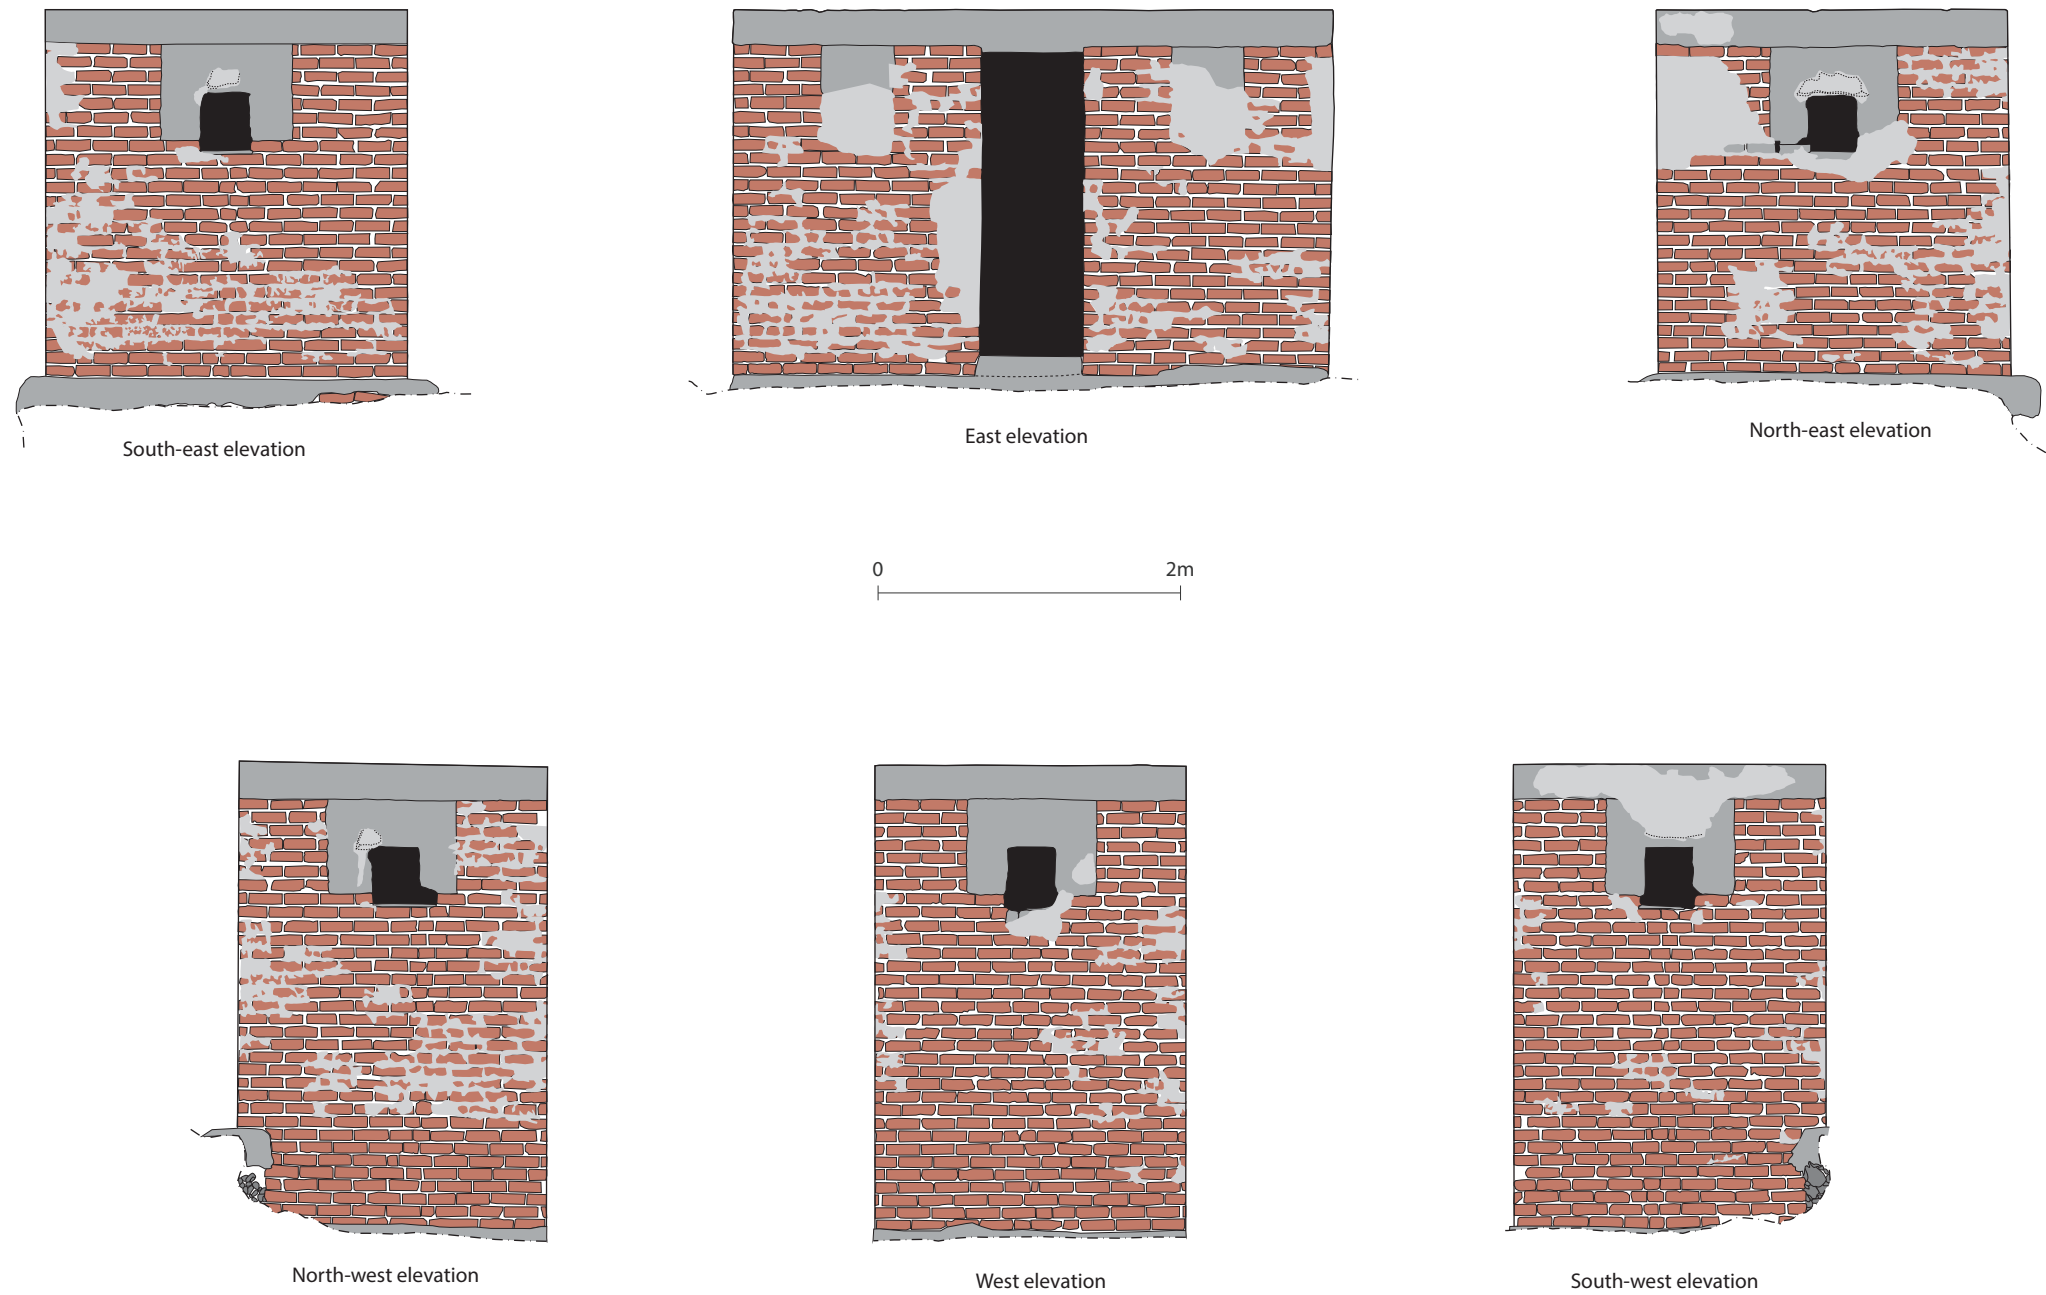
Figure 5. External elevations of pillbox PRN 34151 at 1:50

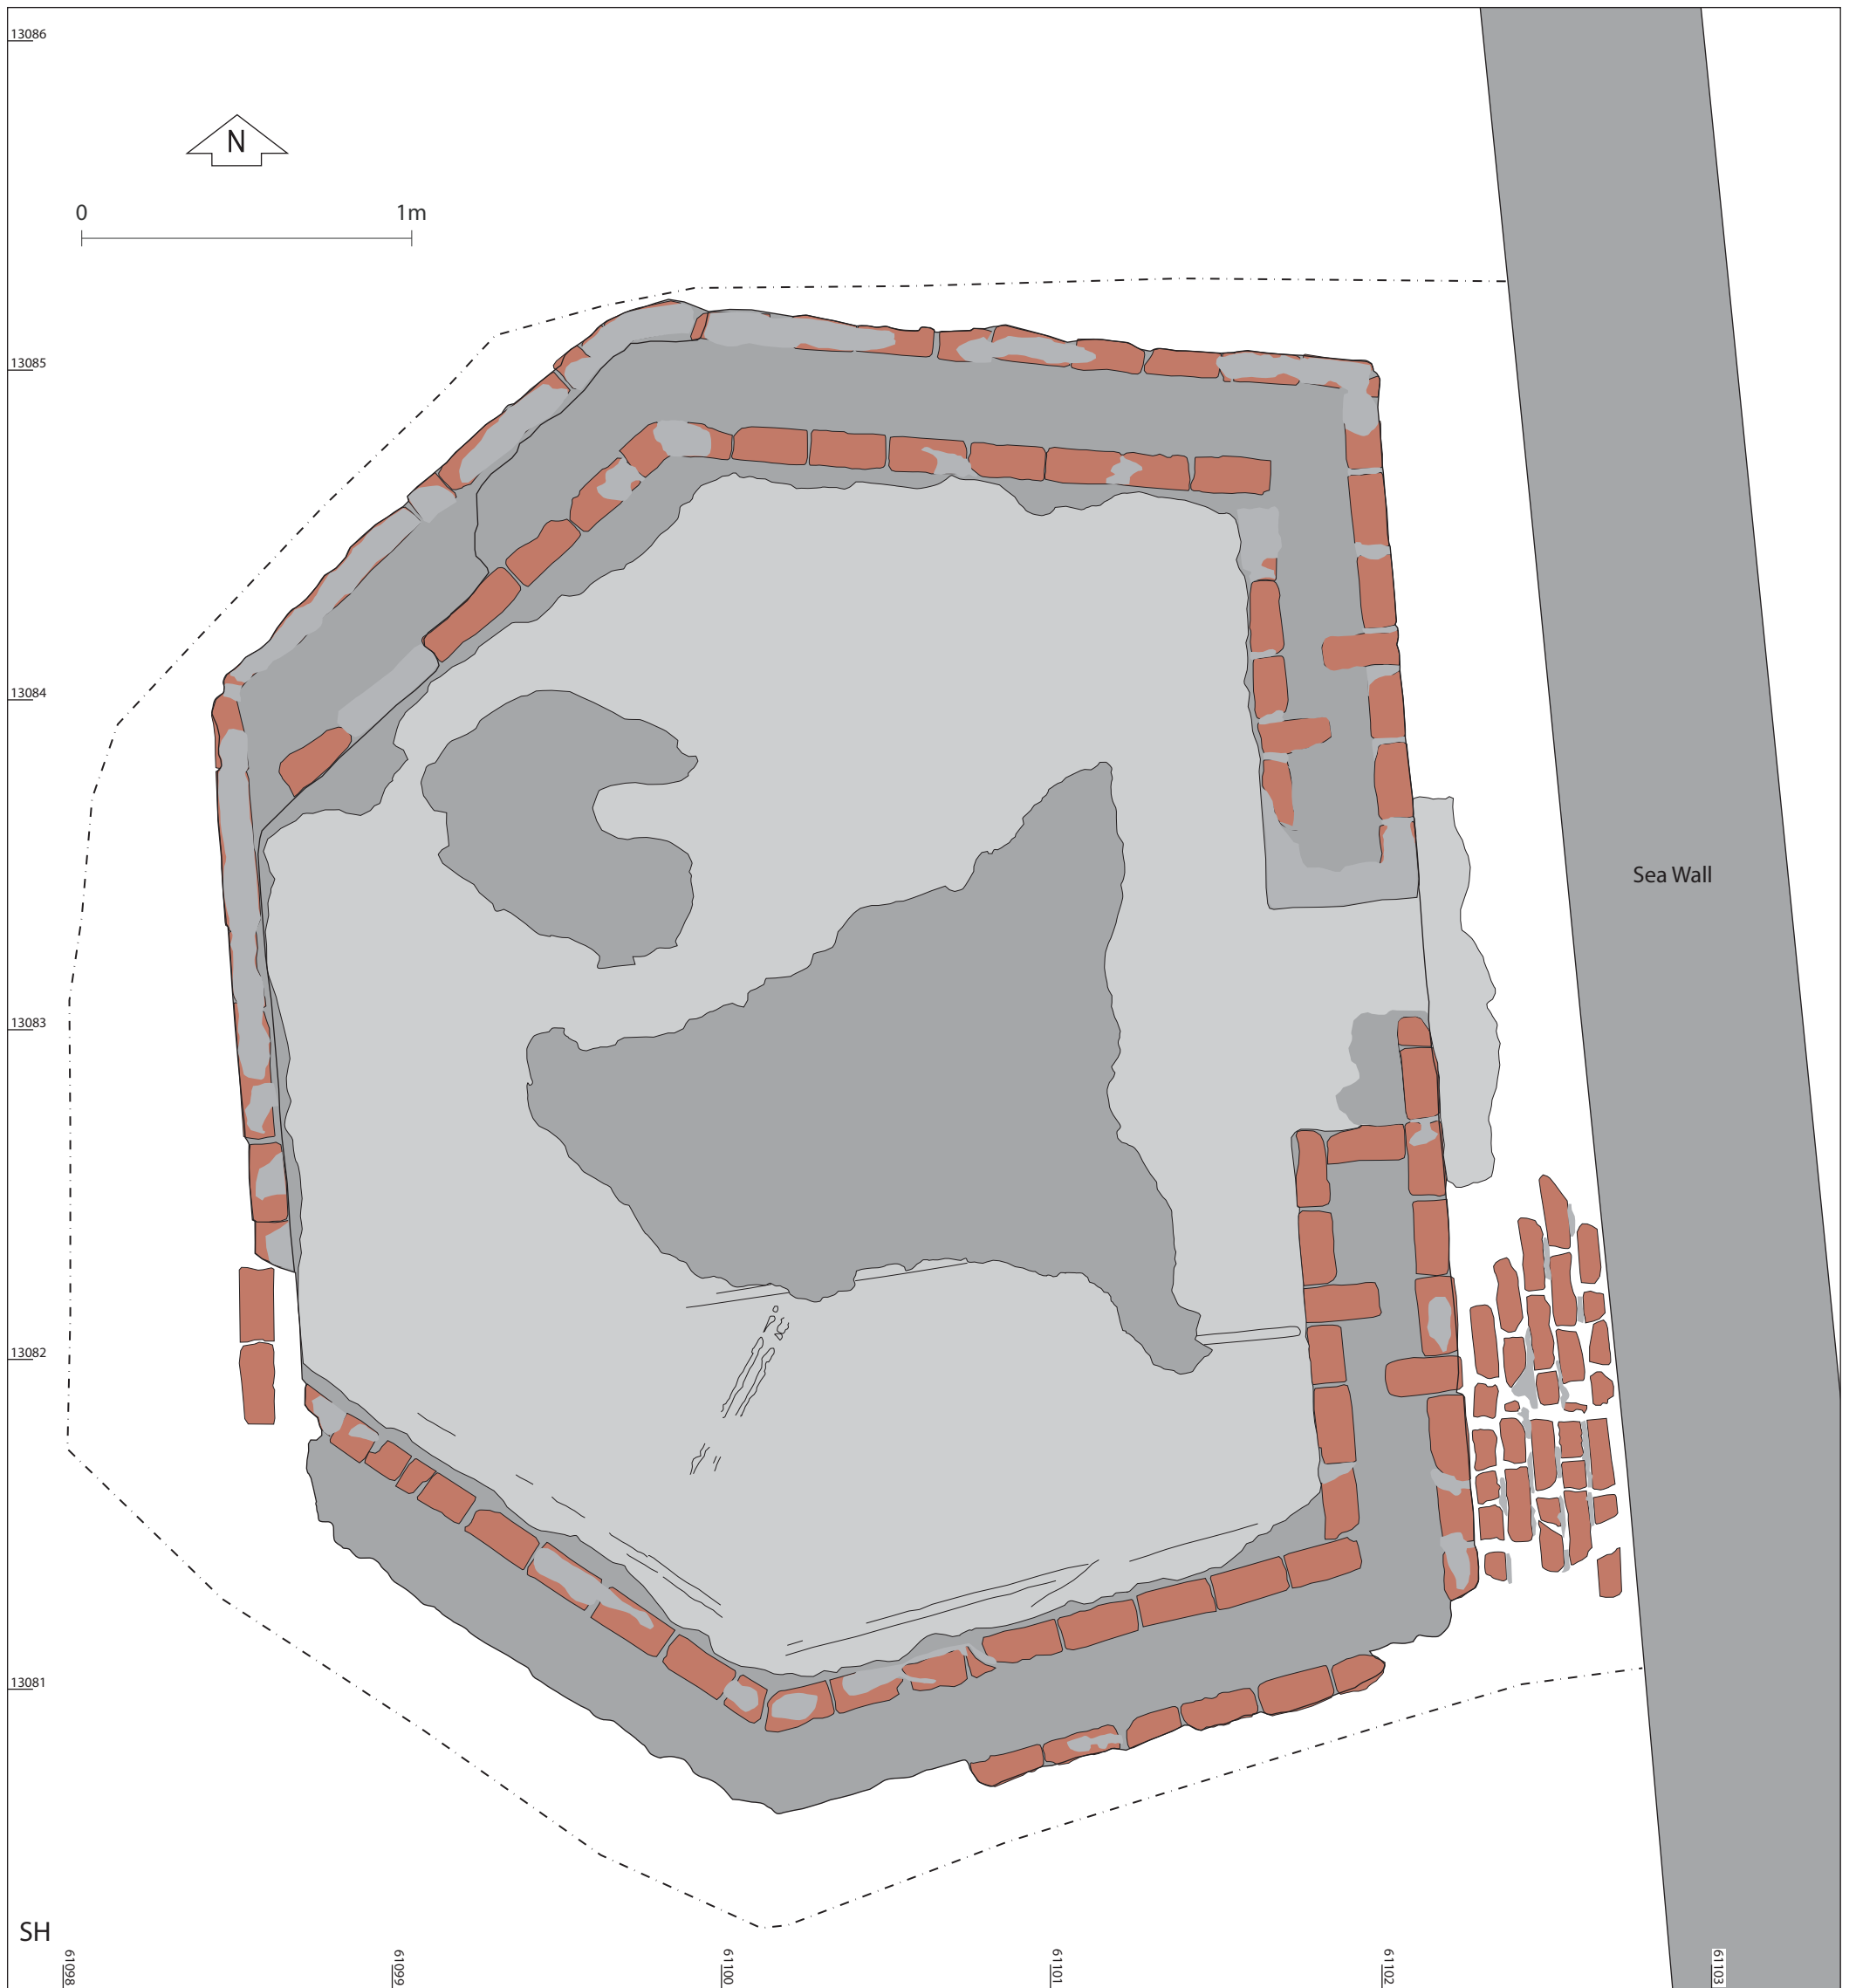
Figure 8. Plan of pill box base PRN 34152 at 1:20

The removal of beach pebbles and soil revealed the base of the pillbox which survives in quite a complete condition and provides a section through the walls of a pillbox as the foundations of the walls survive while the superstructure has been removed (plate 31). The plan of the pillbox is an irregular hexagon with the entrance on the eastern, landward side (figure 8). The damaged state of the remains makes measurement of the walls less precise than for PRN 34151 but the eastern side measures about 3.83m externally, the north-eastern side 2.20m, the north-western side 1.76m, the western side 2.75m, the south-western side 1.84m and the south-eastern side 2.30m.

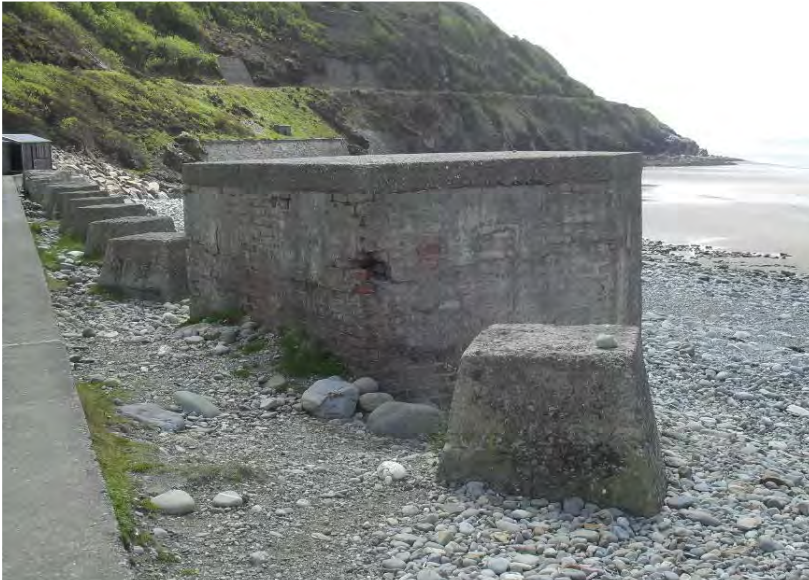
Plate 7. Traces of render surviving on pillbox PRN 34150 before its destruction  
(Photo taken by Matt Rimmer 2013)

Examination in May 2013 of the damaged pillbox at the southern end of Fairbourne beach indicated that it had also received a thin layer of render at some point (plate 7), although it is again not easy to establish when this might have been applied; the fact the render appeared to cover the bricks which had been used to block the original entrance and embrasures would seem to suggest it was applied post war. This pillbox was significantly damaged by the storm of January 2014, and its remains were subsequently moved during sea defence works.

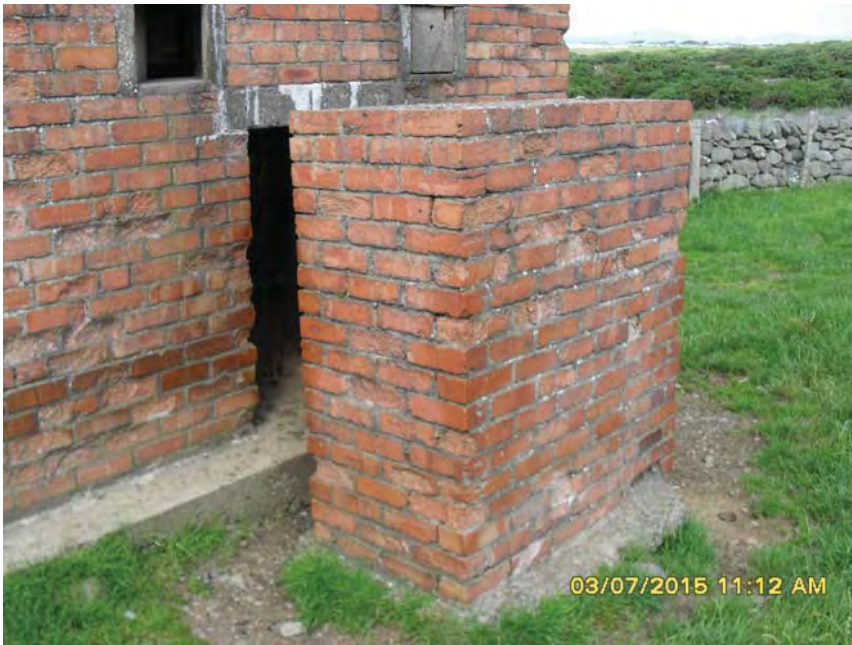
Plate 10. Intact example of an external blast wall protecting the entrance to the pillbox at Egryn, near Llanaber, Barmouth (Photo taken by Matt Rimmer)

The entrance to most pillboxes would originally have been protected by either an external anti-blast wall (plate 10), or in some cases a steel door. Visual examination of the Type 24 at Fairbourne has failed to reveal any clear indication of either, though it is possible if external blast walls had been built at Fairbourne, they may have been removed when the pillbox was used for civilian purposes post-war, or when the later sea defences were constructed.

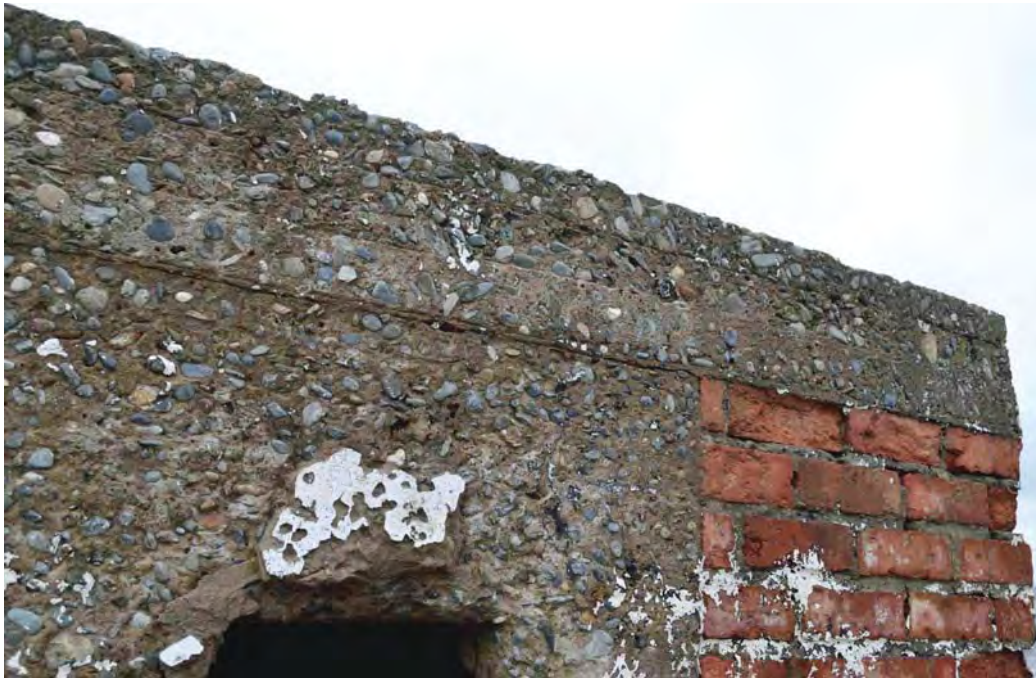
Plate 20. Edge of the roof on the south-east side showing it built up in three layers (29/10/2015)

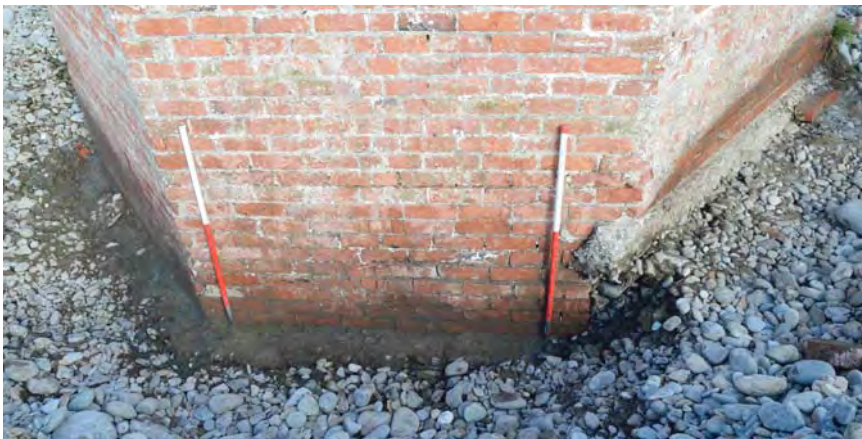
Plate 25. Detail of concrete foundations from west (26/10/2015)

A thin deposit of concrete projects from under the base of the brick walls (plate 25) and it appears that trenches were dug in the pebbles and concrete placed as a foundation. Some bricks were used in the foundations on the south-east side. The walls were built on these foundations and then the concrete for the floor was laid within the walls. The floor is covered in screed which is only
