# Second World War Defences, Fairbourne Seafront

## Archaeological Recording and Excavation

Project No. G2400

Report No. 1301

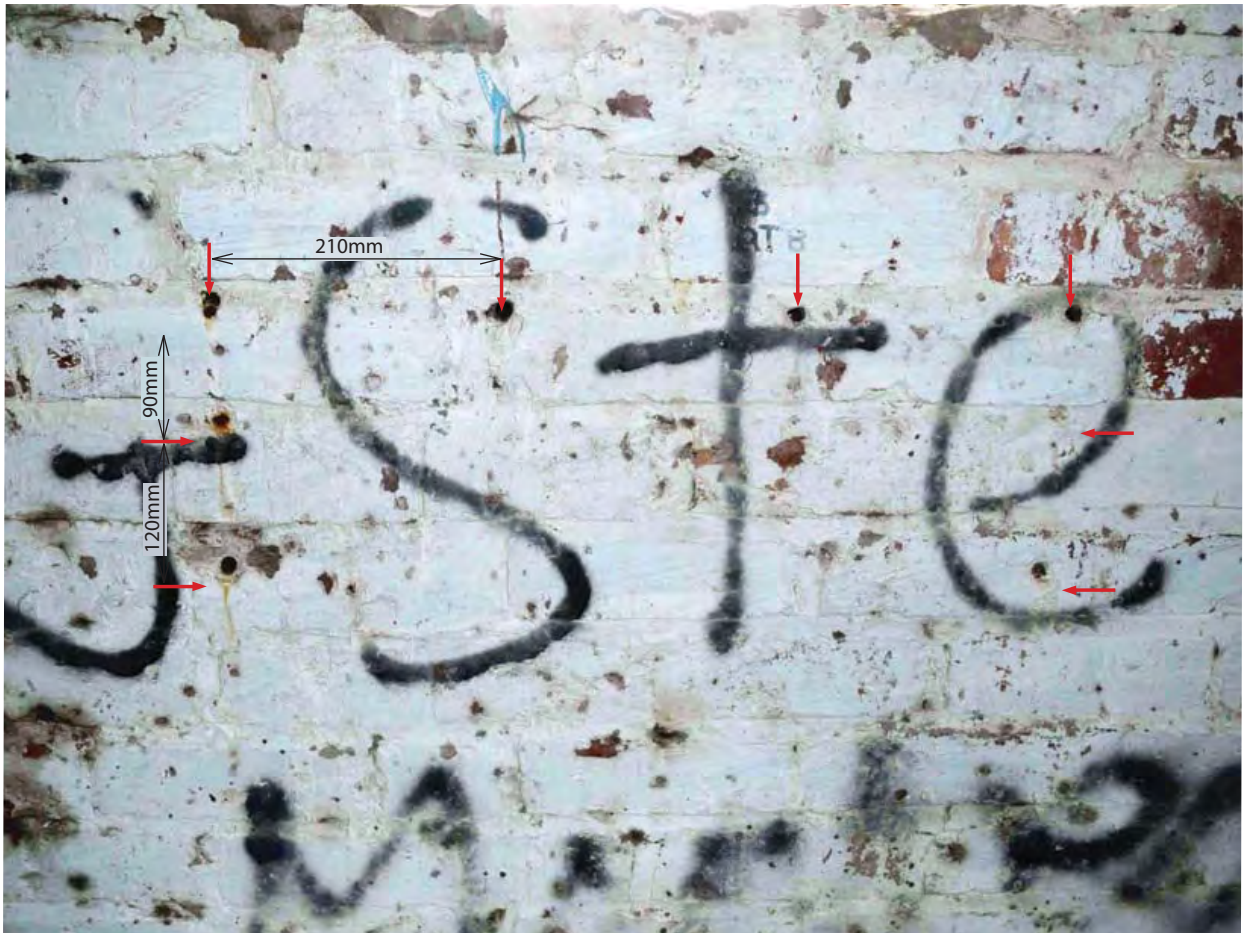
Plate 29. Drill holes under embrasure in south-west wall for fixing a shelf (red arrows point to holes) (27/10/2015)

*The investigation of pillbox PRN 34151 showed that while there was photographic evidence for an external blast wall no traces of this now survive. There is also no evidence for an internal anti-ricochet wall although the neighbouring pillbox (PRN 34152) does seem to have had one as shown by the damage to the screed on the floor. A passage in PRN 34151 was a later addition but possibly added during wartime. PRN 34151 formerly had shelves fitted under the embrasures as shown by drill holes to fix them.*

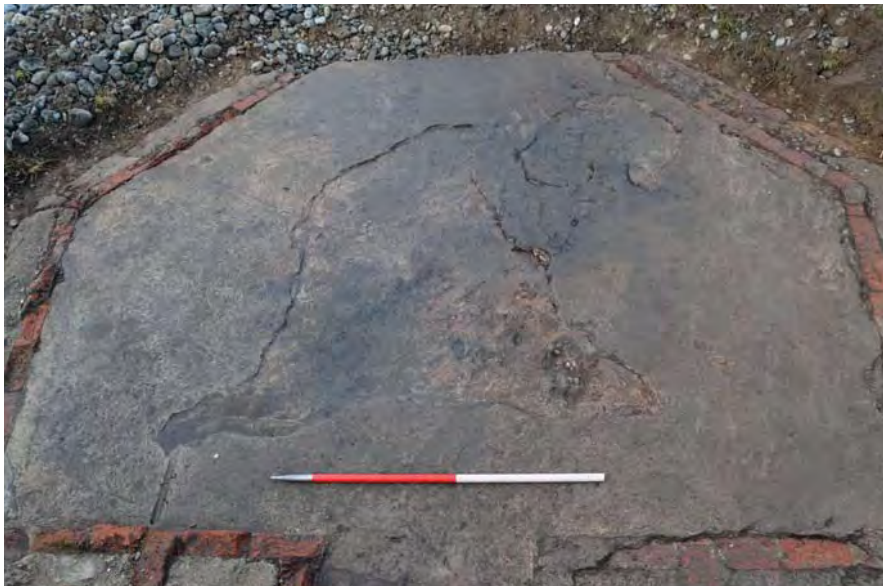
Plate 34. Floor of pillbox showing roughly Y-shaped damage to the screed and impressions in the screed on the southern/left side (28/10/2015)

The floor of the pillbox was made of concrete covered with a layer of screed. In the centre of the floor a roughly Y-shaped area of screed has eroded away (plate 34). It is probable that this indicates where the internal blast wall was located and the removal of that wall has damaged the screed in this area. There are also impressions in the screed. One is a groove 30mm wide and extending perpendicularly from the rear wall for 320mm before being lost in the screed damage (plate 32). This groove is 5mm deep and the eastern end is rounded. There are also impressions of battens along the floor inside the south-eastern and south-western walls, which may be related to a lining or some furniture. Other slight grooves are difficult to explain but must have been made when the screed was wet and are related to the construction of the pillbox (plate 35).

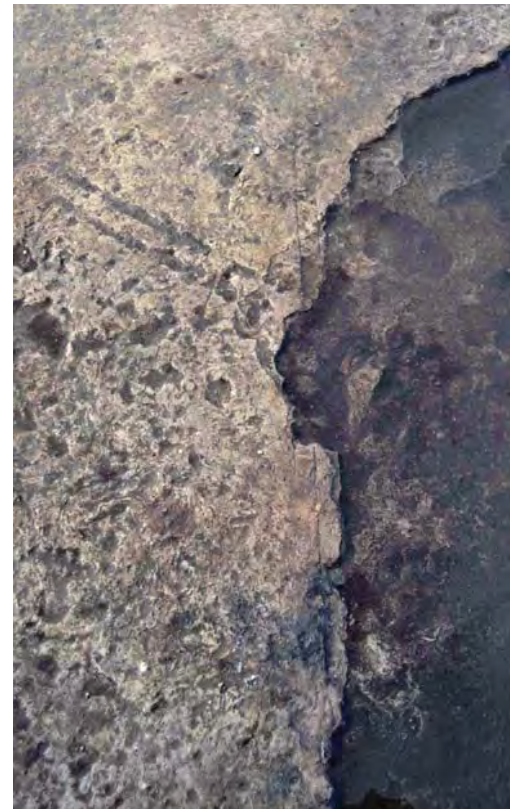
Plate 35. Impressions in screed on the floor (28/10/2015)
