# A55(T) ABERGWYNGREGYN TO TAI'R MEIBION IMPROVEMENT

Pre-Commencement Archaeological Evaluation

Prosiect Rhif / Project No. G2424

Adroddiad Rhif / Report No.1323

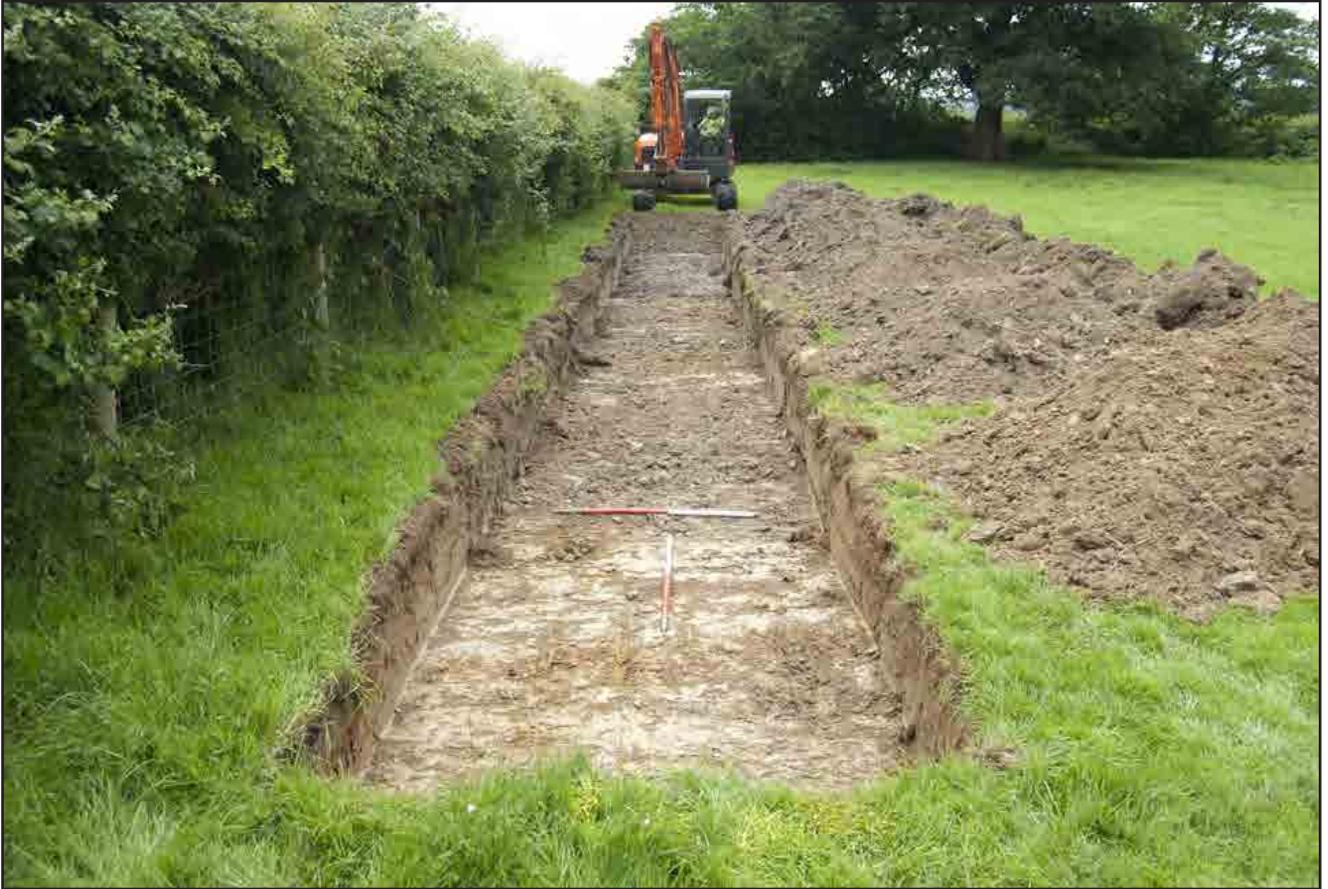
Plate 01: Post-ex shot of Trench 01, viewed from the NE (scale: 2x1m; archive image: G2424\_PCTT\_2016\_011).

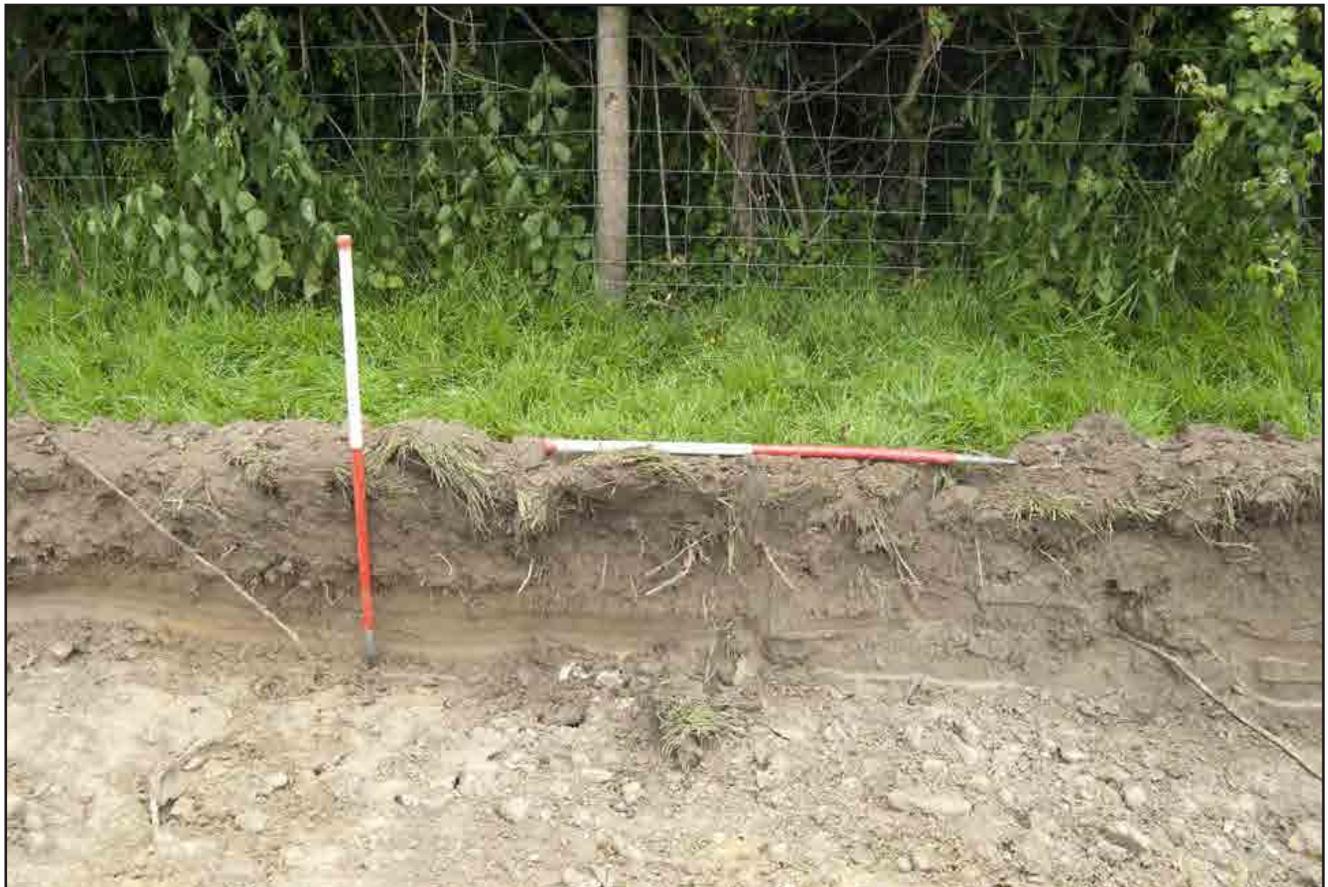
A 0.15m deep layer of topsoil **(0101)** was visible overlying an alluvial deposit of light brownish grey silty clay **(0102)**, on average 0.35m deep. This had been deposited over the natural drift geology **(0103)**, a wet, cohesive, light greyish orange, coarse and fine gravel / sand mixture with moderate small and medium sized sub-rounded and sub angular stones.

Plate 02: NW facing baulk section of Trench 01, viewed from the NW (scale: 2x1m; archive image: G2424\_PCTT\_2016\_012).

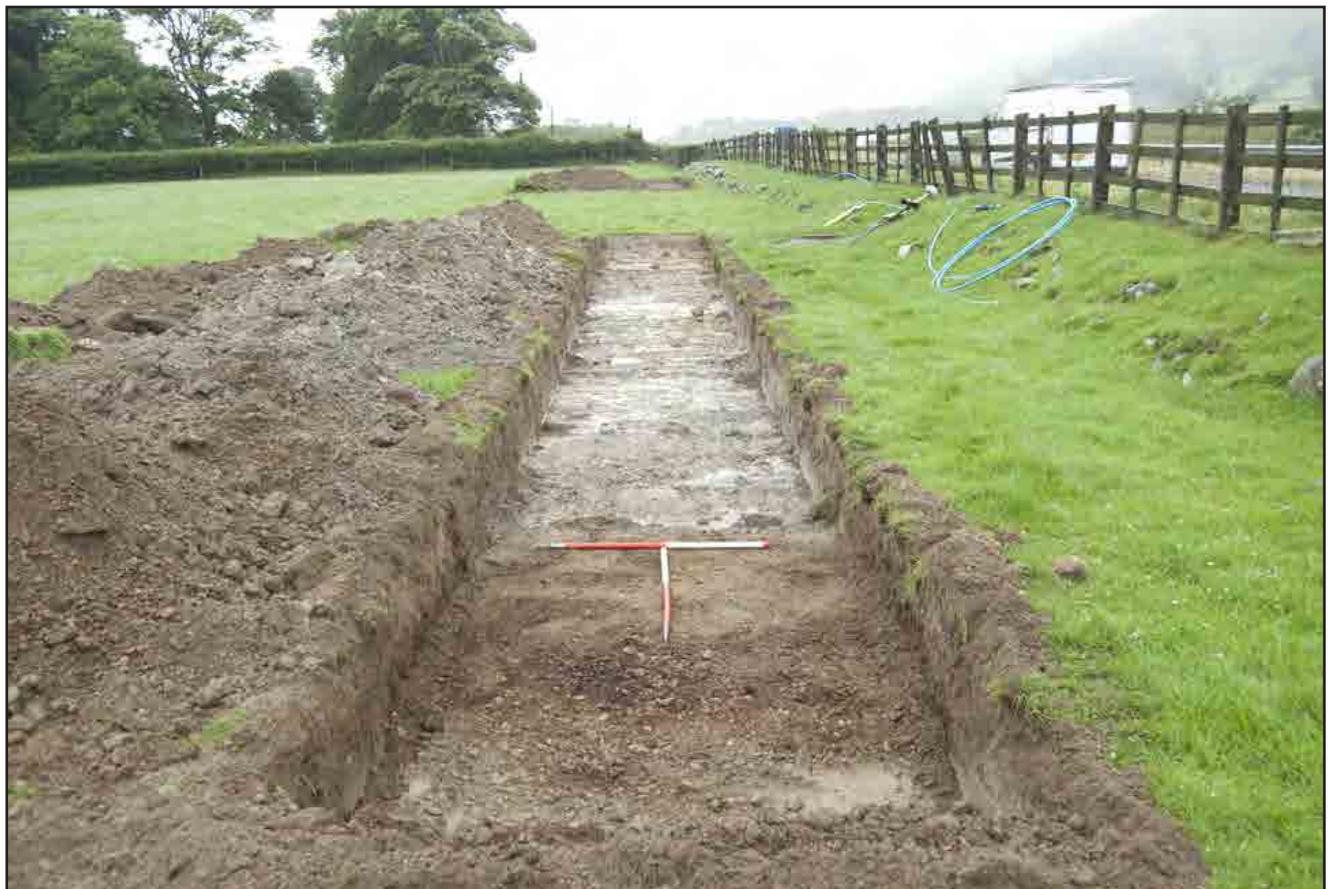
Plate 04: Post-machining shot of Trench 02, viewed from the SW (scale: 2x1m; archive image: G2424\_PCTT\_2016\_006).

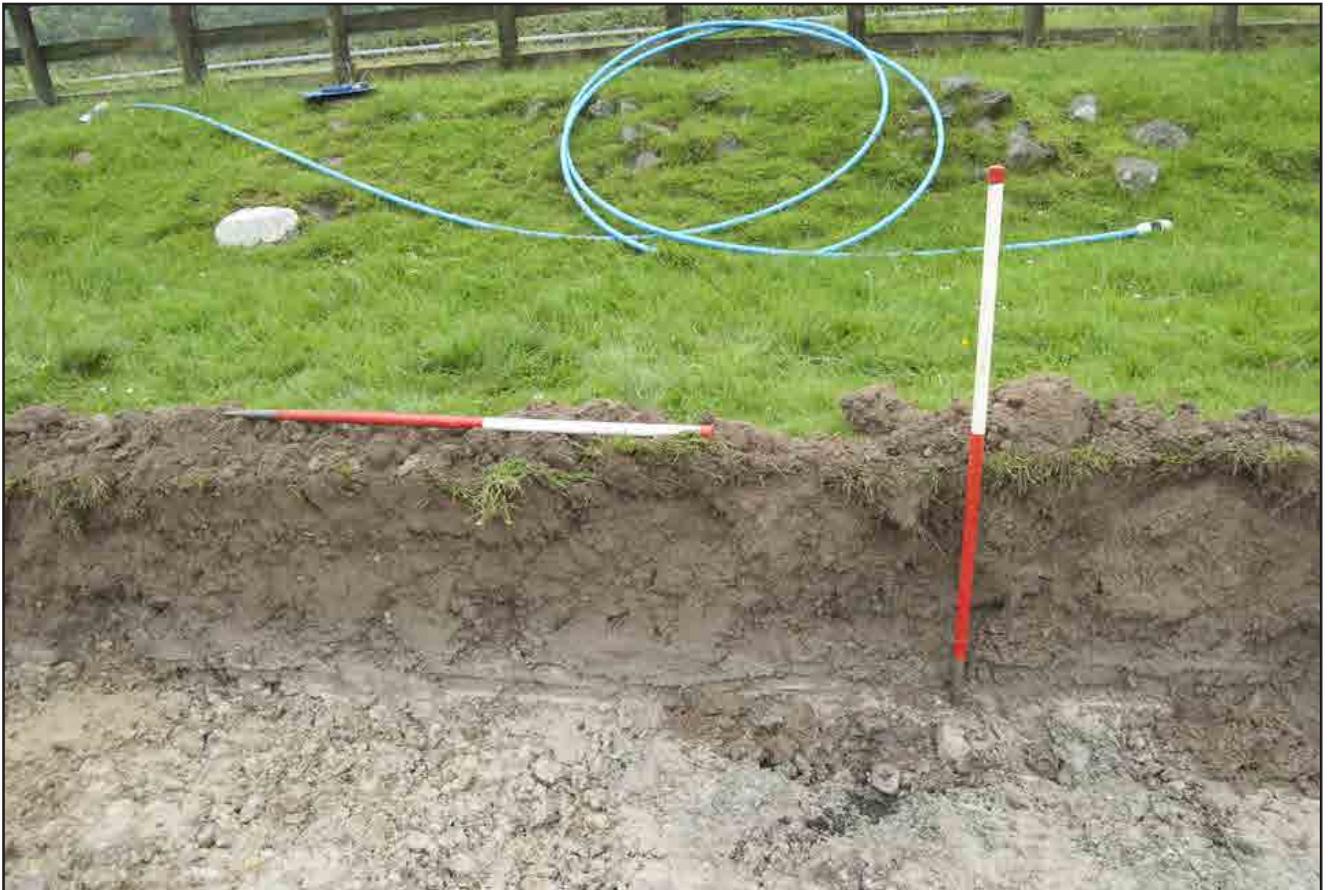
The topsoil **(0201)** in Trench 02 was 0.20m deep, and overlay a 0.35m deep layer of subsoil **(0202)**, a light brownish grey silty clay with occasional small sub-rounded and sub-angular stones. An alluvial deposit of soft, slightly blueish grey slightly sandy clay with very occasional small flecks of charcoal **(0211)** was encountered below the subsoil approximately 5.5m from the NE end of the trench. The natural drift geology was exposed below these deposits at a depth of 0.30- 0.55m. In the NE and middle part of the trench the natural drift geology was recorded as **(0203)**, a compact, light grey clay with occasional veins of cobbles and orange clay deposits. There was a change to the natural drift geology approximately 3m from the SW end of Trench 02 coinciding with the SW limit of the overlying alluvial clay **(0211)**. The natural drift geology here changed abruptly to a deposit of loose, coarse orange pebbles and gravel with very occasional lenses of clean, very fine, mid grey sand **(0204)**.

Plate 05: NW facing baulk section of Trench 02, viewed from the NW (scale: 2x1m; archive image: G2424\_PCTT\_2016\_007).

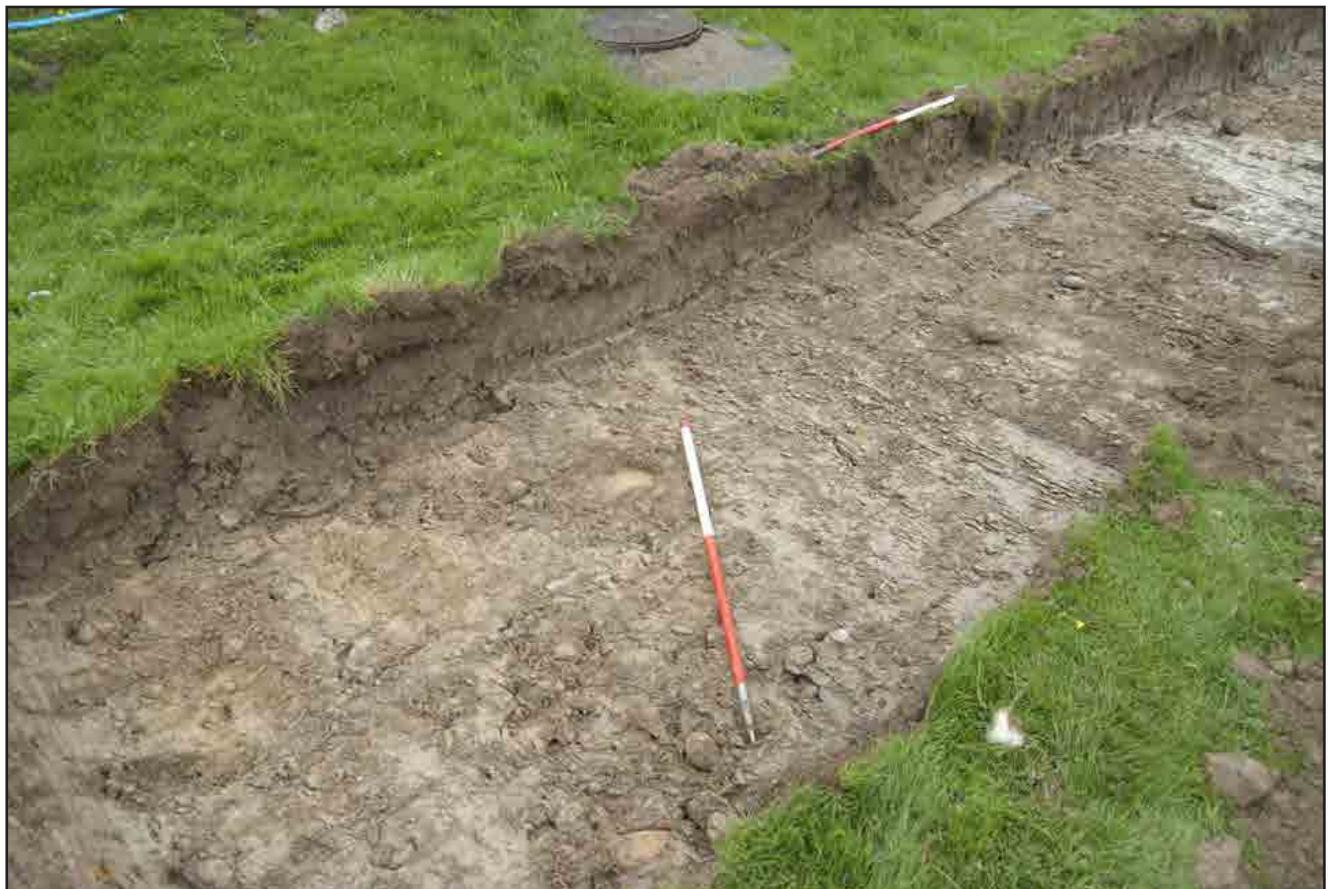
At this NE end of the trench, the 0.50m wide straight linear cut of a modern land drain **[0210]** was visible cutting through the subsoil **(0202)**. It emerged from a presumed junction with the manhole to the SW and ran NE towards the farmhouse at Wig. The drain contained a modern orange ceramic pipe **(0206)** at a depth of approximately 0.30m below the current ground surface (Plate 06).

Plate 06: View of ceramic drain pipe (0206) in Trench 02, viewed from the NNE (scale: 2x1m; archive image: G2424\_PCTT\_2016\_009).

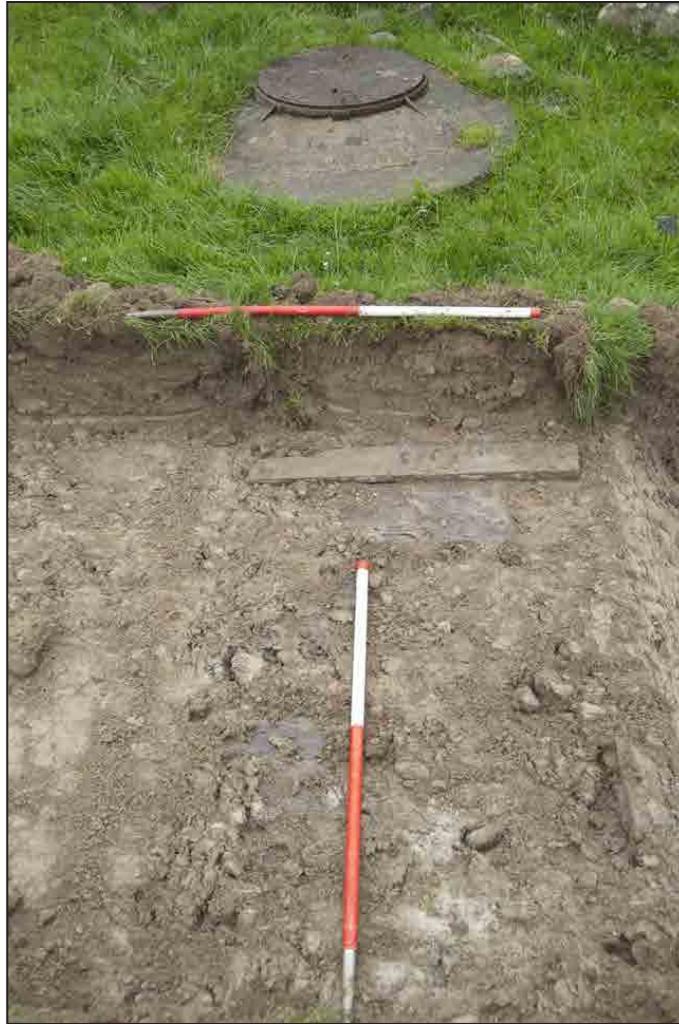
A modern circular cast iron manhole cover, set in a sub-circular concrete surround approximately 1.60 m in diameter, was located on the S side of the trench, set back approximately 0.40m from the baulk and 3.30m from its NE end (Plate 07).

A 0.80m wide stone culvert **(0205)**, the visible portions of which were constructed from horizontally laid flat slabs of slate, also appeared to be associated with the manhole (Plate 07). It was constructed within cut **[0209]** and lay below the topsoil at a depth of 0.30m. It was located just to the south of drain **[0210]** and ran across the trench in a straight linear fashion from the manhole to the SSE in a NNW direction towards the millpond and building that houses the remains of the water wheel at Wig (Plate 08; Plate 09).

Plate 07: View of slate capped culvert (0205) and manhole cover in Trench 02, viewed from the NW (scale: 2x1m; archive image: G2424\_PCTT\_2016\_008).

The slate culvert (**0205**) appears to be part of a Post-medieval water management system. The collapsed remains of most likely the same culvert were identified 50m to the NW at the edge of the field, the water emerging from it and feeding into a disused mill pond (Plate 08). A leat from the mill pond still carries water NW to the location of the disused water wheel. The observation that the culvert is still actively carrying water means that, unless replaced there by a more recent pipe, it may also survive underneath the present carriageway of the A55 to the SE.

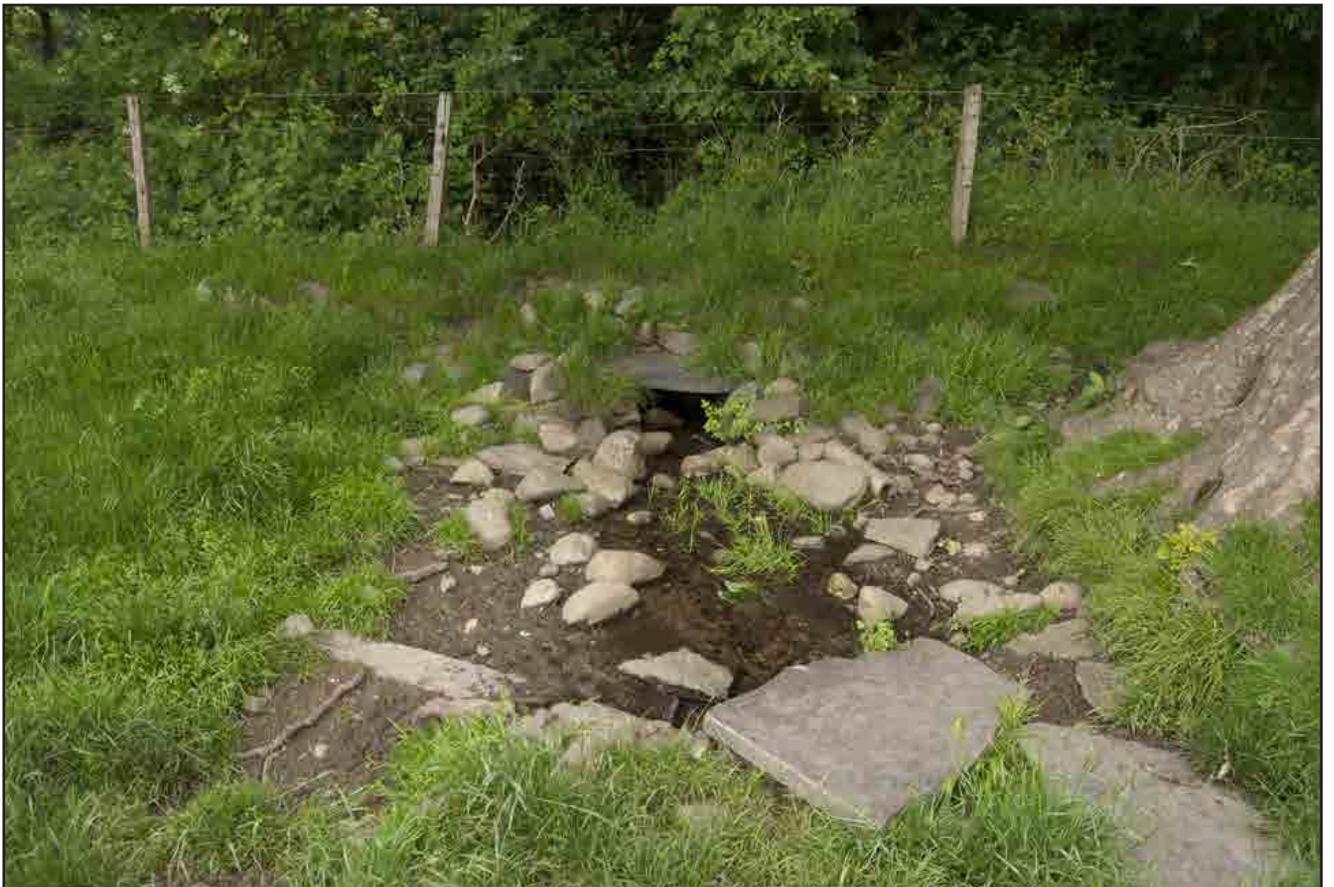
Plate 08: Probable continuation of slate culvert (recorded as 0205) at NW side of field, viewed from the SSE (archive image: G2424\_PCTT\_2016\_027).

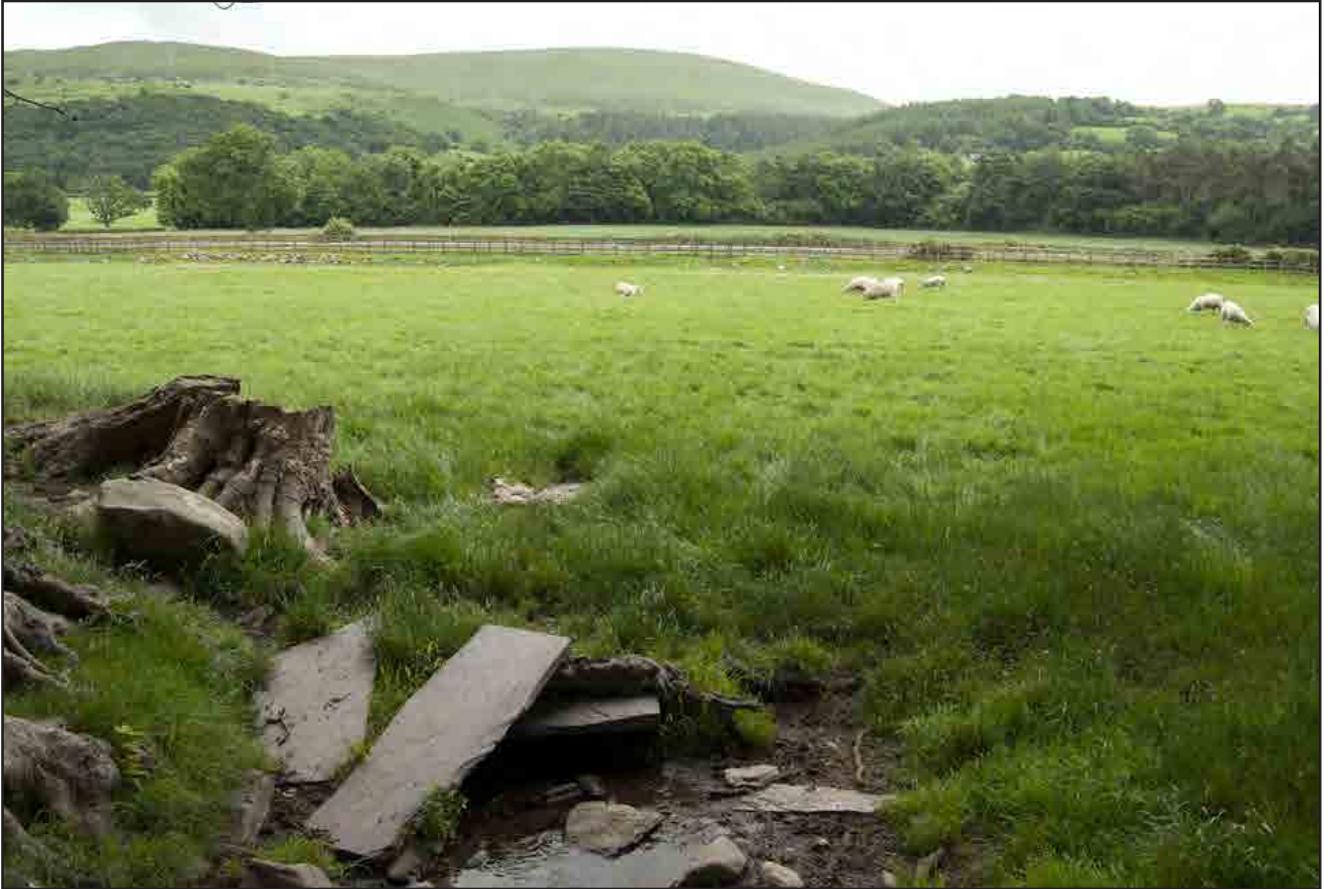
Plate 09: View from culvert SE across field towards manhole cover and Trenches 02 and 03, viewed from the NW (archive image: G2424\_PCTT\_2016\_028).

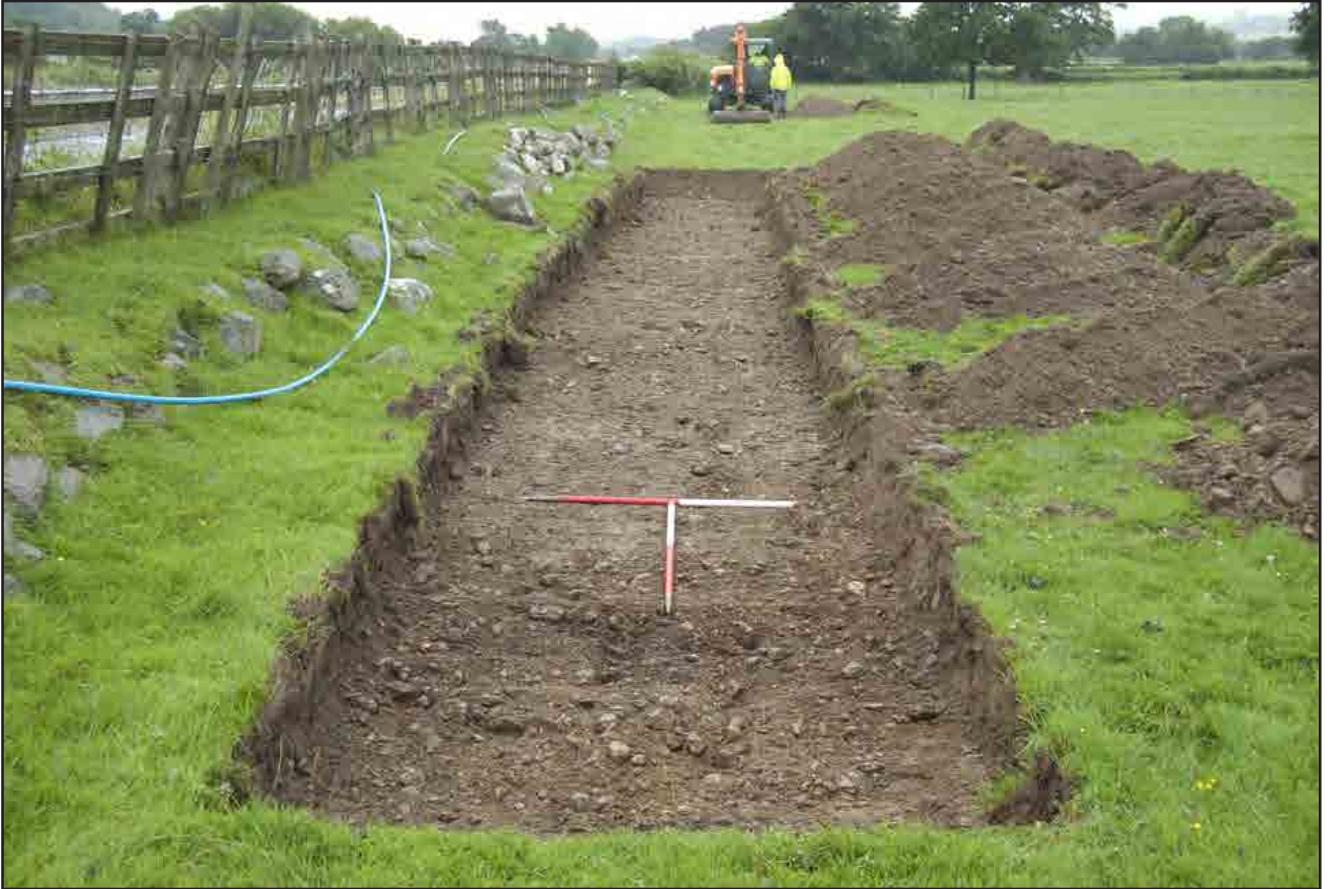
Plate 11: Post-machining shot of Trench 03, viewed from the NE (scale: 2x1m; archive image: G2424\_PCTT\_2016\_005).

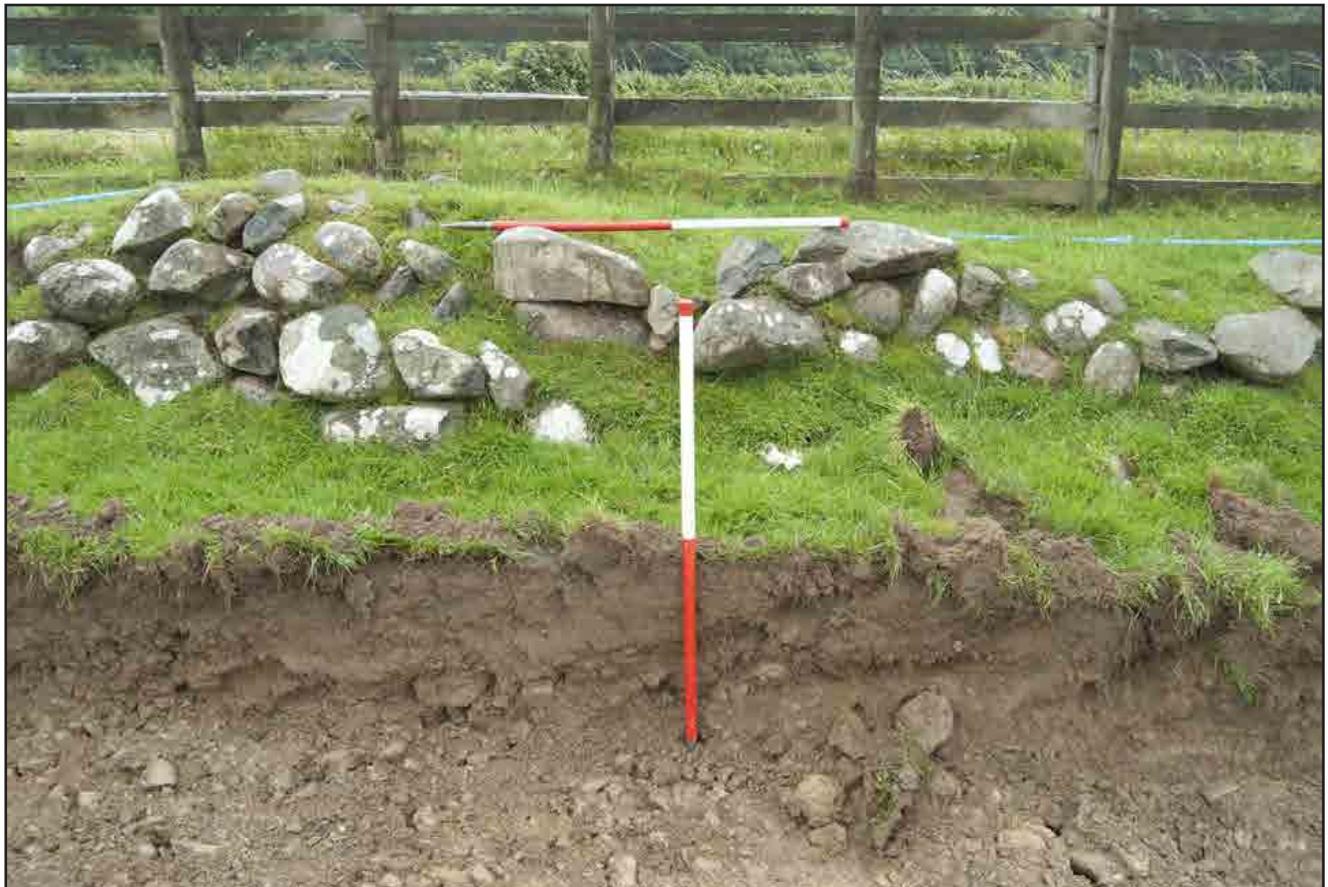
A 0.20m deep layer of topsoil **(0301)** was visible above the subsoil **(0302)**, a 0.20m deep layer of light brown silty clay with occasional small stones. Natural drift geology **(0303)** was encountered at an average depth of 0.40m below the present ground surface and consisted of a compact, coarse, light greyish brown clayey gravel with frequent small sub-angular stones and occasional compact deposits of fine light grey clay (Plate12).

Plate 12: NW facing baulk section of Trench 03 with field boundary in background, viewed from the NW (scale: 2x1m; archive image: G2424\_PCTT\_2016\_004).

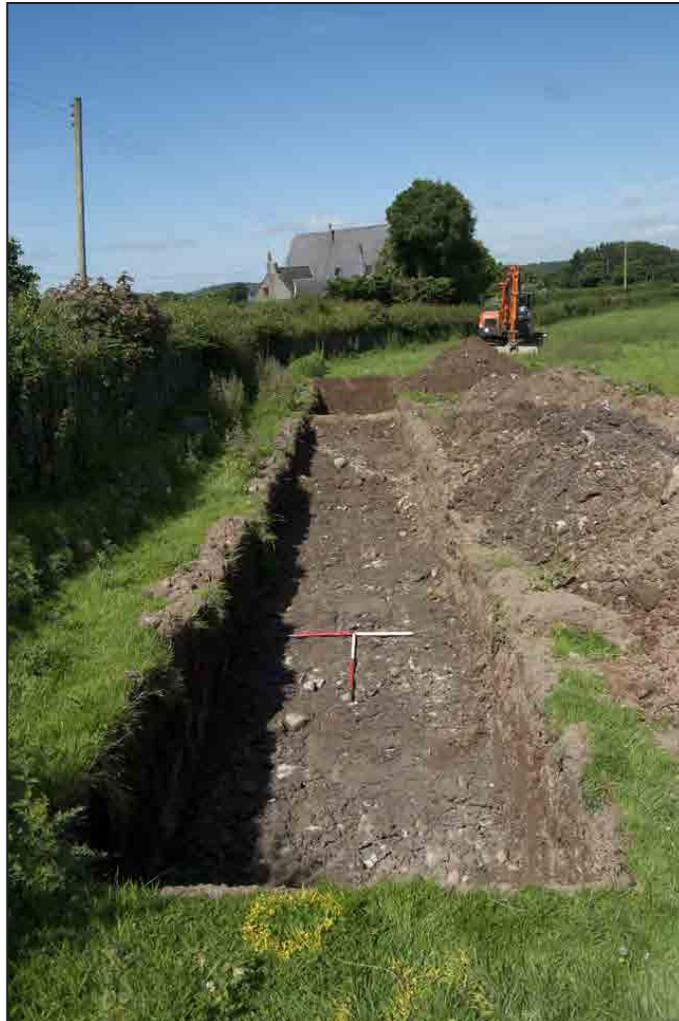
Plate 14: Trench 04 post-machining, viewed from the ESE (scale: 2x1m; archive image: G2424\_PCTT\_2016\_033).

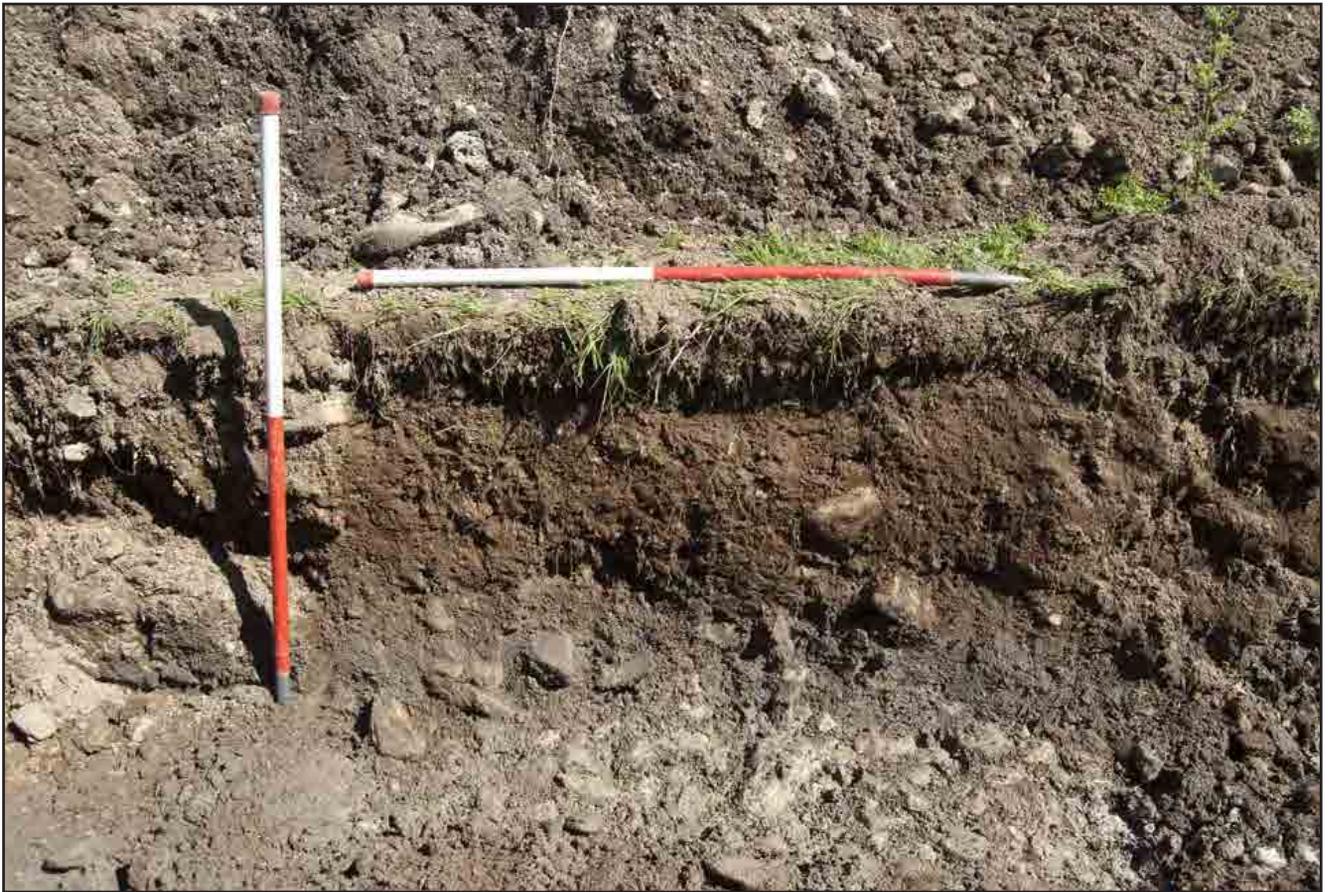
The topsoil **(0401)** in Trench 04 was 0.20m deep, and overlay a 0.35m deep layer of subsoil **(0402)**, a mid orangey brown silty clay with moderate to frequent small sub-rounded and sub-angular stones. The stones occurred in lenses across the length and width of the trench and appeared to be colluvial in origin having washed down the hillslope immediately to the S. A 0.35m deep alluvial deposit of soft, mid grey clay with moderate small to medium sized sub-angular stones **(0403)** was encountered below the subsoil at a depth of 0.55m. Natural drift geology **(0404)** lay below at 0.90m below the level of the current ground surface. It consisted of a soft light grey clay with very frequent small to medium sized sub-angular stones and cobbles (Plate 15).

Plate 15: SSW facing baulk section Trench 04, viewed from the SSW (scale: 2x1m; archive image: G2424\_PCTT\_2016\_036).

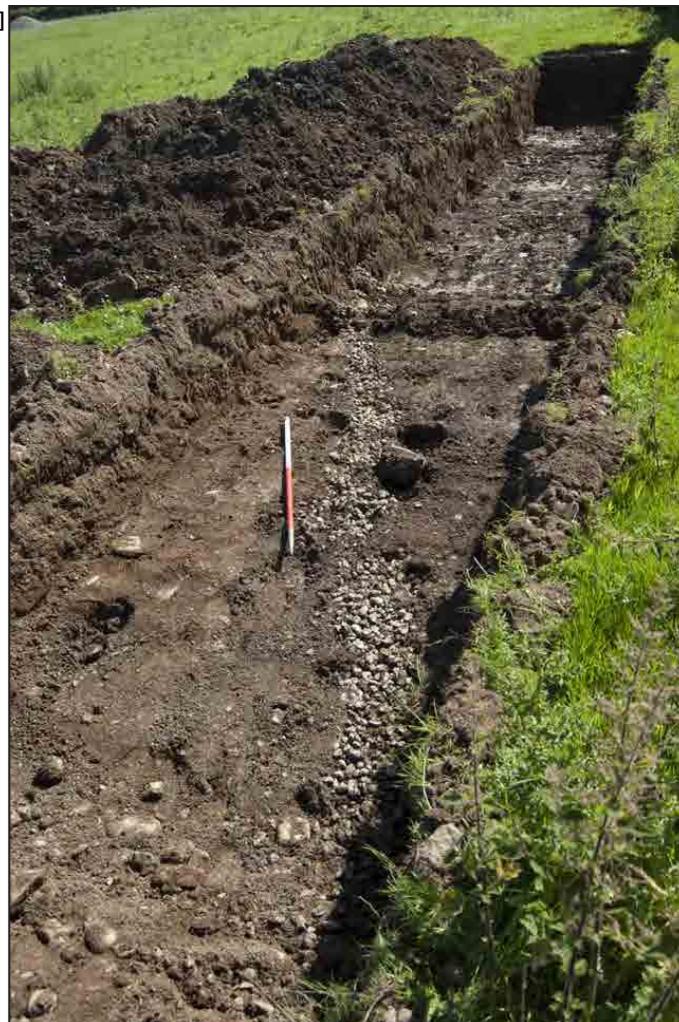
Plate 16: Modern drain [0407] with ceramic pipe, viewed from the SW (scale: 1x1m; archive image: G2424\_PCTT\_2016\_035).

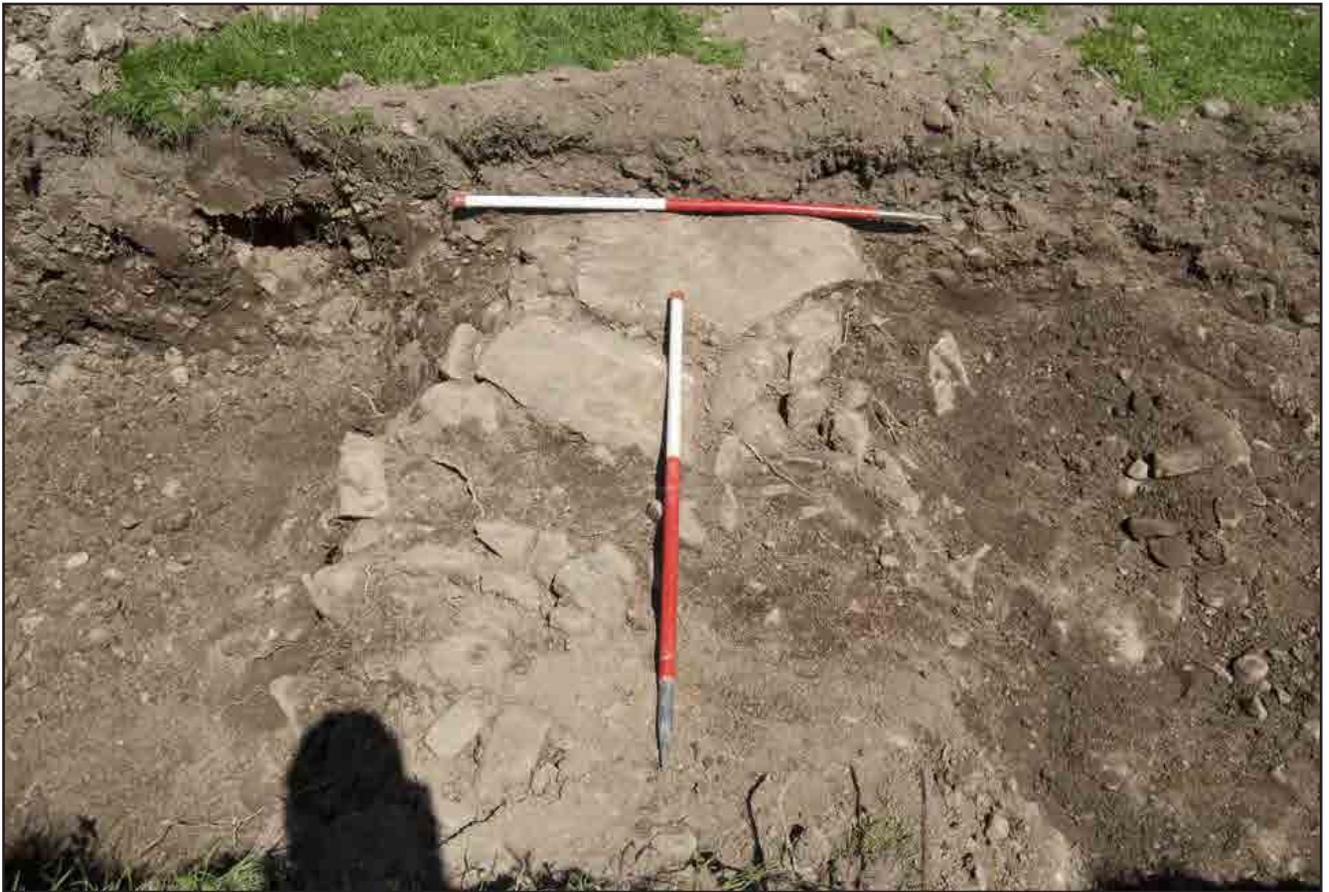
Plate 17: Earth and stone field boundary bank (0409) in Trench 04, viewed from the S (scale: 2x1m; archive image: G2424\_PCTT\_2016\_037).

**(0409)** was not observed within the trench. No field boundary in this location could be positively identified on historic mapping, and it almost certainly predates the large scale re-organisation of local field boundaries that occurred during the 19<sup>th</sup> Century (McNicol, 2015b).
