# BWYTHYN FERRYMAN, PORTHAETHWY / FERRYMAN'S COTTAGE, MENAI BRIDGE

Lliniaru Archeolegol /Archaeological Mitigation  
Cofnodi Adeiladu/Building Recording

Prosiect Rhif / Project No. G2623

Adroddiad Rhif / Report No. 1511

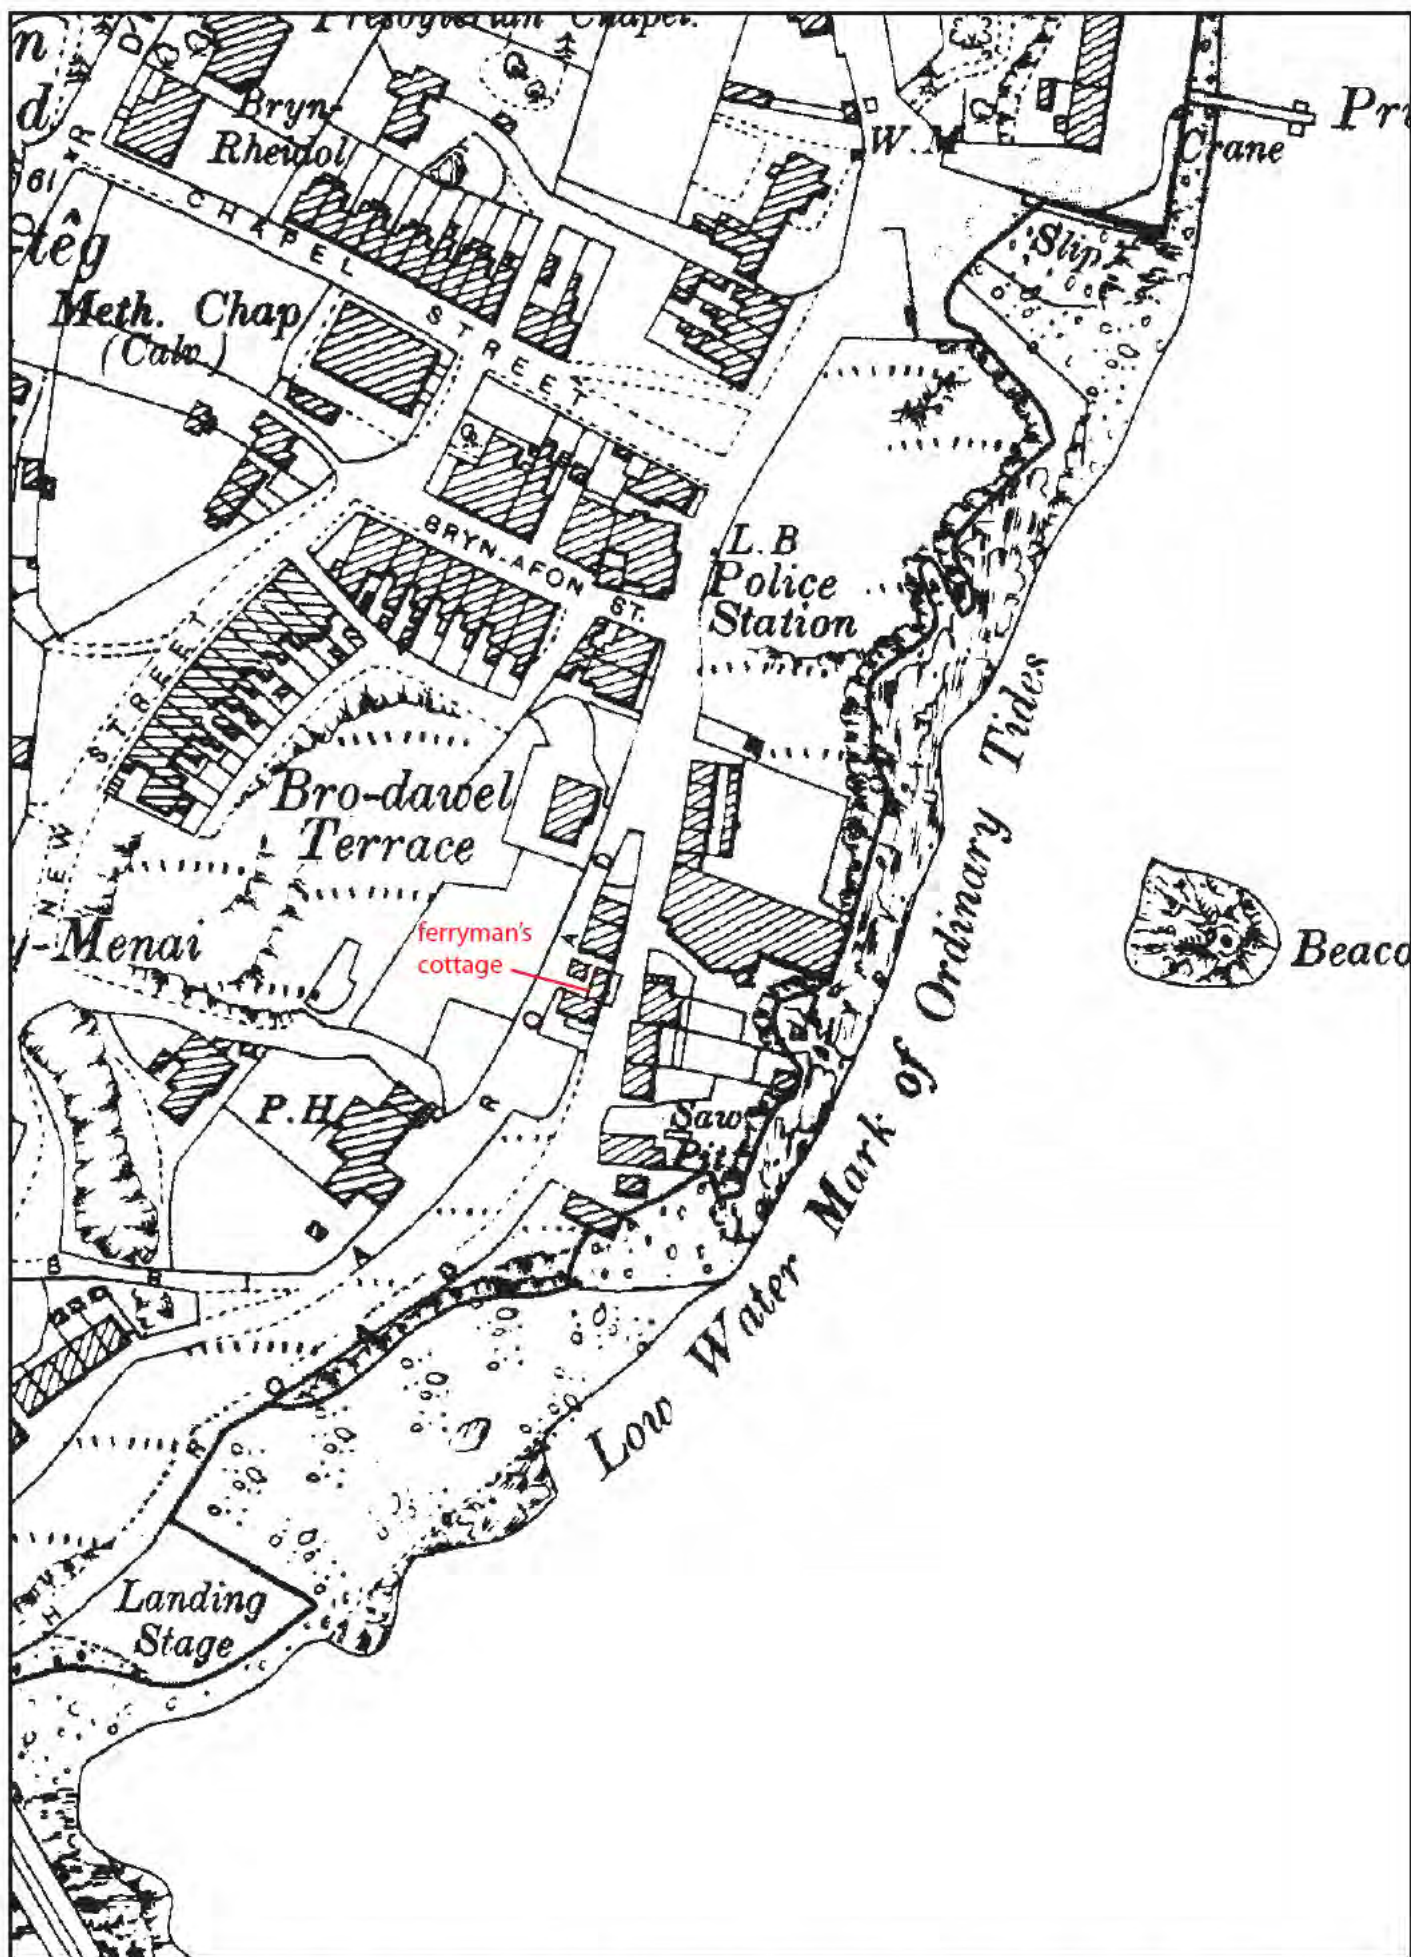
FIGURE 06: Reproduction of Ordnance Survey Second Edition 1-inch to 25-mile County Series Map Sheet XIX.11; published in 1900. Scale 1:1500 @ A4.

The First to Third Edition Ordnance Survey 1-inch to 25-mile County Series Map Sheets of the area (Sheet XXIX.11, 1889, 1900 and 1912 respectively), all show the property clustered amongst a small group of buildings. A smaller building, probably an outbuilding, is shown to the rear of the cottage on all editions (cf. Figure 06 for a reproduction of the 1900 second edition map). This outbuilding is no longer visible at surface level, but may exist at foundation level or as demolished material.

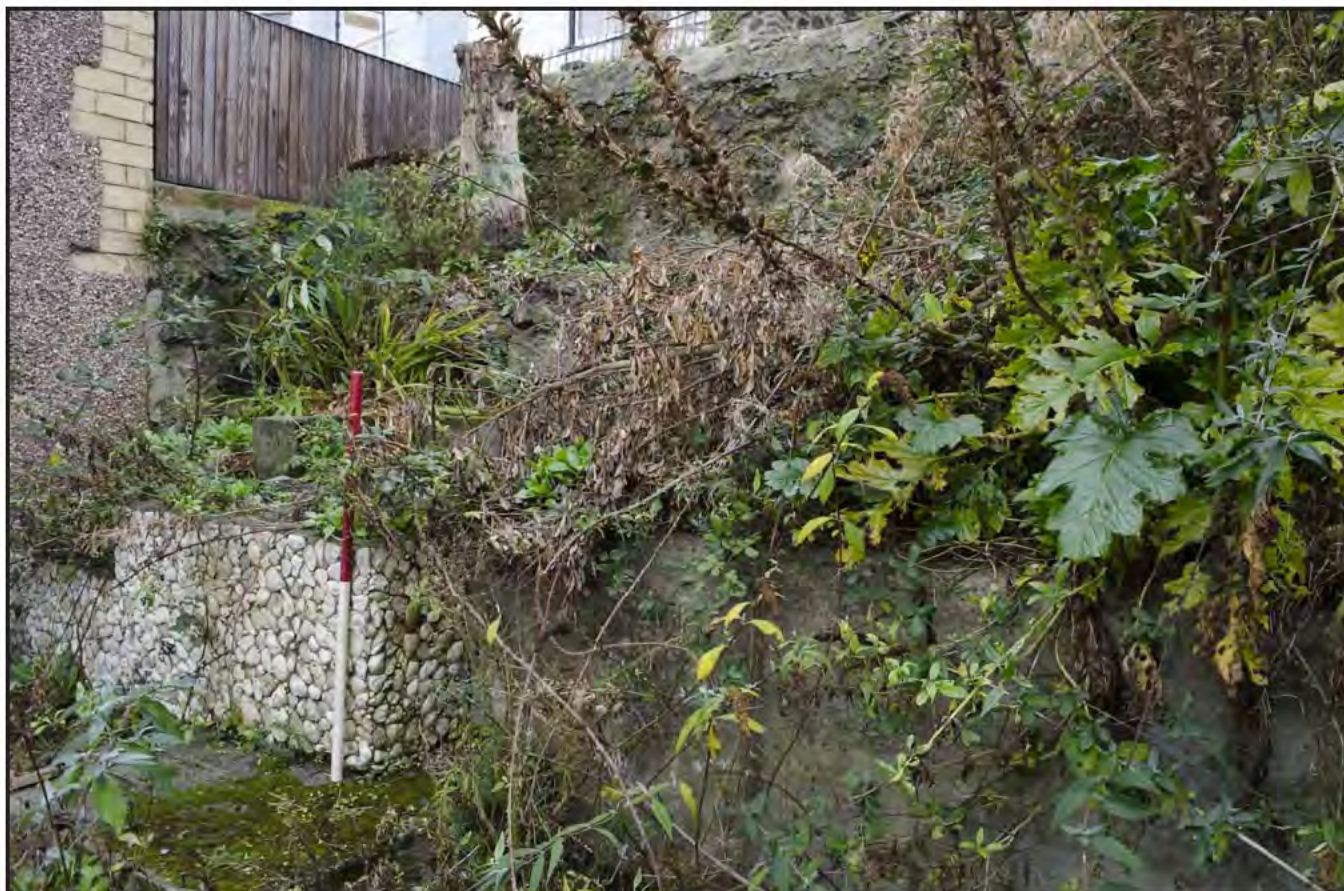
Plate 05: Back garden of the cottage; scale 1x1m; (archive reference G2623\_026).

stepped, with a concrete surface and an overgrown border that was defined by a plastered concrete wall, with a section of the wall also covered in sea shells (Plate 05).

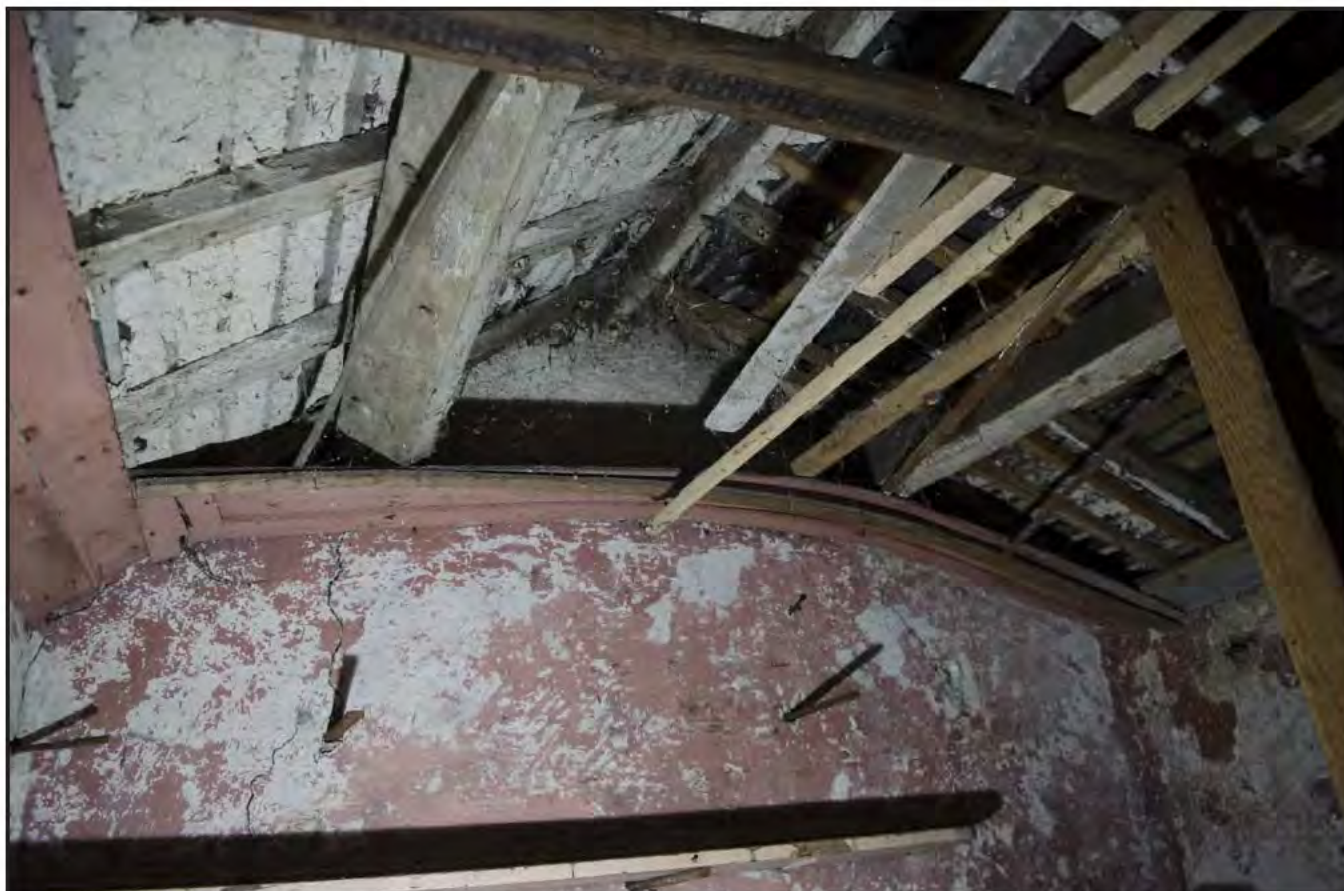
Plate 07: Ceiling and roof at south end and south wall; (archive reference: G2623\_020).

The interior of the cottage consisted of a single room that measured 3.91m in length, 2.27m in width, with a maximum ceiling height of 2.55m. The walls were covered in a rough lime plaster which retained fragments of red paint, with the greatest concentration above a fireplace on the northern wall (Plate 06). The floor consisted of poured concrete, with a stone slab hearth adjacent to the fireplace. The ceiling of the cottage was comprised of lathe and plaster. The plaster had decayed with visible gaps between the lathe and slates of the roof visible. The ceiling and roof was held in place by three wooden beams, one at the centre/apex of the roof, with the other beams situated at the eastern and western elevations. The beams extended north-south along the length of the cottage, being set within the walls of the north and south elevations. The beams on the eastern and western elevations were approximately 0.20m wide and 0.07m deep. At the southern end of the cottage a support beam extended from the floor to a cross beam to support the roof beams. The timber used for the support and cross beam was modern, factory cut pieces of wood, most likely deployed as a temporary support for the sagging roof of the cottage. Concentrated along the base of the ceiling and top of the walls wooden planks were evident. The planks were painted red, which at the time of the survey had faded and were attached to the lathes. They were most evident above the window in the eastern elevation and those along the southern elevation were curved. The planks may have formed the inner lining of the ceiling and would have covered the now exposed lathes and plaster (Plates 07 & 08).

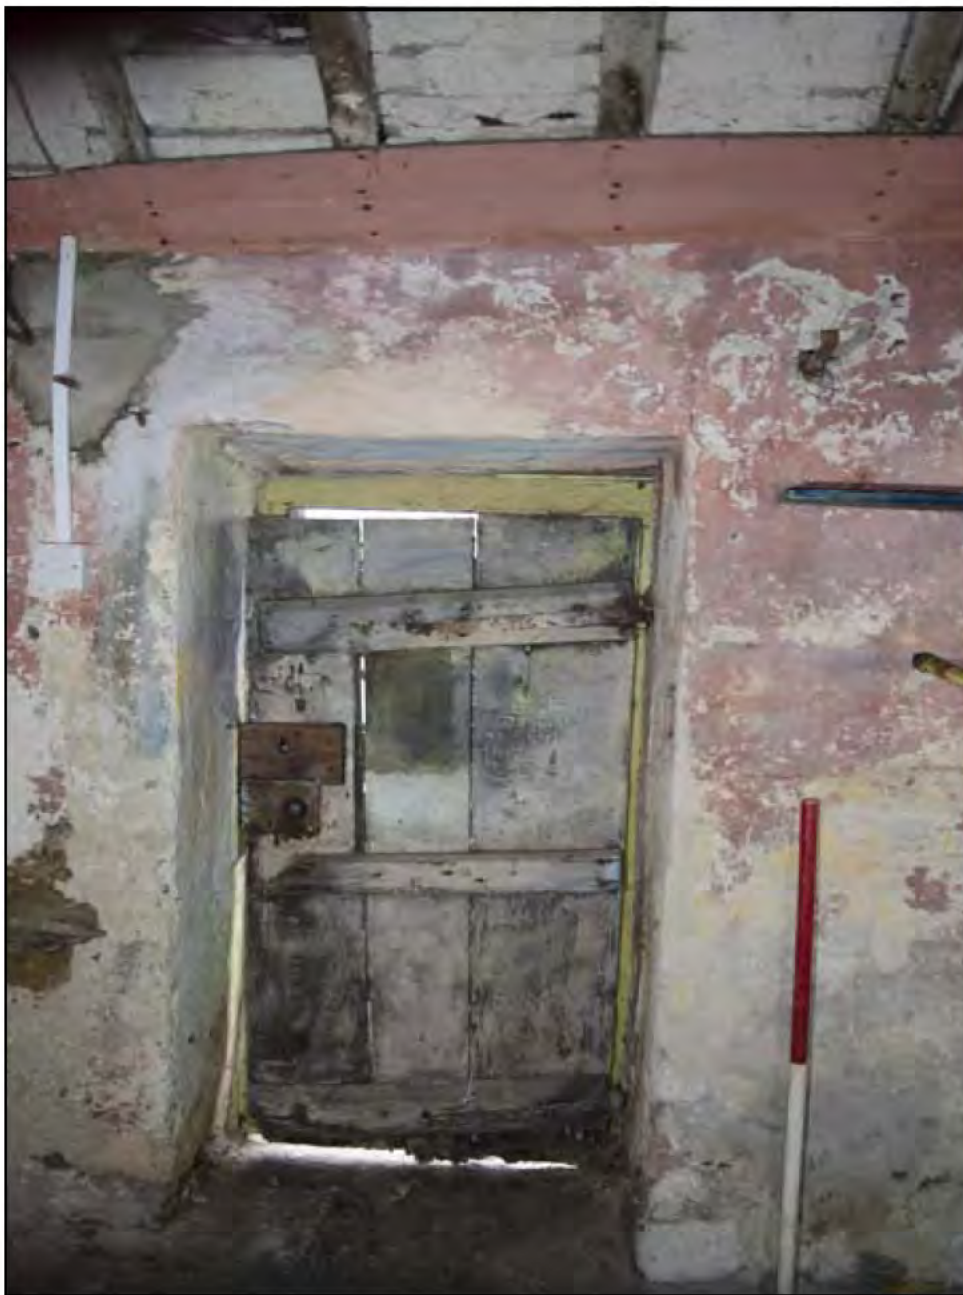
Plate 09: View of front door in eastern wall; scale: 1x1m (archive reference G2623\_016).

The door consisted of three vertical wooden planks, held in place with three horizontal planks of wood (Plate 09). The door was quite dishevelled and worn, measuring 1.5m in height and 0.77m in width. There were the rusted remains of two door locks, one of which had a rounded door handle. It was hung off the doorway with two large metal hinges. The doorway was 1.67m high and 0.84m wide, with a wooden doorframe.

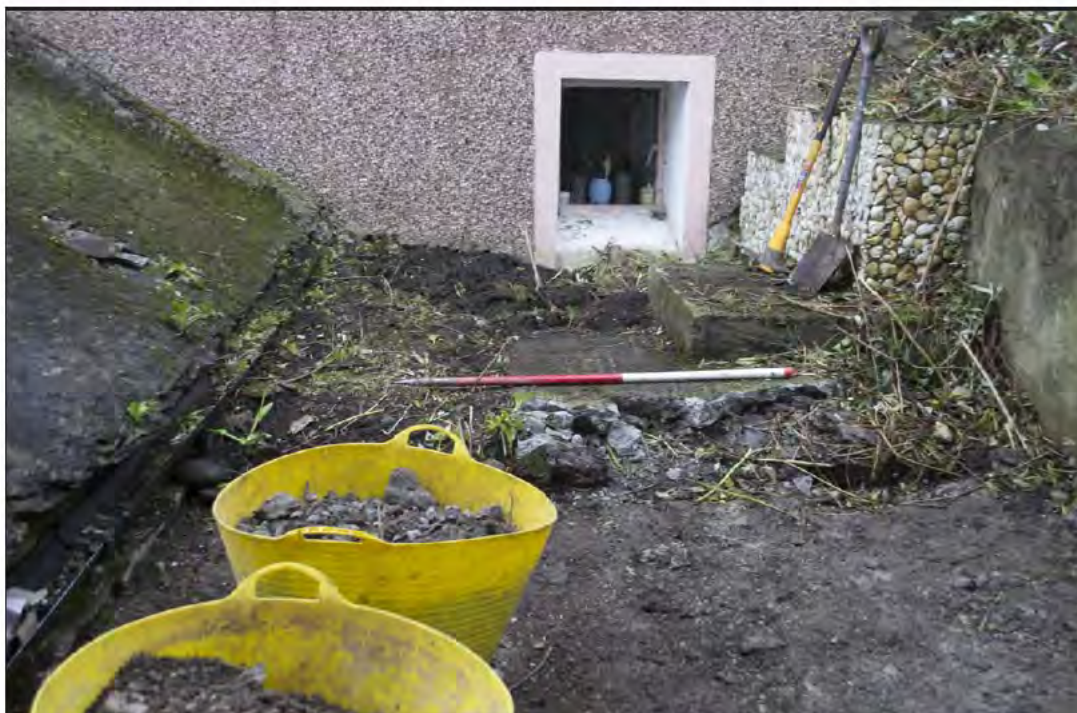
Plate 16: View of rear of the building after concrete was removed; scale: 1x1 m (archive reference: G2623\_031).

The groundworks at the rear of the cottage were all completed by hand, using a mixture of hand tools and hand held pneumatic tools. When the concrete yard at the immediate rear of the cottage was removed a layer of mixed rubble (Plate 16) (mixture of brick and stone fragments along with pieces of mortar) was exposed and also removed onto natural bedrock. This was the same make-up for the steps at the side of the cottage, along the northern elevation. The concrete was removed to reveal a mixture of insitu angular stones, which corresponded with some of the steps noted in the building record, along with a mixture of brick fragments and pieces of mortar (Plate 17).
