## PONT BODFEL, PWLLHELI, GWYNEDD

### ASESU A GWERTHUSO ARCHEOLEGOL / ARCHAEOLOGICAL ASSESSMENT AND EVALUATION

Prosiect Rhif / Project No. G2644

Adroddiad Rhif / Report No. 1526

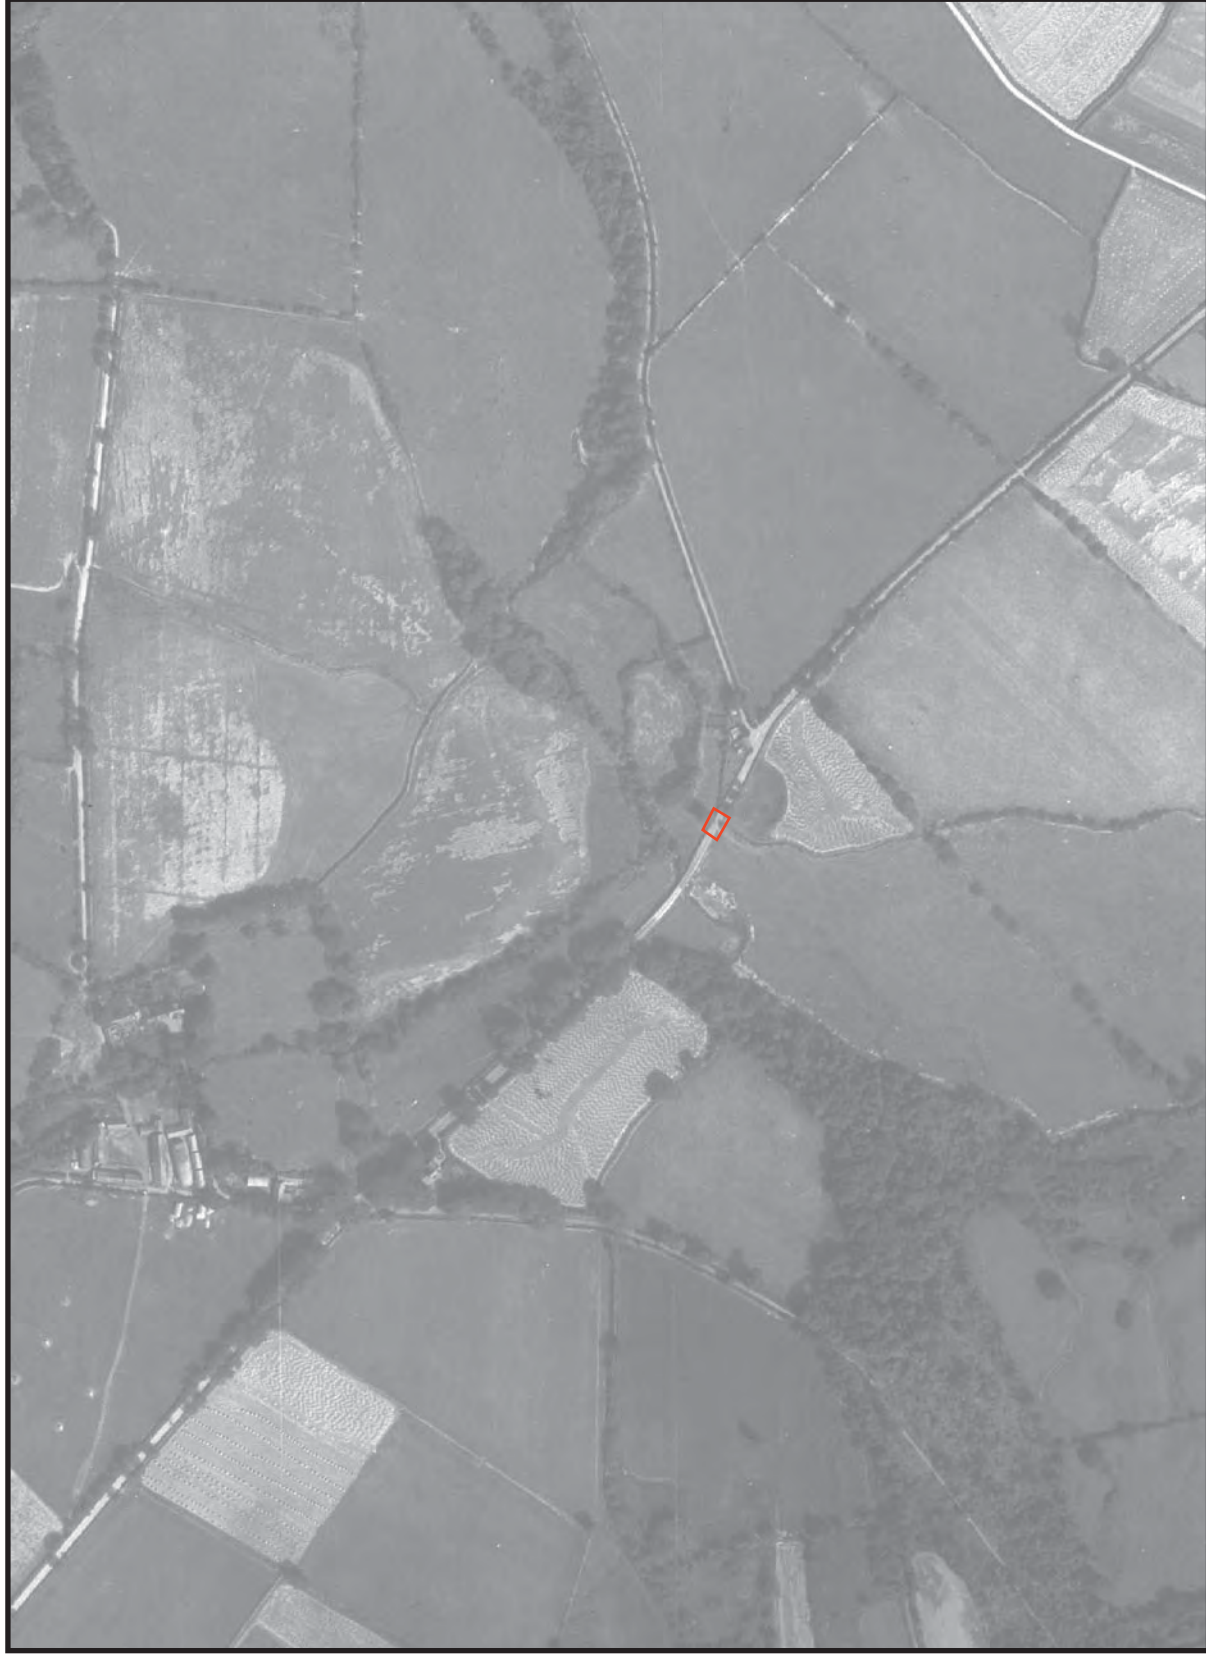
Figure 09: Detail from aerial photograph RAF 4535 106UK\_664 Image 4179, taken on 14th August 1945, showing Pont Bodfel (outlined in red).  
Not to Scale.

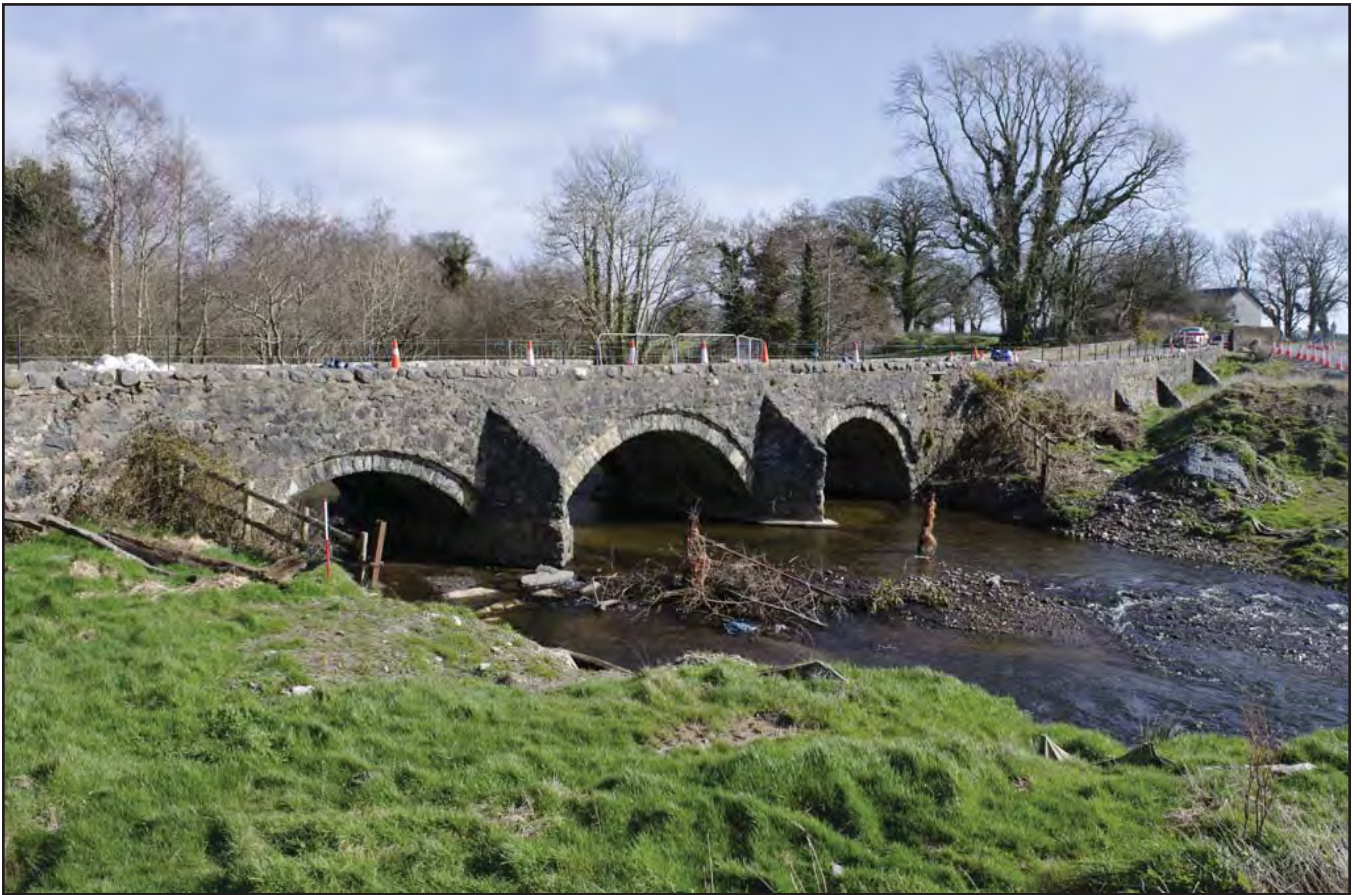
The rubble stone built bridge is set out on a broad curve over the wet valley bottom of the Afon Rhyd Hir, and comprises three segmental arches of shaped rubble voussoirs inset below flush spandrels and parapet (Plates 1, 4 and 10). The cutwaters on both sides are angled back to the base of the parapet, which continues as a parapet with stone copings to the causeway at both ends. The main bridge spans approximately 5.85m rising 2.5m above the river, affording a carriageway of 4.75m wide plus parapets of 60cm depth (Plate 11). The bridge can be seen to have had recent concrete repairs to the eastern cutwater at river level, and concrete supports have been placed at river-bed level (Plate 04). A 3m long section of damage, including both the parapet and the sides of the bridge itself was noted at the north east end of the parapet (Plate 10). The carriageway as it approaches the bridge over the low-lying ground is placed on a raised embankment revetted by parapet walls, which have had to be supported in recent times with buttresses (Plate 03). The new temporary bridge is situated to the south of Pont Bodfel (Plate 02).

Plate 1: G2644\_Pont\_Bodfel; scale SW; view of south side of Pont Bodfel showing concrete repair to the base of SE bridge cutwater (archive reference: G2644\_027).

It is recommended that an archaeological drawn and photographic building record be carried out in advance of any repair work to the damaged parapet of Pont Bodfel, as it is a listed building of some importance (English Heritage 2006). The south side of the bridge was

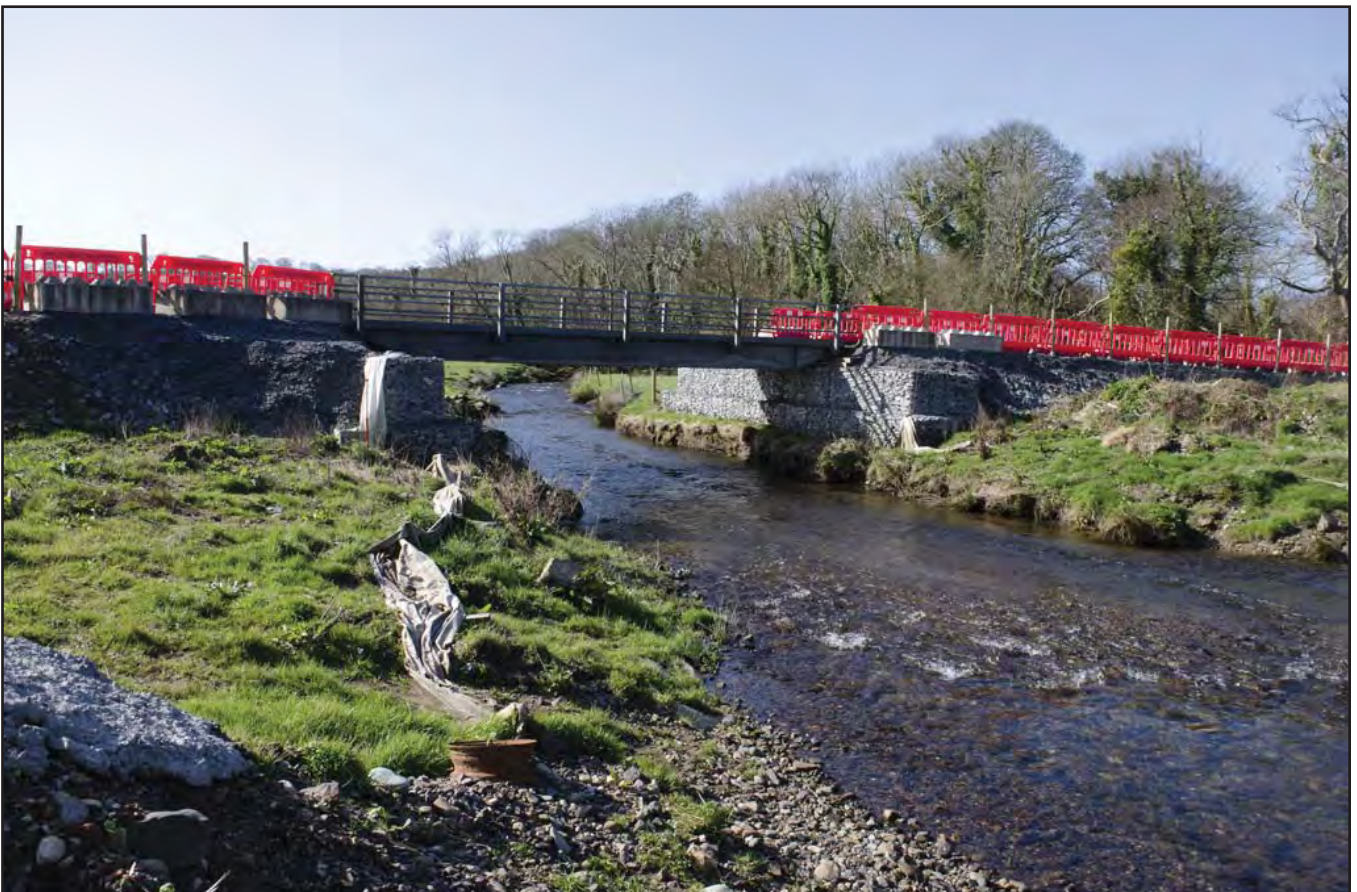
Plate 2: G2644\_Pont\_Bodfel; scale NE; view of the temporary bridge (archive reference: G2644\_024).

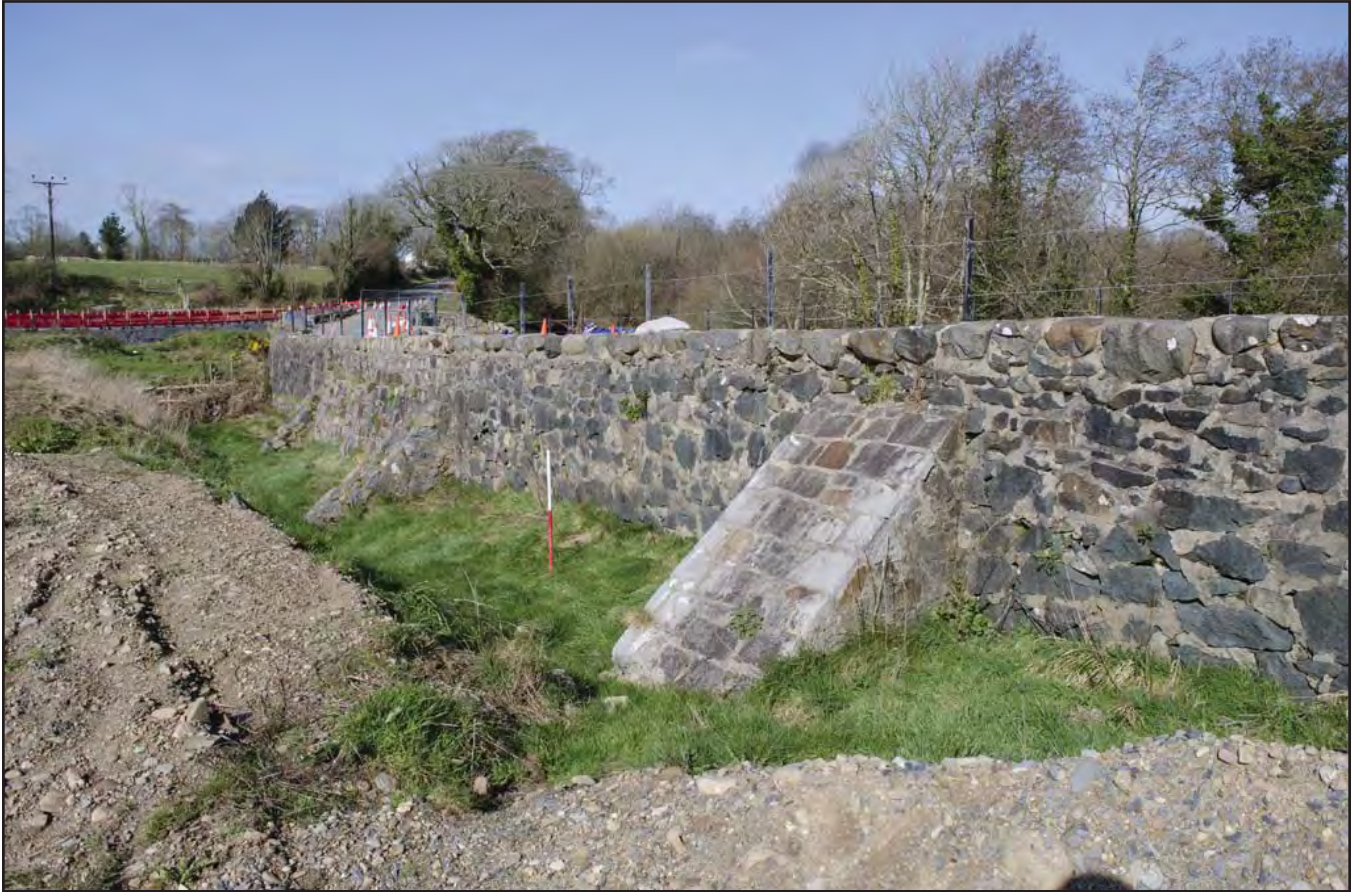
Plate 3: G2644\_Pont\_Bodfel; scale SE; view of modern buttressing on the south side of bridge approach (archive reference: G2644\_025).

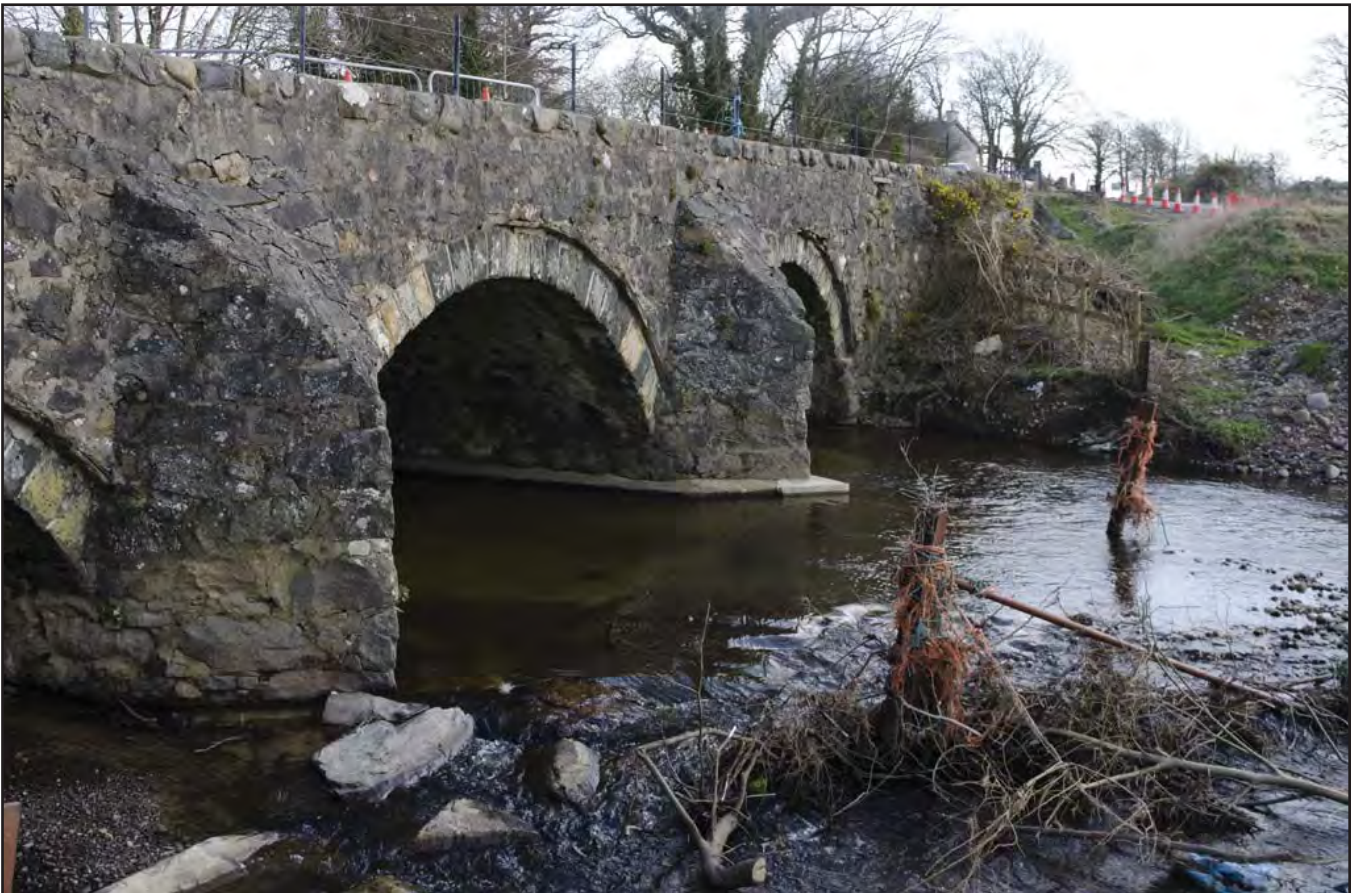
Plate 4: G2644\_Pont\_Bodfel; scale W; Angled view of bridge cutwaters on the south side, showing recent repair (archive reference: G2644\_028).

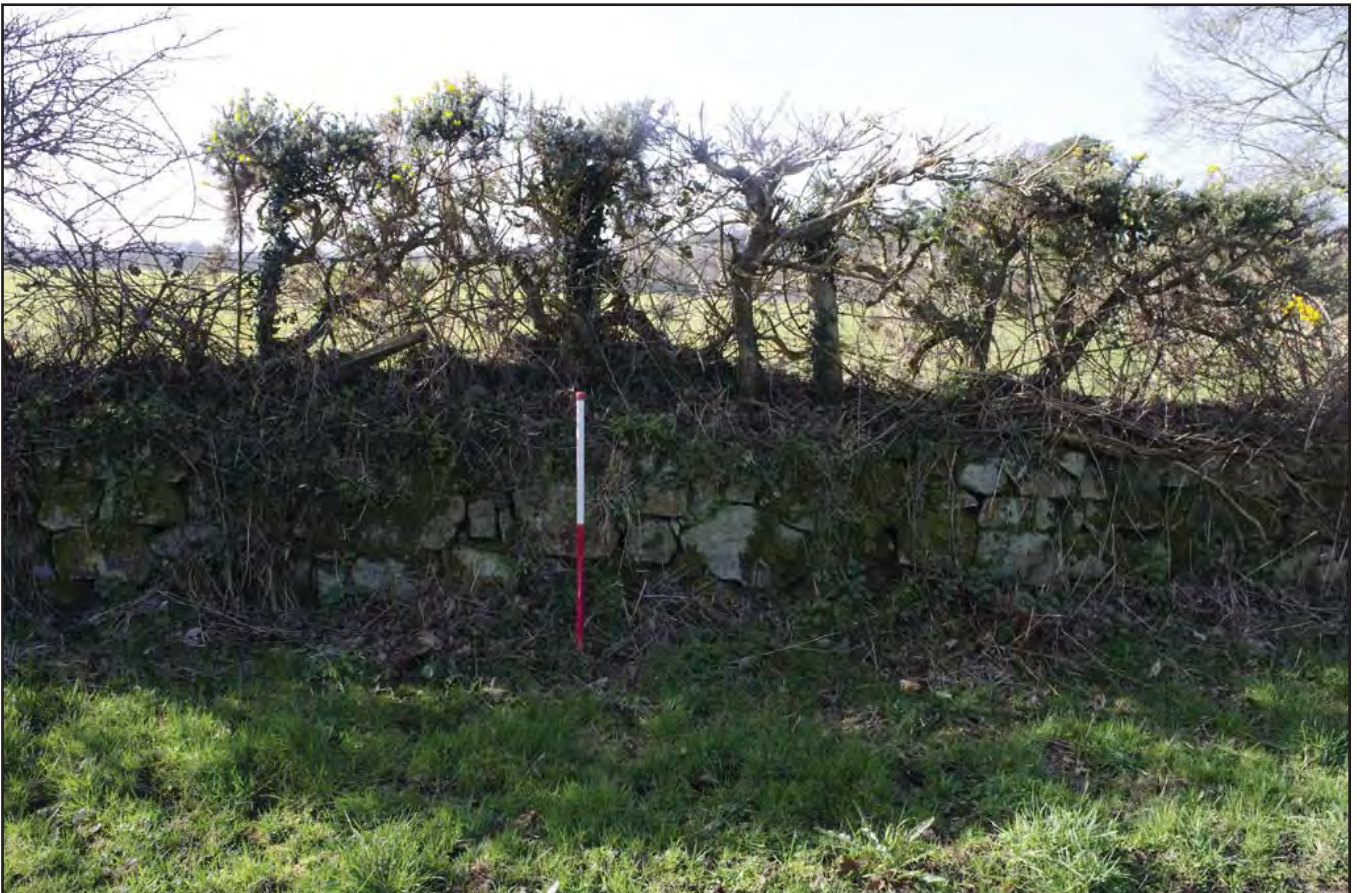
Plate 5: G2644\_Pont\_Bodfel; scale W; View along the eastern end of the proposed southern route (archive reference: G2644\_017).

It demonstrated that the fields to the south of the bridge were heavily improved pastureland (Plate 05), with the exception of Bodfel Wood, and bounded by regular enclosure era field boundaries (Plate 06). Low earthworks and a hollow in the ground provided evidence of the former gravel pit (Feature 1; Plate 13). This might otherwise have been have been interpreted as an earlier archaeological feature, but the evidence demonstrates that it is a post-medieval feature. The Felin Rhyd Hir mill race (Feature 2; Plate 12), could also be traced crossing the field.

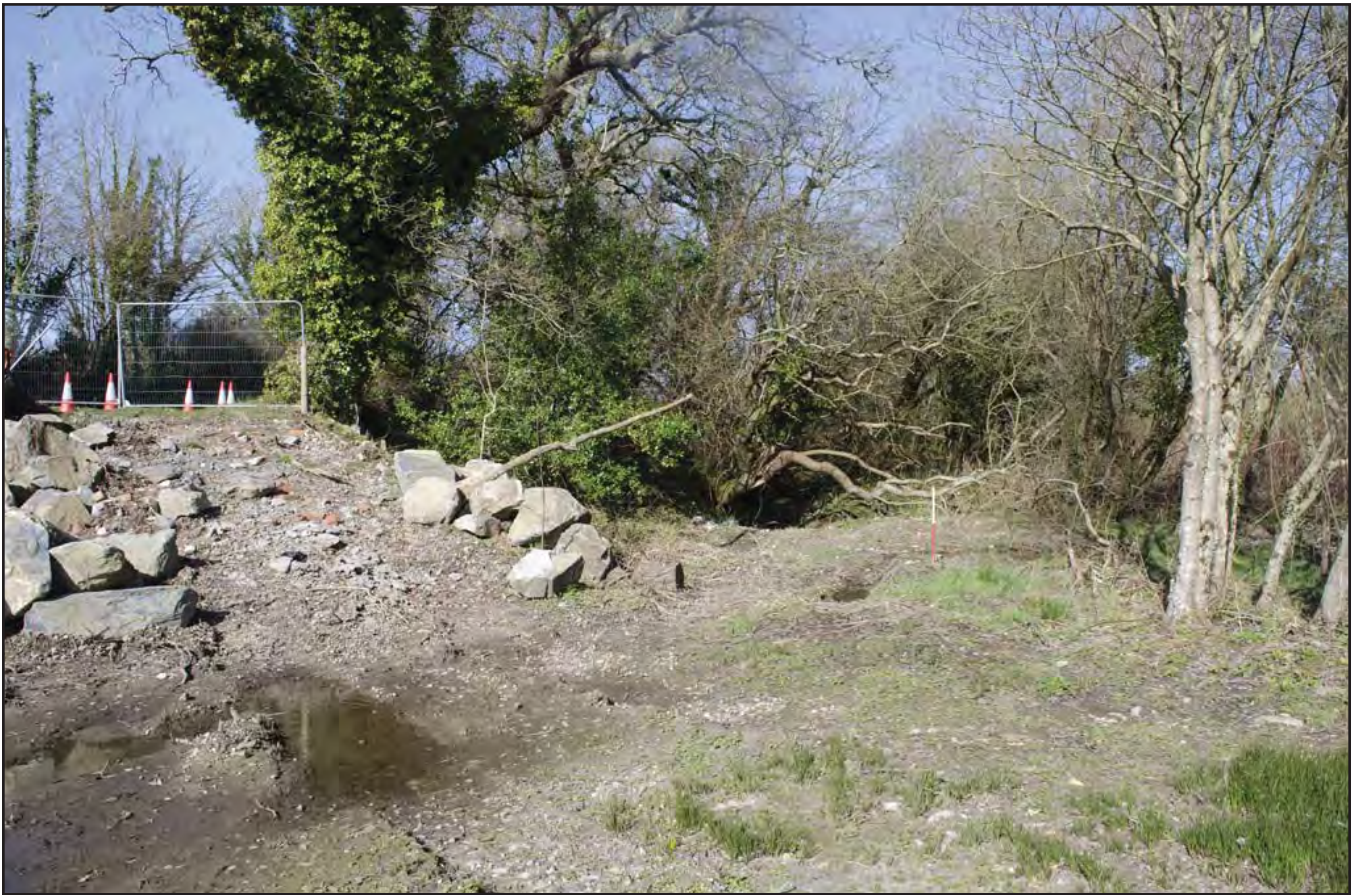
North of the bridge the situation is different. South and west of the watercourse leading from Bodfel Hall there is undergrowth and scrub in very waterlogged ground, and disturbance caused by the recent emergency engineering works (Plate 07-08). To the north and east of this, associated with Bodfel (Bach) and Efail y Bont, small irregular fields predominate (Plates 9 and 12), although there are larger ones to the north-west associated with Bodfel Hall. East of Gefail y Bont more regular, later fields predominate.

Plate 7: G2644\_Pont\_Bodfel; scale ESE; view of the wet/wooded area to the NW of the bridge (archive reference: G2644\_020).

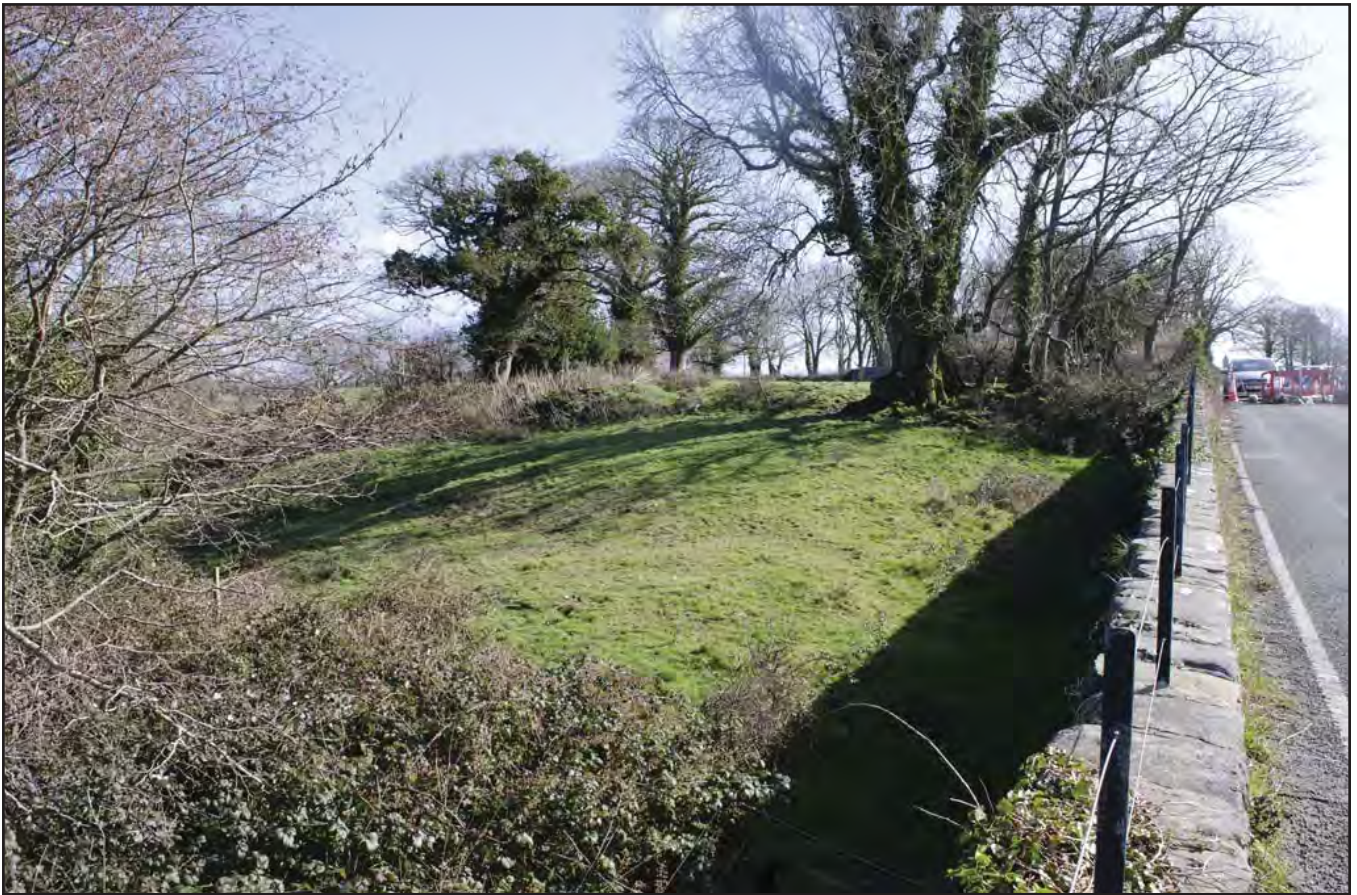
Plate 8: G2644\_Pont\_Bodfel; scale E; General view of the north side of the bridge (archive reference: G2644\_021).

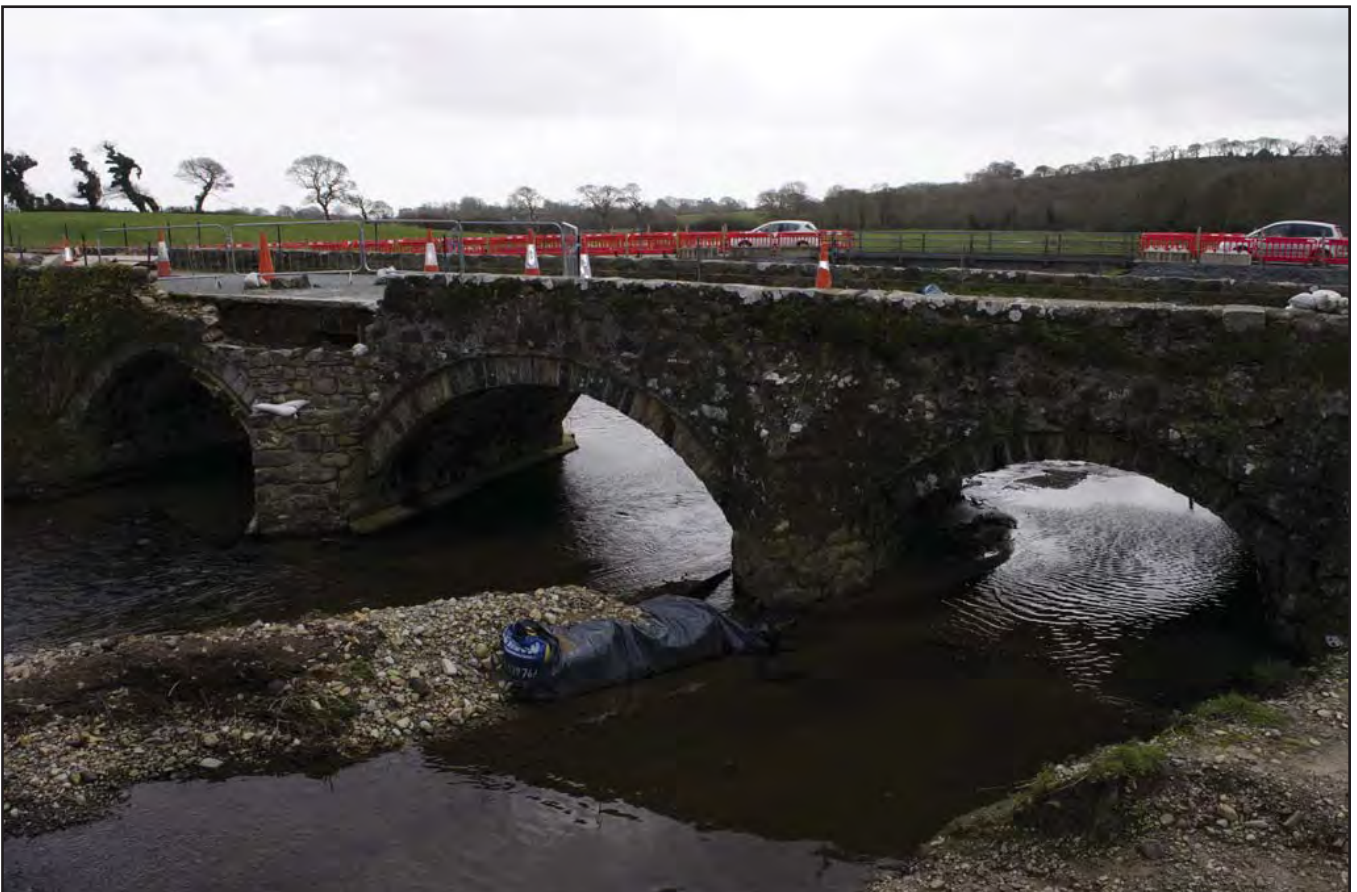
Plate 10: G2644\_Pont\_Bodfel; scale NNW; view of north side of Pont Bodfel (in better light conditions) (archive reference: G2644\_044).

recorded in 2004 (Longley 2004), however this work should be completed with an elevation drawing of the north side of the bridge. In addition to the further specific site recommendations noted in Section 3.3 and below, it is felt that there is generally insufficient evidence for the presence of archaeological features to justify carrying out a full programme of archaeological evaluation trenching along the route of the proposed new road alignment and bridge. However a 20m long and 2m wide trench should be dug in advance of ground operations across the former mill race (Feature 2), and a profile across its section drawn and recorded archaeologically; this could be carried out either before or during the carrying out of site groundworks. A comprehensive archaeological watching brief should be carried out however during sensitive groundworks across the rest of the site, with time allowed for the recording of any archaeological features identified; this would allow for sufficient recording of the quarry pit (Feature 1).

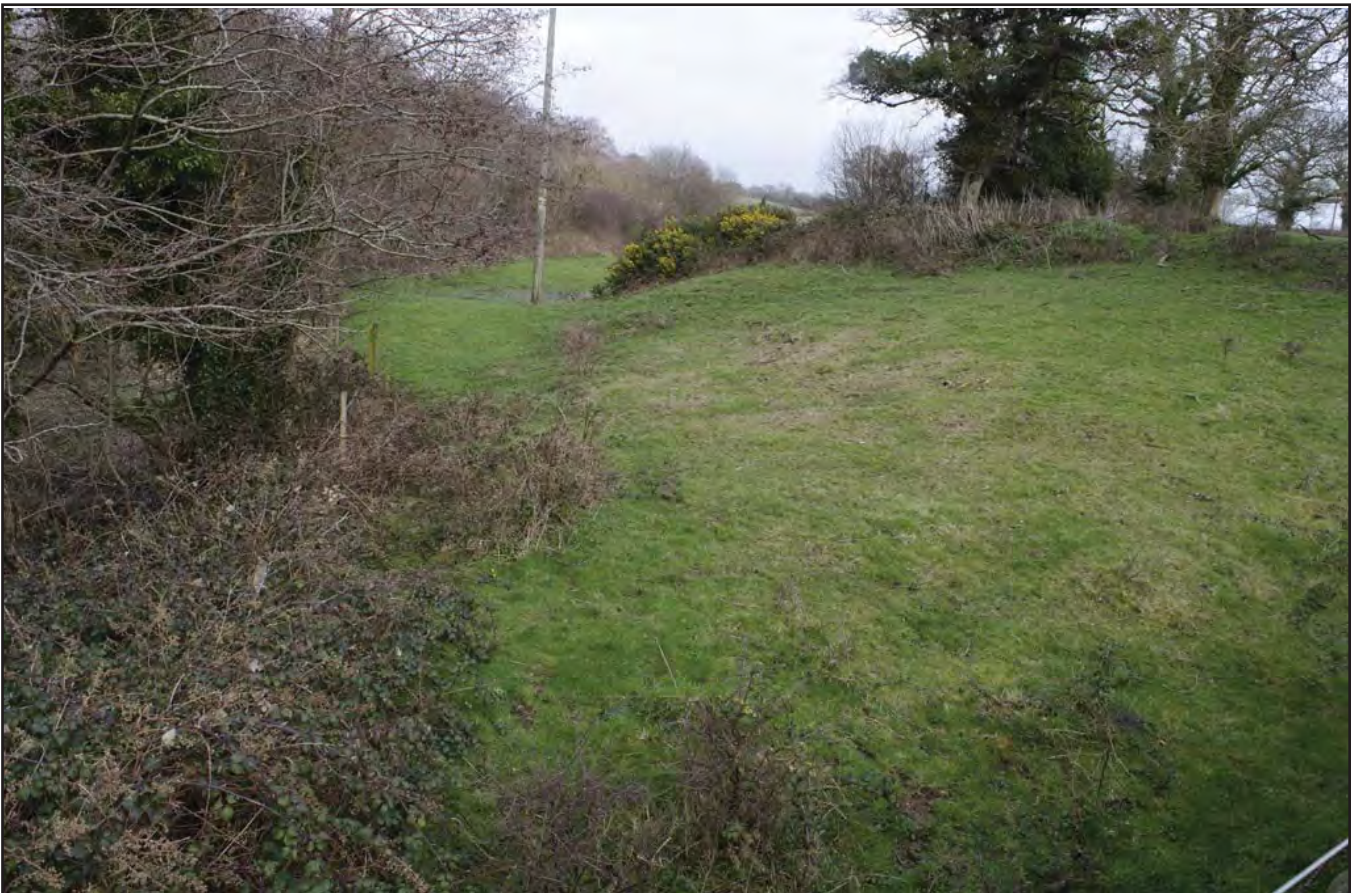
Plate 12: G2644\_Pont\_Bodfel; scale SSW; Line of former mill race (archive reference: G2644\_043).

<b>Feature Number</b>	2
<b>Site name</b>	Mill Race for Melin Rhyd Hir, east of Pont Bodfel
<b>PRN number</b>	90074
<b>Grid reference</b>	SH34333651
<b>Period</b>	Post-Medieval
<b>Site type</b>	Industrial
<b>Assessment category</b>	B
<b>Description</b>	A very long mill race that extended for 1.63km from Melin Rhyd Hir (PRN3477) to the river in the north near Melin Llannor. It survives, albeit heavily overgrown, over its course and served both mills.
<b>Impact</b>	Slight
<b>Recommendation for further assessment/evaluation</b>	None
<b>Recommendation for mitigatory measures</b>	Avoidance. If this is not possible then ensure that a scaled section across the mill race is drawn.

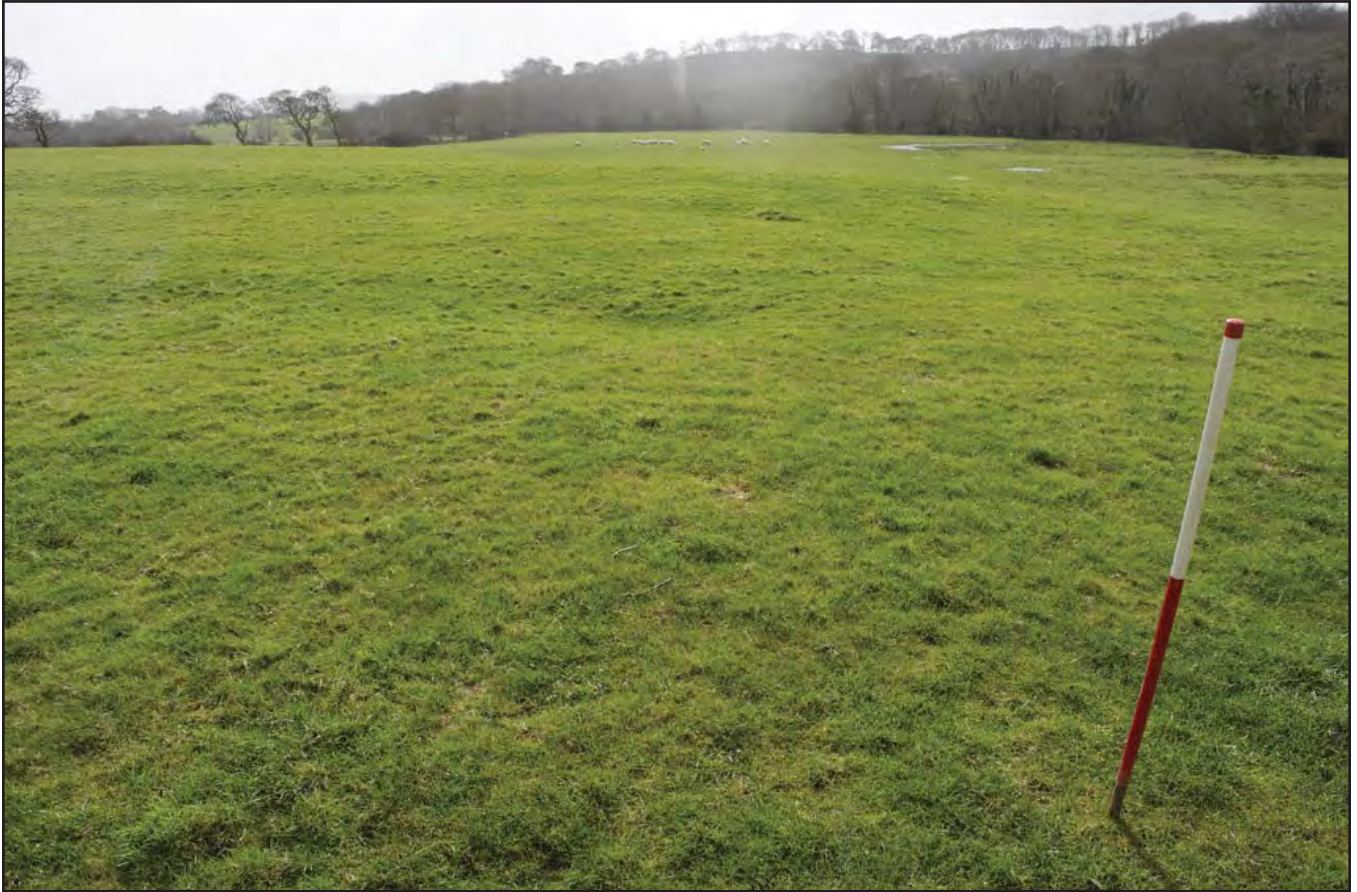
Plate 13: G2644\_Pont\_Bodfel; scale N; Detail showing the former gravel pit location (archive reference: G2644\_047).
