GWYNEDD SLATE QUARRIES

REPORT NO. 154

APPENDIX I

LIST OF QUARRIES AND FEATURES

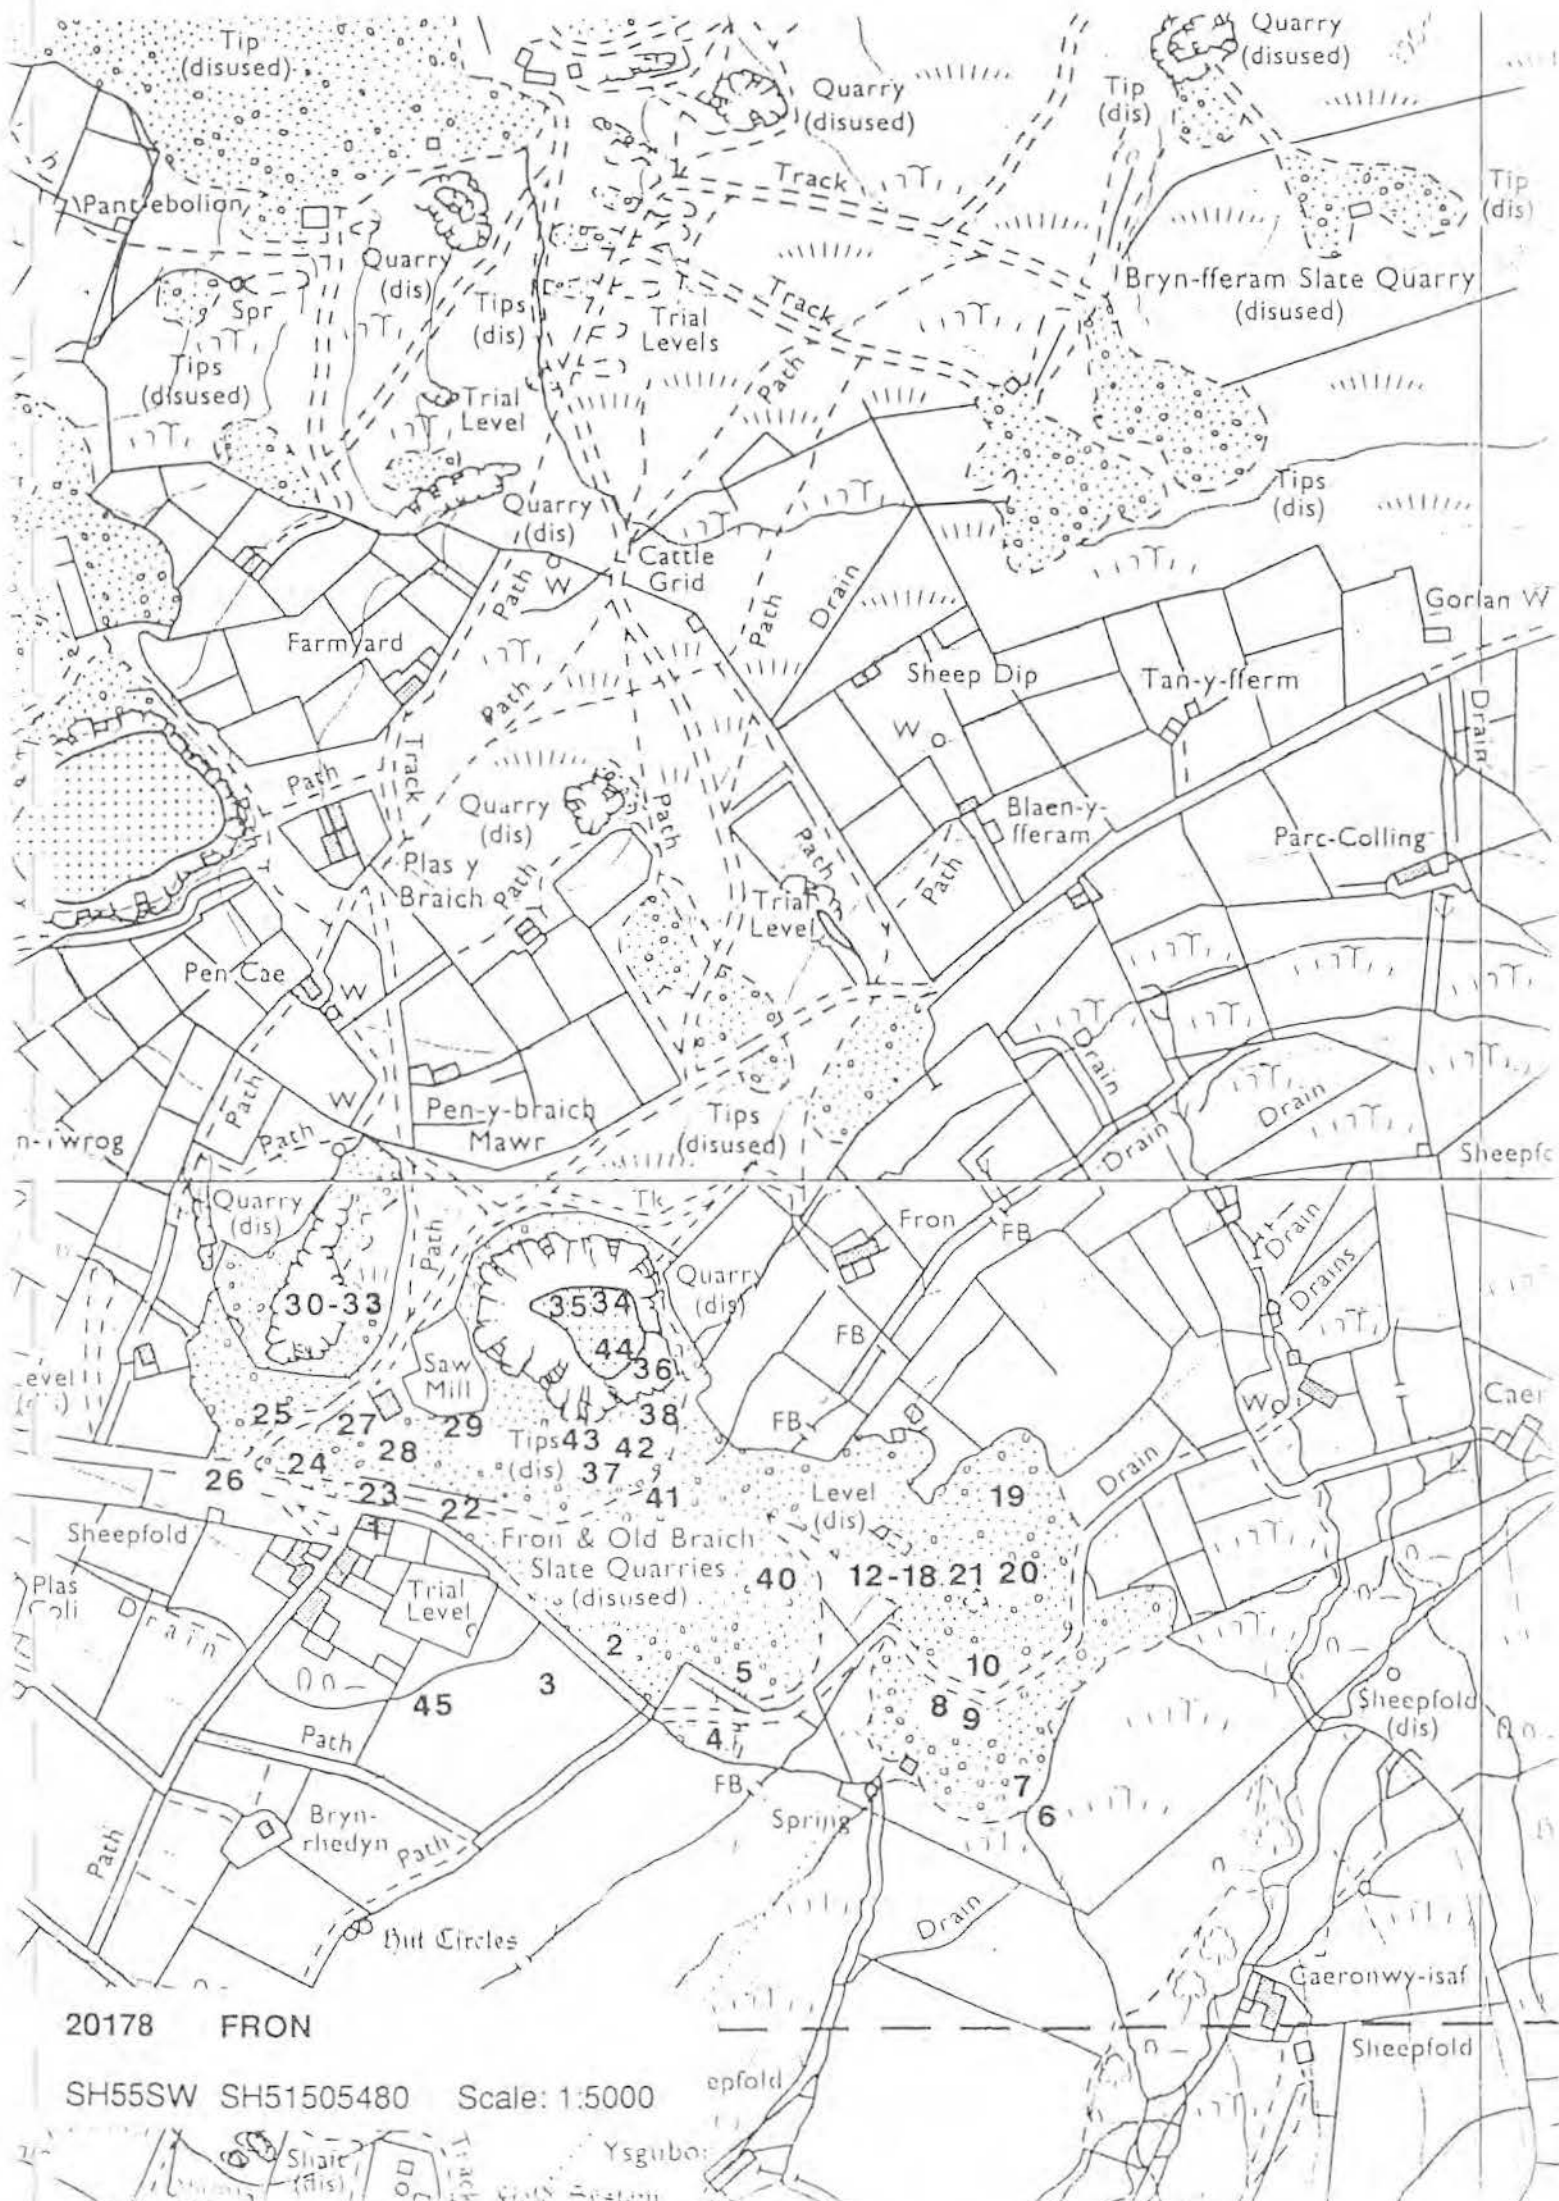
20178 FRON

Diversity 3 Archive Val. 3 Archaeol. Record 3 Amenity Val. 3 Visual Amenity 2

S	C	F	V	P	R	PO	GV
1 INCLINE COUNTERBALANCE	1	1	1	1	-	-	-	-
2 RETAINING WALL	1	2	1	1	-	-	-	-
3 RETAINING WALL	1	2	1	1	-	-	-	-
POSSIBLY FORMED BRIDGE ABUTMENTS AT ONE POINT.								
4 INCLINE COUNTERBALANCE	3	3	3	3	-	-	-	-
SITE ONLY; OBLITERATED BY TIPPING.								
5 MILL ENGINE HOUSE	3	1	1	1	-	-	-	-
HOLDING-DOWN BOLTS SURVIVE.								
6 MILL	3	1	1	1	-	-	-	-
7 STACKYARD	1	1	1	1	-	-	-	-
8 STRUCTURE	2	2	1	1	-	-	-	-
9 STRUCTURE	2	2	1	1	-	-	-	-
10 INCLINE COUNTERBALANCE	3	3	1	1	-	-	-	-
DEGRADED.								
11 GWALIAU	2	2	1	1	-	-	-	-
12 MACHINE BASE	3	1	1	1	-	-	-	-
STRUCTURE OVER MACHINE BASE HEAVILY DILAPIDATED.								
13 ELECTRICITY SUBSTATION	2	2	2	1	-	-	-	-
14 ADIT	-	-	-	-	-	-	-	-
COLLAPSED								
15 GWAL	2	2	1	1	-	-	-	-
16 SHAFT-HEAD	1	1	1	1	-	-	-	-
17 CUTTING	1	1	1	1	-	-	-	-
TO (COLLAPSED) ADIT								
18 ADIT	-	-	-	-	-	-	-	-
COLLAPSED								
19 WEIGHBRIDGE HOUSE	3	3	1	1	-	-	-	-
20 CABAN?	2	2	2	1	-	-	-	-
21 LOCOMOTIVE SHED	2	2	2	1	-	-	-	-

22 CABAN?	2	2	2	1	-	-	-	-
23 STRUCTURE	3	2	1	1	-	-	-	-
BASE OF TIMBER UPRIGHT SURVIVES SUGGESTING AN								
OPEN-SIDED SHED.								
24 OFFICE	1	2	1	1	-	-	-	-
25 OBLITERATED	3	3	3	3	-	-	-	-
IN RE-USE AS SHOOTING RANGE.								
26 TIP CONTRACTORS' WORKINGS	1	1	1	1	-	-	-	-

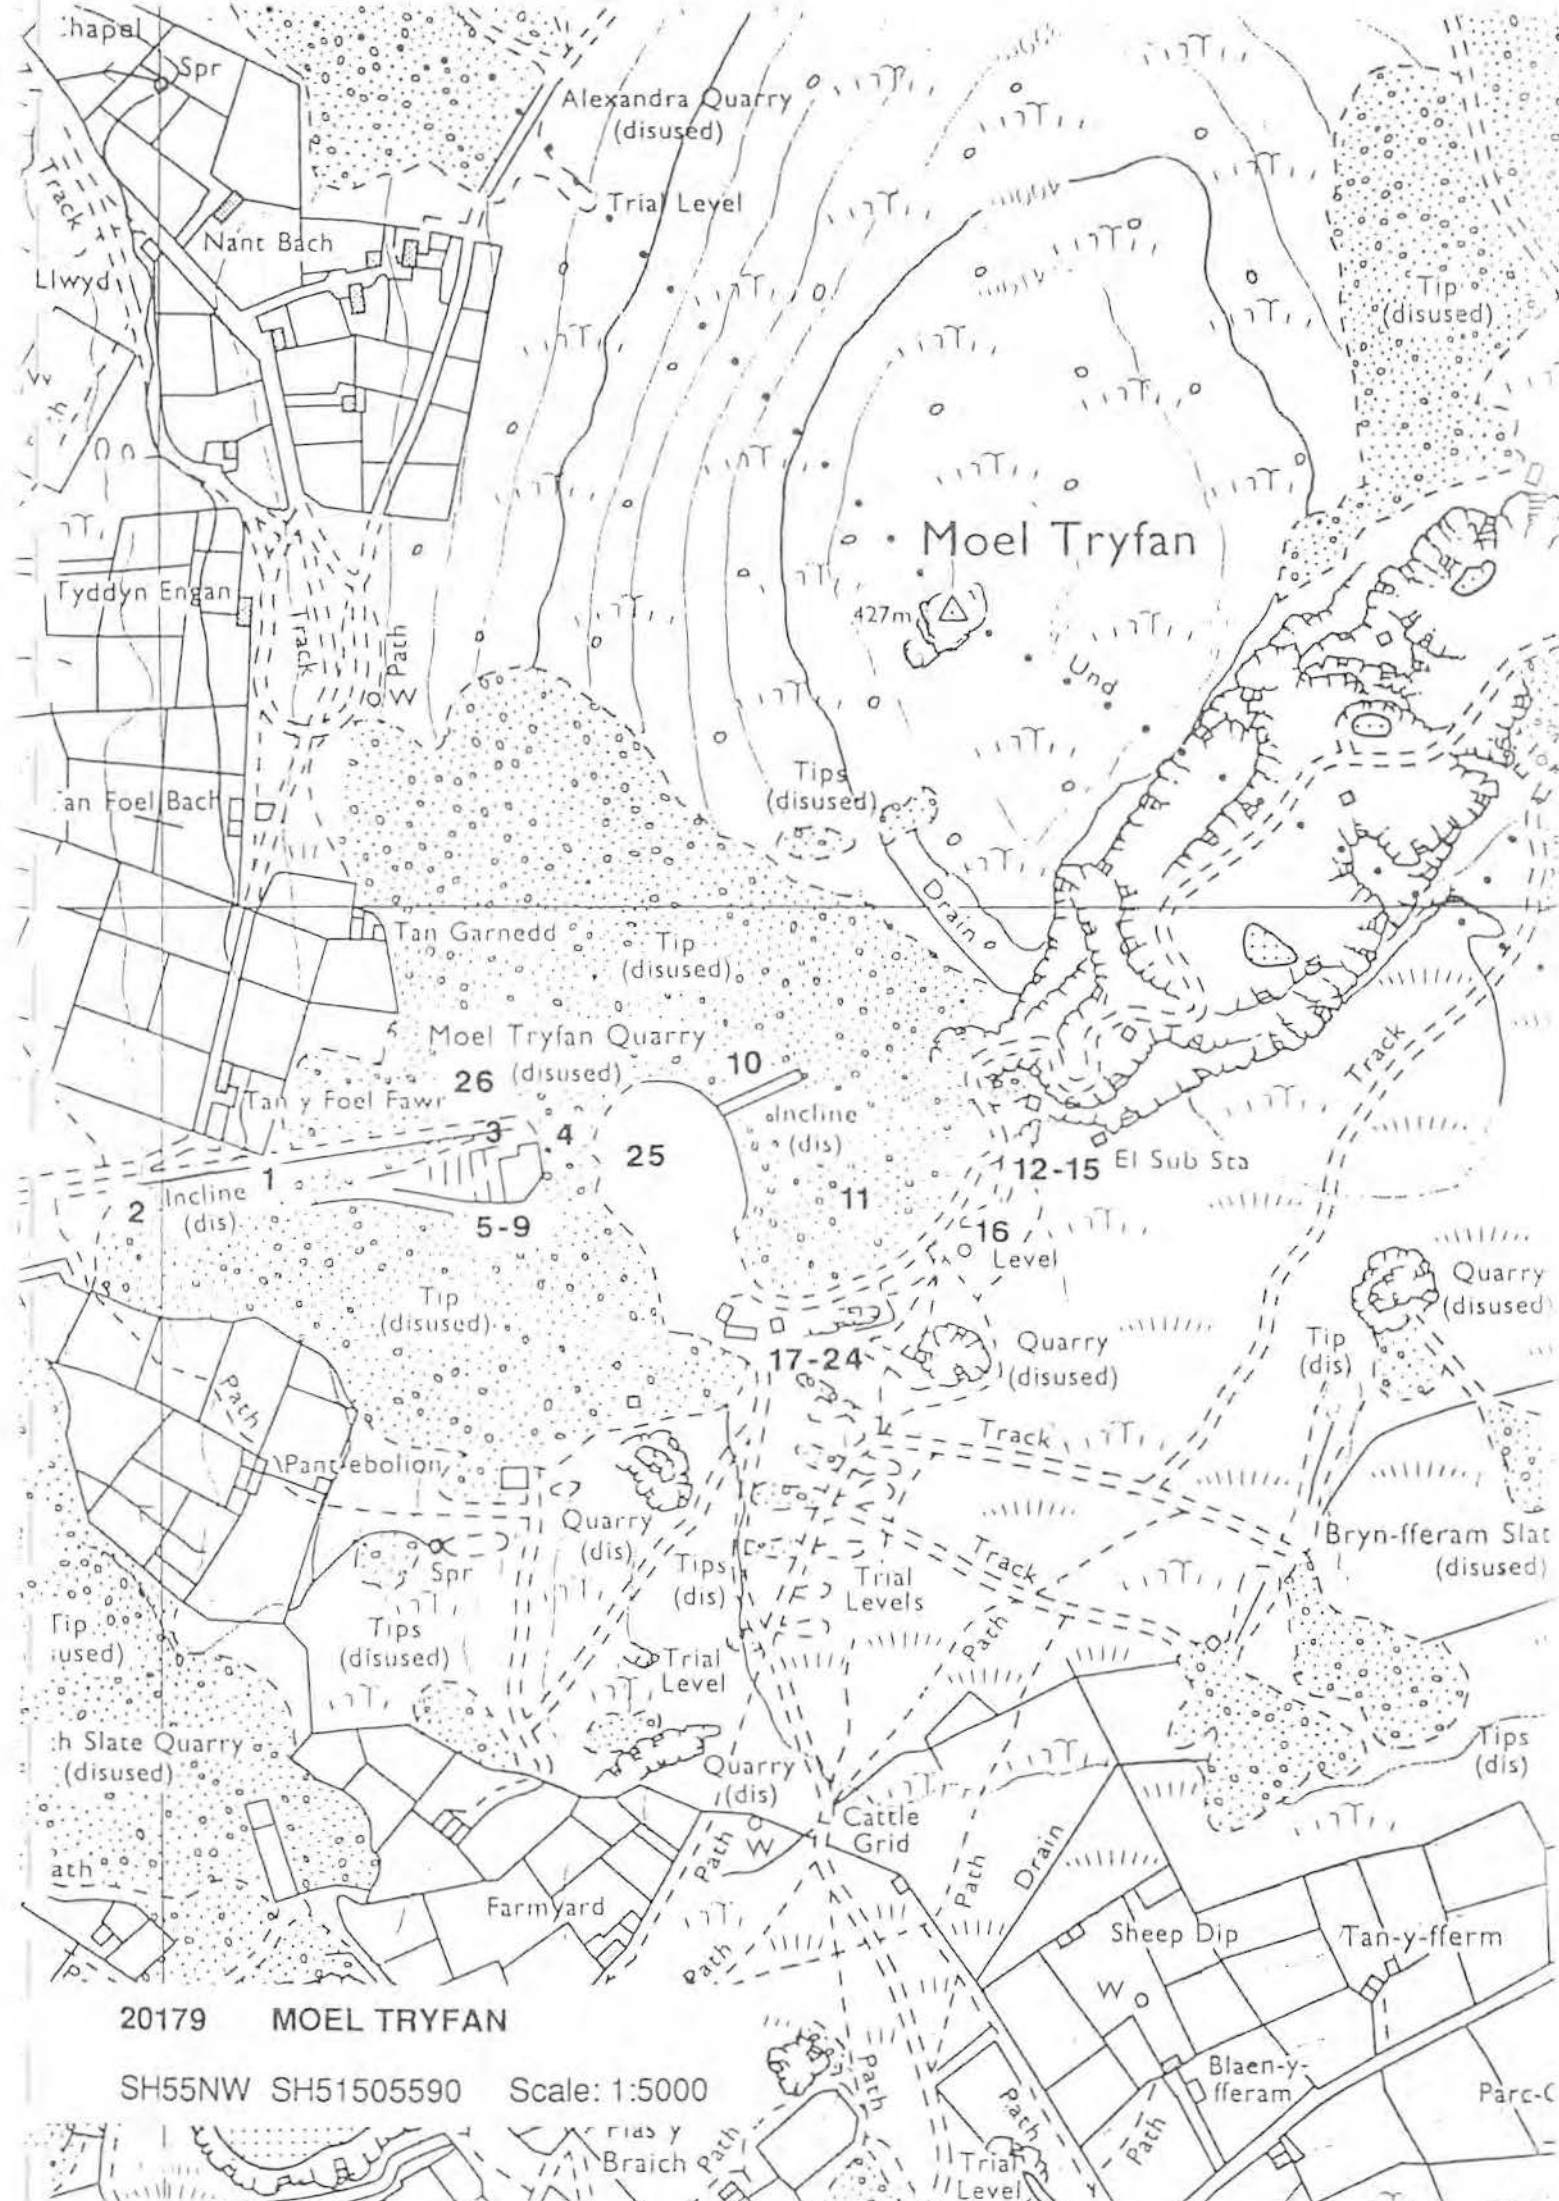
20179 MOEL TRYFAN

Diversity 2, Archive Val. 3 Archaeol. Record 3 Amenity Val. 2 Visual Amenity 2

S	C	F	V	P	R	PO	GV
1	RETAINING WALL	1	1	1	1	-	-	-	-
2	OBLITERATED	3	3	3	3	-	-	-	-
3	ADIT <i>COLLAPSED.</i>	-	-	-	-	-	-	-	-
4	BRIDGE <i>ABUTMENTS ONLY SURVIVE.</i>	3	2	2	2	-	-	-	-
5	WEIGHBRIDGE HOUSE	2	1	1	1	-	-	-	-
6	ROPEWAY SYSTEM WINDING HOUSE <i>HOLDING-DOWN BOLTS AND BRICKS EVIDENT.</i>	3	3	1	1	-	-	-	-
7	ROPEWAY SYSTEM <i>SITE ONLY.</i>	3	3	3	3	-	-	-	-
8	STRUCTURE <i>FUNCTION OBSCURE, LOW 3-SIDED STRUCTURE WITH GAP IN BACK WALL. POSSIBLY TO ALLOW PASSAGE OF CABLE.</i>	3	3	1	1	-	-	-	-
9	STRUCTURE <i>MACHINE BASE EVIDENT.</i>	3	3	1	1	-	-	-	-
10	MILL? <i>COLLAPSED DOUBLE MILL.</i>	3	3	1	3	-	-	-	-
11	TIP CONTRACTORS' WORKINGS	1	1	1	1	-	-	-	-
12	MILL LONGITUDINAL	3	1	1	1	-	-	-	-
13	WALL <i>BRICK, COLLAPSED.</i>	3	3	3	3	-	-	-	-
14	STRUCTURE <i>FUNCTION OBSCURE, INTERNALLY RENDERED.</i>	2	2	1	1	-	-	-	-
15	STRUCTURE	3	1	2	2	-	-	-	-
16	WEIGHBRIDGE HOUSE	1	1	1	1	-	-	-	-
17	ELECTRICITY SUBSTATION	1	1	1	1	-	-	-	-

18	STRUCTURE <i>FUNCTION OBSCURE.</i>	1	1	1	1	-	-	-	-
19	ROPEWAY SYSTEM WINDING HOUSE <i>MECHANICAL.</i>	1	1	1	1	-	-	-	-
20	STRUCTURE <i>CONTAINS MACHINE BASE.</i>	1	1	1	1	-	-	-	-
21	ROPEWAY SYSTEM <i>ENGINE HOUSE AND DRUM BASE SURVIVE.</i>	2	1	1	1	-	-	-	-
22	STRUCTURE <i>INACCESSIBLE.</i>	-	-	-	-	-	-	-	-
23	ADIT	1	1	1	1	-	-	-	-
24	ROPEWAY SYSTEM <i>SITE ONLY.</i>	3	3	3	3	-	-	-	-
25	RAILWAY	1	1	1	1	-	-	-	-
26	OBLITERATED	3	3	3	3	-	-	-	-
27	OBLITERATED	3	3	3	3	-	-	-	-

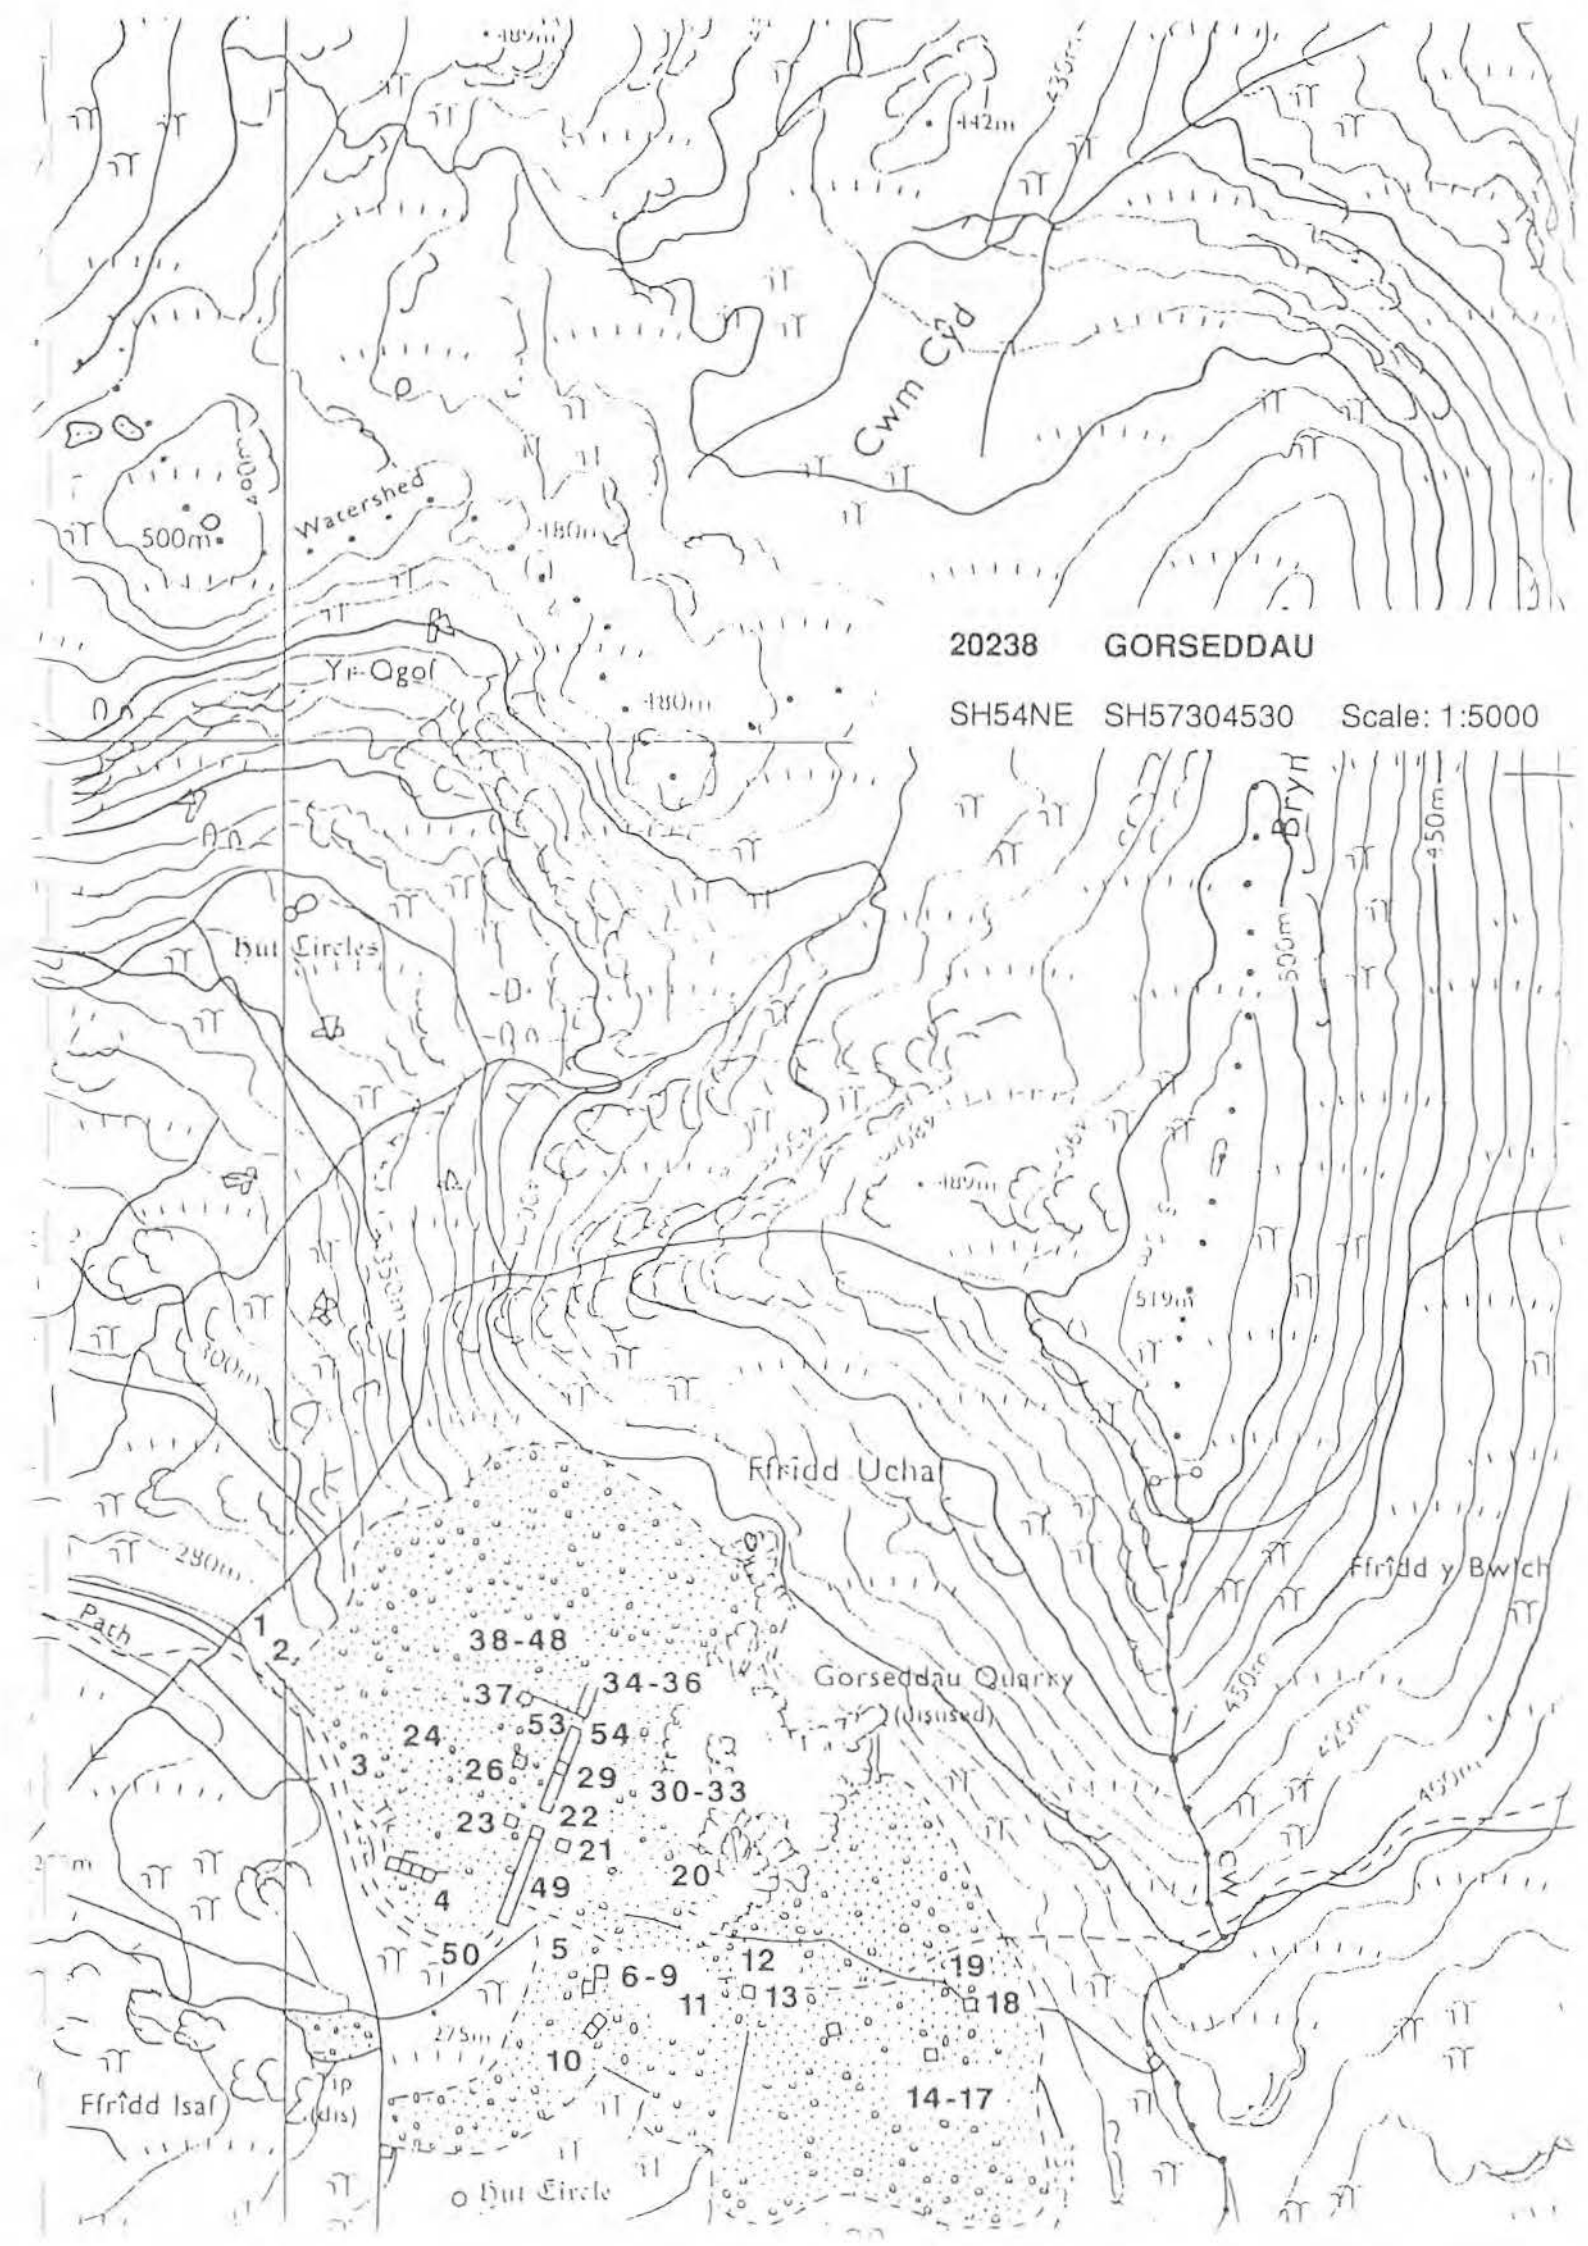
20238 GORSEDDAU

S	C	F	V	P	R	PO	GV
1 MILL <i>CUT IN TWO BY A ROAD TO FARMYARD AT REAR; THE ORIGINAL WAALS AHEY BEEN PATCHED AND THE NORTHERN POART RE-ROOFED.</i>	3	1	1	1	-	-	-	-
2 STRUCTURE <i>EXTENDED AND IN RE-USE.</i>	3	1	1	1	-	-	-	-
3 WATERWHEEL PIT	1	1	1	1	-	-	-	-
4 STRUCTURE <i>BUTTRESSED, 2-STOREY.</i>	1	1	1	1	-	-	-	-
5 WATER CHANNEL <i>CARRIED ON RETAINING WALL.</i>	2	2	1	1	-	-	-	-
6 ROAD? <i>POSSIBLY AN INCLINE, HEAVILY DEGRADED.</i>	3	3	1	1	-	-	-	-
7 WATER STORAGE <i>RESERVOIR IMPOUNDED BY DAM.</i>	1	3	1	1	-	-	-	-
8 ROAD	2	2	1	1	-	-	-	-
9 QUARRY FACE	2	2	1	1	-	-	-	-
10 TIPS	3	3	1	1	-	-	-	-
11 WATER CHANNEL?	2	2	1	1	-	-	-	-
12 STRUCTURE <i>HEAVILY DILAPIDATED - N.W. EXAMPLE MAY BE A SMITHY.</i>	3	3	1	1	-	-	-	-
13 WATER ABSTRACTION POINT	2	2	1	1	-	-	-	-
14 TIPS	1	1	1	1	-	-	-	-
15 QUARRY FACE	1	1	1	1	-	-	-	-
16 OBLITERATED	3	3	3	3	-	-	-	-
17 STRUCTURE <i>LARGE DILAPIDATED STRUCTURE OF CONSIDERABLE WIDTH, WITH EVIDENCE OF A PEDESTRIAN DOORWAY THROUGH IT. ALSO OF AN AXLE-BOX IN THE S.W. WALL. POSSIBLY PART OF A WHEELPIT AND A GABLE END.</i>	3	3	1	1	-	-	-	-

18 OBLITERATED <i>REPLACED BY A COTTAGE.</i>	3	3	3	3	-	-	-	-
19 WATER CHANNEL <i>EVIDENT ONLY AS TRACE. STRUCTURE OF CONSIDERABLE WIDTH, WITH EVIDENCE OF A PEDESTRIAN DOORWAY THROUGH IT. ALSO OF AN AXLE-BOX IN THE S.W. WALL. POSSIBLY PART OF A WHEELPIT AND A GABLE END.</i>	3	3	1	1	-	-	-	-
20 WATER STORAGE <i>NOT SEEN.</i>	-	-	-	-	-	-	-	-

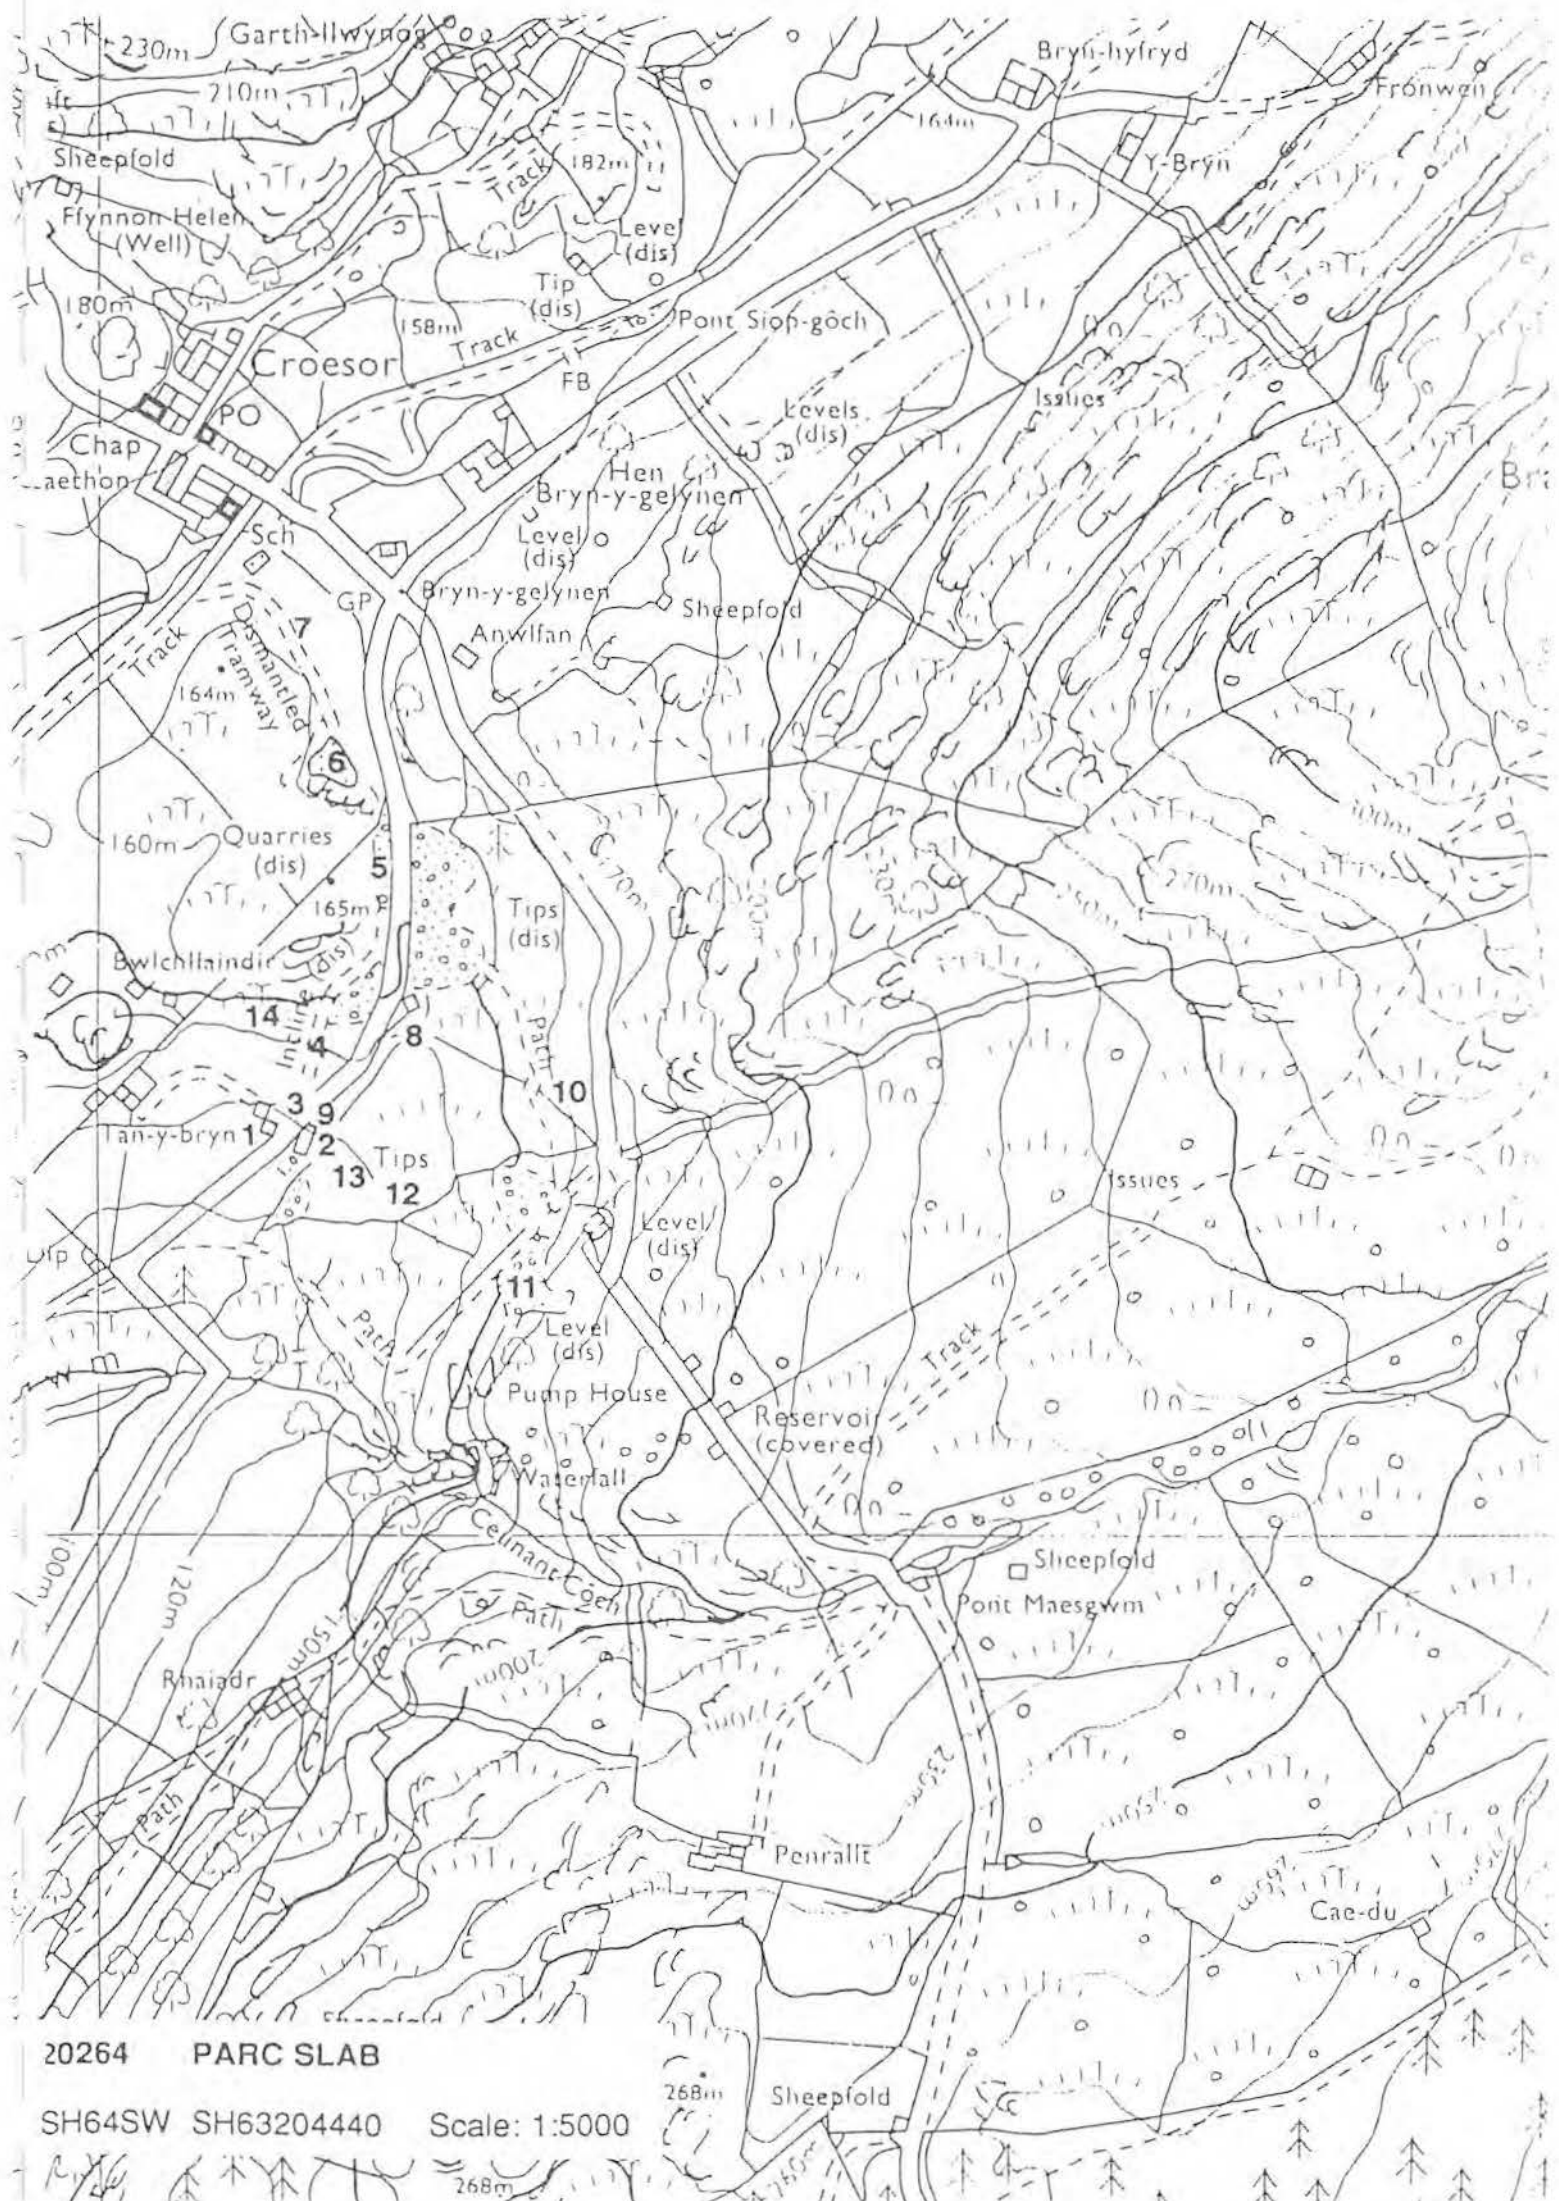
20264 PARC SLAB

S	C	F	V	P	R	PO	GV
1 MILL LONGITUDINAL	2	2	2	1	-	-	-	-
2 STEAM ENGINE SITE <i>LANCASHIRE BOILER SURVIVES IN SITU</i>	2	1	1	1	-	-	-	-
3 STRUCTURE	2	2	2	1	-	-	-	-
4 ADIT	-	-	-	-	-	-	-	-
5 ADIT	-	-	-	-	-	-	-	-
6 ADIT	-	-	-	-	-	-	-	-
7 INCLINE COUNTERBALANCE <i>POSSIBLY A TRWNC.</i>	2	2	2	1	-	-	-	-
8 RAILWAY	1	1	1	1	-	-	-	-
9 OFFICE <i>FOUNDATIONS ONLY, POSSIBLY A WOODEN STRUCTURE.</i>	3	3	2	1	-	-	-	-
10 INCLINE DRUMHOUSE	3	2	2	1	-	-	-	-
11 INCLINE COUNTERBALANCE	1	2	2	1	-	-	-	-
12 BRIDGE <i>ABUTMENTS ONLY.</i>	3	2	2	1	-	-	-	-
12 BRIDGE <i>ABUTMENTS ONLY SURVIVE.</i>	3	2	2	1	-	-	-	-
13 BRIDGE <i>ABUTMENTS ONLY SURVIVE.</i>	3	2	2	1	-	-	-	-
14 ADIT	-	-	-	-	-	-	-	-
15 MILL LONGITUDINAL	3	2	2	1	-	-	-	-
16 ADIT <i>EXIT RAILWAY AND UNDERGROUND WORKING.</i>	-	-	-	-	-	-	-	-
17 QUARRY FACE <i>GALLERIES EVIDENT</i>	1	1	2	1	-	-	-	-

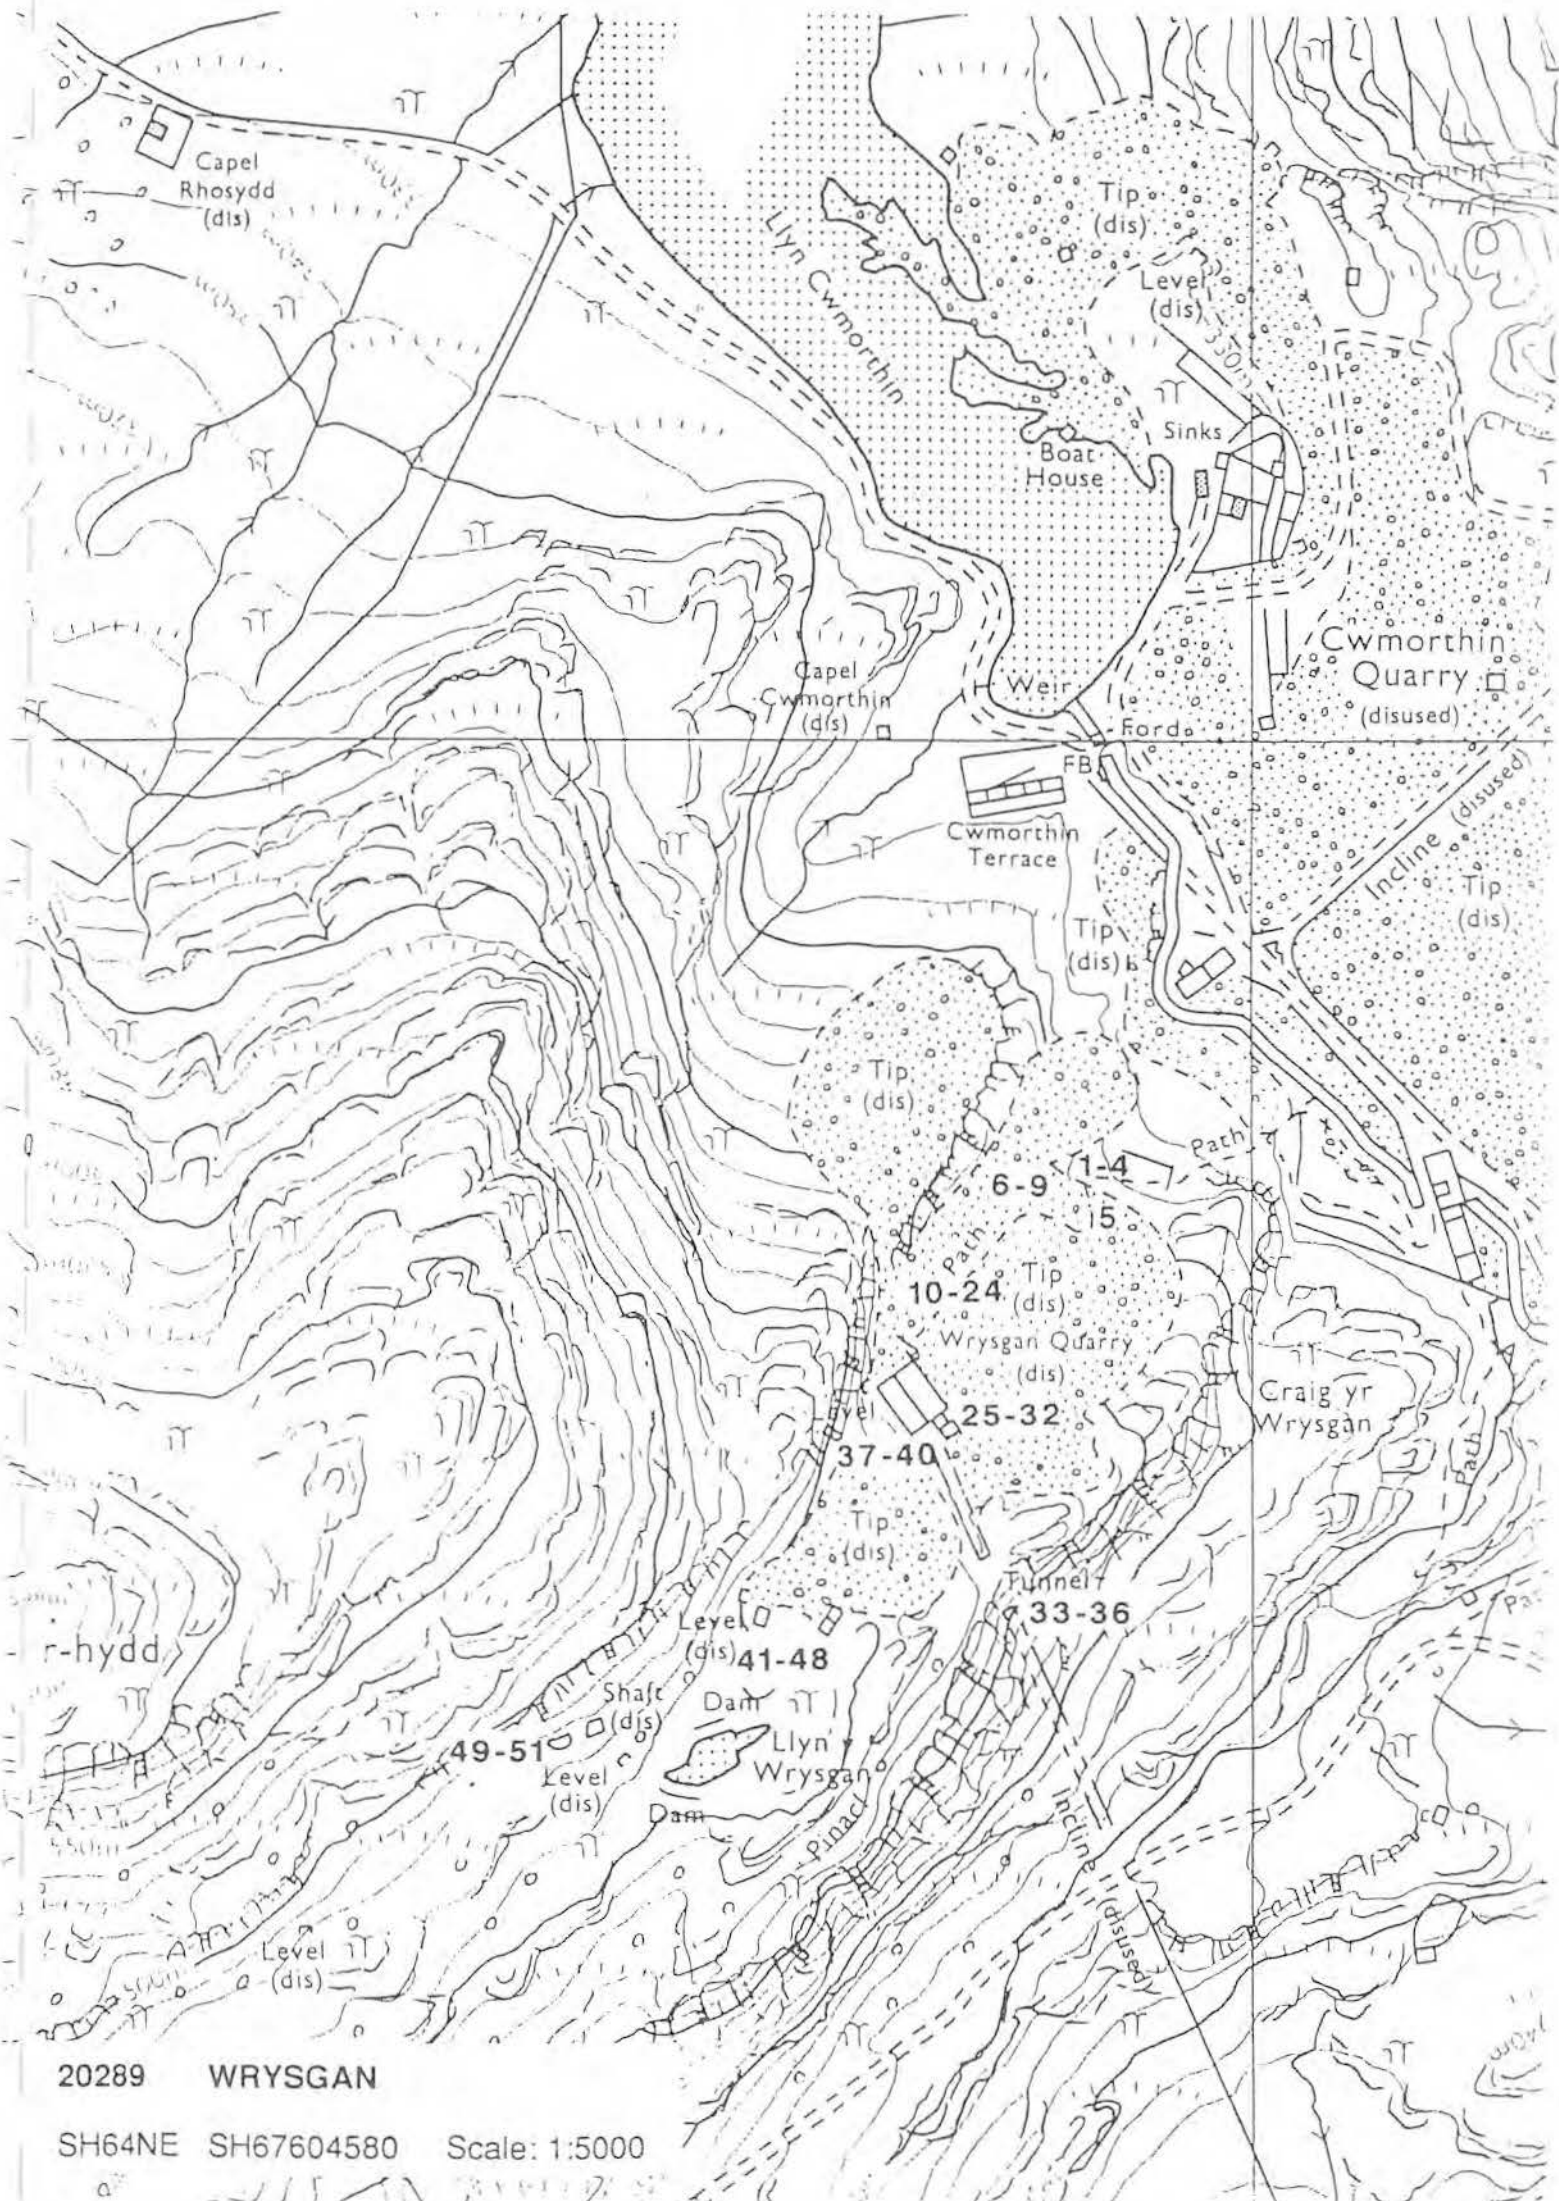
20289 WRYSGAN

S	C	F	V	P	R	PO	GV
1 OBLITERATED	3	3	3	3	-	-	-	-
2 QUARRY AREA <i>NOT VISITED BECAUSE OF BLASTING REGULATIONS.</i>	-	-	-	-	-	-	-	-
3 OBLITERATED	3	3	3	3	-	-	-	-
4 ELECTRICITY SUBSTATION	1	1	1	1	-	-	-	-
5 MILL <i>19C MILL IN RE-USE.</i>	1	1	1	1	-	-	-	-
6 HAULAGE SHAFT-HEAD <i>WATER-BALANCE OPERATED</i>	3	3	1	1	-	-	-	-
7 INCLINE UPHAULAGE MECHANICAL <i>CARRIED ON LARGE EMBANKMENT</i>	1	1	2	1	-	-	-	-
8 INCLINE WINDING HOUSE <i>CLINKER AND FIREBARS NOTED HERE</i>	1	3	2	1	-	-	-	-
9 WATER STORAGE <i>RESERVOIR IMPOUNDED BY DAM.</i>	1	1	1	1	-	-	-	-
10 ADIT	1	1	1	1	-	-	-	-
11 MILL <i>CORNER ONLY SURVIVES</i>	3	2	2	1	-	-	-	-
12 MILL <i>IN RE-USE AS WAREHOUSE</i>	1	1	1	1	-	-	-	-
13 ELECTRICITY SUBSTATION	1	1	1	1	-	-	-	-
14 WORKSHOPS <i>IN RE-USE AS GARAGE</i>	1	1	1	1	-	-	-	-
15 STRUCTURE	1	1	1	1	-	-	-	-
16 OFFICE	1	1	1	1	-	-	-	-
17 INCLINE UPHAULAGE WATERBALANCE	3	3	3	1	-	-	-	-
18 INCLINE WINDING HOUSE WATERBALANCE	2	1	2	1	-	-	-	-

19 INCLINE WINDING HOUSE <i>FOR STEAM WINDER</i>	3	2	2	1	-	-	-	-
20 INCLINE UPHAULAGE STEAM <i>DEGRADED.</i>	3	3	3	1	-	-	-	-
21 INCLINE WINDING HOUSE	2	2	2	1	-	-	-	-
22 GWAL	3	2	2	1	-	-	-	-
23 SHELTER	2	2	2	1	-	-	-	-
24 MILL <i>IN RE-USE, BOTH AS A MILL AND AS A RAILWAY MUSEUM.</i>	2	1	1	1	-	-	-	-
25 INCLINE DRUMHOUSE <i>THROUGH DRUMHOUSE.</i>	1	1	1	1	-	-	-	-
26 INCLINE COUNTERBALANCE	1	1	1	1	-	-	-	-
27 INCLINE DRUMHOUSE	3	3	2	1	-	-	-	-
28 MILL <i>UNDER RECONSTRUCTION.</i>	3	1	3	1	-	-	-	-
29 MILL	1	1	1	1	-	-	-	-
30 CHIMNEY <i>SQUARE PLAN.</i>	1	1	2	1	-	-	-	-
31 MILL ENGINE HOUSE	3	3	2	1	-	-	-	-
32 RETAINING WALL	1	1	2	1	-	-	-	-
33 STRUCTURE	1	1	2	1	-	-	-	-
34 DWELLING <i>2-STOREY.</i>	1	1	3	1	-	-	-	-
35 WEIGHBRIDGE HOUSE	1	1	1	1	-	-	-	-
36 ADIT	1	1	1	1	-	-	-	-

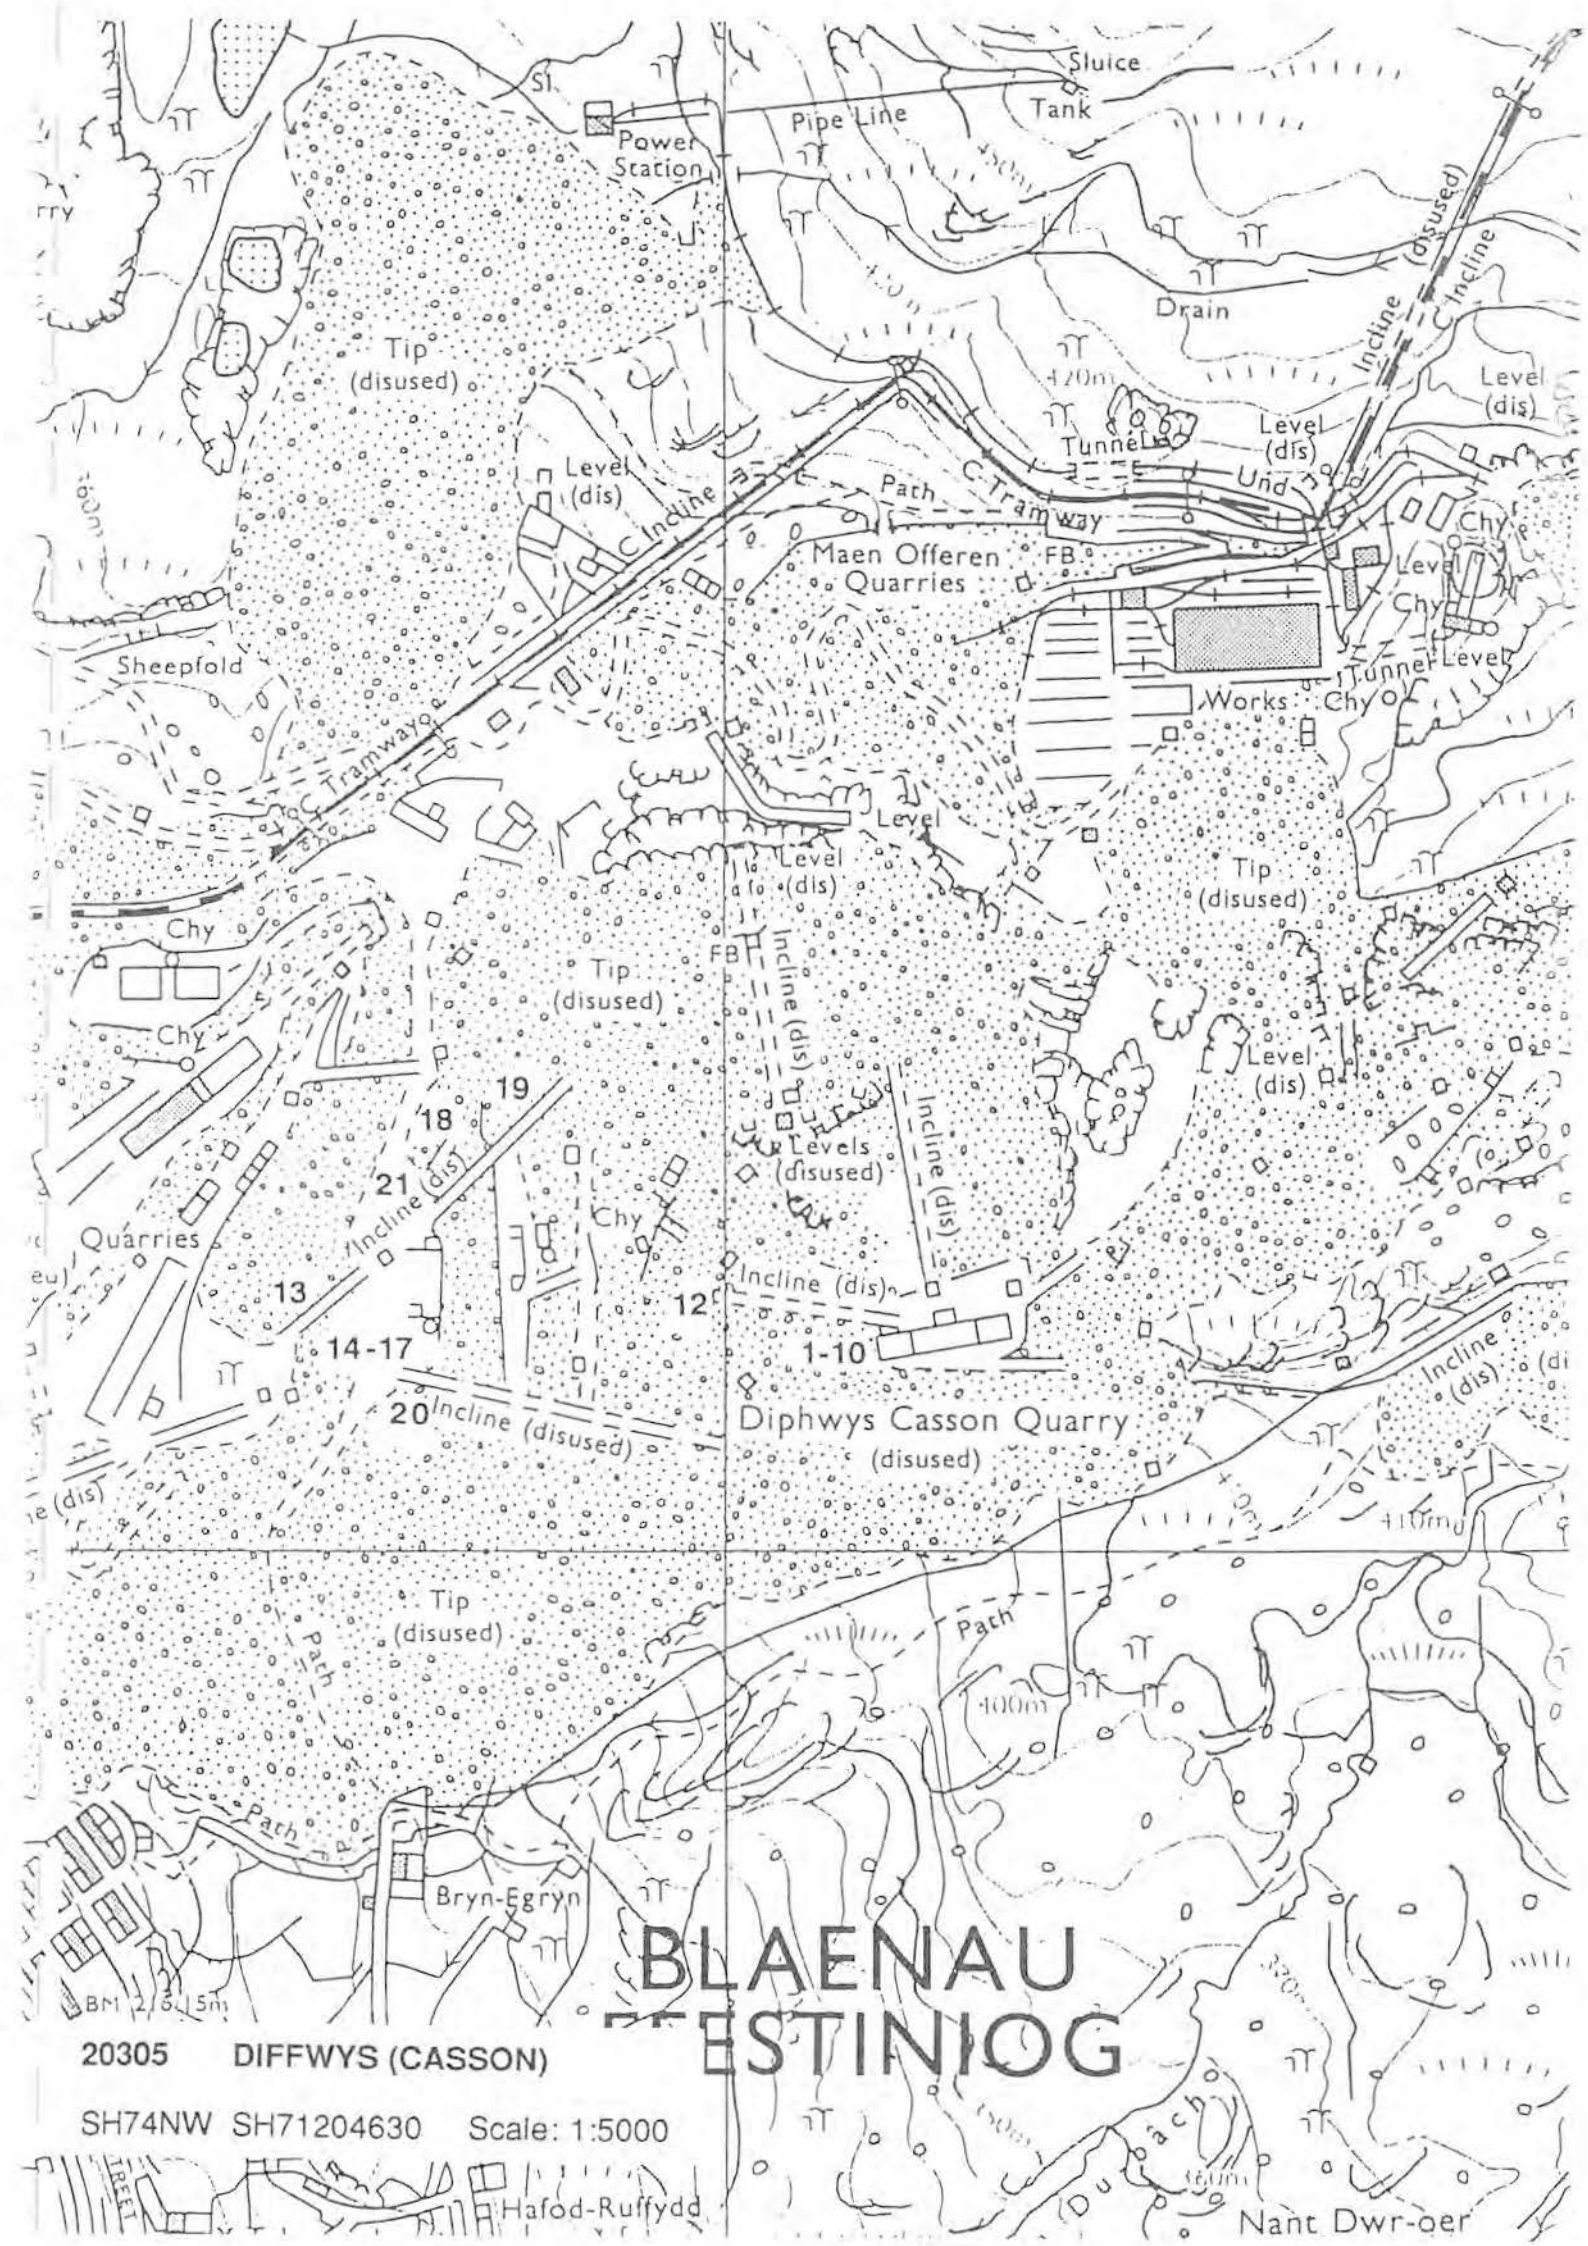
20305 DIFFWYS (CASSON)

S	C	F	V	P	R	PO	GV
1 ELECTRIC POWER STATION <i>IN USE WITH MODERN MACHINERY.</i>	1	1	1	1	-	-	-	-
2 CHIMNEY <i>BRICK BASE AND FLUE ONLY SURVIVE. POSSIBLY A STEEL CHIMNEY. BASE AND FLUE SET IN A RUINED GABLE END. CONTIGUOUS WITH (1).</i>	3	1	1	1	-	-	-	-
3 OFFICE	1	1	1	1	-	-	-	-
4 BARRACKS <i>2-STOREY.</i>	2	3	3	3	-	-	-	-
5 INCLINE COUNTERBALANCE <i>IN USE UNTIL RECENTLY. SOME DEGRADATION, BUT RAILS AND MOST OF ROLLERS SURVIVE IN SITU.</i>	1	1	2	1	-	-	-	Y
6 INCLINE DRUMHOUSE <i>REMOTE, EQUIPMENT INTACT. ROOF COLLAPSING.</i>	1	2	2	1	-	-	-	Y
7 RAILWAY <i>LARGELY INTACT</i>	1	2	2	1	-	-	-	Y
8 ADIT	1	2	2	1	-	-	-	-
9 RAILWAY	1	2	2	1	-	-	-	-
10 INCLINE UPHAULAGE <i>MAINTENANCE INCLINE FOR (1).</i>	1	2	2	1	-	-	-	-
11 LOCOMOTIVE SHED	2	2	2	1	-	-	-	-
12 LOCOMOTIVE SHED	2	2	2	1	-	-	-	-
13 MILL <i>EARLY BUILDING PARTLY REBUILT RECENTLY. WORK INCOMPLETE.</i>	3	1	2	3	-	-	-	-
14 STACKYARD	1	1	1	1	-	-	-	-
15 CABAN	1	1	1	1	-	-	-	-
