GWYNEDD SLATE QUARRIES

REPORT NO. 154

APPENDIX I

LIST OF QUARRIES AND FEATURES

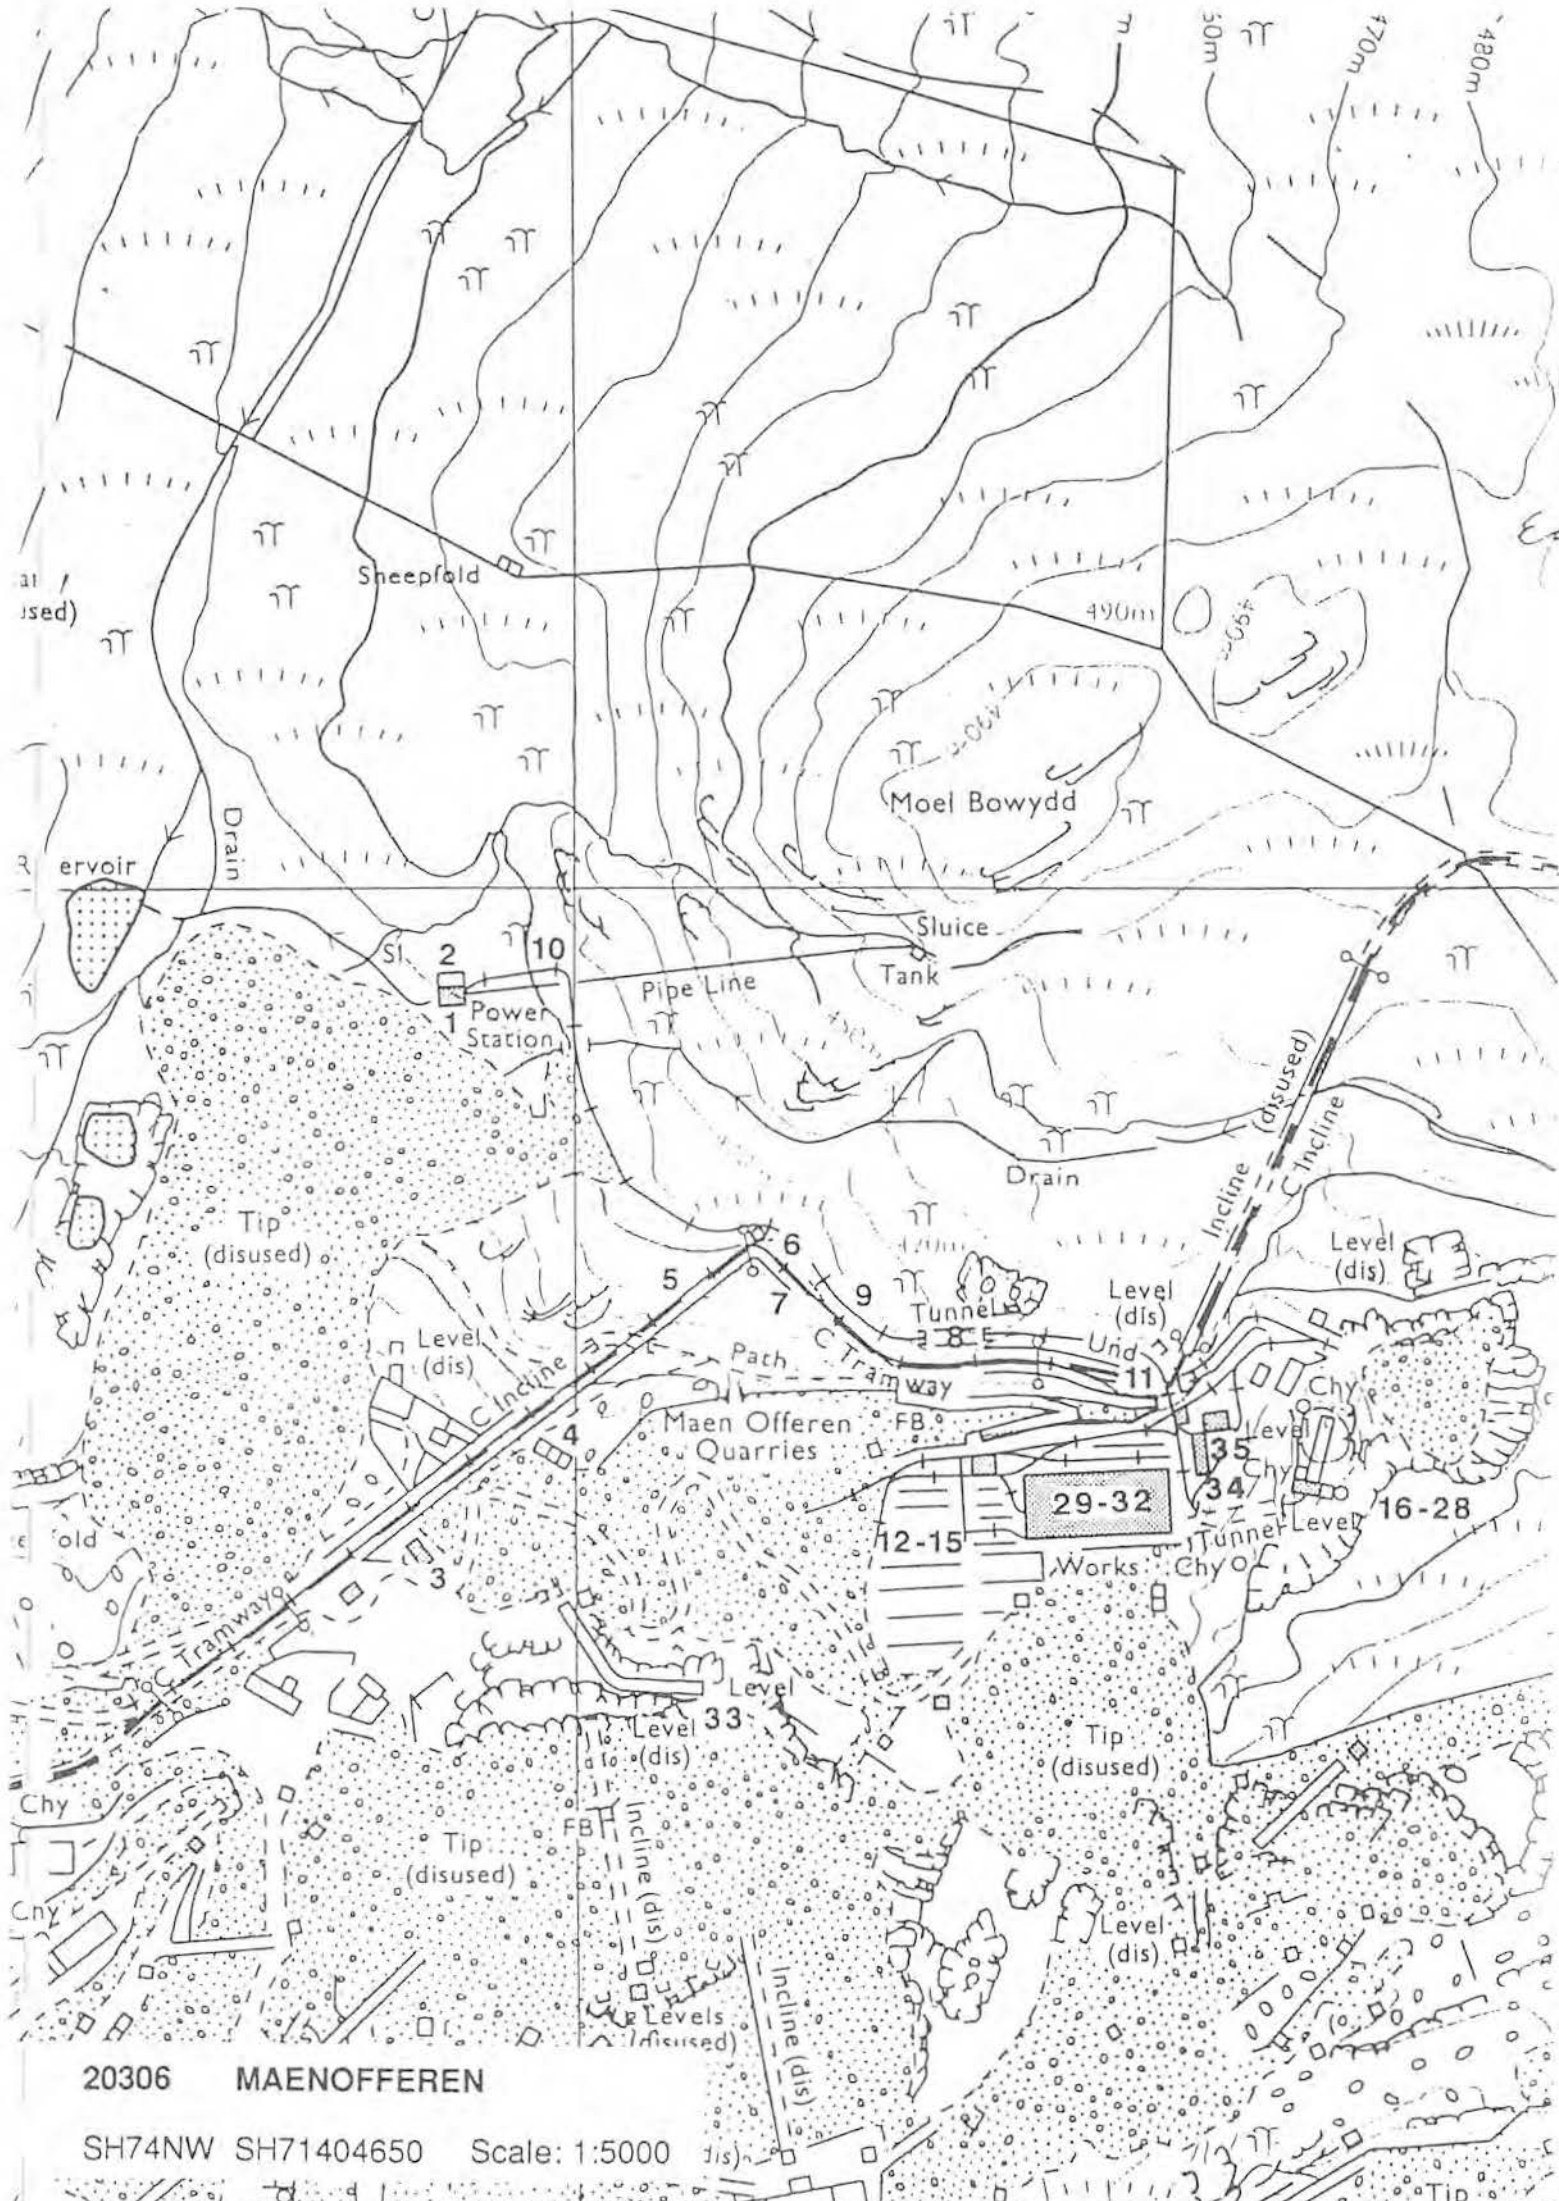
20306 MAENOFFEREN

One of the quarries at the western end of the Ffestiniog group, served by the Rhiwbach Tramway. The steam incline winding engine is a unique survivor of a once-common feature, and is in good condition.

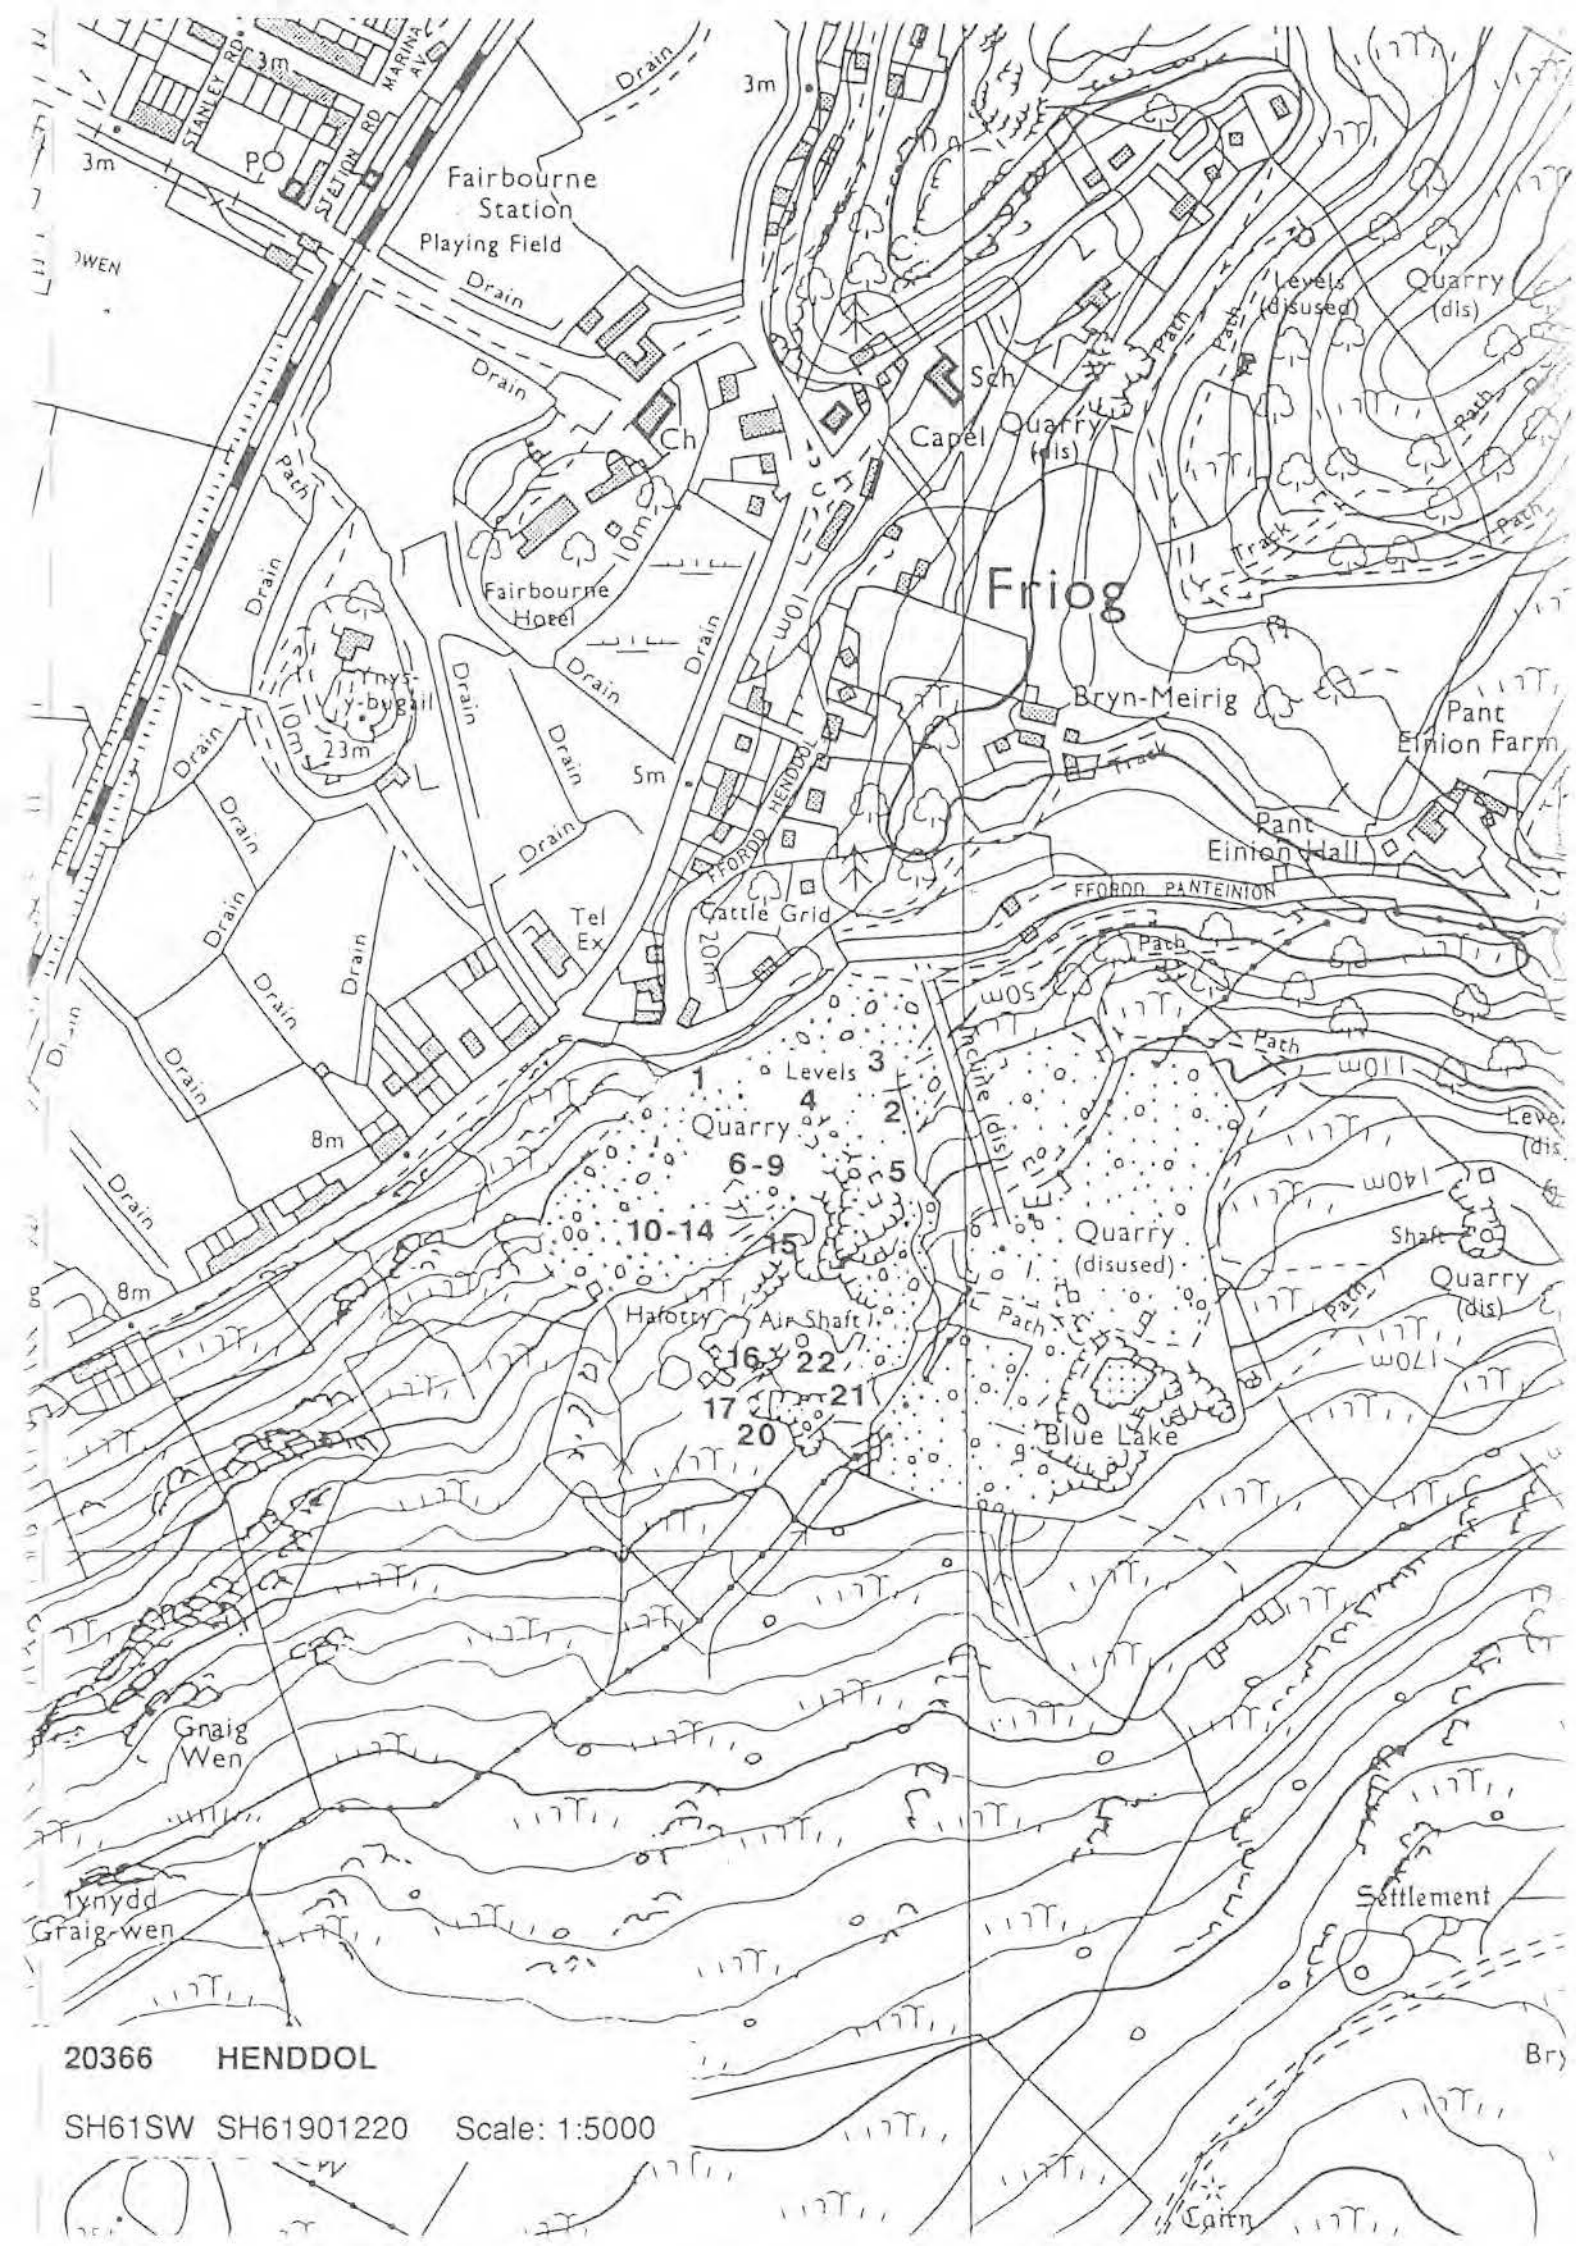
20366 HENDDOL

S	C	F	V	P	R	PO	GV
1 YARD	3	3	1	1	-	-	-	-
2 RETAINING WALL	1	1	2	1	-	-	-	-
3 INCLINE COUNTERBALANCE	2	1	1	1	-	-	-	-
4 BRIDGE	3	2	2	1	-	-	-	-
ABUTMENTS ONLY.								
5 INCLINE INTERMEDIATE LEVEL	2	2	1	1	-	-	-	-
OFF (3)?								
6 ADIT?	-	-	-	-	-	-	-	-
FEATURE OBLITERATED.								
7 GWALIAU	1	1	2	1	-	-	-	-
8 STACKYARD	1	2	2	1	-	-	-	-
9 OBLITERATED	3	3	3	3	-	-	-	-
CRIMP SURVIVES IN GOOD CONDITION.								
10 WATER CHANNEL	1	1	1	1	-	-	-	-
STONE-LINED.								
11 INCLINE WINDING DRUM	1	1	1	1	-	-	-	-
WINDING DRUM: REMOVED FROM ORIGINAL SITE.								
12 EMBANKMENT	1	1	1	1	-	-	-	-
INCLUDES CORBELLED BRIDGE.								
13 DRESSER	2	1	1	1	-	Y	-	-
AMOS AND FRANCIS TYPE.								
14 GWALIAU	3	2	1	1	-	-	-	-
15 ADIT	1	1	1	1	-	-	-	-
TUNNEL EMERGES AT 2 POINTS. RAIL IN SITU.								
16 GALLERY	1	1	1	1	-	-	-	-
17 QUARRY PIT	1	3	1	1	-	-	-	-
FLOODED.								
18 INCLINE COUNTERBALANCE	1	1	1	1	-	-	-	-
19 INCLINE SHEAVE	1	1	1	1	-	-	-	-
MECHANISM INTACT. BRAKE CHANNEL EVIDENT.

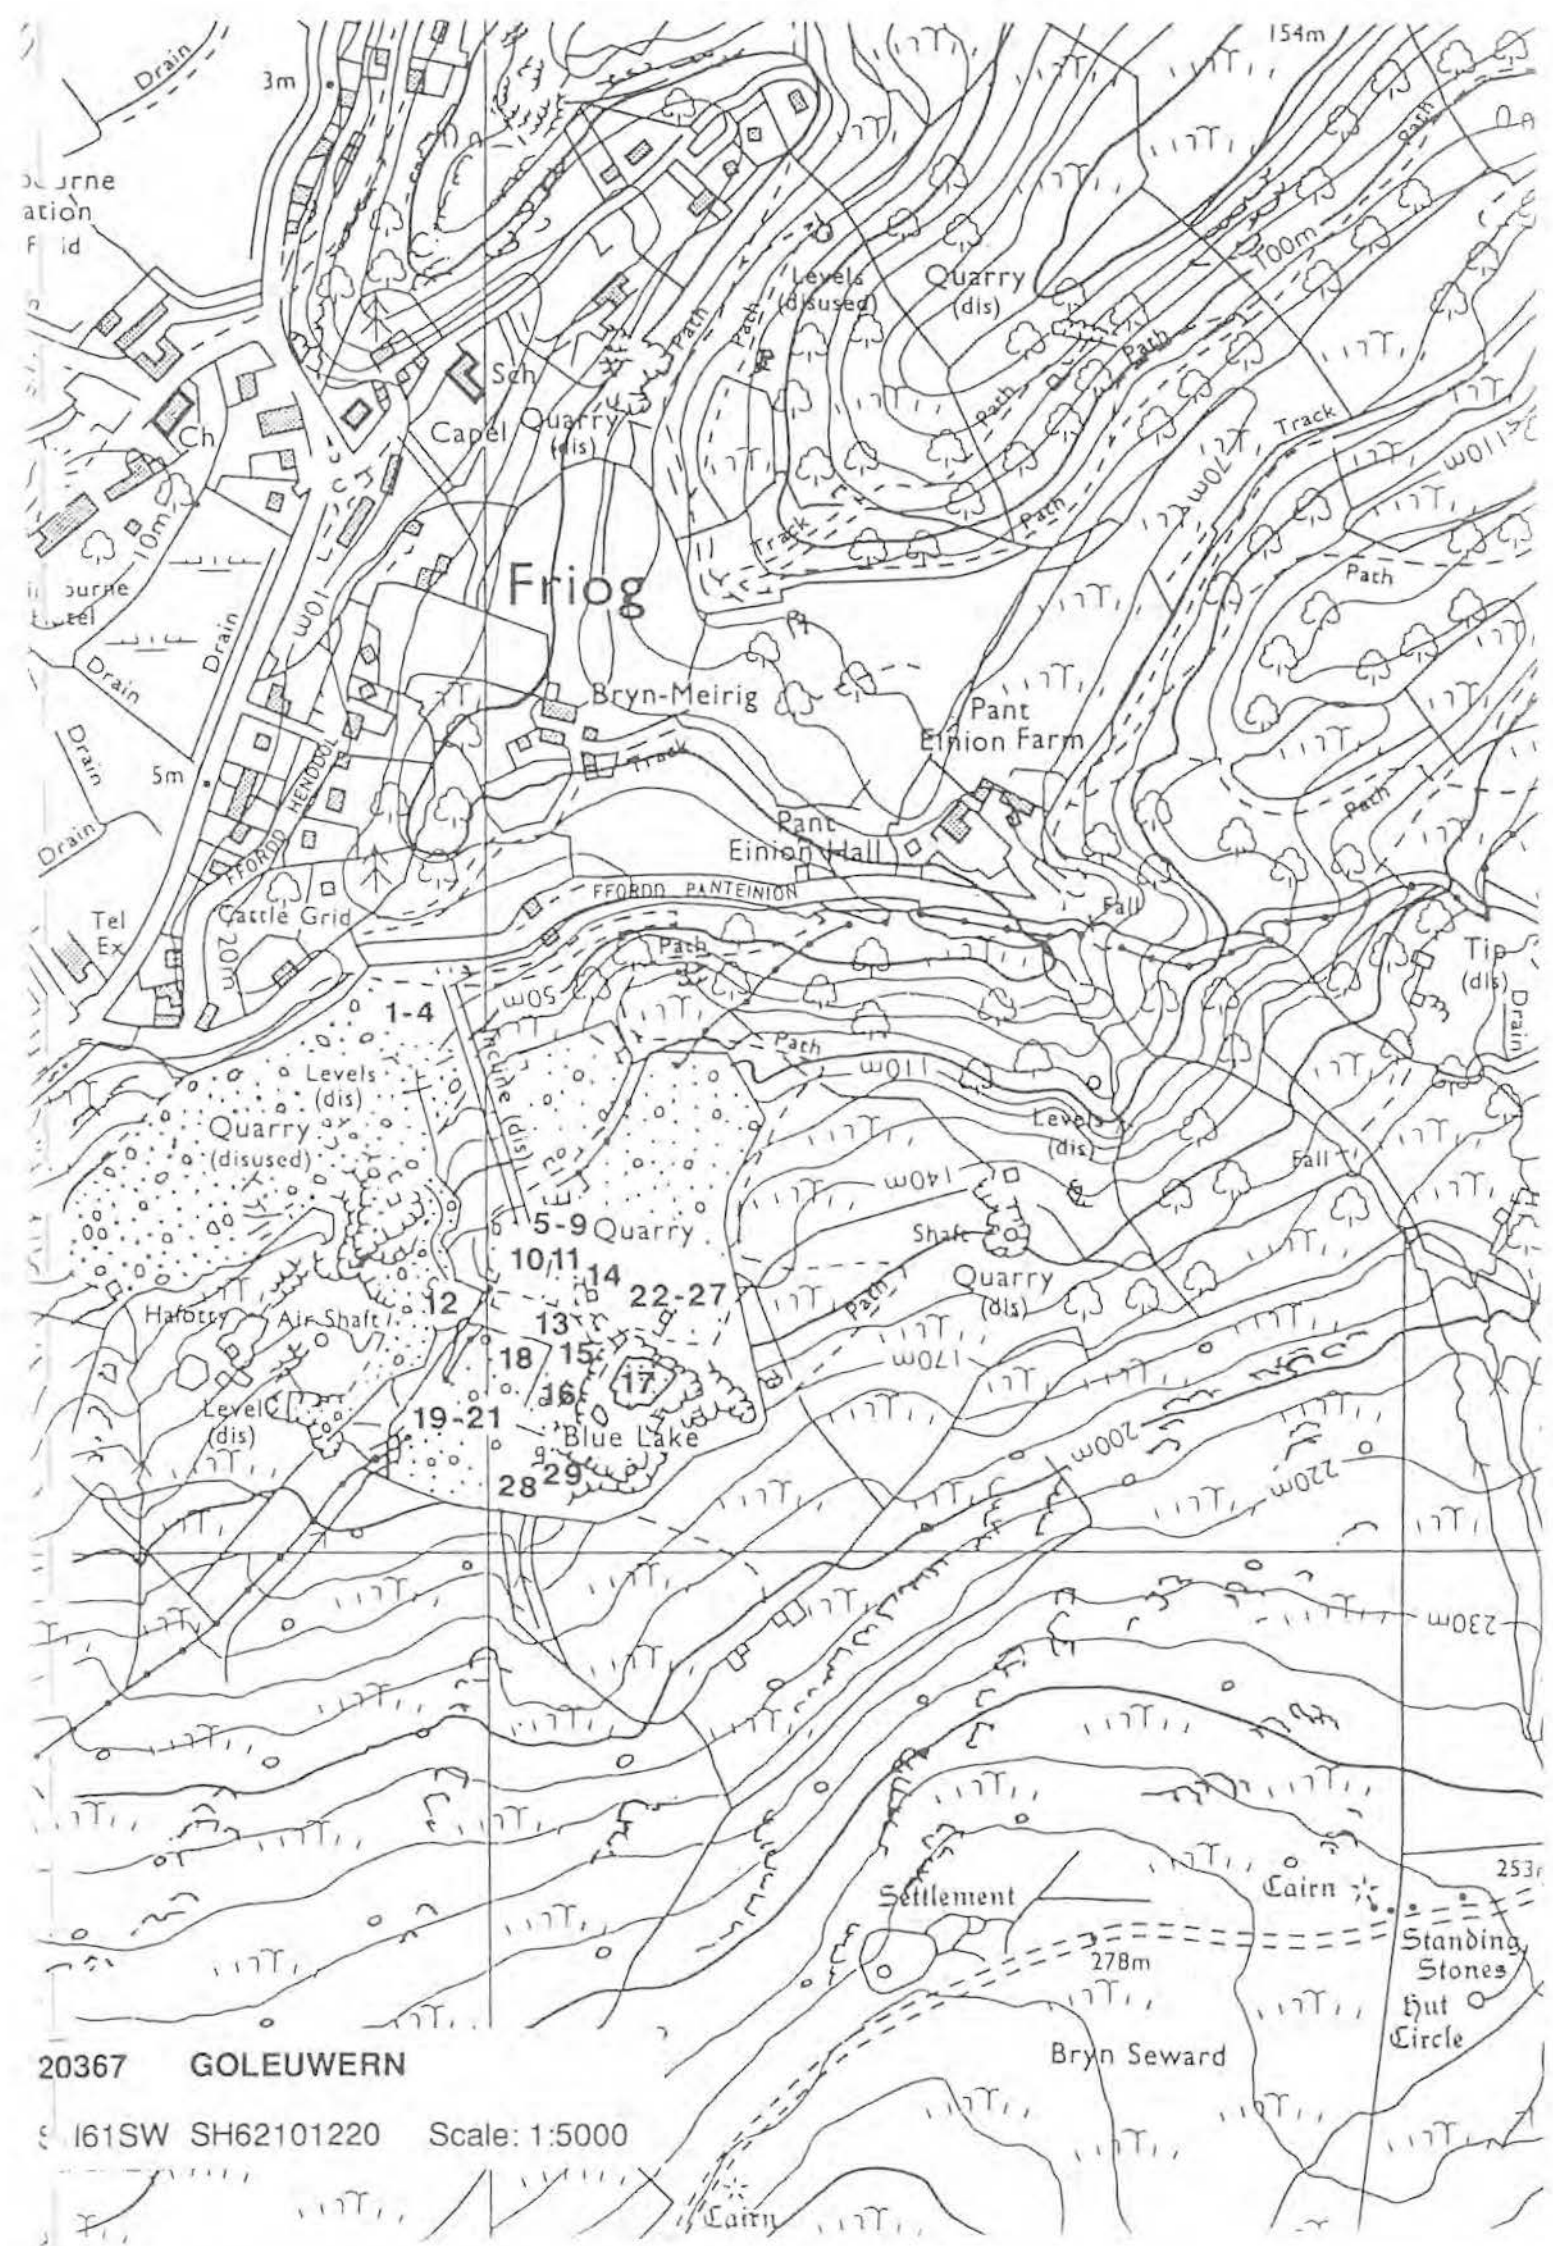
20367 GOLEUWERN

S	C	F	V	P	R	PO	GV
1	STRUCTURE <i>OFFICE?</i>	2	2	2	1	-	-	-	-
2	STACKYARD	2	2	2	1	-	-	-	-
3	MILL <i>EXTENDED AT SOME STAGE. EARLIER PART IN POOR CONDITION.</i>	2	2	3	1	-	-	-	Y
4	WATERWHEEL PIT <i>REMOTE FROM MILL. WORKED LINE-SHAFTING BY ROPE- SYSTEM.</i>	1	1	1	1	-	Y	-	Y
5	INCLINE COUNTERBALANCE	1	2	1	1	-	-	-	-
6	INCLINE INTERMEDIATE LEVEL	1	2	1	1	-	-	-	-
7	INCLINE DRUMHOUSE <i>THROUGH DRUMHOUSE. POSSIBLY NEVER ROOFED.</i>	2	2	2	1	-	-	-	-
8	GWALIAU	3	3	2	1	-	-	-	-
9	WEIGHBRIDGE HOUSE	3	3	2	1	-	-	-	-
10	GWALIAU	3	3	2	1	-	-	-	-
12	OBLITERATED	3	3	3	3	-	-	-	-
13	ADIT	1	1	1	2	-	-	-	-
14	STRUCTURE	3	3	2	1	-	-	-	-
15	WEIGHBRIDGE HOUSE	1	2	2	1	-	-	-	-
16	SMITHY	2	2	2	1	-	-	-	-
17	WEIGHBRIDGE HOUSE	1	1	2	1	-	-	-	-
18	QUARRY PIT	1	2	2	1	-	-	-	-
19	ADIT	-	-	-	-	-	-	-	-
20	ADIT	-	-	-	-	-	-	-	-
21	INCLINE WINDING HOUSE	2	2	2	1	-	-	-	-
22	INCLINE UPHAULAGE	3	3	3	1	-	-	-	-
23	SHAFT-HEAD <i>ONLY VISIBLE AS DEPRESSION IN FIELD.</i>	3	3	3	1	-	-	-	-

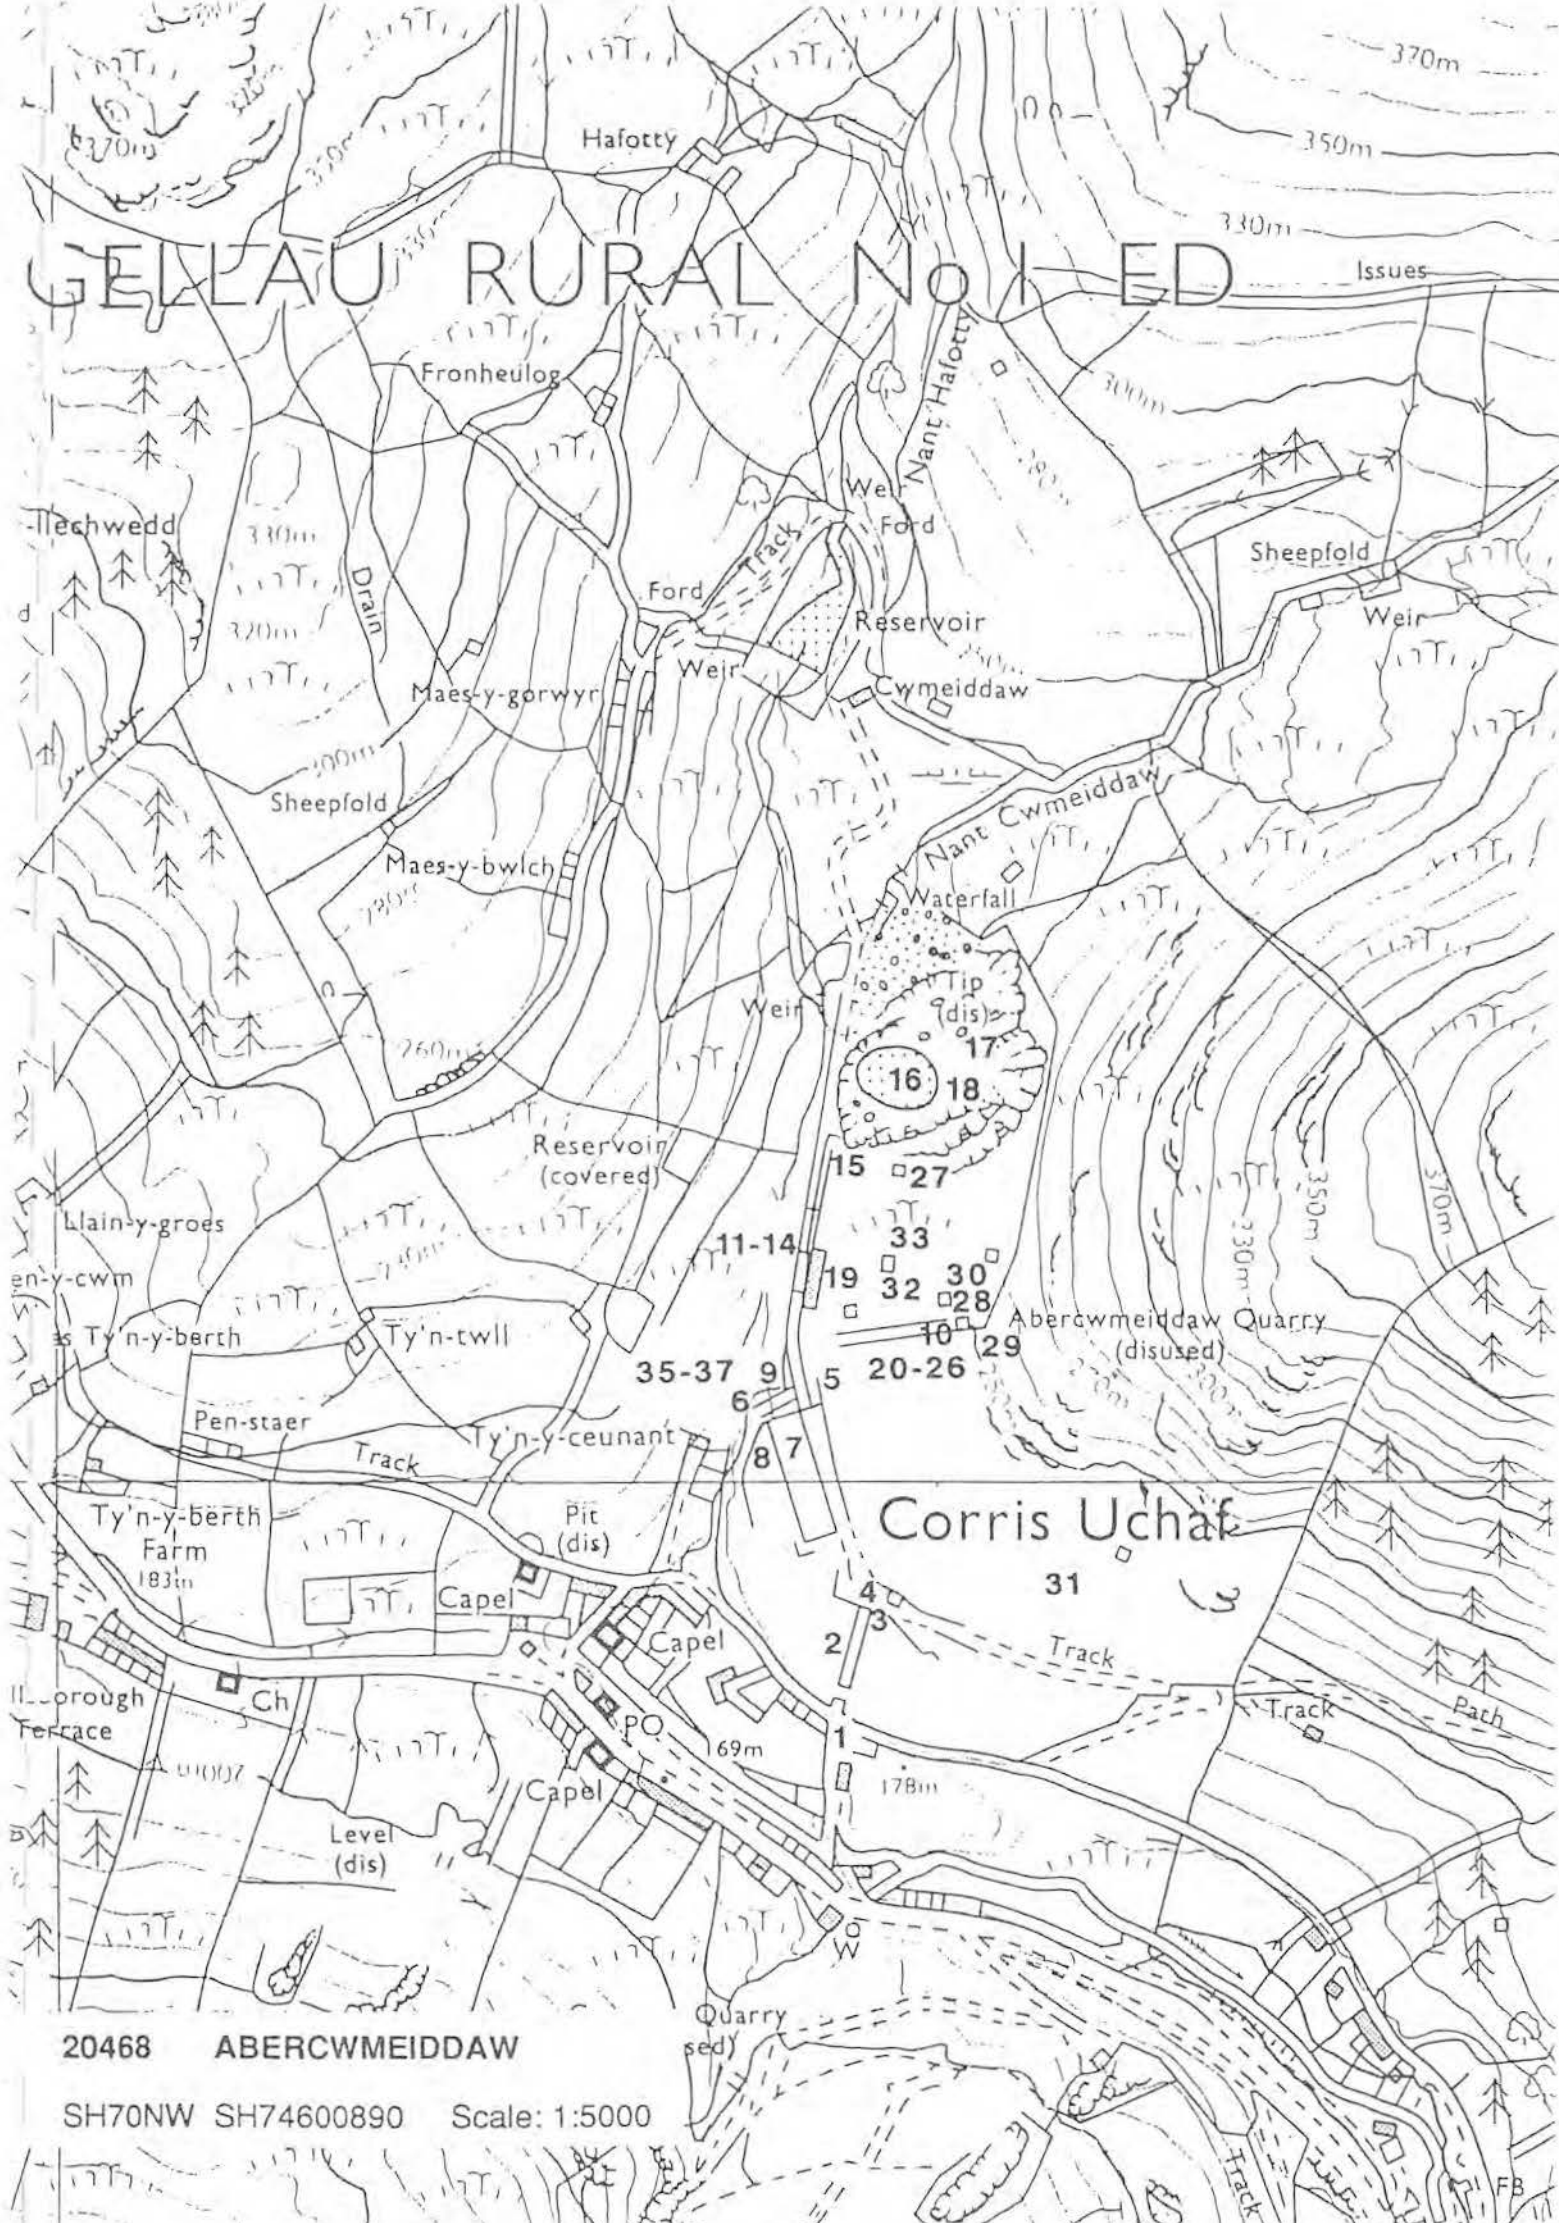
20468 ABERCWMEIDDAW

S	C	F	V	P	R	PO	GV
1	DWELLING <i>2-STOREY, POSSIBLY A FARMHOUSE.</i>	1	1	2	1	-	-	-	-
2	RETAINING WALL	1	1	2	1	-	-	-	-
3	MILL <i>ORIGINAL MILL IS A SINGLE-GABLE STRUCTURE, EITHER BAY OR LONGITUDINAL TYPE, WITH A VOUSOIR ARCH TRAMWAY DOOR IN THE NE GABLE, LATER REPLACED BY A FLAT LINTEL. EXTENSION ON NW SIDE IS LATER, POSSIBLY TRANSVERSE TYPE. MACHINE BASES AND AXLE BOXES EVIDENT IN EARLIER MILL.</i>	2	1	2	1	-	-	-	-
4	WEIGHBRIDGE HOUSE	1	1	2	1	-	-	-	-
5	STRUCTURE <i>POSSIBLY AN EARLY RADIAL MILL. LATTERLY A SMITHY, WITH INTERPOLATED HEARTH. A WATER-COURSE RUNS NEXT TO IT BUT THERE IS NO EVIDENCE OF A WHEELPIT.</i>	2	2	2	1	-	-	-	-
6	WATER STORAGE <i>RESERVOIR IMPOUNDED BY DAM.</i>	2	2	2	1	-	-	-	-
7	INCLINE COUNTERBALANCE	3	3	2	1	-	-	-	-
8	INCLINE DRUMHOUSE <i>REMOTE. BRAKE GEAR SURVIVES.</i>	2	1	1	1	-	-	-	-
9	RAILWAY EQUIPMENT <i>RAILS IN SITU.</i>	1	1	1	1	-	-	-	-
10	WEIGHBRIDGE HOUSE	3	3	2	1	-	-	-	-

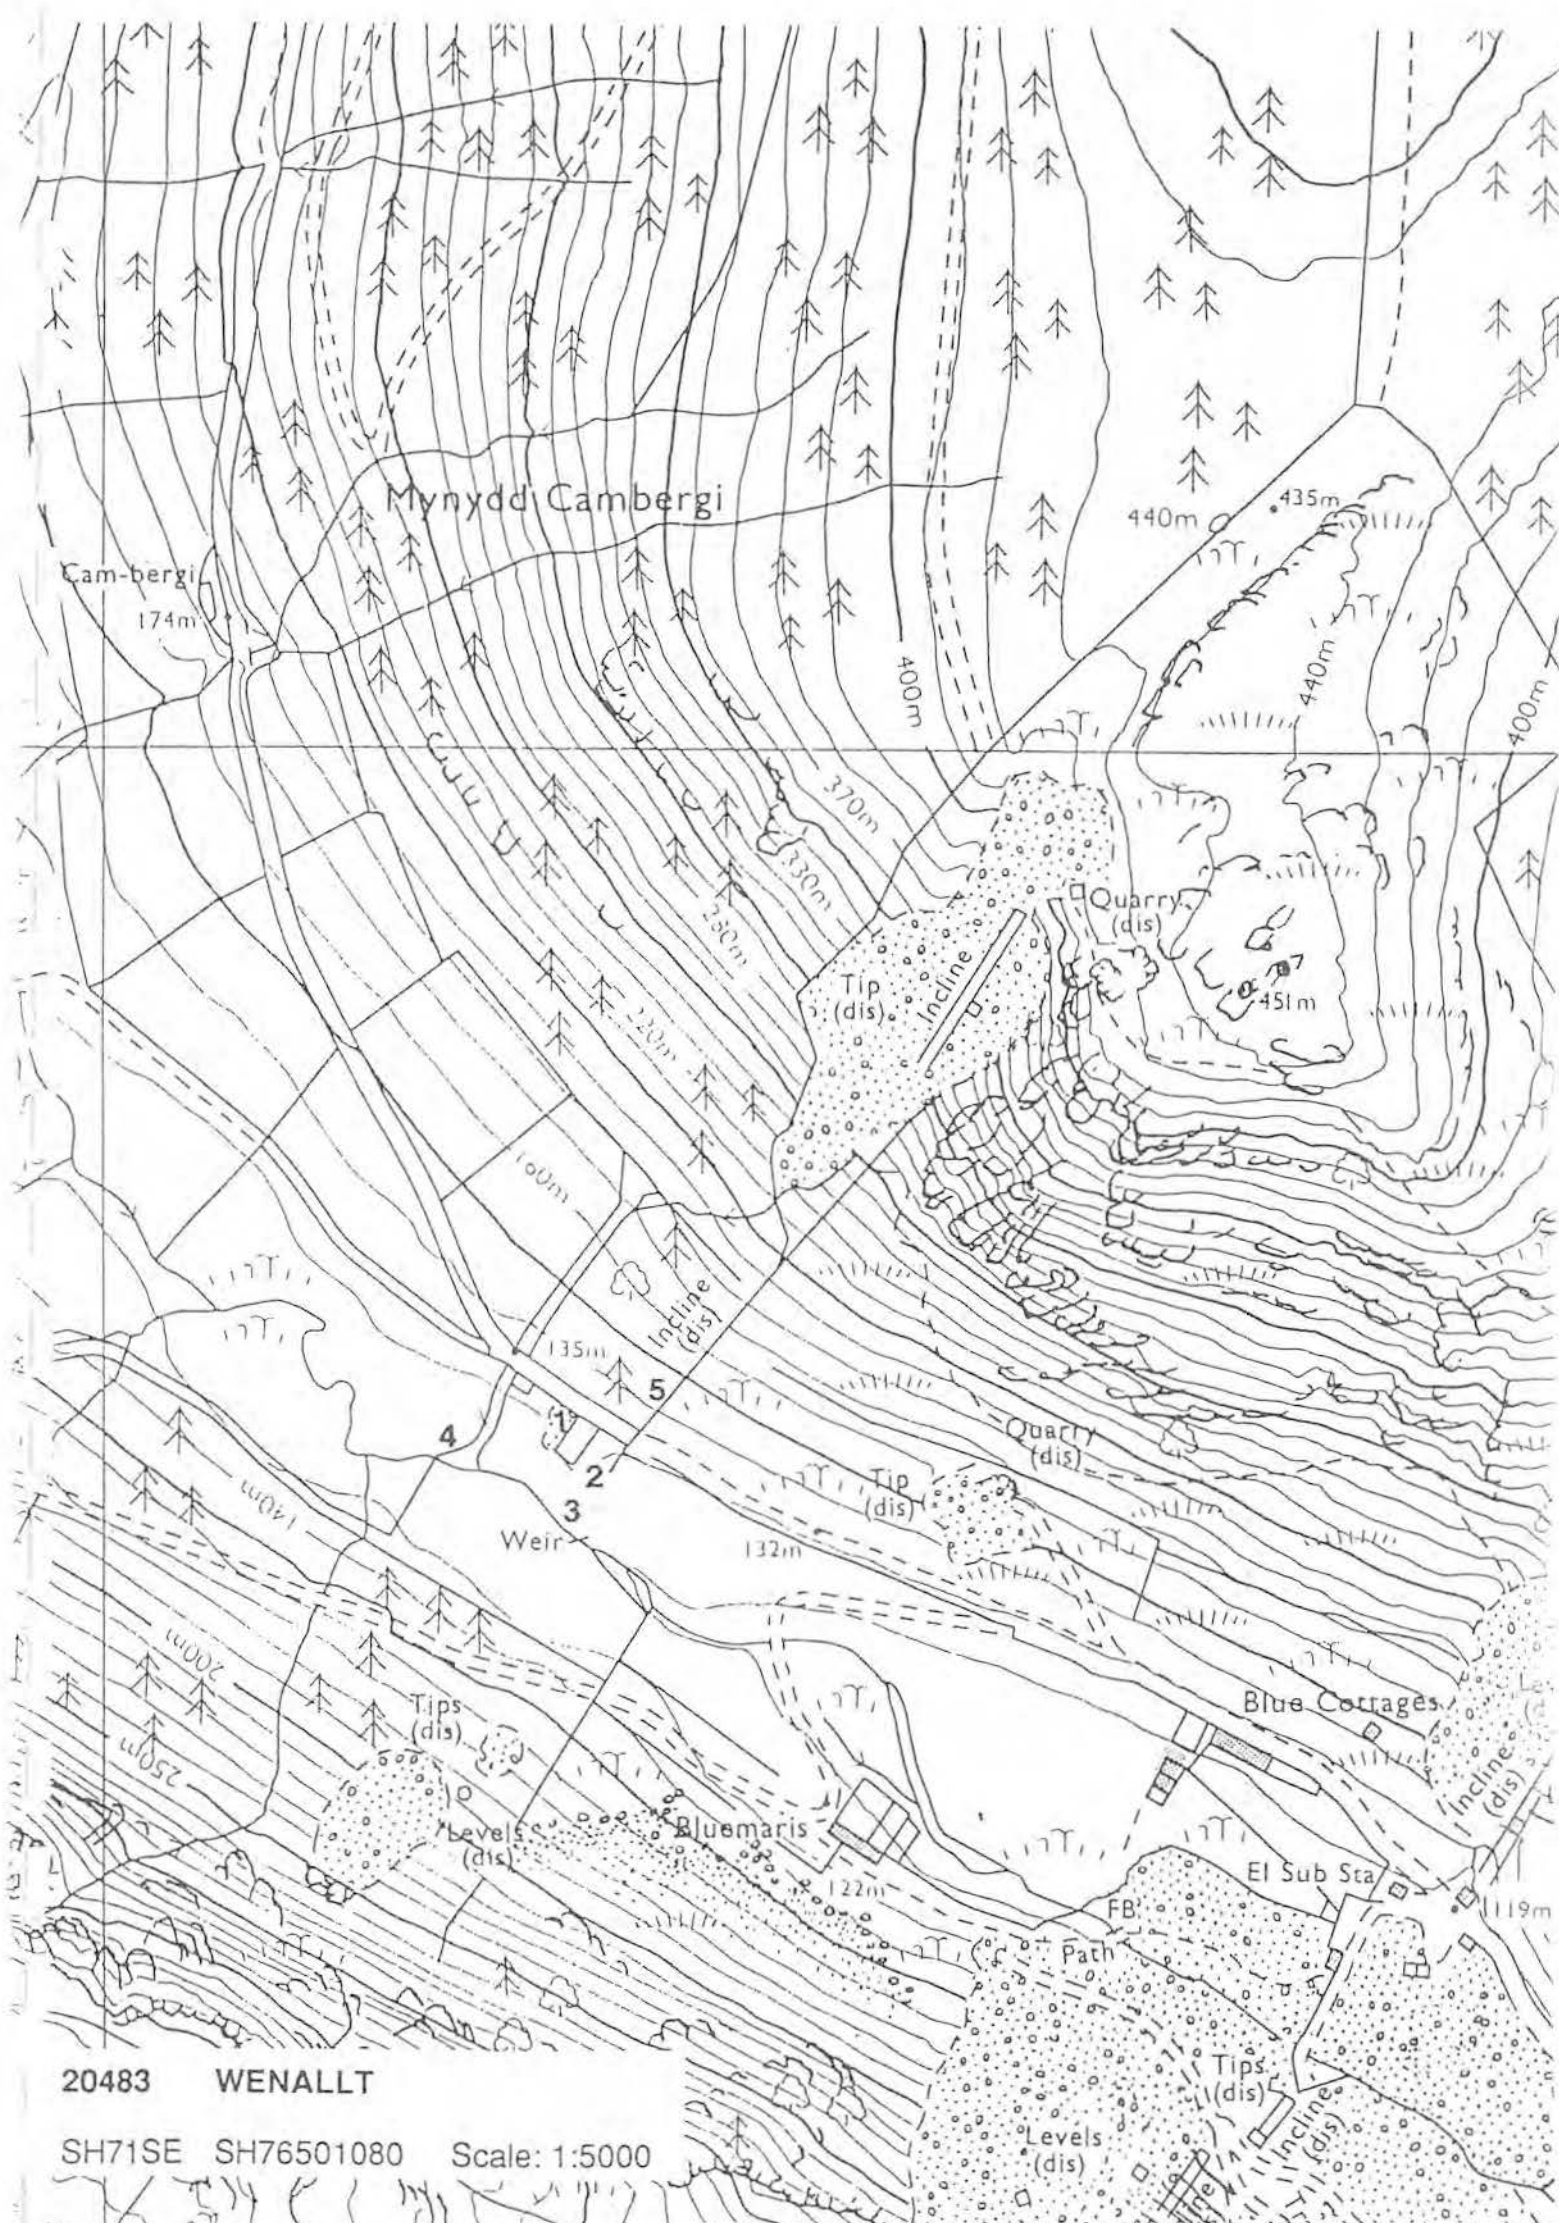
20483 WENALLT

Class	1.0	
28	INCLINE COUNTERBALANCE	2	2	1	1	-	-	-	-
	UPPER PART DEGRADED.								
29	INCLINE DRUMHOUSE	-	-	-	-	-	-	-	-
	NOT VISITED.								
30	INCLINE COUNTERBALANCE	-	-	-	-	-	-	-	-
	NOT VISITED.								
31	INCLINE DRUMHOUSE	-	-	-	-	-	-	-	-
	NOT VISITED.								
32	INCLINE COUNTERBALANCE	3	3	3	1	-	-	-	-
33	INCLINE DRUMHOUSE	3	3	3	1	-	-	-	-
34	INCLINE COUNTERBALANCE	3	3	3	1	-	-	-	-
35	INCLINE DRUMHOUSE	3	3	3	1	-	-	-	-
36	STRUCTURE	3	3	3	1	-	-	-	-
37	INCLINE COUNTERBALANCE	3	3	3	1	-	-	-	-
38	INCLINE DRUMHOUSE	3	3	3	1	-	-	-	-
39	SHAFT-HEAD	1	1	1	1	-	-	-	-
