PANDORA MINE, TREFRIW, CONWY

ASESIAD ARCHEOLEGOL / ARCHAEOLOGICAL ASSESSMENT

Prosiect Rhif / Project No. G2682

Adroddiad Rhif / Report No. 1580

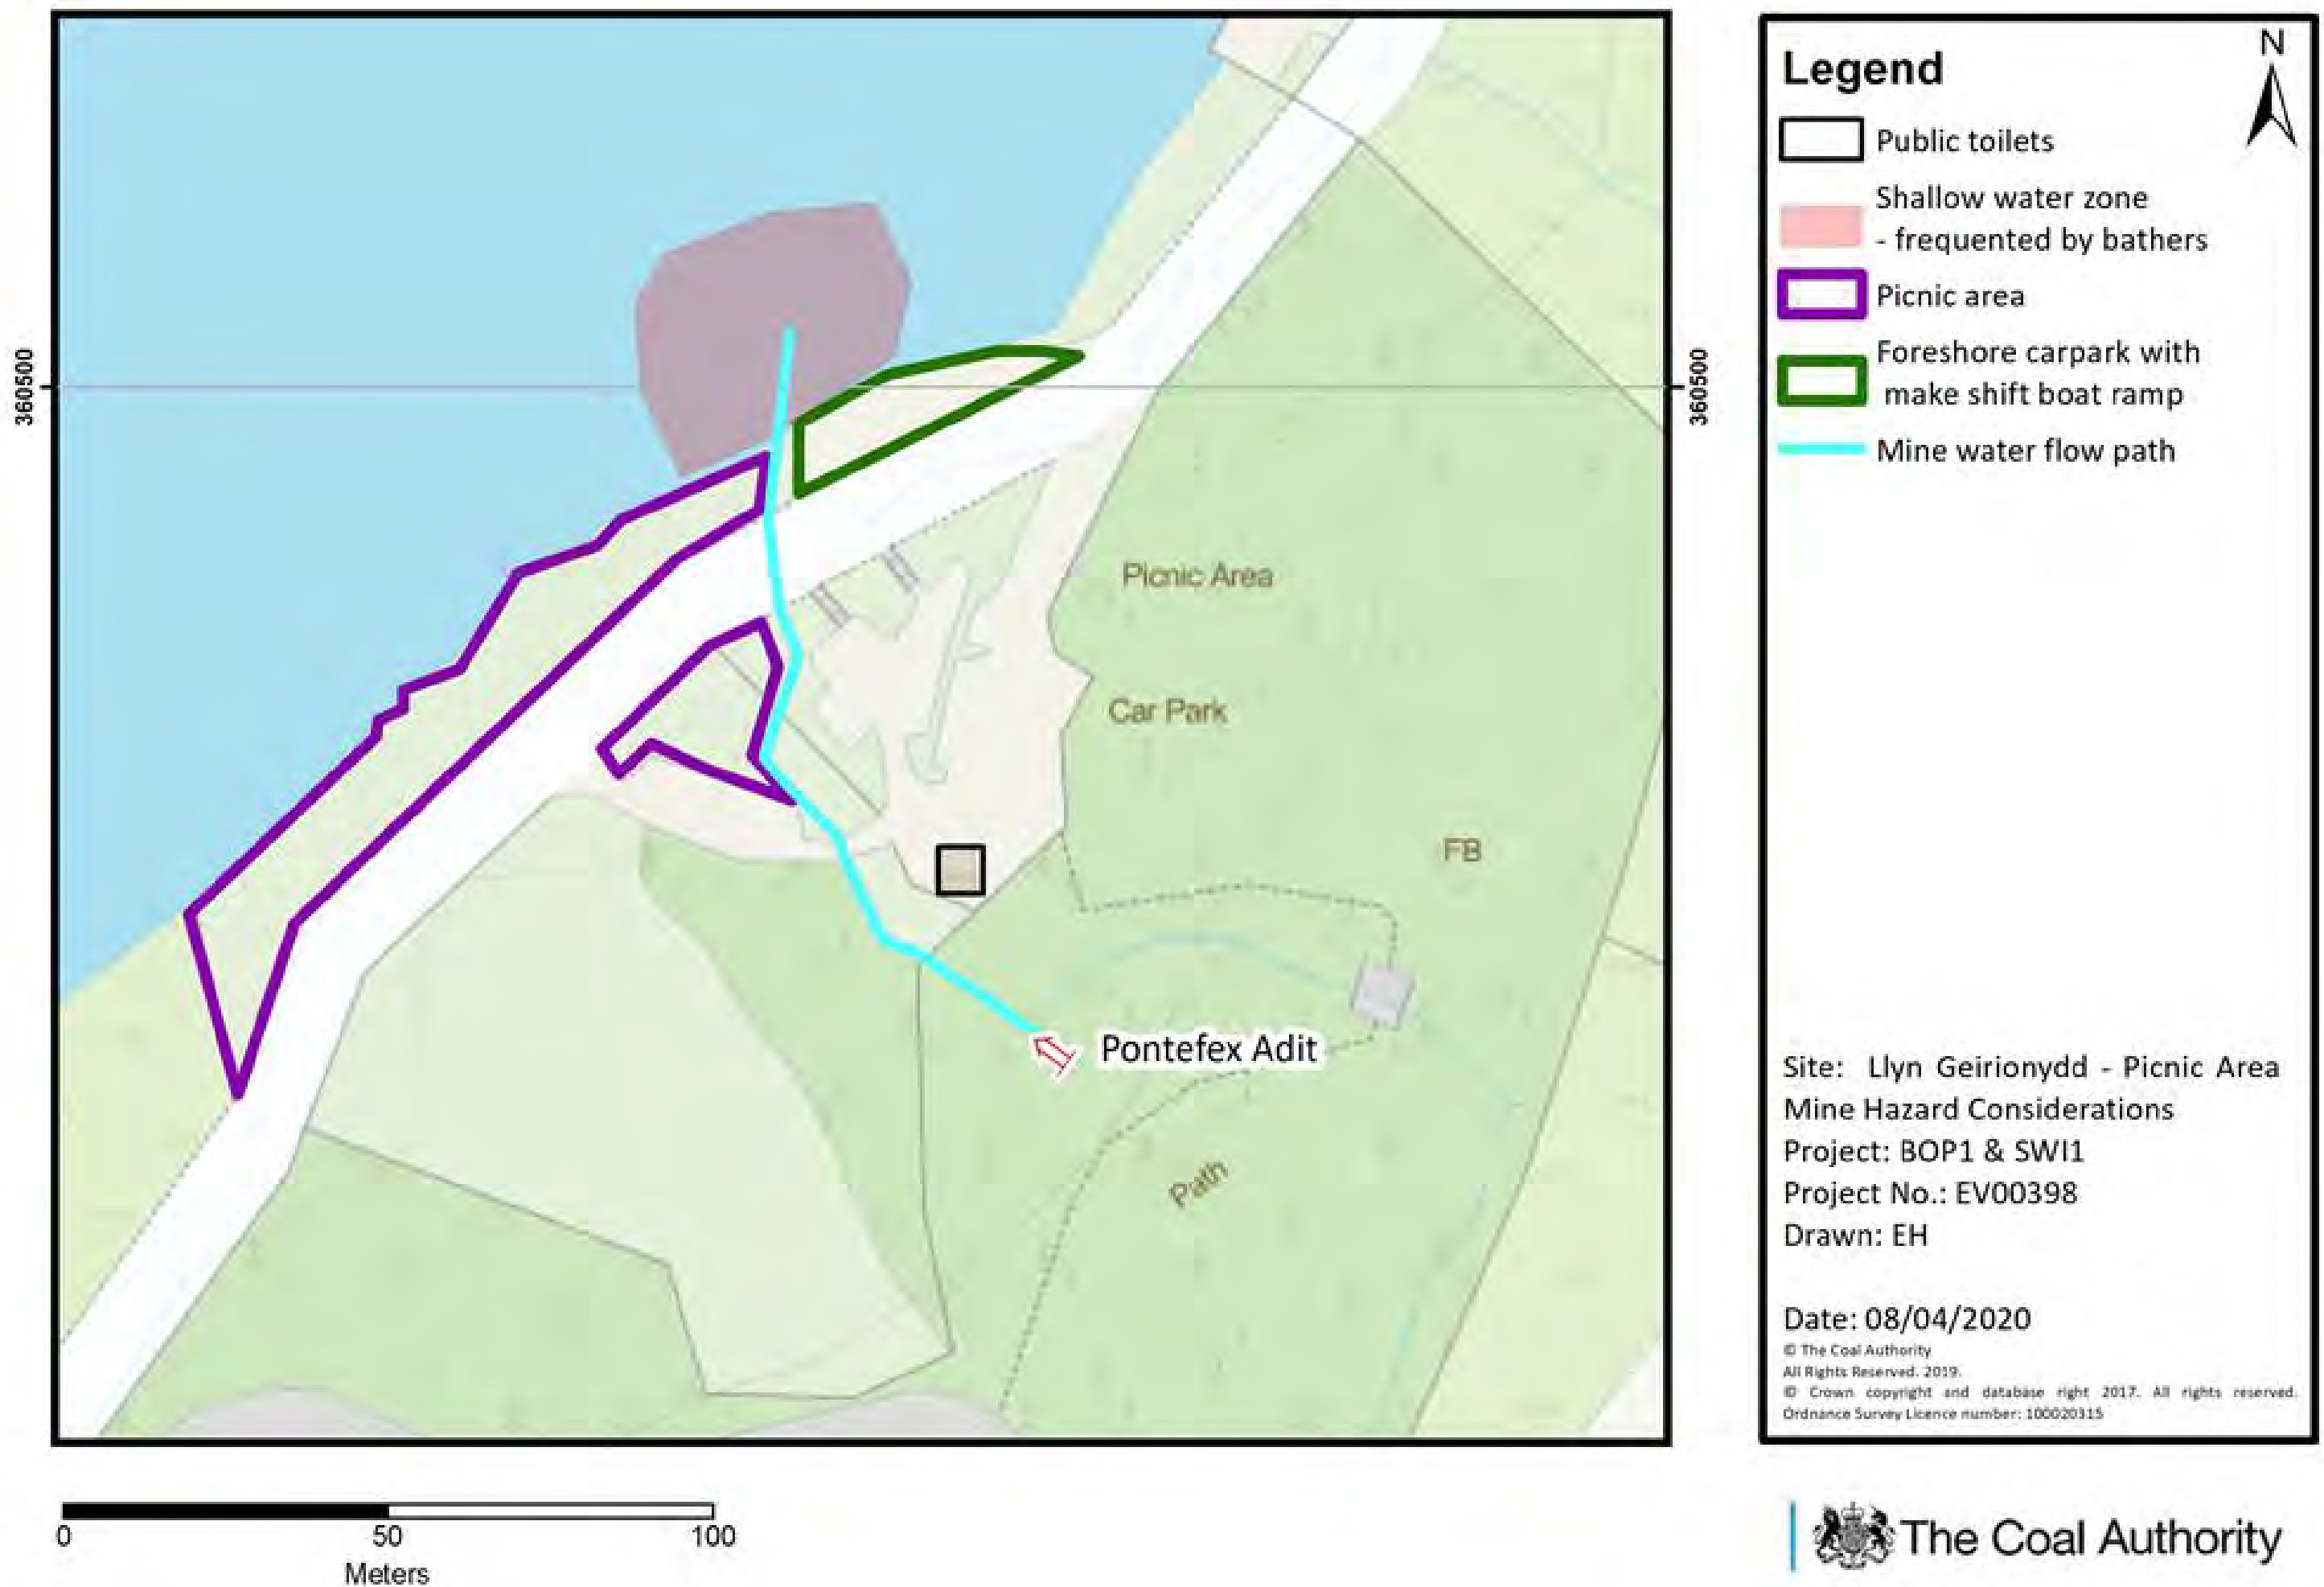
Figure 02 - Pontifex Adit outflow, Llyn Geirionydd car park/day-use area and anticipated flow monitoring locations. Source: Binnies.

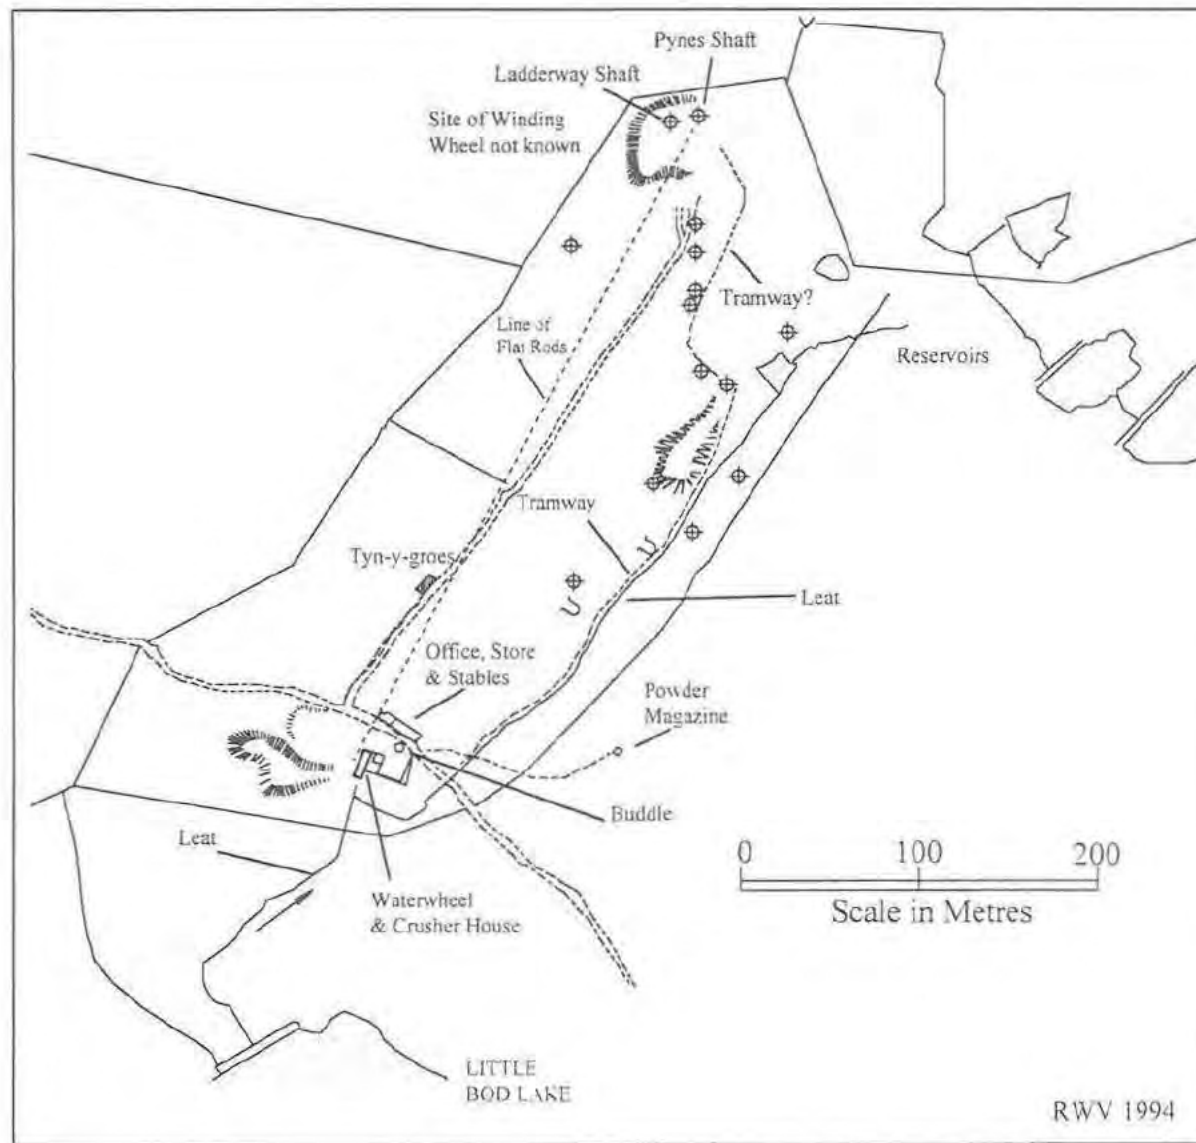
Pandora Mine (Willoughby Mine) 1875.

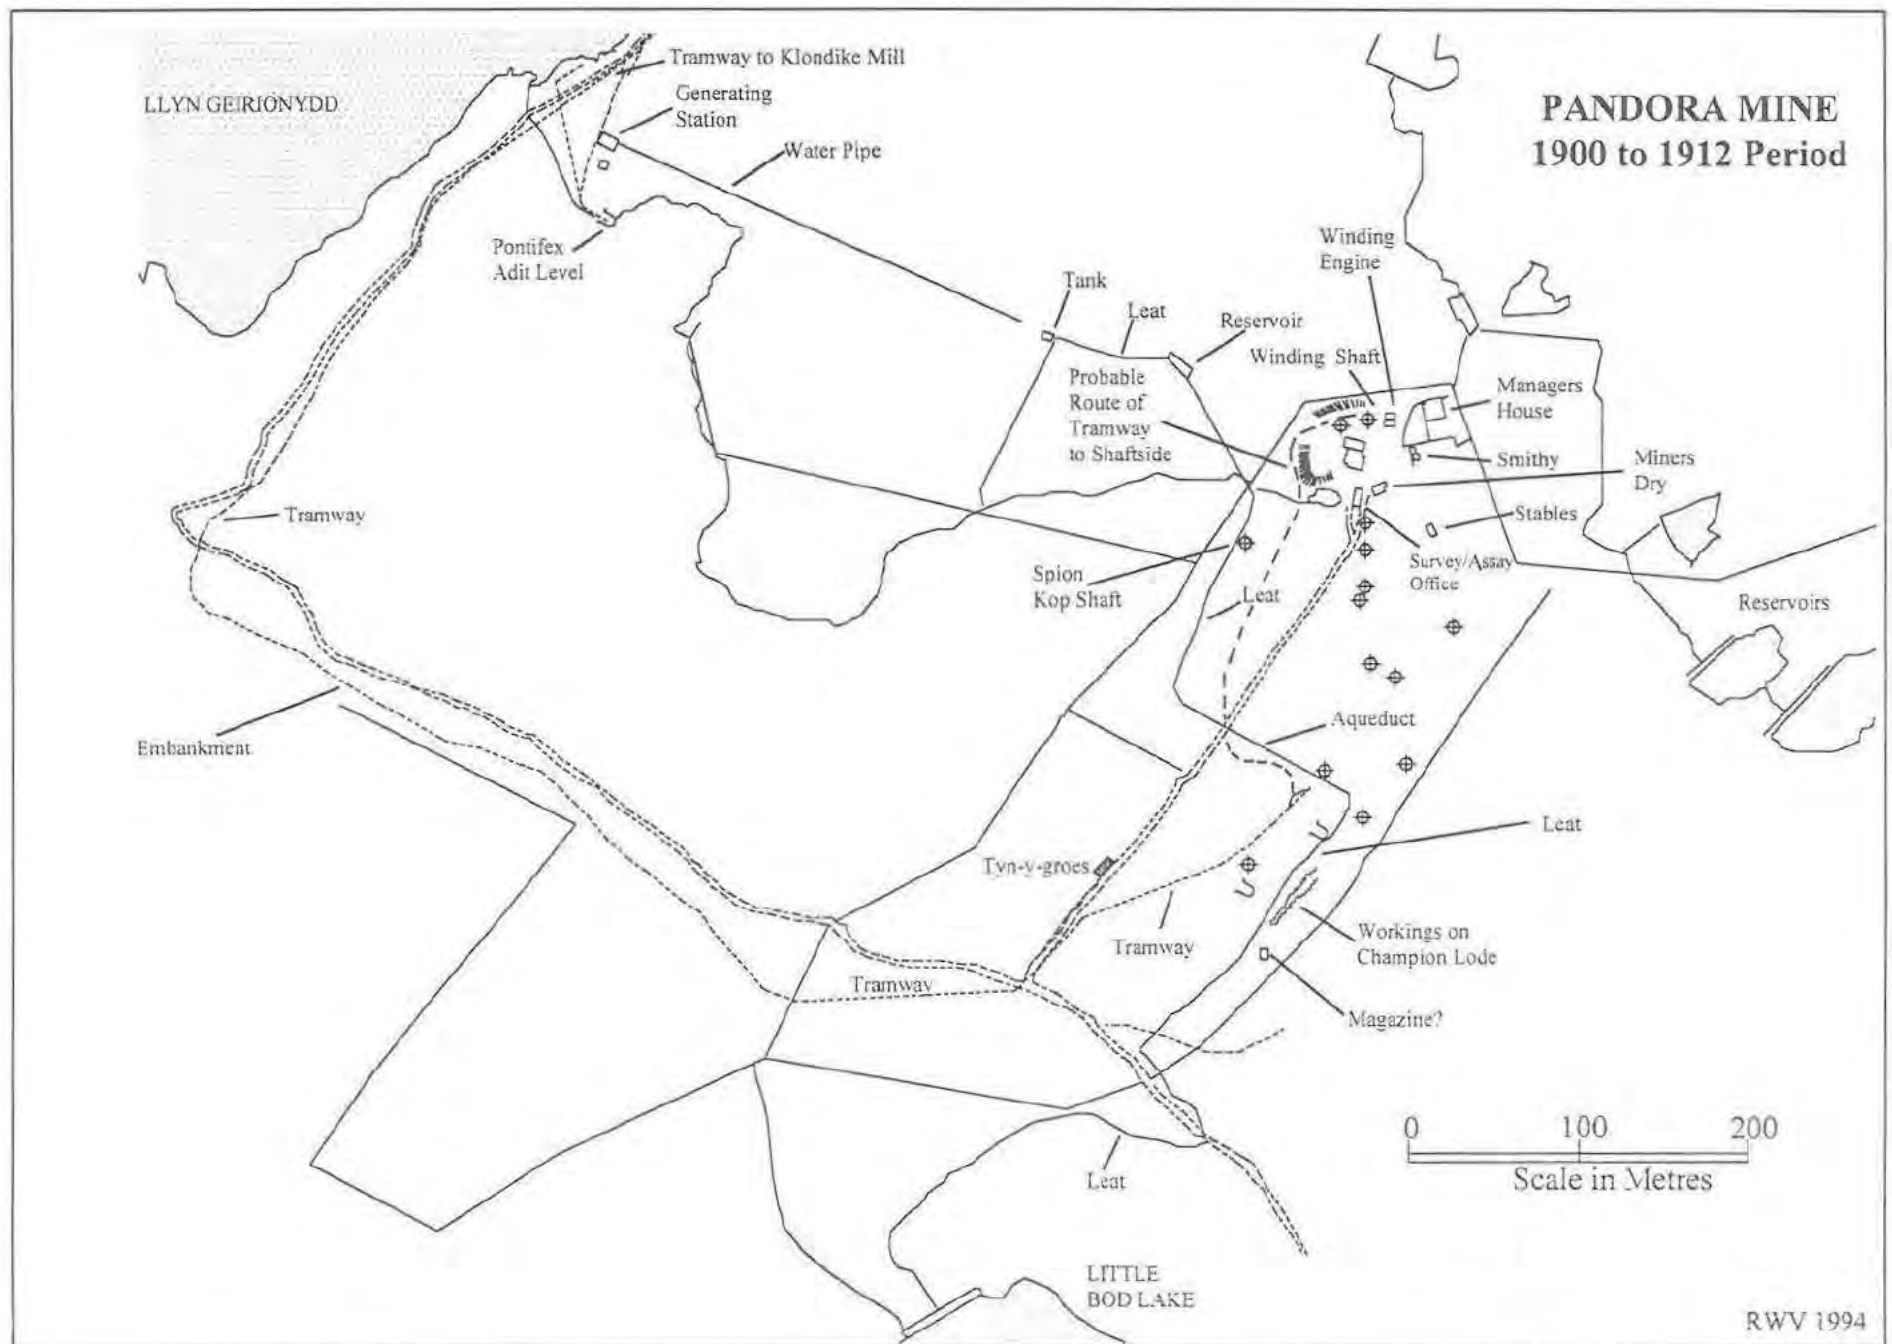
Figure 04 - Plan of Pandora Mine between 1900 and 1912. Source: Dutton, Roberts & Vernon, 1995. GAT Report No: 136.

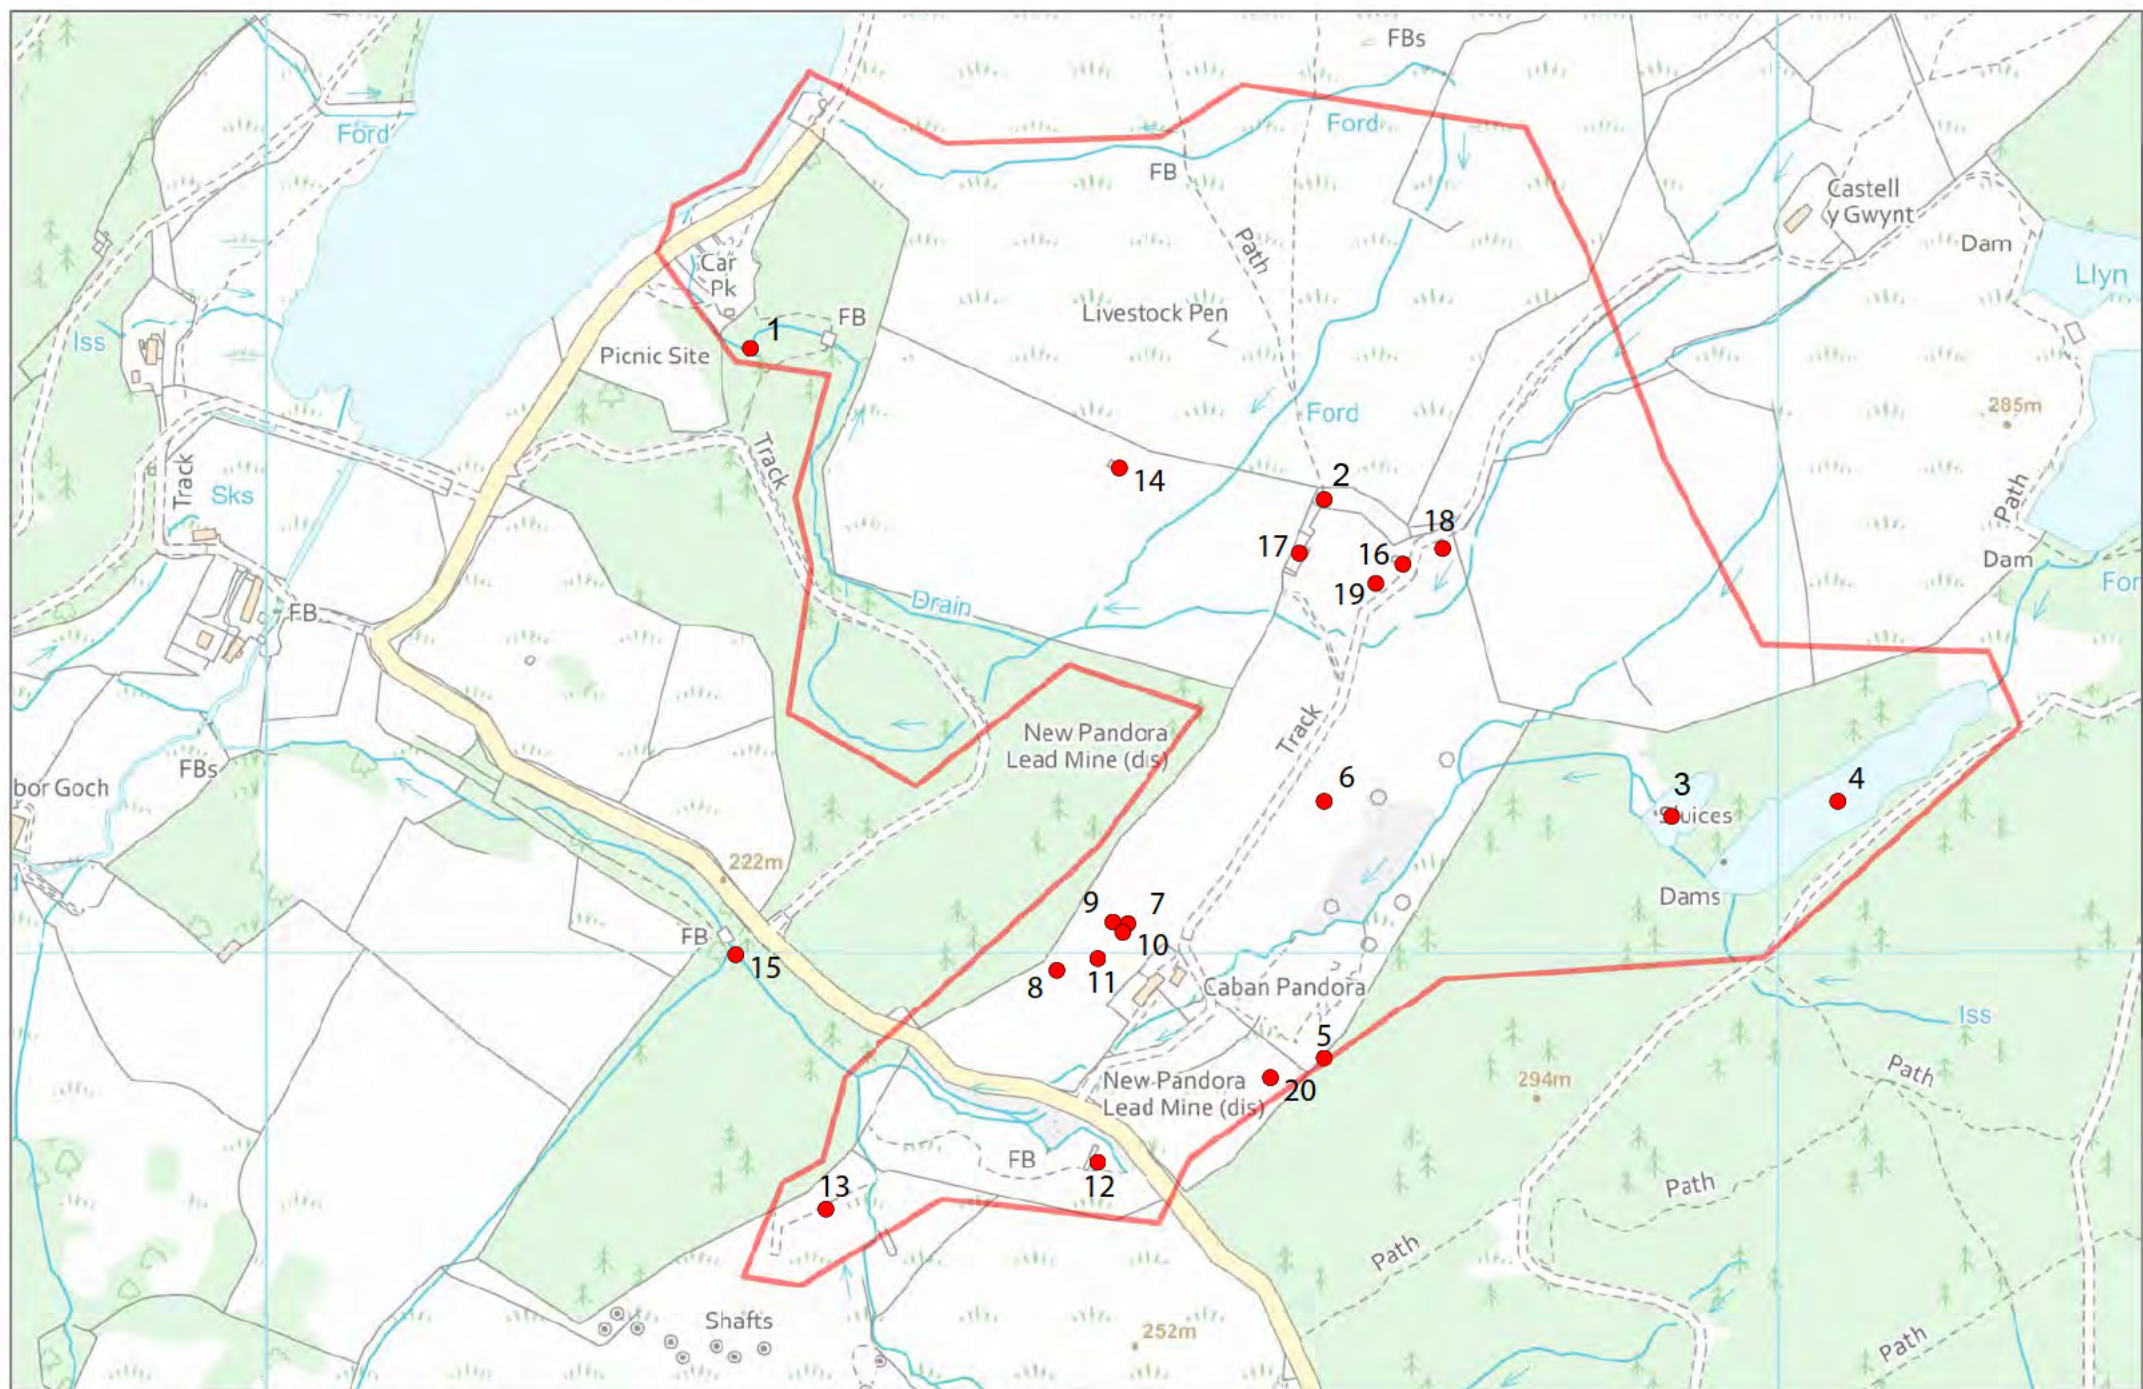
Figure 12 - Gazetteer of Features. Background mapping reproduced from Ordnance Survey VectorMap Local with the permission of H.M.S.O.
 ©Crown Copyright and database right 2021, license number AL 100020895

All the sites included in the gazetteer are shown on Figure 12. All recommendations are based on the current understanding of the scheme proposals and their impact on the features, and may have to be revised if information about the scheme impacts changes. In the event of alterations to the scheme, the recommendations might have to be revisited.

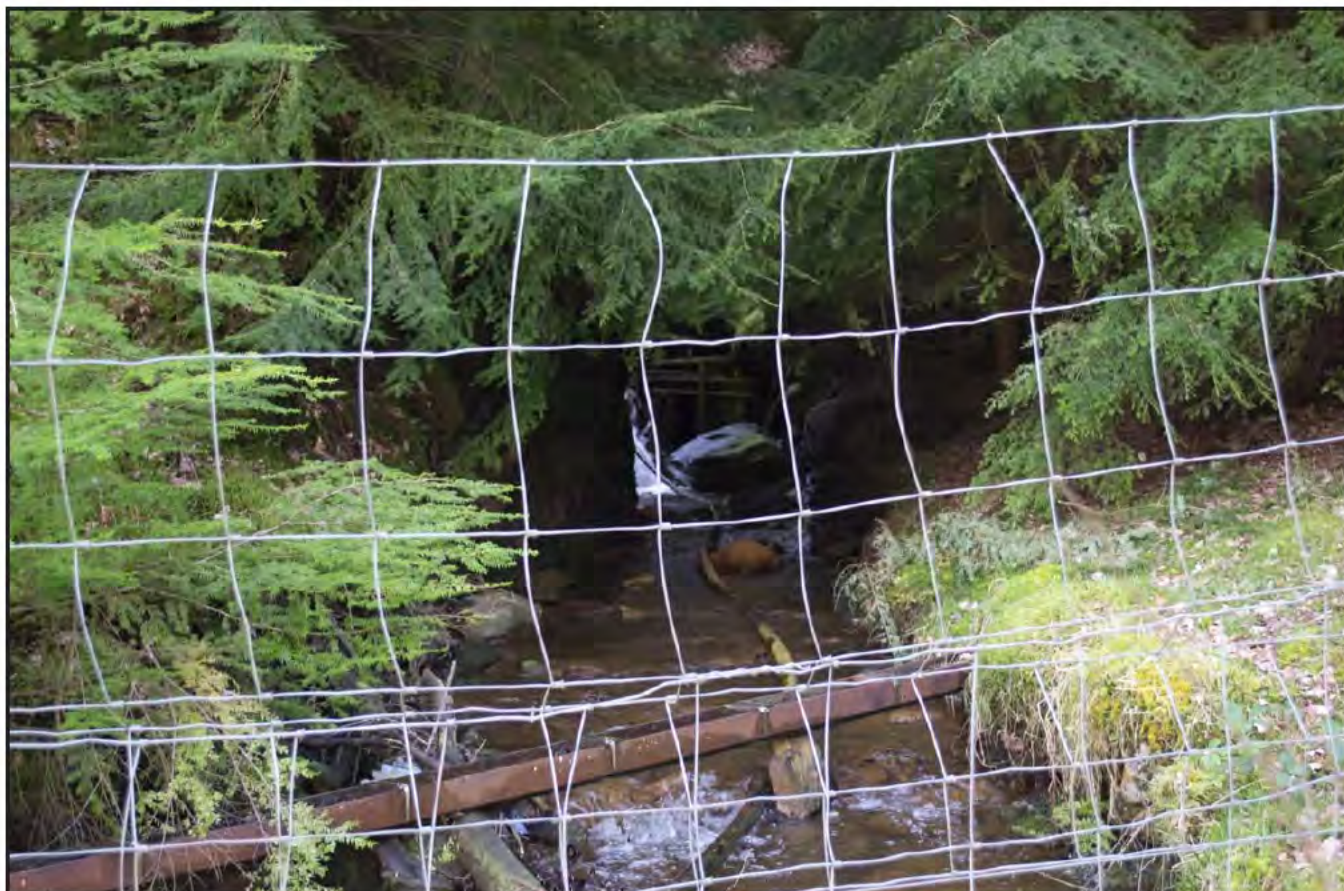
Plate 1: Pontifex Adit; no scale; view from NW (archive reference: G2682_016).

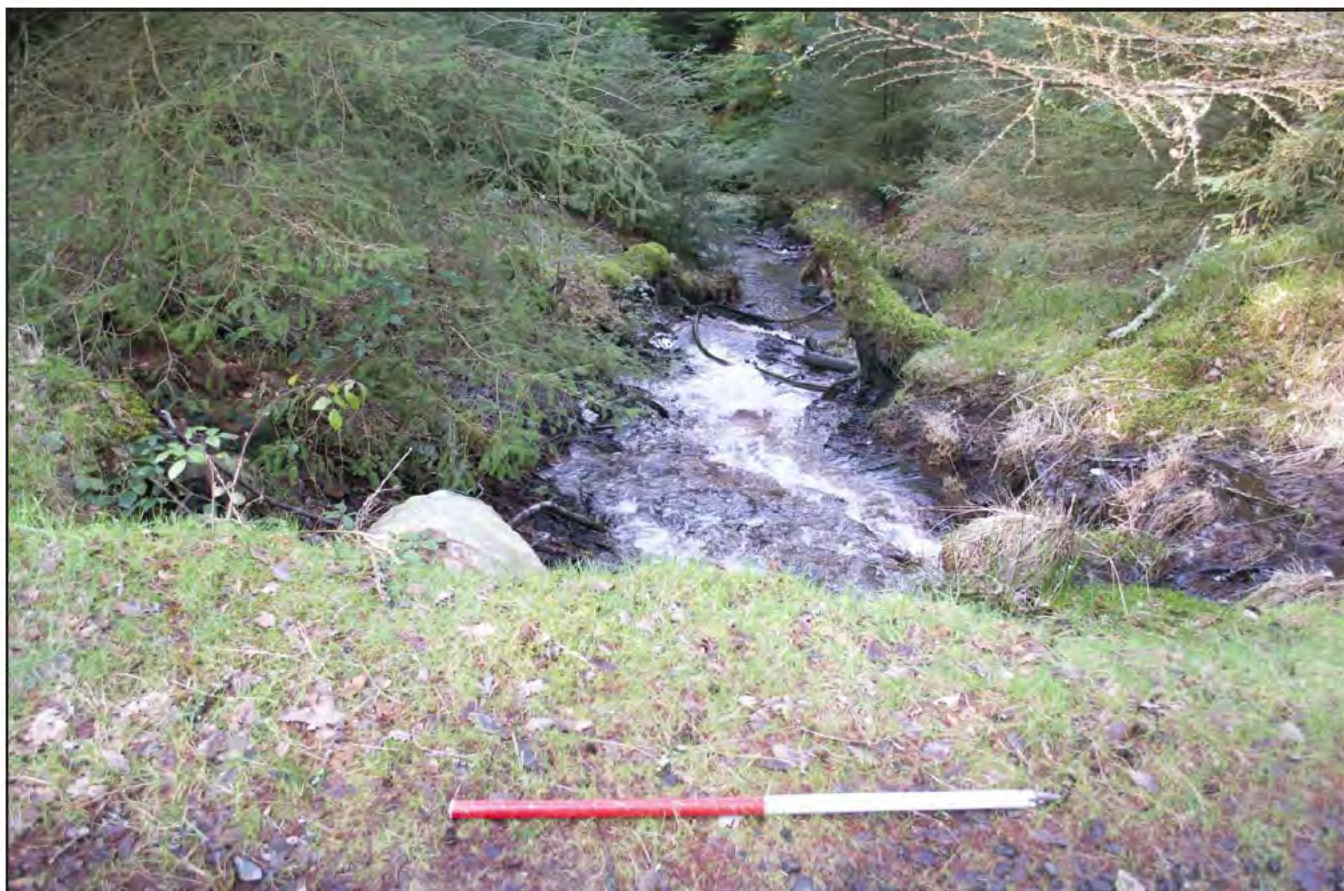
Plate 2: Downstream towards Pontifex Adit from current flow monitoring apparatus; scale 1x1m; view from ESE (archive reference: G2682_009).

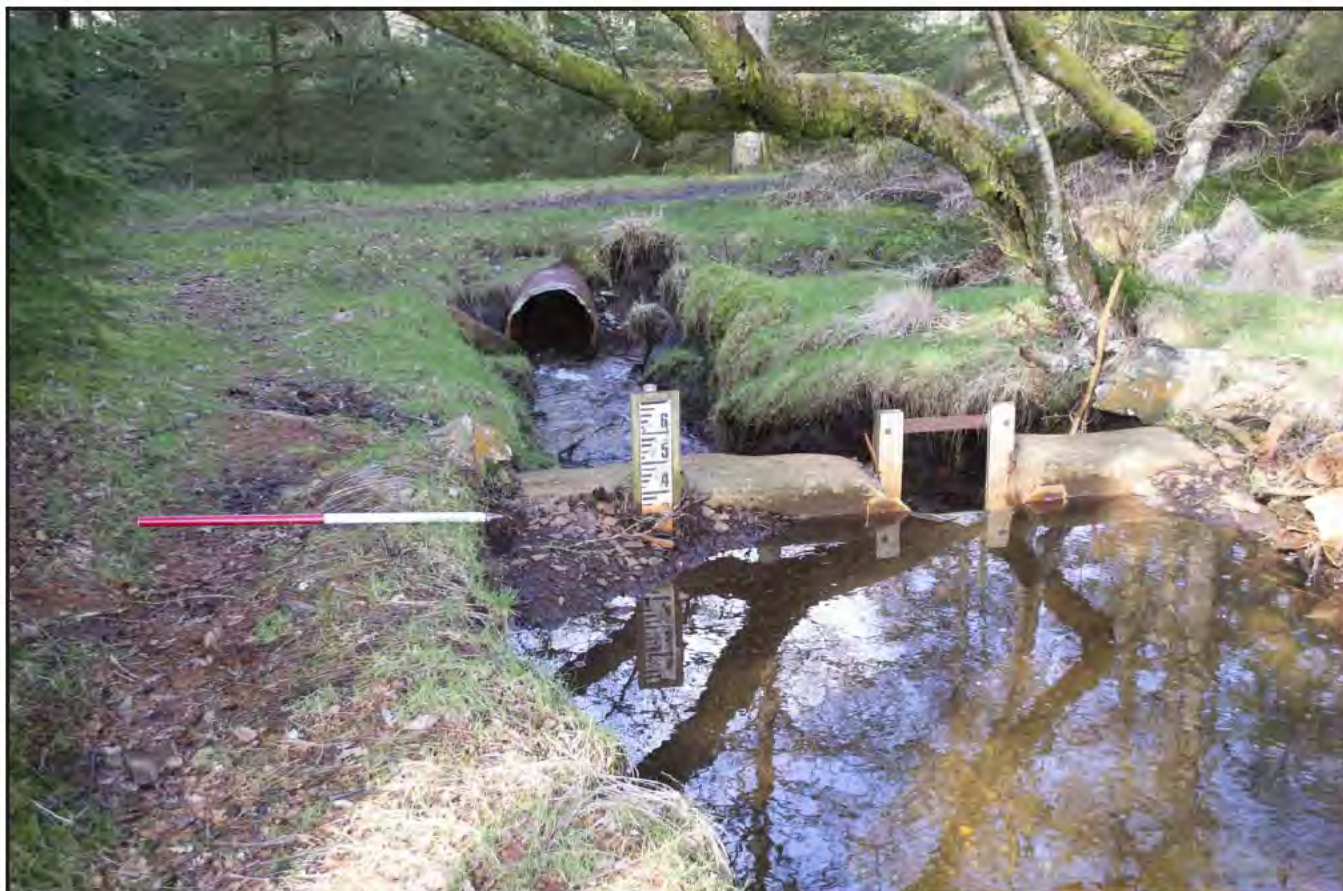
Plate 3: Current flow rate monitor - Pontifex Adit; scale 1x1m; view from SE (archive reference: G2682_007).

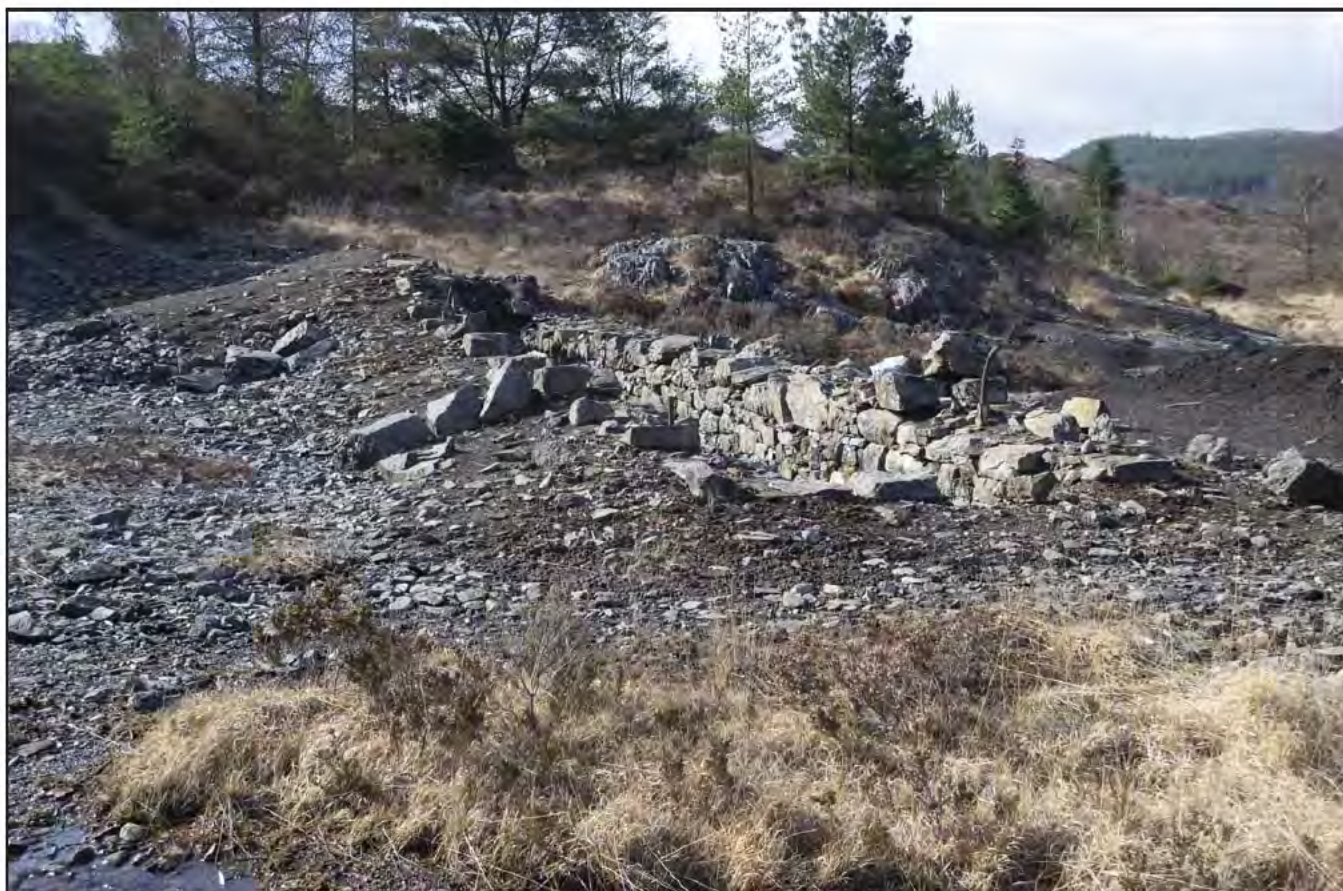
Plate 4: Waterwheel Pit; no scale; view from NE (archive reference: G2682_001).

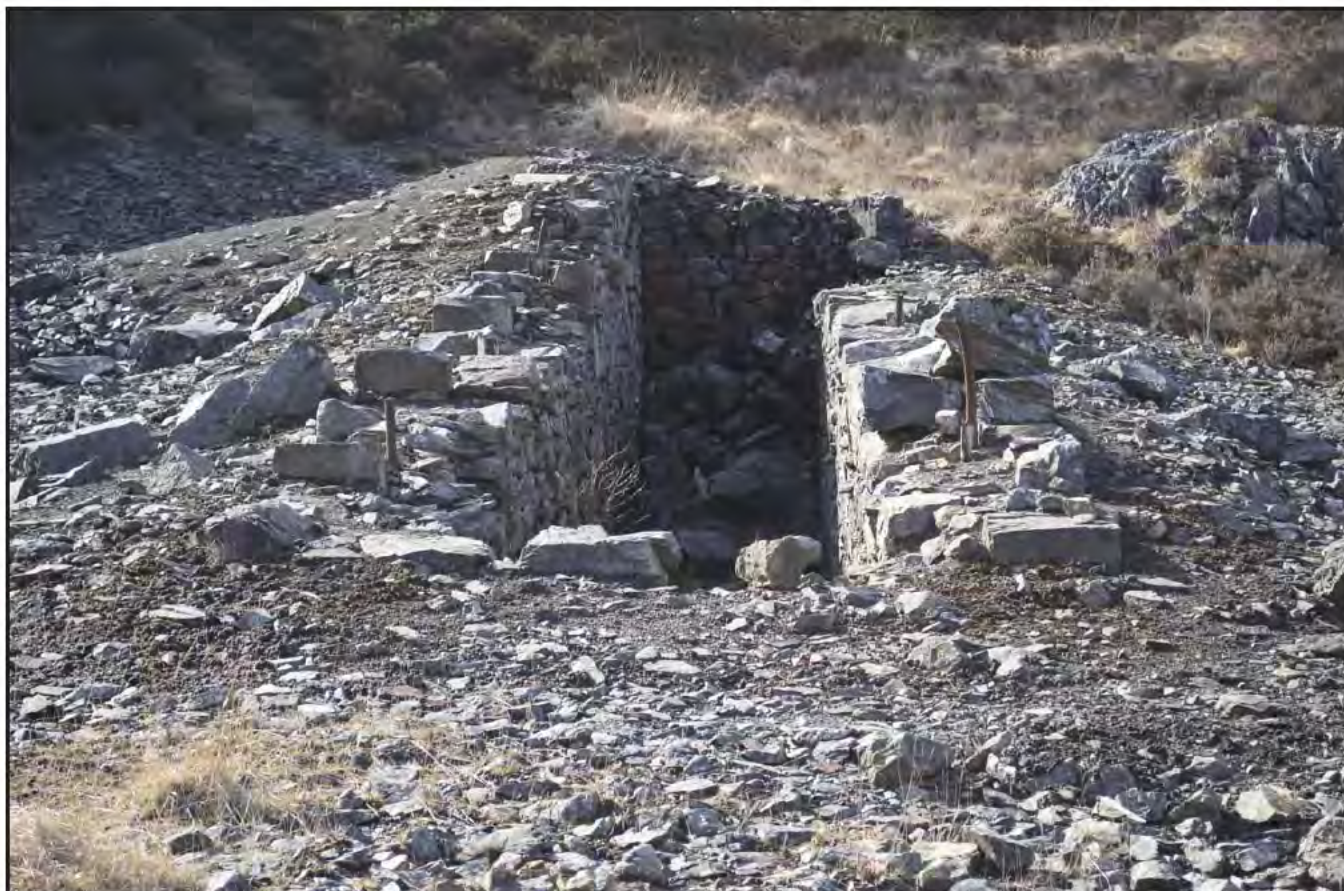
Plate 5: Waterwheel Pit; no scale; view from NNE (archive reference: G2682_002).

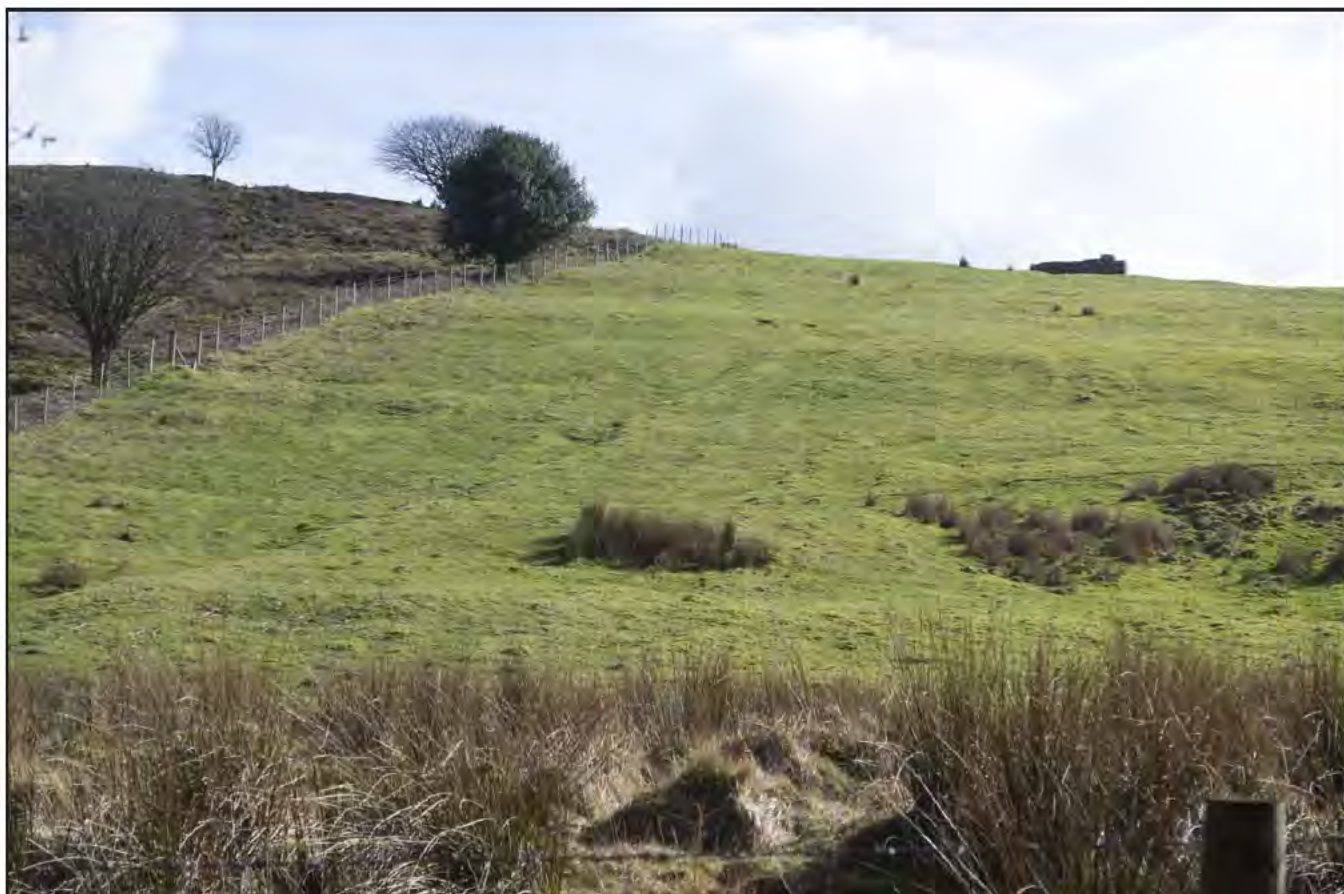
Plate 6: Remains of old tank building - linear channel visible running down field; no scale; view from NNW (archive reference: G2682_008).

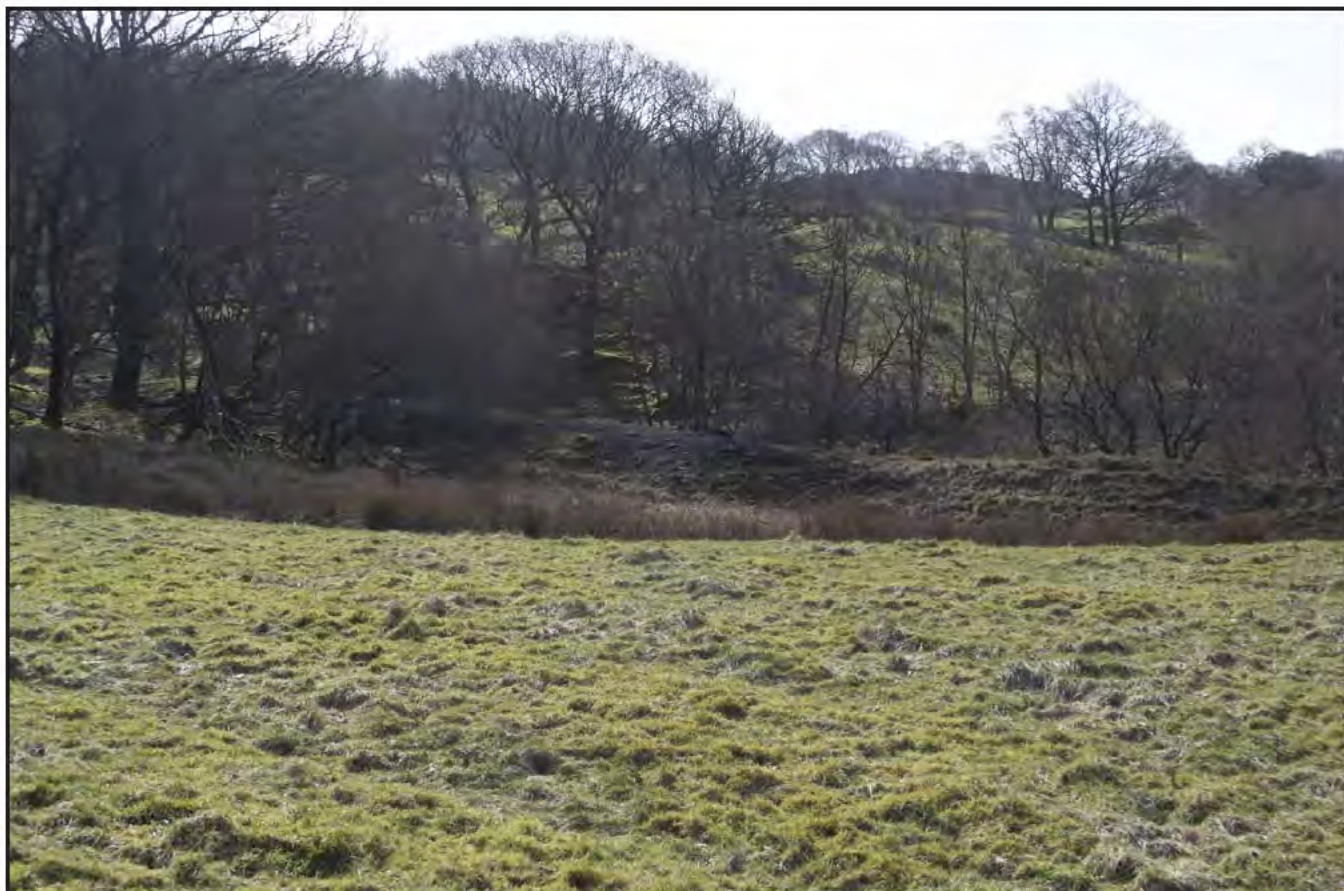
Plate 7: Embankment/Tramway; no scale; view from N (archive reference: G2682_005).

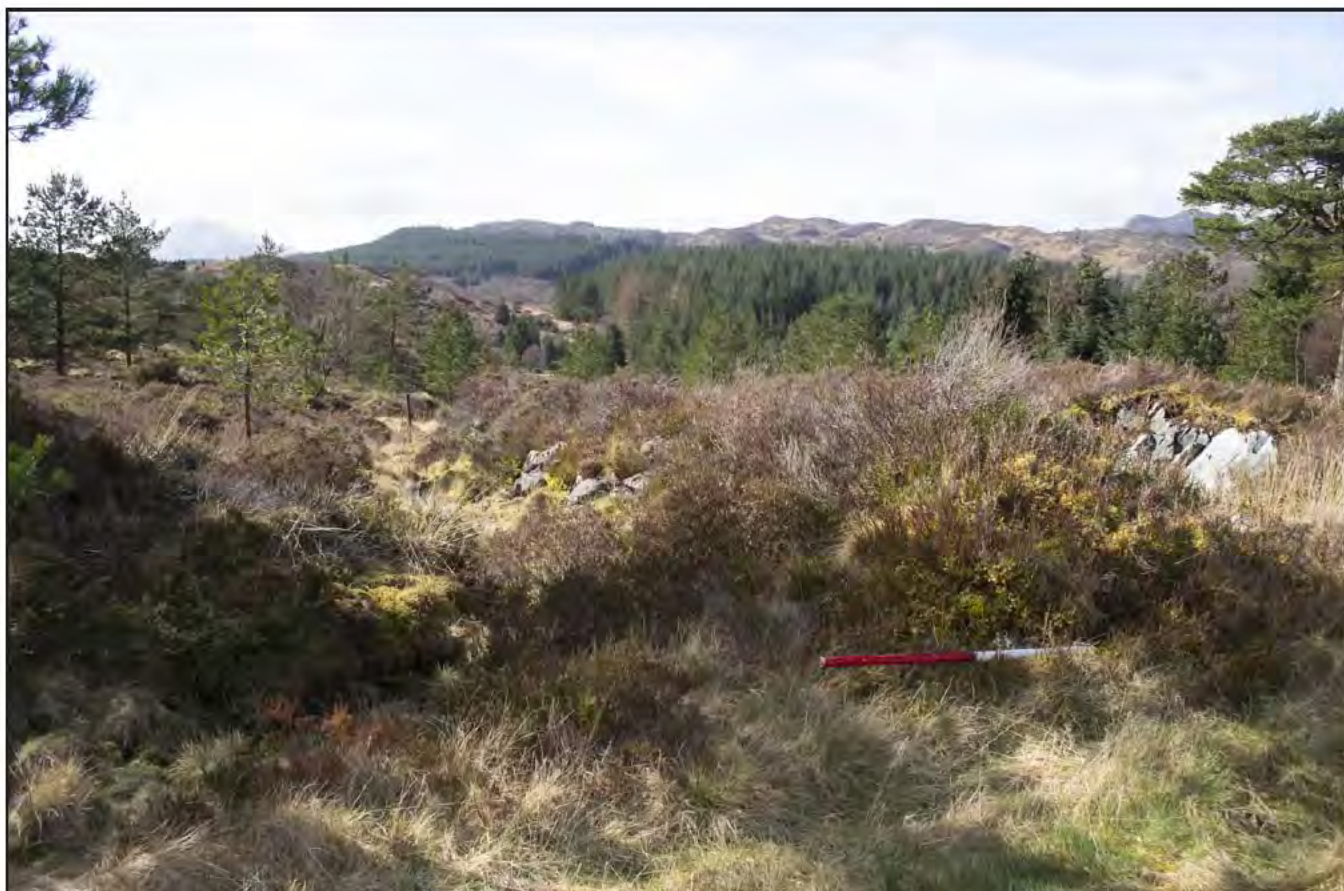
Plate 8: Tramway; scale 1x1m; view from E (archive reference: G2682_021).

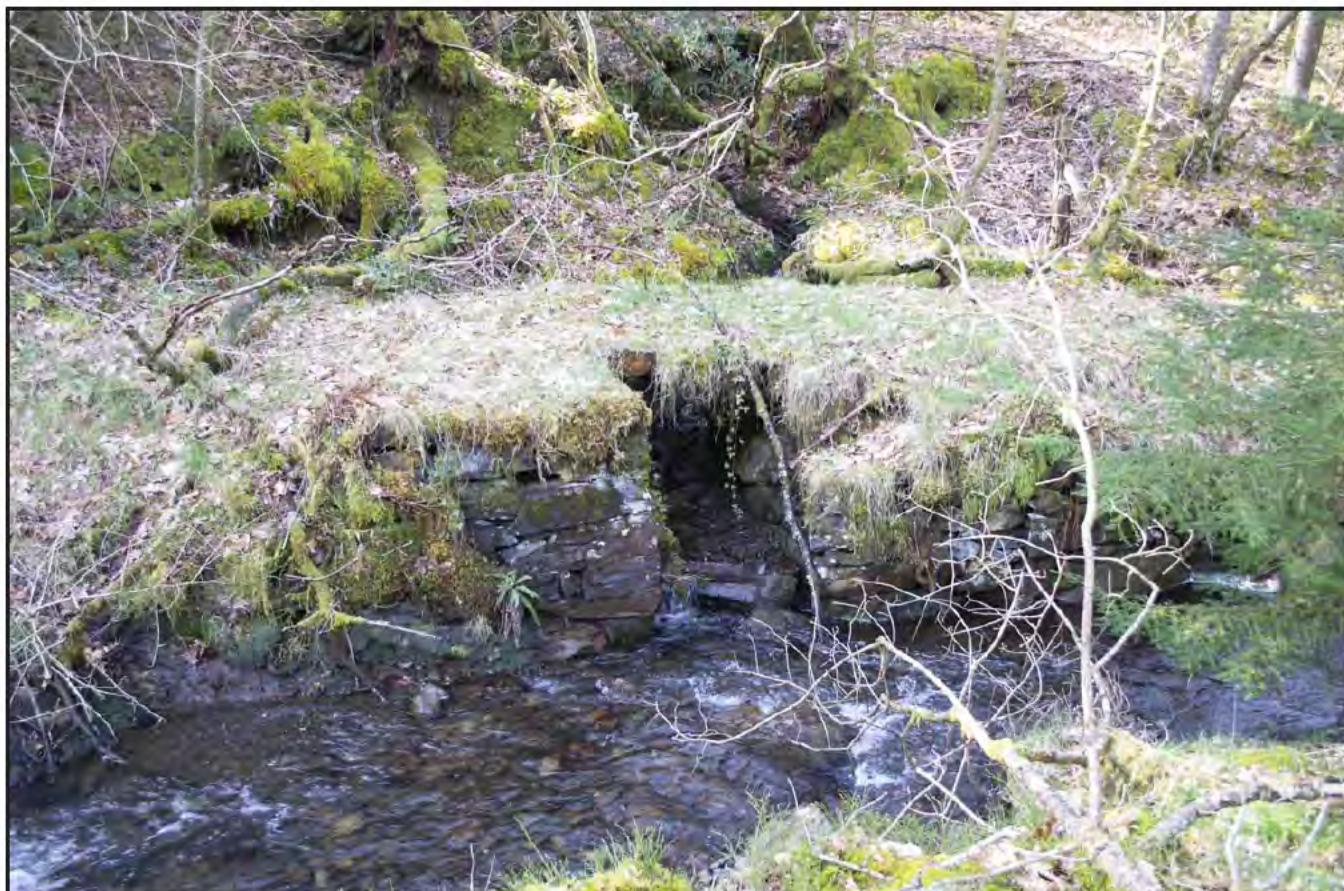
Plate 9: Tramway with culvert for stream; no scale; view from NE (archive reference: G2682_017).

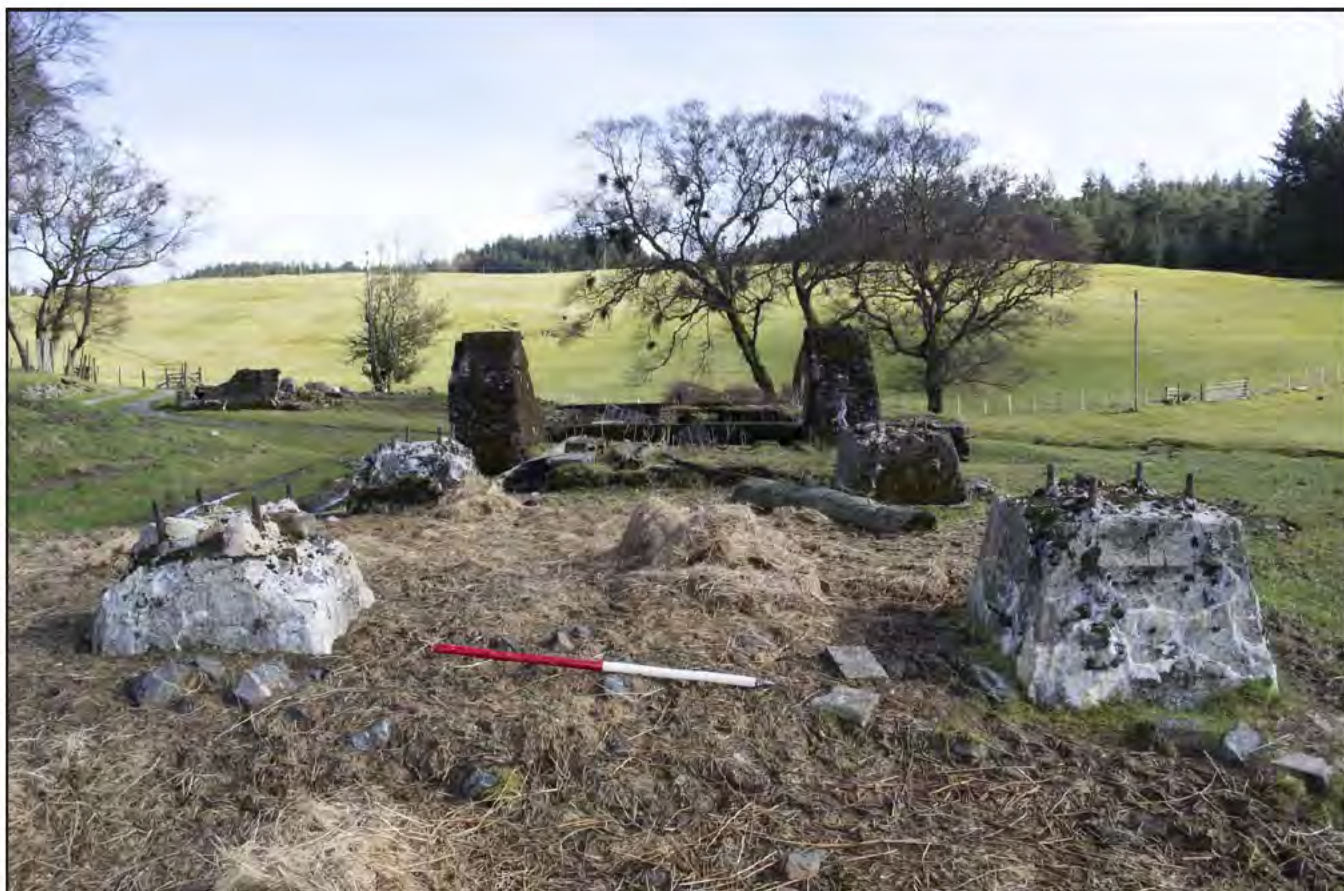
Feature Number	16
Site name	Pynes Shaft Winding house and headframe supports
PRN number	91914
Grid reference	SH7675060263
Period	Post Medieval
Site type	Winder House
Assessment category	C
Description	<p>Winder house near Pynes shaft. First winding wheel was erected in 1871 by the Willoughby Mining Company and was then replaced by Alfred Endean around 1884 (Dutton, Roberts & Vernon, 1995; See Figure 03).</p> <p>The remains of the winder building were noted during the field survey and look to be in a similar condition to that observed and recorded during the 1995 survey (Plate 10).</p>
Impact	None
Recommendation for further assessment/evaluation	None
Recommendation for mitigatory measures	Avoidance

Plate 10: Remains of Winding house; scale 1x1m; view from W (archive reference: G2682_025).
